MISSOURI DEPARTMENT OF NATURAL RESOURCES
STATE HISTORIC PRESERVATION OFFICE, P.O. Box 176, Jefferson City, MO 65102
ARCHITECTURAL/HISTORIC INVENTORY FORM

1. Survey No. JP-AS-007-001		2. Survey name: East Town (Original Joplin) Historic Survey Phase 2	
3. County: JASPER		4. Address (Street No.) 618	Street (name) E. 2 nd Street
5. City: Joplin	Vicinity: <input type="checkbox"/>	6. Geographical Reference:	7. Township/Range/Section: T: R: S:
8. Historic name (if known):		9. Present/other name (if known):	
10. Ownership: <input checked="" type="checkbox"/> Private <input type="checkbox"/> Public		11a. Historic use (if known): Domestic: Single Dwelling	11b. Current use: Domestic: Single Dwelling

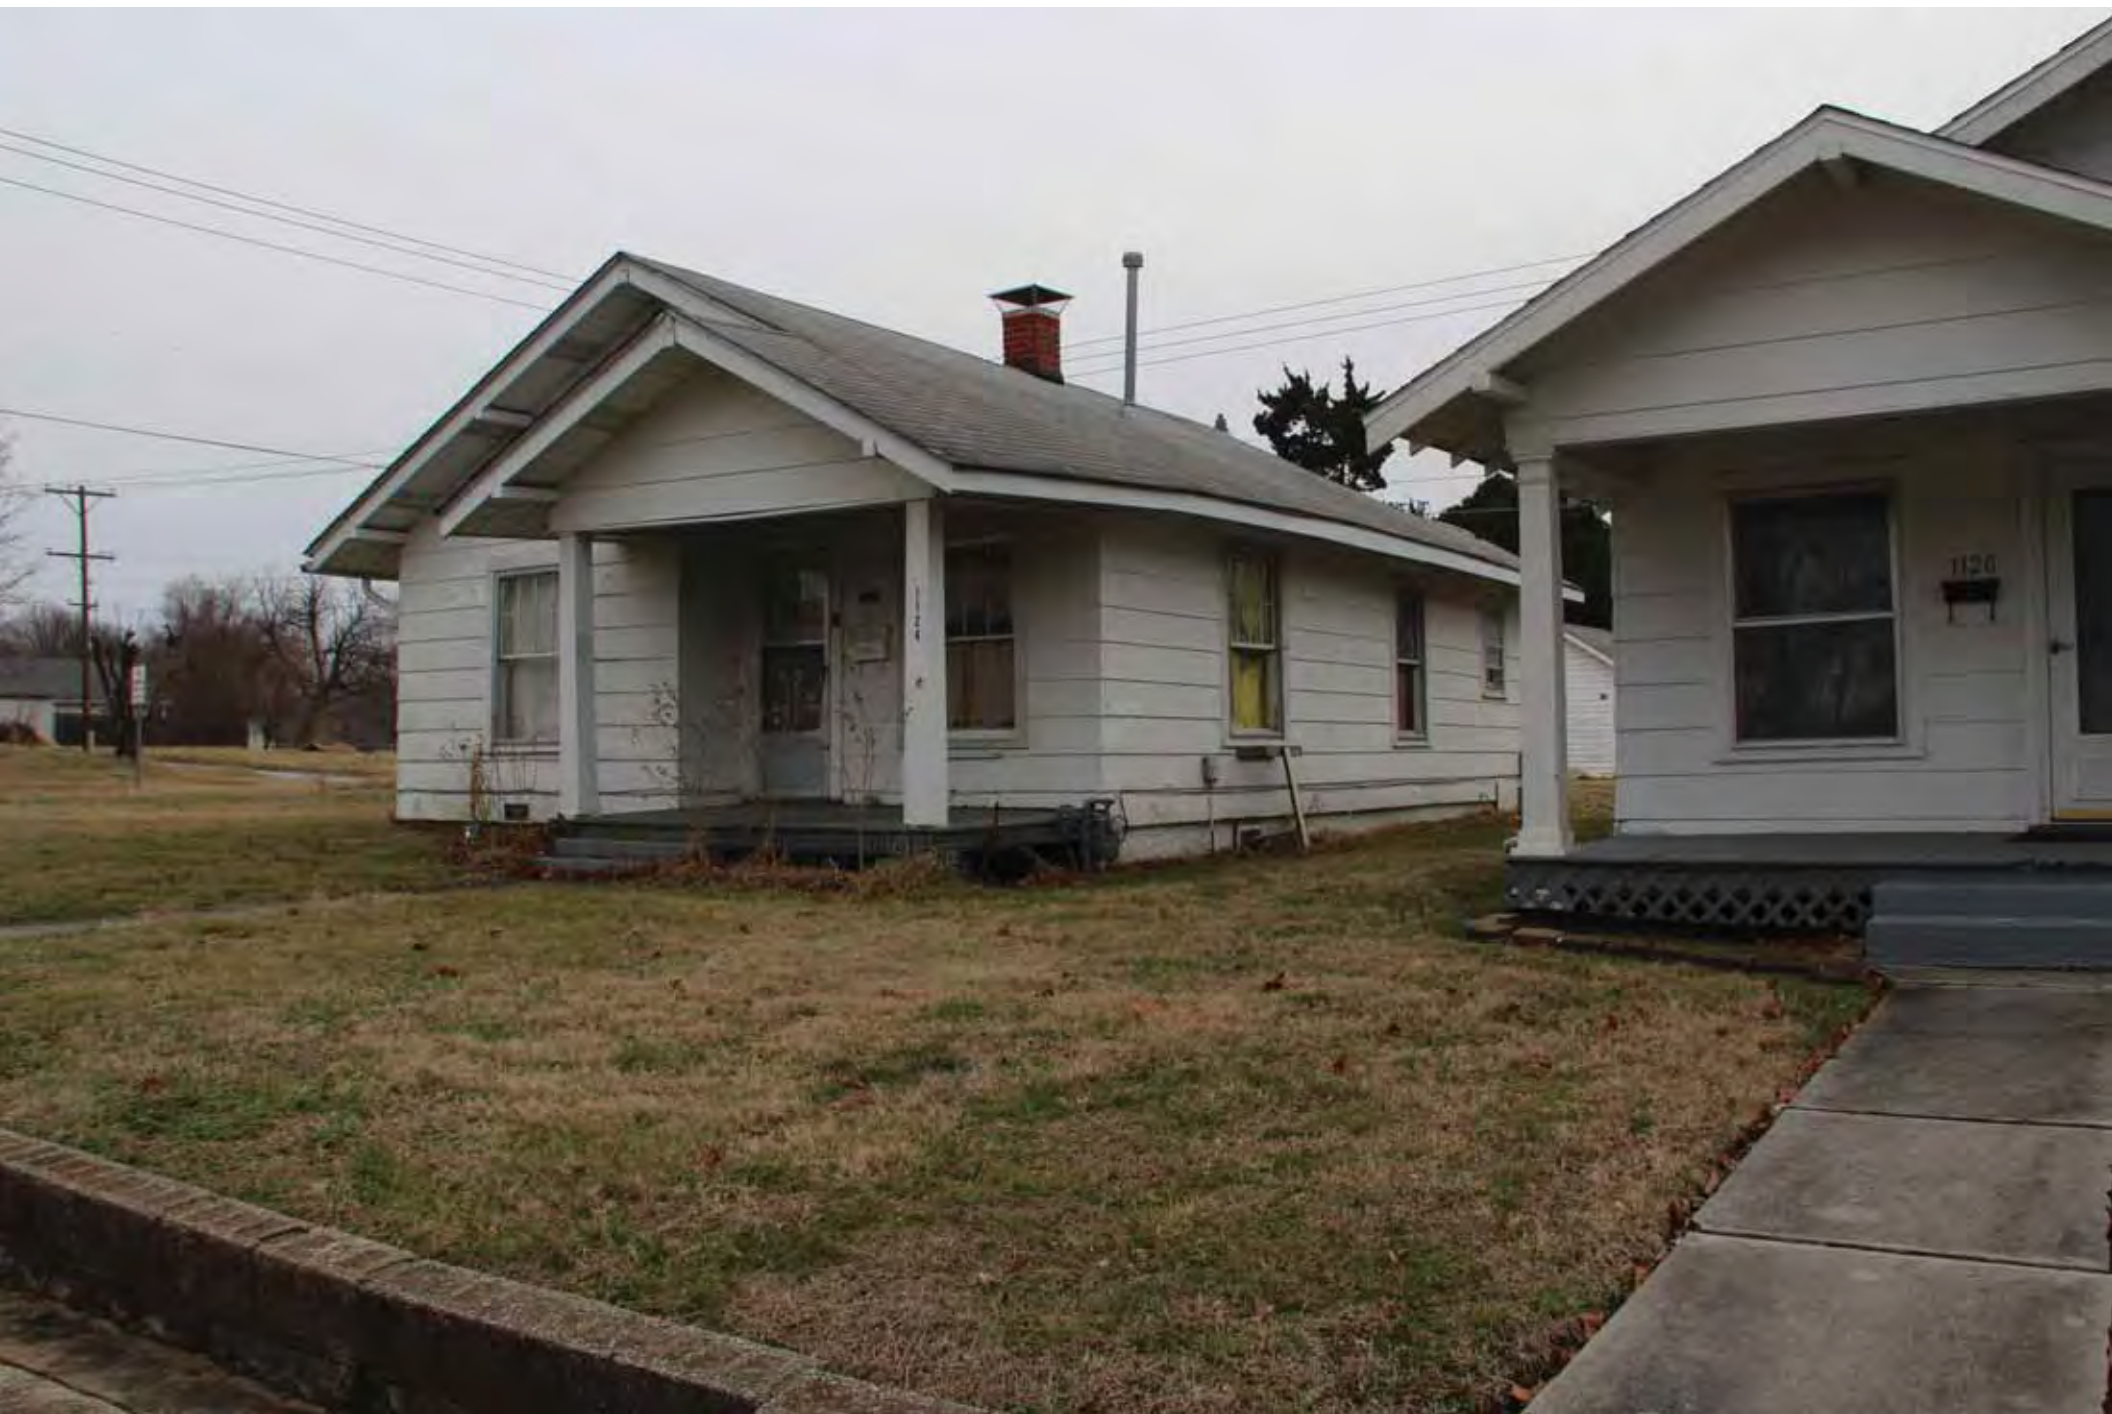
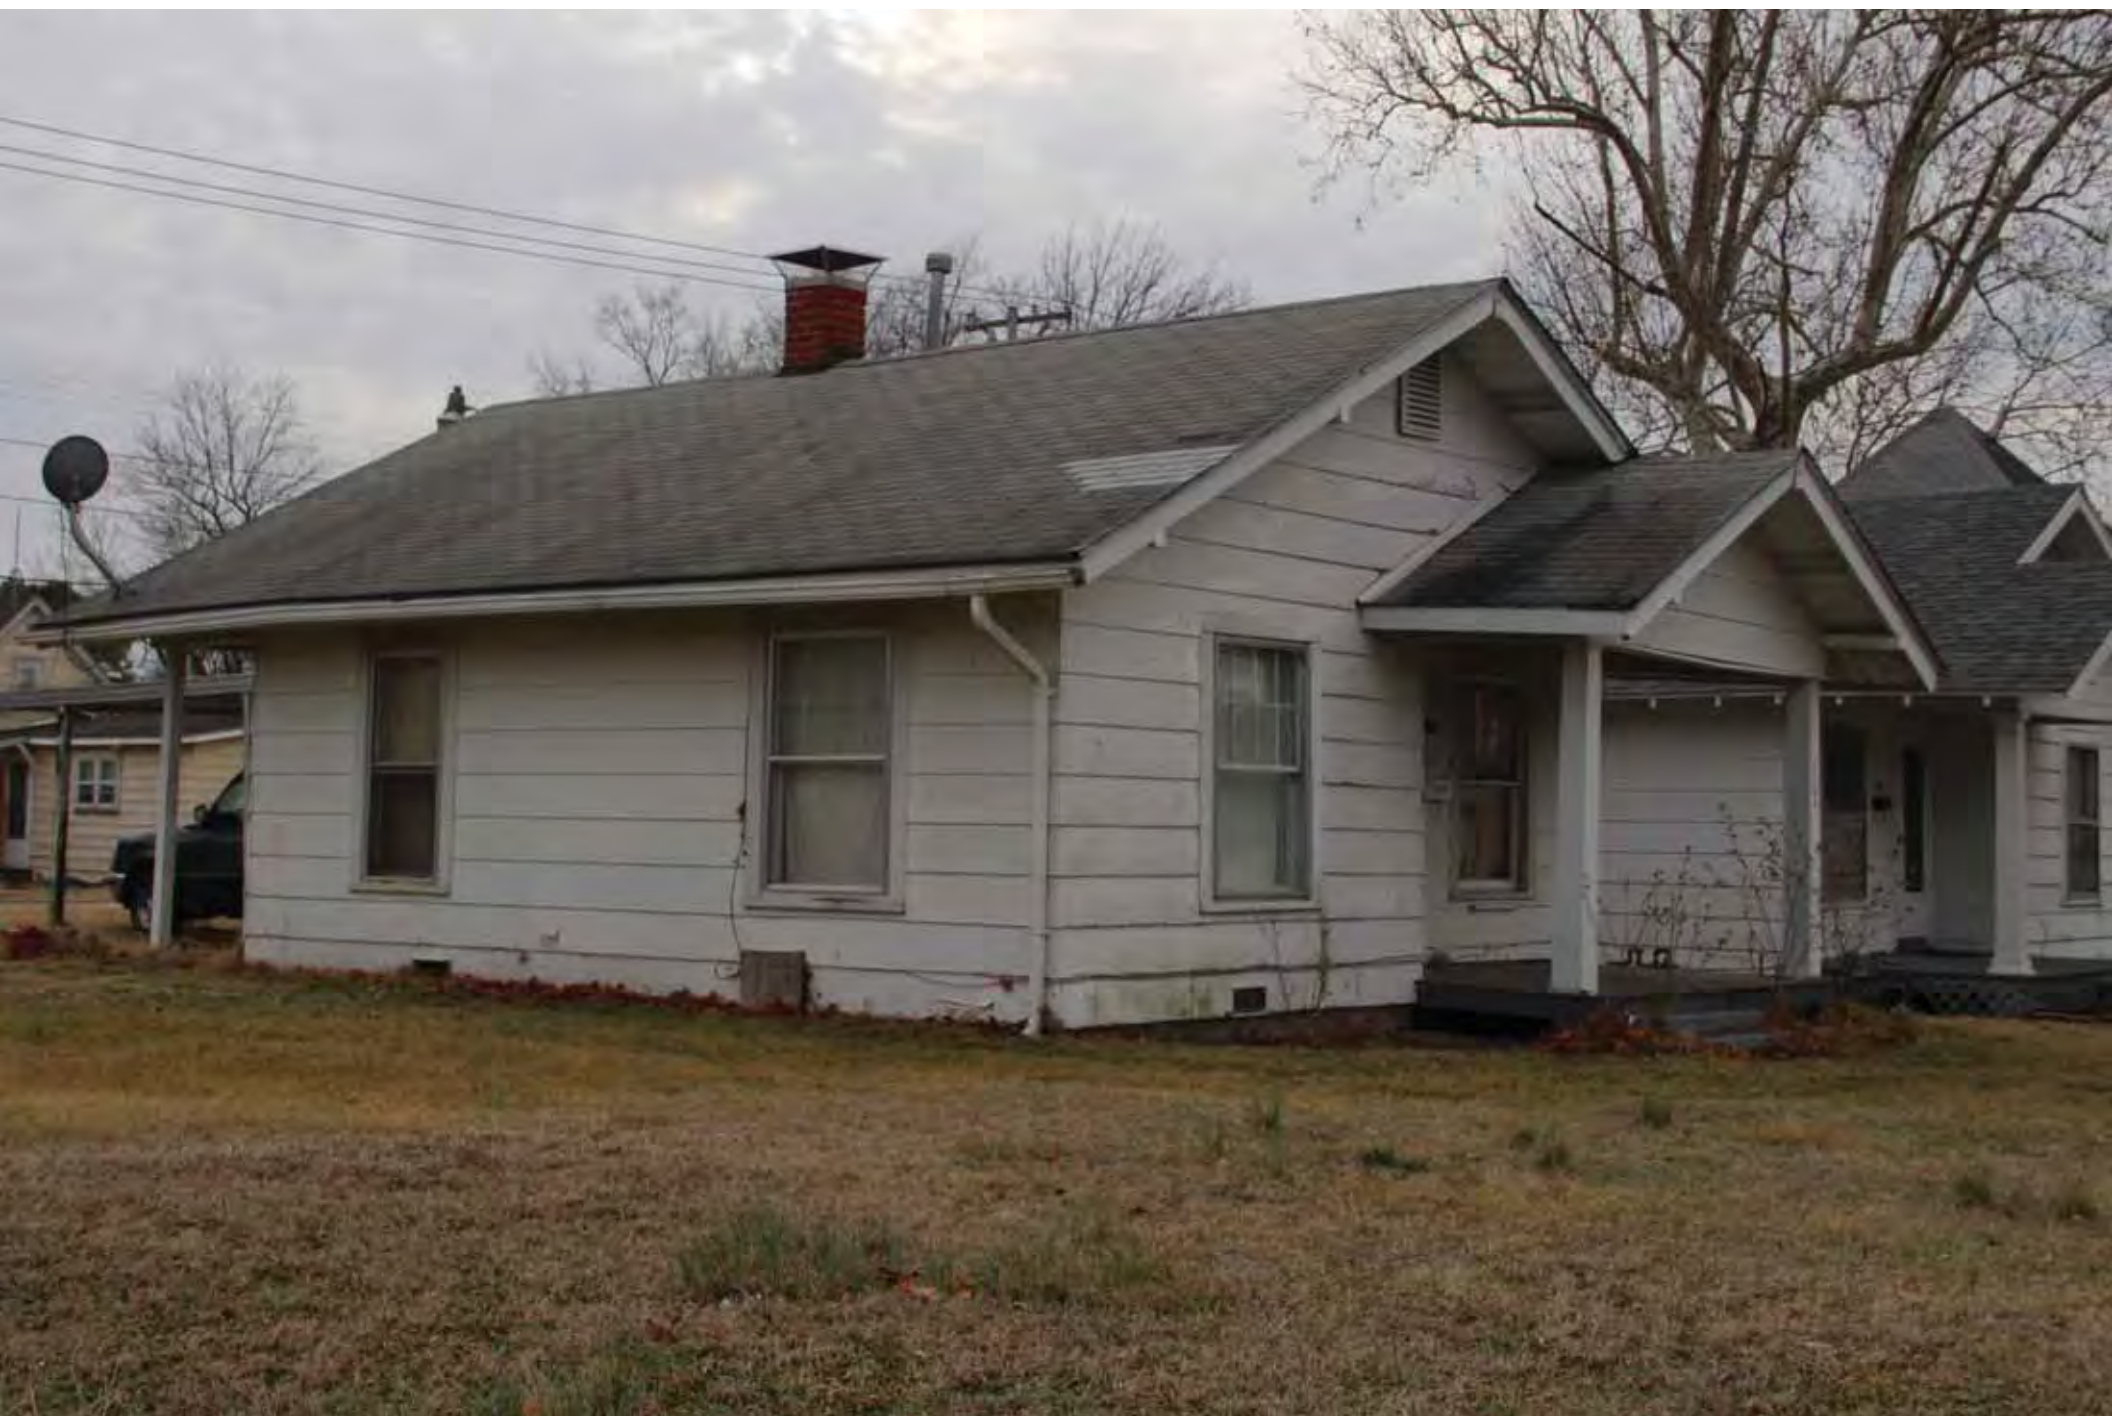
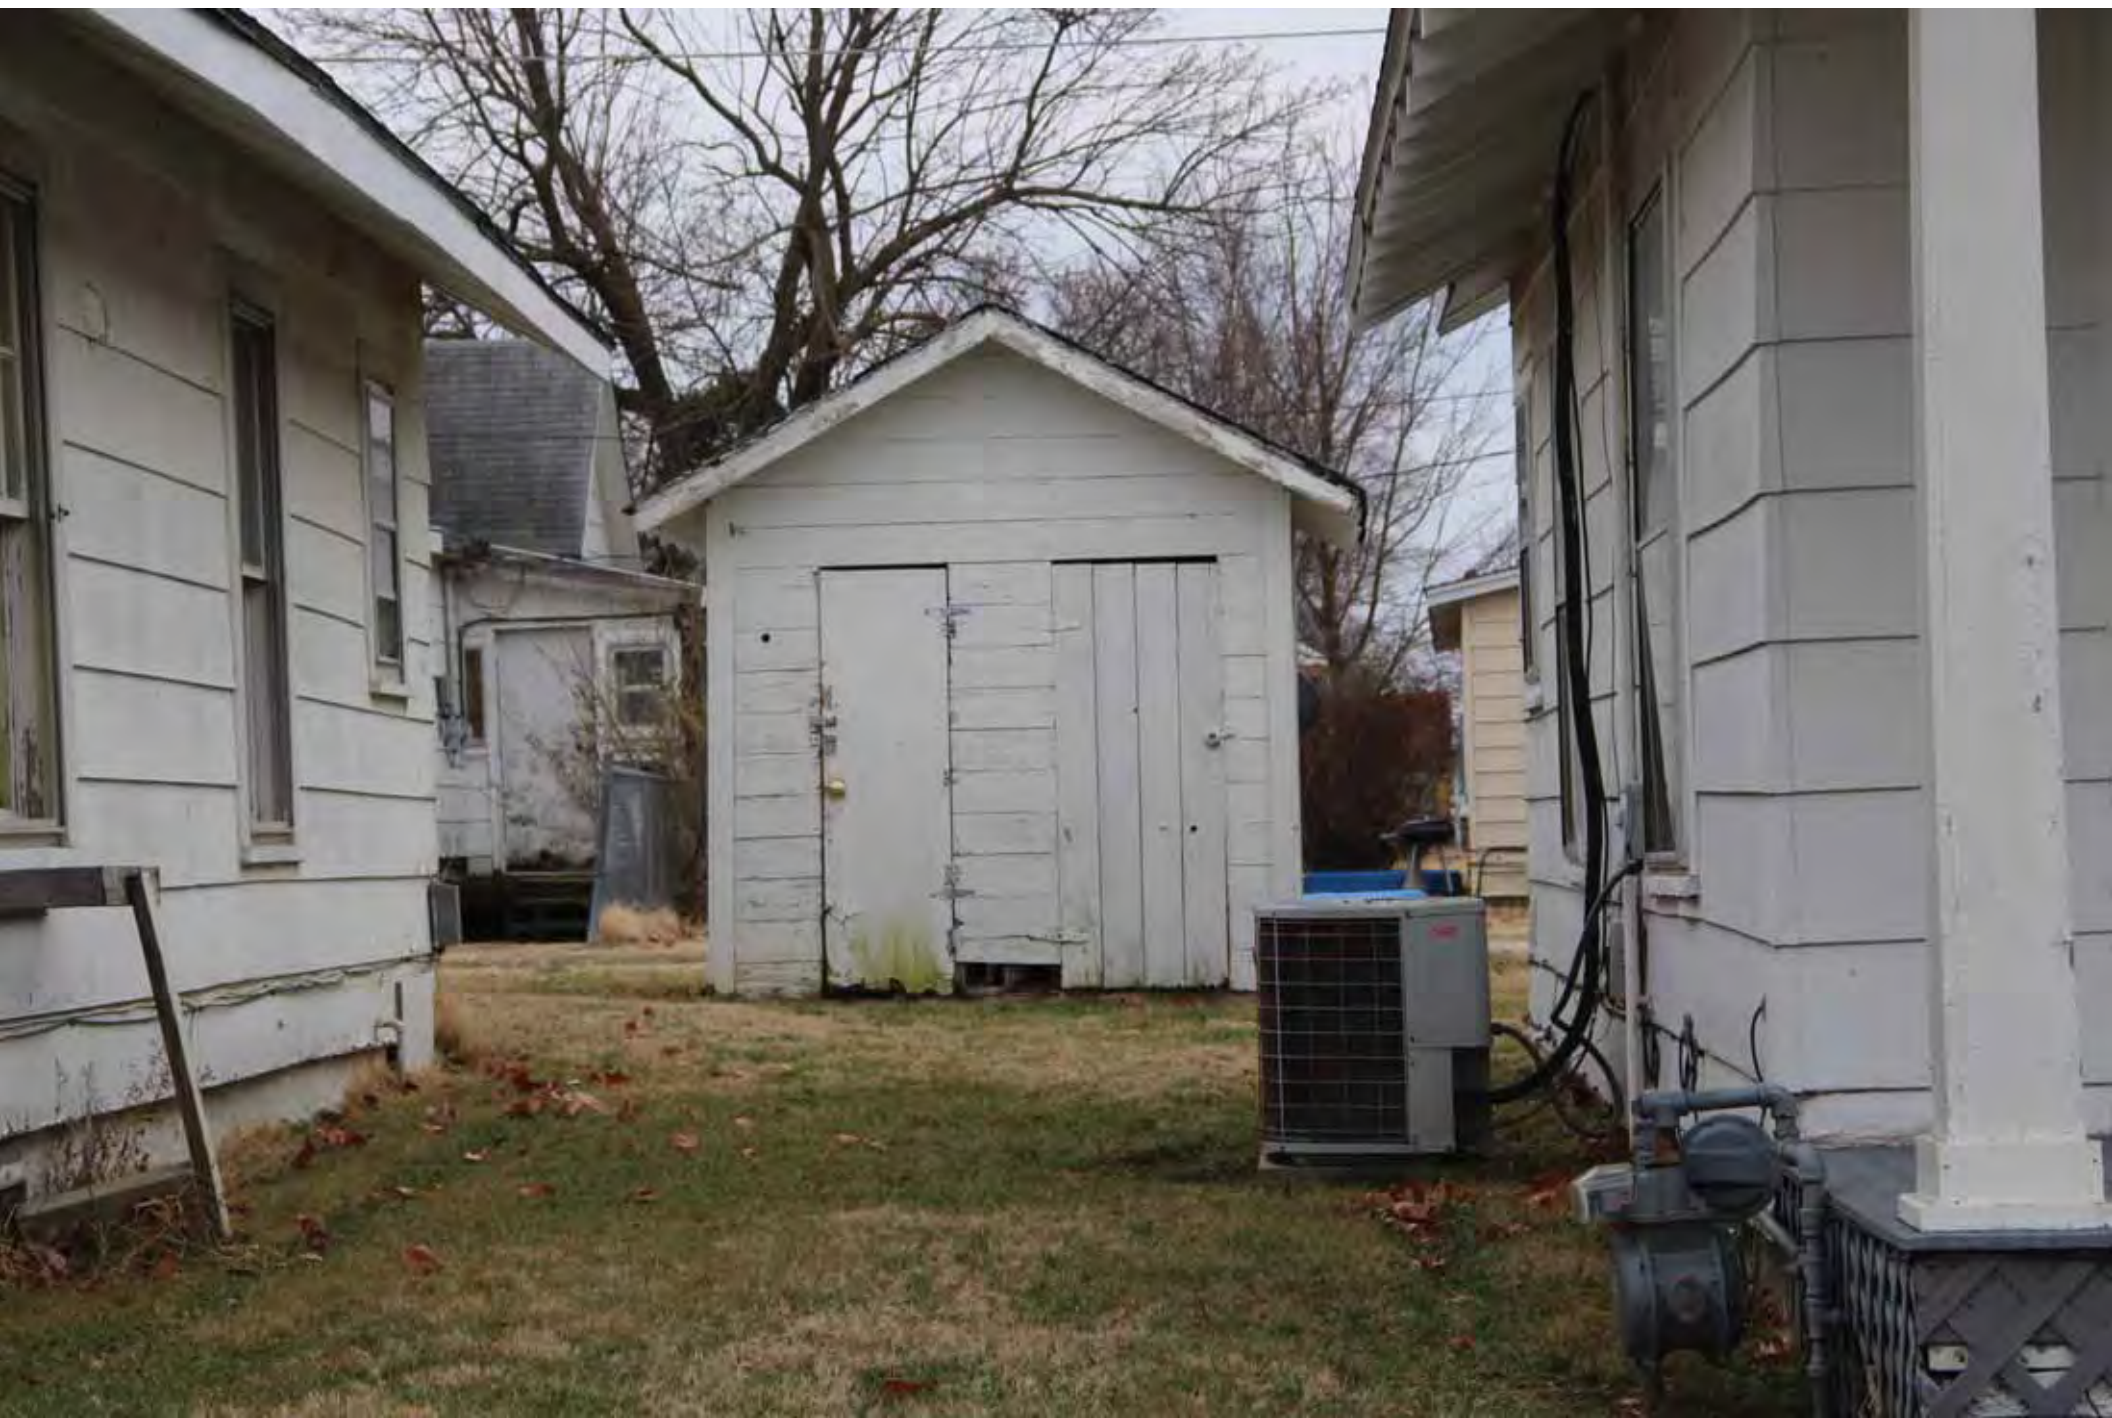
The property at 1124 E. Broadway is a single-story gable-front plan Bungalow with an asphalt shingled roof, exterior wide board siding and a concrete foundation. The primary (north) elevation supports an off-center gabled porch supported by two flared wood columns. The porch has a wood pier foundation. The remaining foundation is concrete rubble. Within the porch bay is a replacement (c. 1960) door with an upper single light. Flanking the door are single six-over-one windows. Some windows on side elevations have missing lights. The front façade wall extends slightly north at the east end of the porch. The porch roof and open eaves feature exposed rafter beams. In the front gable is a louvered vent.

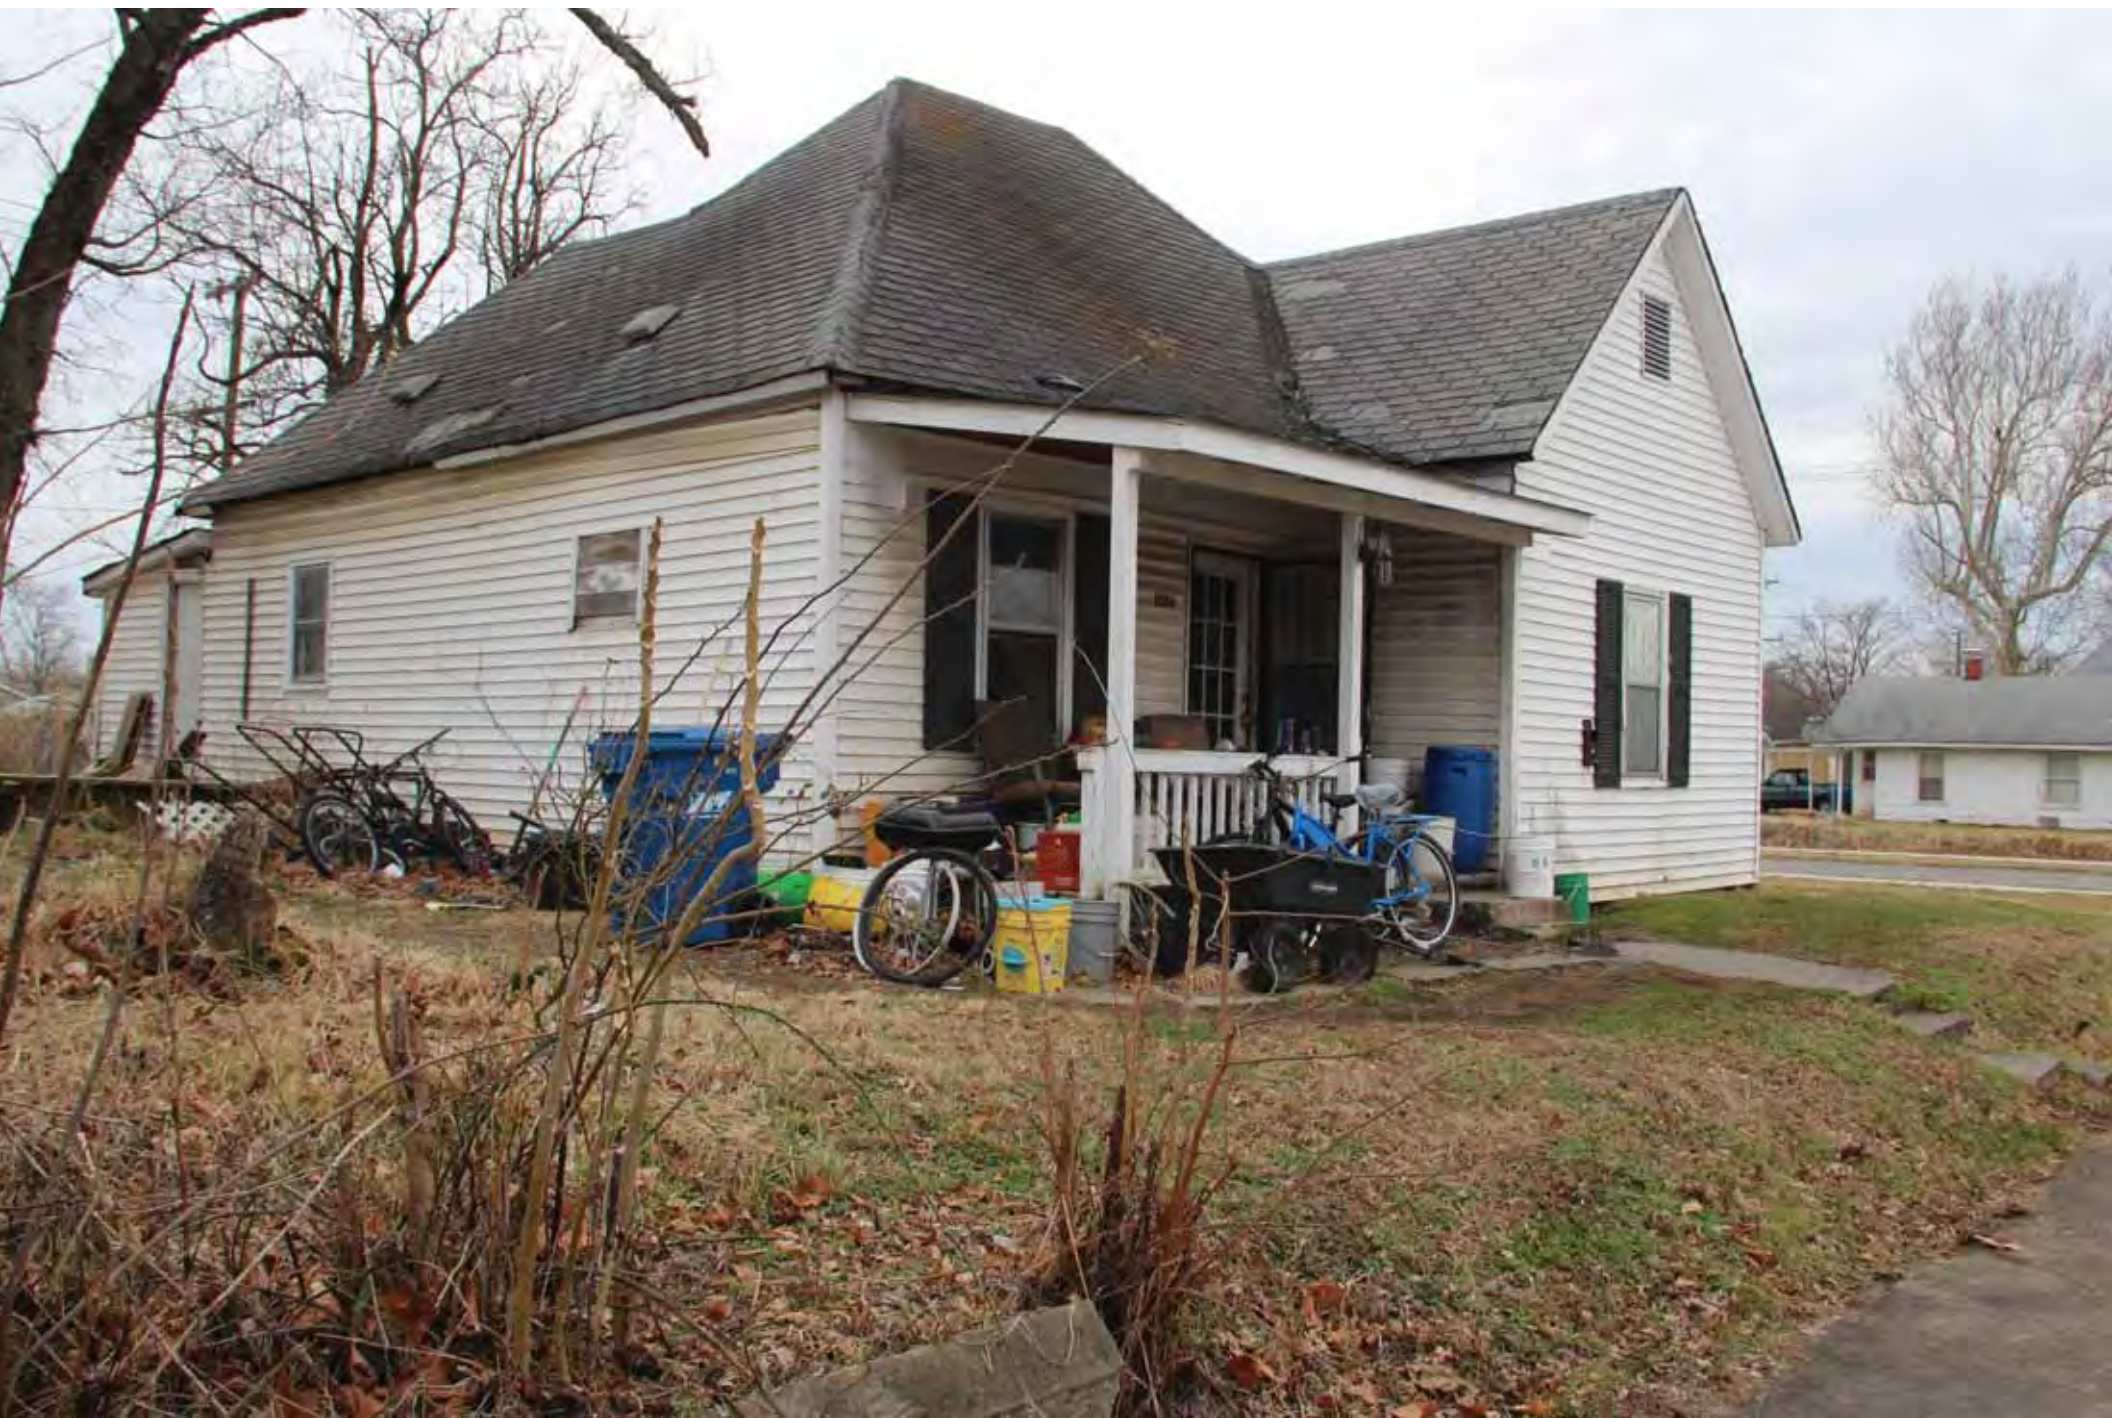
The property at 1206 E. Broadway Street features a 1.5-story National style dwelling with exterior vinyl siding and an asphalt shingled roof consisting of a central high hip and front facing cross gable. The dwelling has a covered limestone foundation. The front facing gable creates the west wall of a shed porch supported by two square wood columns. The porch has a contemporary balustrade. Within the porch by is a multi-light replacement door (c. 2010) offset by a one-over-one window. Most windows have faux shutters. The front facing gabled wing's north wall holds a similar one-over-one window. The dwelling has a rear one-story shed wing. Side elevations hold one-over-one windows. The east elevation of the rear shed wing has a solid wood door.

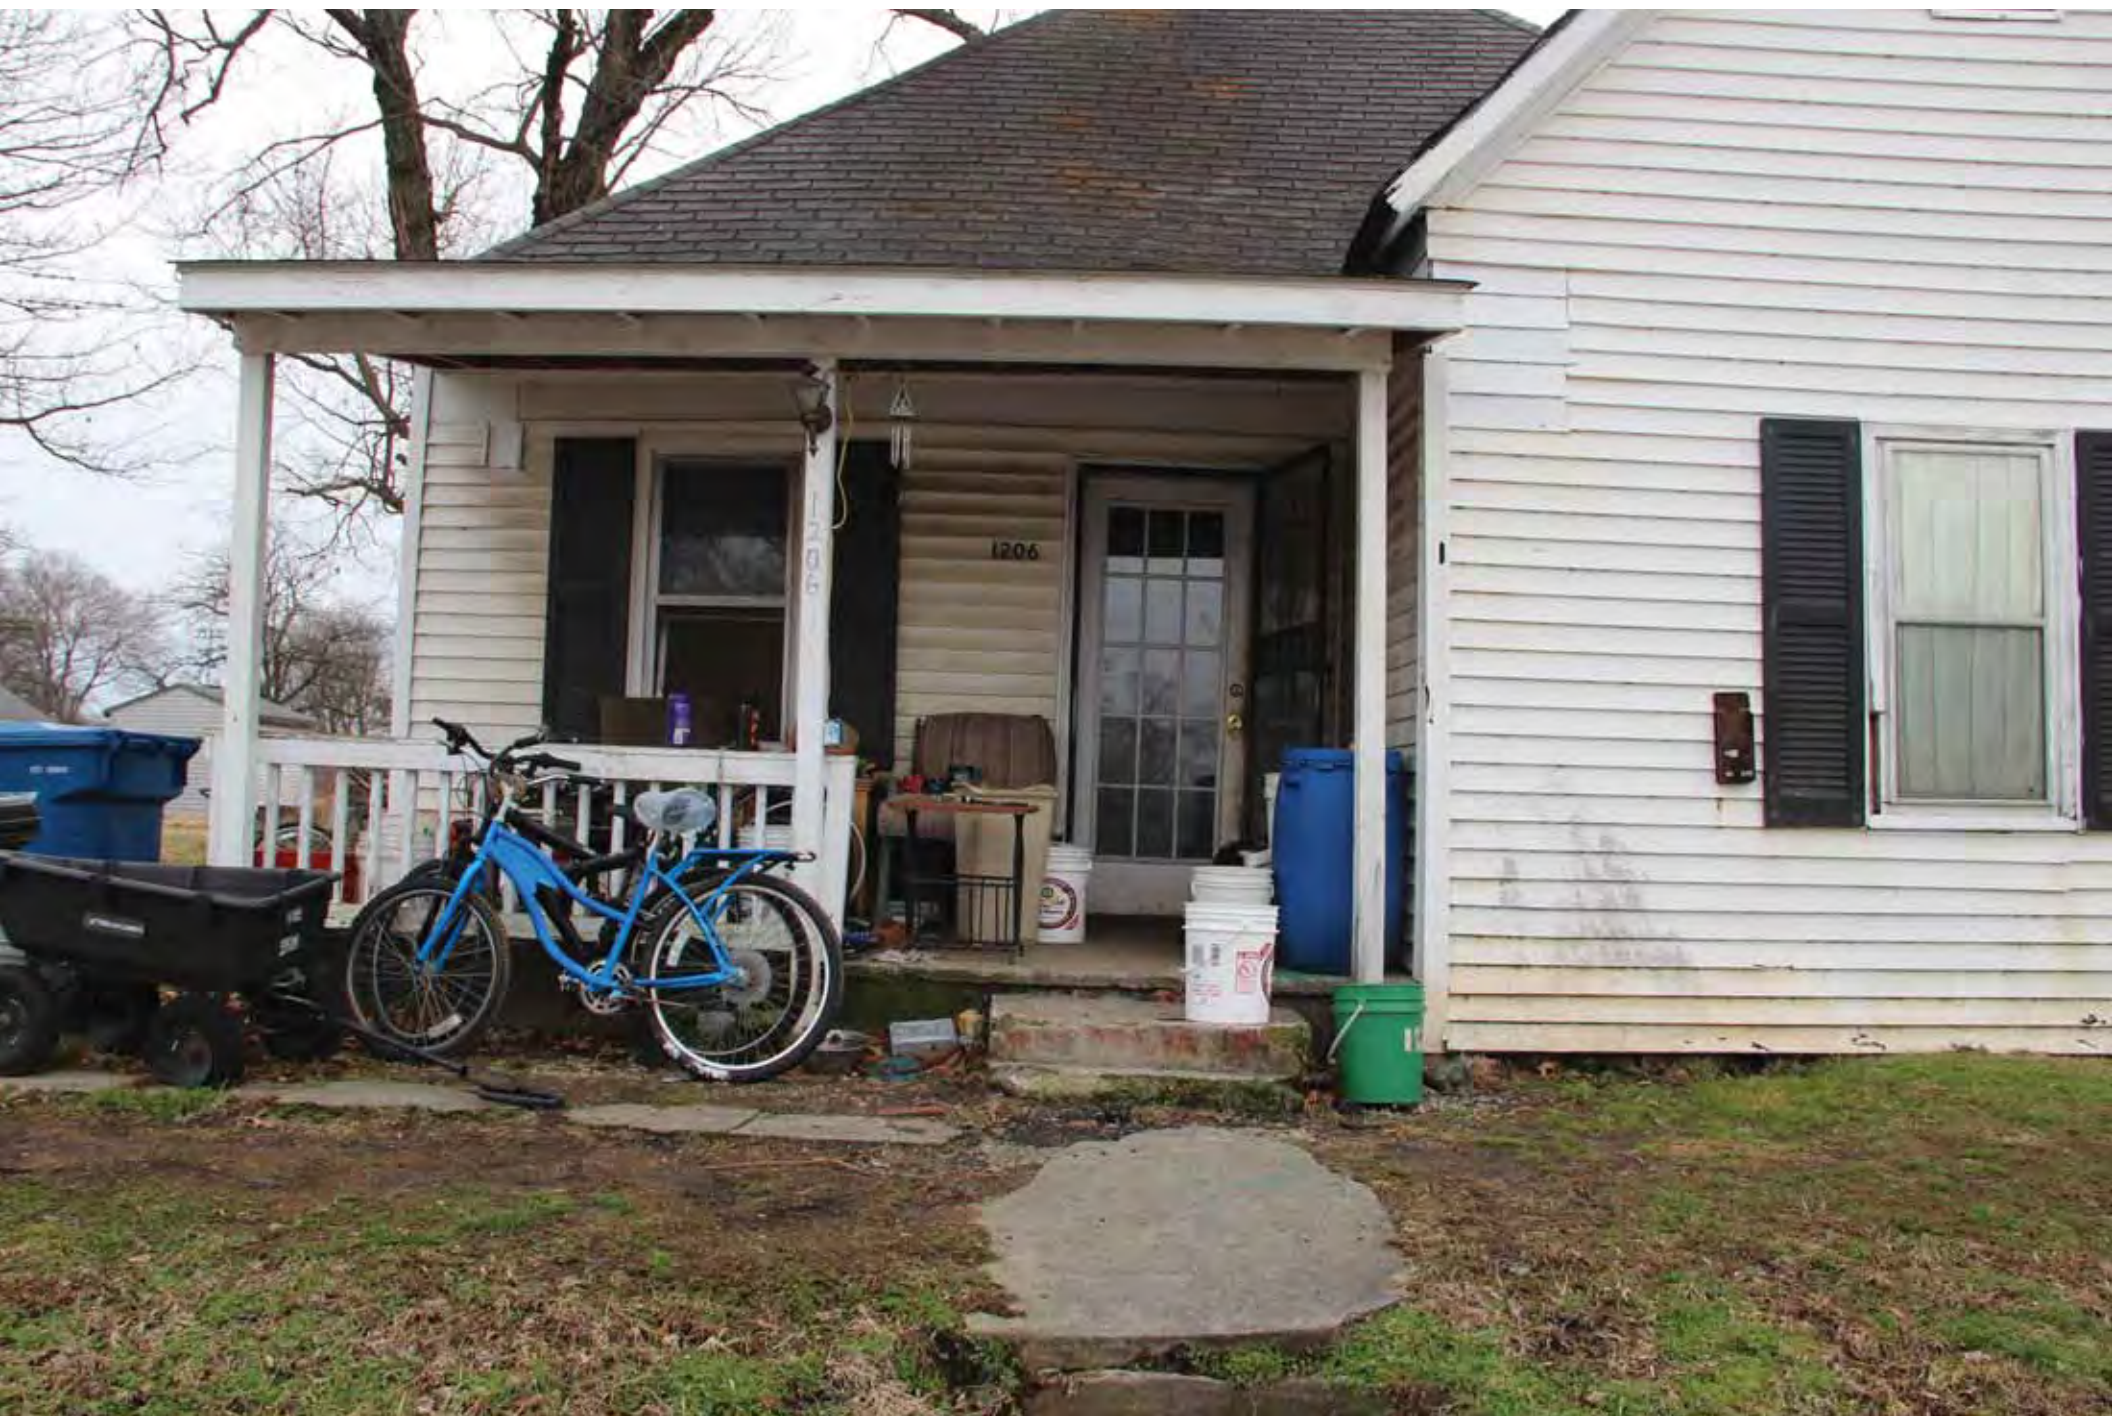
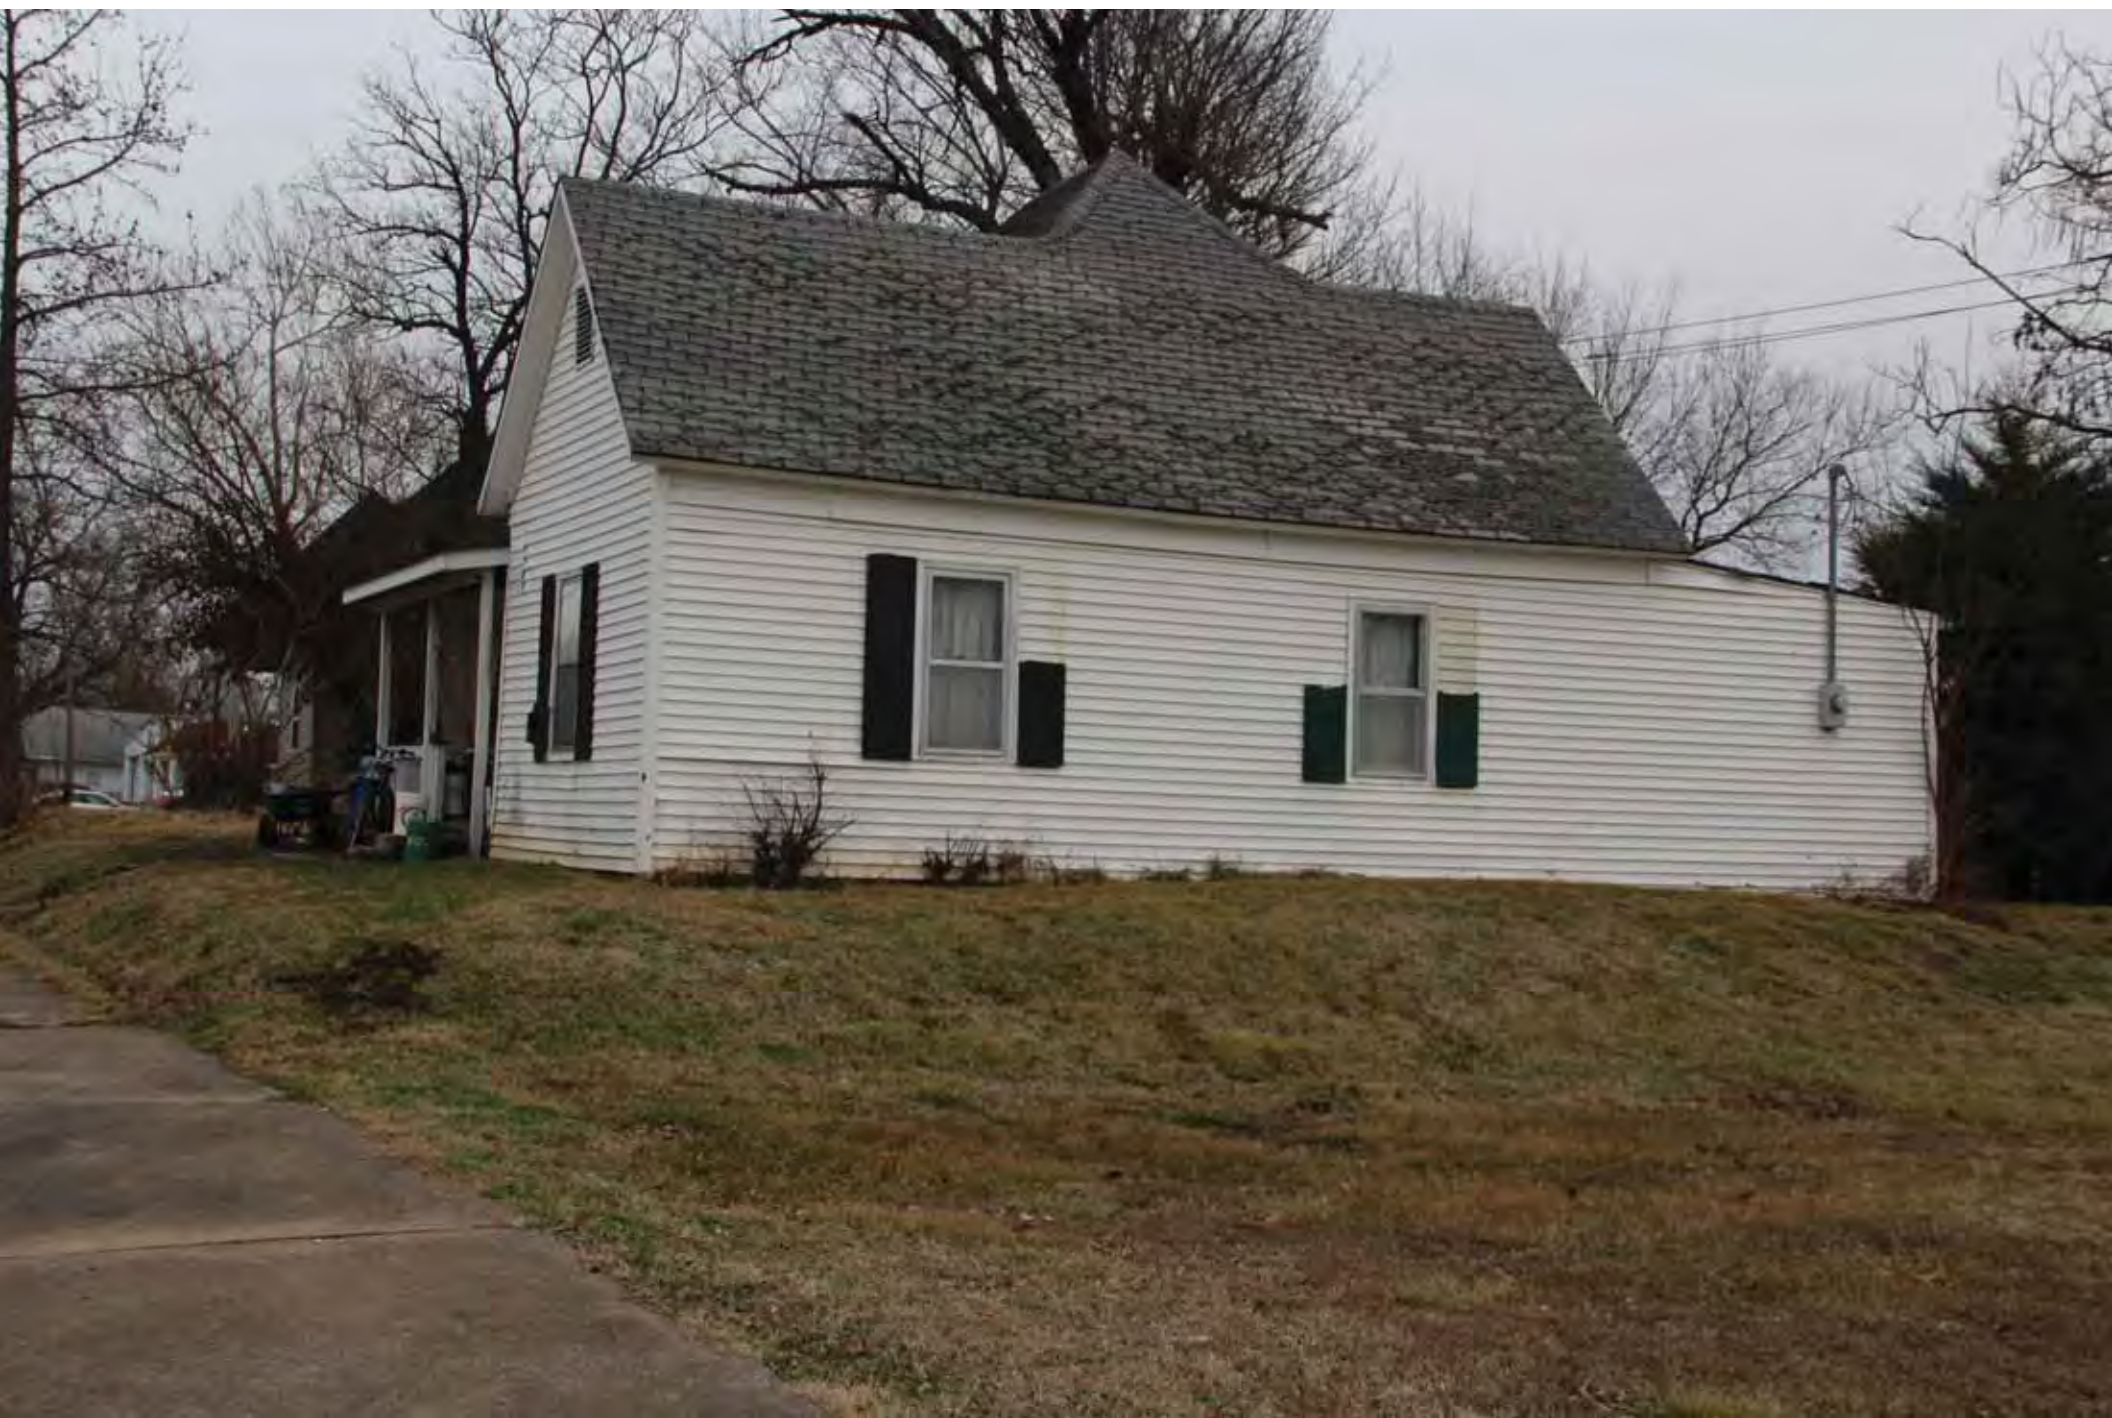
This dwelling has been altered through the addition of c. 1990 exterior siding (vinyl). Due to the lack of exterior original siding, the dwelling does not retain integrity that would render it individually eligible for the National Register of Historic Places. The dwelling is not situated in an area recommended as a historic district.
