MISSOURI DEPARTMENT OF NATURAL RESOURCES
STATE HISTORIC PRESERVATION OFFICE, P.O. Box 176, Jefferson City, MO 65102
ARCHITECTURAL/HISTORIC INVENTORY FORM

1. Survey No. JP-AS-007-001		2. Survey name: East Town (Original Joplin) Historic Survey Phase 2	
3. County: JASPER		4. Address (Street No.) 618	Street (name) E. 2 nd Street
5. City: Joplin	Vicinity: <input type="checkbox"/>	6. Geographical Reference:	7. Township/Range/Section: T: R: S:
8. Historic name (if known):		9. Present/other name (if known):	
10. Ownership: <input checked="" type="checkbox"/> Private <input type="checkbox"/> Public		11a. Historic use (if known): Domestic: Single Dwelling	11b. Current use: Domestic: Single Dwelling

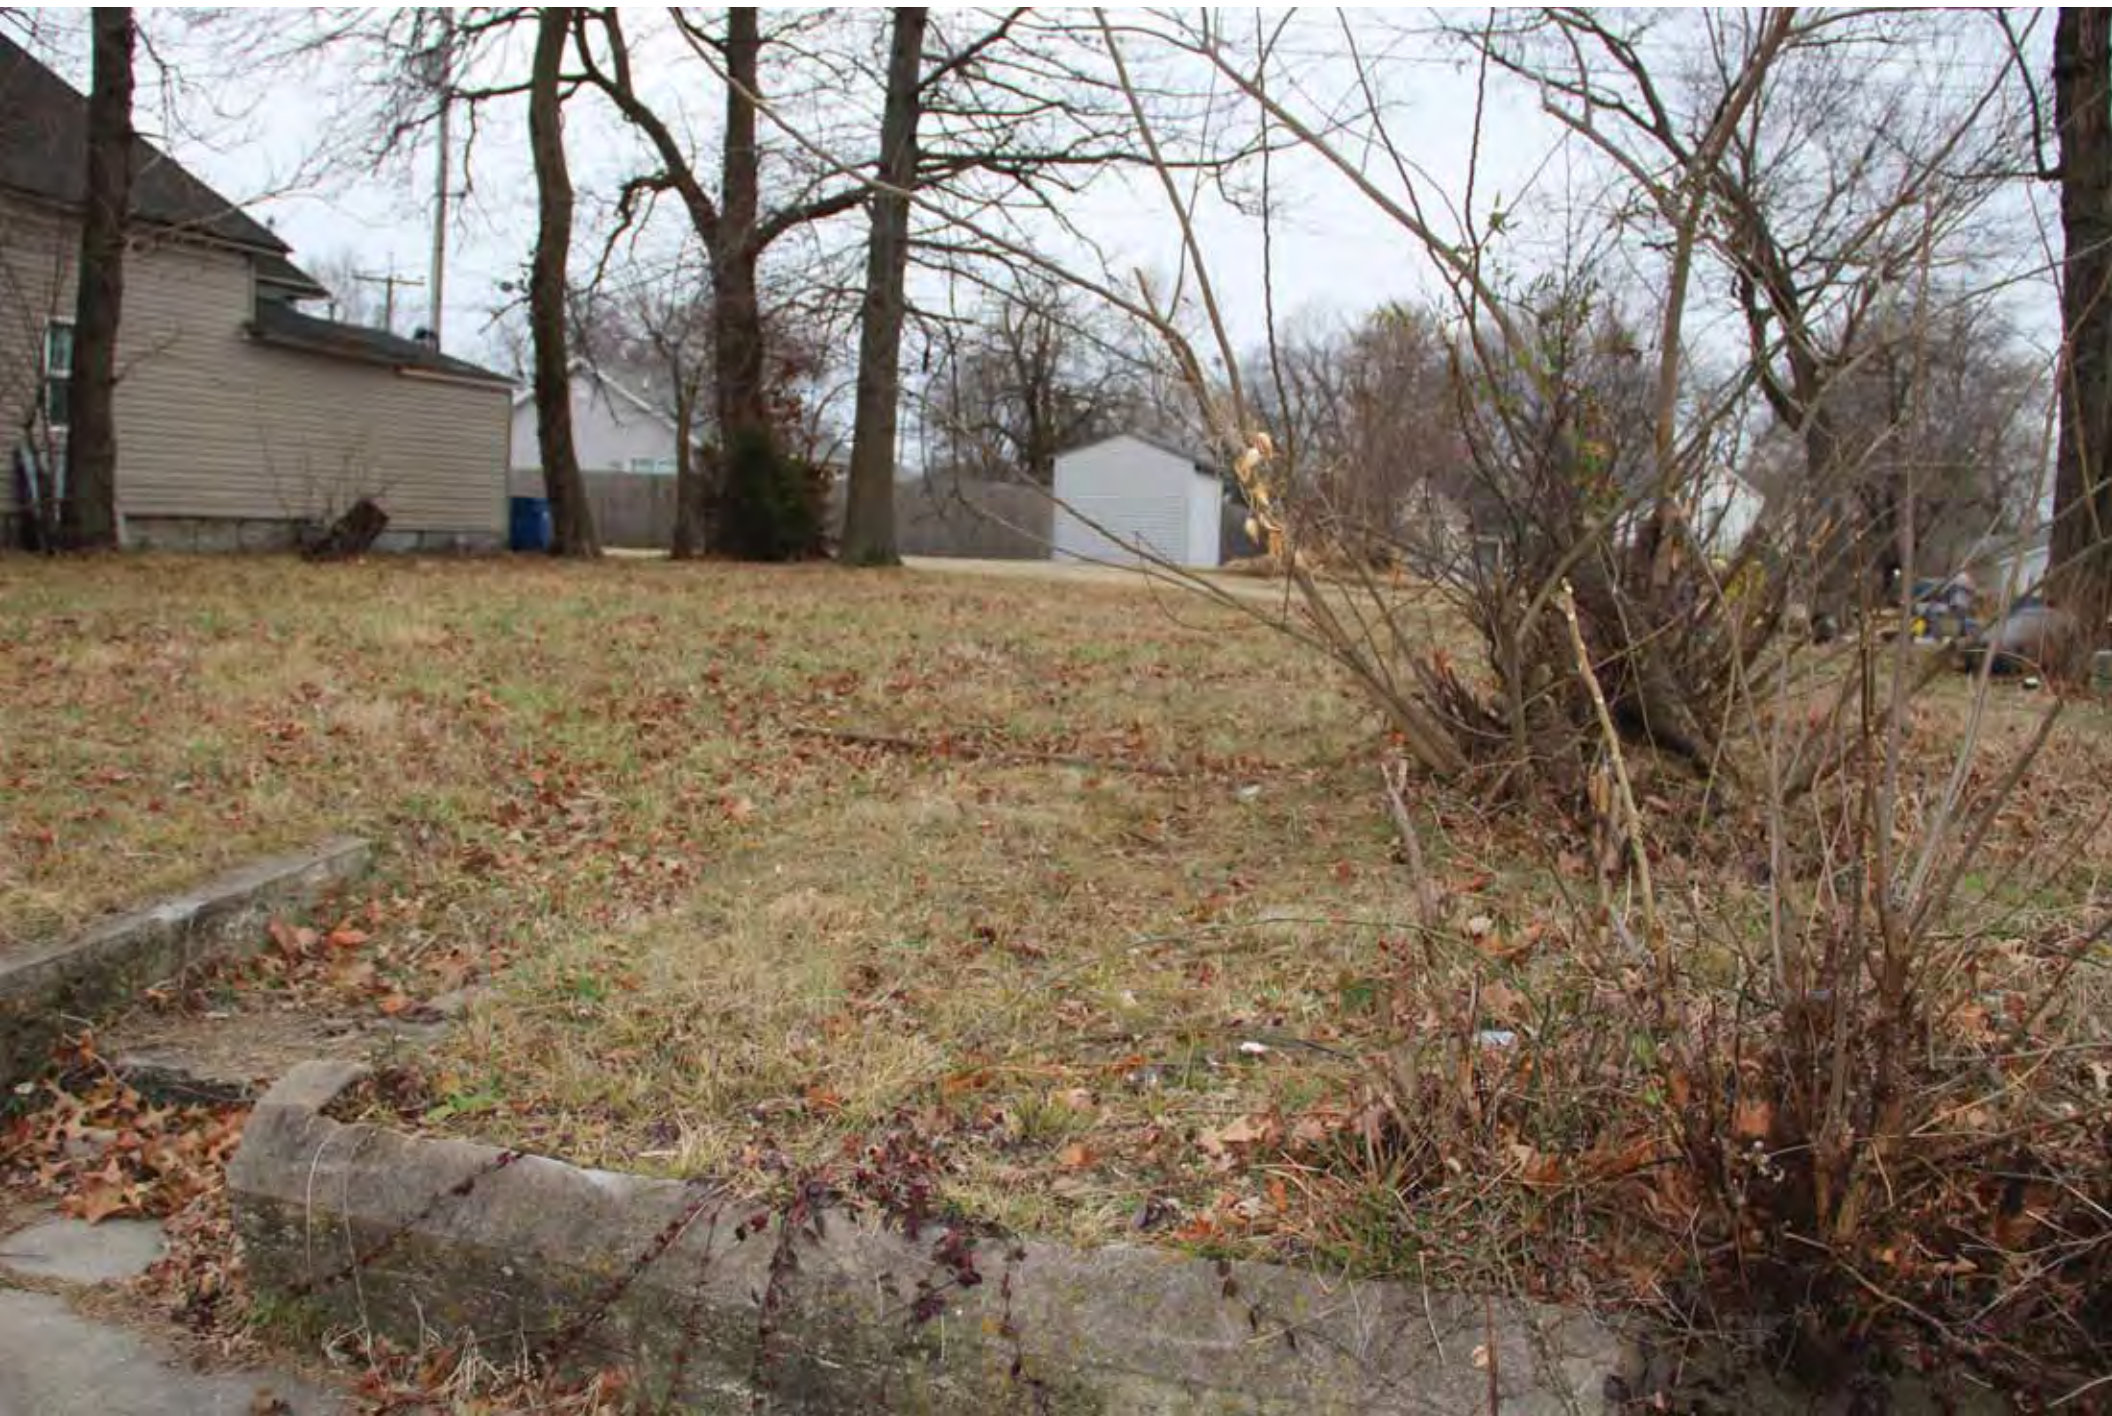
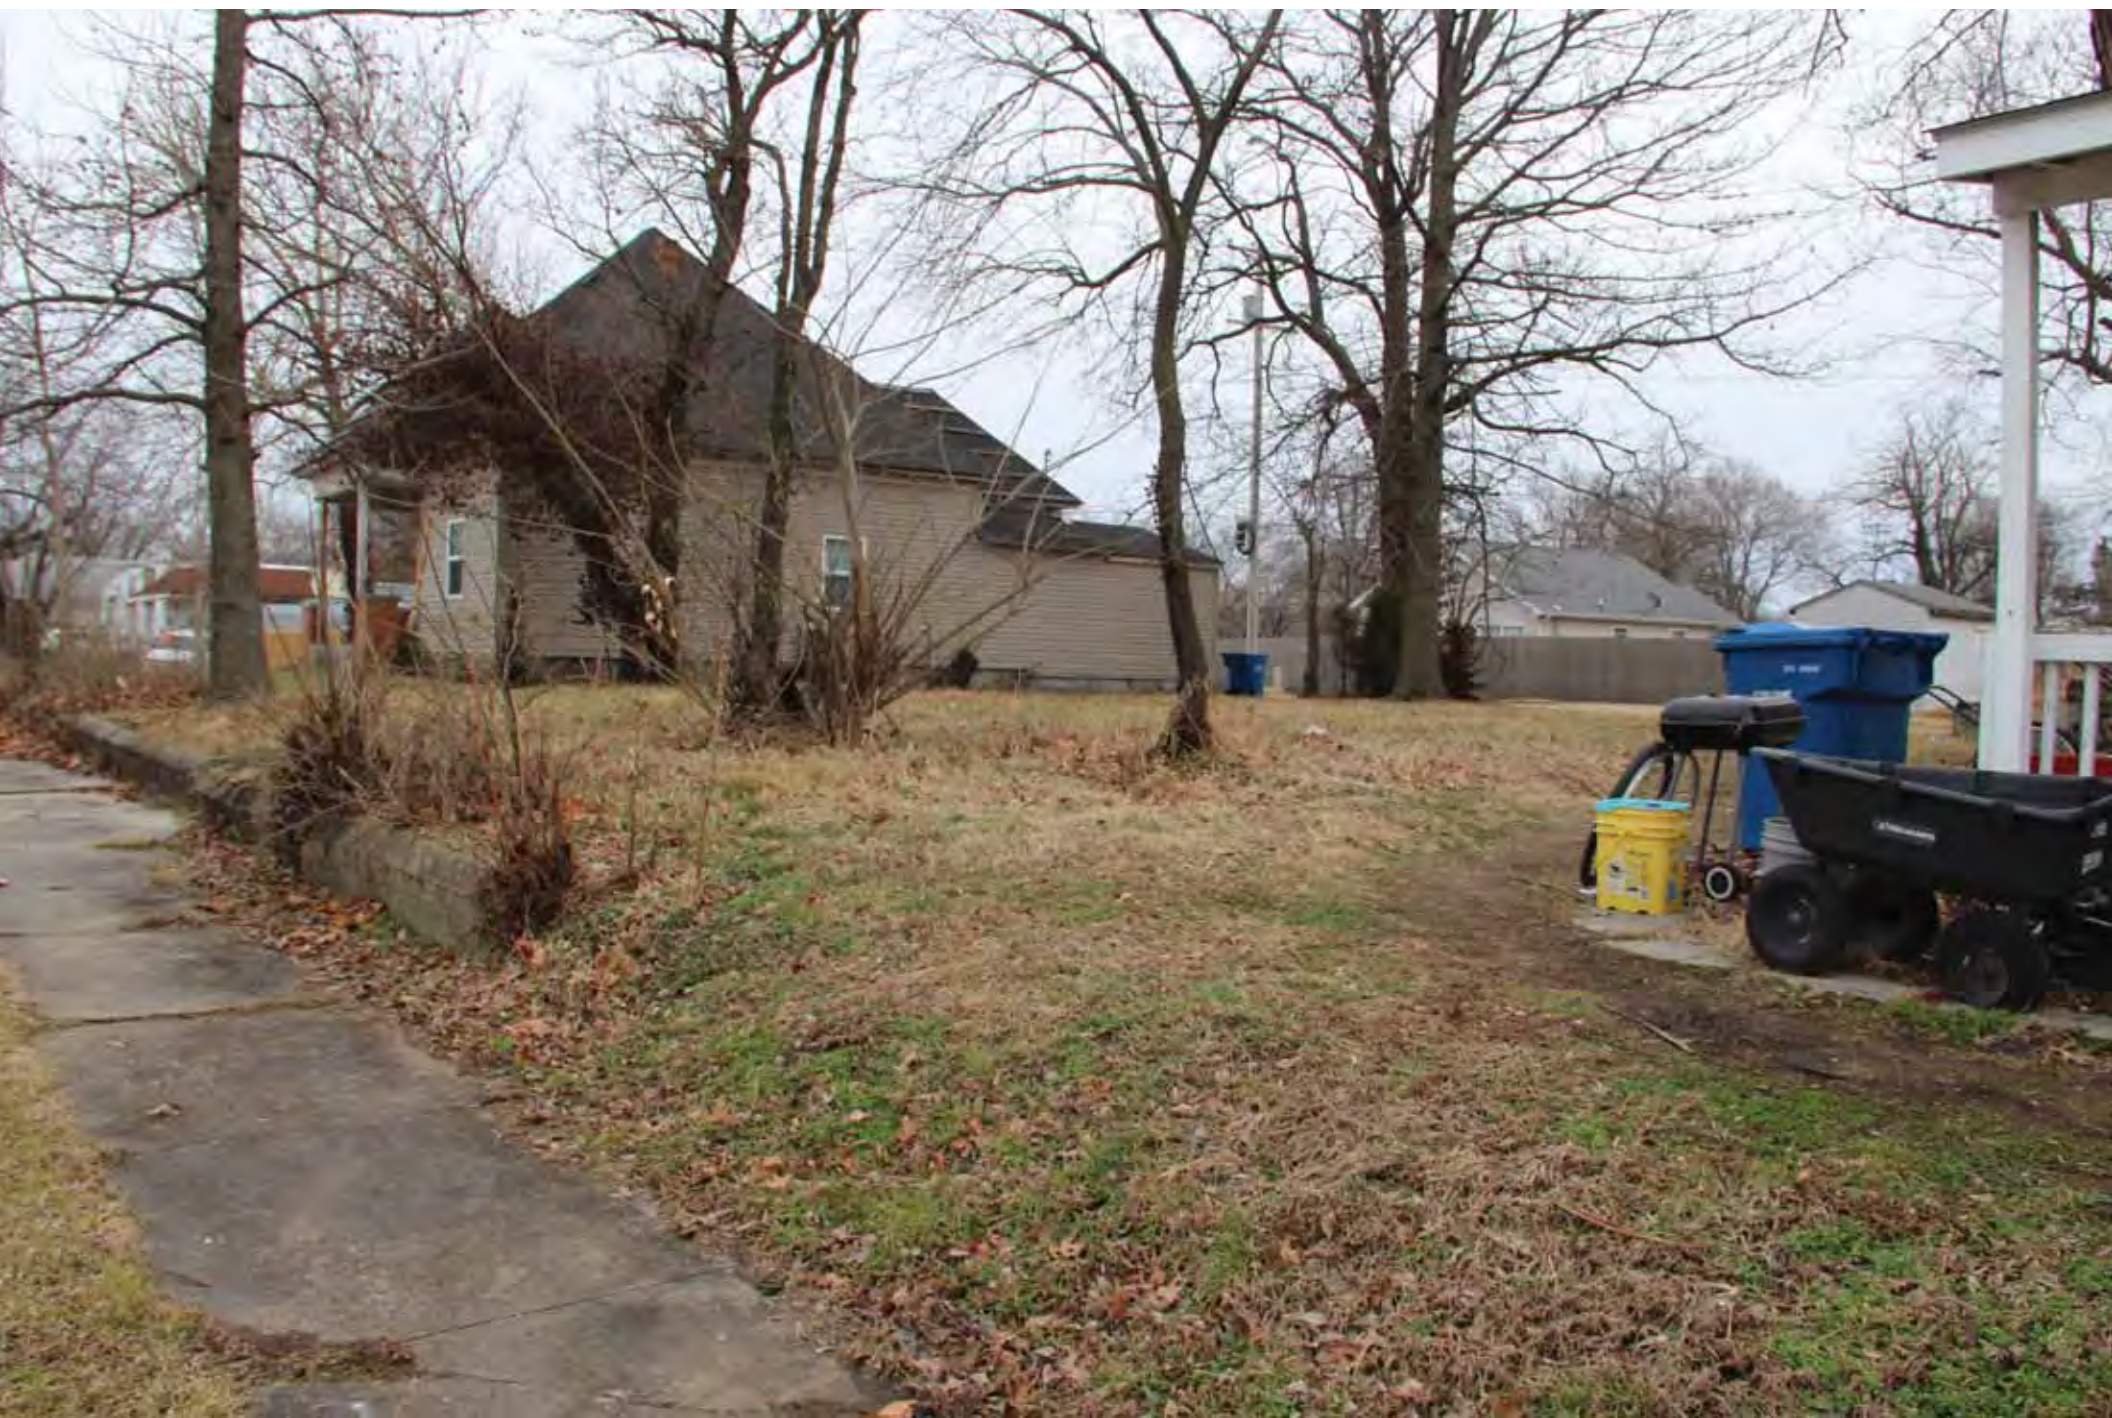
The property is a vacant lot that holds no outbuildings. The parcel is in a mixed-use neighborhood. The lot is flanked by a public concrete walk on the north (E. Broadway). A low concrete wall separates the yard from the sidewalk along E. Broadway. The remains of the property's private walk to the house and part of the foundation are extant. A paved gravel alley bounds the south end of the lot.

The property at 1212 E. Broadway is a vacant grassy lot that formerly held a single family dwelling. The lot is as described above. The lot features mature foliage.

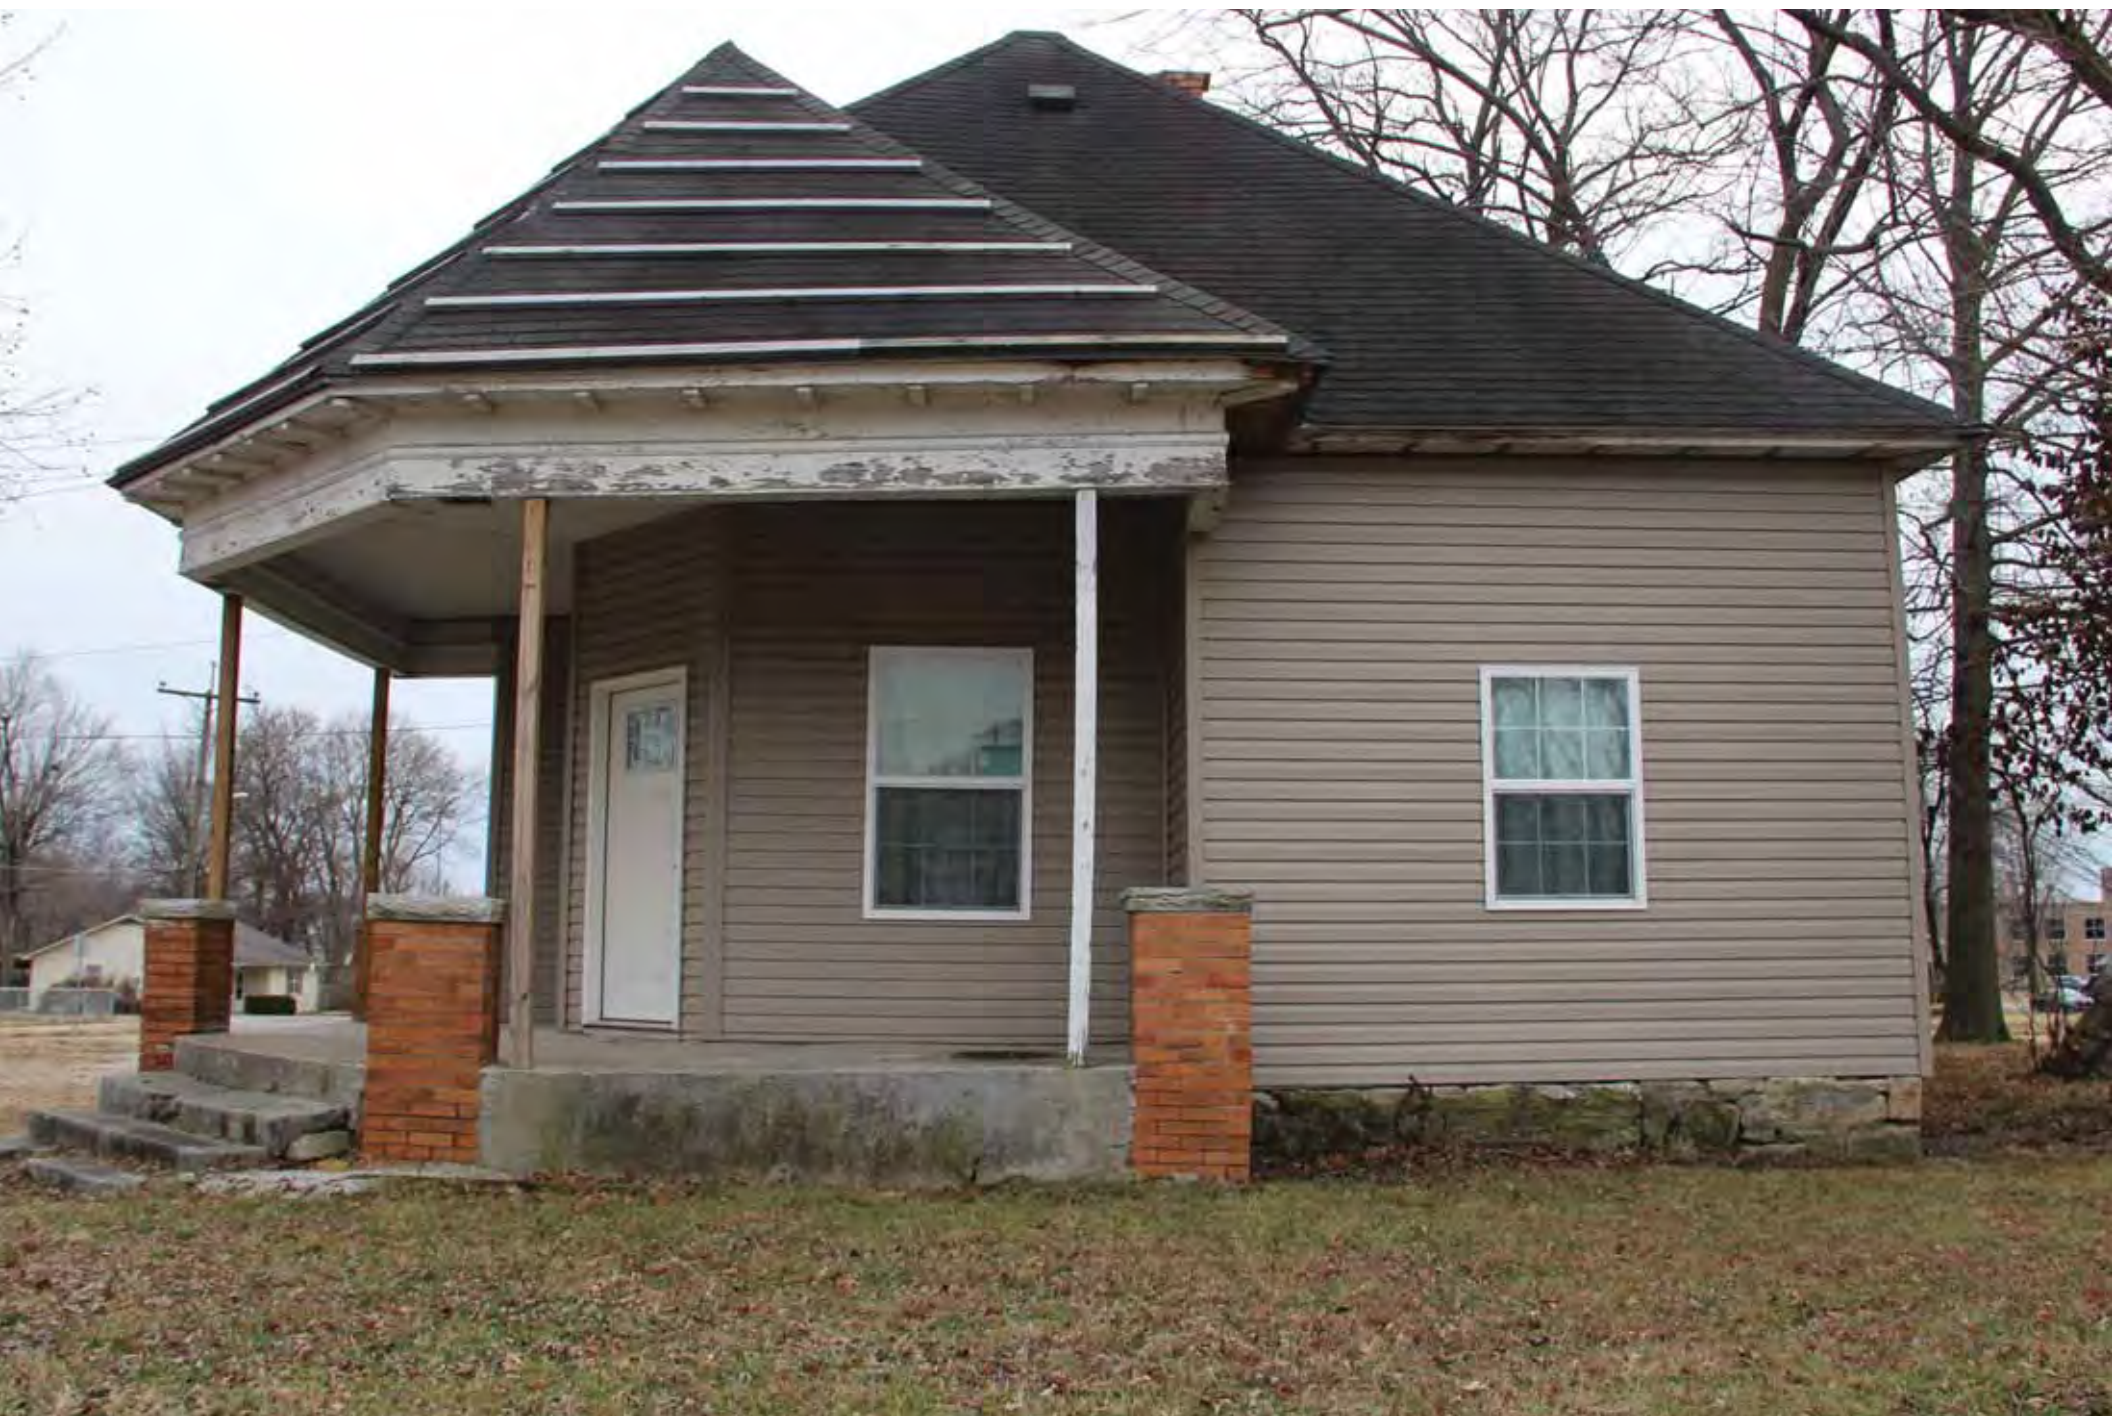
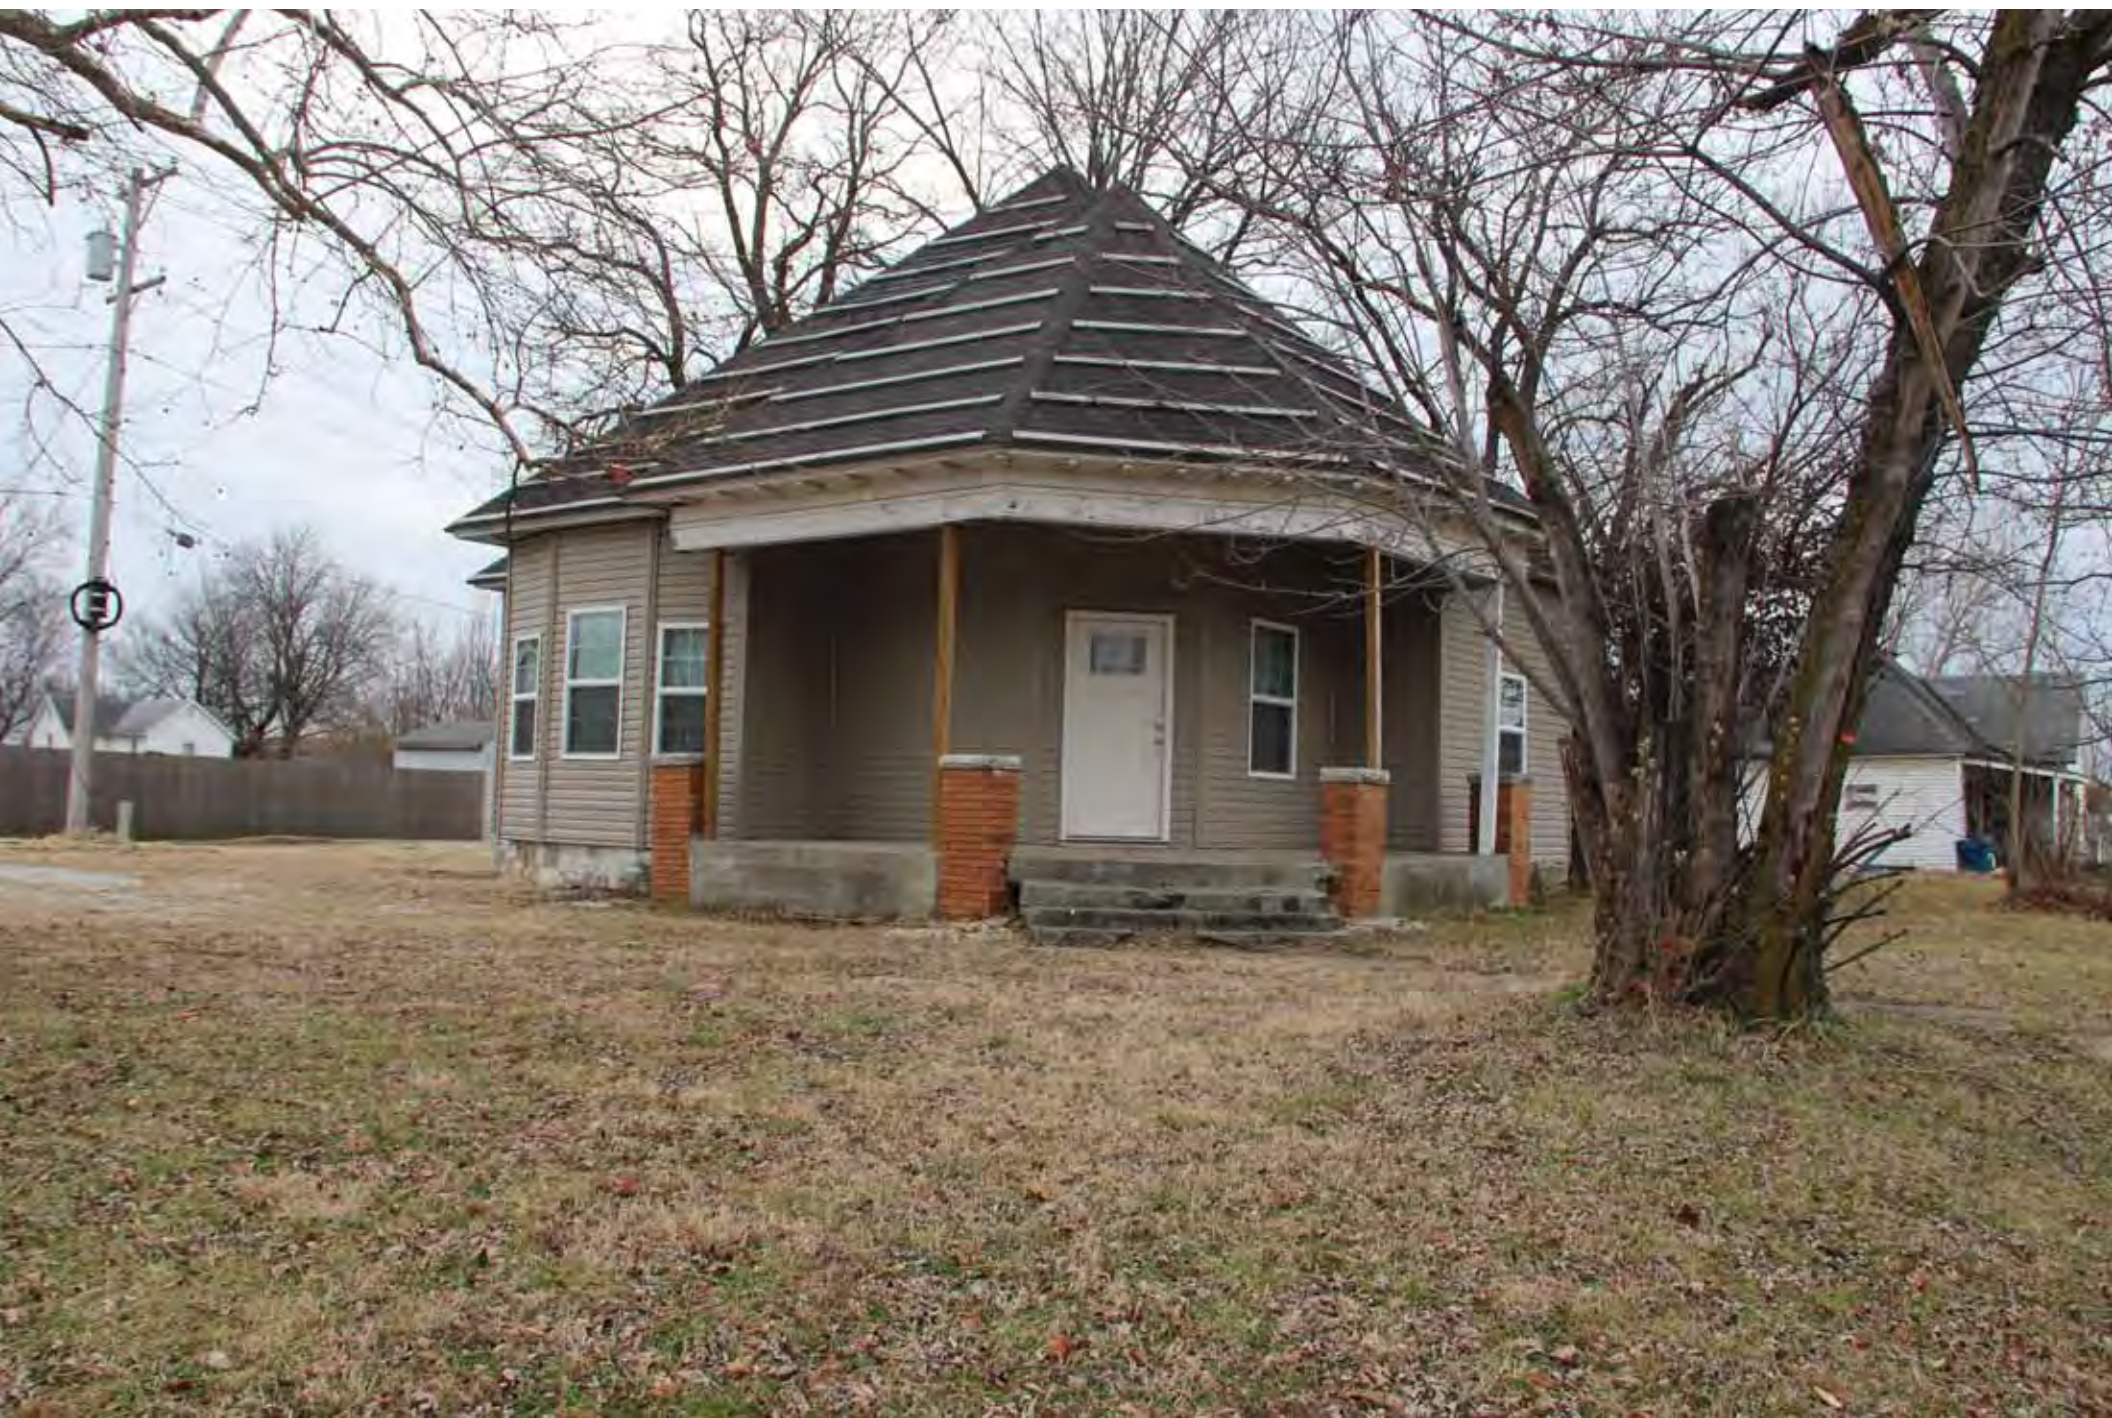
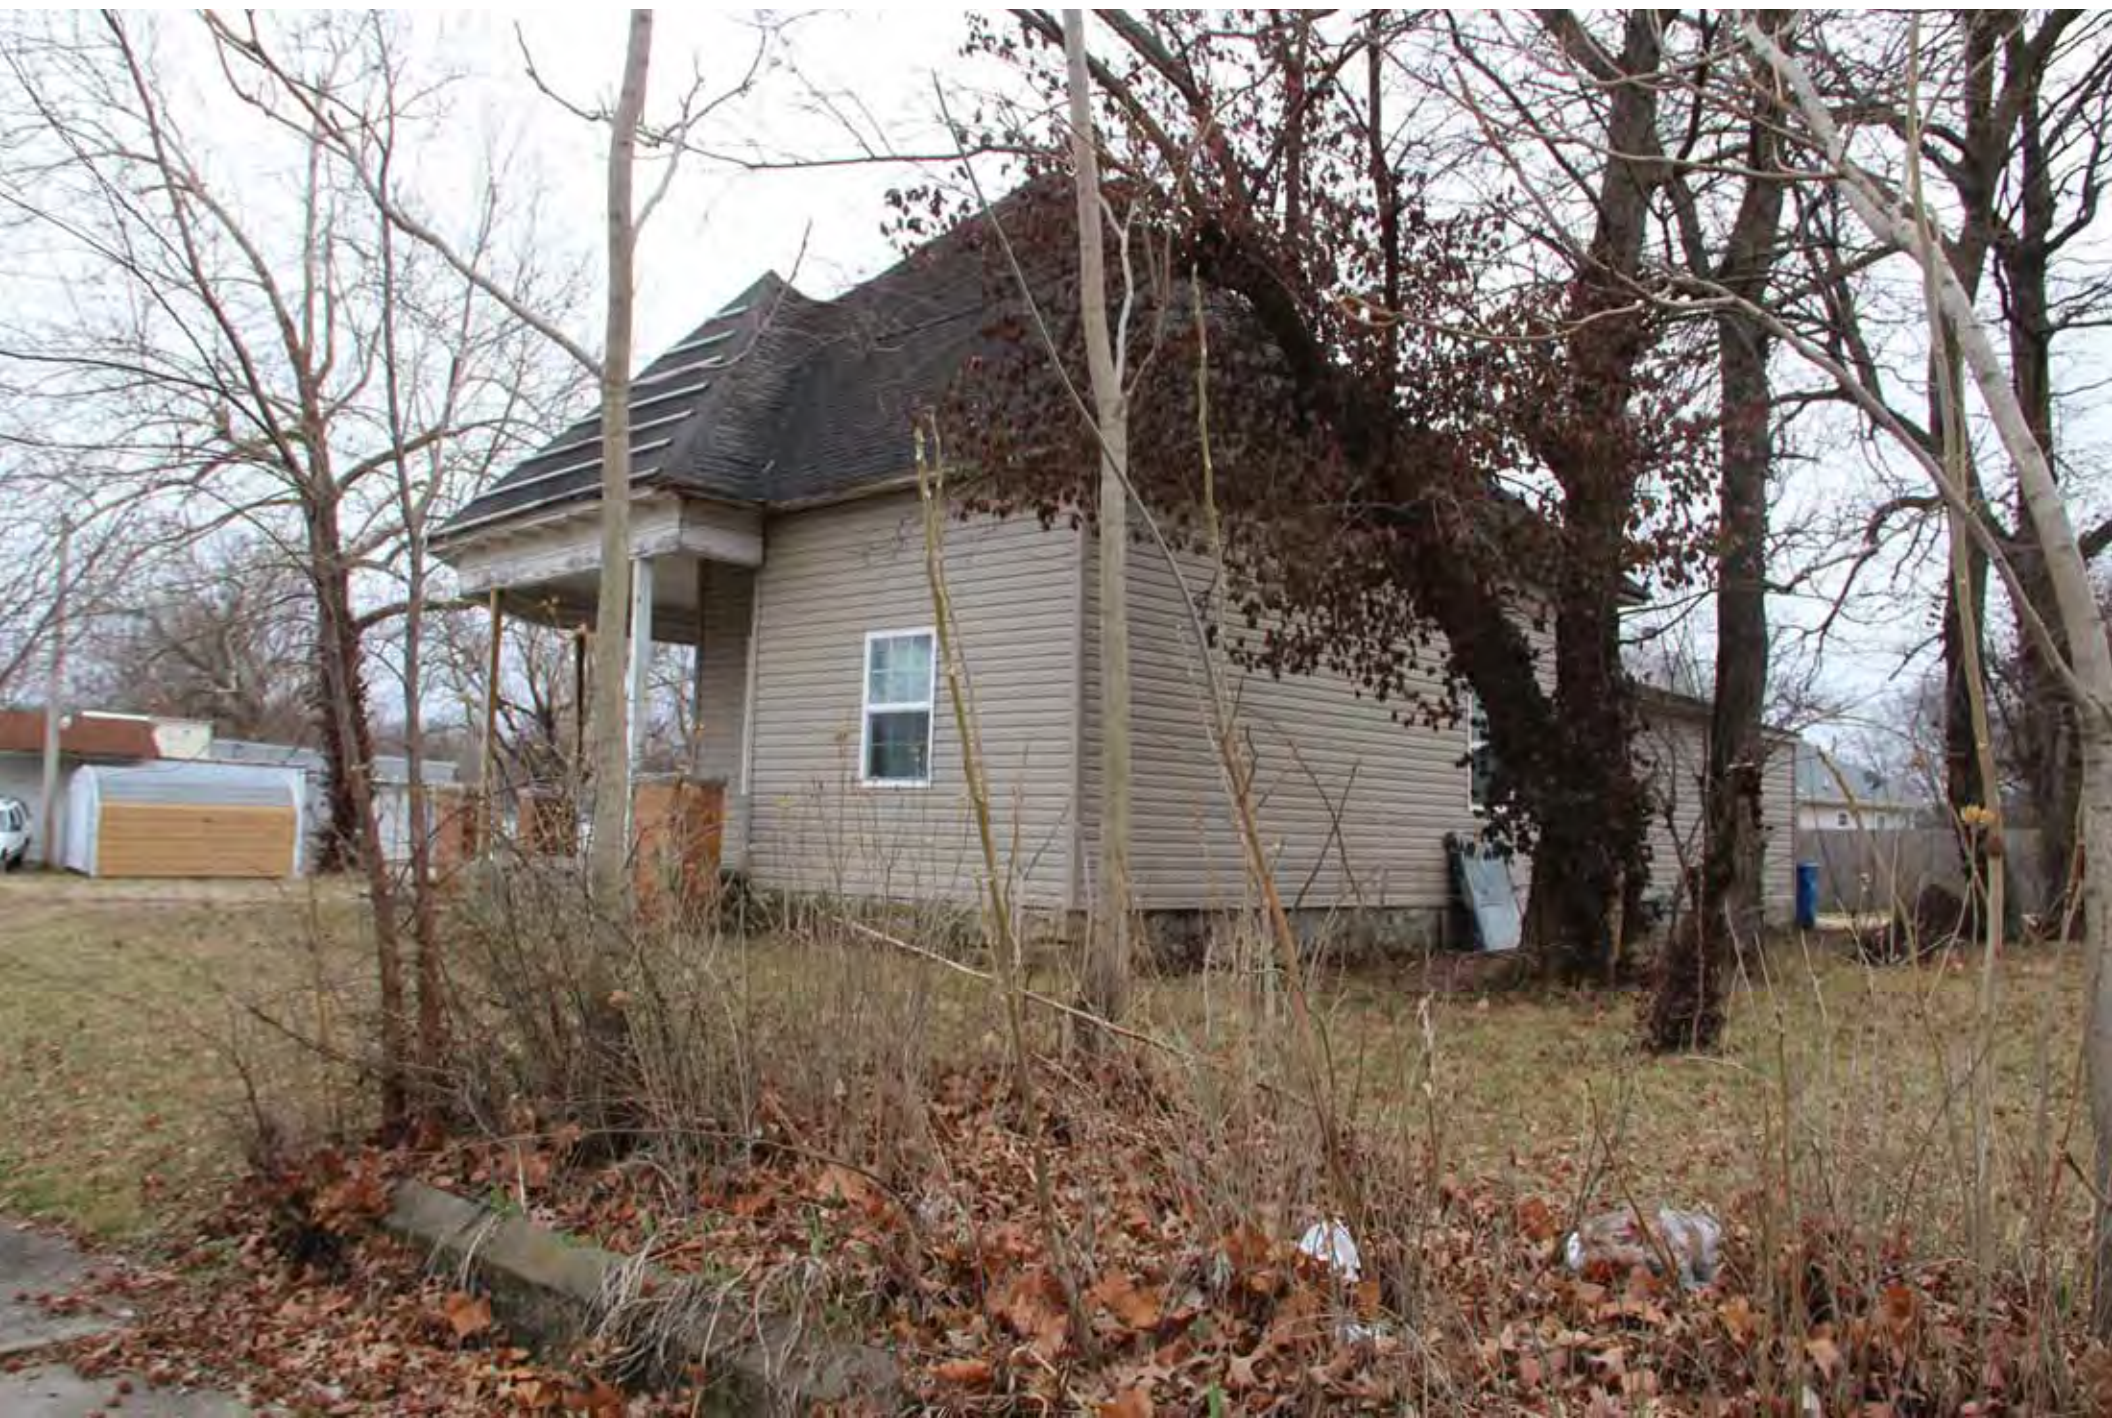
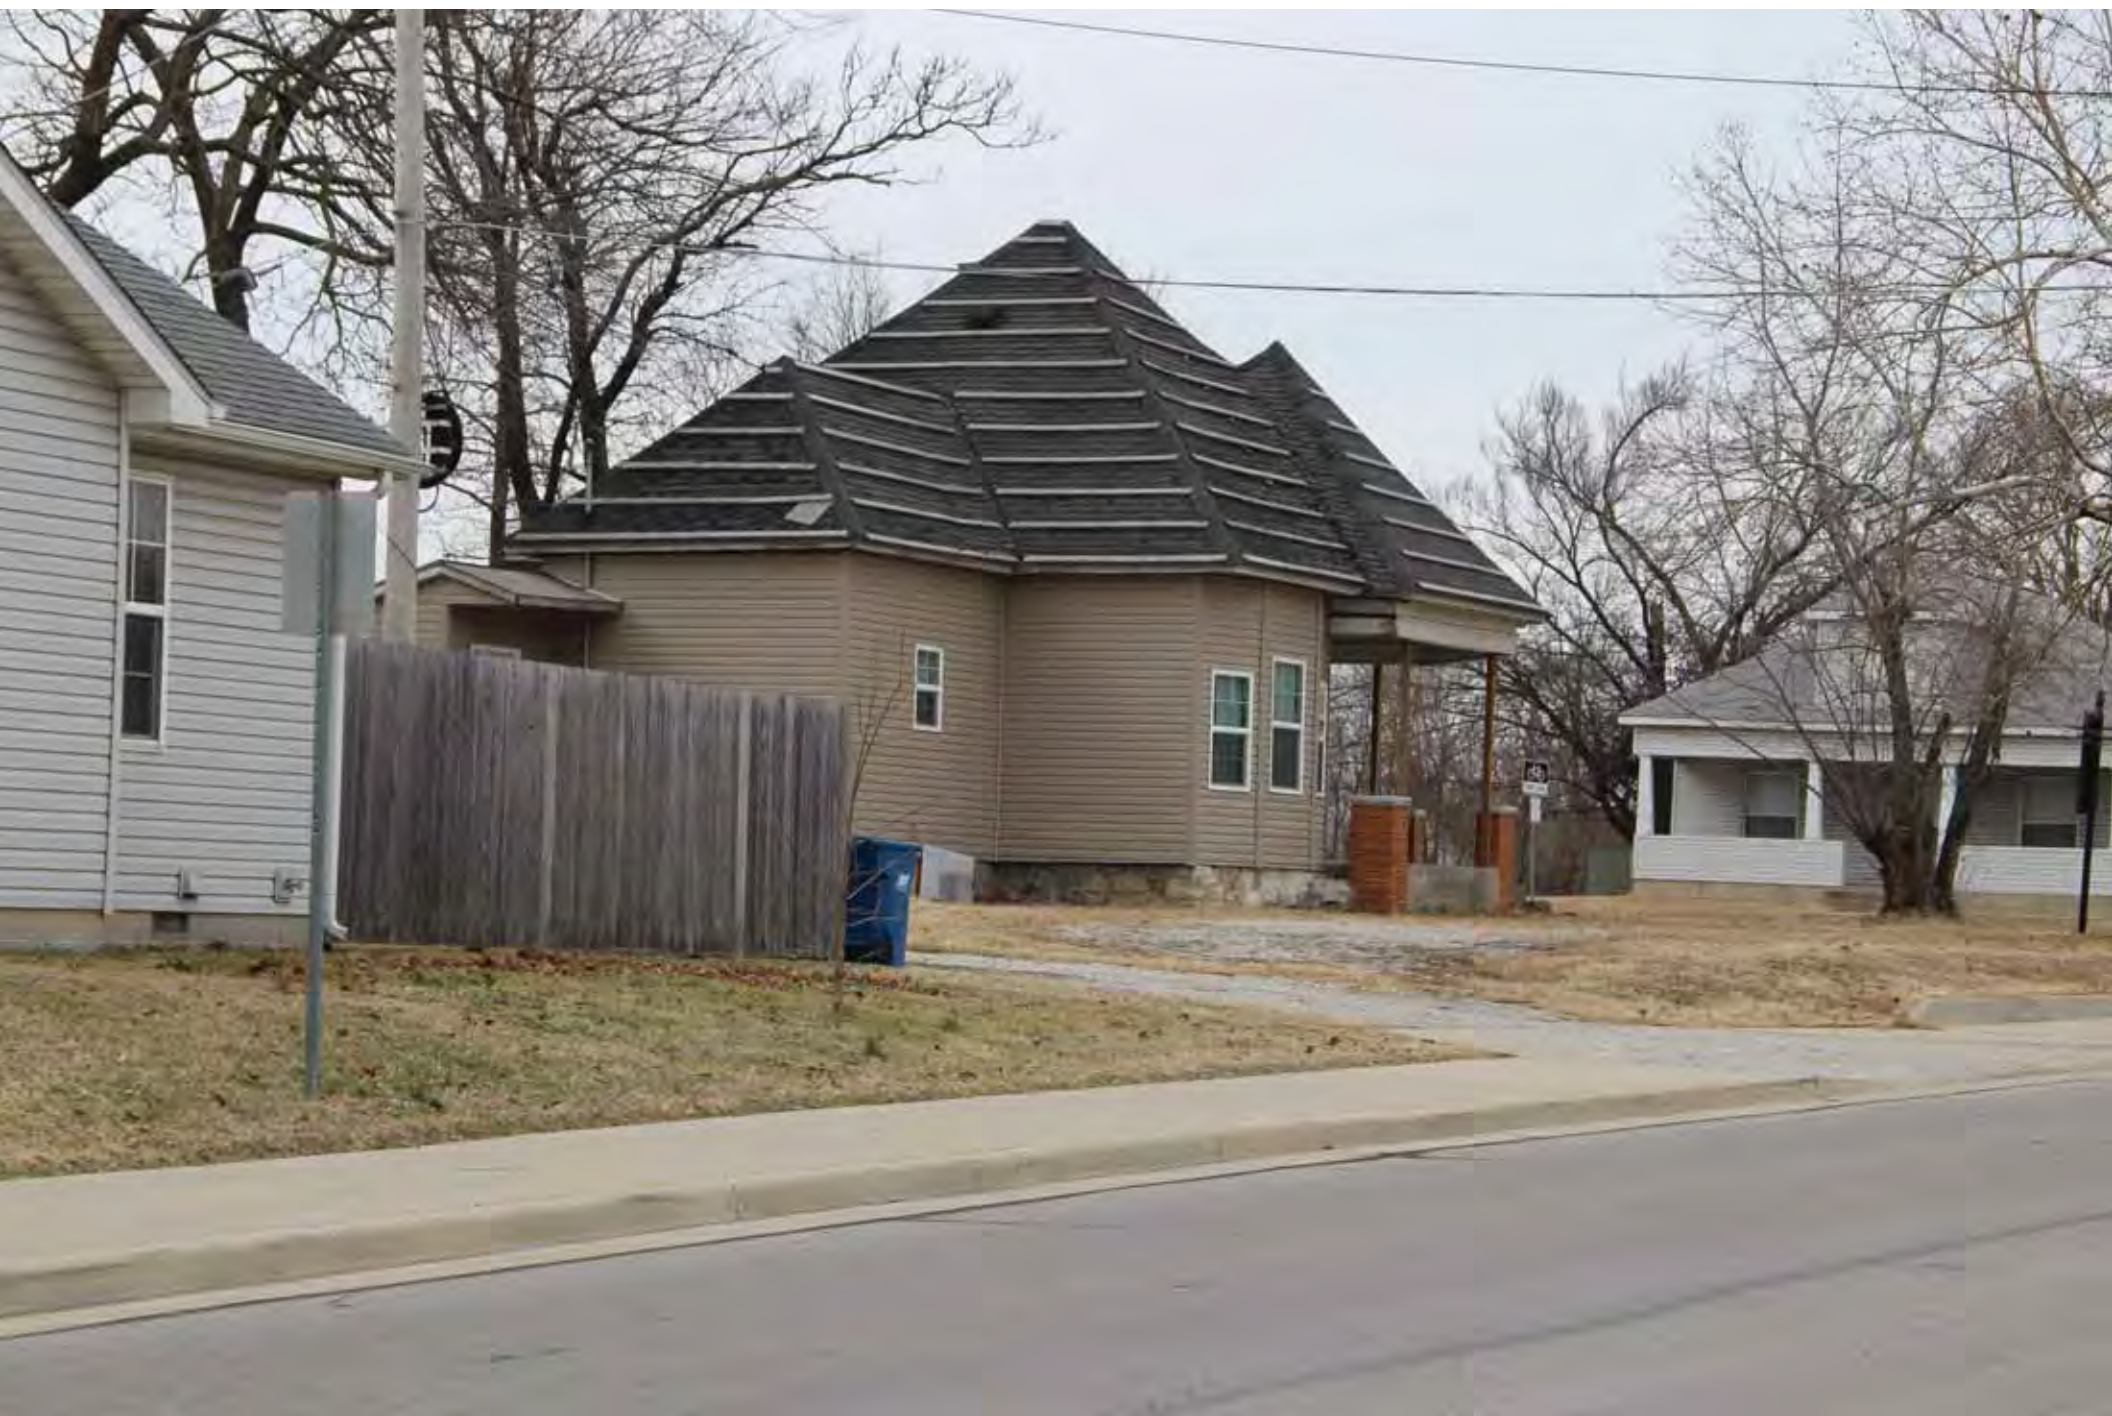
This dwelling has been altered through the addition of c. 2010 exterior siding (vinyl) and replacement of original doors and windows. Due to these alterations, the dwelling does not retain integrity that would render it individually eligible for the National Register of Historic Places. The dwelling is not situated in an area recommended as a historic district.

The property at 1214 E. Broadway Street features a single-story dwelling with a steeply pitched pyramidal roof clad with asphalt shingles. The dwelling is currently undergoing renovation. The exterior is clad with vinyl and all windows and doors are replacement (2019-2020). The foundation is limestone. Near the peak of the roofline is an interior brick chimney. The northeast corner of the dwelling supports a pyramidal roofed porch supported by thin wood columns resting on brick piers. Within the porch bay is a paneled contemporary door with an upper light. The door is offset on the west by a six-over-six window. The base of the porch is poured concrete. Stone and concrete steps lead to the porch at the northeast corner. The dwelling has a rear hipped wing.
