MISSOURI DEPARTMENT OF NATURAL RESOURCES
STATE HISTORIC PRESERVATION OFFICE, P.O. Box 176, Jefferson City, MO 65102
ARCHITECTURAL/HISTORIC INVENTORY FORM

1. Survey No. JP-AS-007-001		2. Survey name: East Town (Original Joplin) Historic Survey Phase 2	
3. County: JASPER		4. Address (Street No.) 618	Street (name) E. 2 nd Street
5. City: Joplin	Vicinity: <input type="checkbox"/>	6. Geographical Reference:	7. Township/Range/Section: T: R: S:
8. Historic name (if known):		9. Present/other name (if known):	
10. Ownership: <input checked="" type="checkbox"/> Private <input type="checkbox"/> Public		11a. Historic use (if known): Domestic: Single Dwelling	11b. Current use: Domestic: Single Dwelling

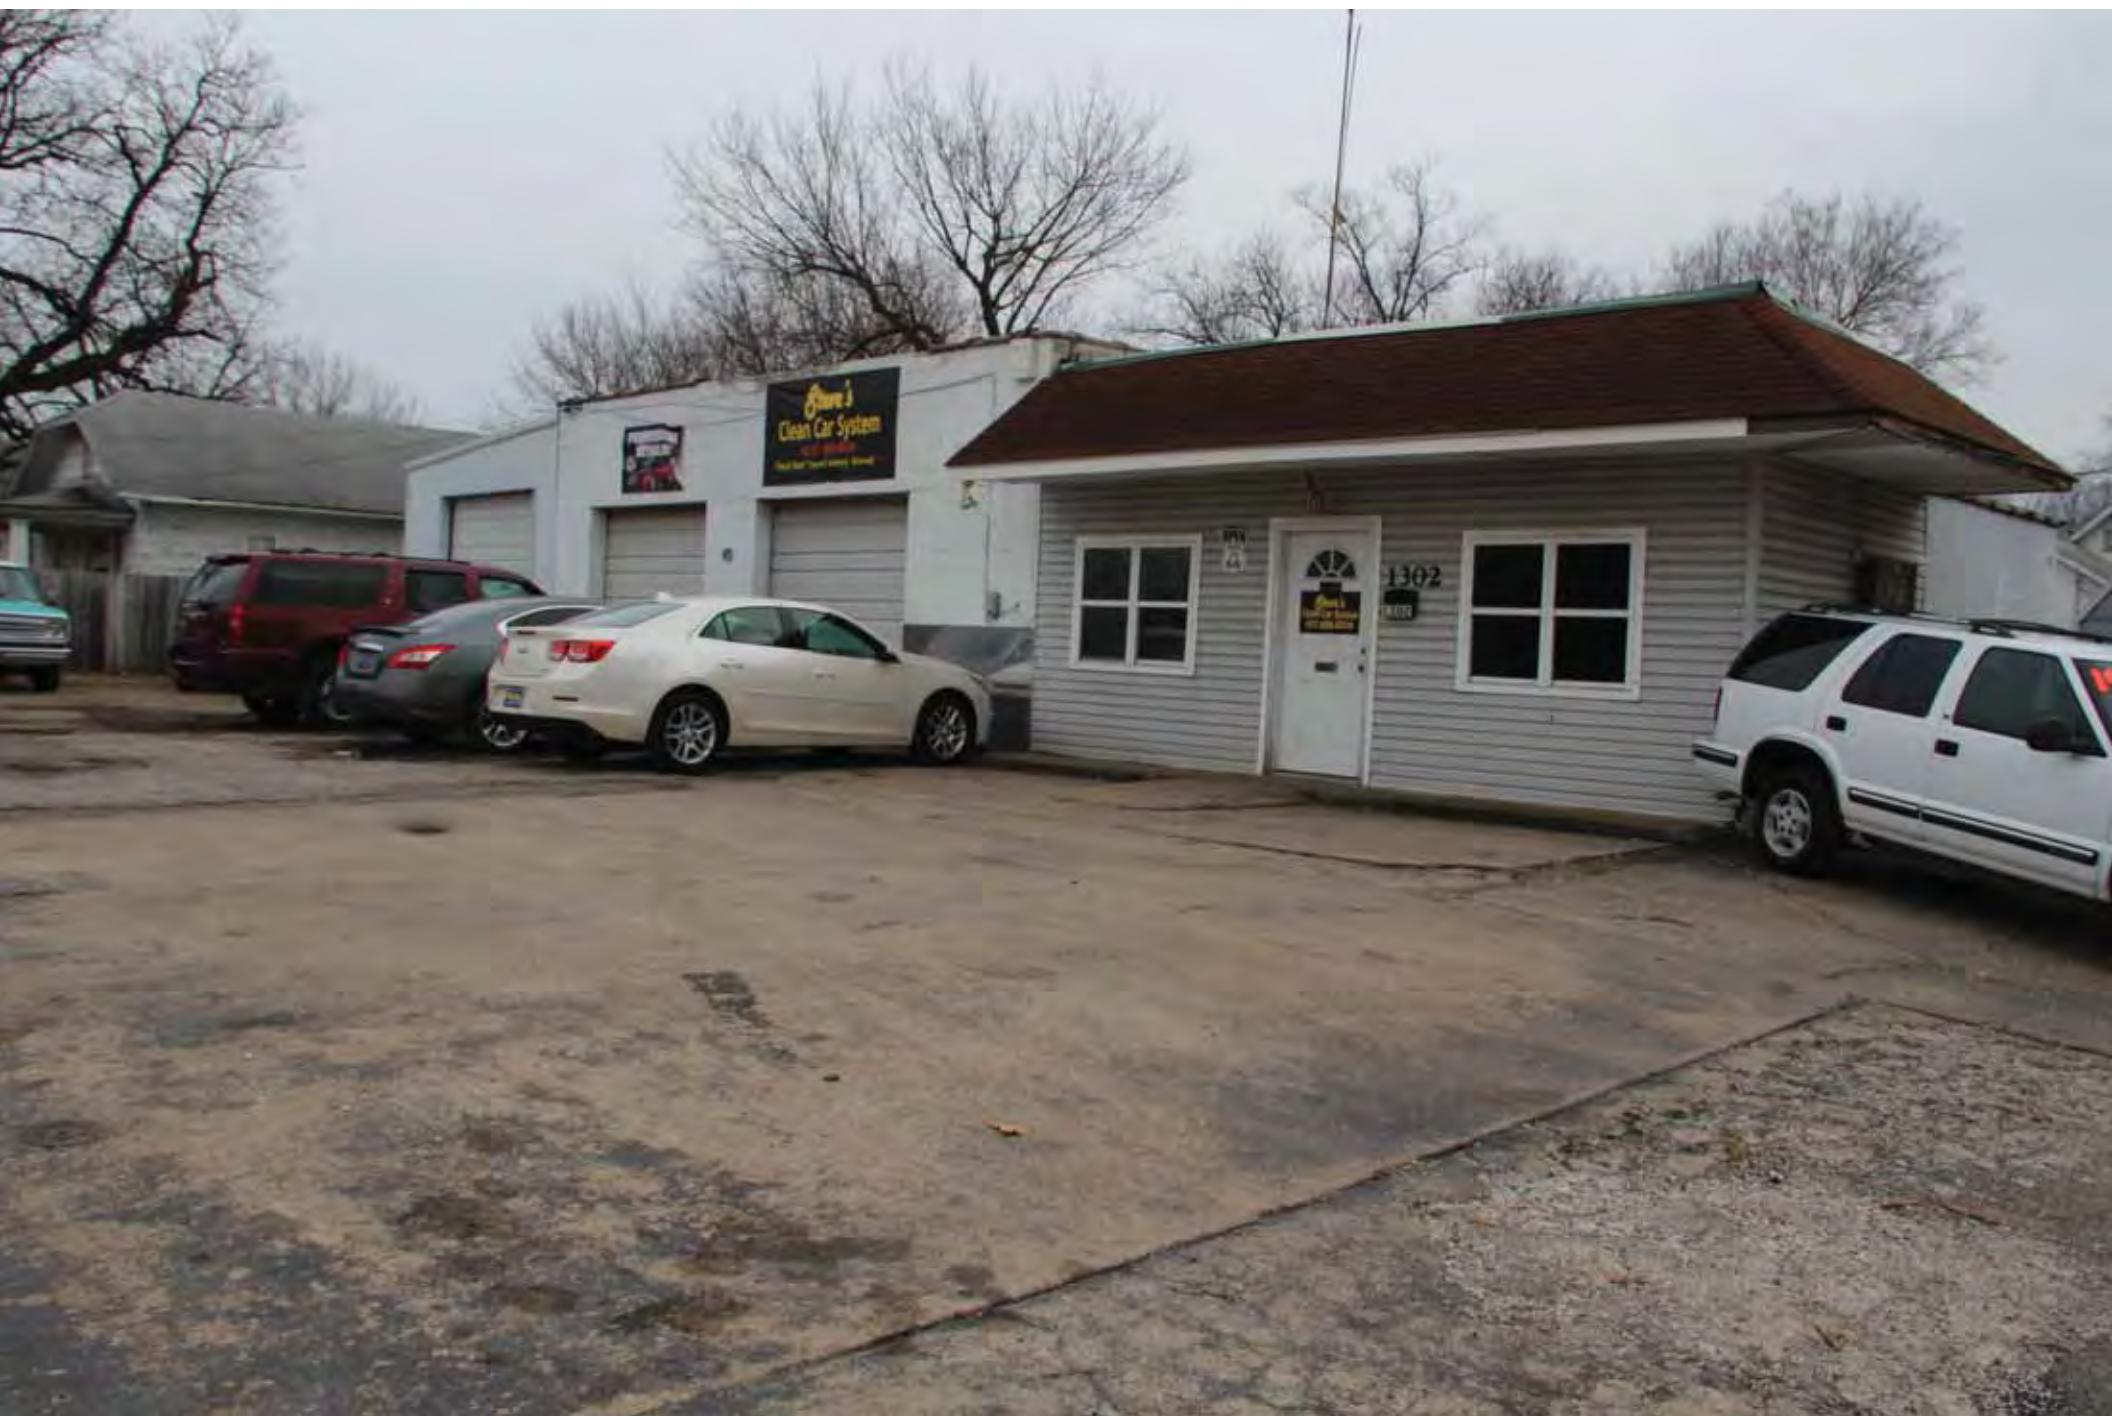
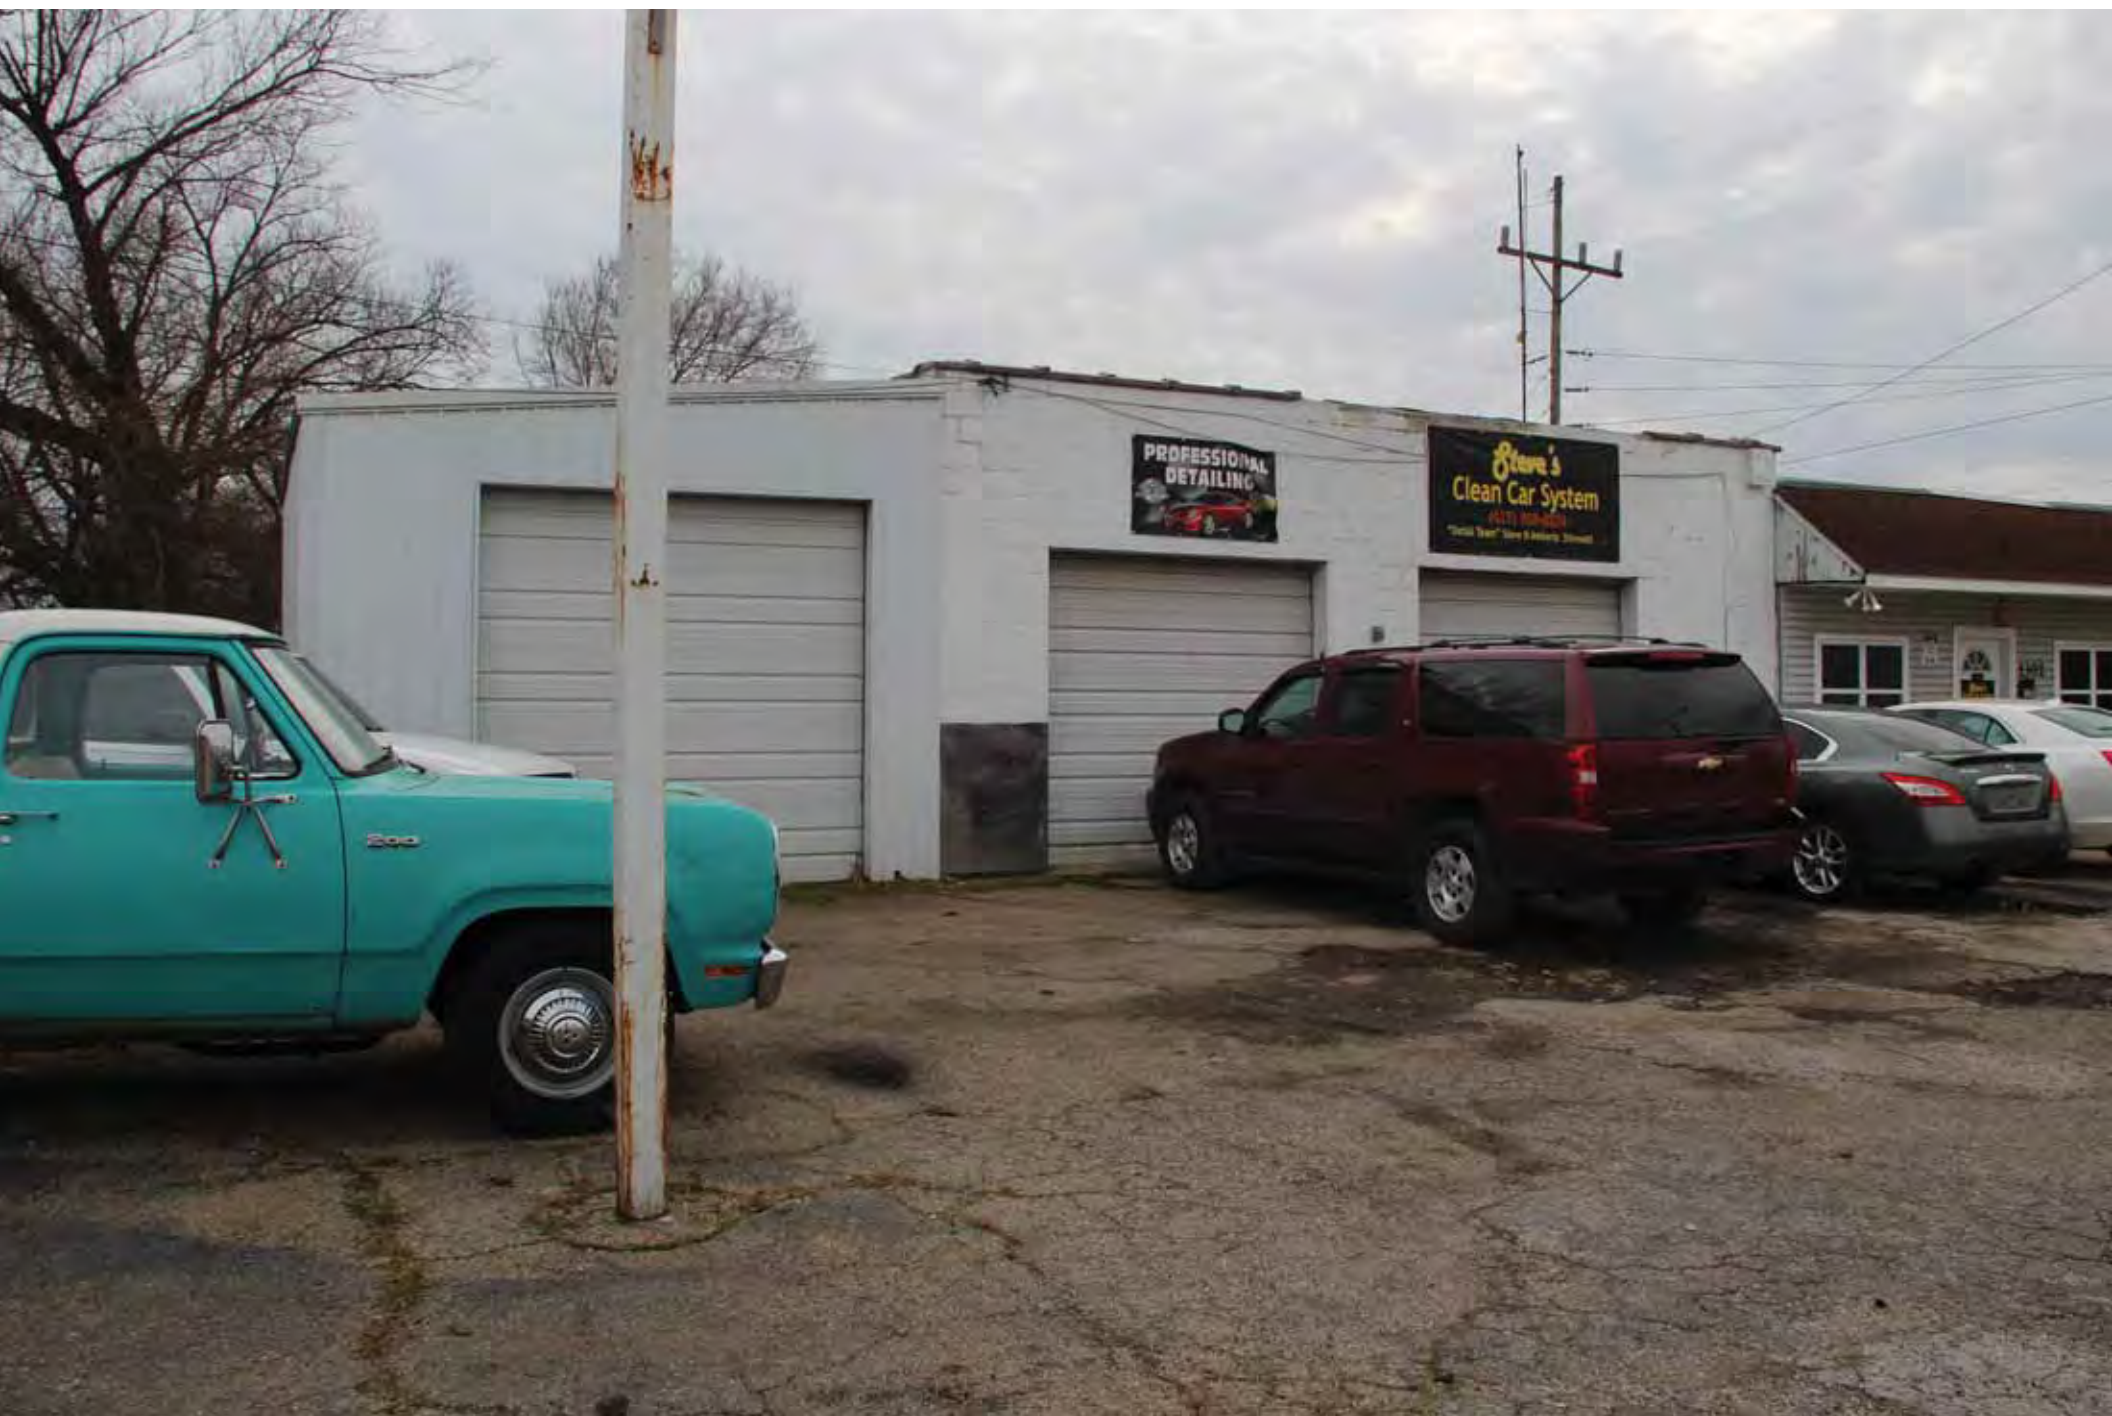
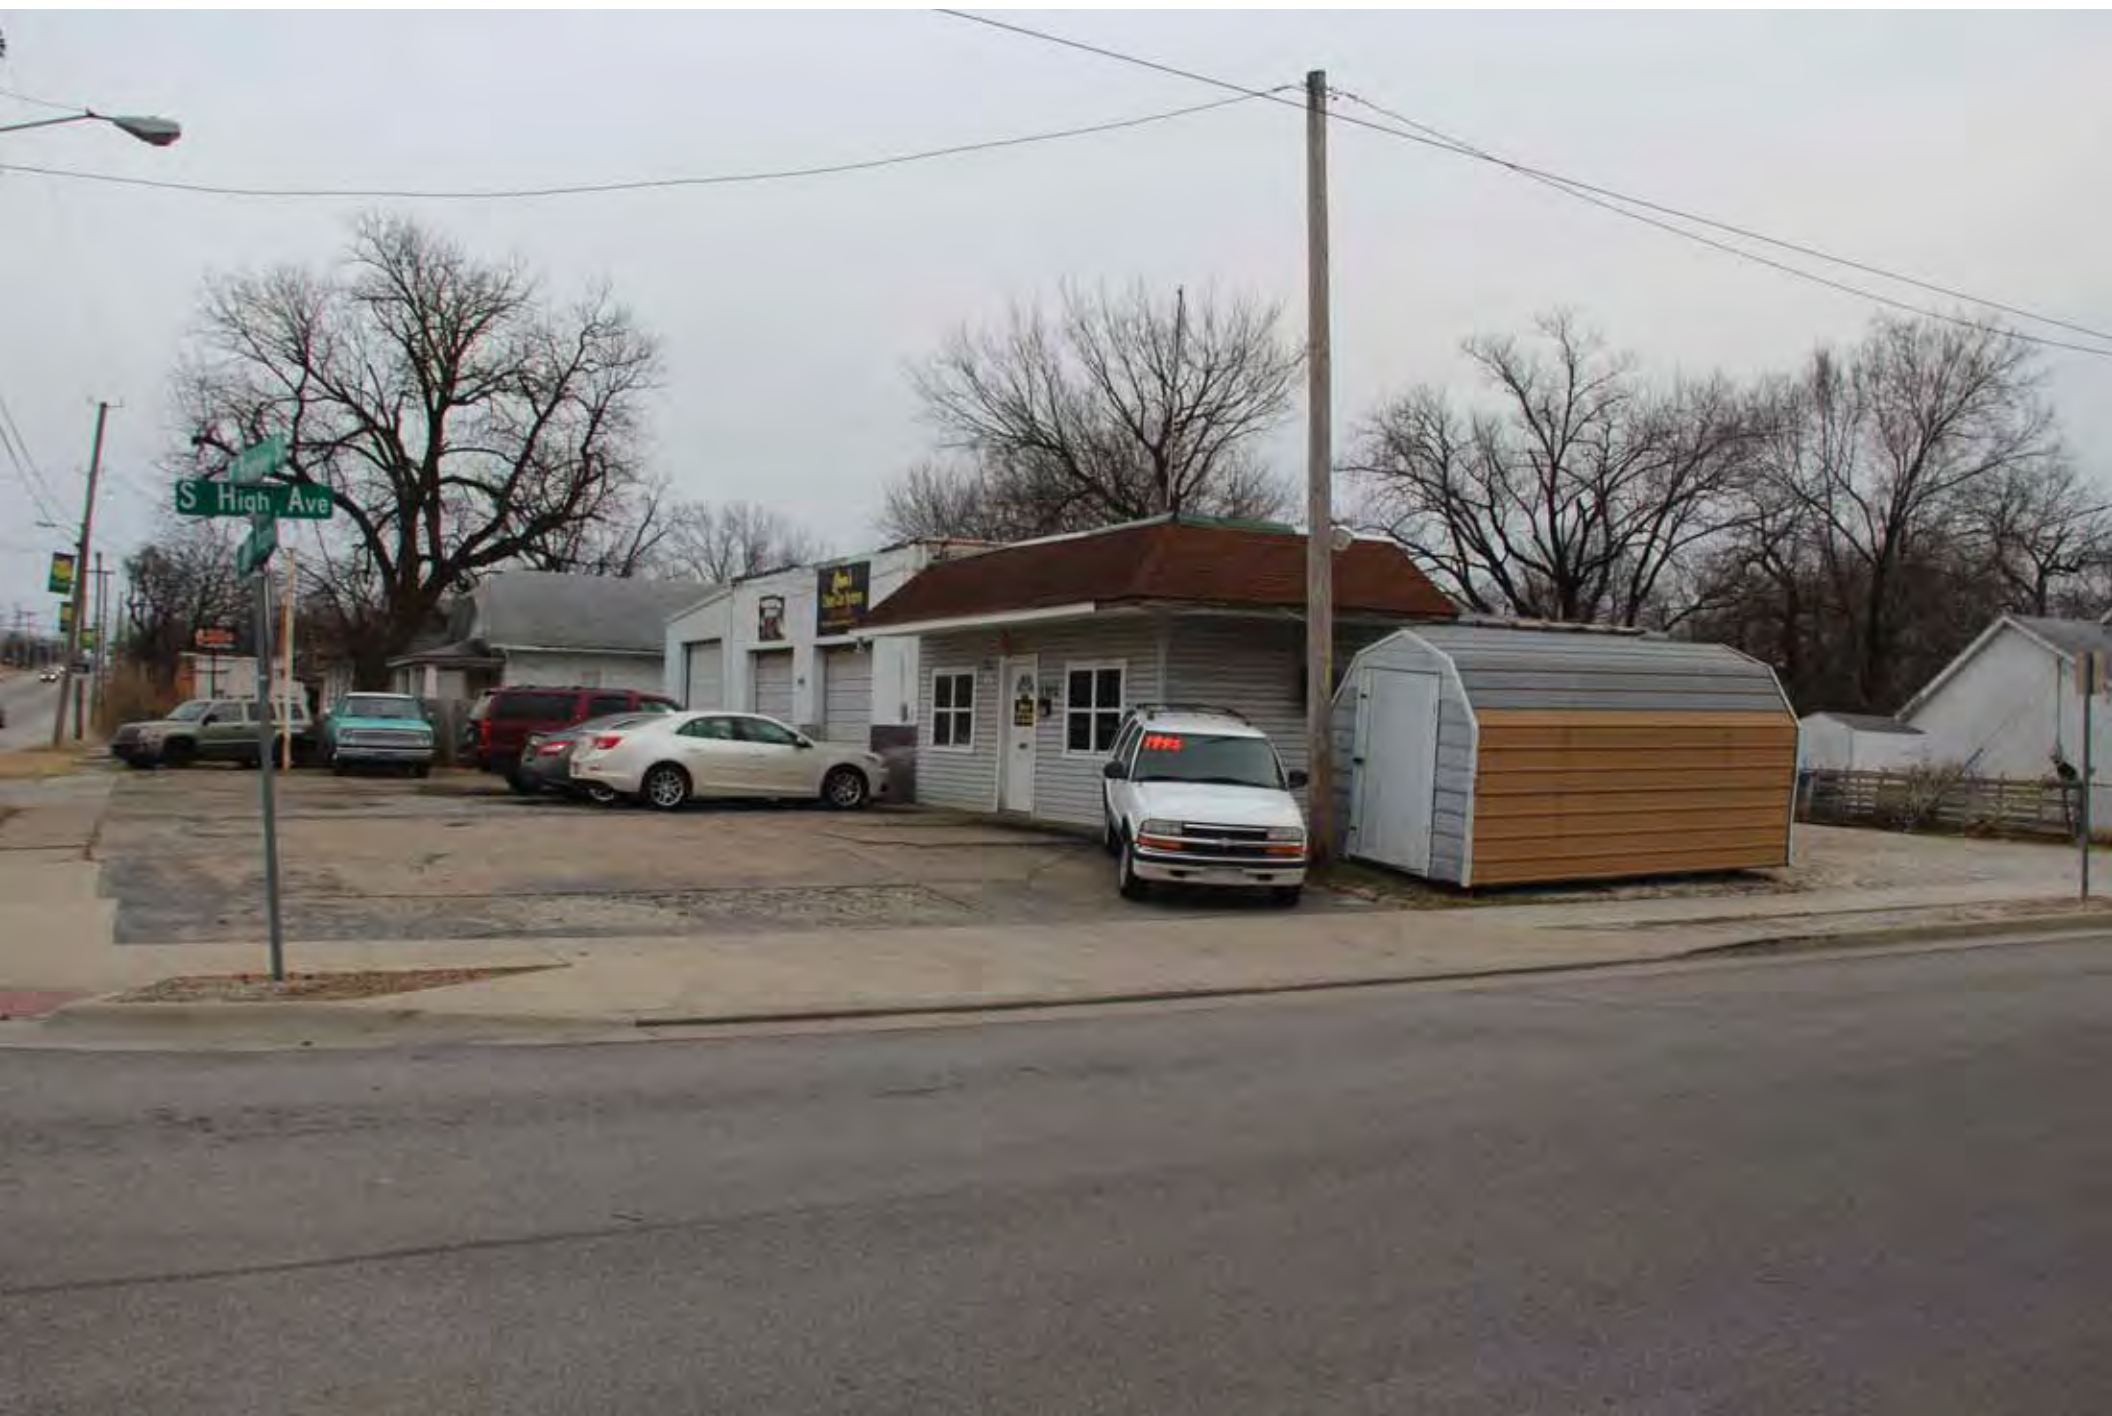
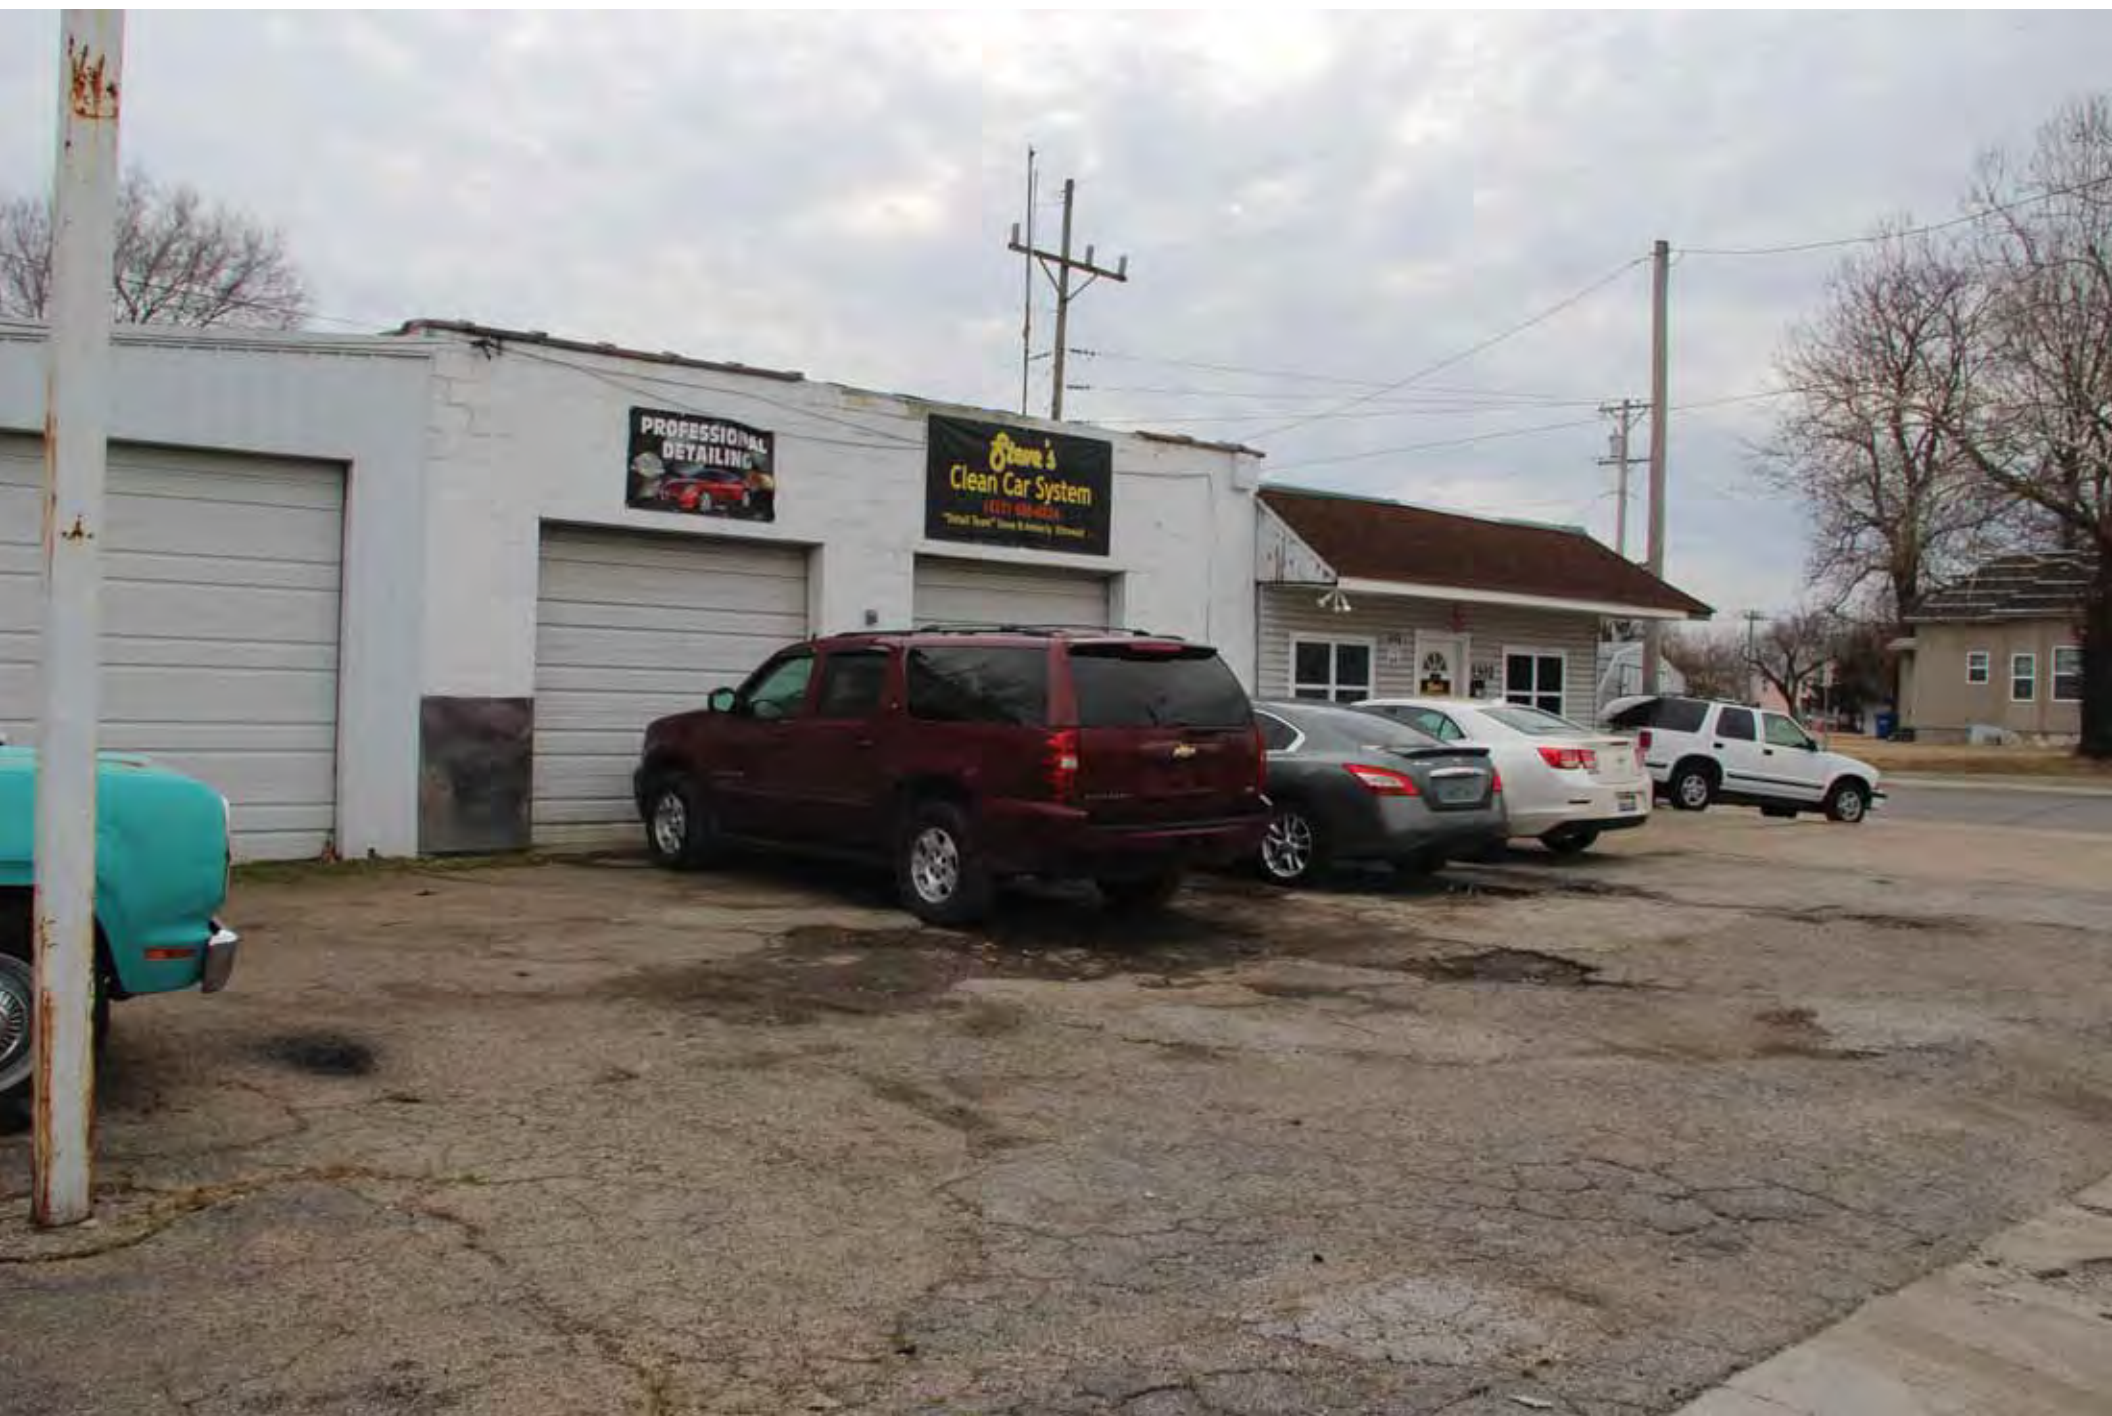
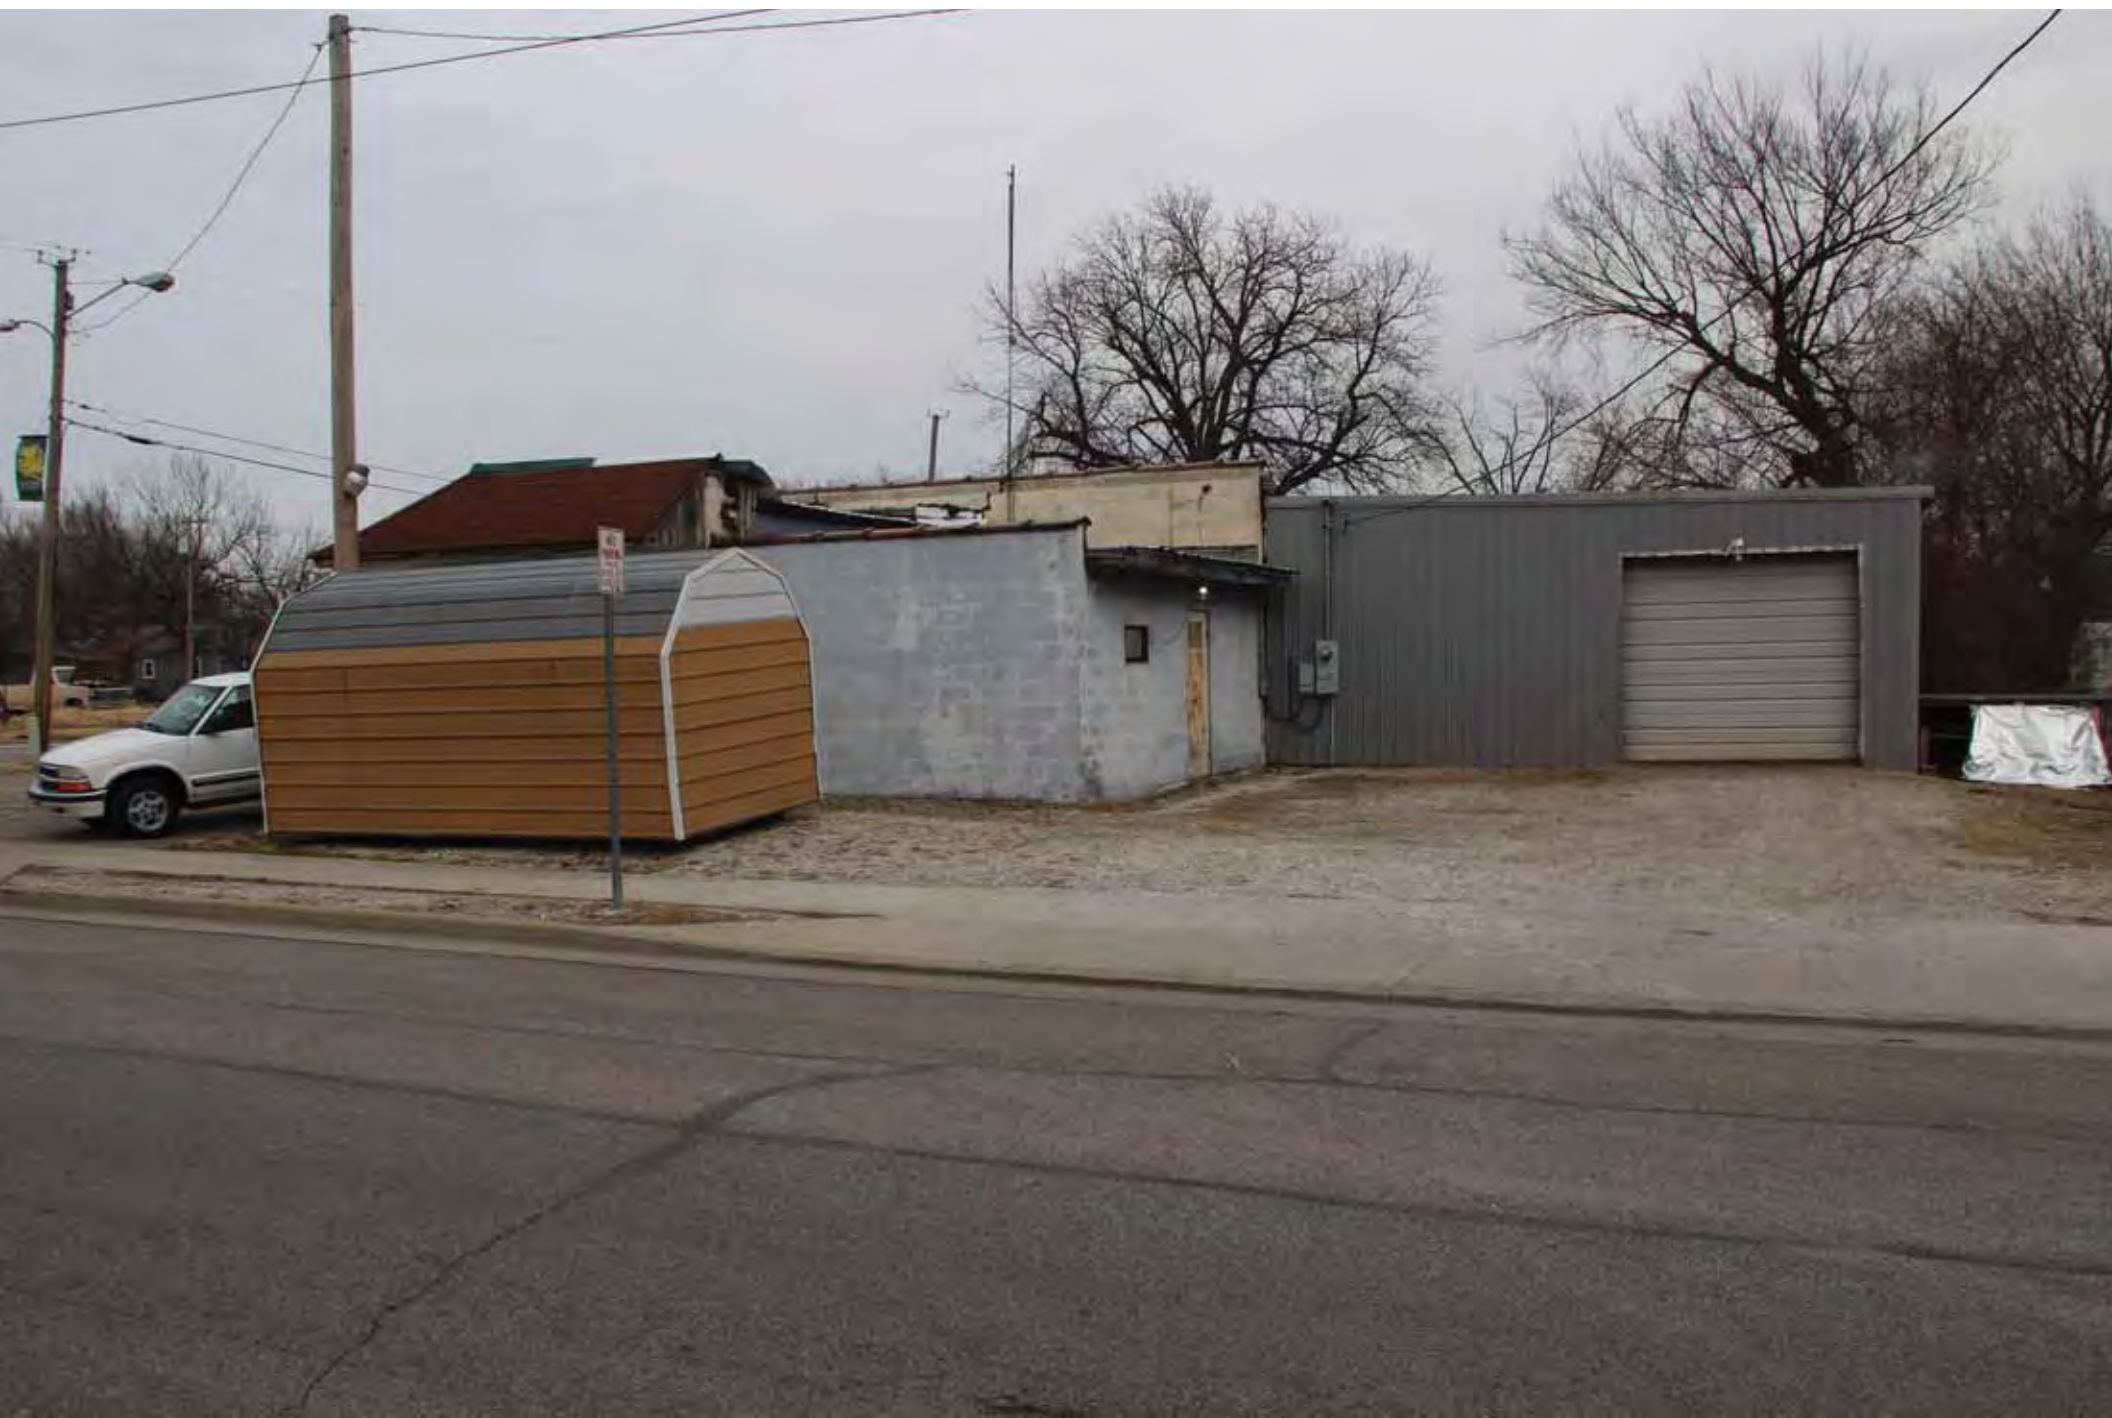
The building has been significantly modified by the addition of vinyl siding and replacement of all windows and doors on the customer service wing at the east end of the property. Due to these modifications, the property does not retain integrity that would render it individually eligible for the National Register of Historic Places. The property is not within an area recommended as a historic district.

The building associated with this parcel is a single-story rectangular commercial property. The east end of the building comprises an auto-service garage. Exterior walls are concrete block and the north elevation holds three overhead track doors. The easternmost bay is within a shed roof concrete block wing. Terra cotta coping caps the rectangular wing at the roofline. The west end of the building supports a customer service office. This portion of the building is clad with vinyl siding. The north elevation of the customer area holds a contemporary paneled door with an upper fanlight. The door is flanked by paired double-hung vinyl frame windows. A large fixed shed awning mimicking a mansard roof is attached to the primary (north) elevation. The awning is clad with asphalt shingles. The rear elevation of the customer service wing has a small fixed sash window and metal door. The garage wing's west elevation has exterior ribbed metal siding and an overhead track door.
