MISSOURI DEPARTMENT OF NATURAL RESOURCES
STATE HISTORIC PRESERVATION OFFICE, P.O. Box 176, Jefferson City, MO 65102
ARCHITECTURAL/HISTORIC INVENTORY FORM

1. Survey No. JP-AS-007-001		2. Survey name: East Town (Original Joplin) Historic Survey Phase 2	
3. County: JASPER		4. Address (Street No.) 618	Street (name) E. 2 nd Street
5. City: Joplin	Vicinity: <input type="checkbox"/>	6. Geographical Reference:	7. Township/Range/Section: T: R: S:
8. Historic name (if known):		9. Present/other name (if known):	
10. Ownership: <input checked="" type="checkbox"/> Private <input type="checkbox"/> Public		11a. Historic use (if known): Domestic: Single Dwelling	11b. Current use: Domestic: Single Dwelling

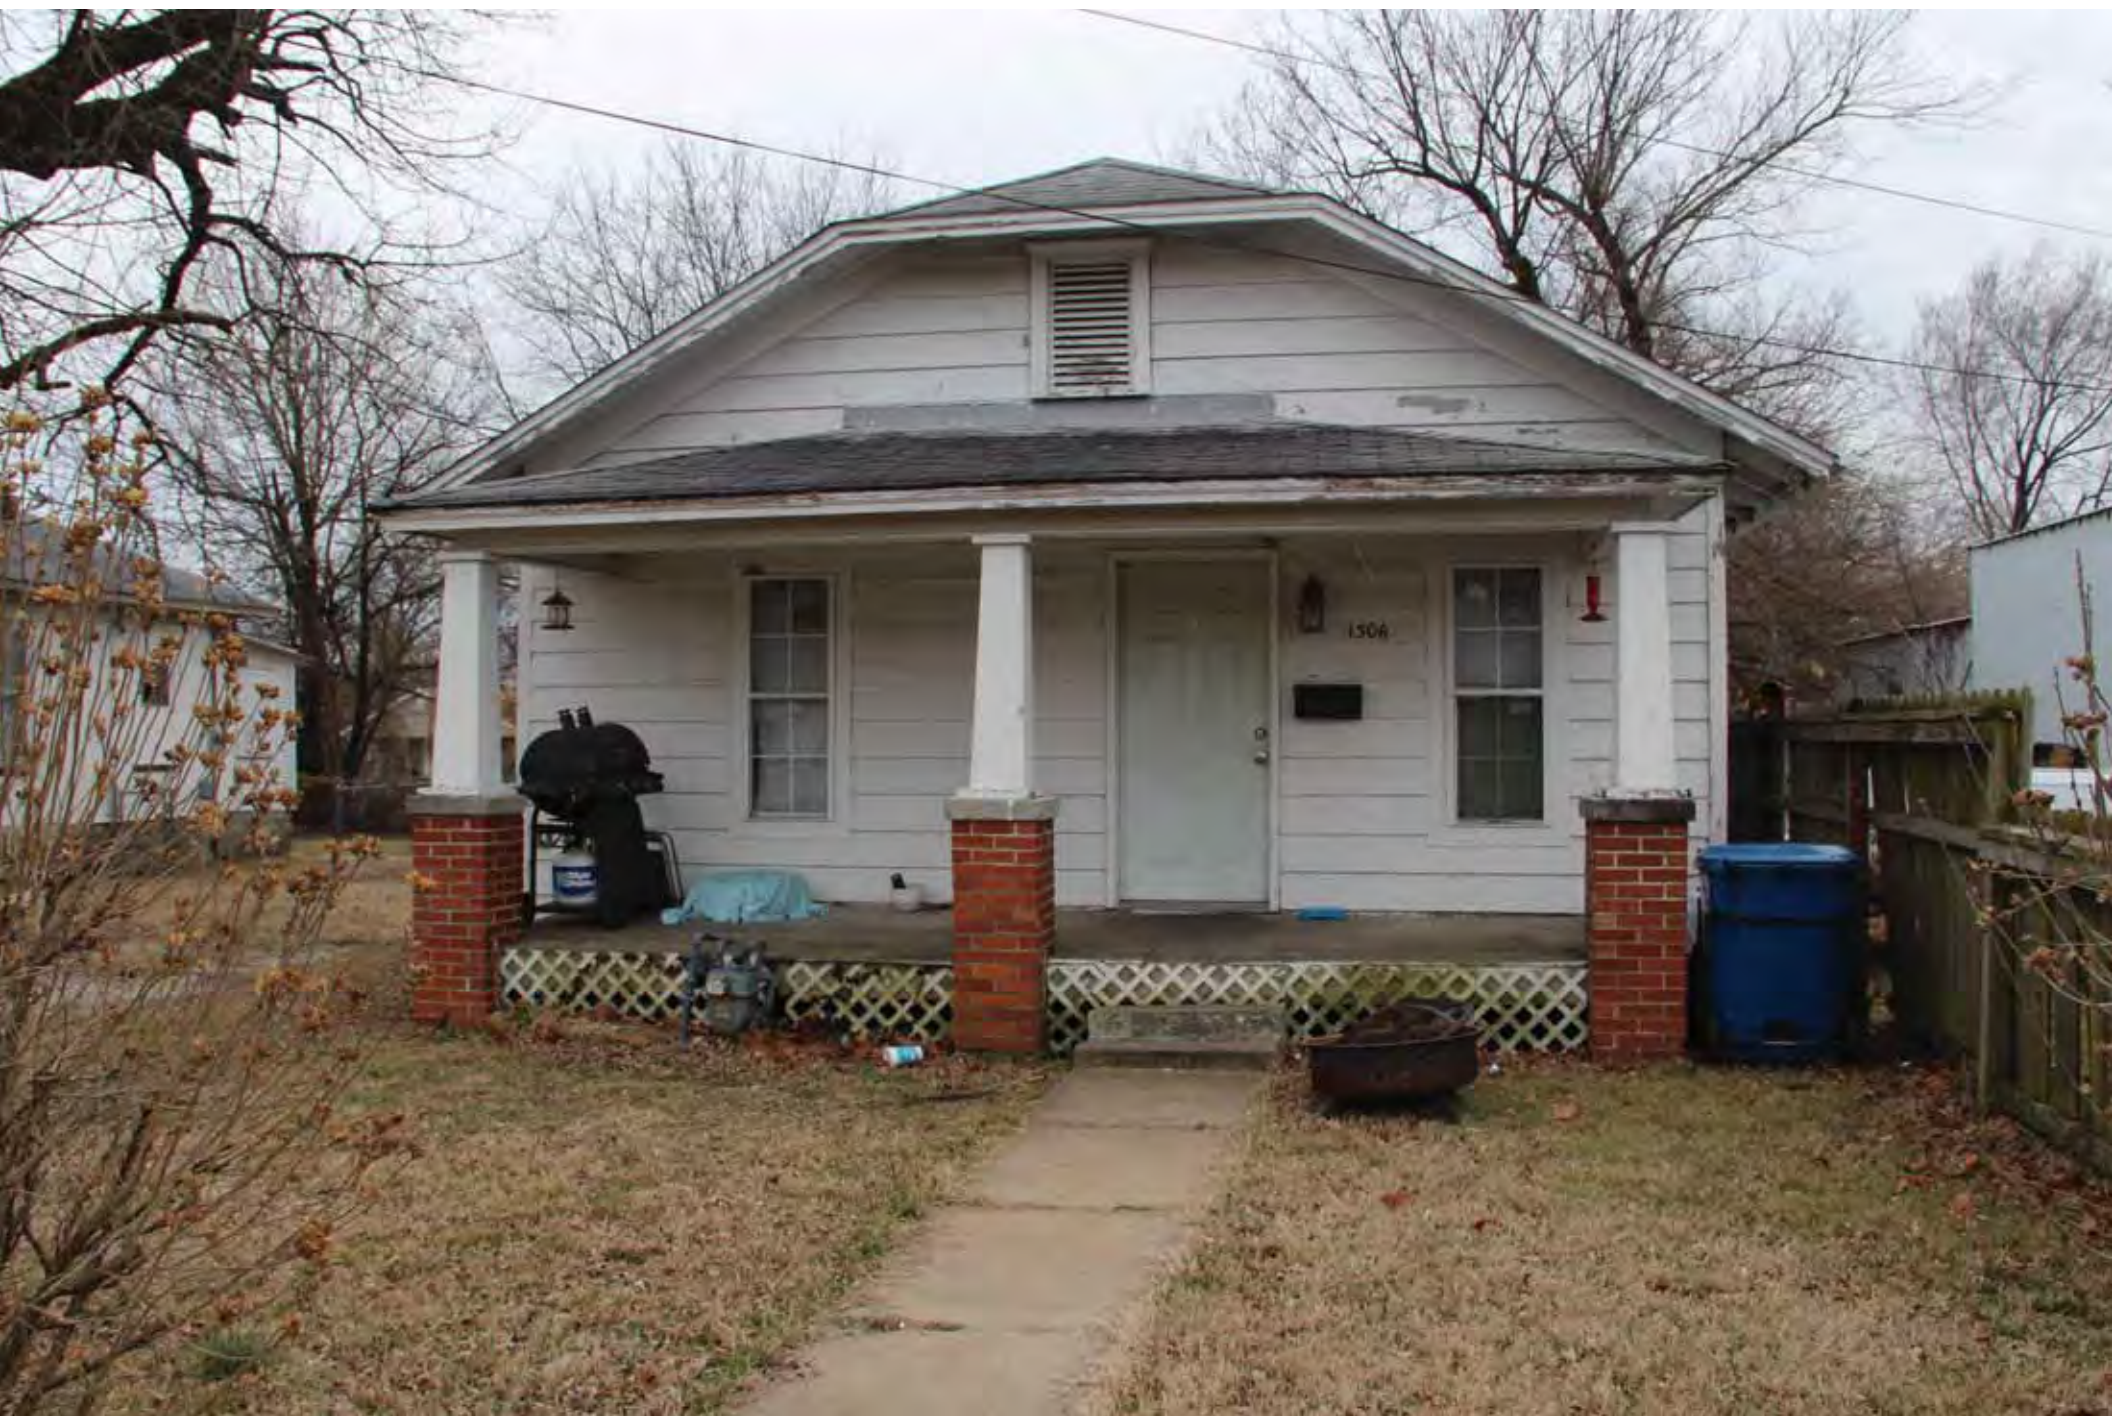
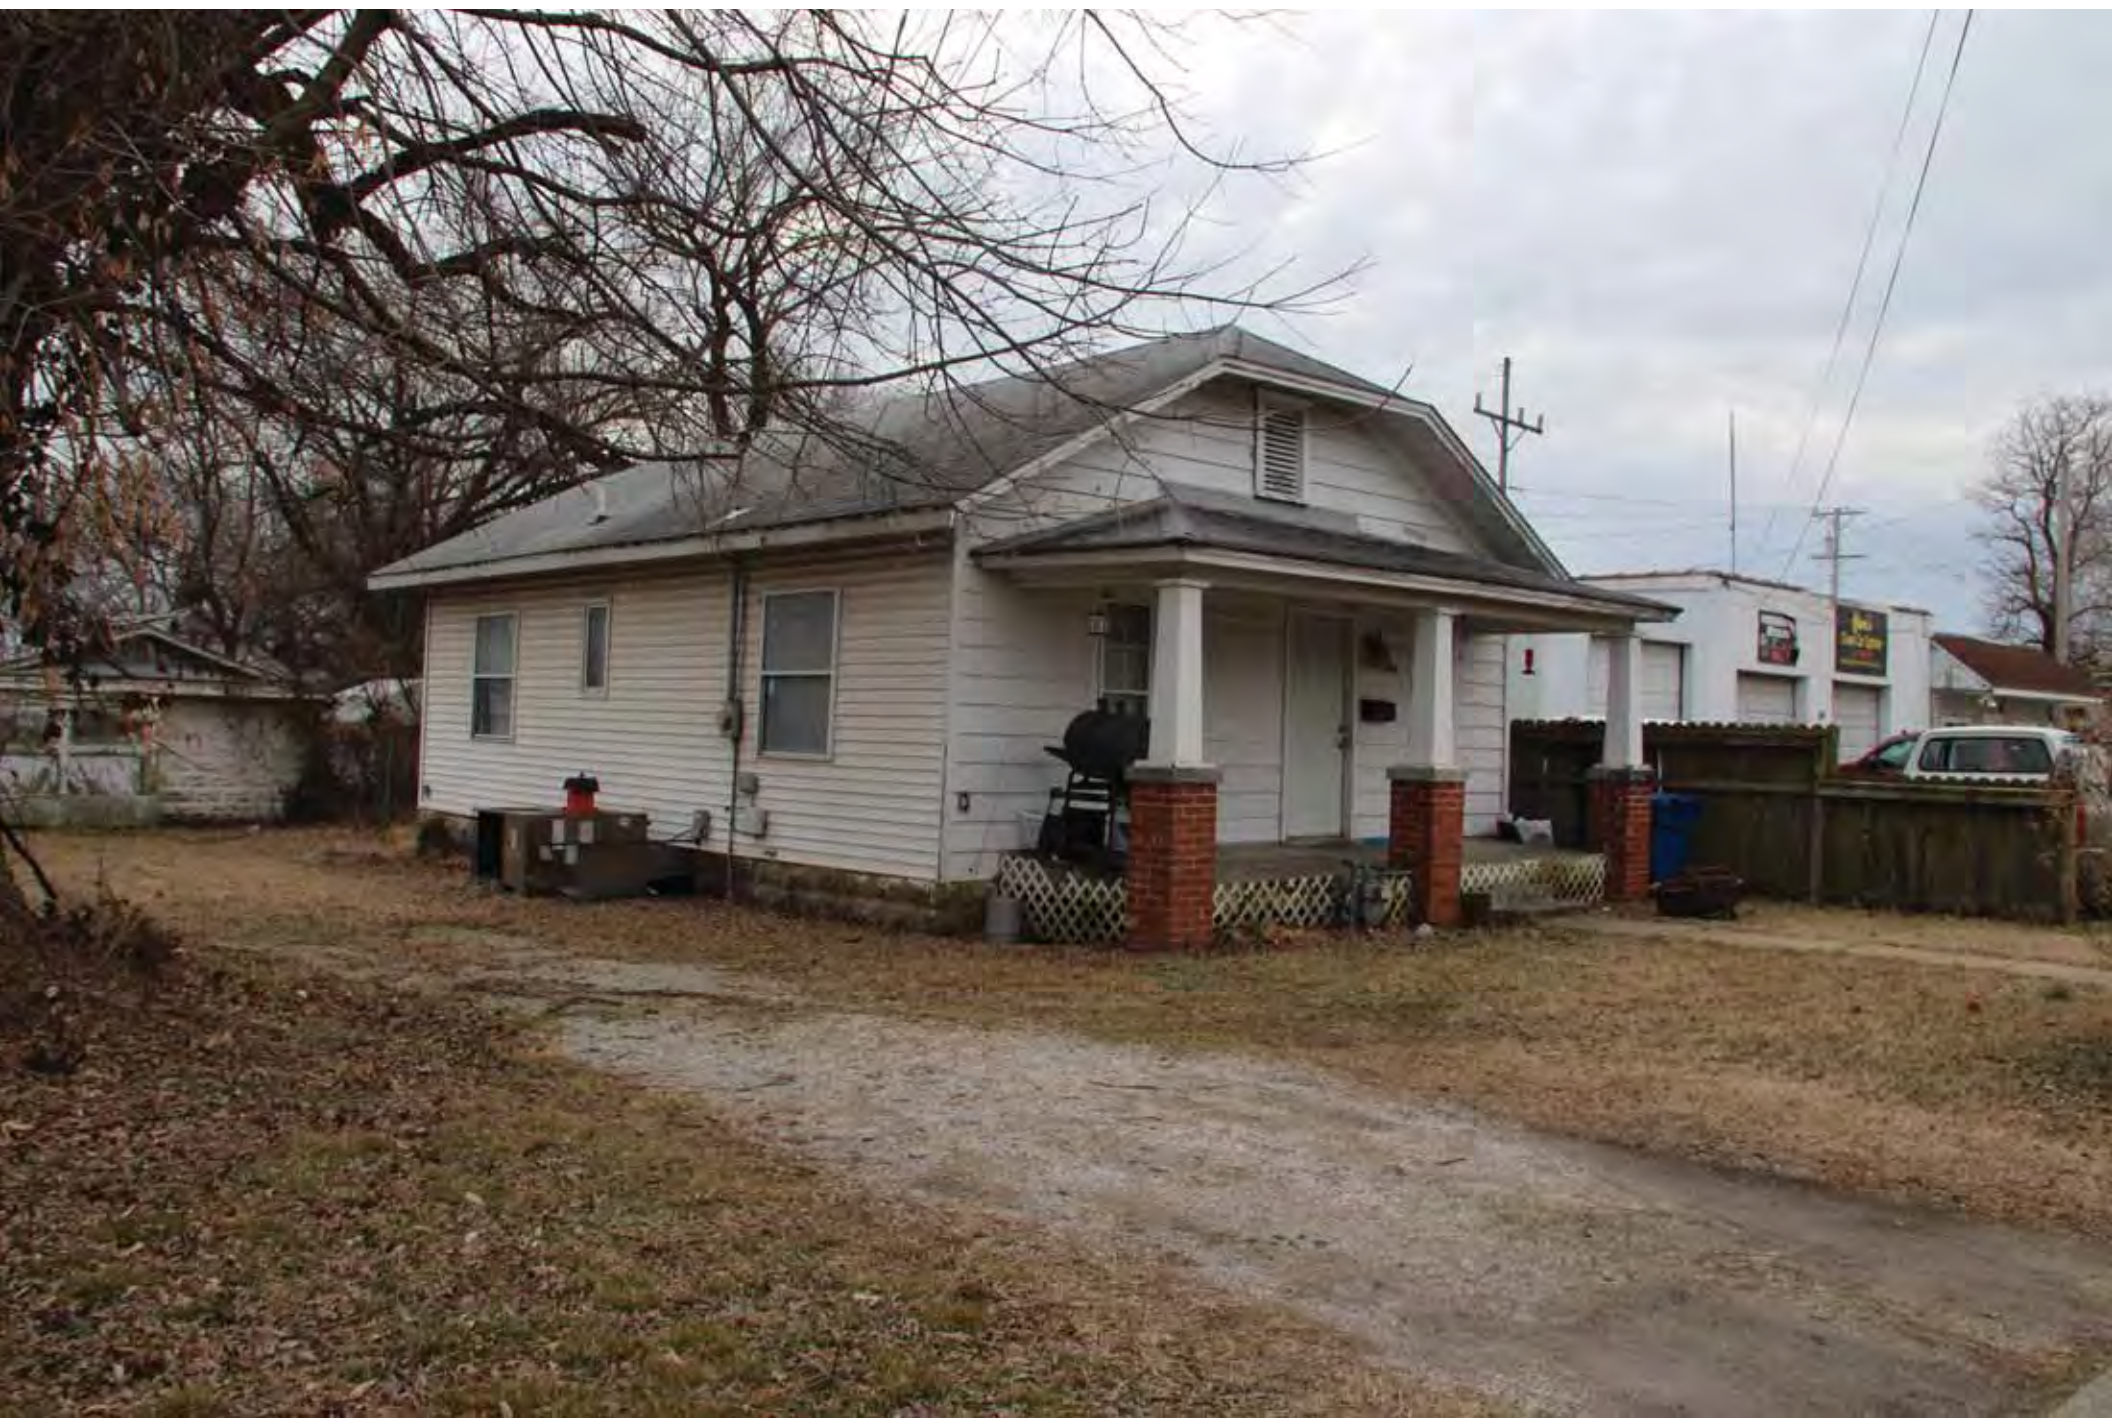
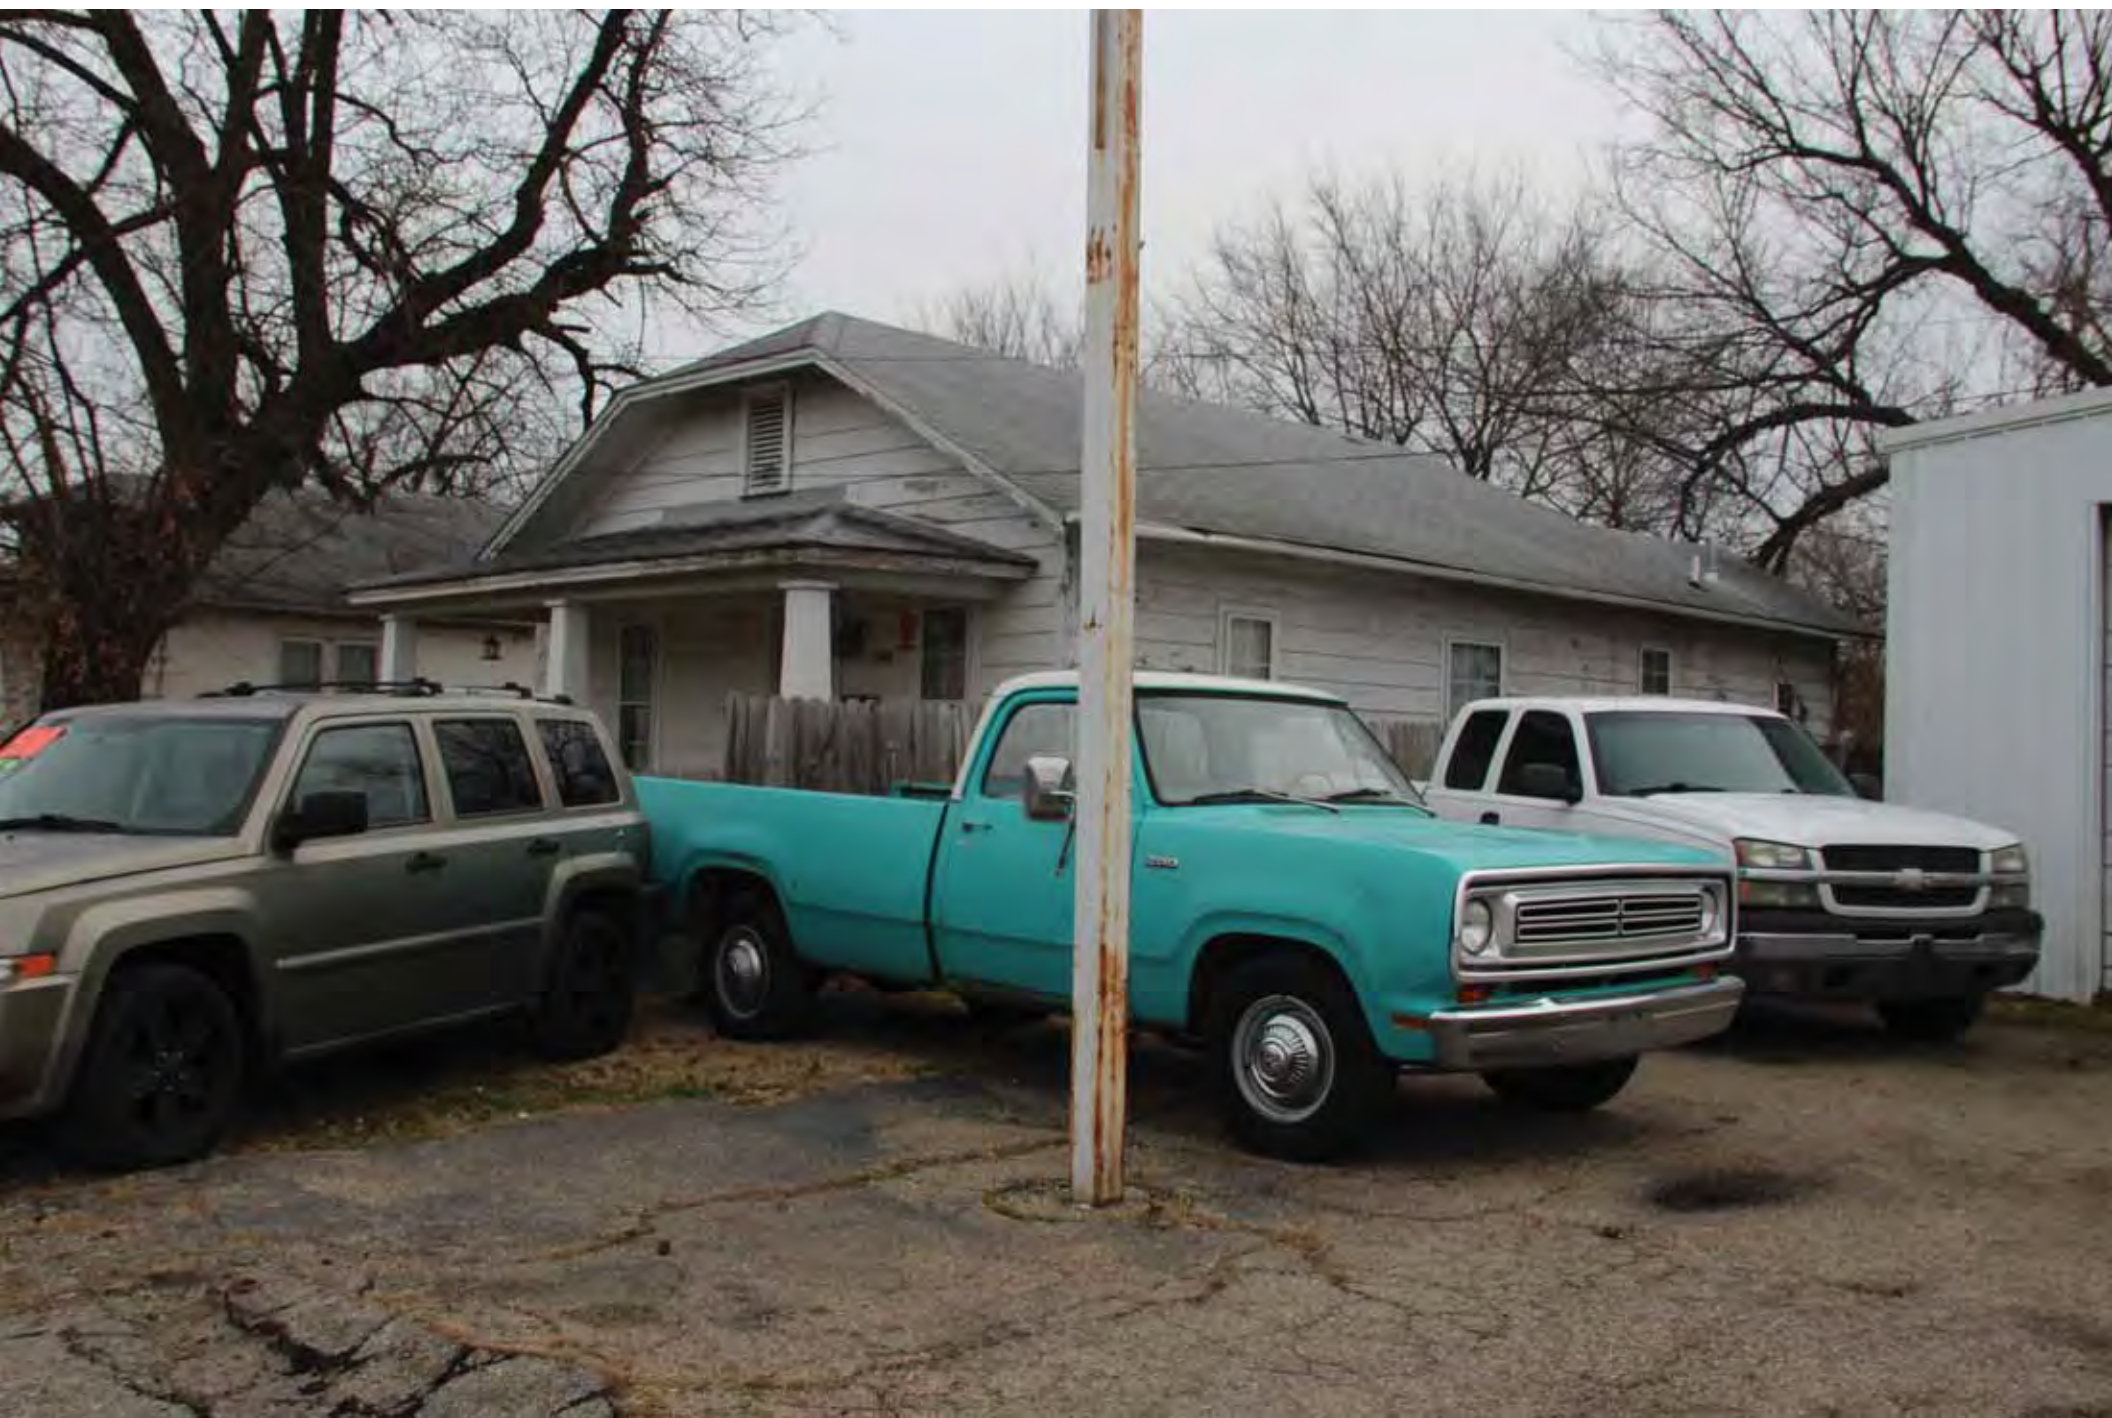
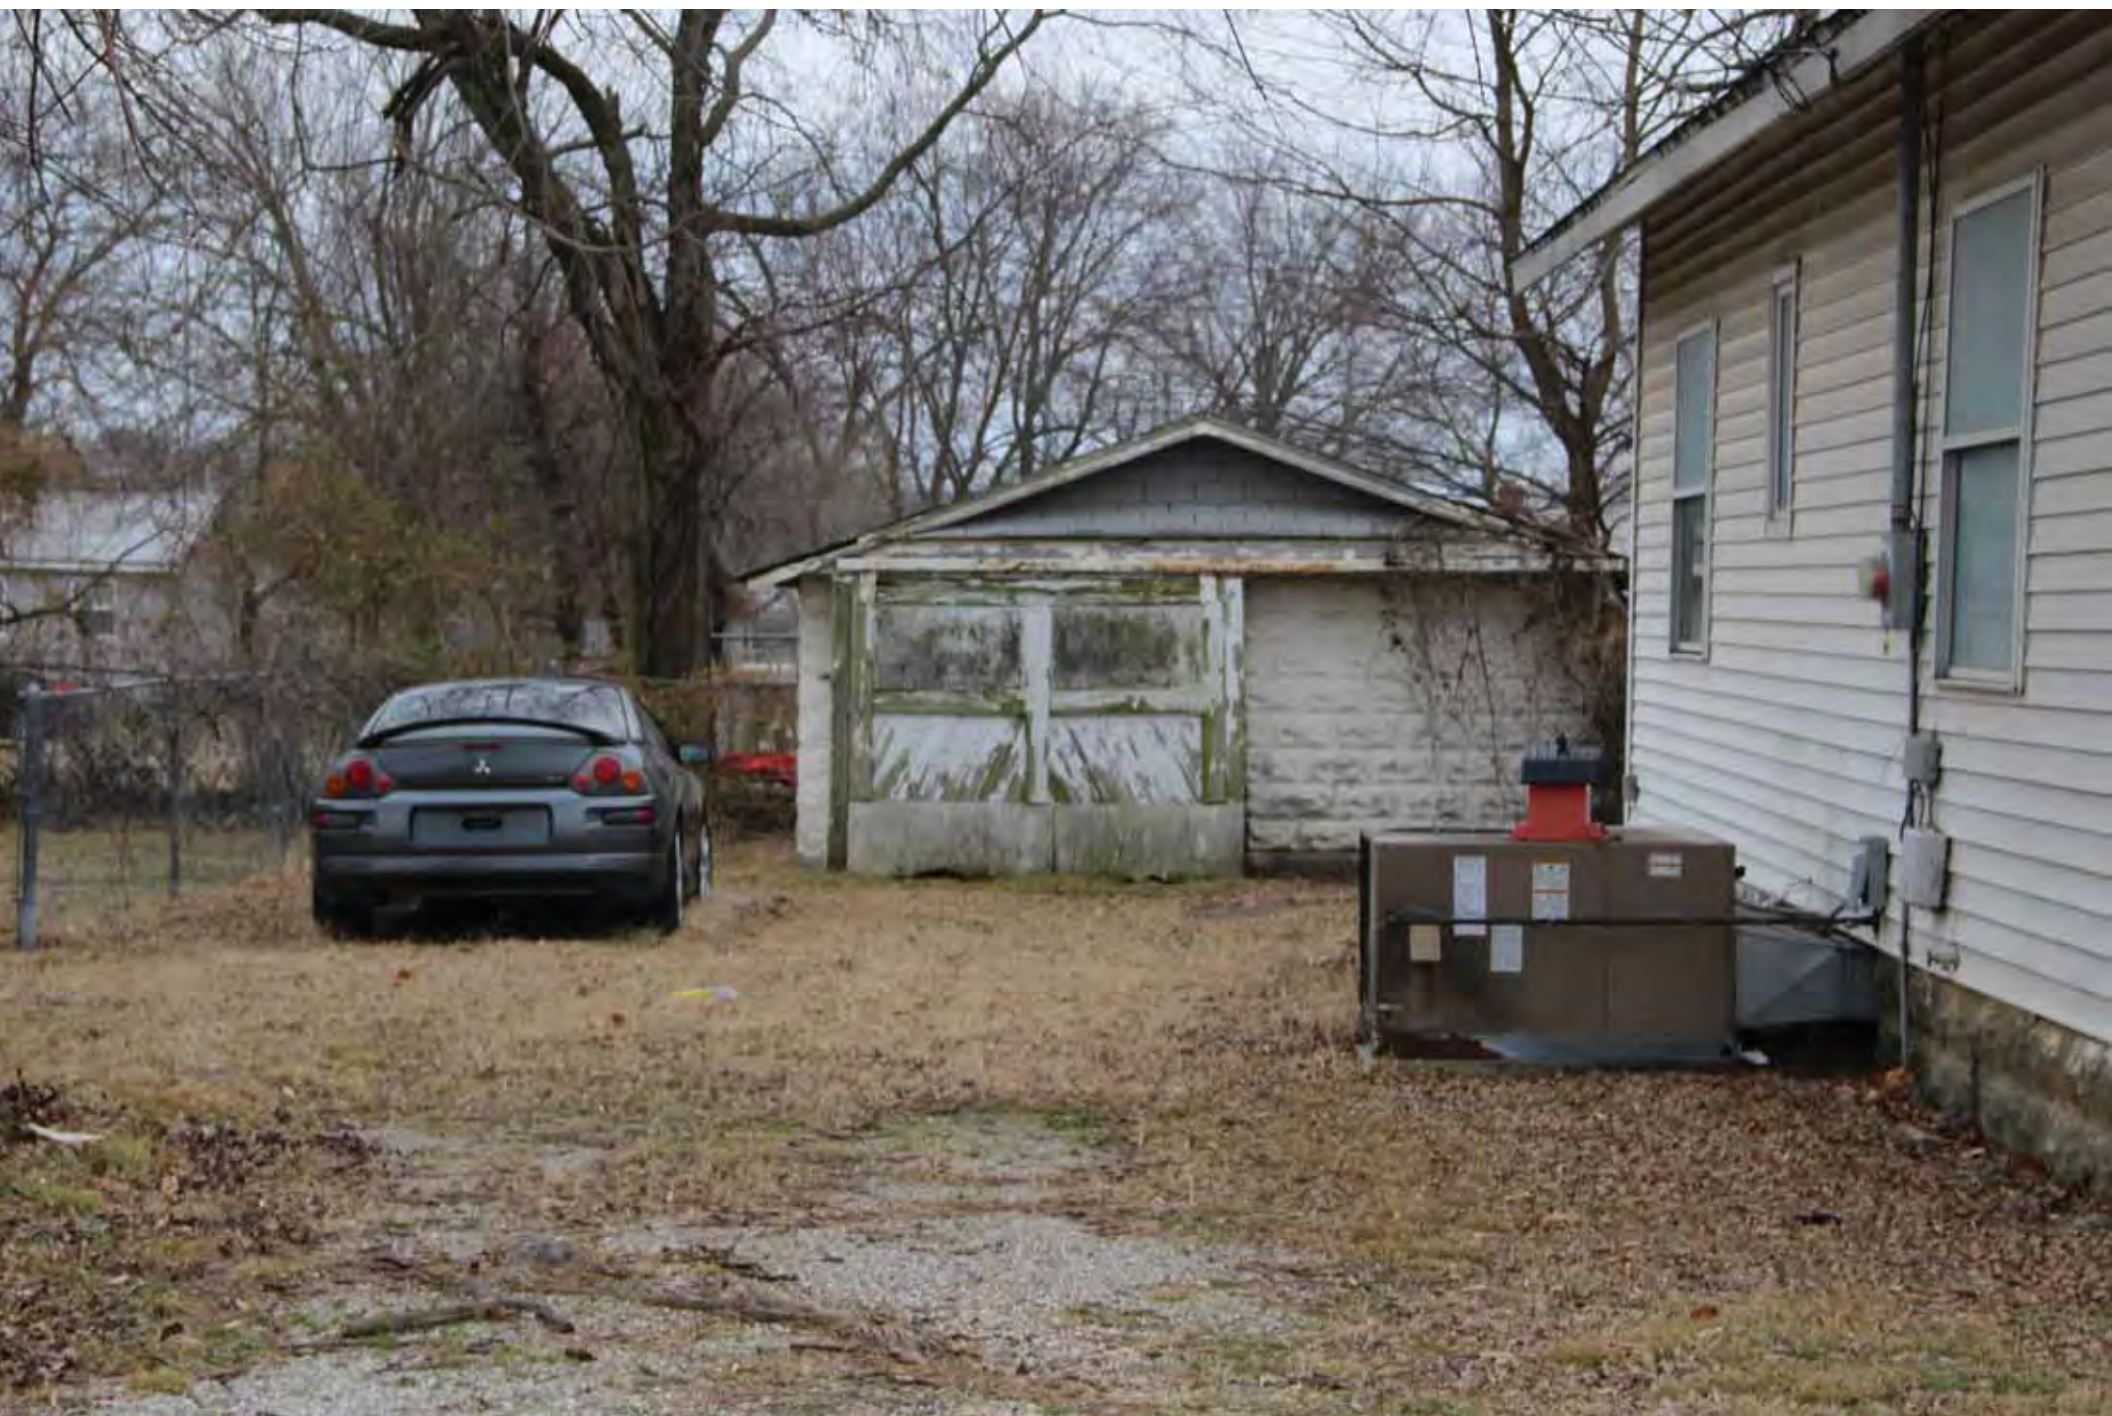
This dwelling has been altered through the addition of synthetic siding on the east elevation. Additionally some windows have been replaced in recent years. For these reasons, the property suffers loss of its architectural (Criterion C) integrity. Research failed to associate the dwelling with any individual (Criterion B) or historical association (Criterion A) that would render the property eligible. The dwelling is not in an area recommended as a historic district. For these reasons, 1306 E. Broadway does not appear eligible for the National Register of Historic Places.

The property at 1306 E. Broadway Street features a single-story clipped gable Bungalow with an asphalt shingled roof, exterior wood (primary and west elevations) and vinyl (east elevation) siding, and a textured block foundation. The primary (north) elevation features a hipped original porch with tapered columns resting on brick piers. The entry is slightly off center within the porch and holds a replacement paneled door. The door is flanked by original four-over-four windows. Above the porch is a louvered vent. The east elevation has replacement one-over-one and a fixed sash small window. The west elevation retains one four-over-four original window – the remaining windows on this elevation appear to be replacement.

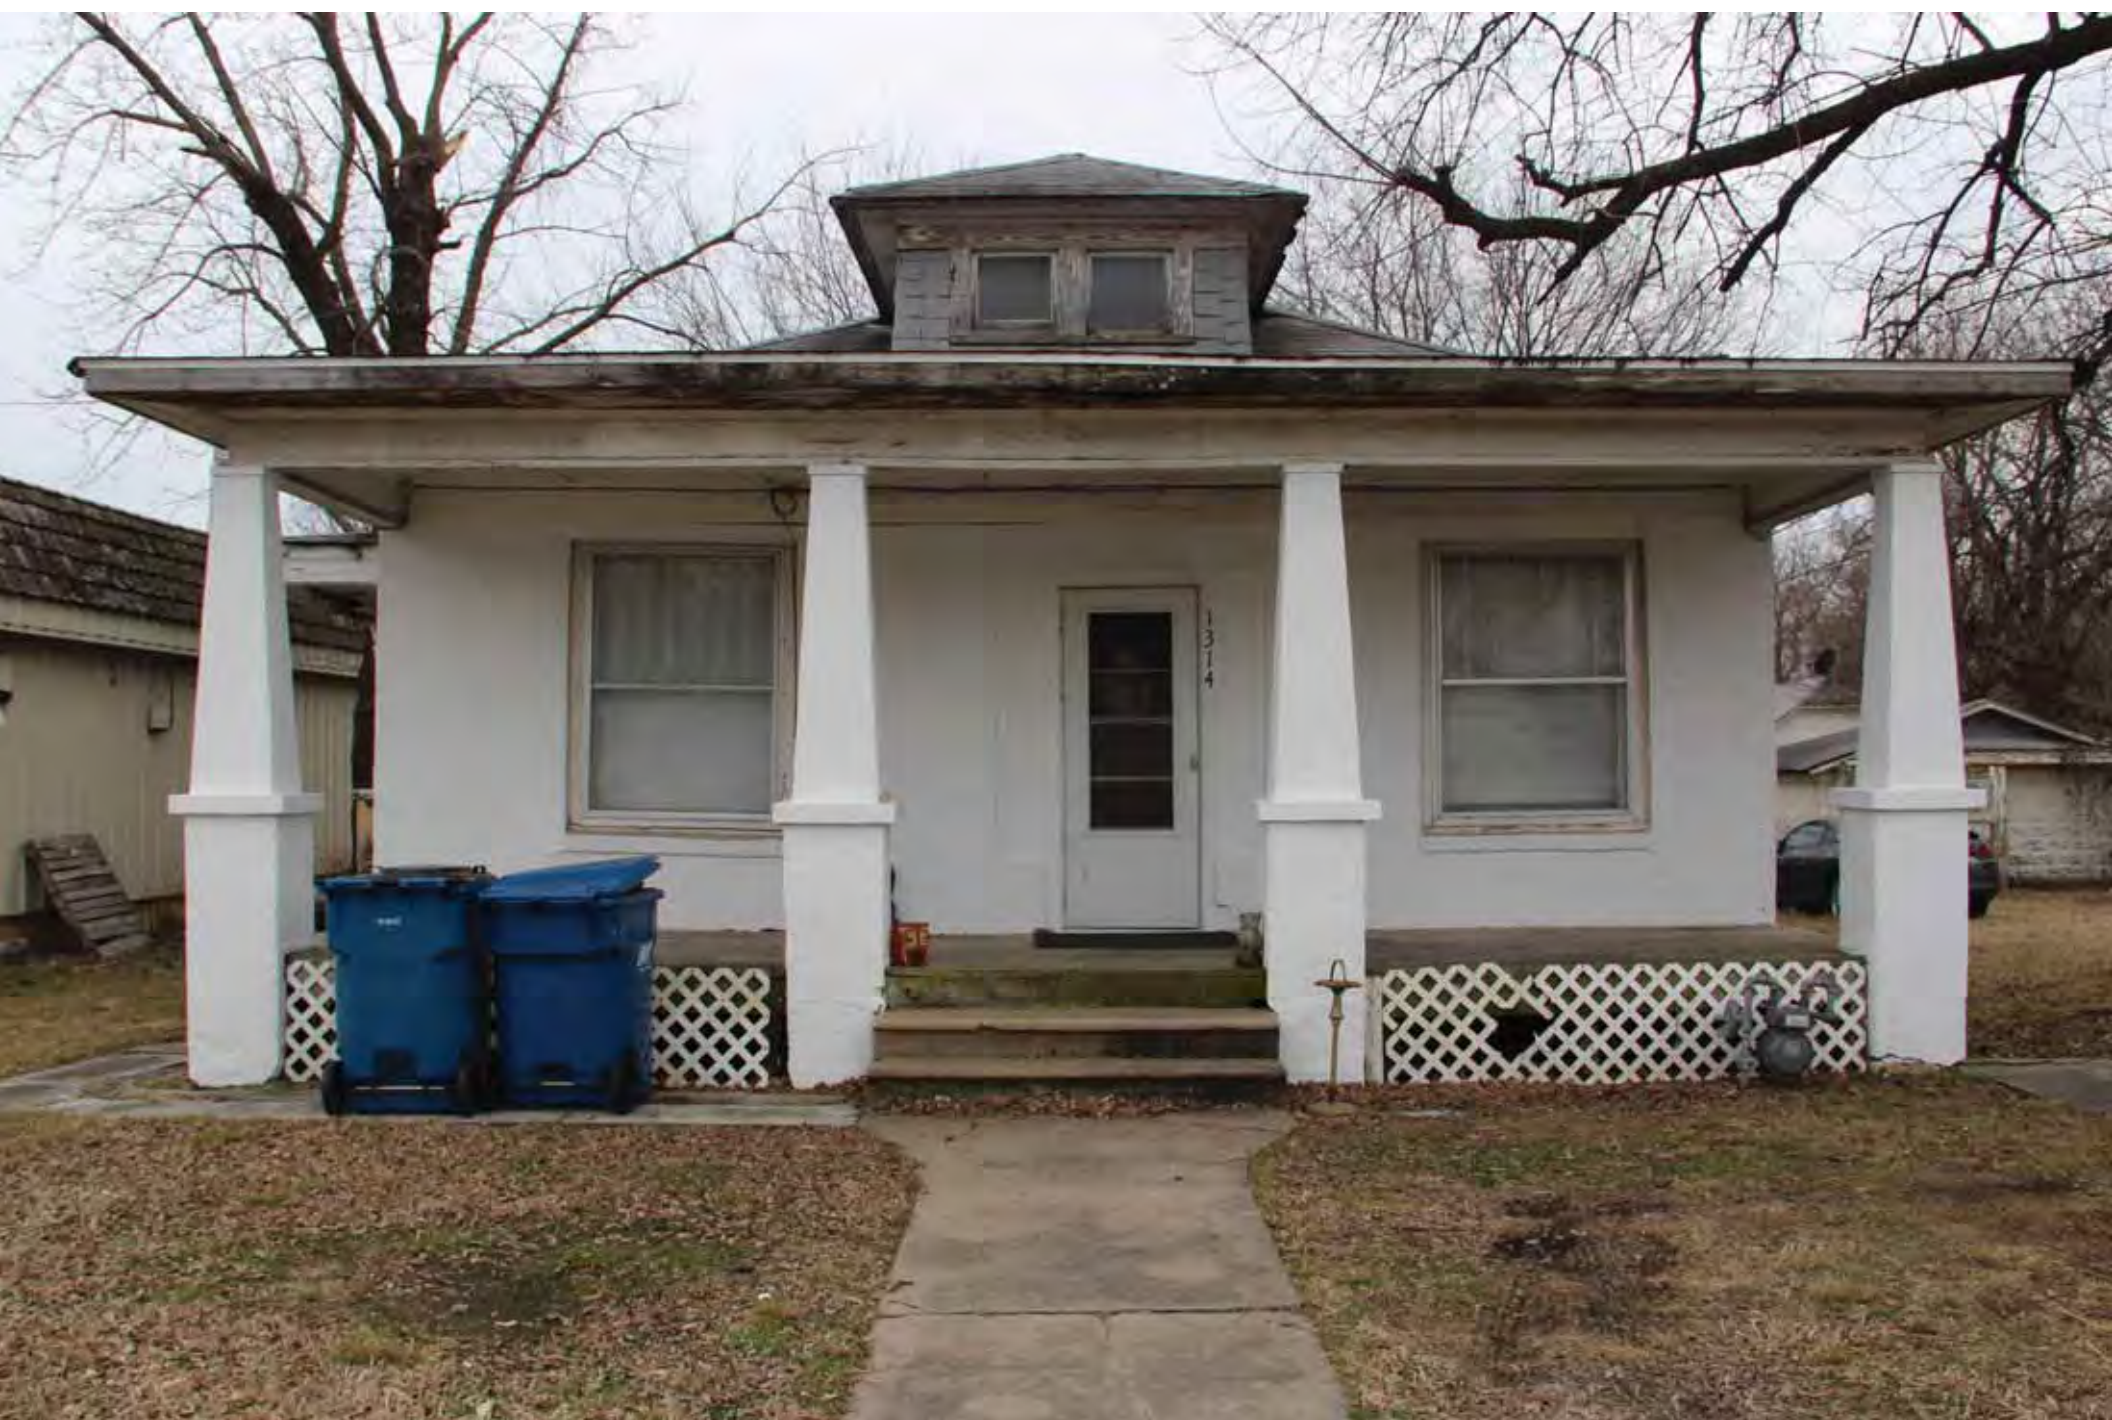
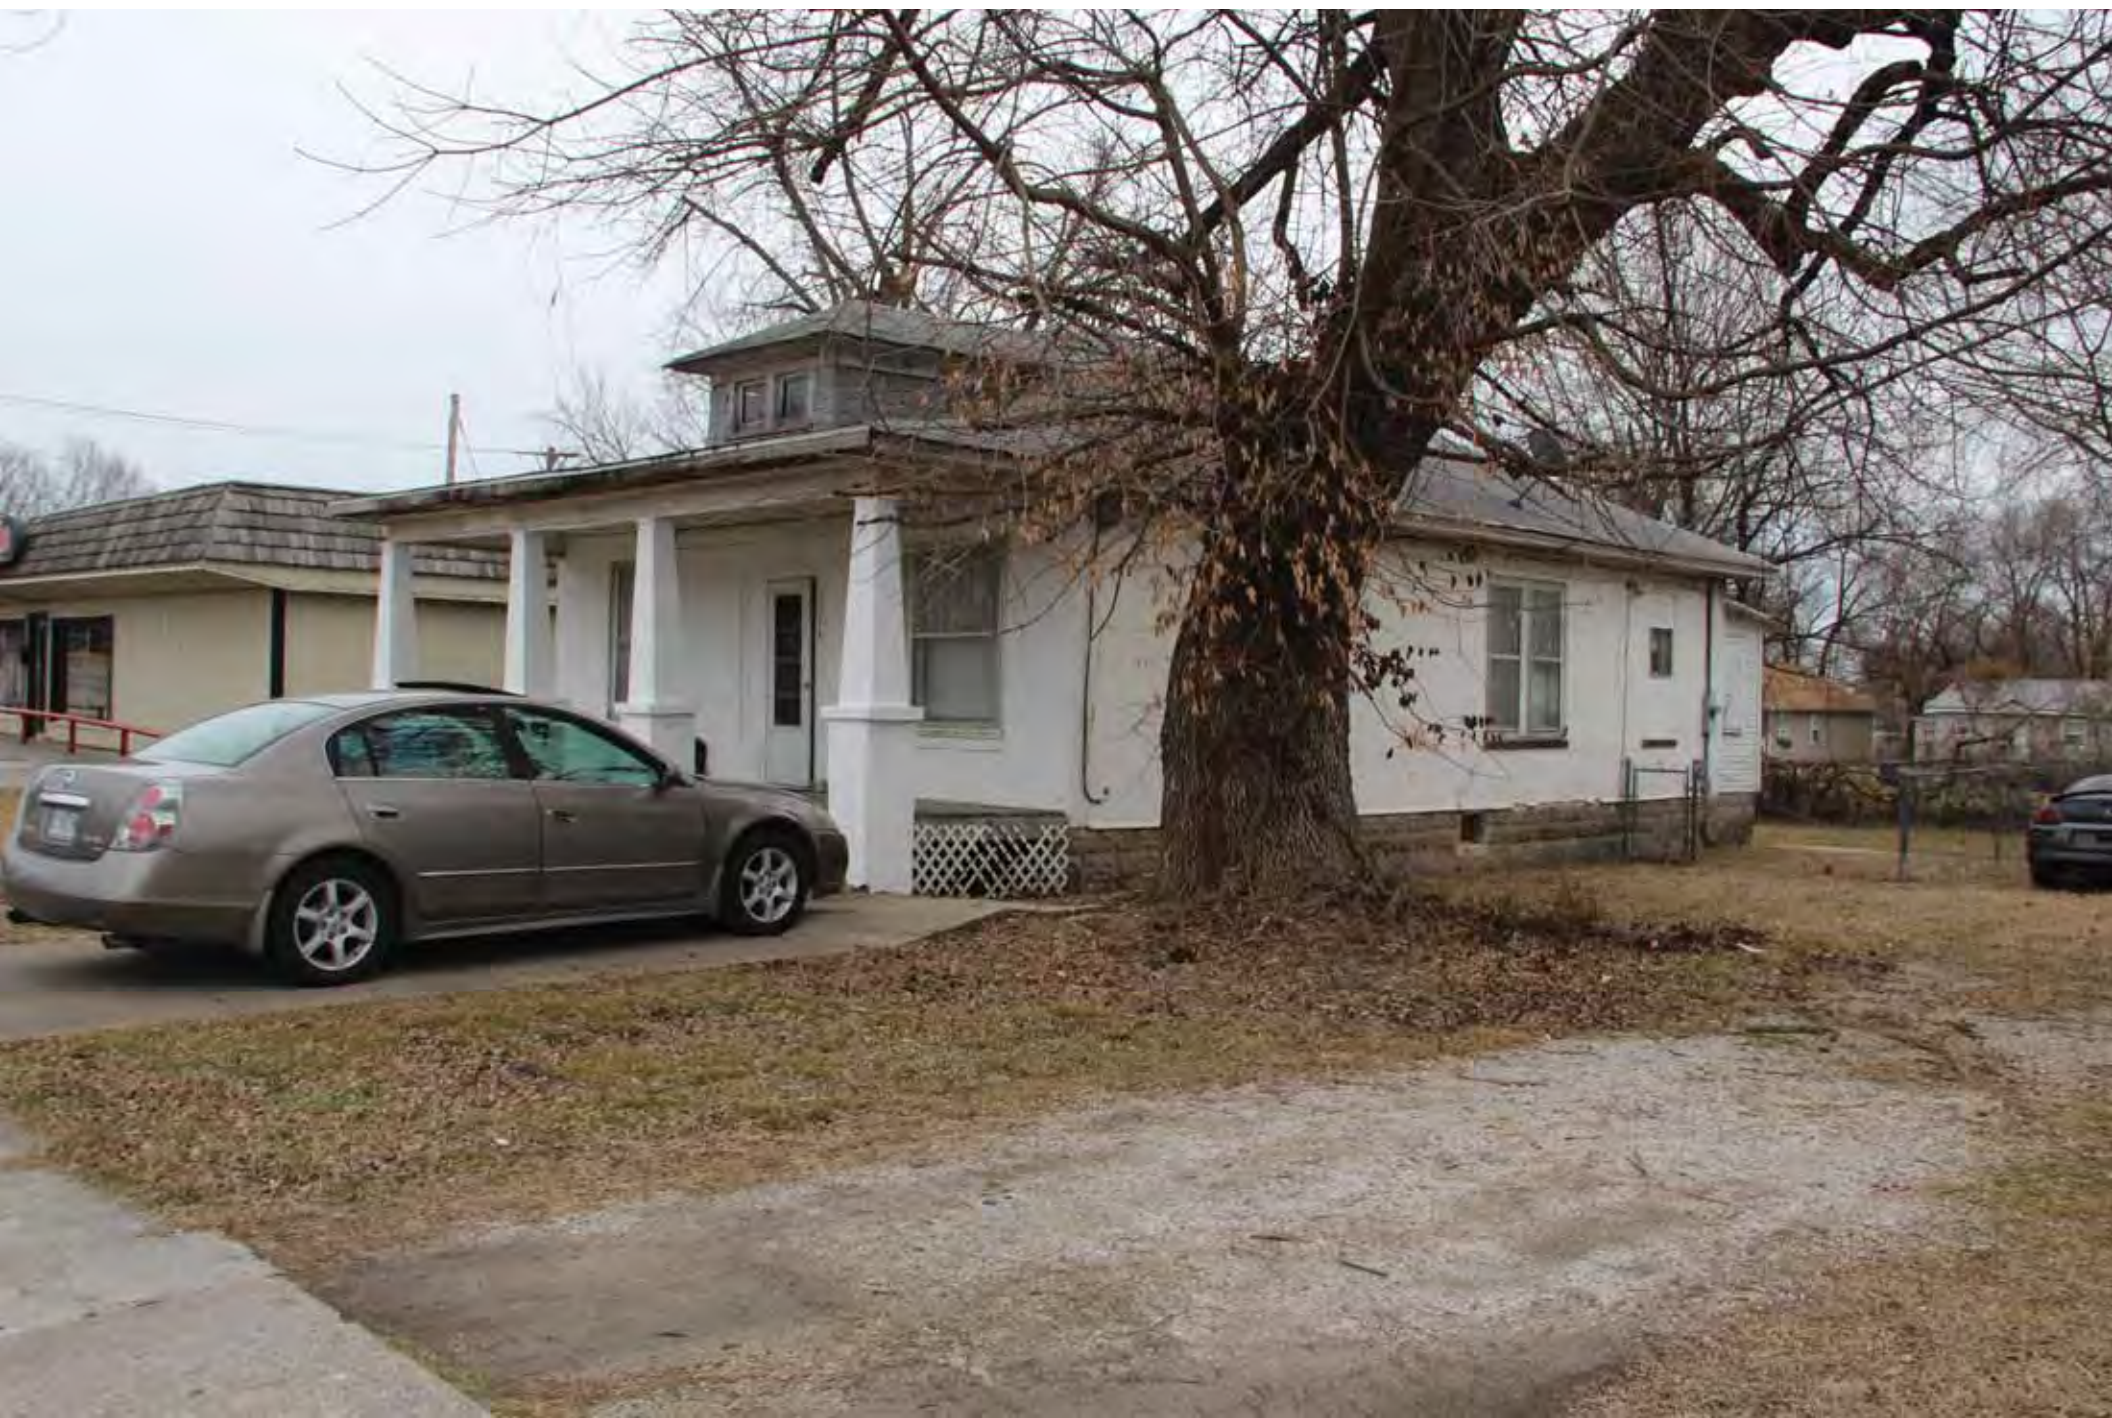
The property at 1314 E. Broadway Street features a single-story Craftsman style Bungalow with a hipped asphalt-shingled roof, exterior stucco walls and a textured concrete block foundation. The primary (north) elevation features a full-width hipped porch supported by tapered columns on stucco clad piers. The porch floor is frame and the foundation is pier, surrounded by lattice. The primary entry is slightly off center within the porch and holds a single-light door flanked by original seven-over-one windows. Above the porch is a hipped dormer clad with asphalt shingles. The dormer features two single-sash original casement windows. On the east elevation is a secondary porch with a flat hipped roof supported by milled columns resting on stucco clad posts. The porch leads to an entry offset by a single window. The remaining elevation features two sets of paired windows and a single window. The west elevation holds two sets of paired windows and a small upper elevation window. The dwelling has a rear shed wing clad with weatherboard.
