MISSOURI DEPARTMENT OF NATURAL RESOURCES
STATE HISTORIC PRESERVATION OFFICE, P.O. Box 176, Jefferson City, MO 65102
ARCHITECTURAL/HISTORIC INVENTORY FORM

1. Survey No. JP-AS-007-001		2. Survey name: East Town (Original Joplin) Historic Survey Phase 2	
3. County: JASPER		4. Address (Street No.) 618	Street (name) E. 2 nd Street
5. City: Joplin	Vicinity: <input type="checkbox"/>	6. Geographical Reference:	7. Township/Range/Section: T: R: S:
8. Historic name (if known):		9. Present/other name (if known):	
10. Ownership: <input checked="" type="checkbox"/> Private <input type="checkbox"/> Public		11a. Historic use (if known): Domestic: Single Dwelling	11b. Current use: Domestic: Single Dwelling

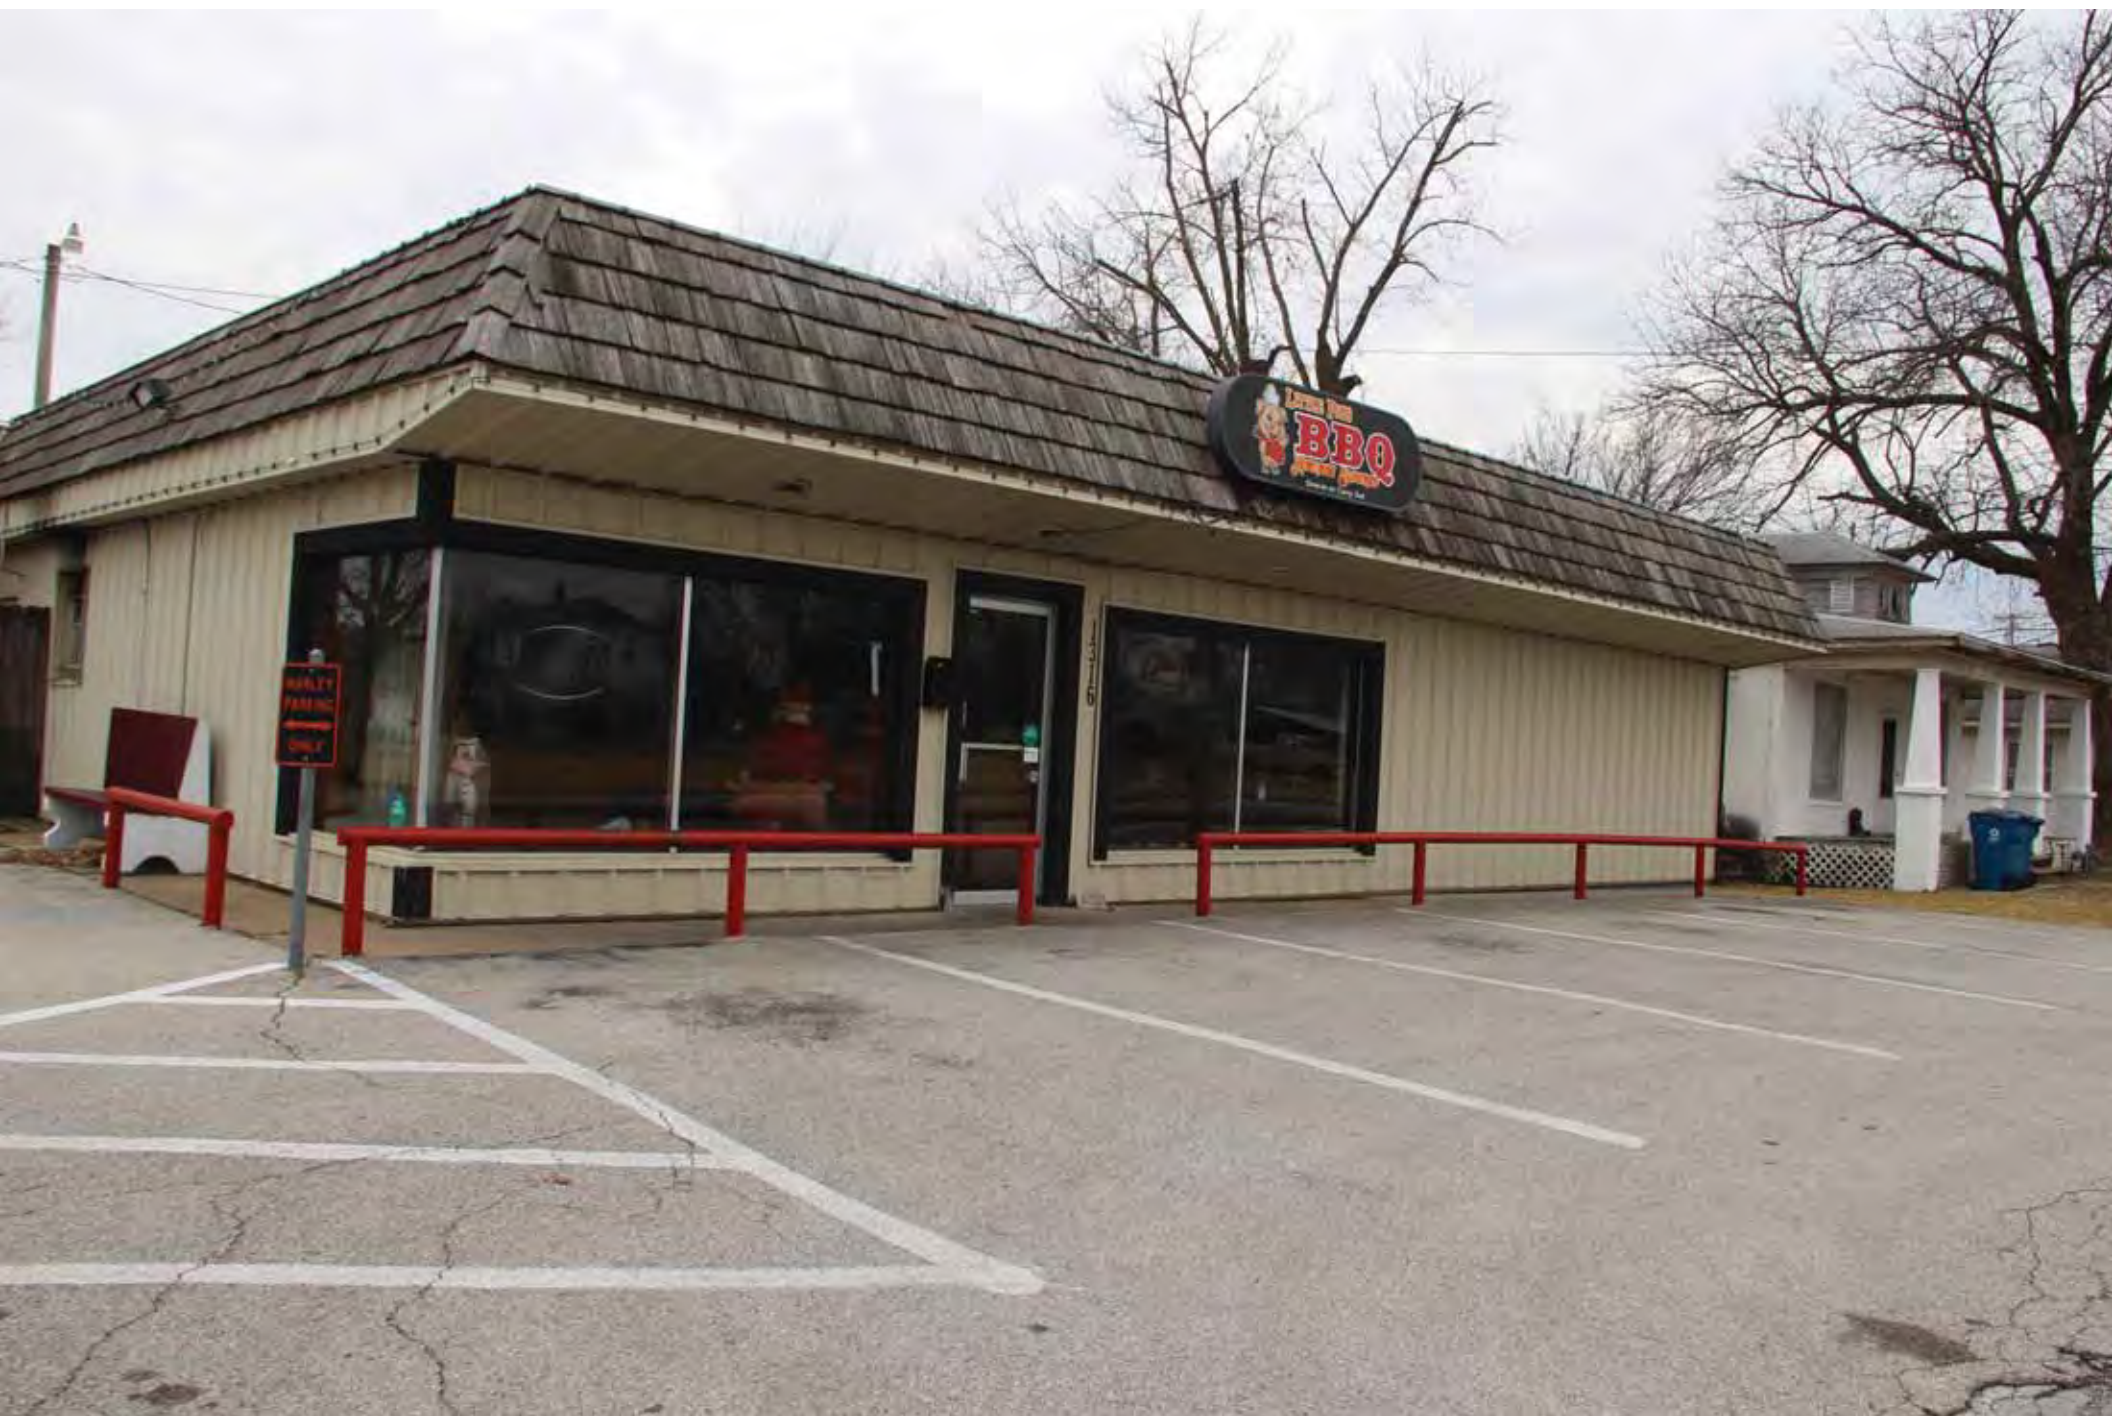
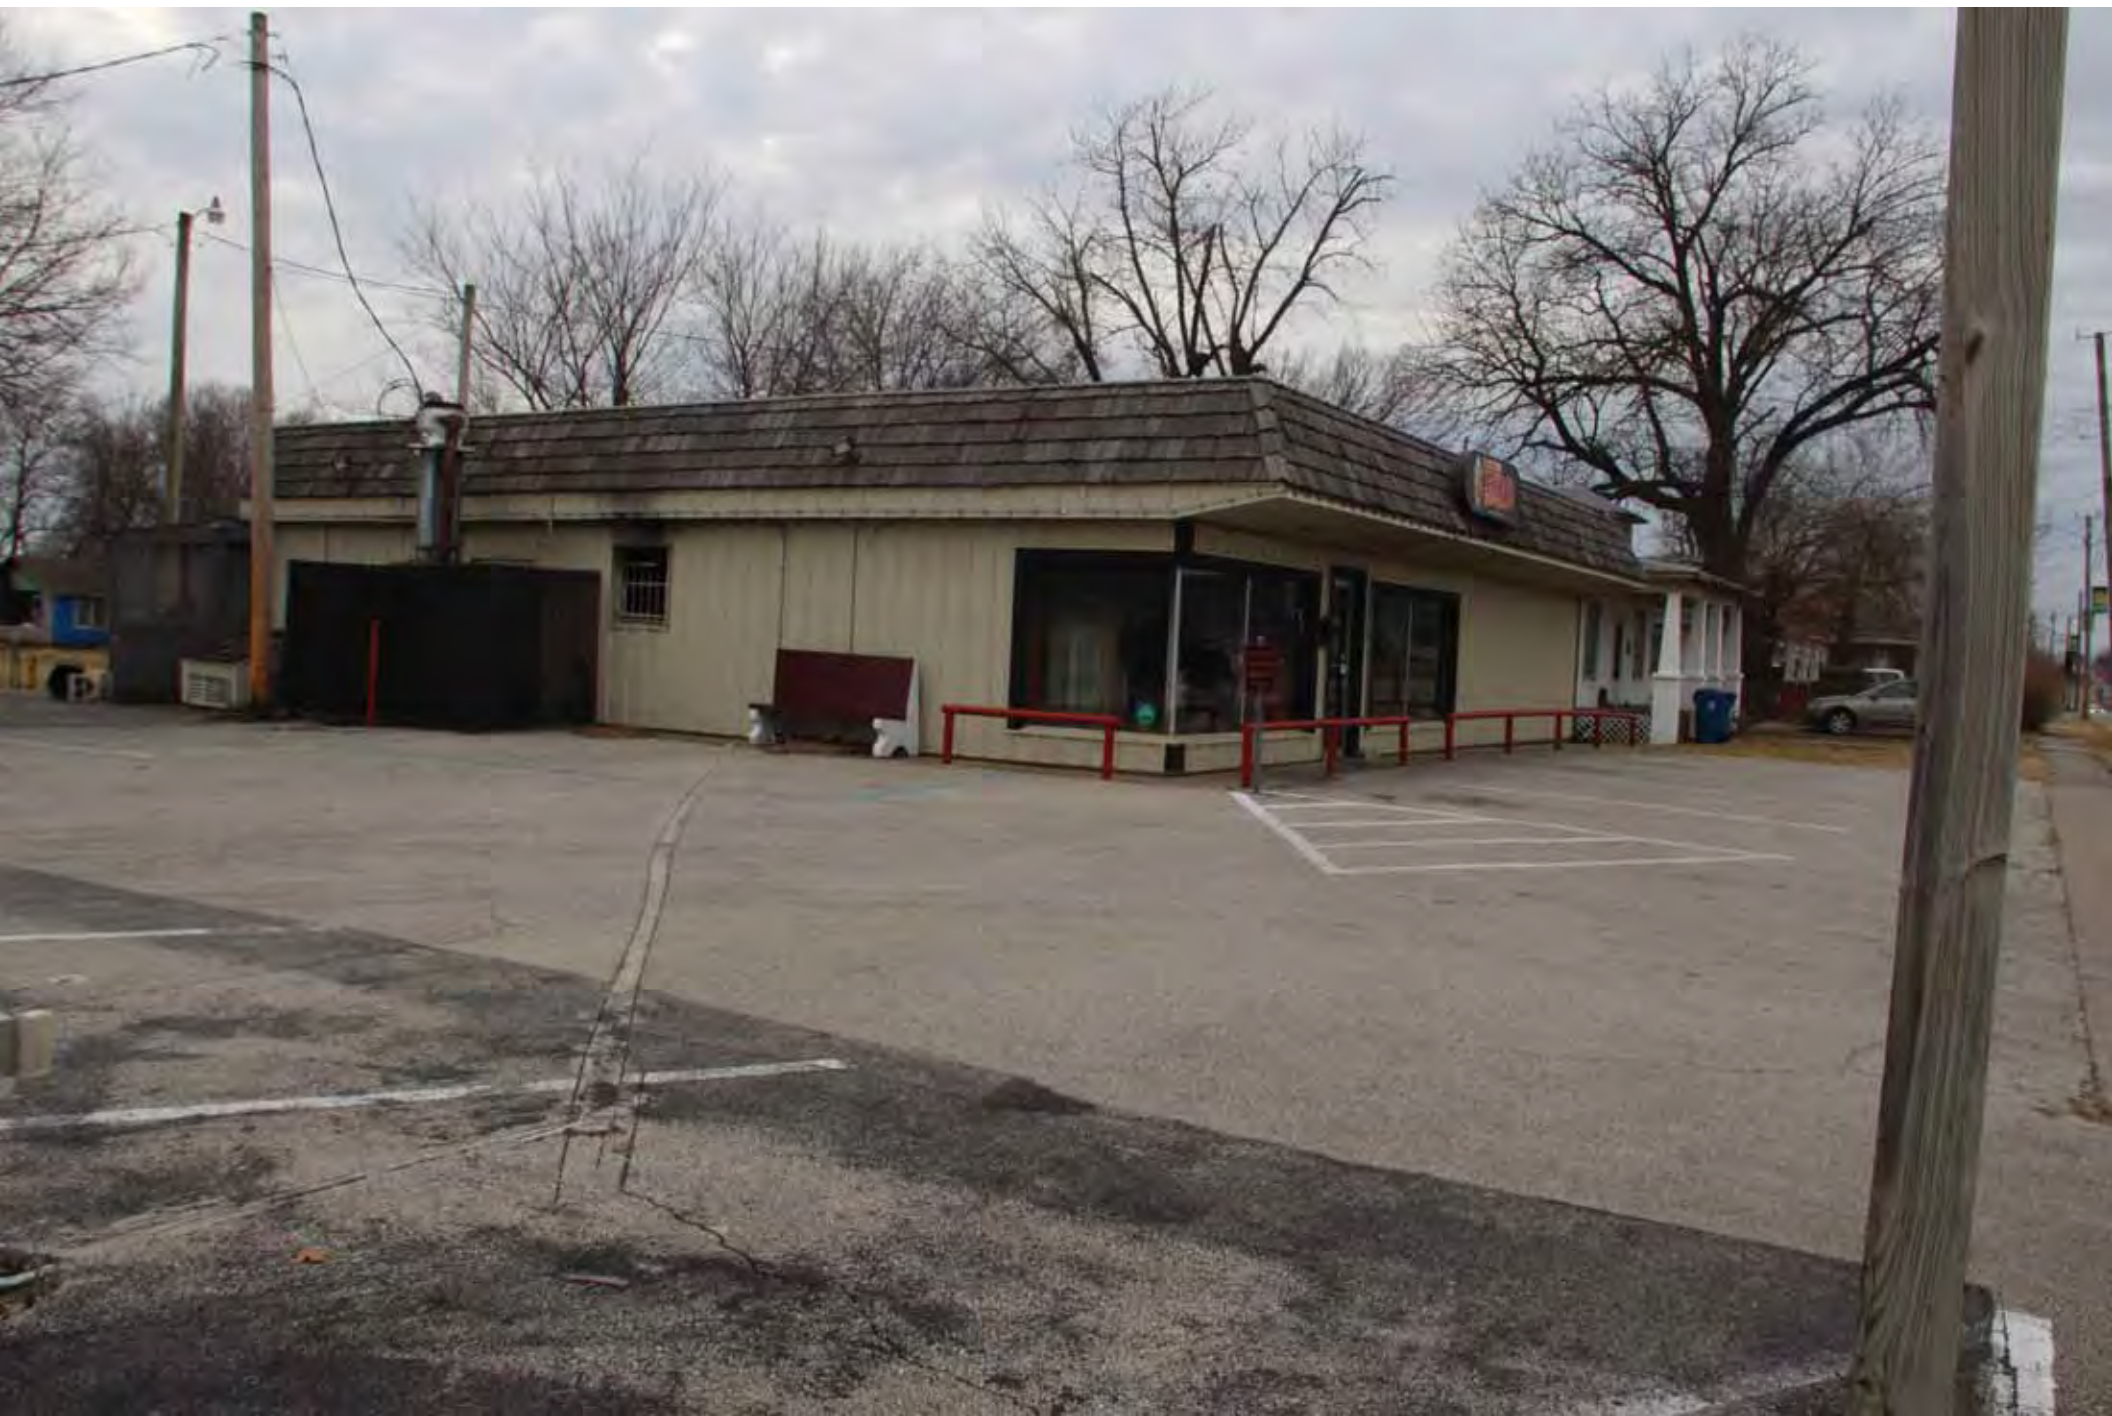
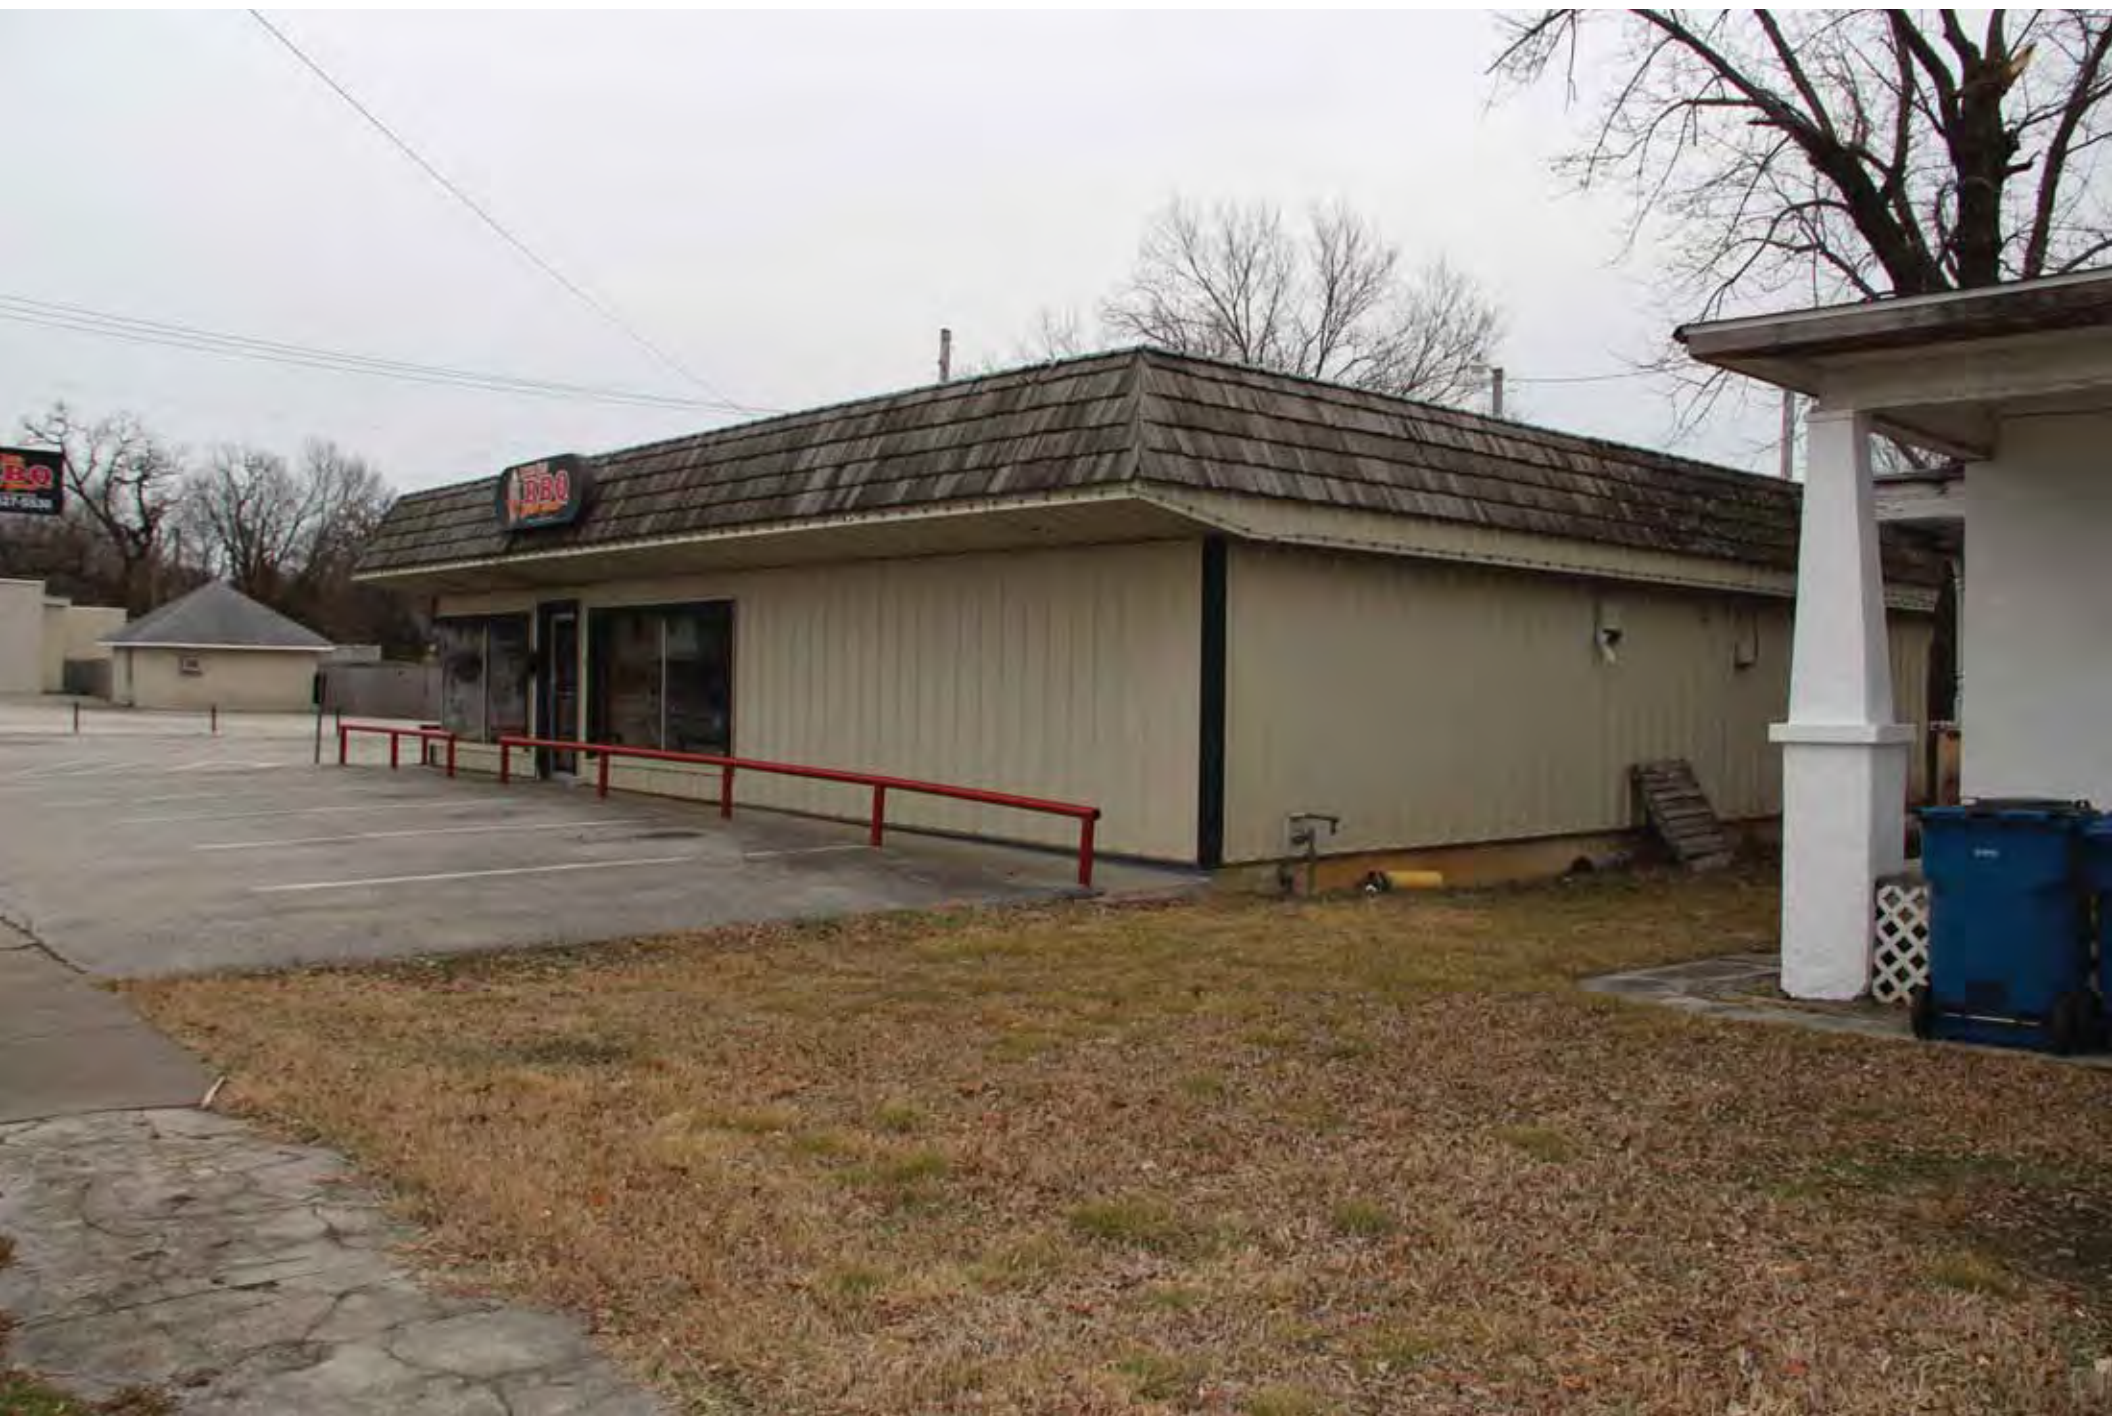
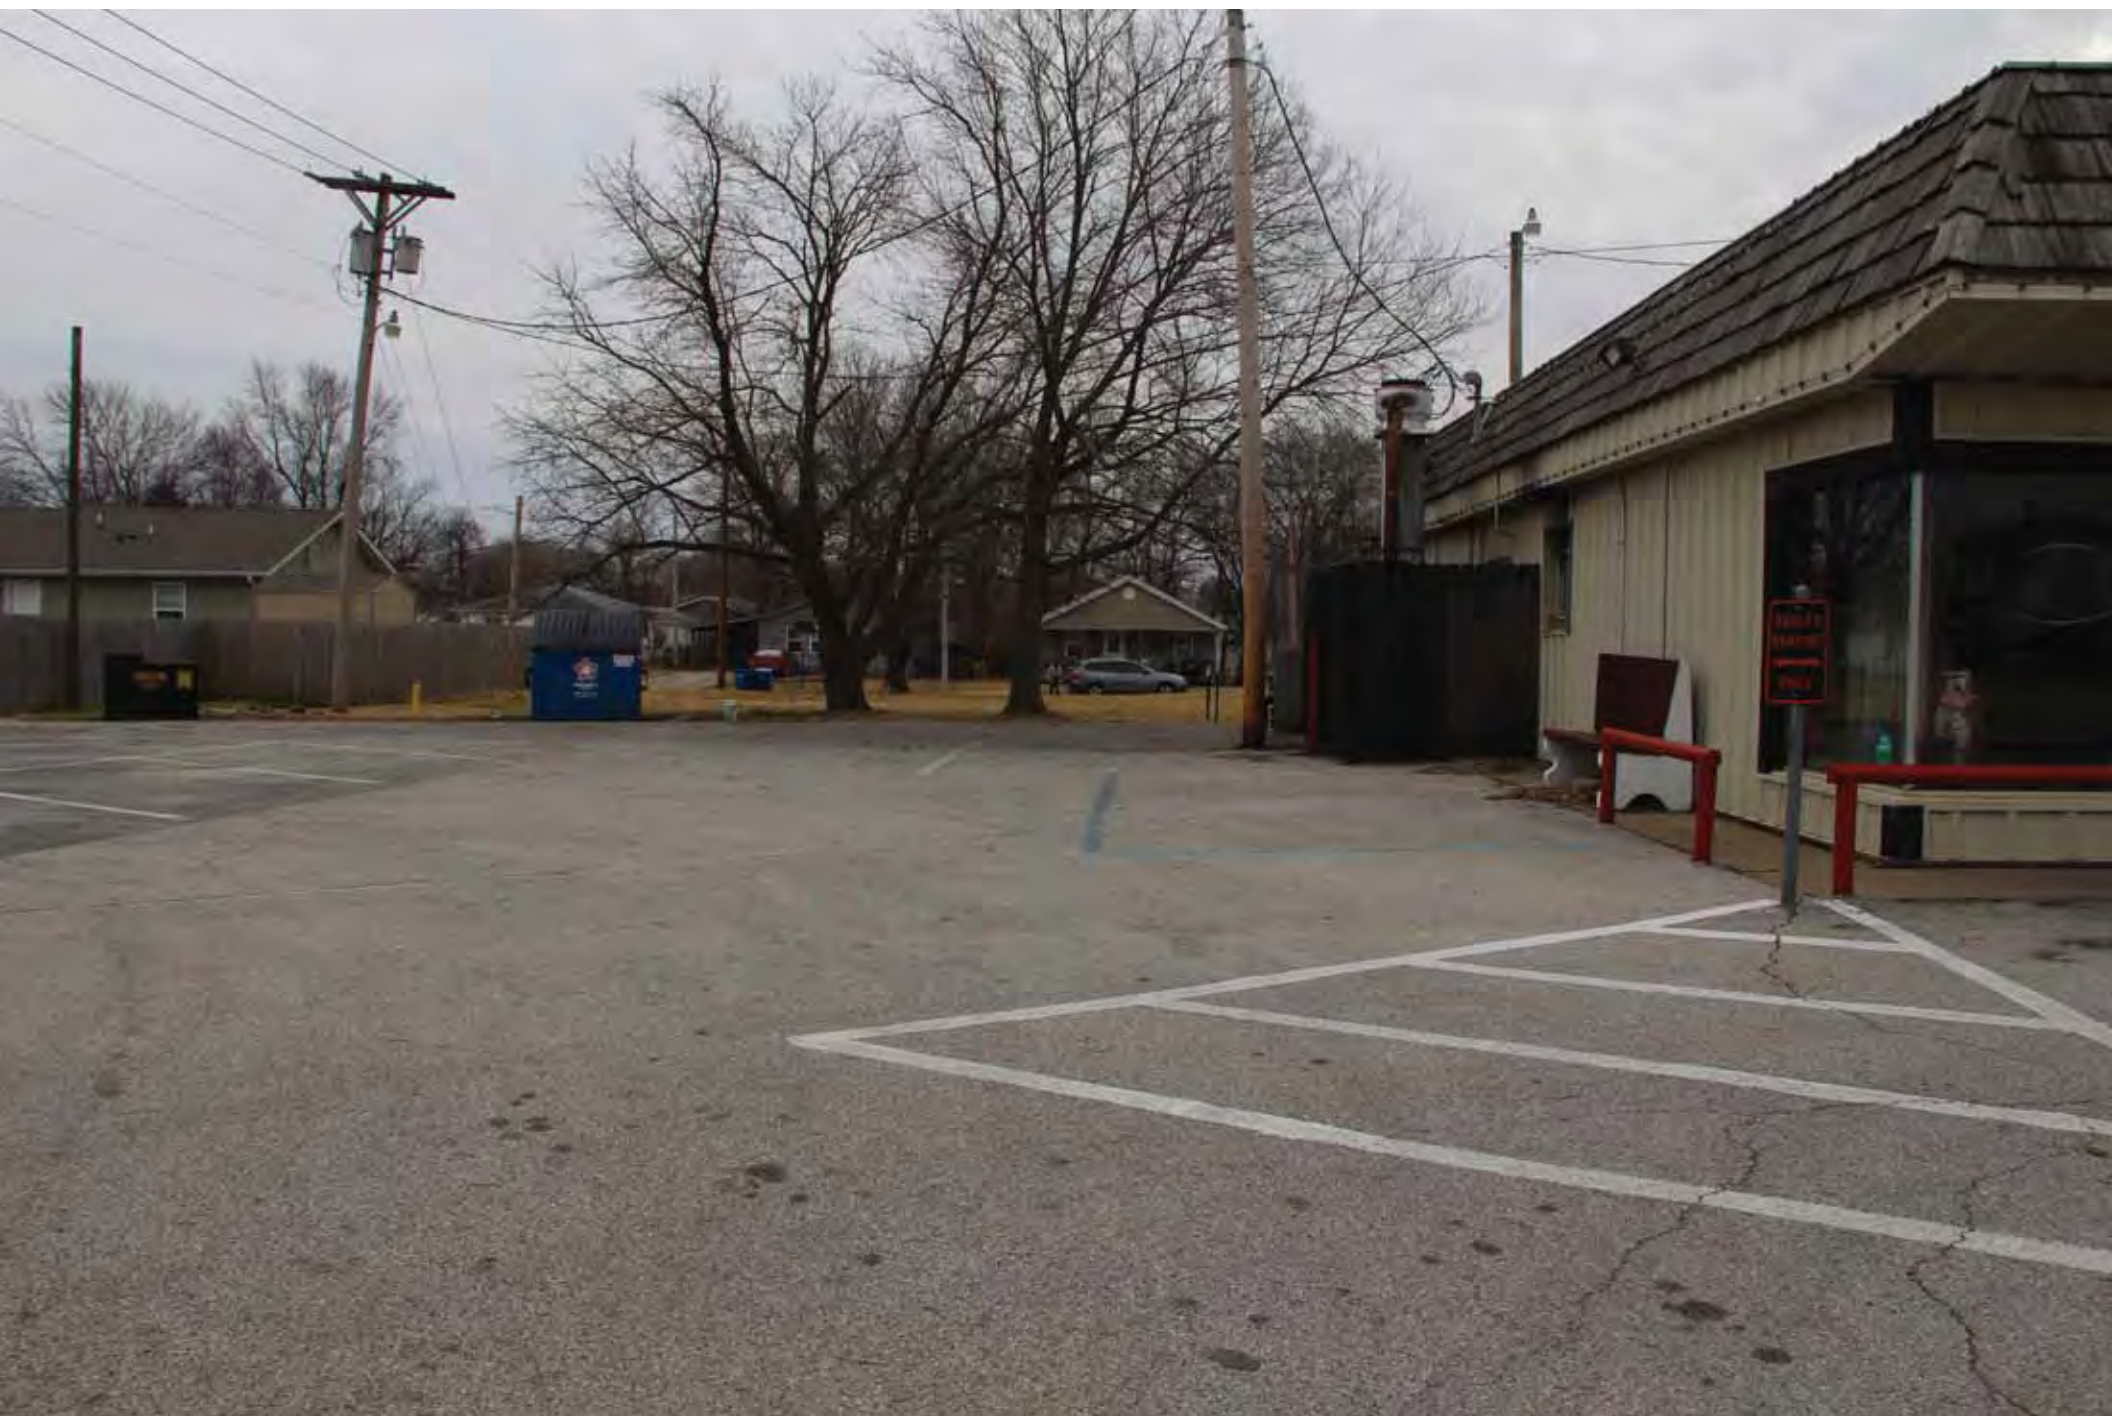
The building associated with this parcel is a single-story rectangular commercial property. The building has exterior prefabricated metal siding and a wood shingled fixed awning that surrounds the façade and side elevations. Centered on the awning at the north (primary) elevation is a prefabricated sign. The primary entry is off-center on the façade, filled with a single-light aluminum framed door. Flanking the entry are large fixed commercial windows with slender aluminum framing. The commercial windows wrap the northwest corner. The west elevation features a small pick-up window. Near the south end of this elevation is a privacy fence. The rear (south) elevation features a screened porch. There is no fenestration on the west elevation.

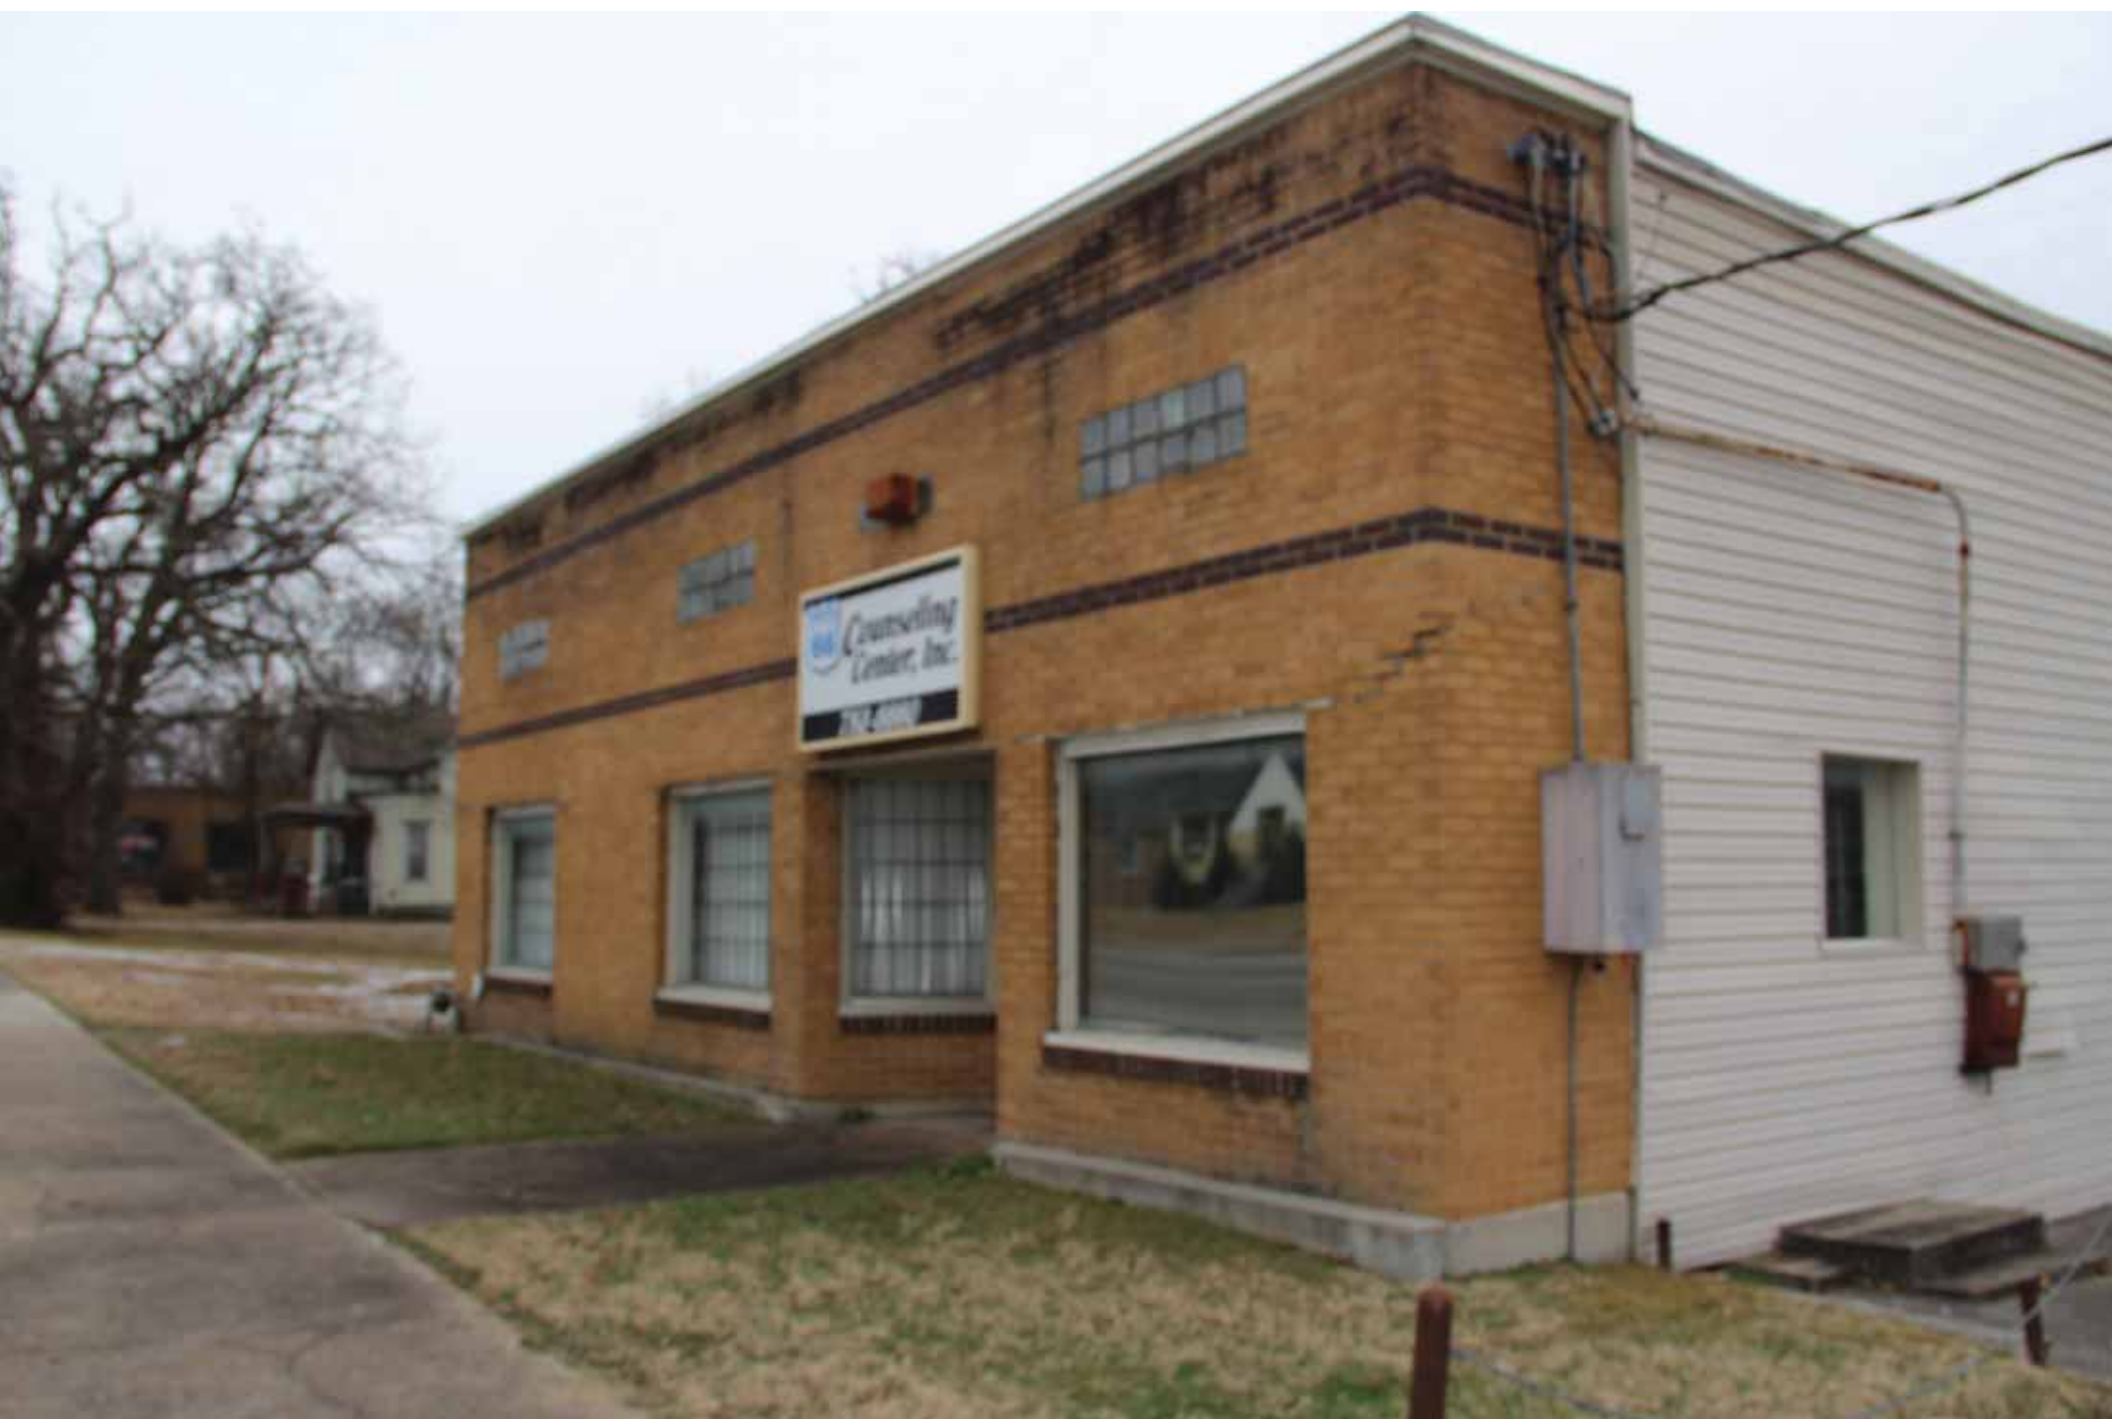
The building associated with this parcel is a two-story commercial building with exterior blonde brick walls, a flat roof and a concrete foundation. The primary and east elevations retain exposed brick walls, which feature two continuous bands of dark red brick framing the second floor windows. The primary (north) elevation features an off-center recessed primary entry bay. Within the bay, the north elevation features an original single-light aluminum framed door covered with a metal grate. Walls flanking the door are slightly angled, each featuring a single large commercial window. The window on the east is original with multiple lights; the west window is single-sash replacement design. All first floor windows retain original dark brick sills. Above the entry bay is a sign bearing the name of the current tenant. The second floor of the primary elevation features three slender glass block windows. Glass blocks are arranged to create a basket weave pattern. The east elevation, upper floor, retains two large original glass block windows. The lower floor windows are multi-sash. A secondary entry is noted at the north end of the east elevation, filled with a single-light door similar to that on the façade. An original metal awning is intact above the door. At the northwest corner of the primary building block is an attached rear warehouse clad with non-original vinyl siding. The rear wing has a stepped roof and no fenestration on the north or west elevations. A large rear brick chimney rises above the roofline near the vinyl wrapped wing. The west elevation of the primary building is likewise clad with vinyl siding. The elevation has one small multi-light window.

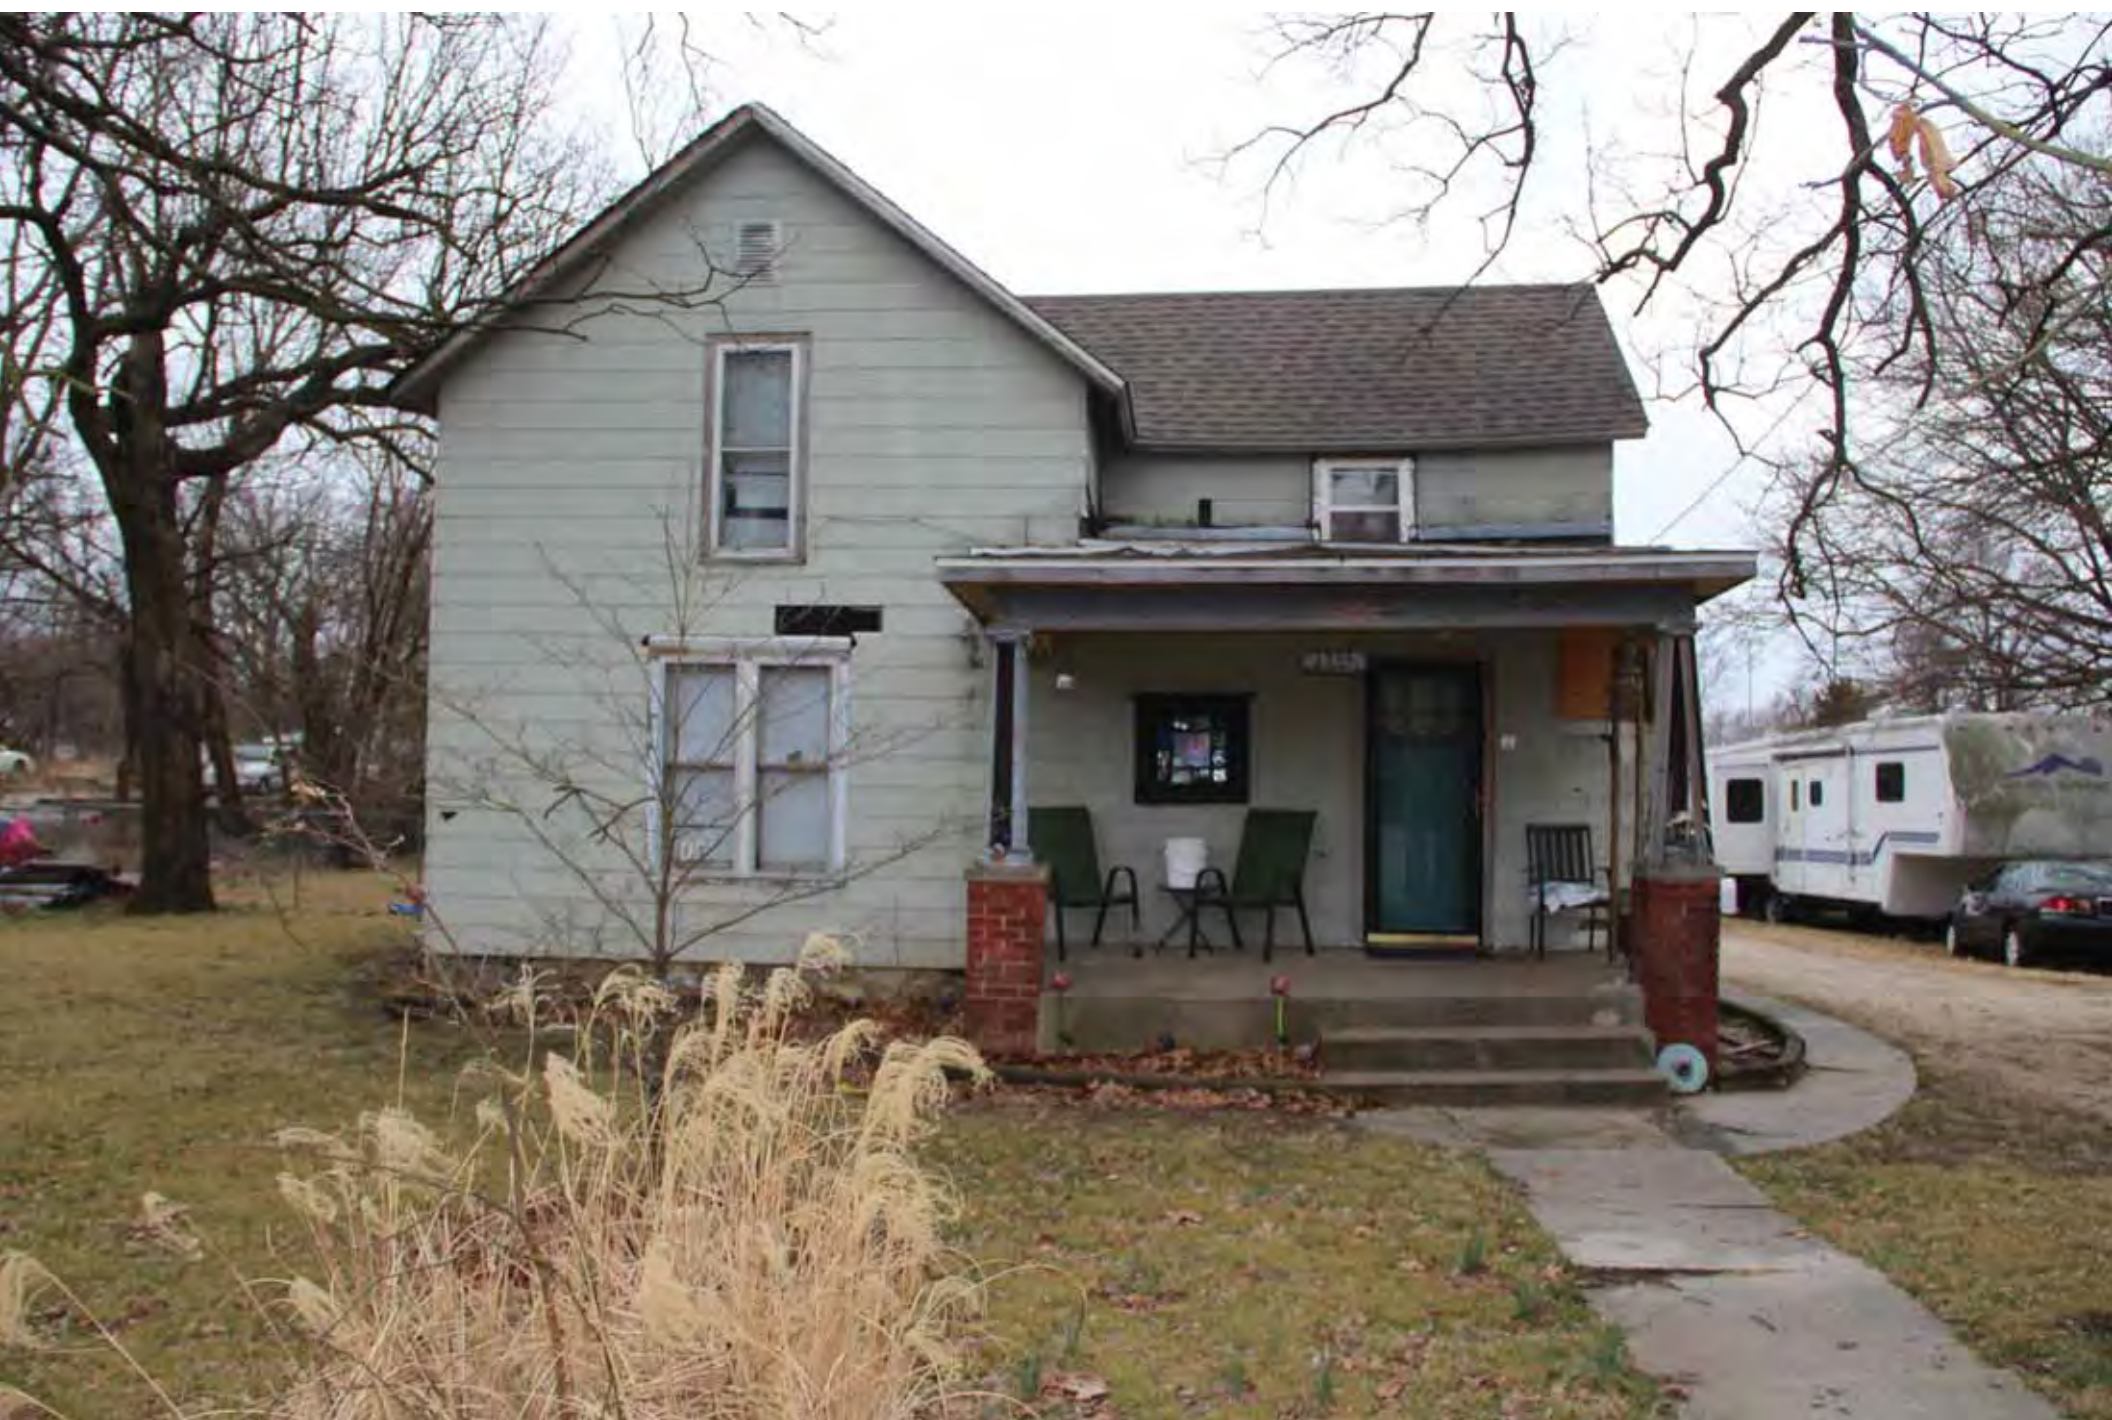
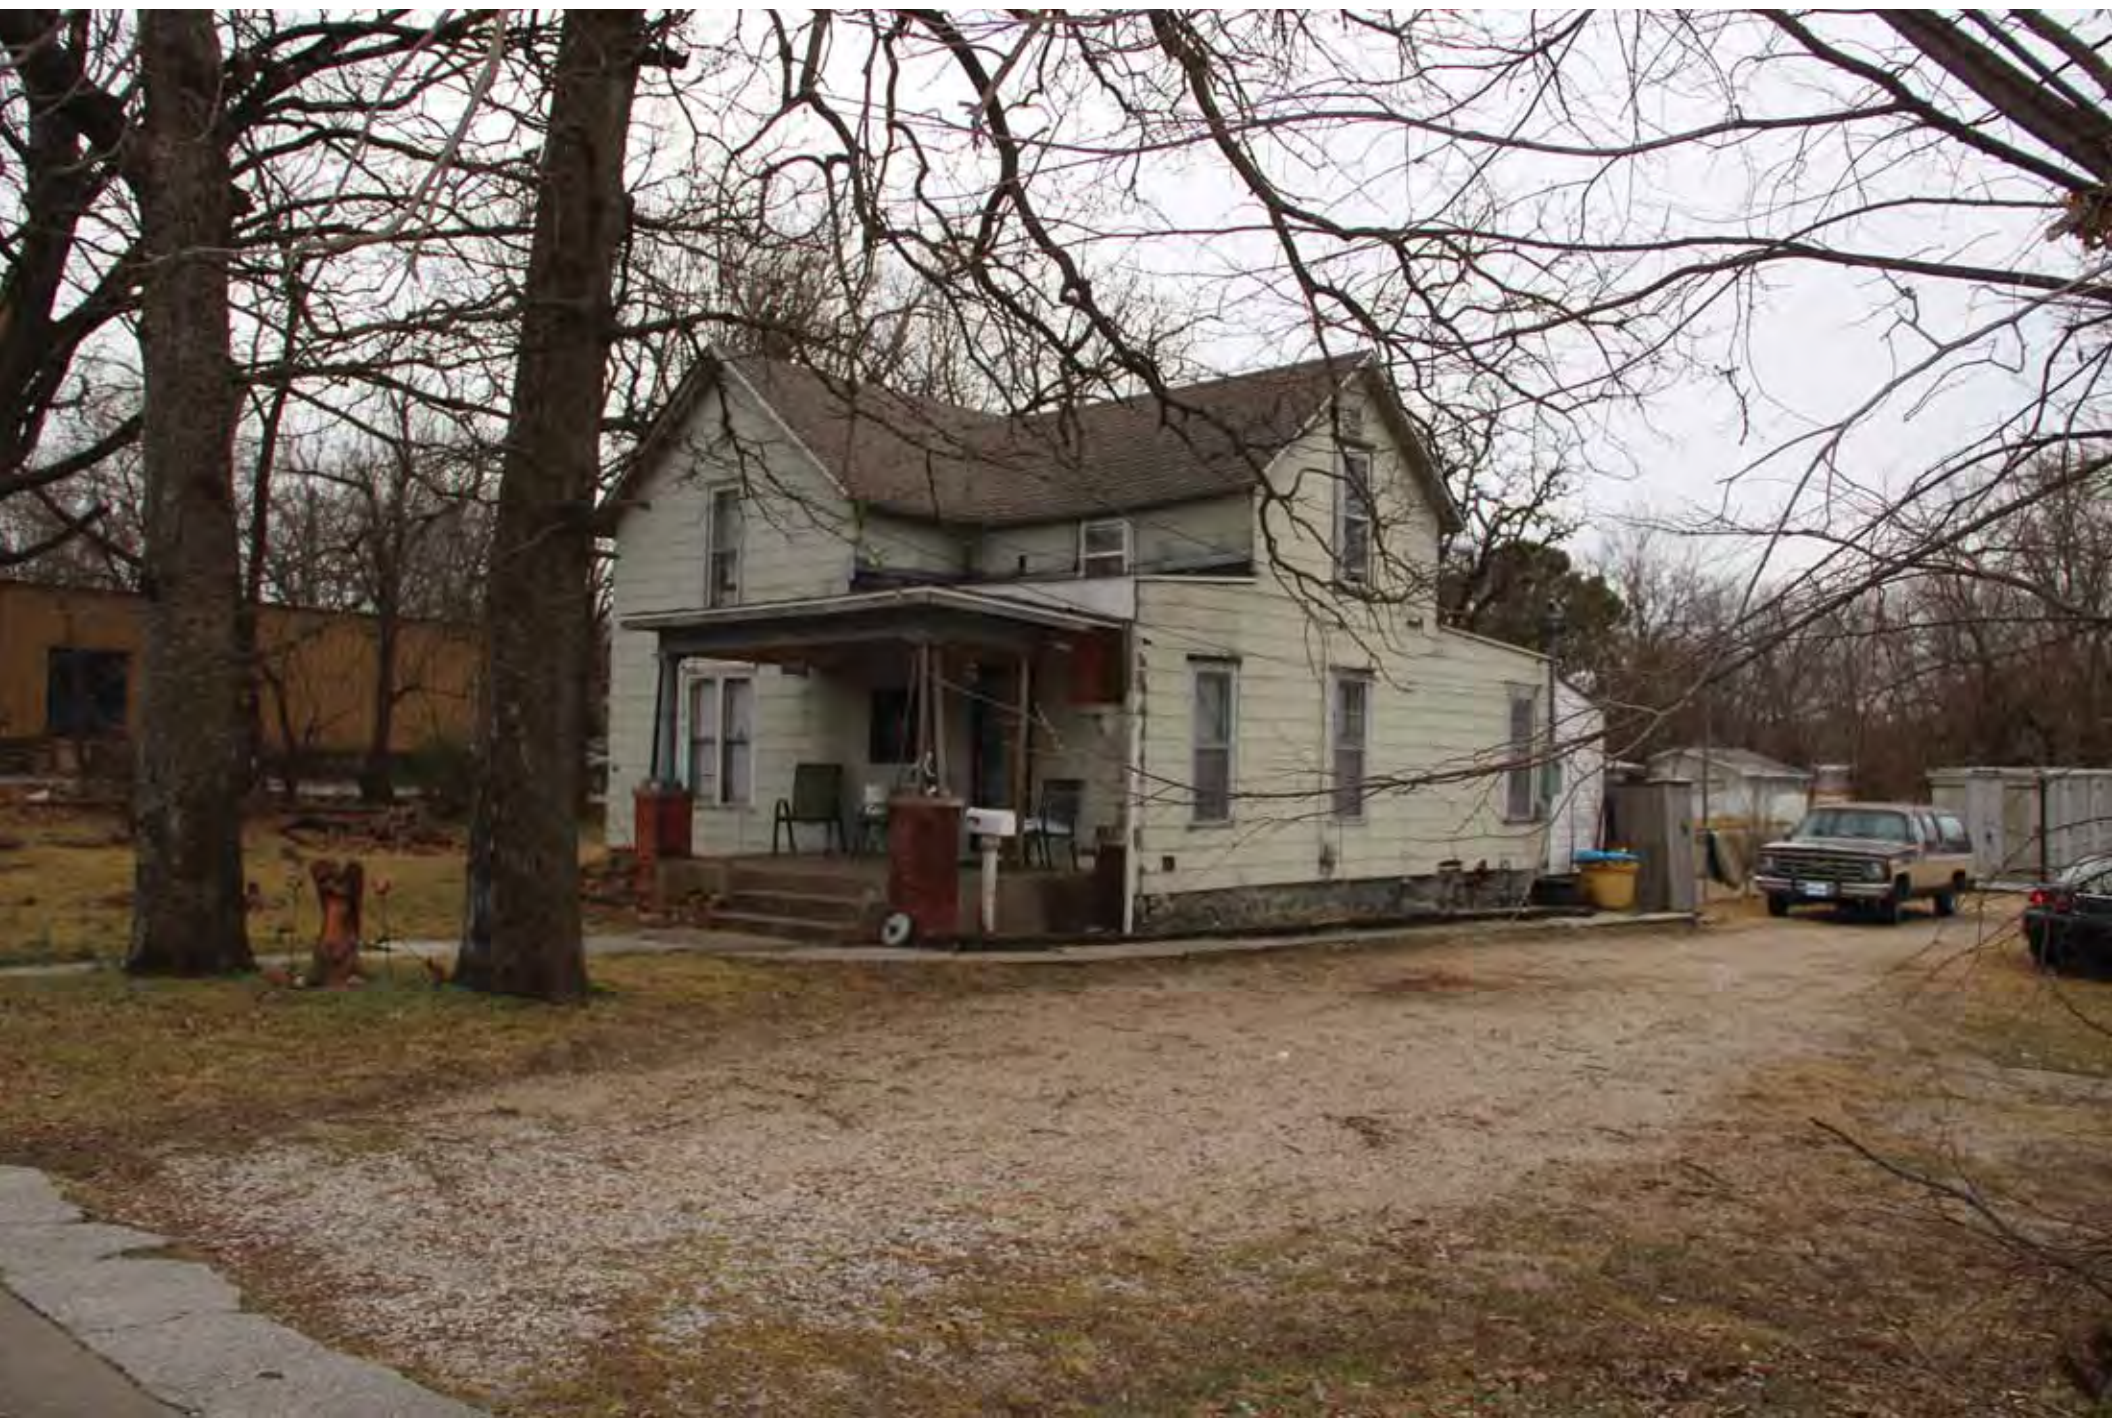
The property at 1412 E. Broadway Street features a two-story front gable and wing plan dwelling with an asphalt shingled cross-gabled roof, exterior asbestos shingle siding and a limestone foundation. The primary porch is off center, comprising the western half of the lower primary elevation. The porch has a hipped roof supported by makeshift frame columns resting on brick piers. The porch has a concrete base. Within the porch bay, the primary entry is filled with a six-light paneled door. A square Queen Anne light window offsets the entry to the east; an enclosed similar sized bay is situated in the upper west corner of the north wall near the entry. The projecting east wing has a square multi-sash window on the west elevation. Remaining windows are one-over-one. Above the porch, the north elevation holds a small double-hung window. The dwelling has a rear shed wing clad with vinyl siding. A set of paired double-hung windows is noted at the lower elevation of the front facing (east) gabled wing's north elevation.
