MISSOURI DEPARTMENT OF NATURAL RESOURCES
STATE HISTORIC PRESERVATION OFFICE, P.O. Box 176, Jefferson City, MO 65102
ARCHITECTURAL/HISTORIC INVENTORY FORM

1. Survey No. JP-AS-007-001		2. Survey name: East Town (Original Joplin) Historic Survey Phase 2	
3. County: JASPER		4. Address (Street No.) 618	Street (name) E. 2 nd Street
5. City: Joplin	Vicinity: <input type="checkbox"/>	6. Geographical Reference:	7. Township/Range/Section: T: R: S:
8. Historic name (if known):		9. Present/other name (if known):	
10. Ownership: <input checked="" type="checkbox"/> Private <input type="checkbox"/> Public		11a. Historic use (if known): Domestic: Single Dwelling	11b. Current use: Domestic: Single Dwelling

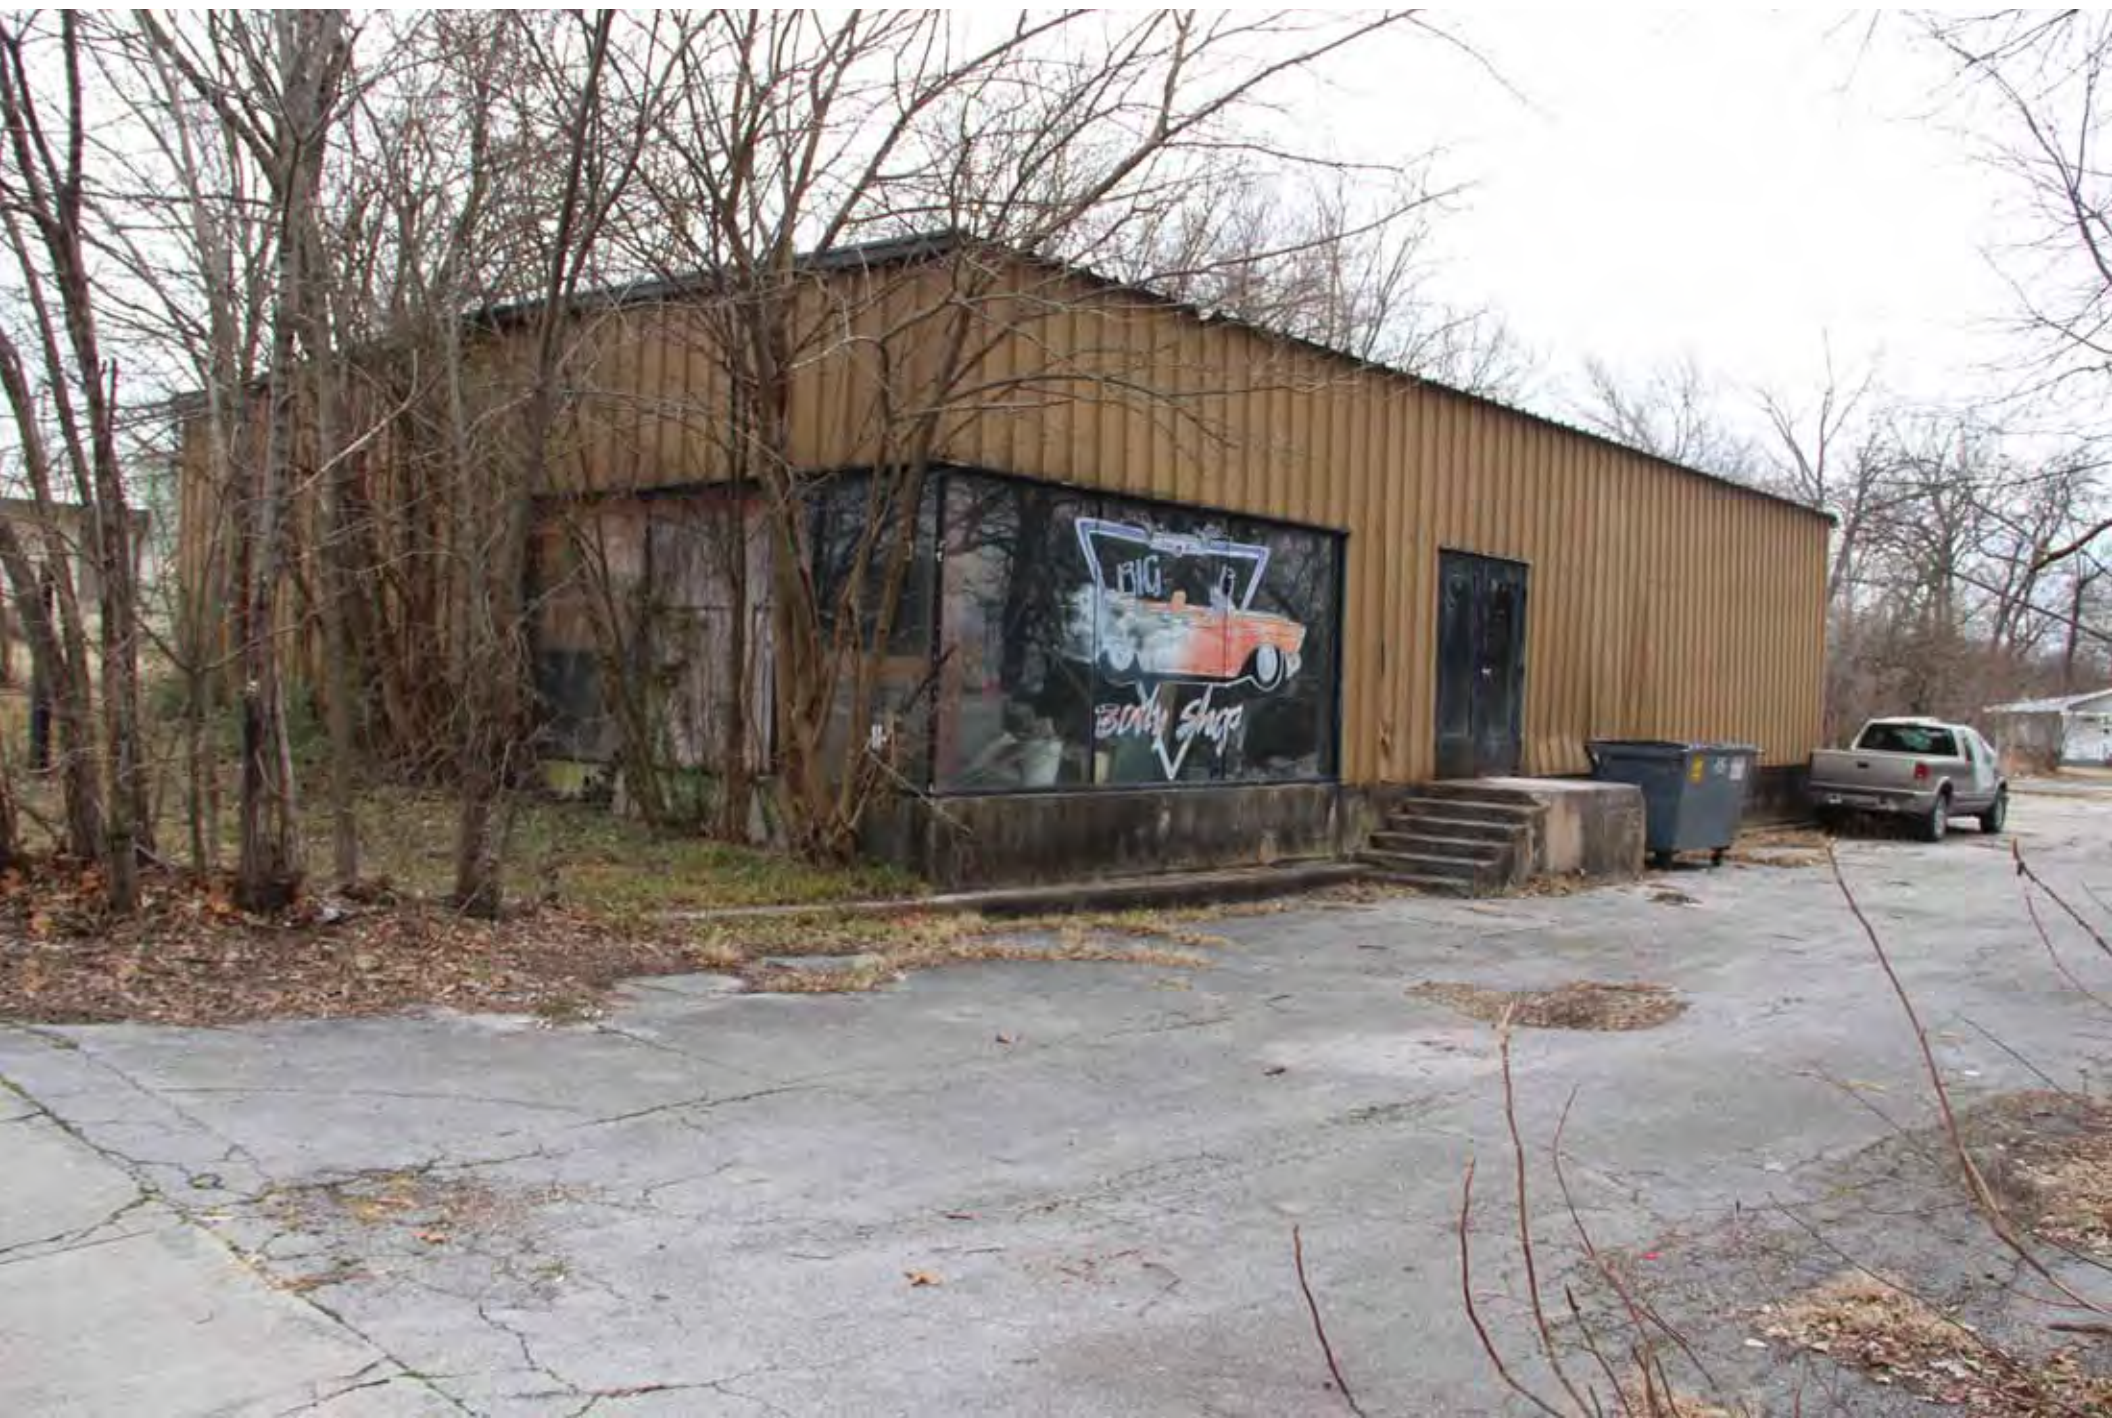
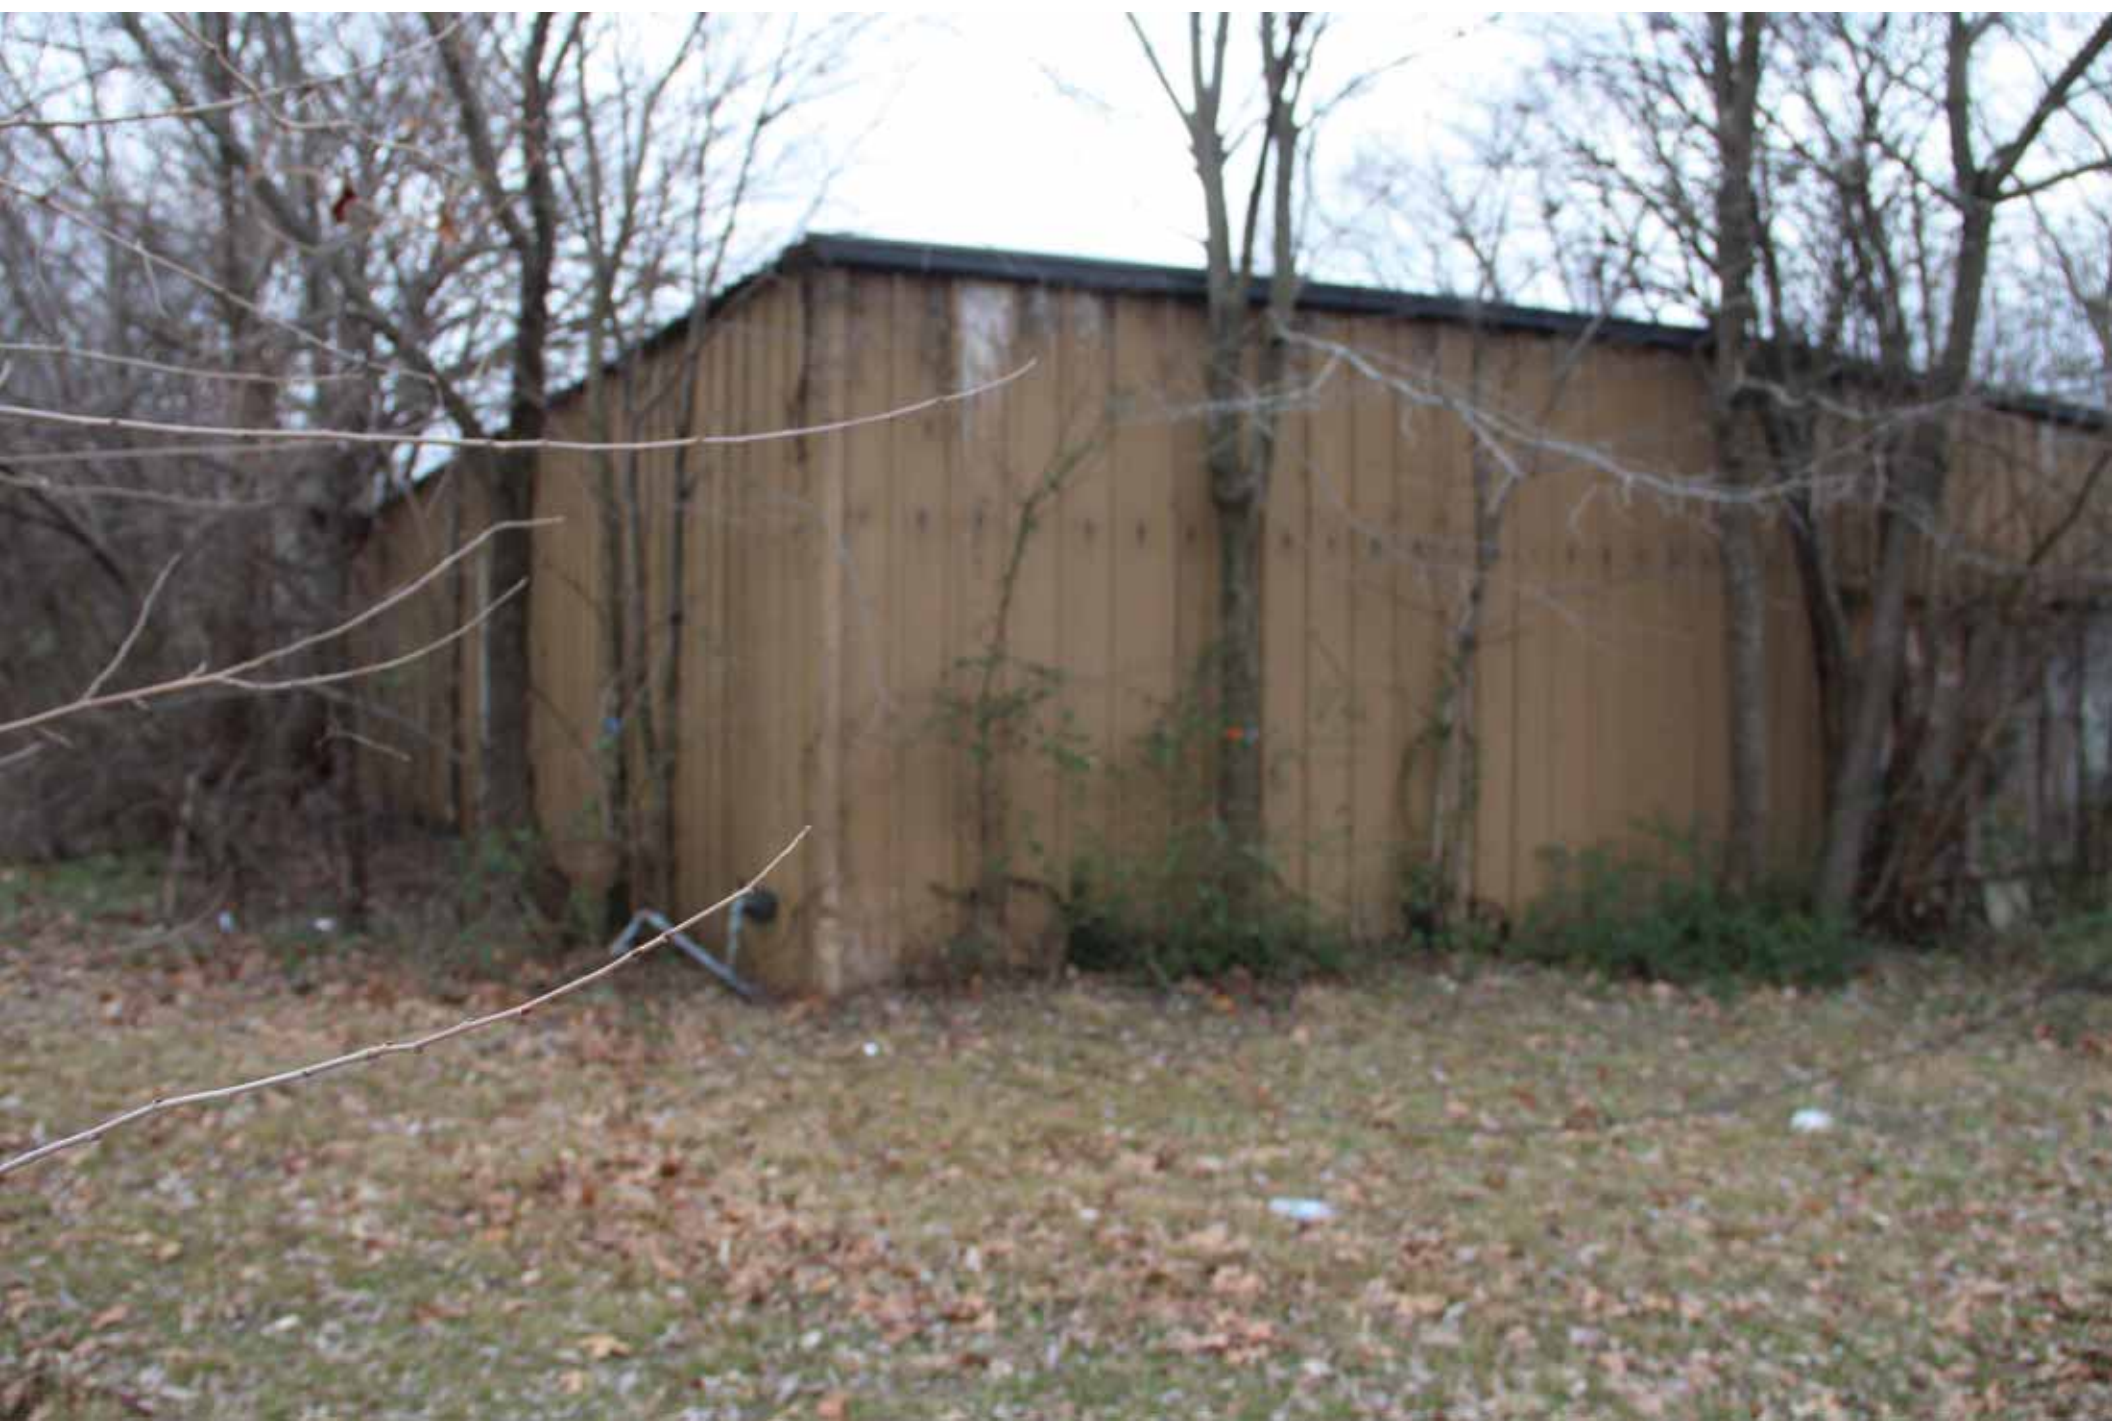
The building associated with this parcel is a single-story rectangular commercial property with exterior corrugated metal siding and a concrete foundation. The north elevation holds fixed commercial windows (two lights) that wrap to the west elevation (three lights) facing the drive flanking the building. Immediately south of the window wrap (west elevation) are paired solid metal doors and a concrete stoop. The south elevation has an overhead track door offset by a solid metal door. A concrete ramp leads to the garage bay. The door is accessible via a concrete stoop.

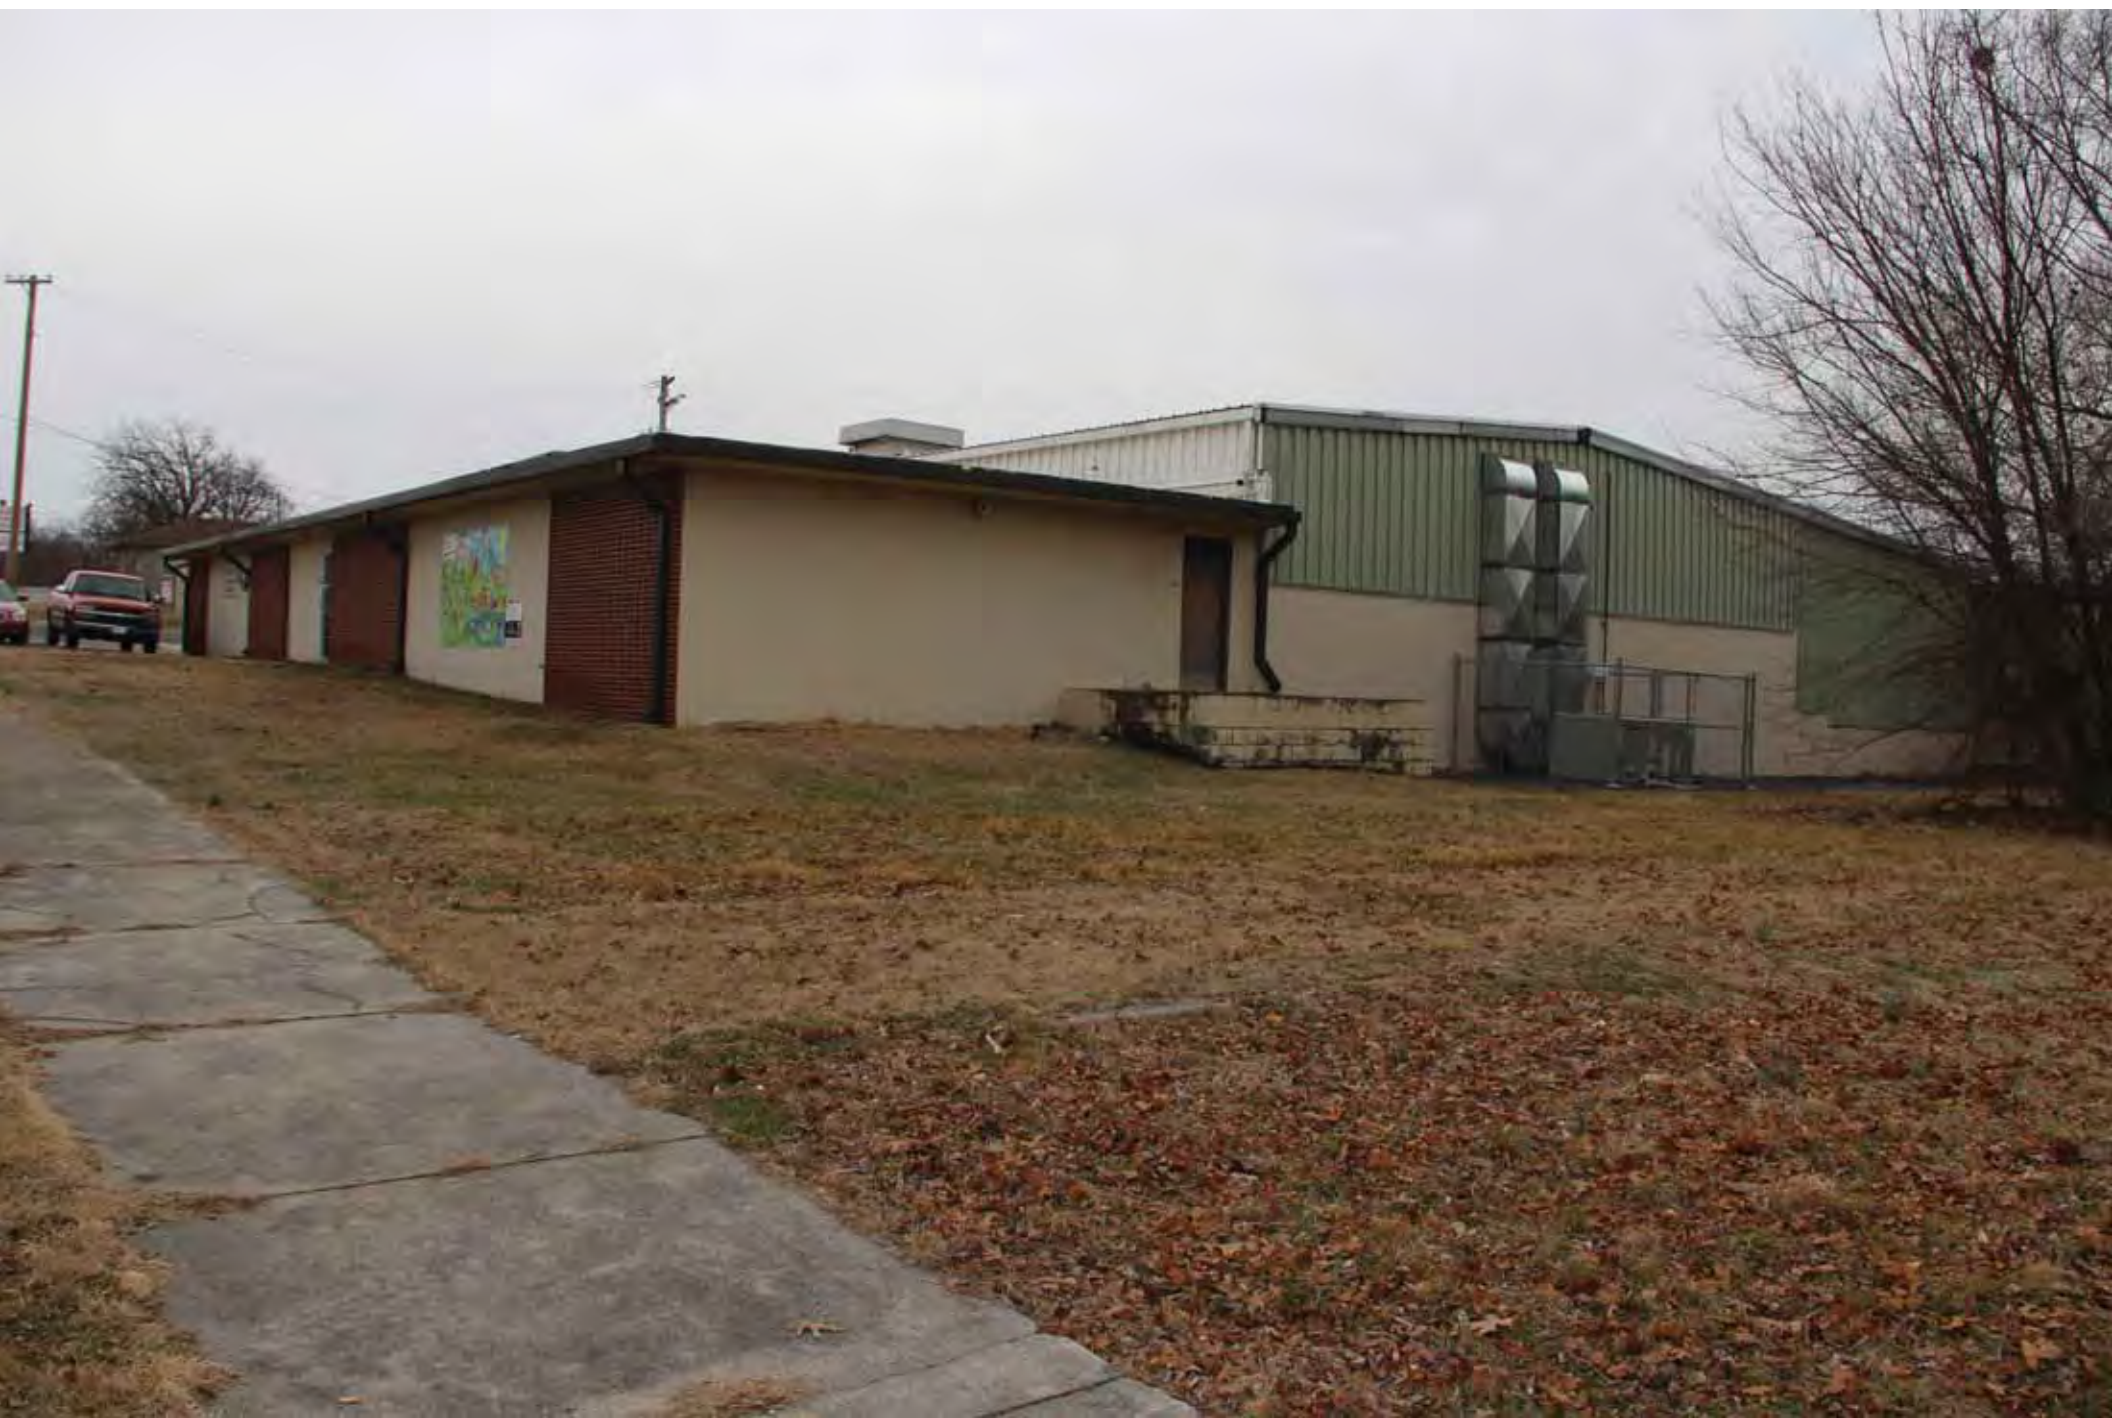
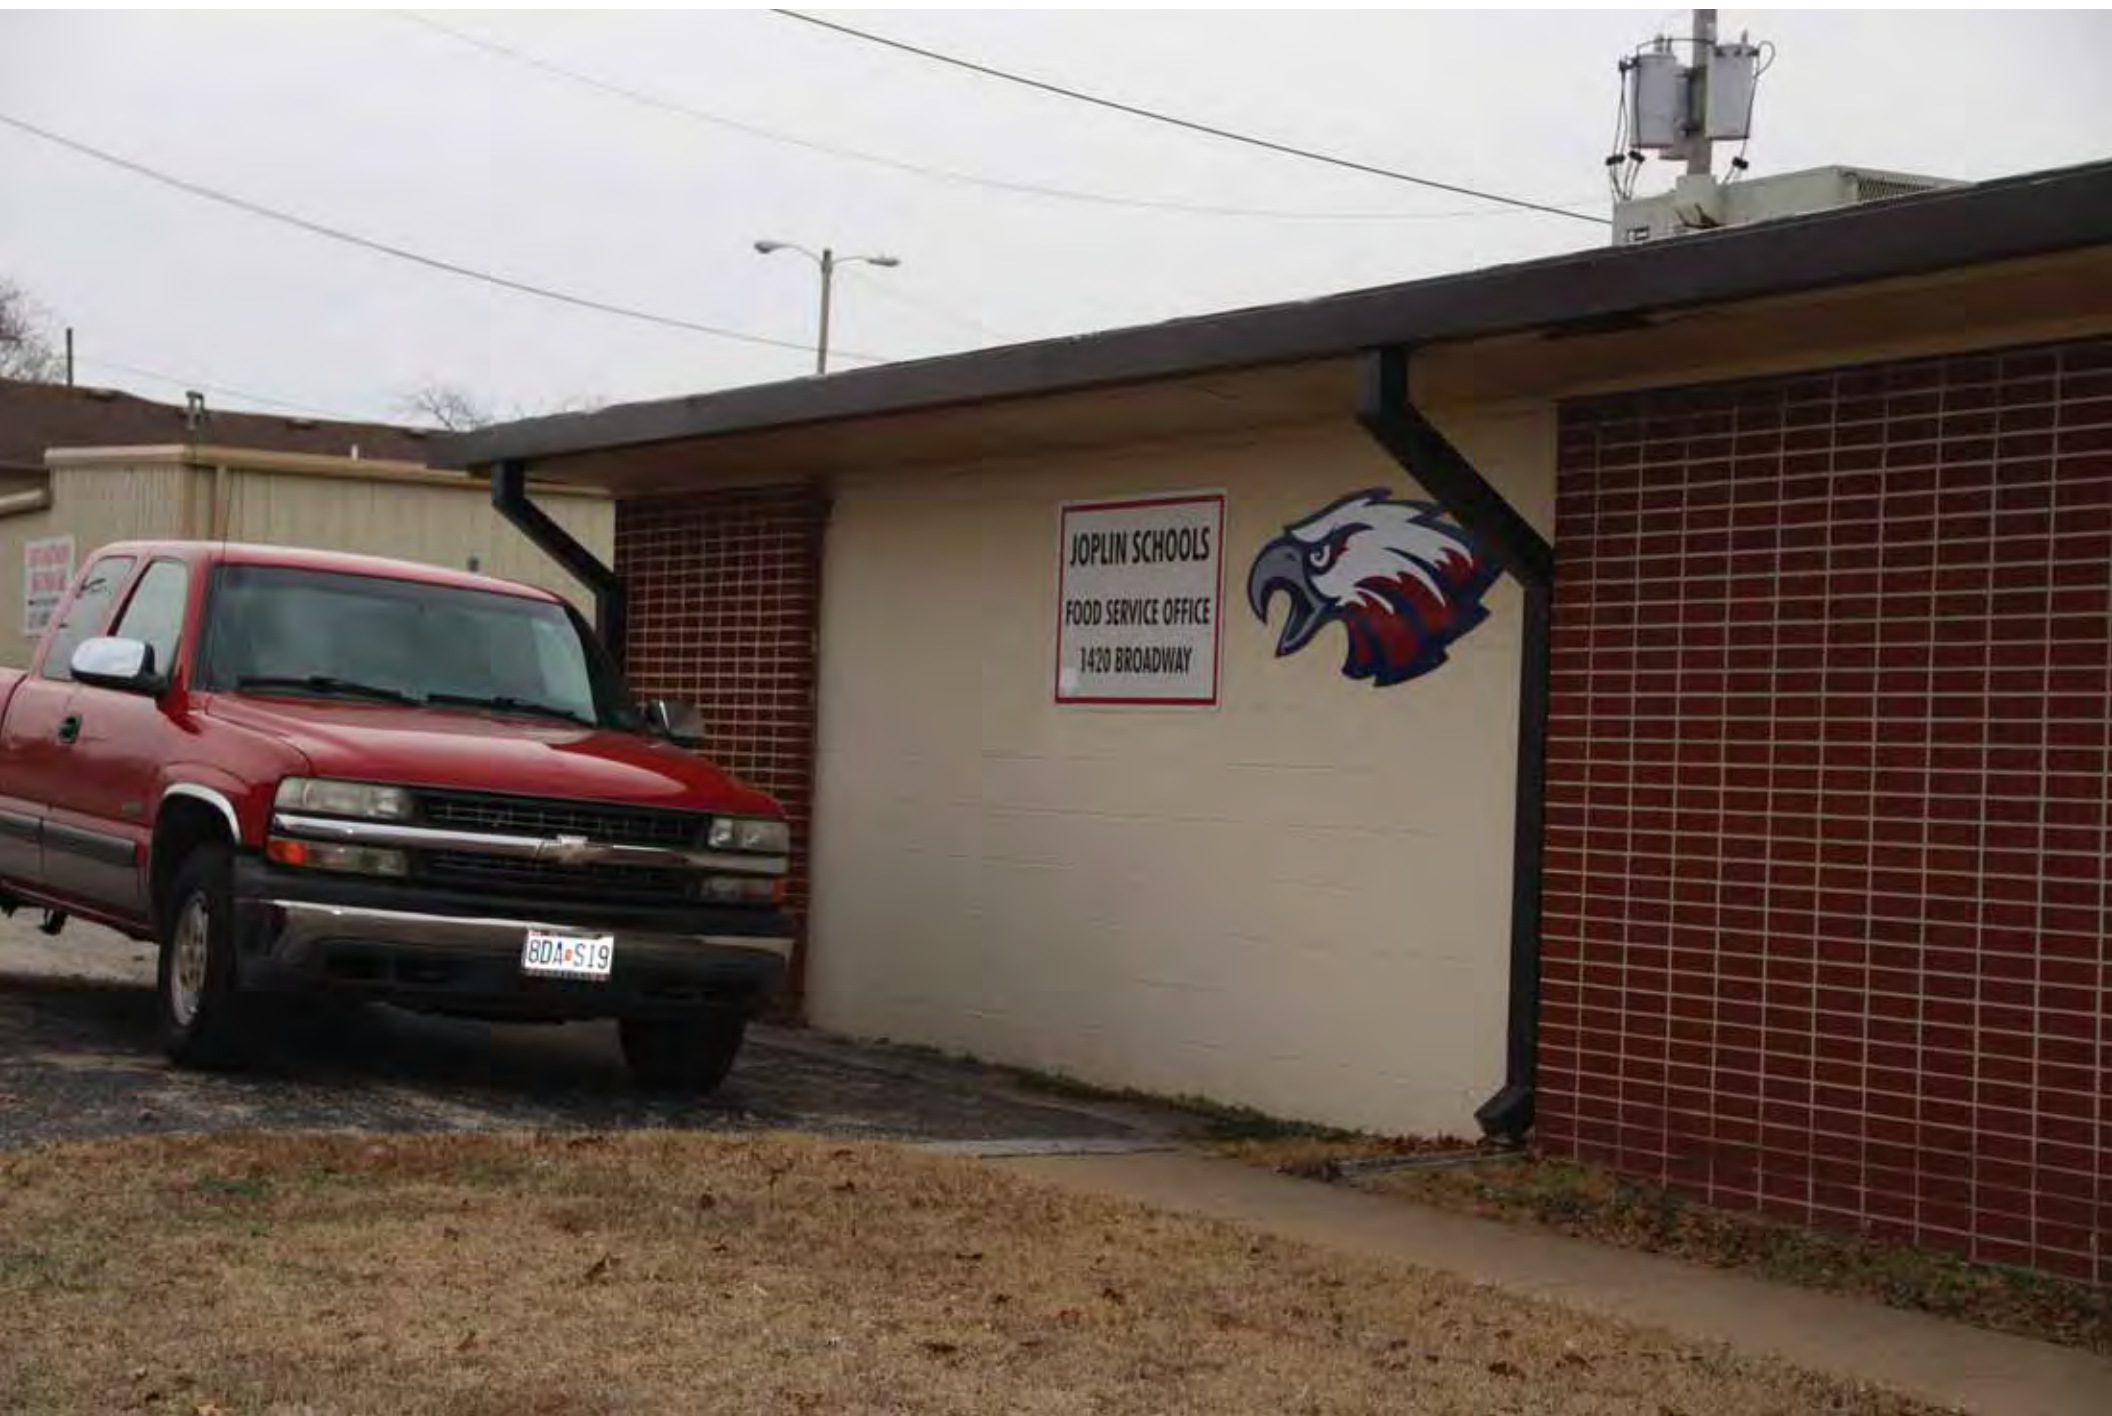
The building associated with this parcel is a large warehouse complex composed primarily of a large prefabricated metal warehouse facility. Exterior walls of the warehouse wings are metal. At the north end of the warehouse is a customer service/office wing. The north elevation of the wing has a single light glass and metal door. Flanking the door, the bays of the elevation are composed of tile and concrete block. A sign indicating the building's occupant is situated near the east end of the elevation. The office wing has a secondary entry on the east elevation, filled with a solid metal door. The east end of the complex is composed of two shed metal warehouse wings – these wings appear to be attached to the larger central warehouse and the office wing. The rear (south) elevation of the complex features five overhead track doors. A loading dock supporting three of these overhead track doors is situated at the southeast end of the property.

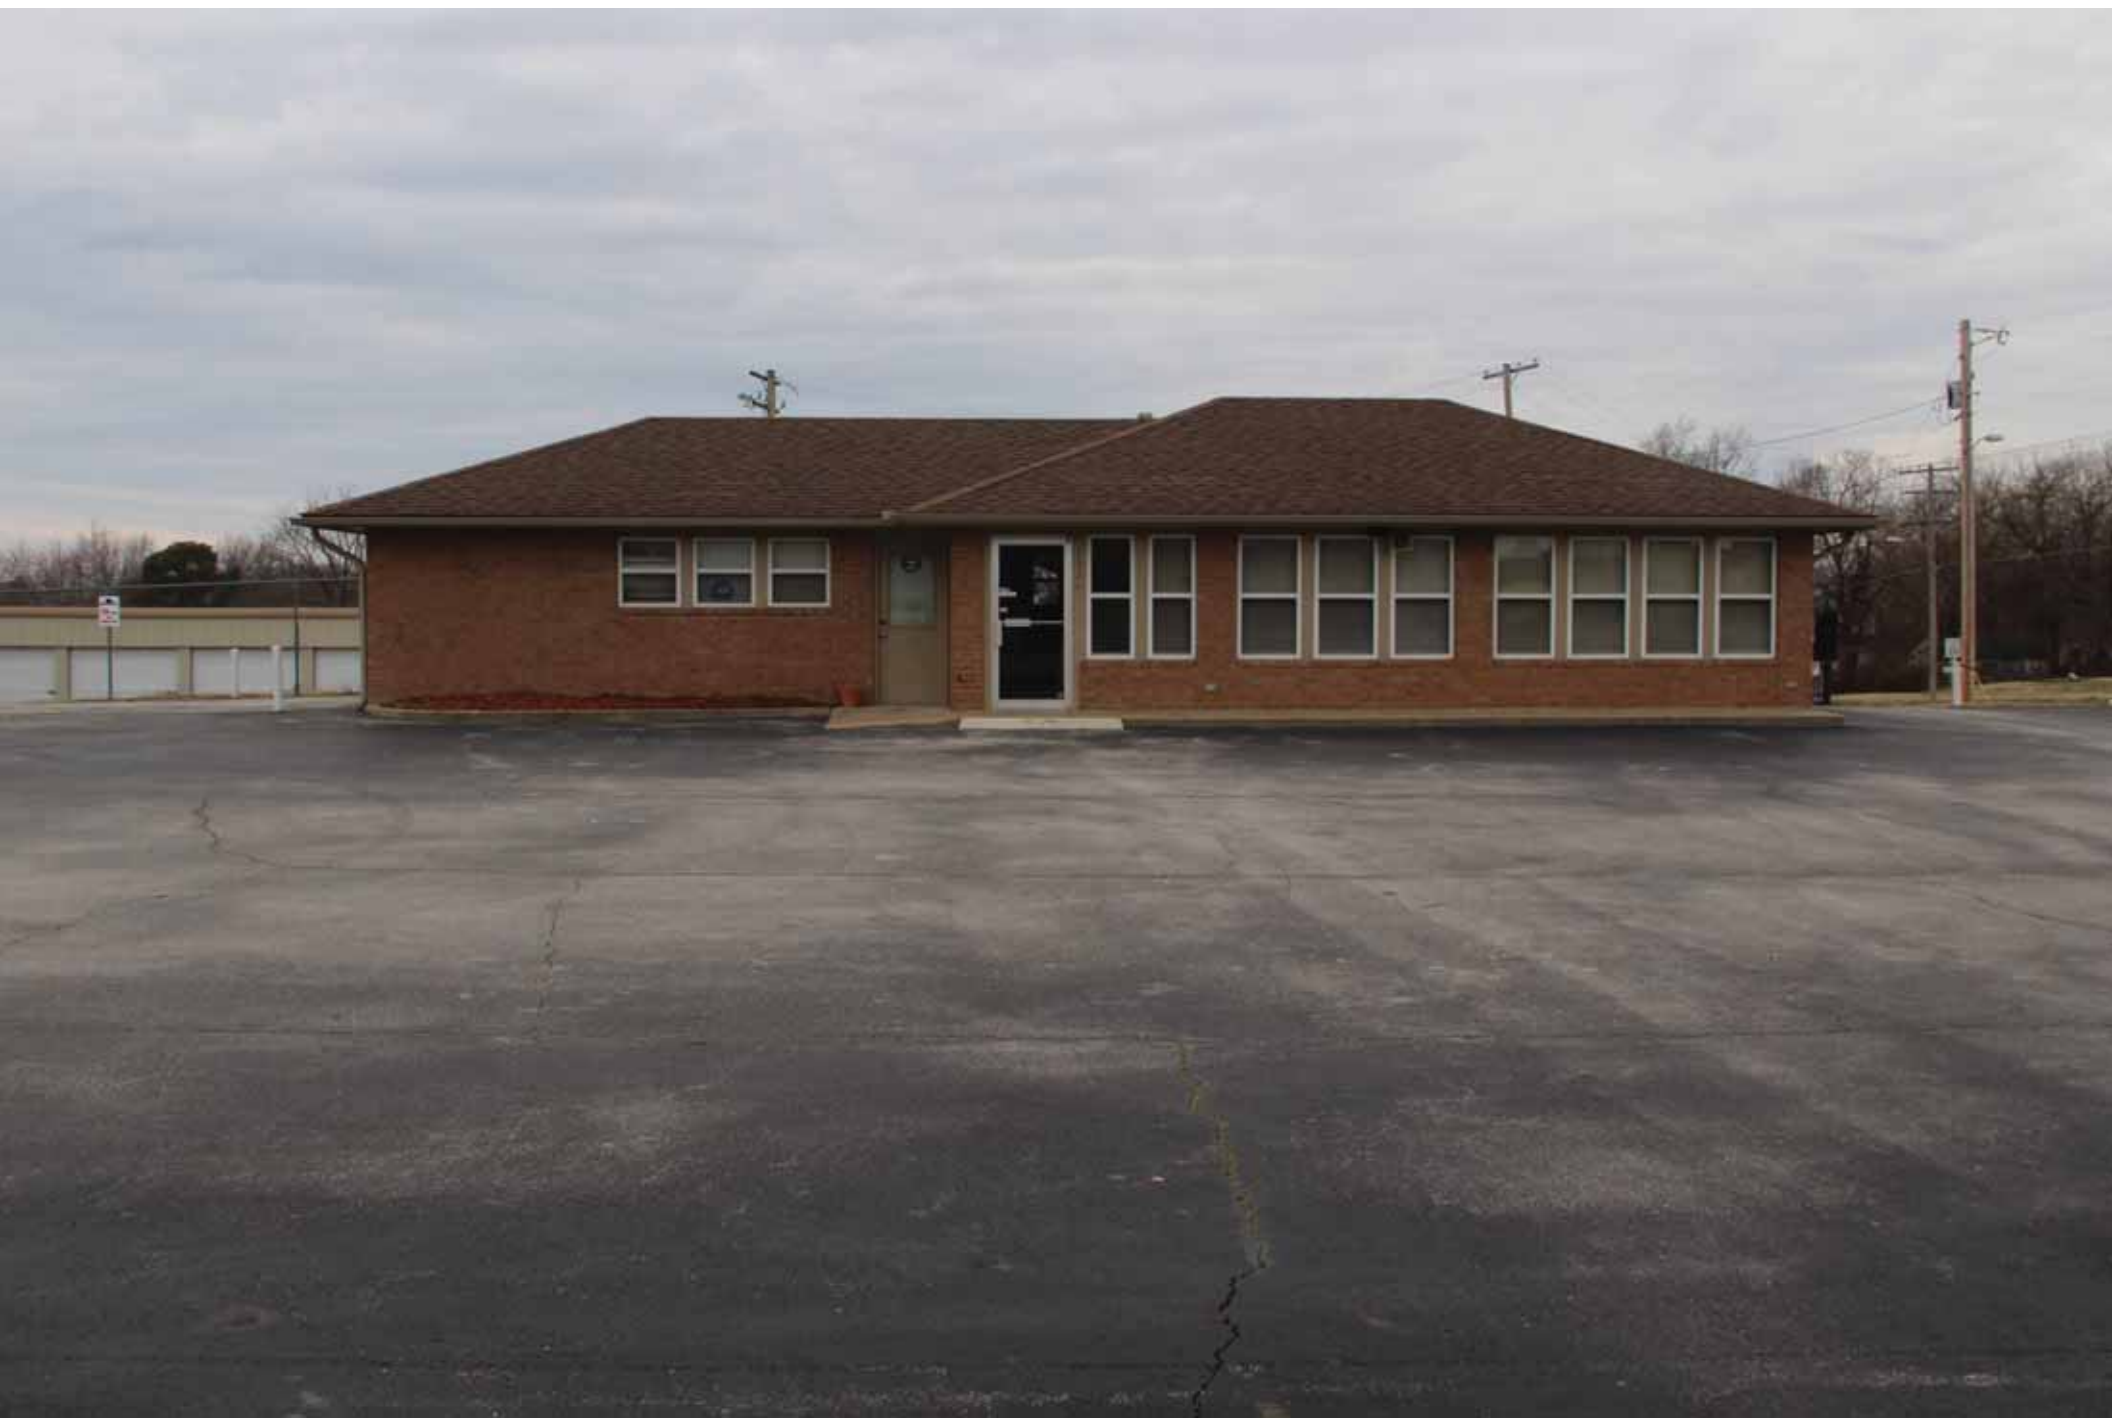
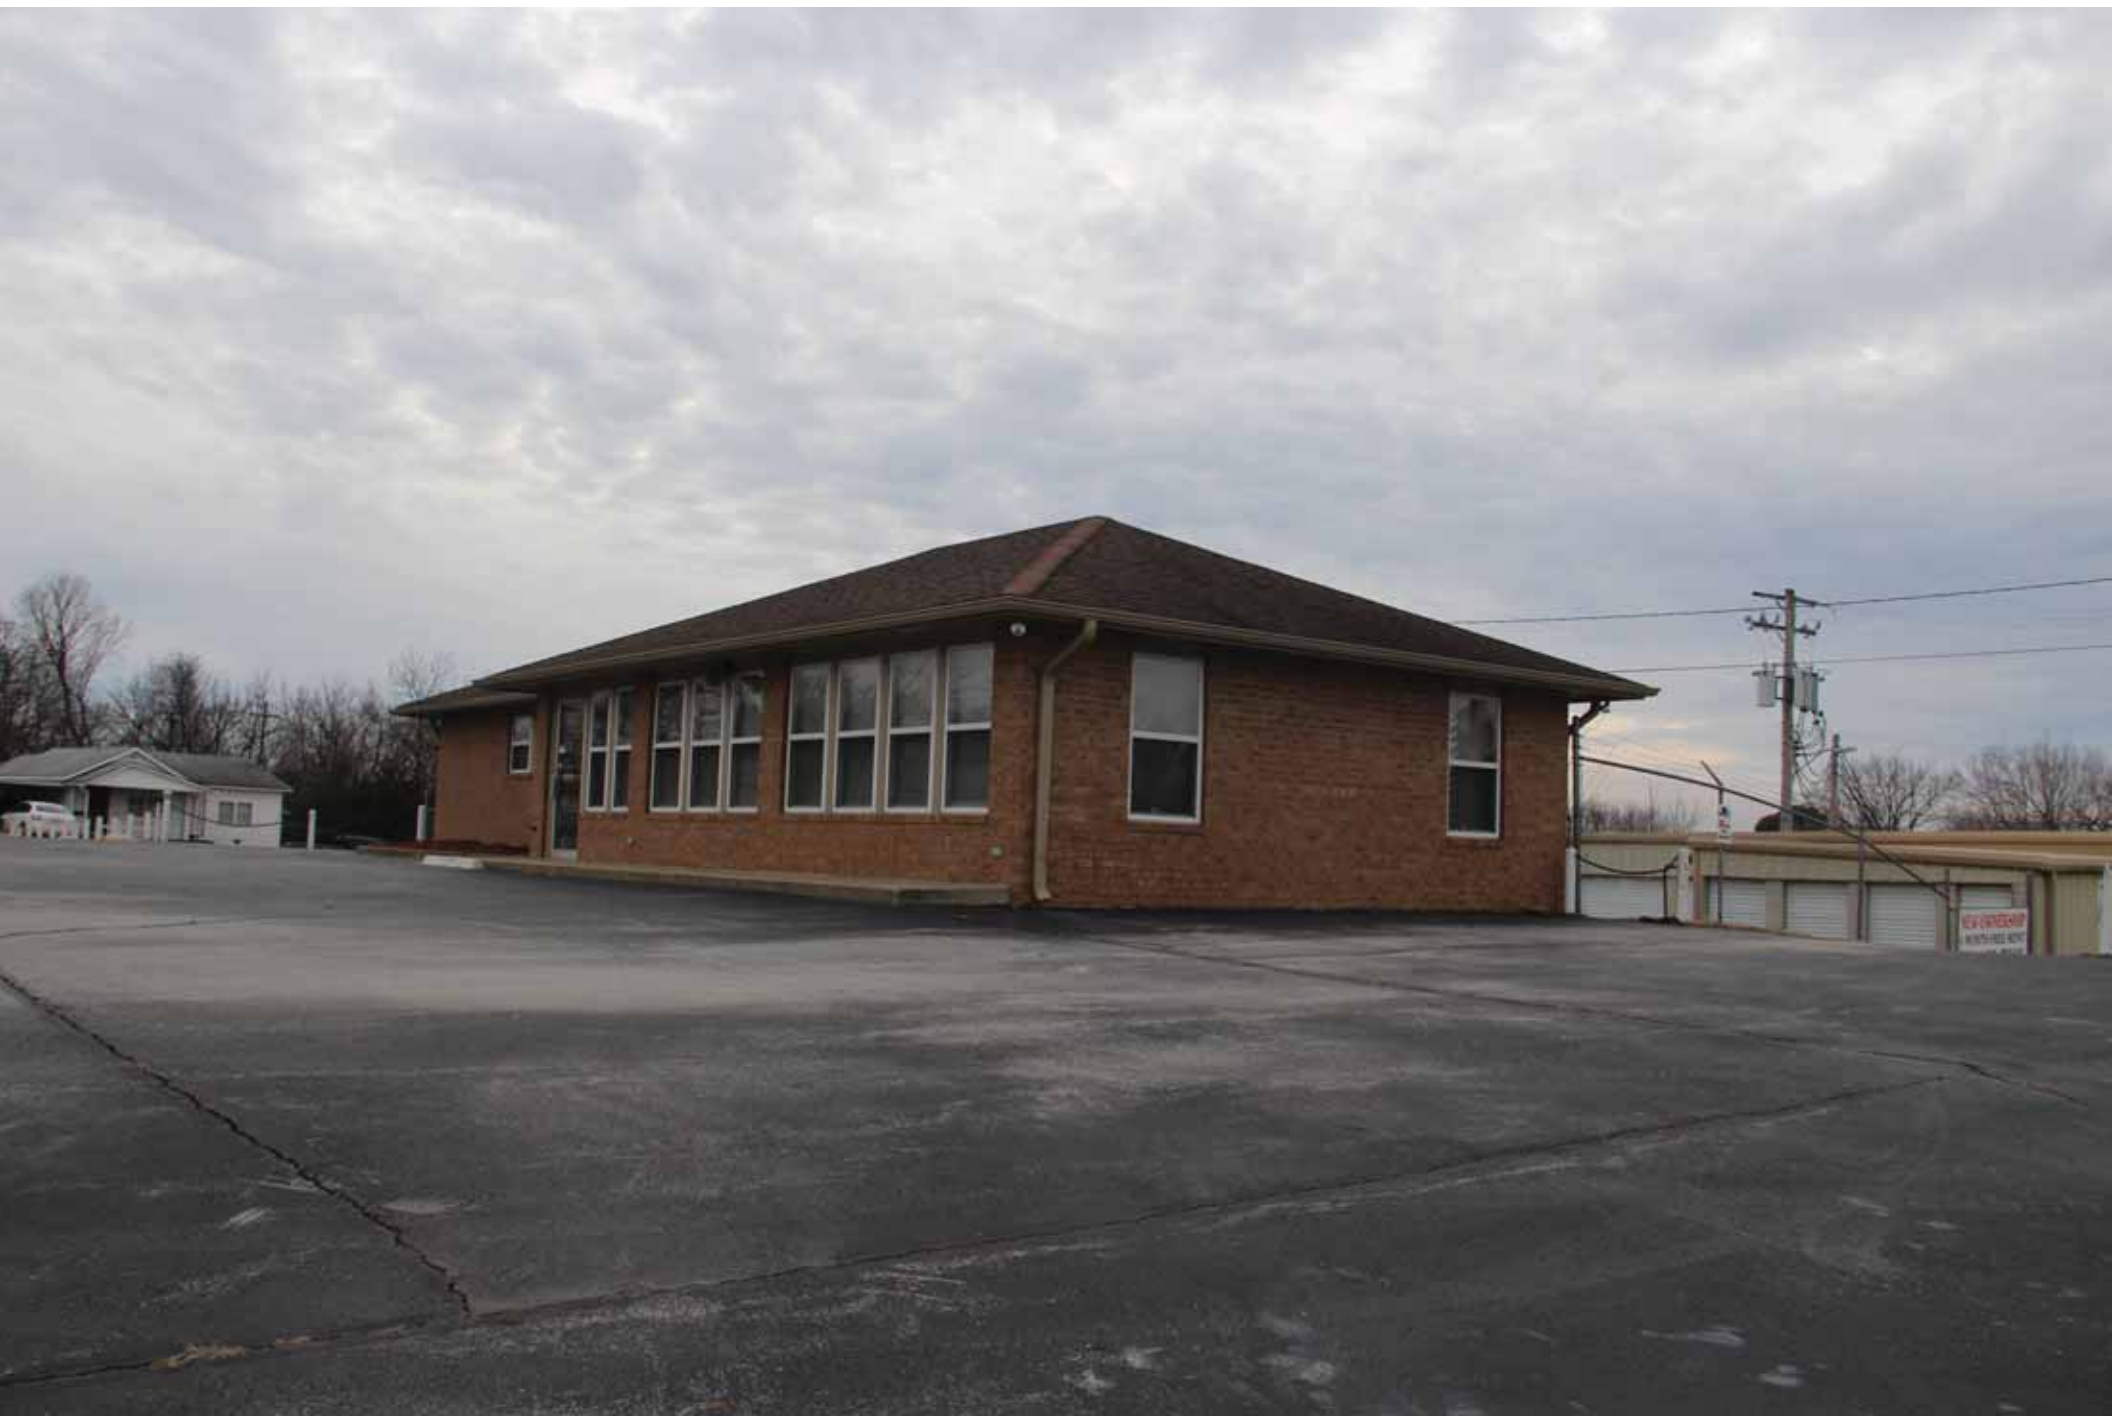
The property holds two buildings – a detached office and large U-shaped storage warehouse (described above). The office has a hipped asphalt shingled roof and exterior brick walls. The primary (east) elevation has a projecting hipped wing with nine double-hung windows (1/1) offset on the south by a glass and metal commercial door. The wall south of the door is set back, featuring a single-light door offset by three small one-over-one windows. The north elevation holds two single windows. The west elevation holds three windows – two of which are small. The south elevation features an overhead track door.
