MISSOURI DEPARTMENT OF NATURAL RESOURCES
STATE HISTORIC PRESERVATION OFFICE, P.O. Box 176, Jefferson City, MO 65102
ARCHITECTURAL/HISTORIC INVENTORY FORM

1. Survey No. JP-AS-007-001		2. Survey name: East Town (Original Joplin) Historic Survey Phase 2	
3. County: JASPER		4. Address (Street No.) 618	Street (name) E. 2 nd Street
5. City: Joplin	Vicinity: <input type="checkbox"/>	6. Geographical Reference:	7. Township/Range/Section: T: R: S:
8. Historic name (if known):		9. Present/other name (if known):	
10. Ownership: <input checked="" type="checkbox"/> Private <input type="checkbox"/> Public		11a. Historic use (if known): Domestic: Single Dwelling	11b. Current use: Domestic: Single Dwelling

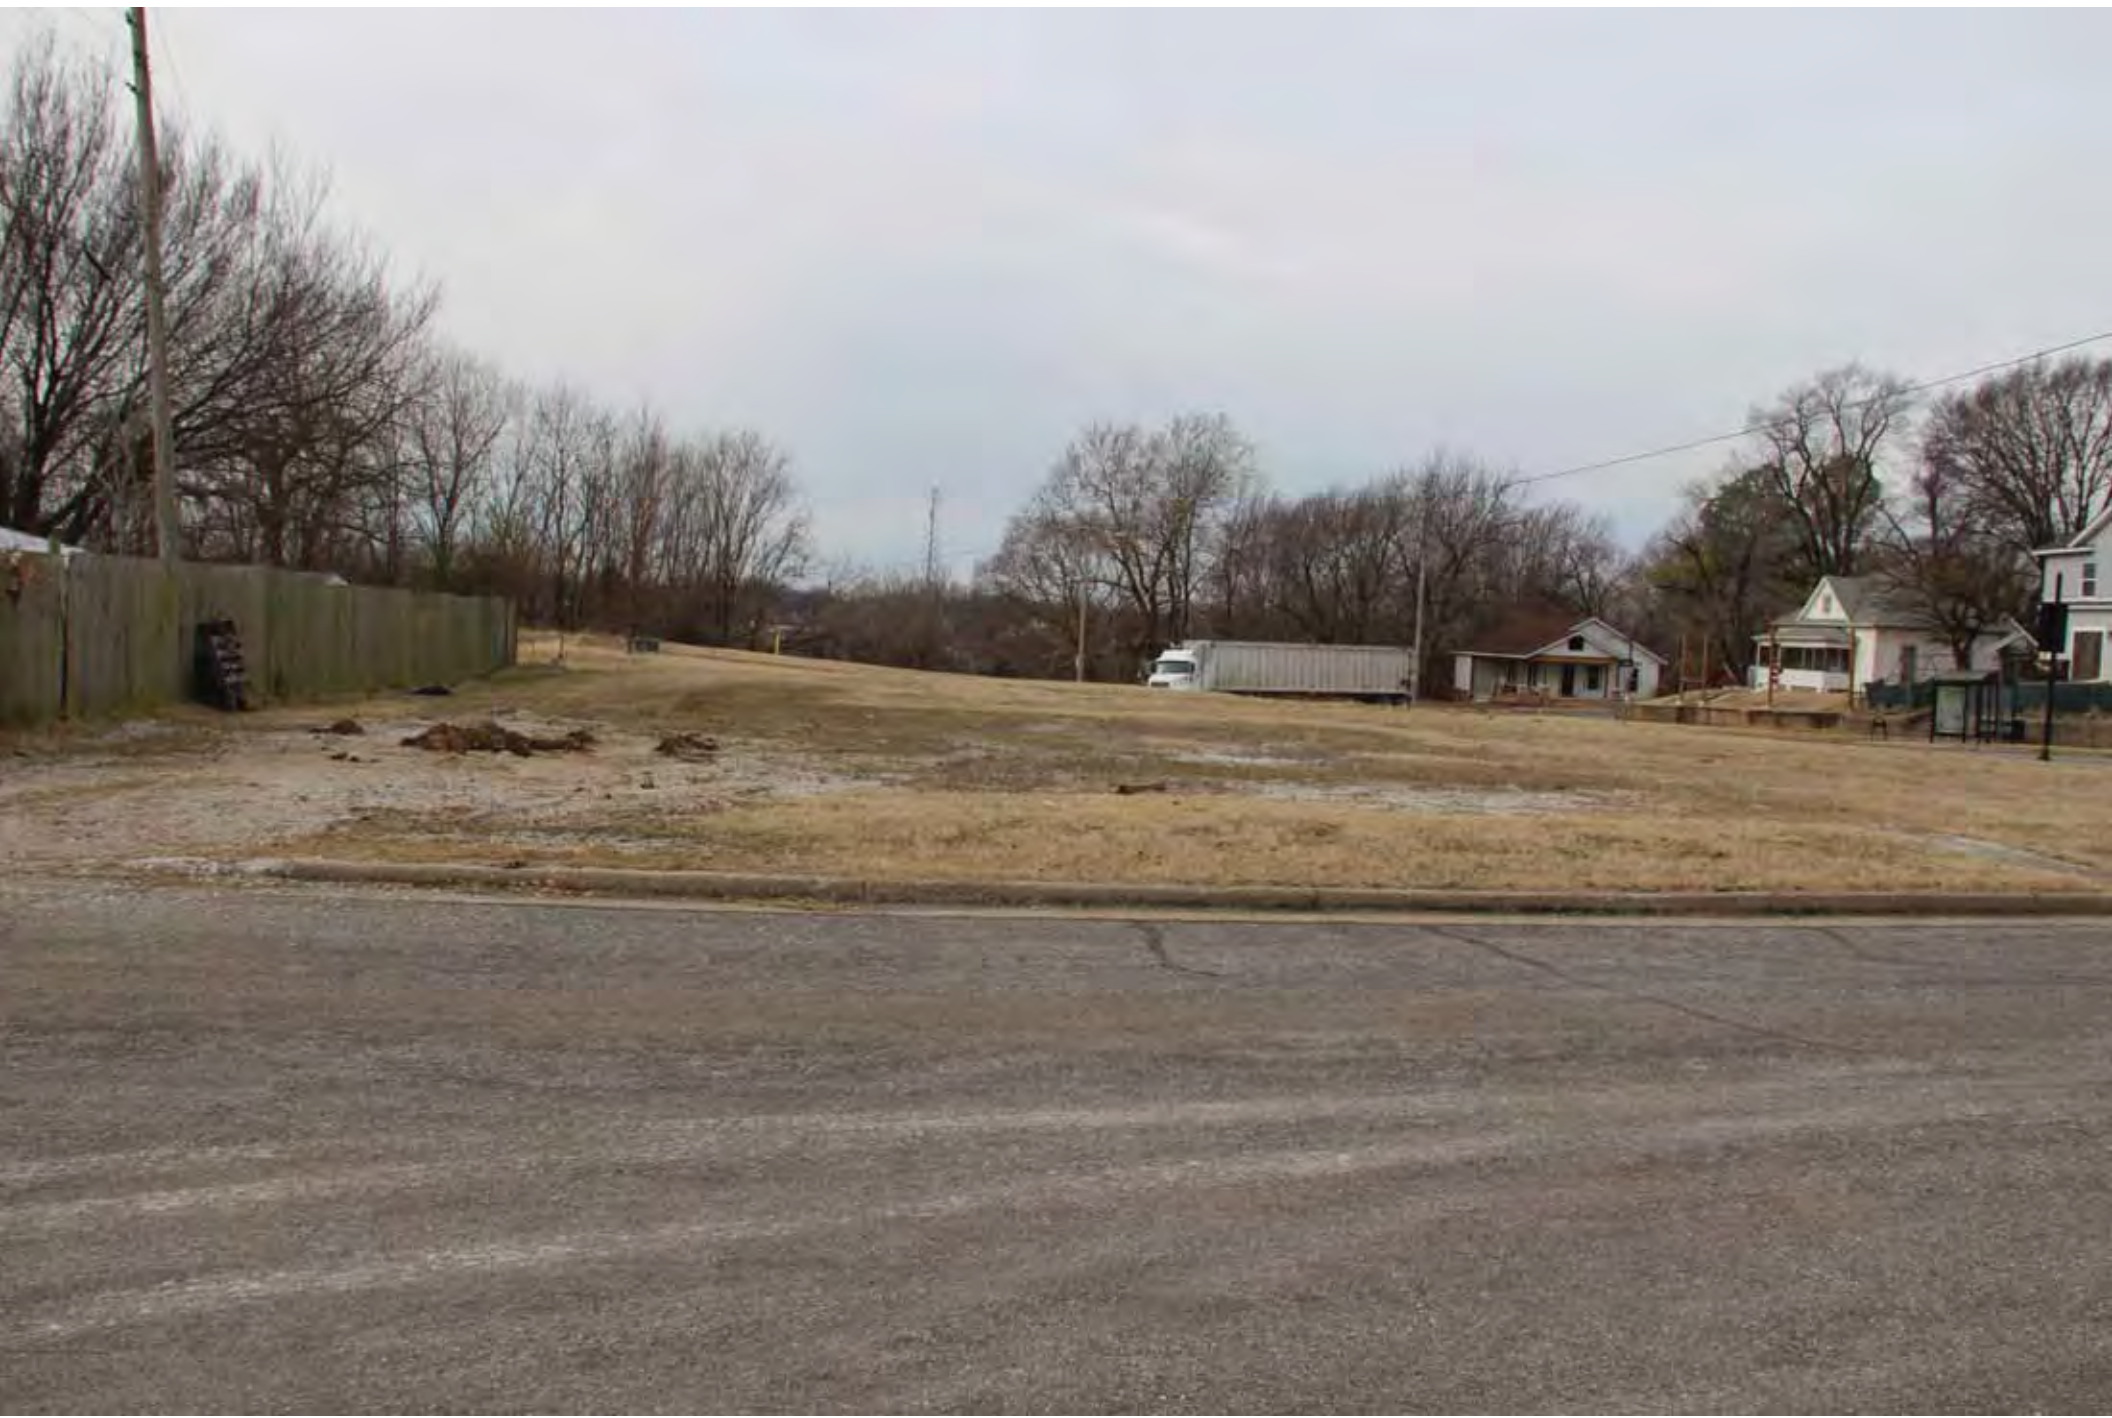
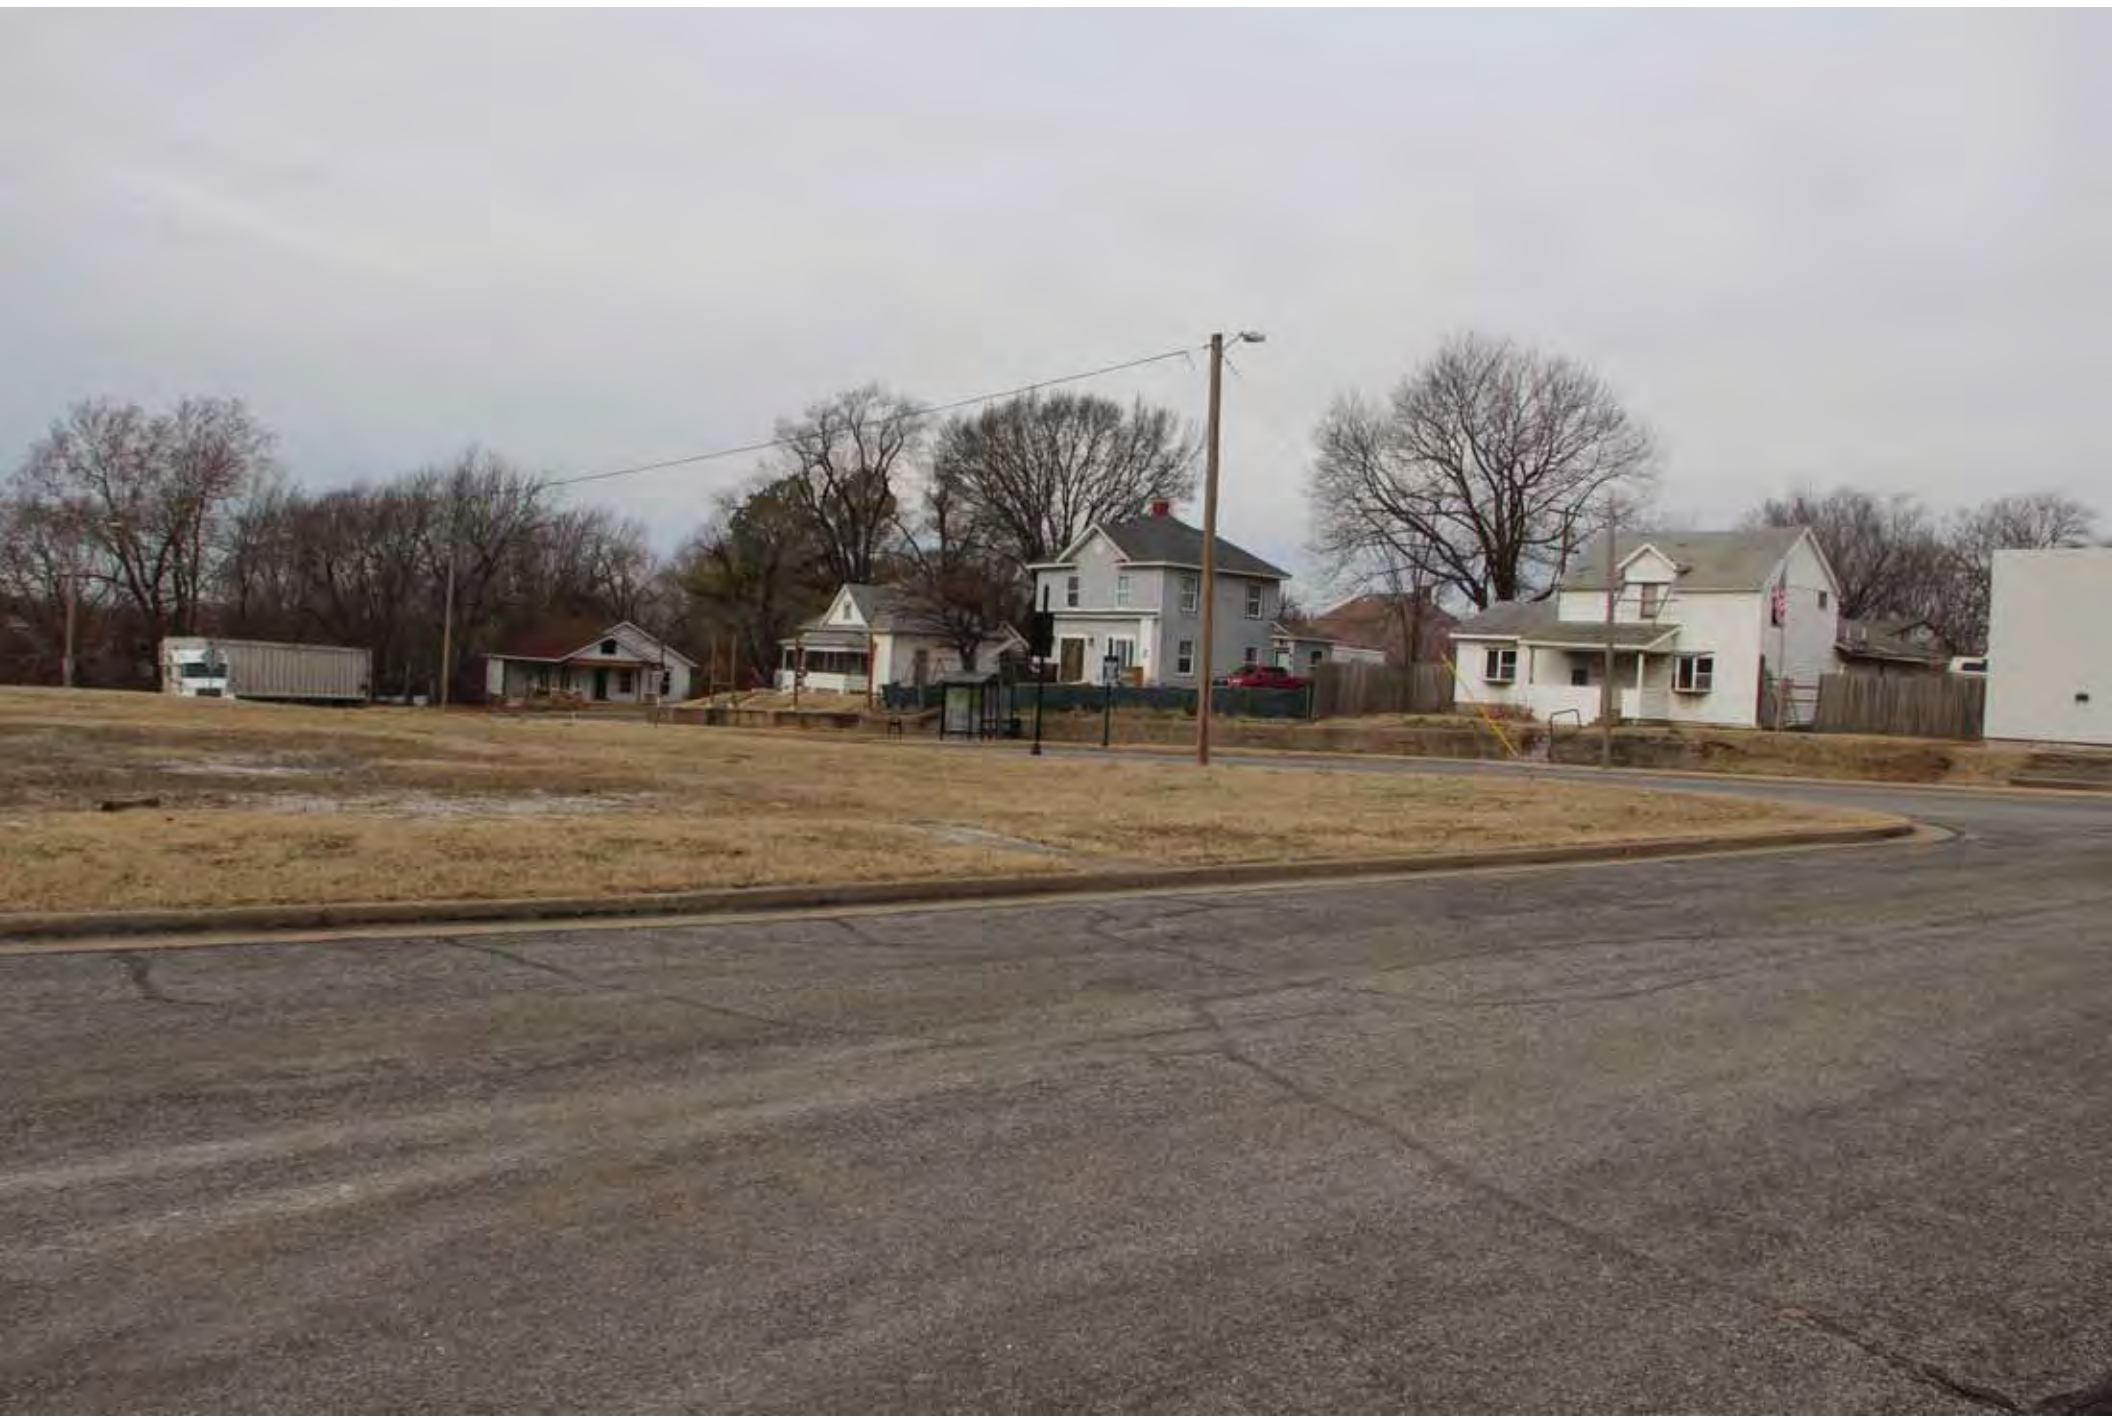
The property at the southwest intersection of E. Broadway Street and S. Galena Avenue is a vacant lot covered with grass, as described above.

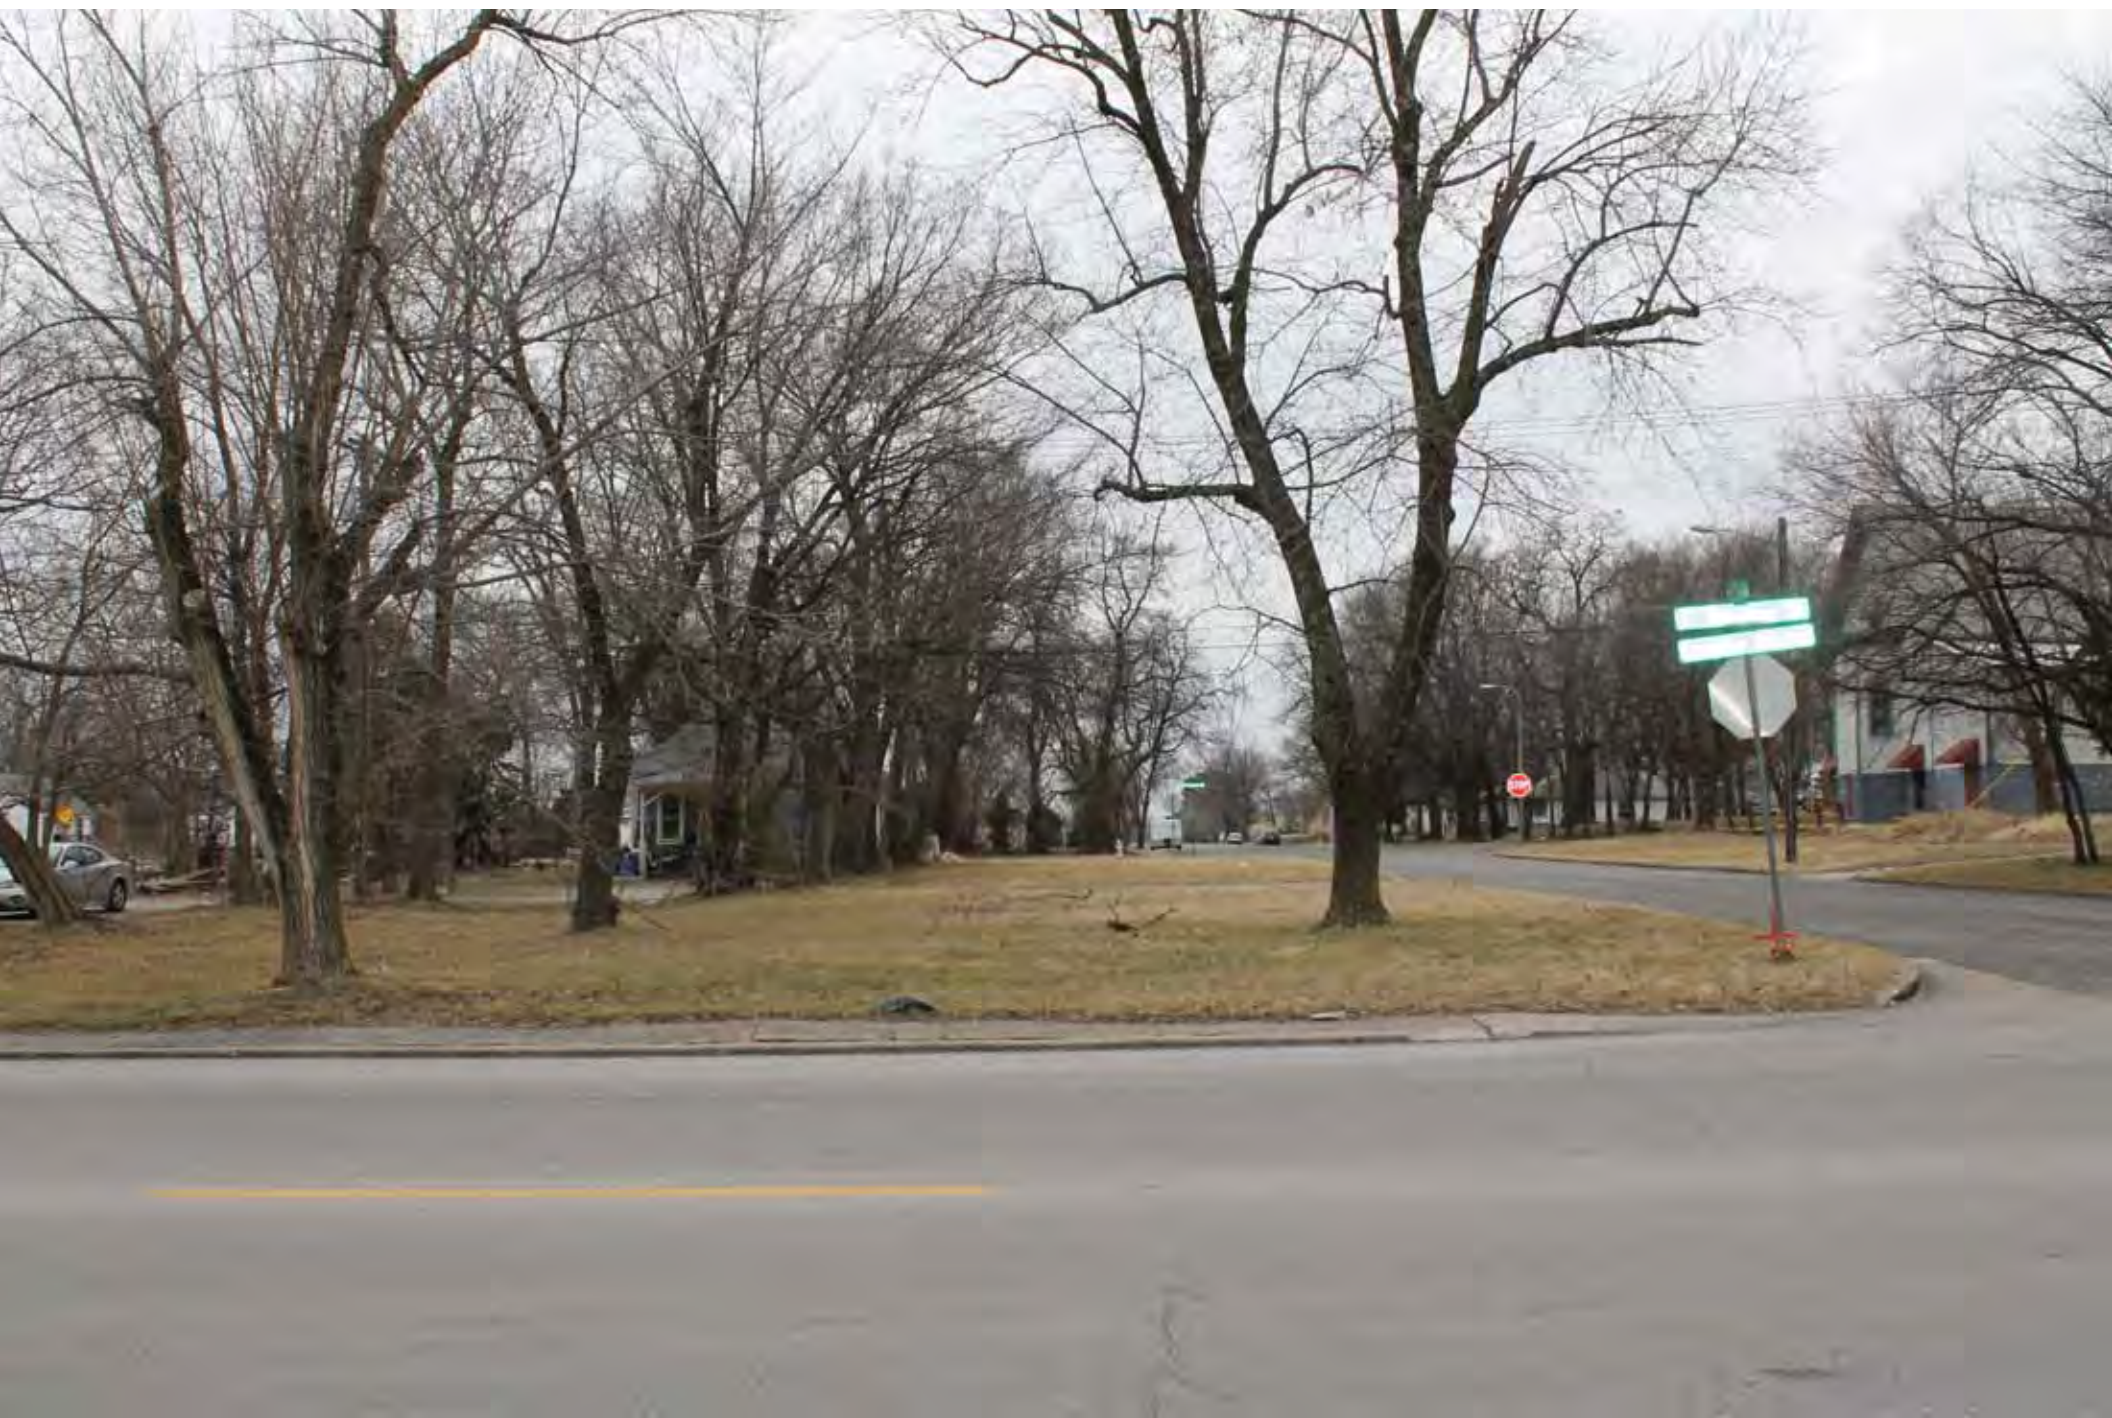
The property at the southwest intersection of E. Broadway Street and S. Division Avenue is a vacant lot covered with grass, as described above.

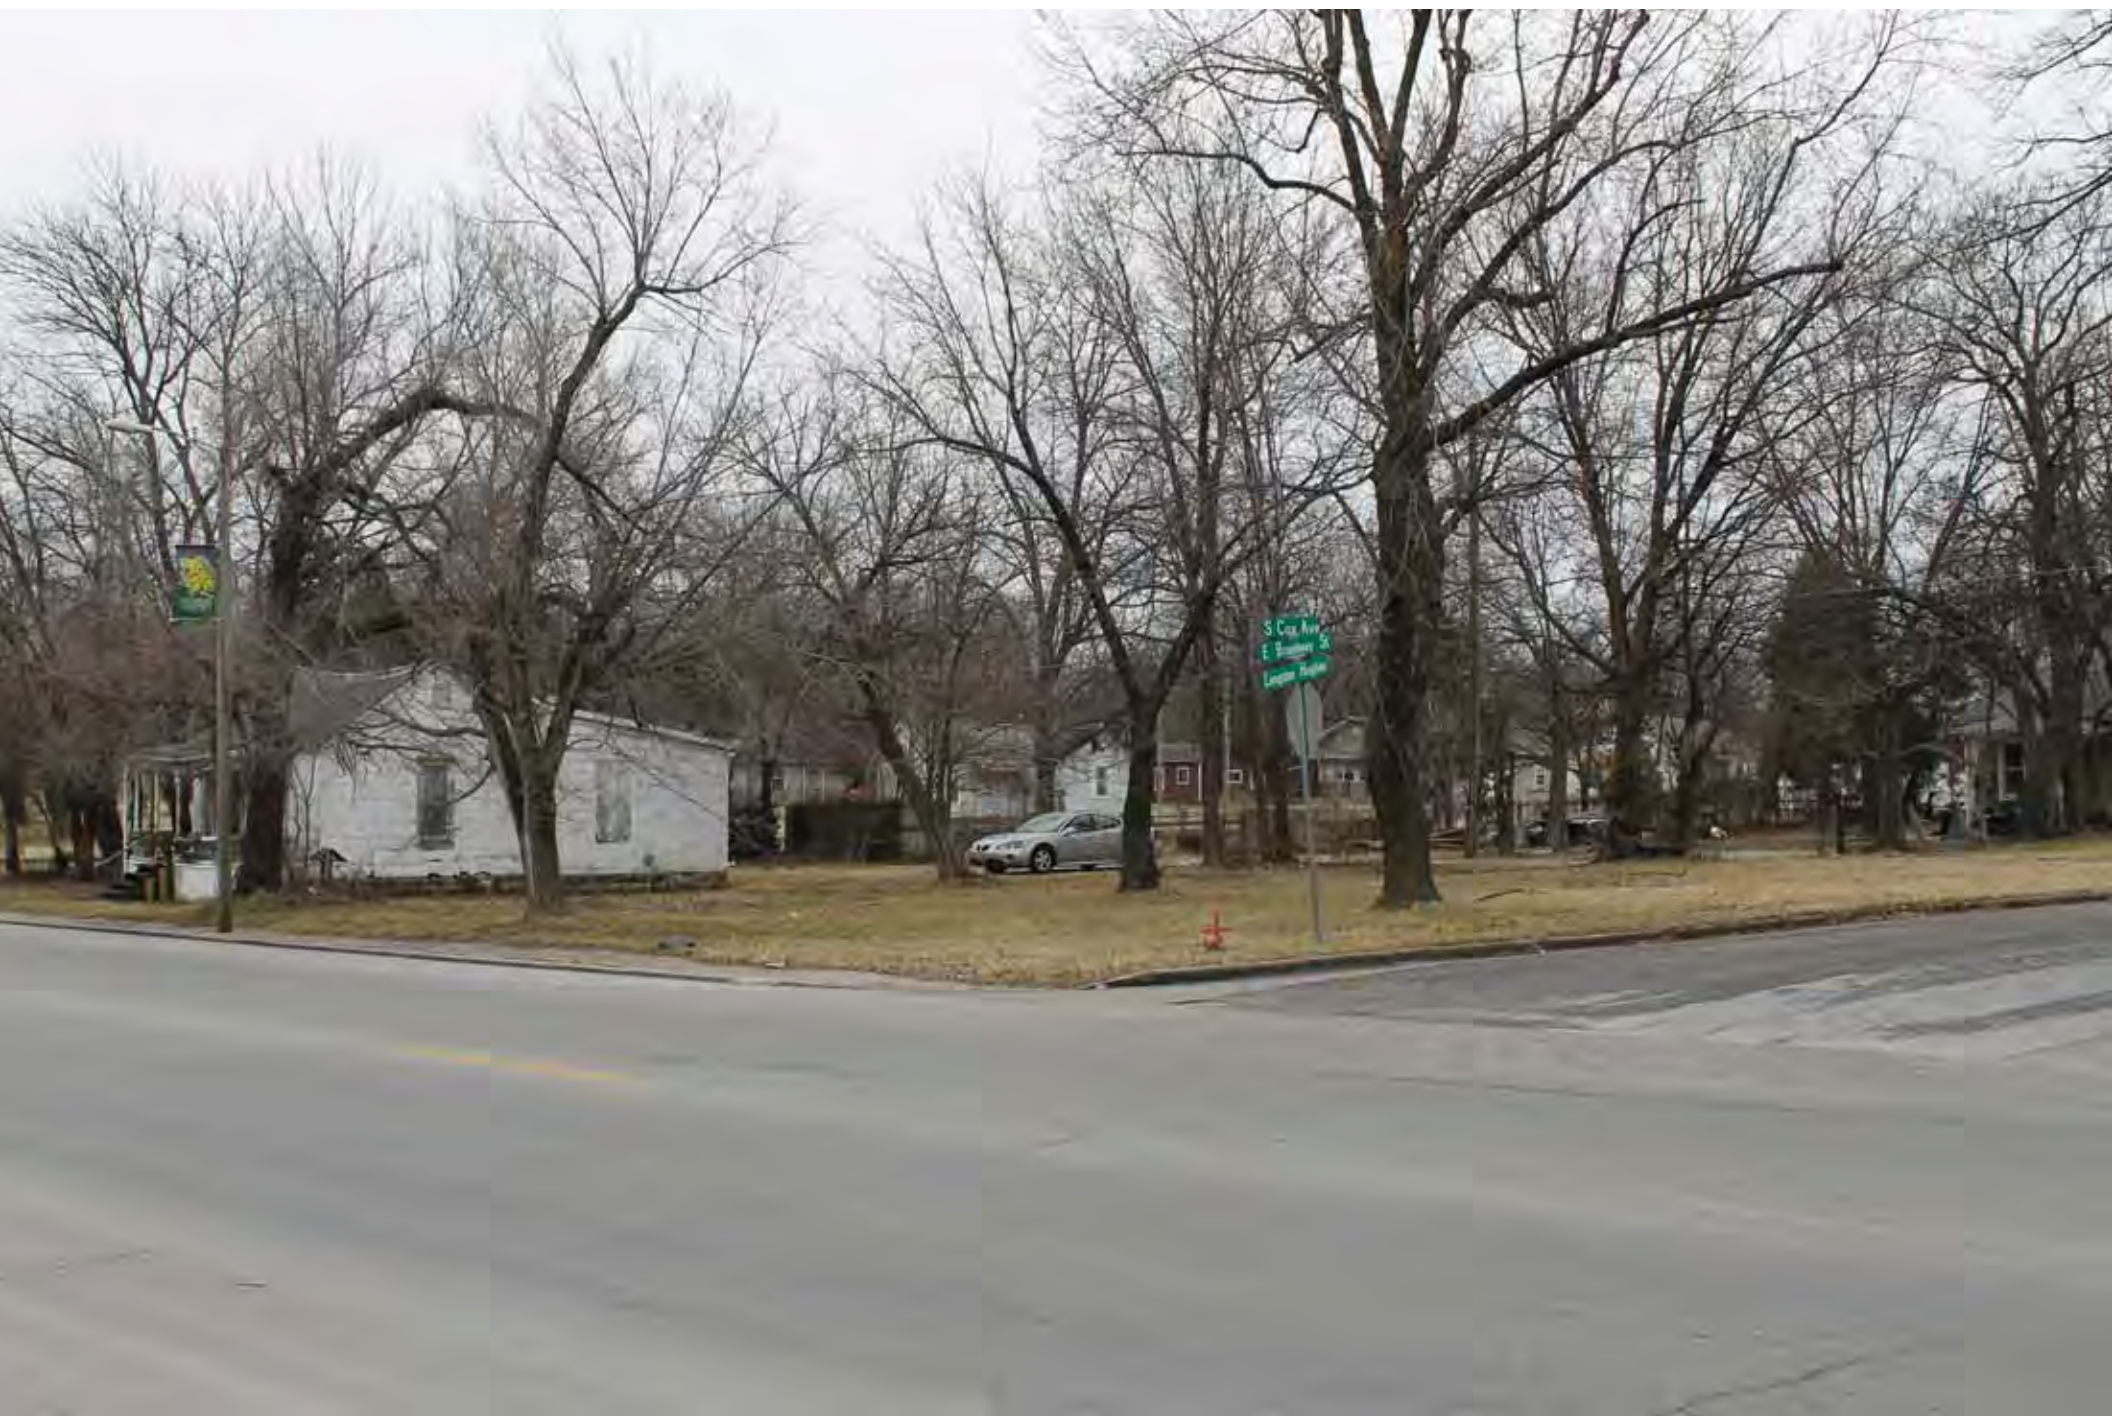
The property at the southeast intersection of E. Broadway Street and S. Cox Avenue is a vacant lot covered with grass, as described above.

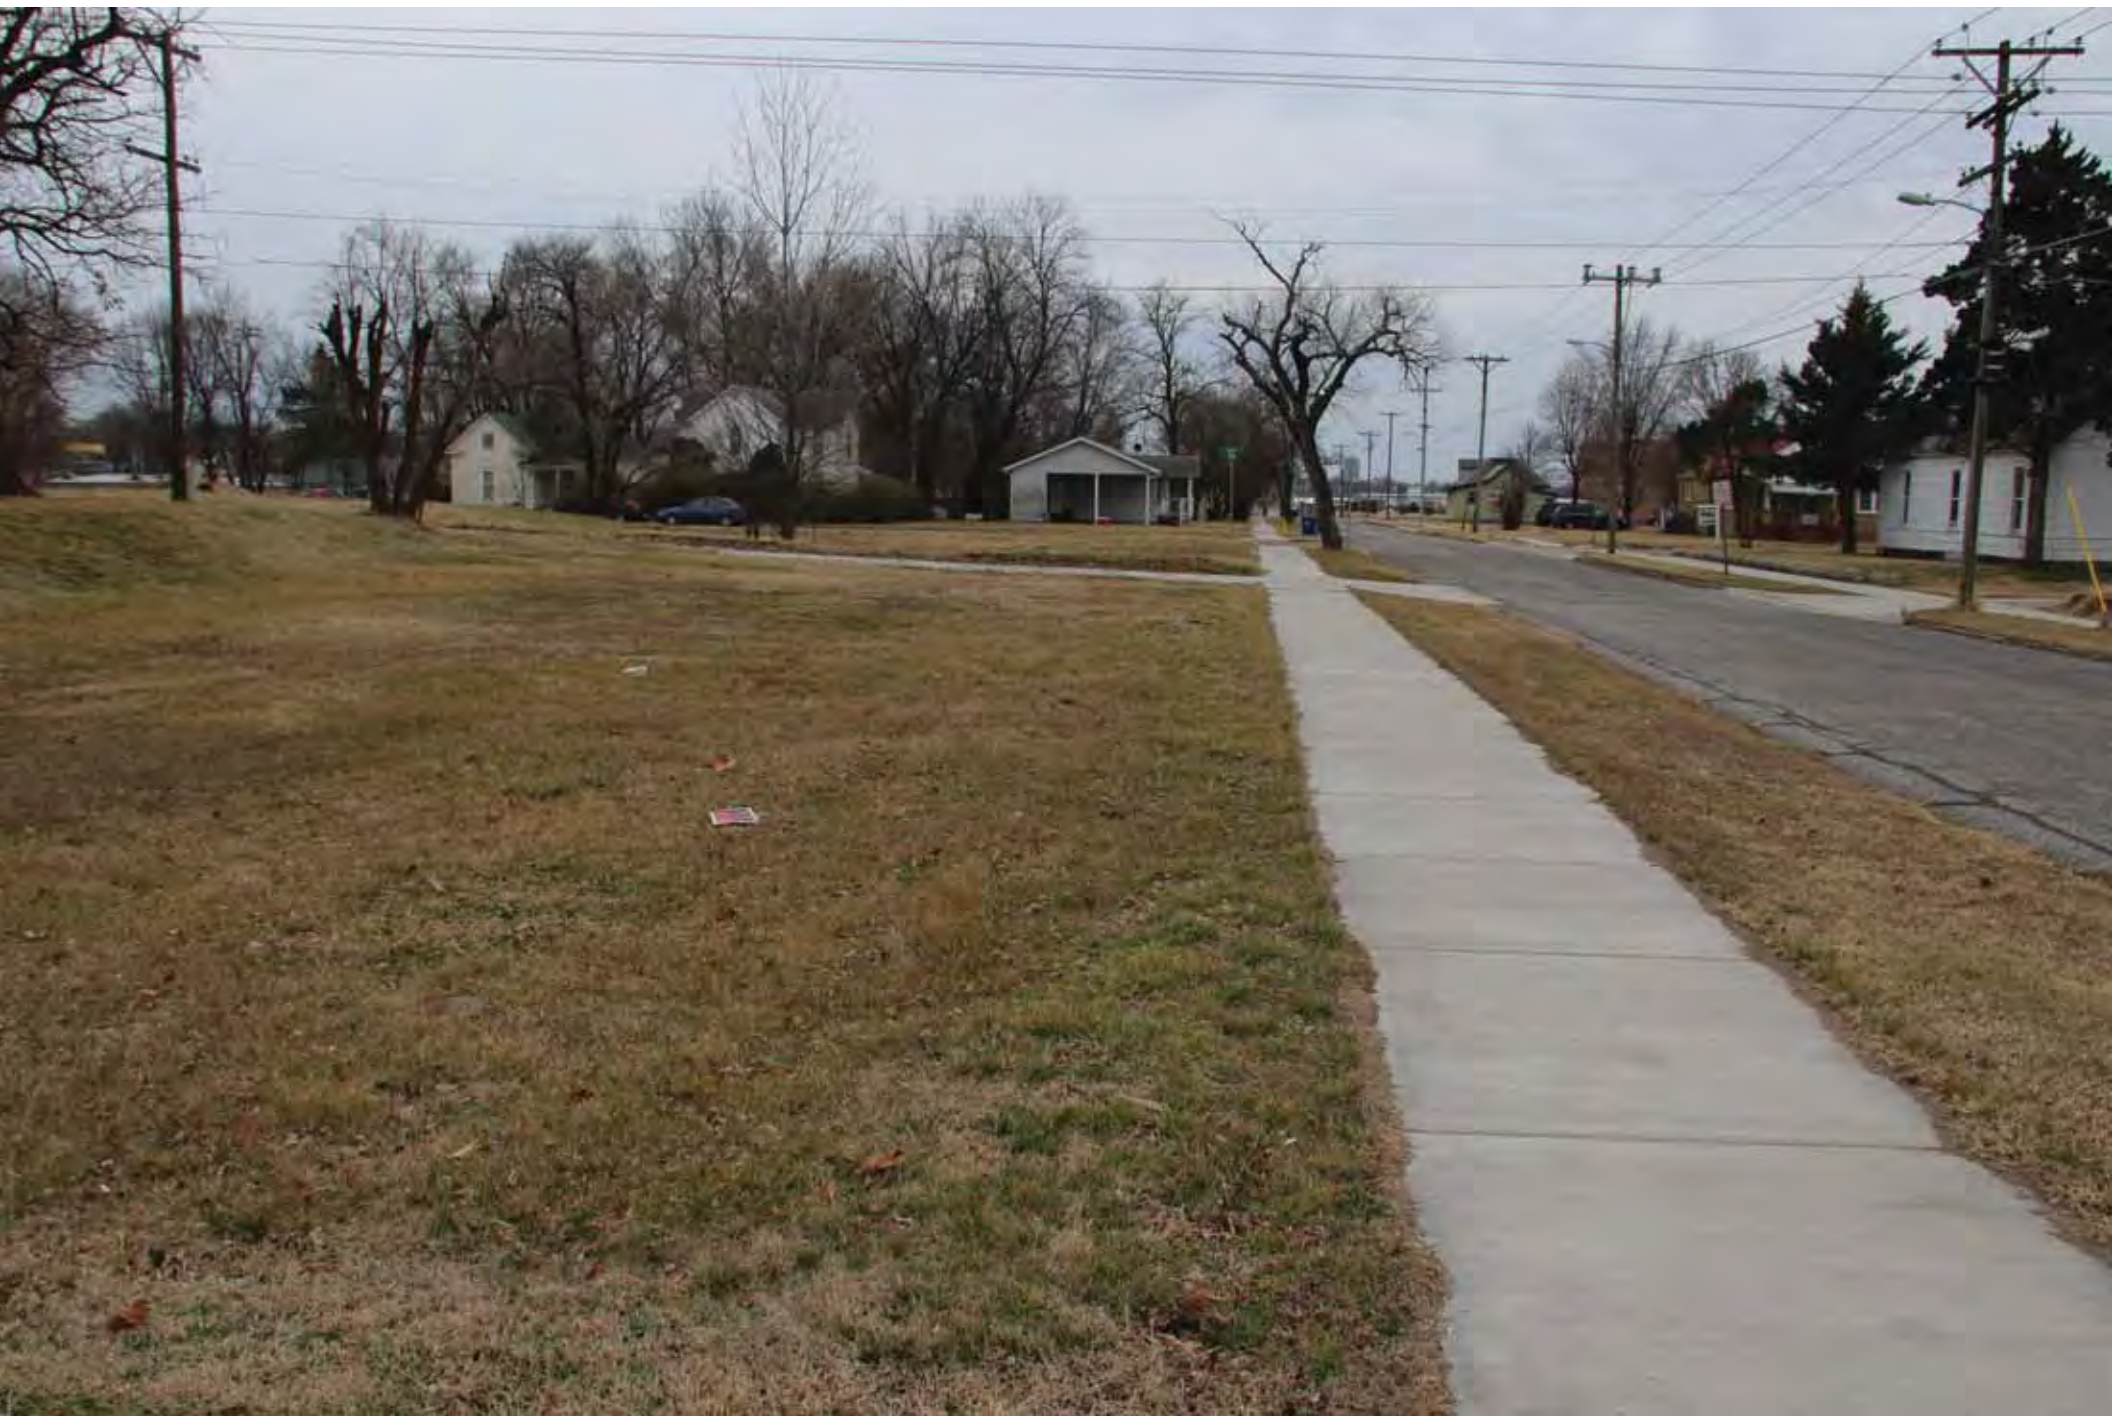
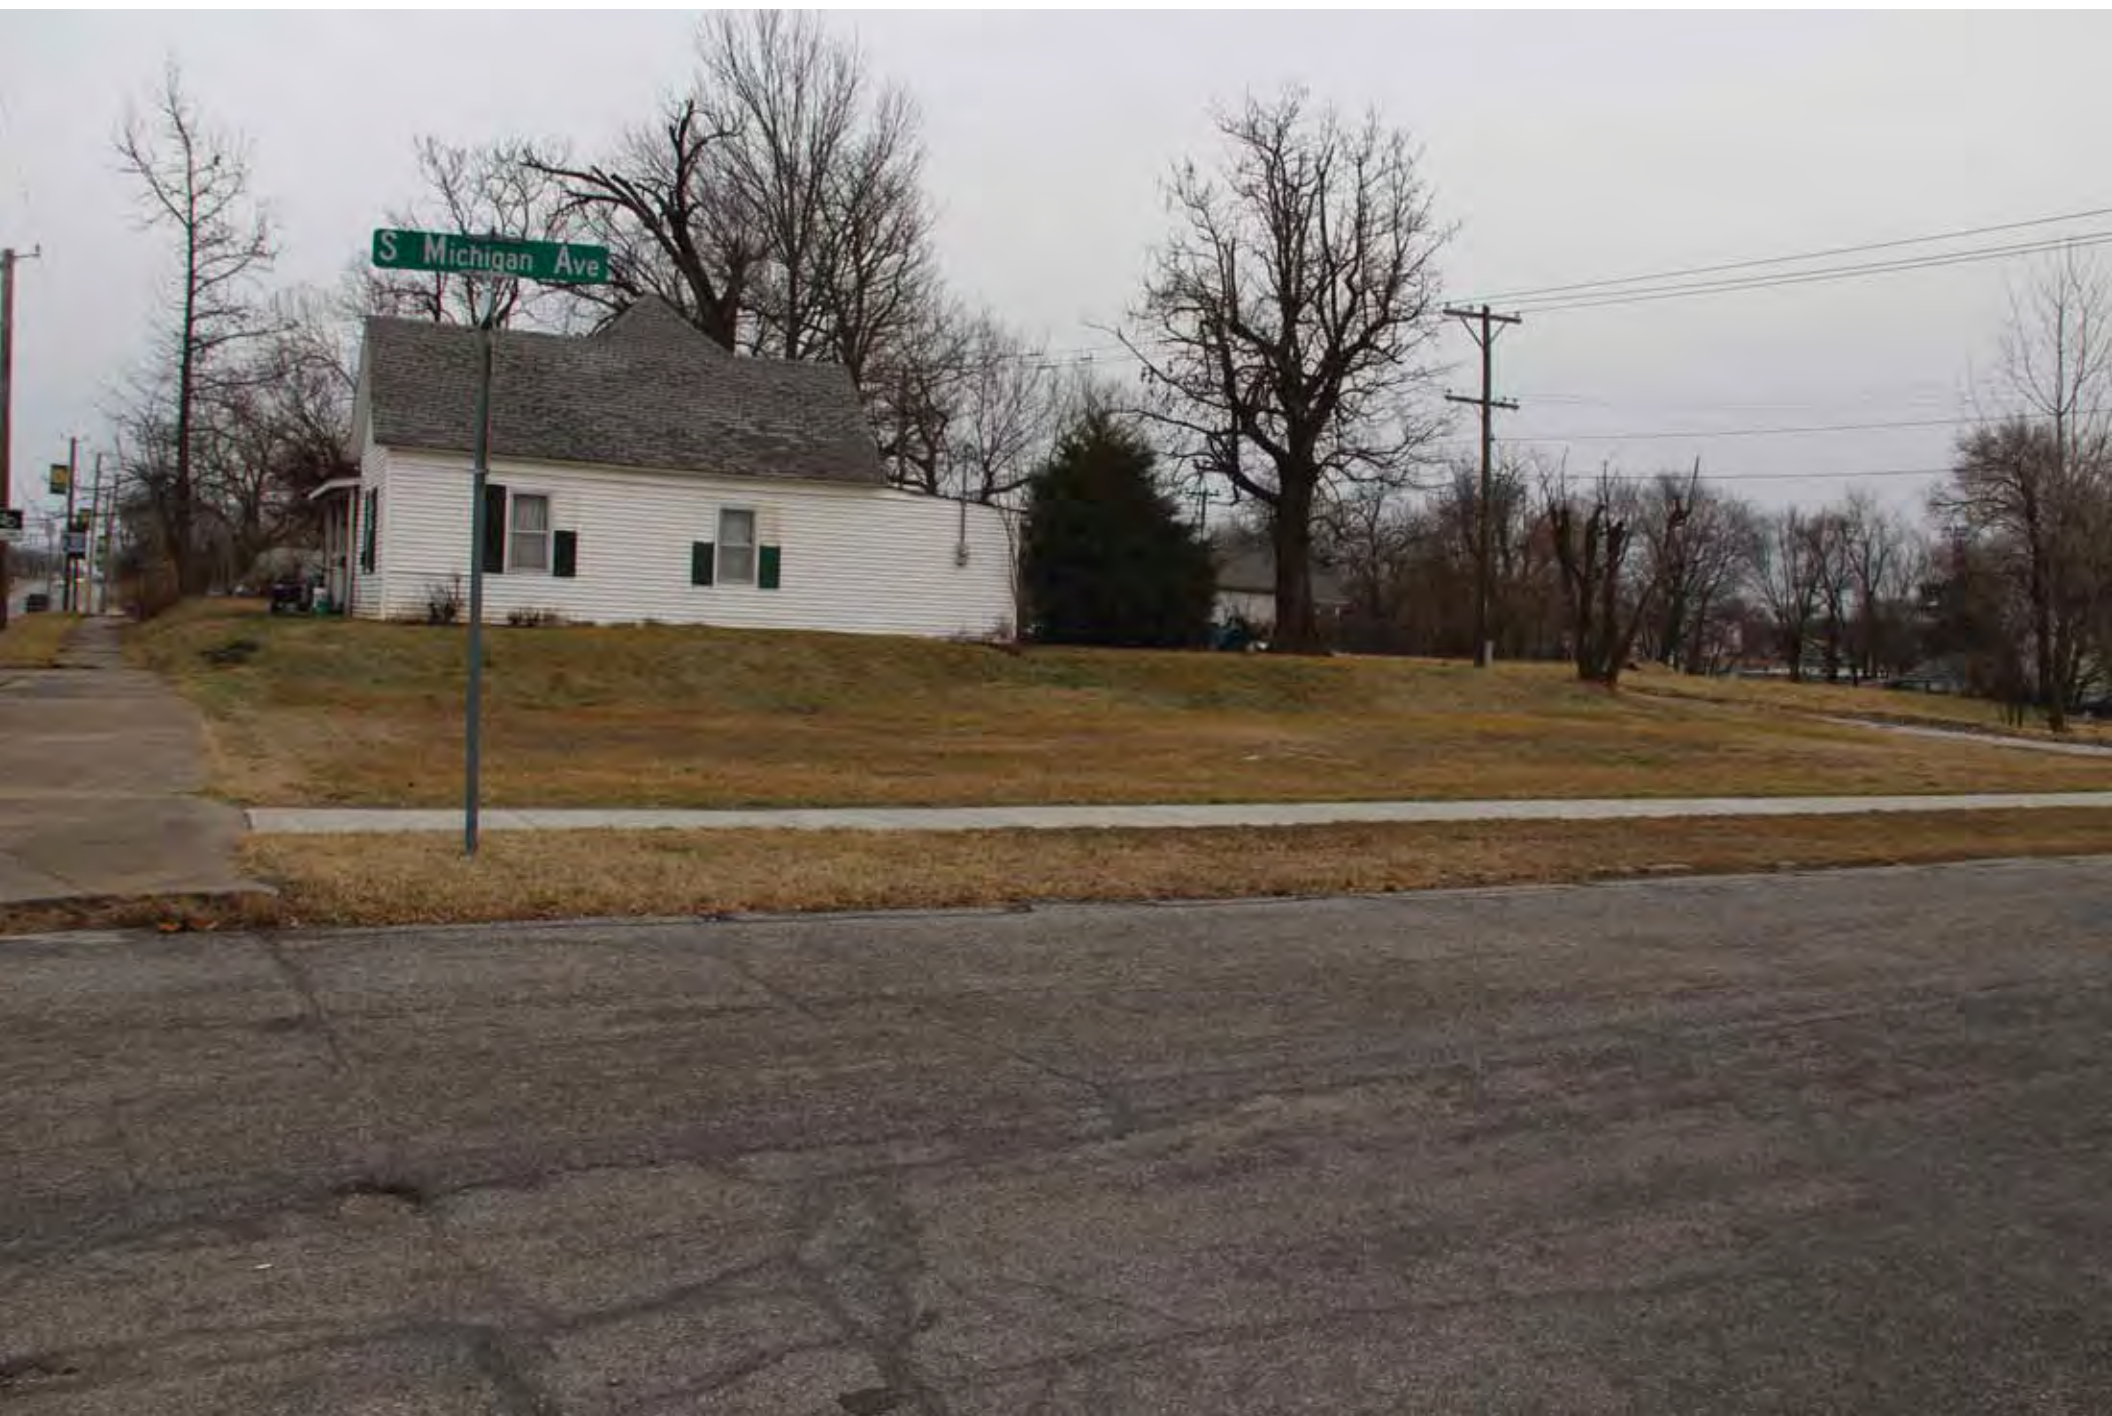
The property at the southeast corner of E. Broadway and S. Michigan is a vacant grassy lot that formerly held a grocery store. A single tree is situated near the rear (south) end of the lot.

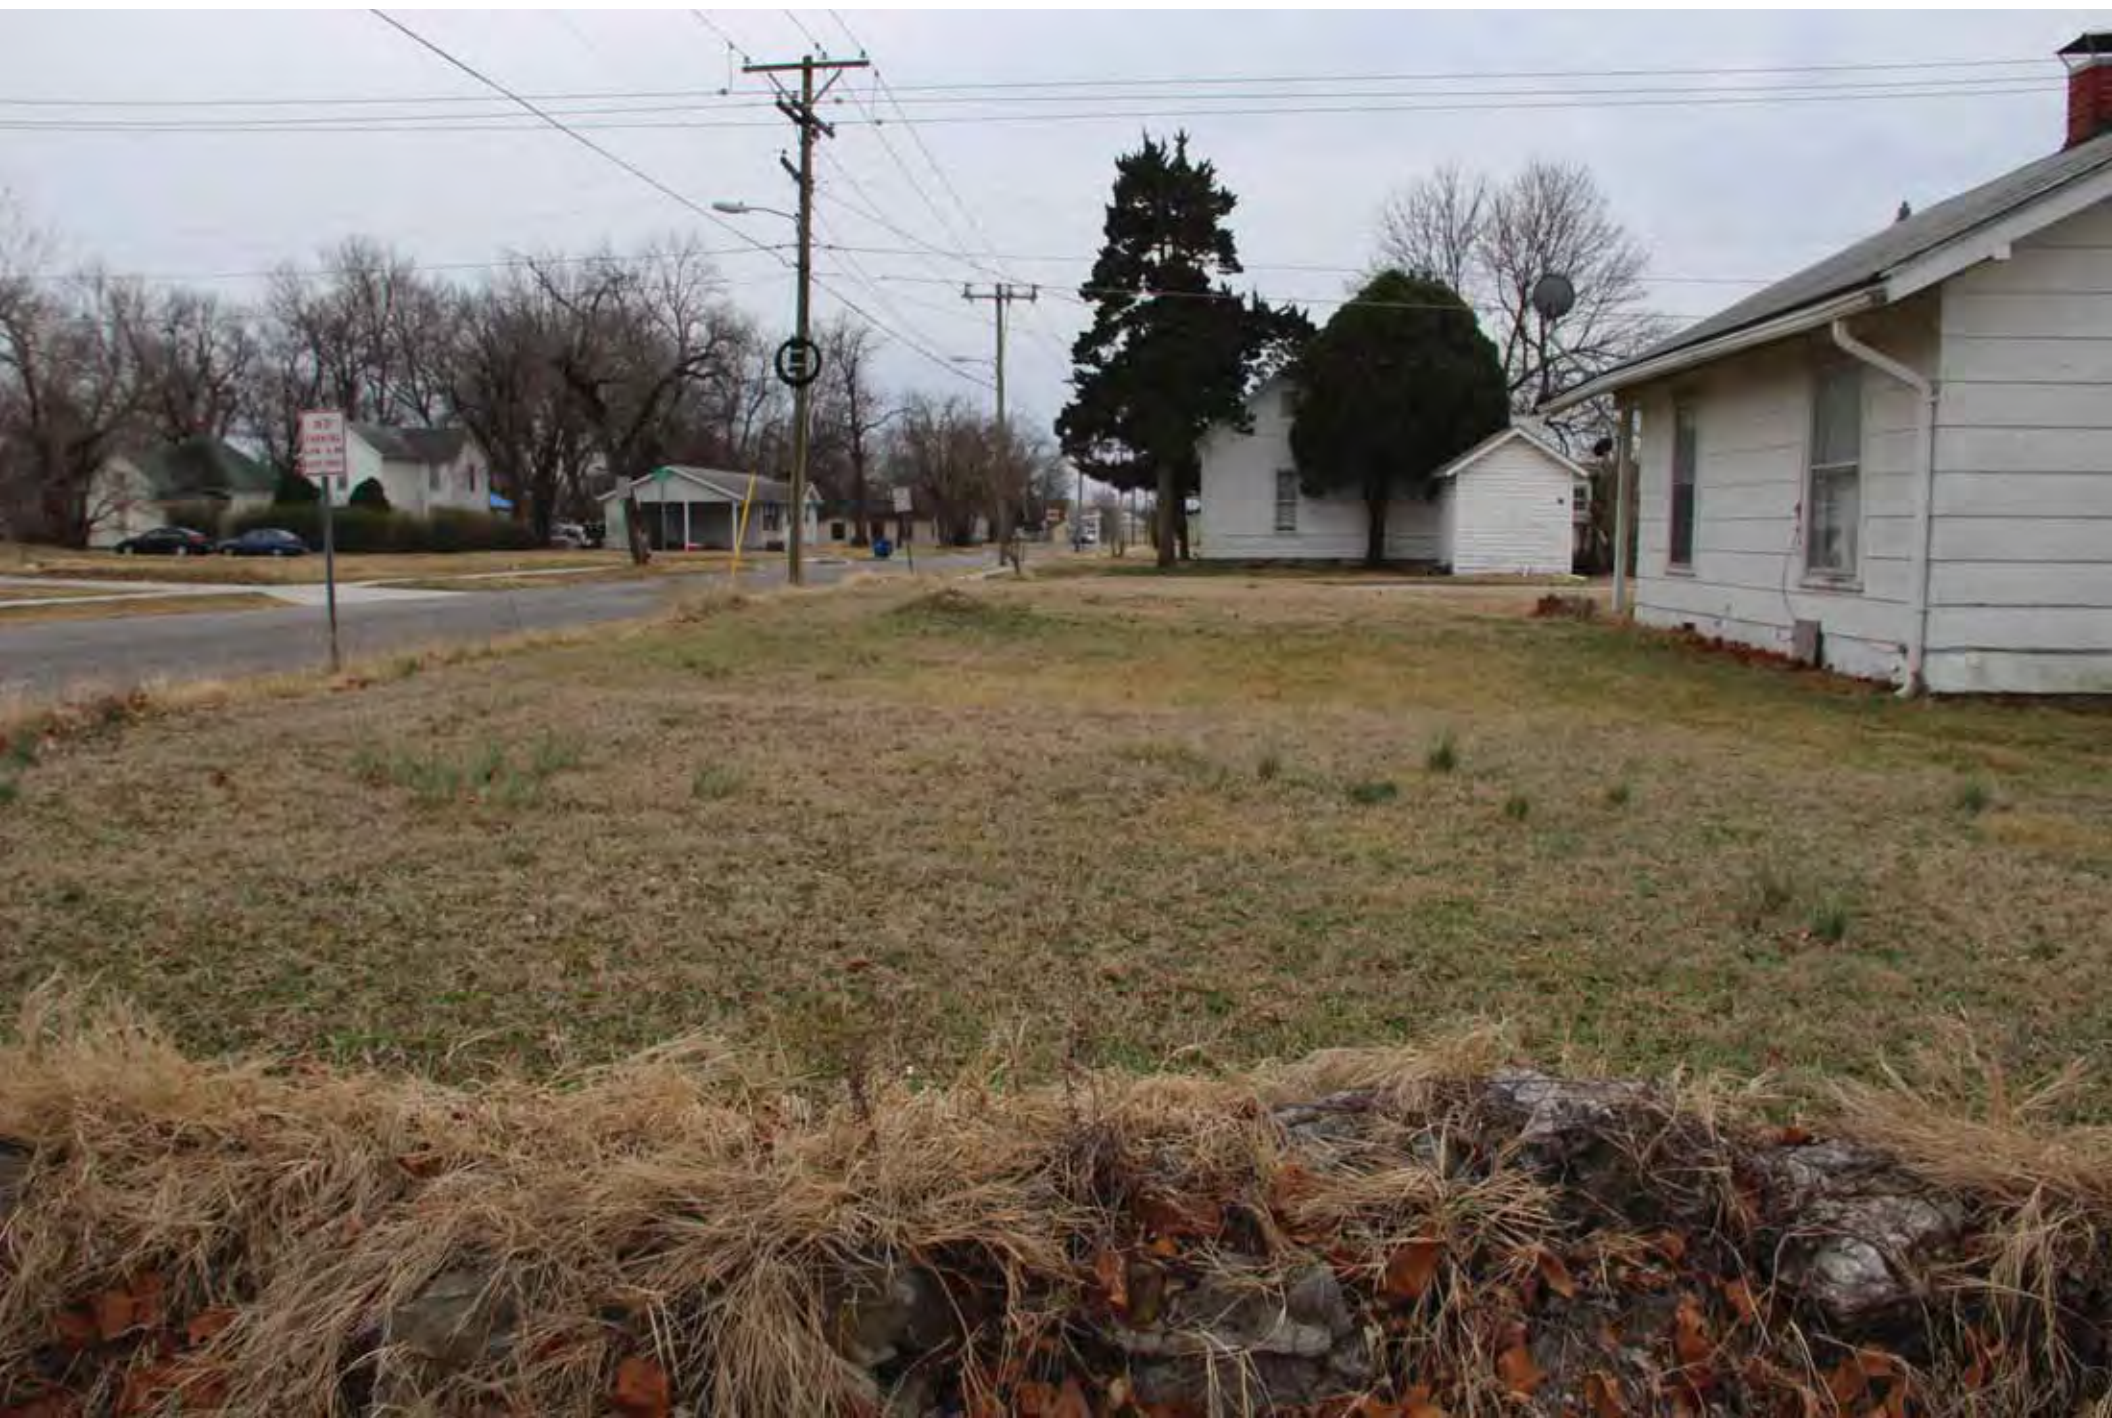
<p>41. (cont.) Description of primary resource. Expand box as necessary, or add continuation pages.</p> <p>The property at the southwest intersection of E. Broadway Street and S. Michigan Avenue is a vacant lot covered with grass, as described above.</p>
