MISSOURI DEPARTMENT OF NATURAL RESOURCES
STATE HISTORIC PRESERVATION OFFICE, P.O. Box 176, Jefferson City, MO 65102
ARCHITECTURAL/HISTORIC INVENTORY FORM

1. Survey No. JP-AS-007-001		2. Survey name: East Town (Original Joplin) Historic Survey Phase 2	
3. County: JASPER		4. Address (Street No.) 618	Street (name) E. 2 nd Street
5. City: Joplin	Vicinity: <input type="checkbox"/>	6. Geographical Reference:	7. Township/Range/Section: T: R: S:
8. Historic name (if known):		9. Present/other name (if known):	
10. Ownership: <input checked="" type="checkbox"/> Private <input type="checkbox"/> Public		11a. Historic use (if known): Domestic: Single Dwelling	11b. Current use: Domestic: Single Dwelling

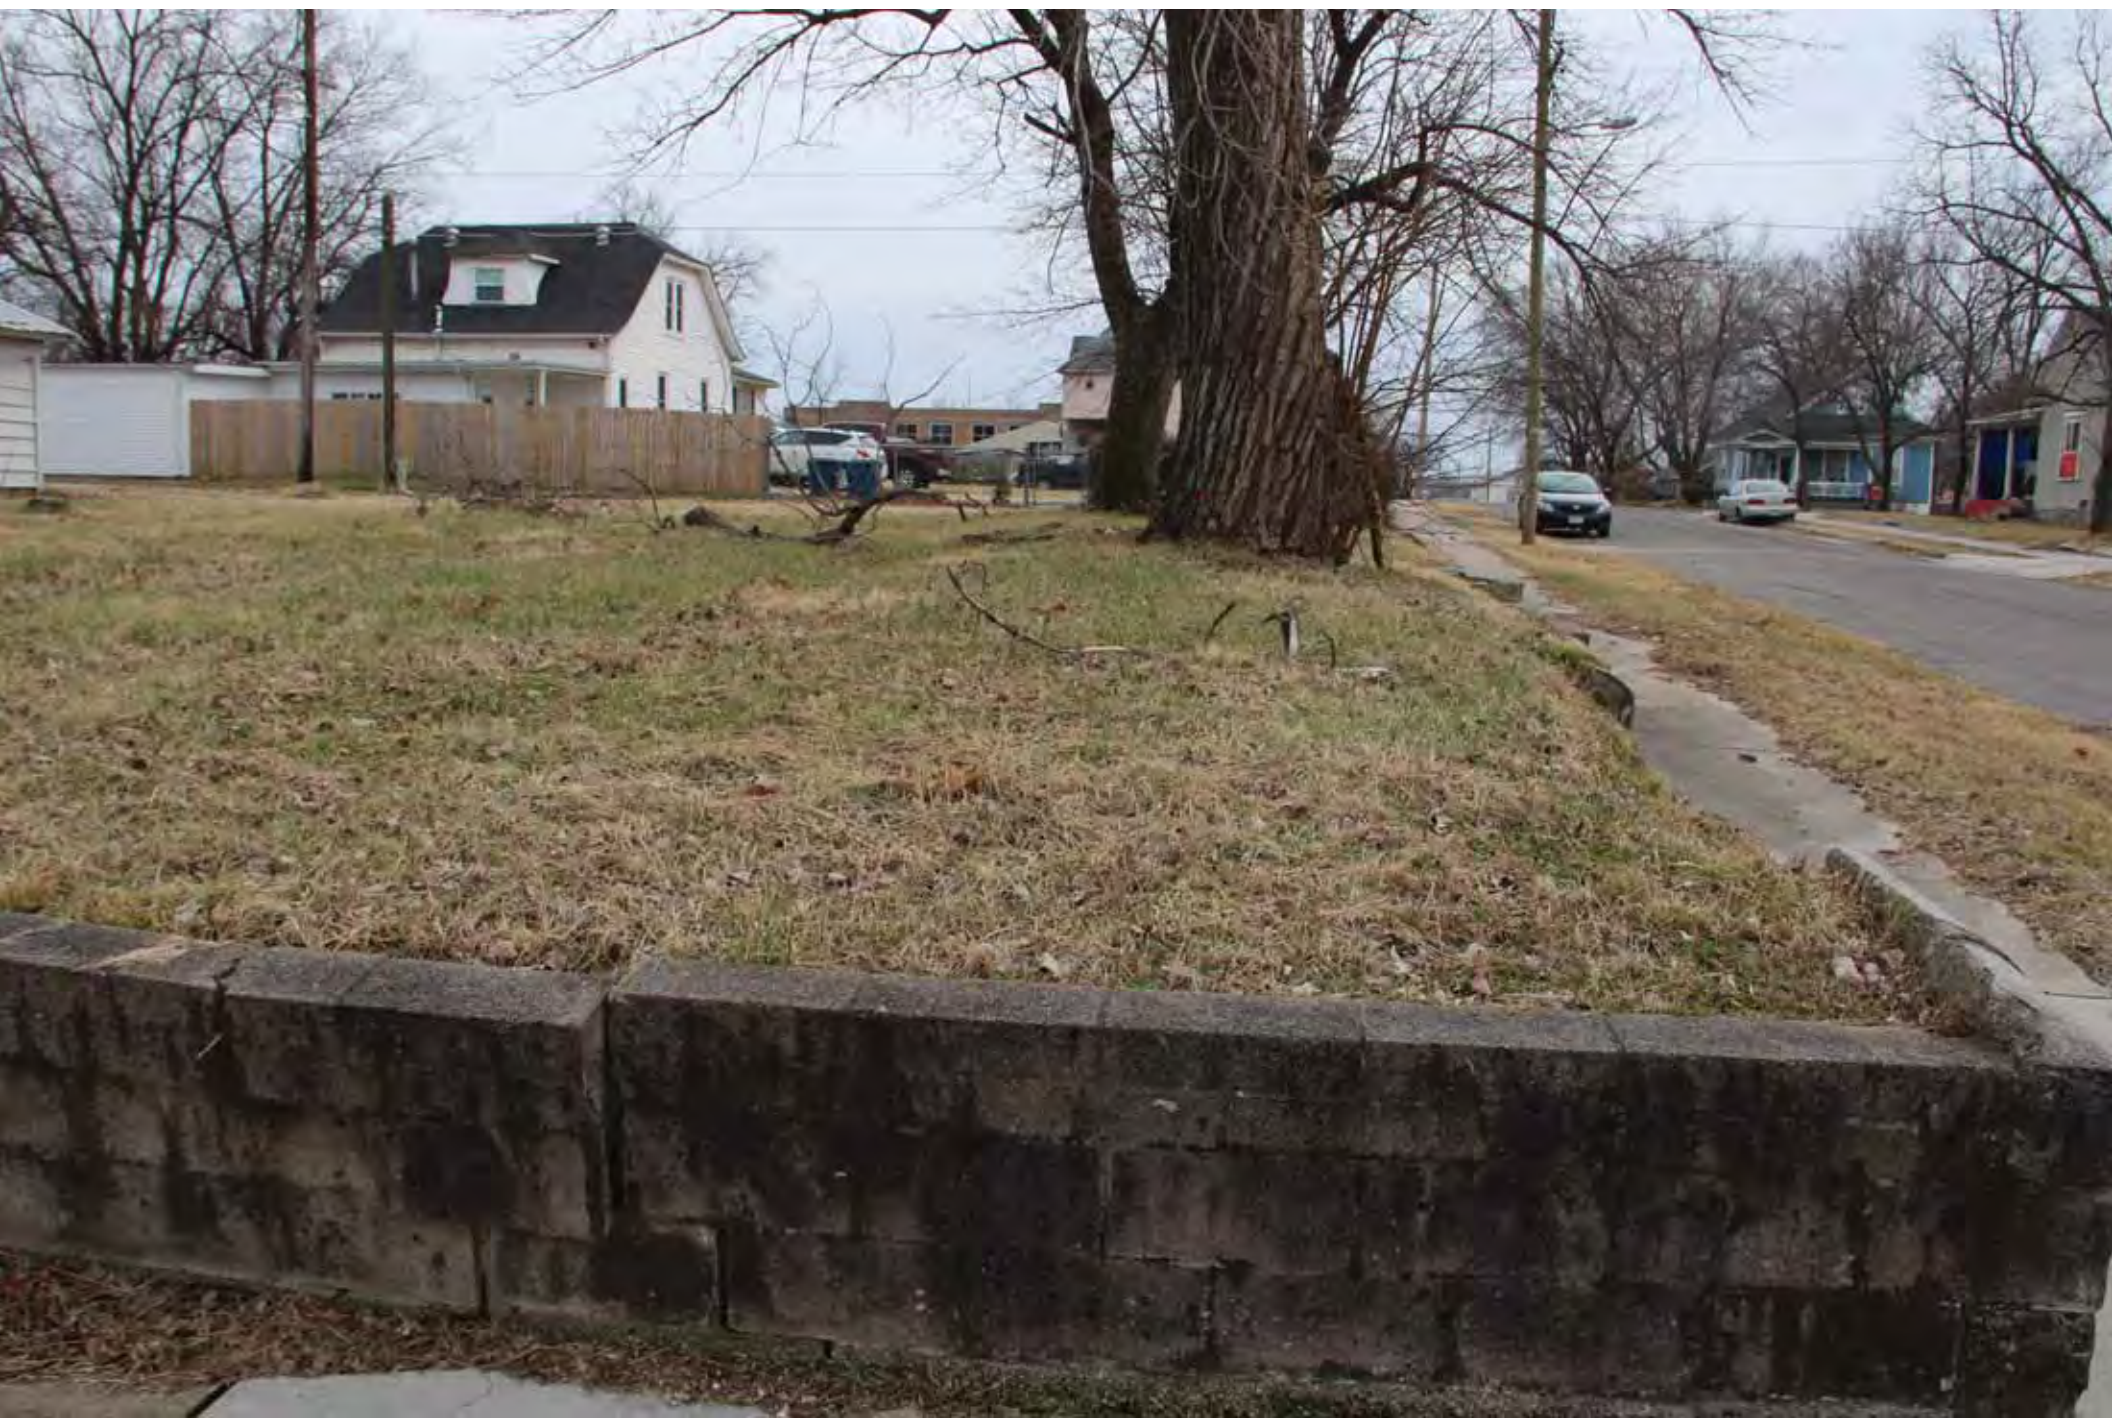
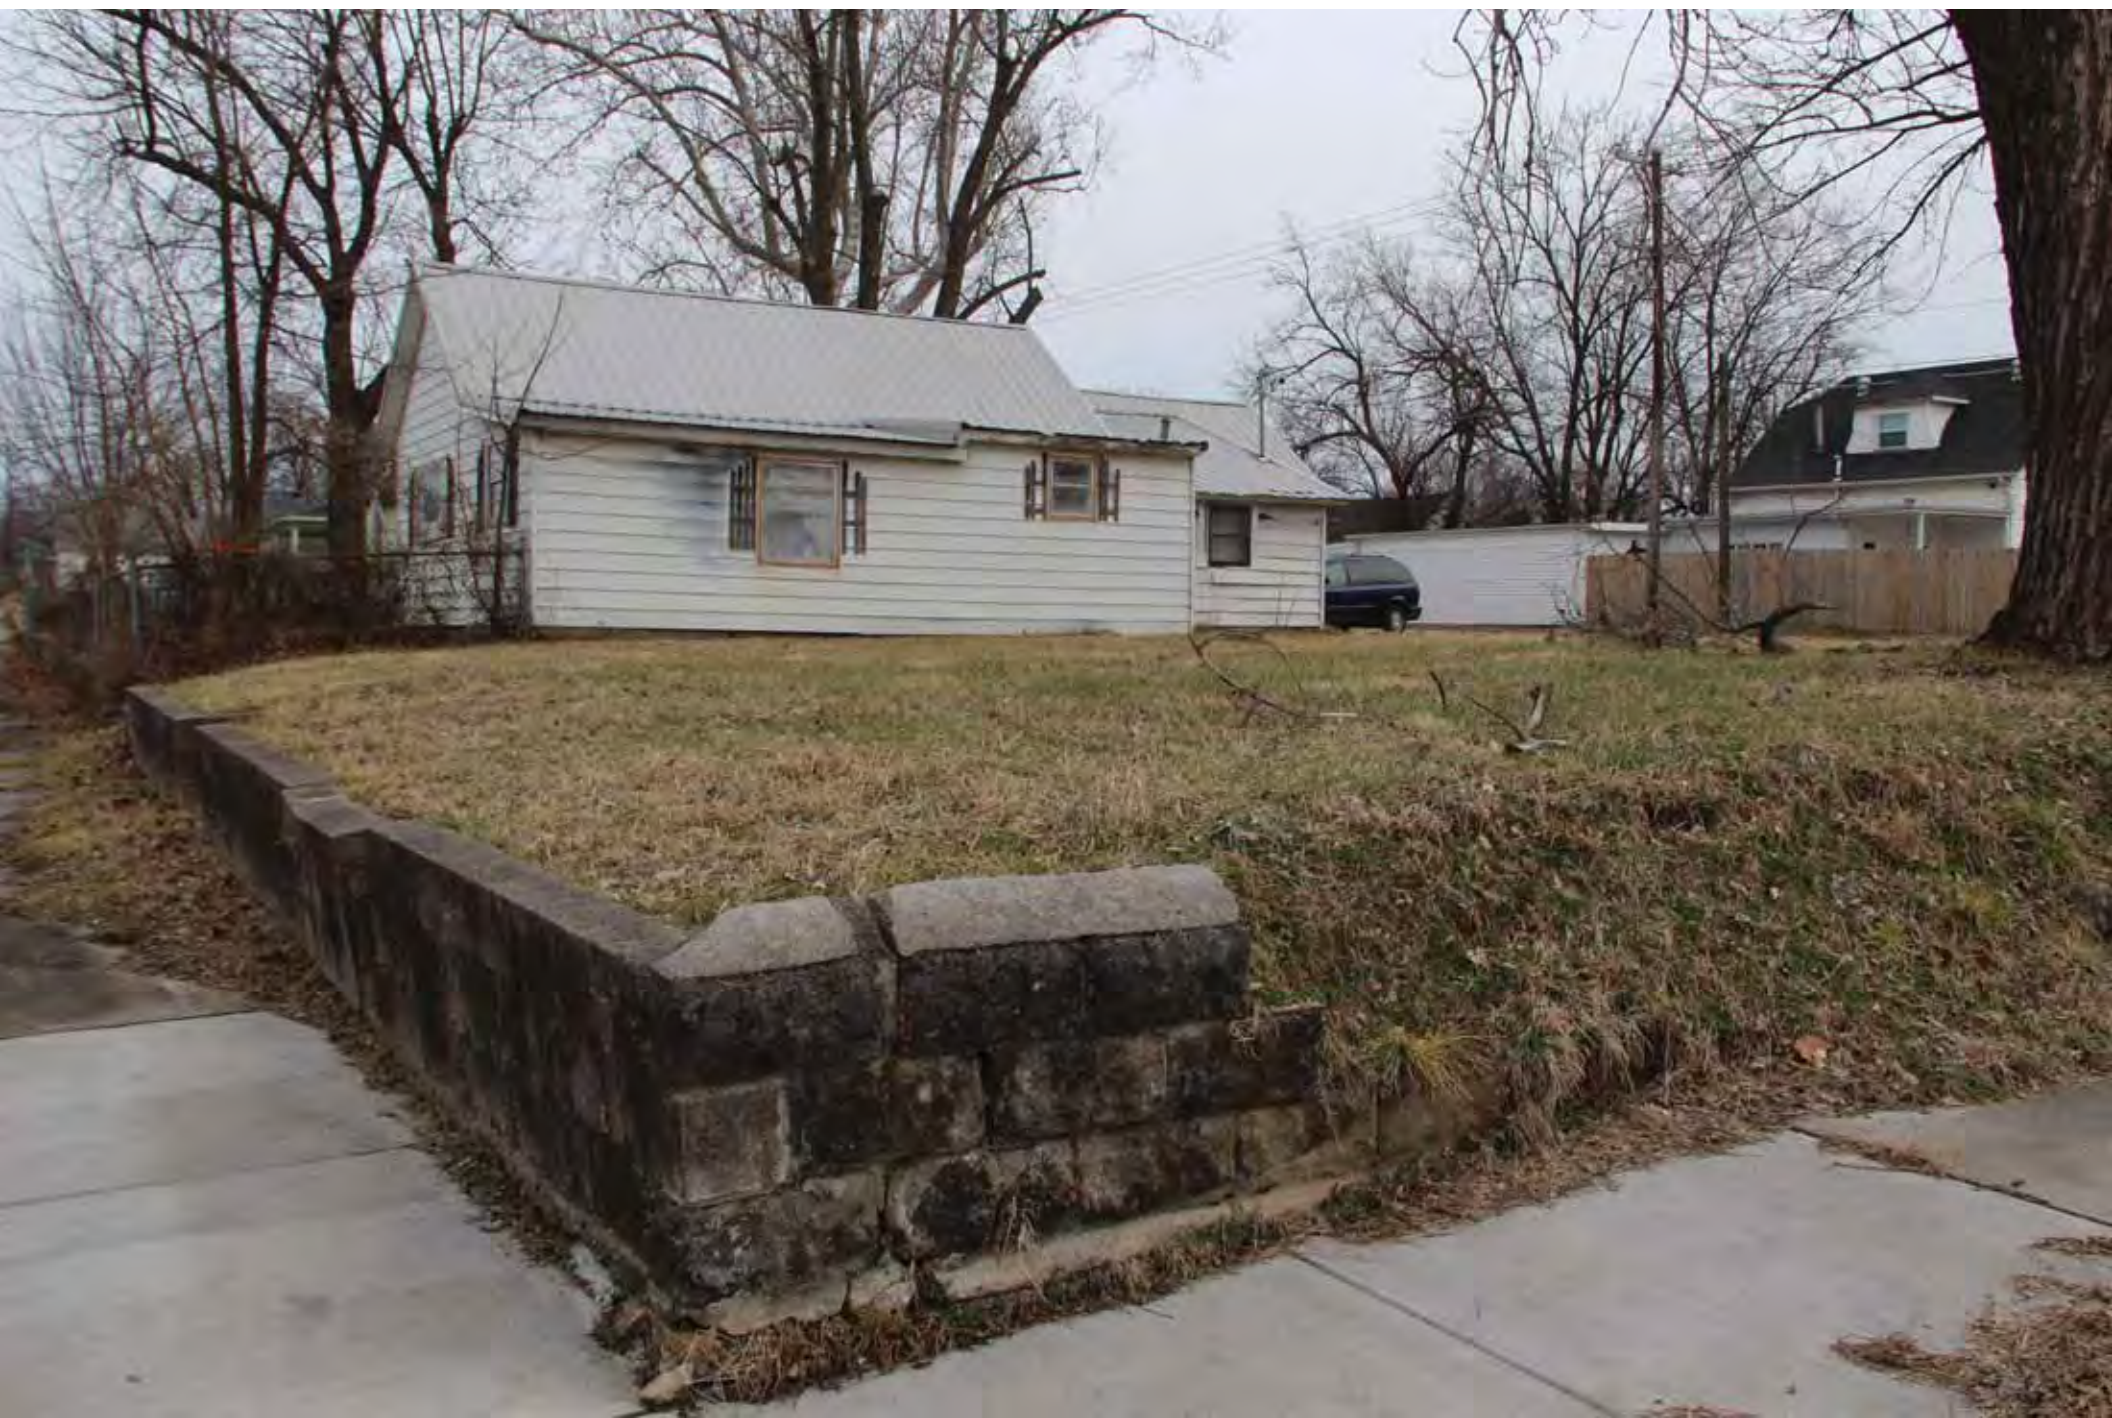
The property at the southeast corner of E. Broadway and School Avenue is a vacant grassy lot as described above.

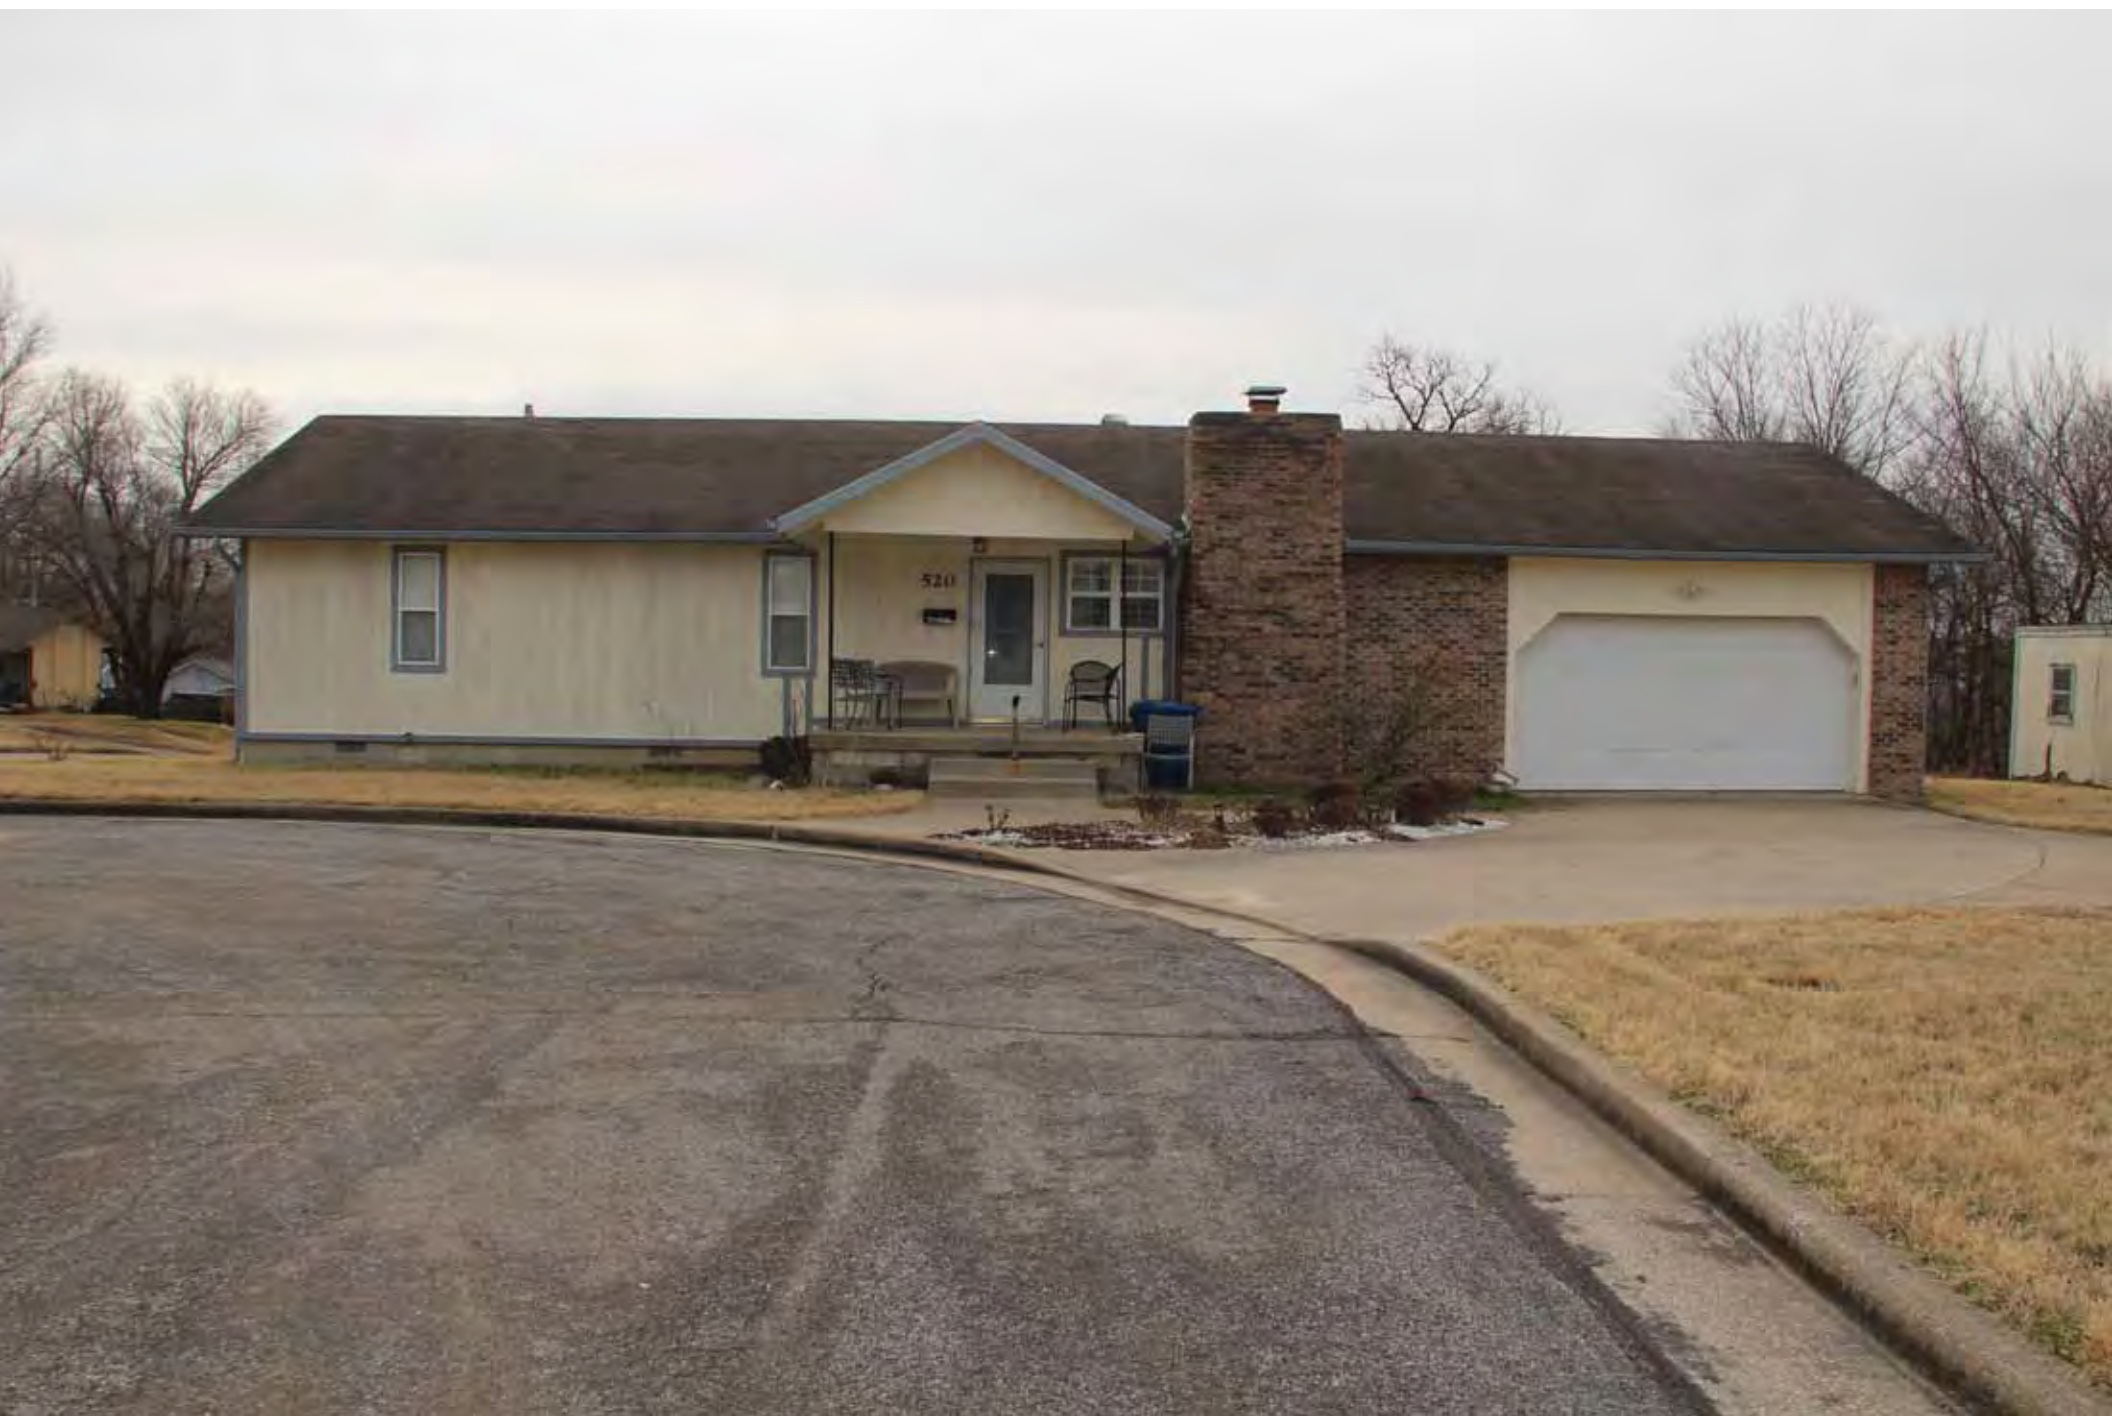
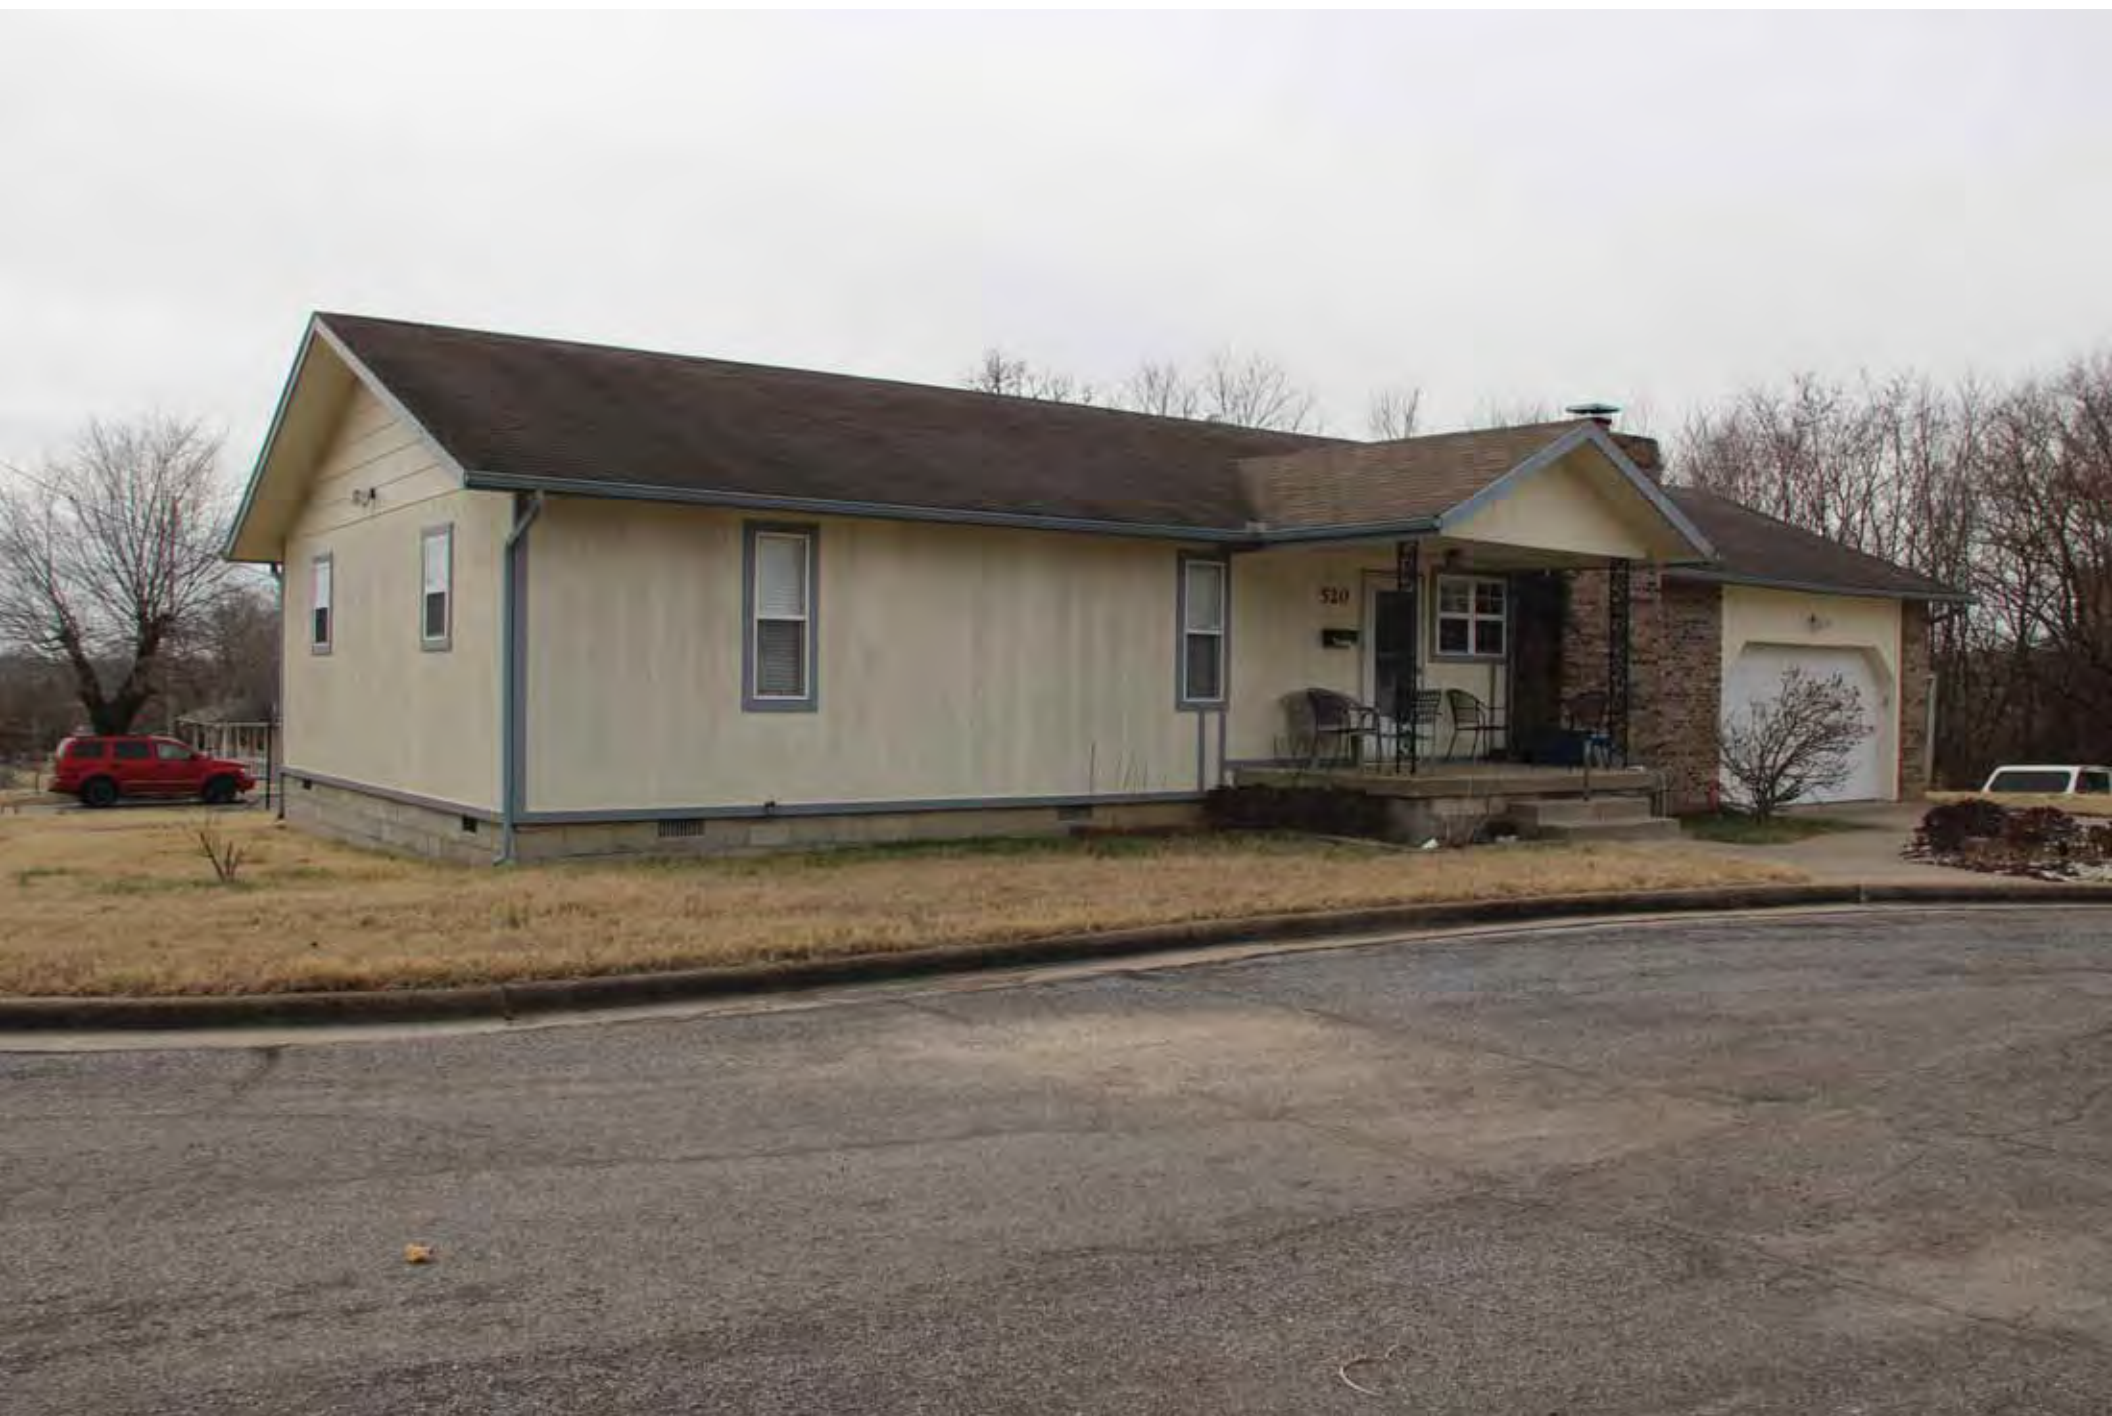
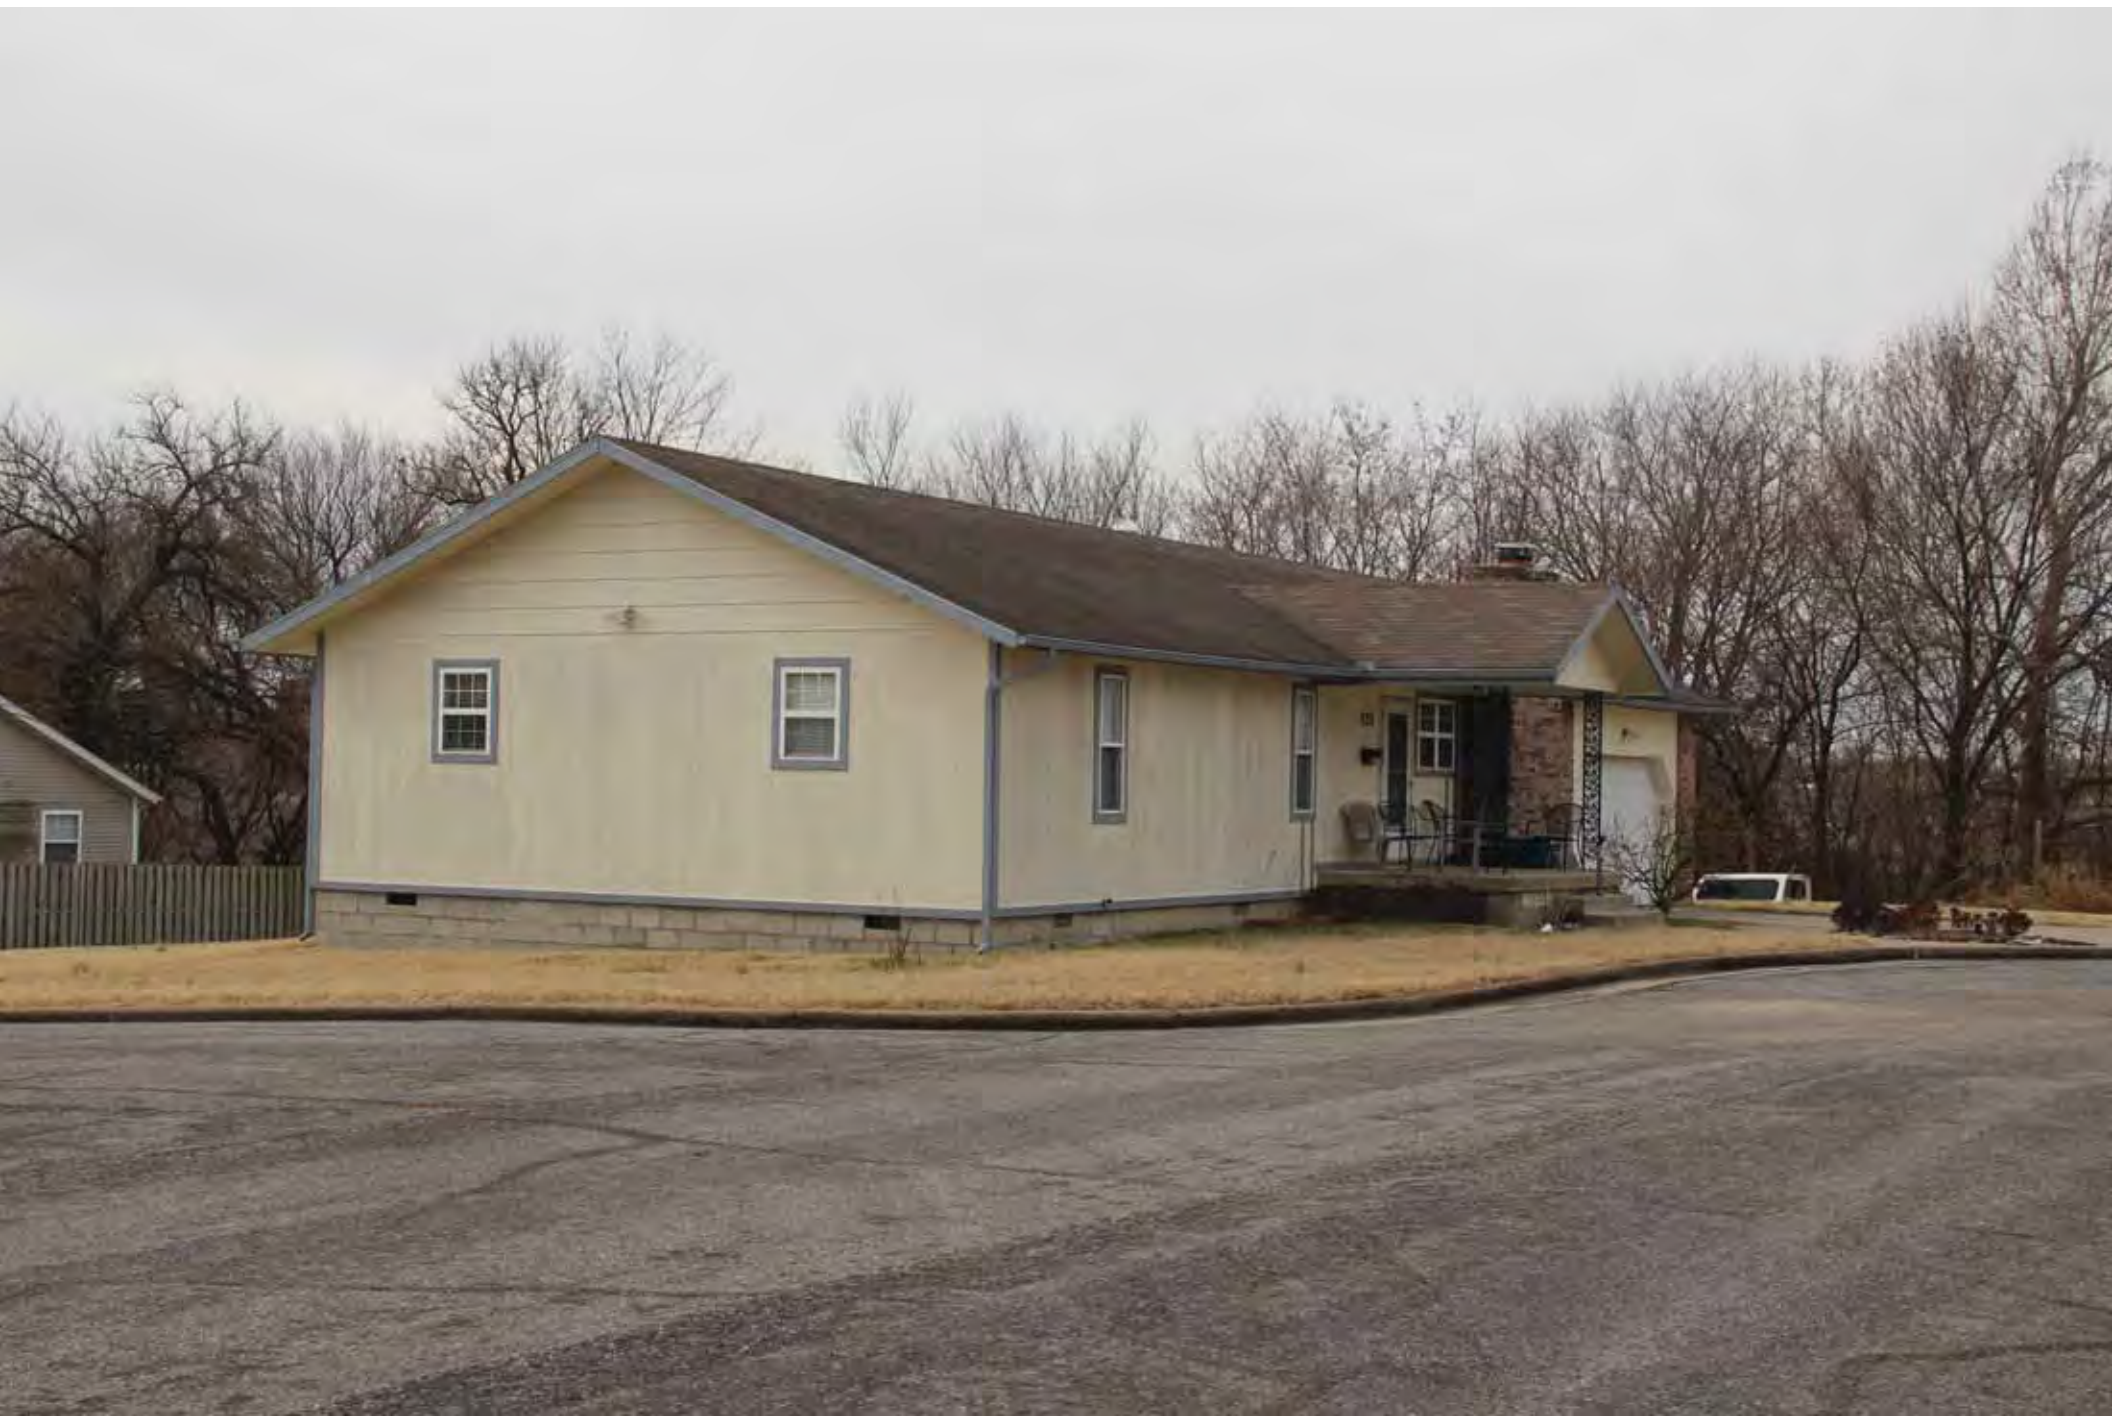
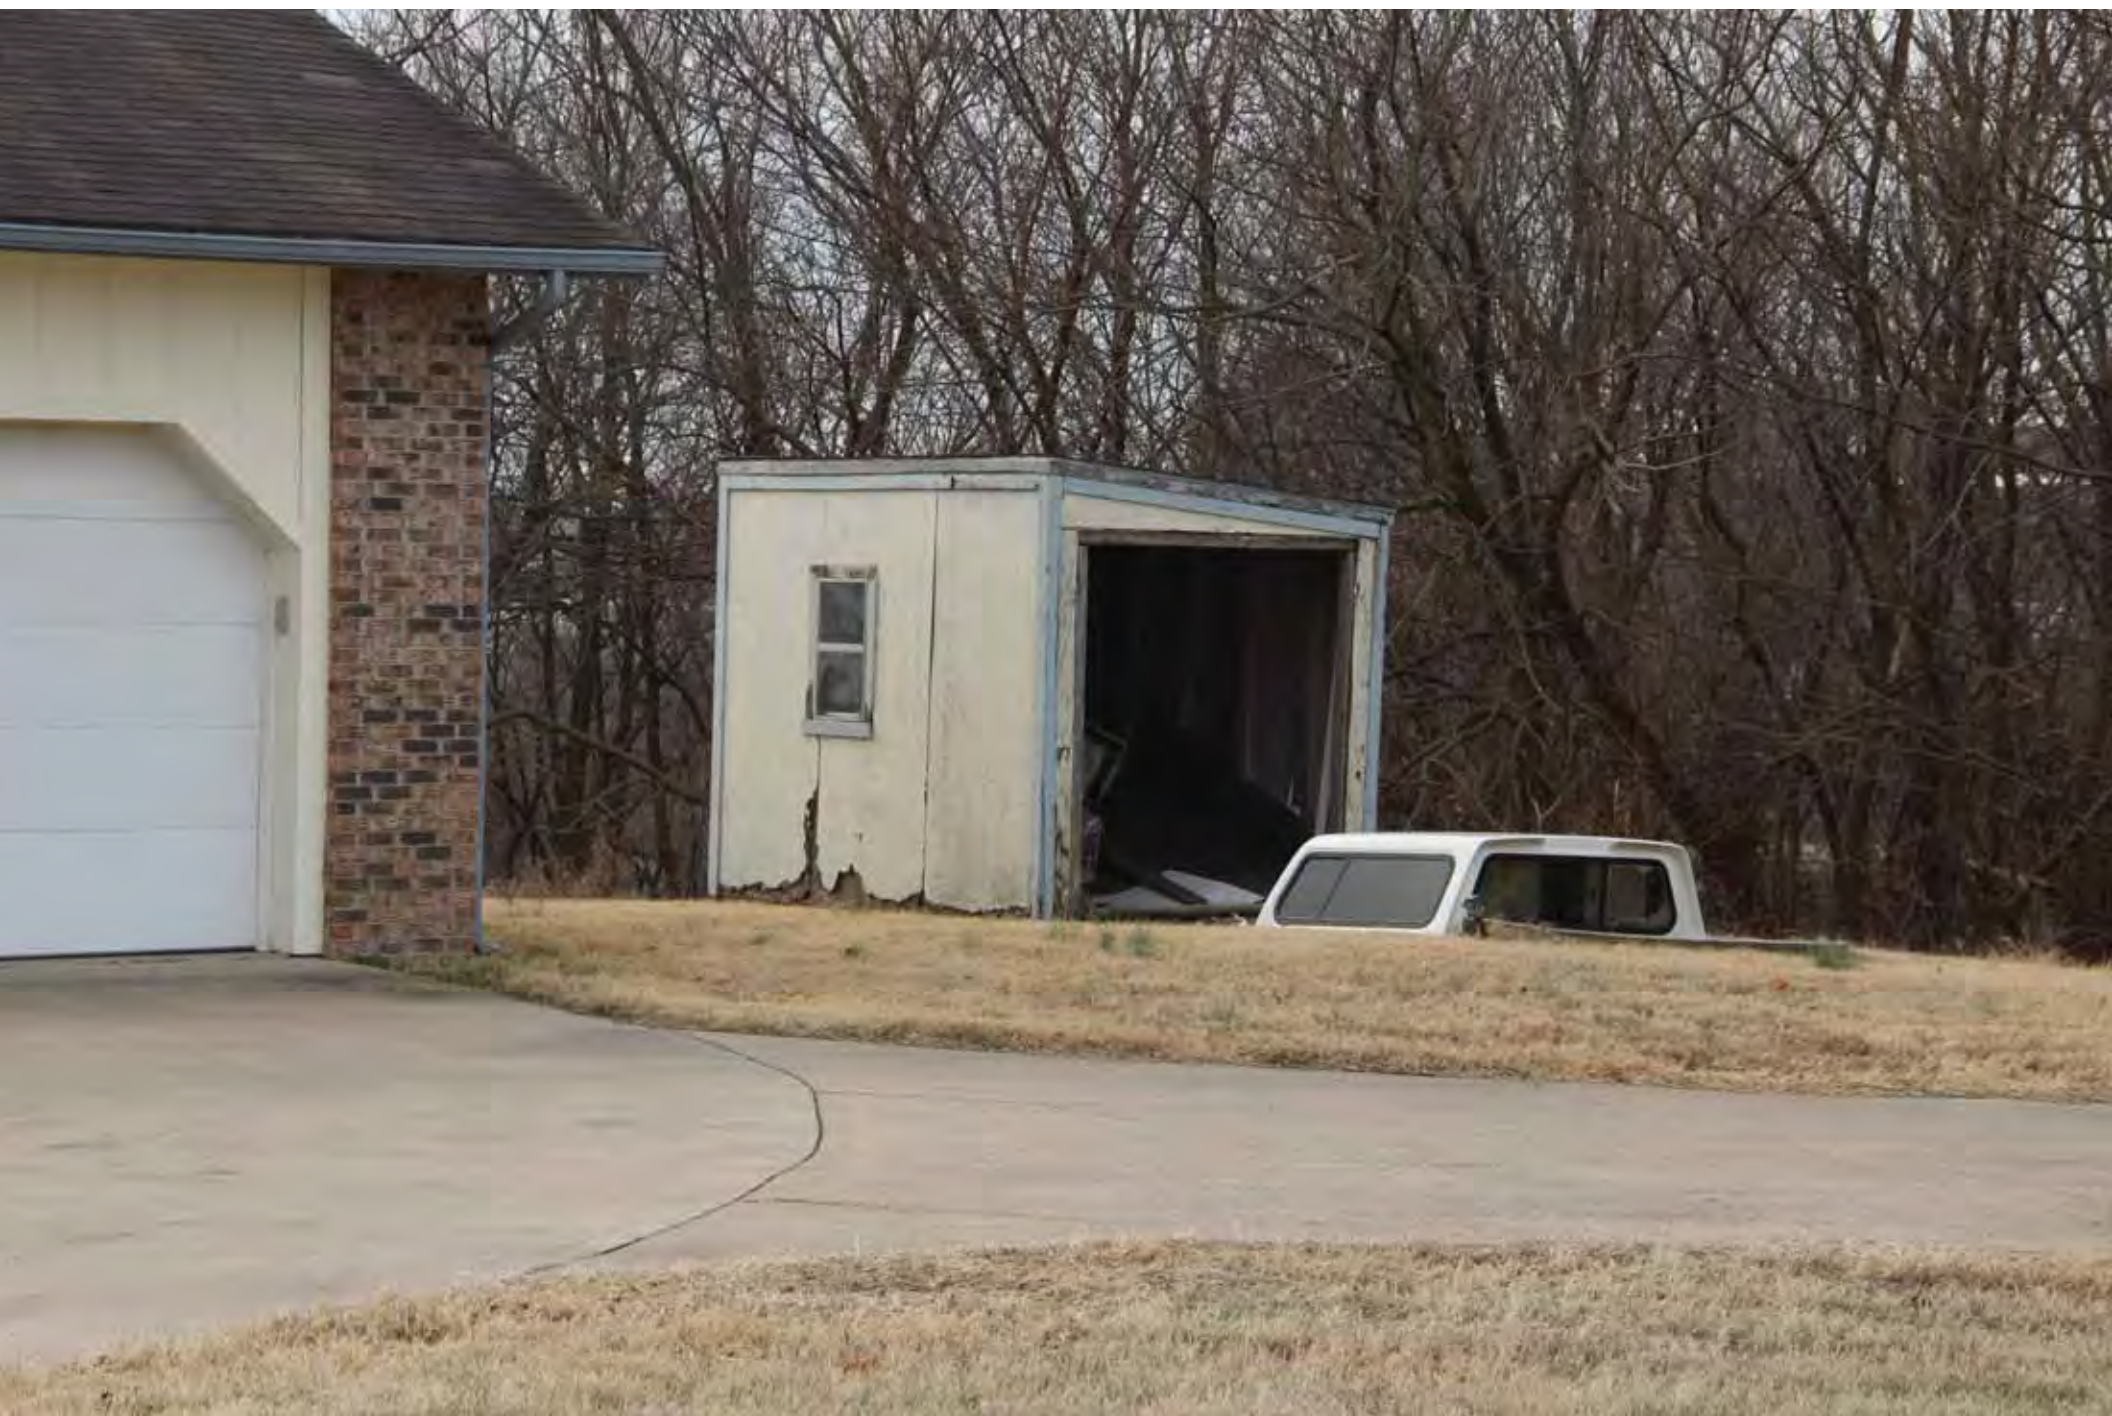
The property at 520 Central street is a one-story ranch house, with a gable roof covered in asphalt siding. It has rectangular plan with an attached garage on the west end of the house, which is approached by a curved concrete driveway. On the front façade, or north elevation of the house, is a central open front porch with a front-facing gable roof. The porch sits on metal supports on a concrete foundation. It shelters a single front door and a six-over-six single vinyl window. To the right of the front porch is an exterior brick chimney that extends about a foot from the front wall. To the left, or east of the front porch, are two narrow, single one-over-one vinyl windows. The exterior of the house is covered in hardboard, except for the area around the garage bay which is covered in a brick veneer.

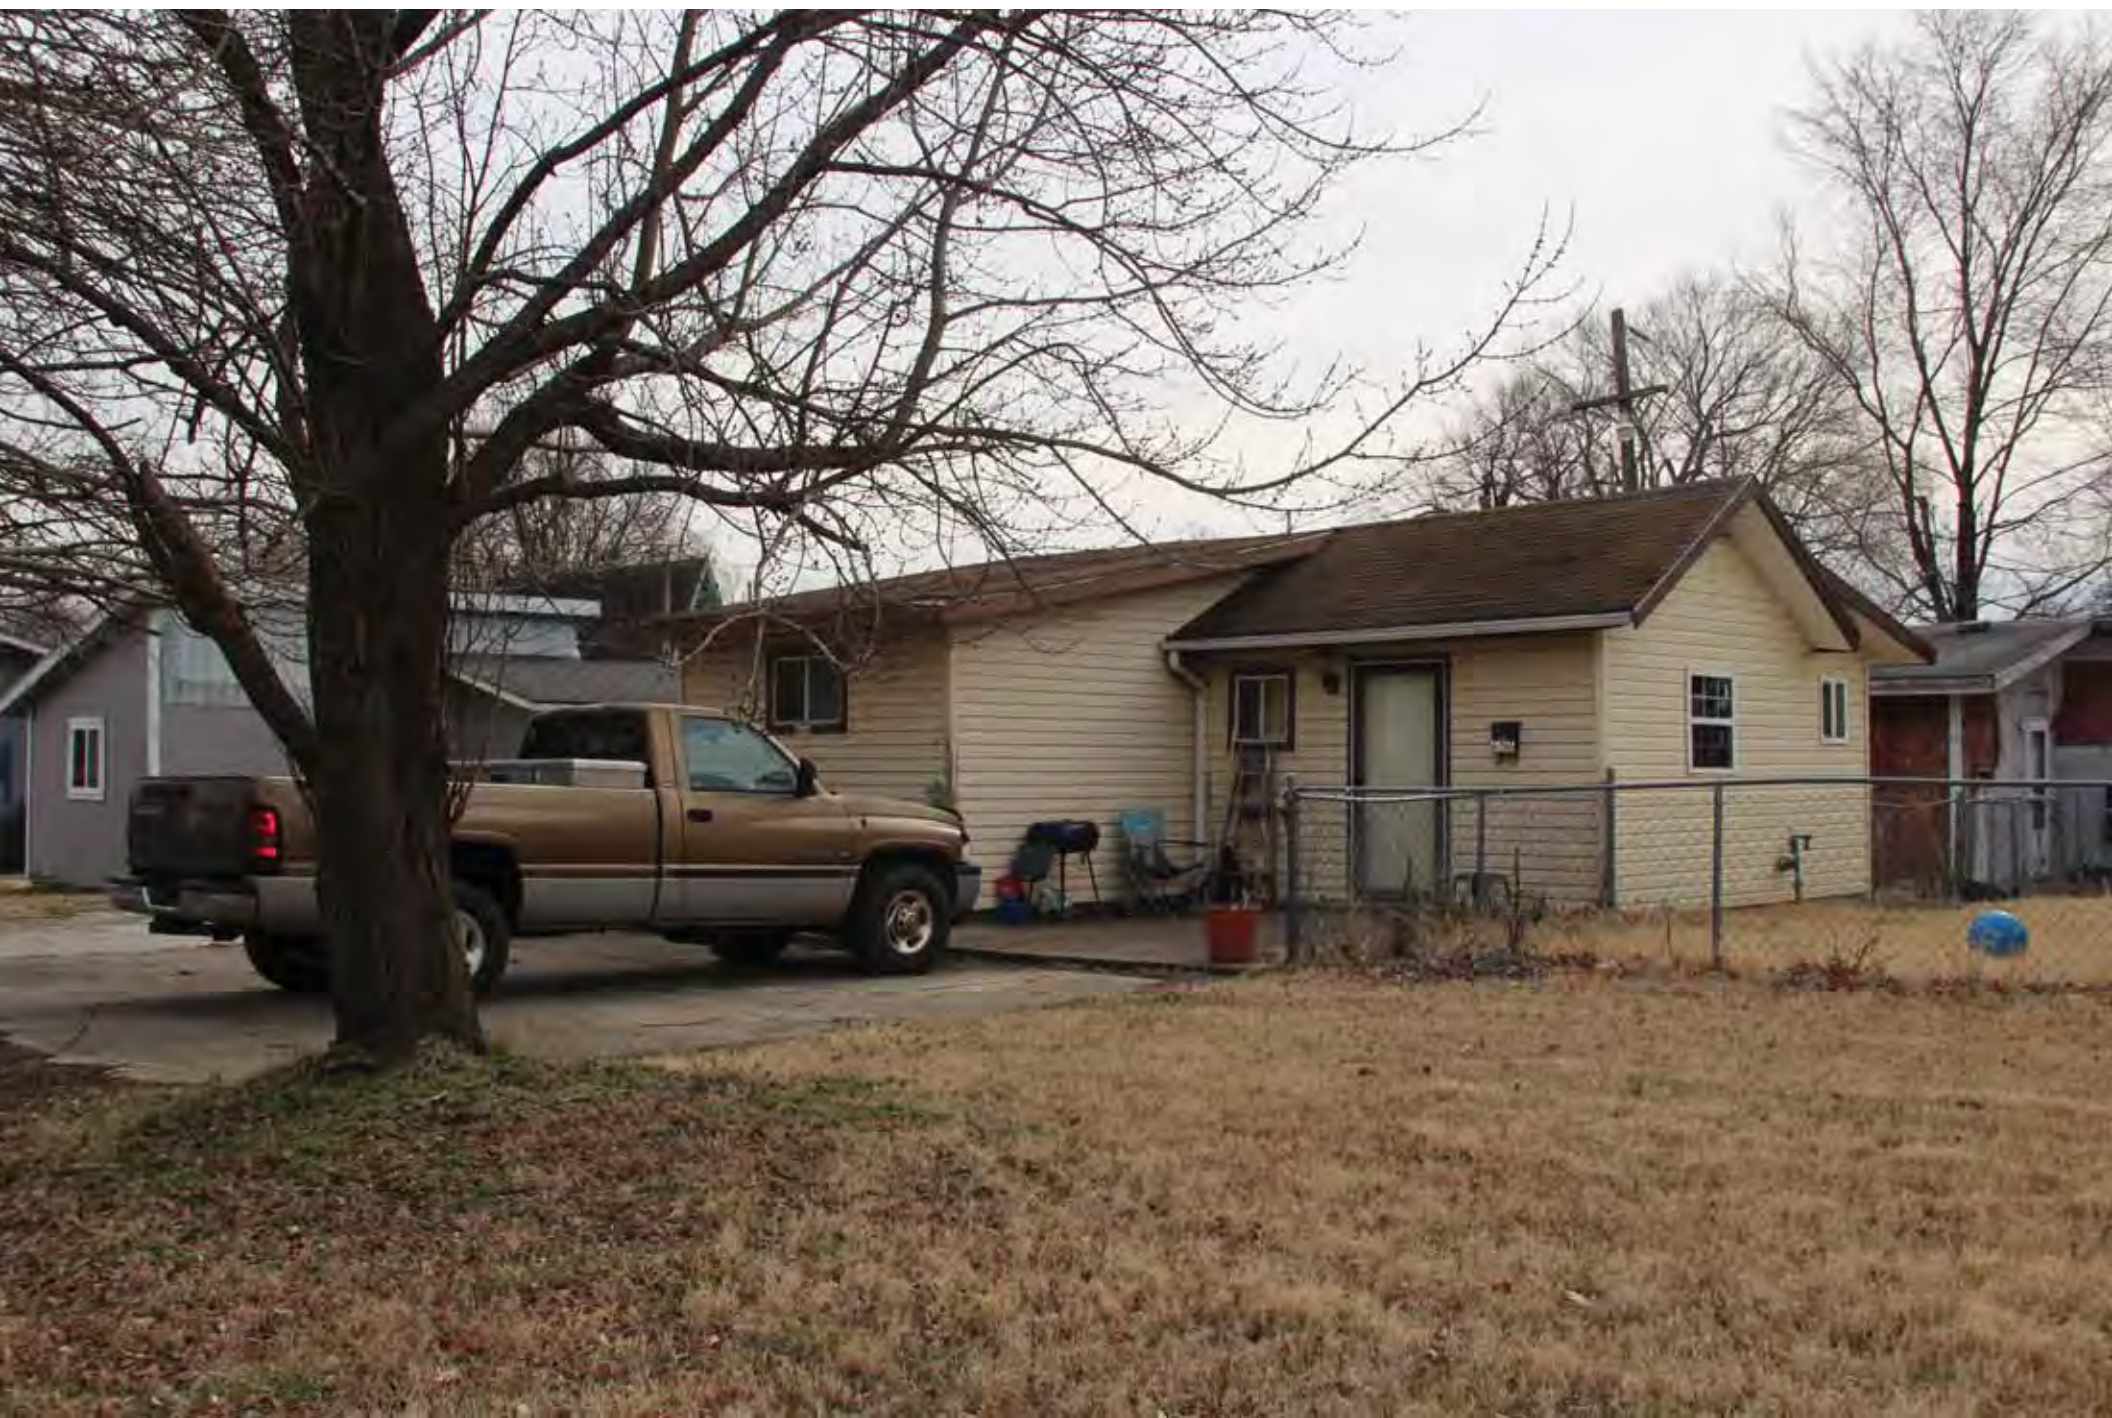
The property at 606 Central Street has an irregular roofline with the east side of the house having a shed roof, and the west side of the house with a gable roof. The entire house is covered in vinyl siding and has a concrete foundation. The front entrance is on the west side of the front elevation, beneath the side-gabled roof. It is a single metal replacement door. To the left or east of this door is a small vinyl casement window. There is one more casement window on the front elevation.
