MISSOURI DEPARTMENT OF NATURAL RESOURCES
STATE HISTORIC PRESERVATION OFFICE, P.O. Box 176, Jefferson City, MO 65102
ARCHITECTURAL/HISTORIC INVENTORY FORM

1. Survey No. JP-AS-007-001		2. Survey name: East Town (Original Joplin) Historic Survey Phase 2	
3. County: JASPER		4. Address (Street No.) 618	Street (name) E. 2 nd Street
5. City: Joplin	Vicinity: <input type="checkbox"/>	6. Geographical Reference:	7. Township/Range/Section: T: R: S:
8. Historic name (if known):		9. Present/other name (if known):	
10. Ownership: <input checked="" type="checkbox"/> Private <input type="checkbox"/> Public		11a. Historic use (if known): Domestic: Single Dwelling	11b. Current use: Domestic: Single Dwelling

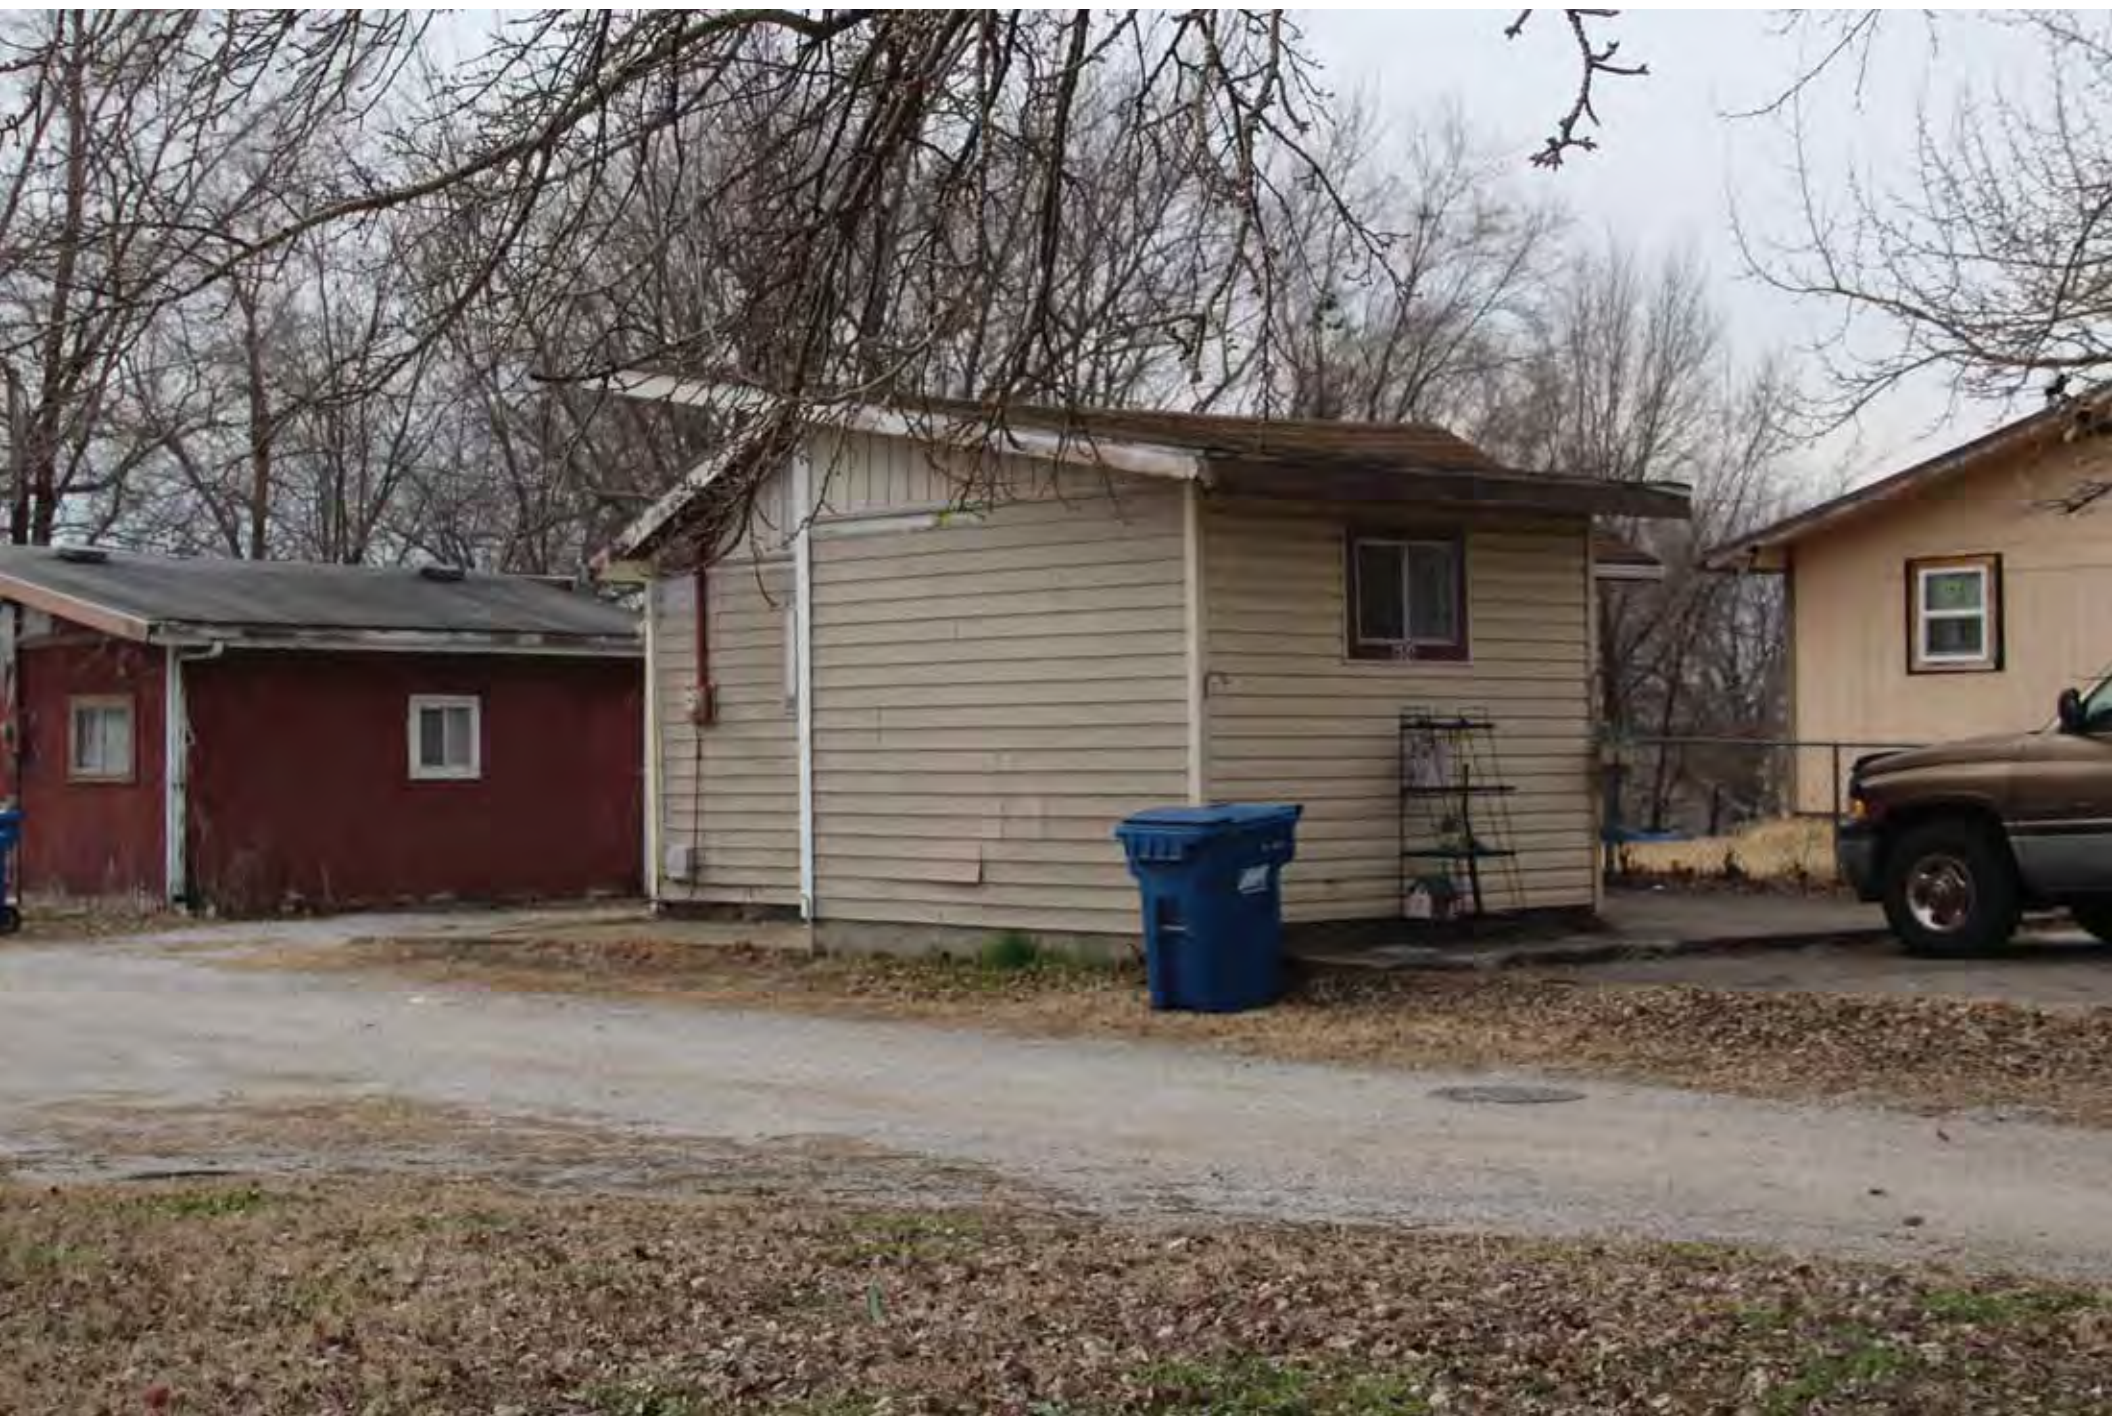
The property at 606 Central Street has an irregular roofline with the east side of the house having a shed roof, and the west side of the house with a gable roof. The entire house is covered in vinyl siding and has a concrete foundation. The front entrance is on the west side of the front elevation, beneath the side-gabled roof. It is a single metal replacement door. To the left or east of this door is a small vinyl casement window. There is one more casement window on the front elevation.

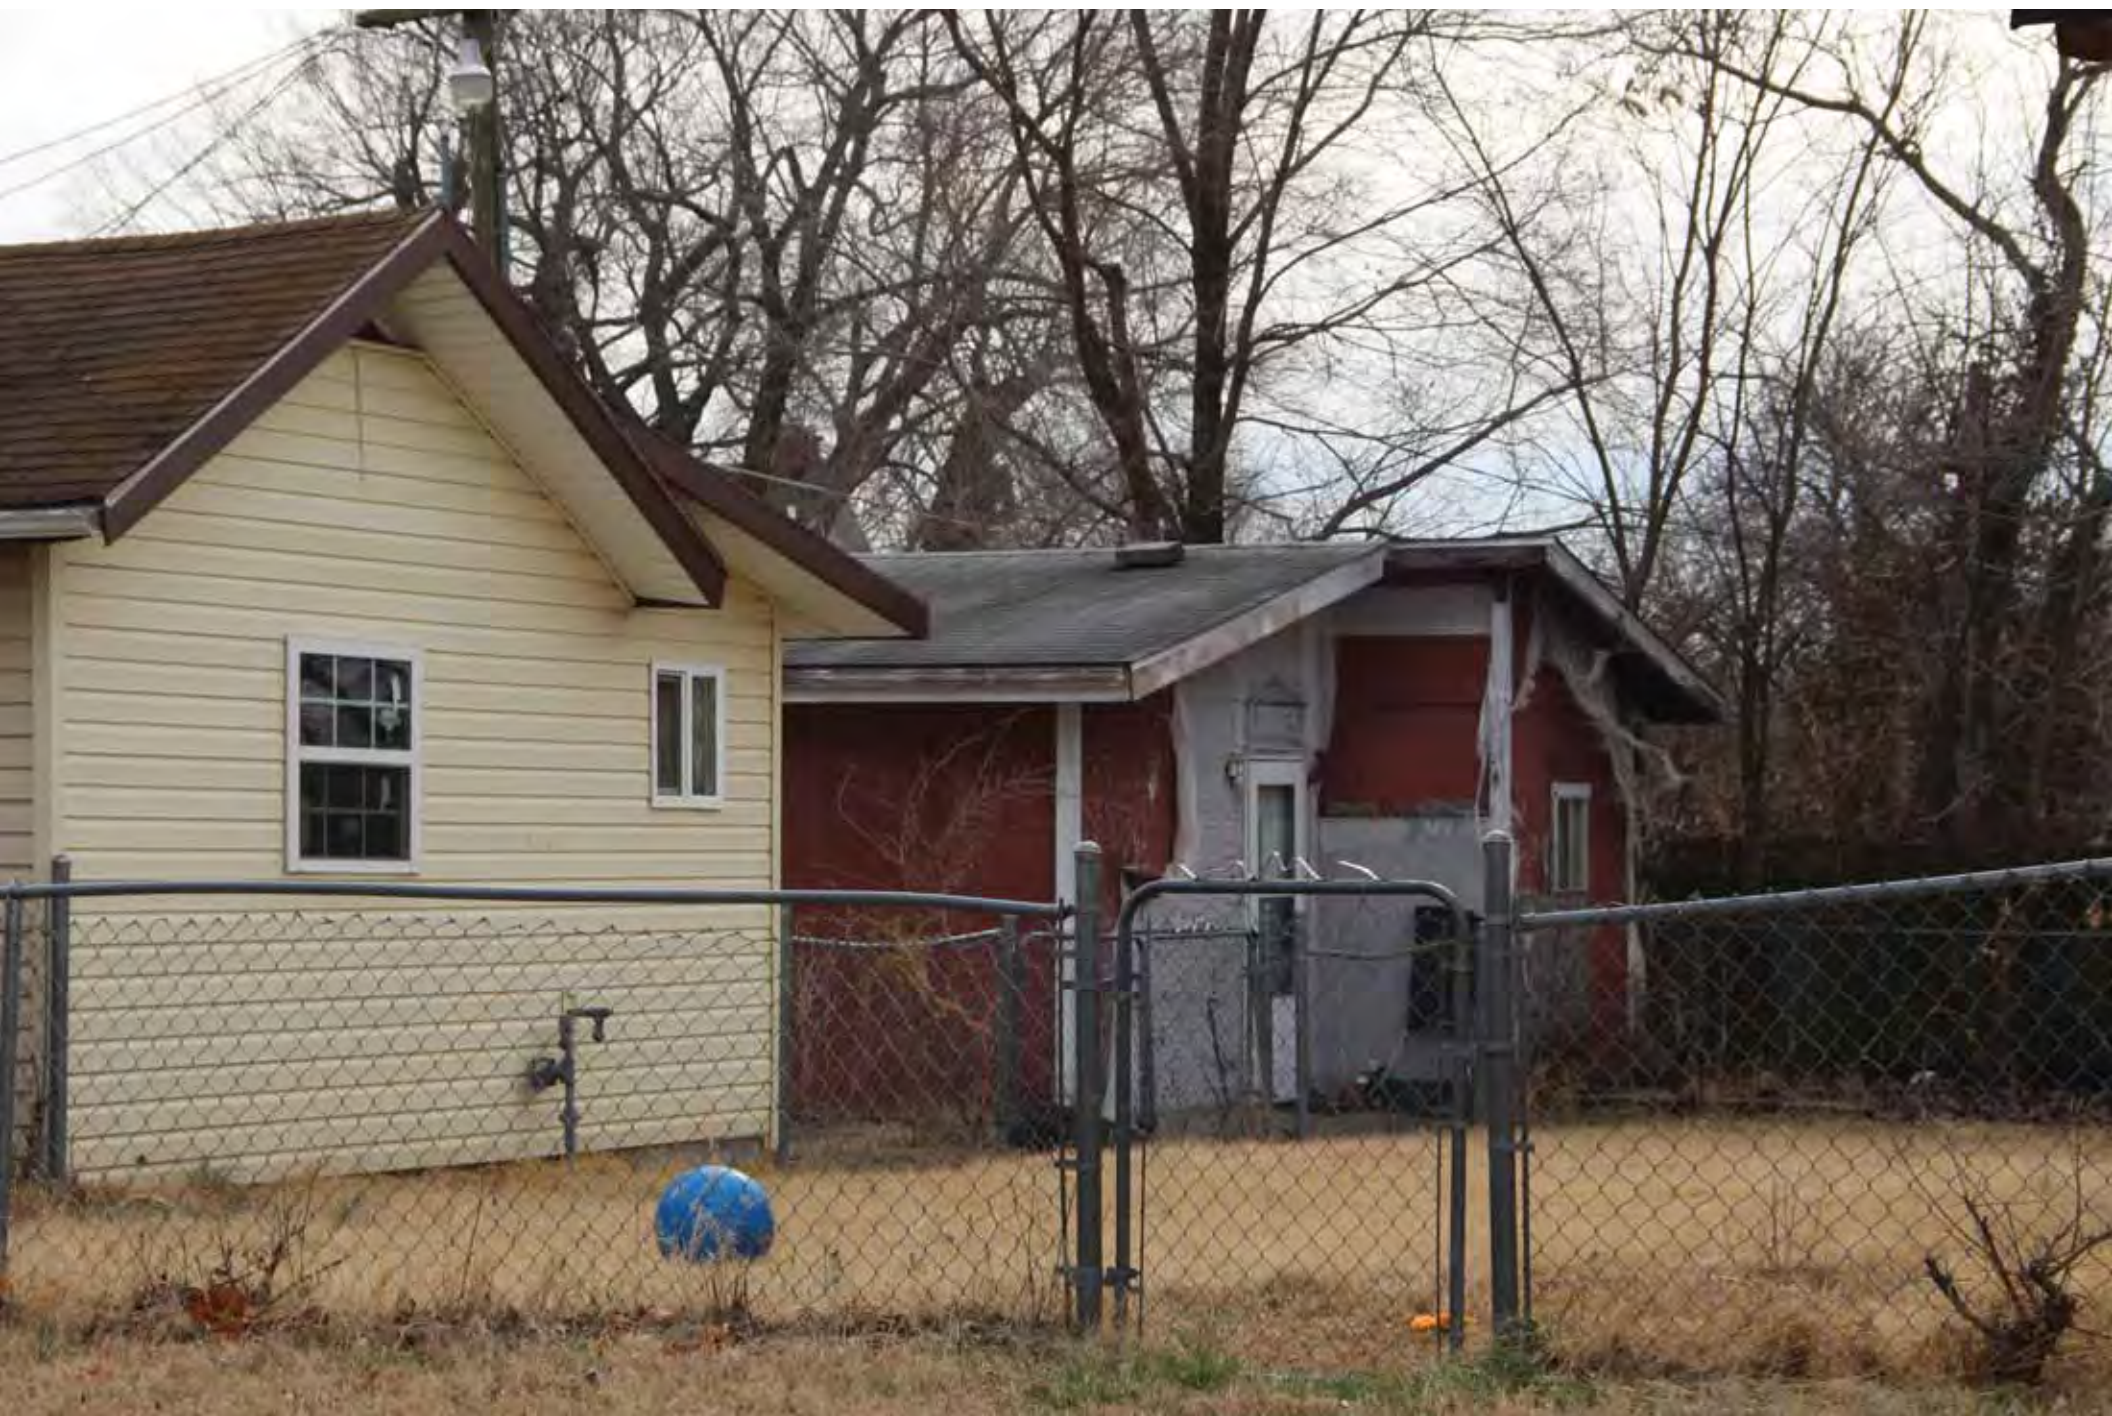
The property at 606 1/2 Central Street has an irregular roofline with two shed roofs covered in asphalt siding. The entire house is covered in asphalt siding and has a concrete foundation. The front entrance is on the east side elevation of the house. Much of the details are obscured, as it is not well visible from the street. It does have several small vinyl casement windows.

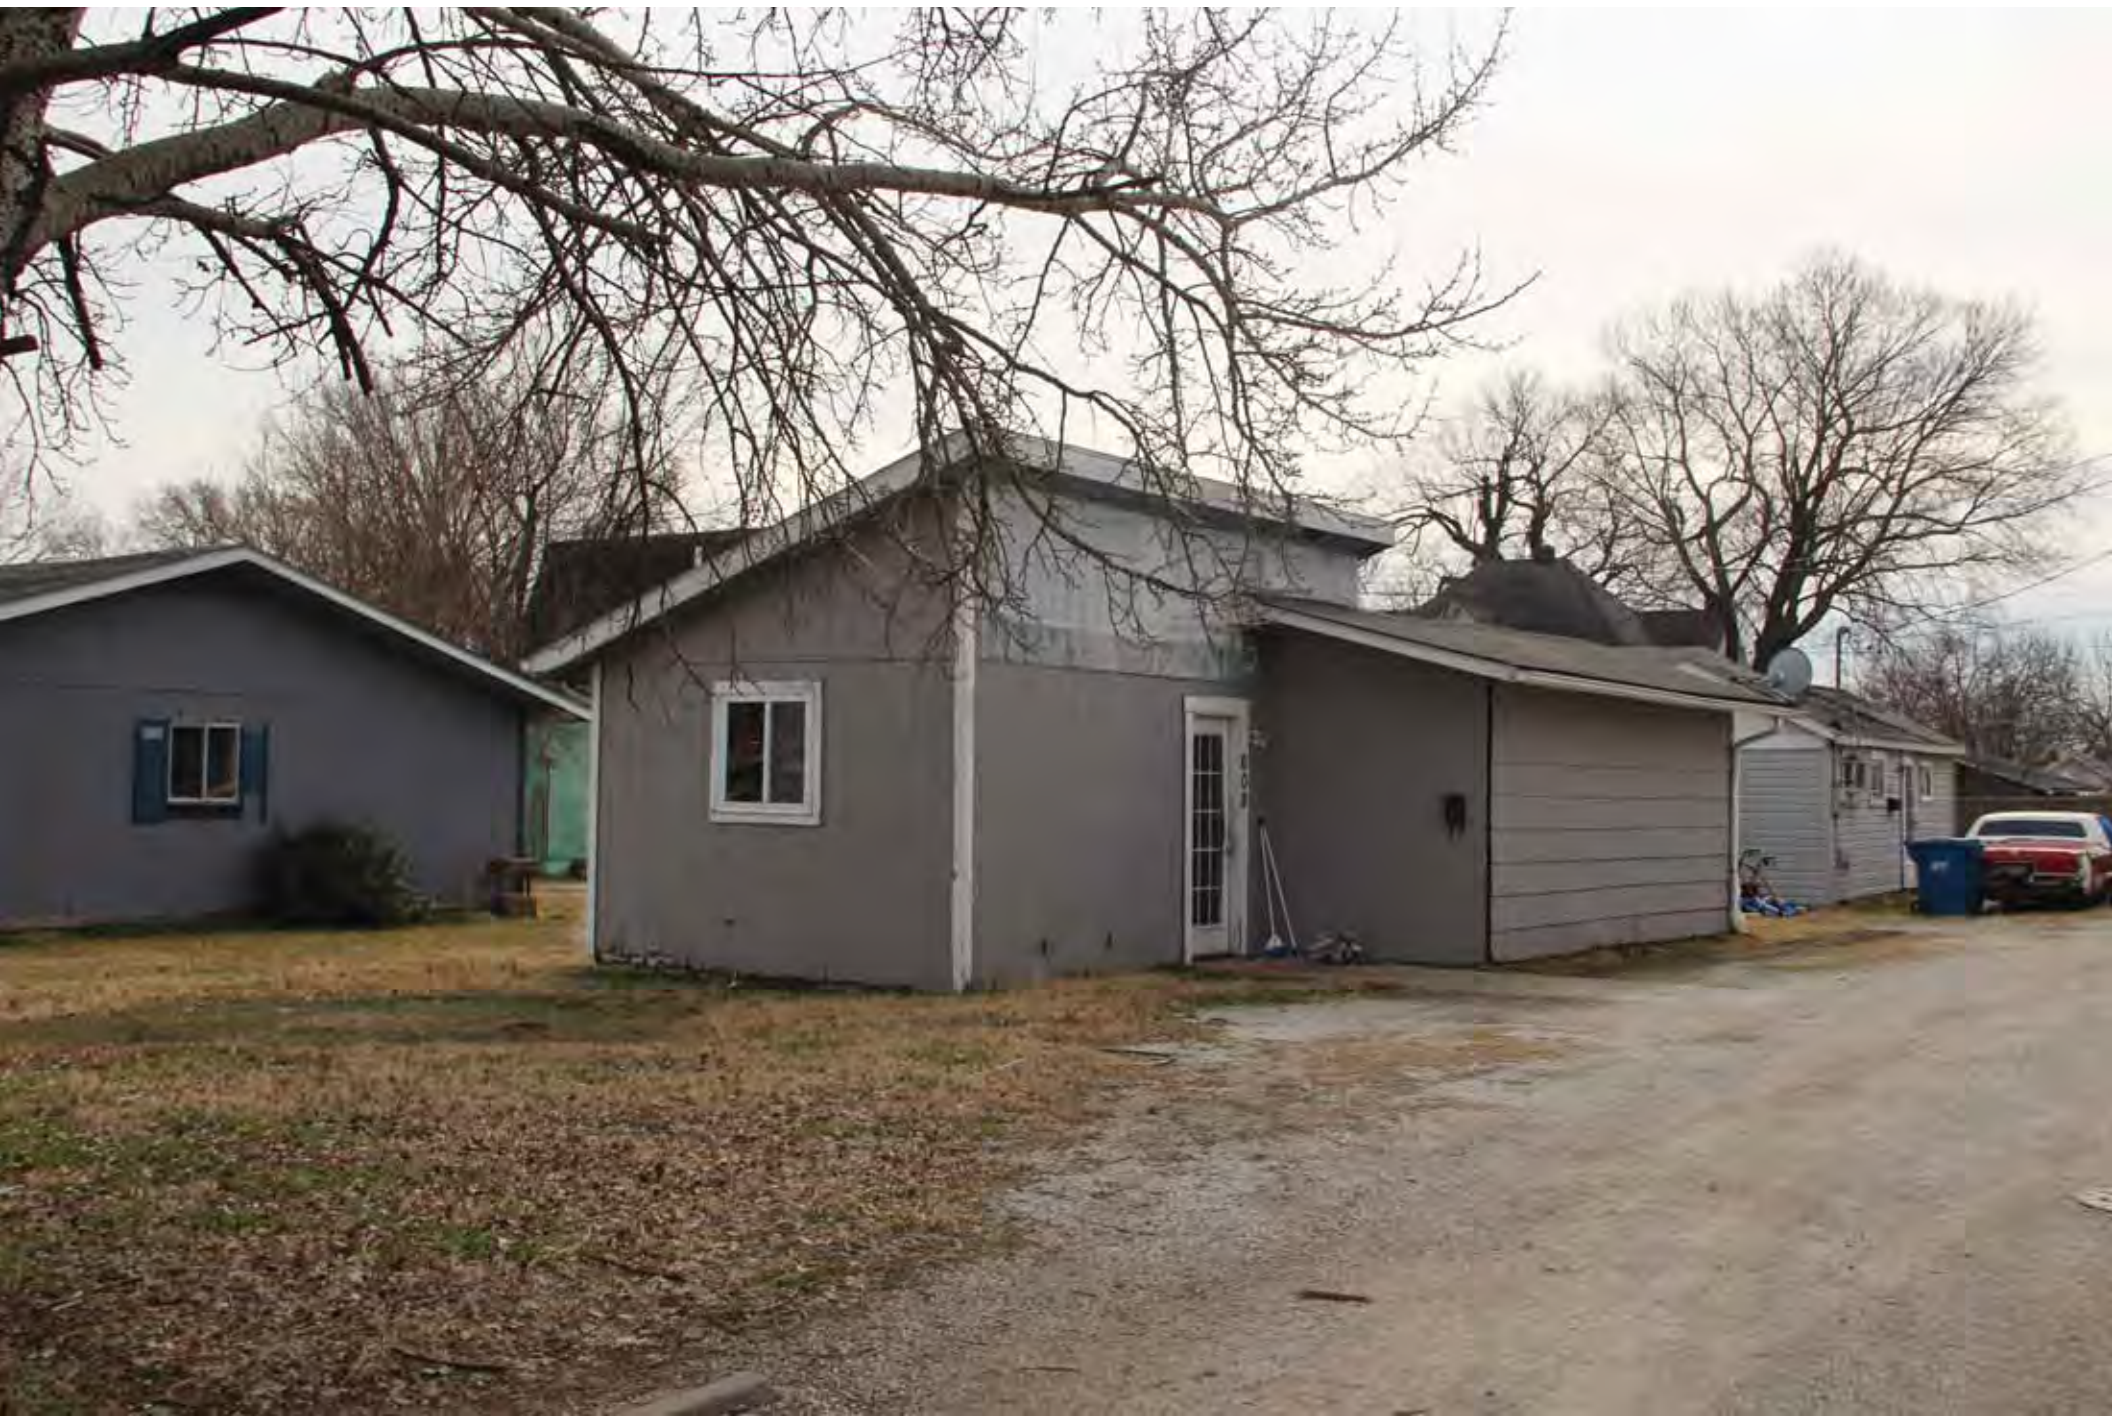
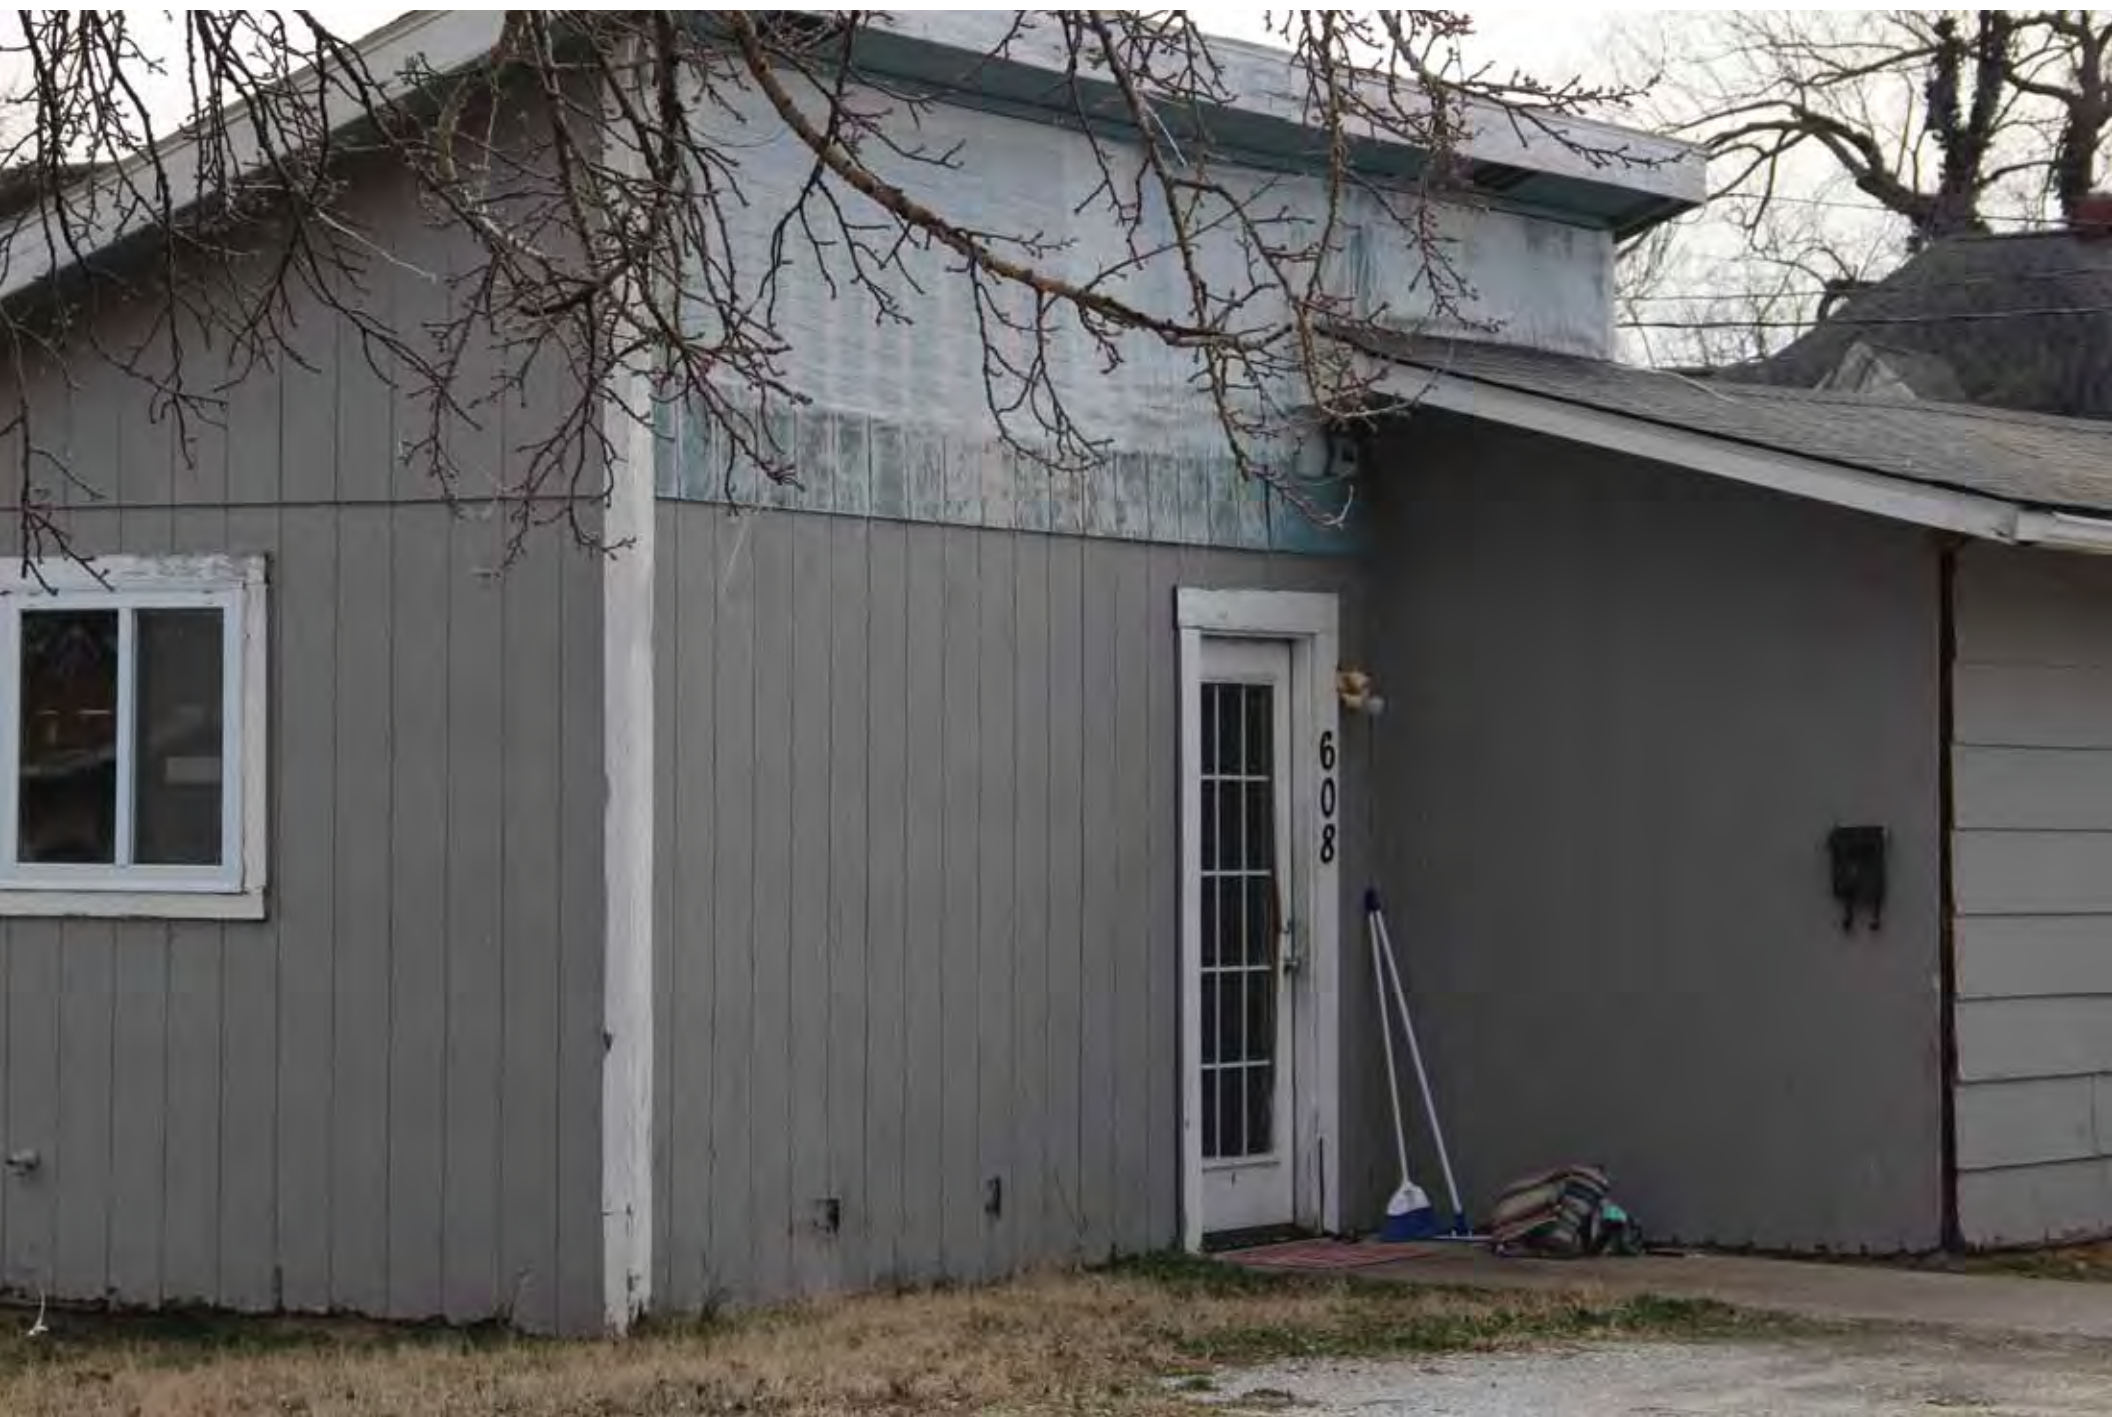
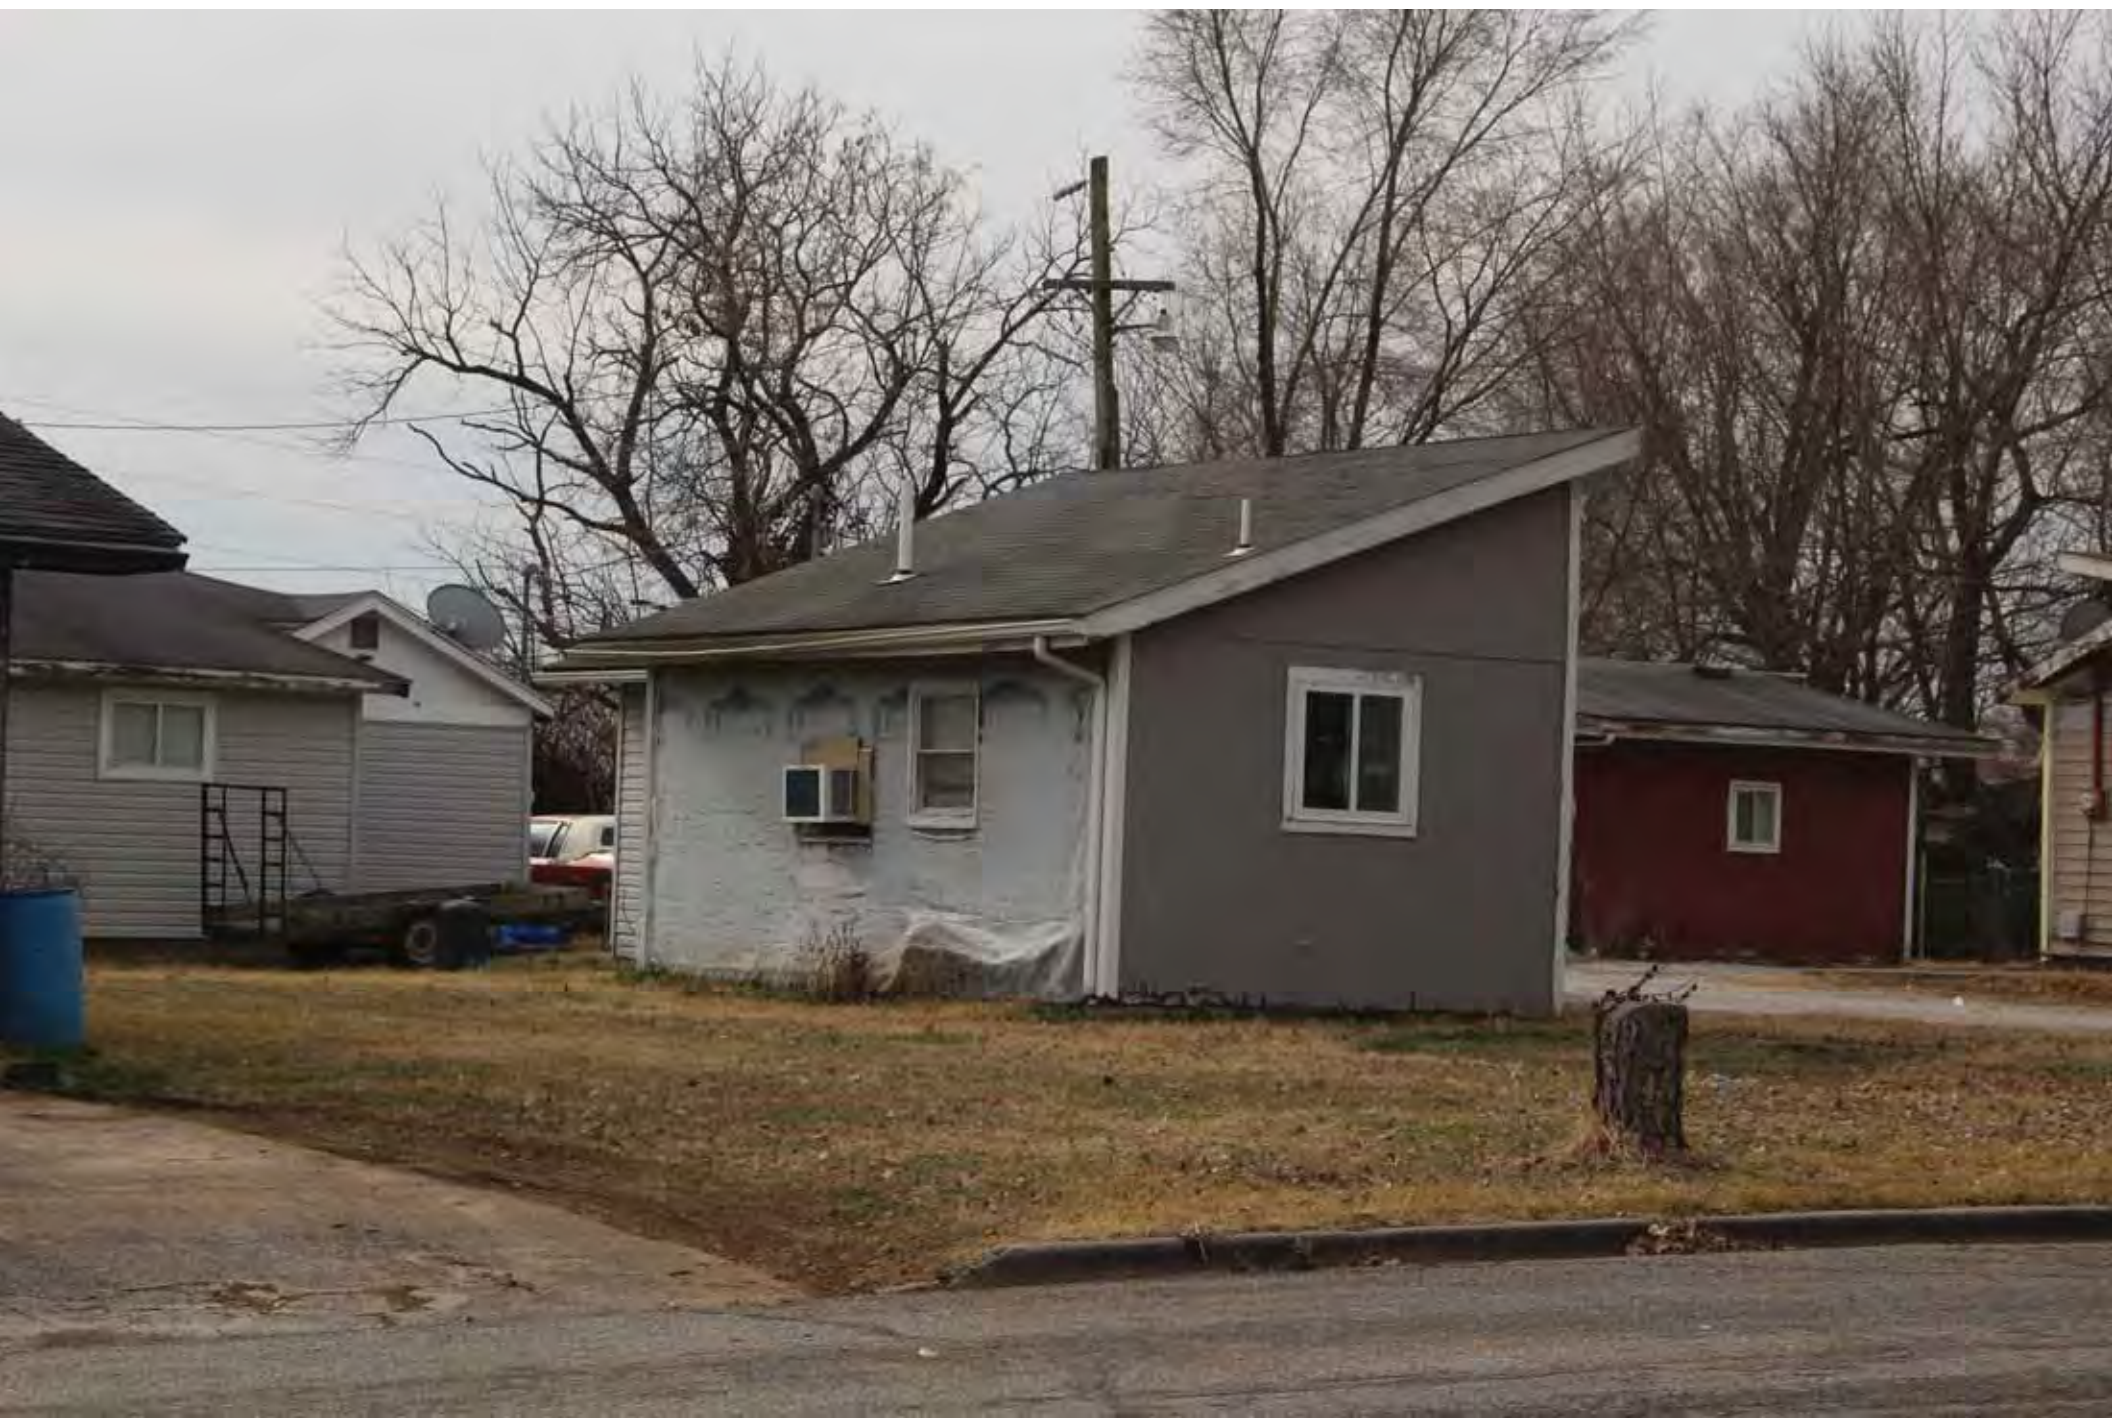
The property at 608 Central Street has an irregular roofline with two shed roofs covered in asphalt siding. The entire house is covered in hardboard siding and has a concrete foundation. The front entrance is on the east side elevation of the house. There is a small shed-roof addition on the southwest corner of the house. On the north elevation, facing Central Street, there is a small vinyl casement window.

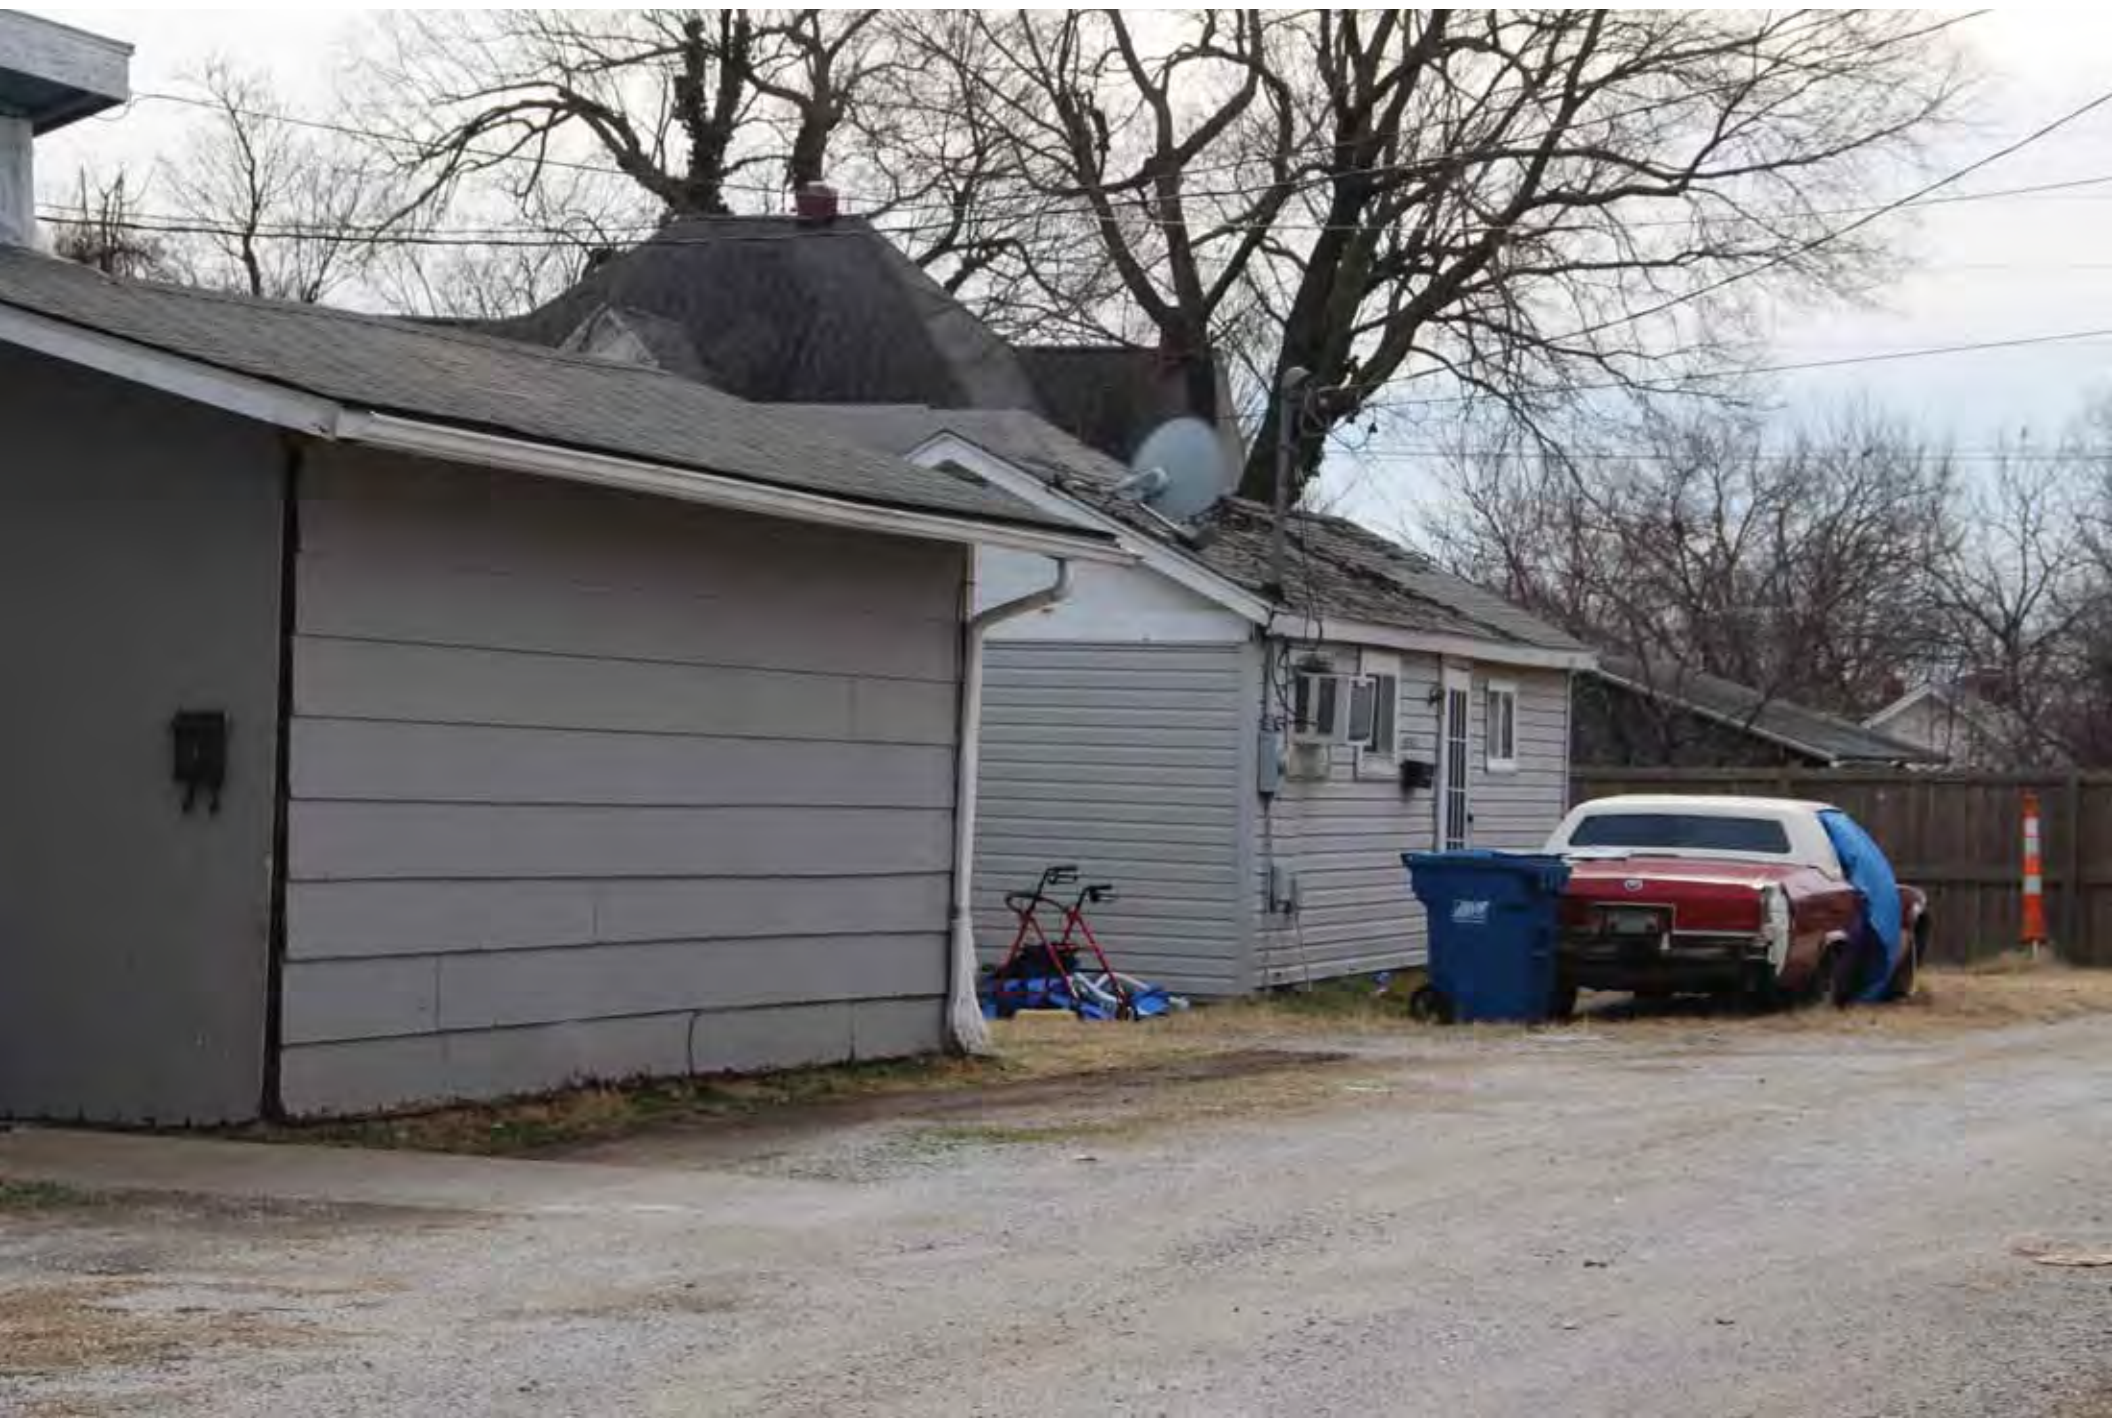
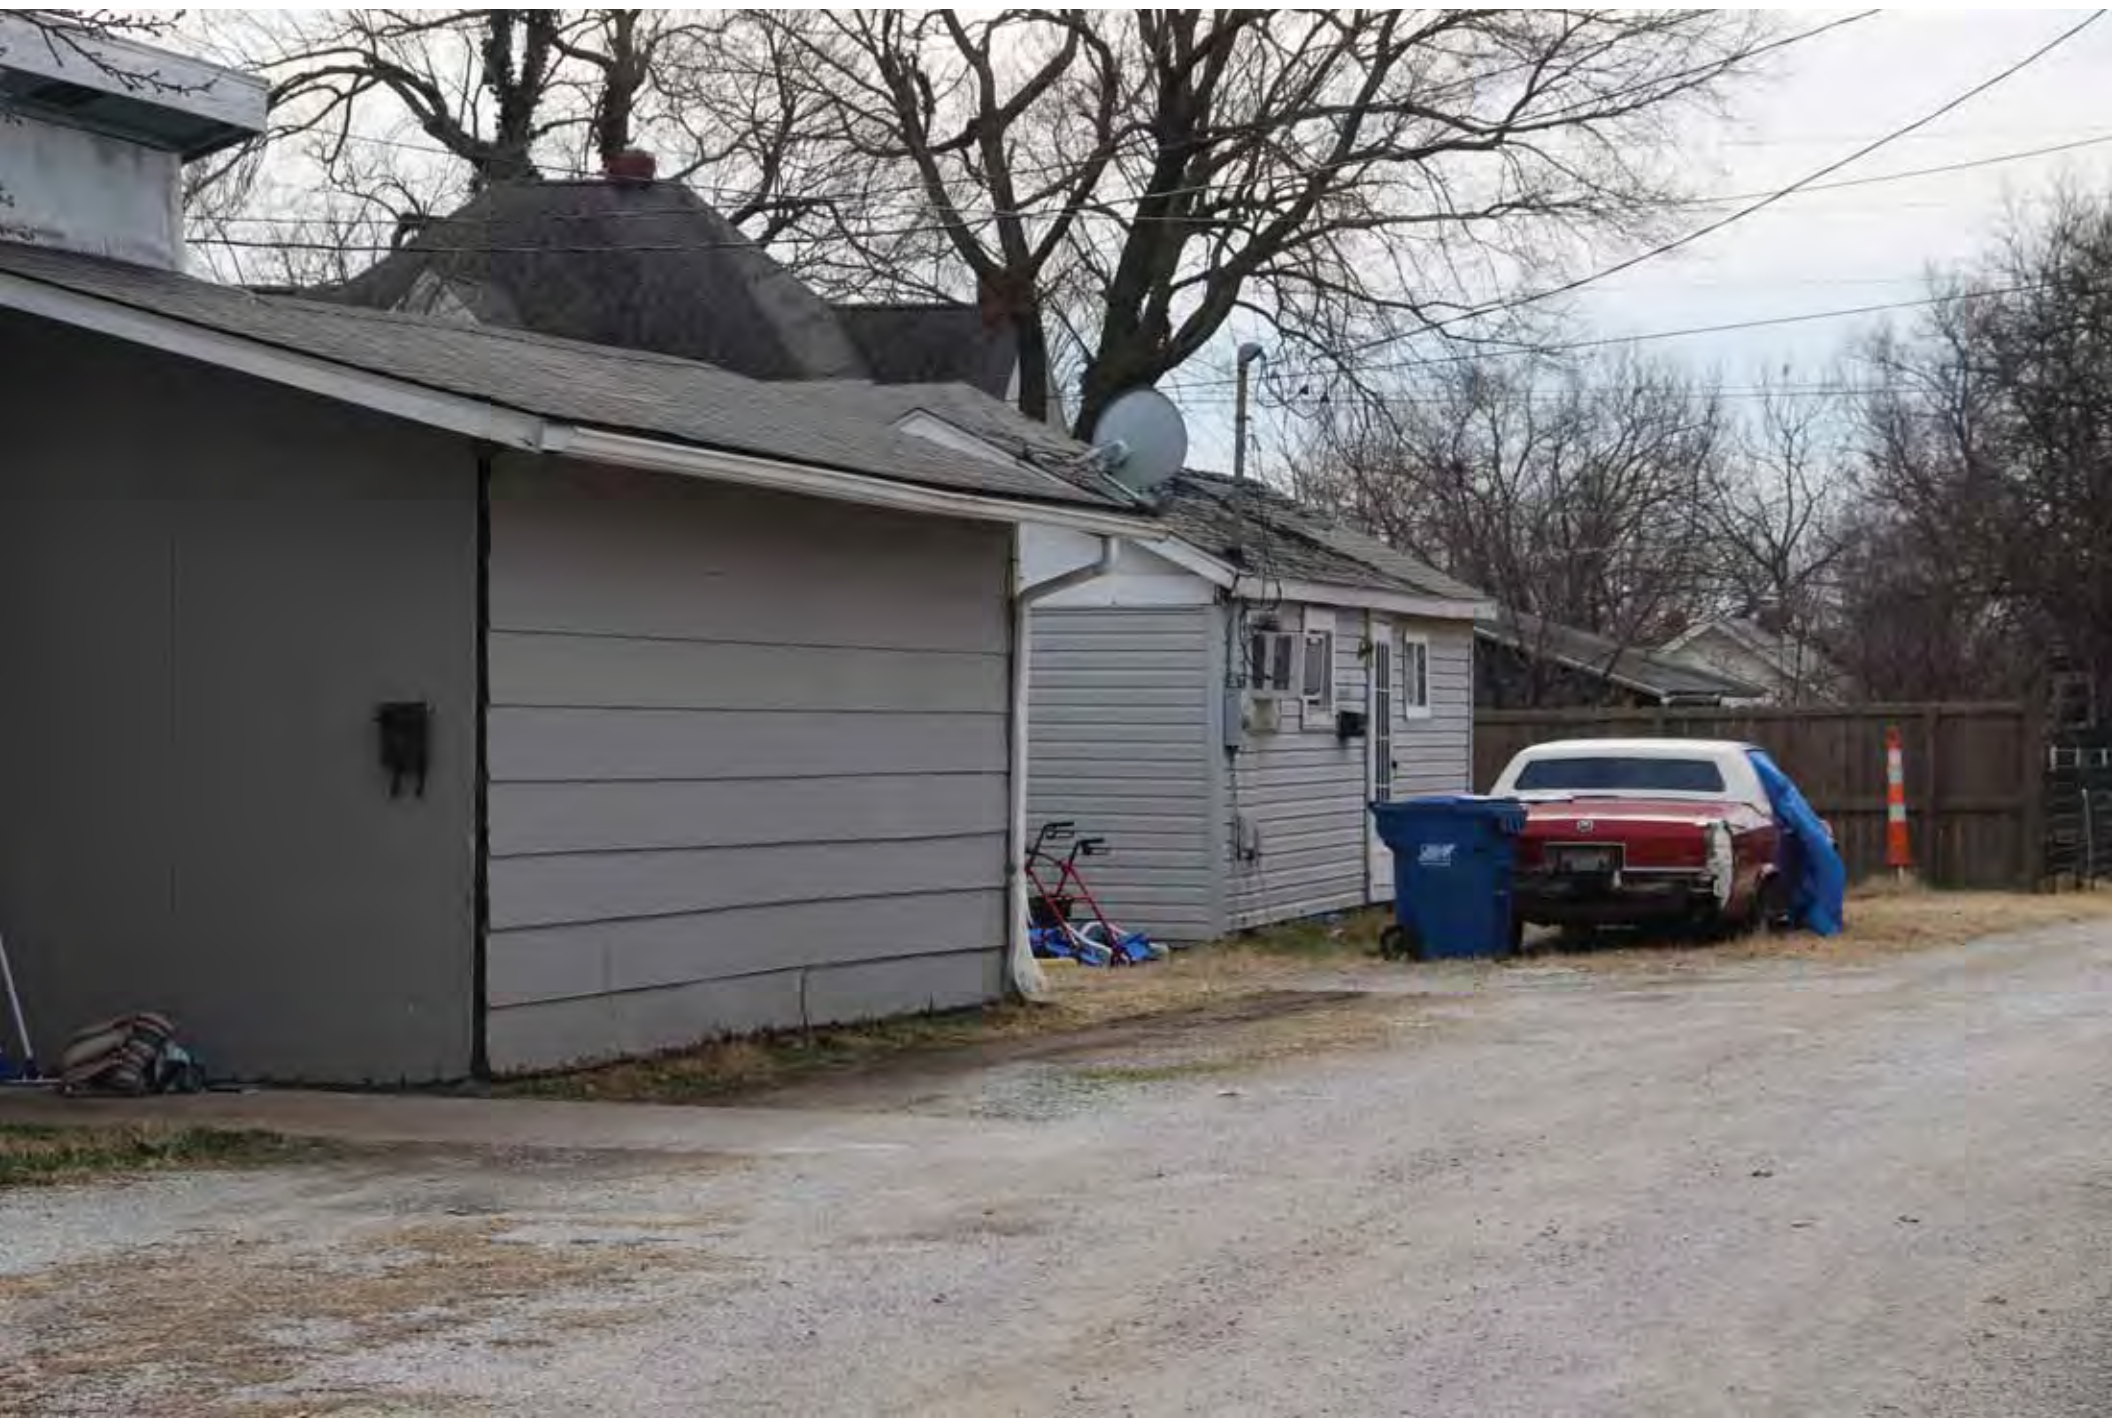
The property at 608 ½ Central Street has a gable-roof covered in asphalt siding. The entire house is covered in vinyl siding and has a concrete foundation. The front entrance is on the east side elevation of the house, facing the gravel driveway. The small house sits behind 608 Central, so is difficult to see from the street.
