MISSOURI DEPARTMENT OF NATURAL RESOURCES
STATE HISTORIC PRESERVATION OFFICE, P.O. Box 176, Jefferson City, MO 65102
ARCHITECTURAL/HISTORIC INVENTORY FORM

1. Survey No. JP-AS-007-001		2. Survey name: East Town (Original Joplin) Historic Survey Phase 2	
3. County: JASPER		4. Address (Street No.) 618	Street (name) E. 2 nd Street
5. City: Joplin	Vicinity: <input type="checkbox"/>	6. Geographical Reference:	7. Township/Range/Section: T: R: S:
8. Historic name (if known):		9. Present/other name (if known):	
10. Ownership: <input checked="" type="checkbox"/> Private <input type="checkbox"/> Public		11a. Historic use (if known): Domestic: Single Dwelling	11b. Current use: Domestic: Single Dwelling

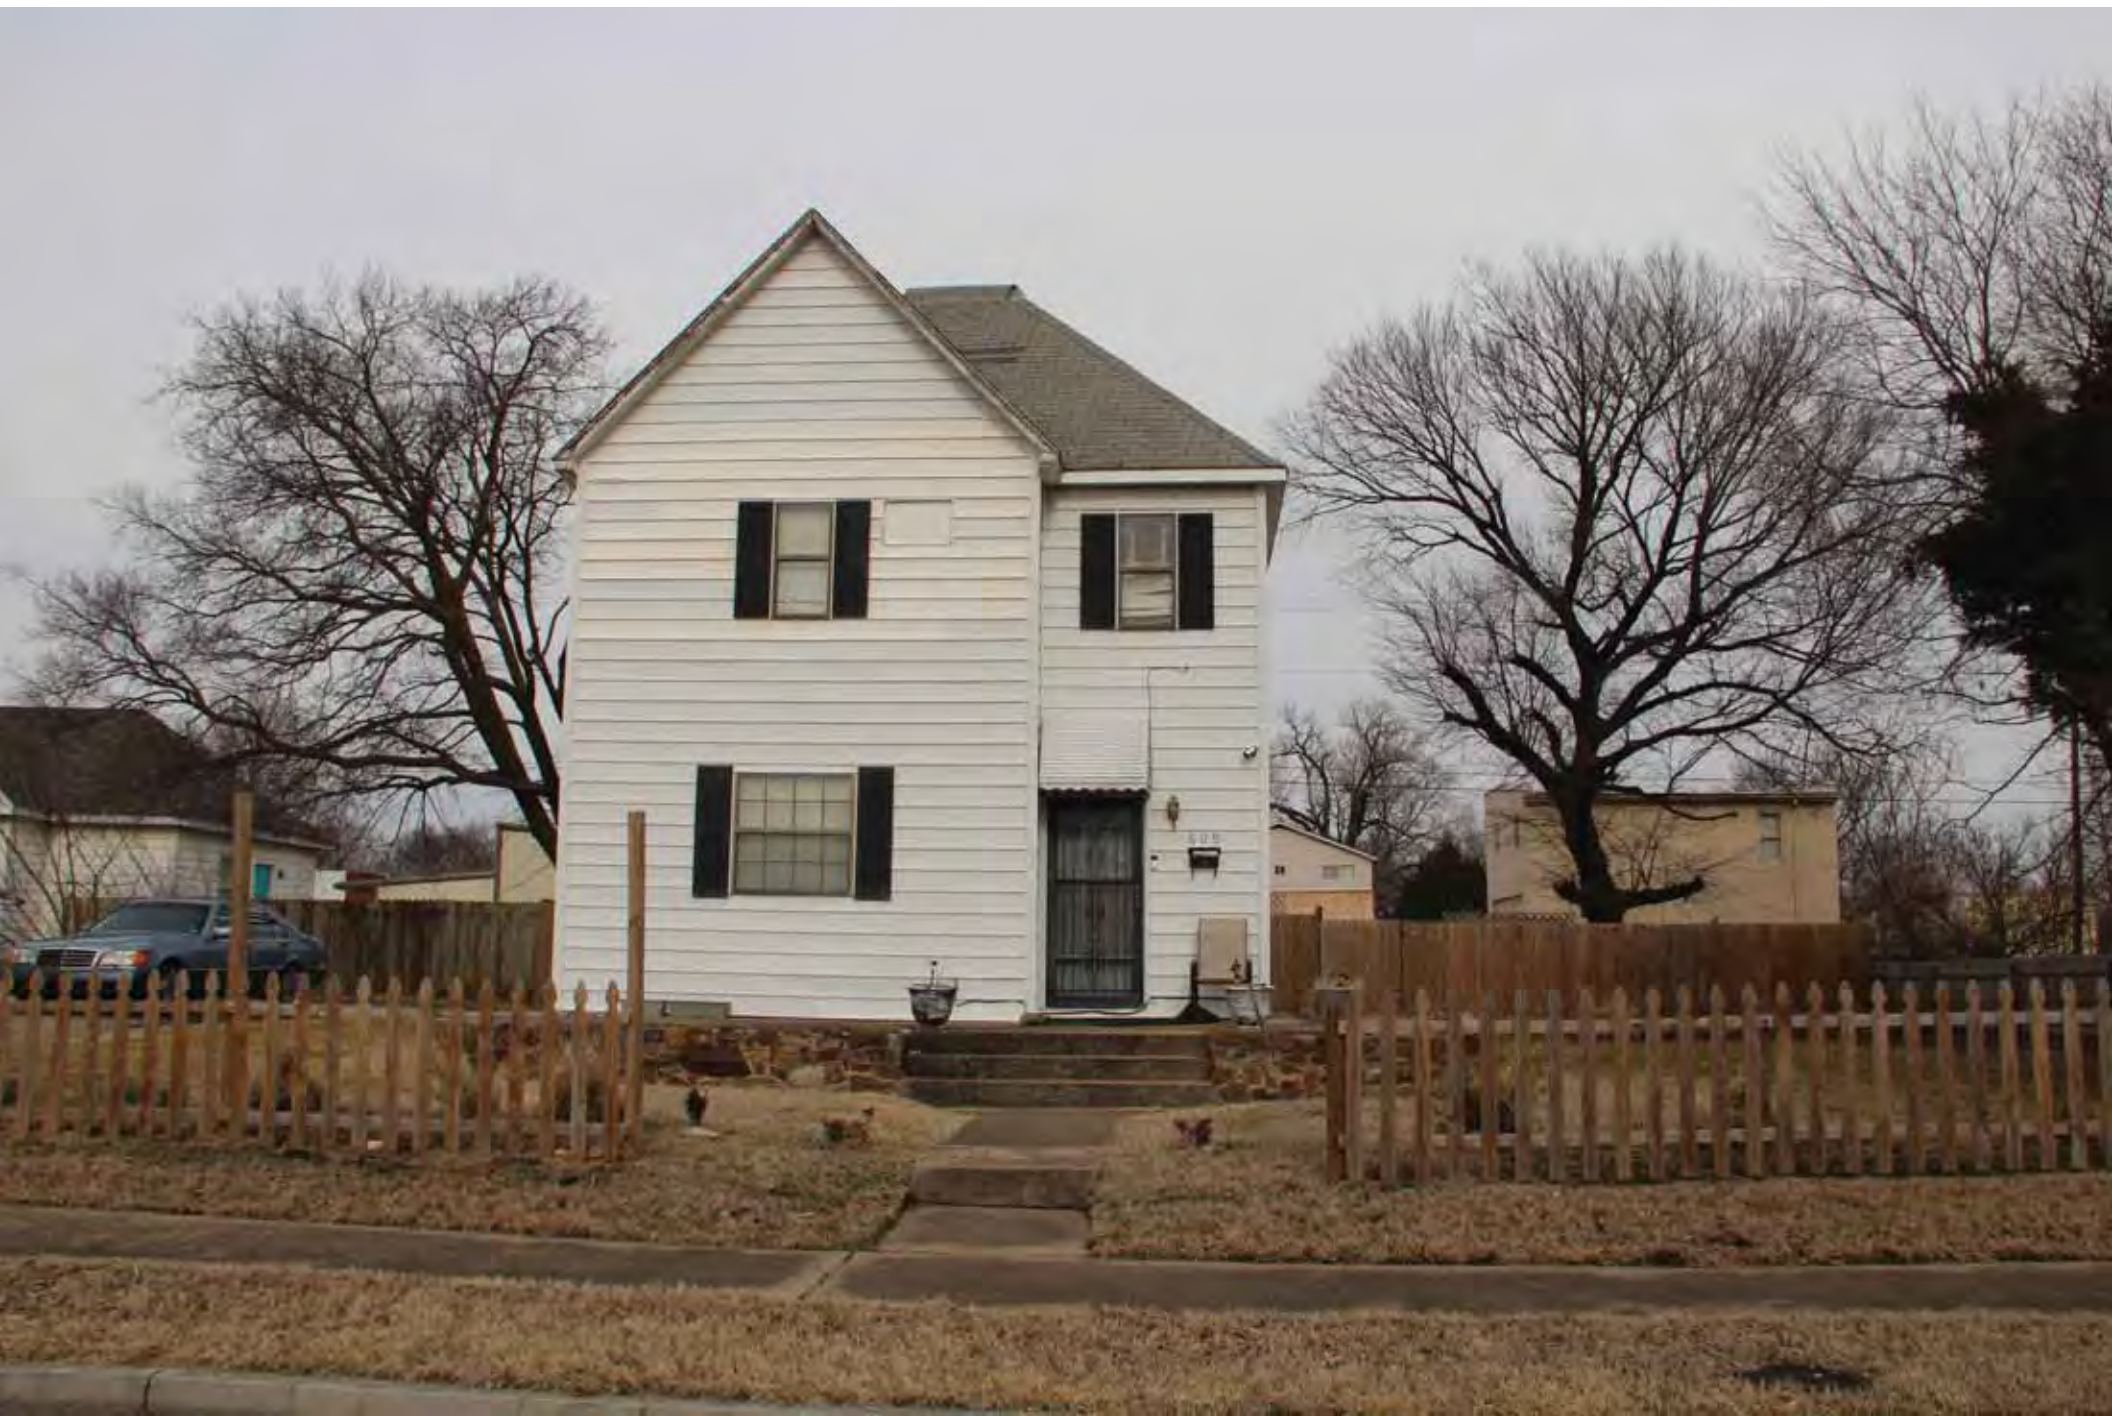
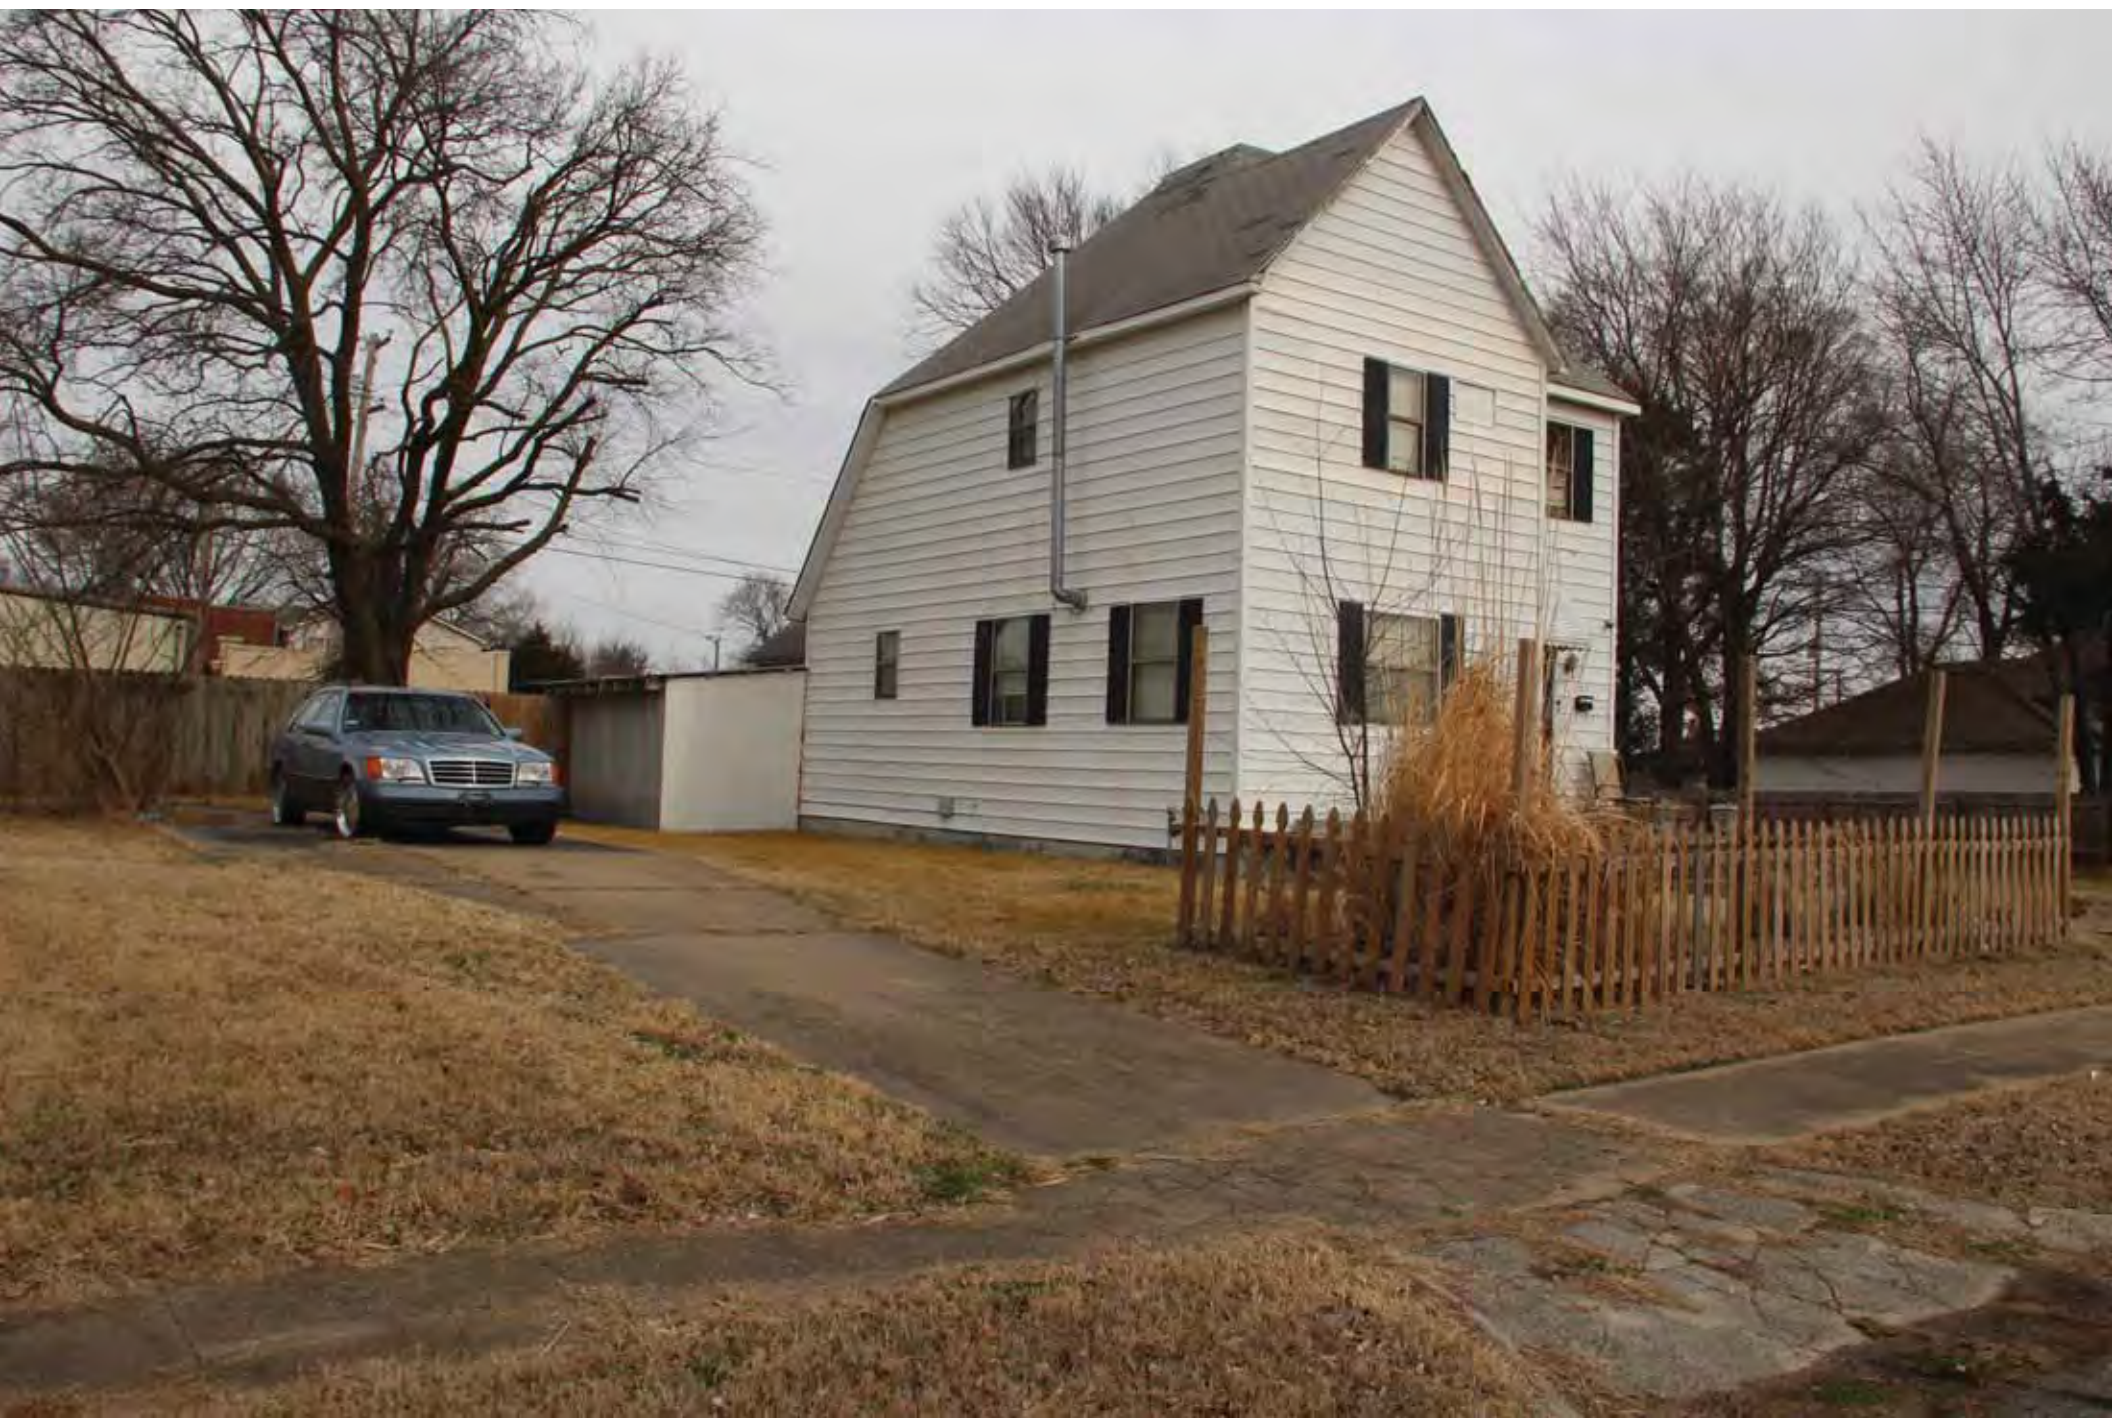
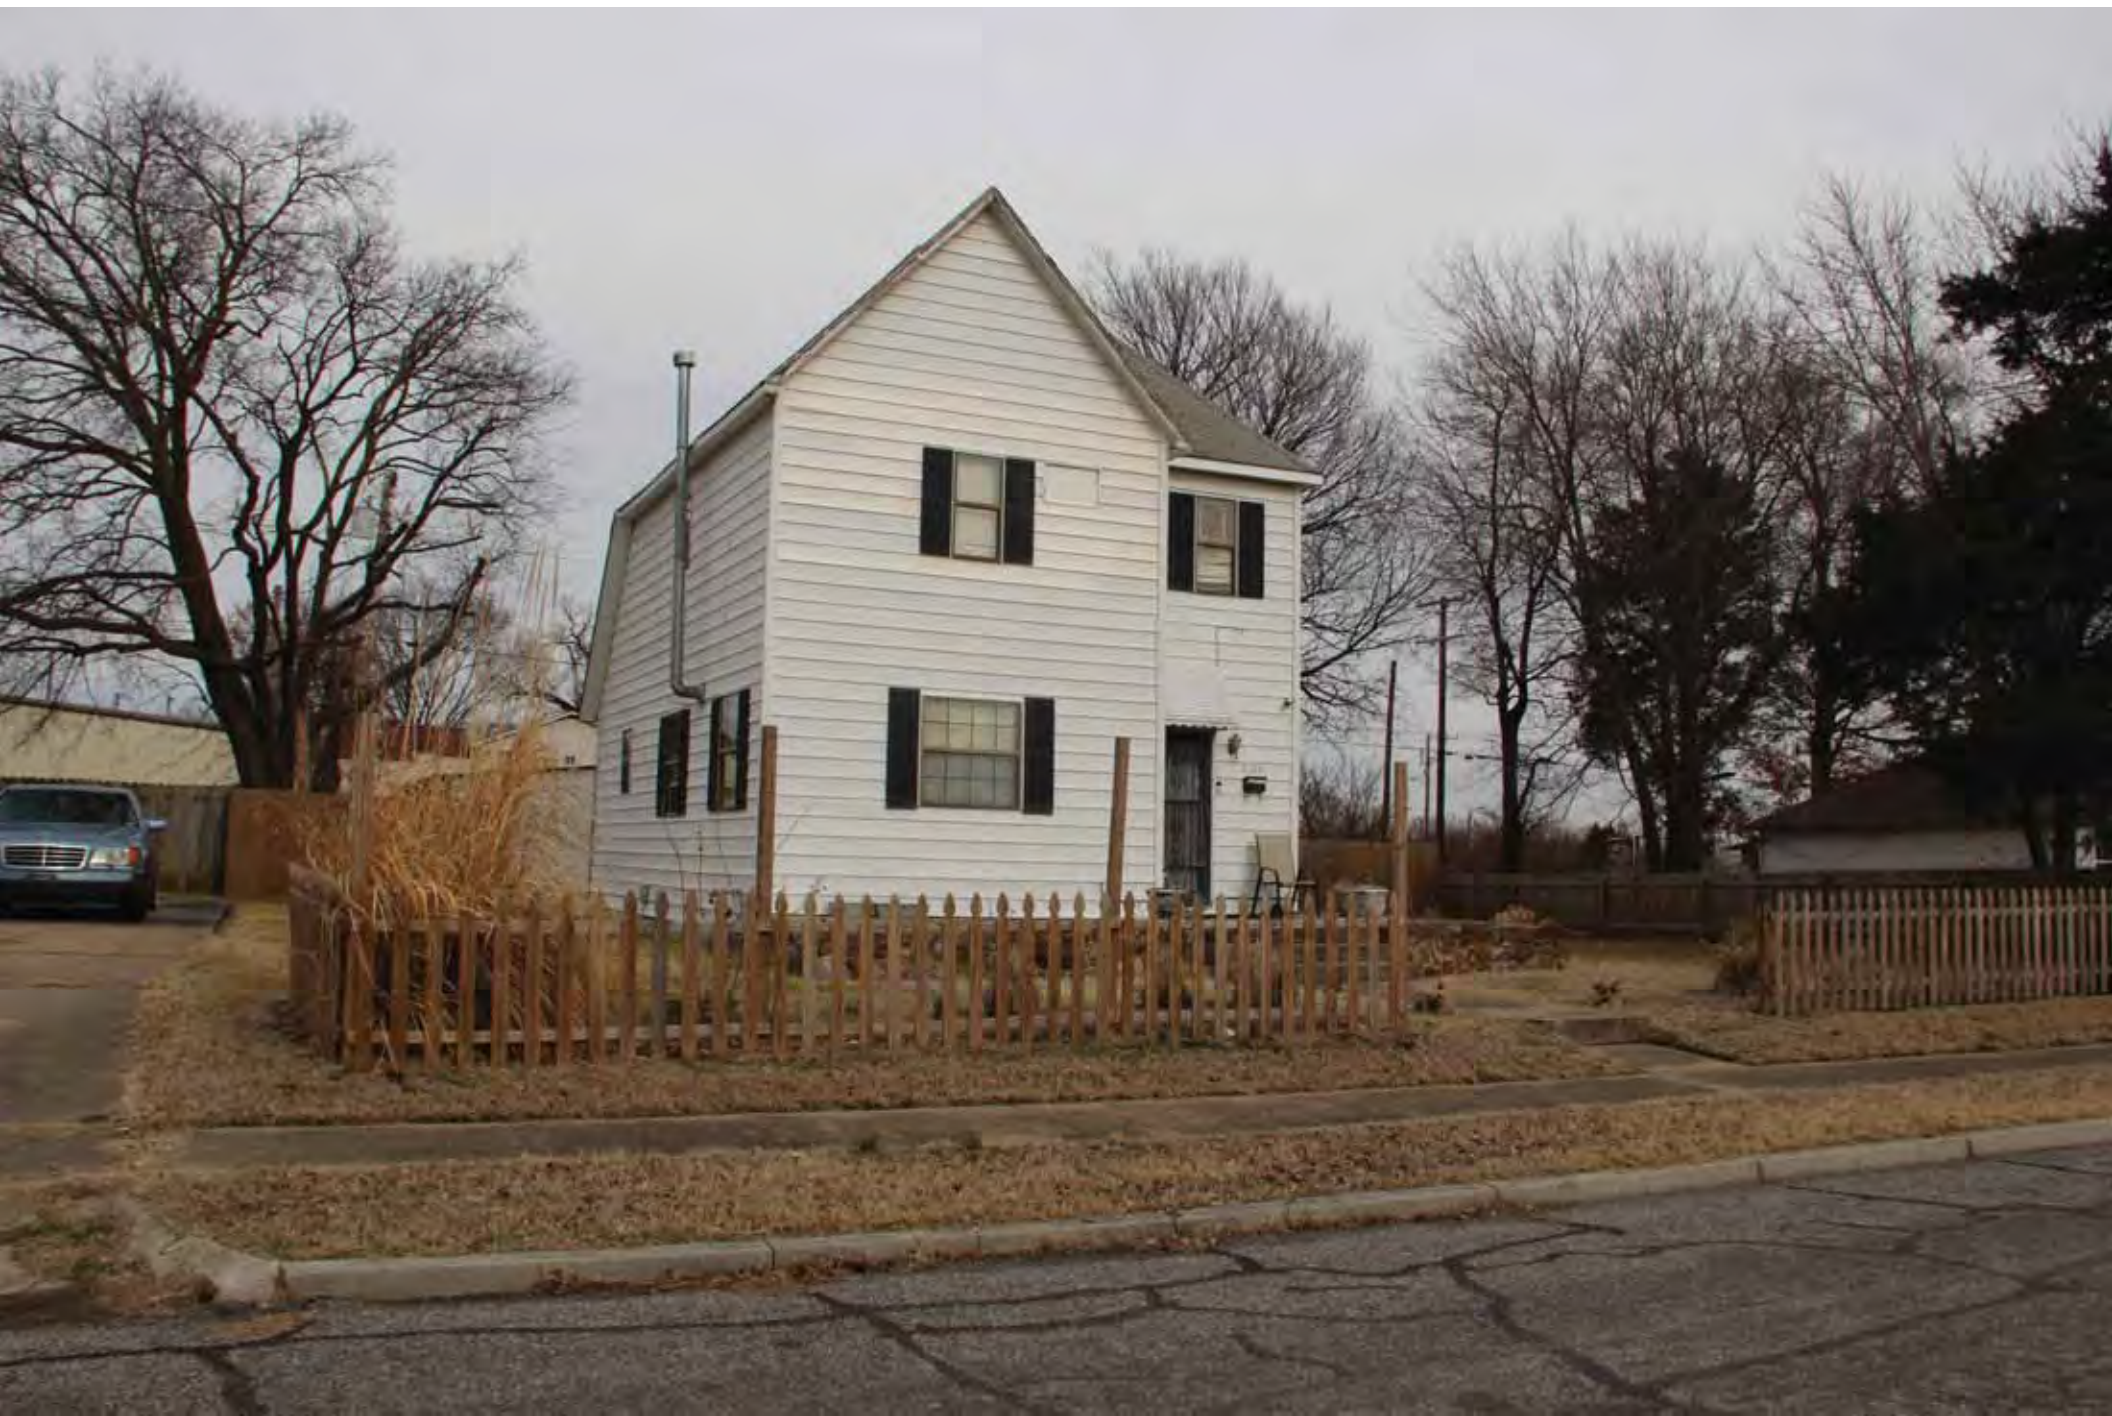
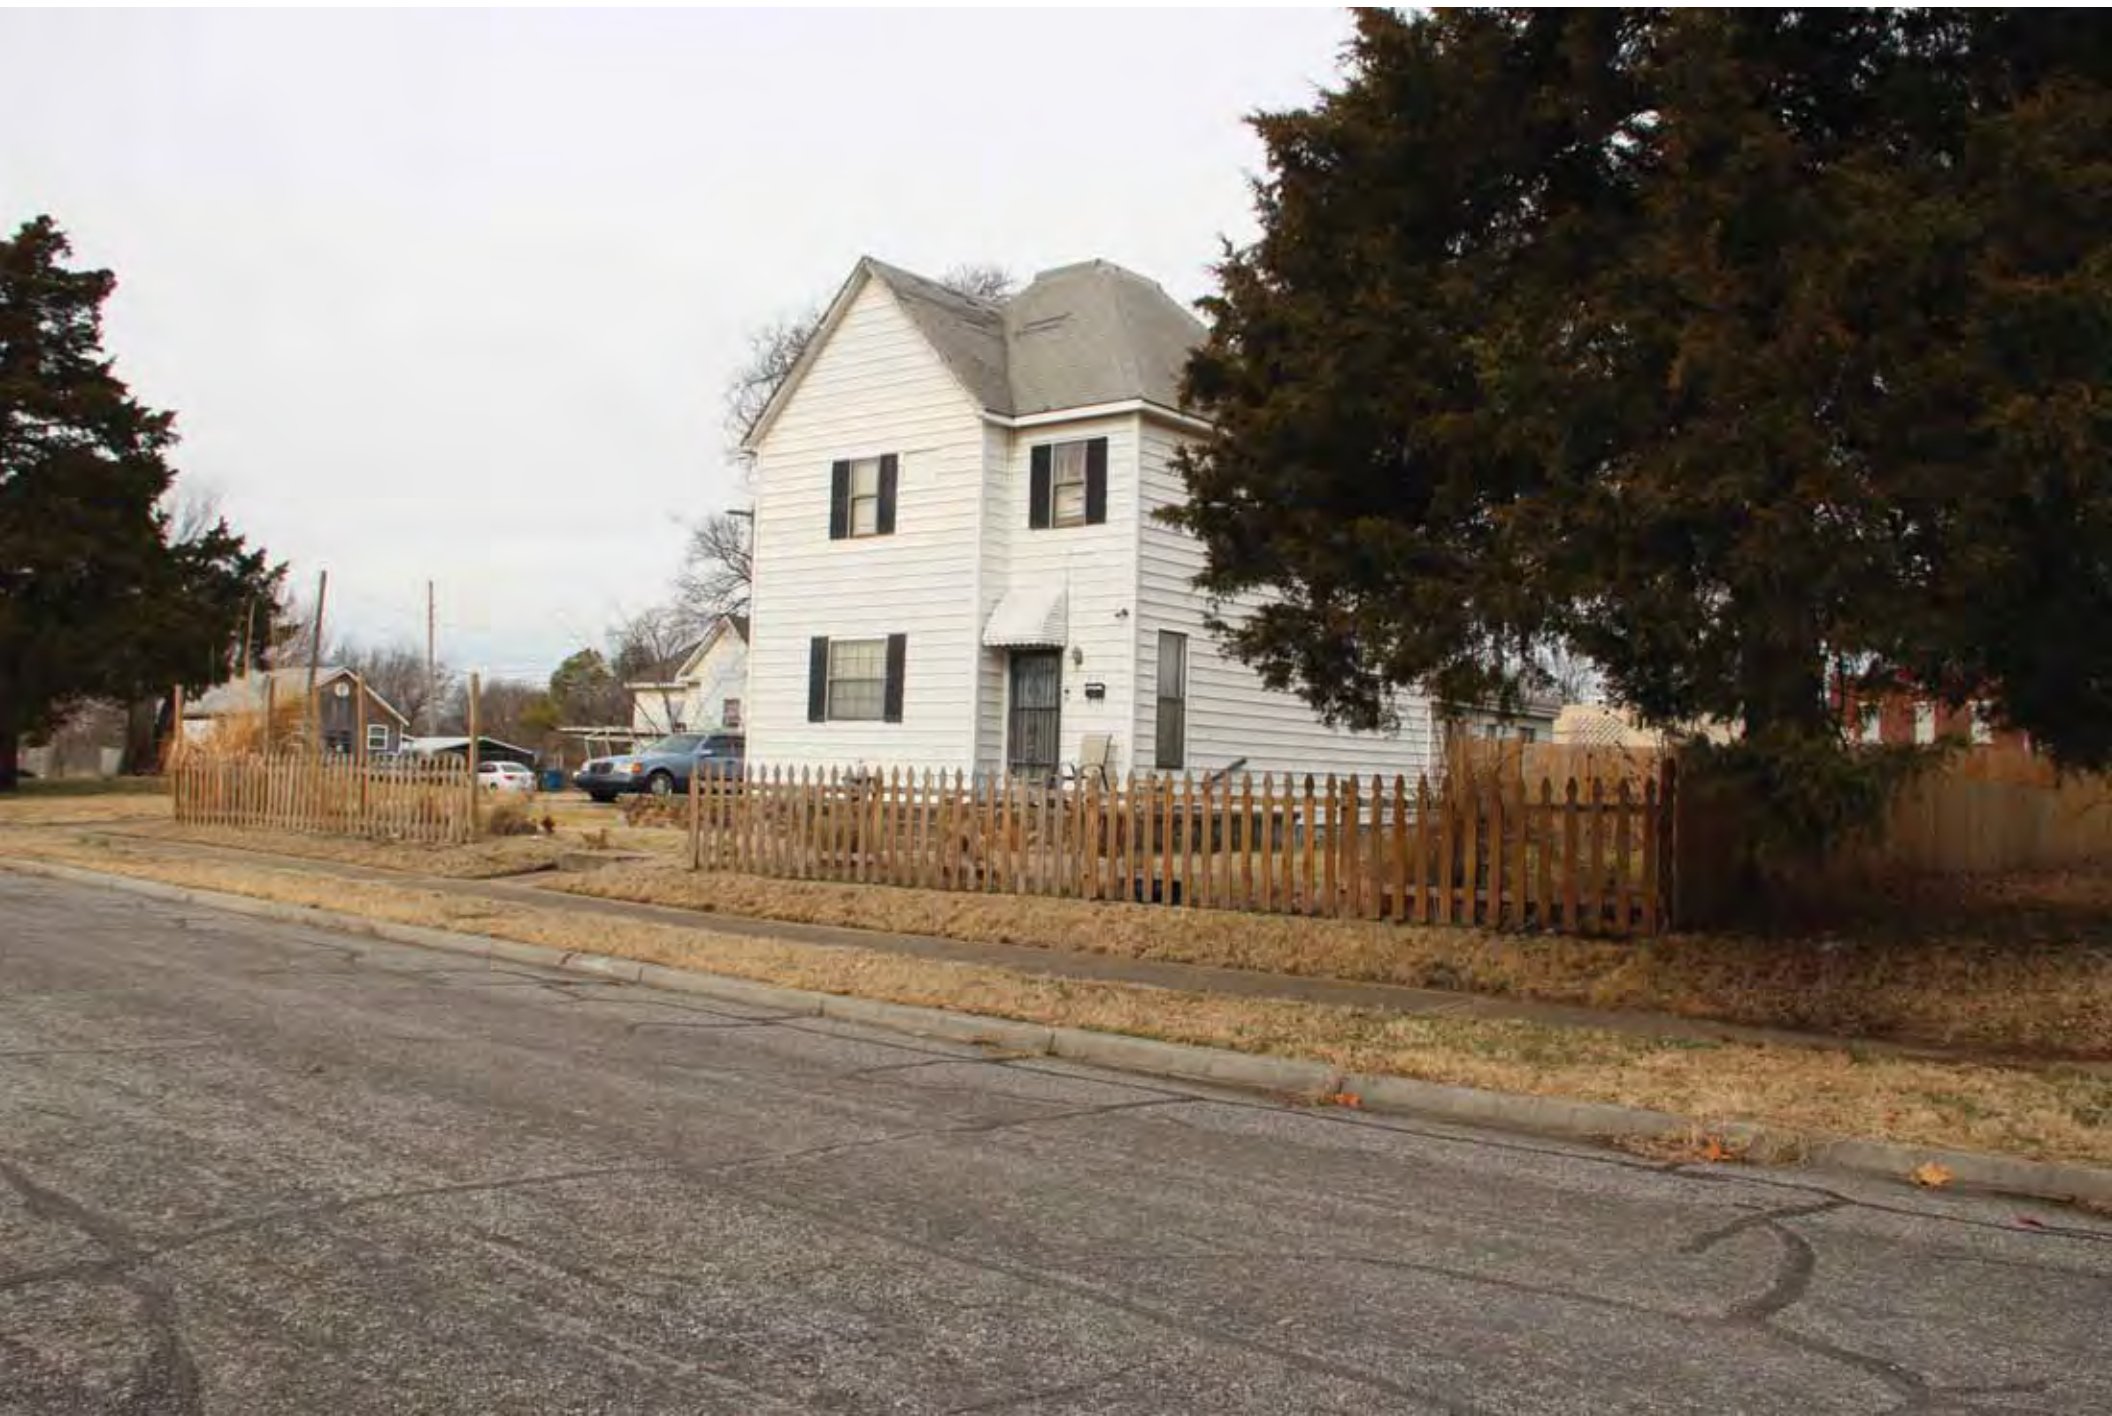
The property at 609 Central Street is a two-story frame dwelling. The entire house is covered in vinyl siding. It has a high-pitched hipped roof, with a front facing gable on the front elevation. At the rear of the house there appears to be an addition, creating a sloped shed roof portion. The front entrance is on the east side of the front façade of the house, and is a single replacement door under a metal awning. To the left of the front entrance is a six-over-six vinyl replacement window with non-functioning shutters. On the second floor, on the front façade, are two single vinyl replacement windows, also with non-functioning metal shutters.

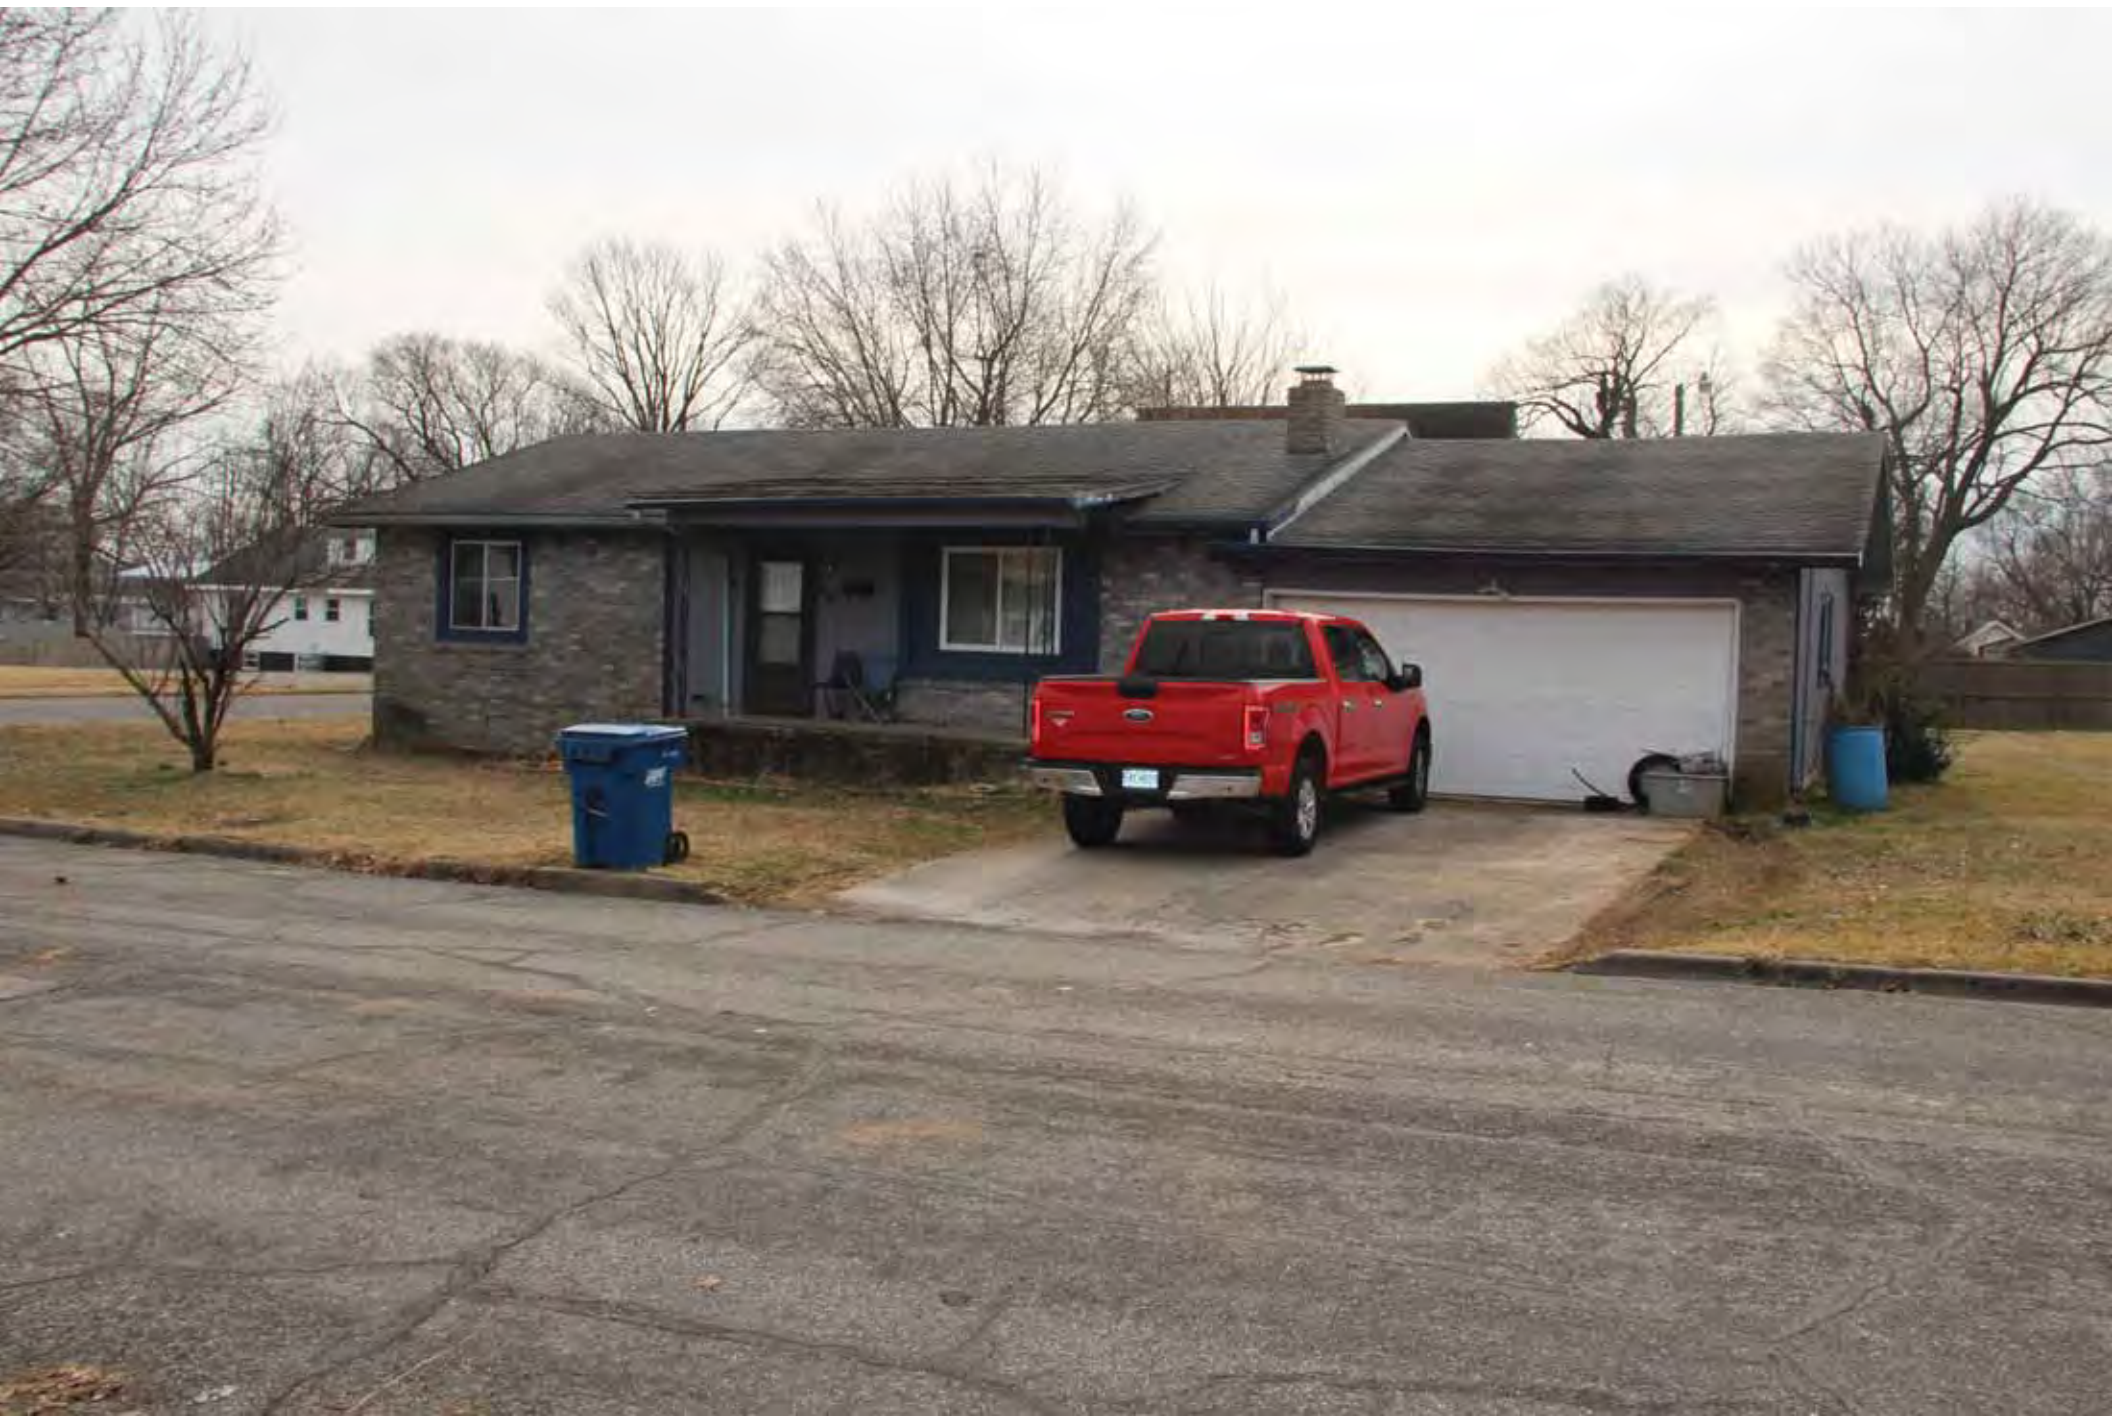
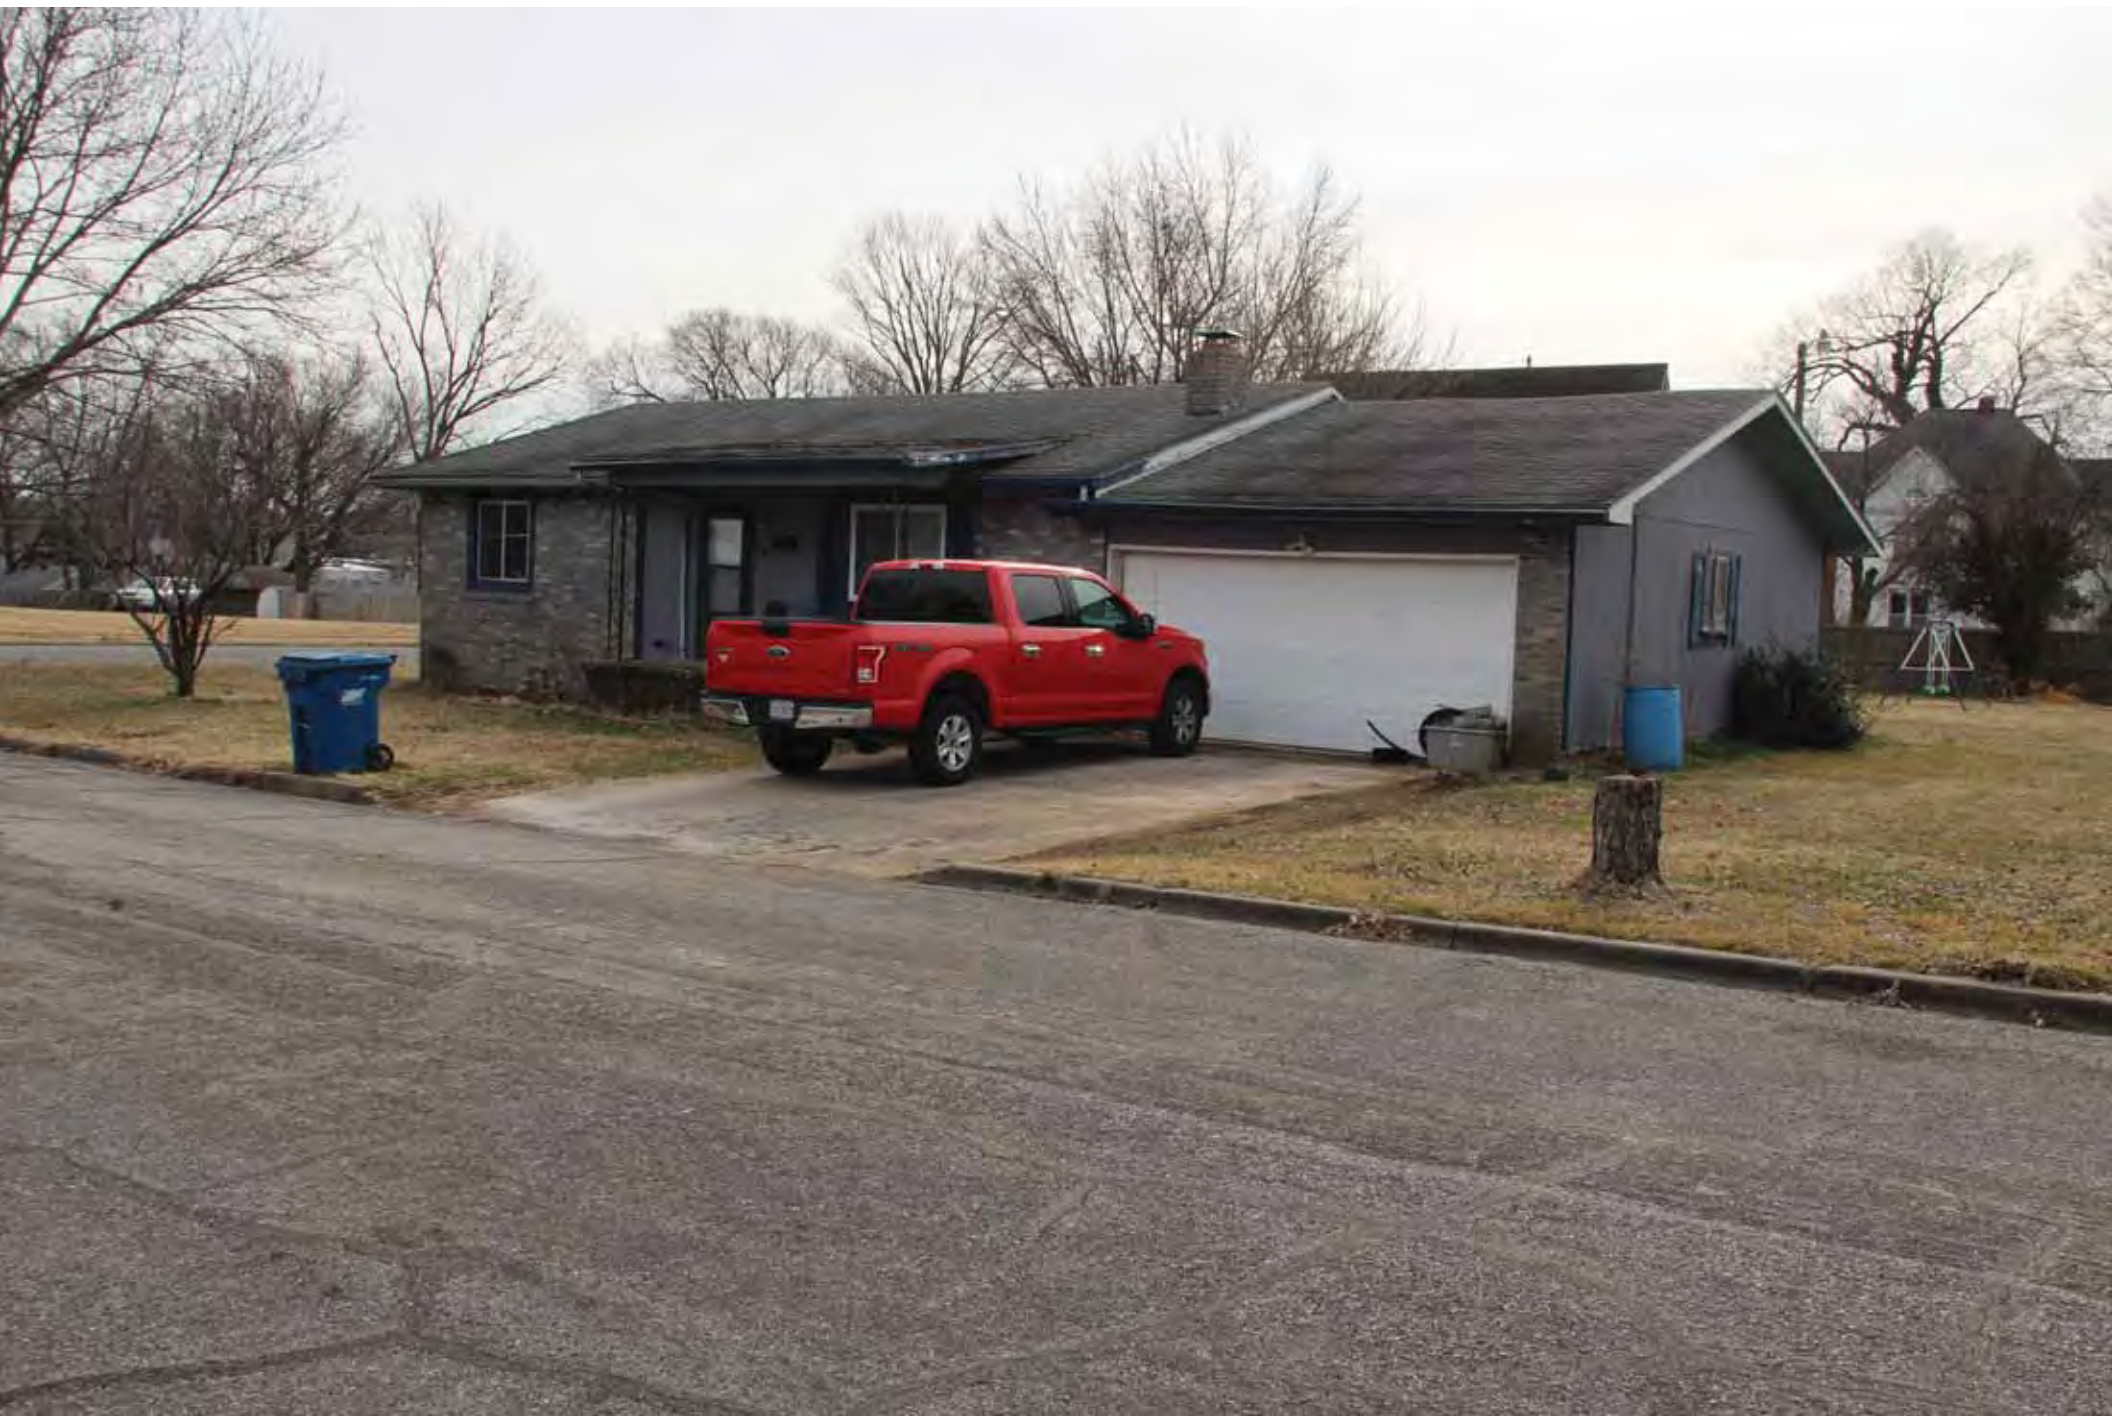
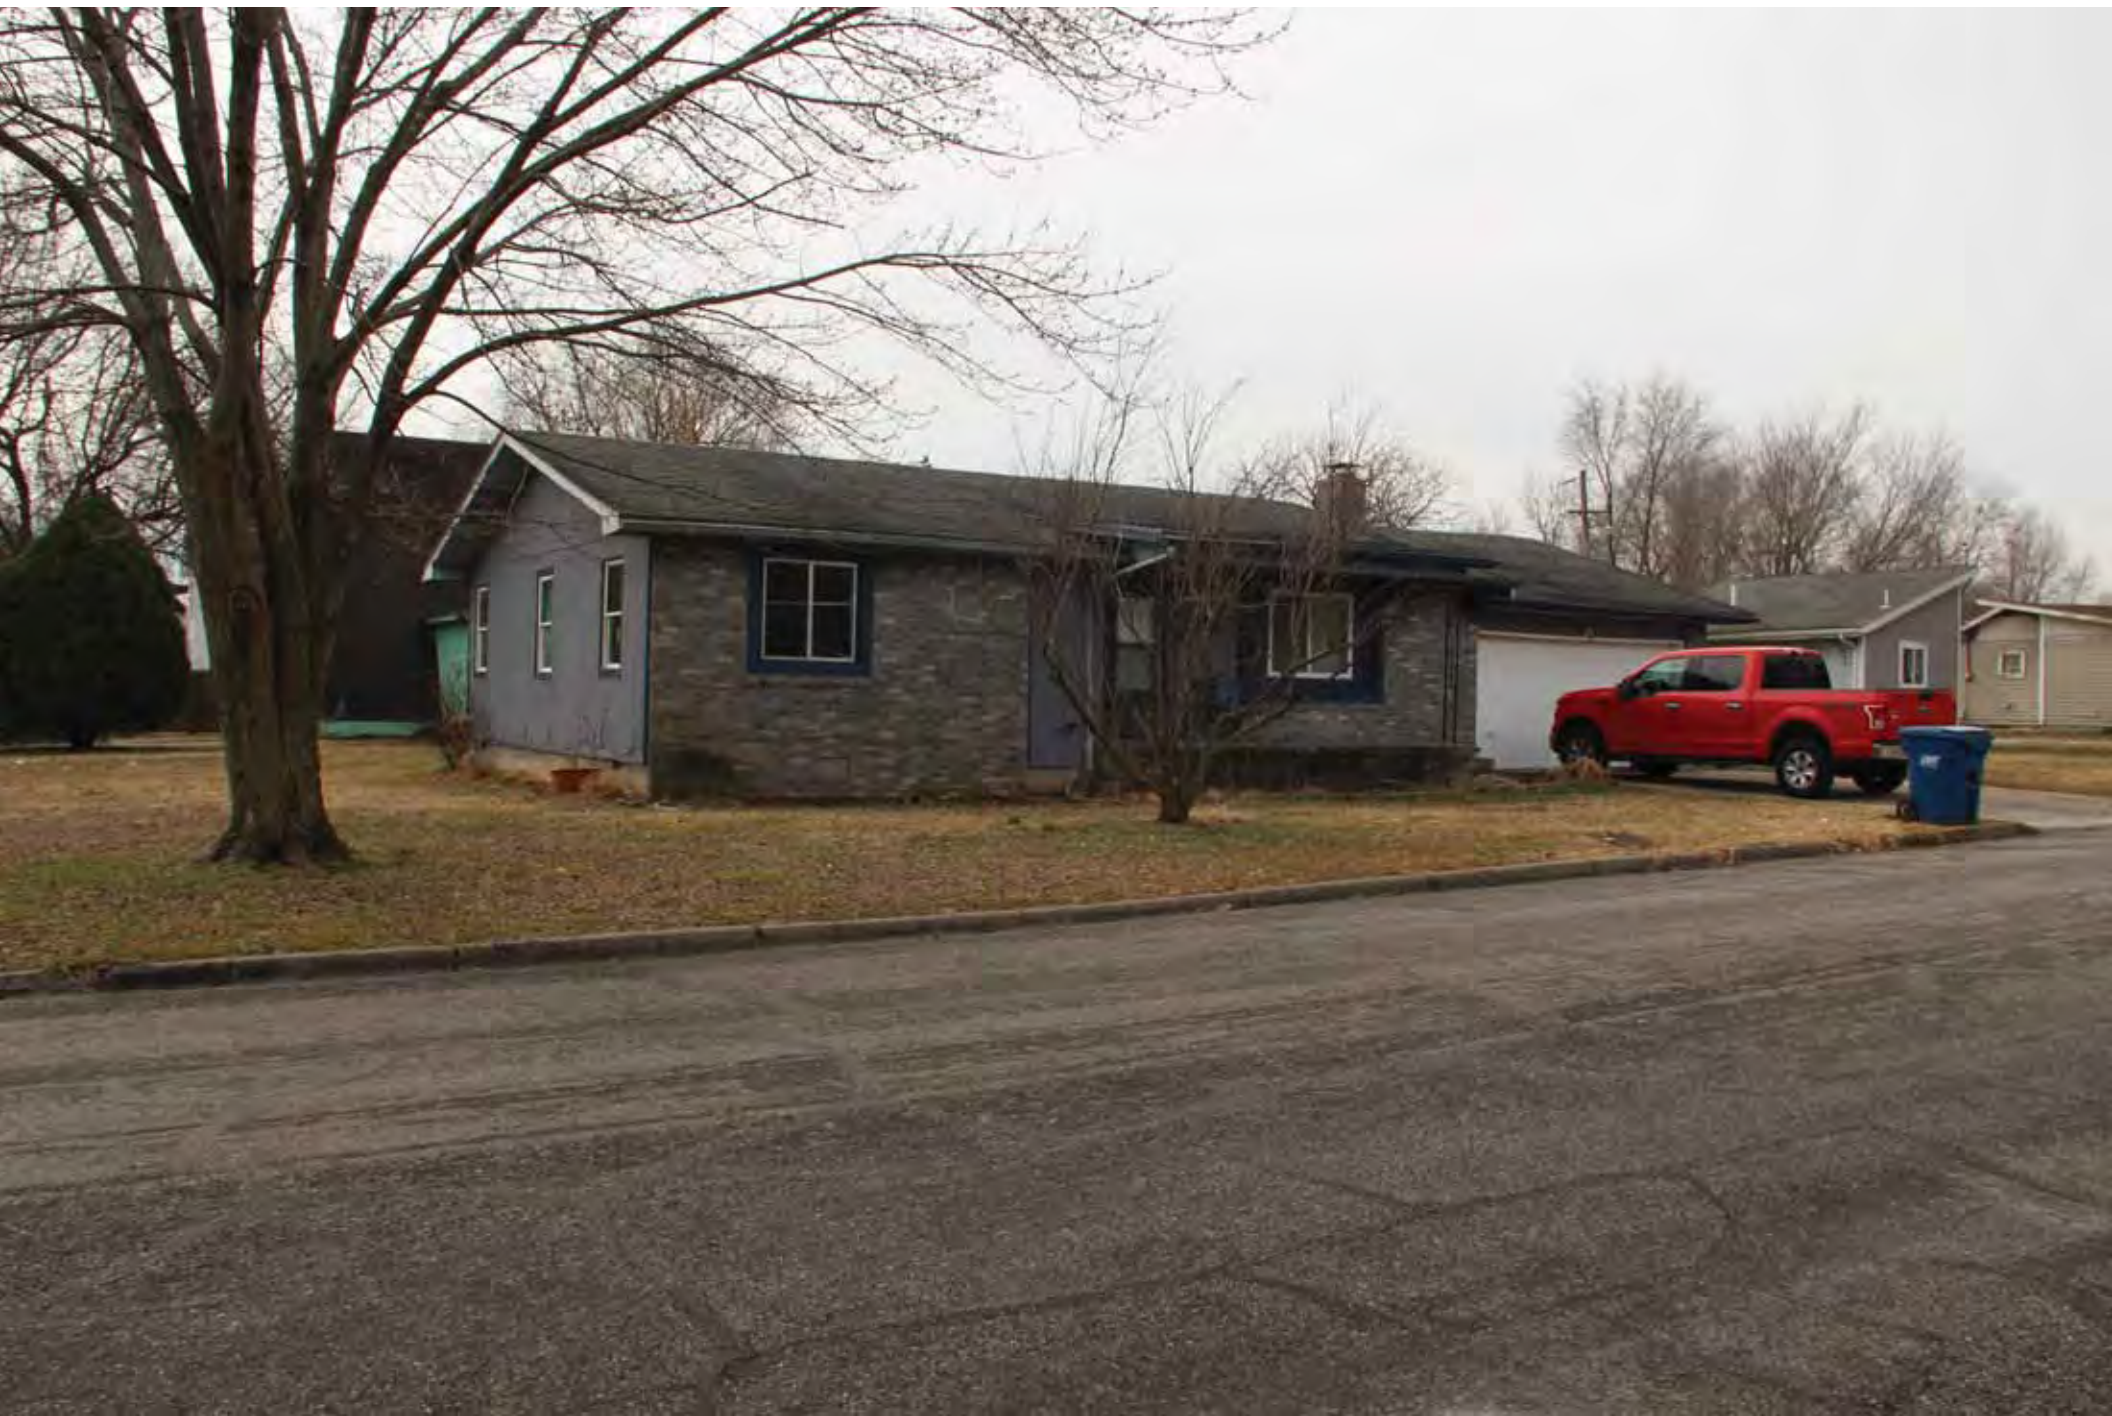
The property at 610 Central street is a one-story ranch house, with a side gable roof covered in asphalt siding. It has rectangular plan with an attached garage on the west end of the house. The attached garage is 2 cars or bays wide, and has one metal track door. A concrete driveway off of Central Street accesses the garage. On the front façade, or north elevation of the house, is a central open front porch with a shed roof. The porch sits on metal supports on a concrete foundation. It shelters a single front door and a single vinyl casement window. To the left, or east of the front porch, is another single vinyl casement window. The exterior of the house is covered in hardboard, except for the front façade on Central, which is covered in a brick veneer.
