MISSOURI DEPARTMENT OF NATURAL RESOURCES
STATE HISTORIC PRESERVATION OFFICE, P.O. Box 176, Jefferson City, MO 65102
ARCHITECTURAL/HISTORIC INVENTORY FORM

1. Survey No. JP-AS-007-001		2. Survey name: East Town (Original Joplin) Historic Survey Phase 2	
3. County: JASPER		4. Address (Street No.) 618	Street (name) E. 2 nd Street
5. City: Joplin	Vicinity: <input type="checkbox"/>	6. Geographical Reference:	7. Township/Range/Section: T: R: S:
8. Historic name (if known):		9. Present/other name (if known):	
10. Ownership: <input checked="" type="checkbox"/> Private <input type="checkbox"/> Public		11a. Historic use (if known): Domestic: Single Dwelling	11b. Current use: Domestic: Single Dwelling

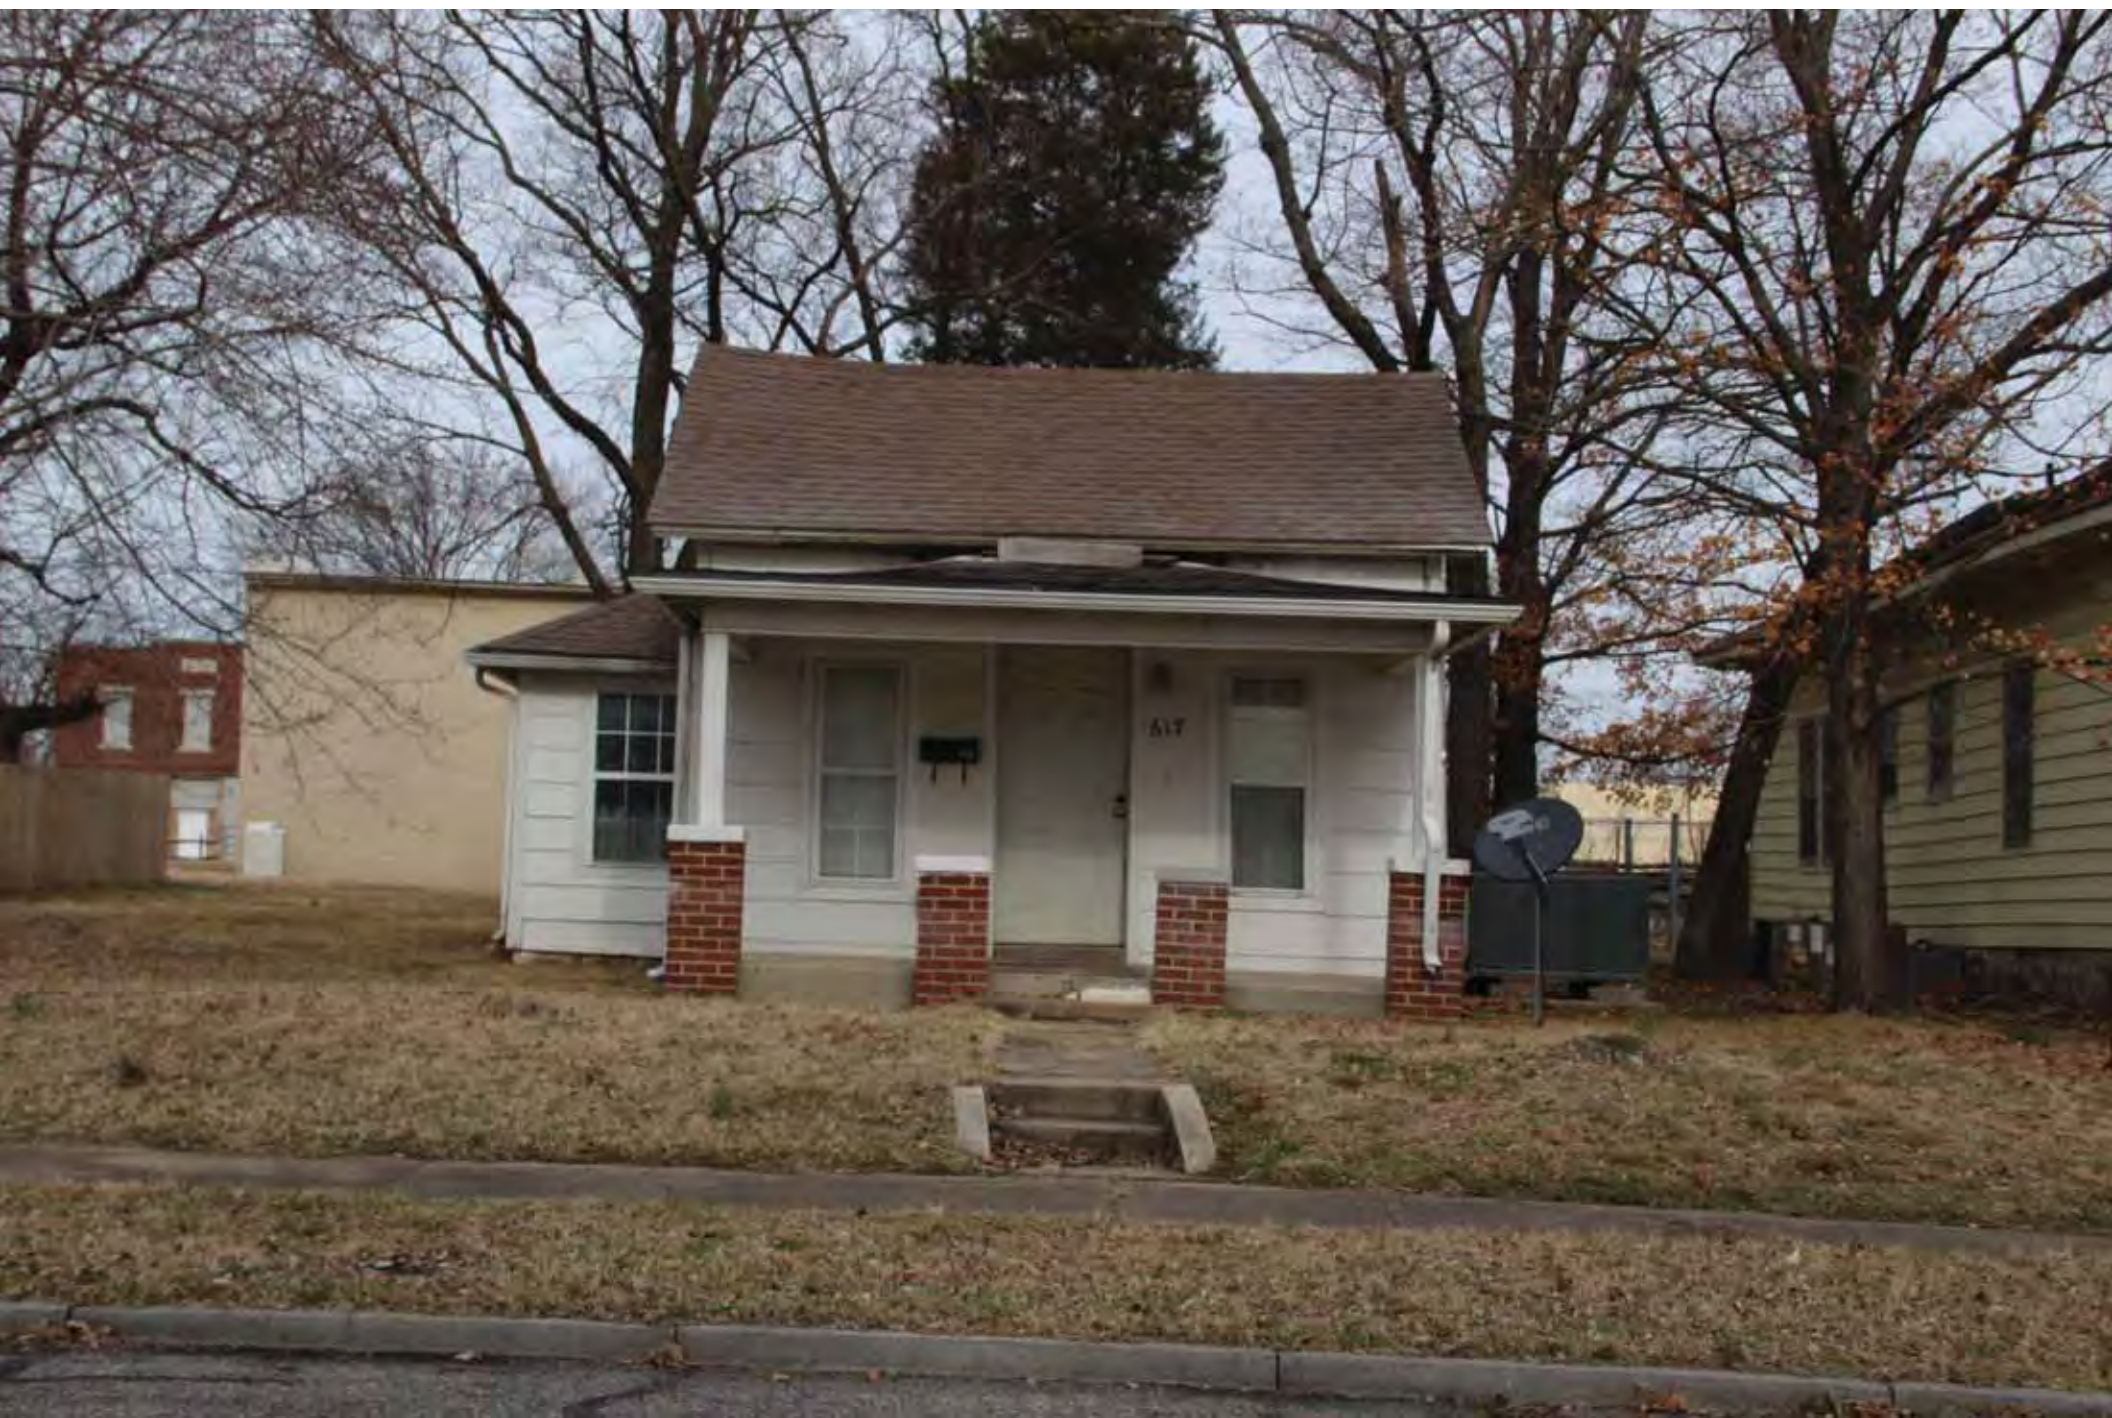
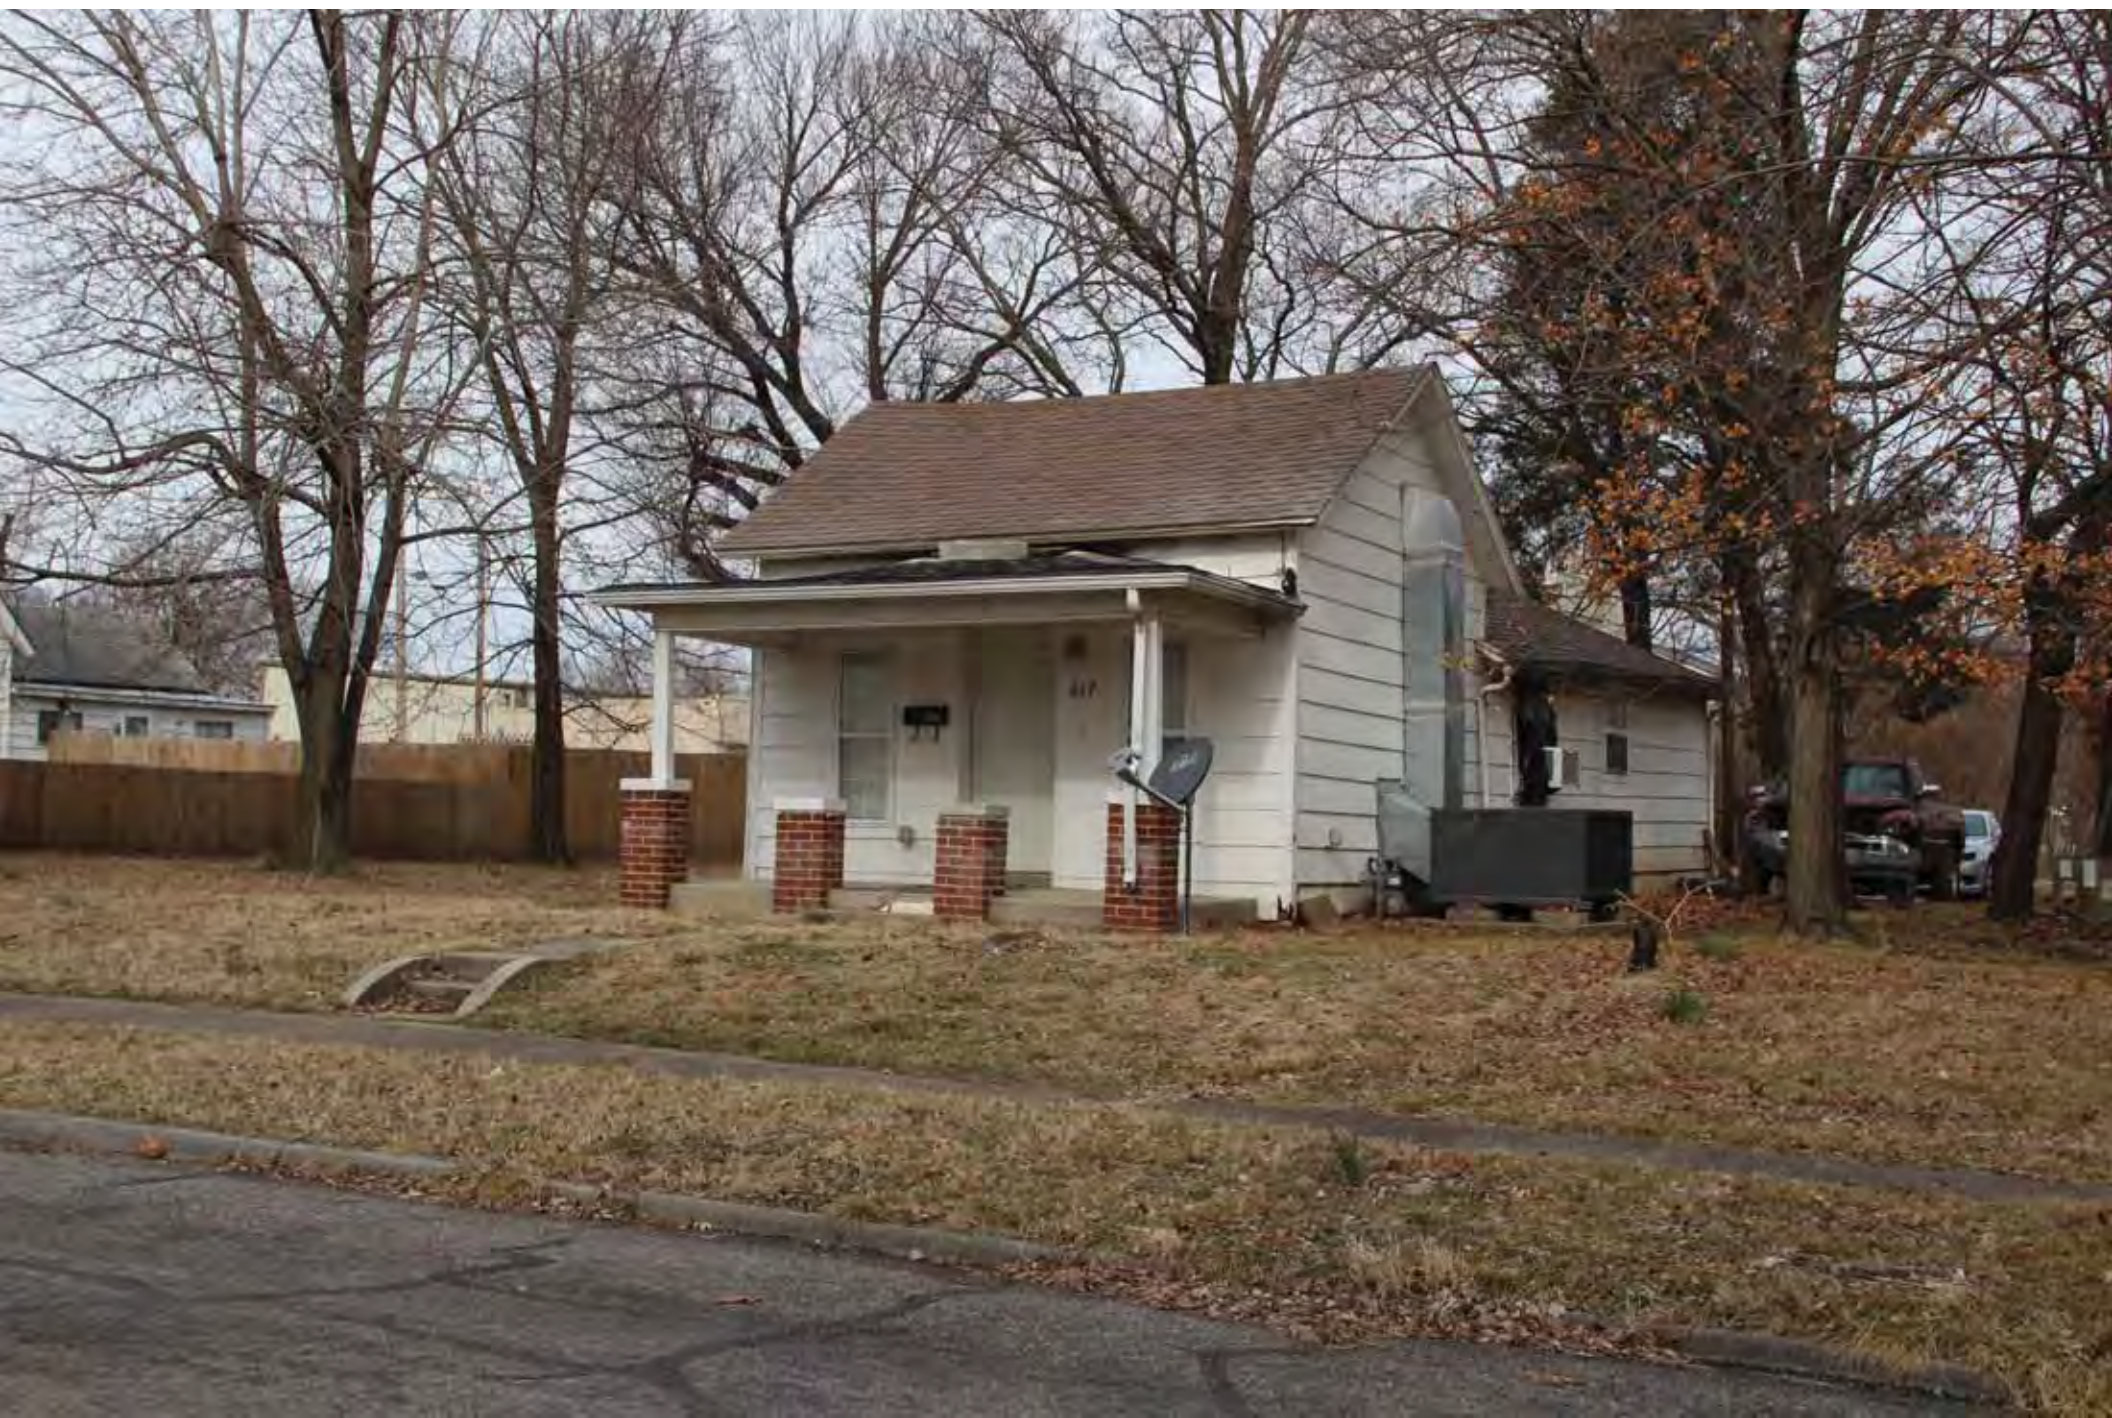
The property at 617 Central Street is a small frame dwelling with a side-gabled roof along the front elevation. The roof is covered in asphalt siding and the house is covered in metal siding. The front entrance is in the center of the front façade. It is flanked on either side by six-over-six single vinyl windows. On the front of the house is an older front porch with a low-pitched hipped roof. The porch has a concrete foundation and the wooden supports sit on square brick piers. A small portion of the rear of the house has a hipped roof.

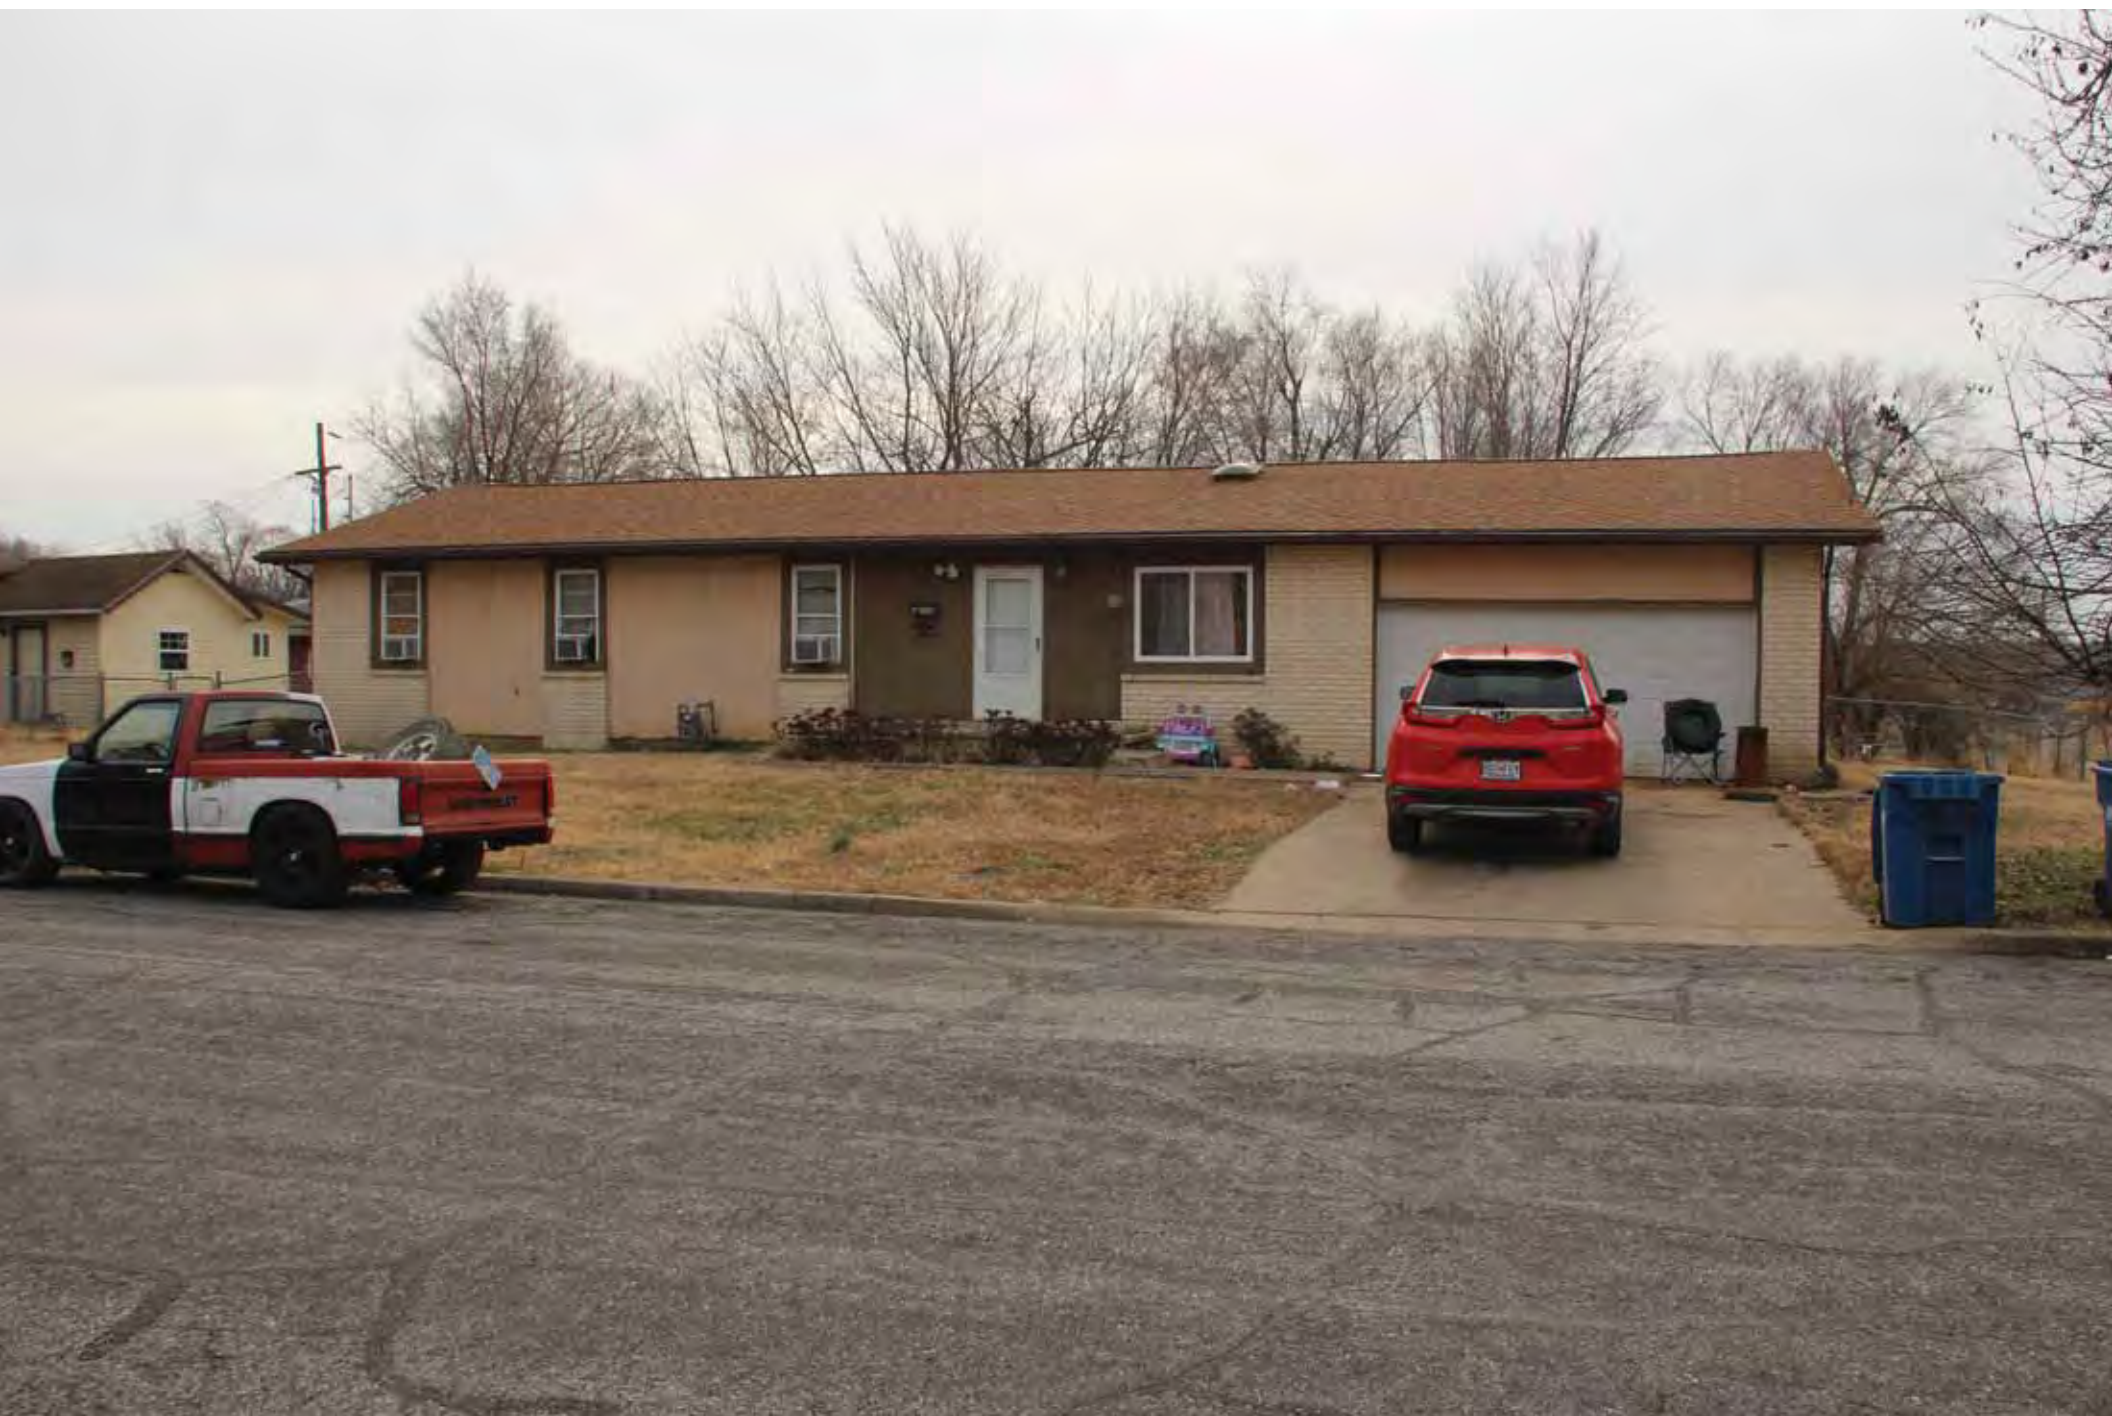
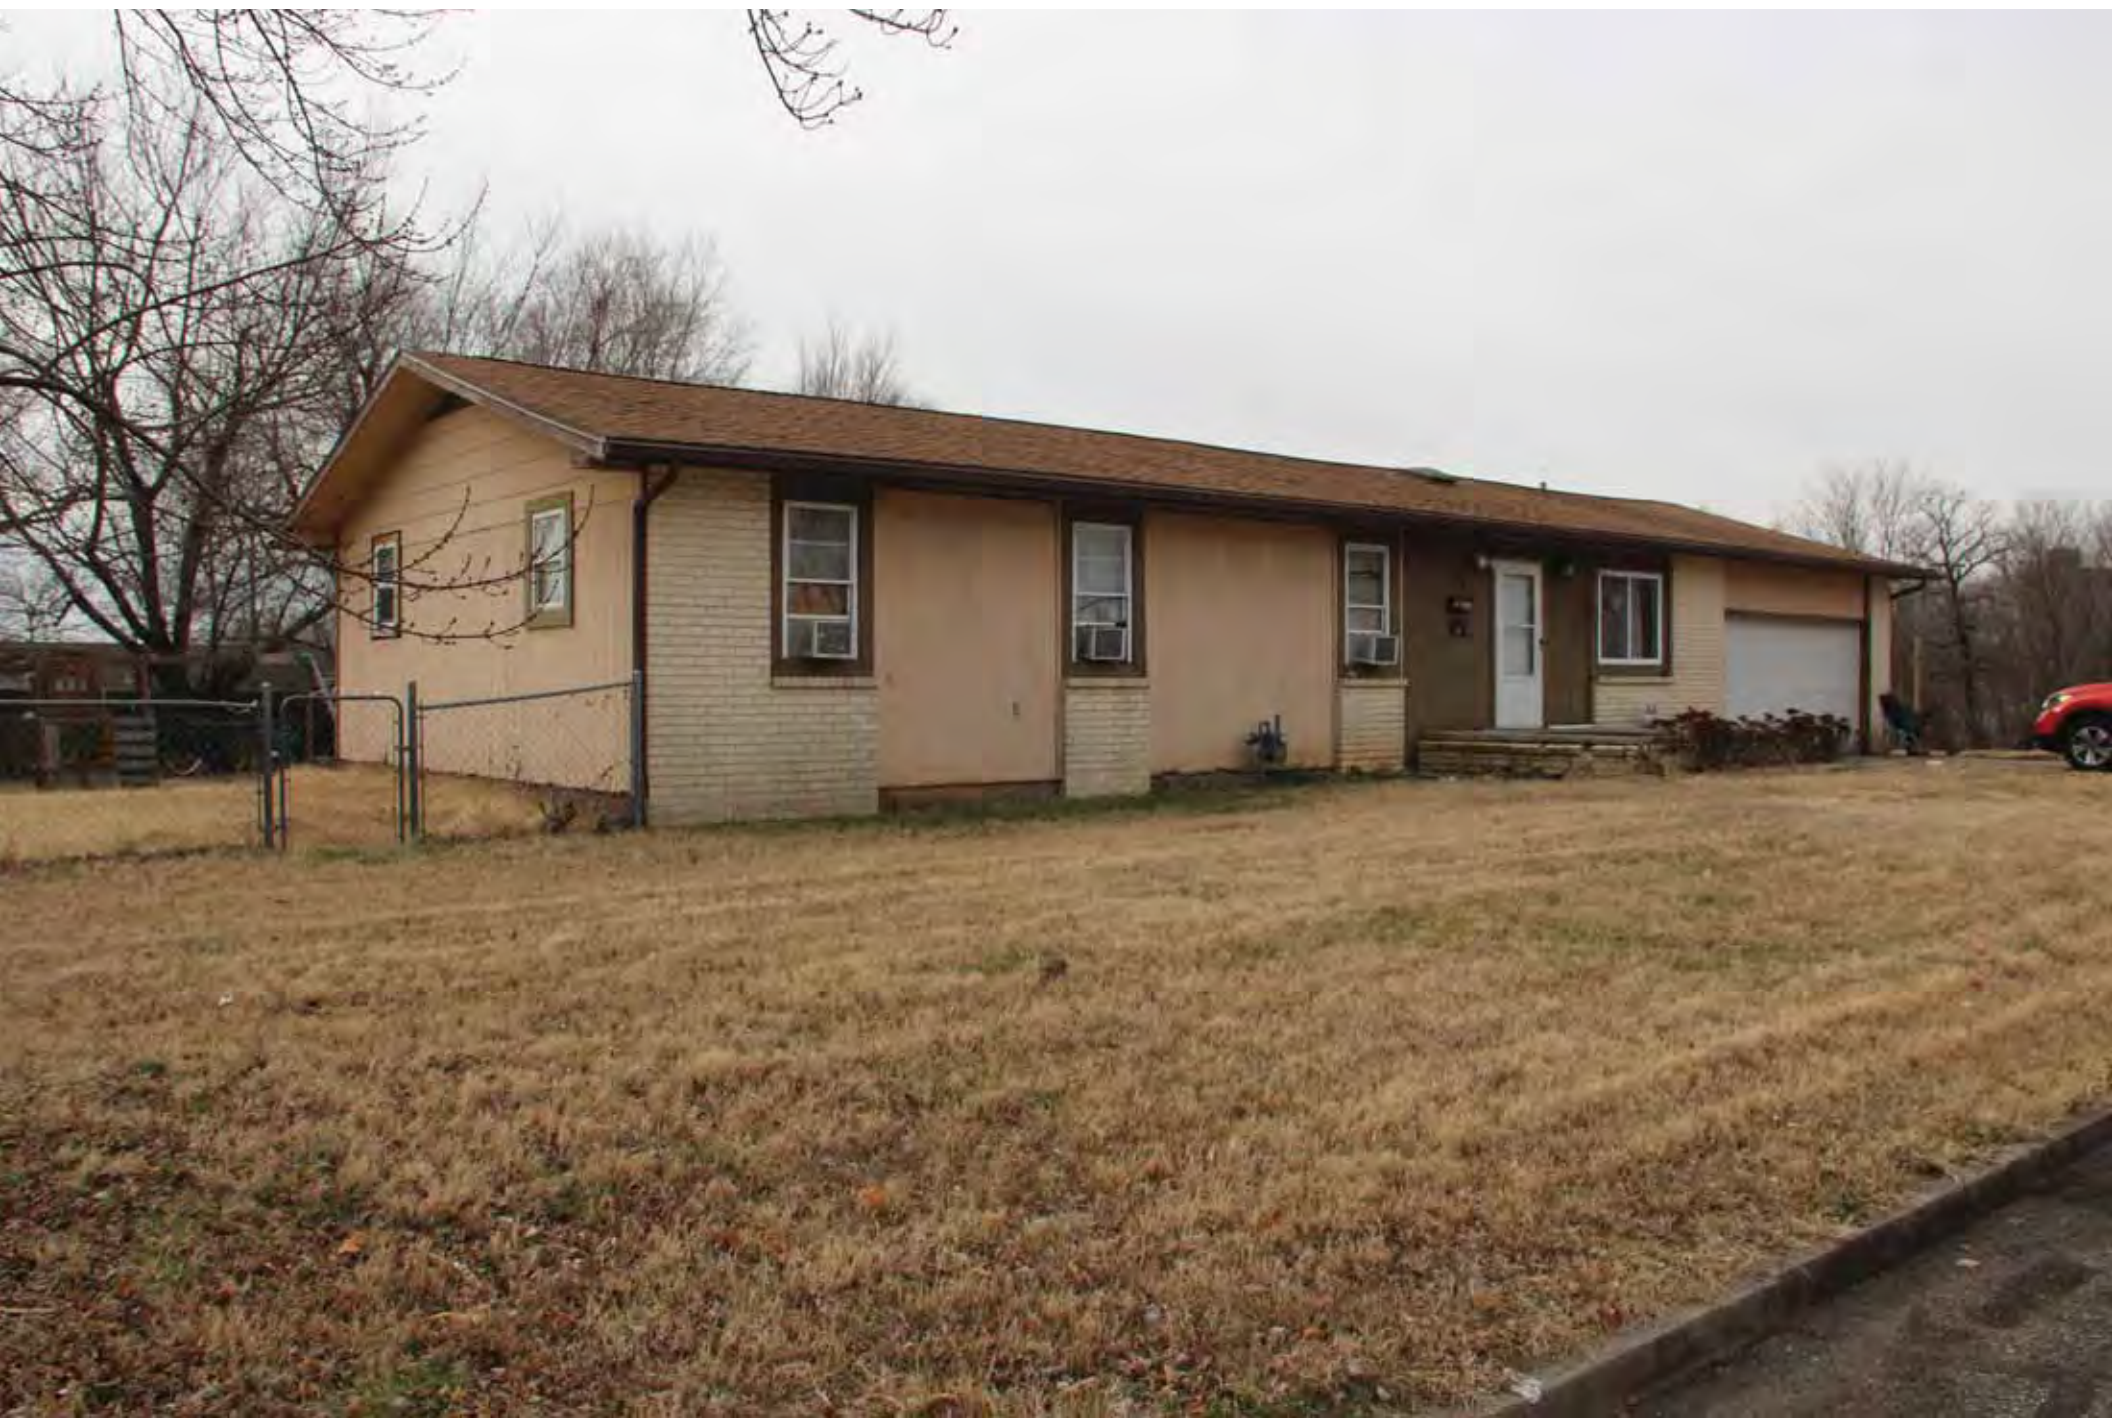
The property at 620 Central street is a one-story ranch house, with a side gable roof covered in asphalt siding. It has rectangular plan with an attached garage on the east end of the house. The attached garage has one metal track door. A concrete driveway off of Central Street accesses the garage. On the front façade, or south elevation of the house, is a central front door. To the right of the door is a single vinyl casement window. To the left, or west of the front door, are three single one-over-one vinyl windows. The exterior of the house is covered in hardboard.
