MISSOURI DEPARTMENT OF NATURAL RESOURCES
STATE HISTORIC PRESERVATION OFFICE, P.O. Box 176, Jefferson City, MO 65102
ARCHITECTURAL/HISTORIC INVENTORY FORM

1. Survey No. JP-AS-007-001		2. Survey name: East Town (Original Joplin) Historic Survey Phase 2	
3. County: JASPER		4. Address (Street No.) 618	Street (name) E. 2 nd Street
5. City: Joplin	Vicinity: <input type="checkbox"/>	6. Geographical Reference:	7. Township/Range/Section: T: R: S:
8. Historic name (if known):		9. Present/other name (if known):	
10. Ownership: <input checked="" type="checkbox"/> Private <input type="checkbox"/> Public		11a. Historic use (if known): Domestic: Single Dwelling	11b. Current use: Domestic: Single Dwelling

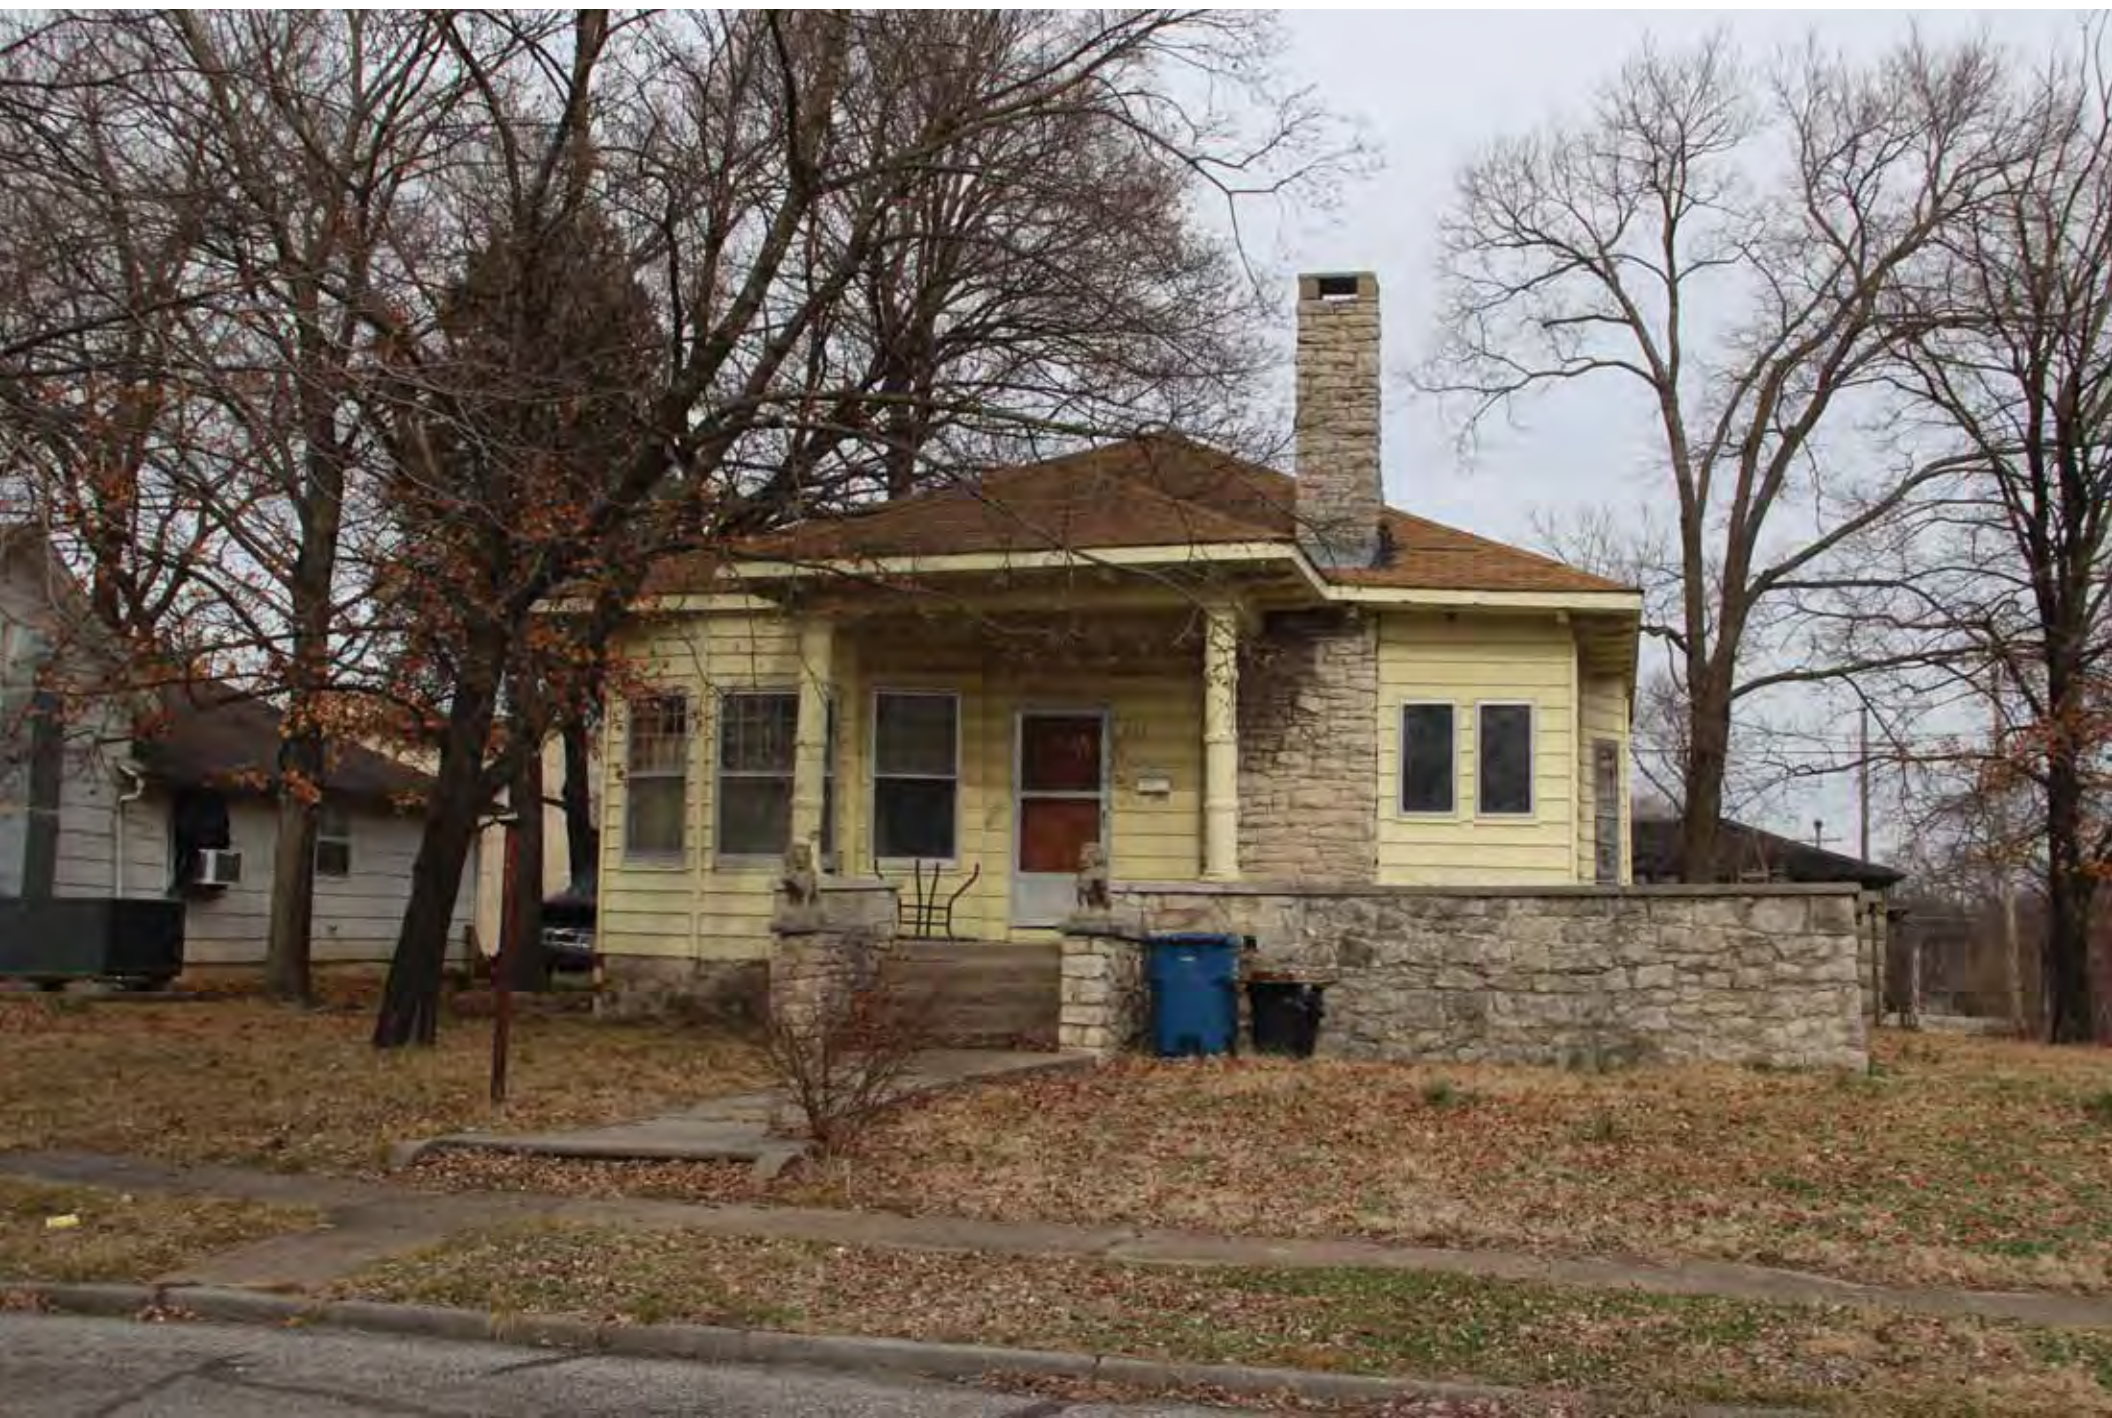
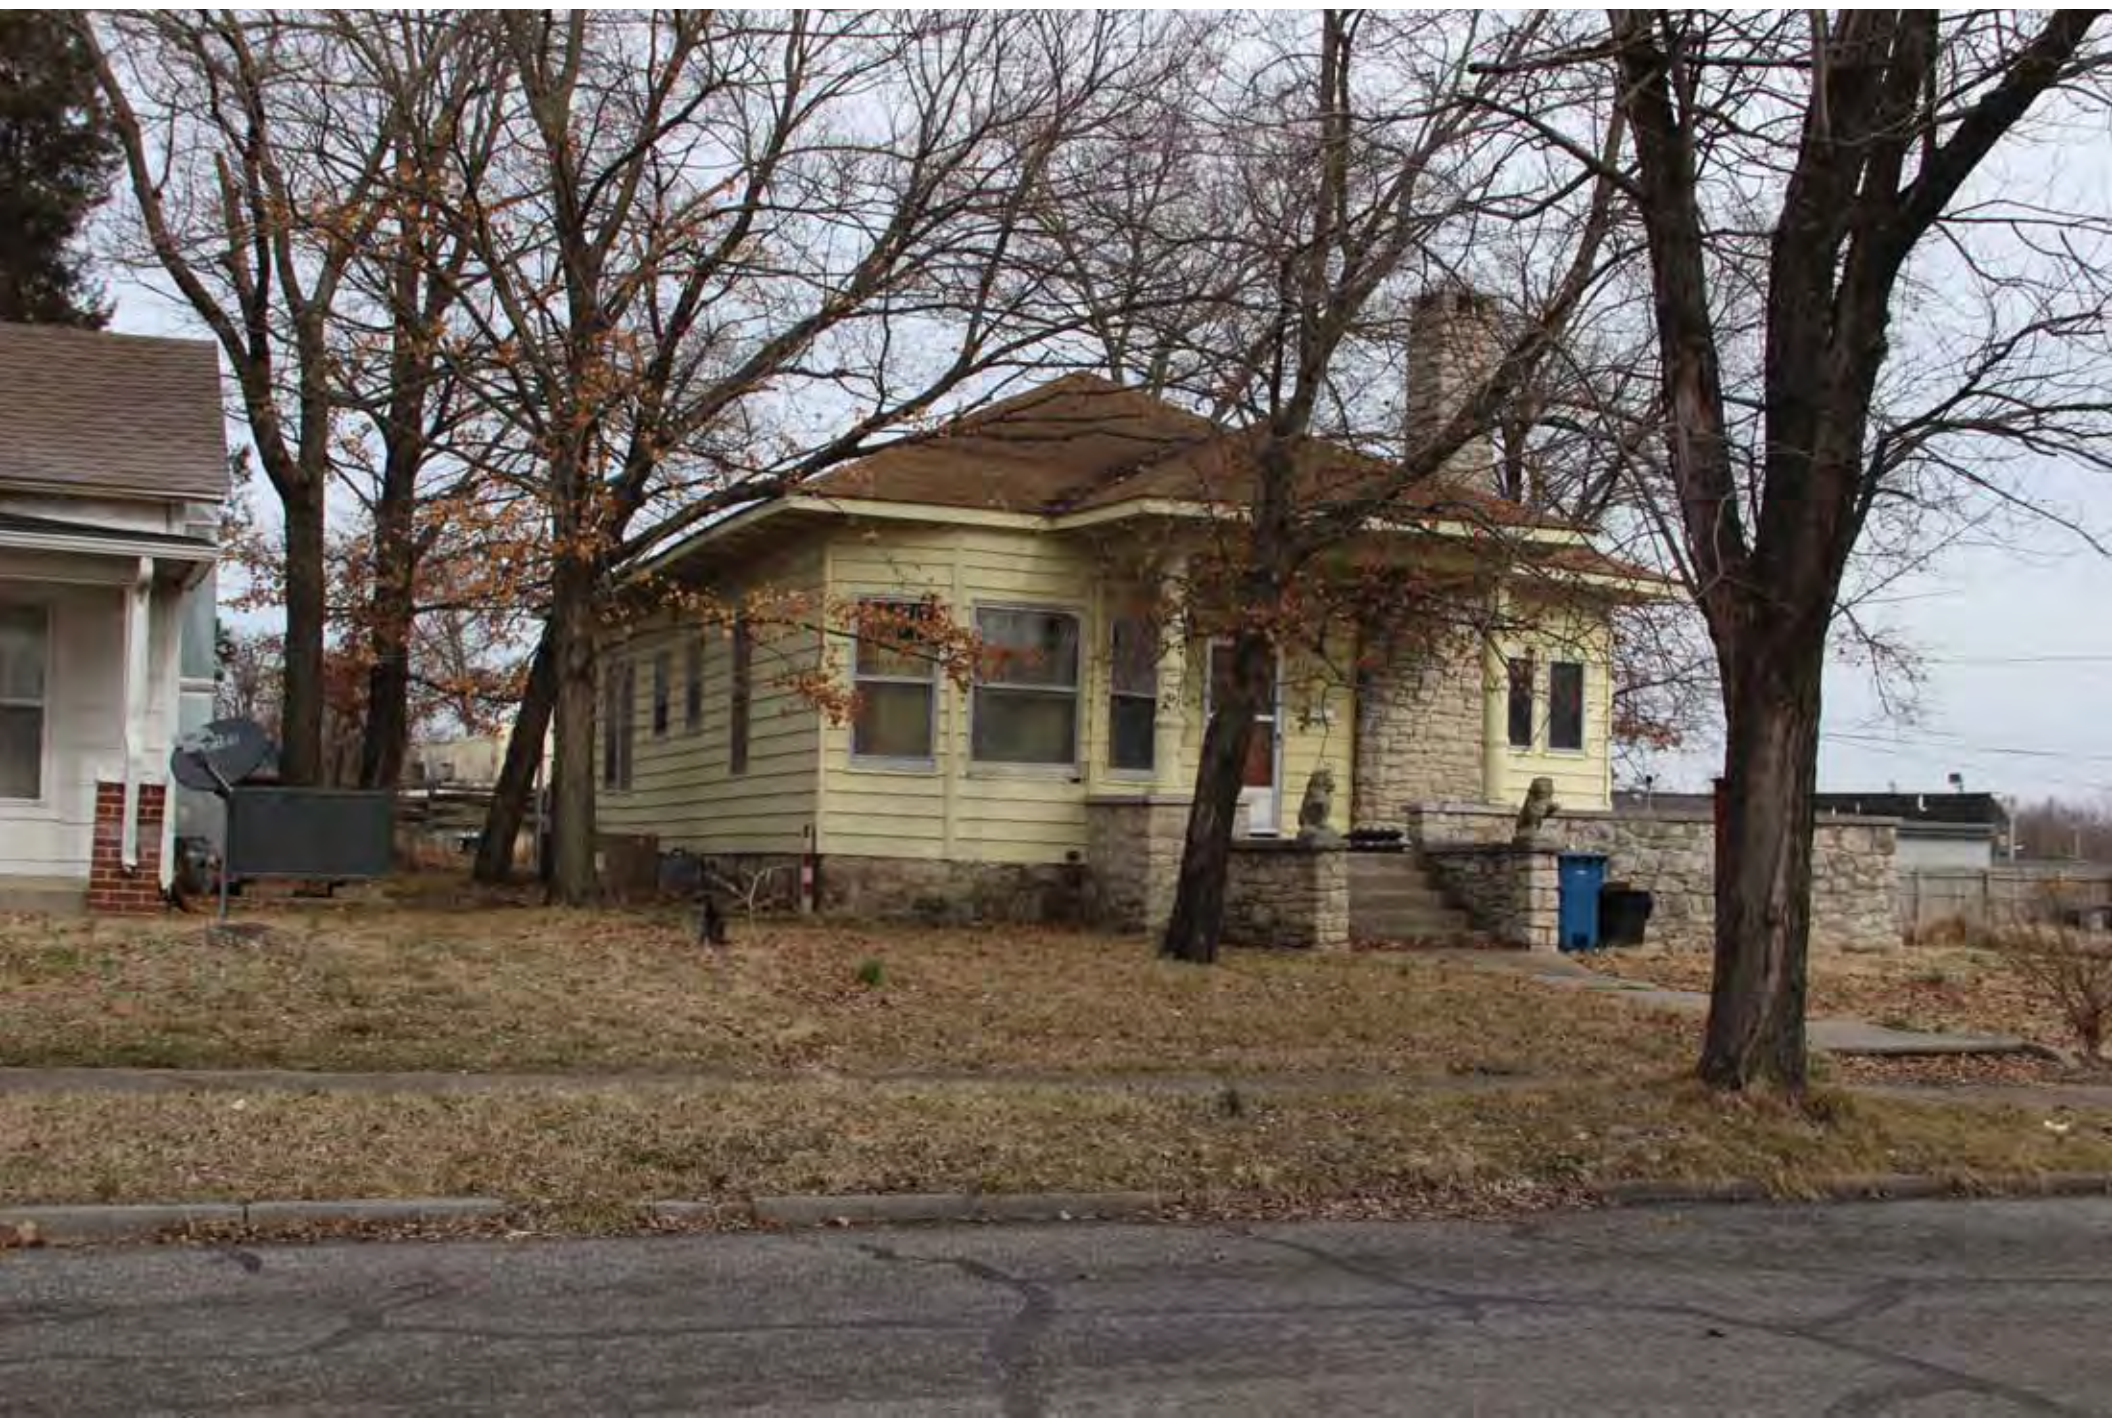
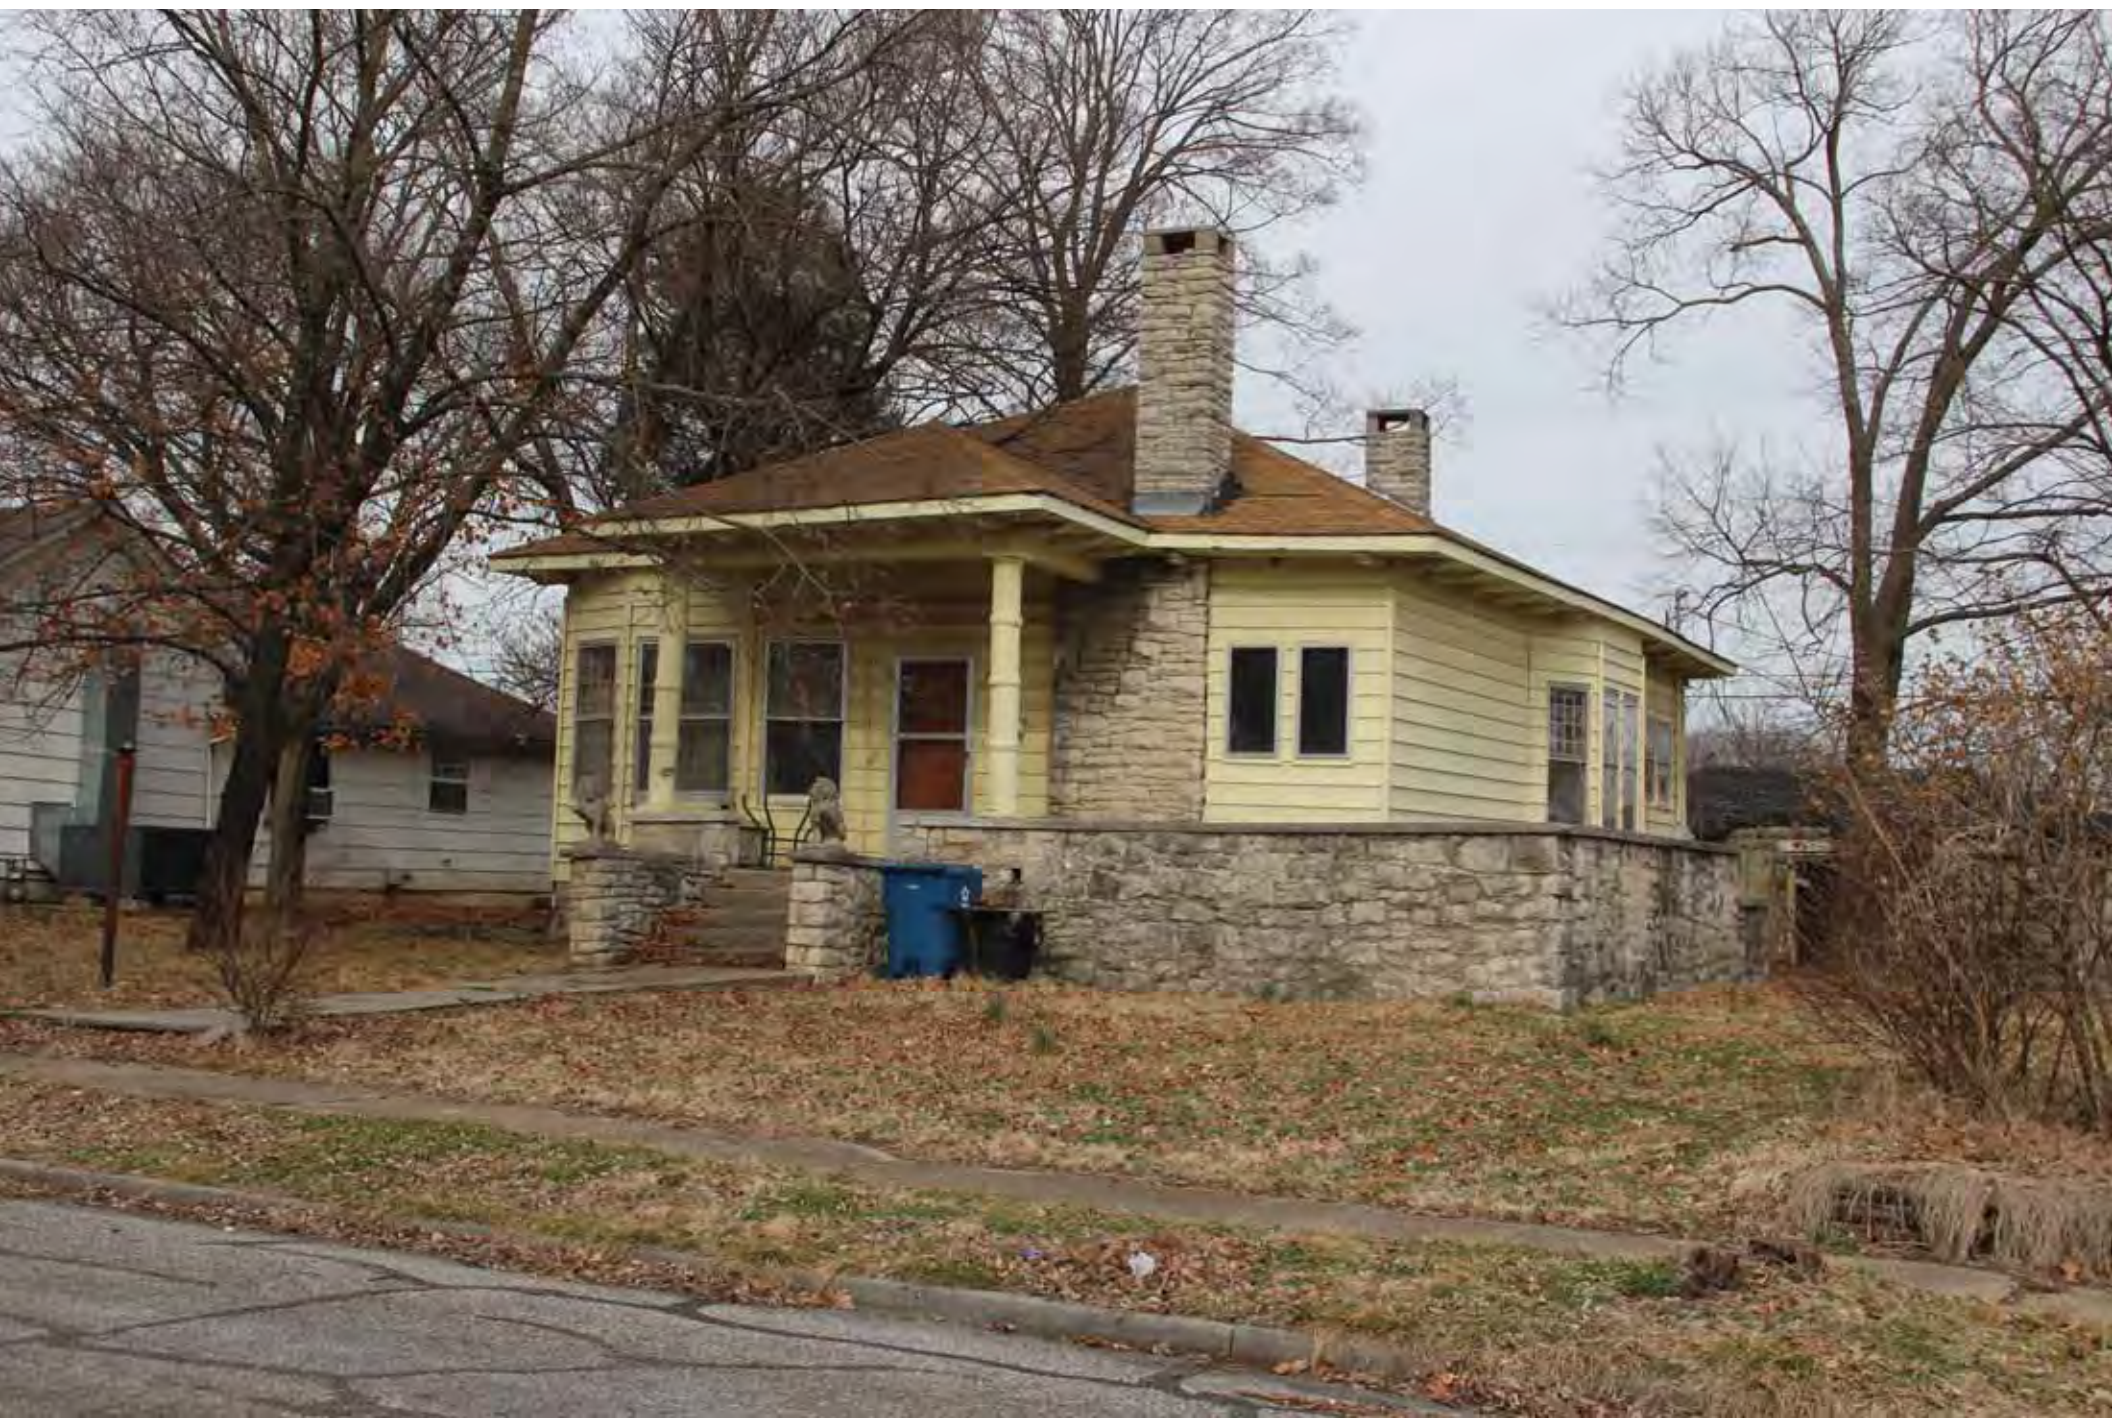
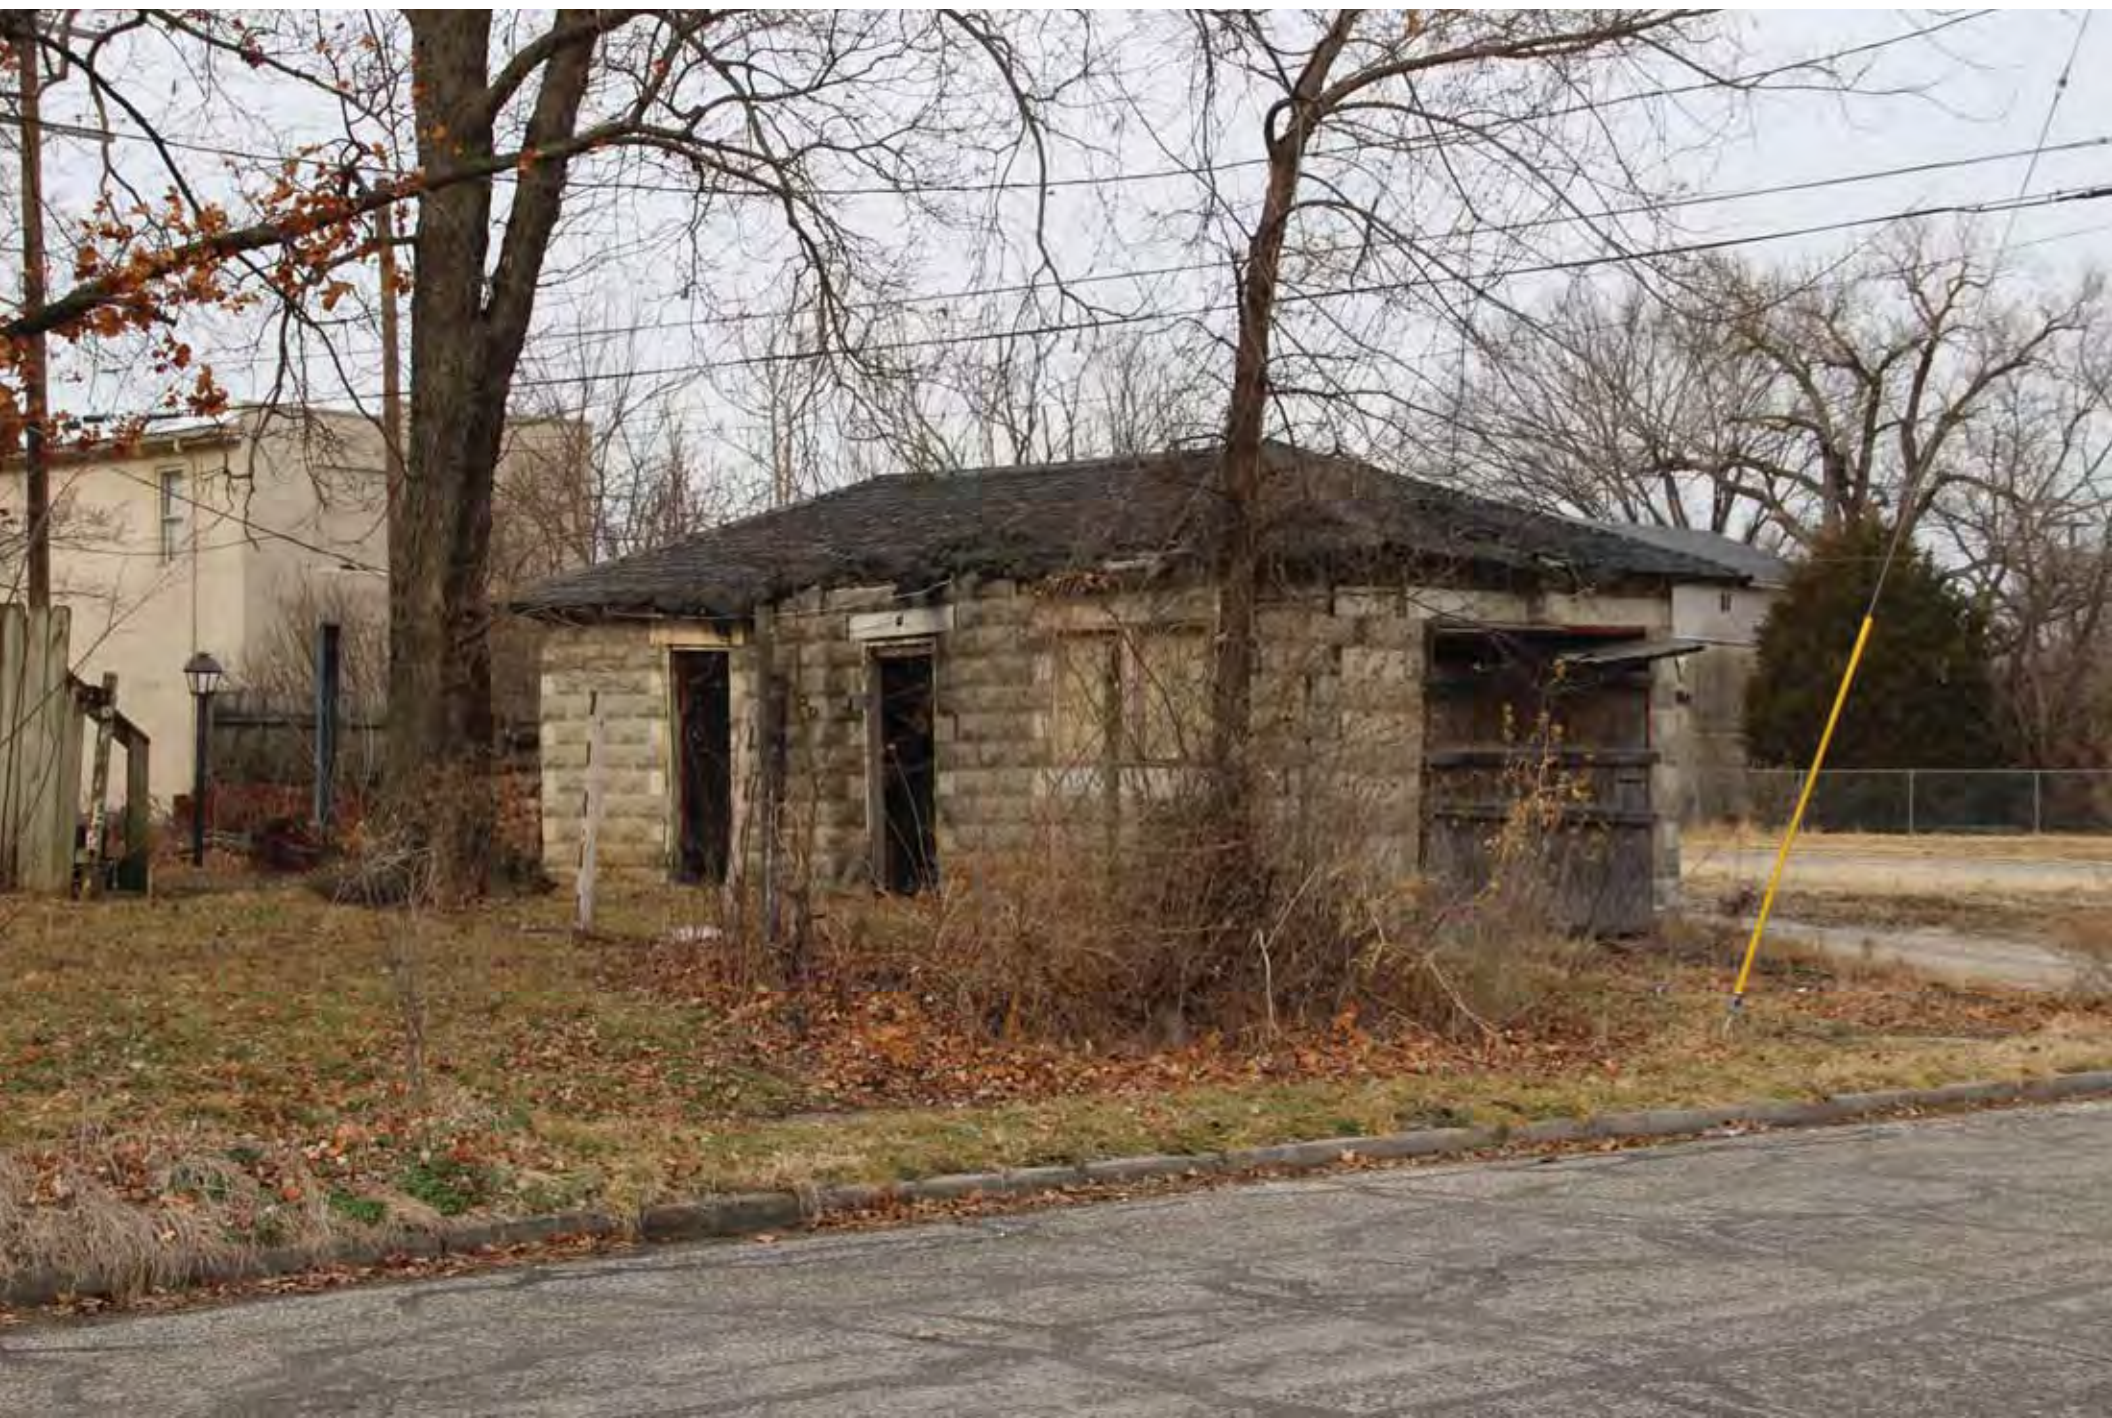
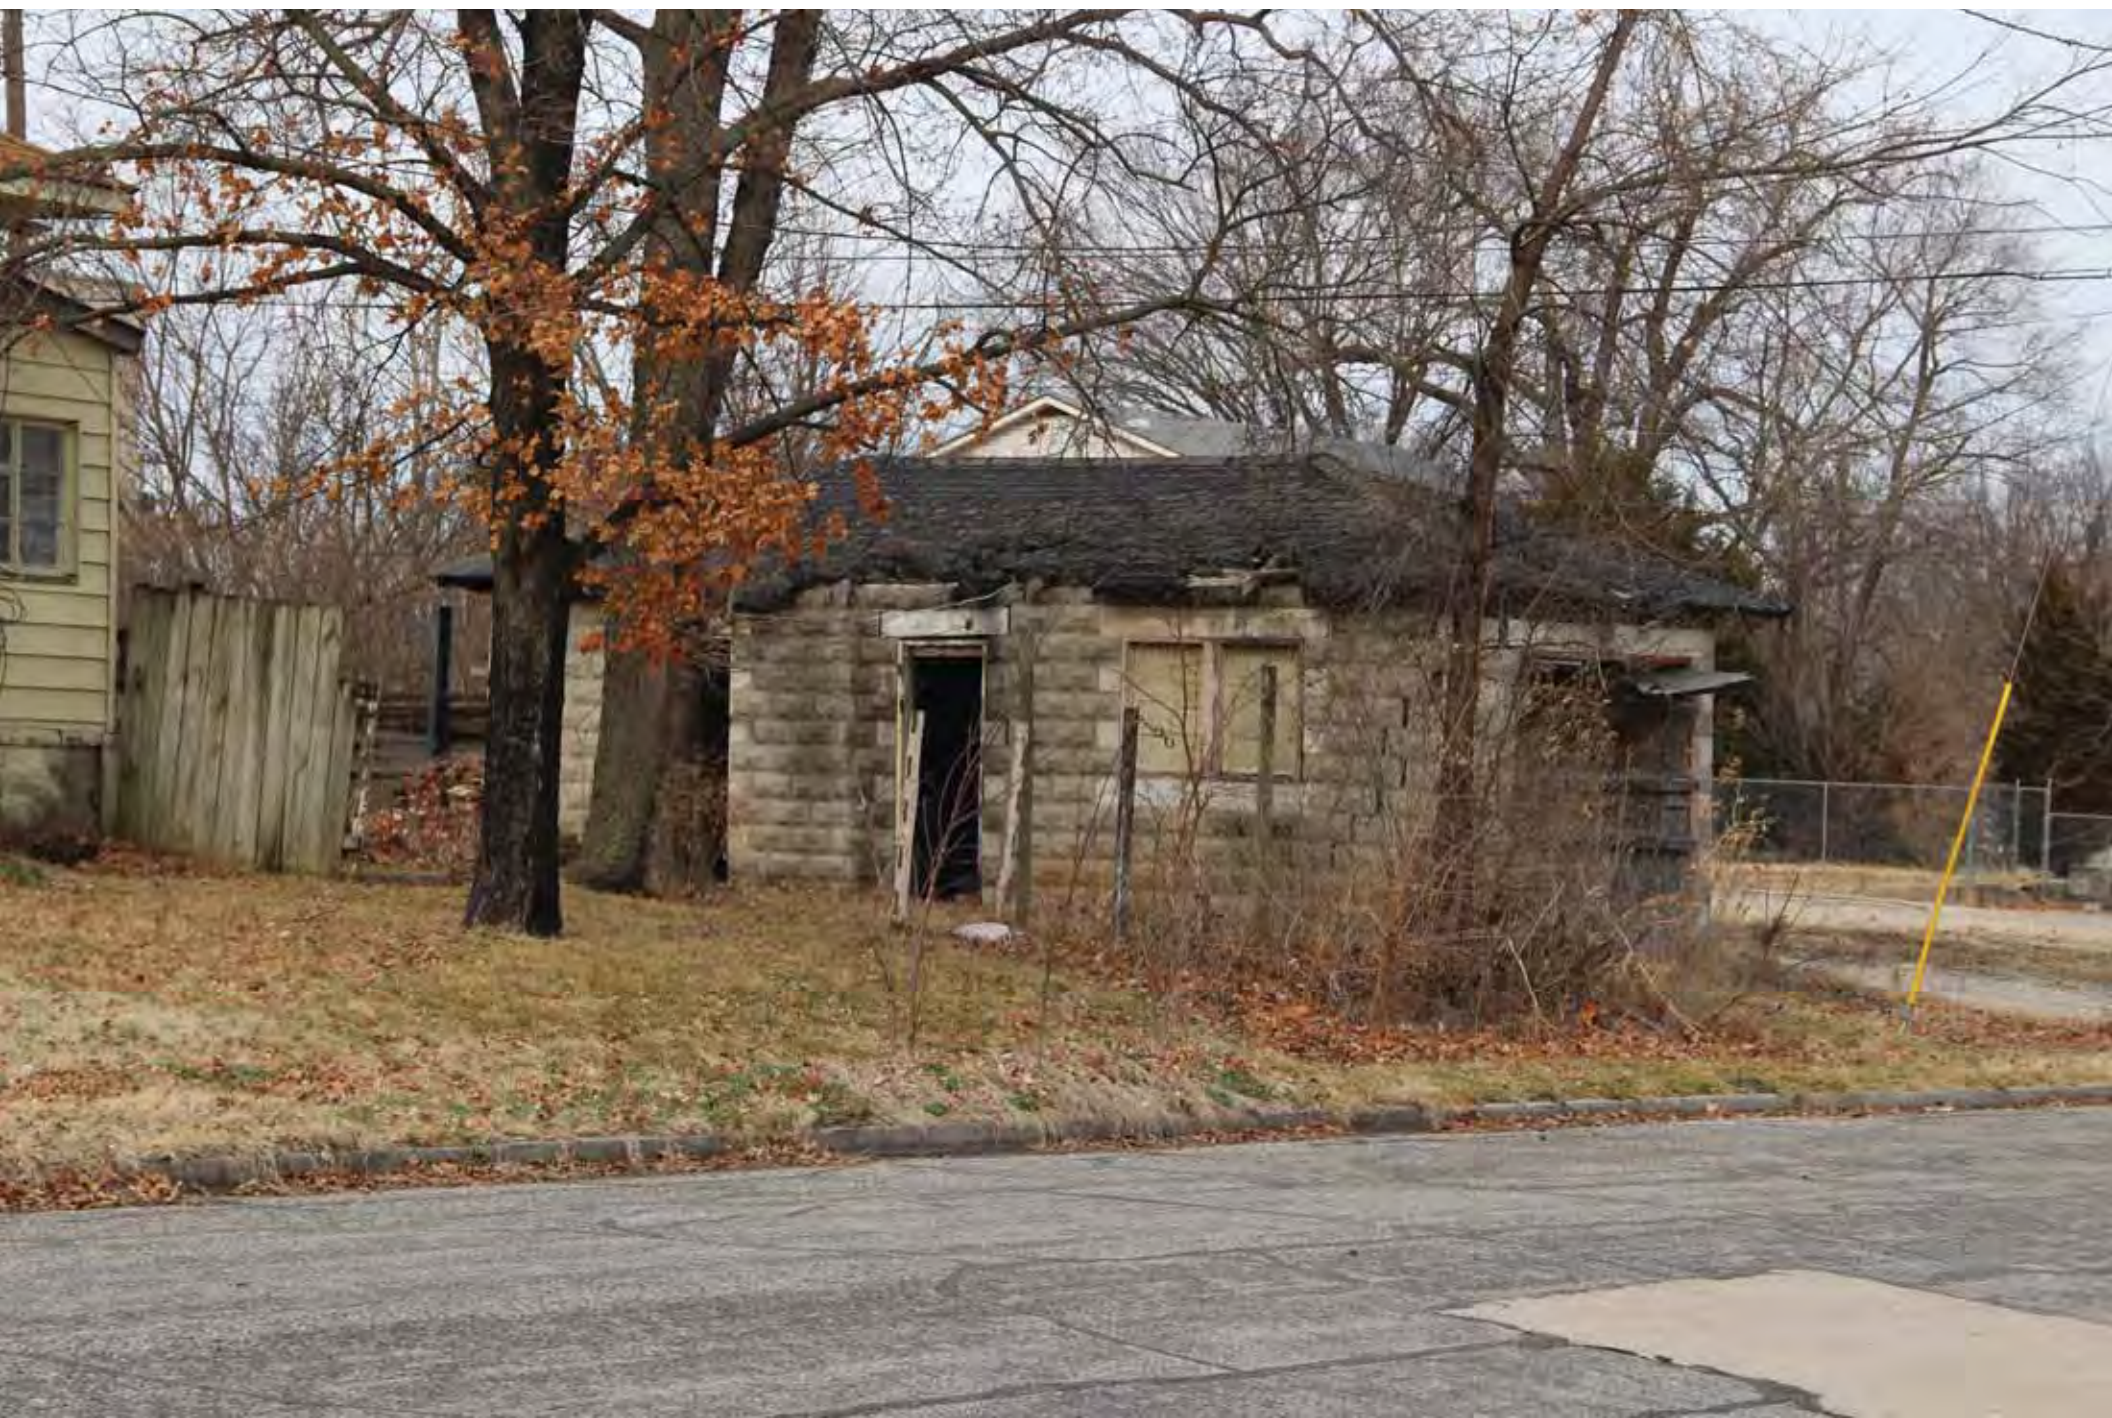
The property at 621 Central street is a one-story frame house, with low-pitched hipped covered in asphalt siding. The front façade has an attached open porch, also with a hipped roof. It has round wood columns that sit on a limestone porch, which wraps around the east side elevation. The limestone extends to the banisters of the stairs, which lead to the front porch, and to the exterior chimney on the front façade. To the left of the front entrance is a bay window, with three six-over-one windows. These windows may be original but details are obscured by storm windows. To the right of the front porch and the stone chimney are two small single paned windows. There are four single windows on the west elevation of the home. On the west elevation there is also another bay window, with three multi-paned windows. There is another stone chimney at the rear of the house. There is also a small shed-roofed addition at the rear of the home.

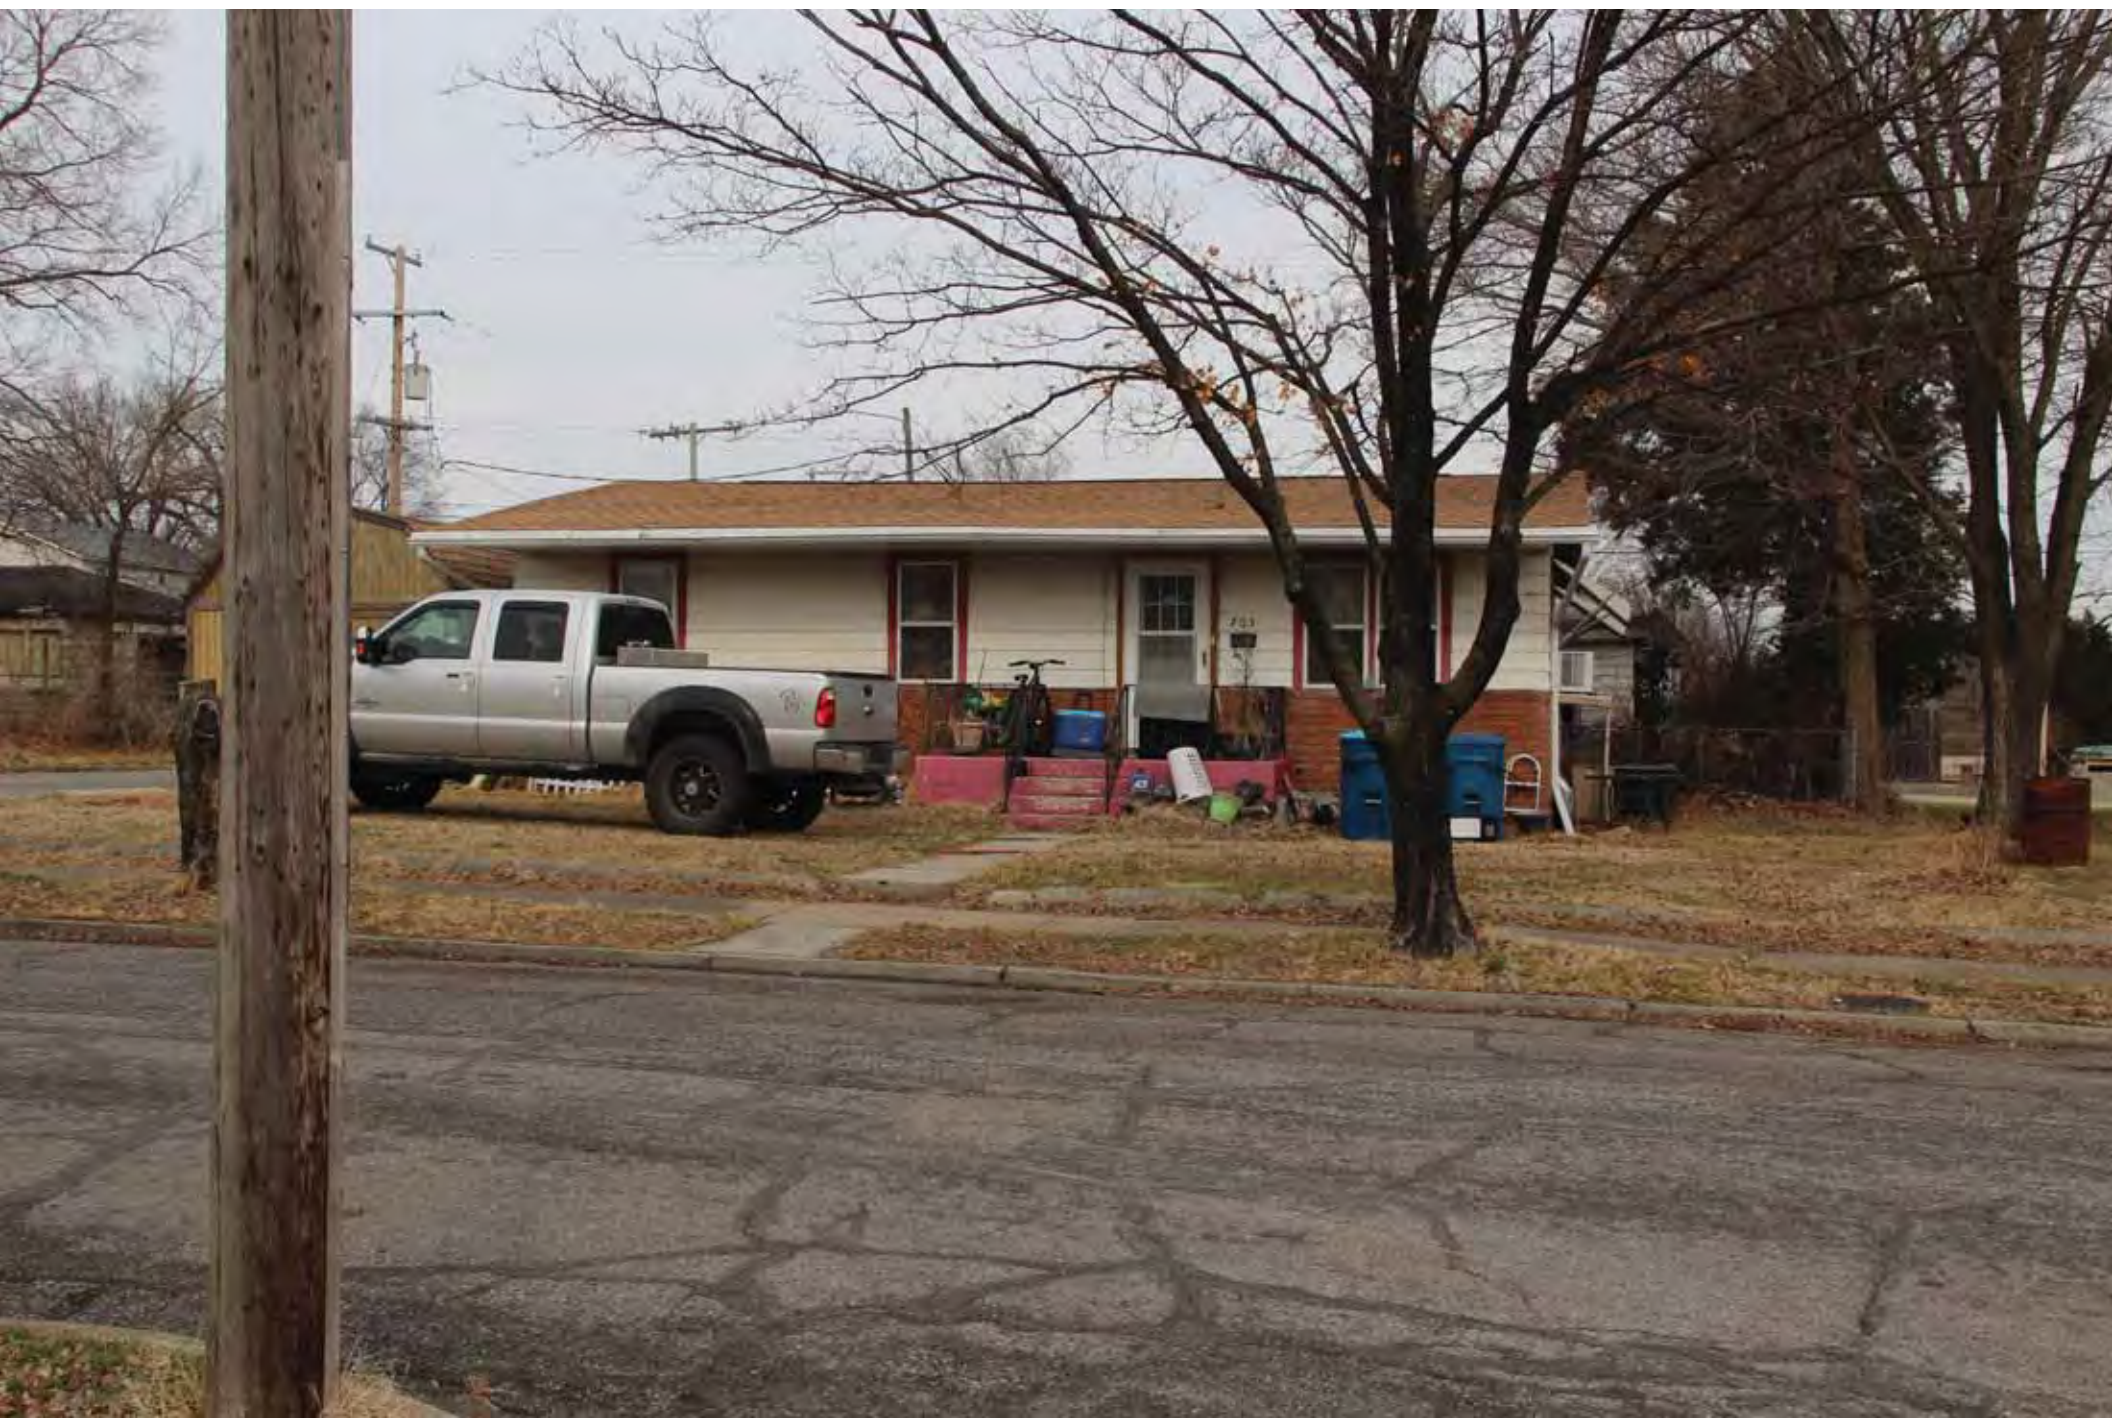
<p>41. (cont.) Description of primary resource. Expand box as necessary, or add continuation pages.</p> <p>The property at 703 Central street is a one-story ranch house, with a side gable roof covered in asphalt siding. On the front façade, or south elevation of the house, is a front door, slightly to the right of center. There is a concrete foundation front porch in front of the door. The porch does not have a roof. To the right of the door are double one-over-one windows. To the left, or west of the front door, are two single one-over-one vinyl windows. The exterior of the house is covered in hardboard. Below the front windows the house is covered in a brick veneer.</p>
