MISSOURI DEPARTMENT OF NATURAL RESOURCES
STATE HISTORIC PRESERVATION OFFICE, P.O. Box 176, Jefferson City, MO 65102
ARCHITECTURAL/HISTORIC INVENTORY FORM

1. Survey No. JP-AS-007-001		2. Survey name: East Town (Original Joplin) Historic Survey Phase 2	
3. County: JASPER		4. Address (Street No.) 618	Street (name) E. 2 nd Street
5. City: Joplin	Vicinity: <input type="checkbox"/>	6. Geographical Reference:	7. Township/Range/Section: T: R: S:
8. Historic name (if known):		9. Present/other name (if known):	
10. Ownership: <input checked="" type="checkbox"/> Private <input type="checkbox"/> Public		11a. Historic use (if known): Domestic: Single Dwelling	11b. Current use: Domestic: Single Dwelling

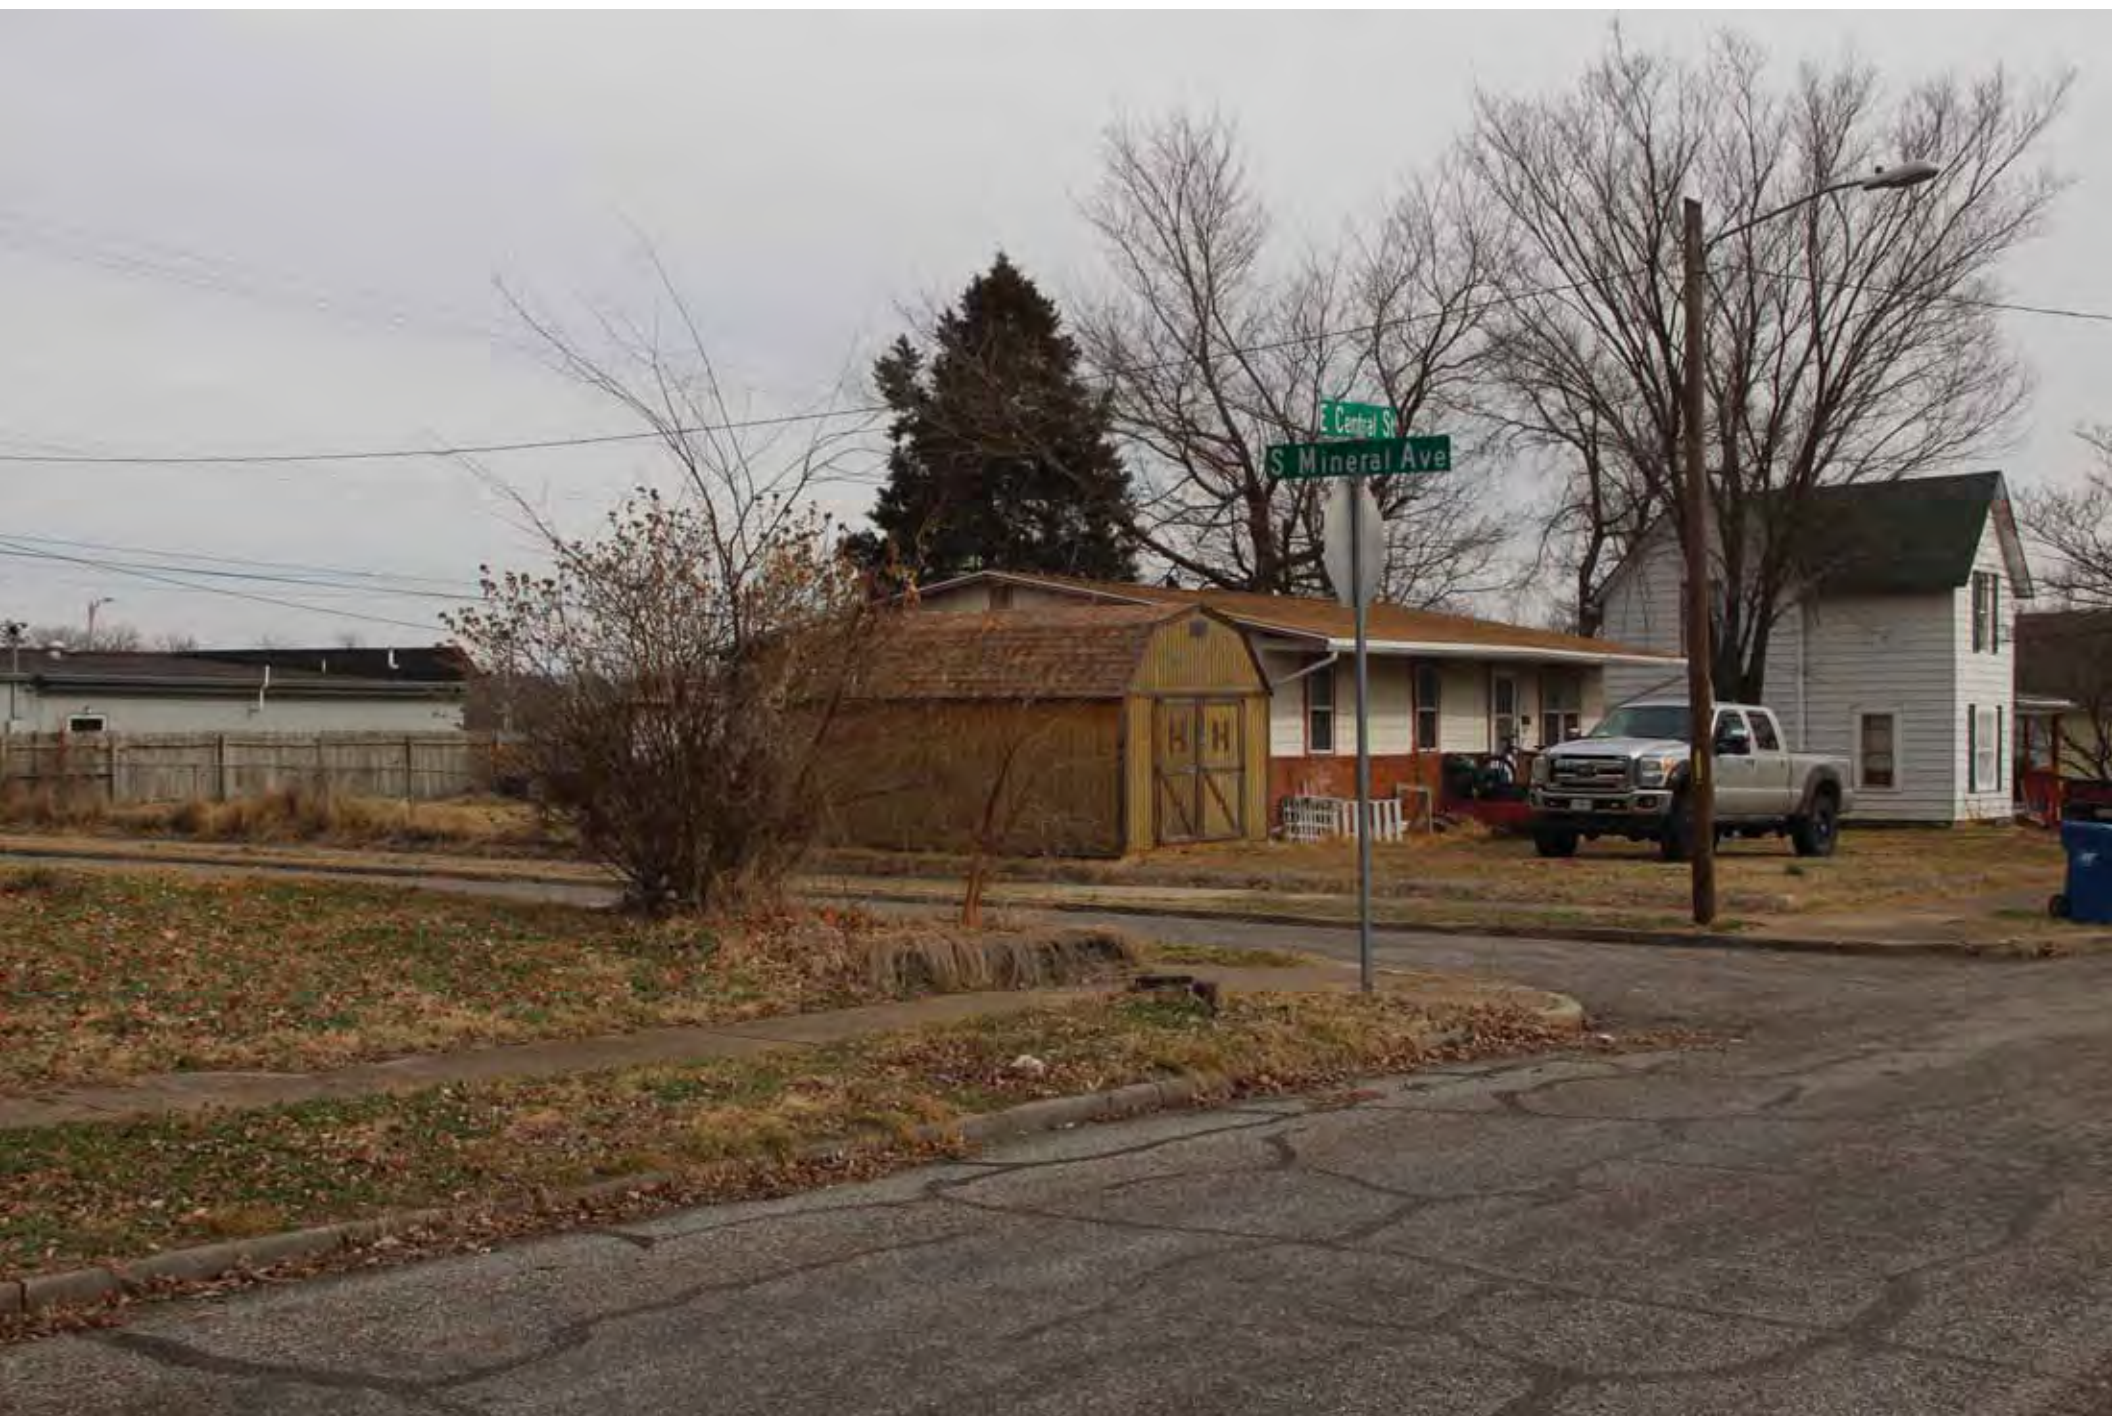
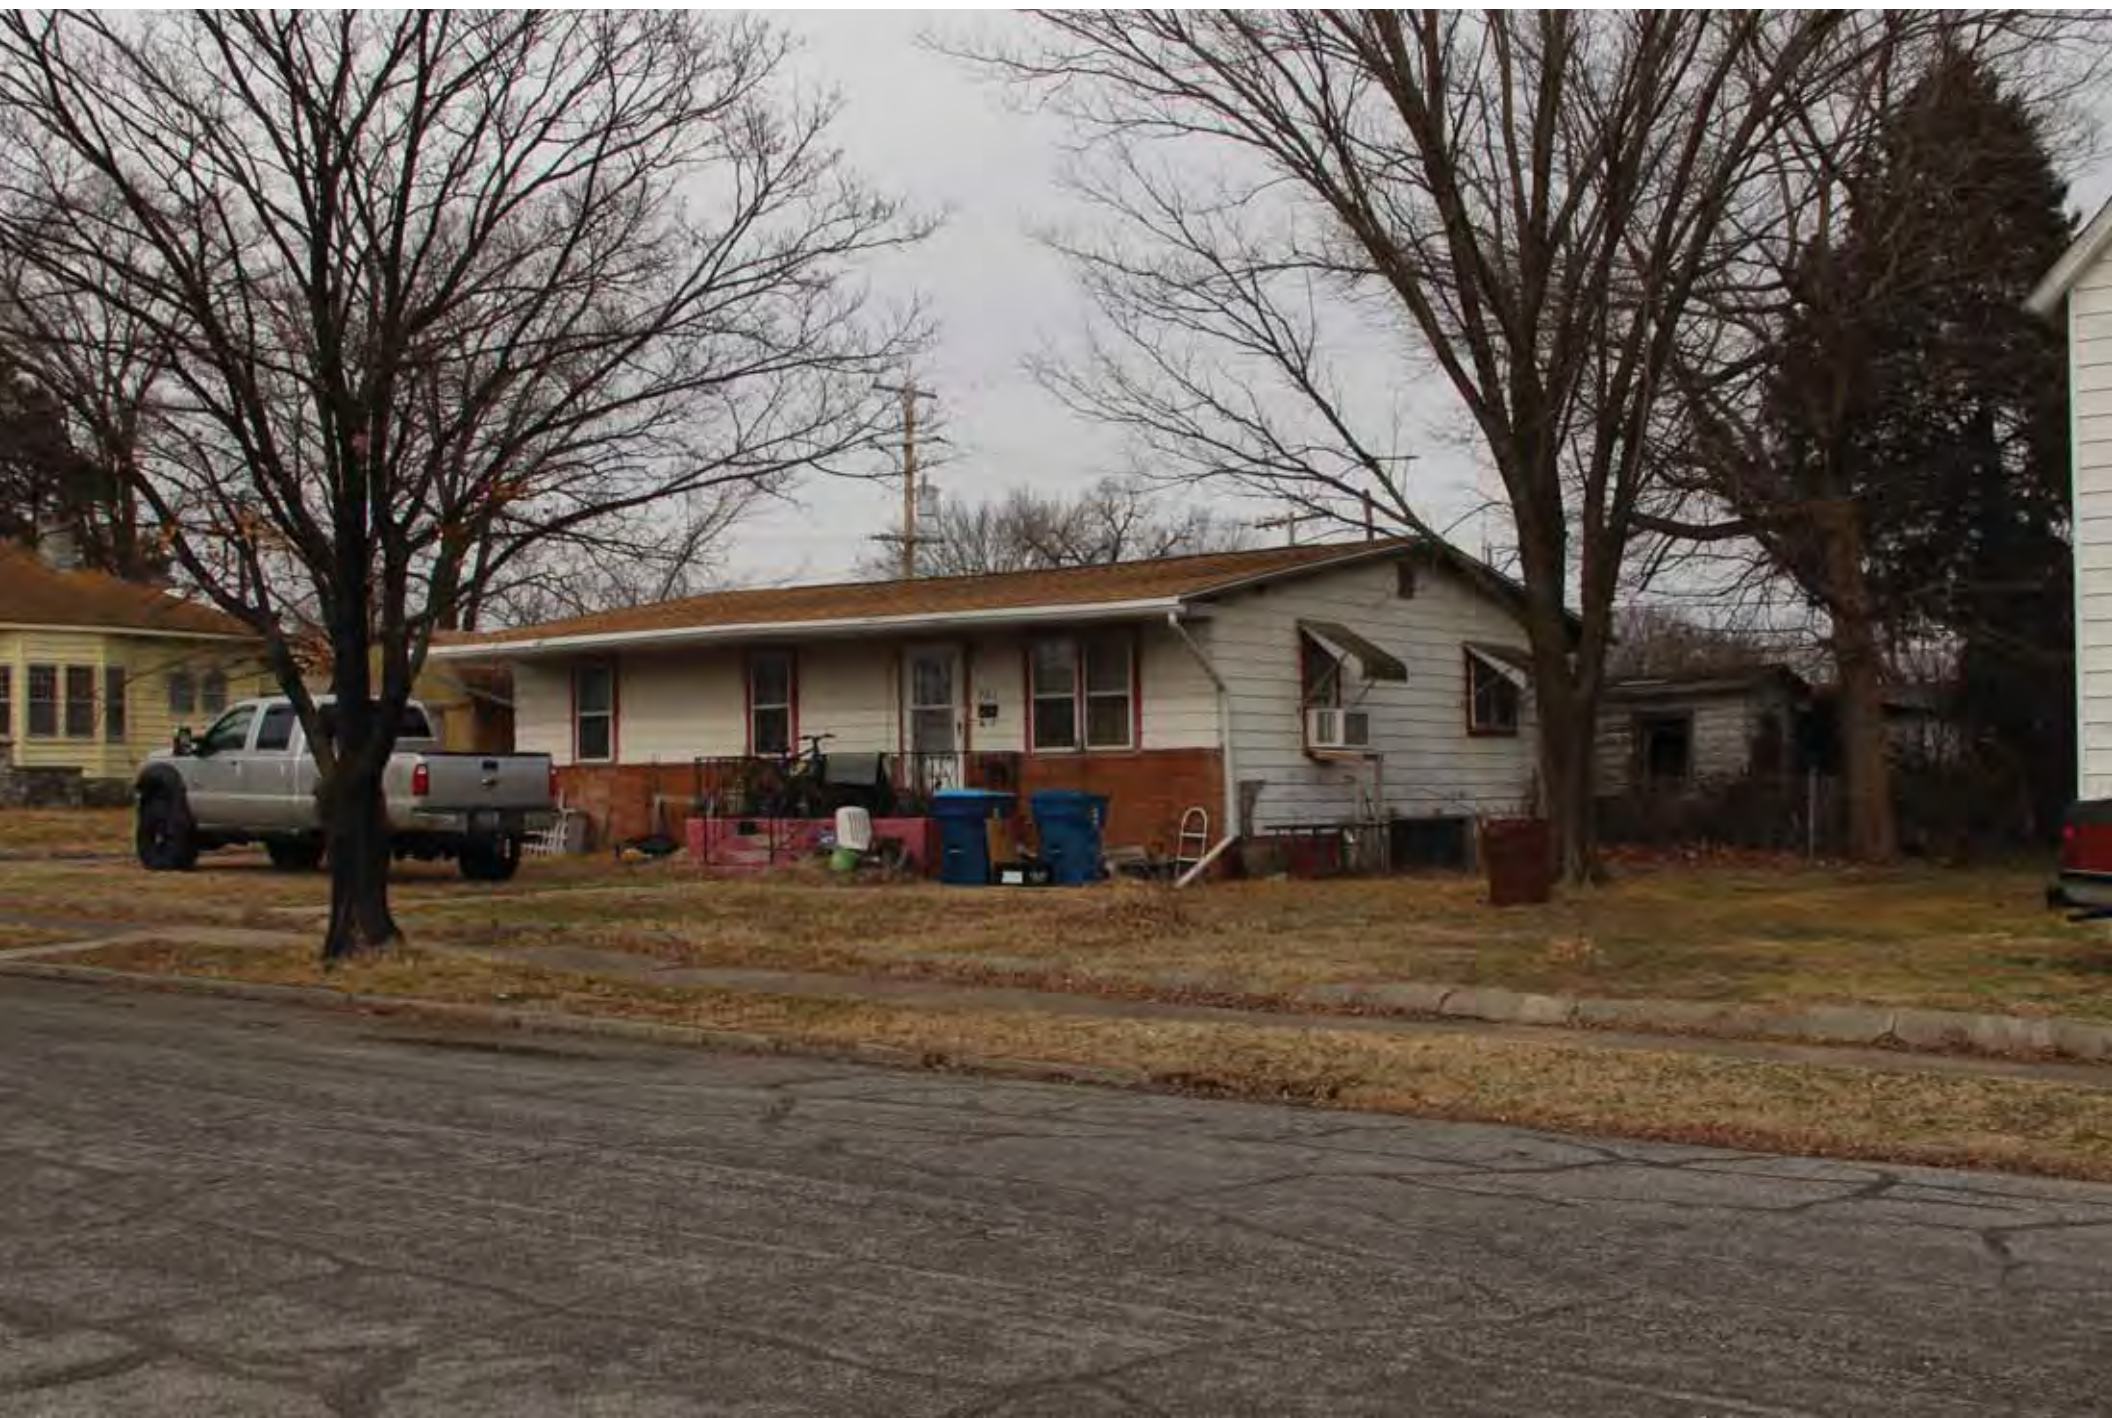
<p>41. (cont.) Description of primary resource. Expand box as necessary, or add continuation pages.</p> <p>The property at 703 Central street is a one-story ranch house, with a side gable roof covered in asphalt siding. On the front façade, or south elevation of the house, is a front door, slightly to the right of center. There is a concrete foundation front porch in front of the door. The porch does not have a roof. To the right of the door are double one-over-one windows. To the left, or west of the front door, are two single one-over-one vinyl windows. The exterior of the house is covered in hardboard. Below the front windows the house is covered in a brick veneer.</p>

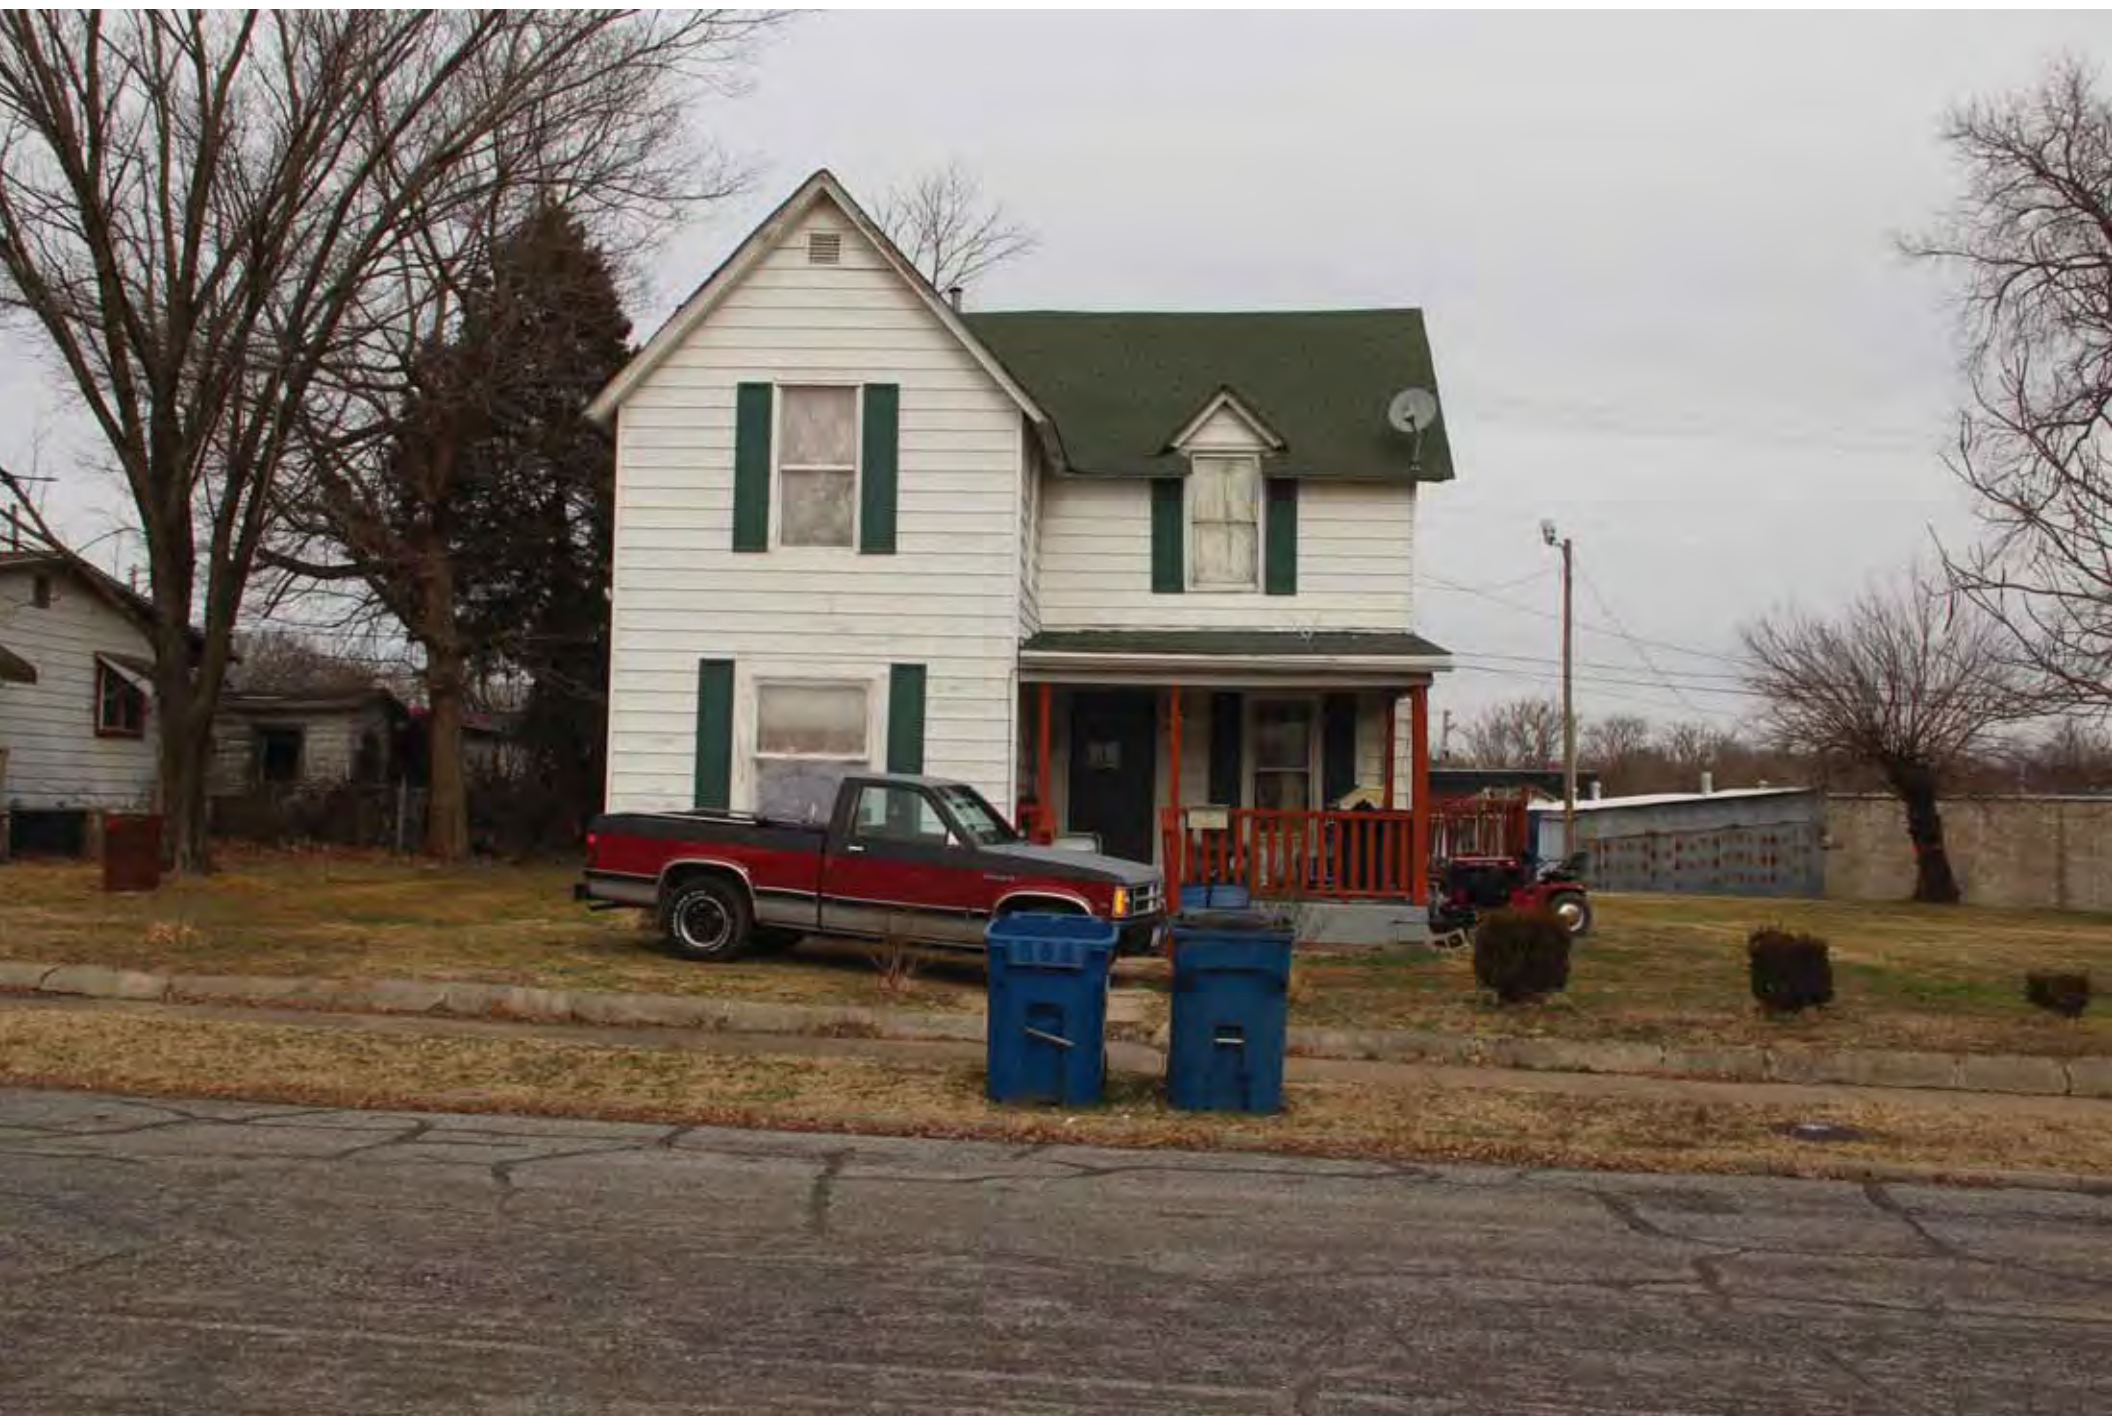
The property at 707 Central Street is a two-story frame dwelling. The entire house is covered in vinyl siding. It has a high-pitched cross-gabled roof, with a front facing gable on the front elevation. The front entrance is on the east side of the front façade of the house, along the side-gable section of the home. A shed roof front porch shelters the front entrance. The porch has wooden posts supported on a concrete foundation. Above the porch, at the second floor, is a single one-over-one window below its own gable pediment end dormer, which intersects the side gable of the roof. It has non-functioning shutters. To the right of the porch is a single one-over-one window, also with non-functioning shutters. To the left of the front entrance, and the gable end of the house, is a single one-over-one window with non-functioning shutters. On the second floor, at this gable end, is another smaller one-over-one wood window with non-functioning shutter. There is a one-story addition at the rear of the house, and a small wooden deck.

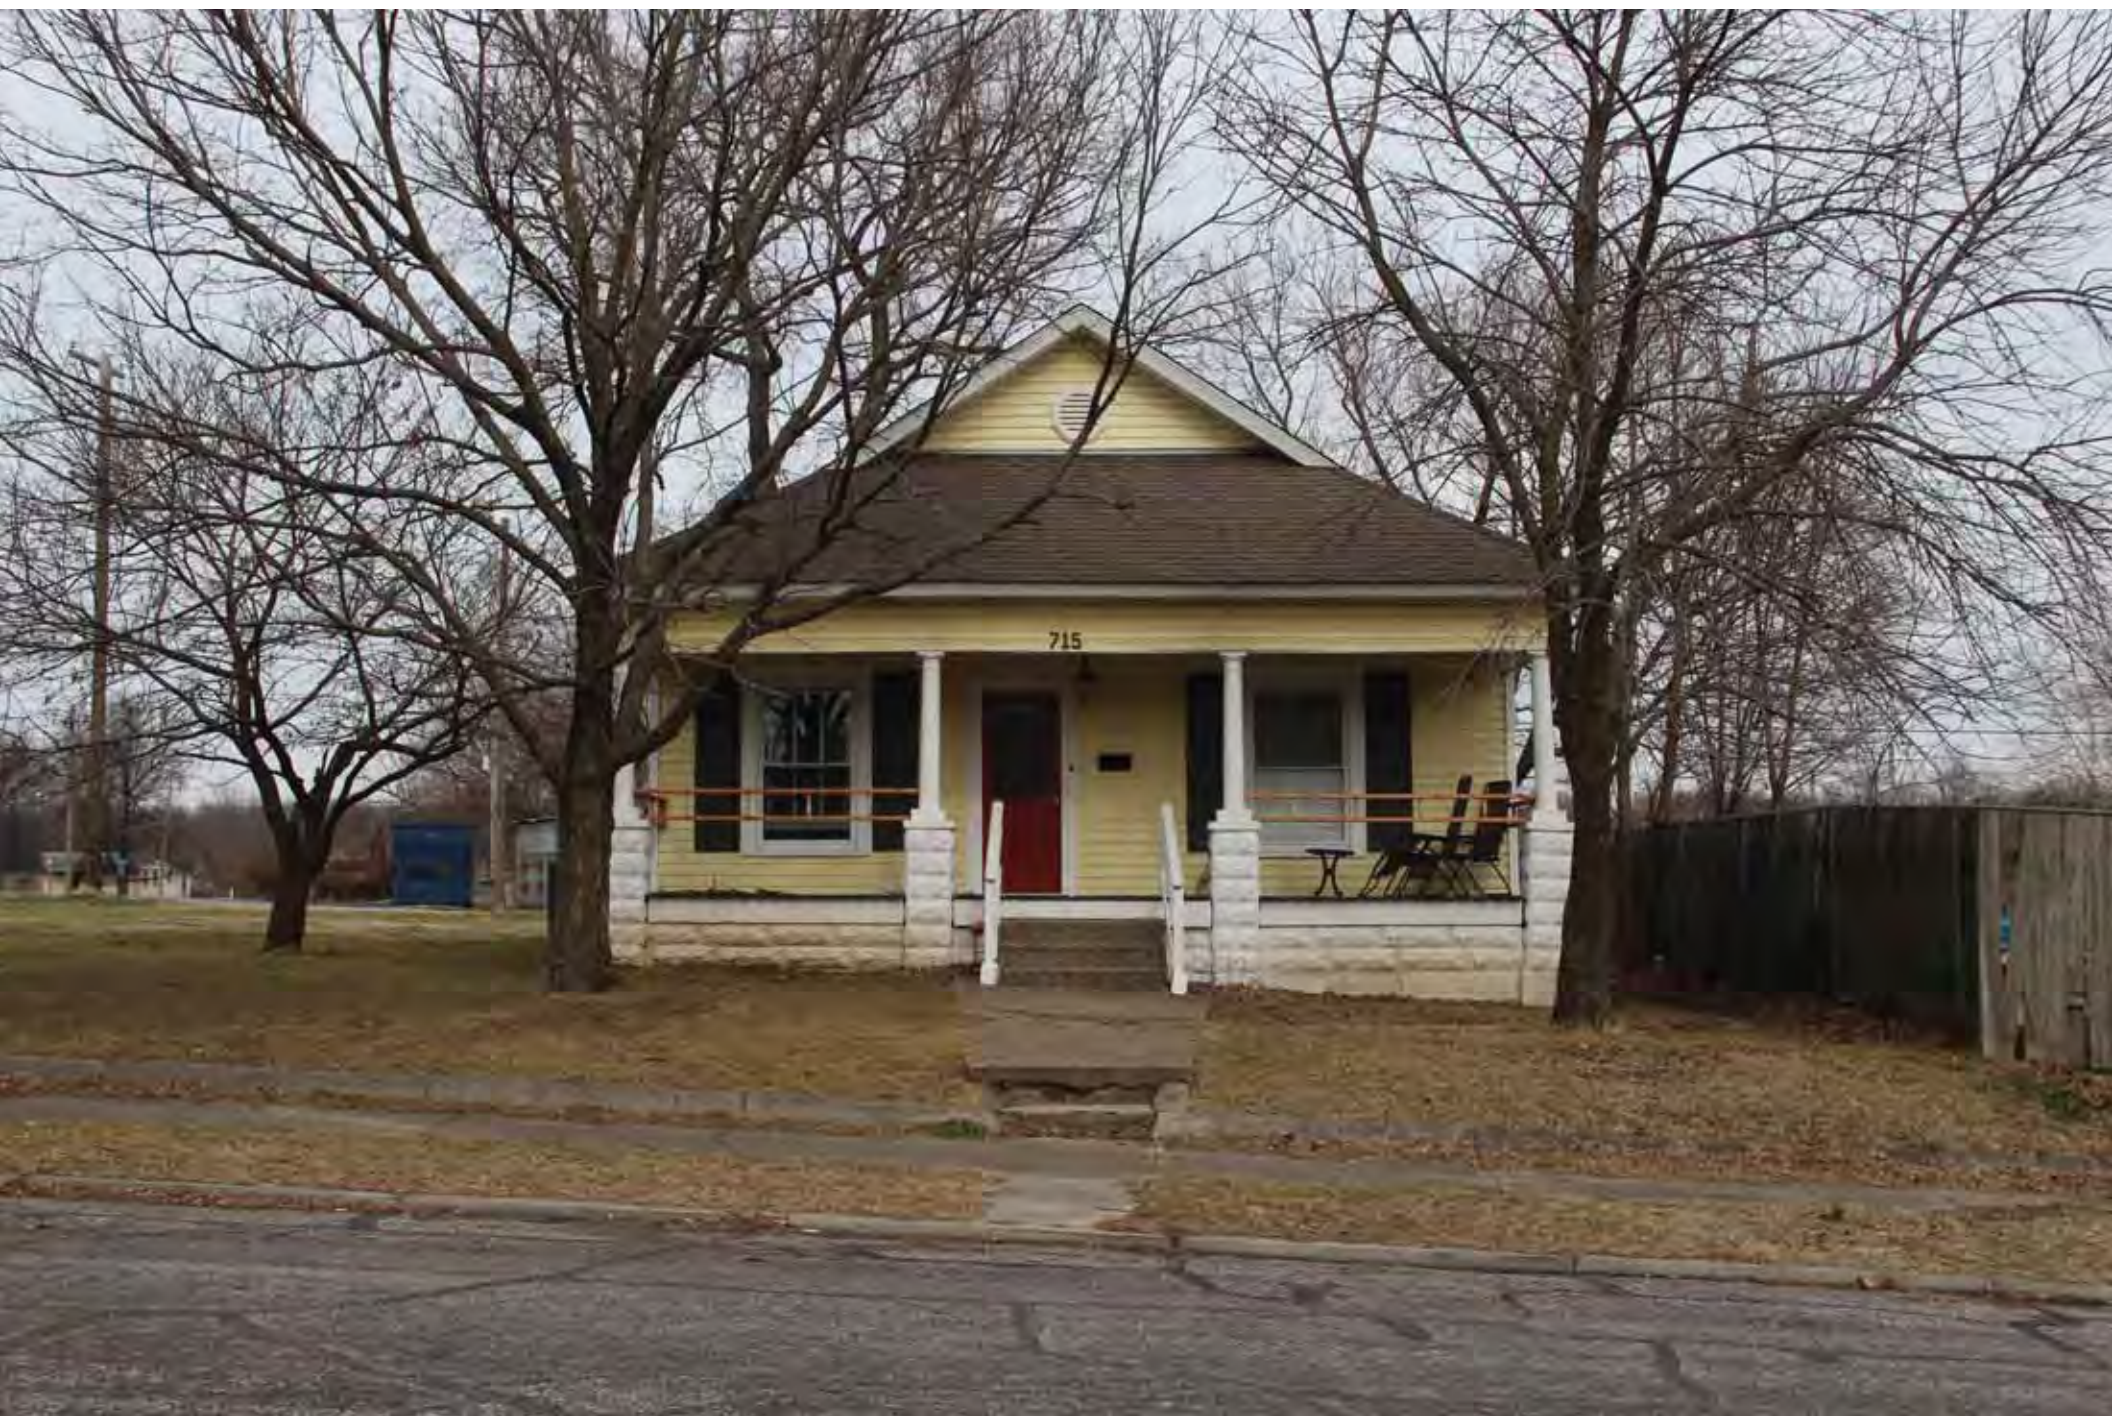
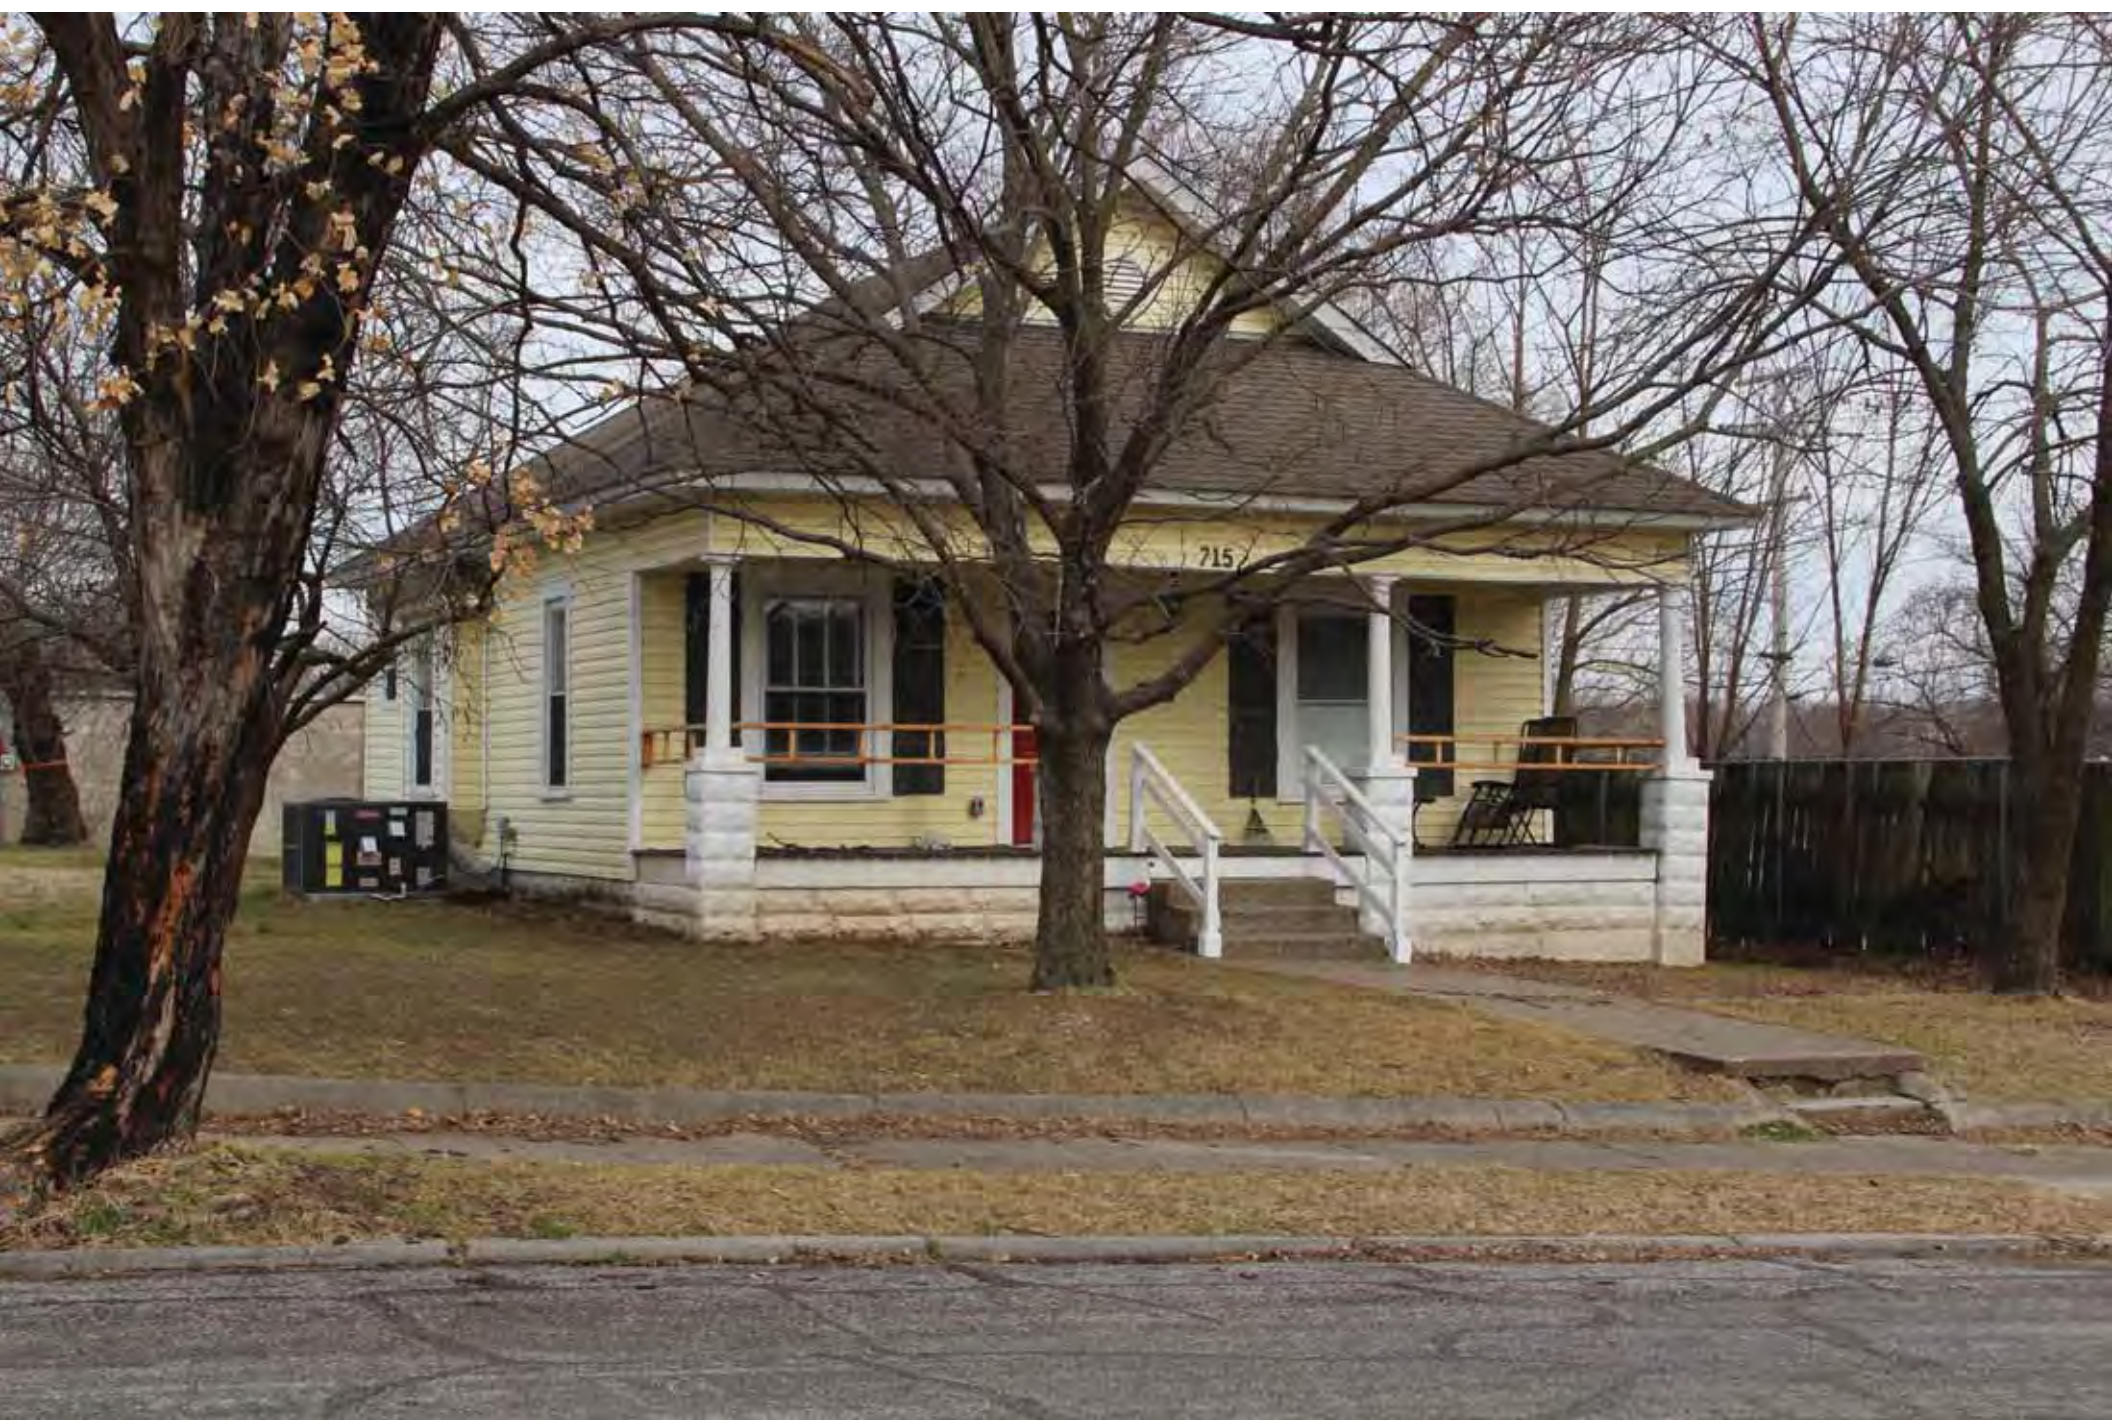
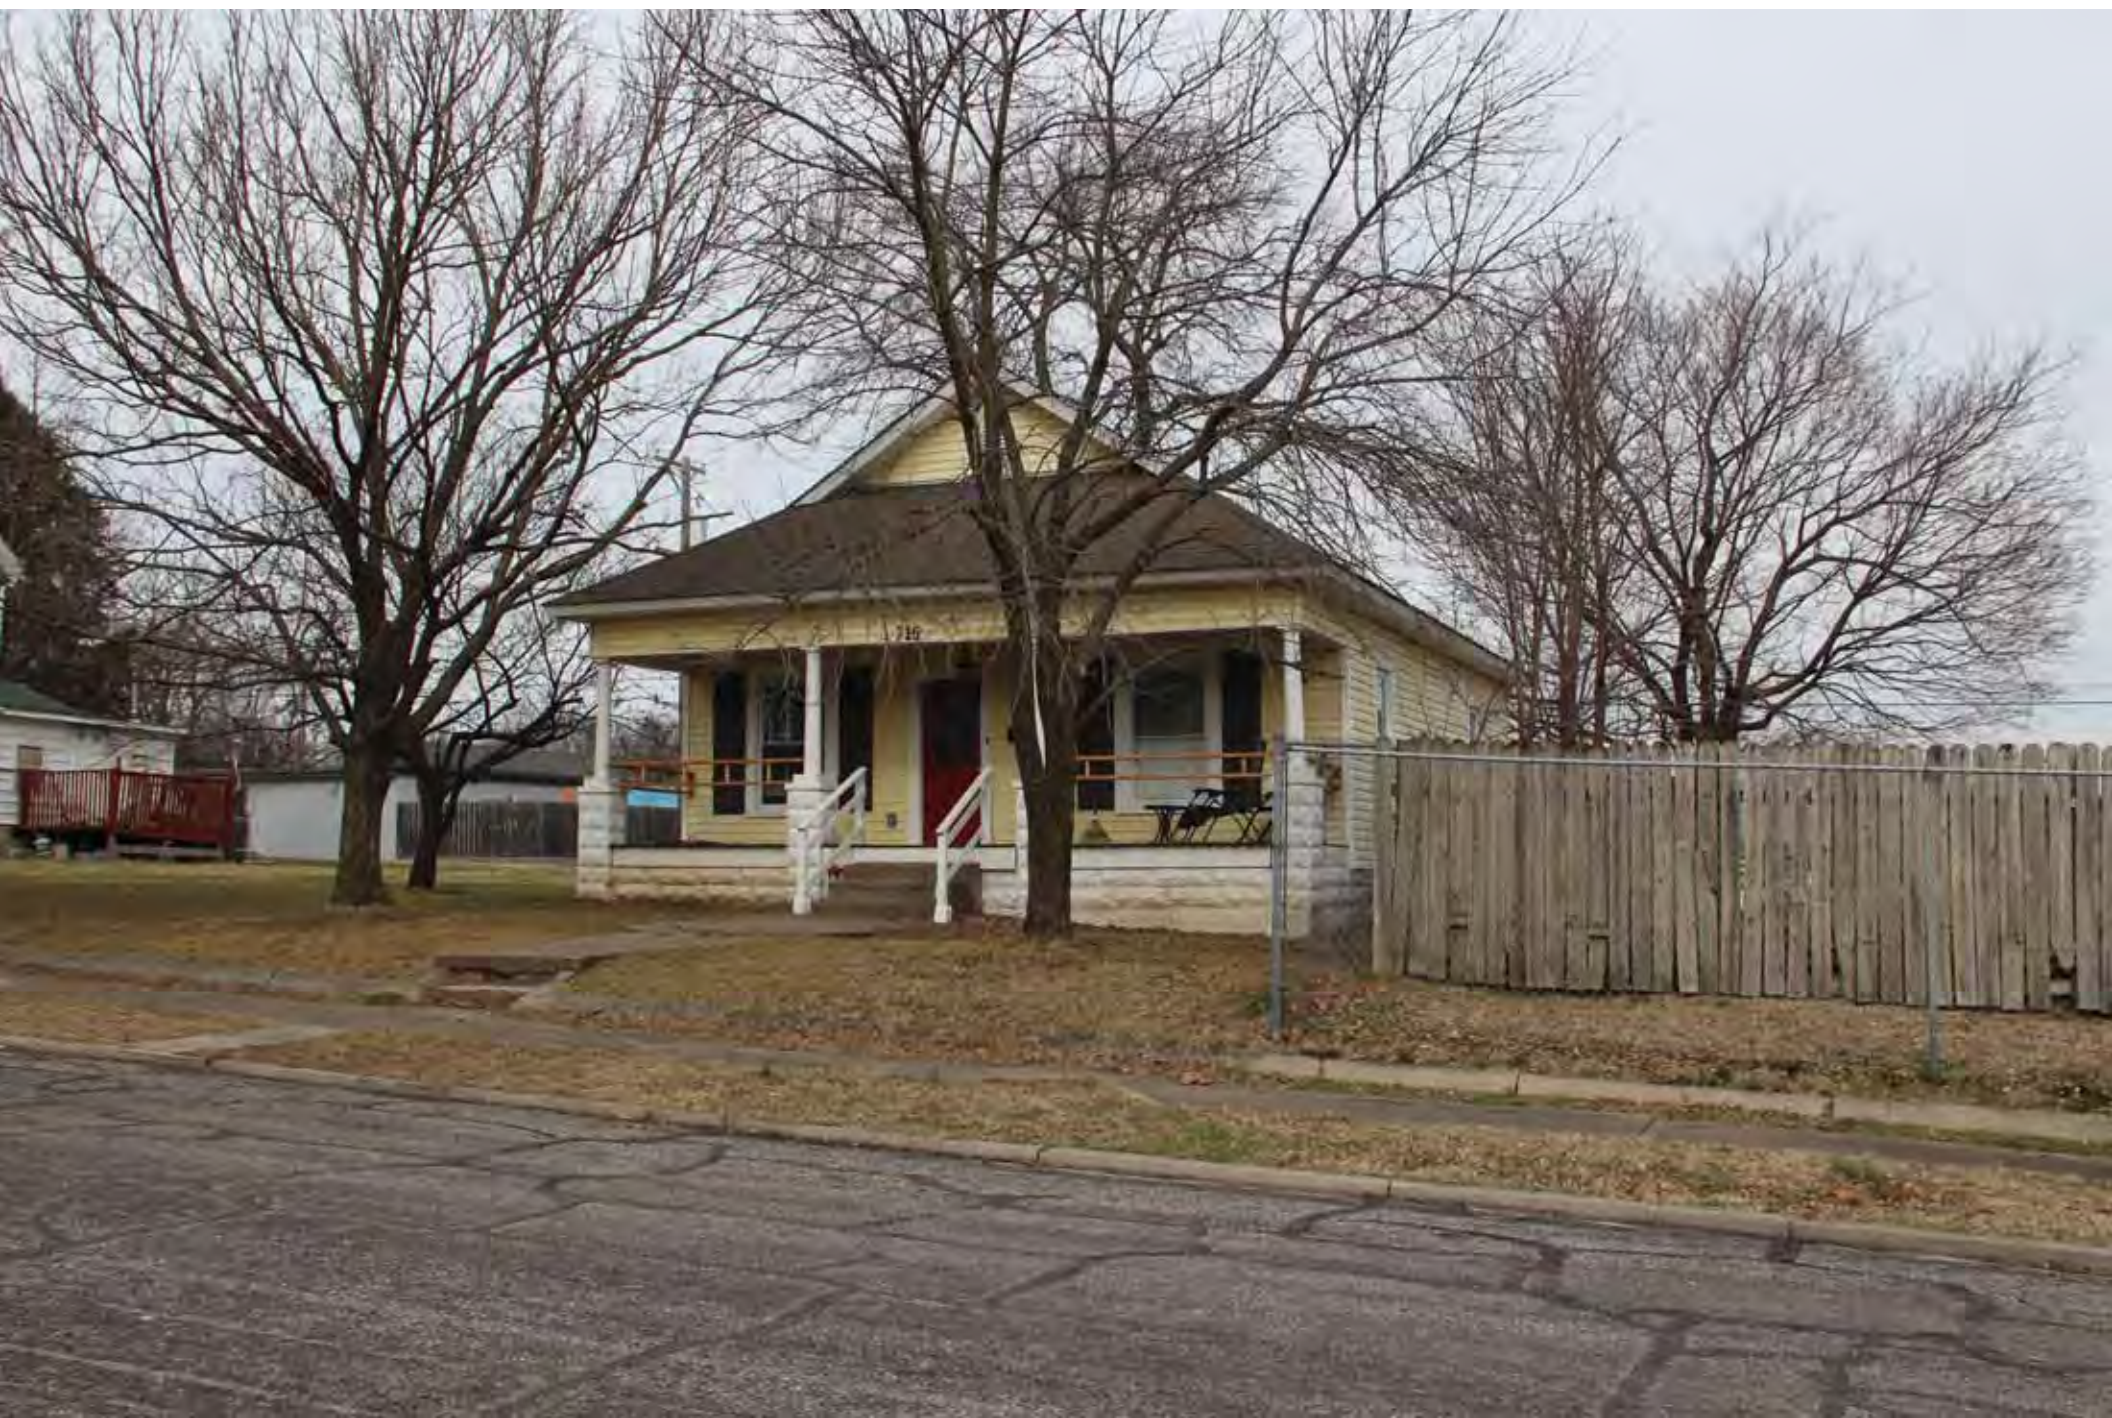
The property at 715 Central street is a one-story frame house, with low-pitched gable-on-hip roof covered in asphalt siding. The front façade has an attached open veranda, beneath the hipped roof. It has round wood columns that sit on a rough-cut concrete block foundation, which has been painted. The porch shelters a single front door, flanked on either side by large single one-over-one windows. Each of the windows have non-functioning shutters. Along the west elevation are three single replacement windows.
