MISSOURI DEPARTMENT OF NATURAL RESOURCES
STATE HISTORIC PRESERVATION OFFICE, P.O. Box 176, Jefferson City, MO 65102
ARCHITECTURAL/HISTORIC INVENTORY FORM

1. Survey No. JP-AS-007-001		2. Survey name: East Town (Original Joplin) Historic Survey Phase 2	
3. County: JASPER		4. Address (Street No.) 618	Street (name) E. 2 nd Street
5. City: Joplin	Vicinity: <input type="checkbox"/>	6. Geographical Reference:	7. Township/Range/Section: T: R: S:
8. Historic name (if known):		9. Present/other name (if known):	
10. Ownership: <input checked="" type="checkbox"/> Private <input type="checkbox"/> Public		11a. Historic use (if known): Domestic: Single Dwelling	11b. Current use: Domestic: Single Dwelling

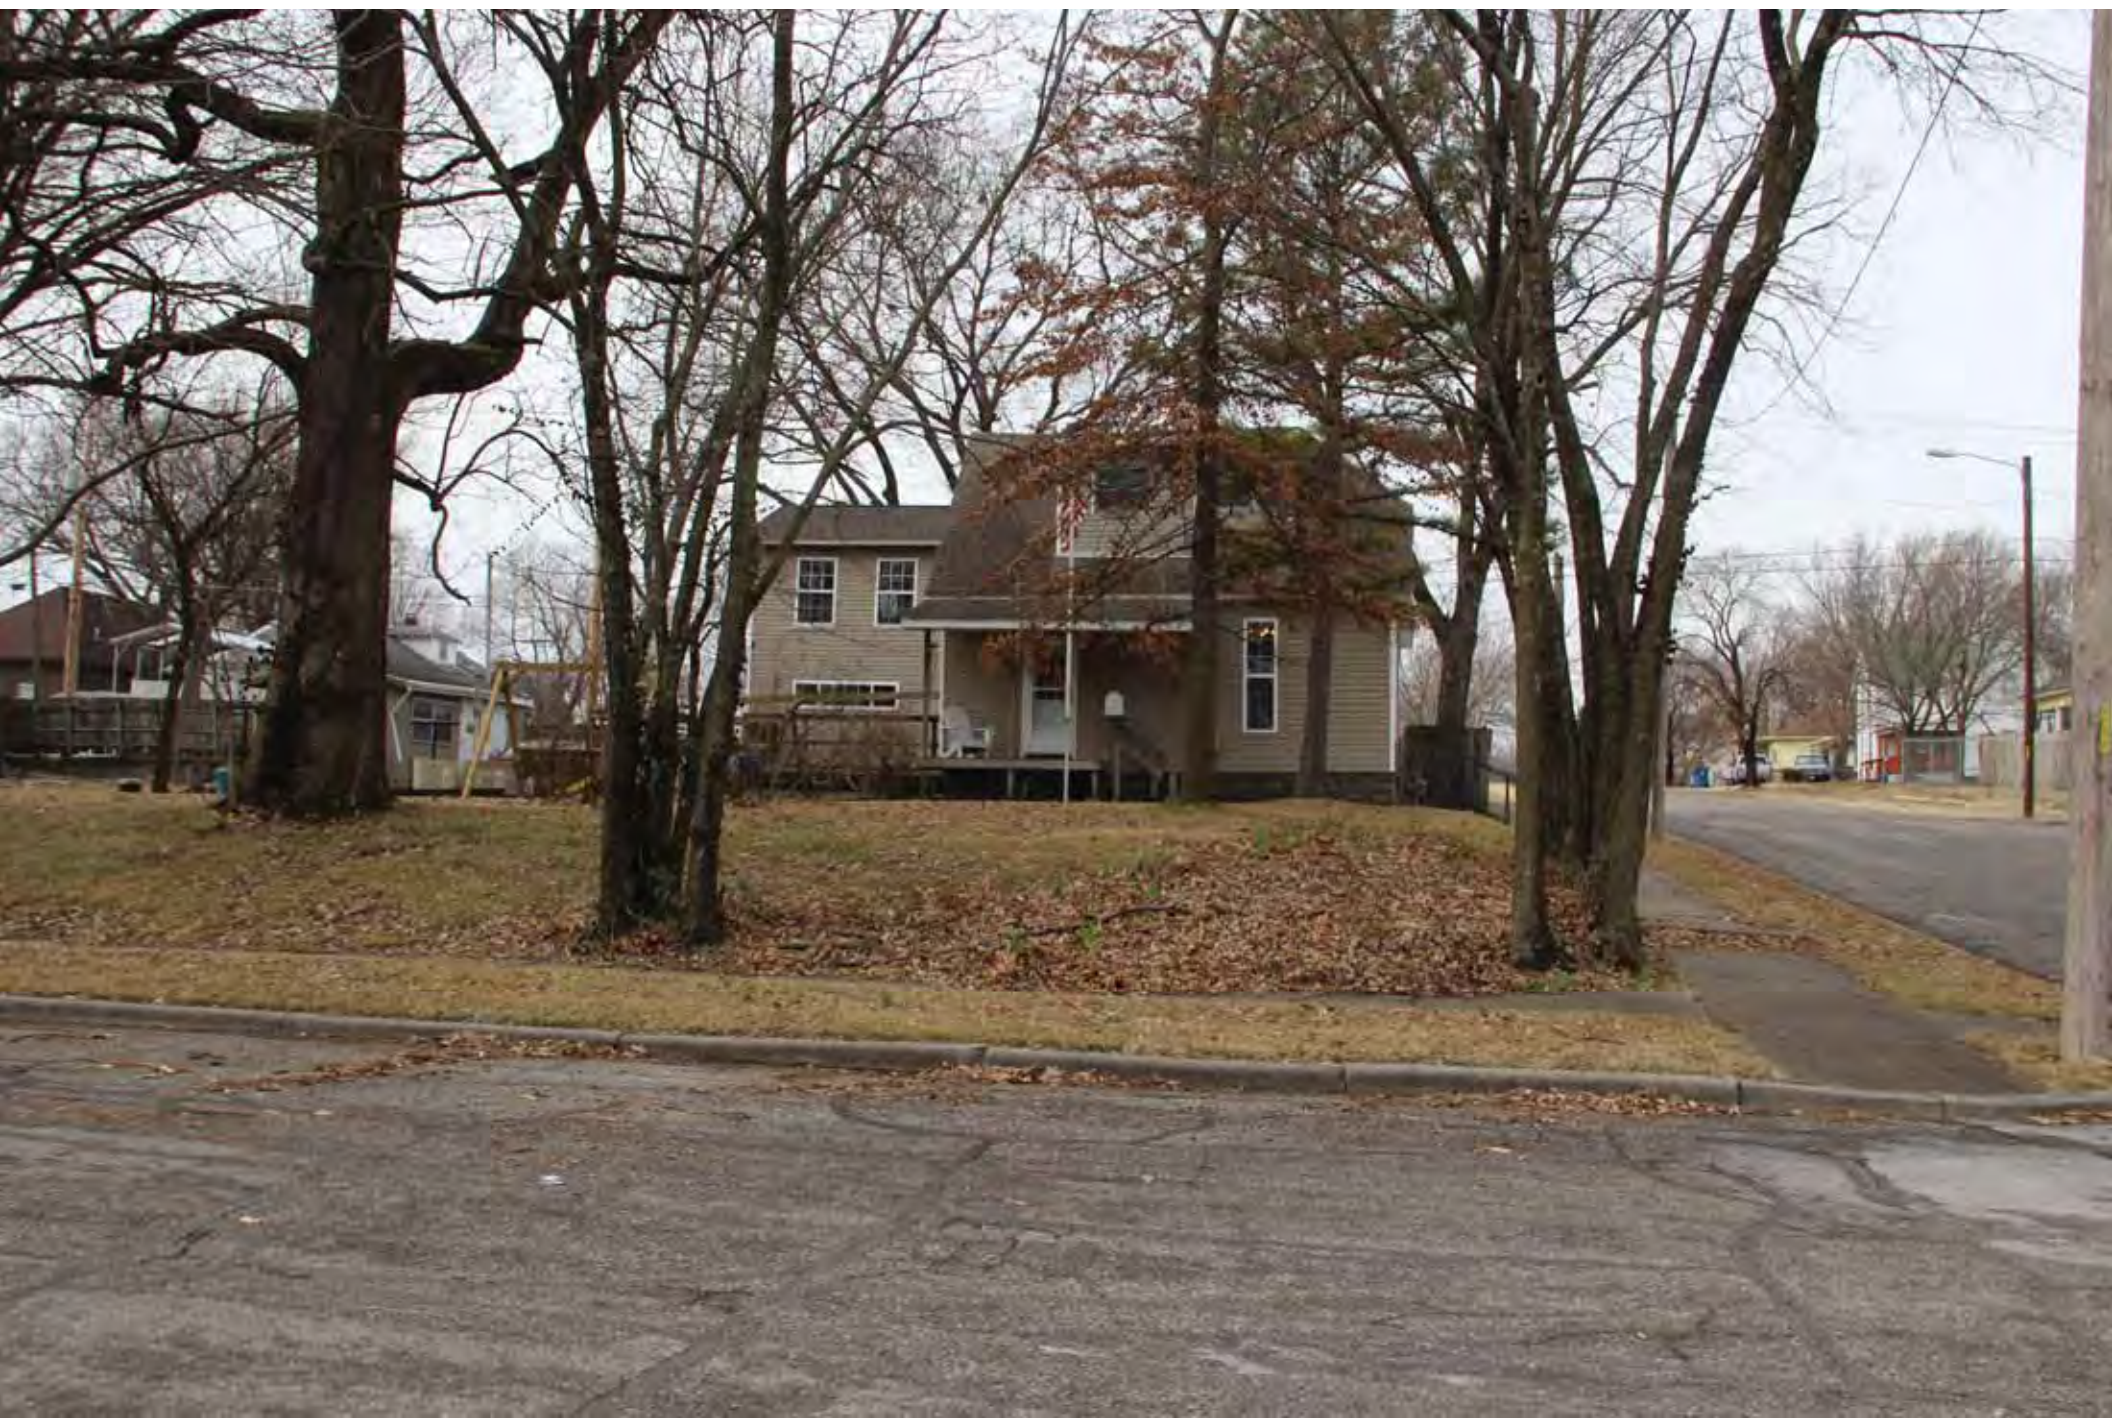
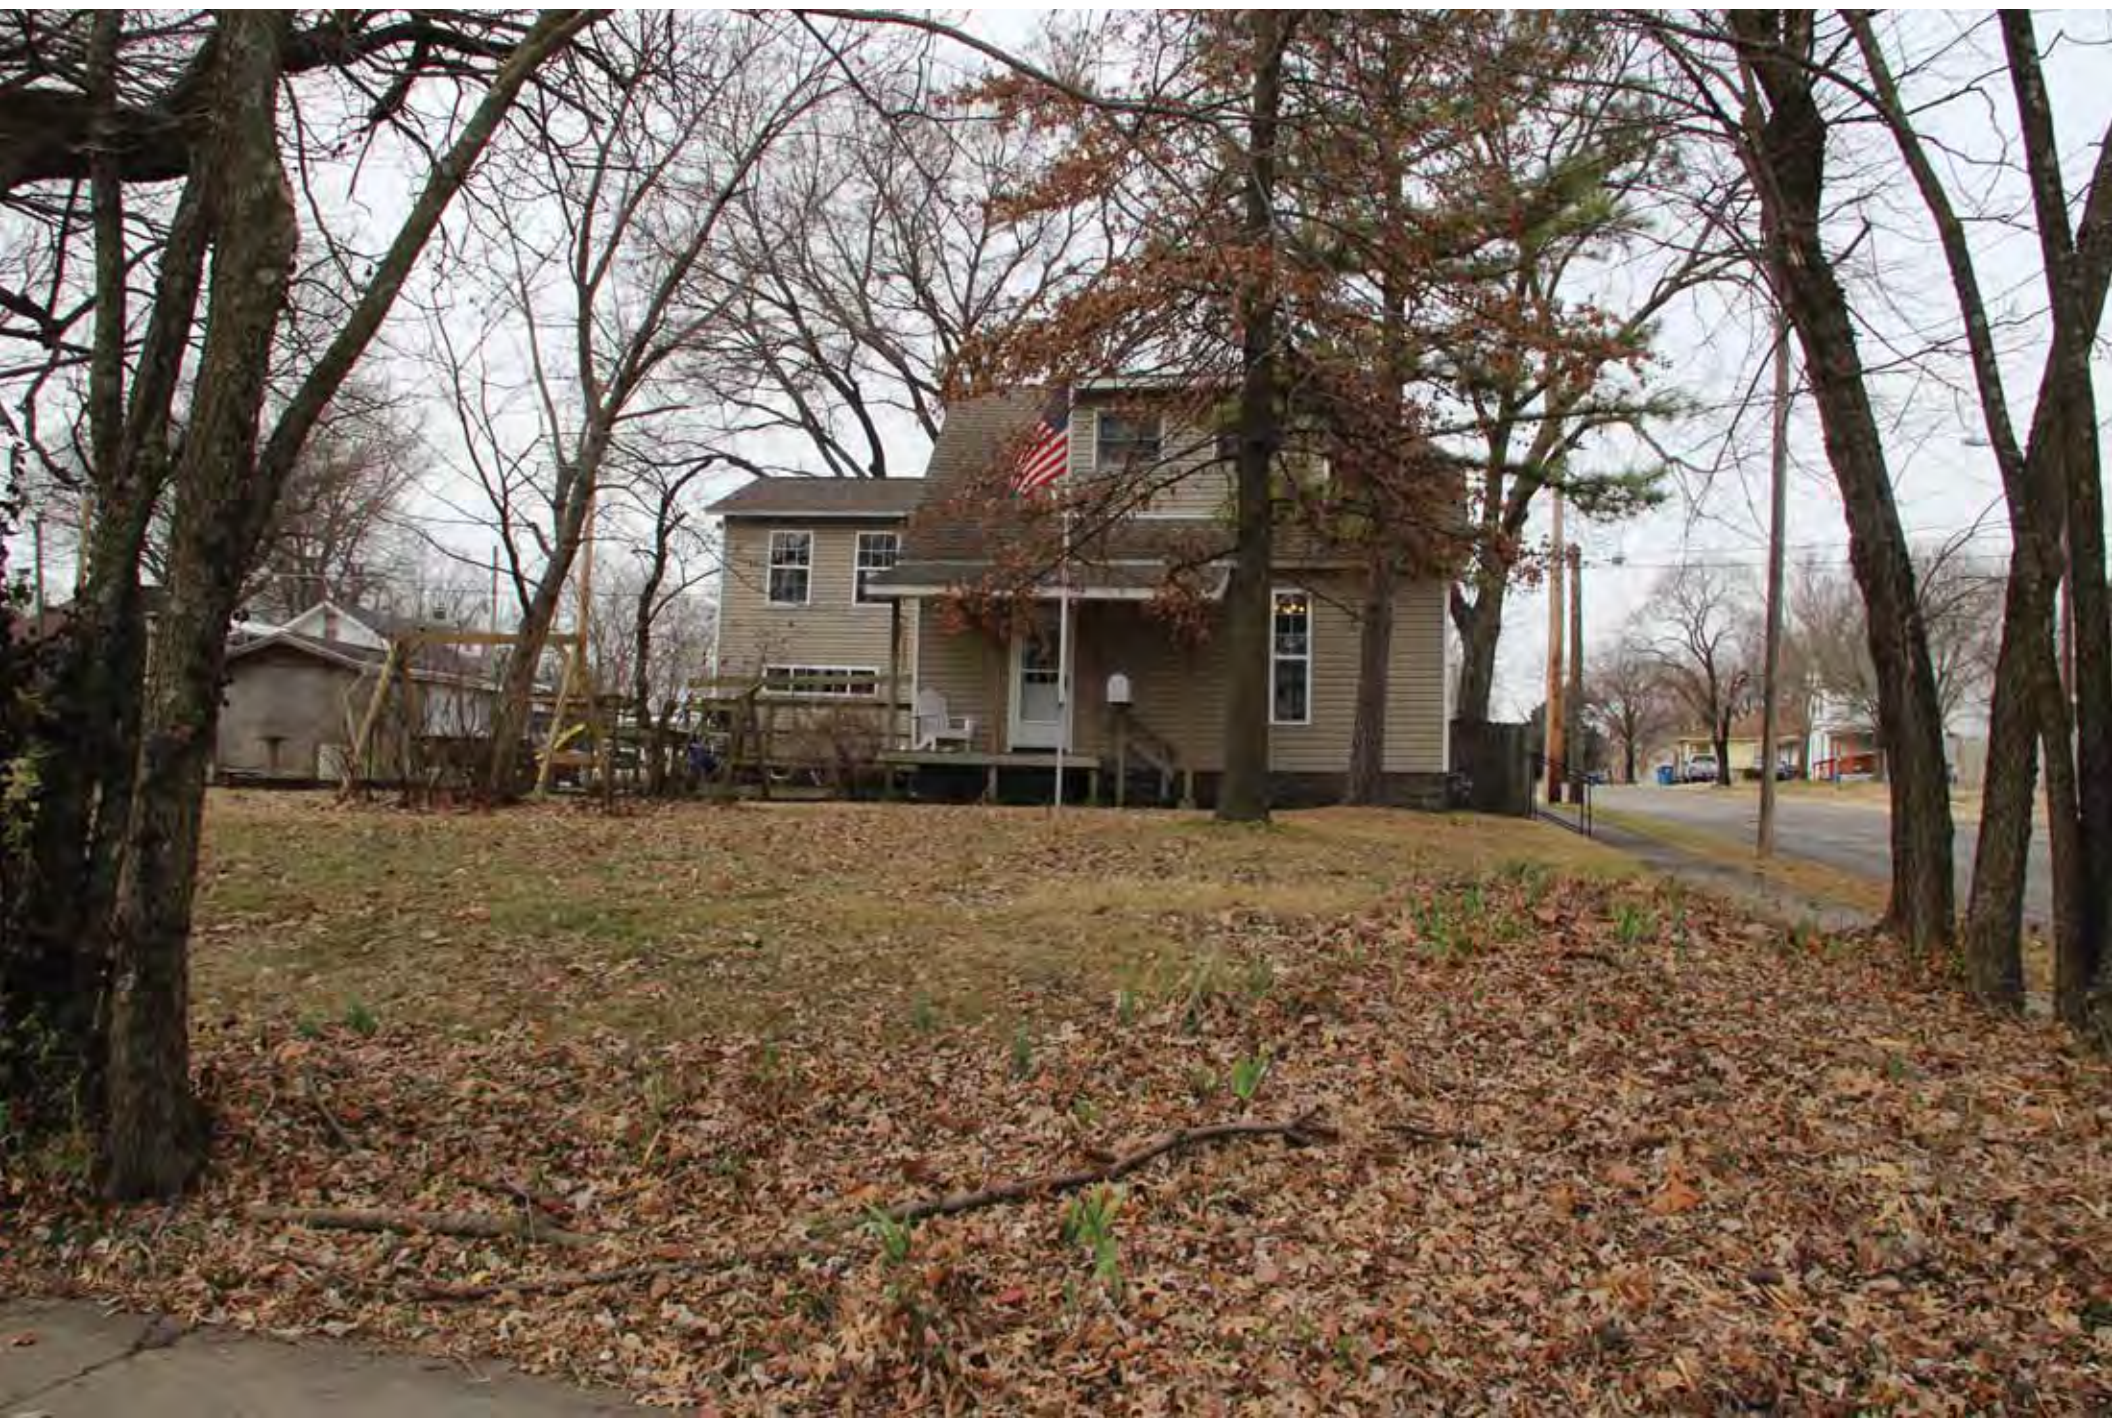
The property at 716 Central street is a two story frame house. The house has been added on to extensively, created an irregular roofline. The original portion of the house appears to have an L-shaped plan, with a hip on gable roof along Central Avenue. At the rear of the house is a two-story gable roofed addition. The house is entered on the west side elevation. It is a single front door, accessed by a wooden open porch with a shed roof. To the right of this porch is a single one-over-one vinyl replacement window.

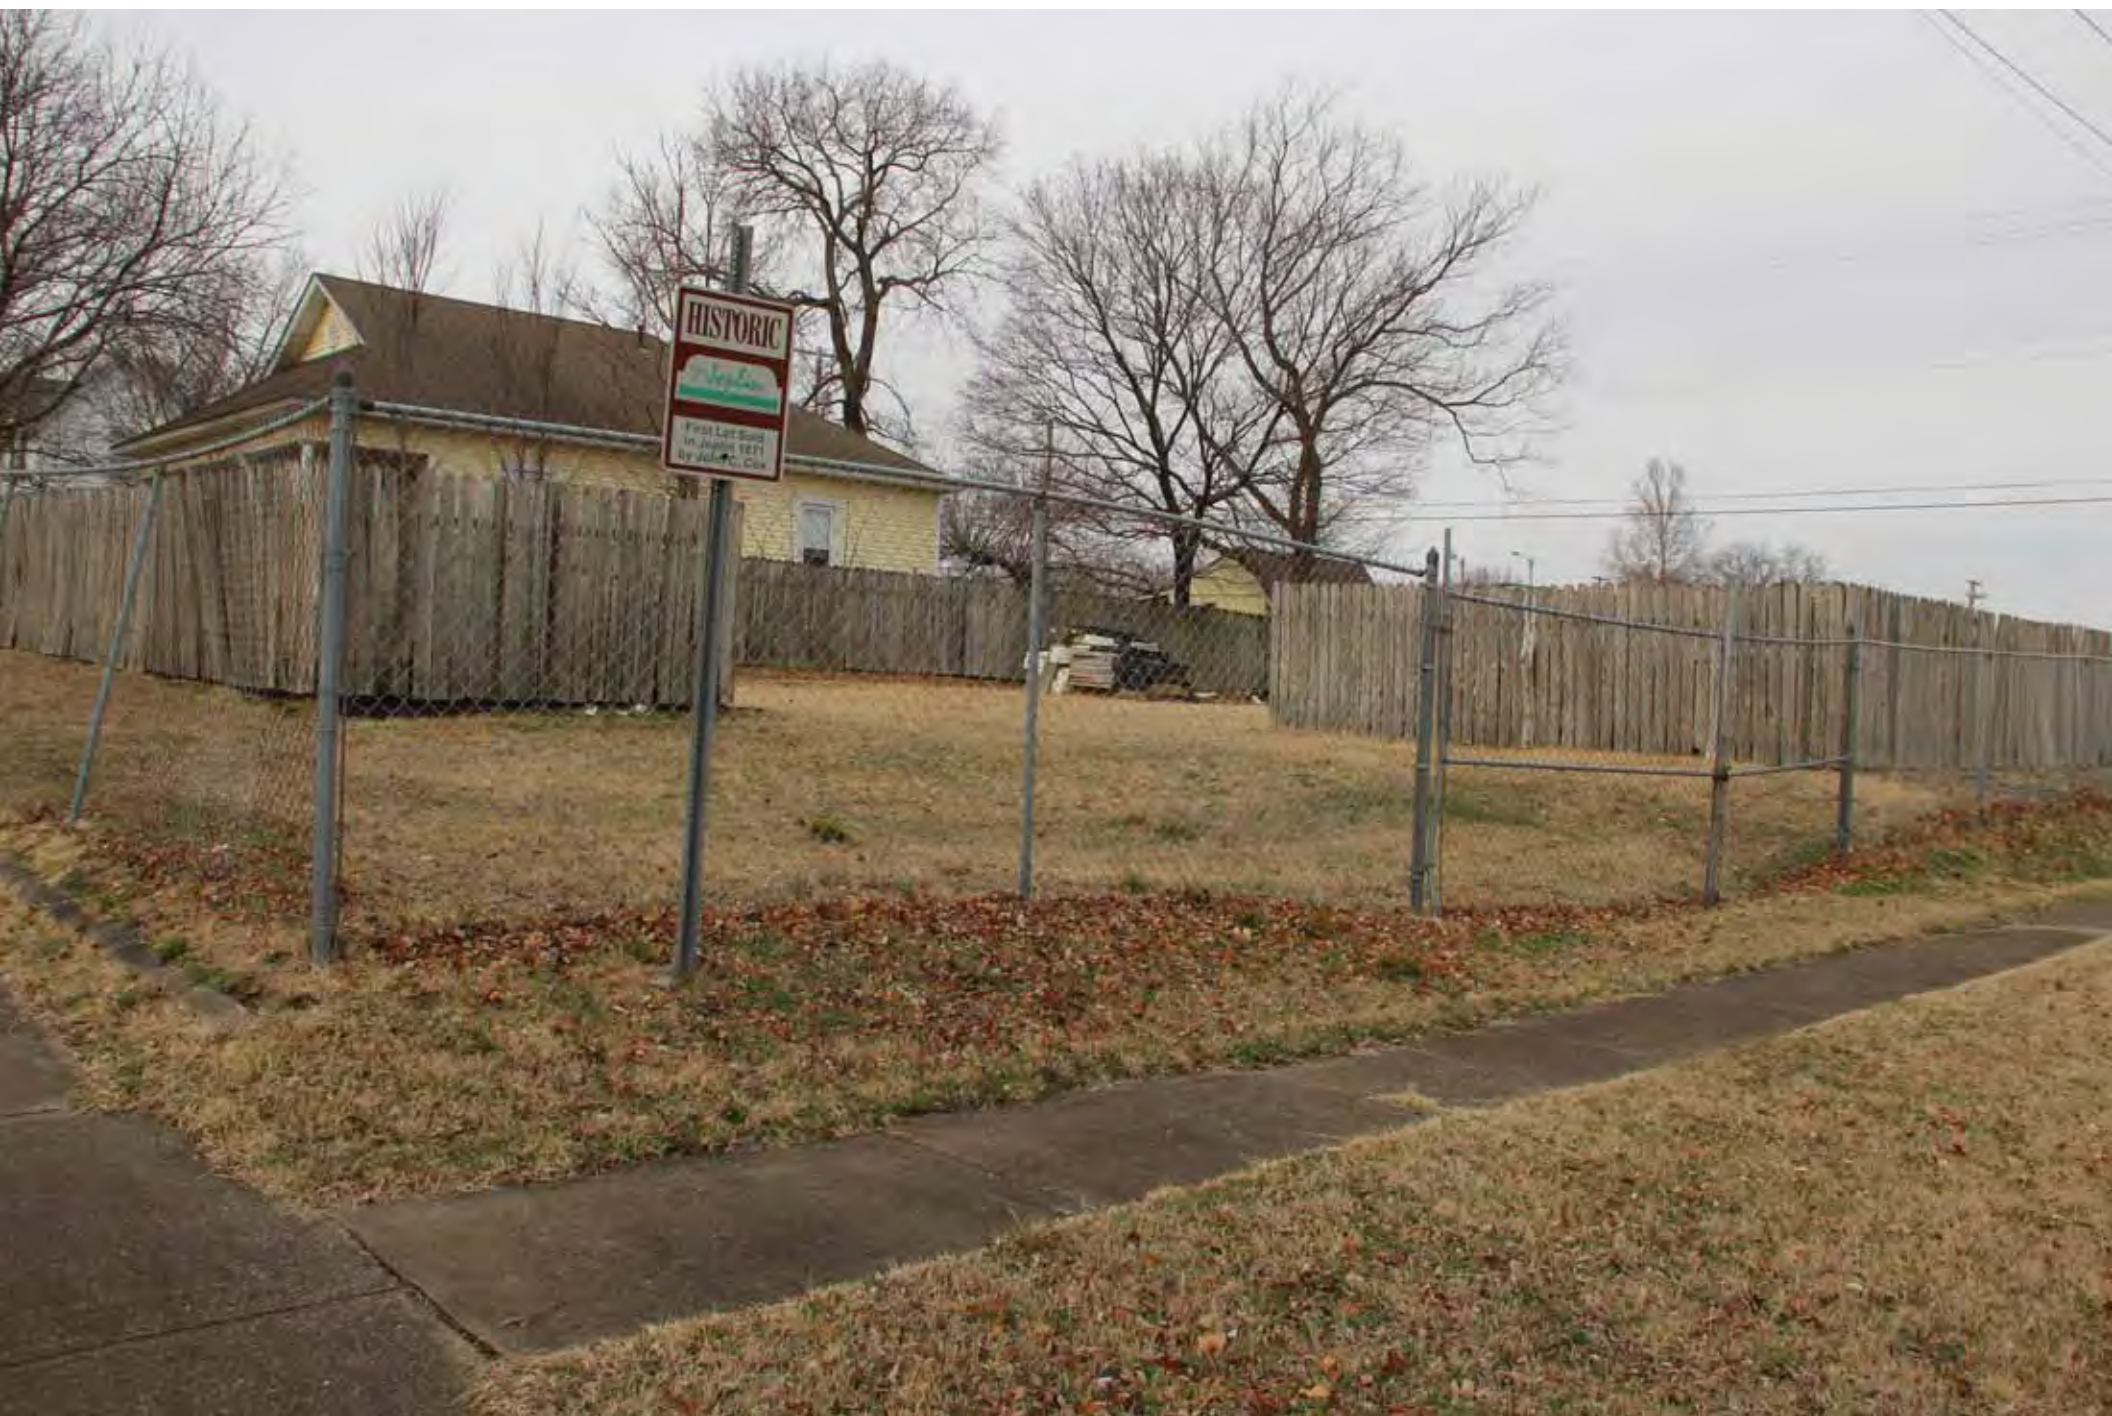
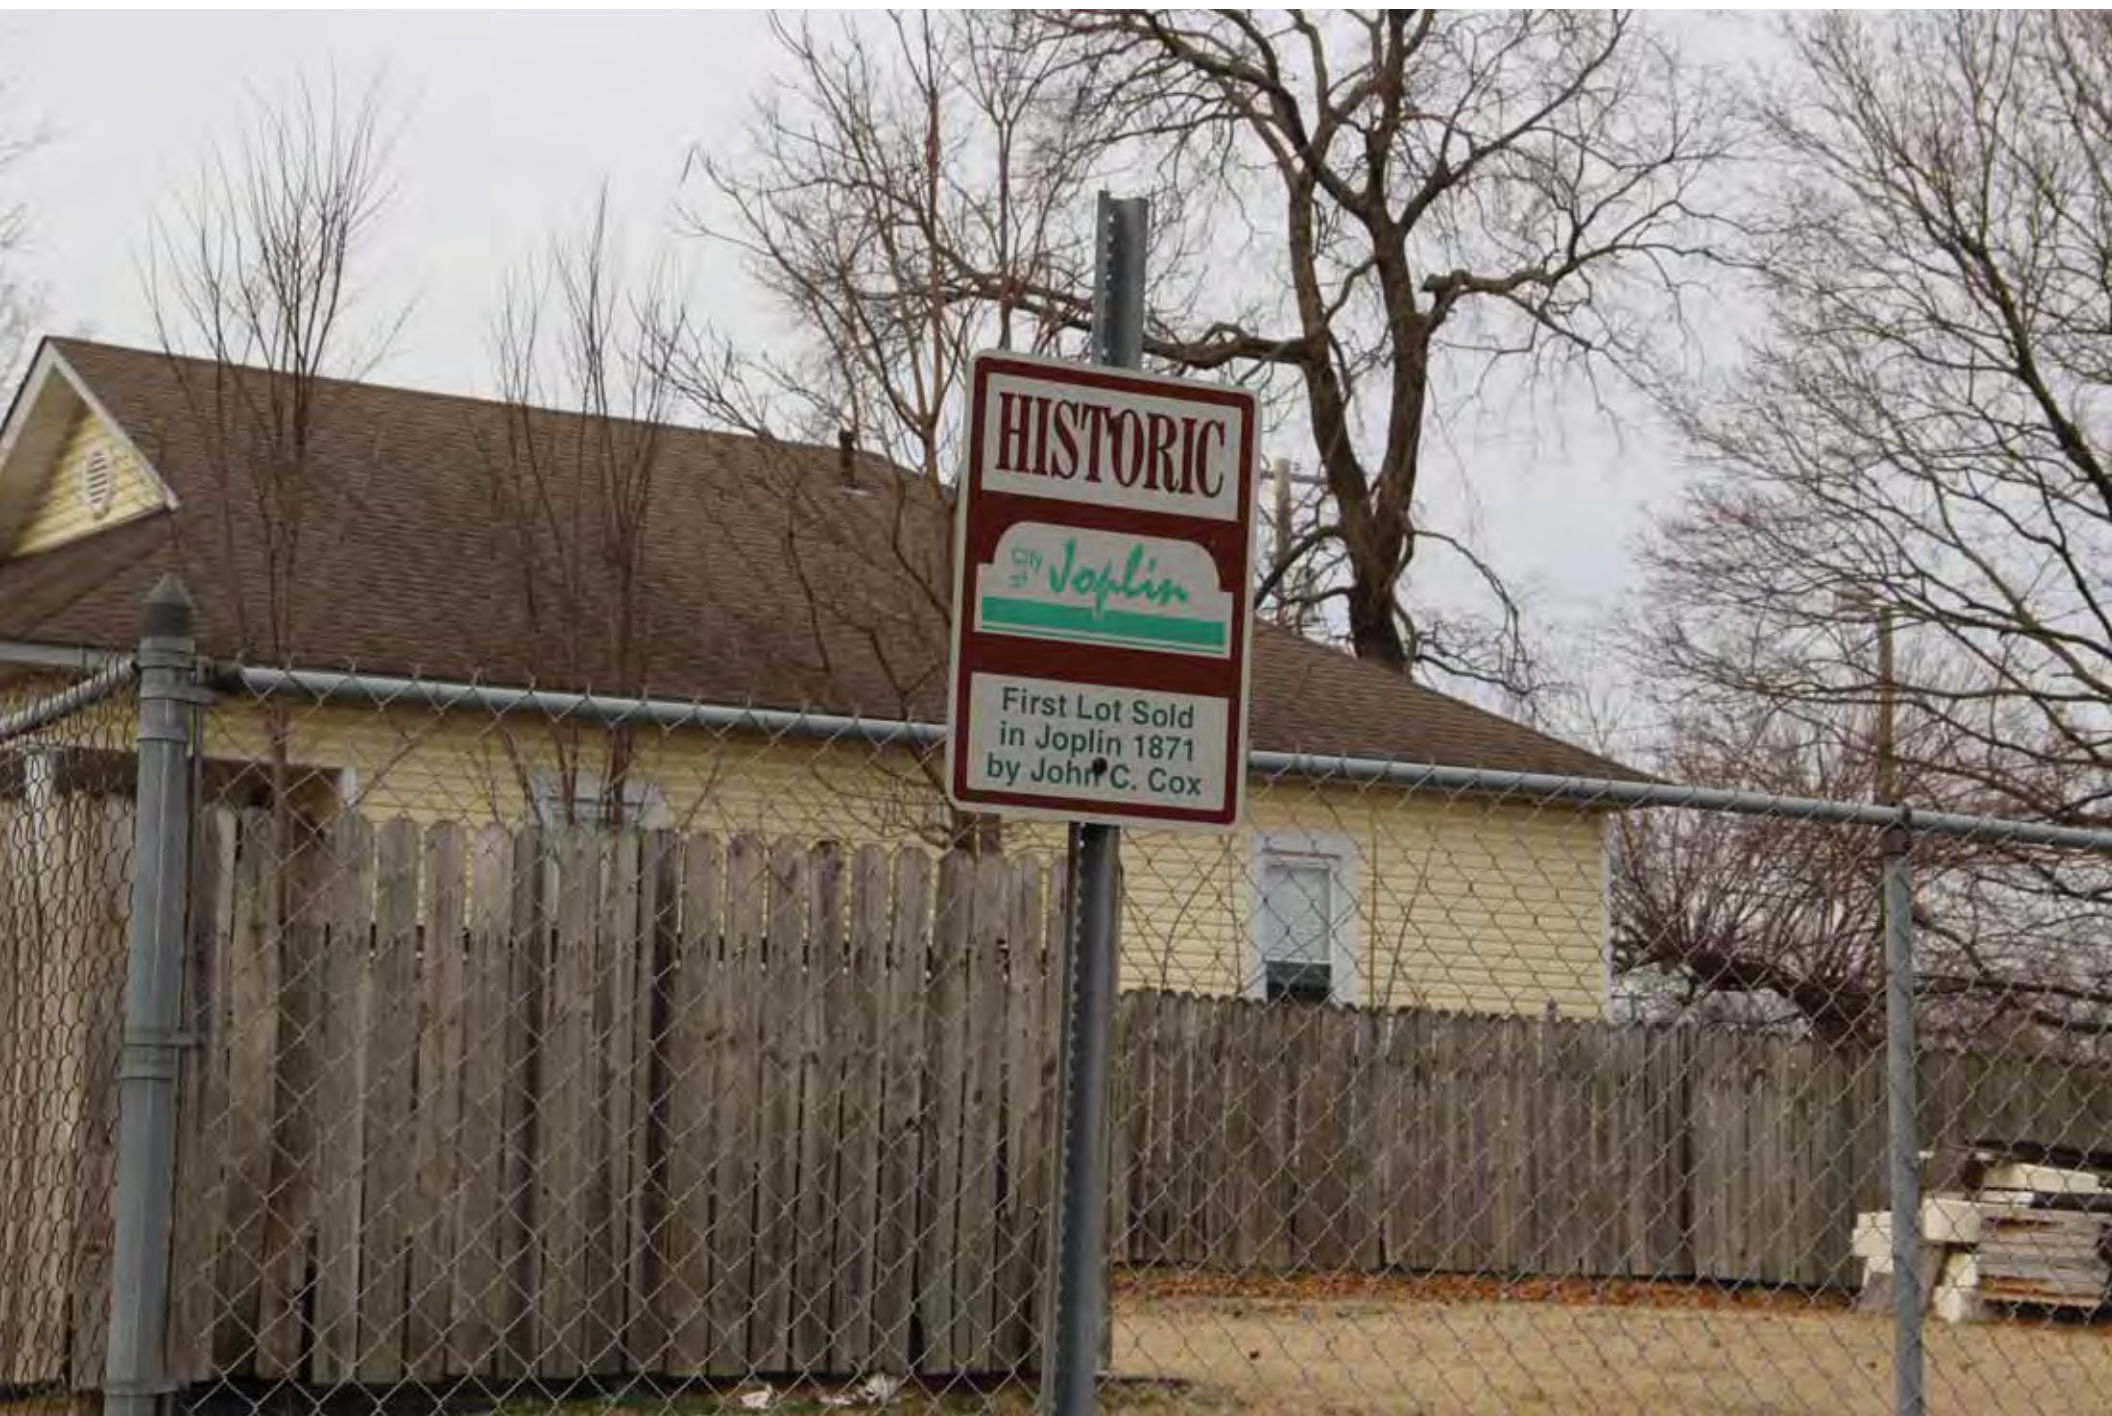
The property at 717 E. Central Street is a vacant lot covered with grass, as described above.
