MISSOURI DEPARTMENT OF NATURAL RESOURCES
STATE HISTORIC PRESERVATION OFFICE, P.O. Box 176, Jefferson City, MO 65102
ARCHITECTURAL/HISTORIC INVENTORY FORM

1. Survey No. JP-AS-007-001		2. Survey name: East Town (Original Joplin) Historic Survey Phase 2	
3. County: JASPER		4. Address (Street No.) 618	Street (name) E. 2 nd Street
5. City: Joplin	Vicinity: <input type="checkbox"/>	6. Geographical Reference:	7. Township/Range/Section: T: R: S:
8. Historic name (if known):		9. Present/other name (if known):	
10. Ownership: <input checked="" type="checkbox"/> Private <input type="checkbox"/> Public		11a. Historic use (if known): Domestic: Single Dwelling	11b. Current use: Domestic: Single Dwelling

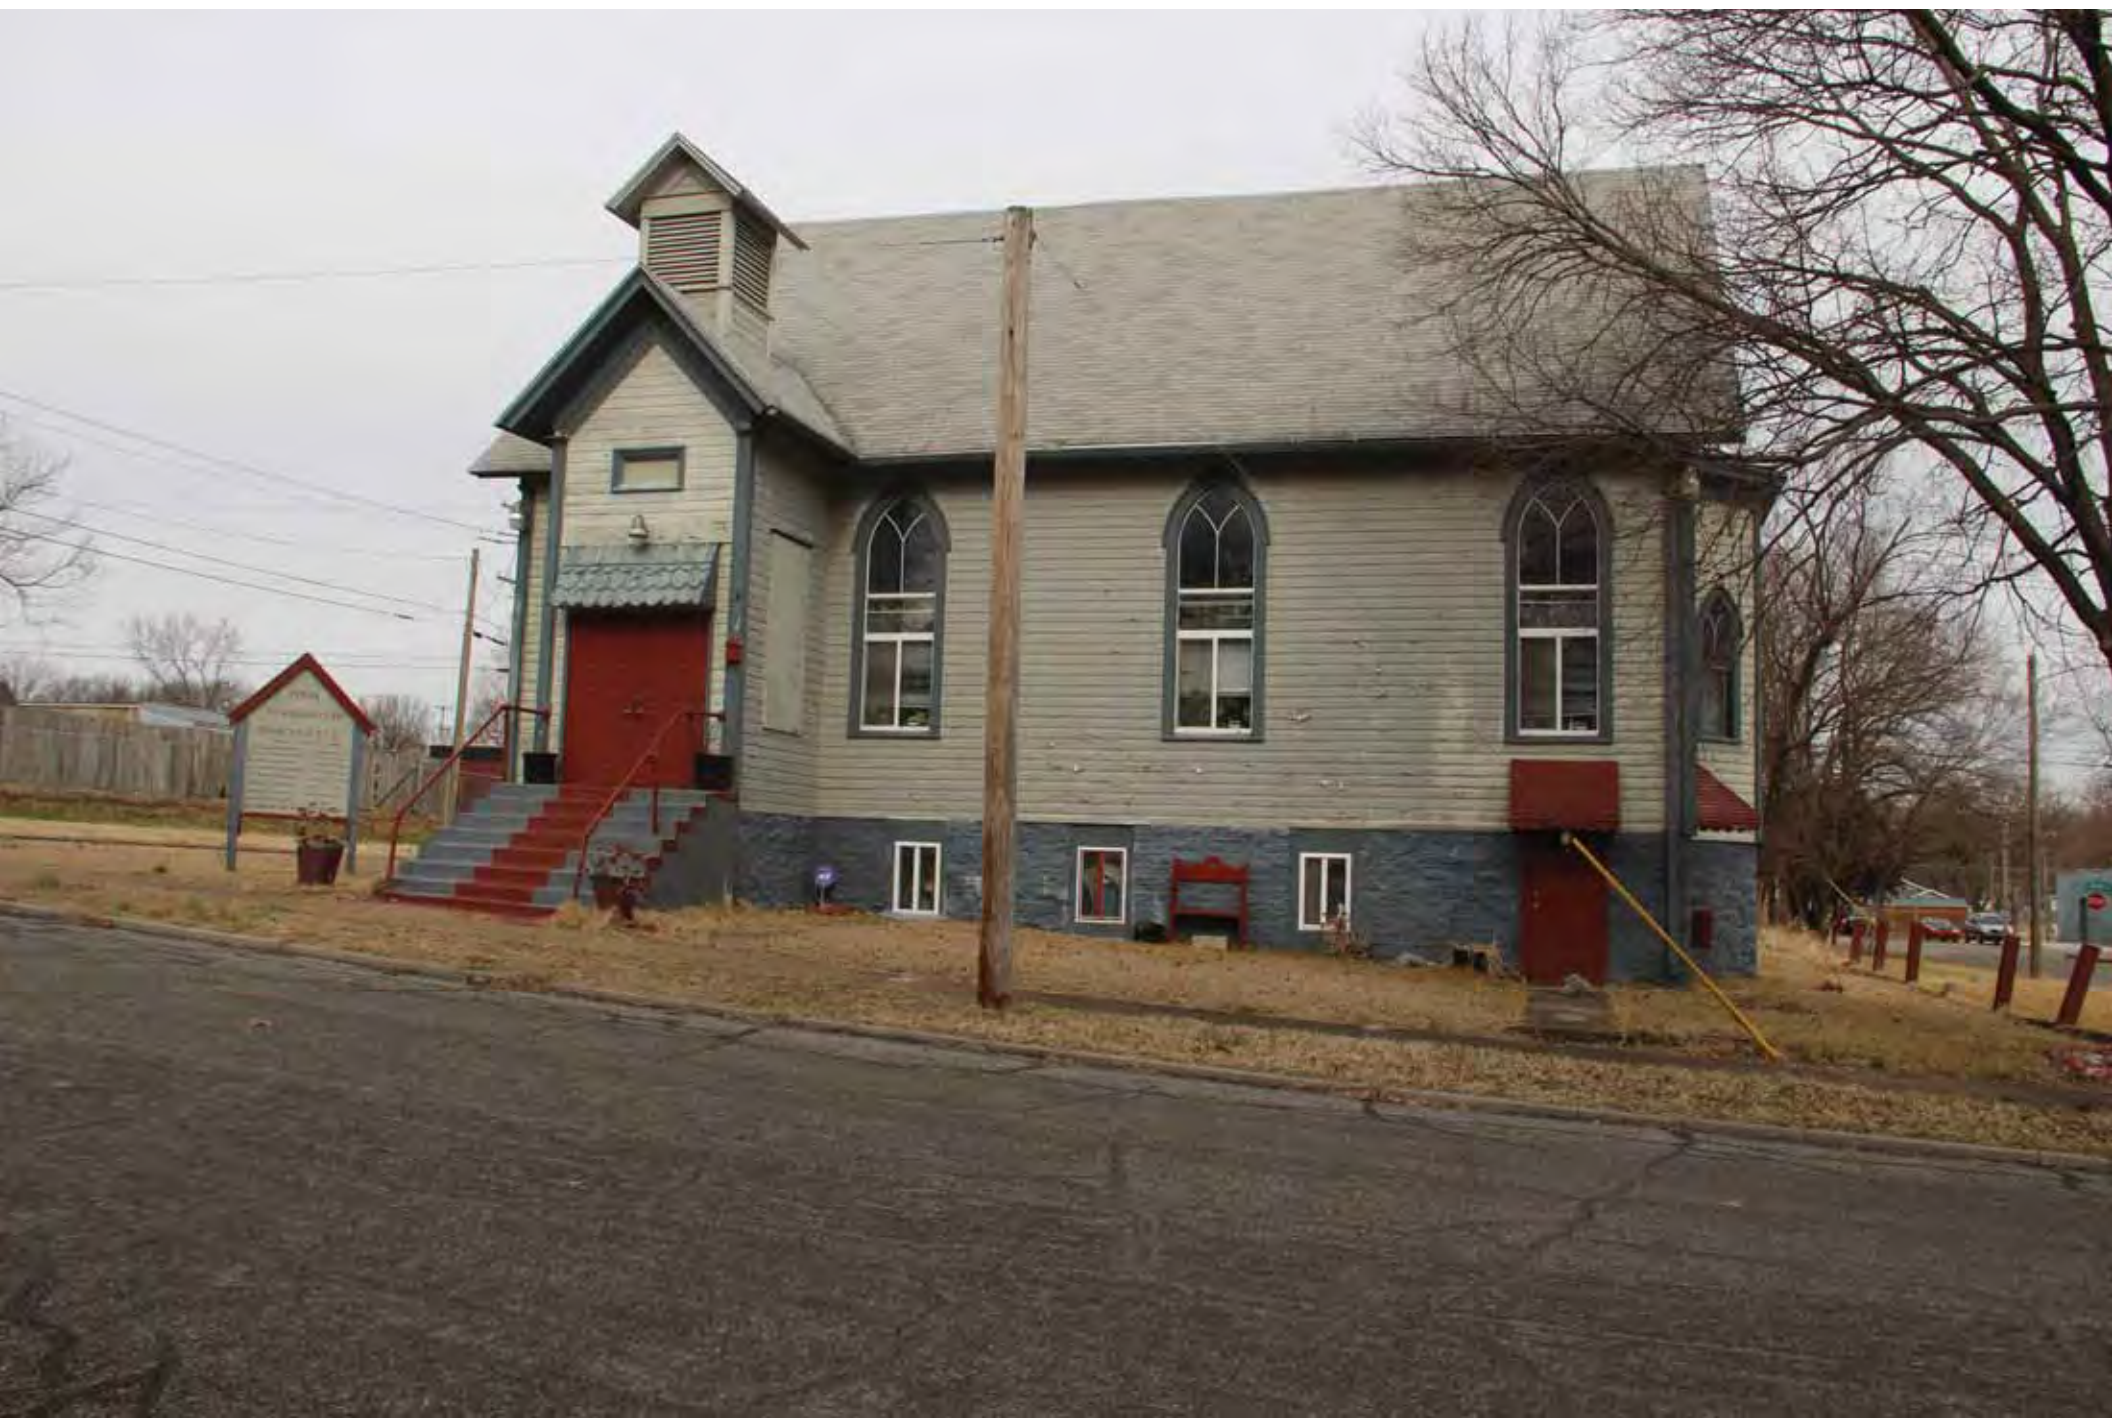
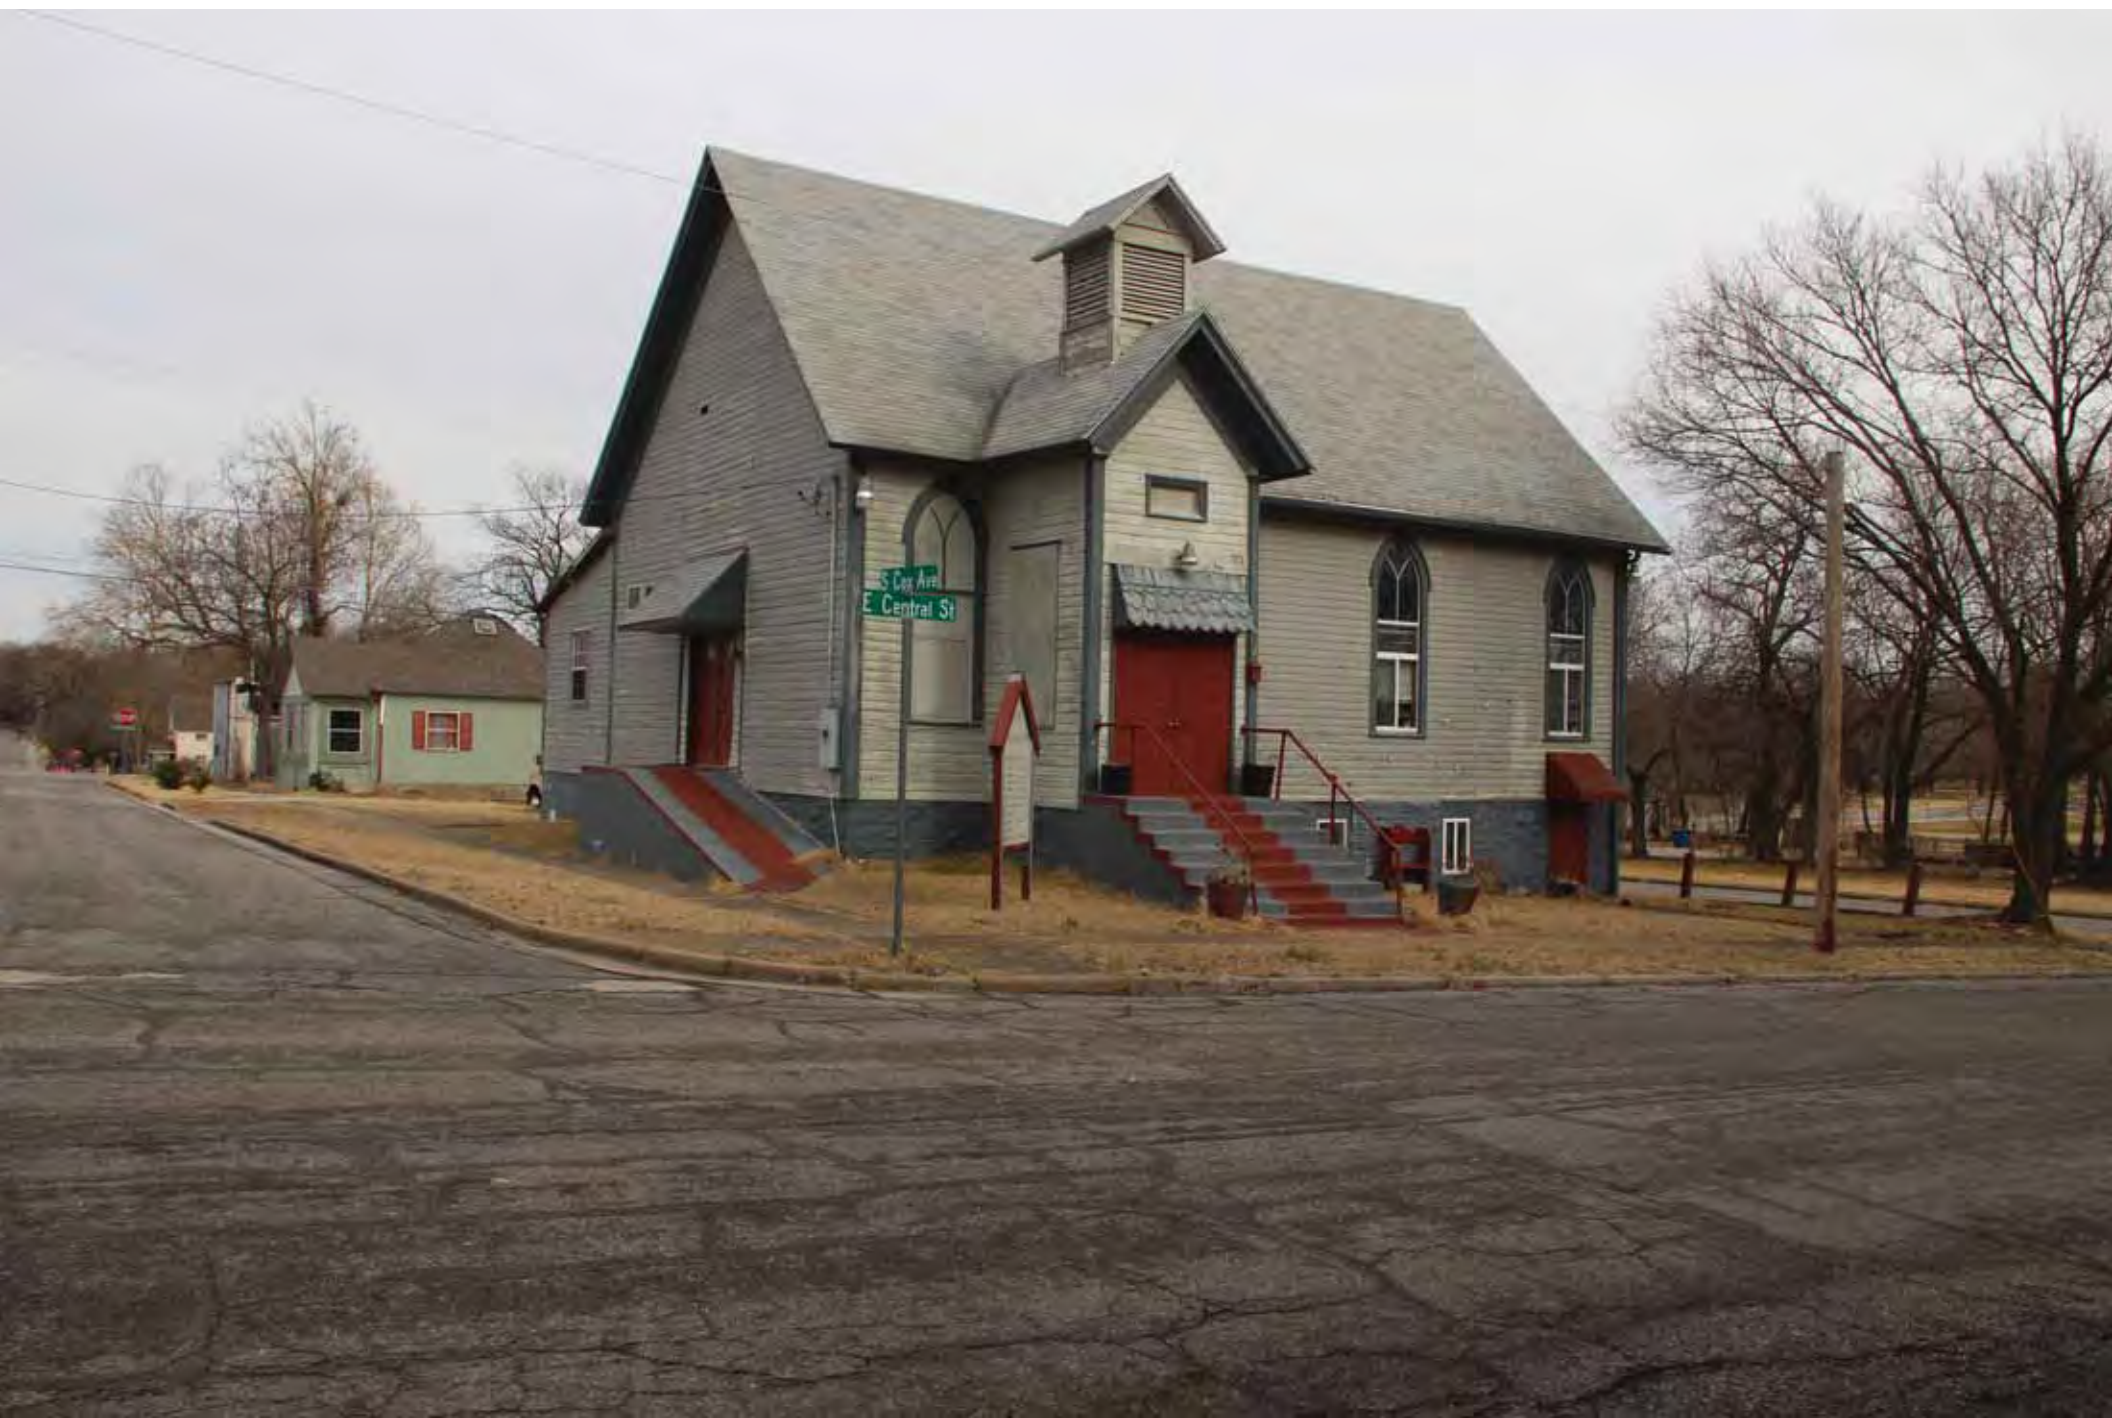
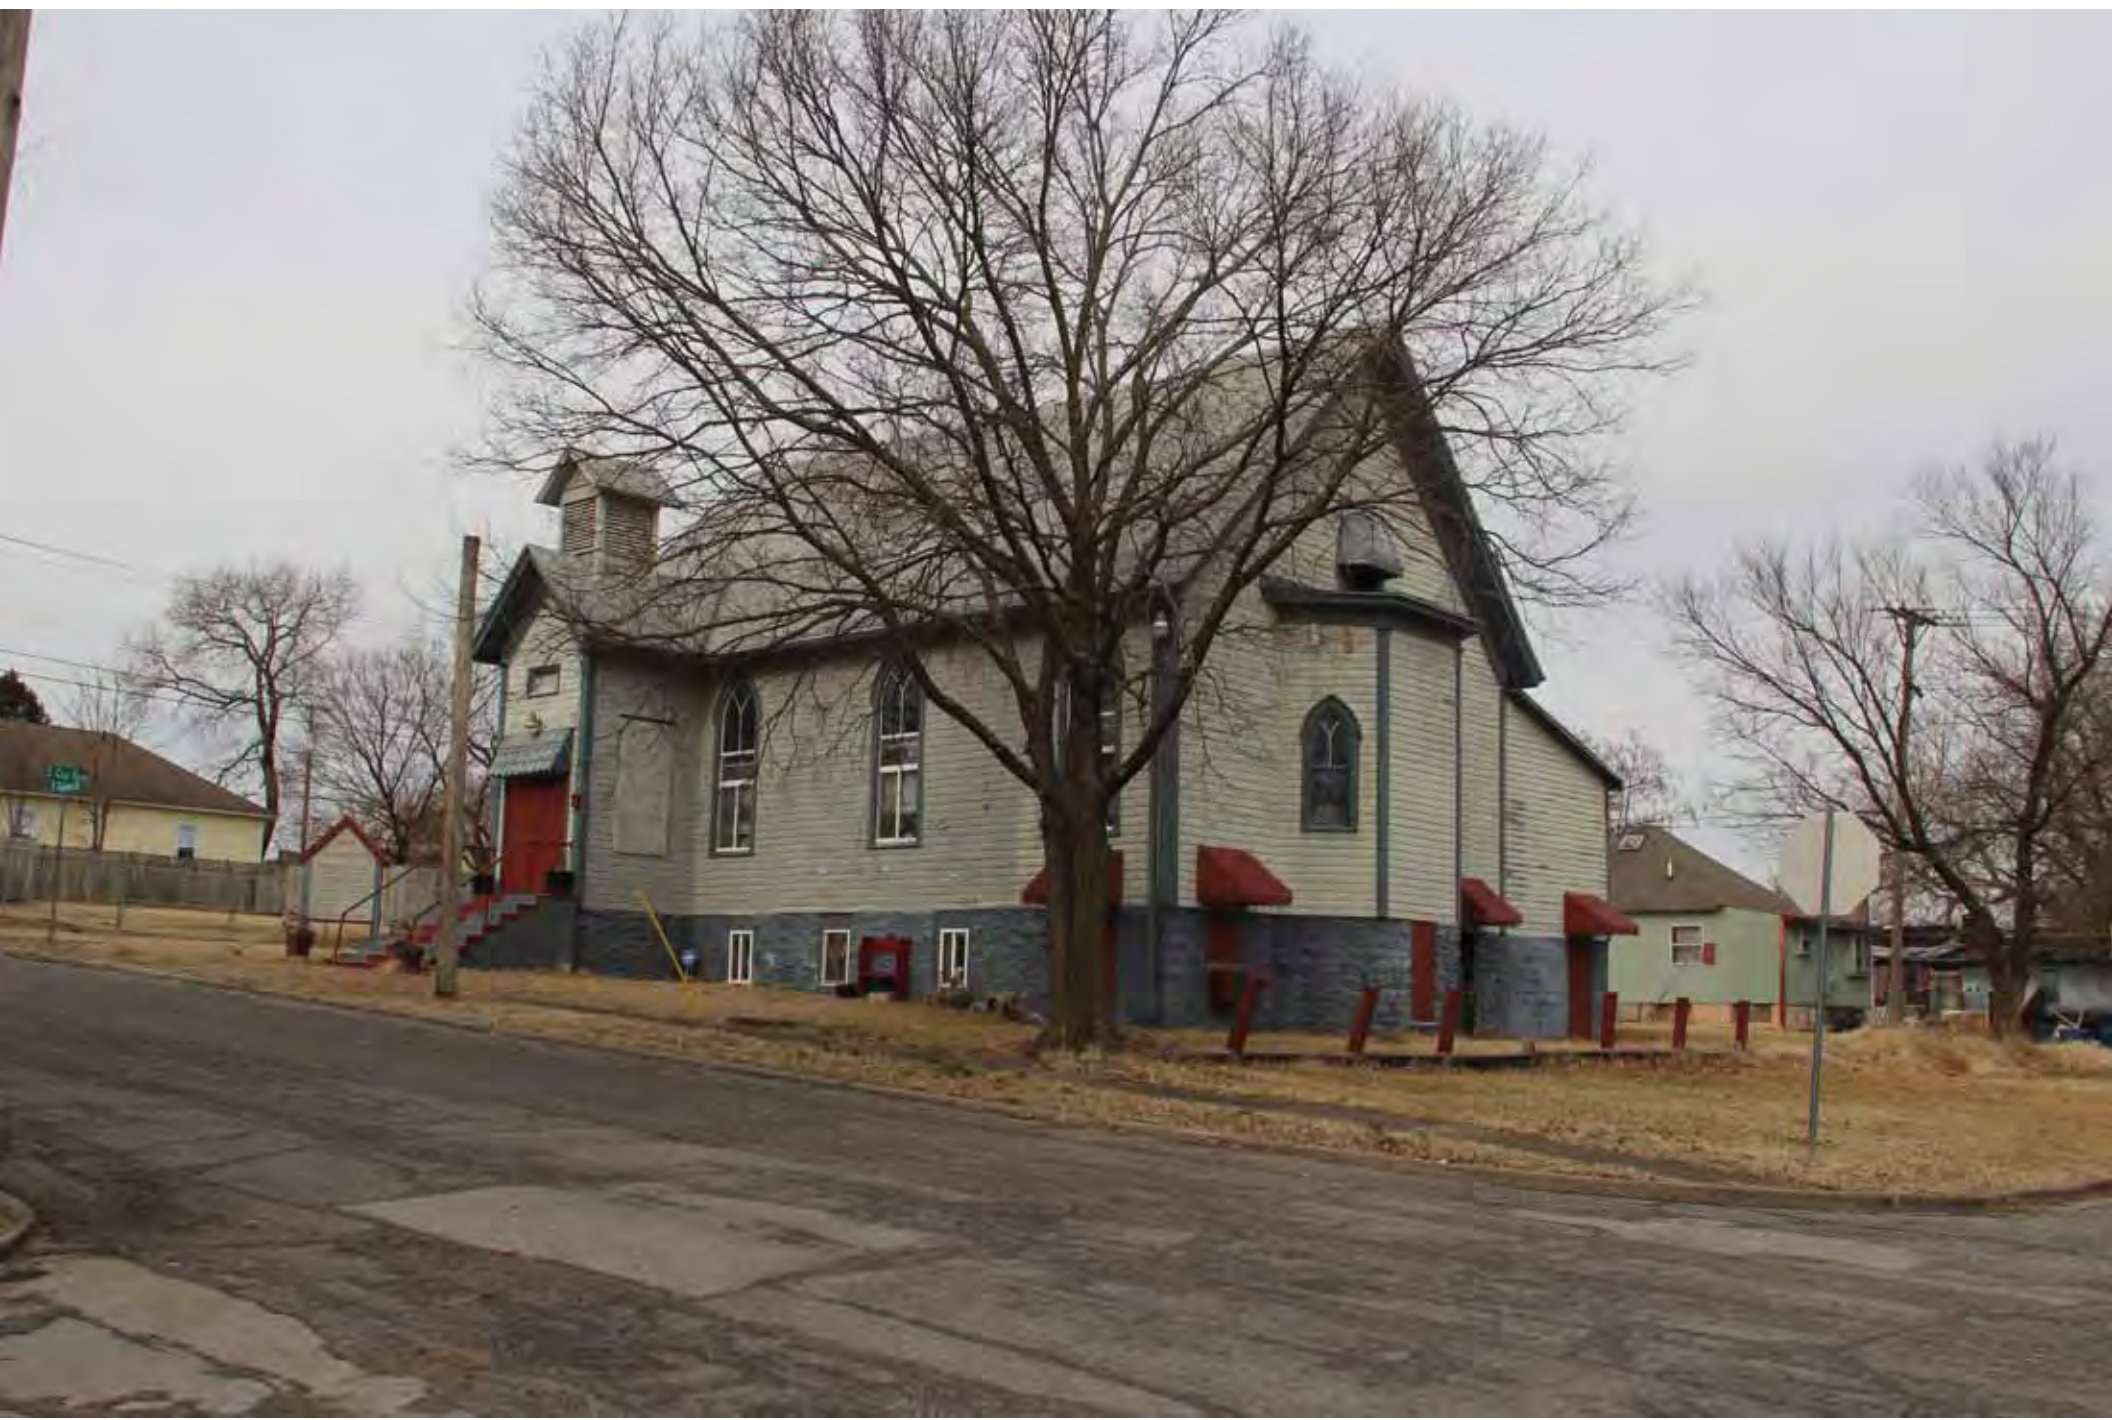
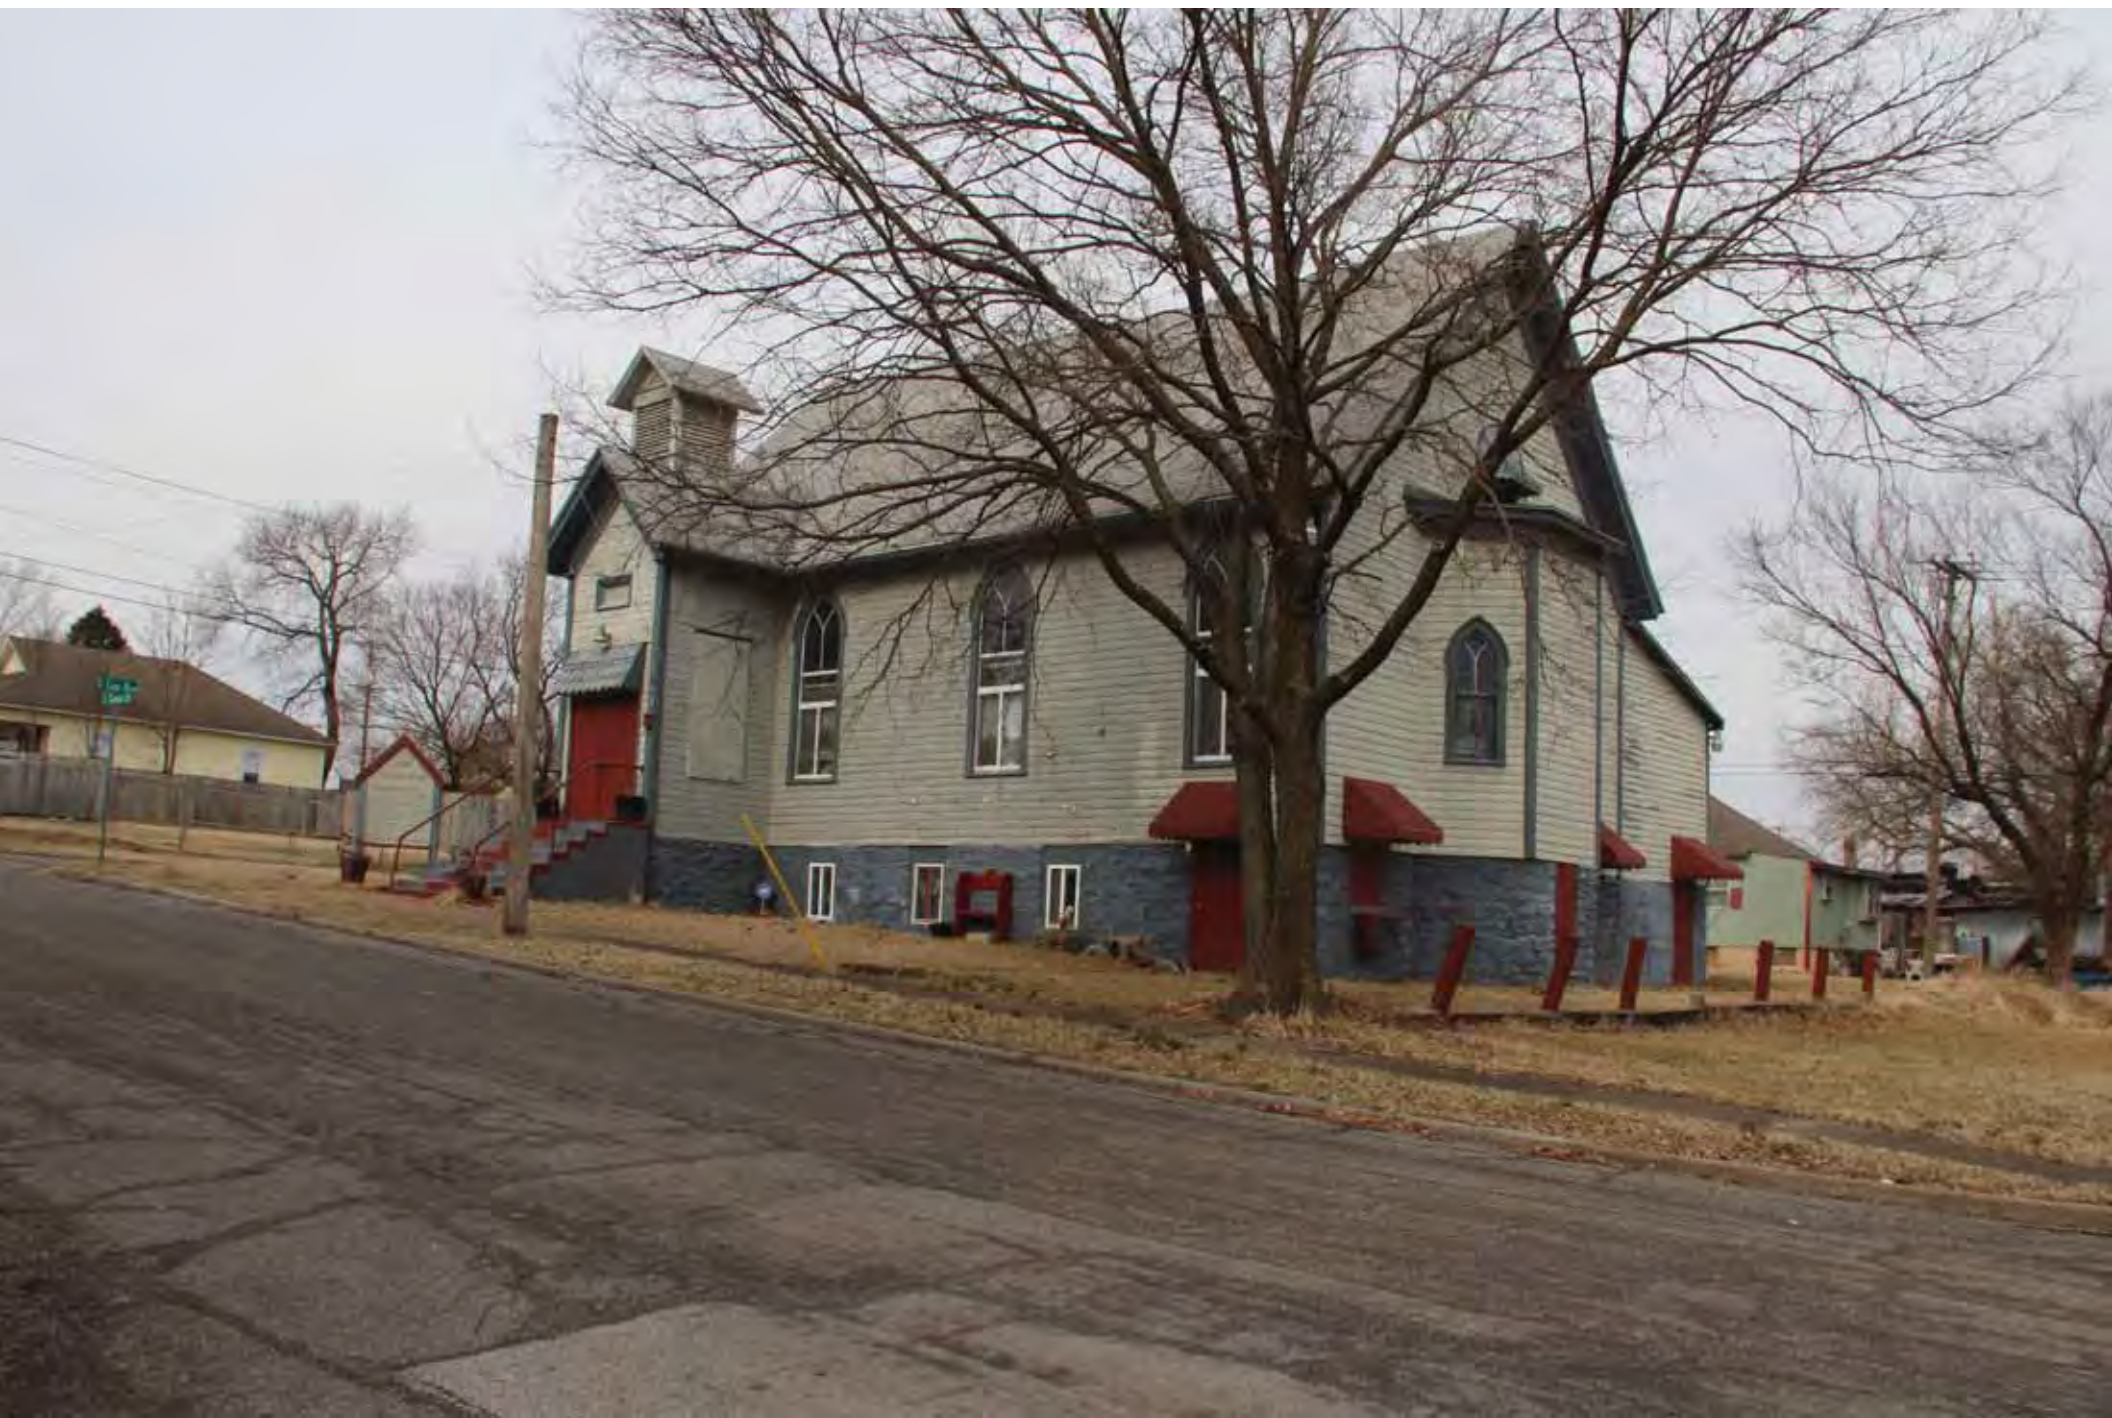
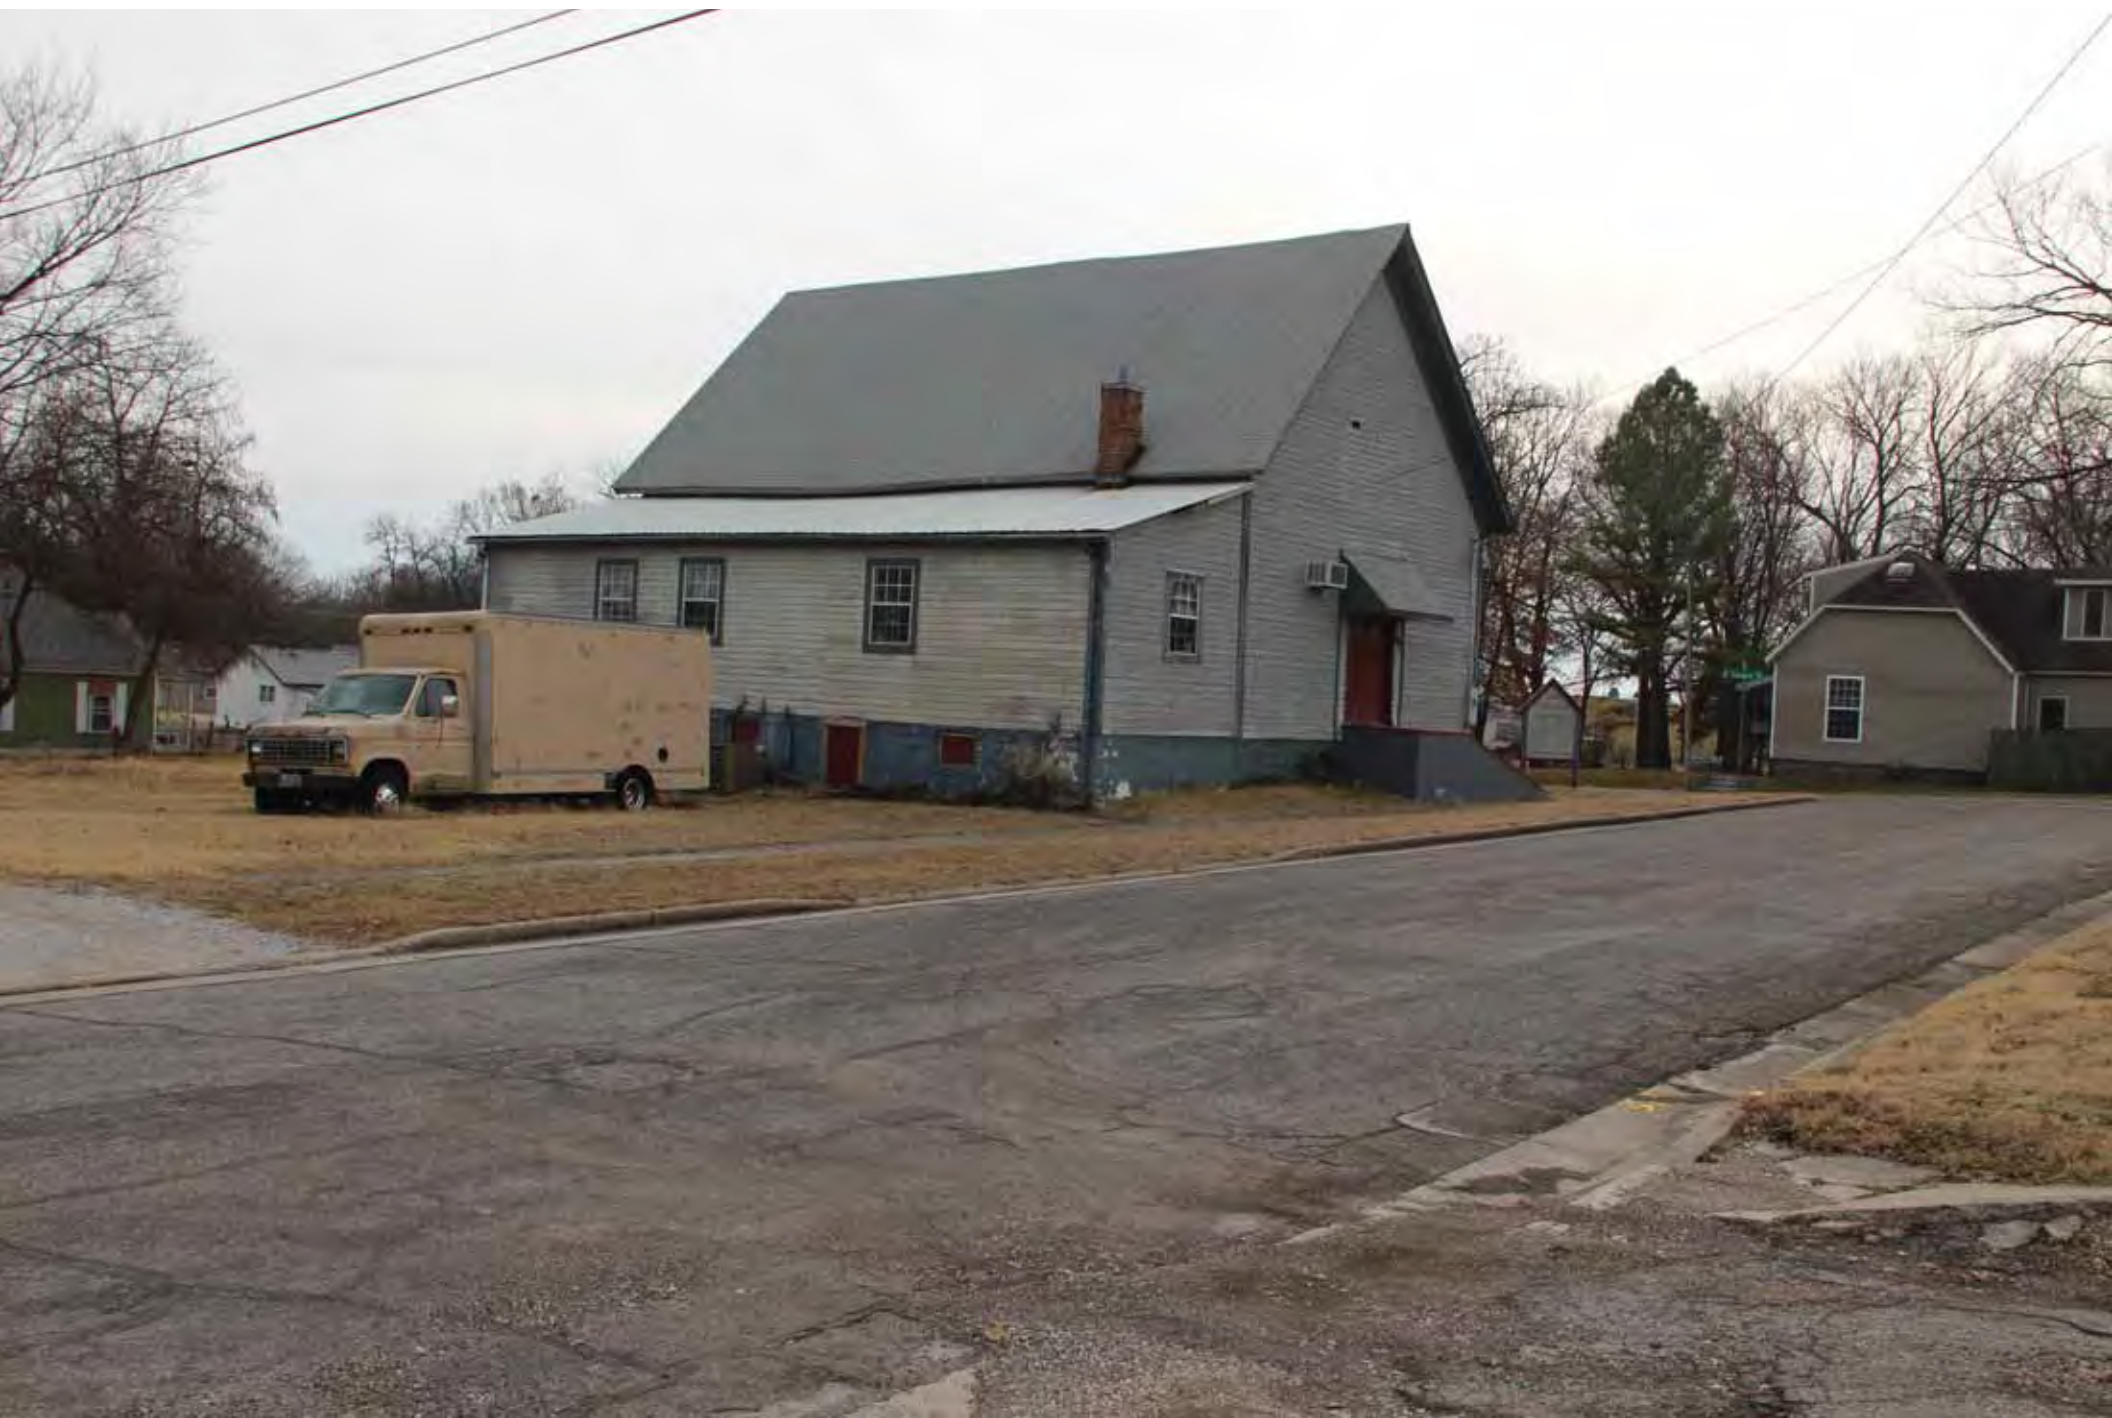
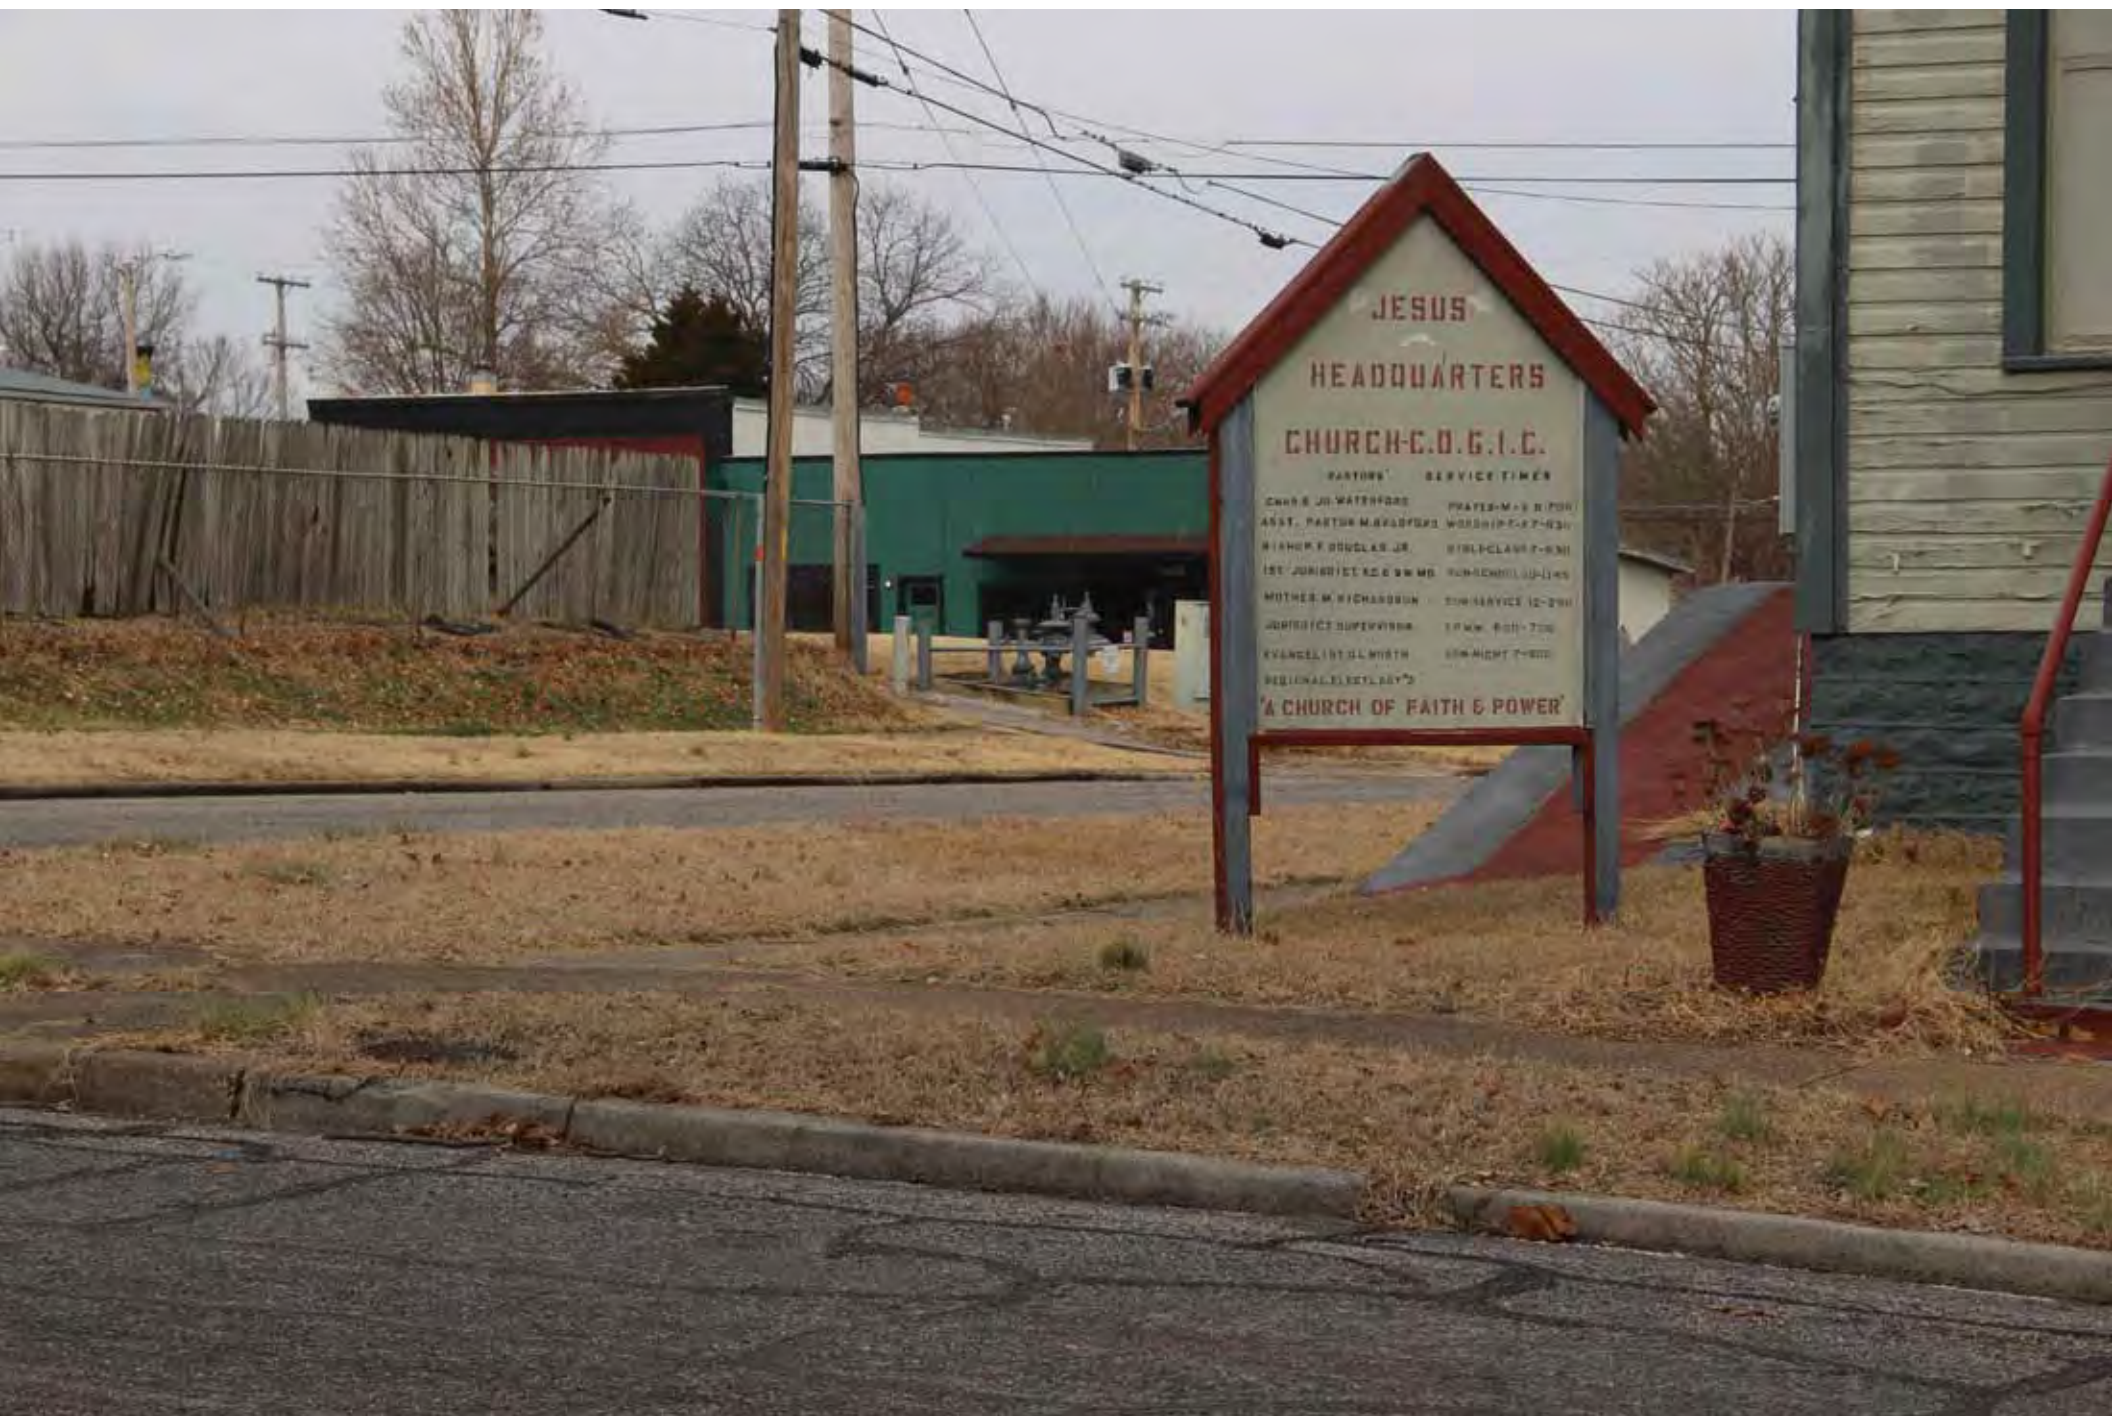
The building at 801 Central Street is a simple frame church in the Gothic Revival style. On its main elevation on Central Avenue is a small frame entrance bay, with its own gable roof. On top of this gable roof entrance is a small wooden steeple or tower. This entrance bay has double doors beneath a wood awning, accessed by non-historic concrete stairs with a metal railing. To the right, or east, of the entrance are three Gothic arched windows. On the west elevation of the building are double entrance doors accessed by a ramp. On the east elevation of the building is a bay window, with two small Gothic windows. The foundation of the building is stone, which has been painted. The entire building has its original wood siding. The basement is partially above ground and has a number of small replacement casement windows. On the north or rear elevation of the church is a one-story frame addition with a shed roof. This addition has several small six-over-one windows.
