MISSOURI DEPARTMENT OF NATURAL RESOURCES
STATE HISTORIC PRESERVATION OFFICE, P.O. Box 176, Jefferson City, MO 65102
ARCHITECTURAL/HISTORIC INVENTORY FORM

1. Survey No. JP-AS-007-001		2. Survey name: East Town (Original Joplin) Historic Survey Phase 2	
3. County: JASPER		4. Address (Street No.) 618	Street (name) E. 2 nd Street
5. City: Joplin	Vicinity: <input type="checkbox"/>	6. Geographical Reference:	7. Township/Range/Section: T: R: S:
8. Historic name (if known):		9. Present/other name (if known):	
10. Ownership: <input checked="" type="checkbox"/> Private <input type="checkbox"/> Public		11a. Historic use (if known): Domestic: Single Dwelling	11b. Current use: Domestic: Single Dwelling

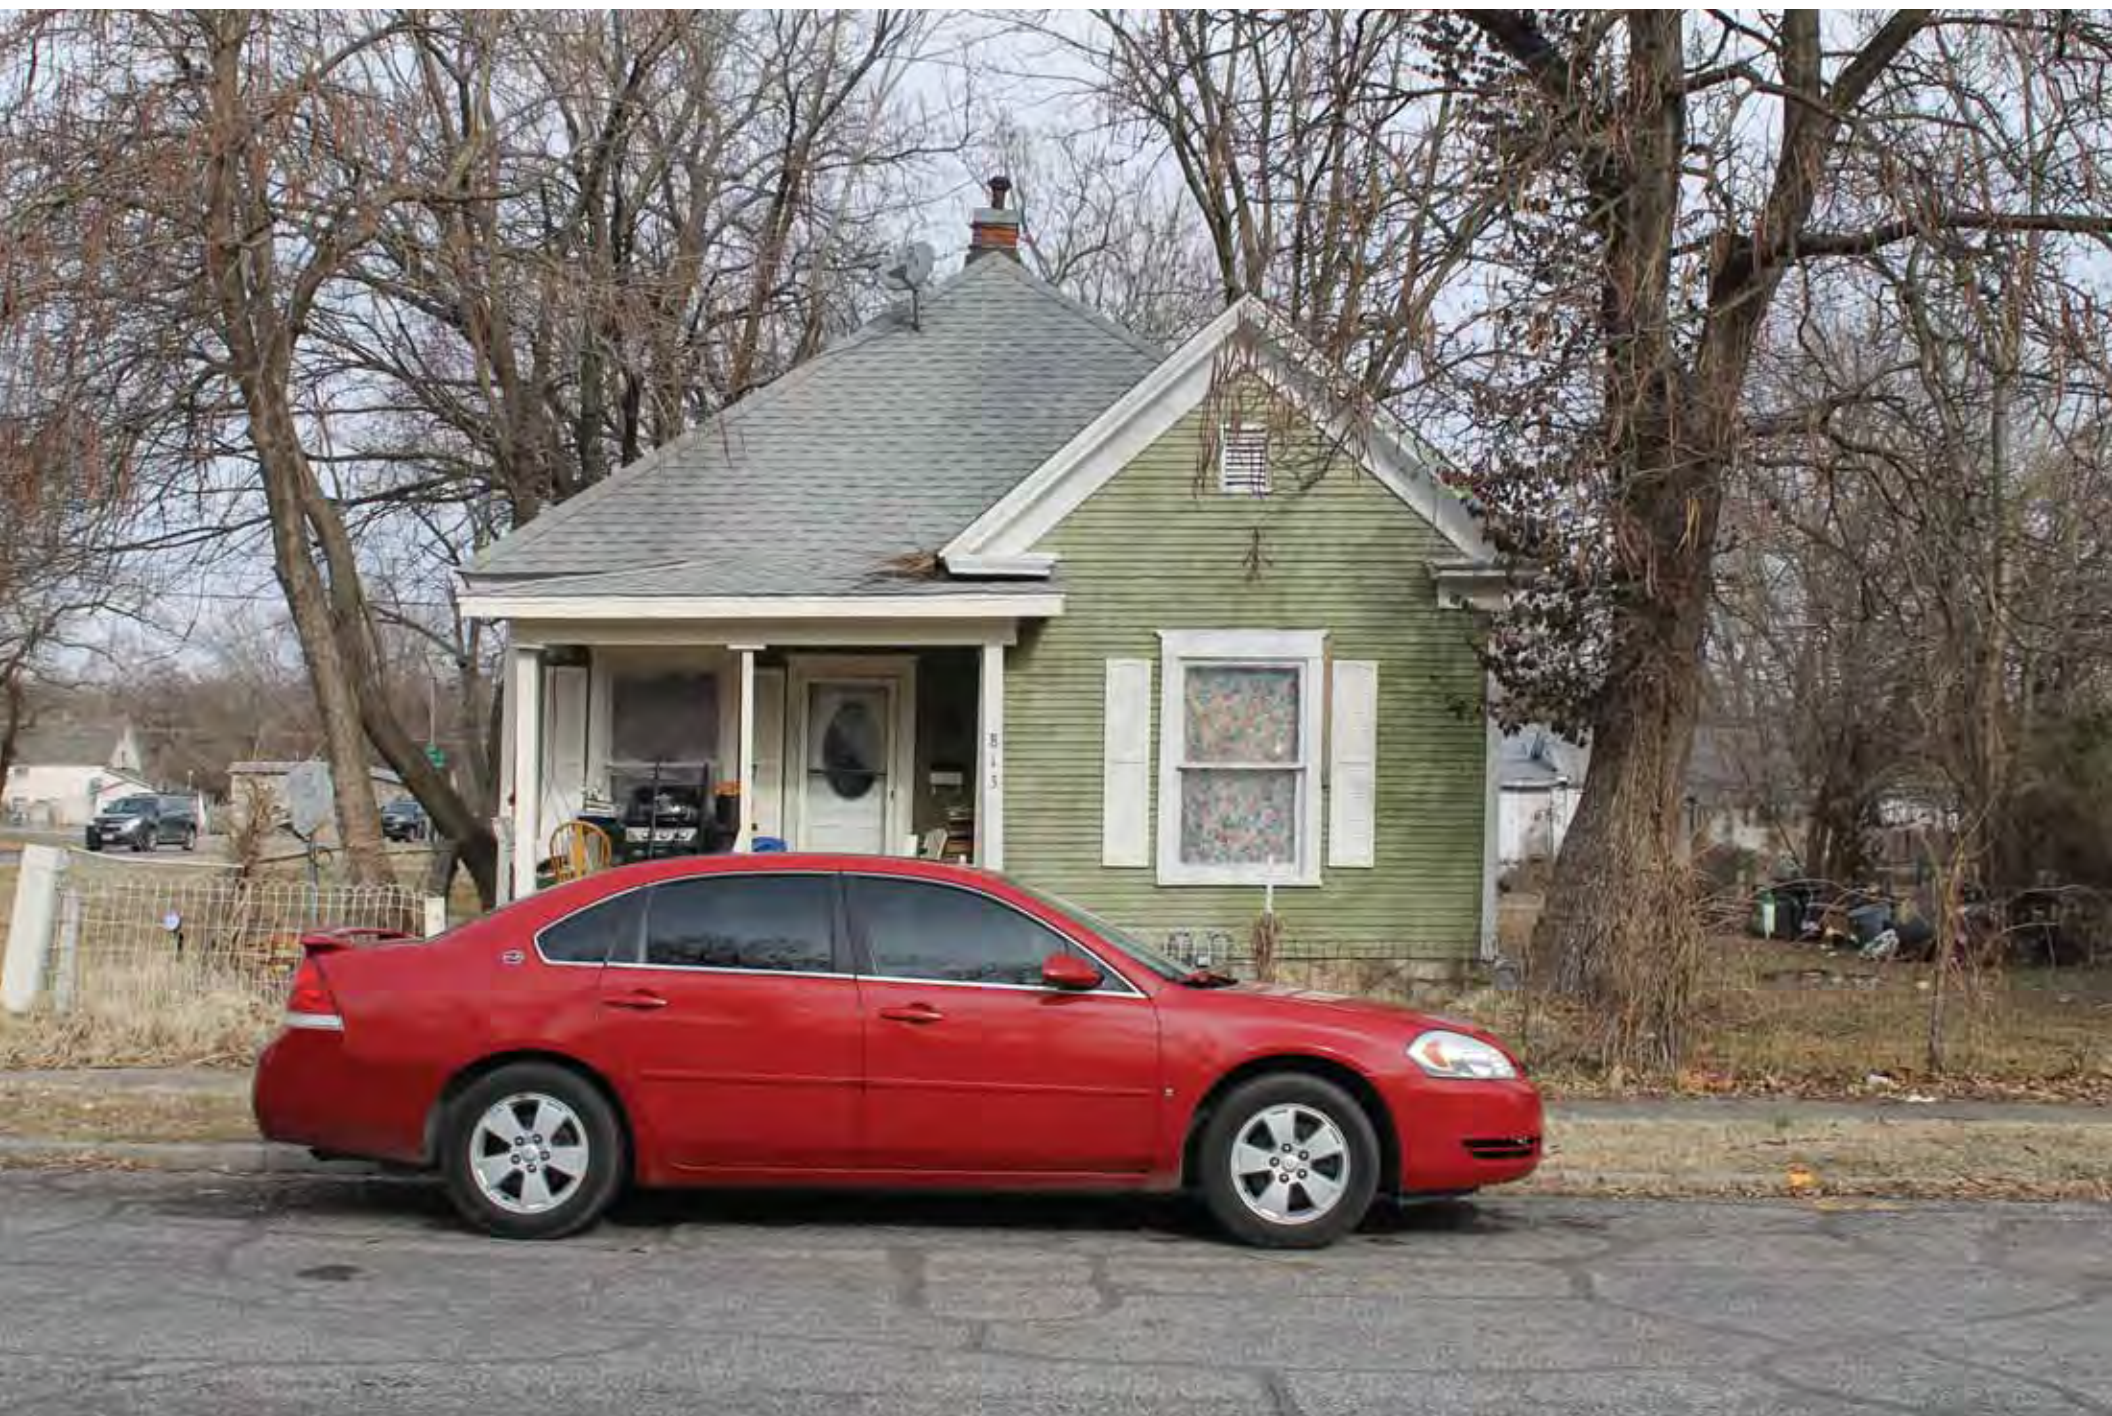
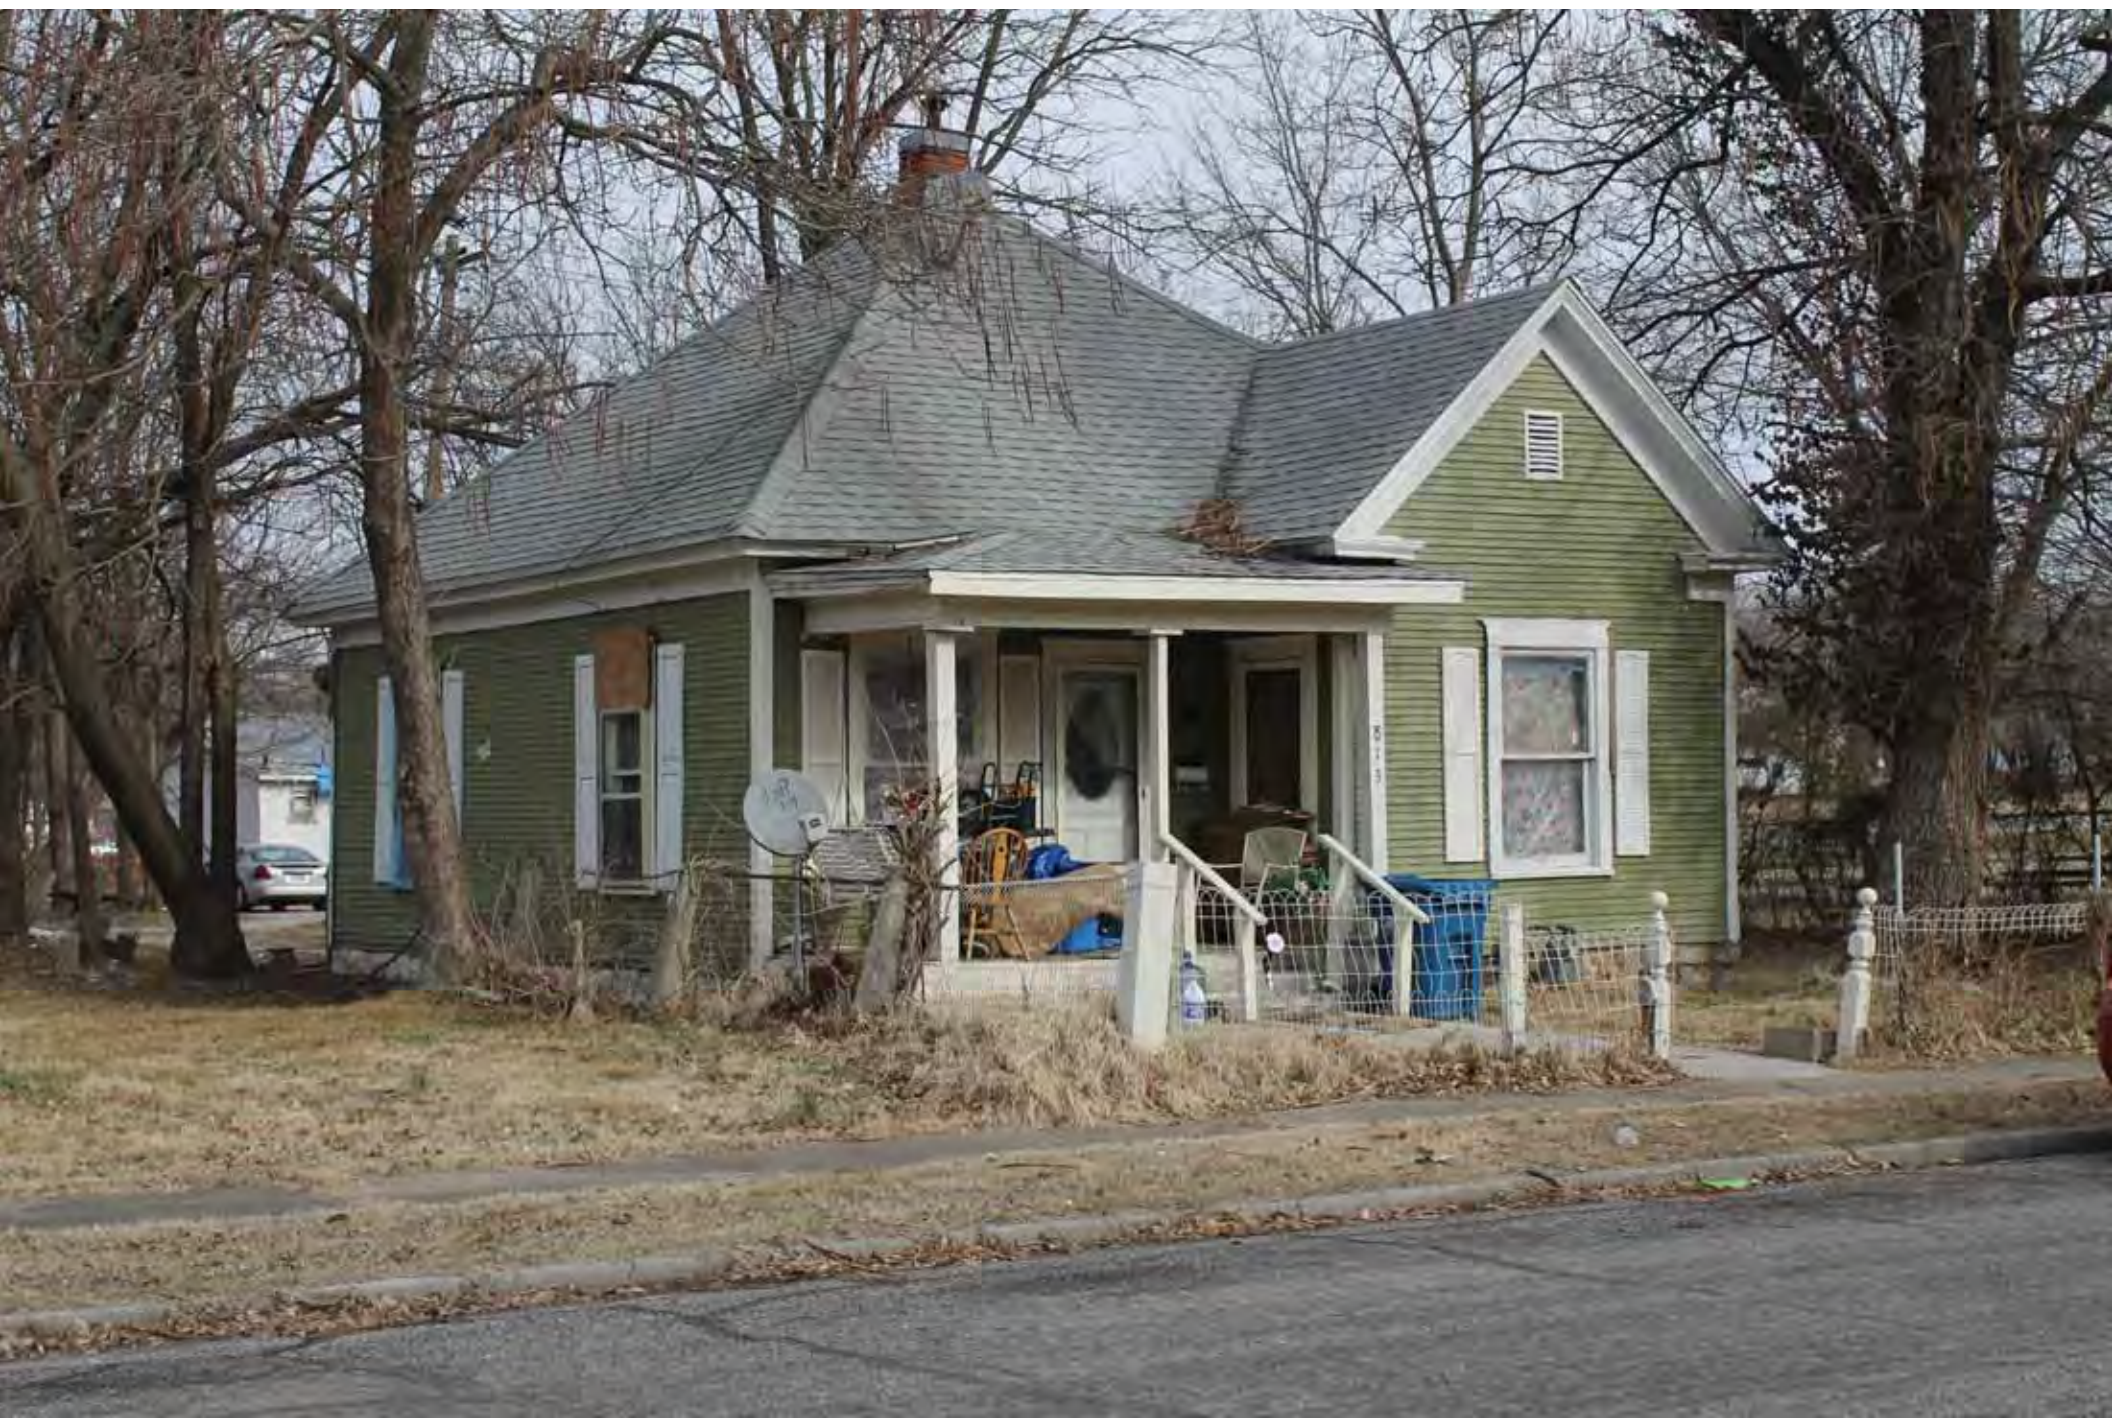
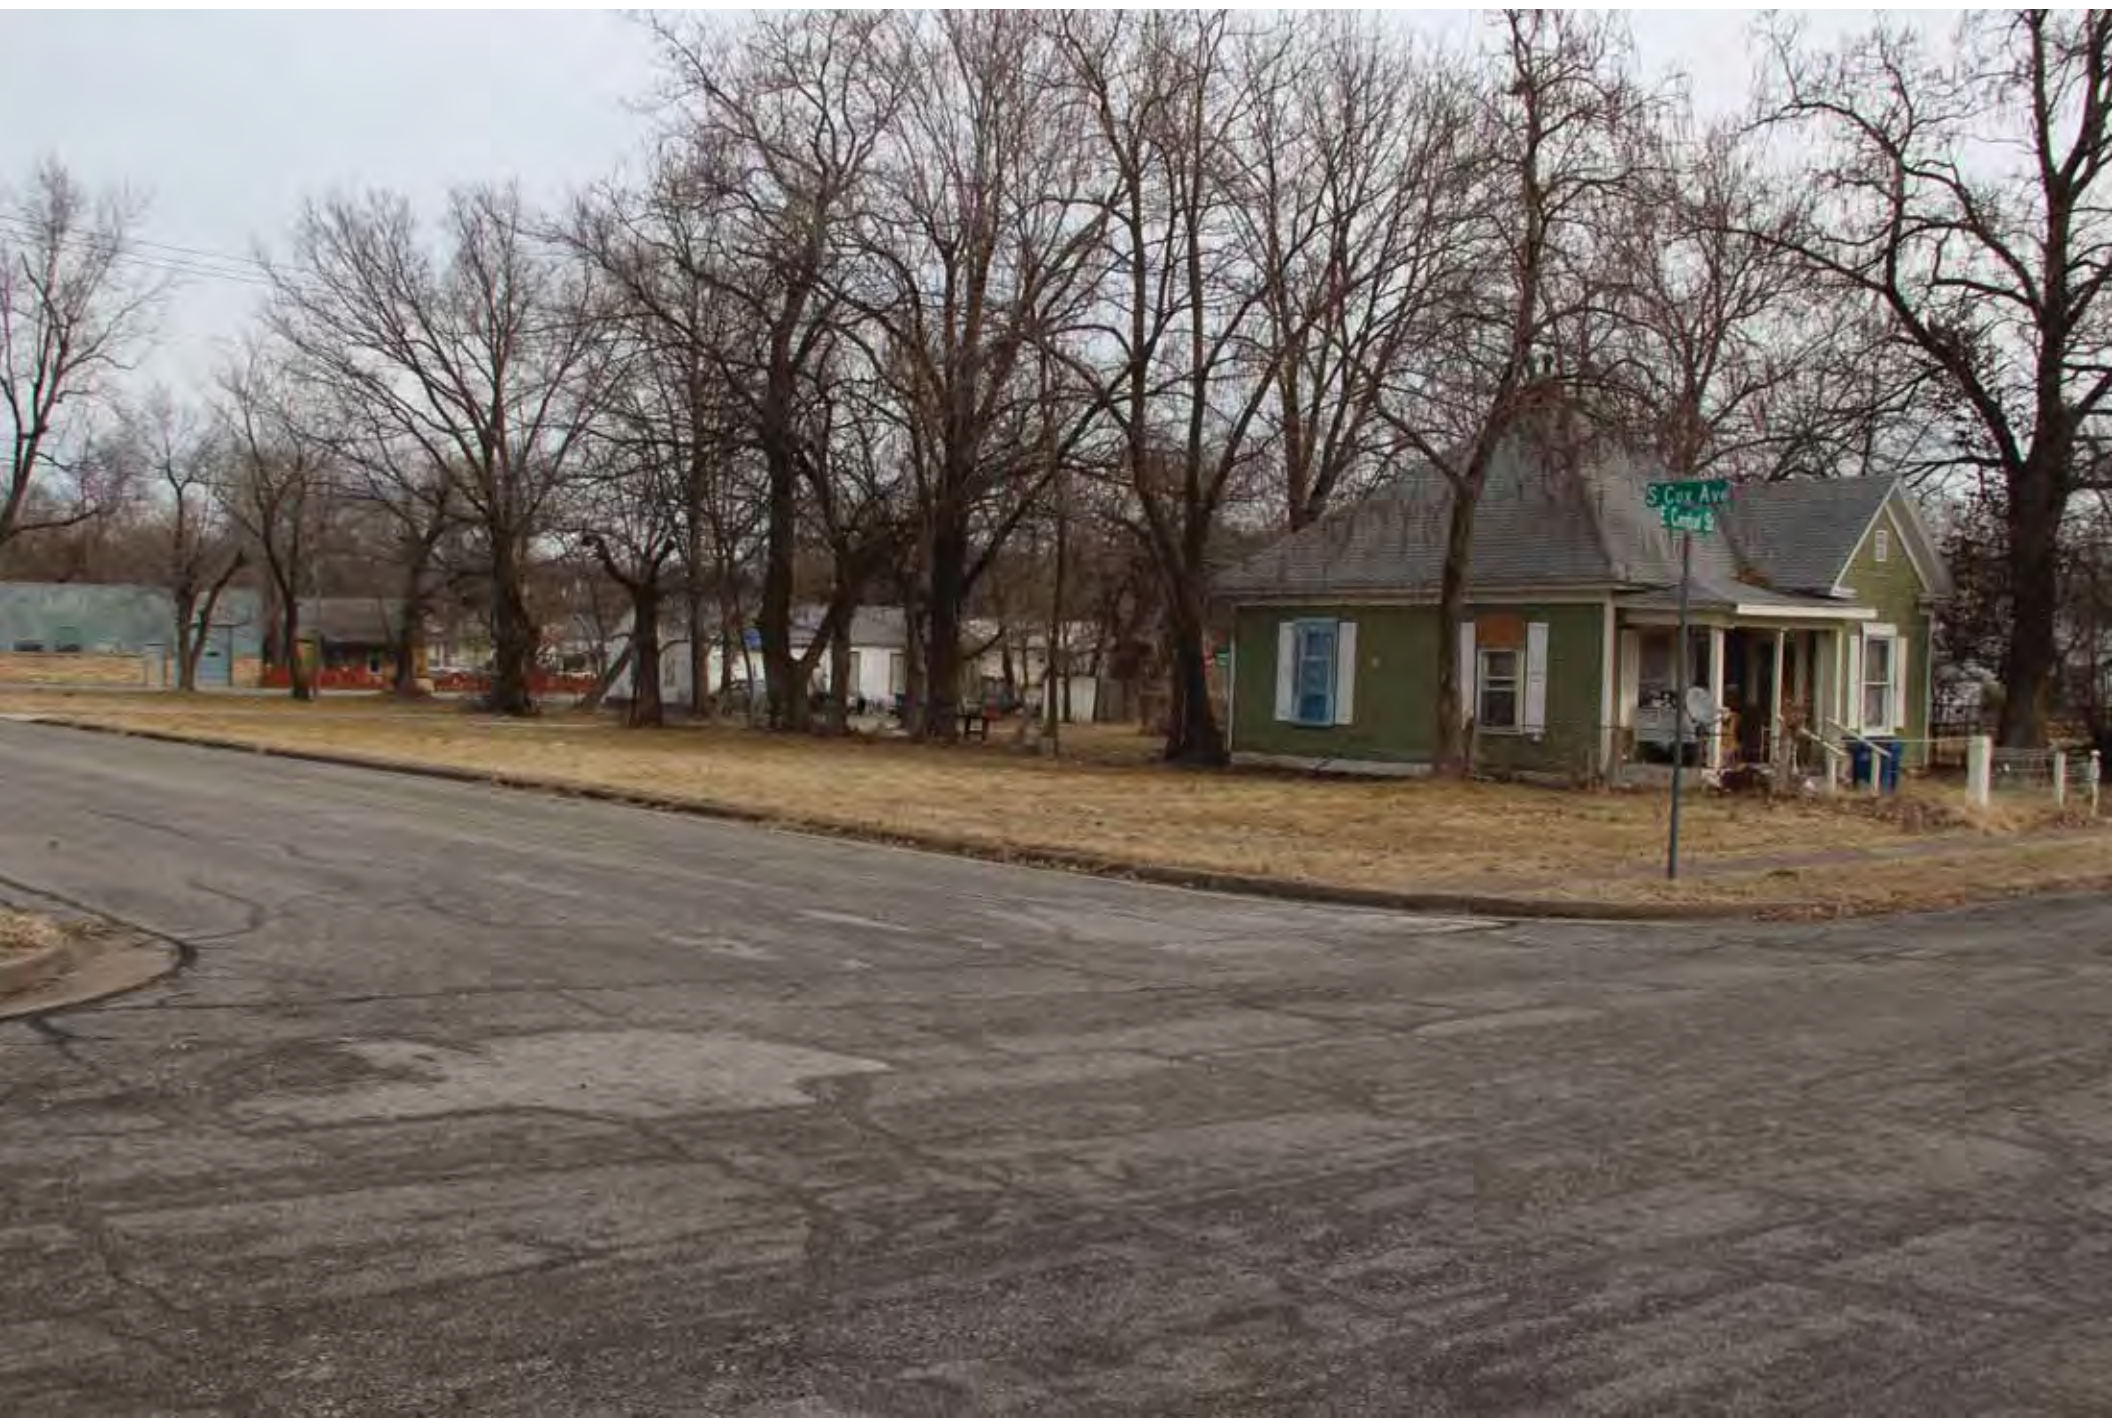
The property at 813 Central street is a one-story frame house, with high-pitched hipped roof with a front-facing gable on the front elevation. The entire roof is covered in asphalt siding and has an interior brick chimney in the middle of the roof. The front facing gable end is on the right side of the front elevation. It has wood returned eaves and on the first floor a large single one-over-one wood window. To the left of this window, on the left side of the front façade, is a small low-pitched hipped roof front porch. It has square wooden posts on a concrete foundation. It shelters the front door, which appears to be original to the house. To the left of the front door is another one-over-one windows. All windows have non-functioning shutters. On the side west elevation are two one-over-one windows, also with non-functioning shutters. The entire house is covered in wood siding.

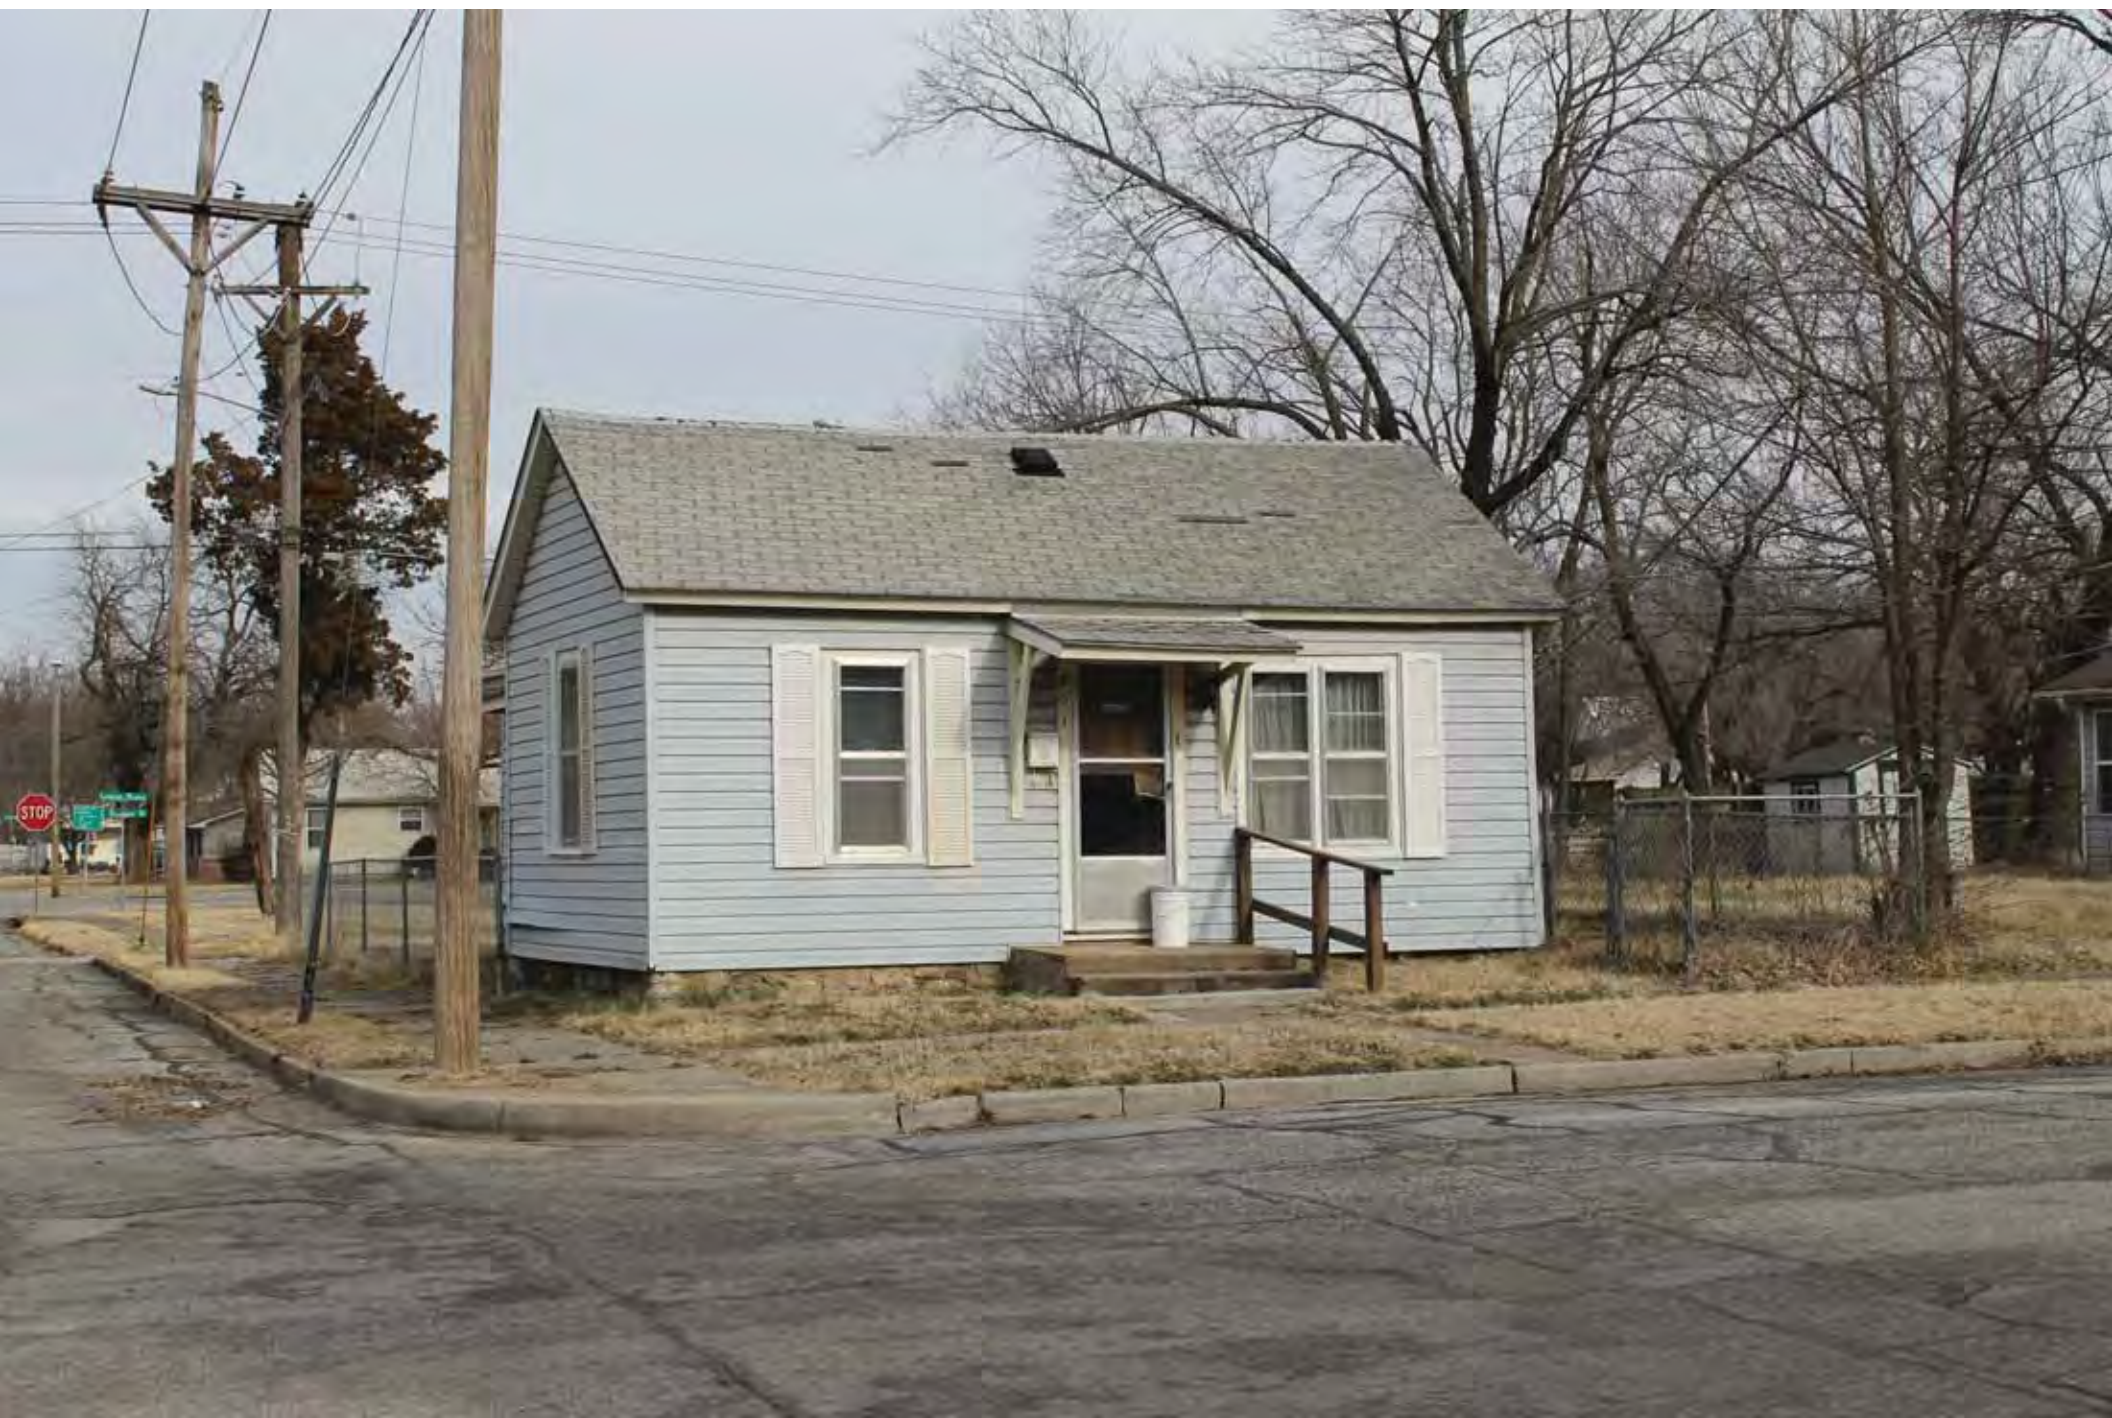
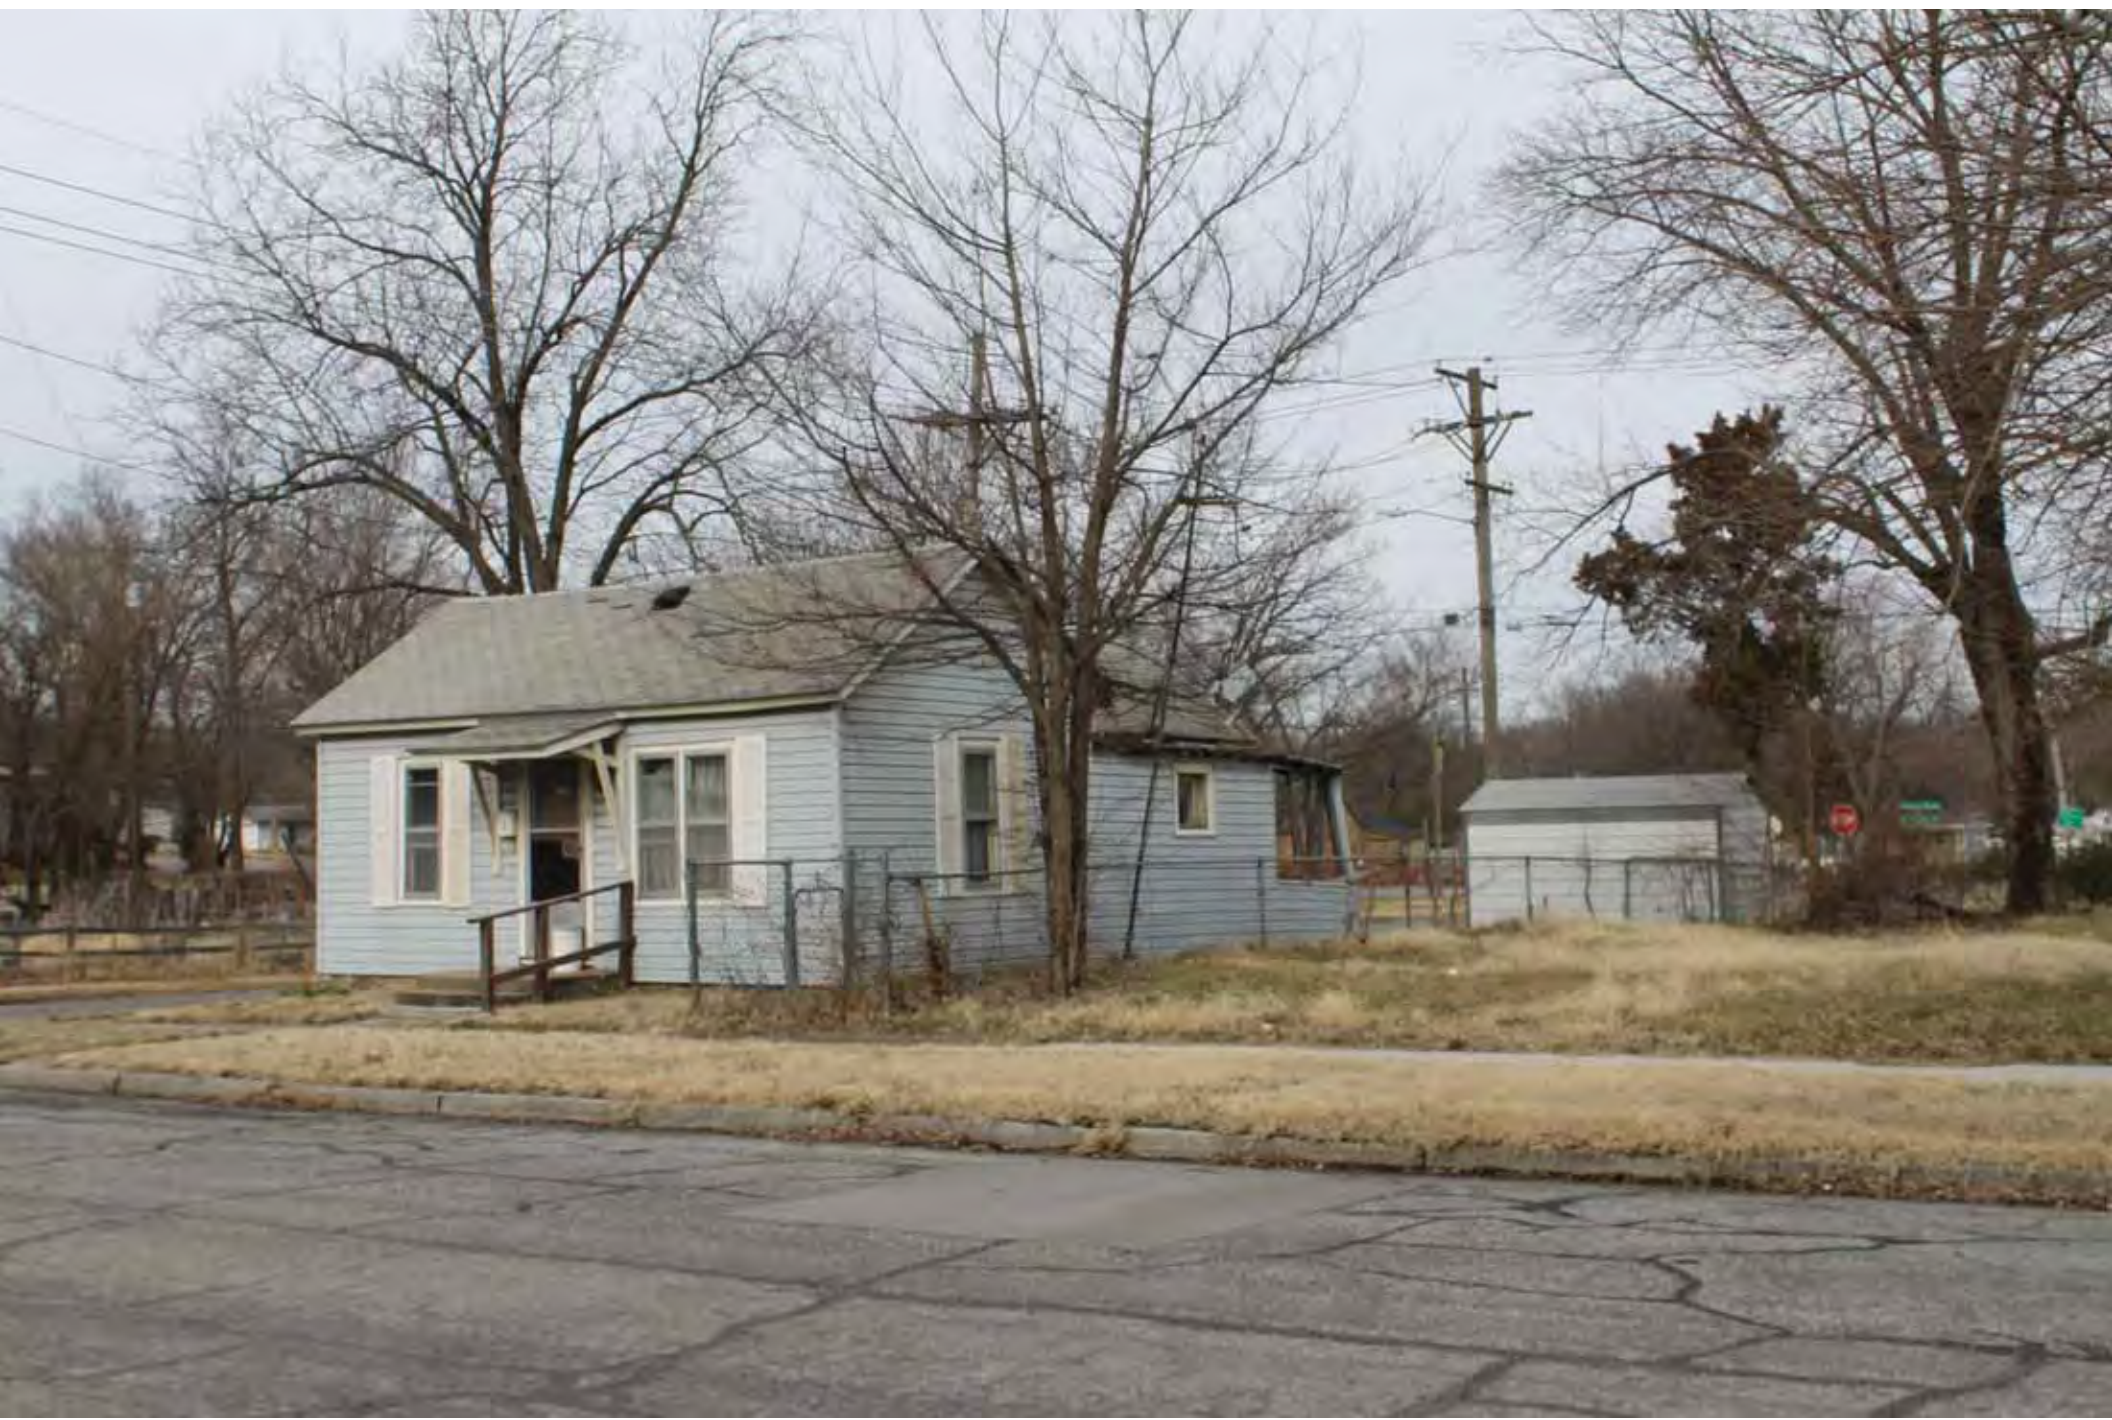
The property at 901 Central street is a one-story frame house, with side-gabled roof covered in asphalt siding. The small house is covered in vinyl siding. In the middle of the front elevation is a single replacement door beneath a wood awning. On the left of the entrance is a single one-over-one vinyl replacement window. To the right of the entrance is a double one-over-one vinyl replacement window. There are single windows on the side elevations. All windows have non-functioning shutters.

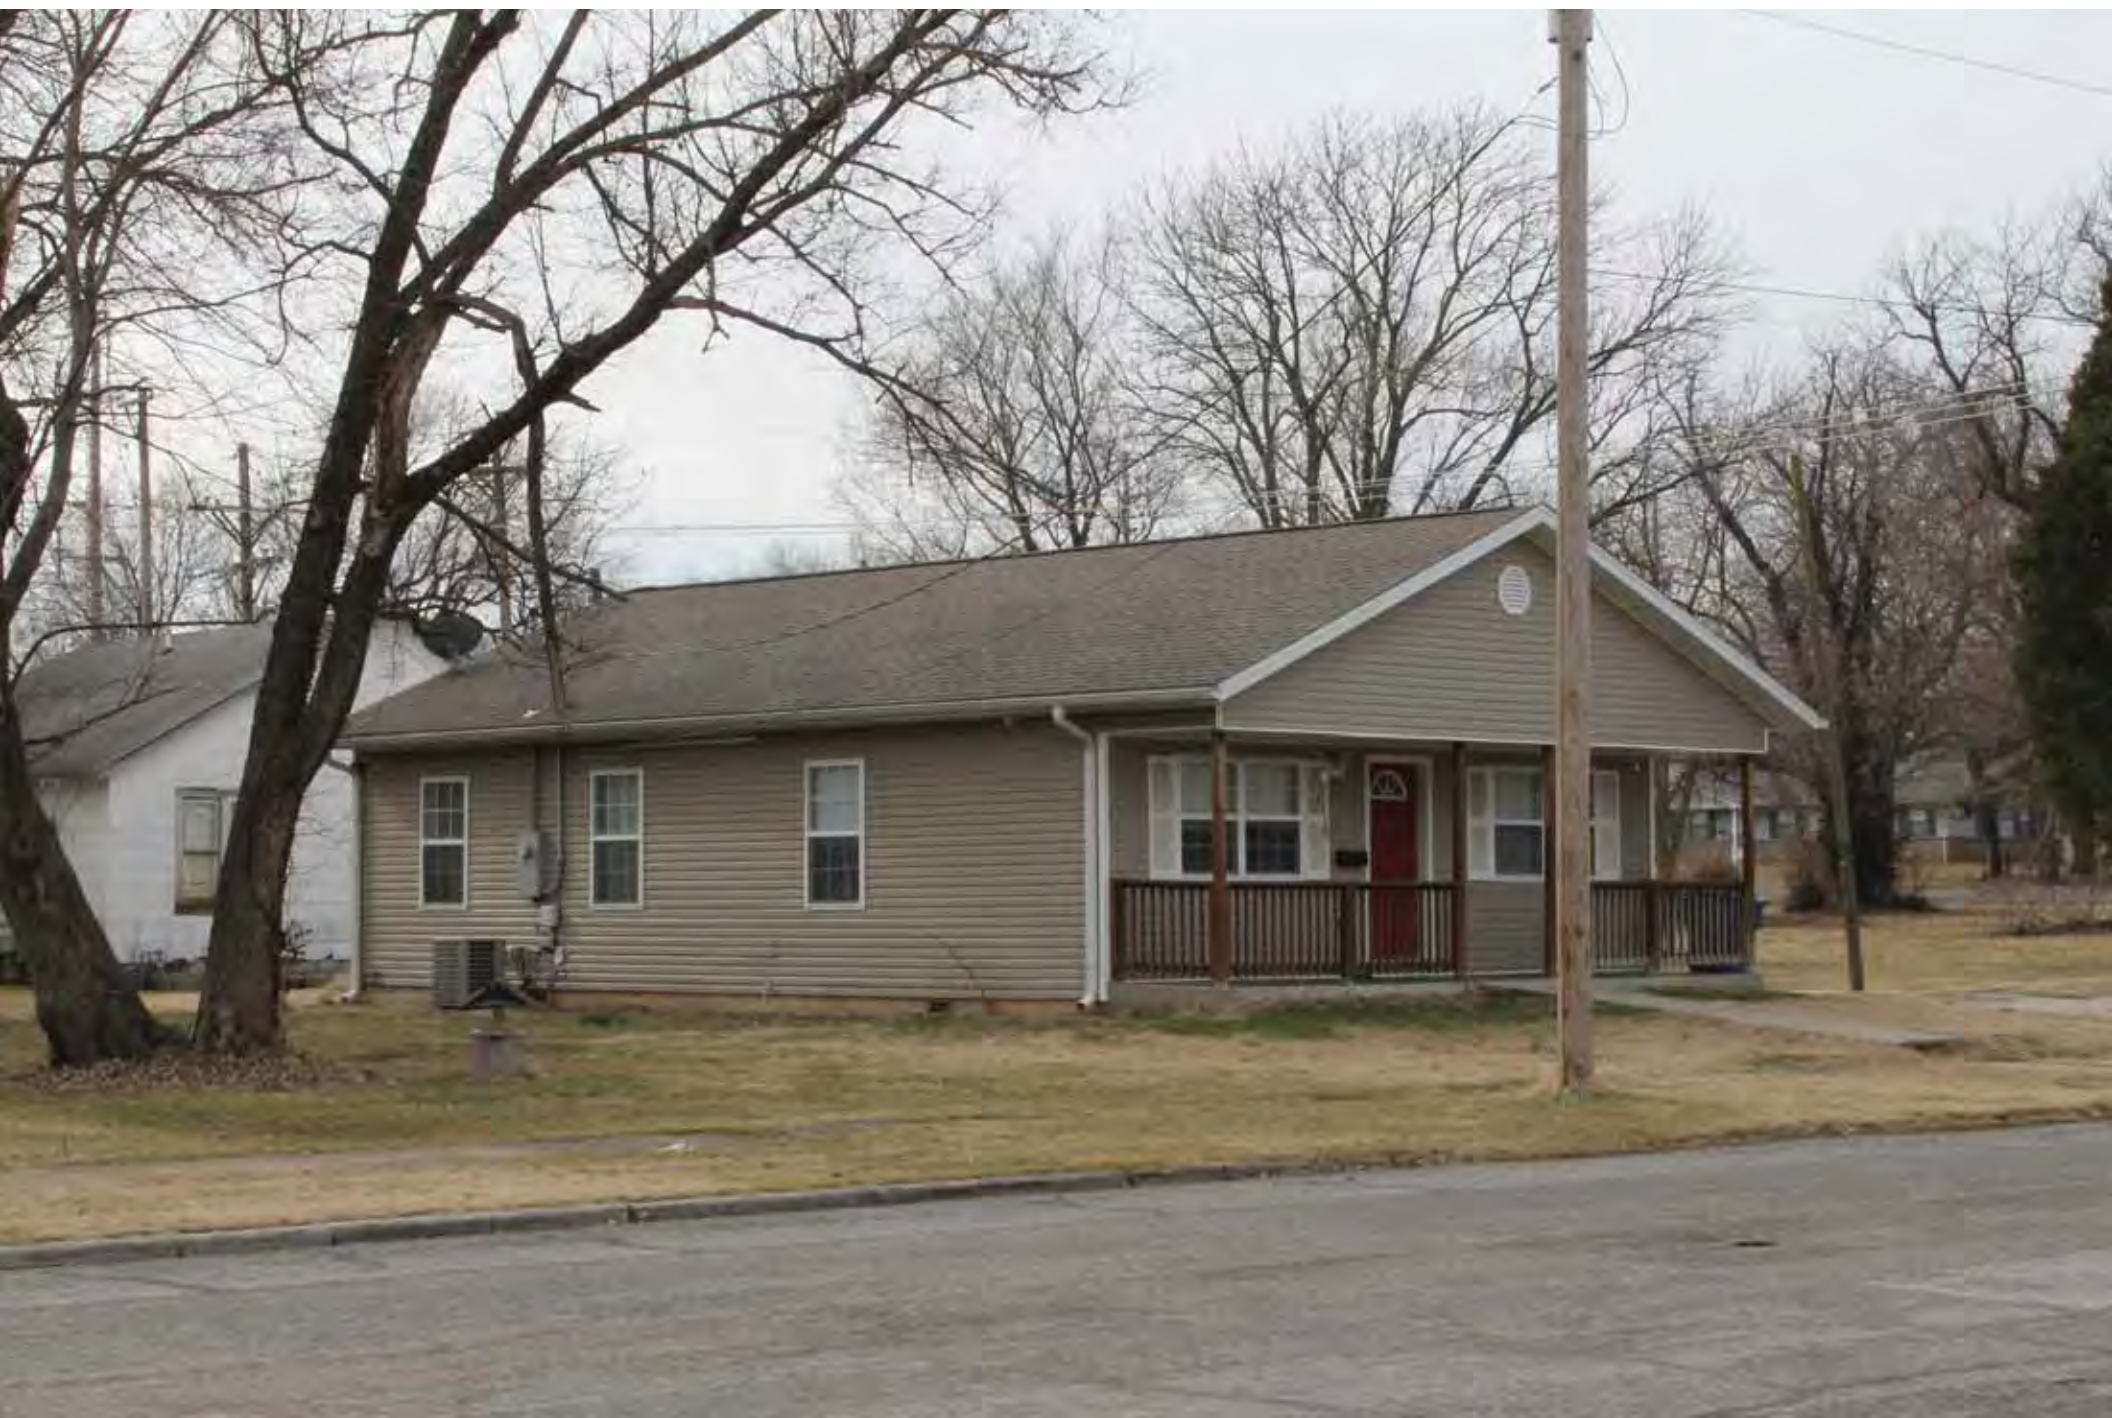
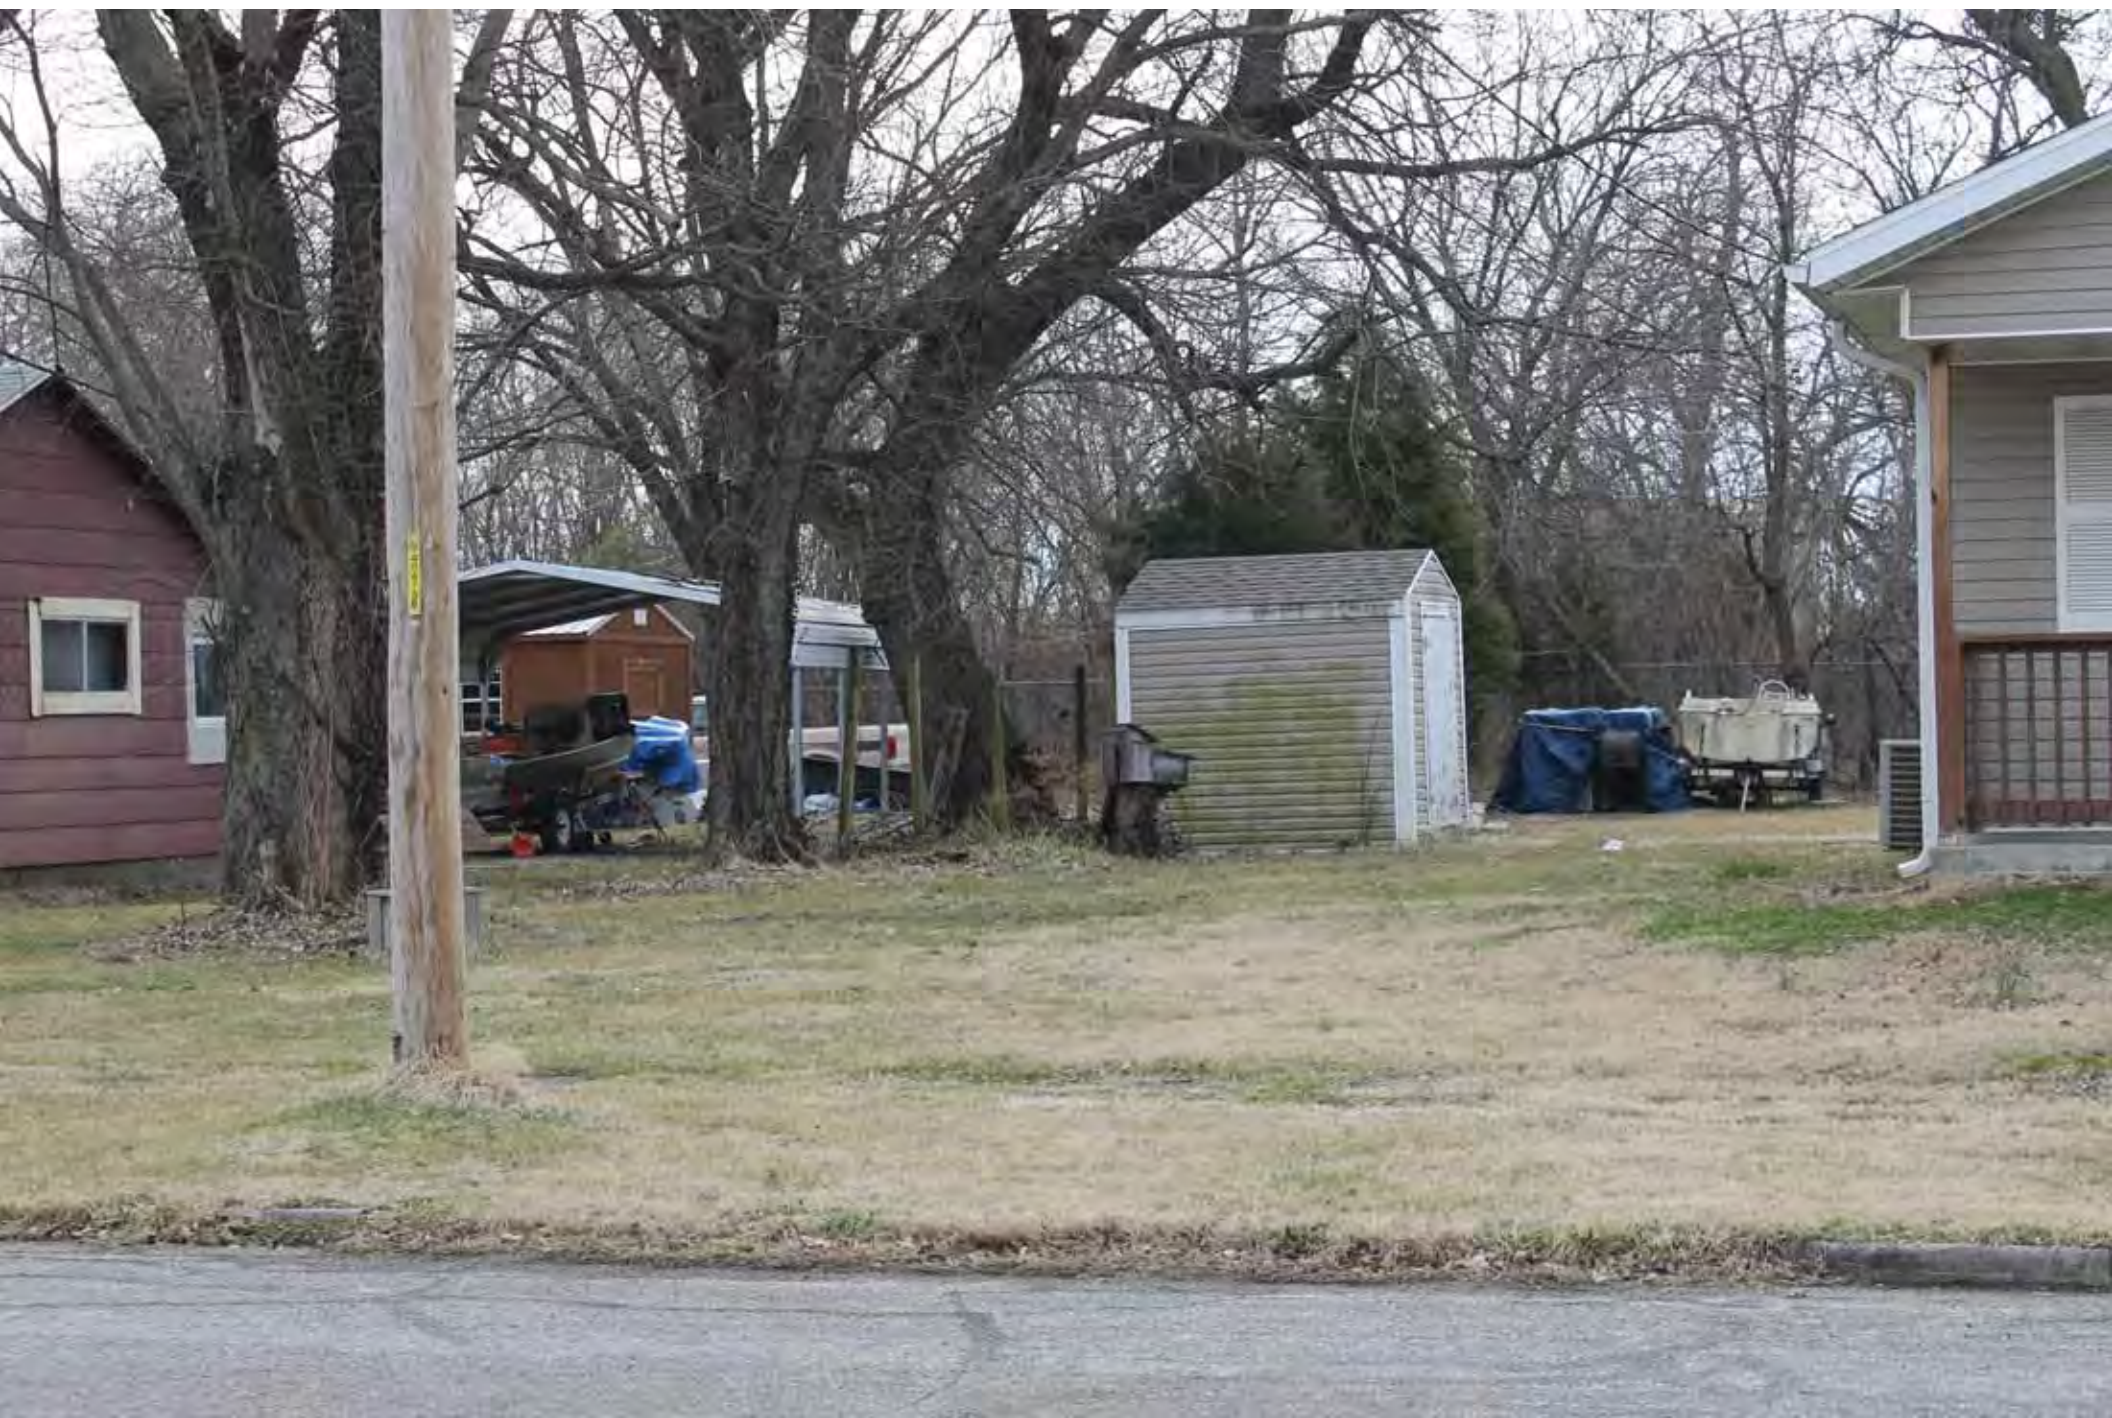
The property at 902 Central street is a one-story frame house, with a front facing gable roof covered in asphalt siding. It has rectangular plan with a veranda along the front elevation. The porch sits on wooden posts on a concrete foundation. It shelters a single front door flanked on either side by six-over-six double vinyl windows. All windows have non-functioning shutters. On the side elevations are three six-over-six single vinyl windows.
