MISSOURI DEPARTMENT OF NATURAL RESOURCES
STATE HISTORIC PRESERVATION OFFICE, P.O. Box 176, Jefferson City, MO 65102
ARCHITECTURAL/HISTORIC INVENTORY FORM

1. Survey No. JP-AS-007-001		2. Survey name: East Town (Original Joplin) Historic Survey Phase 2	
3. County: JASPER		4. Address (Street No.) 618	Street (name) E. 2 nd Street
5. City: Joplin	Vicinity: <input type="checkbox"/>	6. Geographical Reference:	7. Township/Range/Section: T: R: S:
8. Historic name (if known):		9. Present/other name (if known):	
10. Ownership: <input checked="" type="checkbox"/> Private <input type="checkbox"/> Public		11a. Historic use (if known): Domestic: Single Dwelling	11b. Current use: Domestic: Single Dwelling

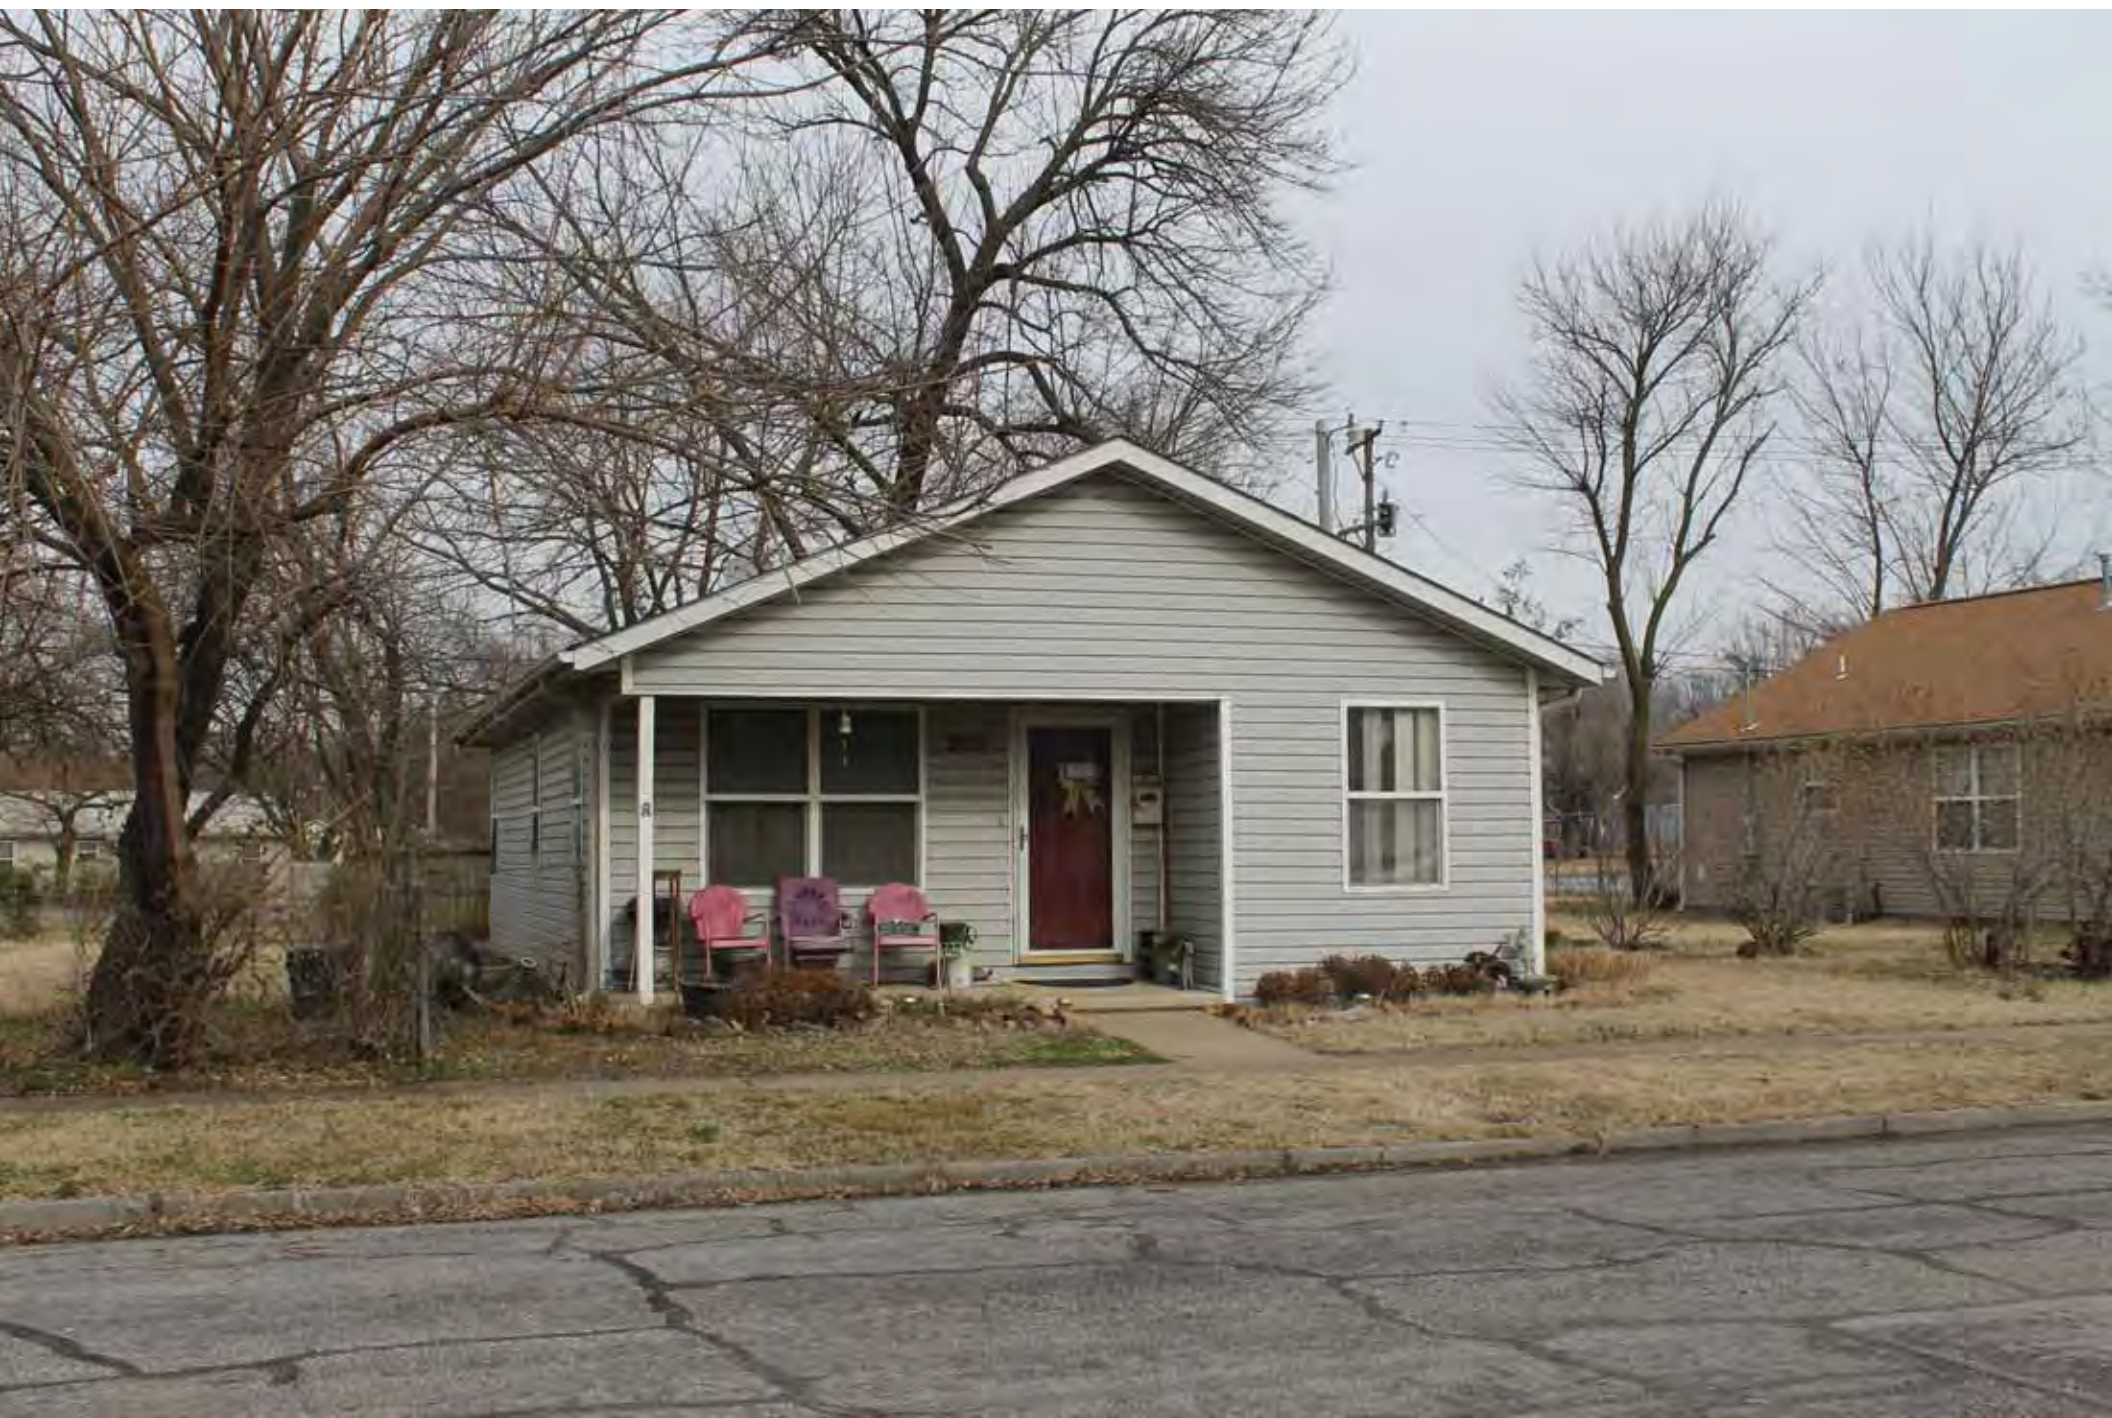
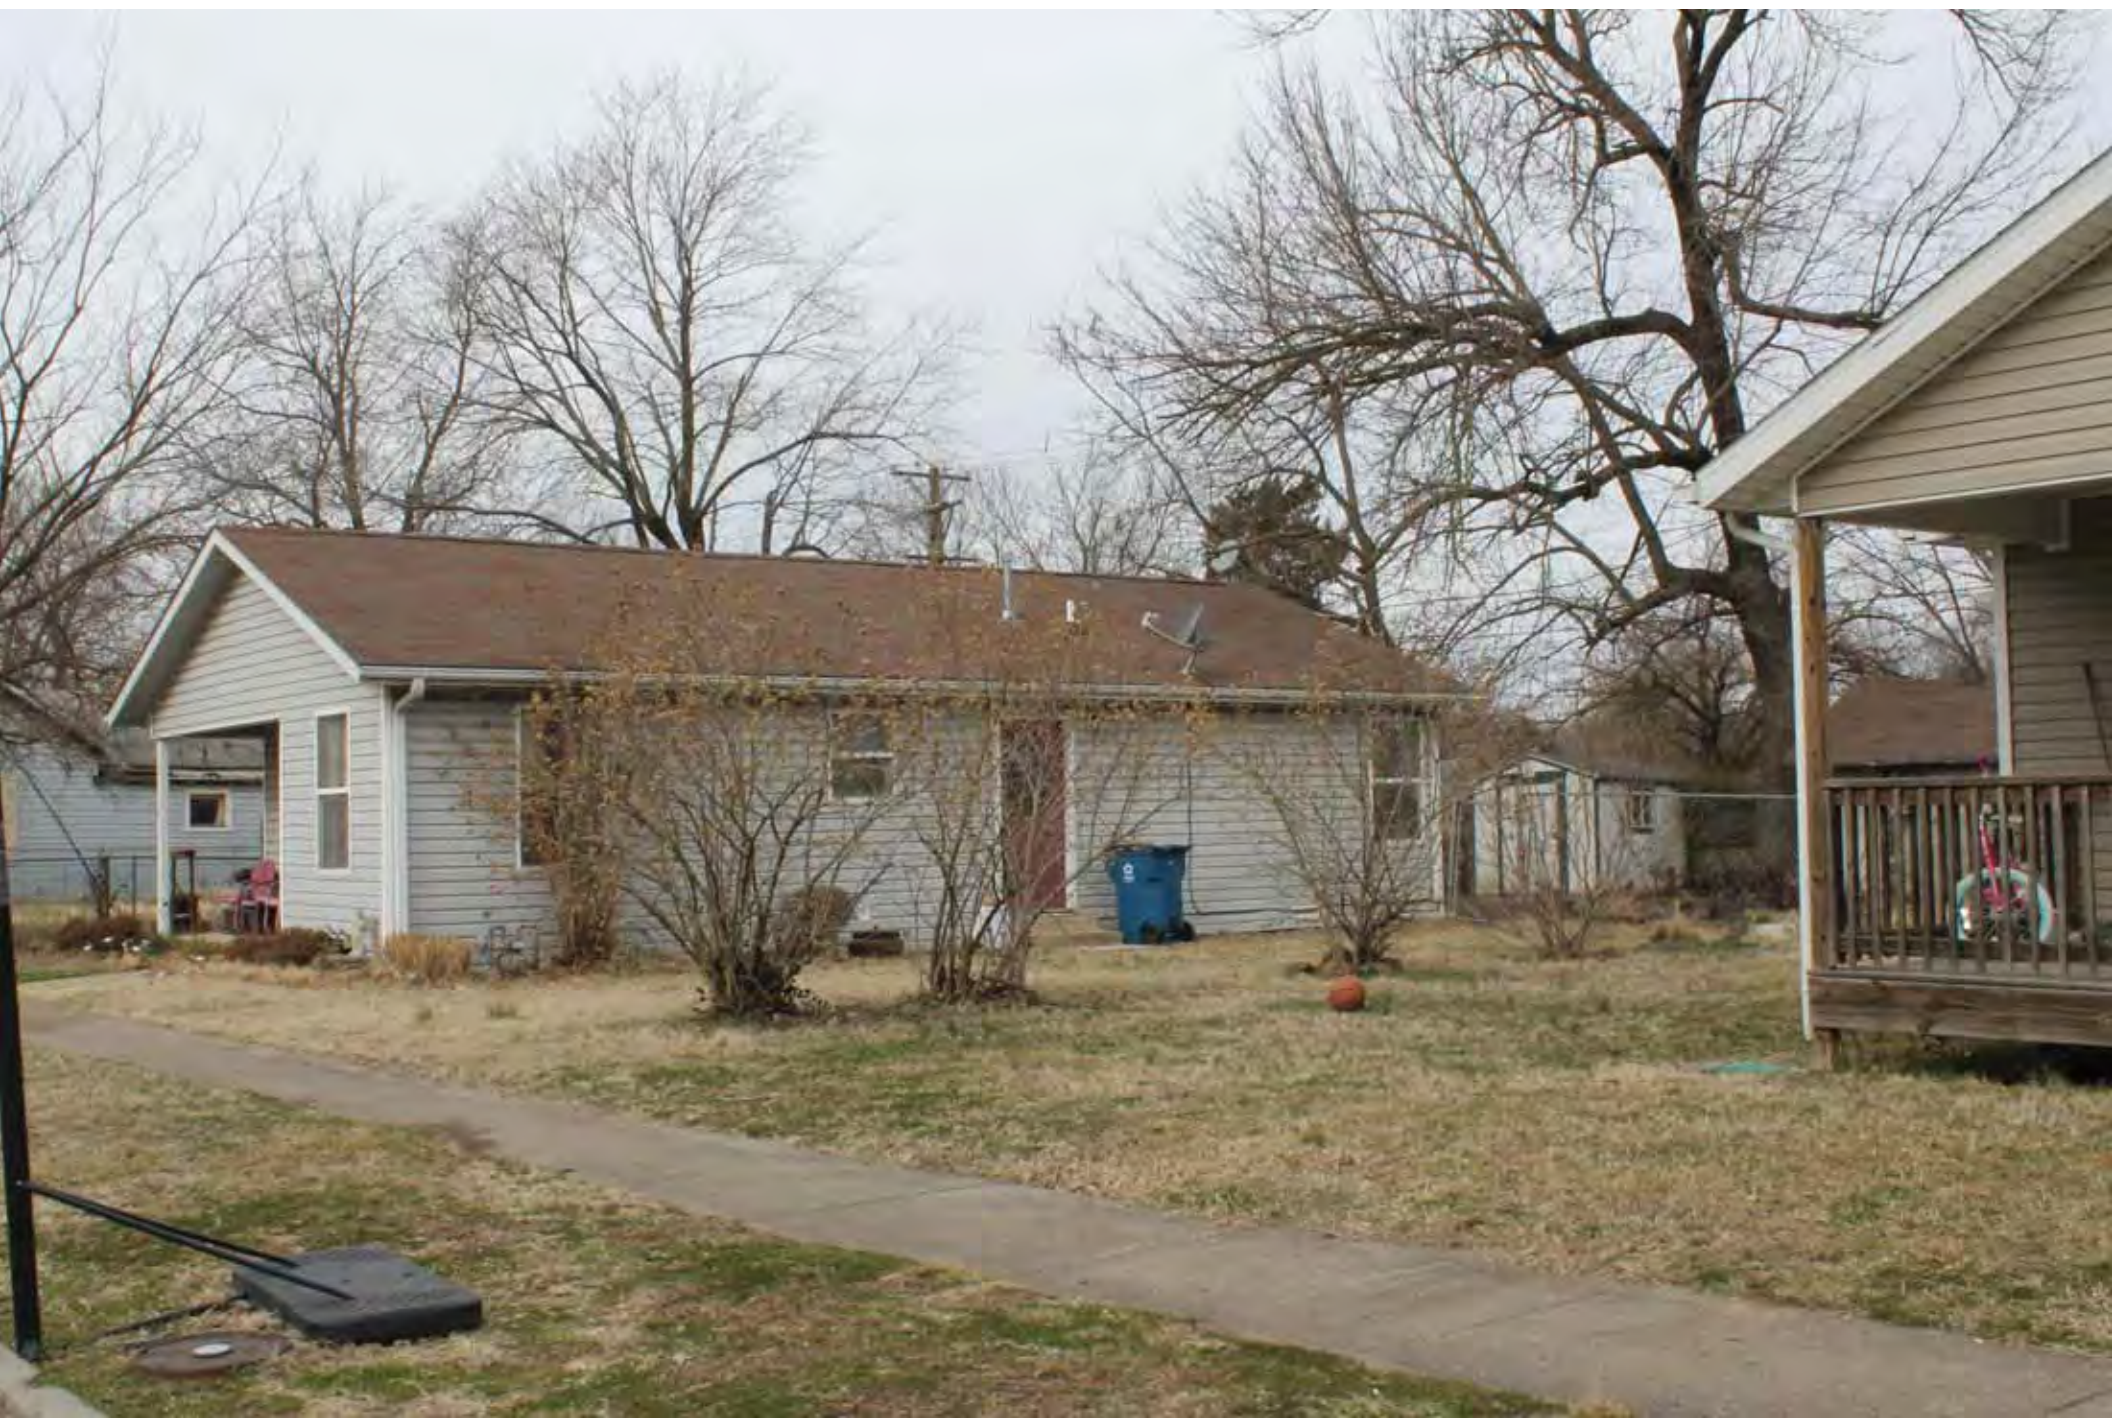
<p>41. (cont.) Description of primary resource. Expand box as necessary, or add continuation pages.</p> <p>The property at 909 Central street is a one-story frame house, with a front facing gable roof covered in asphalt siding. It has rectangular plan with a porch along the west side of the front elevation. The porch sits on wooden posts on a concrete foundation. It shelters a single front door and double one-over-one vinyl windows. To the right of the porch is a single one-over-one vinyl window.</p>

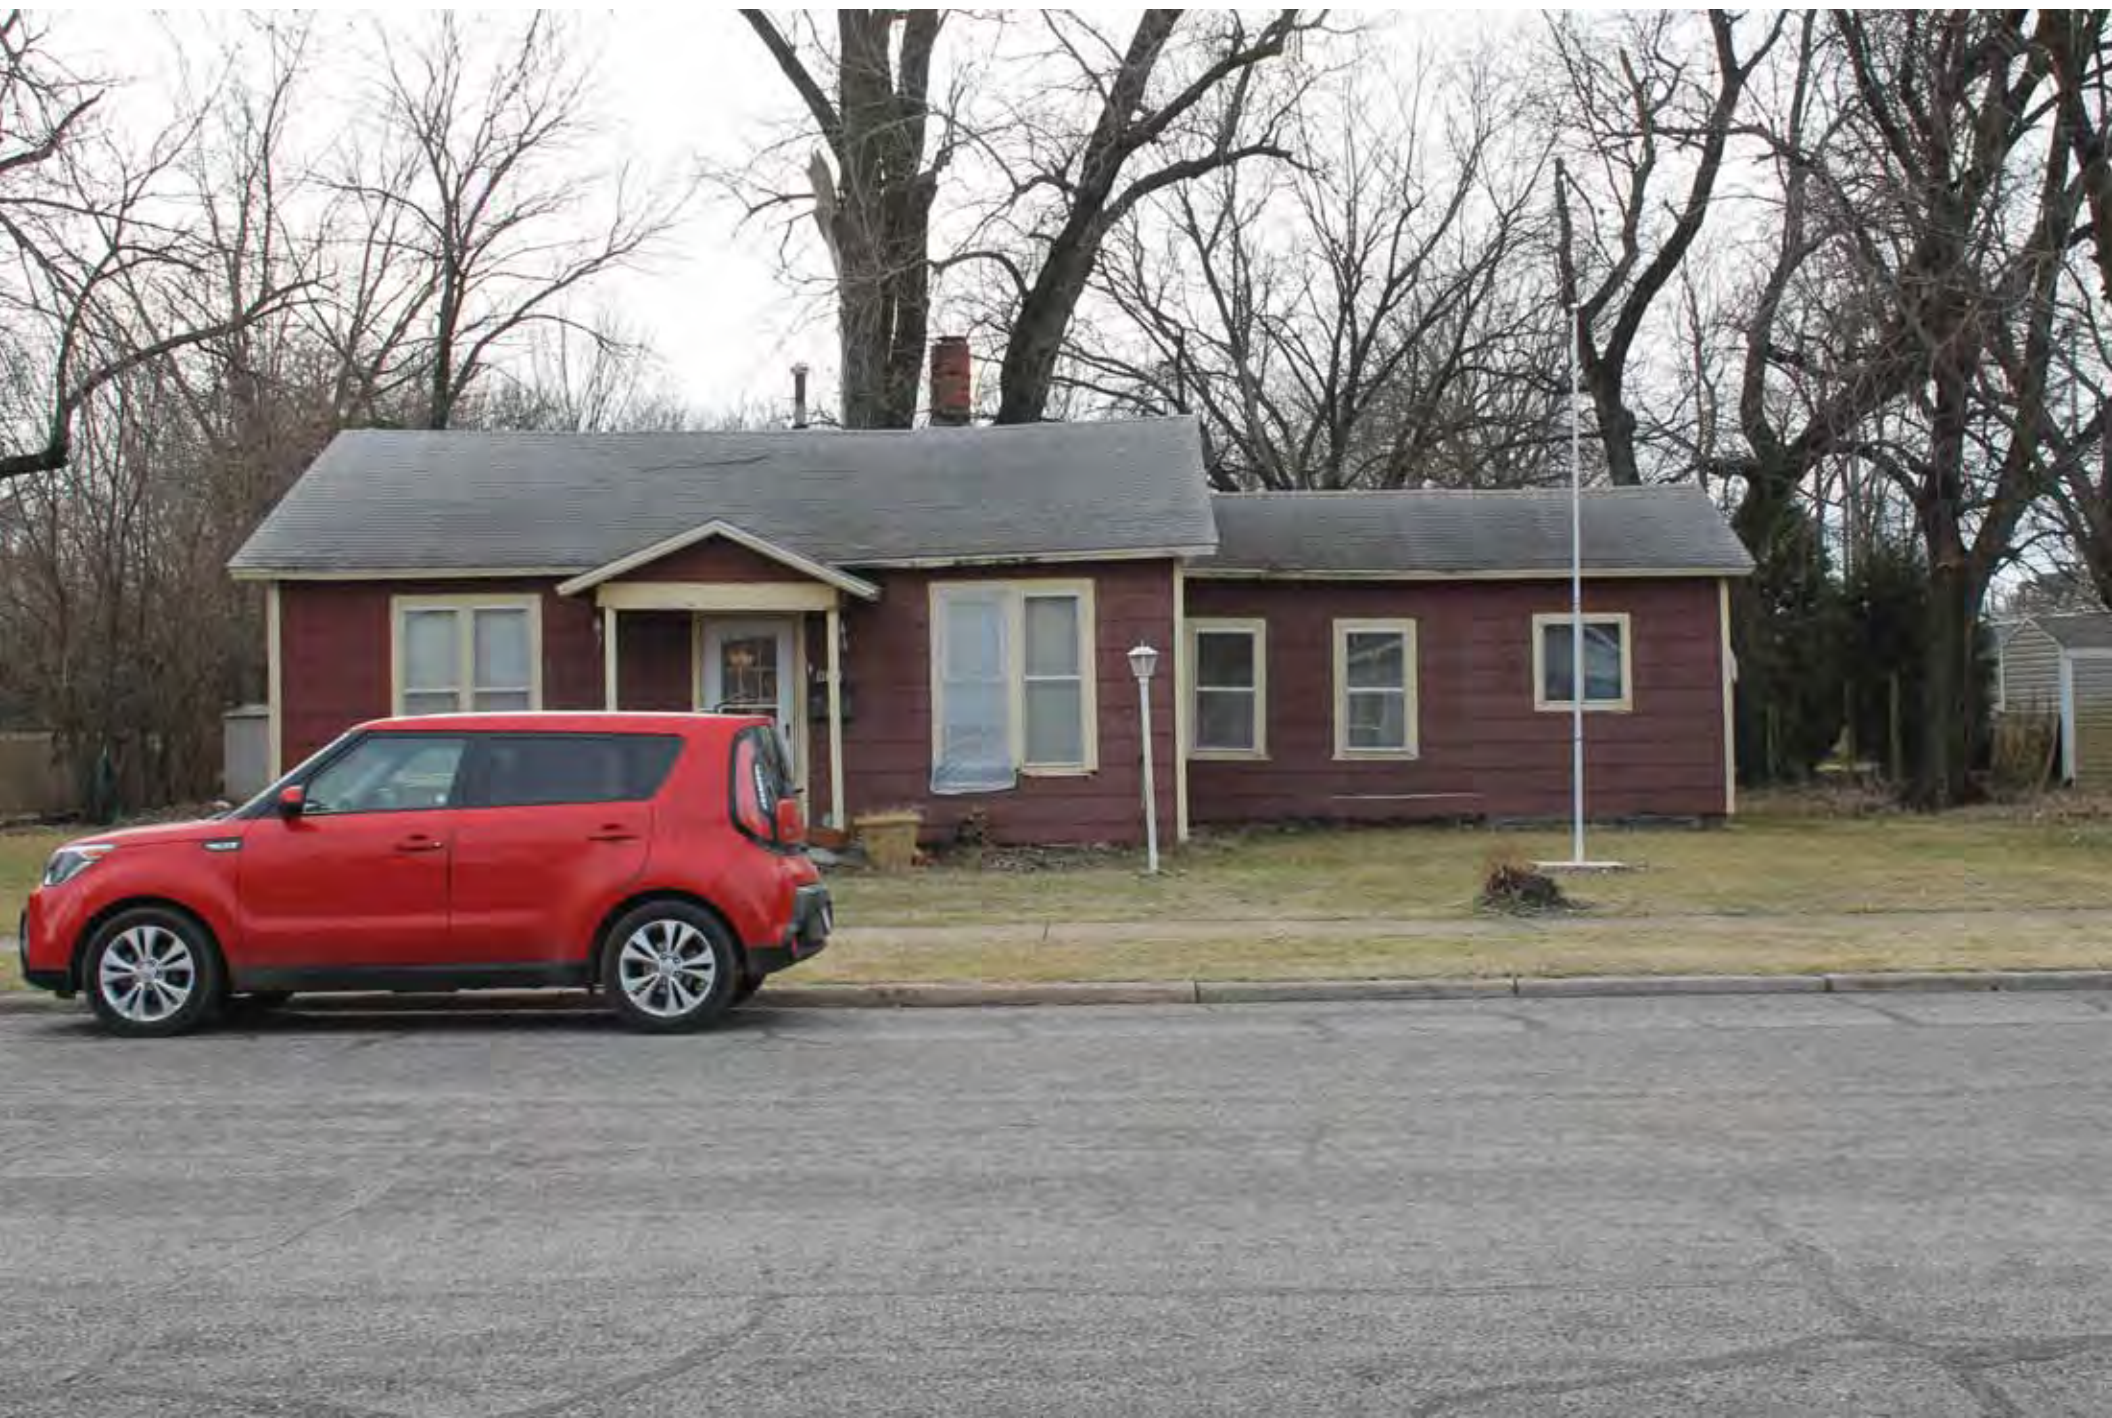
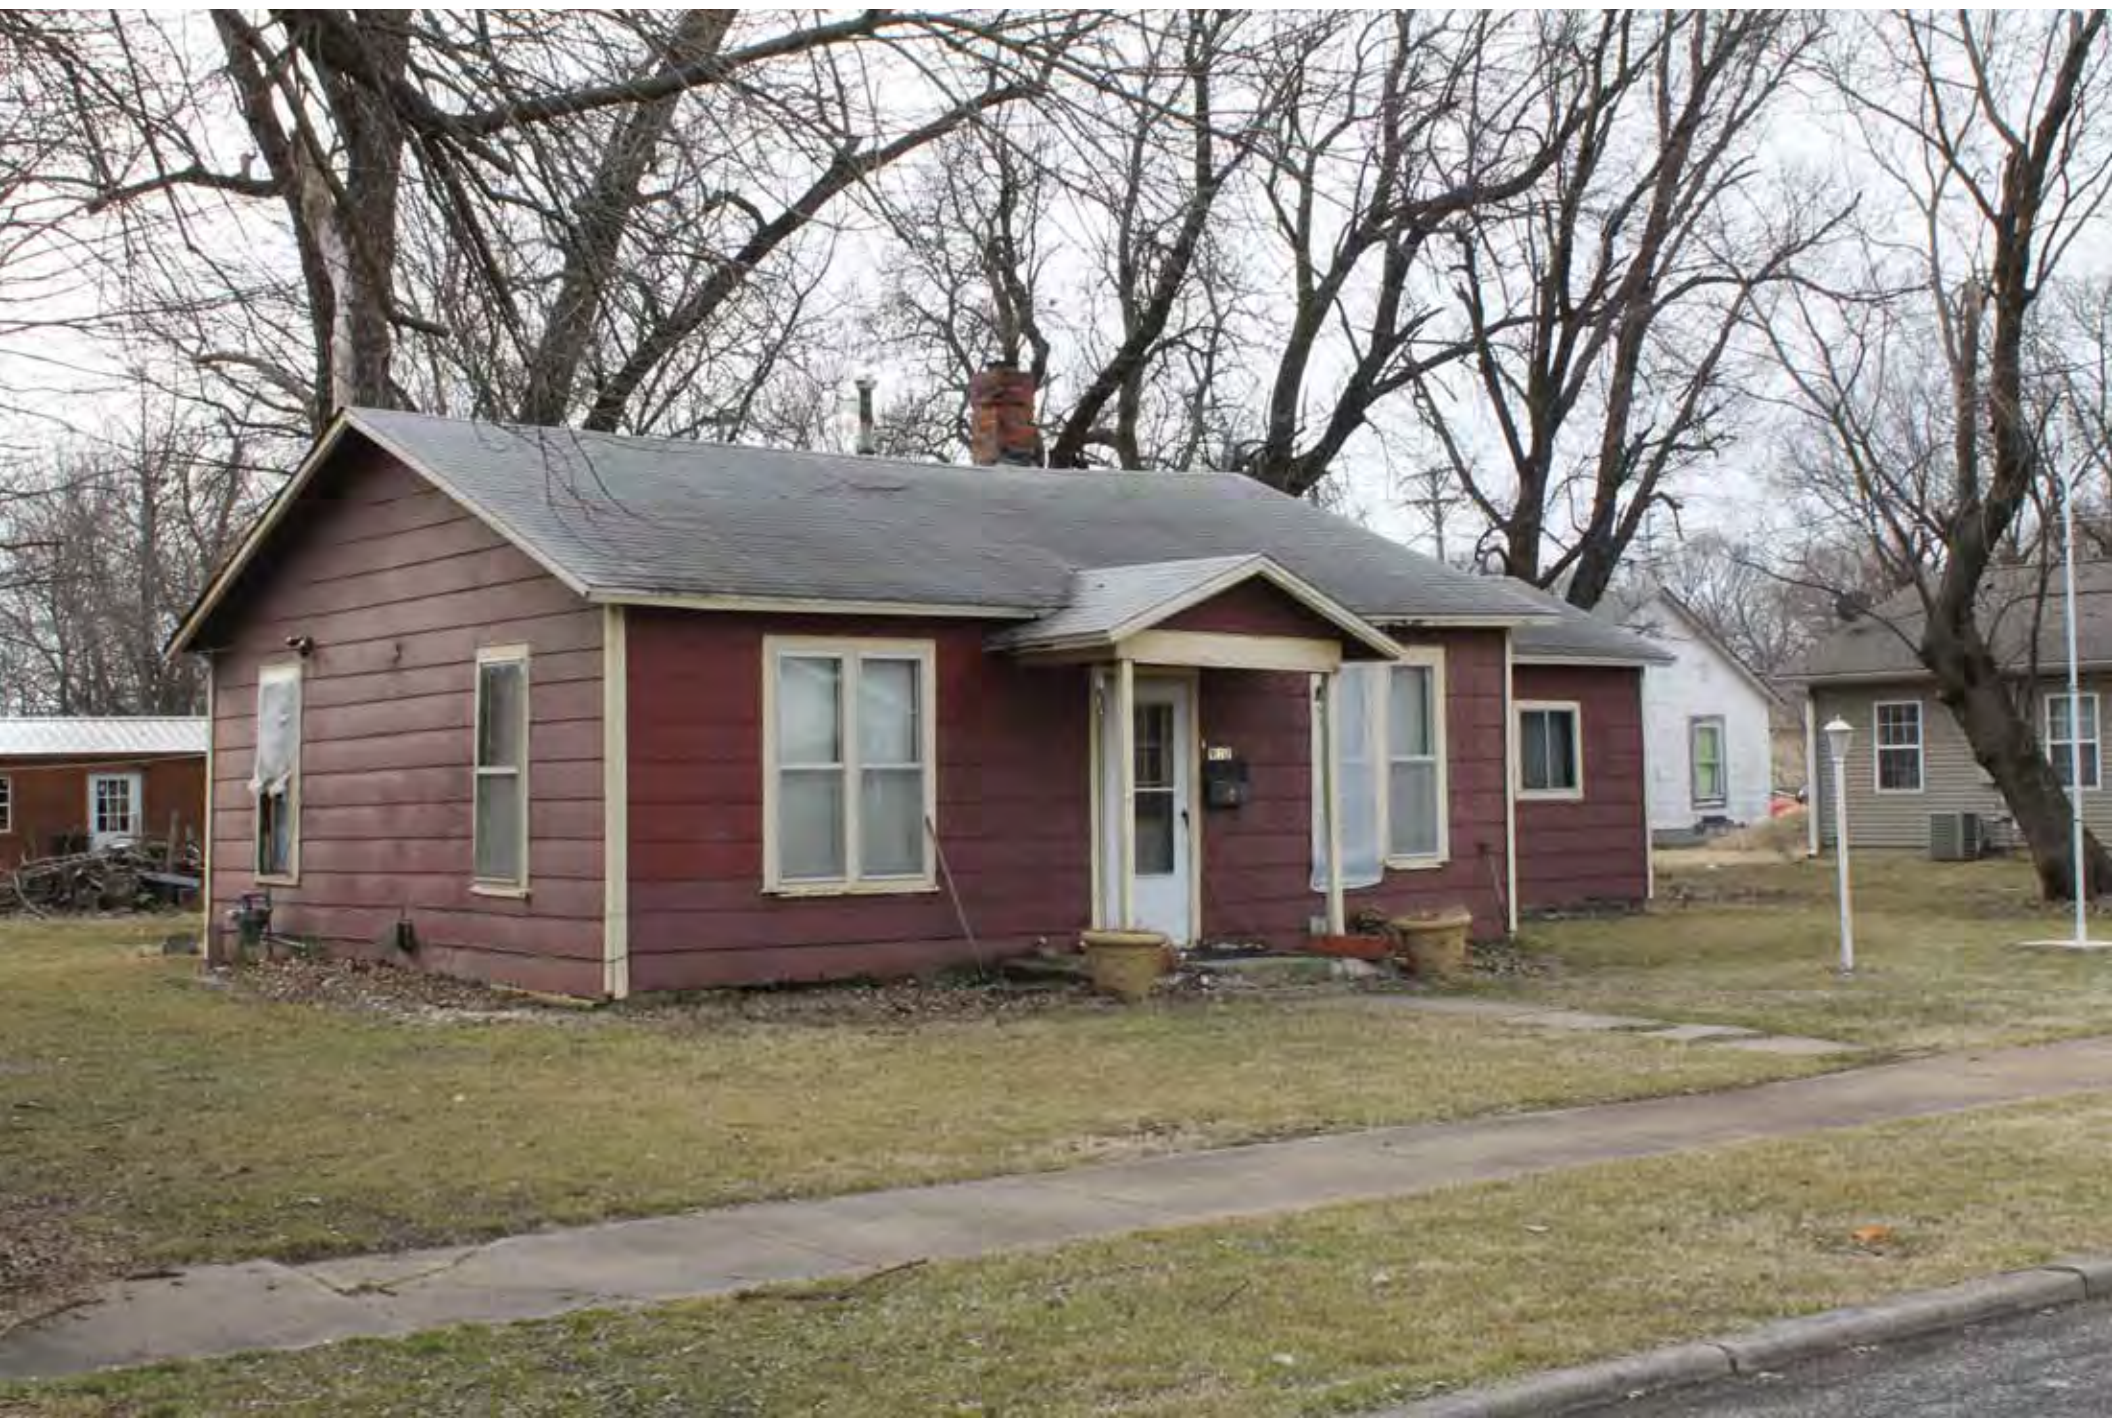
The property at 902 Central street is a one-story frame house, with a side-gable roof covered in asphalt siding. In the center of the roof is a brick chimney. The front façade has a small, attached open porch, with a front facing gable awning roof. It sits on wood posts on a concrete foundation. It shelters a single entrance door. Flanking the porch on either side are double one-over-one windows. This portion of the house appears to be the original dwelling. On the west side of the house is a small addition, also with a side-gabled roof, although it sits lower than the original roofline. On the front elevation of this addition are three single windows. Two are one-over-one and one is a small casement window. On the side elevations are single one-over-one windows.

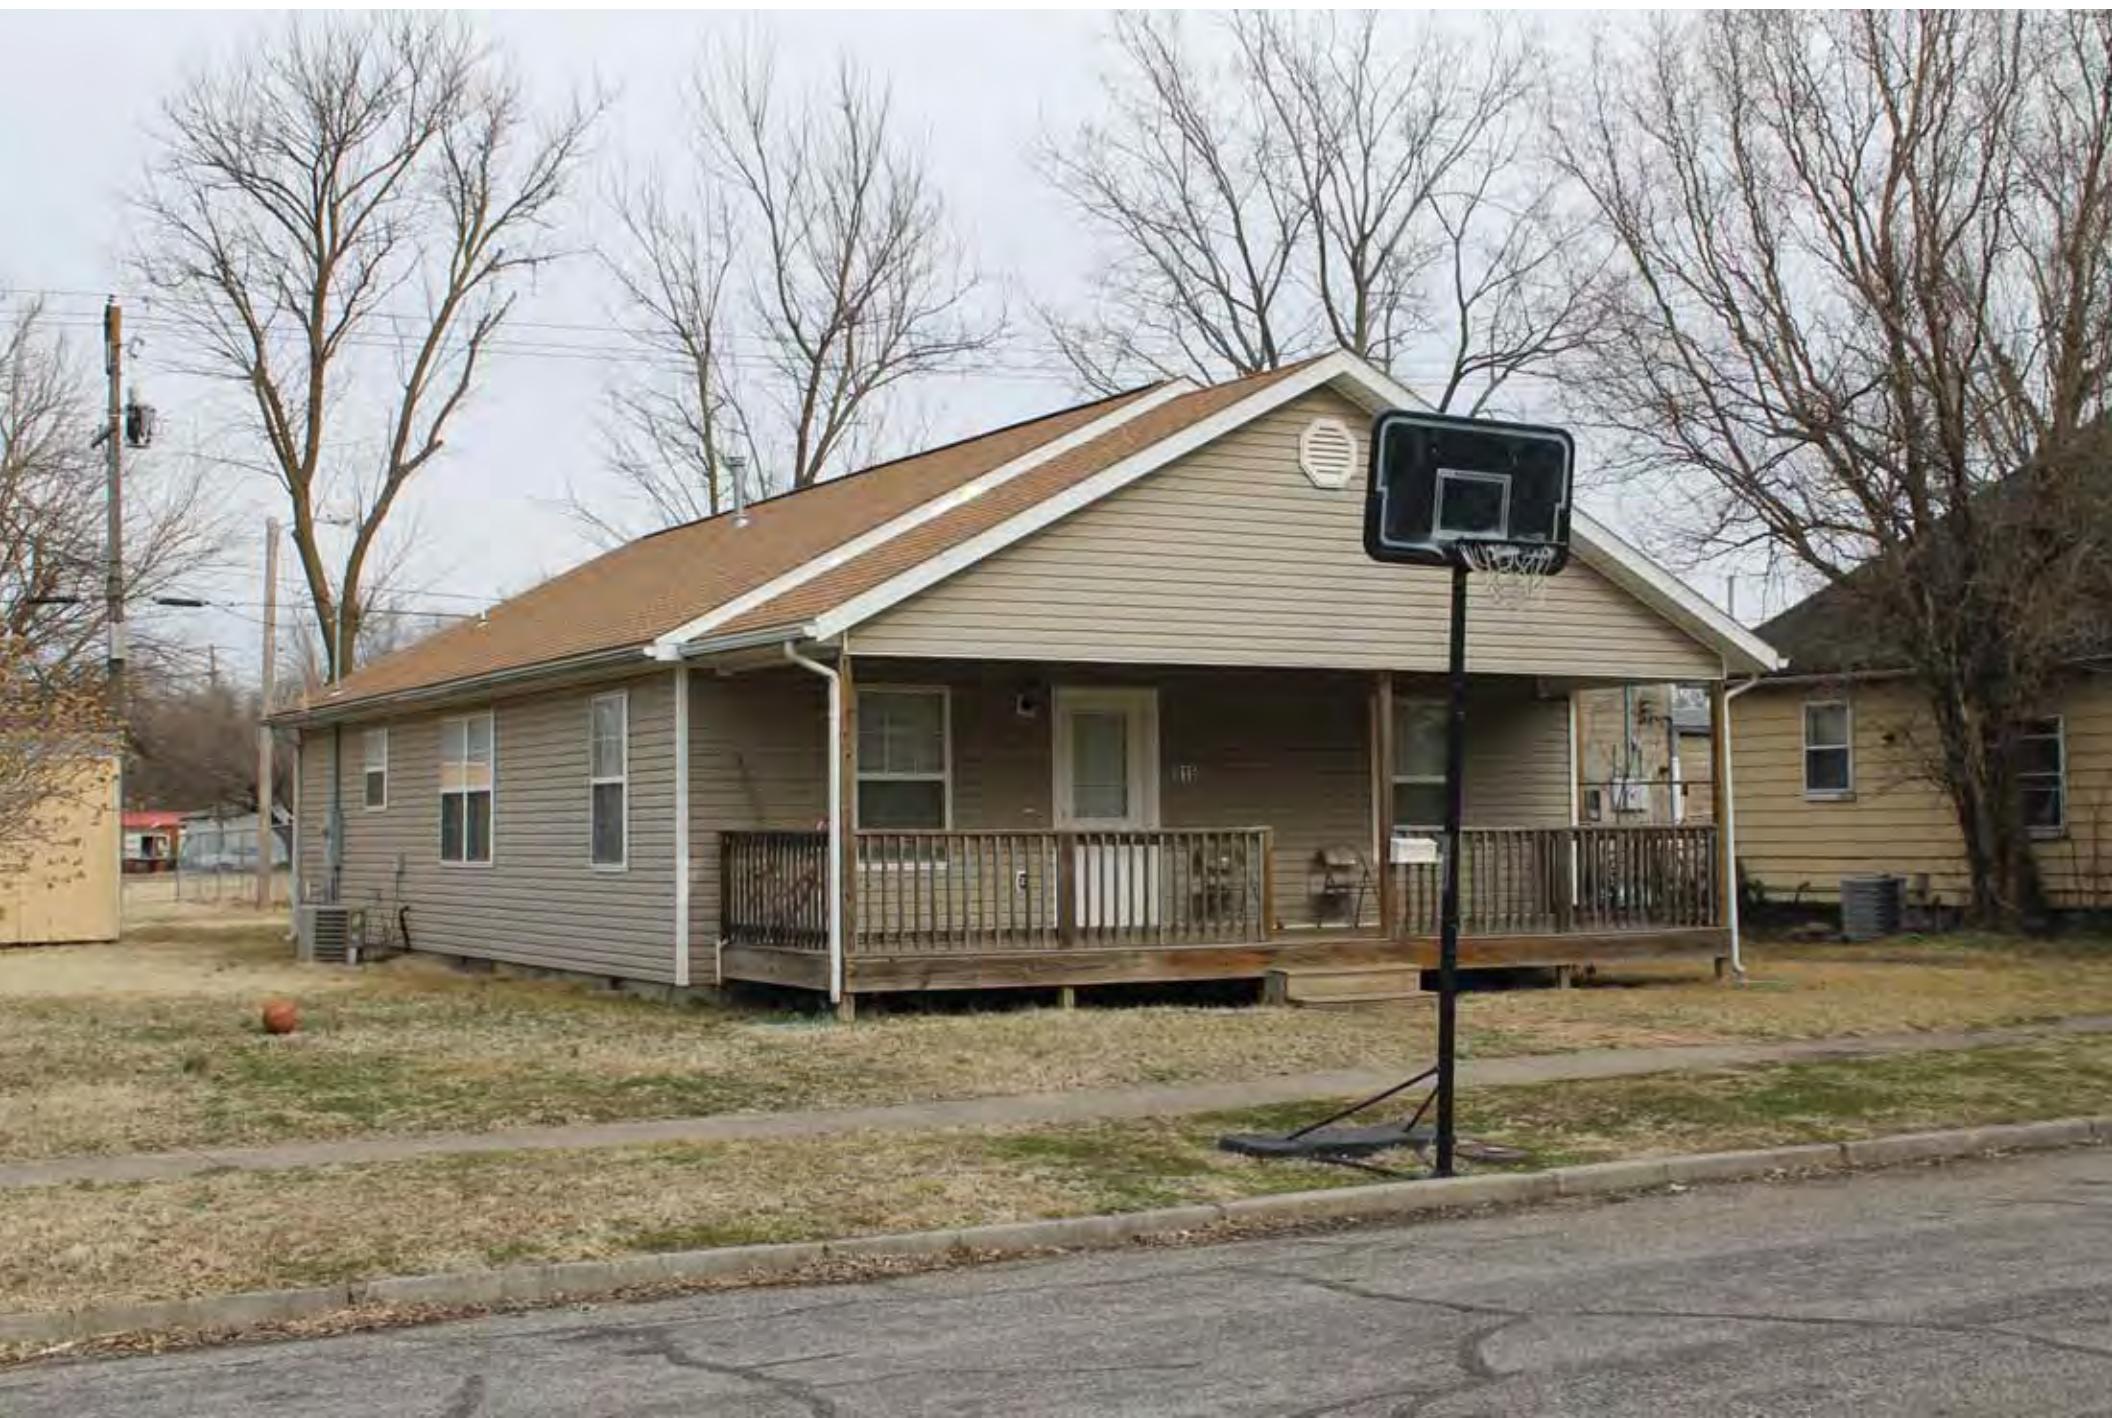
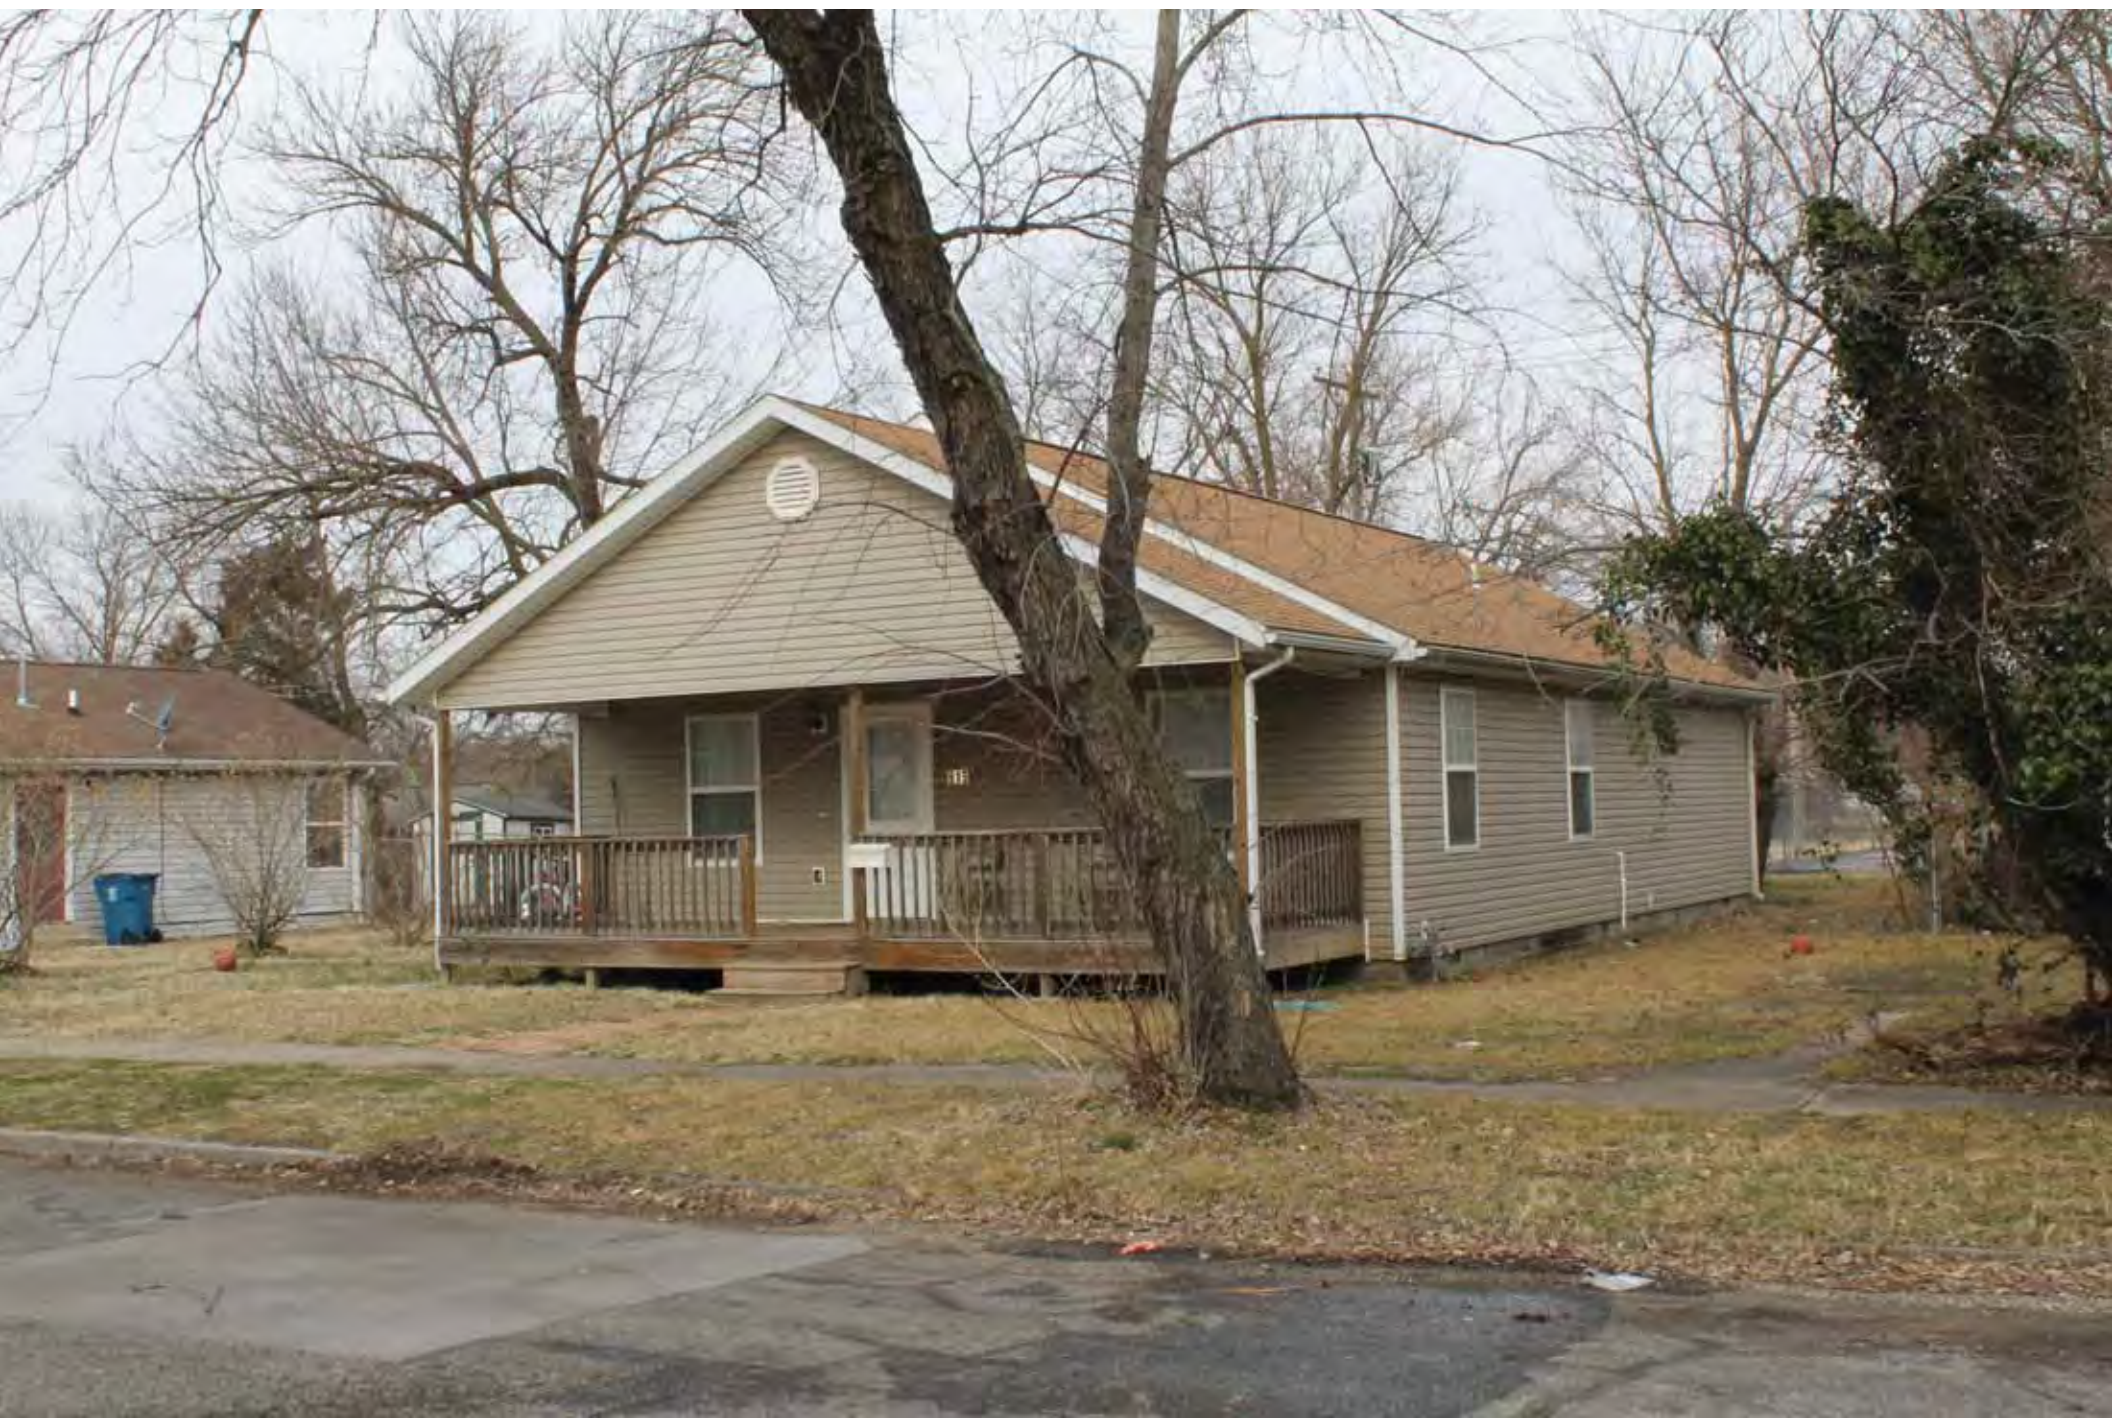
The property at 915 Central Street is a one-story frame house, with a front facing gable roof covered in asphalt siding. It has rectangular plan with a gable roofed front porch along the front elevation. The porch sits on wooden posts on a concrete foundation. It shelters a single front door flanked on either side by six-over-six vinyl windows. On the side elevations are three six-over-six vinyl windows.
