MISSOURI DEPARTMENT OF NATURAL RESOURCES
STATE HISTORIC PRESERVATION OFFICE, P.O. Box 176, Jefferson City, MO 65102
ARCHITECTURAL/HISTORIC INVENTORY FORM

1. Survey No. JP-AS-007-001		2. Survey name: East Town (Original Joplin) Historic Survey Phase 2	
3. County: JASPER		4. Address (Street No.) 618	Street (name) E. 2 nd Street
5. City: Joplin	Vicinity: <input type="checkbox"/>	6. Geographical Reference:	7. Township/Range/Section: T: R: S:
8. Historic name (if known):		9. Present/other name (if known):	
10. Ownership: <input checked="" type="checkbox"/> Private <input type="checkbox"/> Public		11a. Historic use (if known): Domestic: Single Dwelling	11b. Current use: Domestic: Single Dwelling

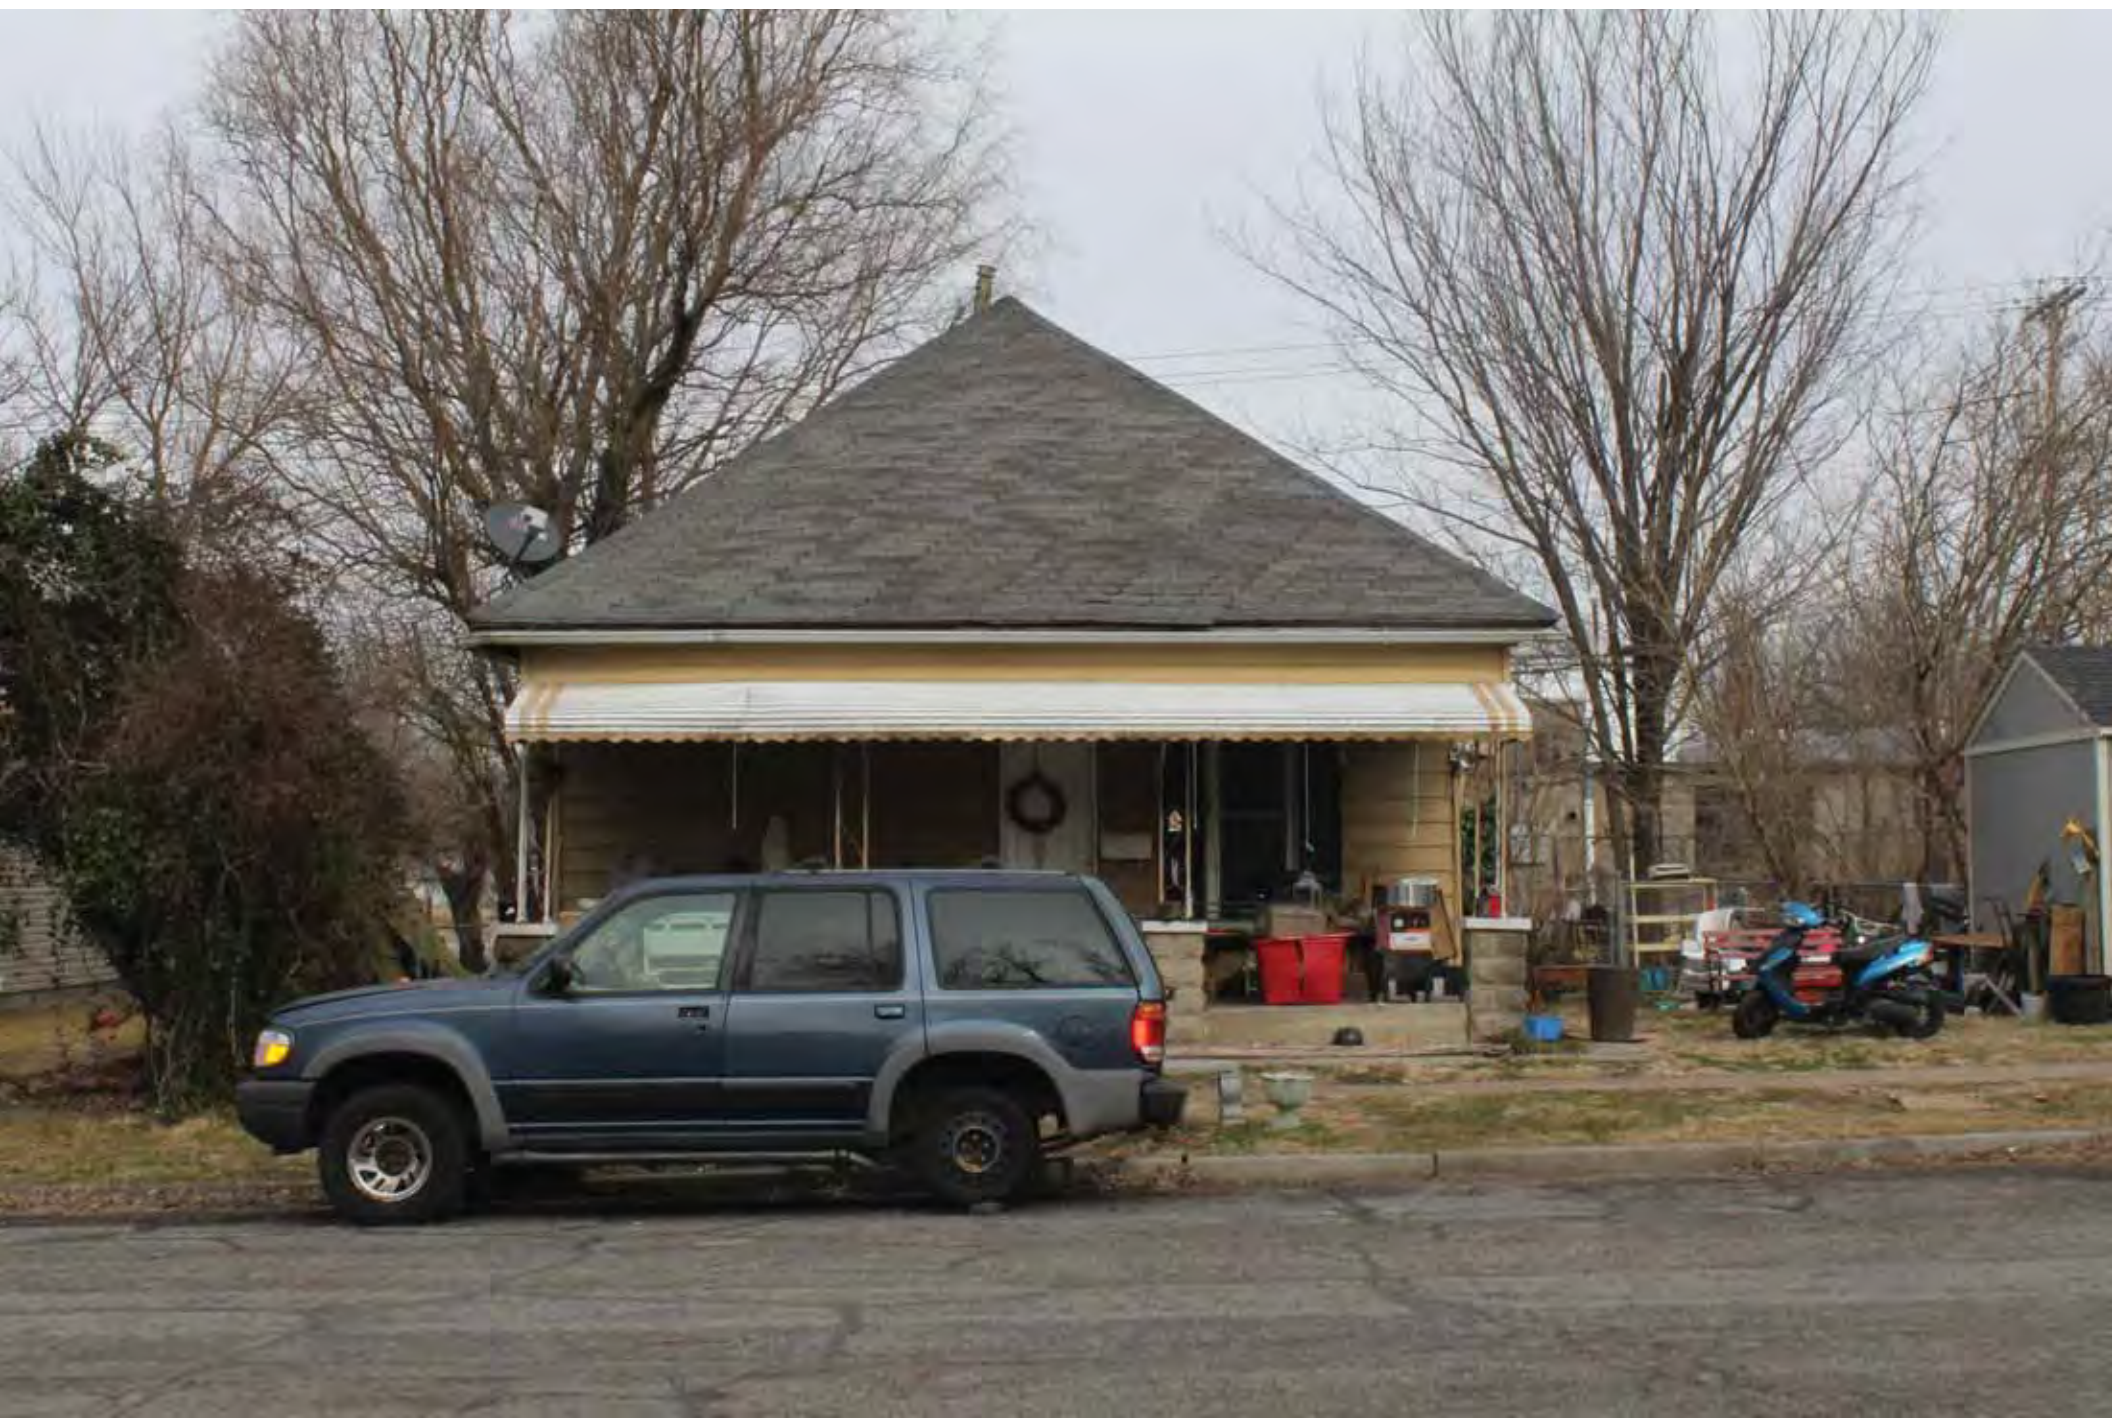
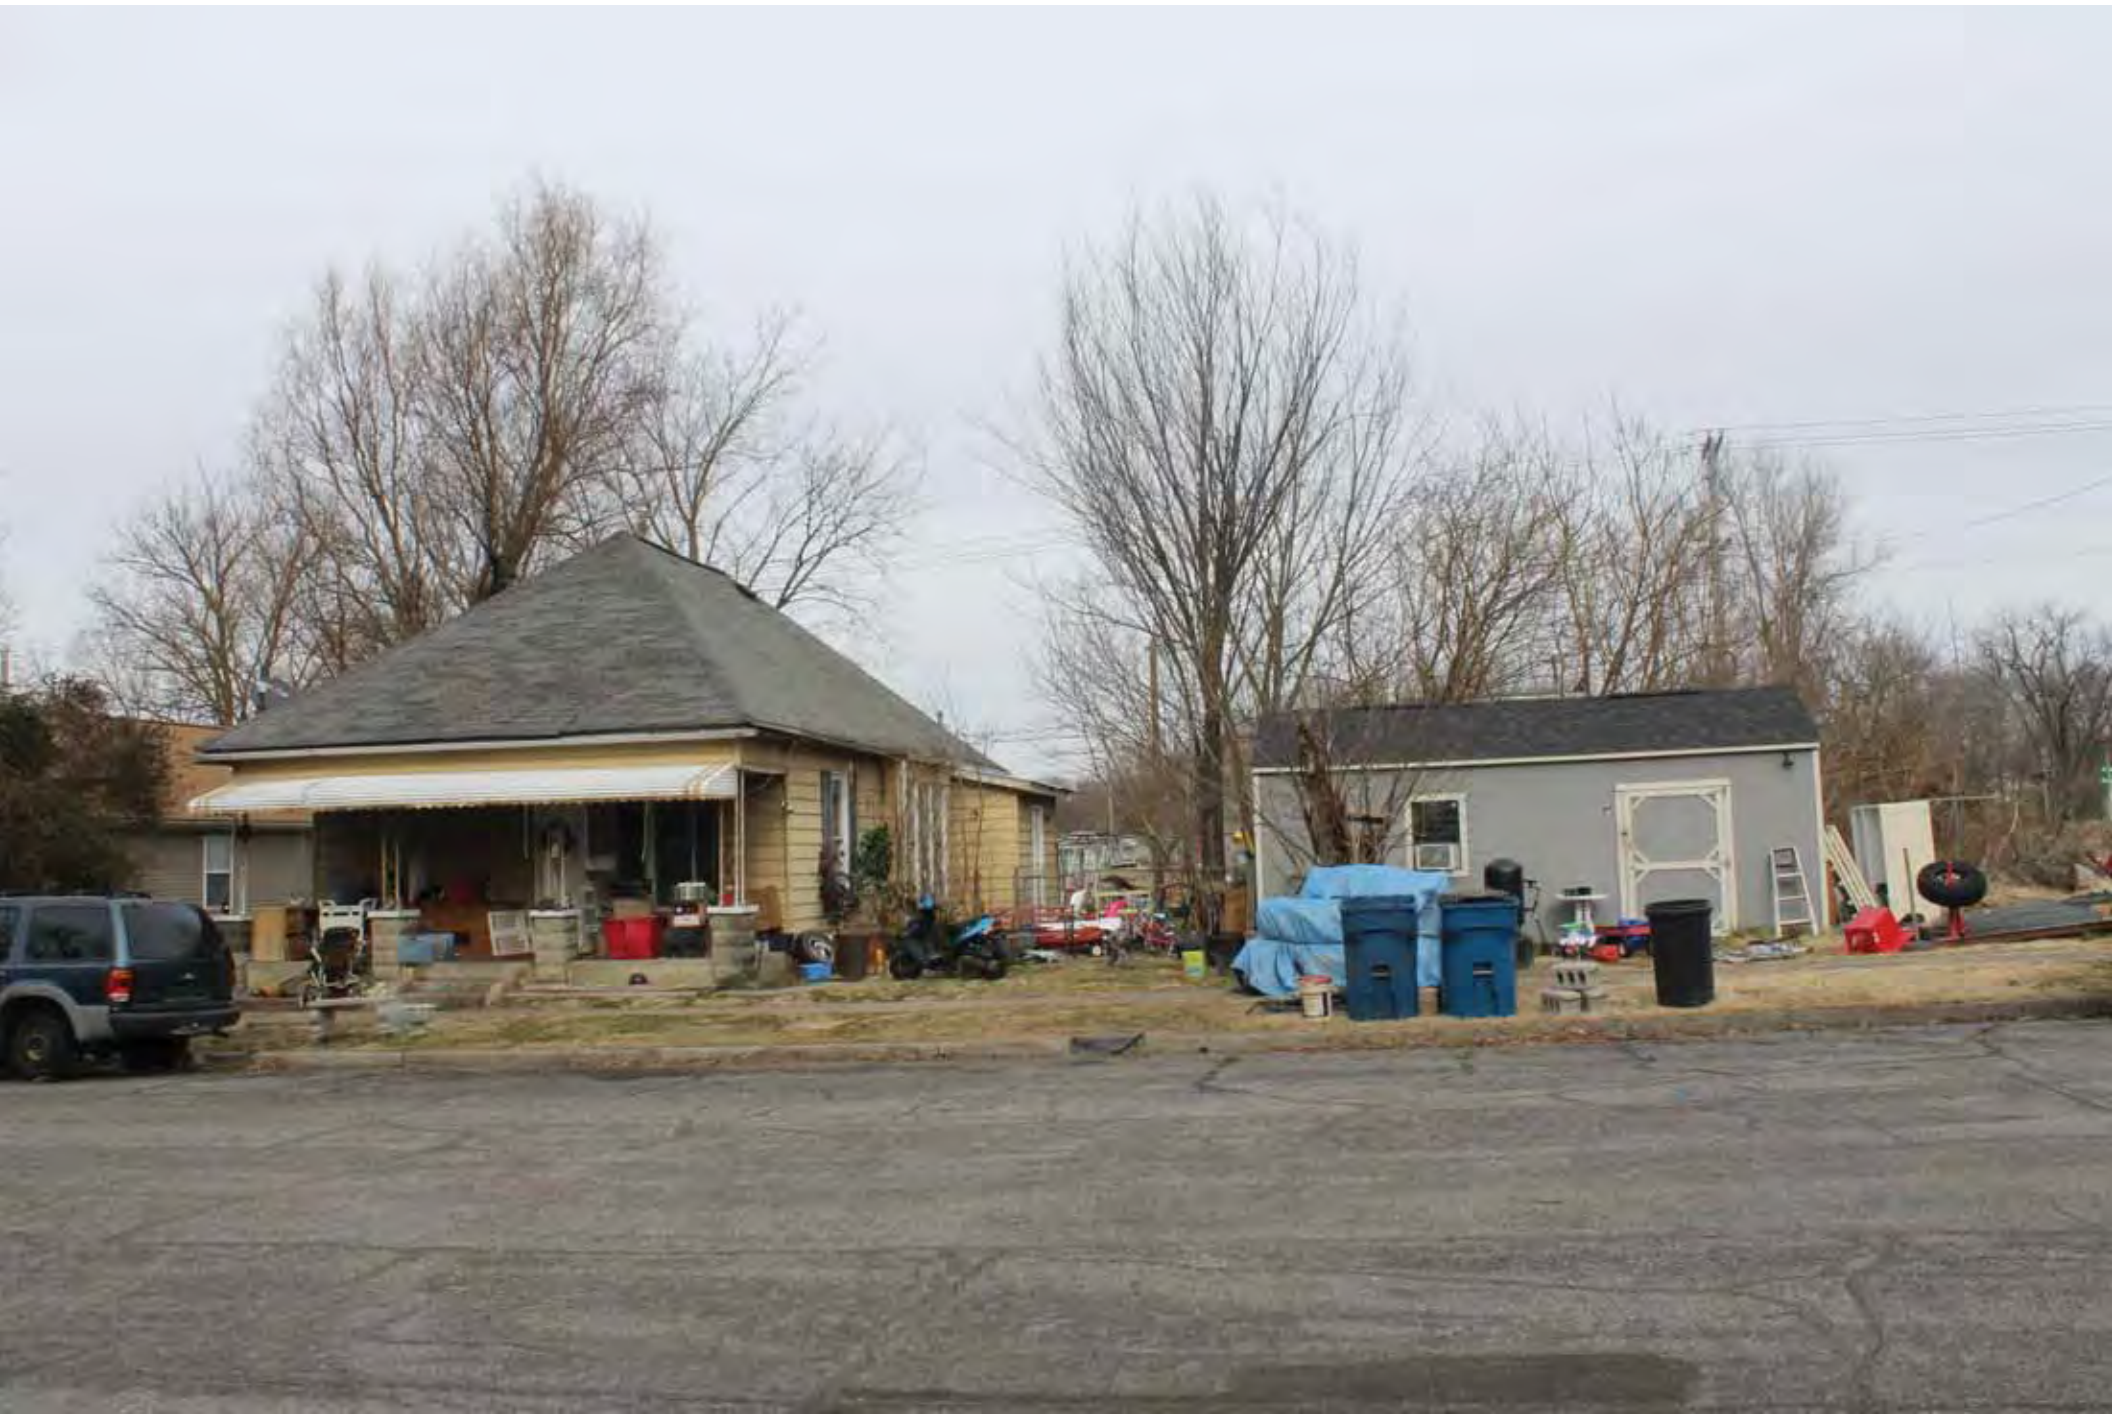
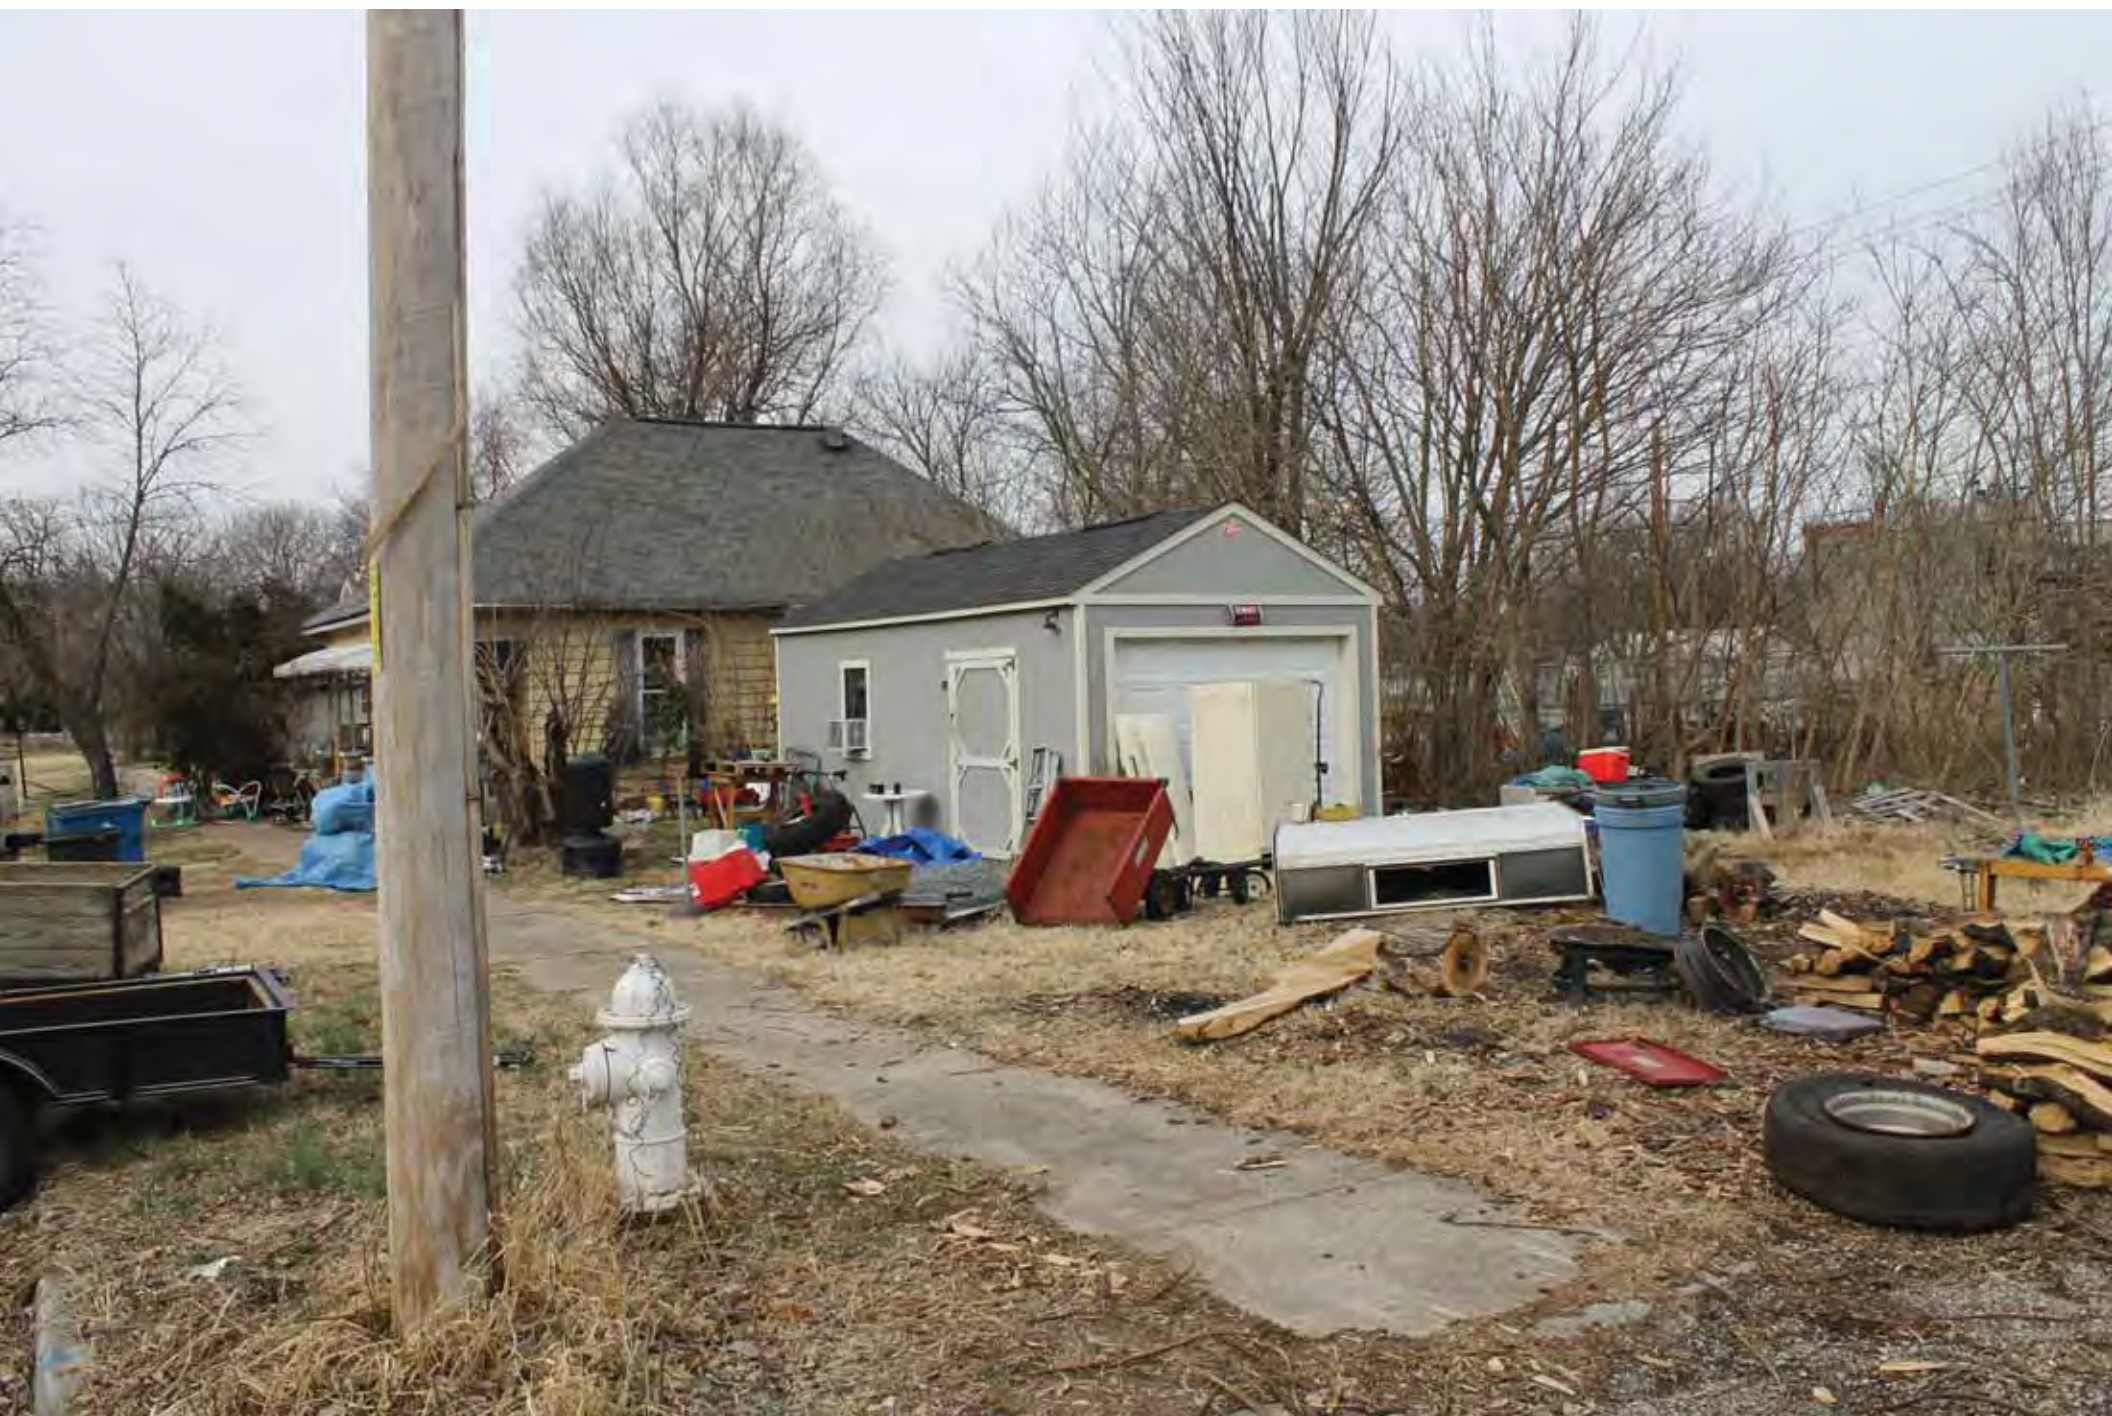
The property at 917 Central street is a one-story frame house, with high-pitched hipped roof. The entire roof is covered in asphalt siding and has an interior brick chimney in the middle of the roof. On the front elevation is a porch with a metal roof and metal supports on a rough cut concrete block foundation. It shelters a central replacement door and a single one-over-one window with non-functioning shutters.

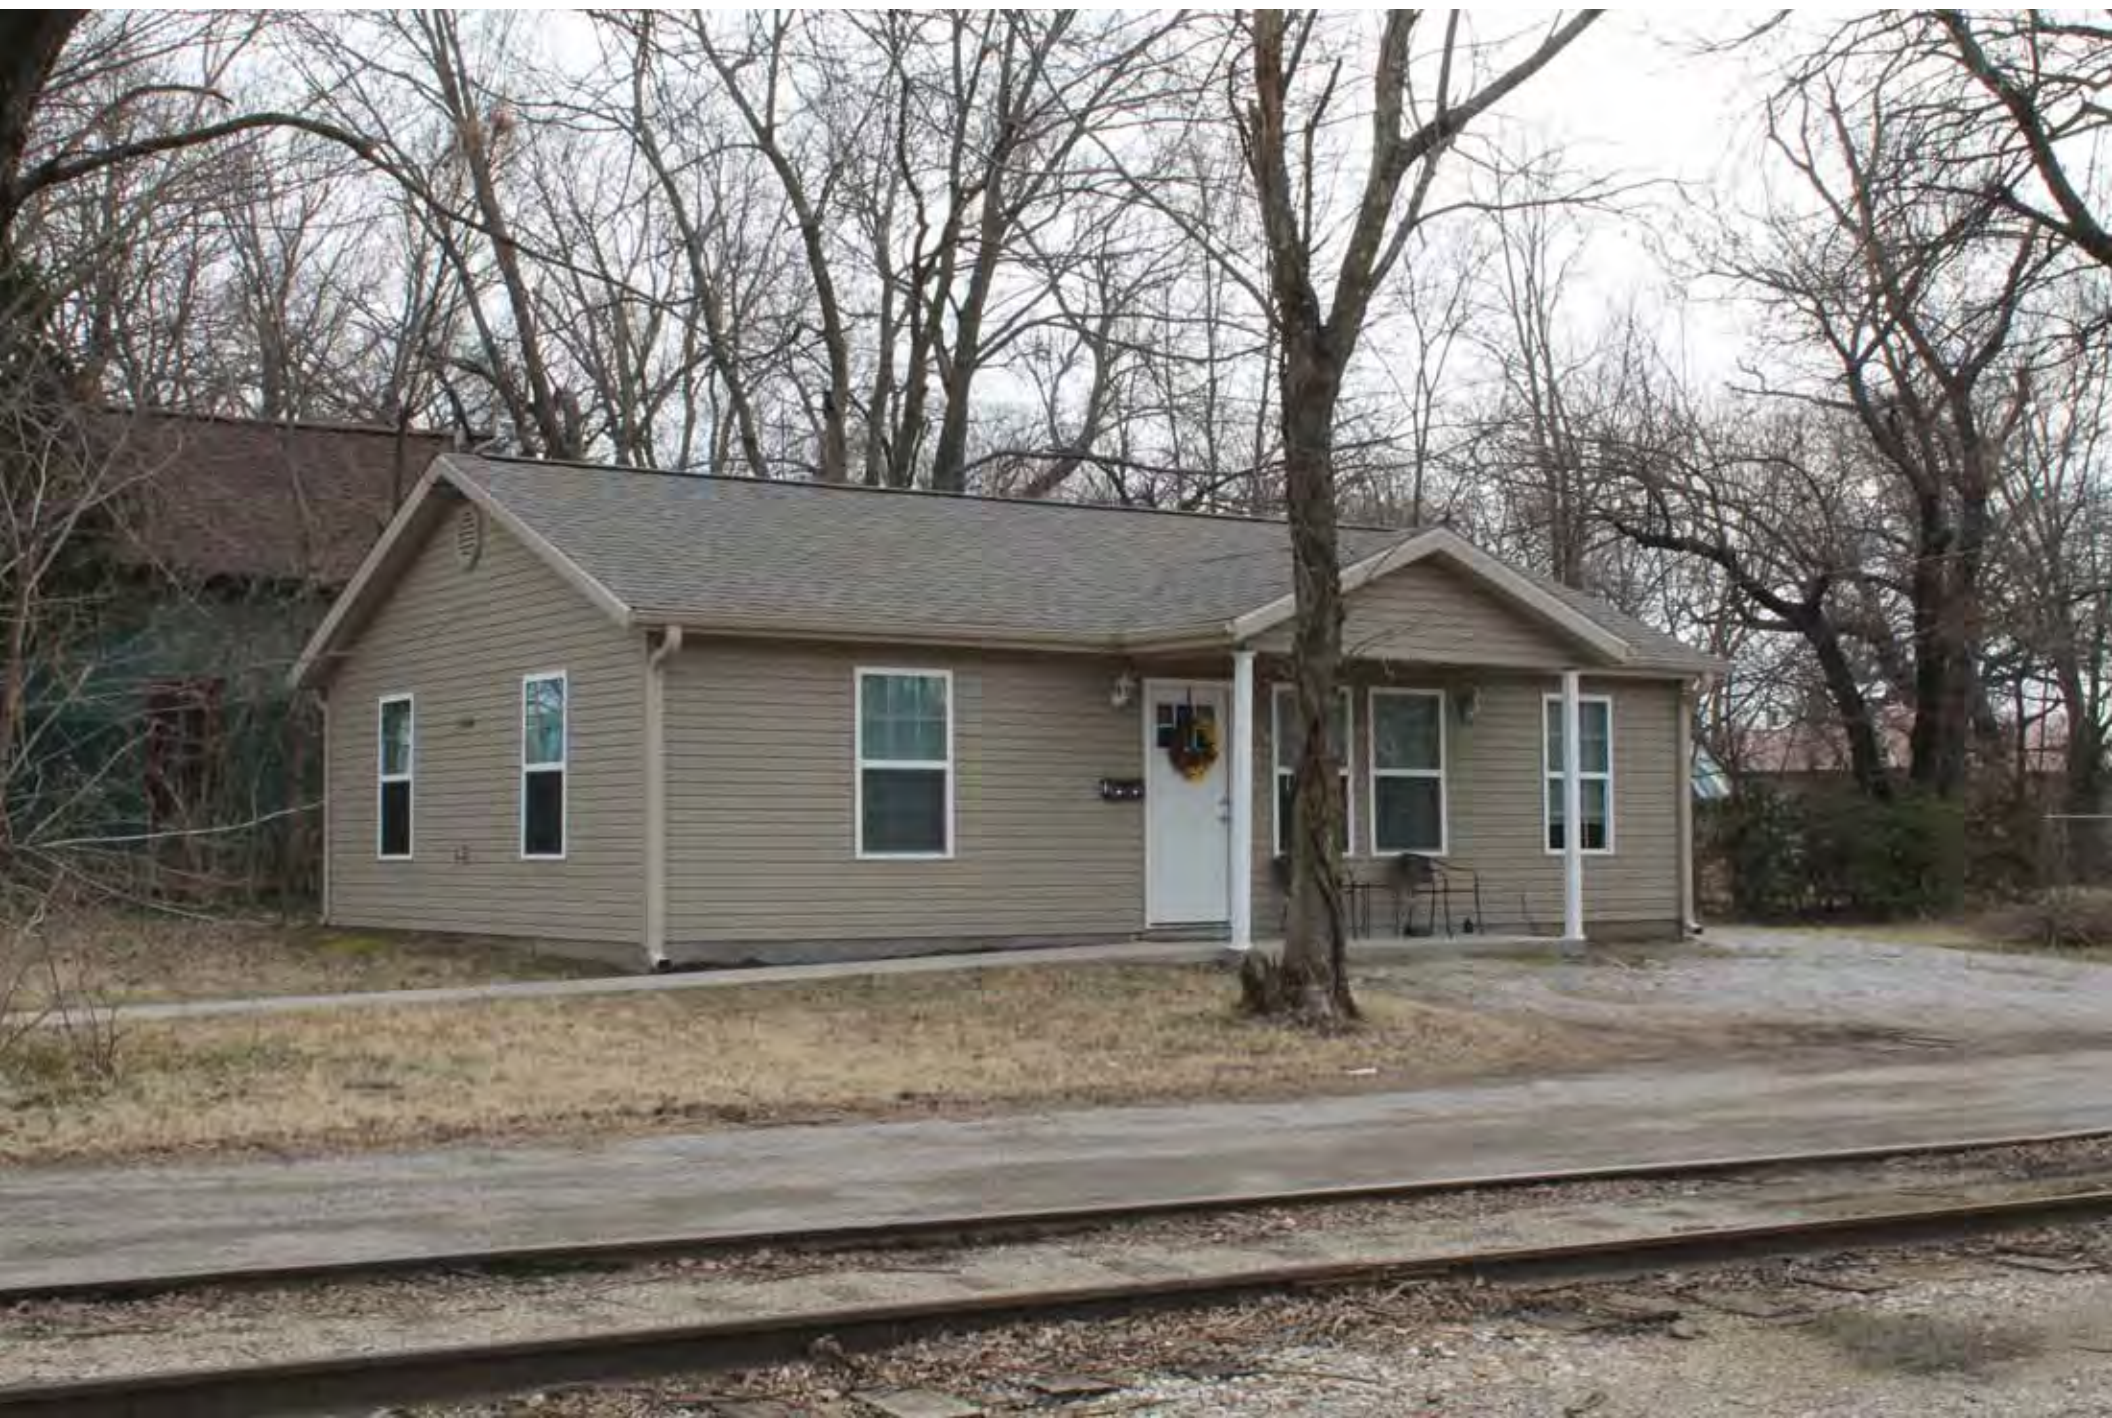
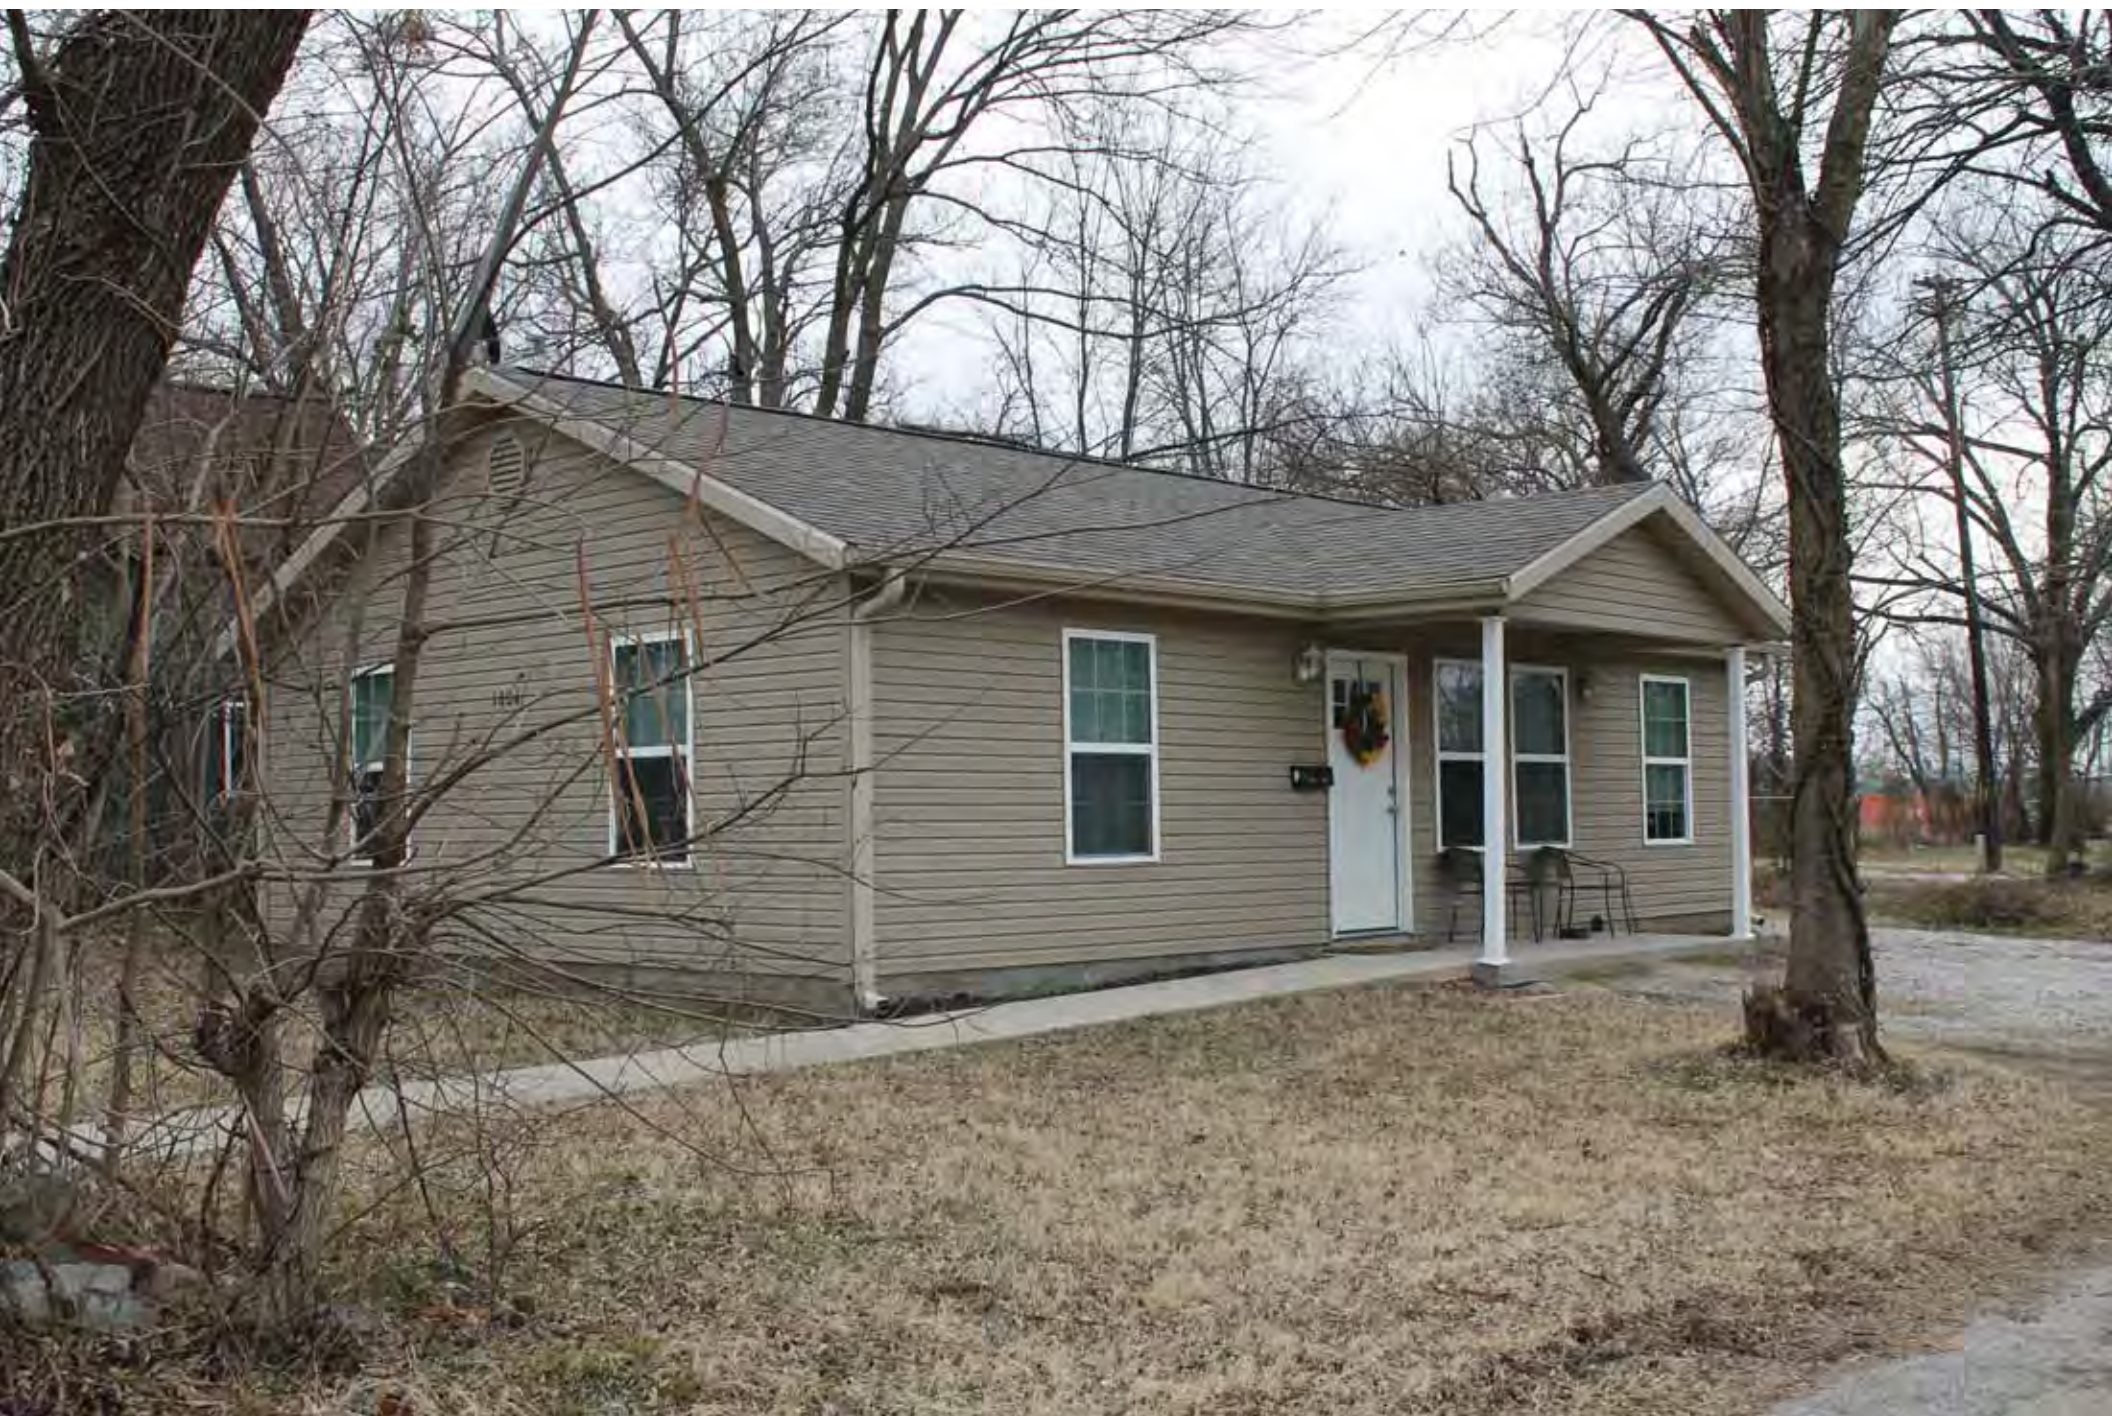
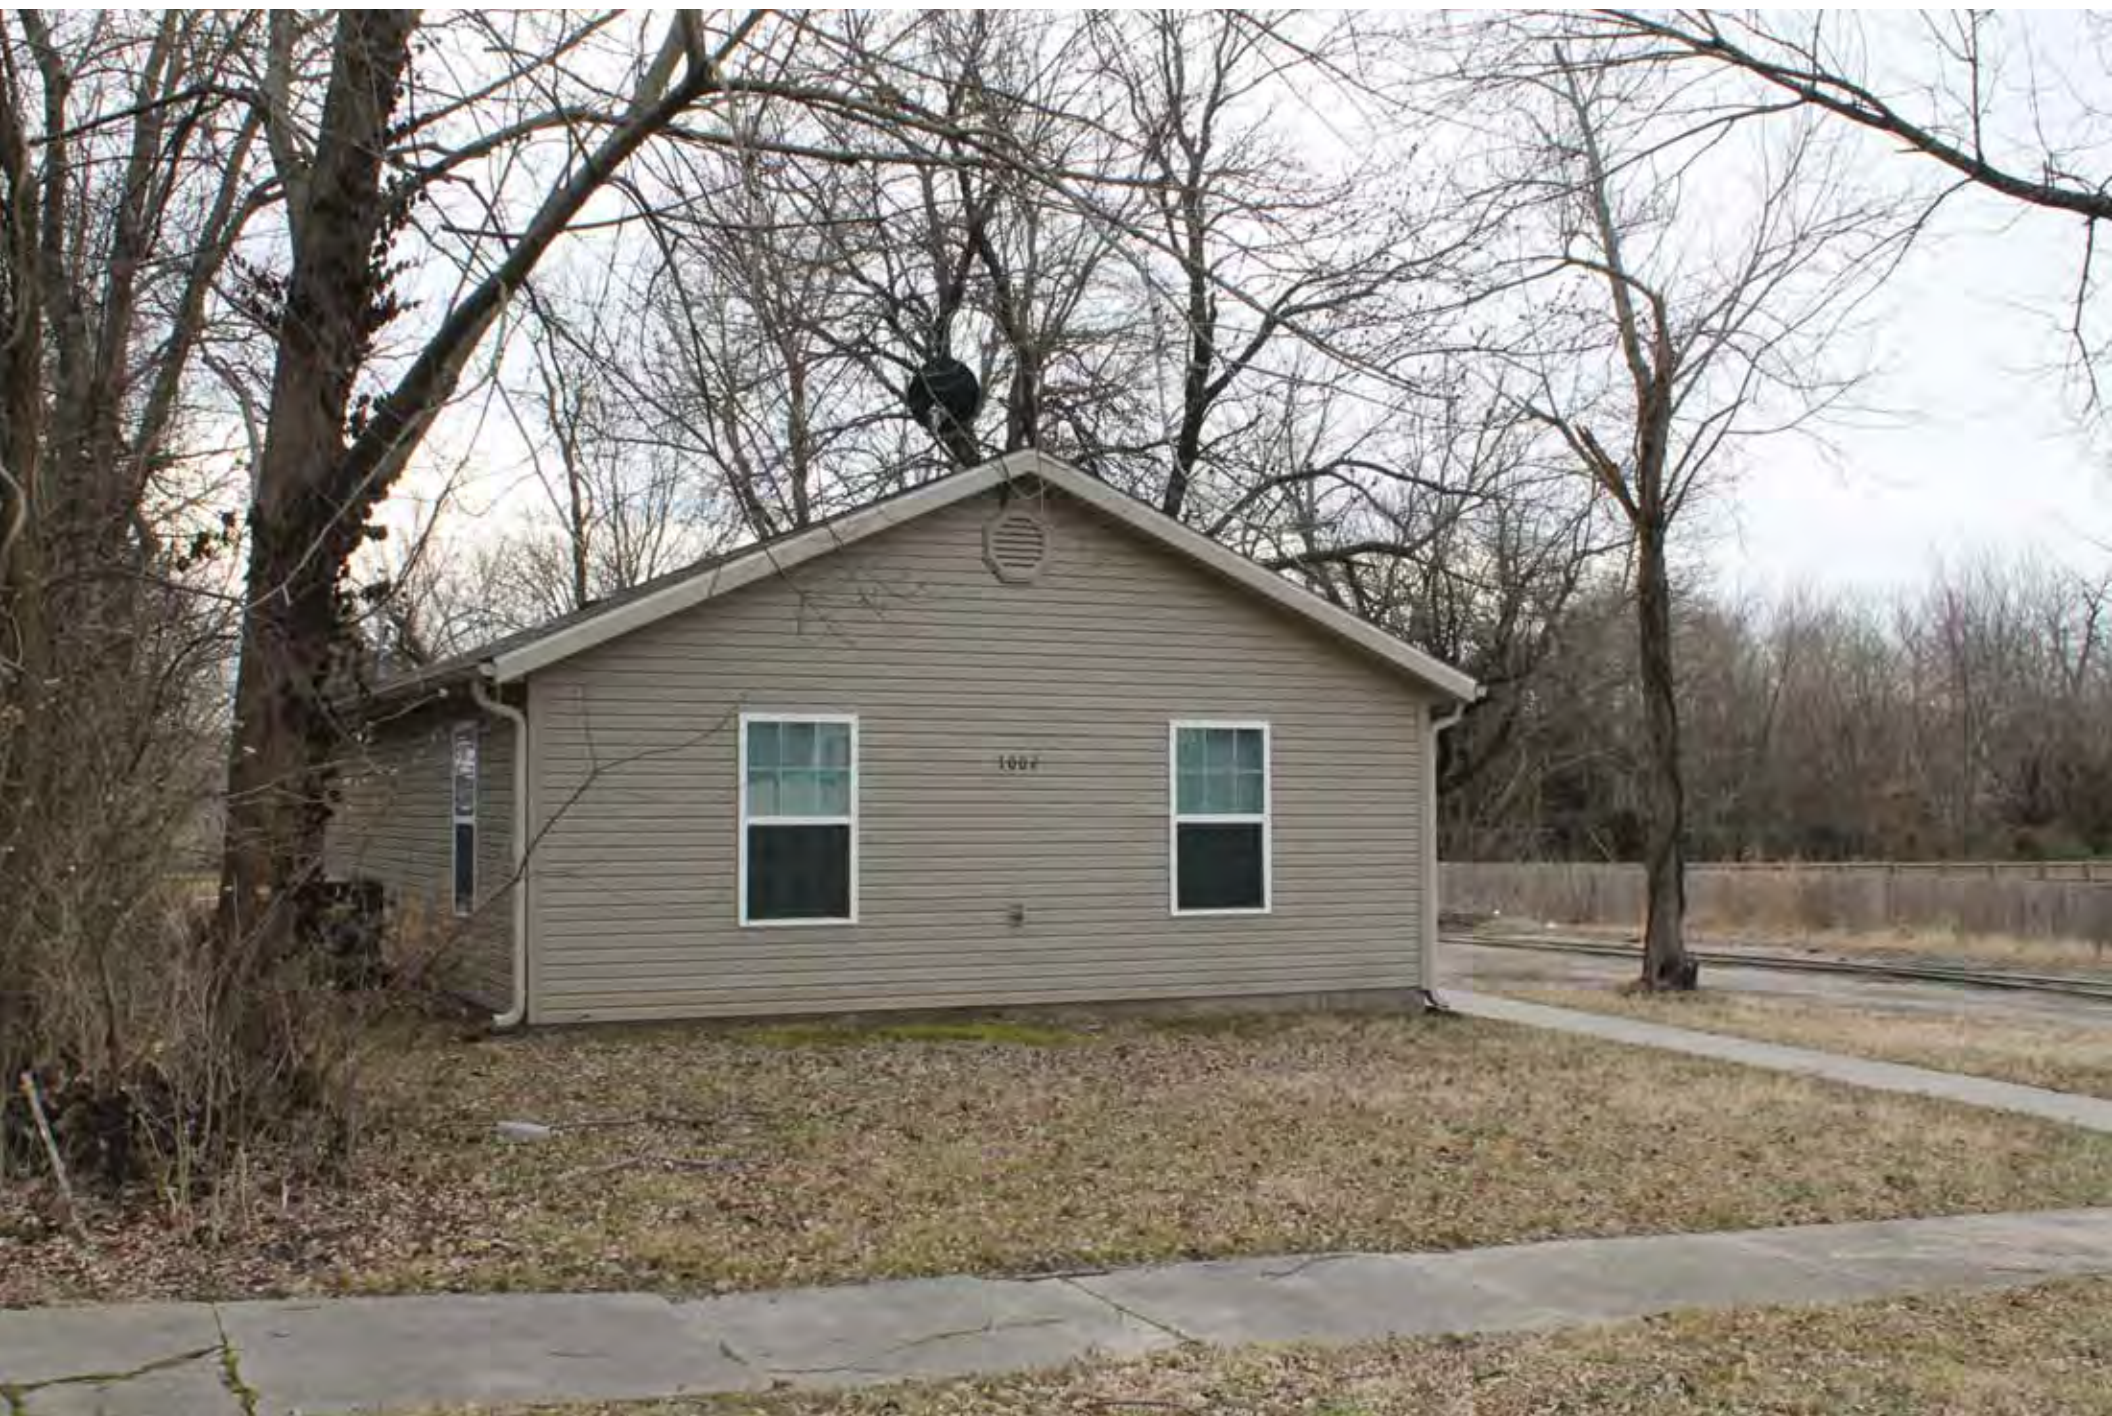
The property at 1004 Central Street is a one-story frame house, with a gable roof covered in asphalt siding. The front elevation is oriented towards Railroad Avenue. It has rectangular plan with a gable roofed front porch along the front elevation. The porch sits on square posts on a concrete foundation. It shelters a single front door. On the left side of the front door is a single six-over-six vinyl window. To the right of the front door are three identical windows. On the Central Avenue elevation are two single six-over-six vinyl windows.

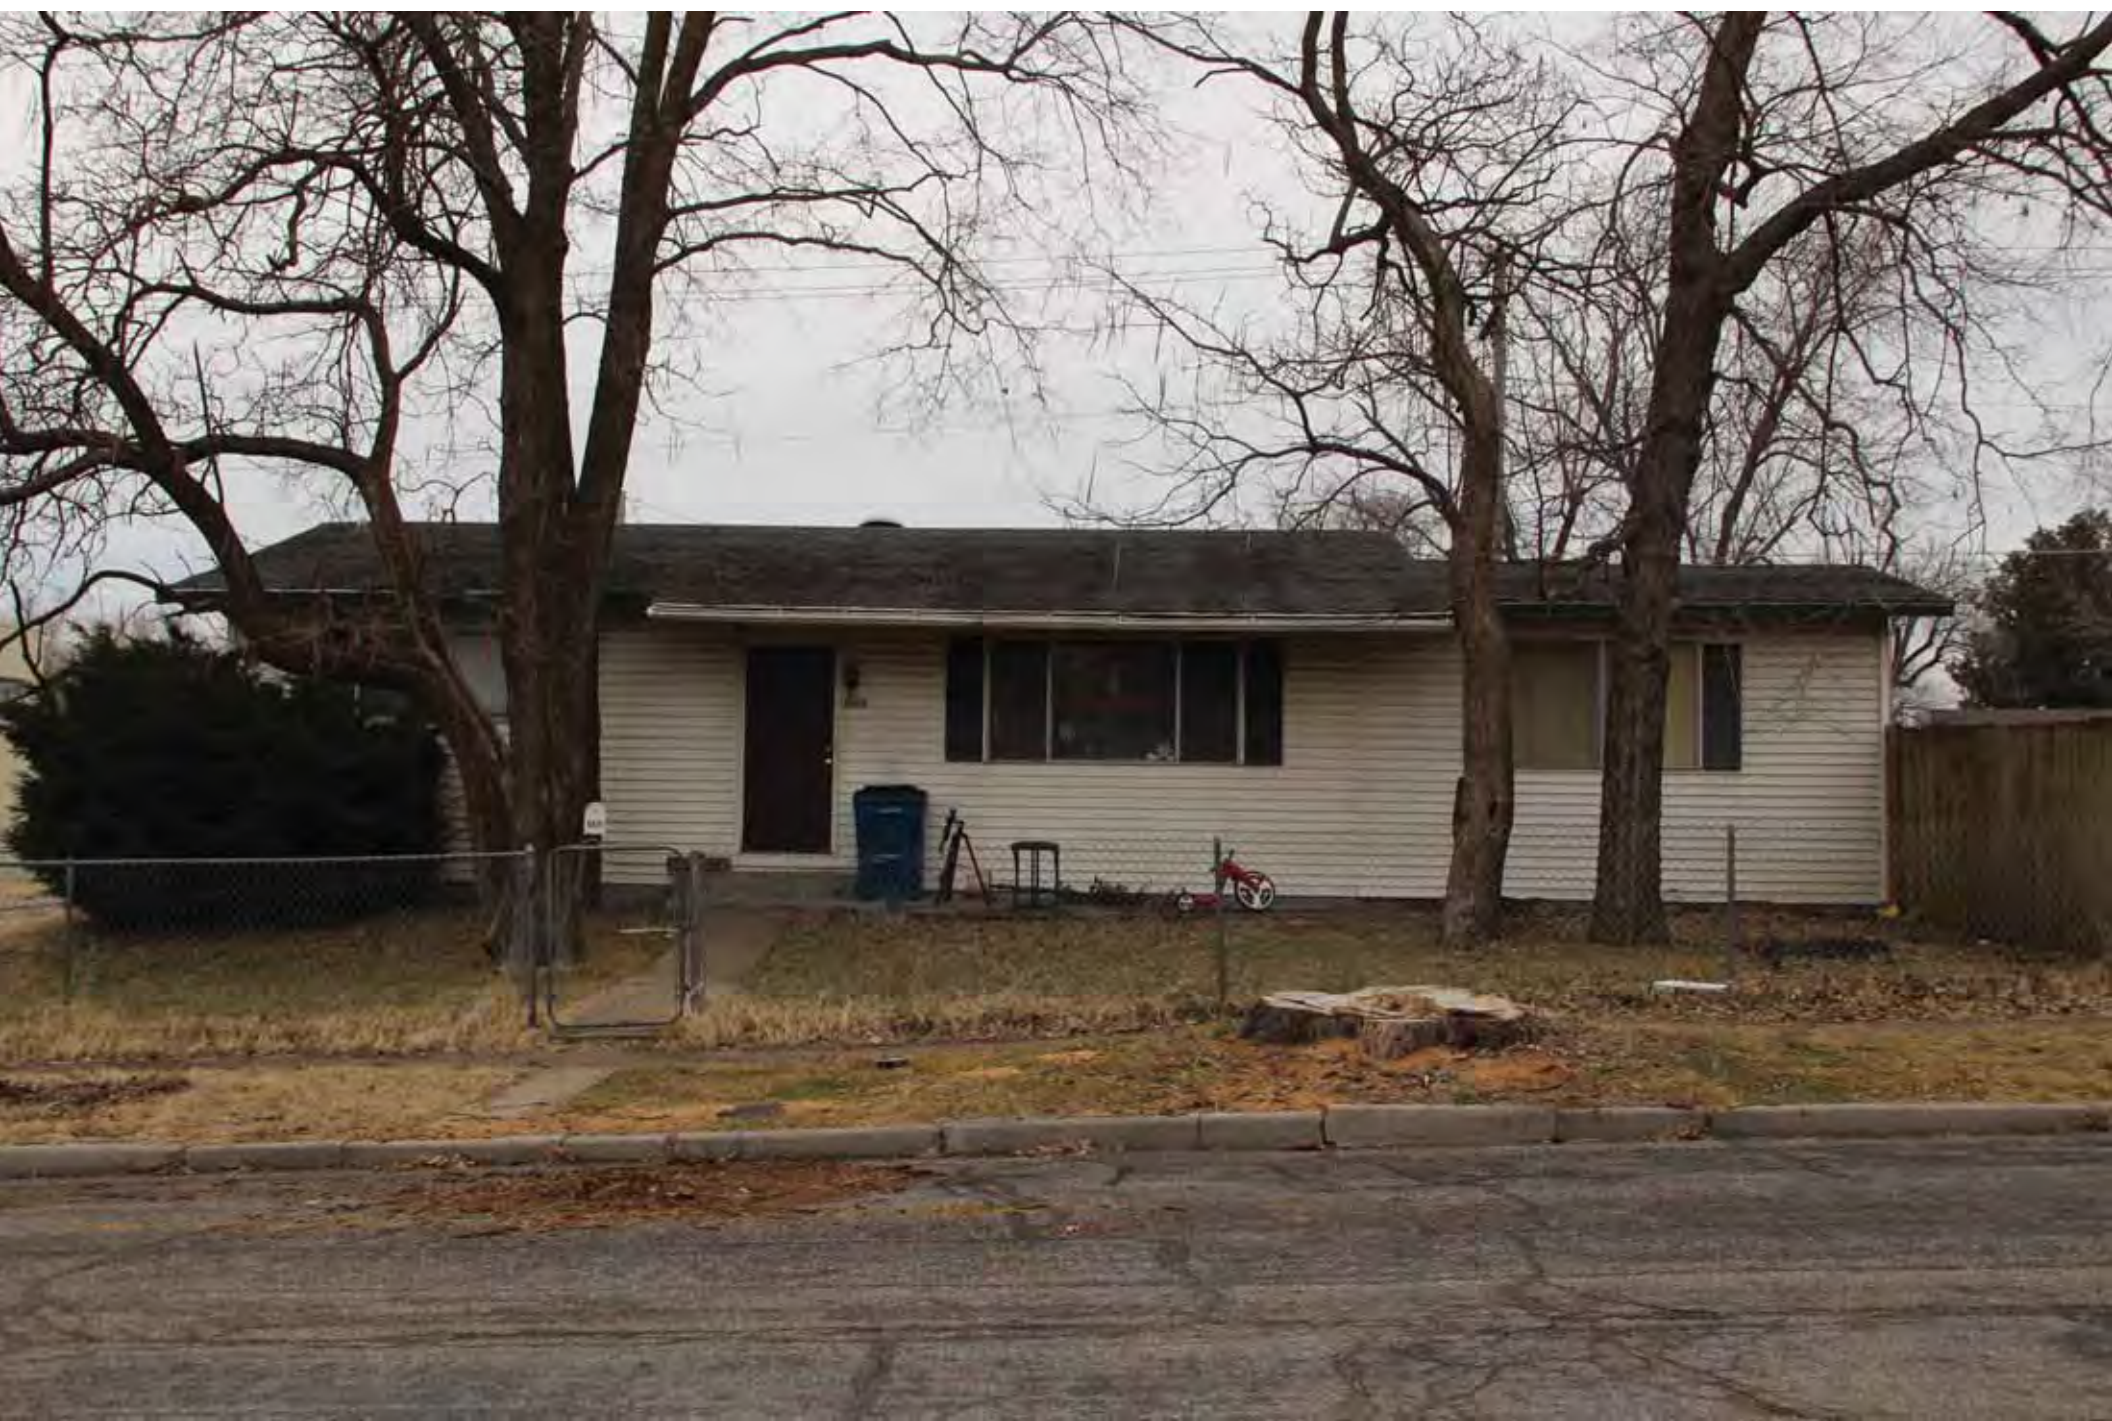
<p>41. (cont.) Description of primary resource. Expand box as necessary, or add continuation pages.</p> <p>The property at 1005 Central Street is a one-story frame house, with a side gable roof covered in asphalt siding. The front elevation has a central replacement door. To the left of the door is a metal casement window. To the right of the door are two similar metal casement windows. All windows have non-functioning metal shutters. The house is covered in vinyl siding.</p>
