MISSOURI DEPARTMENT OF NATURAL RESOURCES
STATE HISTORIC PRESERVATION OFFICE, P.O. Box 176, Jefferson City, MO 65102
ARCHITECTURAL/HISTORIC INVENTORY FORM

1. Survey No. JP-AS-007-001		2. Survey name: East Town (Original Joplin) Historic Survey Phase 2	
3. County: JASPER		4. Address (Street No.) 618	Street (name) E. 2 nd Street
5. City: Joplin	Vicinity: <input type="checkbox"/>	6. Geographical Reference:	7. Township/Range/Section: T: R: S:
8. Historic name (if known):		9. Present/other name (if known):	
10. Ownership: <input checked="" type="checkbox"/> Private <input type="checkbox"/> Public		11a. Historic use (if known): Domestic: Single Dwelling	11b. Current use: Domestic: Single Dwelling

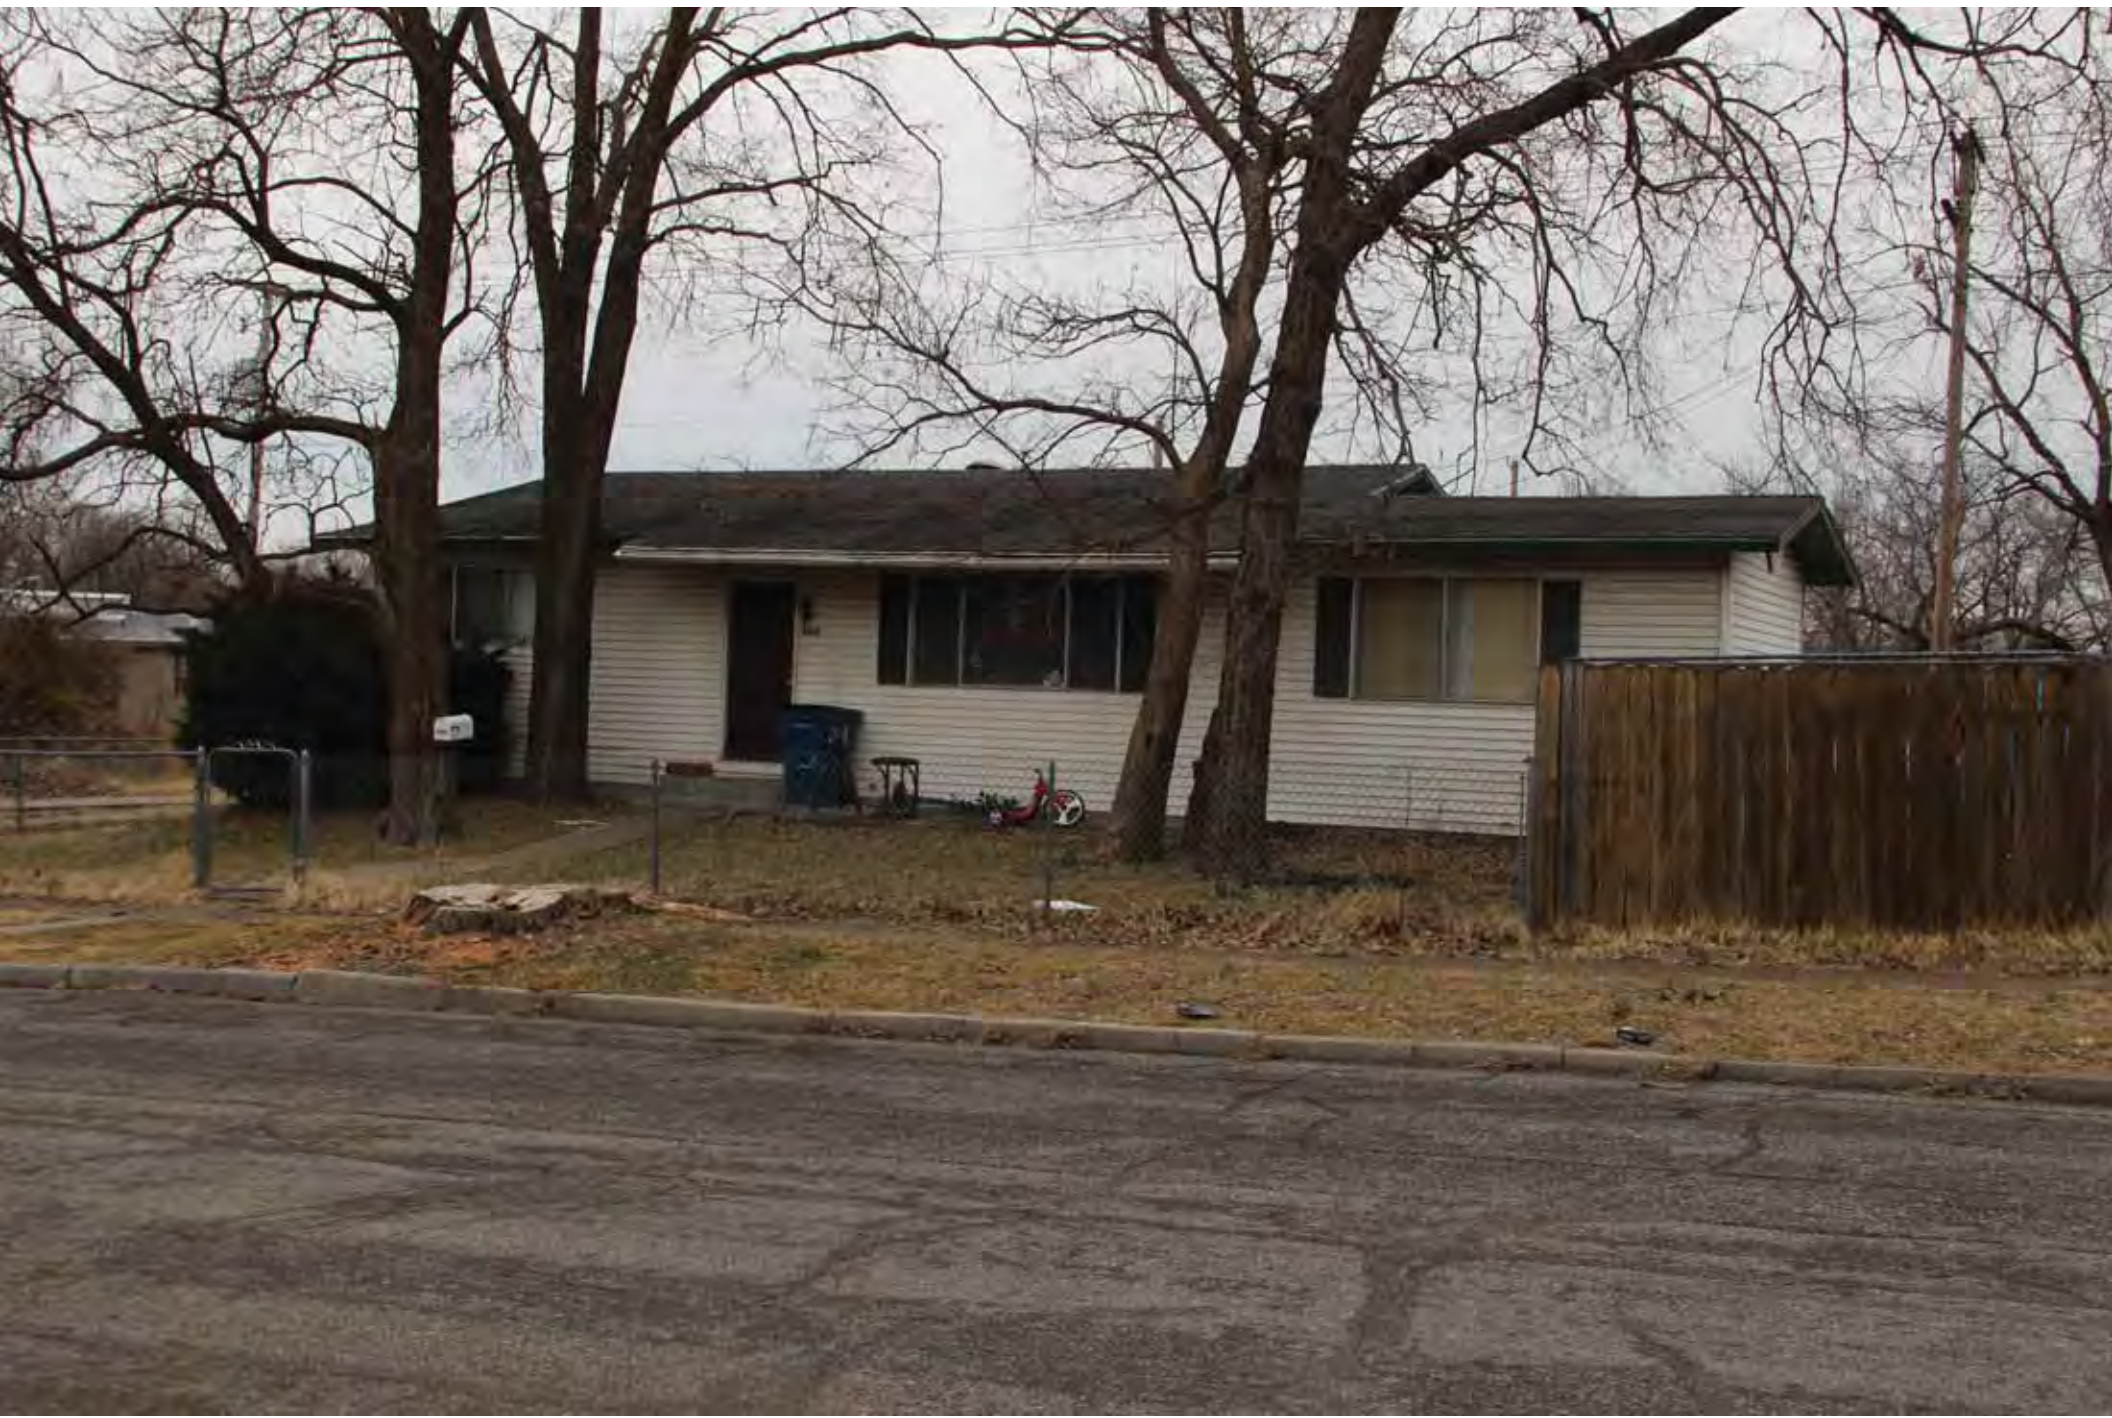
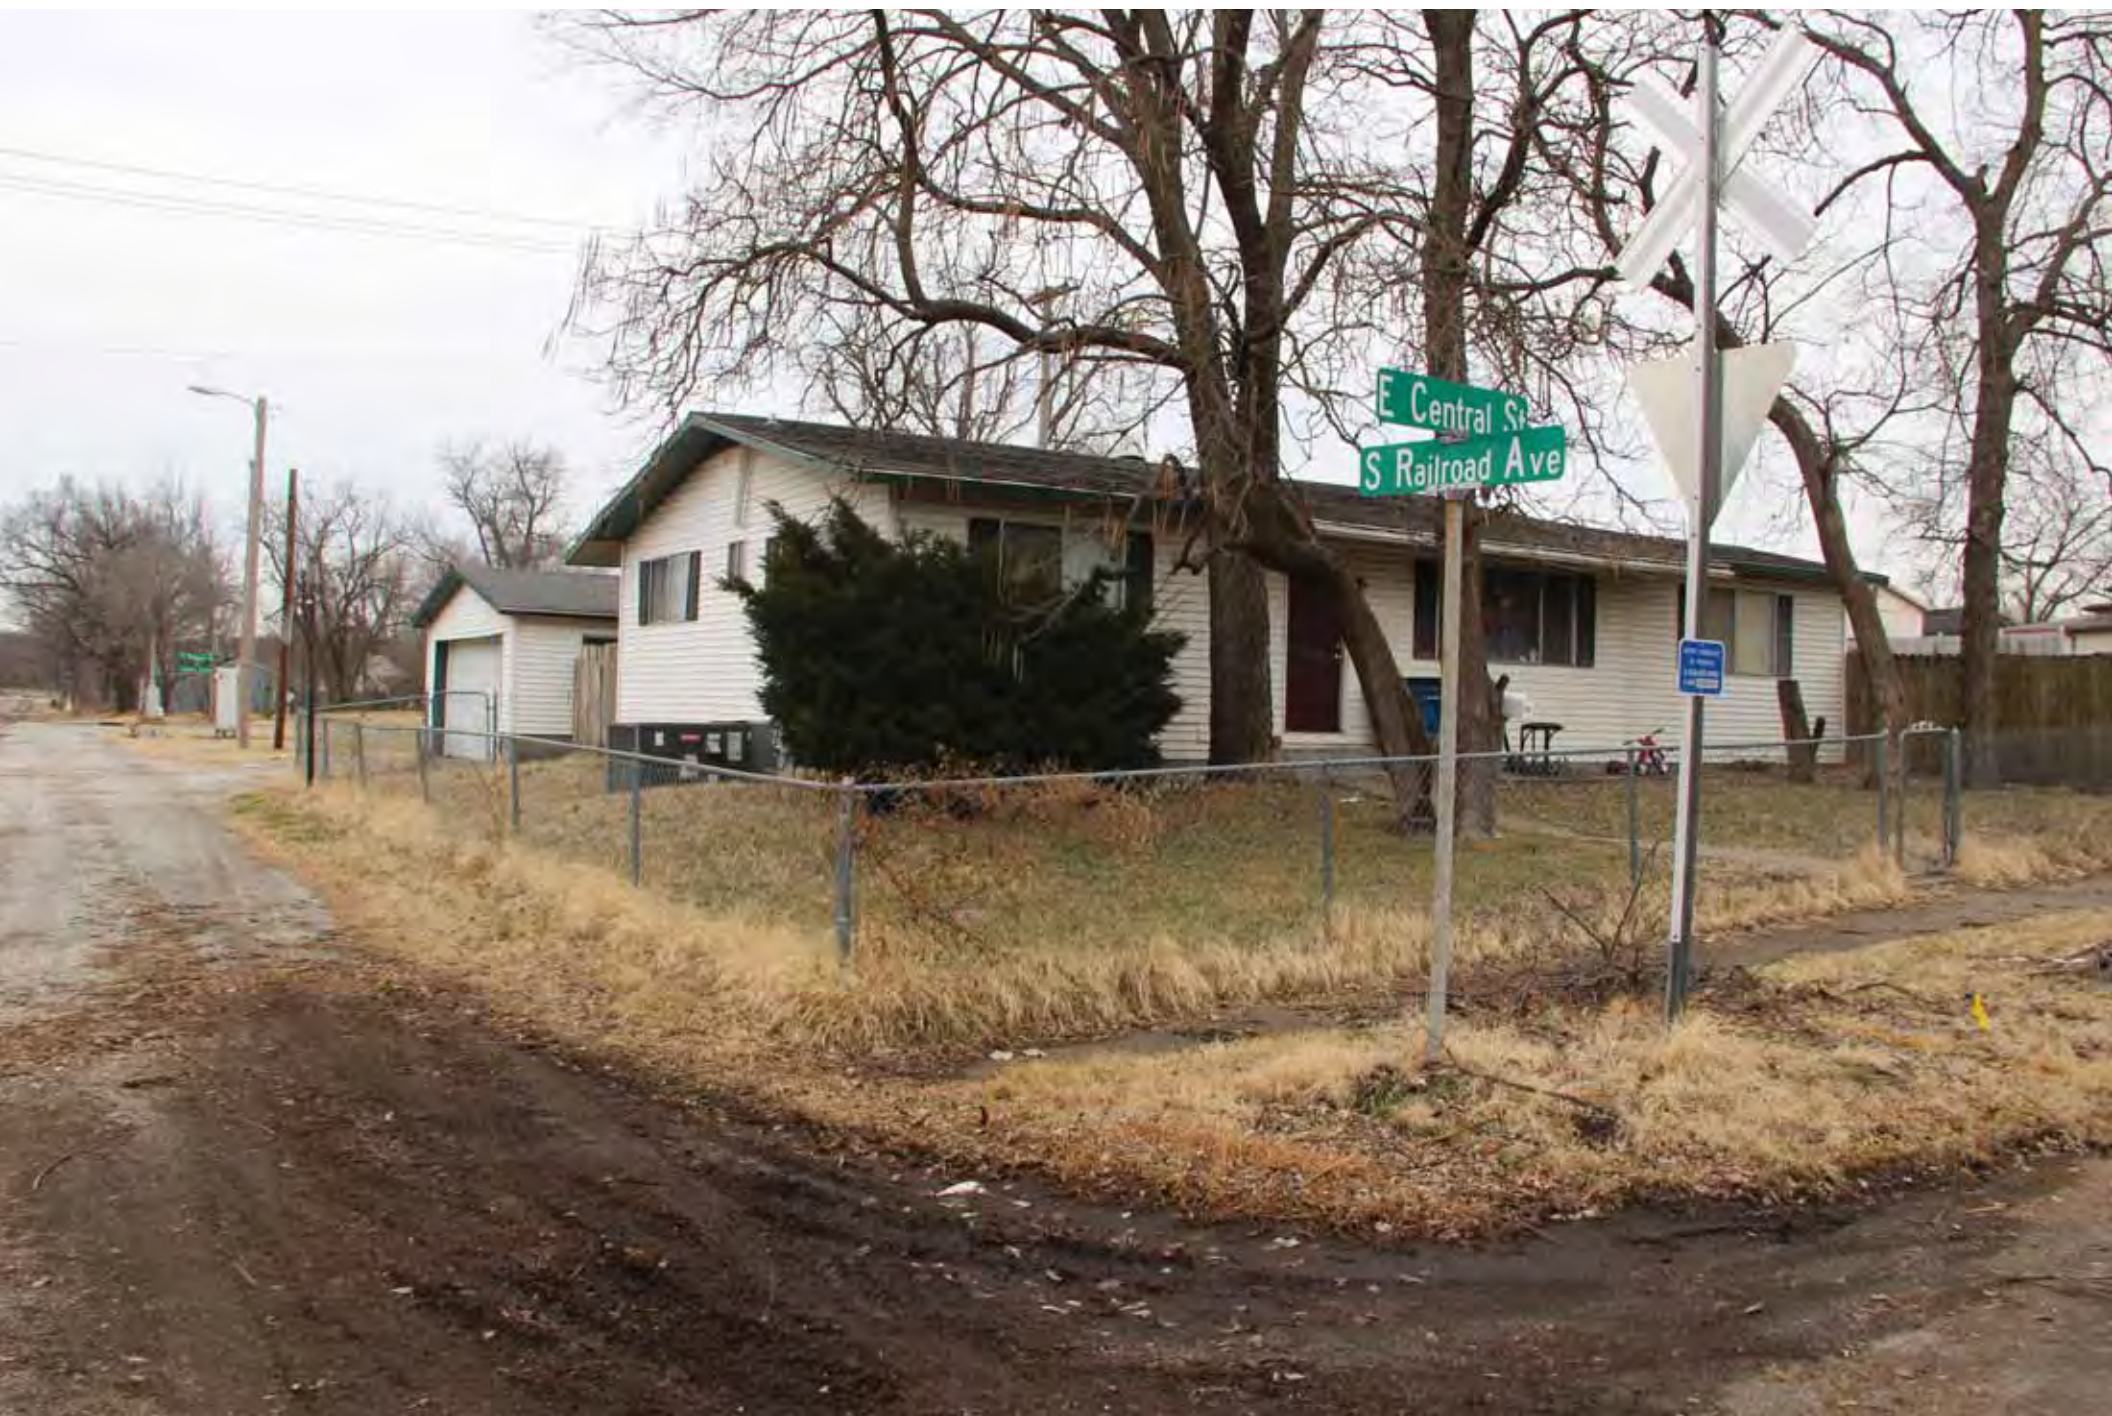
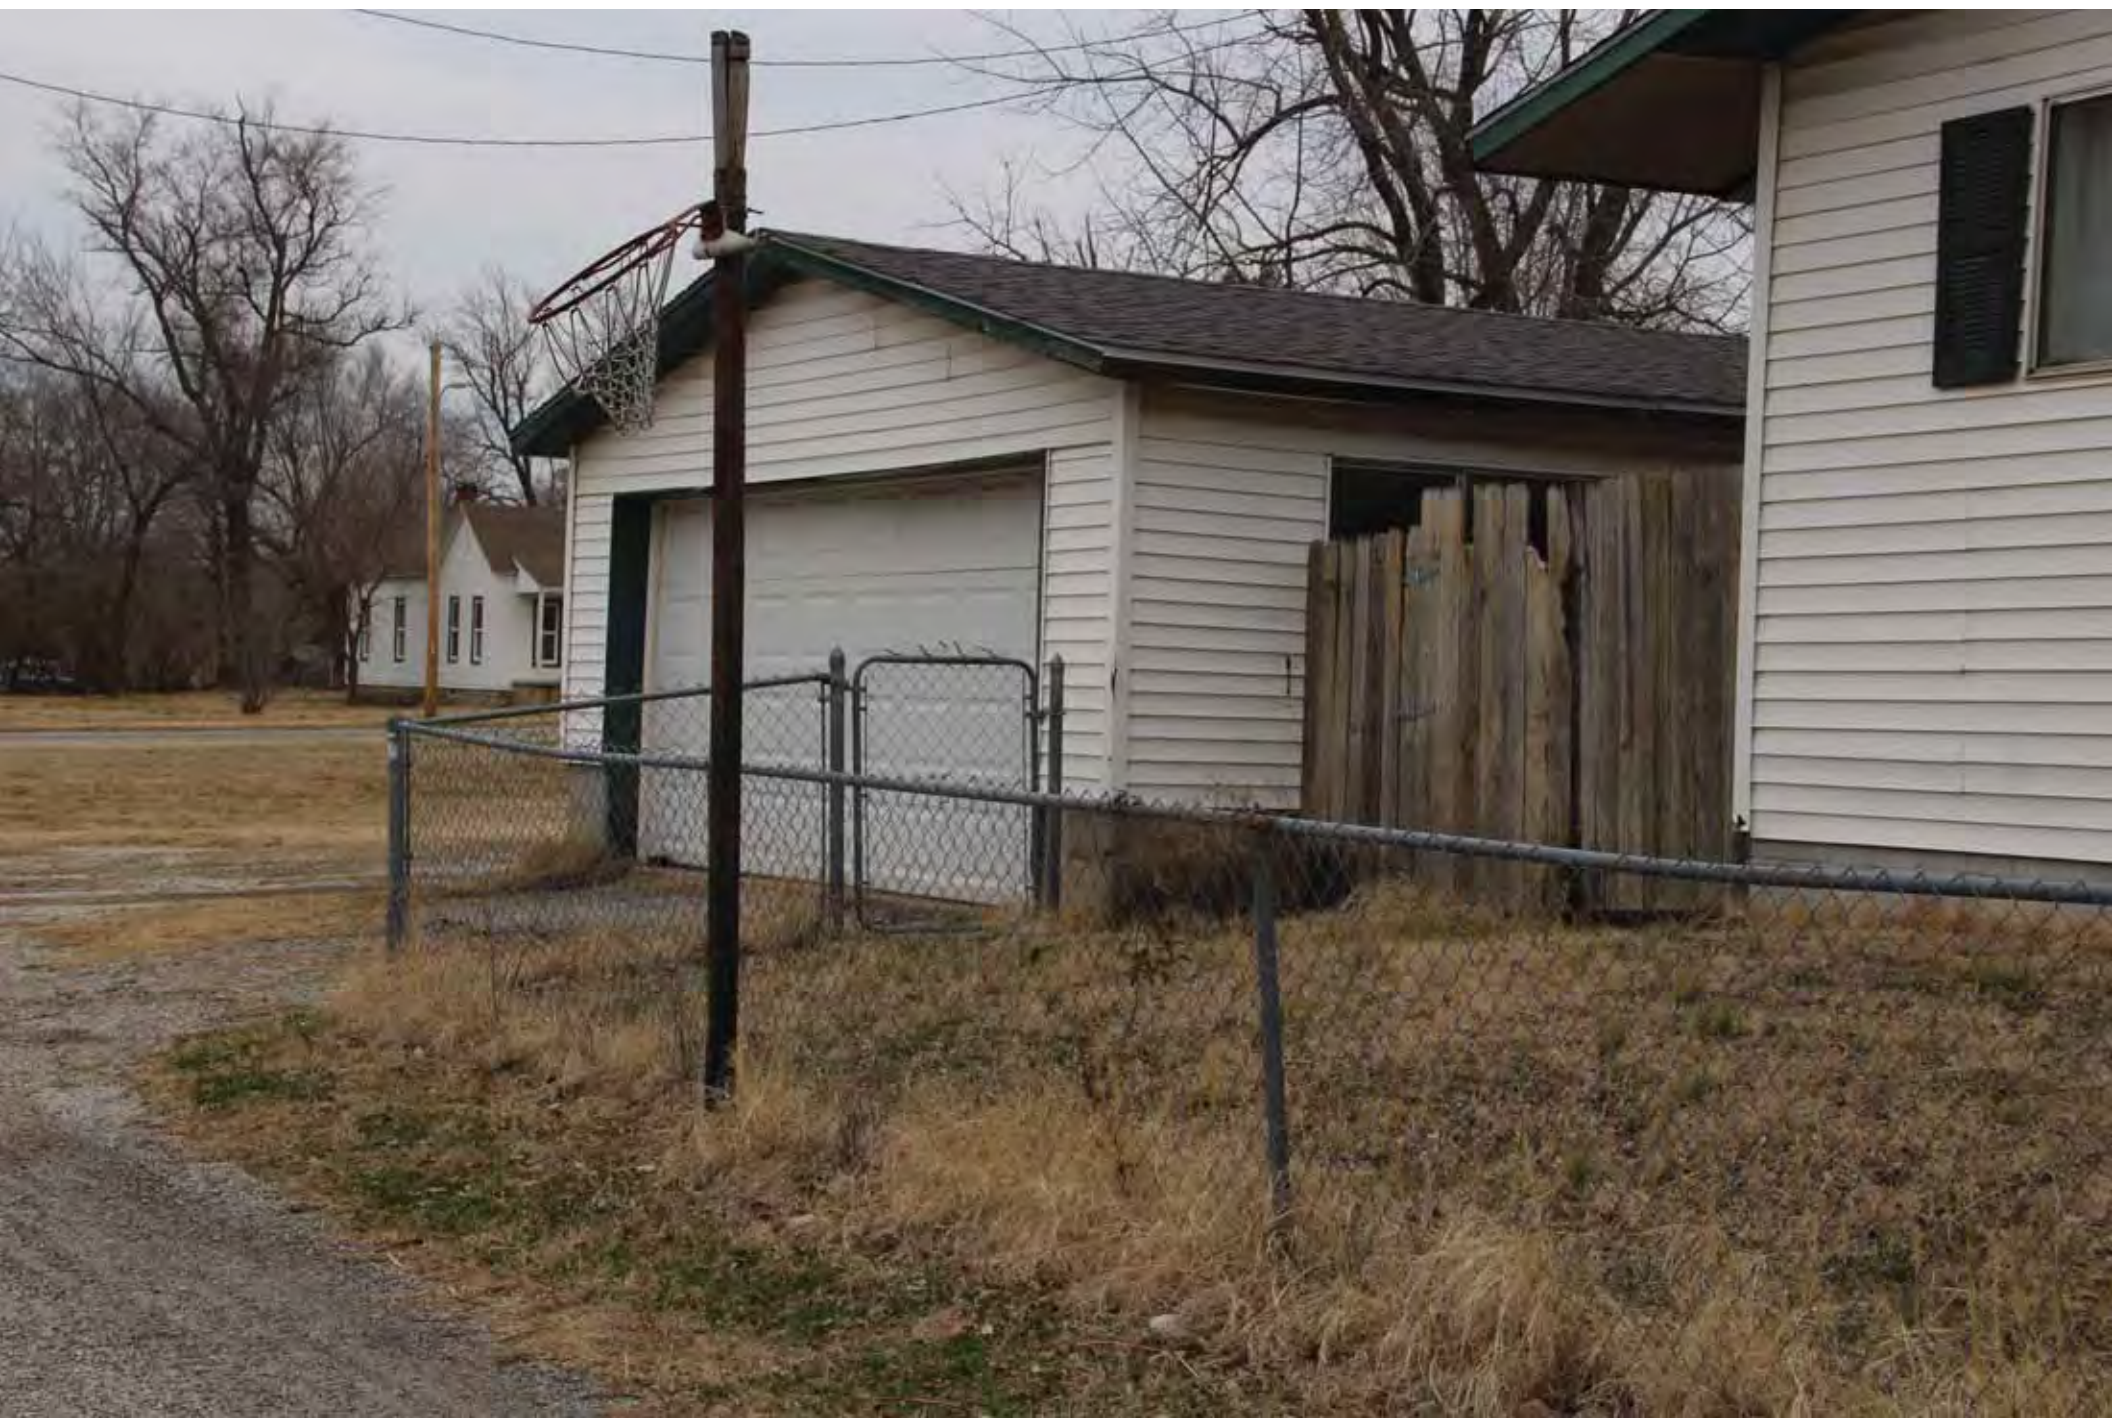
<p>41. (cont.) Description of primary resource. Expand box as necessary, or add continuation pages.</p> <p>The property at 1005 Central Street is a one-story frame house, with a side gable roof covered in asphalt siding. The front elevation has a central replacement door. To the left of the door is a metal casement window. To the right of the door are two similar metal casement windows. All windows have non-functioning metal shutters. The house is covered in vinyl siding.</p>

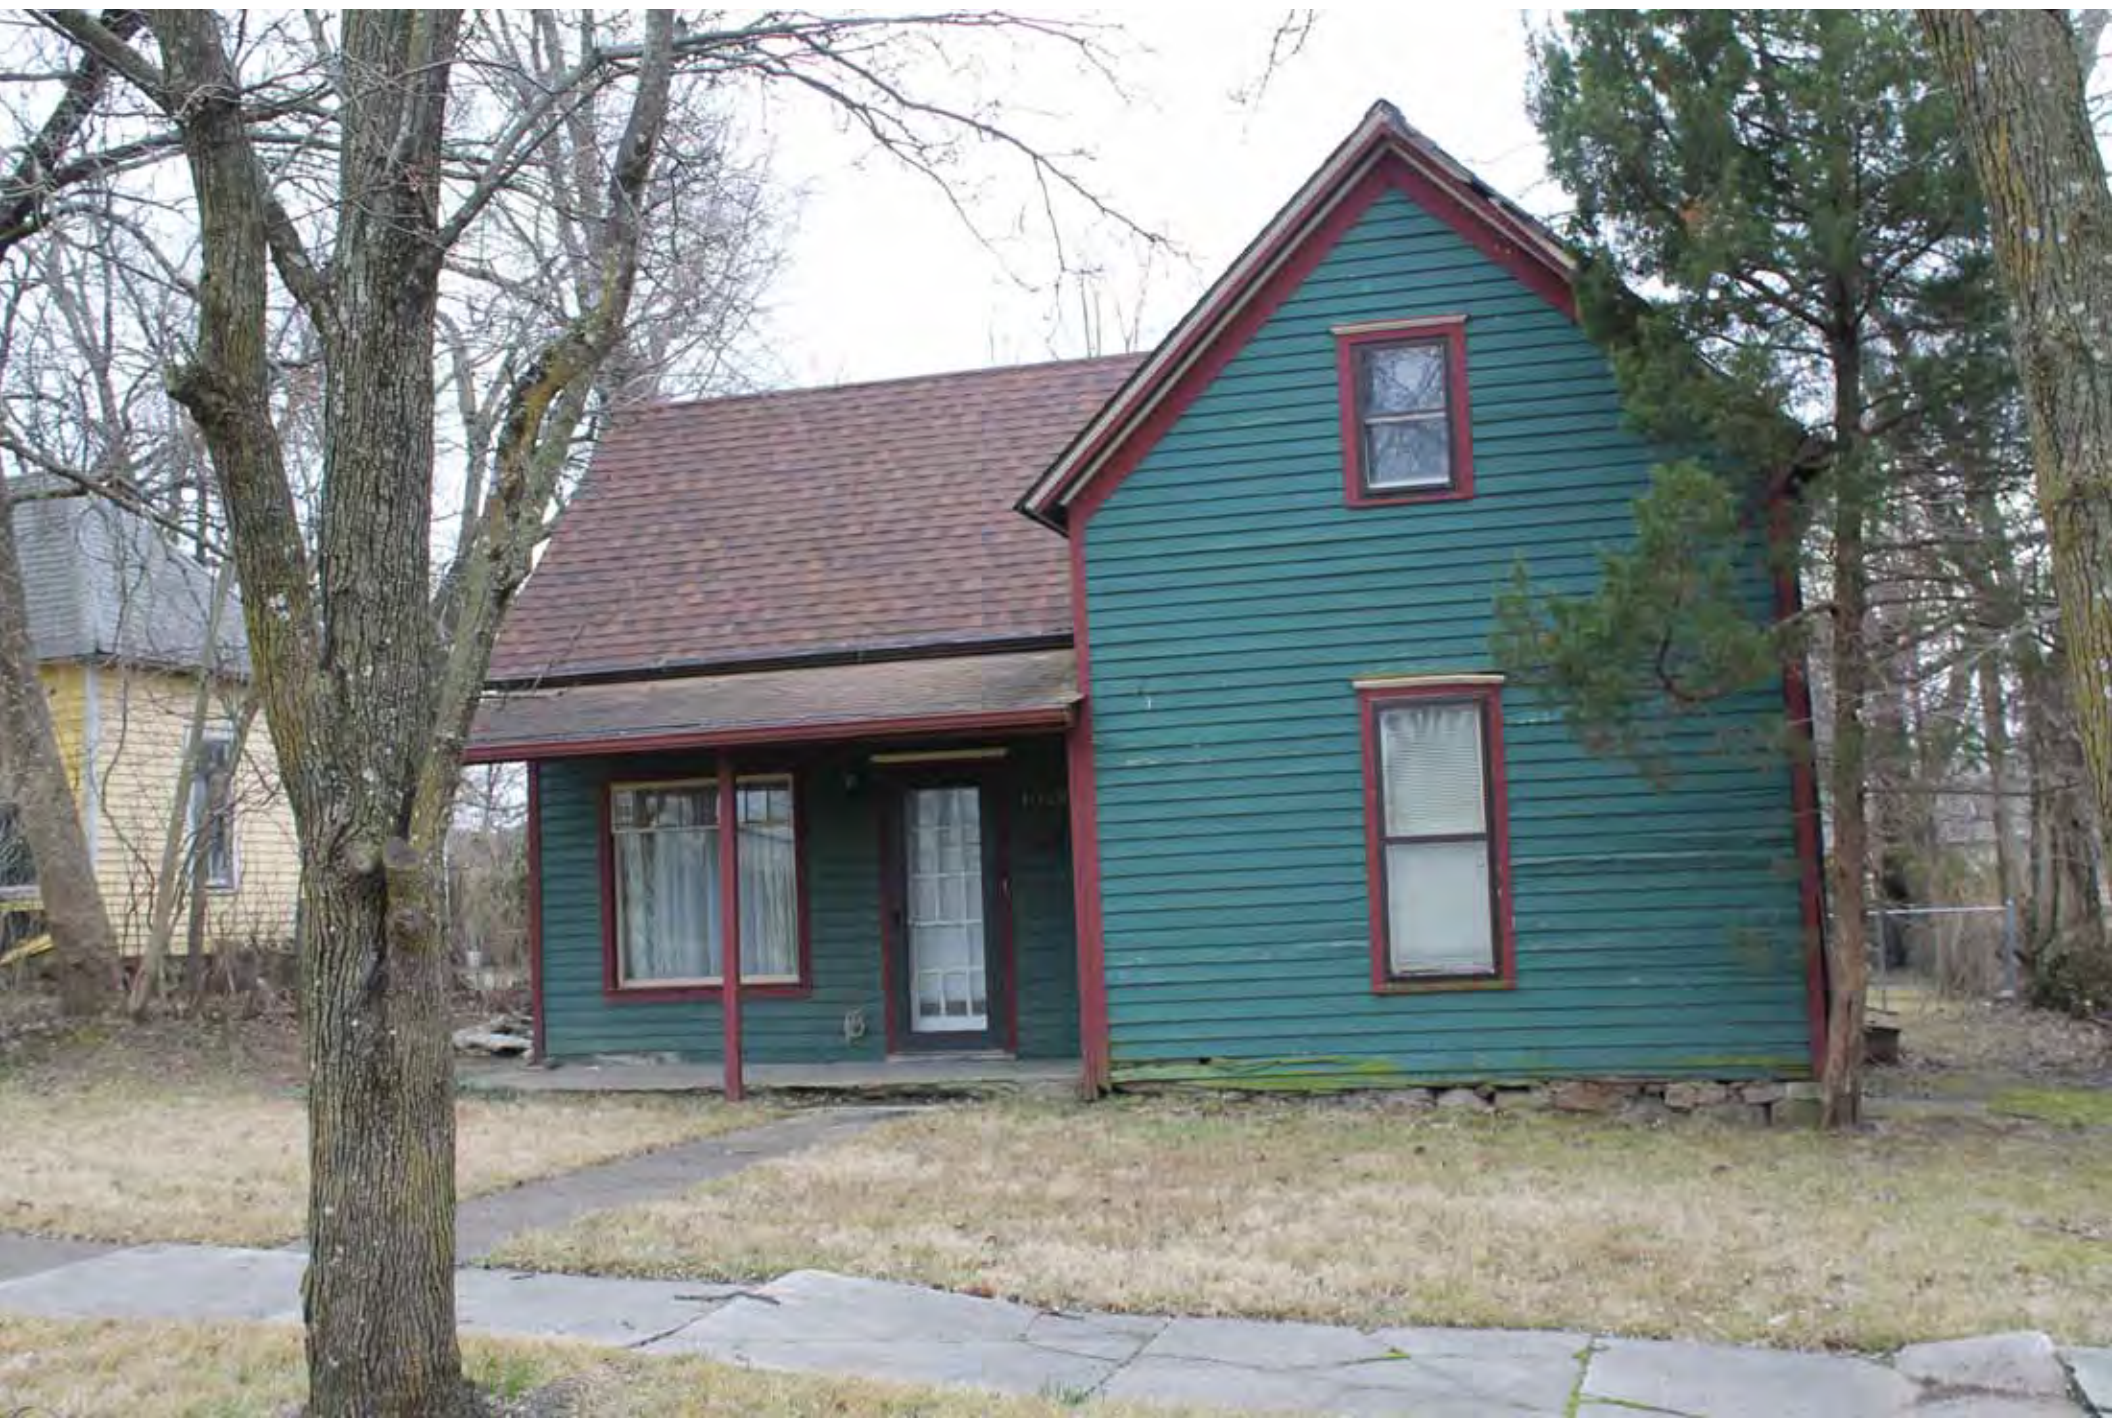
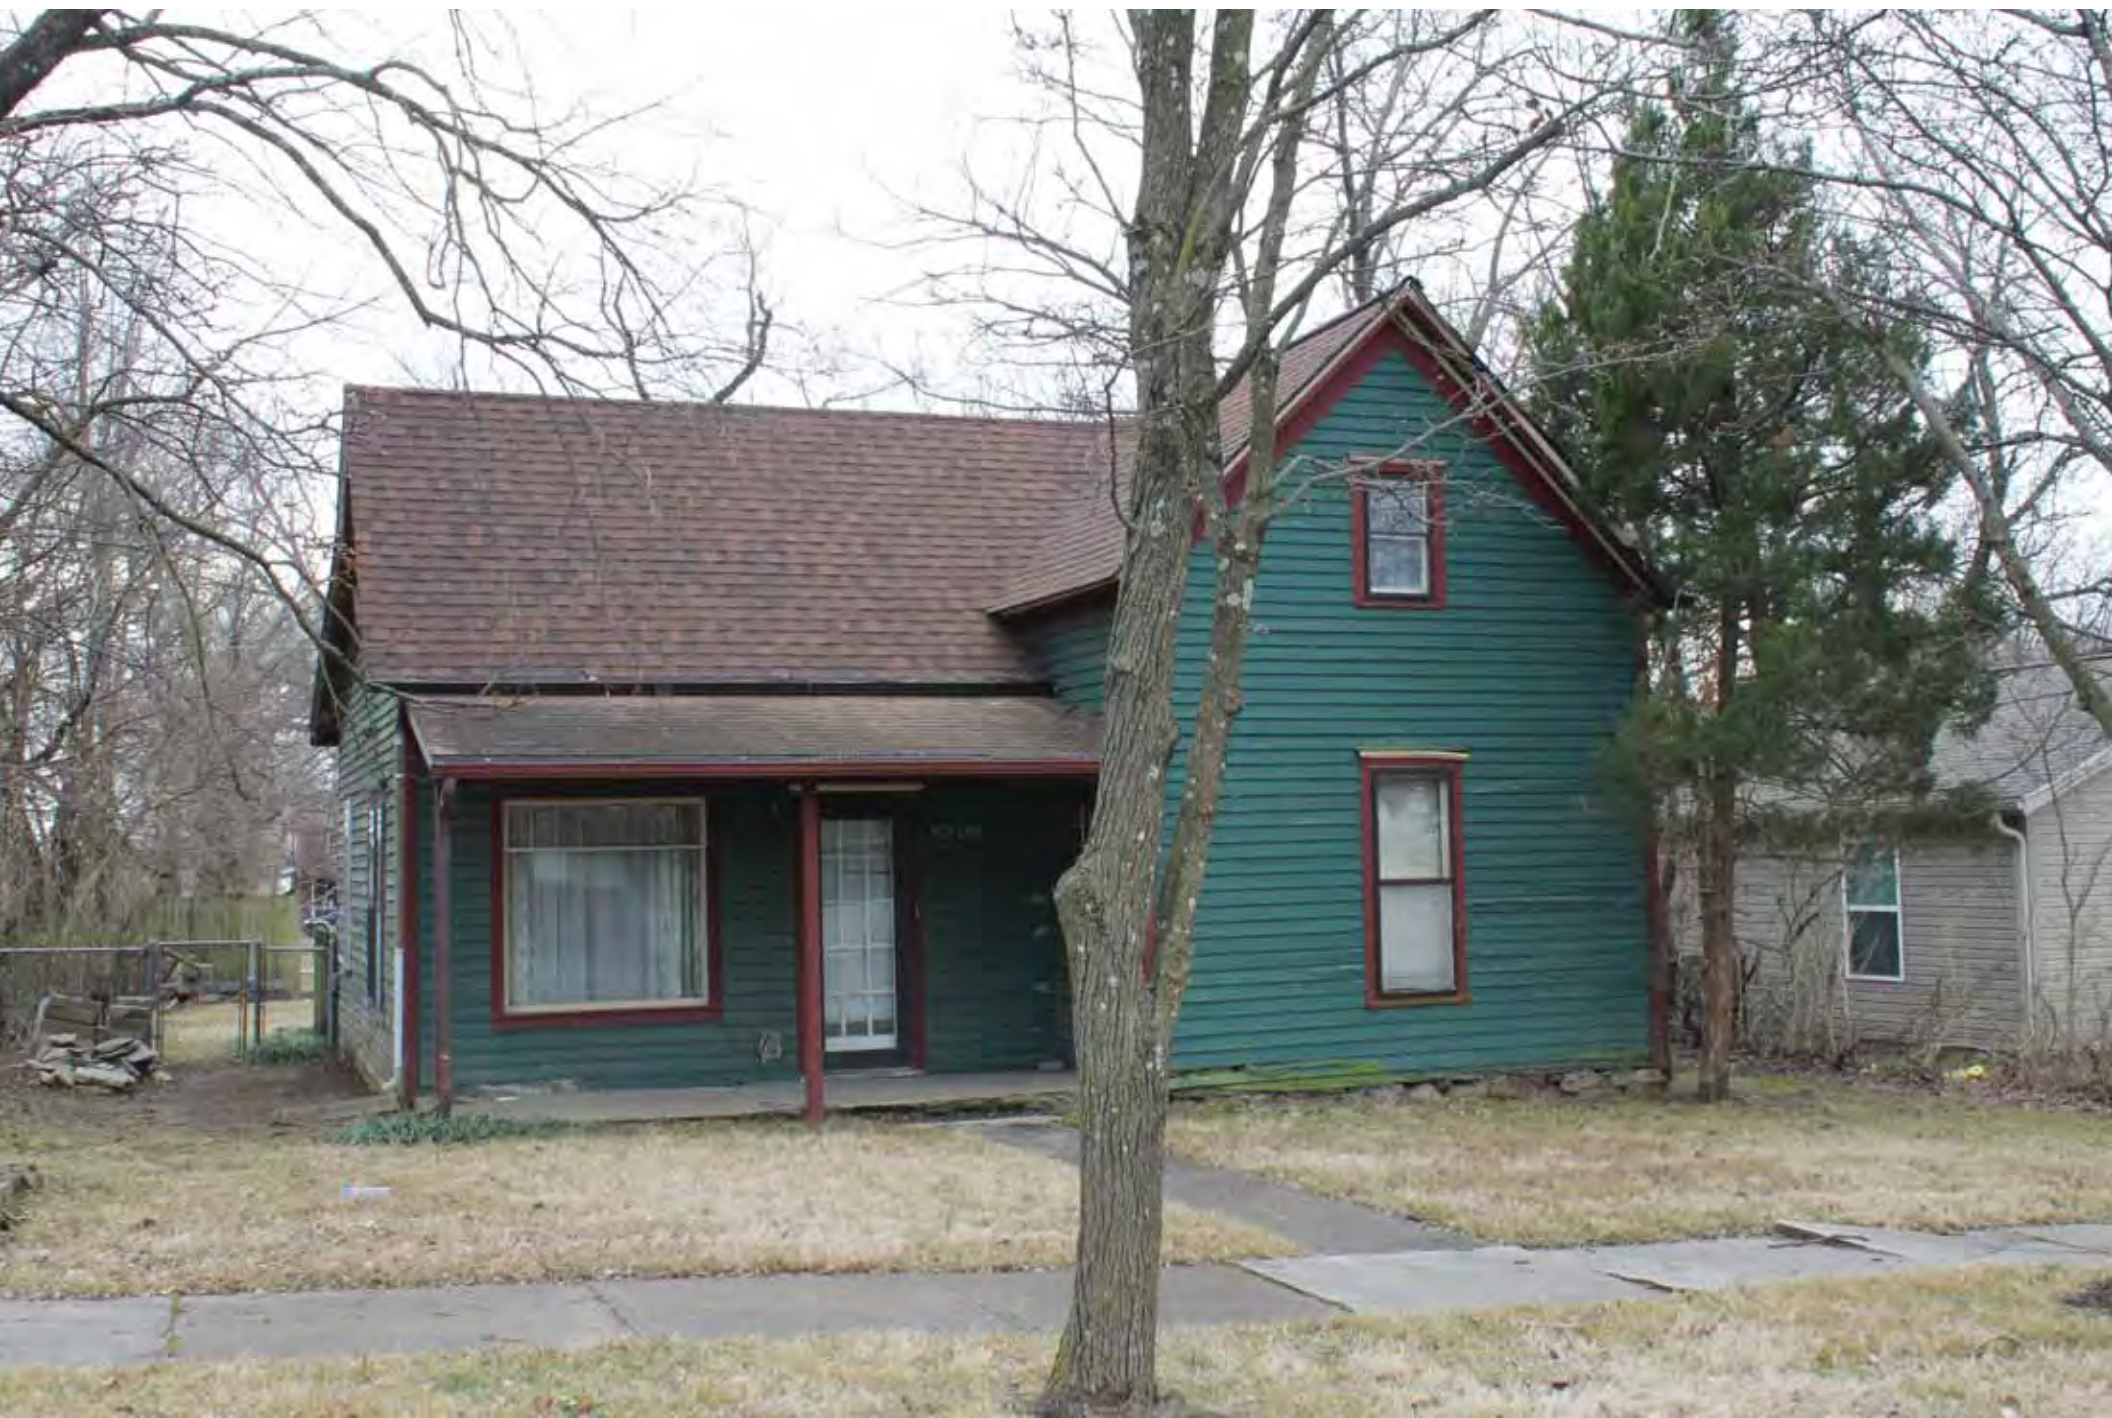
The property at 1006 Central Street is a small frame dwelling with an L-shaped plan and cross gabled roof. The roof is covered in asphalt siding. The house has a rubble stone foundation and retains its original wood siding. On the side-gabled end of the front elevation is a small porch with a shed roof supported by wood posts. It shelters a single entrance door and a large fixed window. To the right of this porch, where the gable end of the front elevation sits, is a single one-over-one window on the first floor. Above it, at the half story level, is a small one-over-one window. All windows have wooden surrounds.
