MISSOURI DEPARTMENT OF NATURAL RESOURCES
STATE HISTORIC PRESERVATION OFFICE, P.O. Box 176, Jefferson City, MO 65102
ARCHITECTURAL/HISTORIC INVENTORY FORM

1. Survey No. JP-AS-007-001		2. Survey name: East Town (Original Joplin) Historic Survey Phase 2	
3. County: JASPER		4. Address (Street No.) 618	Street (name) E. 2 nd Street
5. City: Joplin	Vicinity: <input type="checkbox"/>	6. Geographical Reference:	7. Township/Range/Section: T: R: S:
8. Historic name (if known):		9. Present/other name (if known):	
10. Ownership: <input checked="" type="checkbox"/> Private <input type="checkbox"/> Public		11a. Historic use (if known): Domestic: Single Dwelling	11b. Current use: Domestic: Single Dwelling

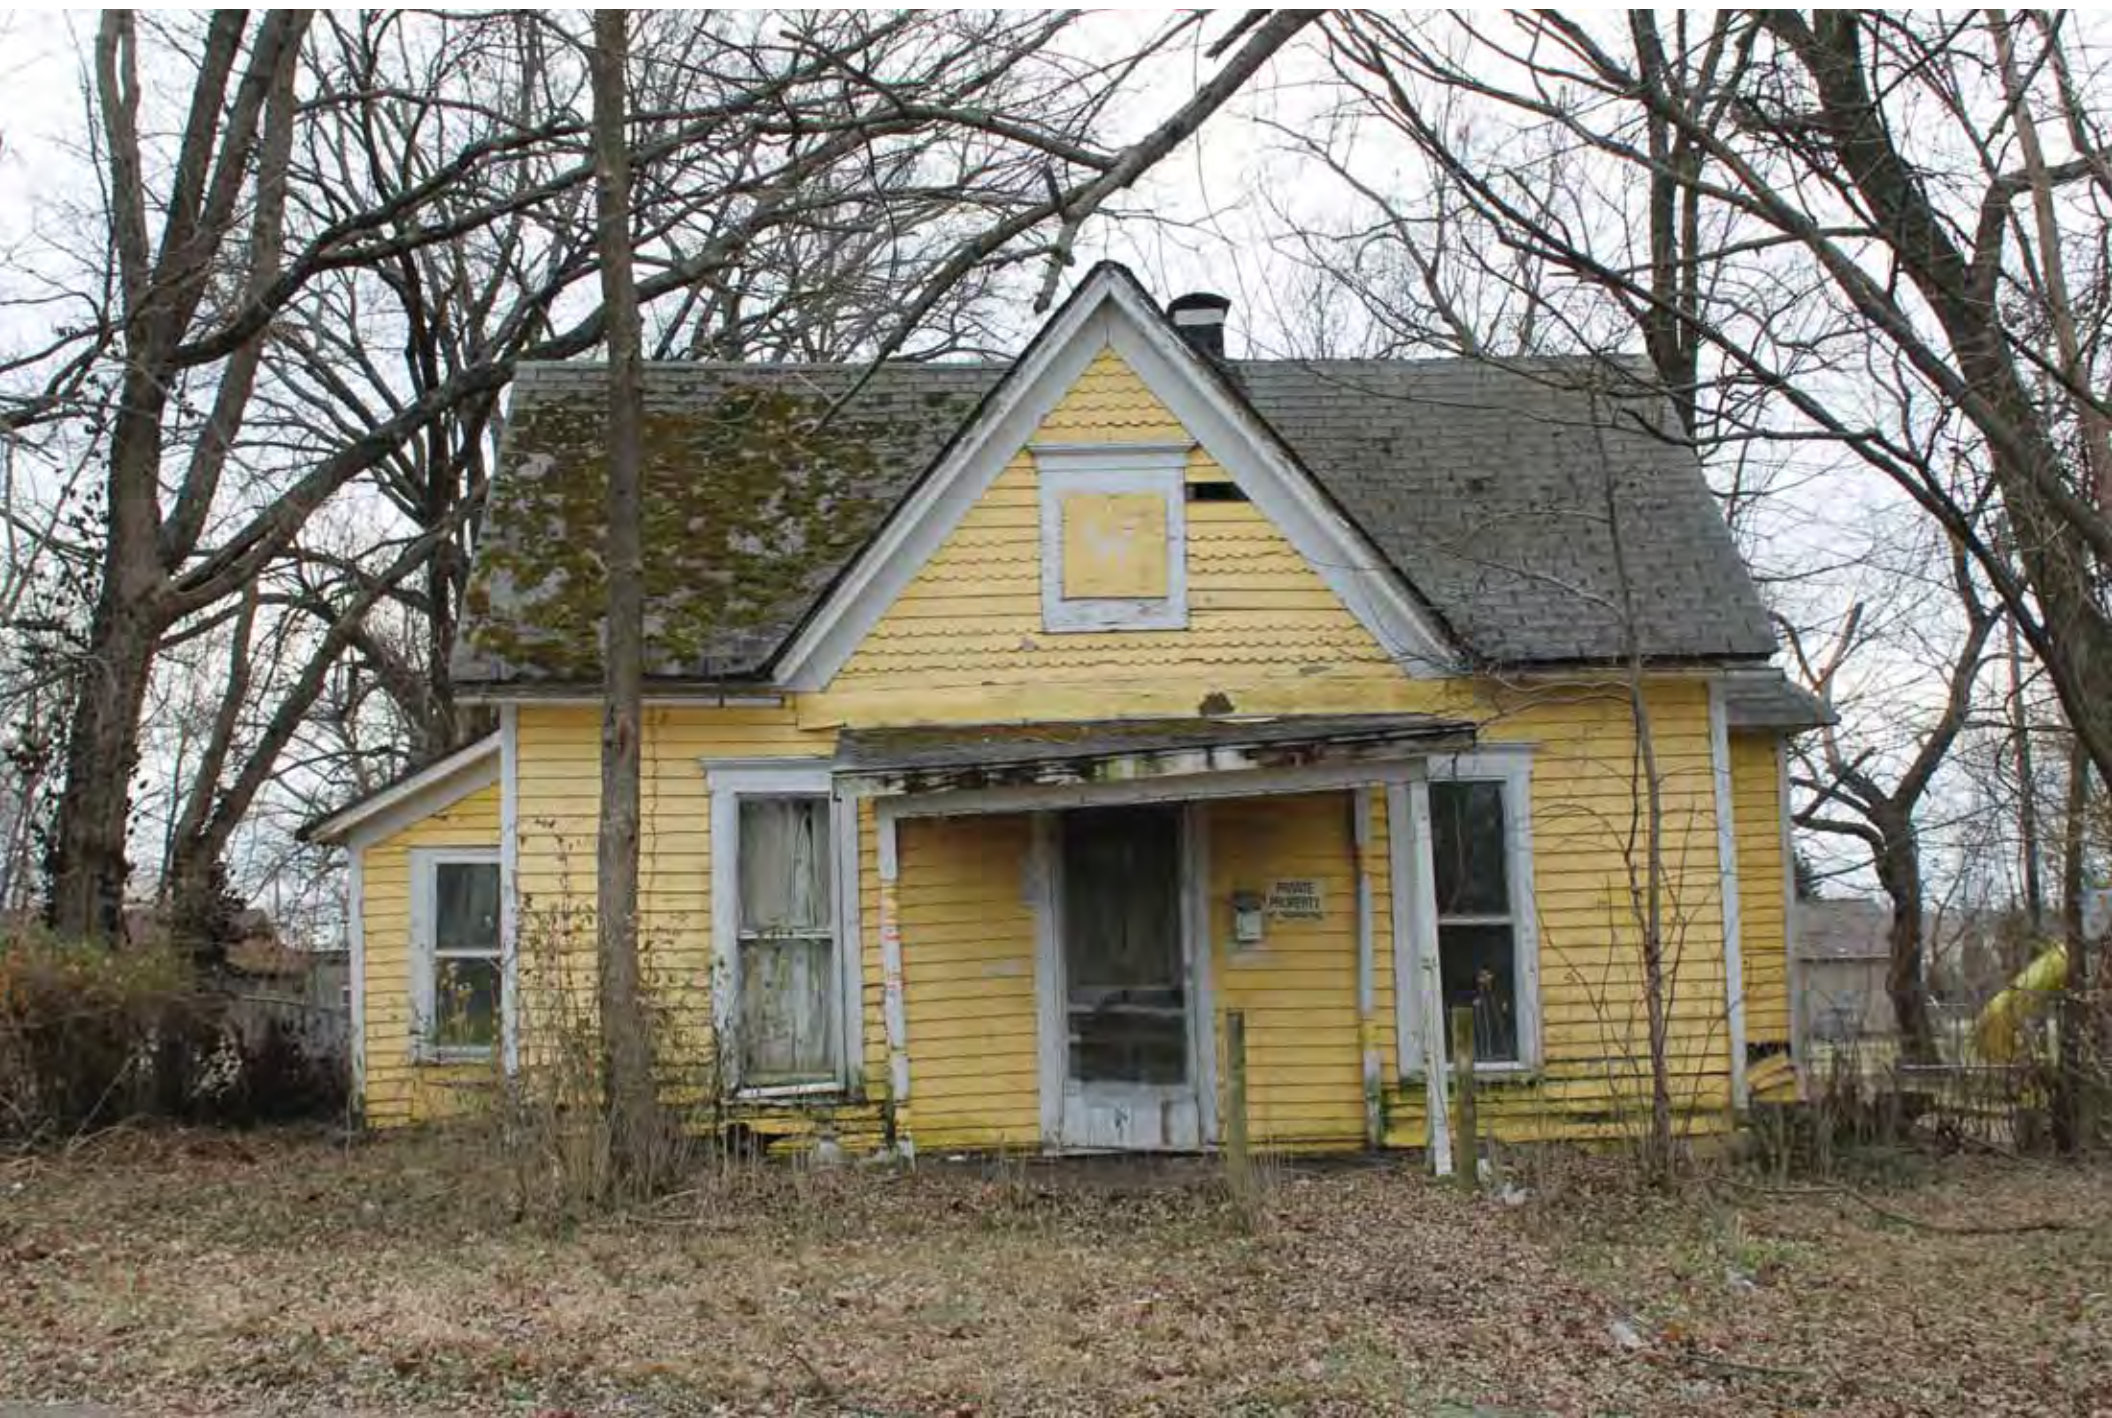
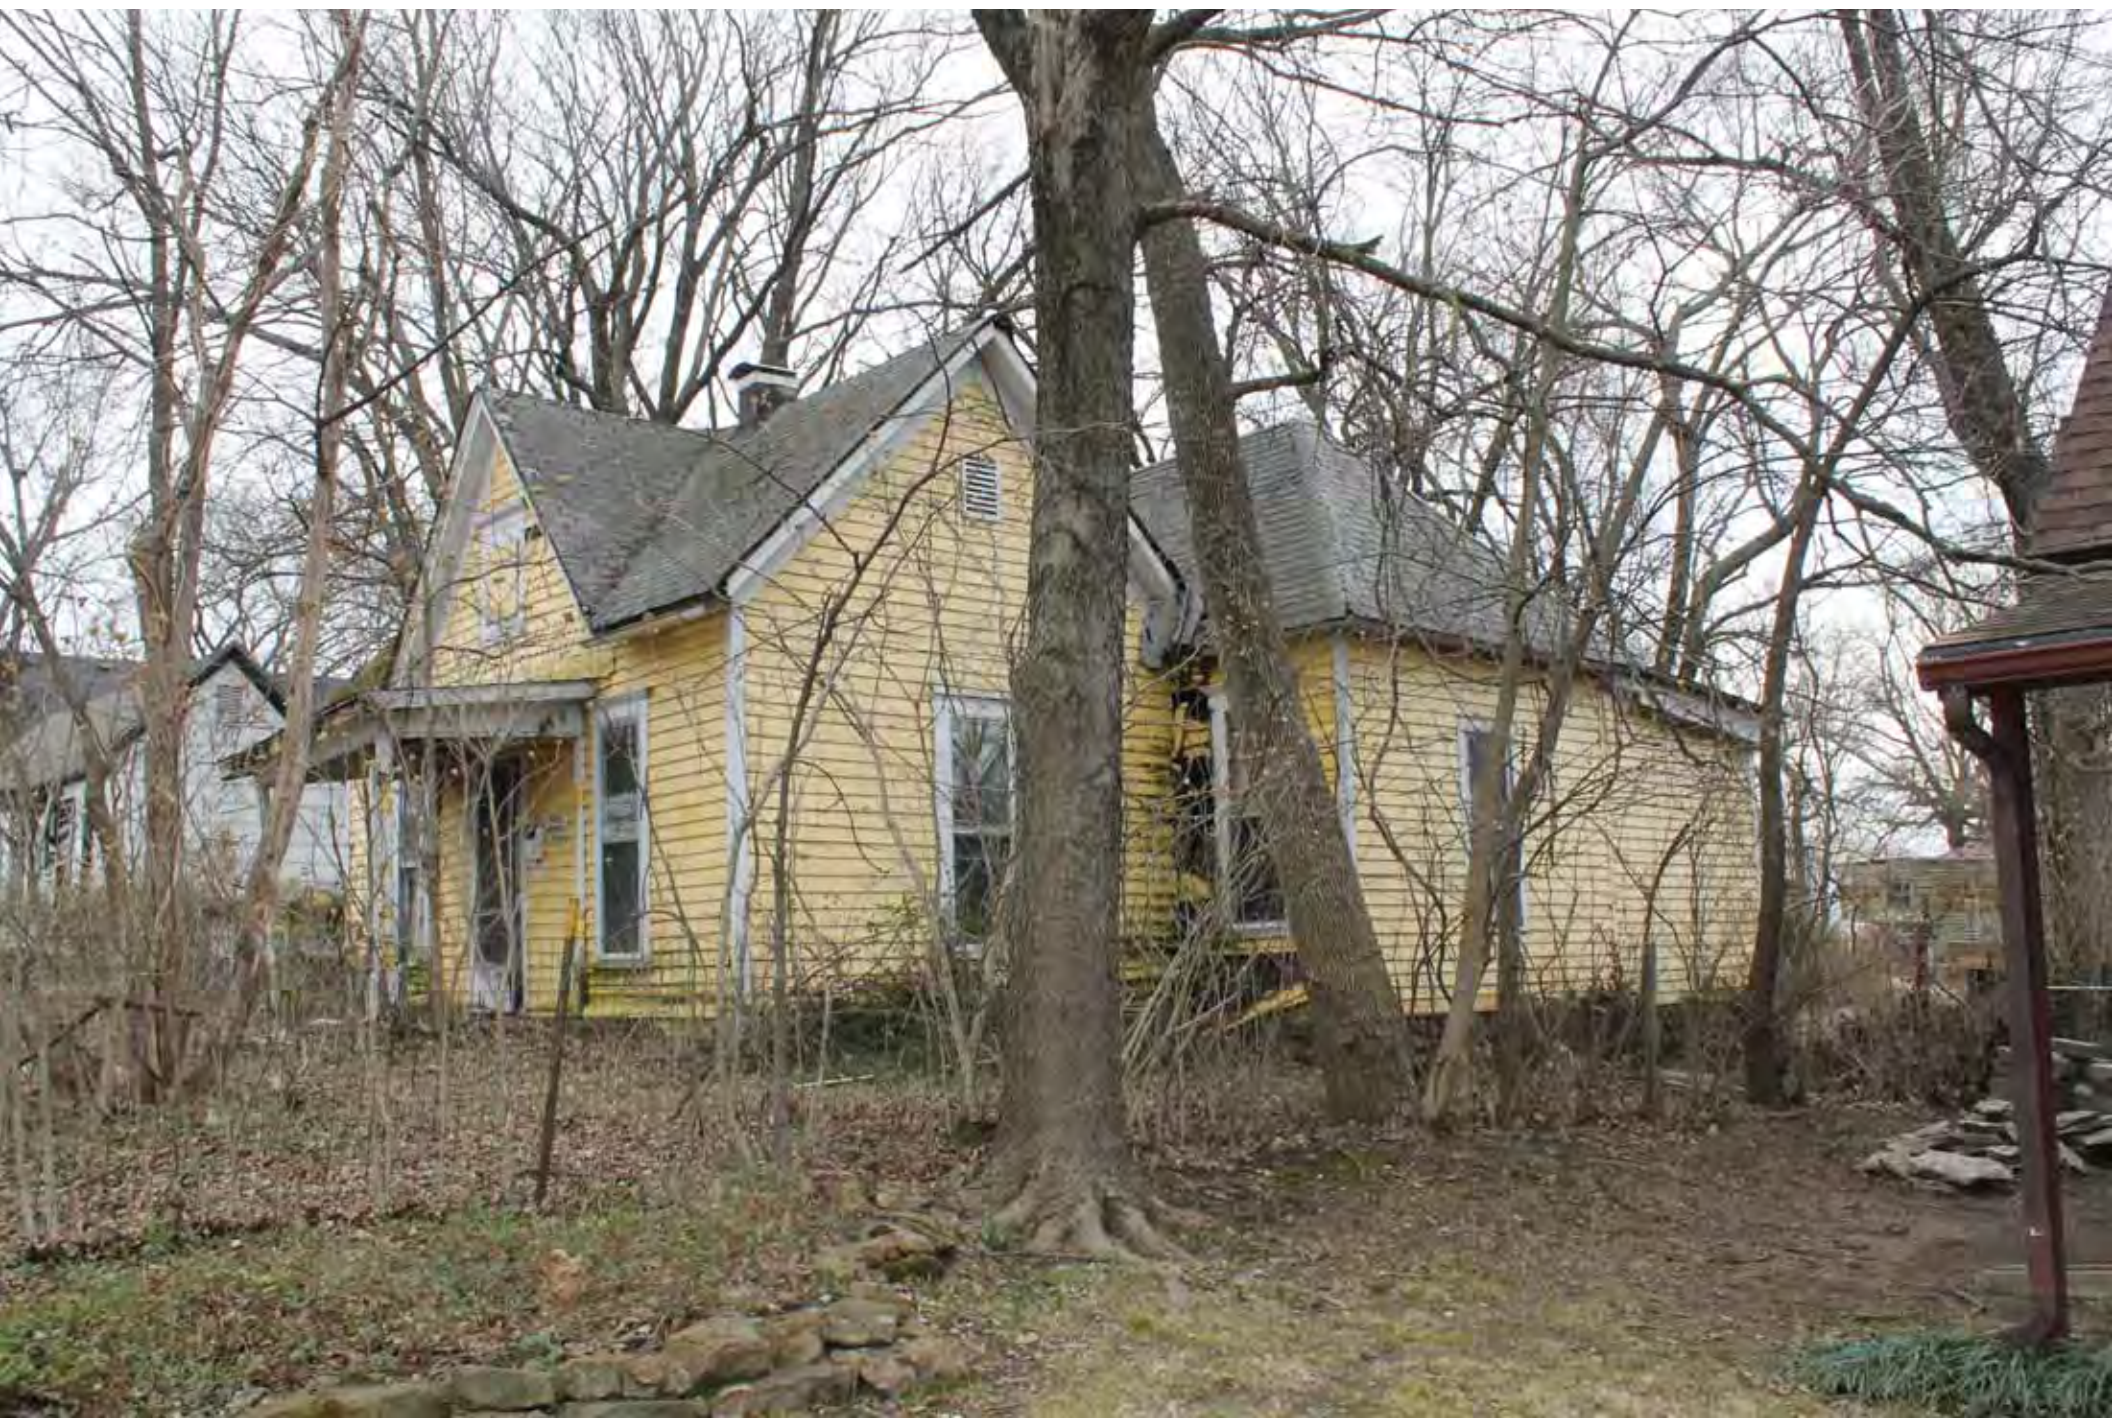
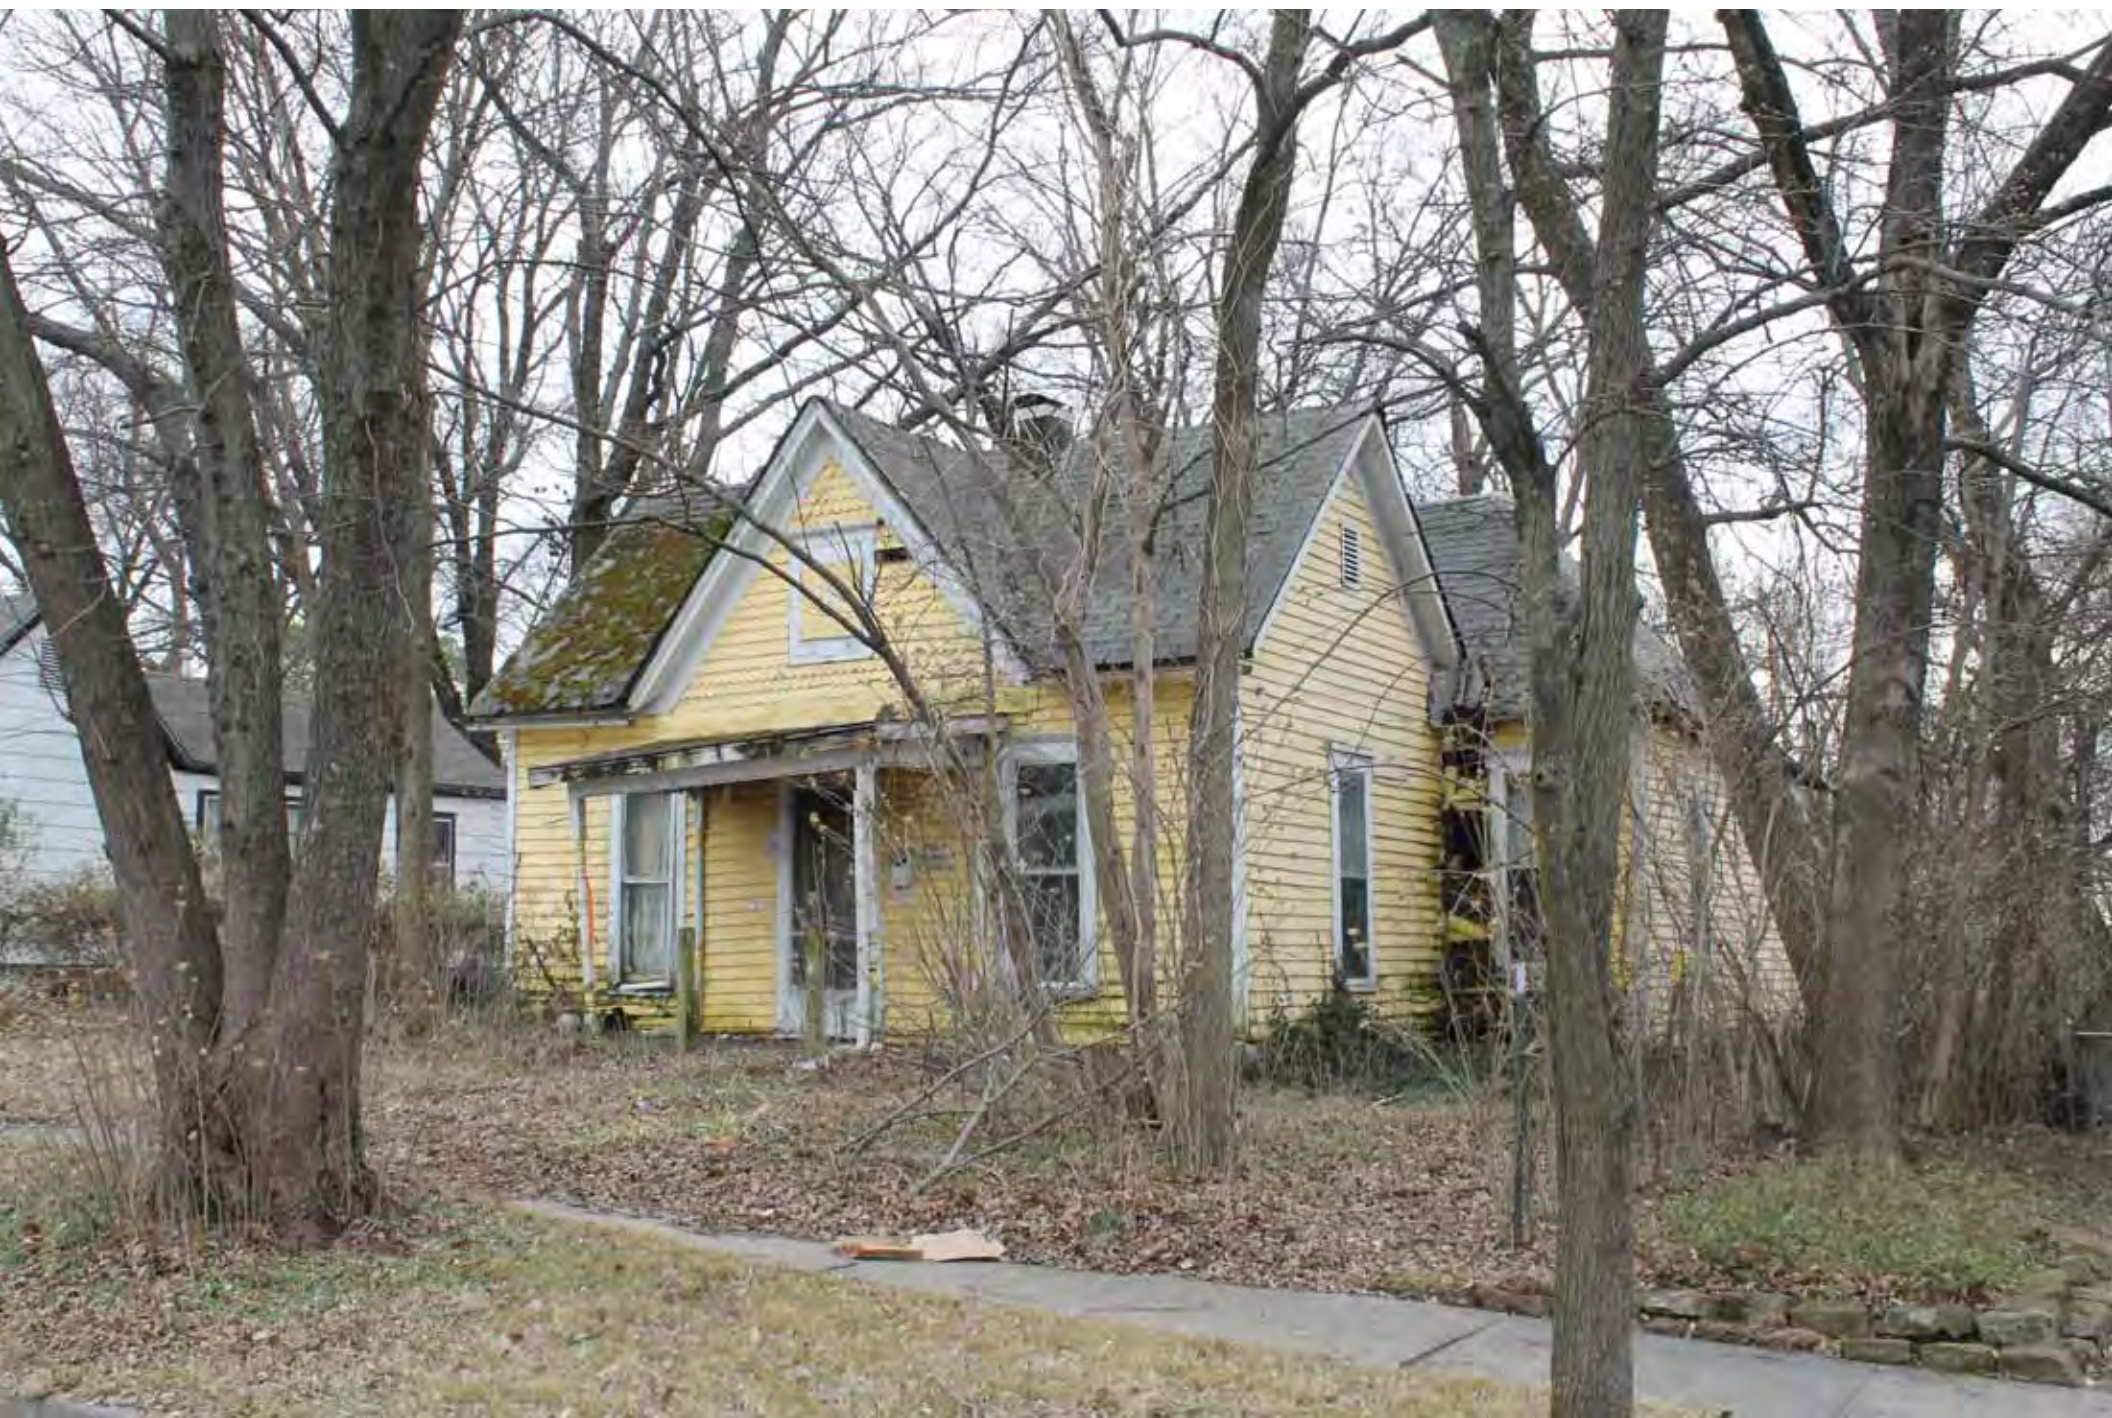
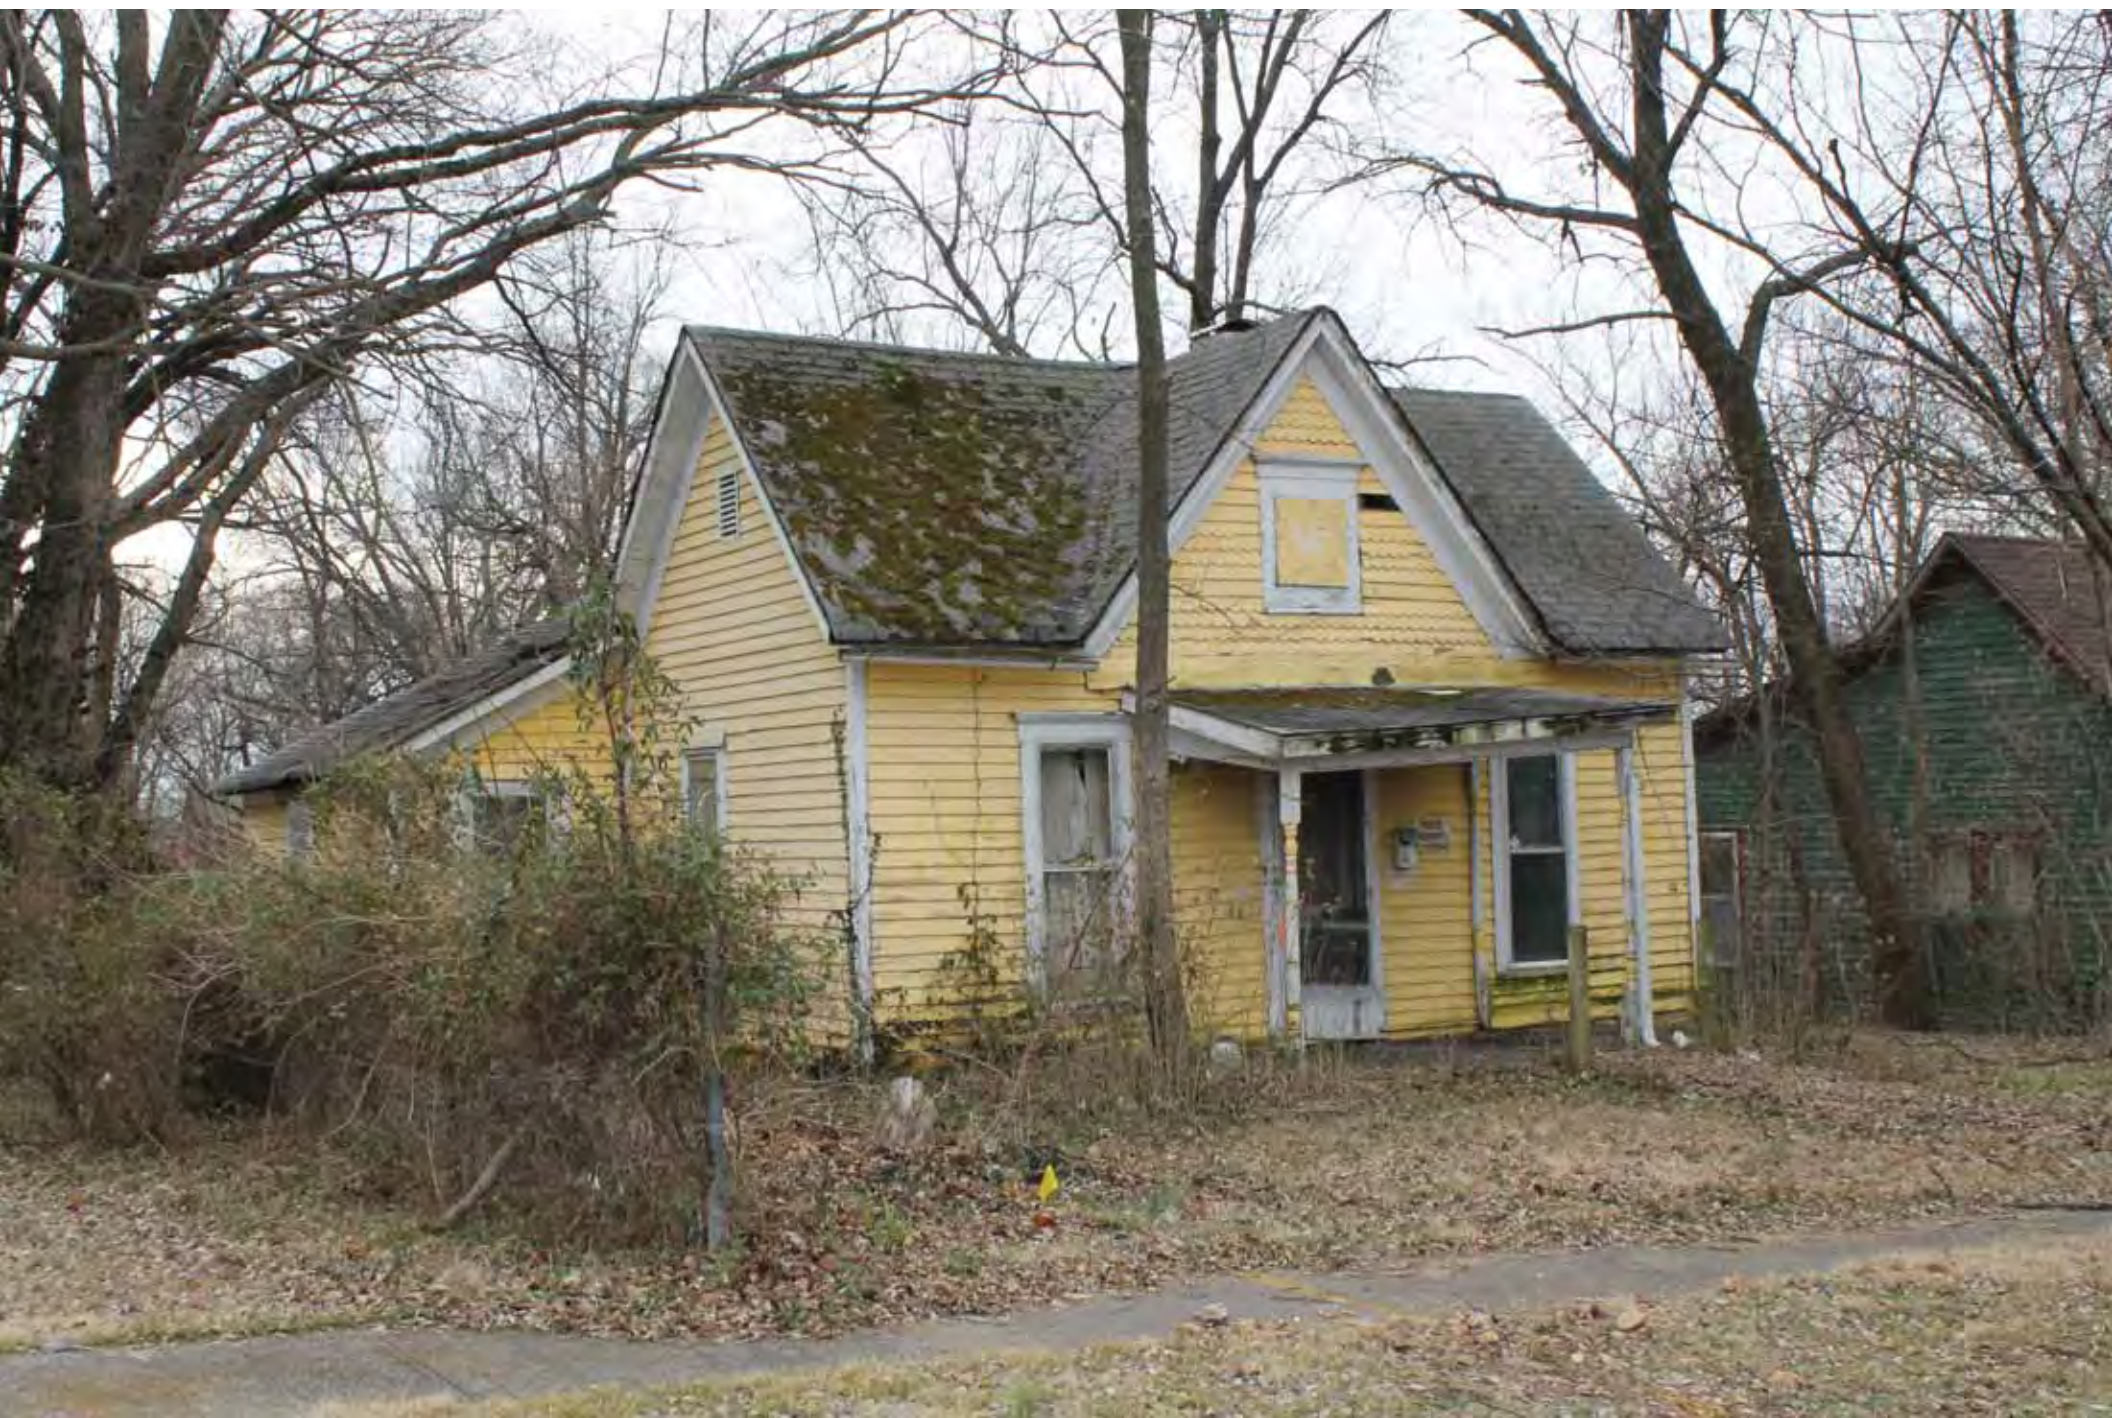
The property at 1012 Central Street is a small frame dwelling with a rectangular plan and a cross gabled roof. The house retains its original wood siding. There is an interior brick chimney. The front façade is symmetrical, with a central pediment gable end at the roof. There is a central entrance door flanked on either side by original one-over-one wood windows with wood surrounds. There is a front porch with a flat roof and turned wood posts, which is in poor condition. There is a large frame hipped roof addition at the rear of the house, and a smaller lean-to addition.

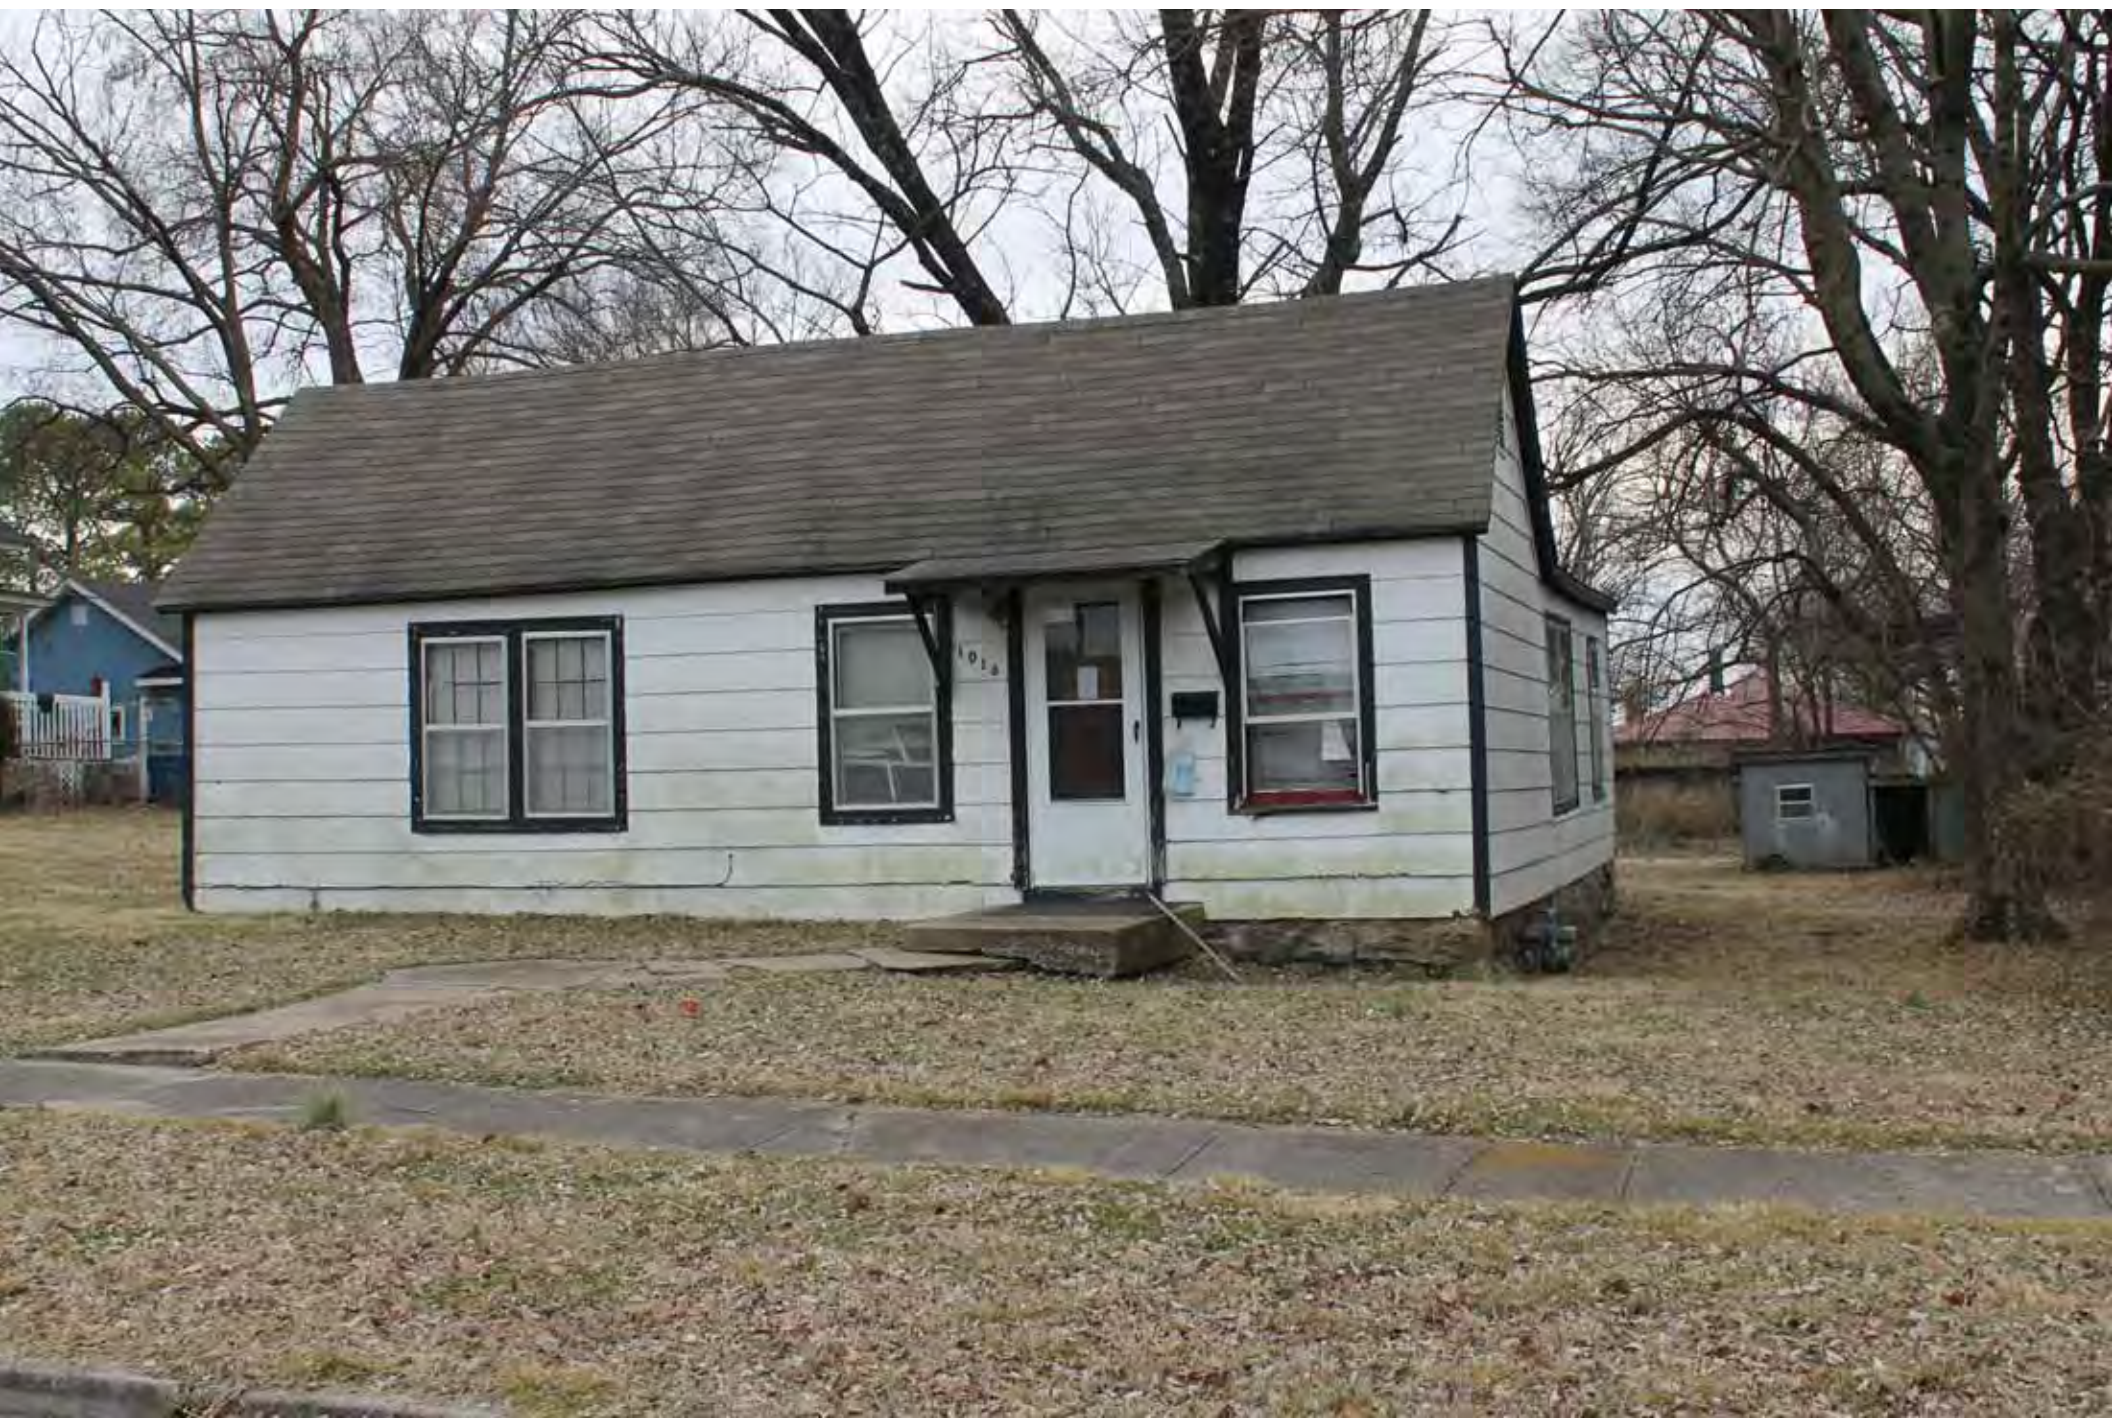
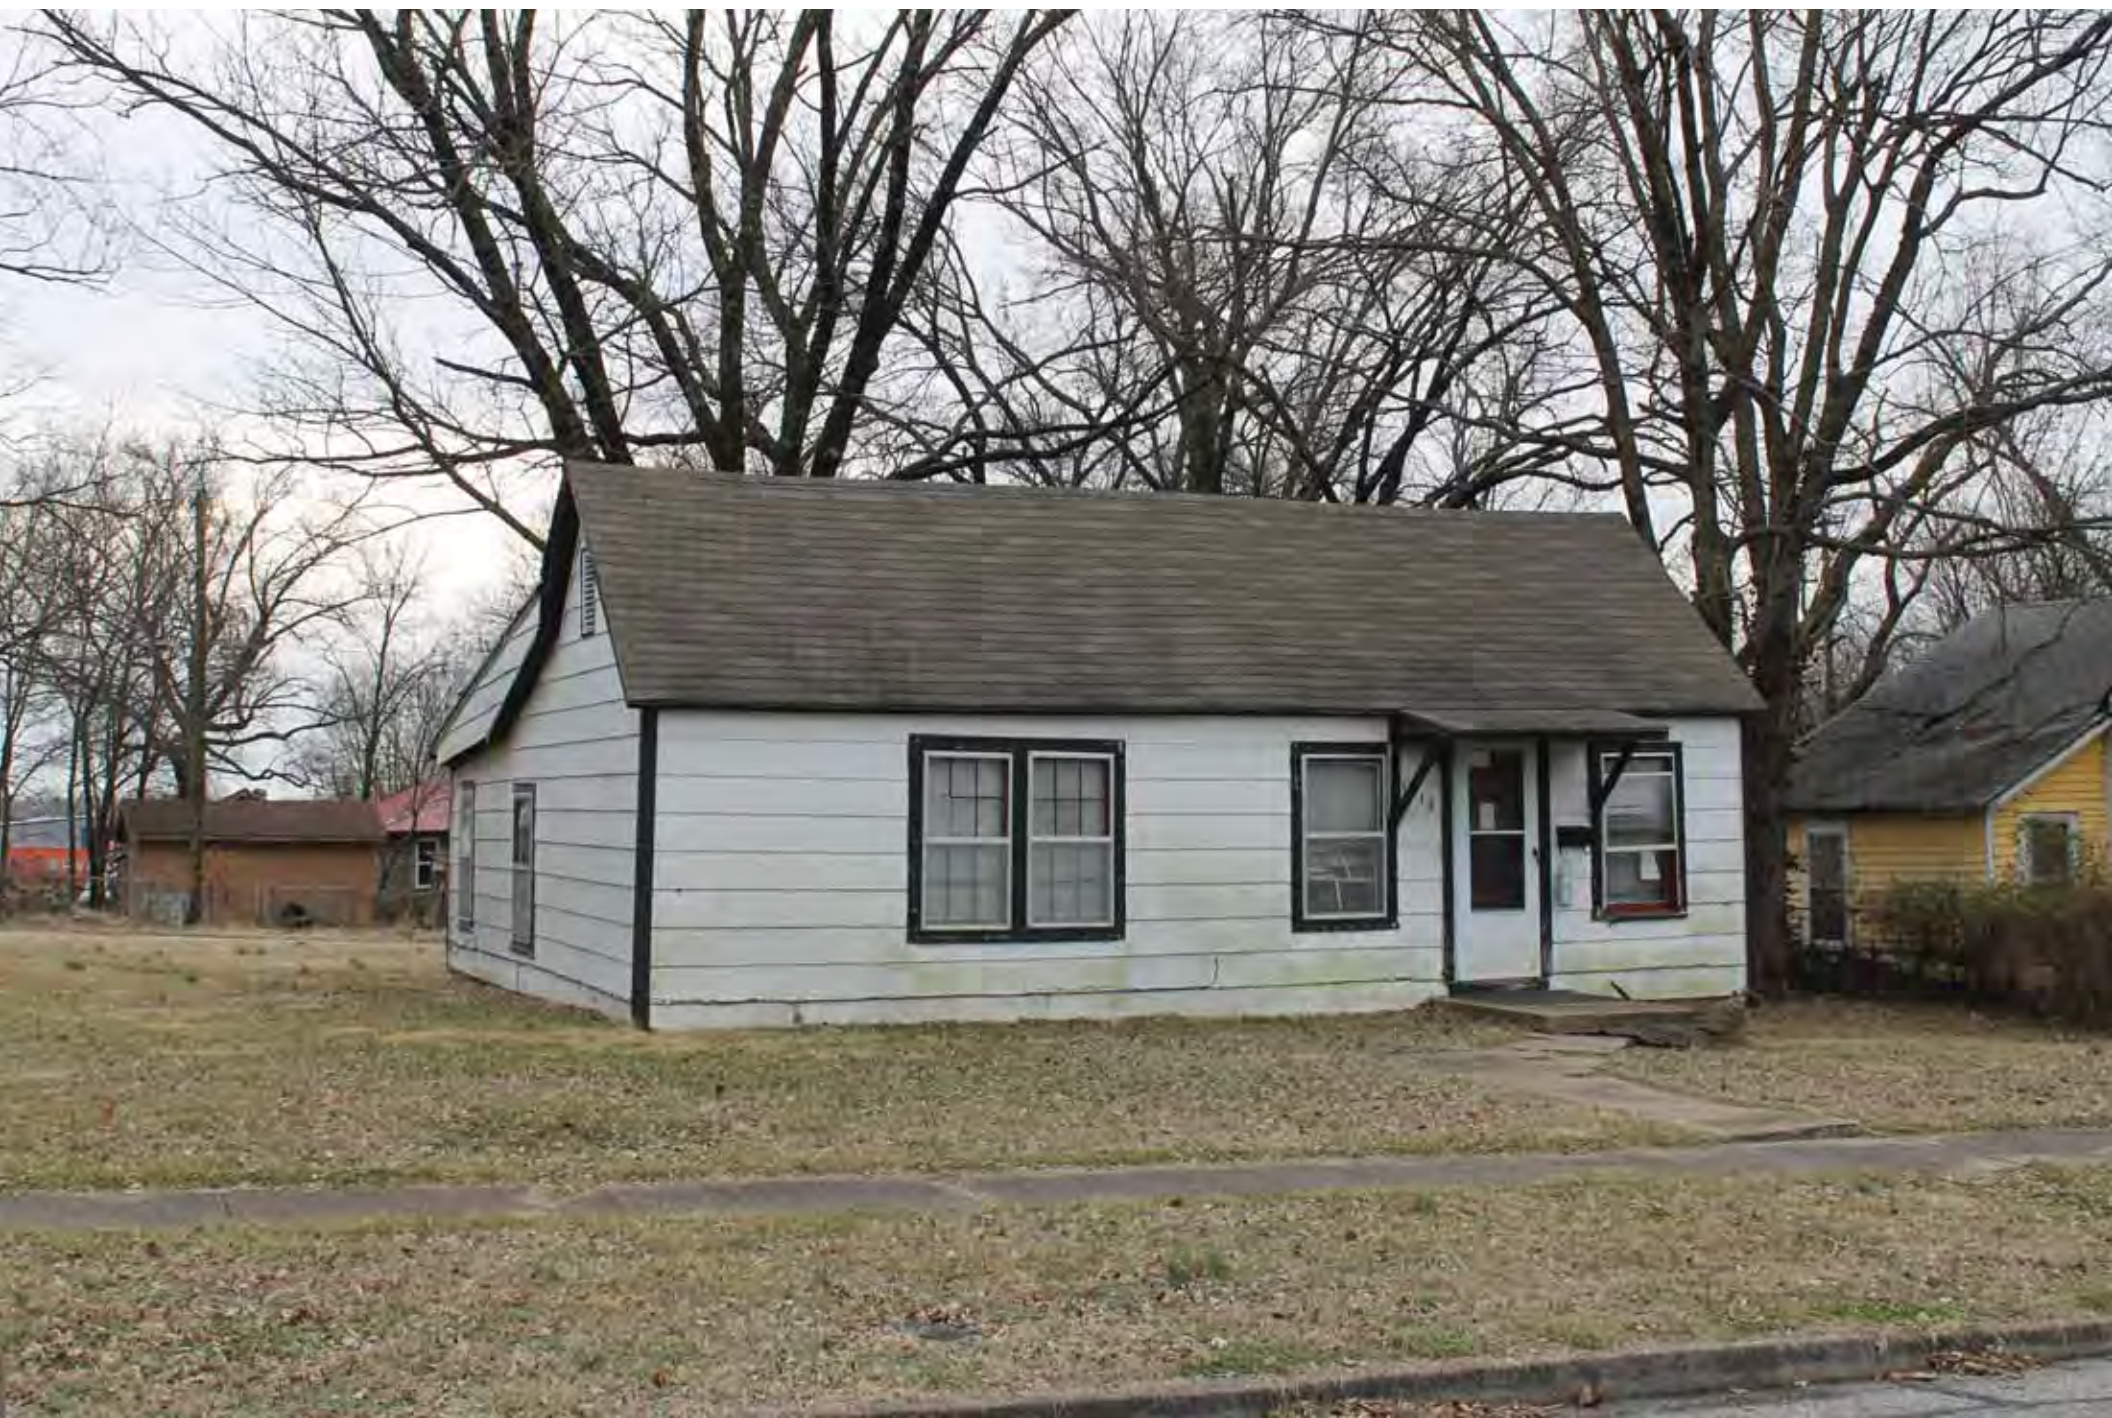
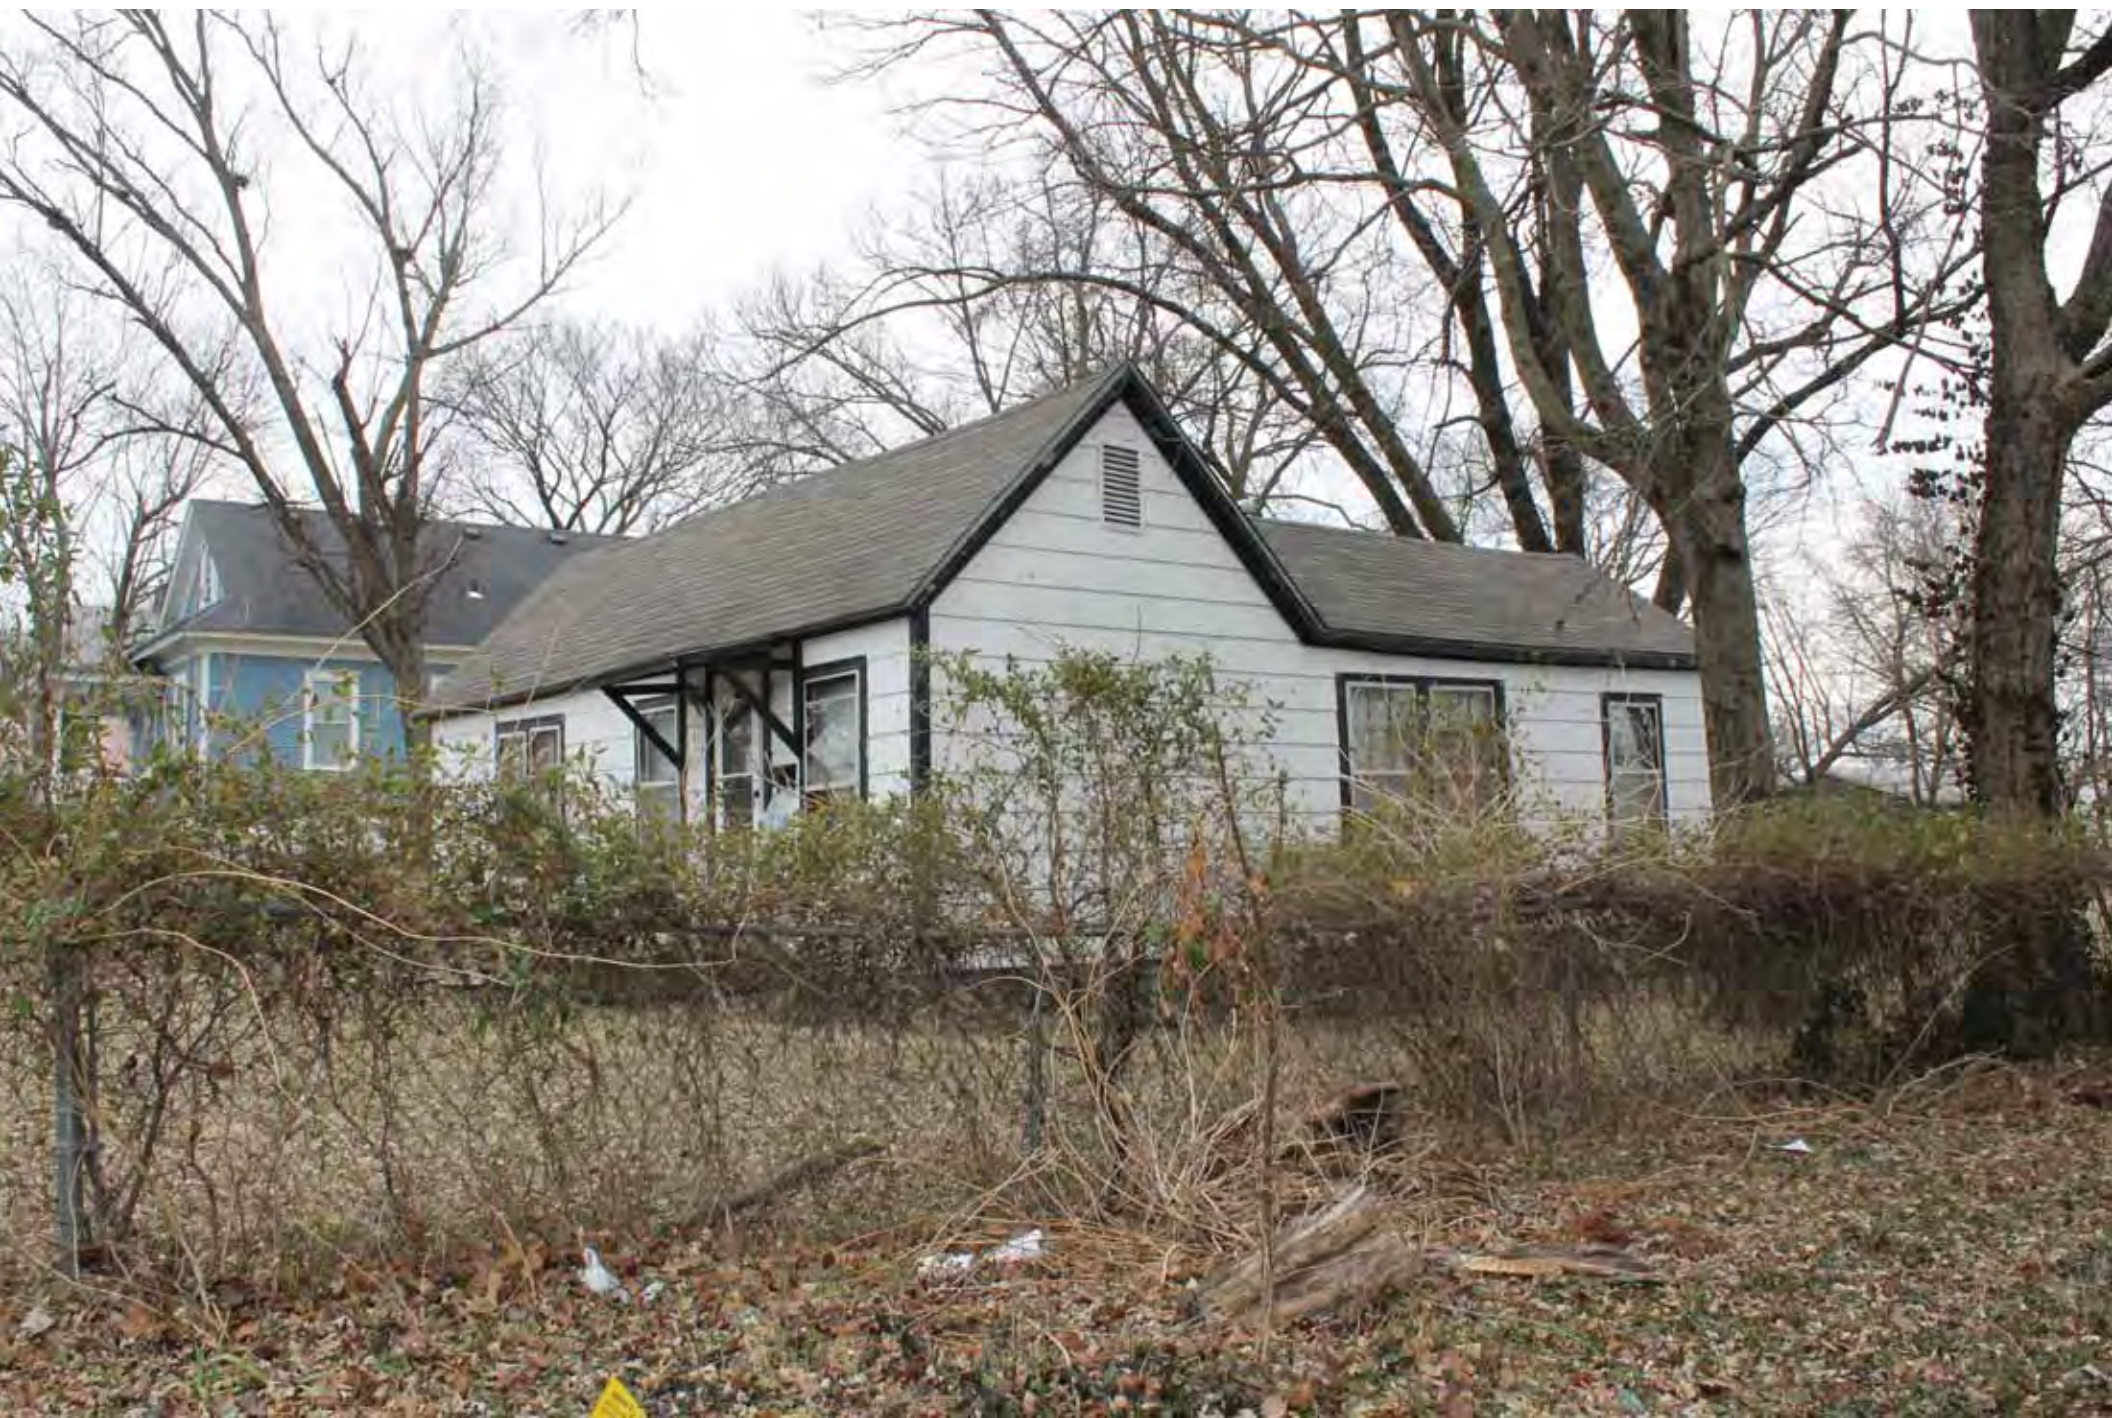
The property at 1016 Central Street is a small frame dwelling with a rectangular plan and a side gabled roof. The house has a stone foundation and appears to be covered in asphalt siding. The front façade is asymmetrical, with a entrance door under an awning slightly right of center. Flanking the entrance on either side are single one-over-one windows. To the left, or the east, of this entrance bay is a set of paired six-over-six wood windows. There are similar windows on the side elevations of the house.
