MISSOURI DEPARTMENT OF NATURAL RESOURCES
STATE HISTORIC PRESERVATION OFFICE, P.O. Box 176, Jefferson City, MO 65102
ARCHITECTURAL/HISTORIC INVENTORY FORM

1. Survey No. JP-AS-007-001		2. Survey name: East Town (Original Joplin) Historic Survey Phase 2	
3. County: JASPER		4. Address (Street No.) 618	Street (name) E. 2 nd Street
5. City: Joplin	Vicinity: <input type="checkbox"/>	6. Geographical Reference:	7. Township/Range/Section: T: R: S:
8. Historic name (if known):		9. Present/other name (if known):	
10. Ownership: <input checked="" type="checkbox"/> Private <input type="checkbox"/> Public		11a. Historic use (if known): Domestic: Single Dwelling	11b. Current use: Domestic: Single Dwelling

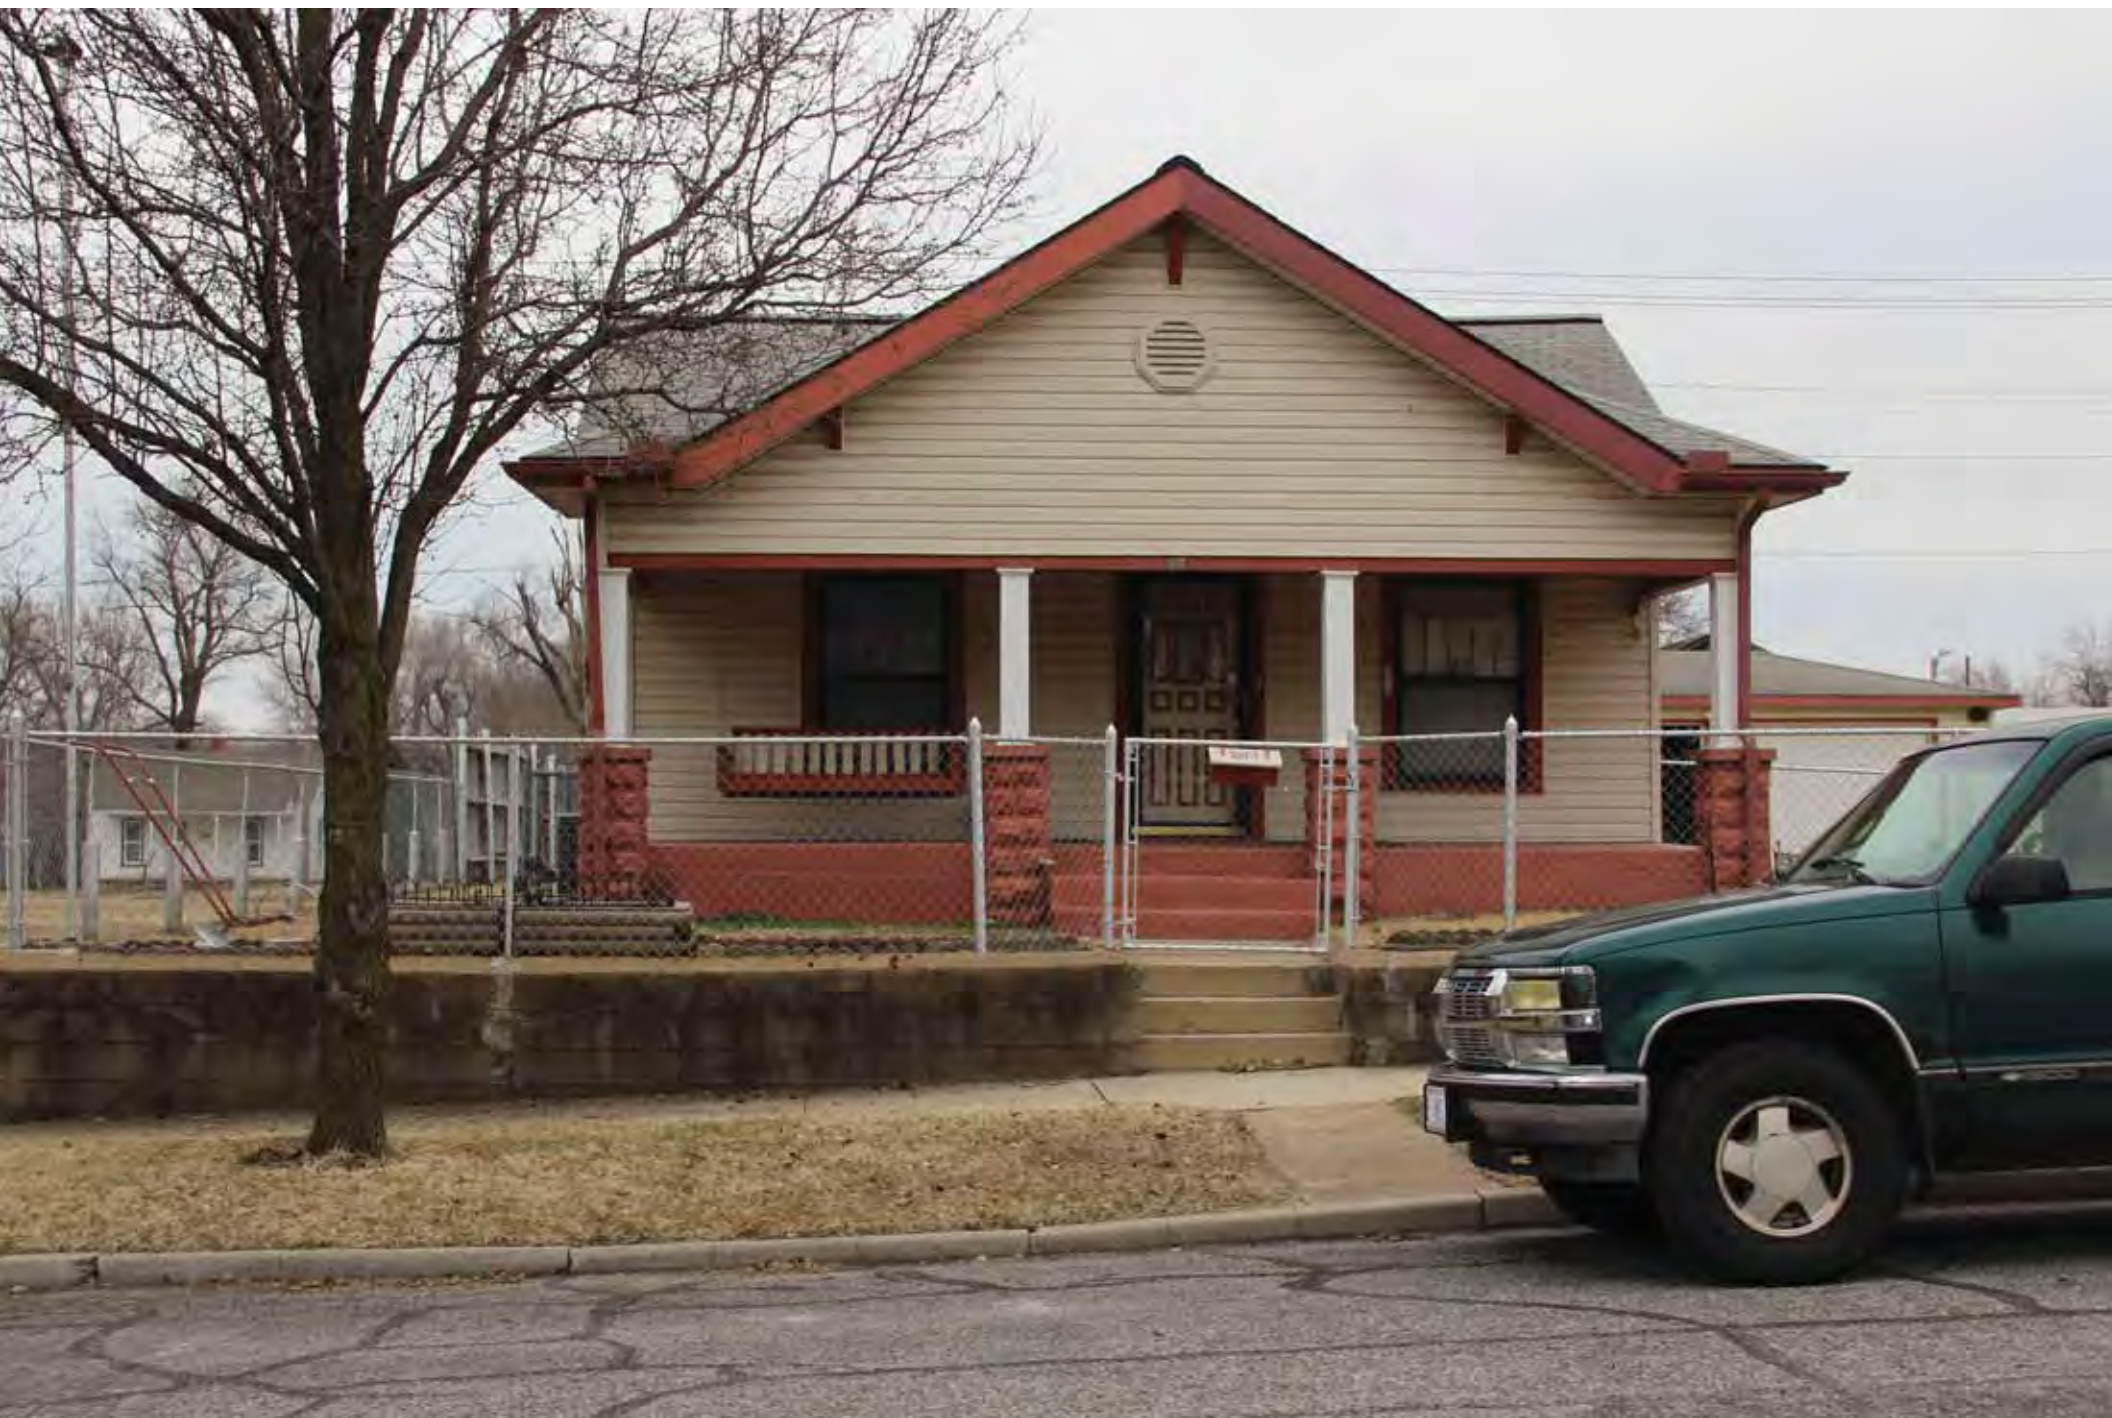
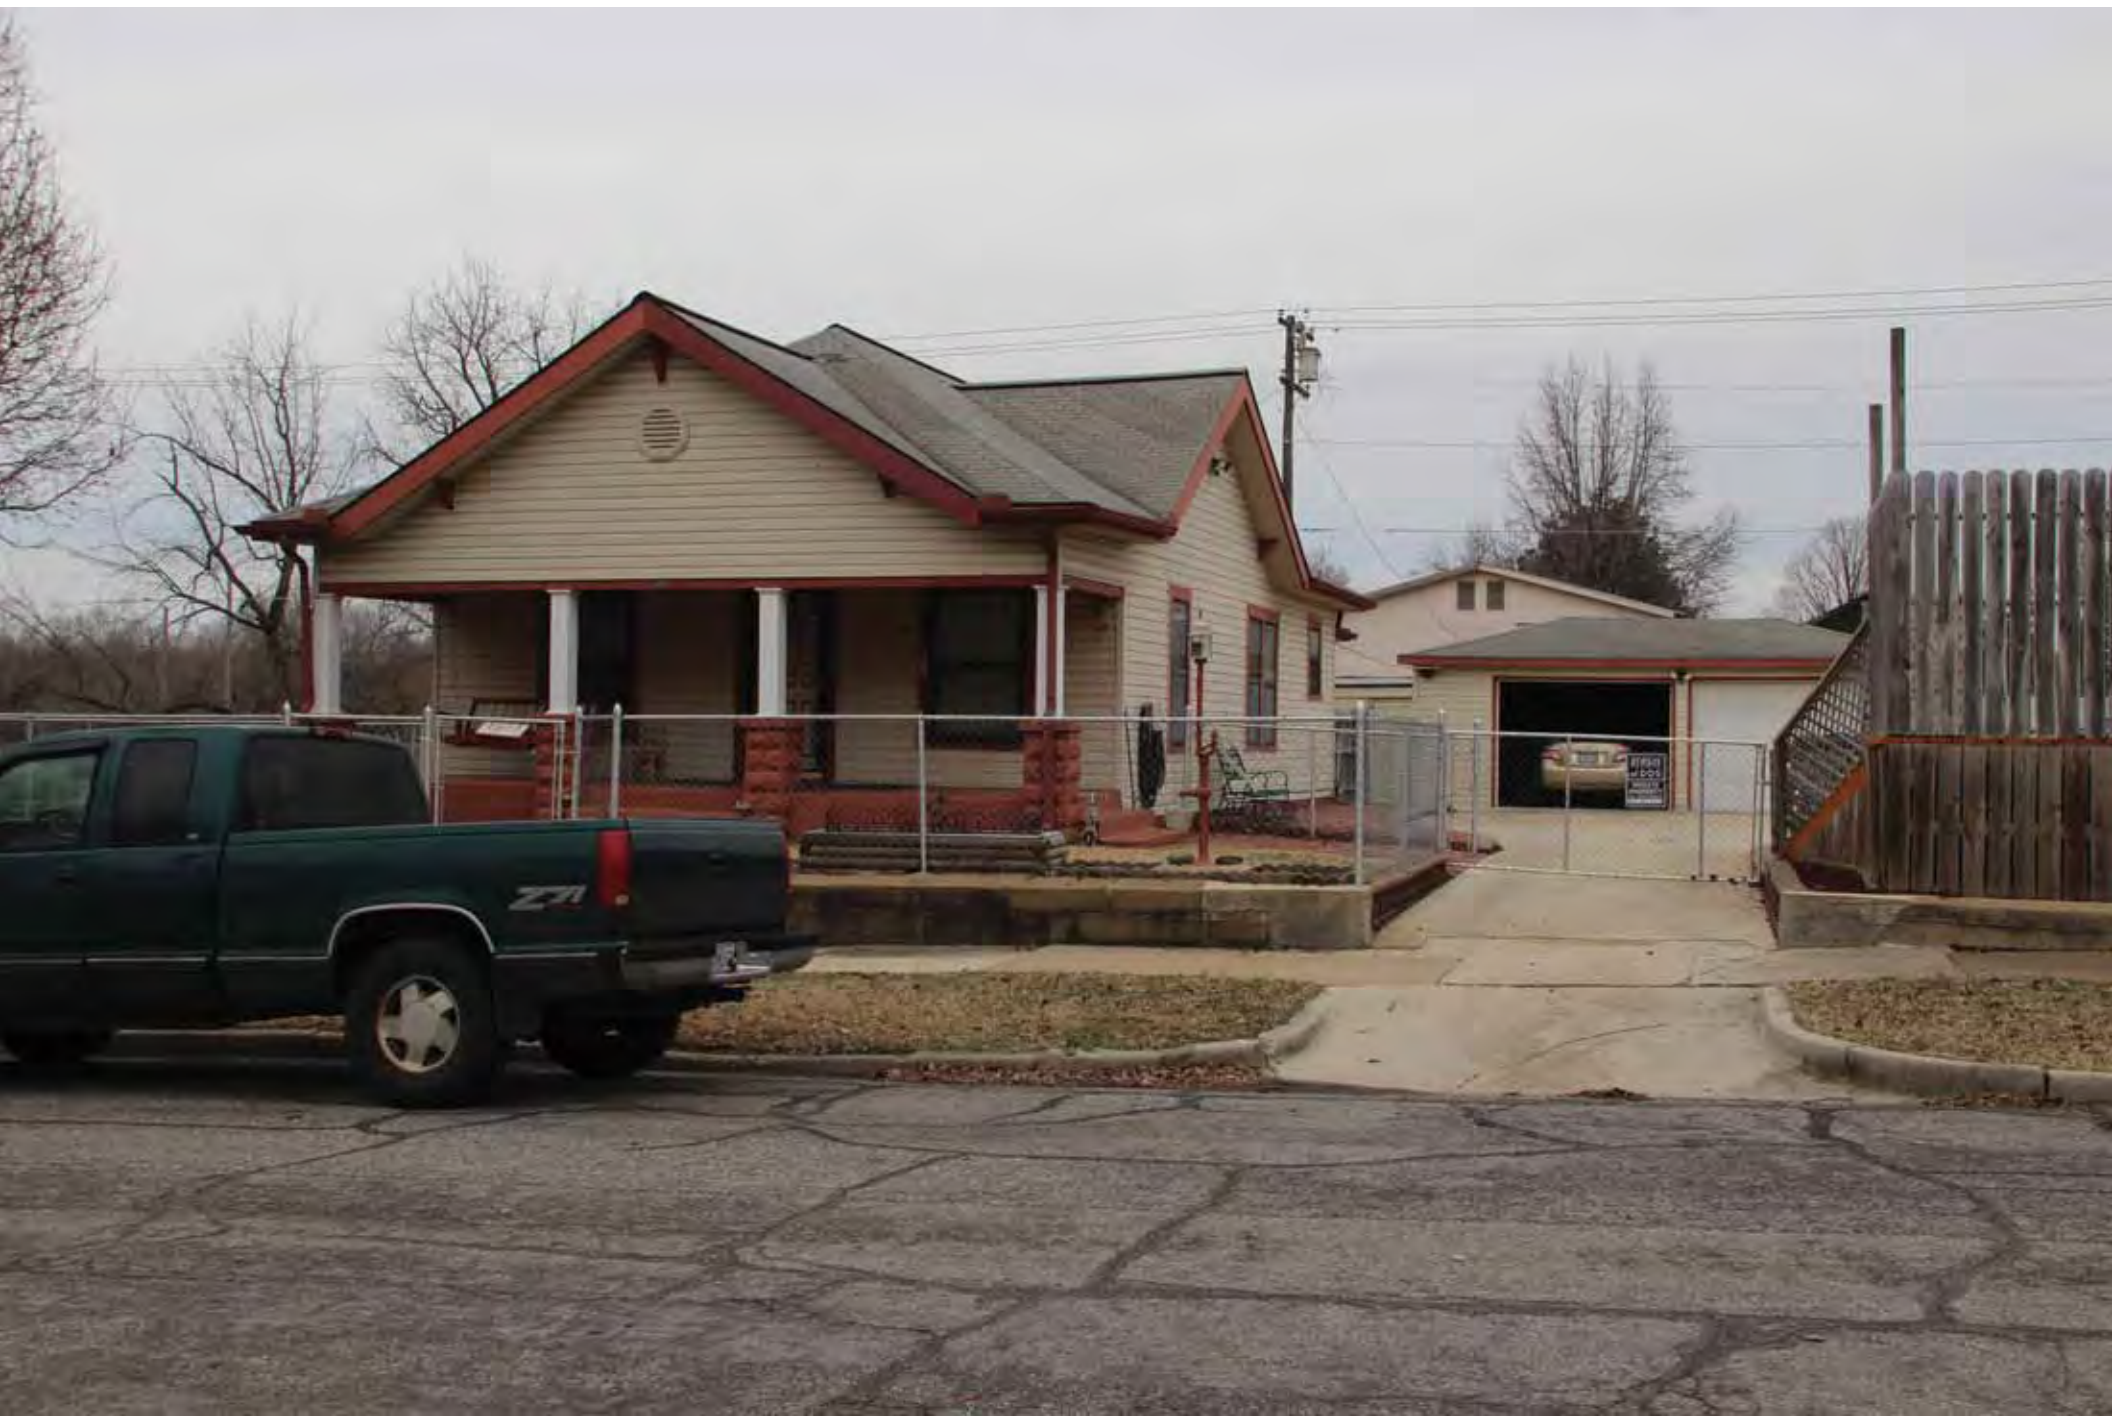
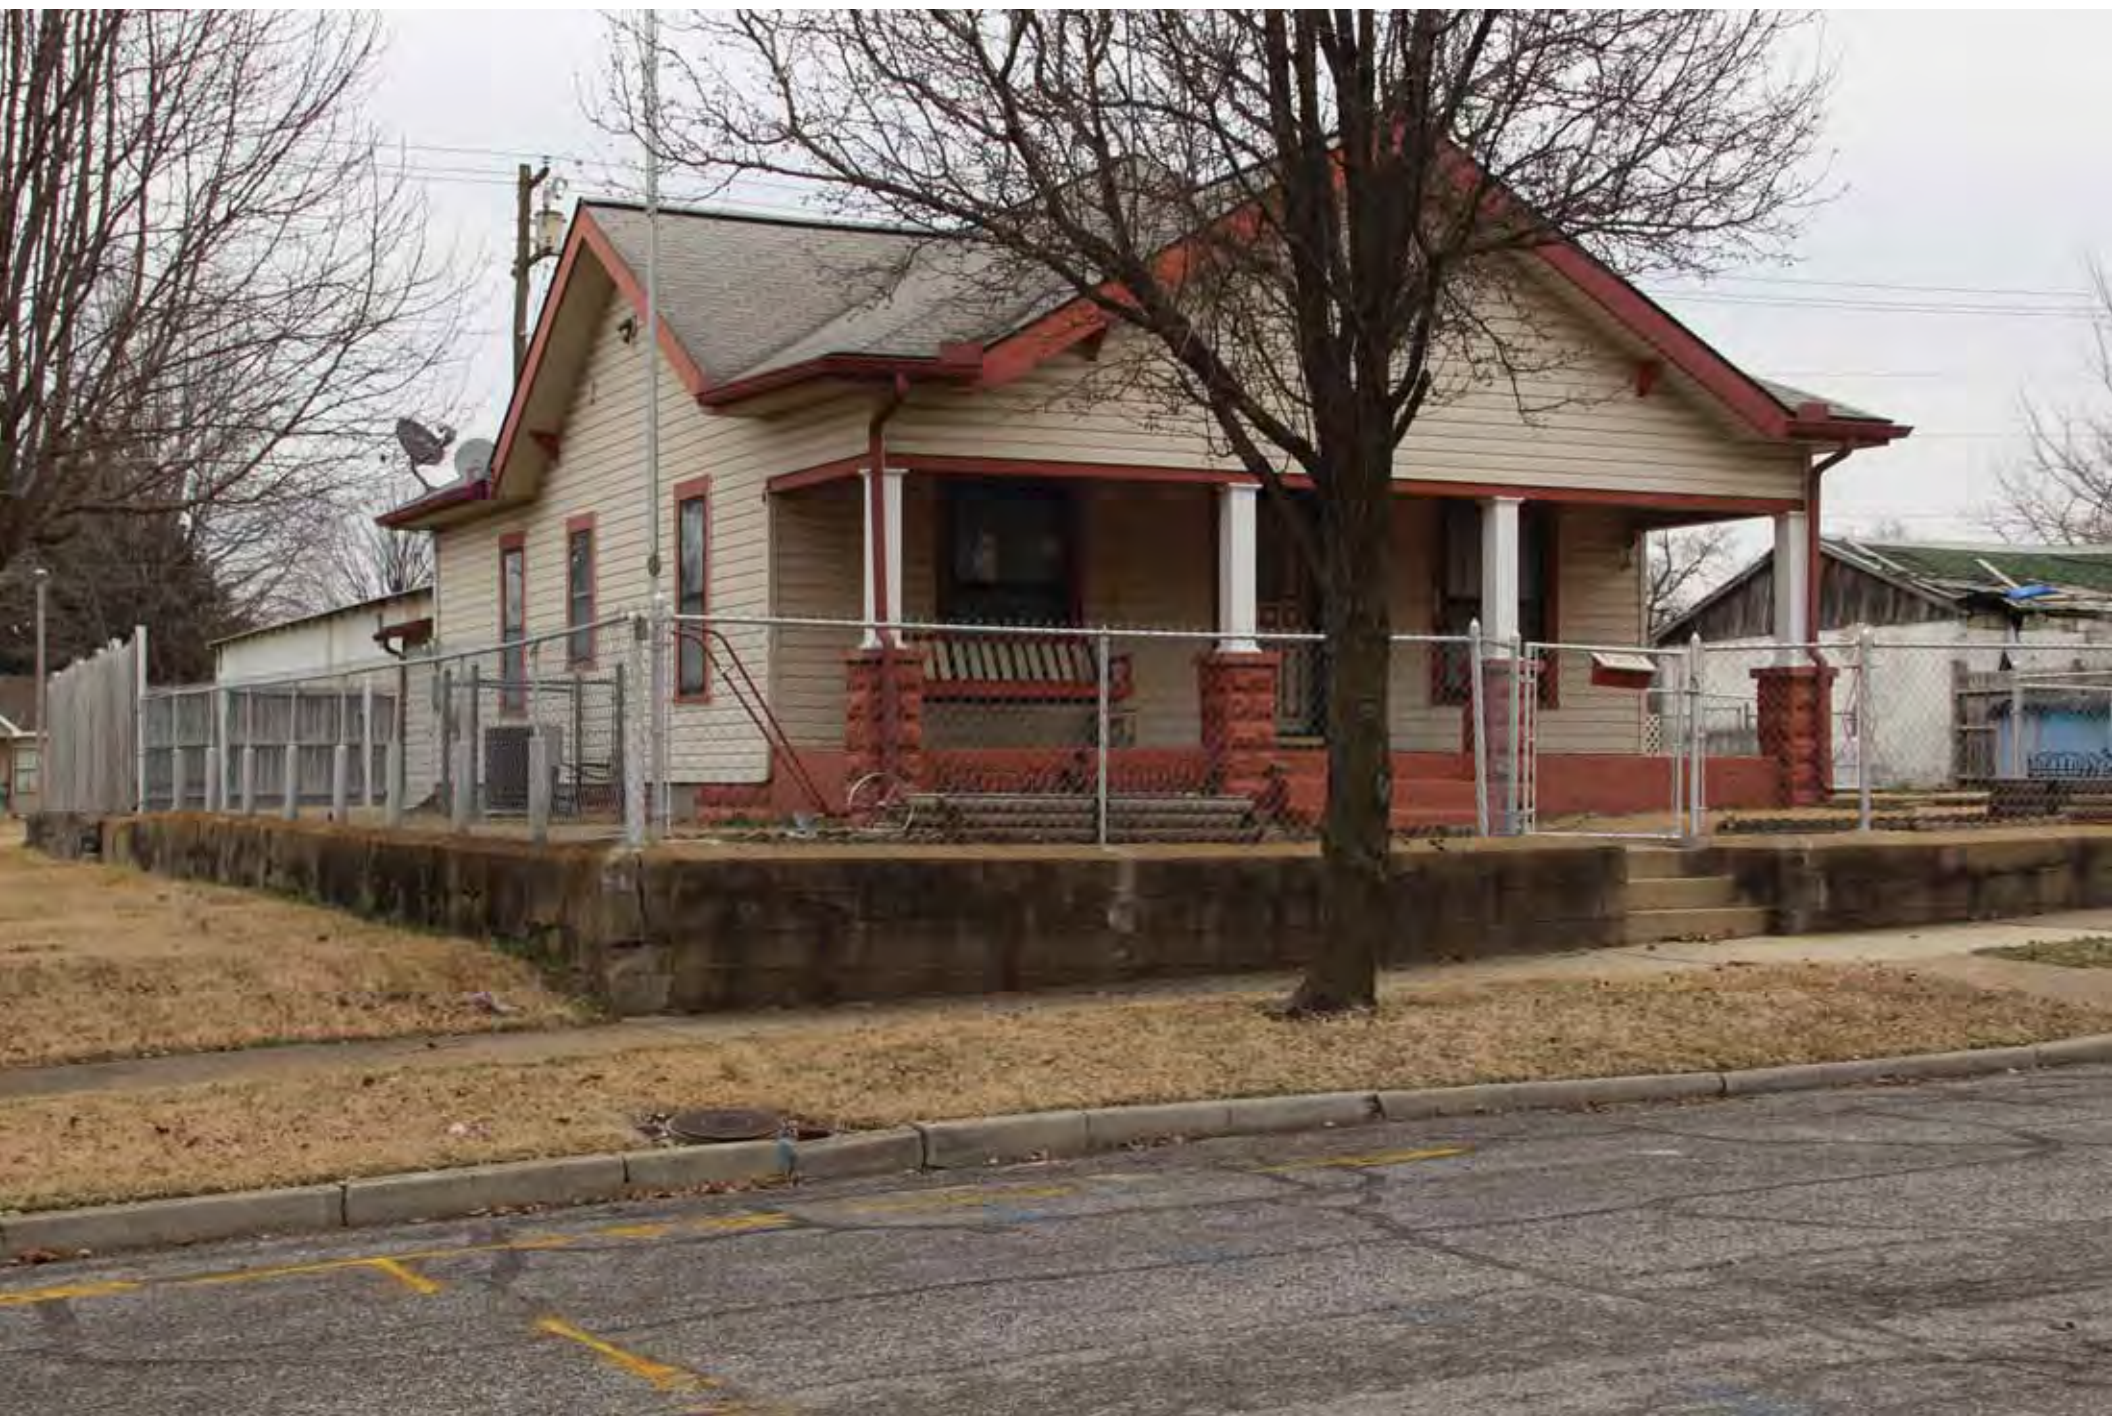
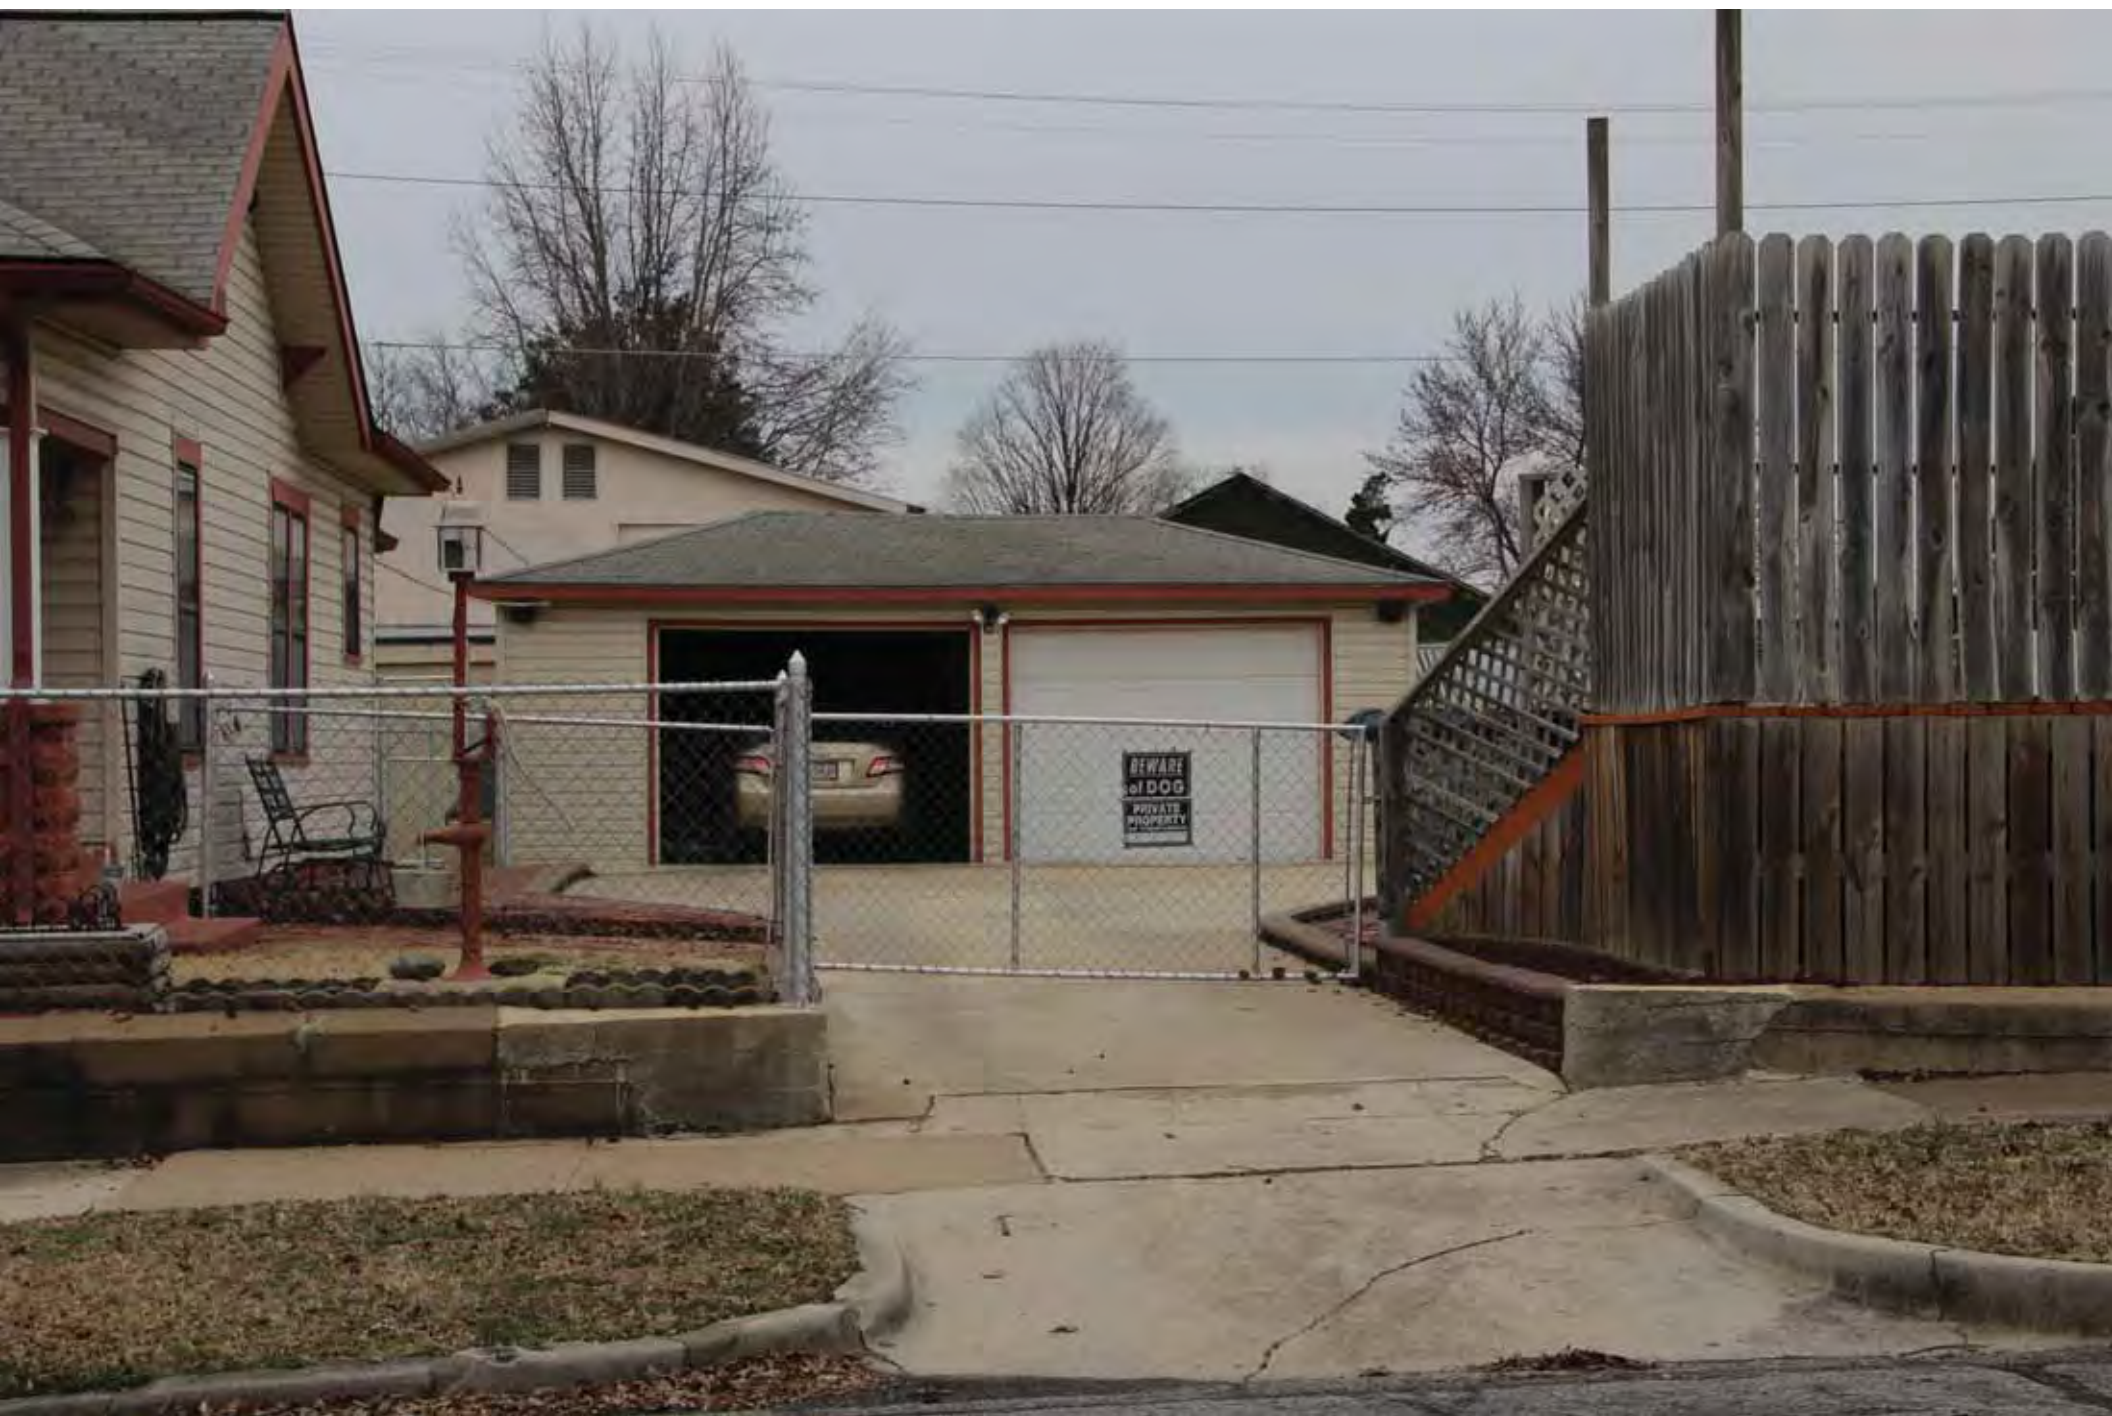
The property at 1017 Central Street is a frame bungalow covered in vinyl siding. The veranda has a large front facing gable roof on the front elevation, with exposed brackets. Square wooden posts on rusticated stone bases support the veranda. It extends the length of the front façade and shelters a central wooden entrance door. The door is flanked on either side by original five-over-one wood windows, with wooden surrounds. Each of the side elevations have three single windows.
