MISSOURI DEPARTMENT OF NATURAL RESOURCES
STATE HISTORIC PRESERVATION OFFICE, P.O. Box 176, Jefferson City, MO 65102
ARCHITECTURAL/HISTORIC INVENTORY FORM

1. Survey No. JP-AS-007-001		2. Survey name: East Town (Original Joplin) Historic Survey Phase 2	
3. County: JASPER		4. Address (Street No.) 618	Street (name) E. 2 nd Street
5. City: Joplin	Vicinity: <input type="checkbox"/>	6. Geographical Reference:	7. Township/Range/Section: T: R: S:
8. Historic name (if known):		9. Present/other name (if known):	
10. Ownership: <input checked="" type="checkbox"/> Private <input type="checkbox"/> Public		11a. Historic use (if known): Domestic: Single Dwelling	11b. Current use: Domestic: Single Dwelling

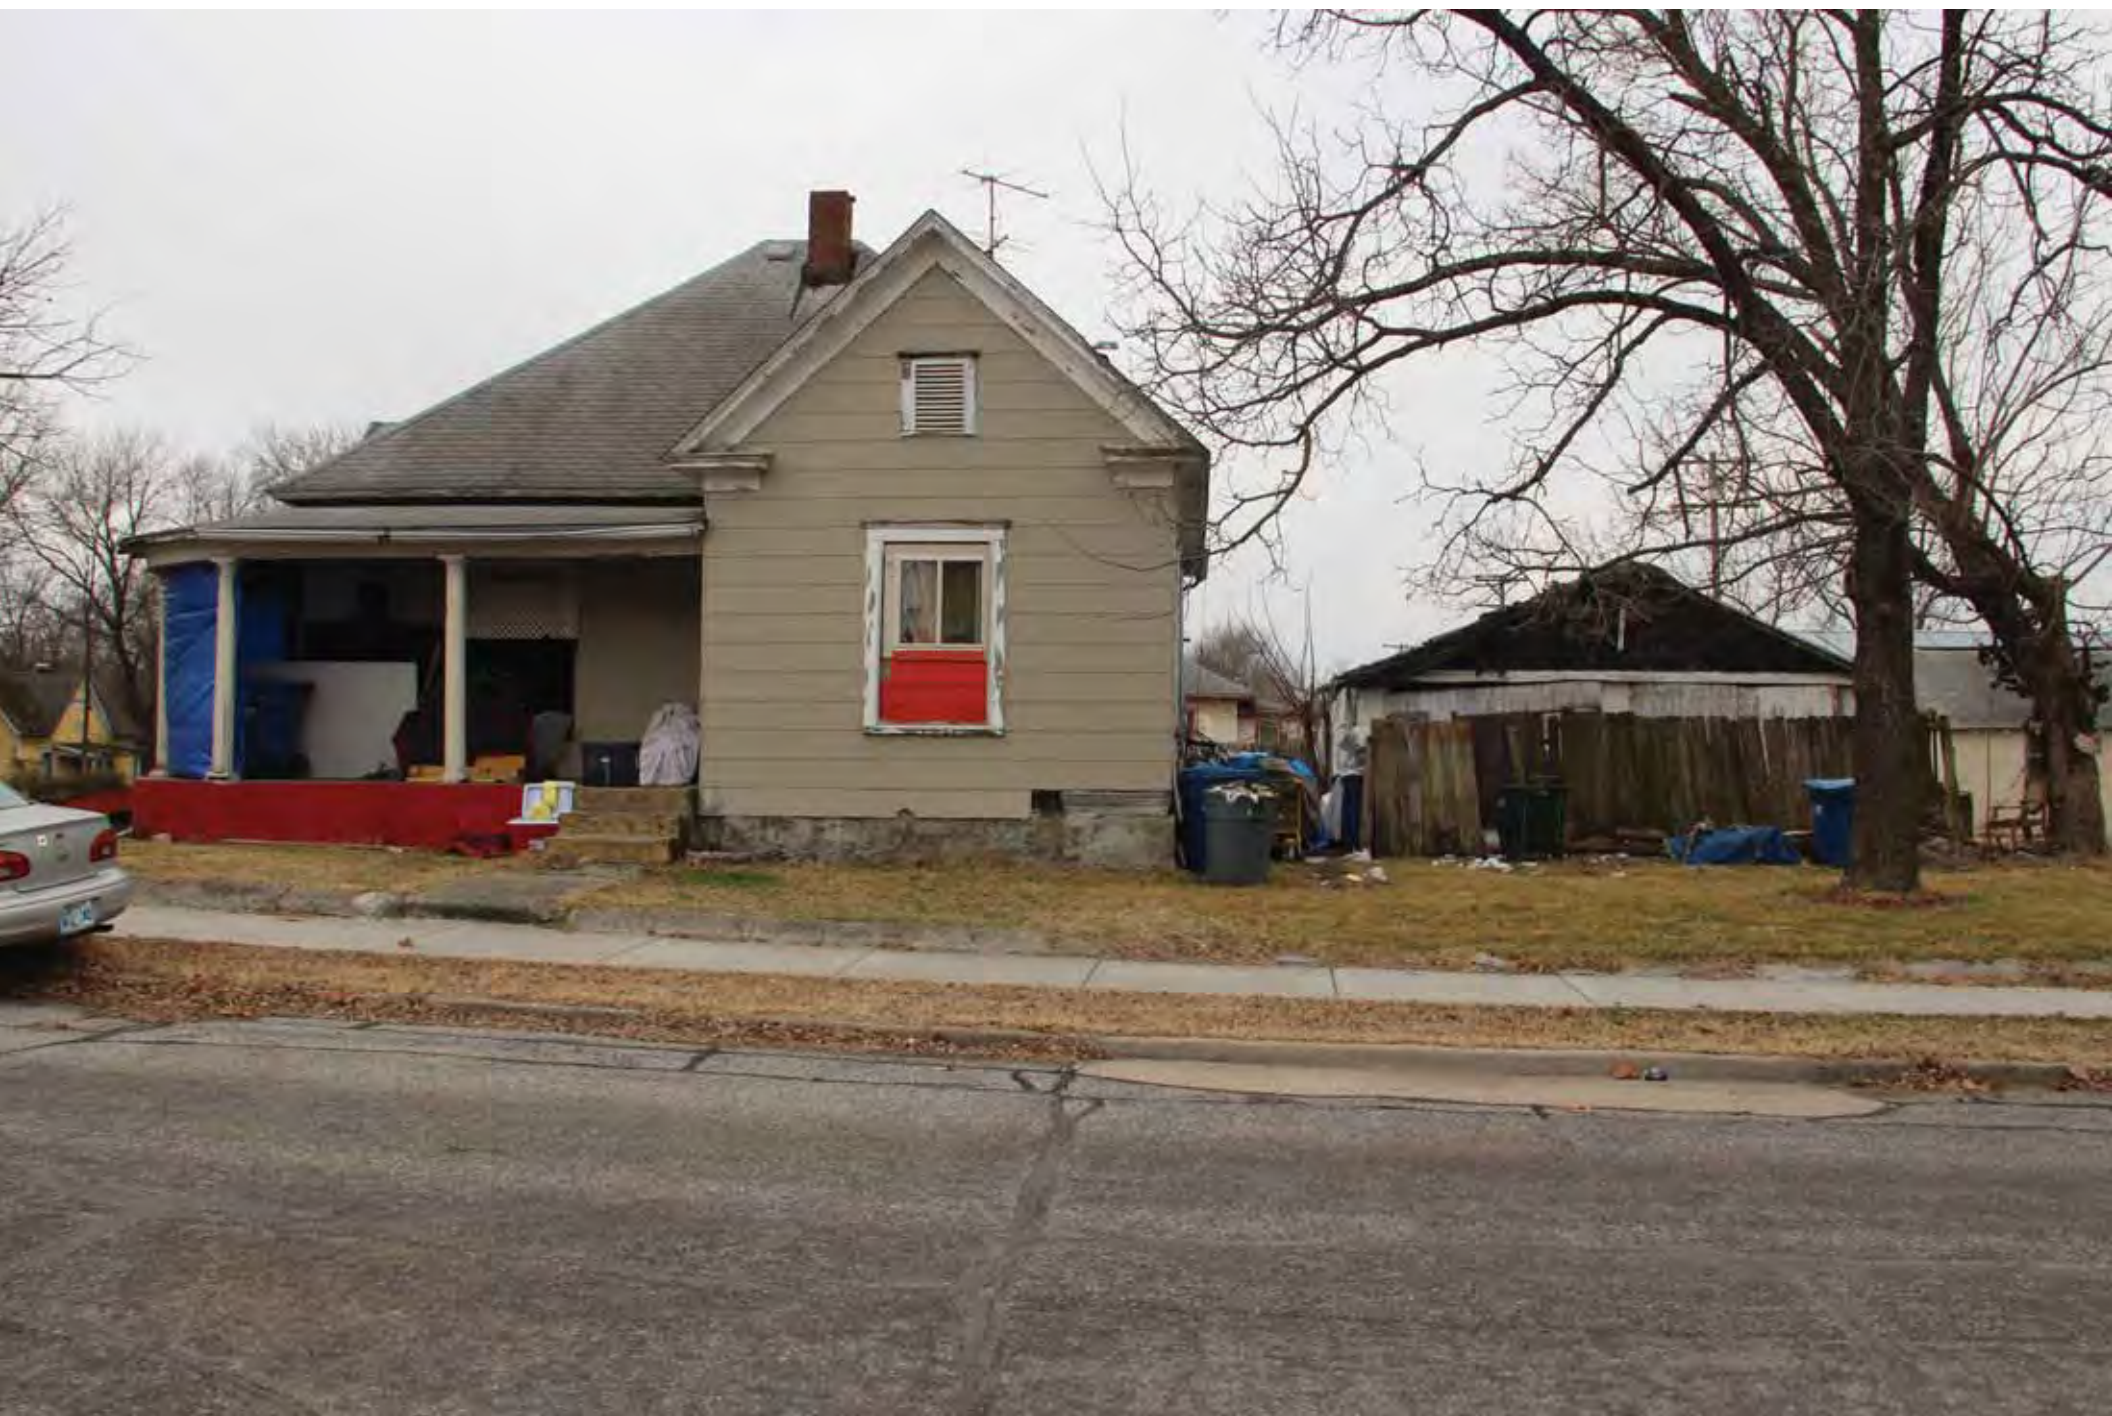
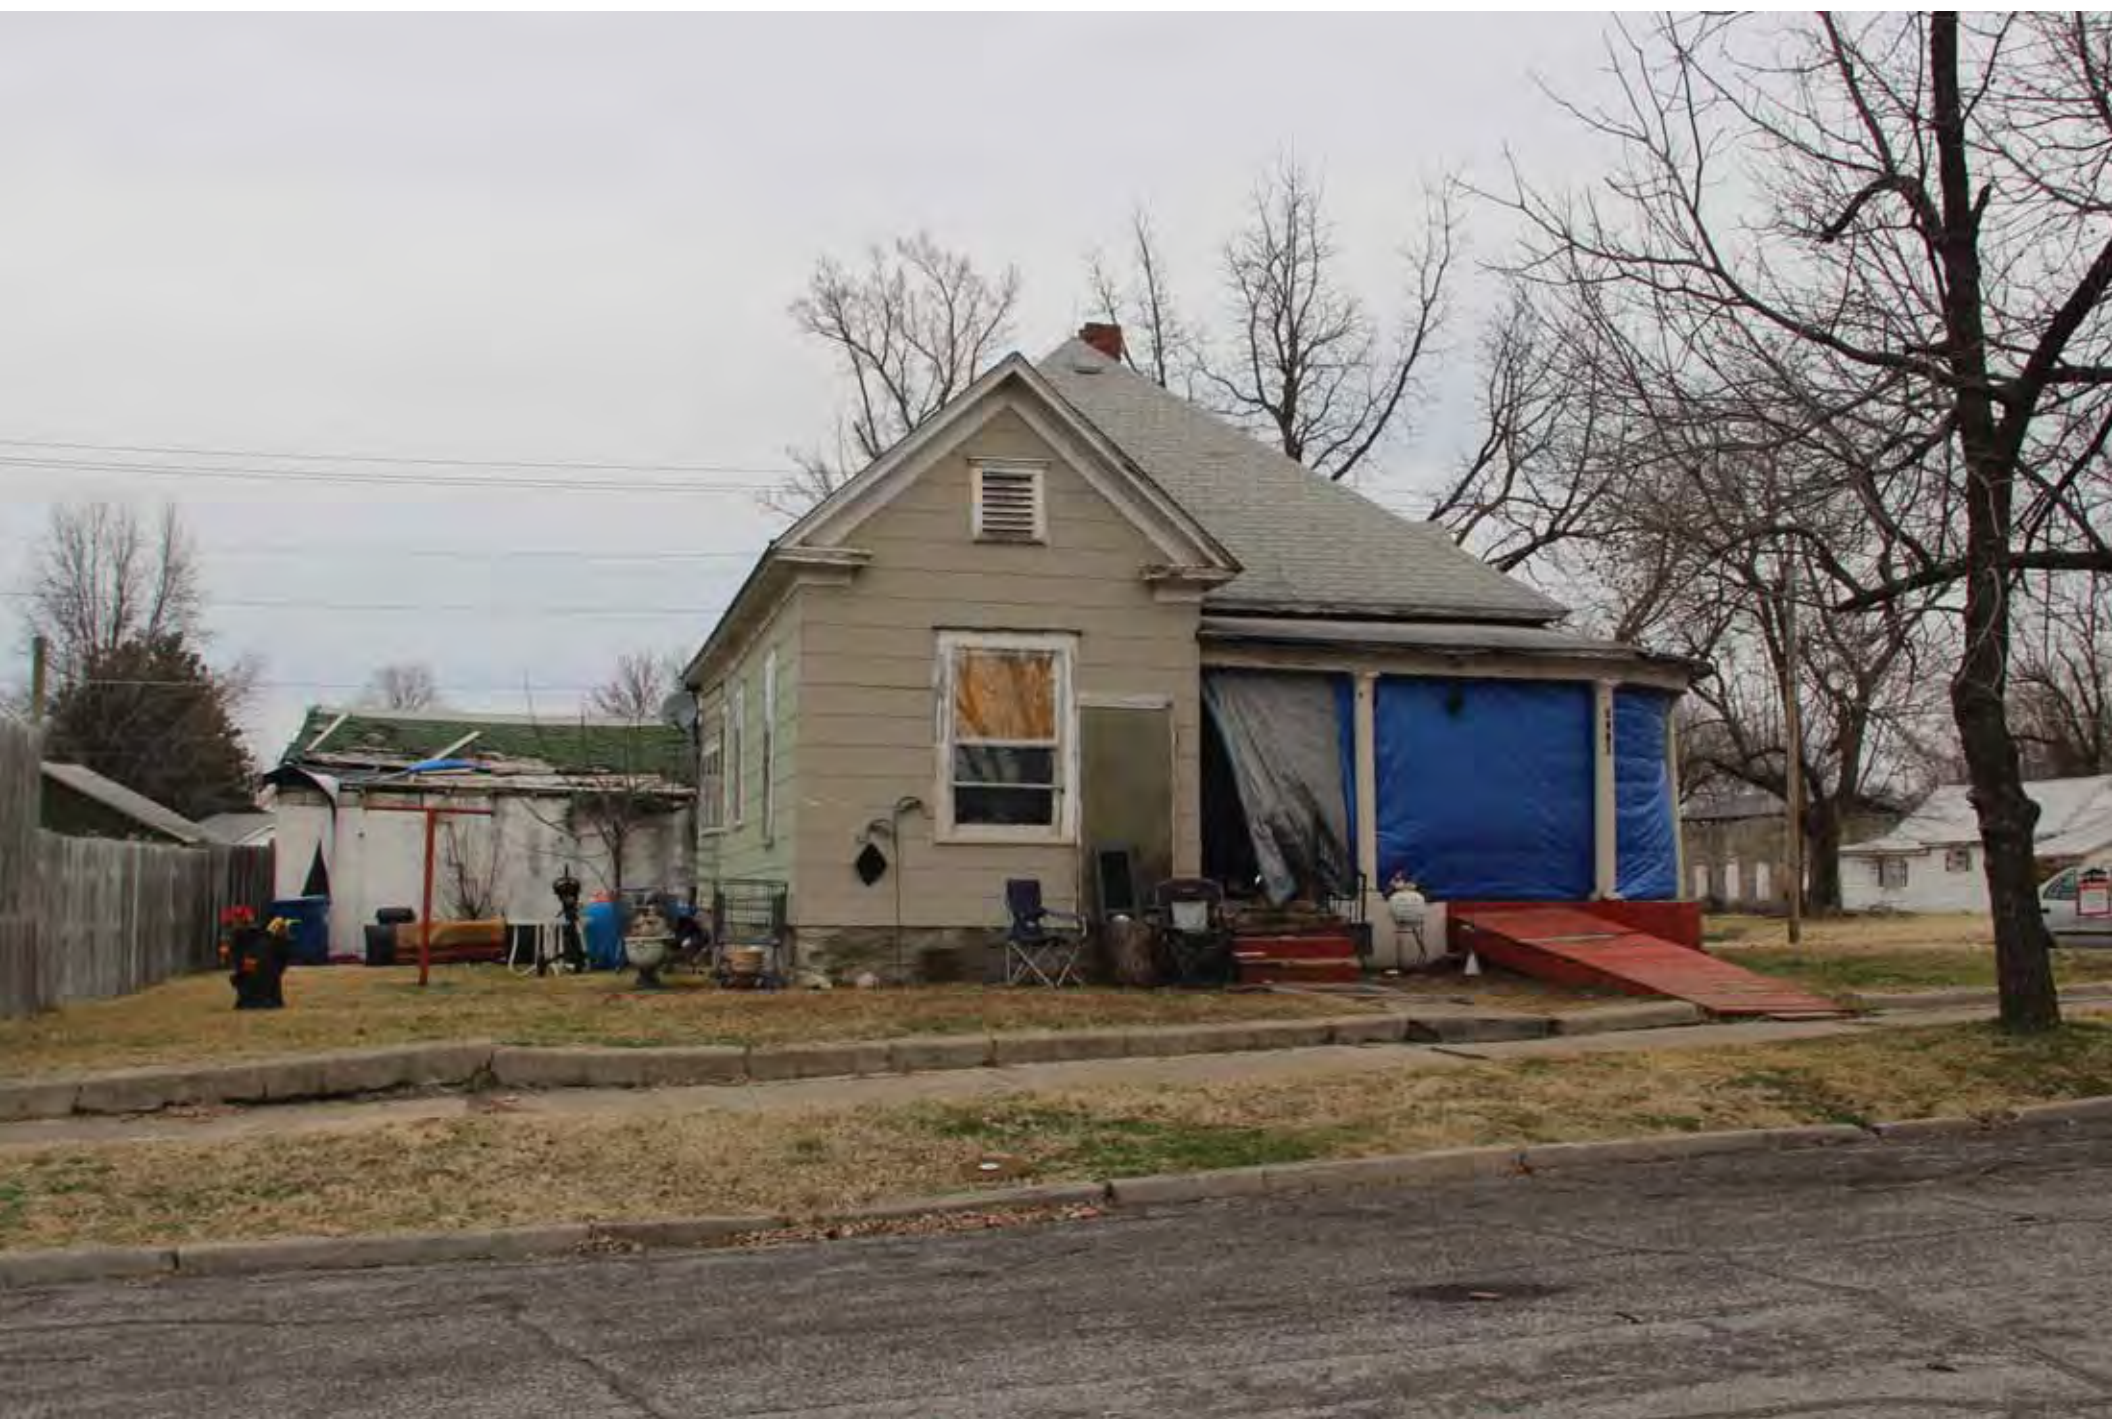
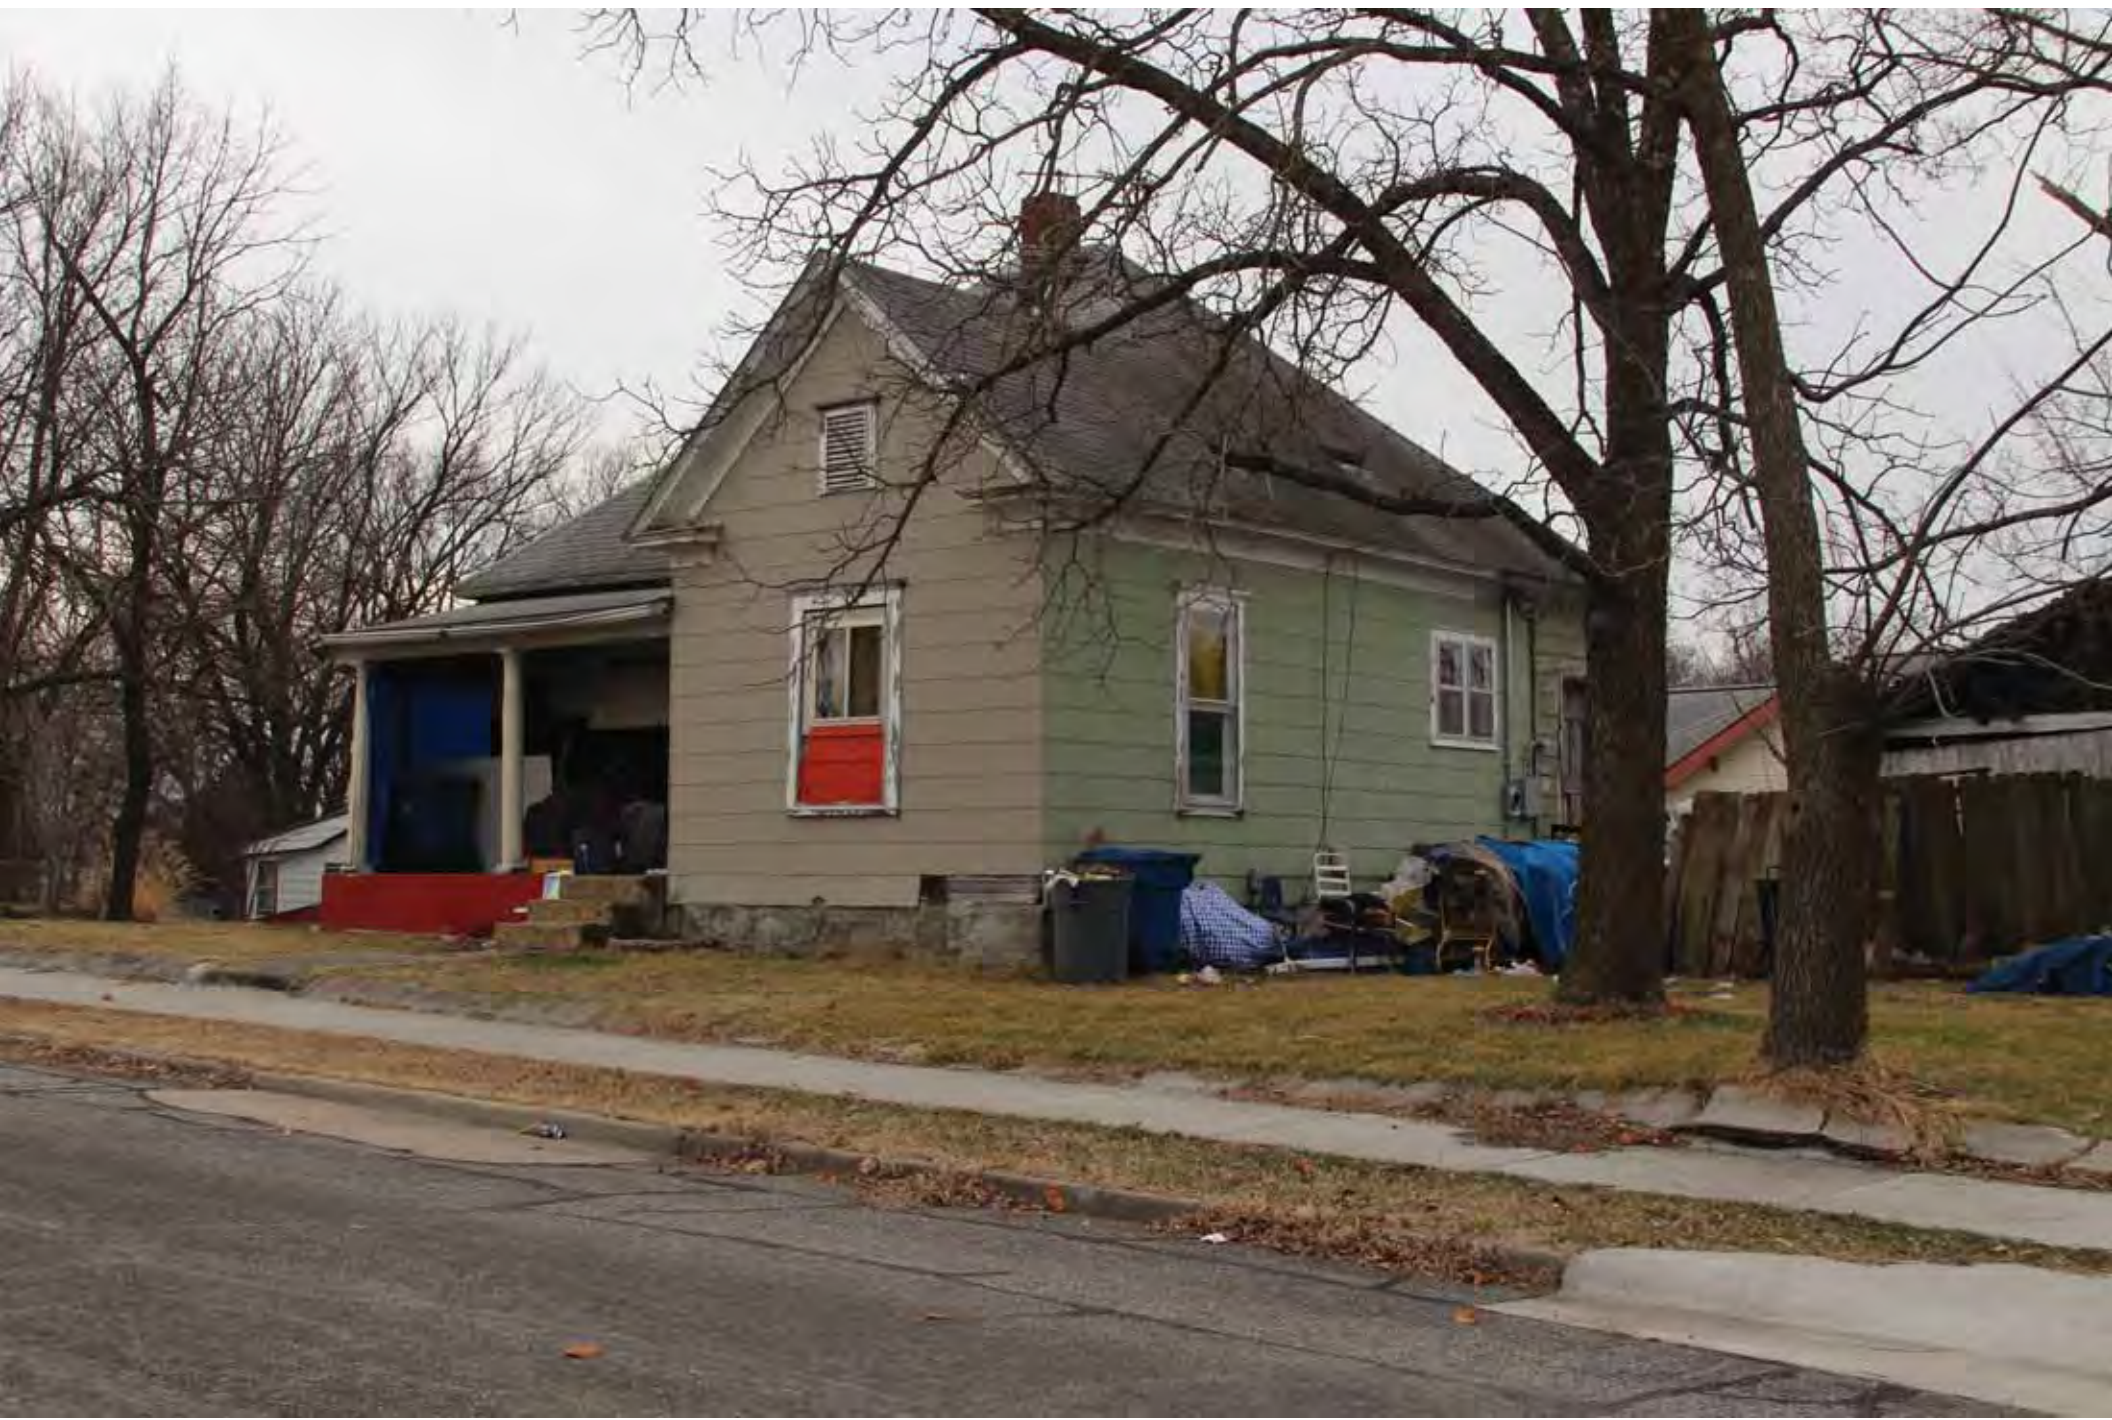
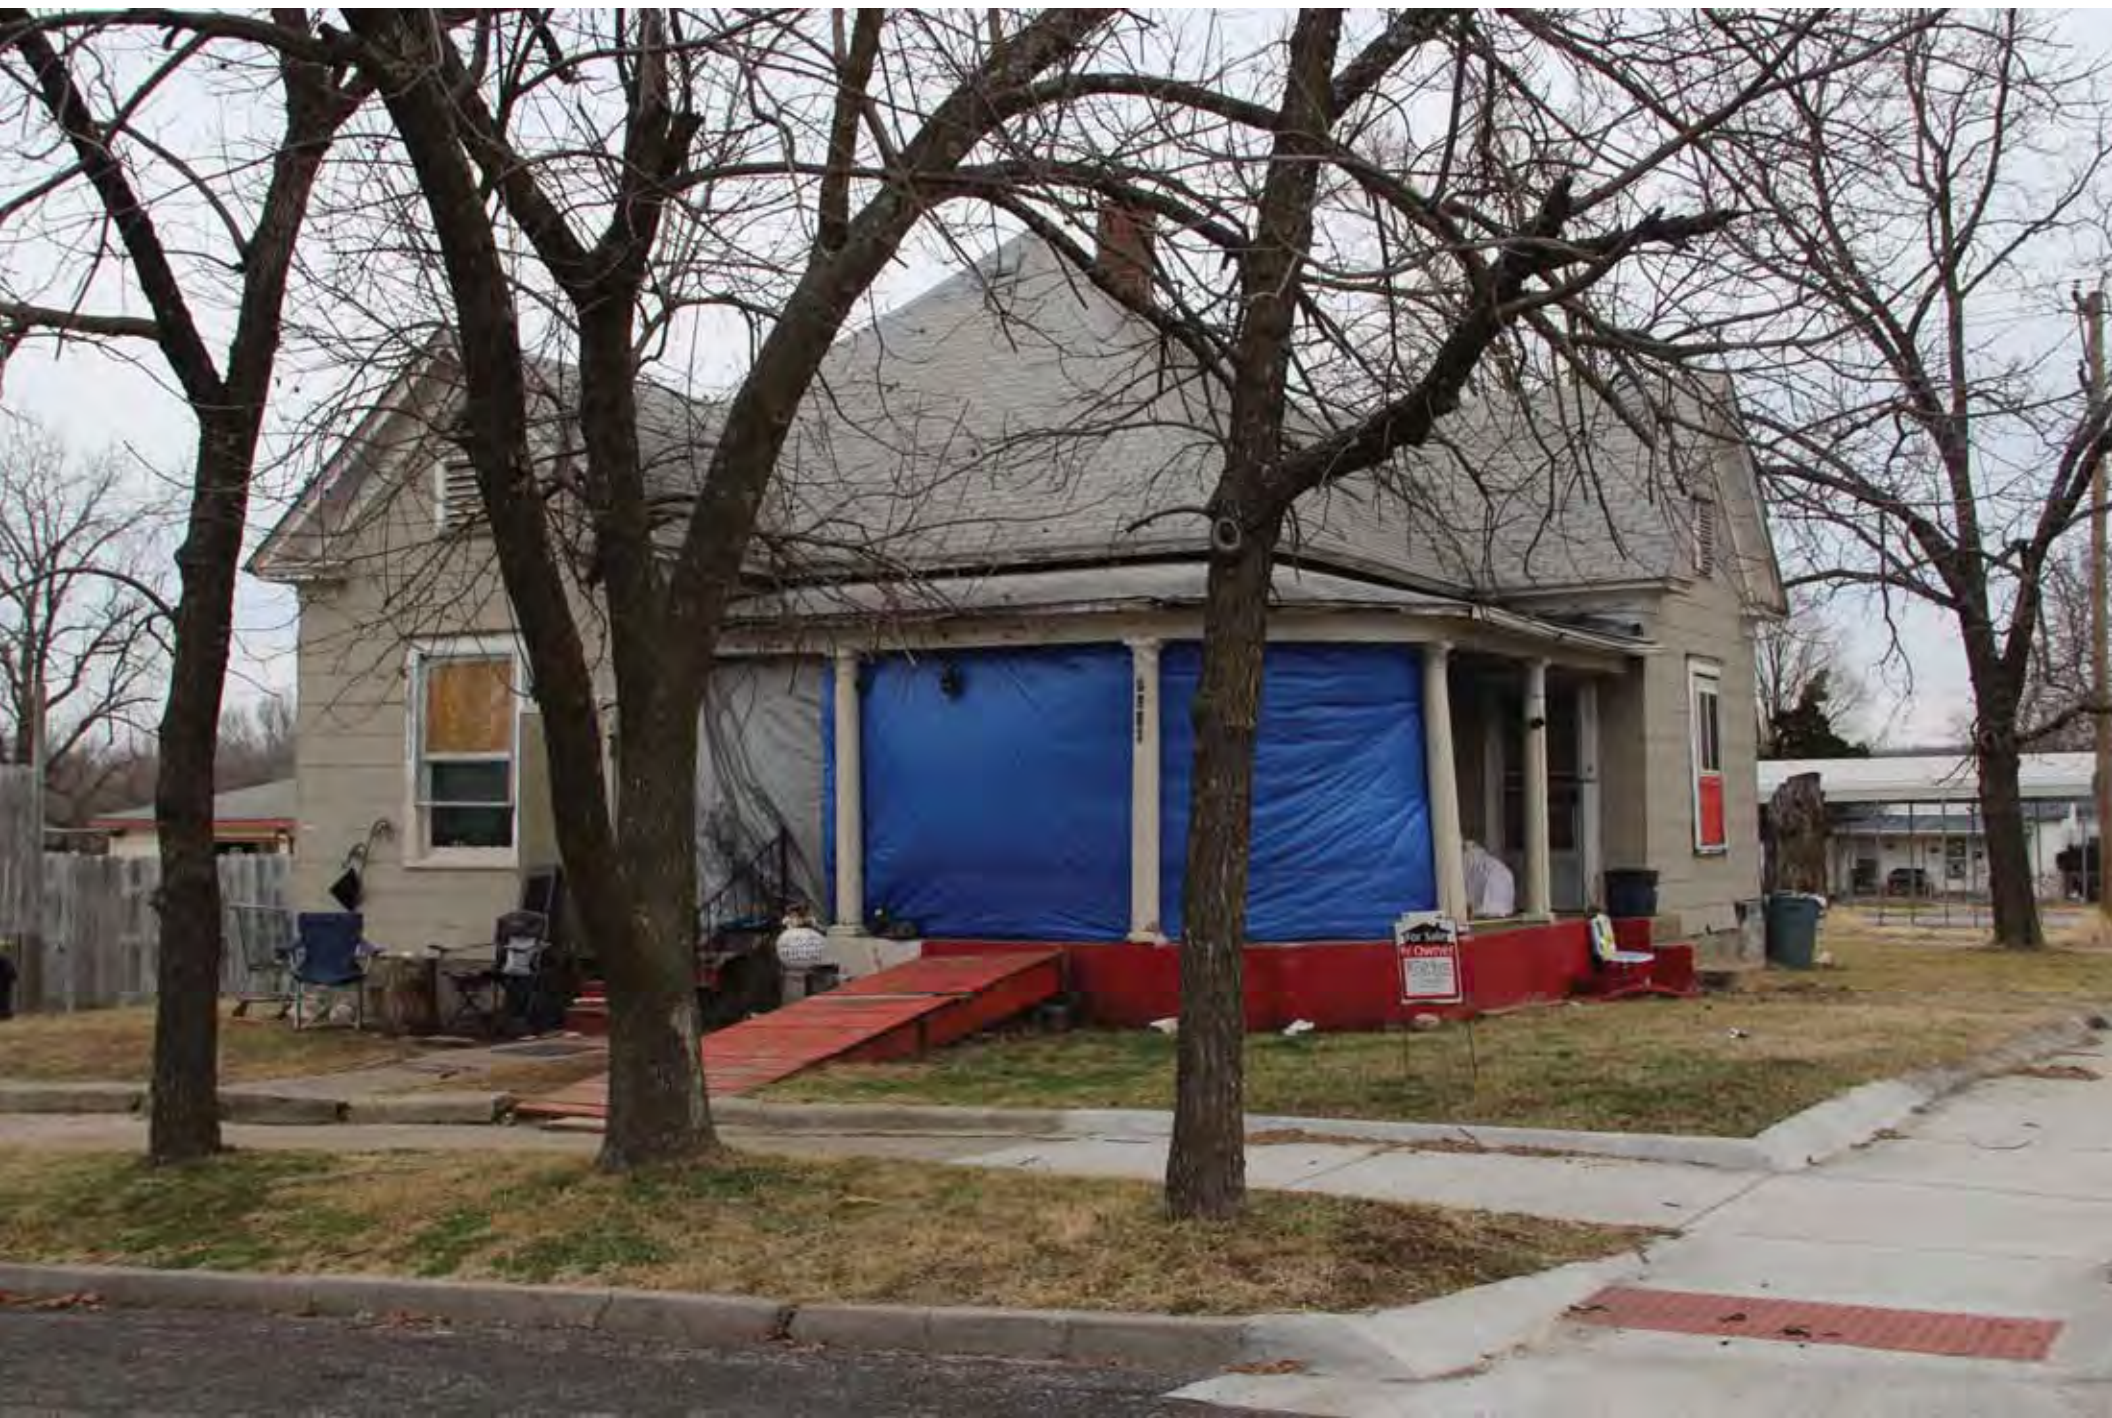
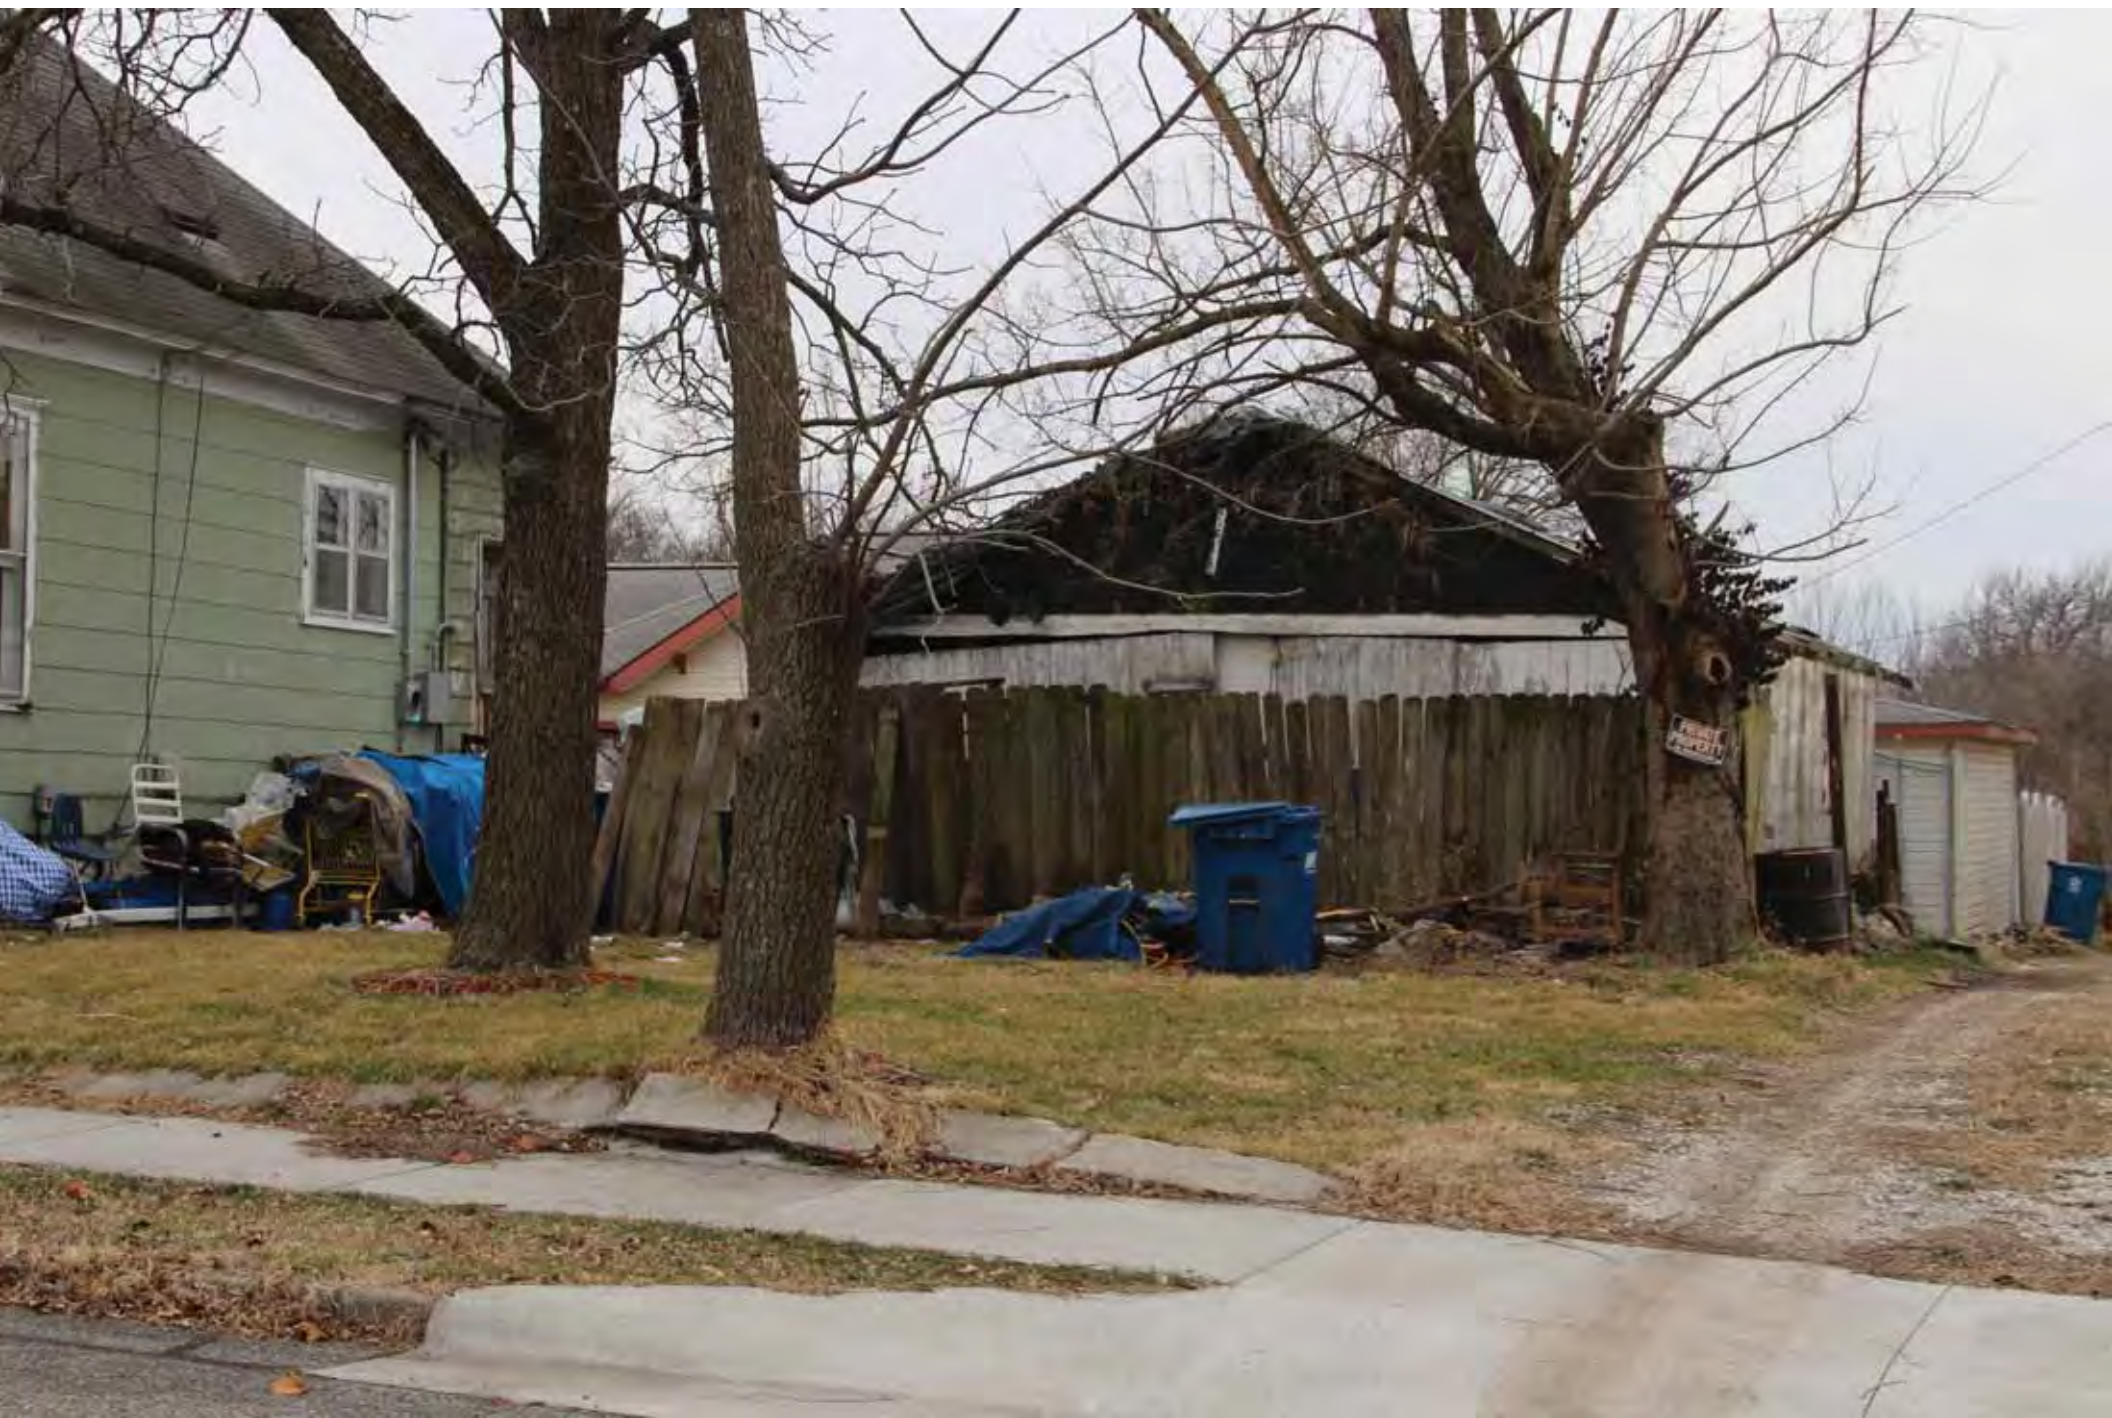
There is a garage at the rear of the property, which according to Jasper County was also built in 1905, although it looks like it could have been built in the 1920s or 1930s. It is frame with a hipped roof with exposed rafters. It is in poor condition. The outbuilding is not individually eligible for listing on the National Register.

The property at 1023 Central Street is a frame house with a stone foundation. It has high pitched hip roof with a front facing gable end with returned eaves on the front façade. The roof is covered in asphalt siding and there is a central brick chimney. On the southwest side of the house is the original wrap around porch. It is curved with wooden posts. Tarps hang on the porch so details of this portion of the house are not visible from the street. To the west of the porch is the gable end of the house. On the first floor of this portion is one large one-over-one wood window, with a wooden surround. There are three single windows along the west elevation of the house.
