MISSOURI DEPARTMENT OF NATURAL RESOURCES
STATE HISTORIC PRESERVATION OFFICE, P.O. Box 176, Jefferson City, MO 65102
ARCHITECTURAL/HISTORIC INVENTORY FORM

1. Survey No. JP-AS-007-001		2. Survey name: East Town (Original Joplin) Historic Survey Phase 2	
3. County: JASPER		4. Address (Street No.) 618	Street (name) E. 2 nd Street
5. City: Joplin	Vicinity: <input type="checkbox"/>	6. Geographical Reference:	7. Township/Range/Section: T: R: S:
8. Historic name (if known):		9. Present/other name (if known):	
10. Ownership: <input checked="" type="checkbox"/> Private <input type="checkbox"/> Public		11a. Historic use (if known): Domestic: Single Dwelling	11b. Current use: Domestic: Single Dwelling

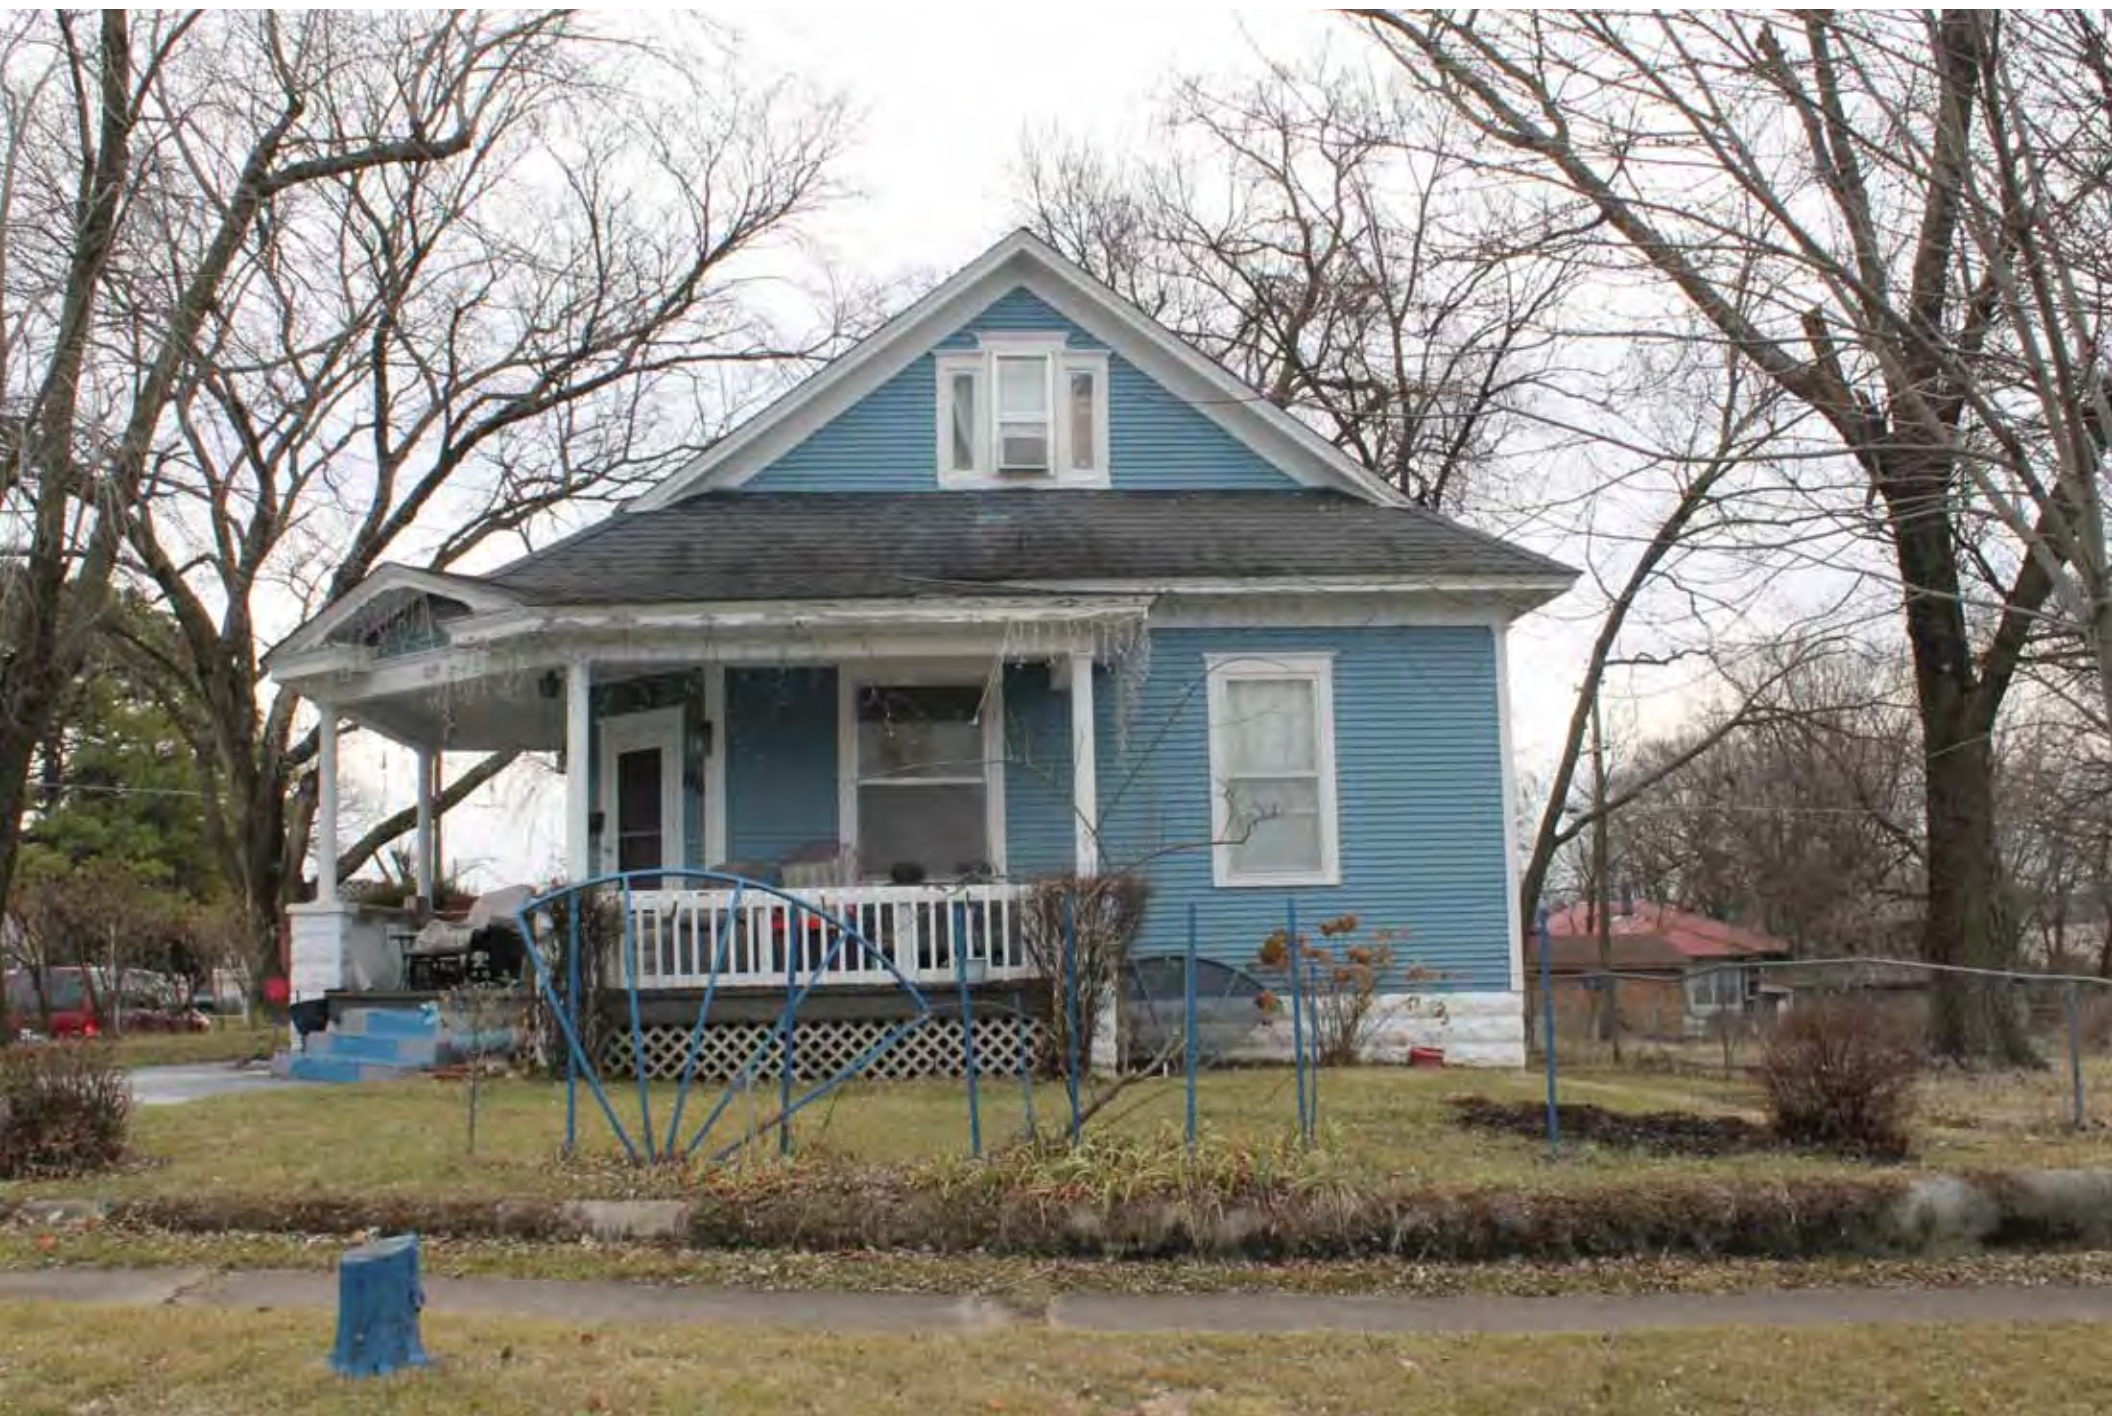
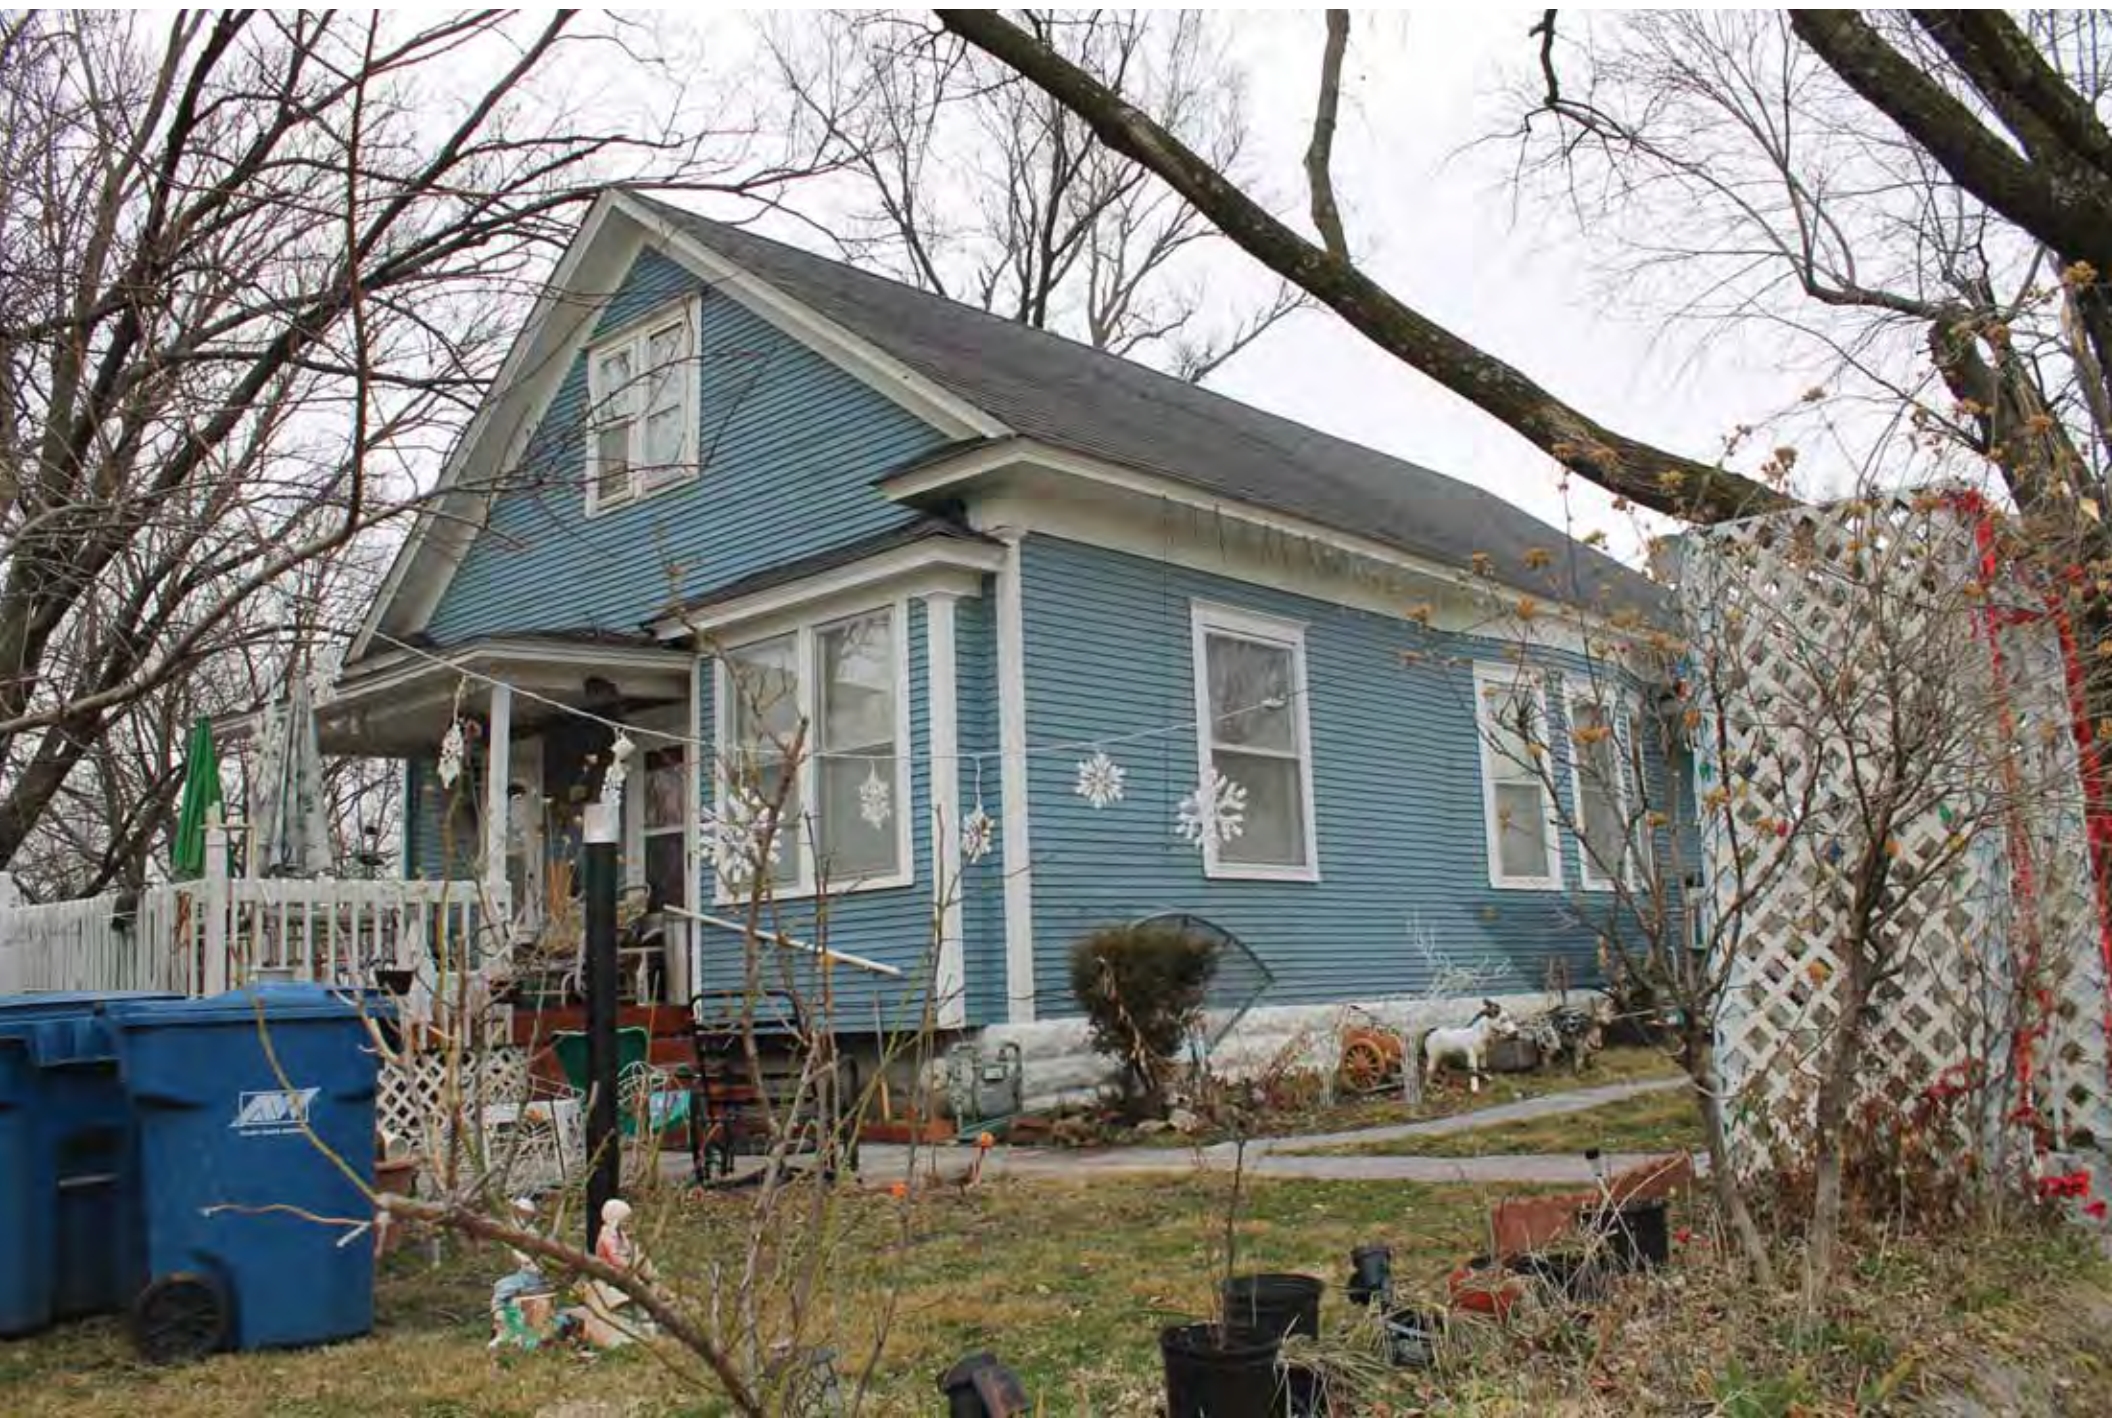
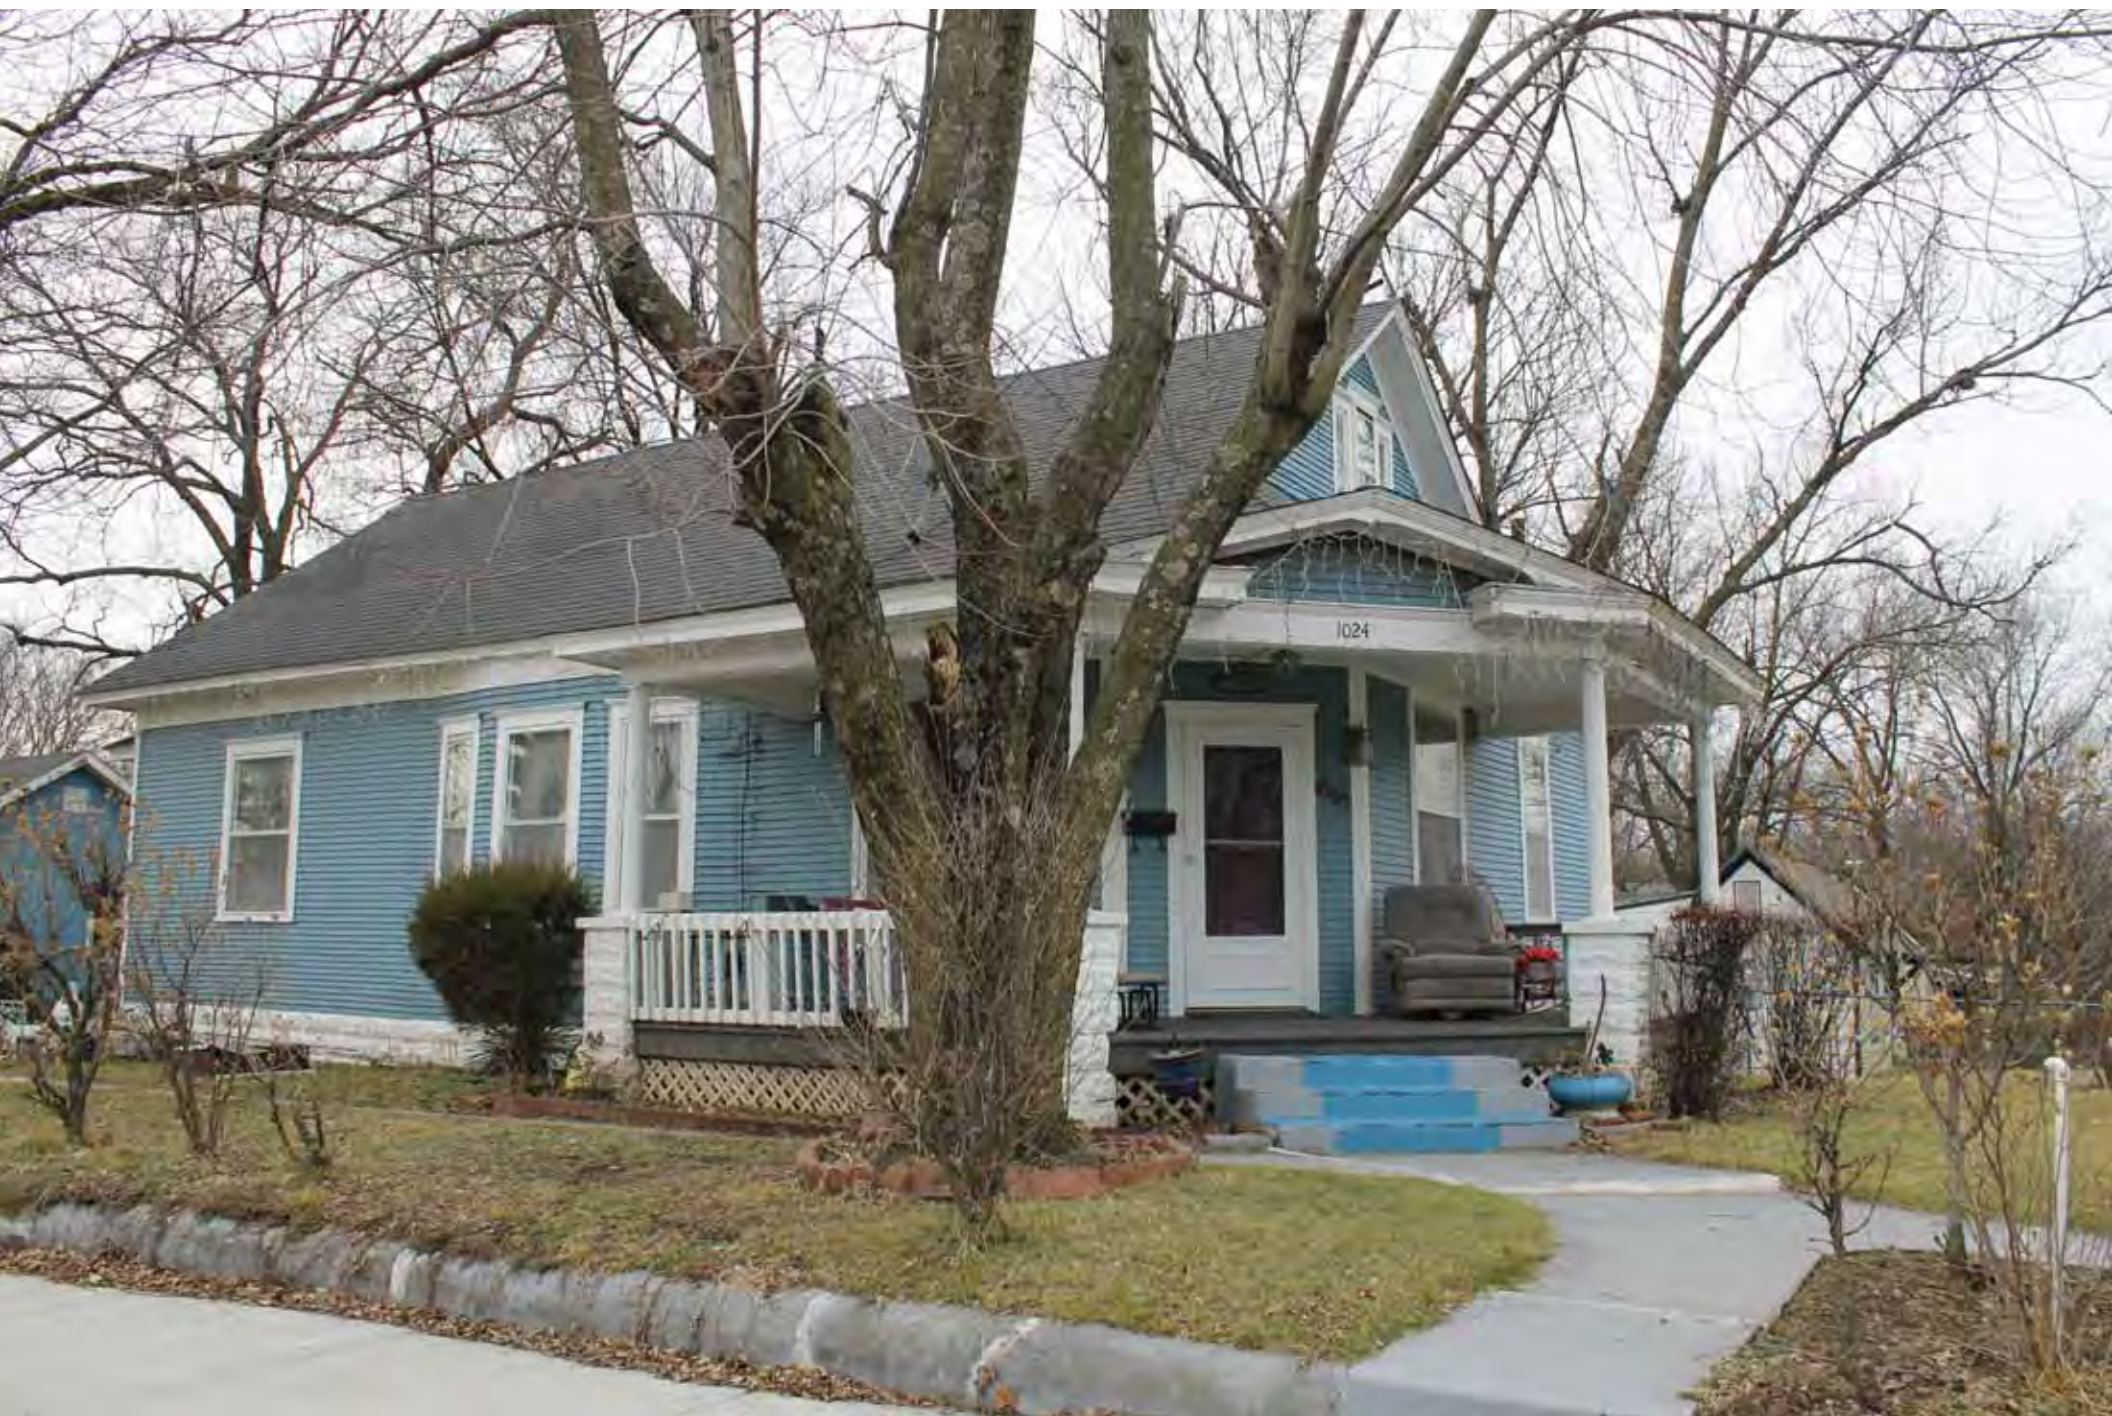
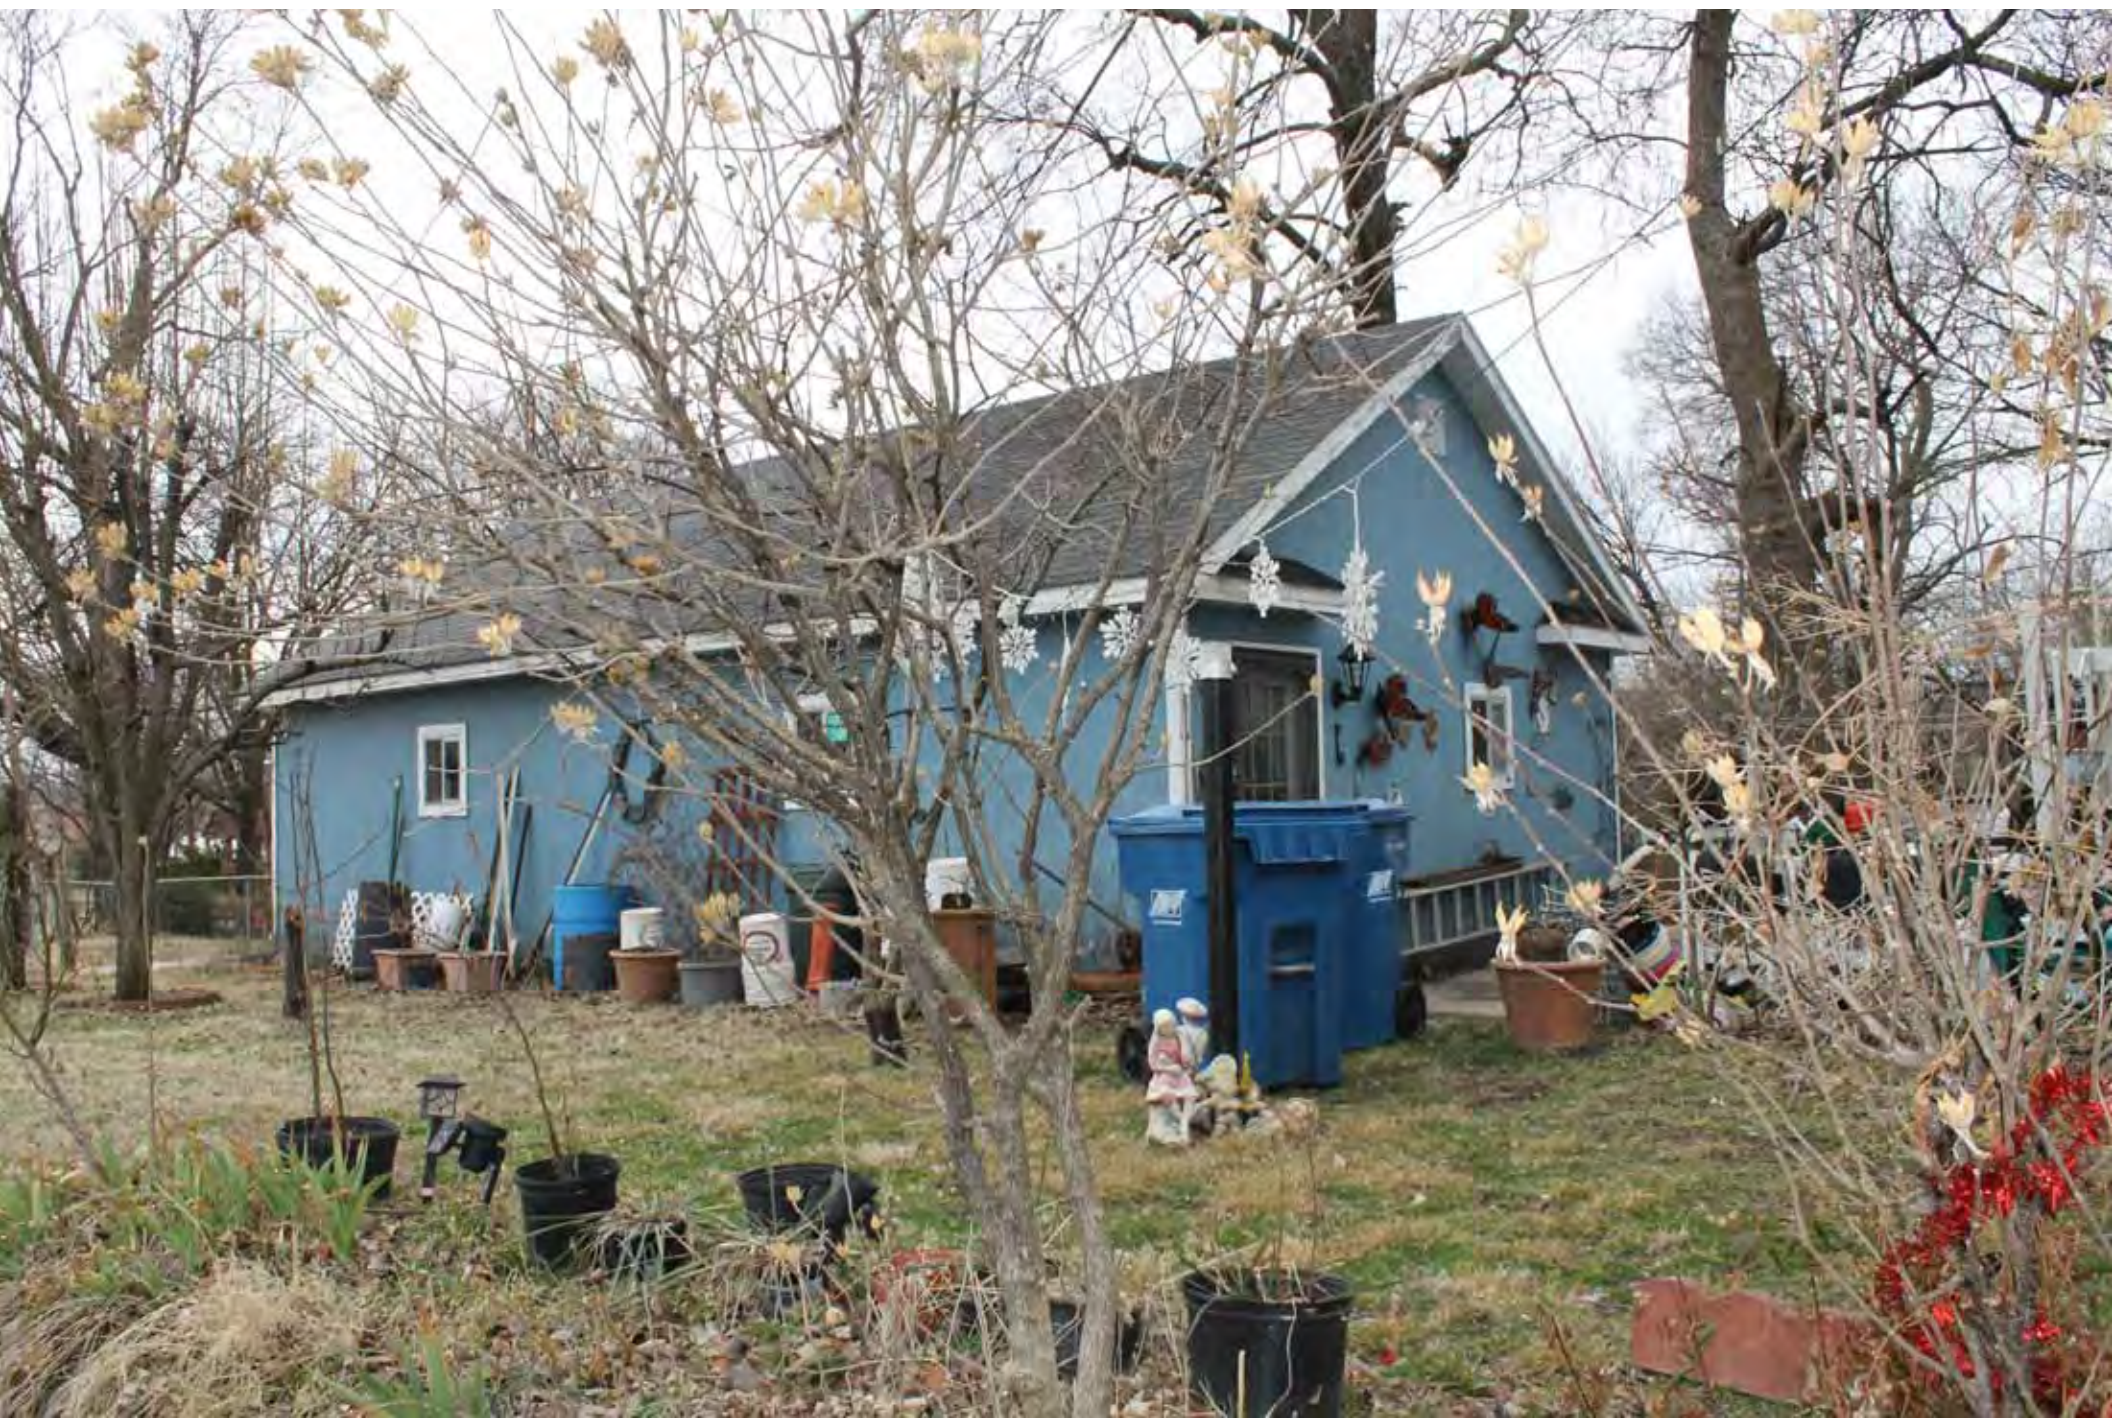
The property at 1024 Central Street is a frame house with a rusticated concrete block foundation. The entire house is covered in its original wood siding. It has front facing gable roof with the original hipped roof front porch or veranda, which surrounds the northeast corner of the house. The concrete steps to the porch and entrance are on the southeast corner, and there is a small pedimented gable end with returned eaves above the stairs, at the roof of the porch. The porch has original wood columns on concrete block piers and an open wood banister. The entrance door is also located on the northeast corner of the house. On the front, or north elevation, are two one-over-one wood windows with wood surrounds. At the half story level on the front elevation is a small wood window with sidelights. Along the side or west elevation of the house is a simple bay window, with three single wood windows. Towards the rear of the house is a larger one-over-one wood window.

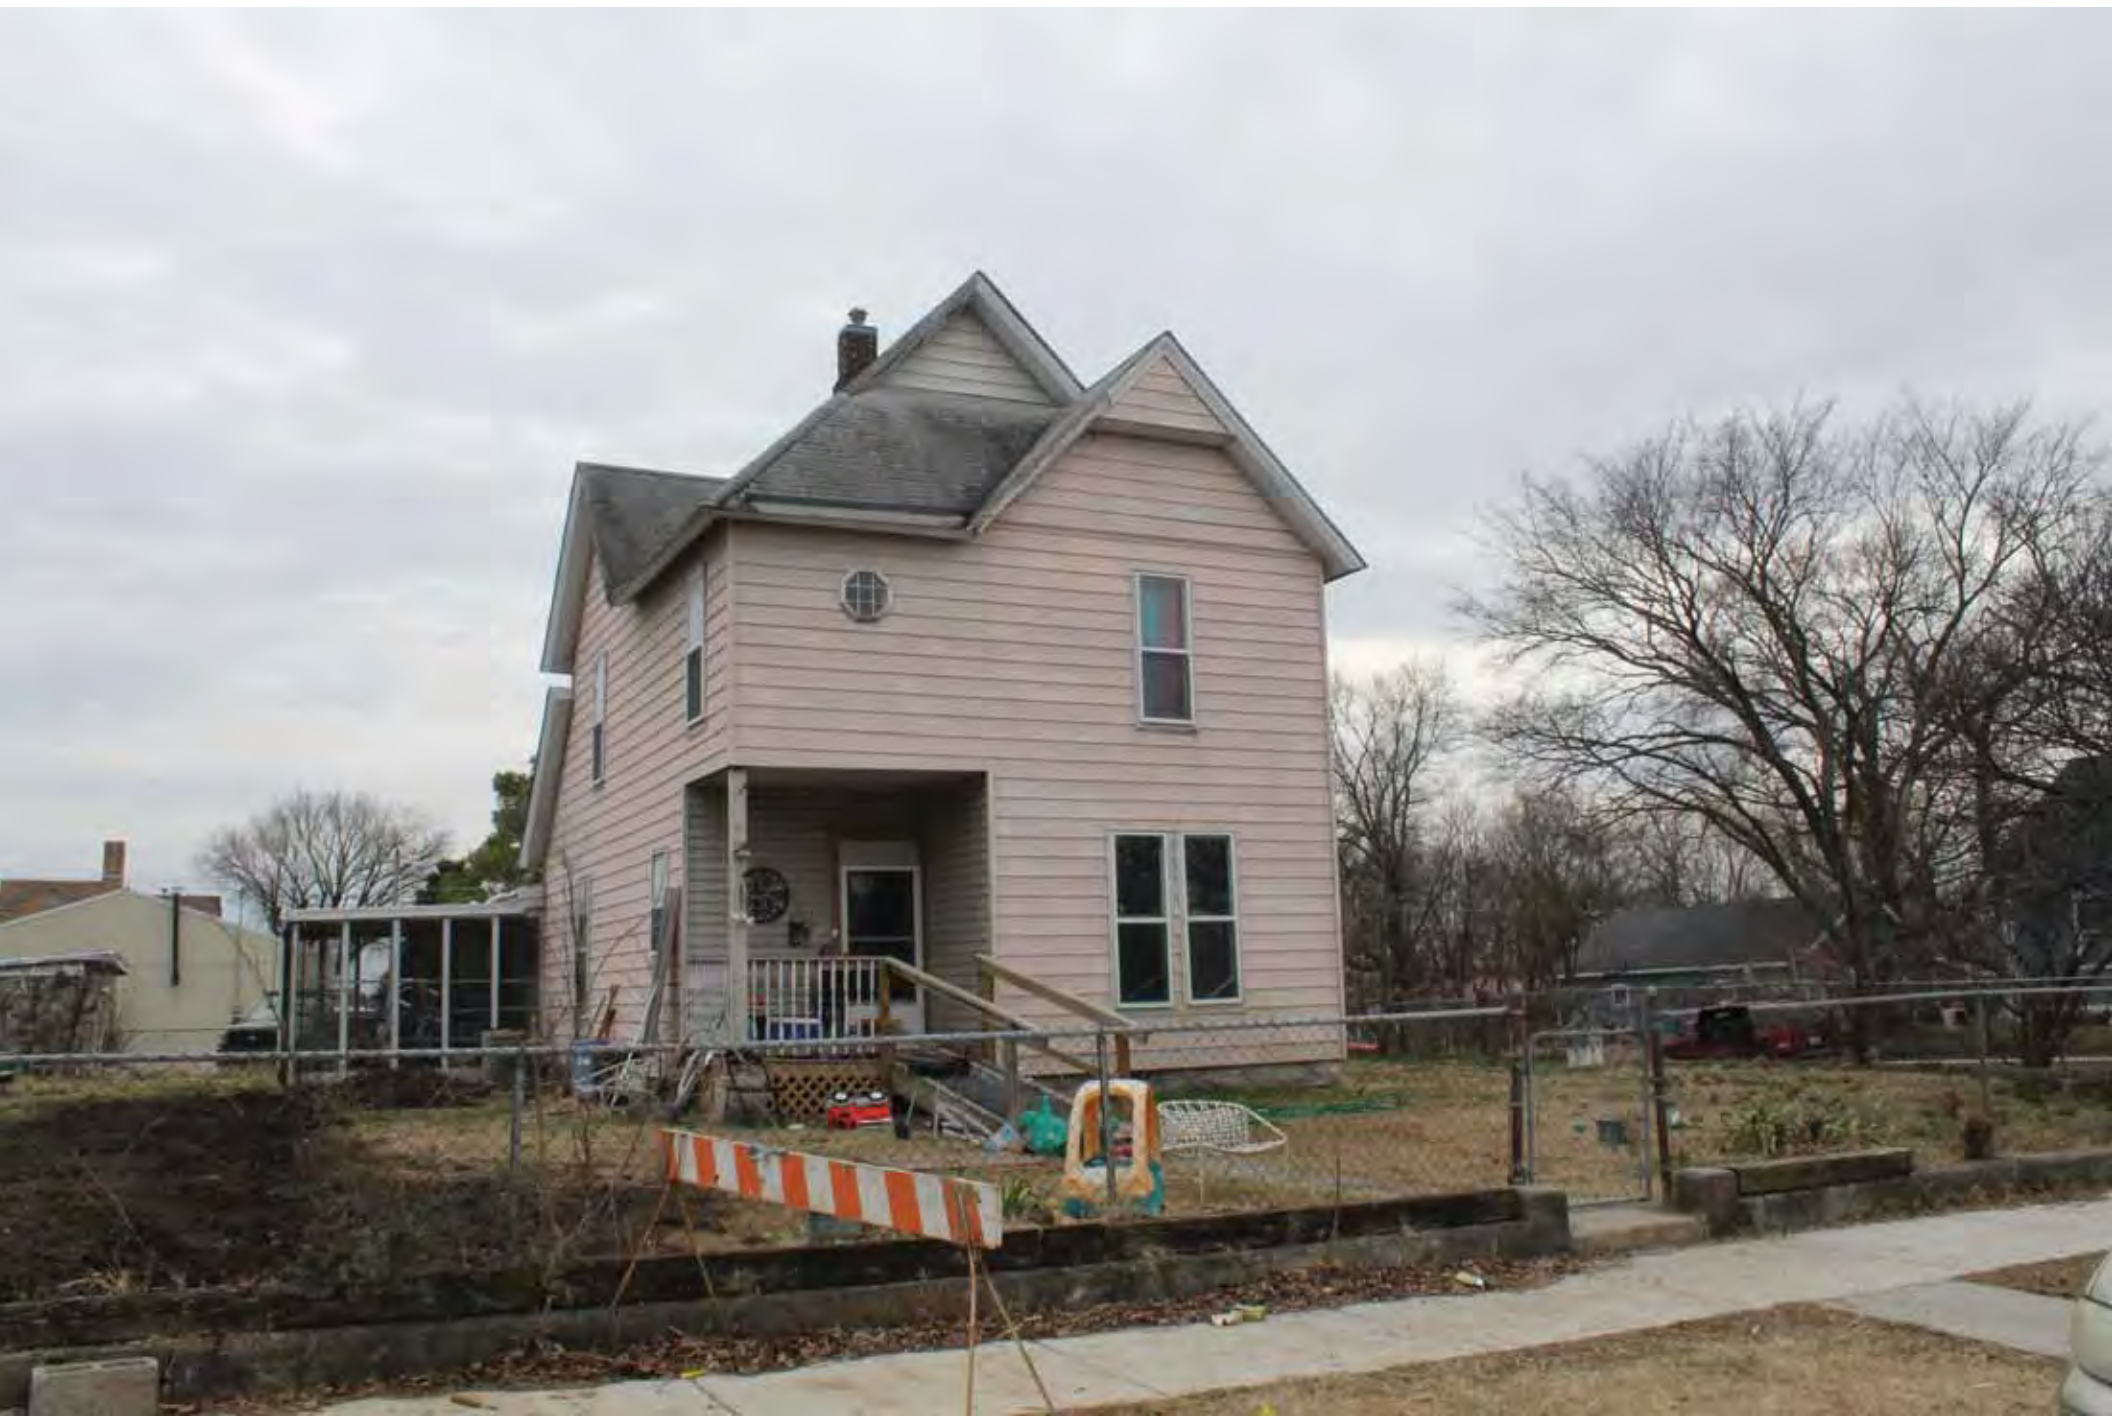
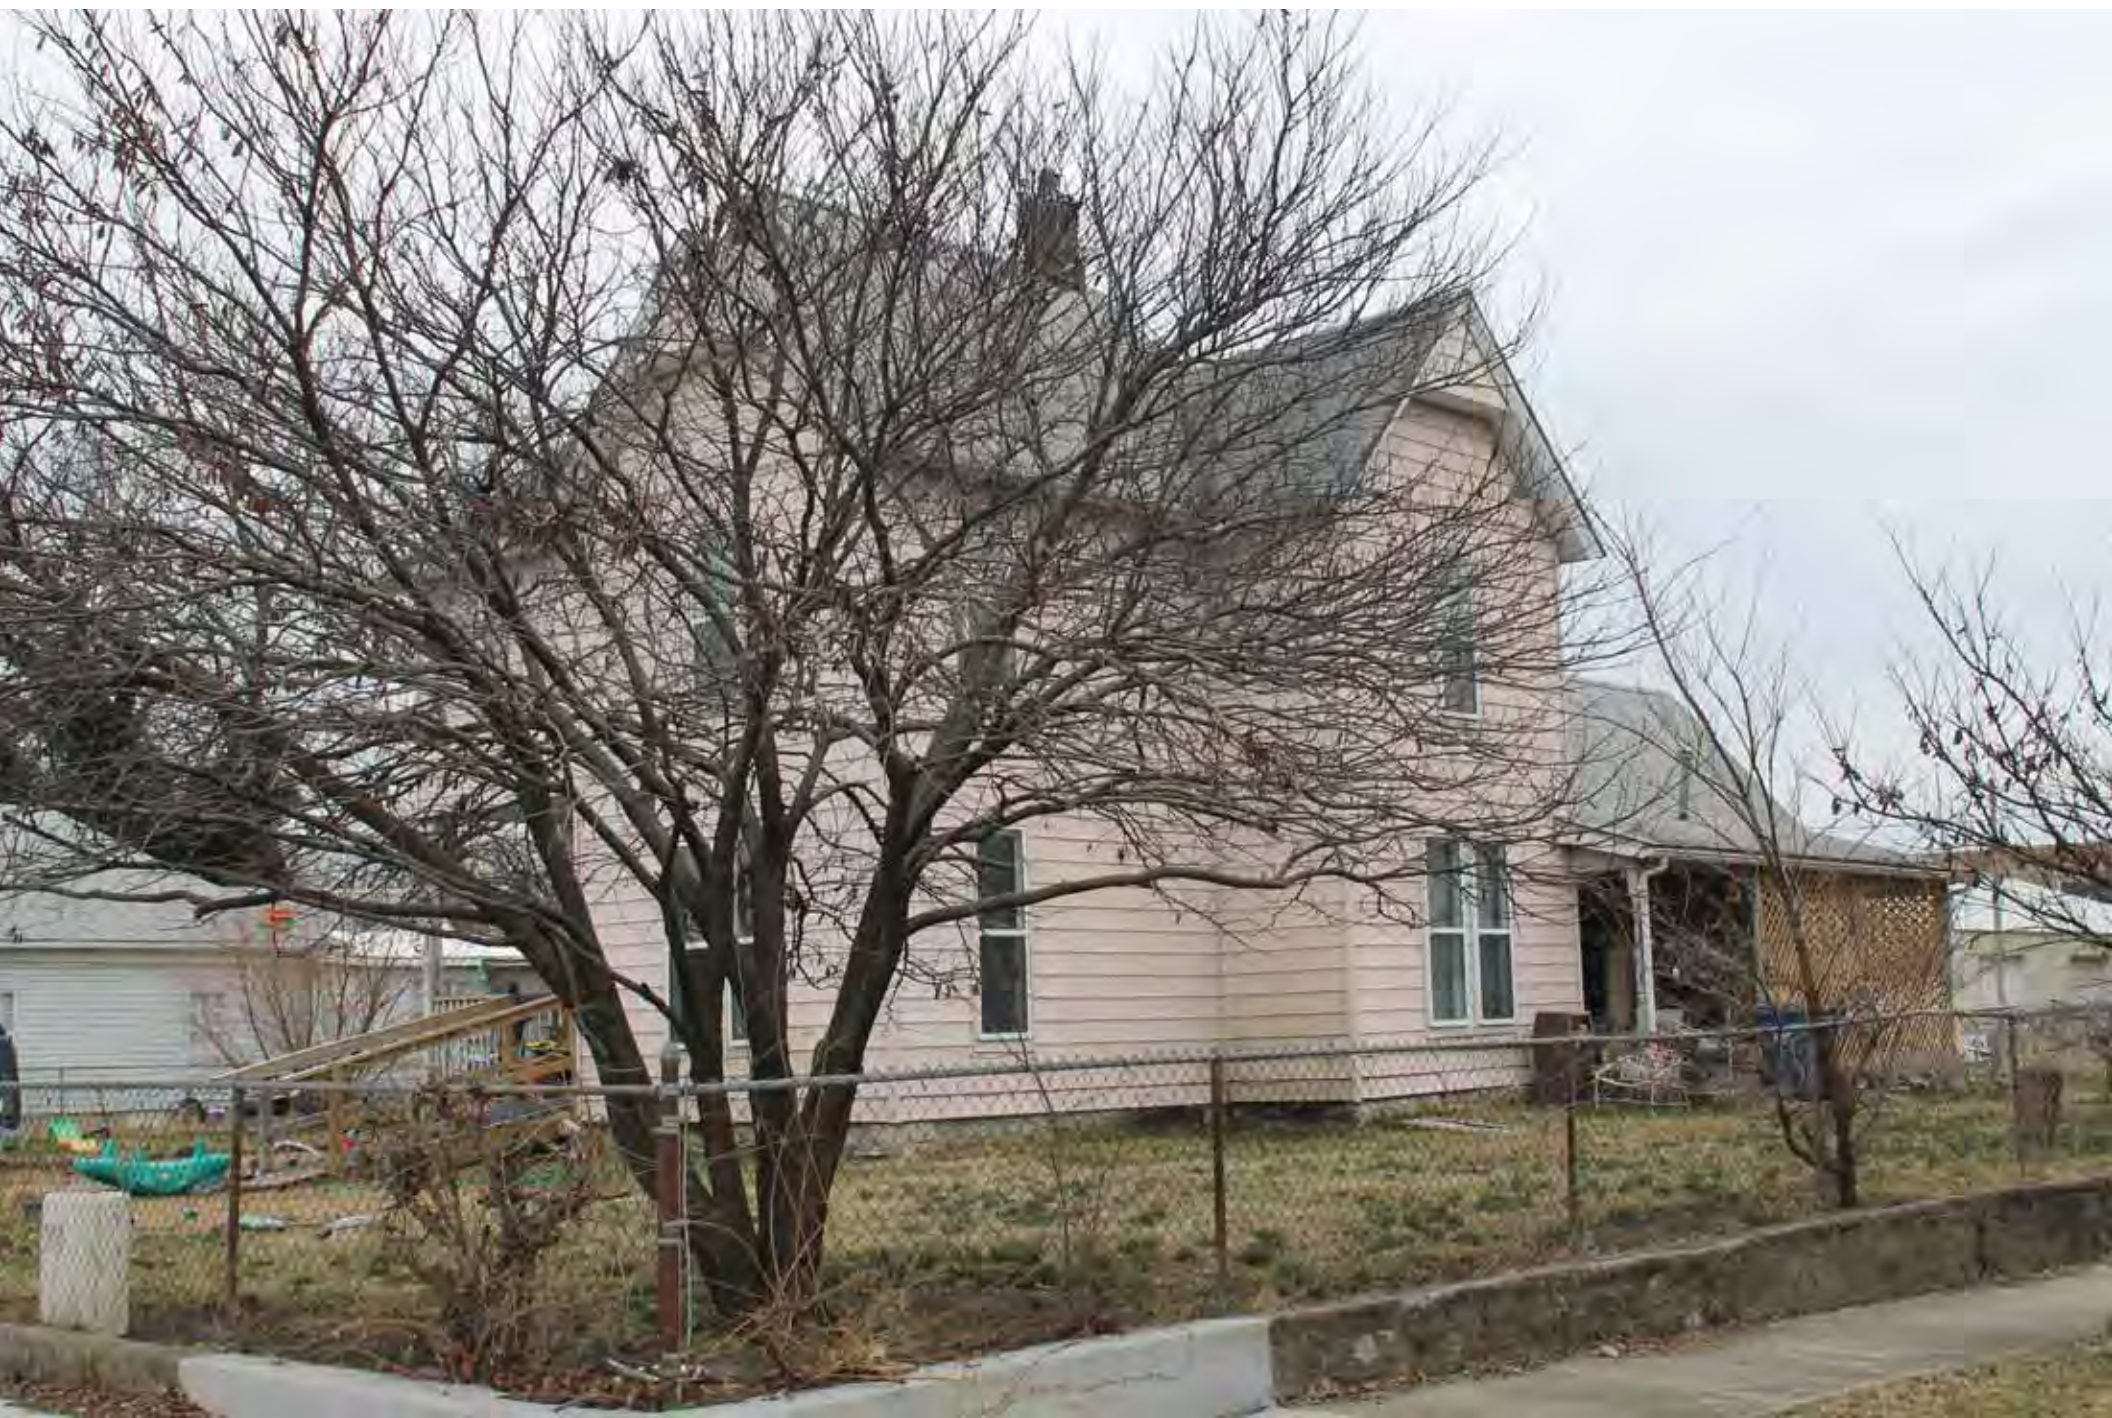
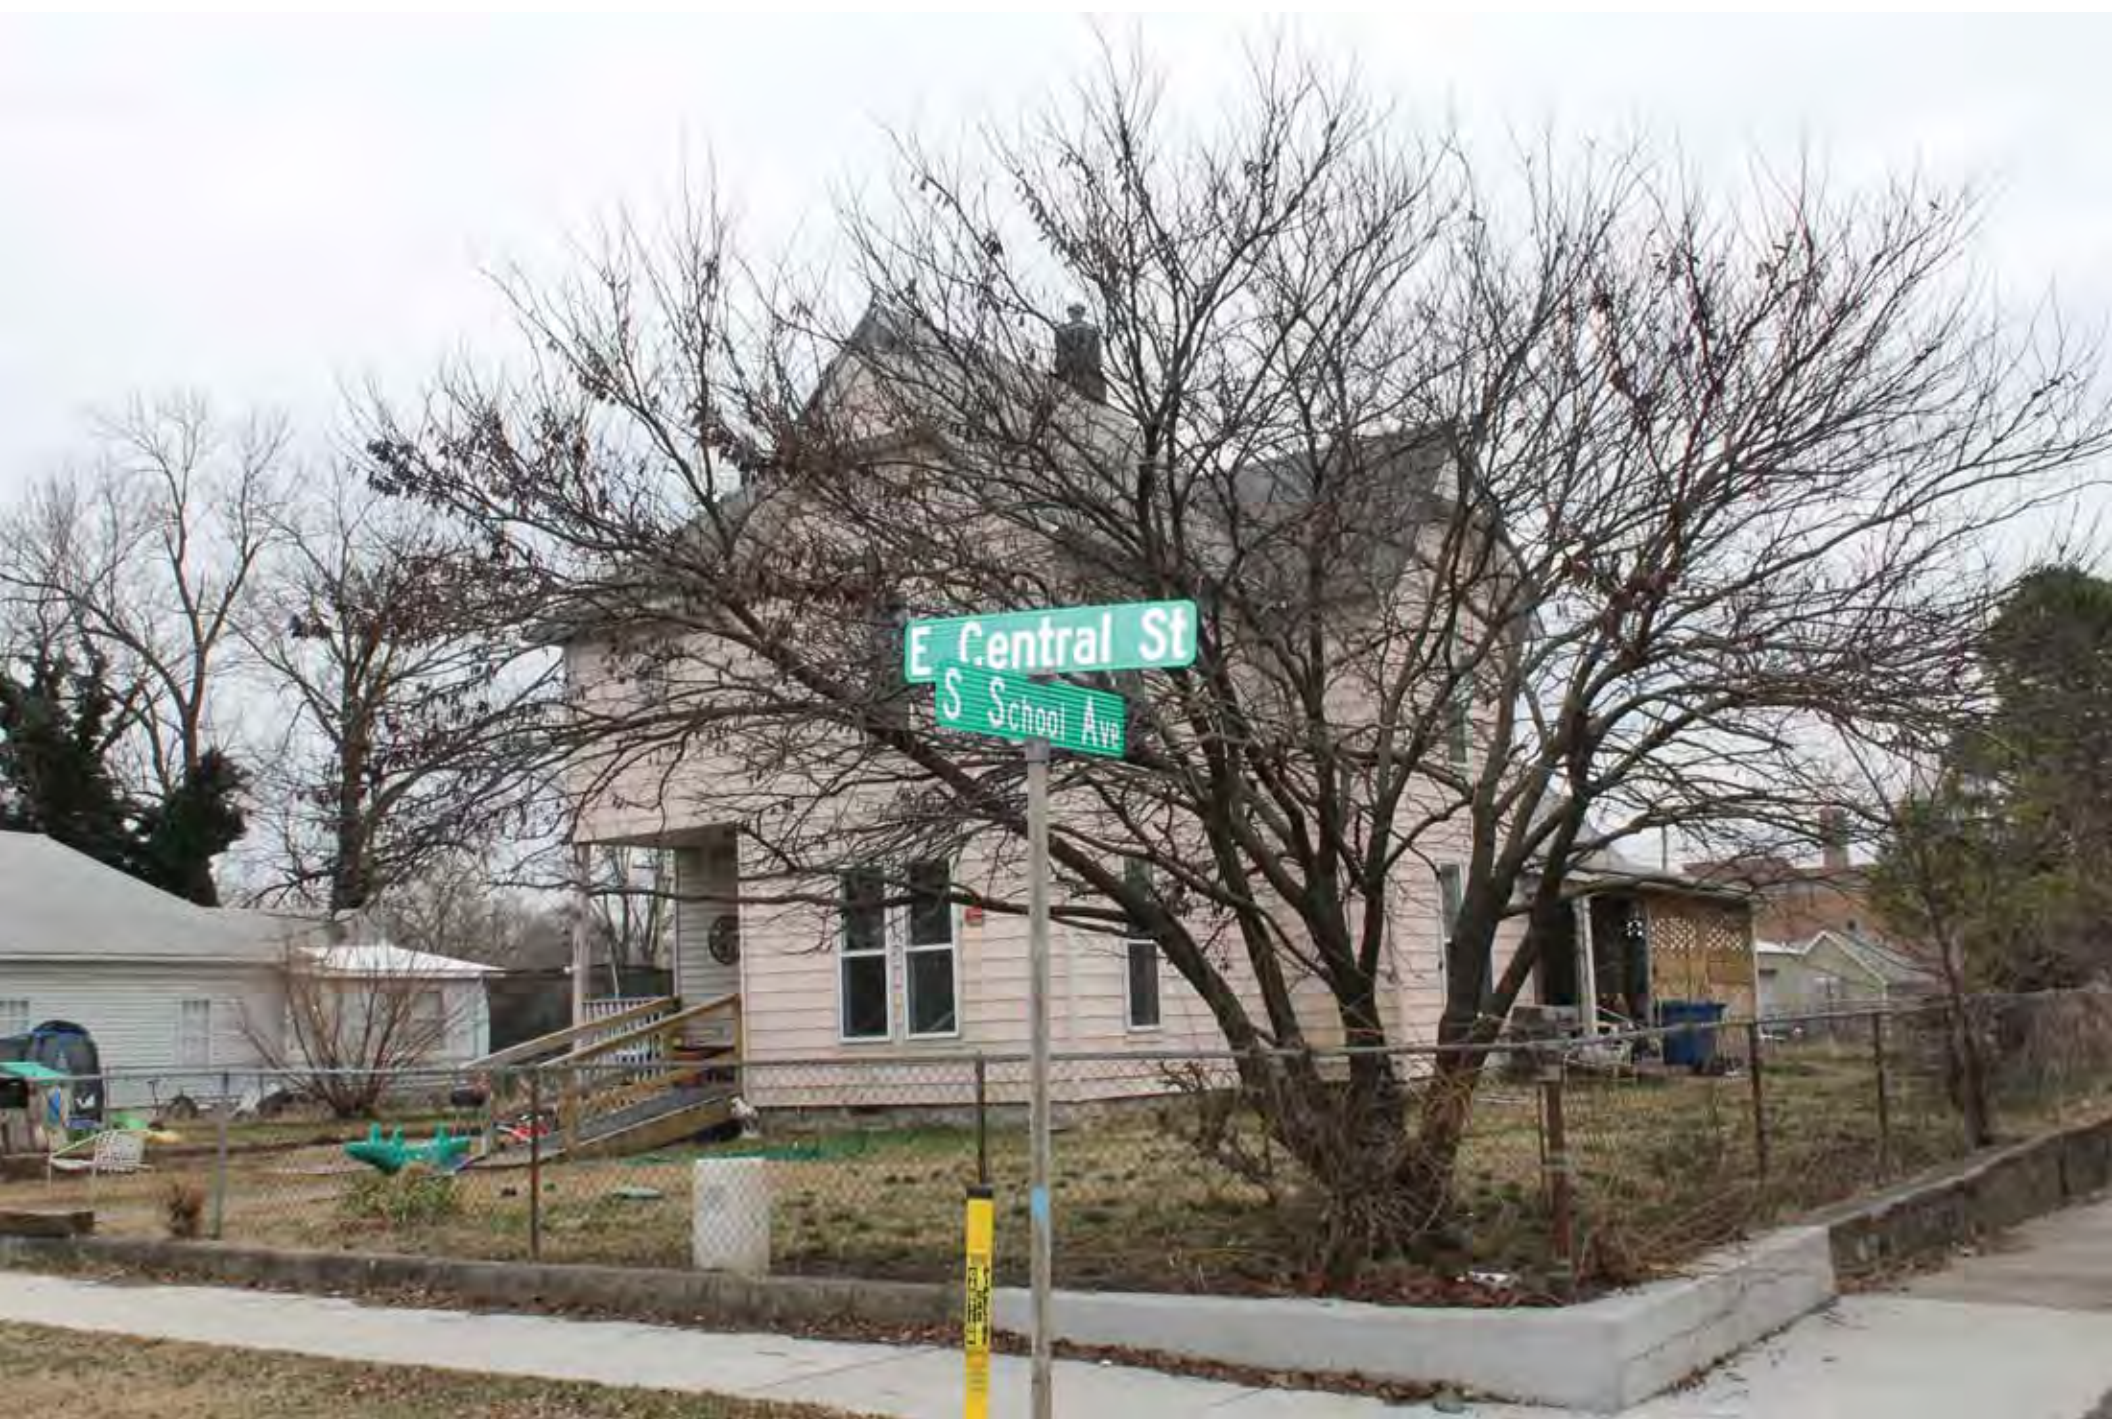
This dwelling has been extensively altered through the addition of c. 2010 exterior siding (vinyl) and replacement of original windows. Due to the lack of exterior original siding, the dwelling does not retain integrity that would render it individually eligible for the National Register of Historic Places. The dwelling is not situated in an area recommended as a historic district.

The property at 1104 E. Central Street features a two-story, gable-front plan National style dwelling with exterior vinyl siding and an asphalt shingled roof consisting of cross-gable and gable-on-hip plan. The dwelling has a cut limestone foundation and rear single-story original wing on the south elevation. The primary (north) elevation has an integral side corner porch supported by a single wood column. The porch is surrounded by a contemporary spindled banister. A frame ramp leads to the porch and primary entry, which is filled with a contemporary metal storm door. The entry bay has been altered with some infill surrounding the door and infill of an original transom above the door. Windows are replacement one-over-one design. An octagonal multi-light window is above the porch on the second-story north elevation. An interior brick chimney, converted to a flue, is visible near the central front facing gable. The rear single-story wing faces west toward S. School Avenue. The wing has a full-width shed porch with milled columns. The porch is partially covered with frame lattice. A shed screened porch is attached to the west (rear) elevation of the rear one-story wing.
