MISSOURI DEPARTMENT OF NATURAL RESOURCES
STATE HISTORIC PRESERVATION OFFICE, P.O. Box 176, Jefferson City, MO 65102
ARCHITECTURAL/HISTORIC INVENTORY FORM

1. Survey No. JP-AS-007-001		2. Survey name: East Town (Original Joplin) Historic Survey Phase 2	
3. County: JASPER		4. Address (Street No.) 618	Street (name) E. 2 nd Street
5. City: Joplin	Vicinity: <input type="checkbox"/>	6. Geographical Reference:	7. Township/Range/Section: T: R: S:
8. Historic name (if known):		9. Present/other name (if known):	
10. Ownership: <input checked="" type="checkbox"/> Private <input type="checkbox"/> Public		11a. Historic use (if known): Domestic: Single Dwelling	11b. Current use: Domestic: Single Dwelling

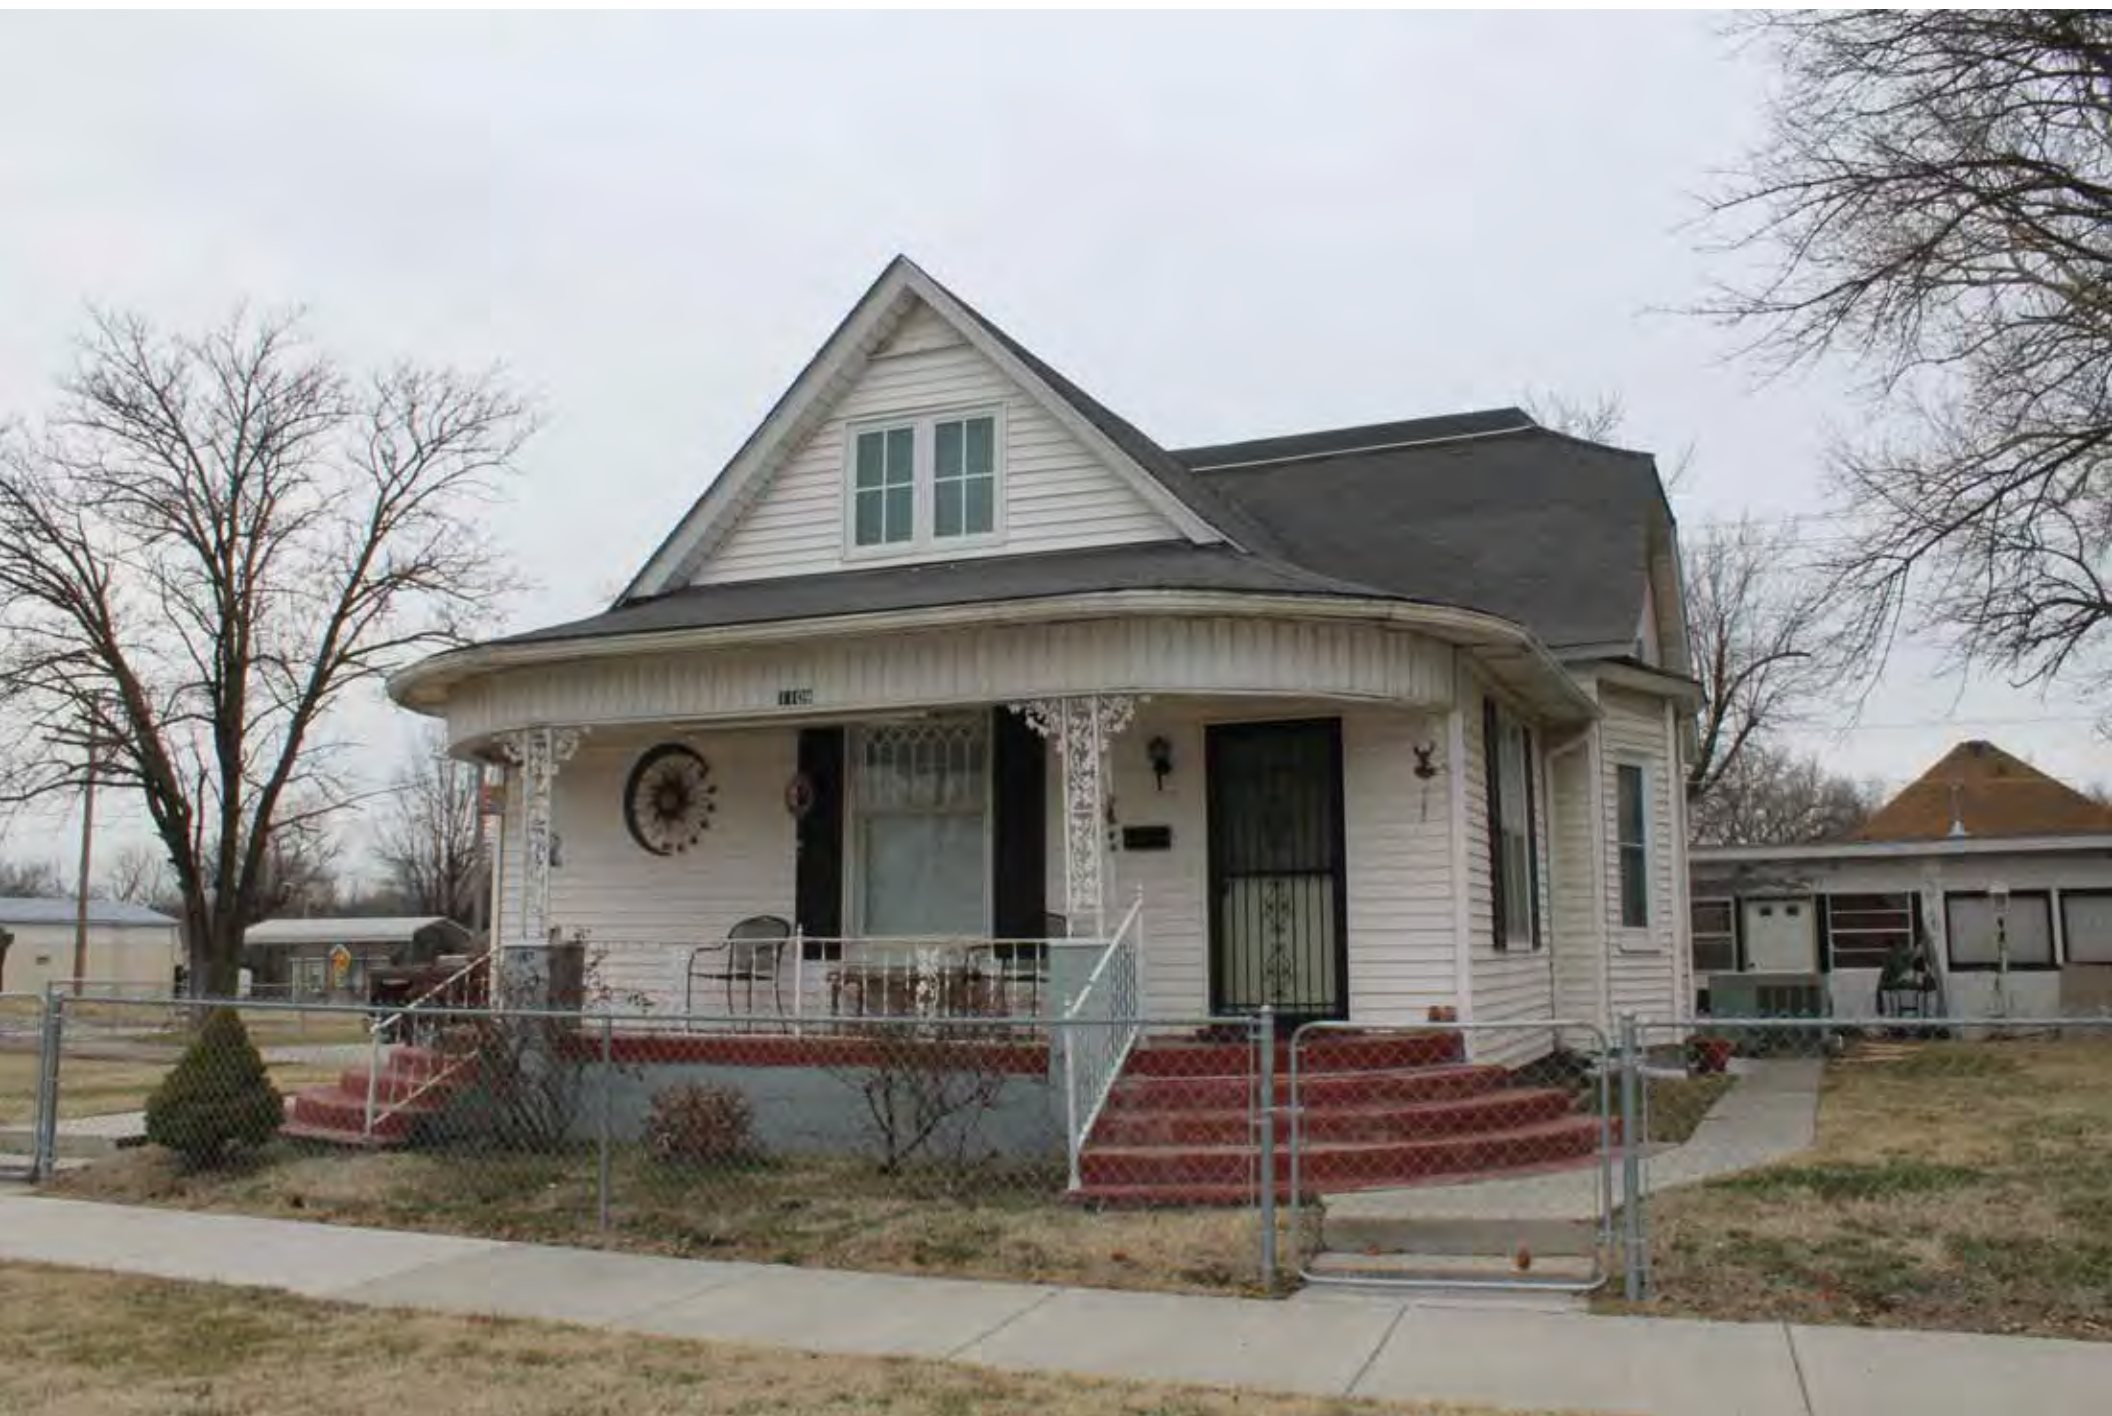
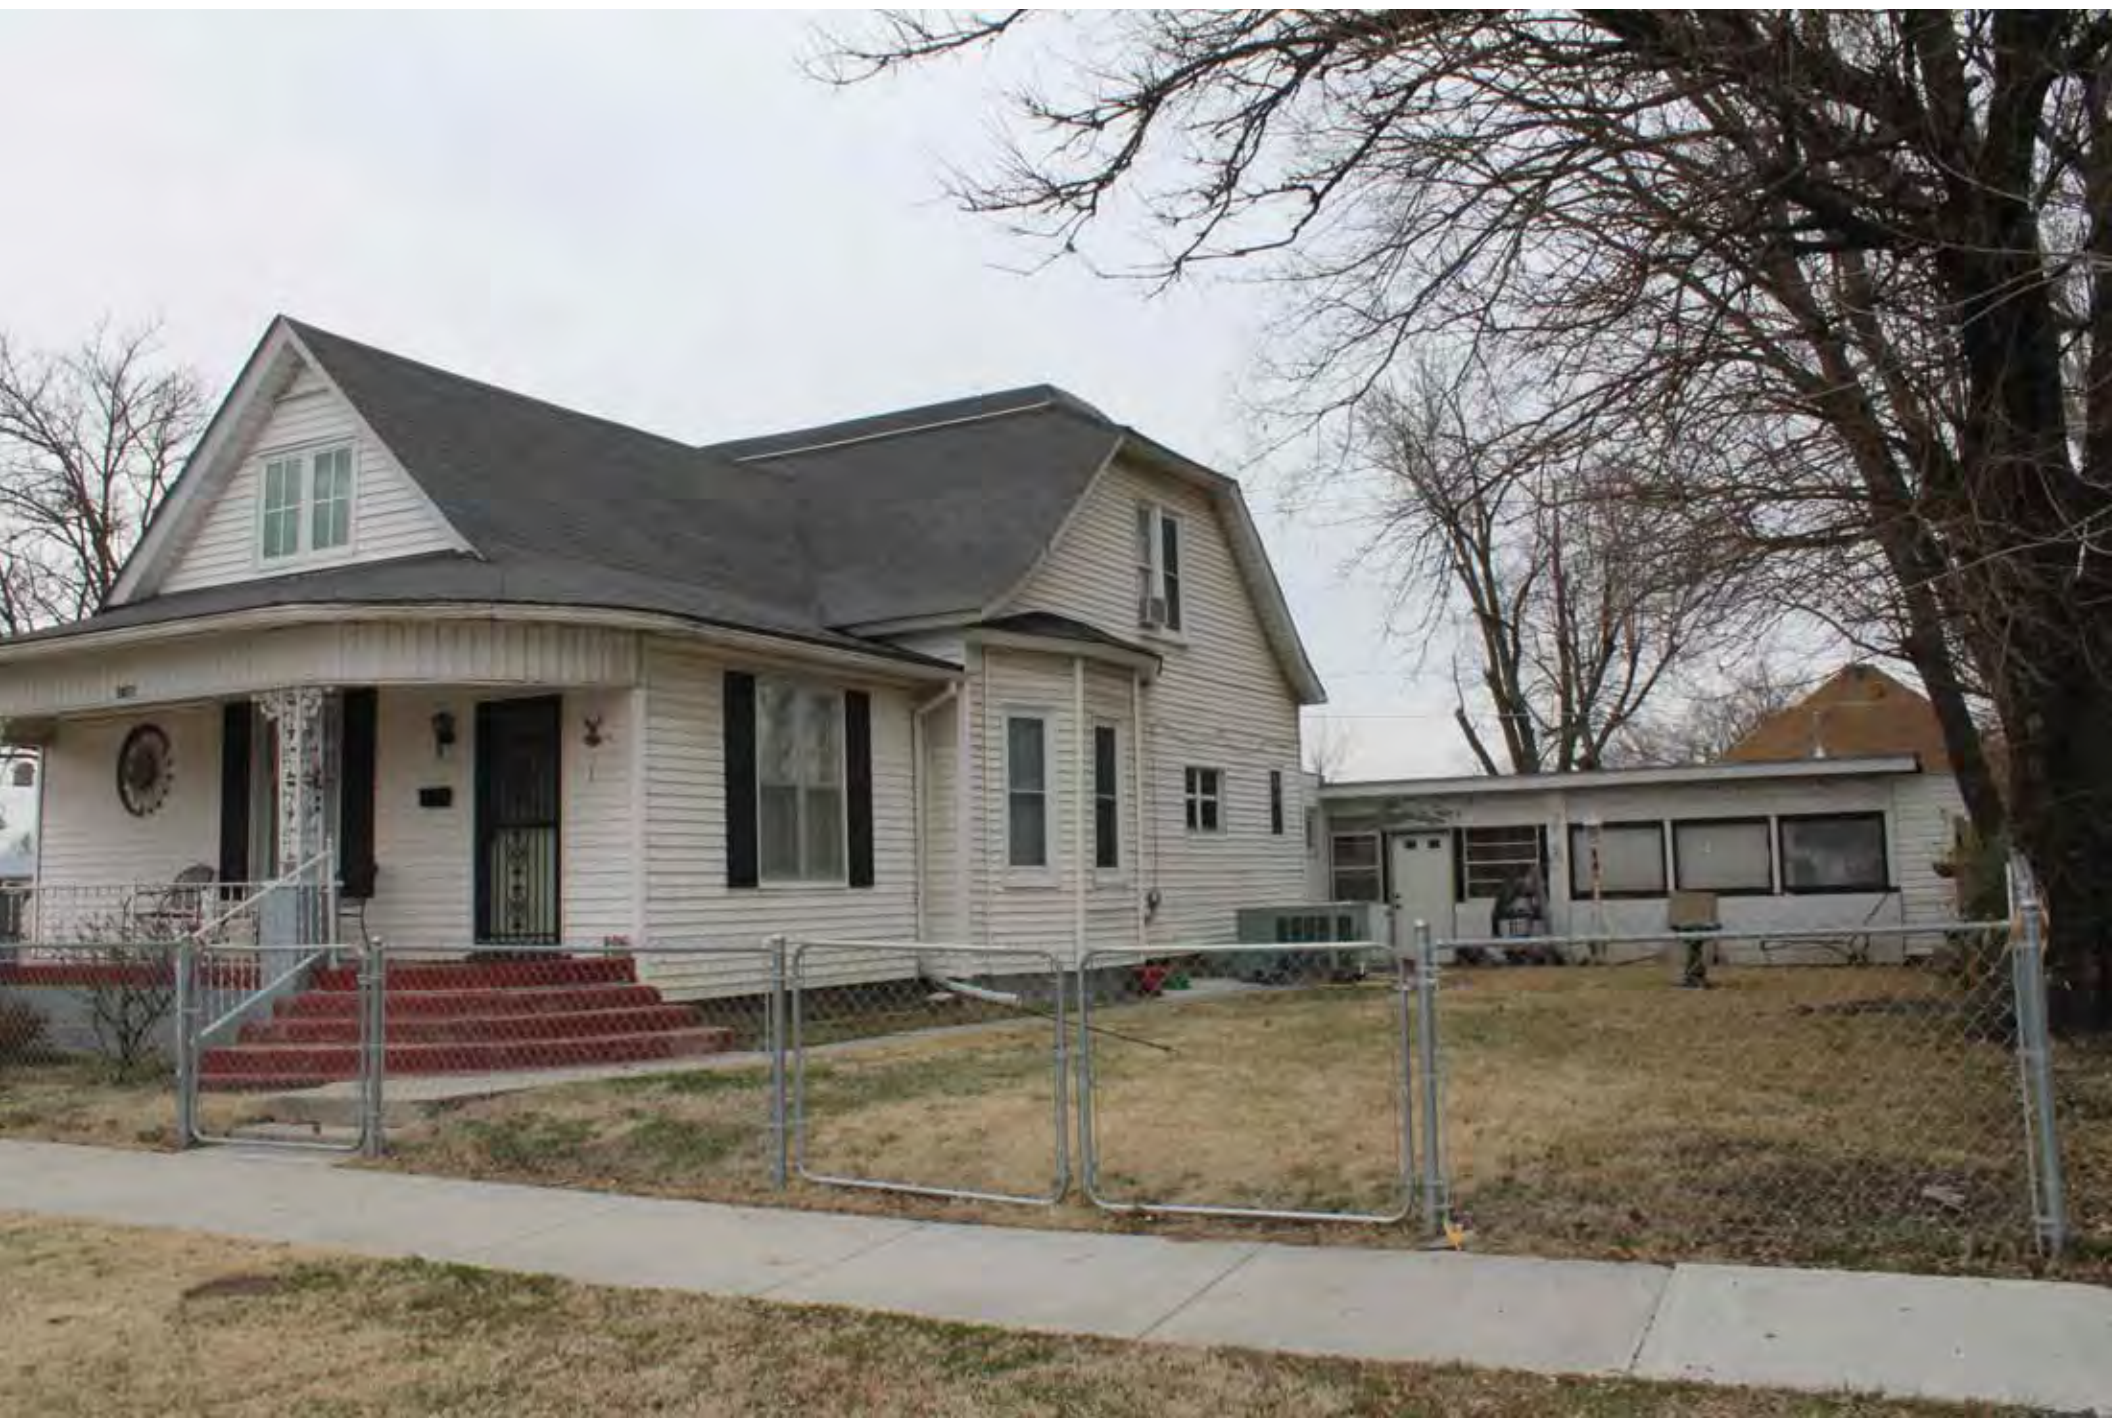
This dwelling has been extensively altered through the addition of c. 2010 exterior siding (vinyl), partial enclosure of an original wrap-around porch and replacement of some original windows. Due to the lack of exterior original siding and porch alterations, the dwelling does not retain integrity that would render it individually eligible for the National Register of Historic Places. The dwelling is not situated in an area recommended as a historic district.

The property 1109 E. Central Street features a 1.5-story Queen Anne style dwelling with a gabled/clipped gable roof, exterior vinyl siding and a concrete foundation. The roofline is flared at either end (east and west) of the cross-gabled roof. The primary (south) elevation features a central open porch supported by wrought iron columns. The porch rests on a concrete block base with original rounded concrete steps at the southeast and southwest ends. The porch originally wrapped the east and west elevations (per Sanborn map) but have since been enclosed. Enclosed porch areas feature paired 1/1 windows with faux shutters. The porch roof is hipped. Above the porch is a front facing gable that holds original four-light casement windows. Eaves are enclosed. The primary entry is off-center within the porch (east end), filled with a paneled door and wrought iron storm door. Offsetting the primary entry on the east is an original Queen Anne style double-hung window with upper diamond-shaped lights. The window has faux shutters. A projecting bay is situated on the west elevation. The bay holds individual one-over-one windows capped by a hipped asphalt-clad "roof." Gable fields on the east and west elevations hold paired one-over-one windows. The dwelling has an attached carport at the northwest corner. At the northeast corner is an attached one-story shed wing with single fixed sash windows and a two-light paneled door (south elevation) flanked by windows. The wing appears to date to c. 1960.

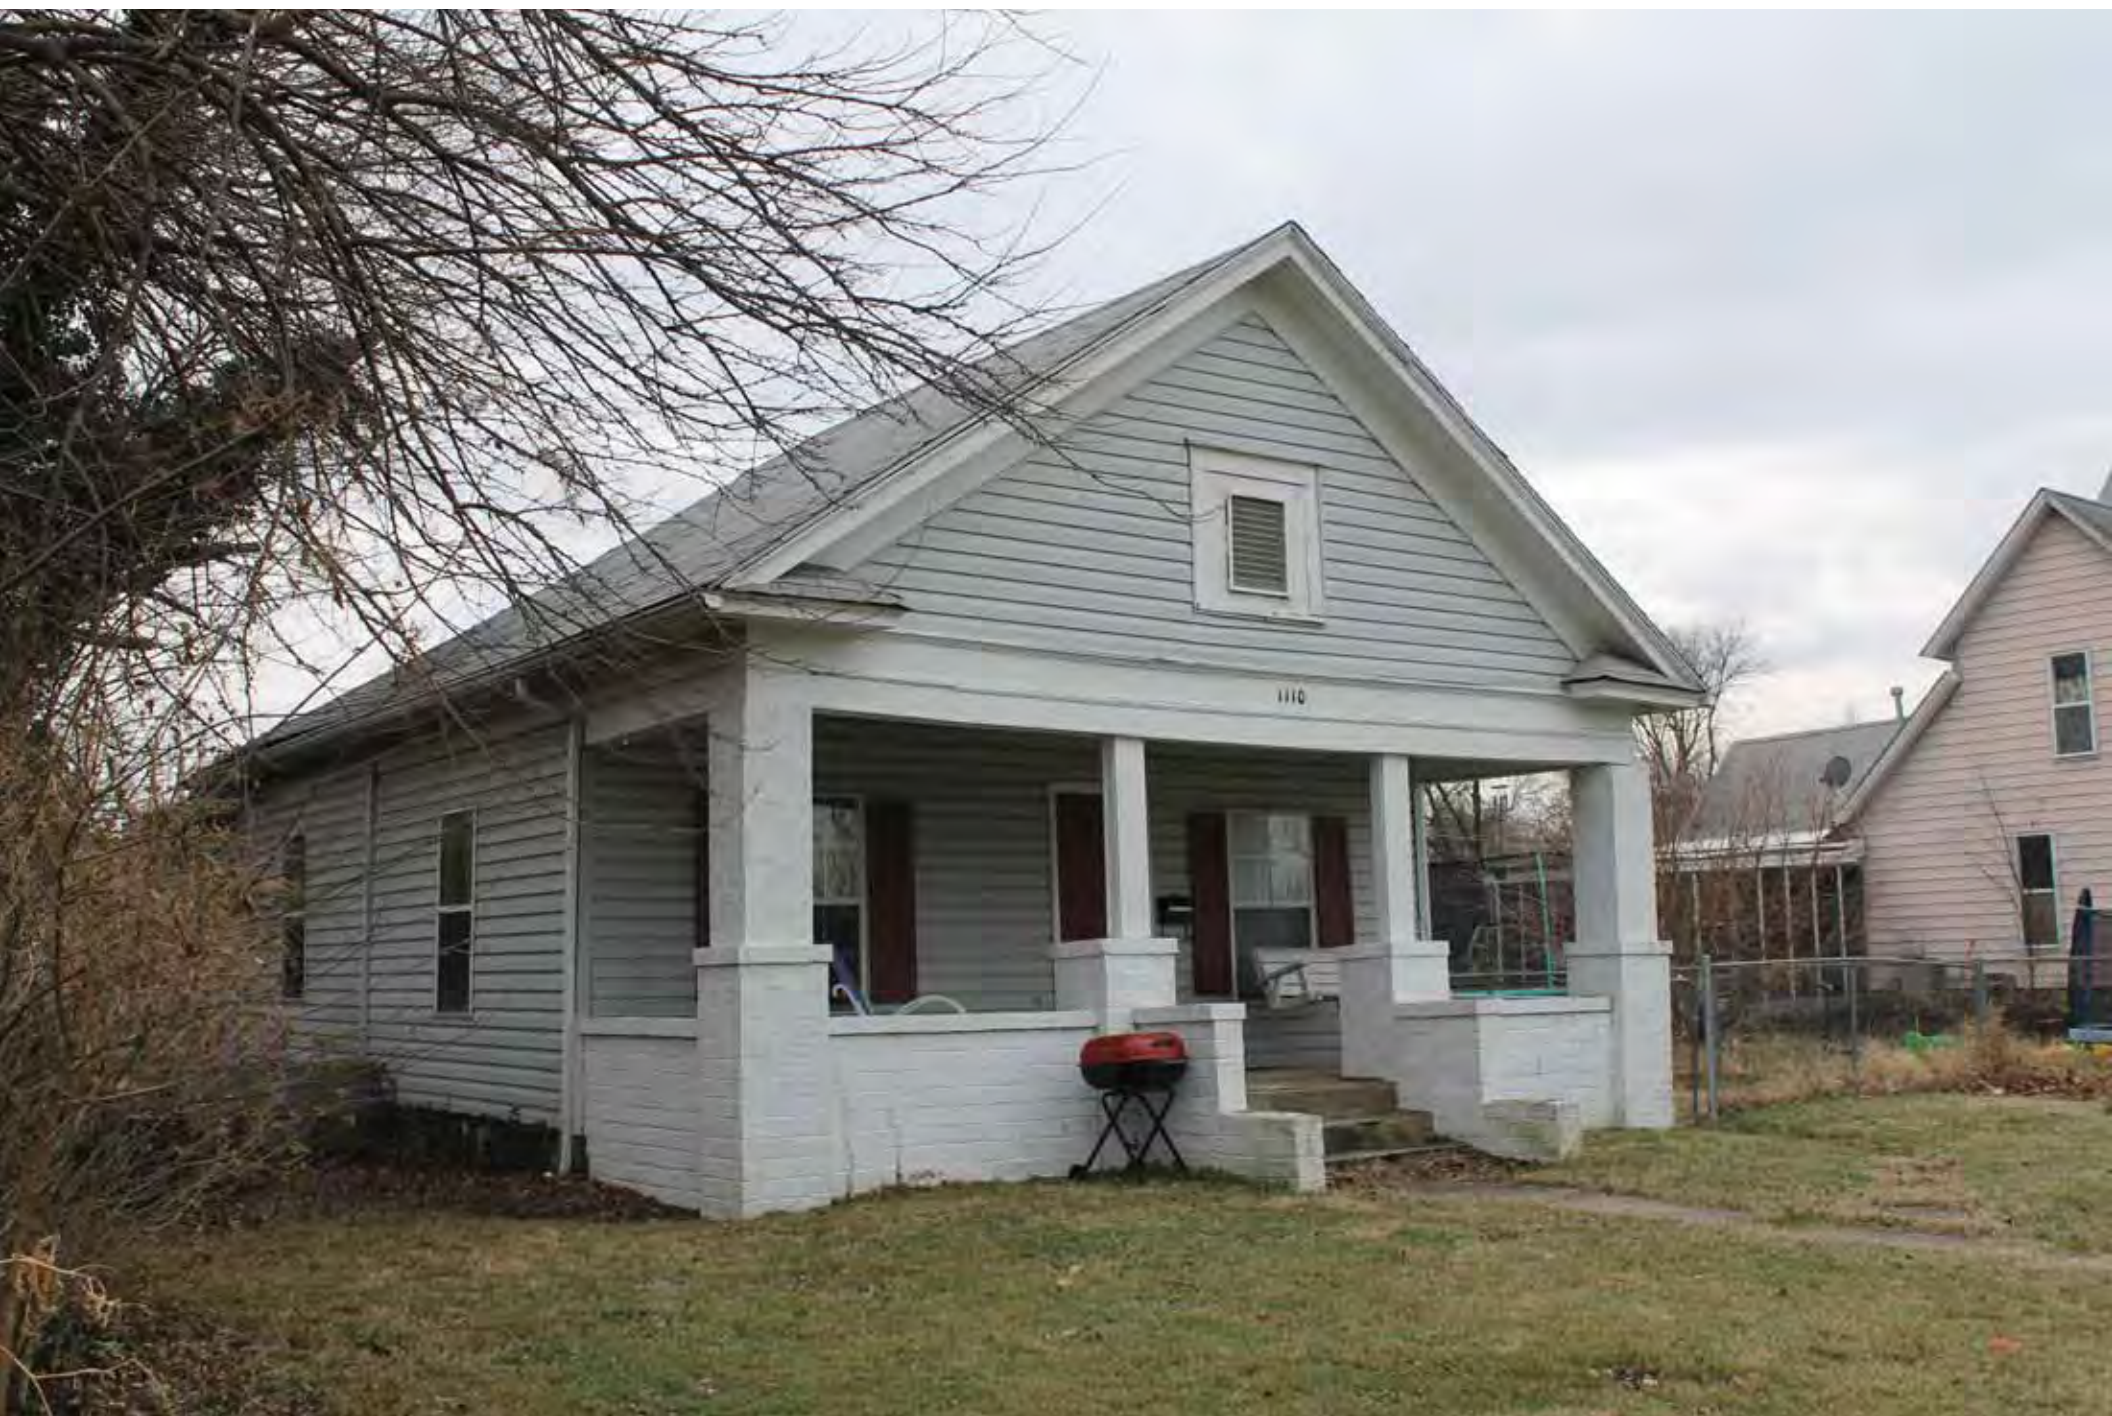
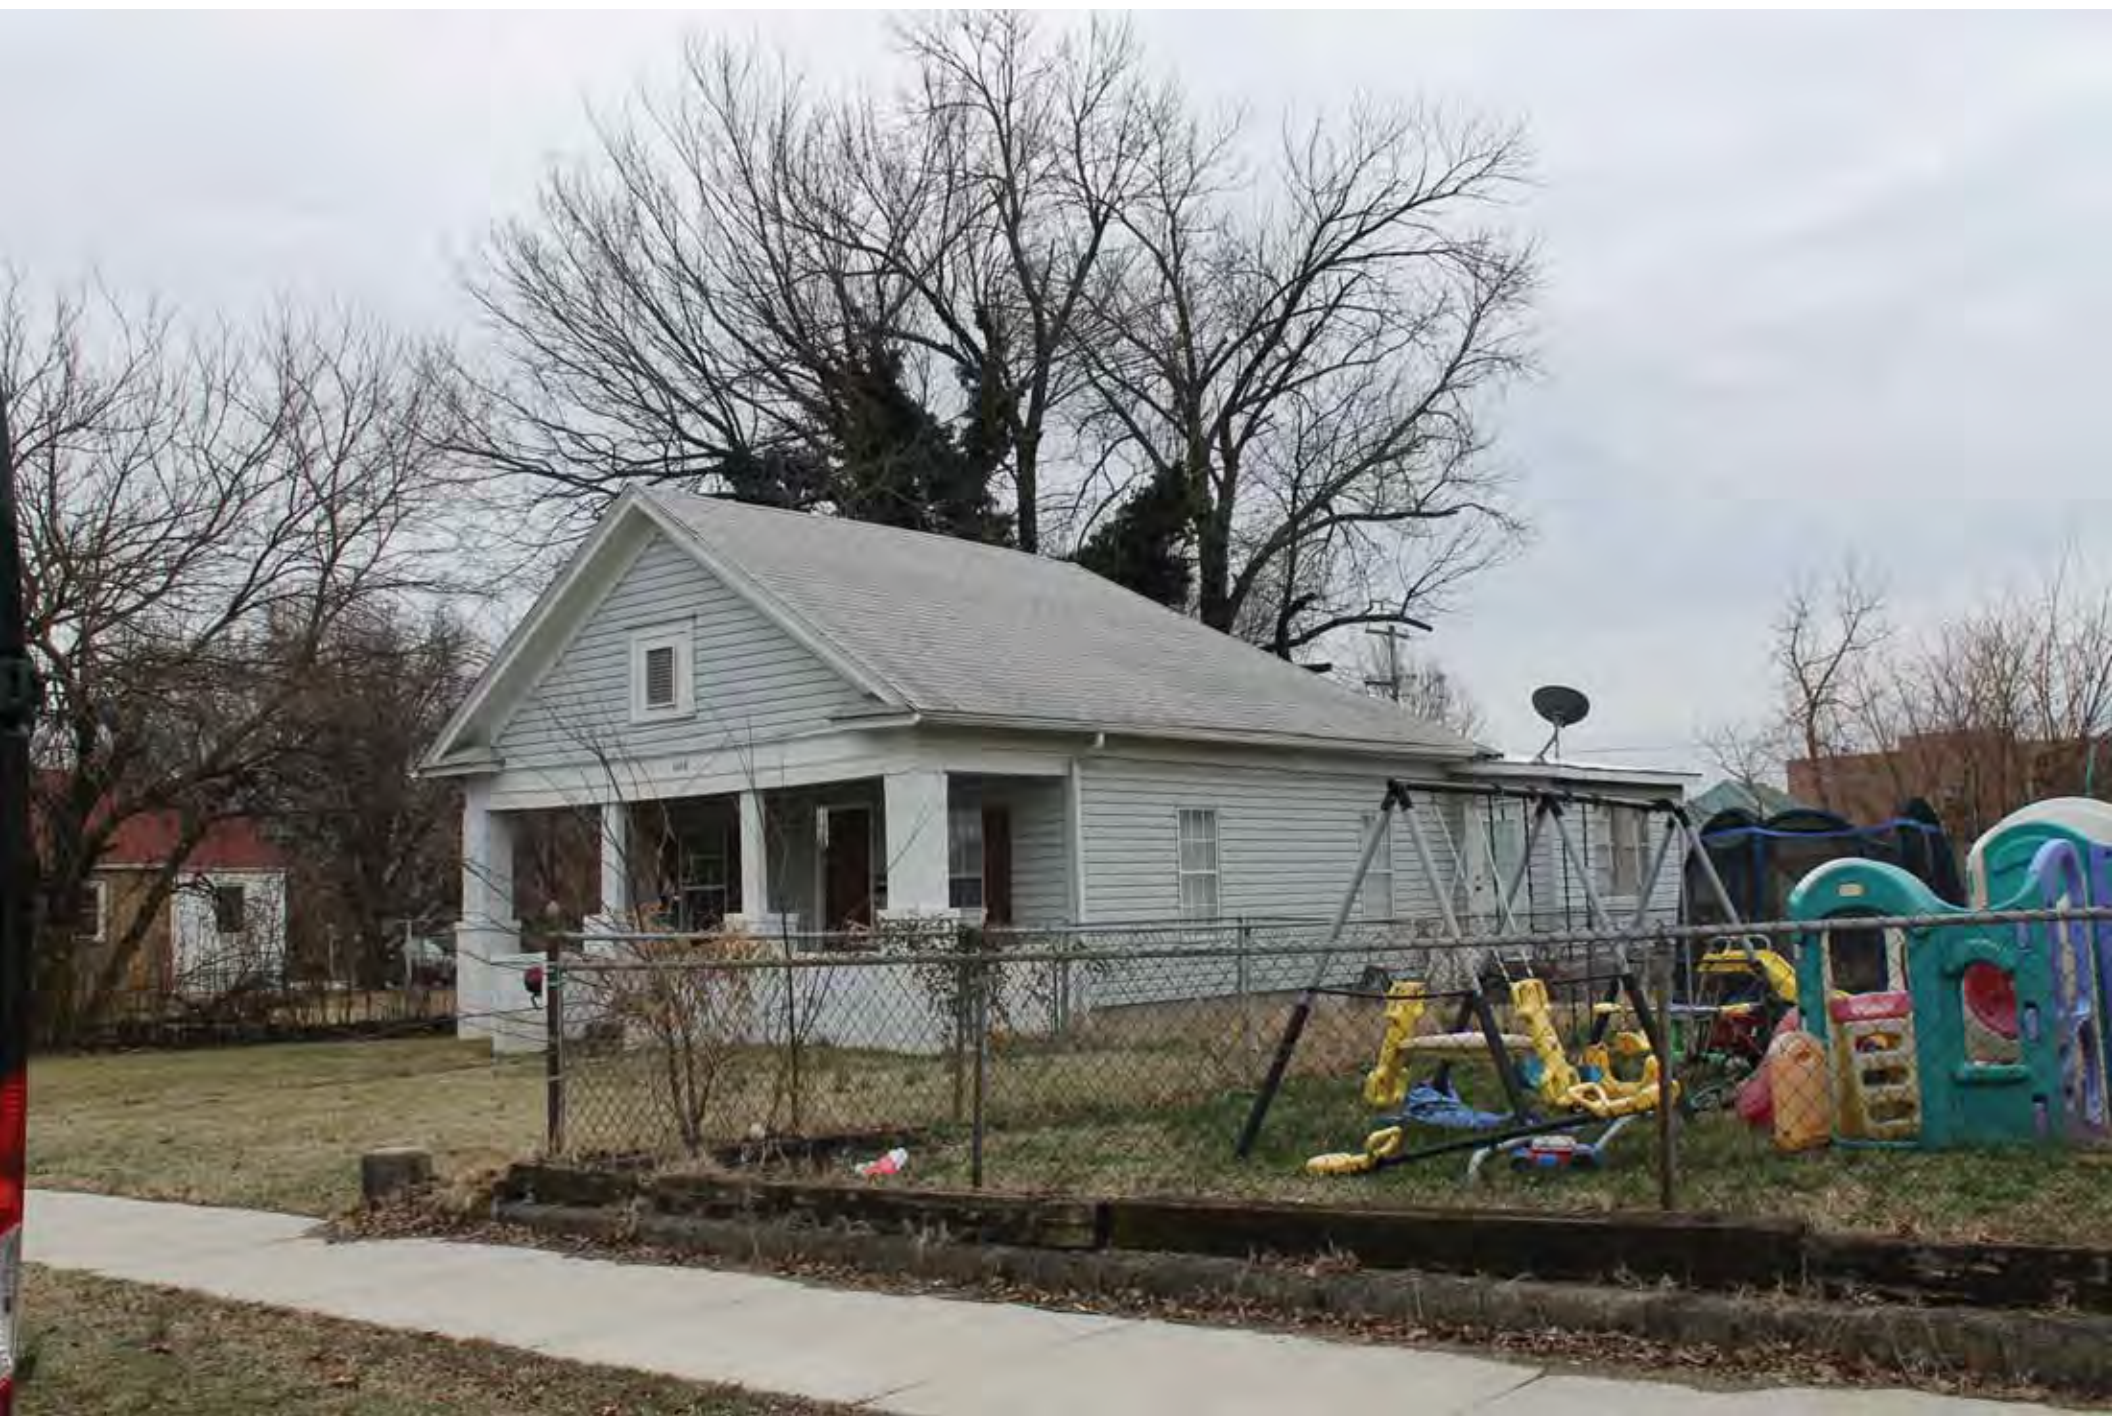
This dwelling has been altered through the addition of c. 2019 exterior siding (vinyl) and replacement of original windows. The porch of the dwelling appears to date to c. 1920. The 1906 Sanborn map illustrates a $\frac{3}{4}$ -width primary porch – the current porch is full-width and reflects Craftsman style influences that were popular during the 1920s-1930s.

The property at 1110 E. Central Street features a single-story, gable-front plan National style dwelling with exterior vinyl siding and a replacement c. 1920 Craftsman style porch. The roof is gable-front plan and clad with asphalt shingles. The foundation is concrete. Windows are replacement with six-over-six muntins. The primary (north) elevation features a full-width integral porch with a textured, painted brick balustrade and piers. At either end (east/west), porch piers are brick. The central porch piers flanking the steps to the porch are tapered wood posts. The primary entry bay is centered within the porch, flanked by single six-over-six windows with faux shutters. Above the porch, the upper gable field holds a partially infilled bay with a louvered vent. The front gable features original returns. An original shed wing with a secondary entry is situated at the southwest corner of the dwelling.

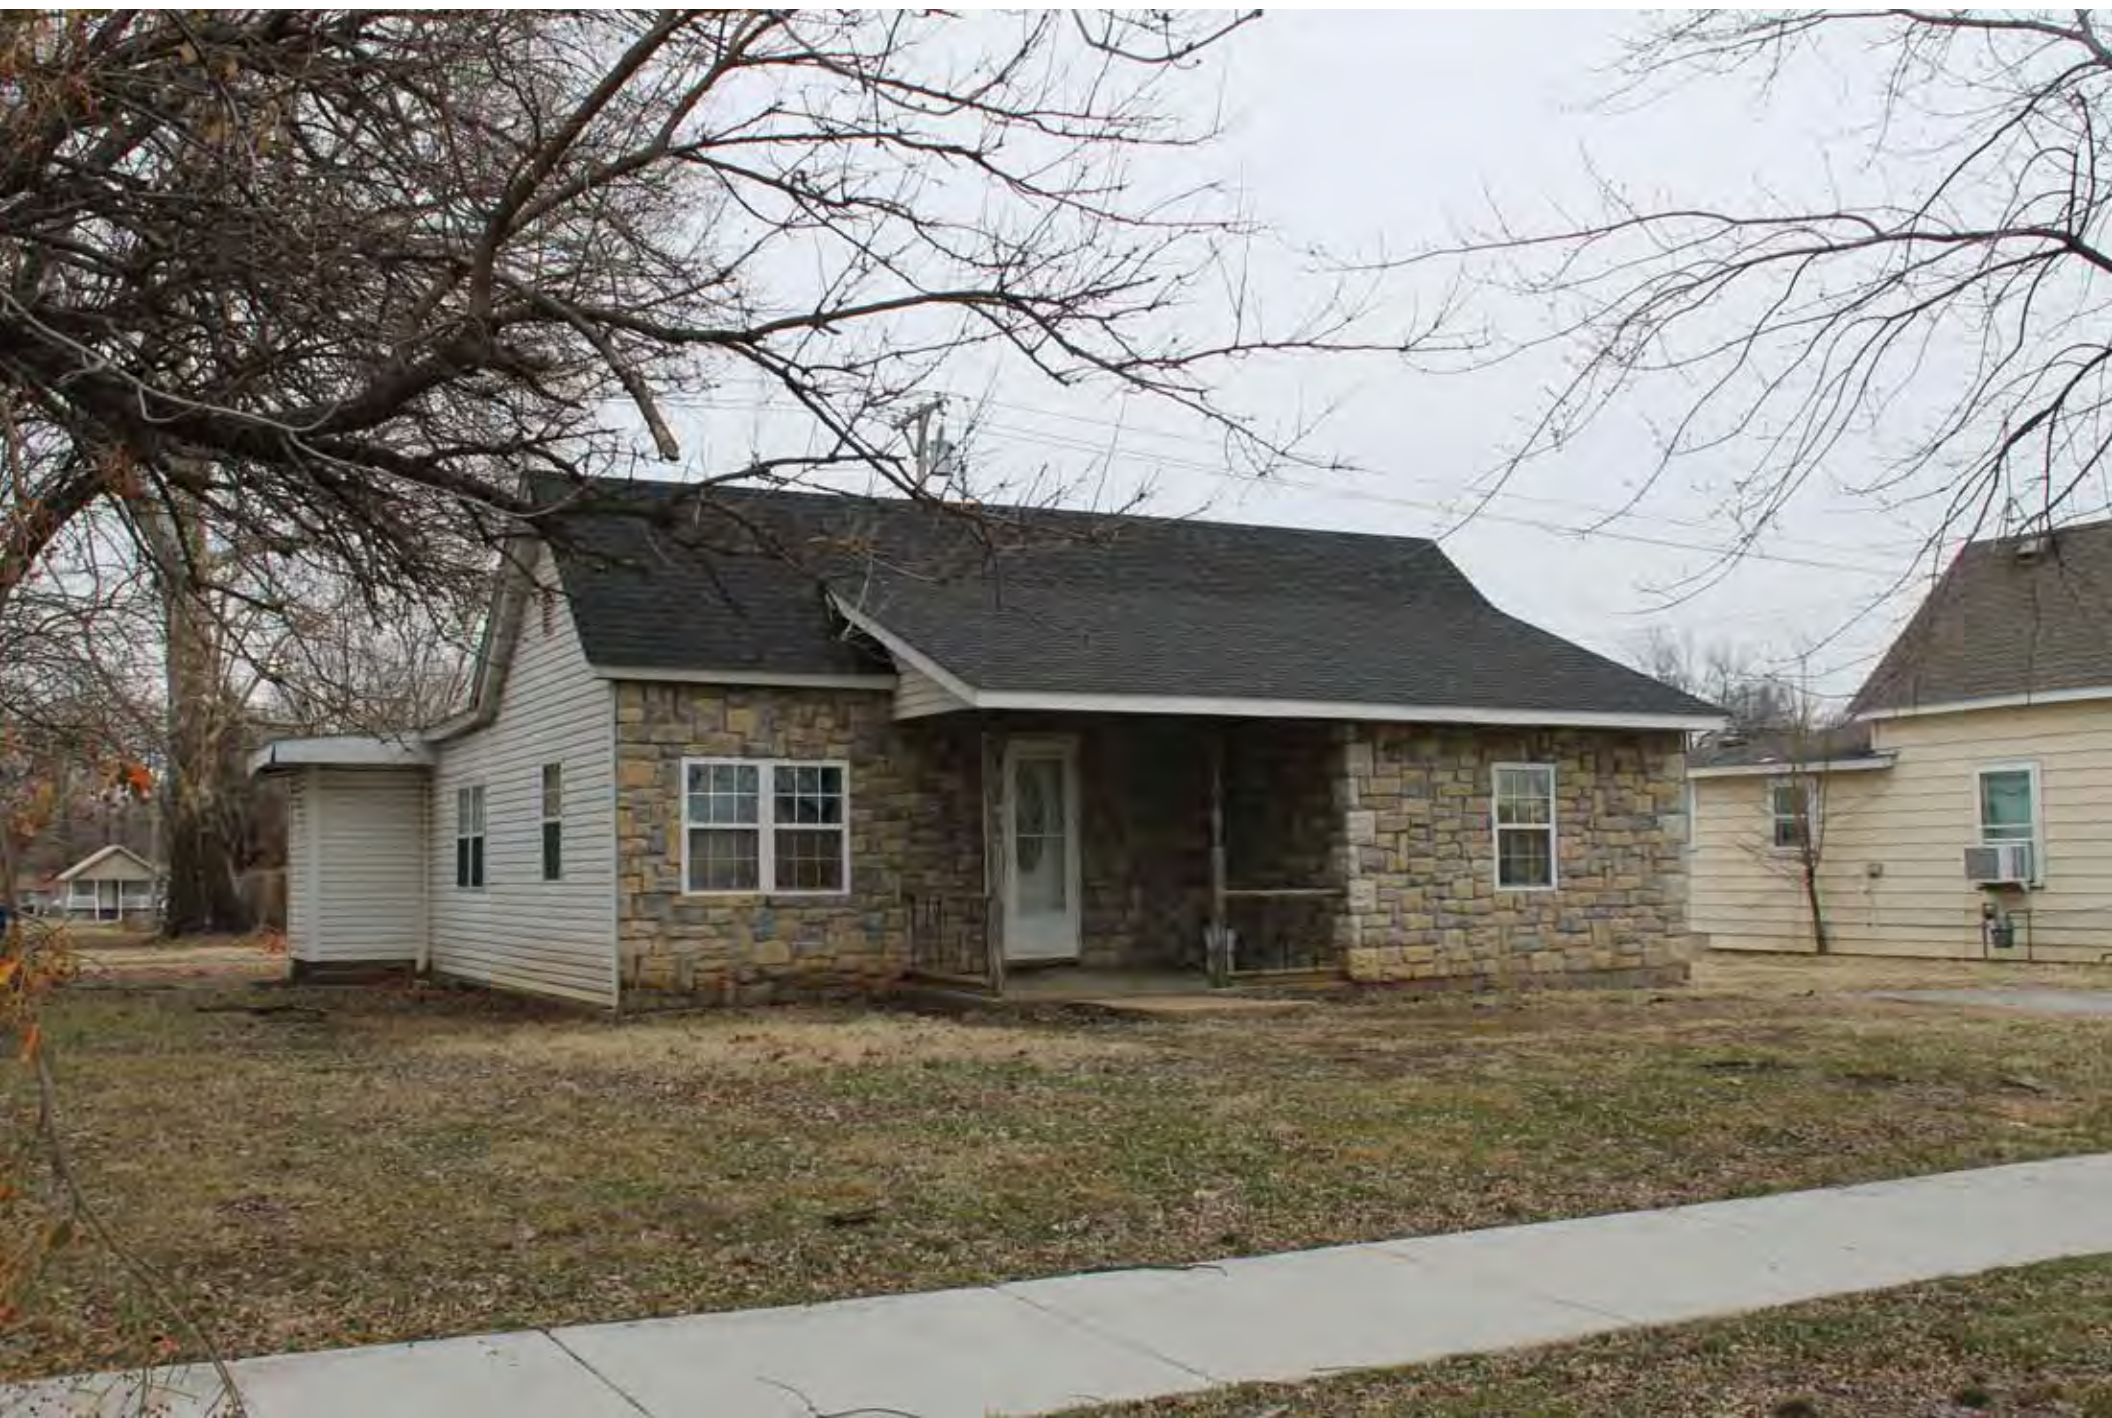
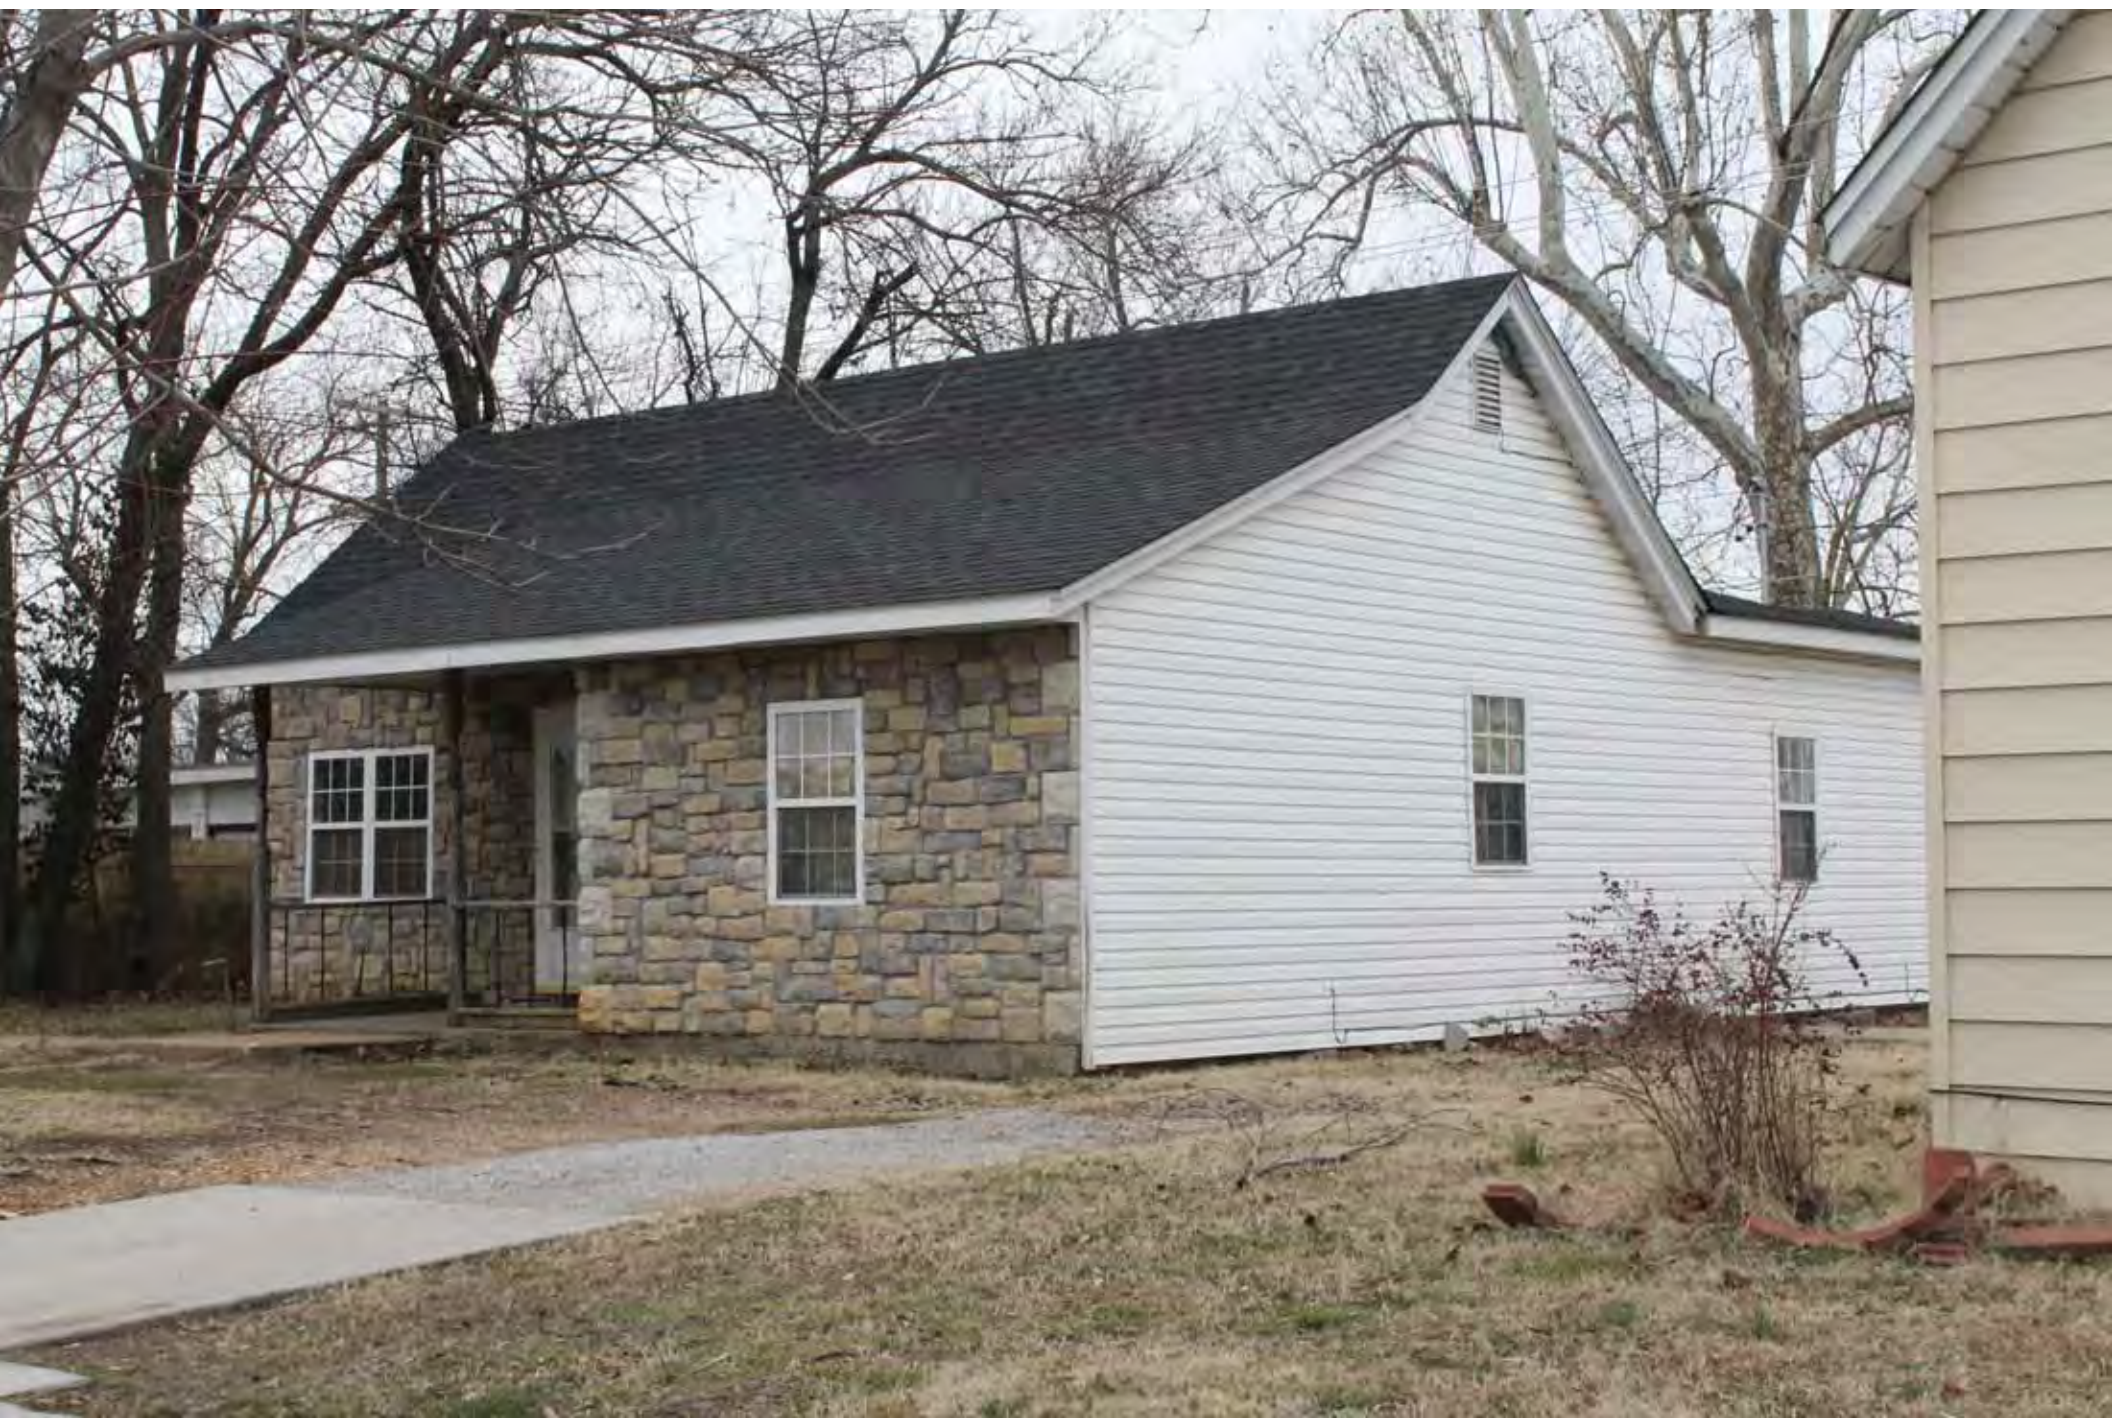
This dwelling has been altered through the addition of c. 2018 exterior siding (stone and vinyl) and replacement of original windows. Due to the lack of exterior original siding and significant window modifications, the dwelling does not retain integrity that would render it individually eligible for the National Register of Historic Places. The dwelling is not situated in an area recommended as a historic district.

The property 1115 E. Central Street features a single-story, end-gable plan dwelling. The primary (south) elevation is clad with stone. Remaining elevations are clad with vinyl siding. The roof is clad with asphalt shingles. Most of the foundation is concrete though limestone is visible at the south end of the house. A wing projects at the east end of the façade. Immediately west of the projecting shed wing is a porch supported by milled c. 2018 columns. A contemporary balustrade surrounds the porch. Within the porch is a single door with a c. 2018 oval light door. Offsetting the entry bay to the west are paired six-over-six replacement windows. A similar set of windows is located on the south wall of the front east wing. Gable fields hold louvered vents. The dwelling has a rear shed wing.
