MISSOURI DEPARTMENT OF NATURAL RESOURCES
STATE HISTORIC PRESERVATION OFFICE, P.O. Box 176, Jefferson City, MO 65102
ARCHITECTURAL/HISTORIC INVENTORY FORM

1. Survey No. JP-AS-007-001		2. Survey name: East Town (Original Joplin) Historic Survey Phase 2	
3. County: JASPER		4. Address (Street No.) 618	Street (name) E. 2 nd Street
5. City: Joplin	Vicinity: <input type="checkbox"/>	6. Geographical Reference:	7. Township/Range/Section: T: R: S:
8. Historic name (if known):		9. Present/other name (if known):	
10. Ownership: <input checked="" type="checkbox"/> Private <input type="checkbox"/> Public		11a. Historic use (if known): Domestic: Single Dwelling	11b. Current use: Domestic: Single Dwelling

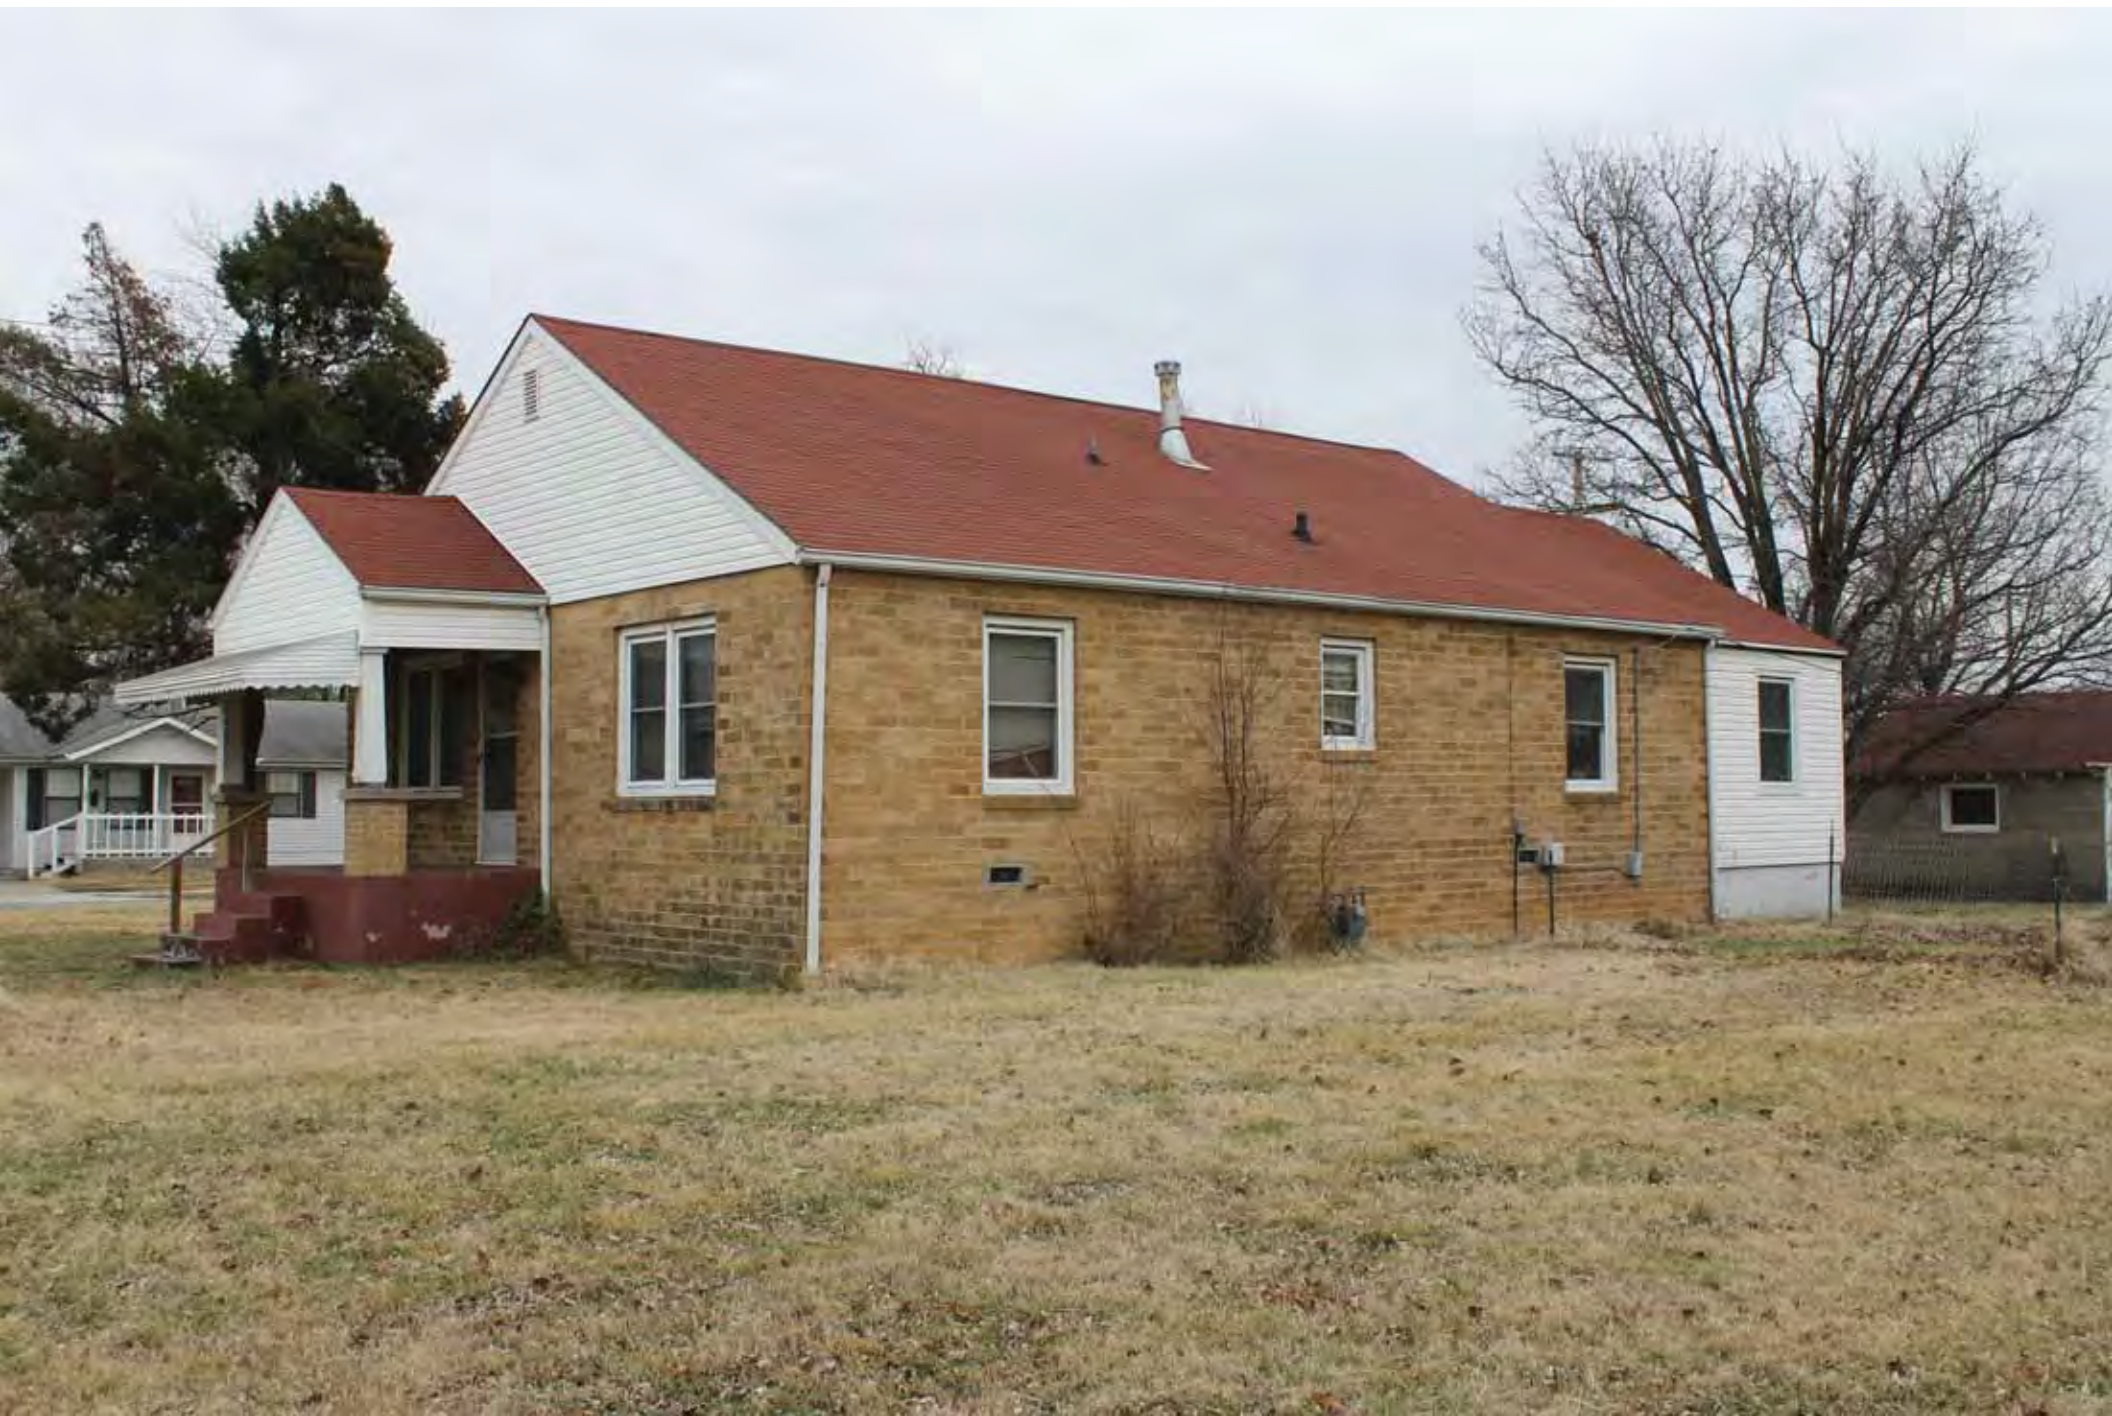
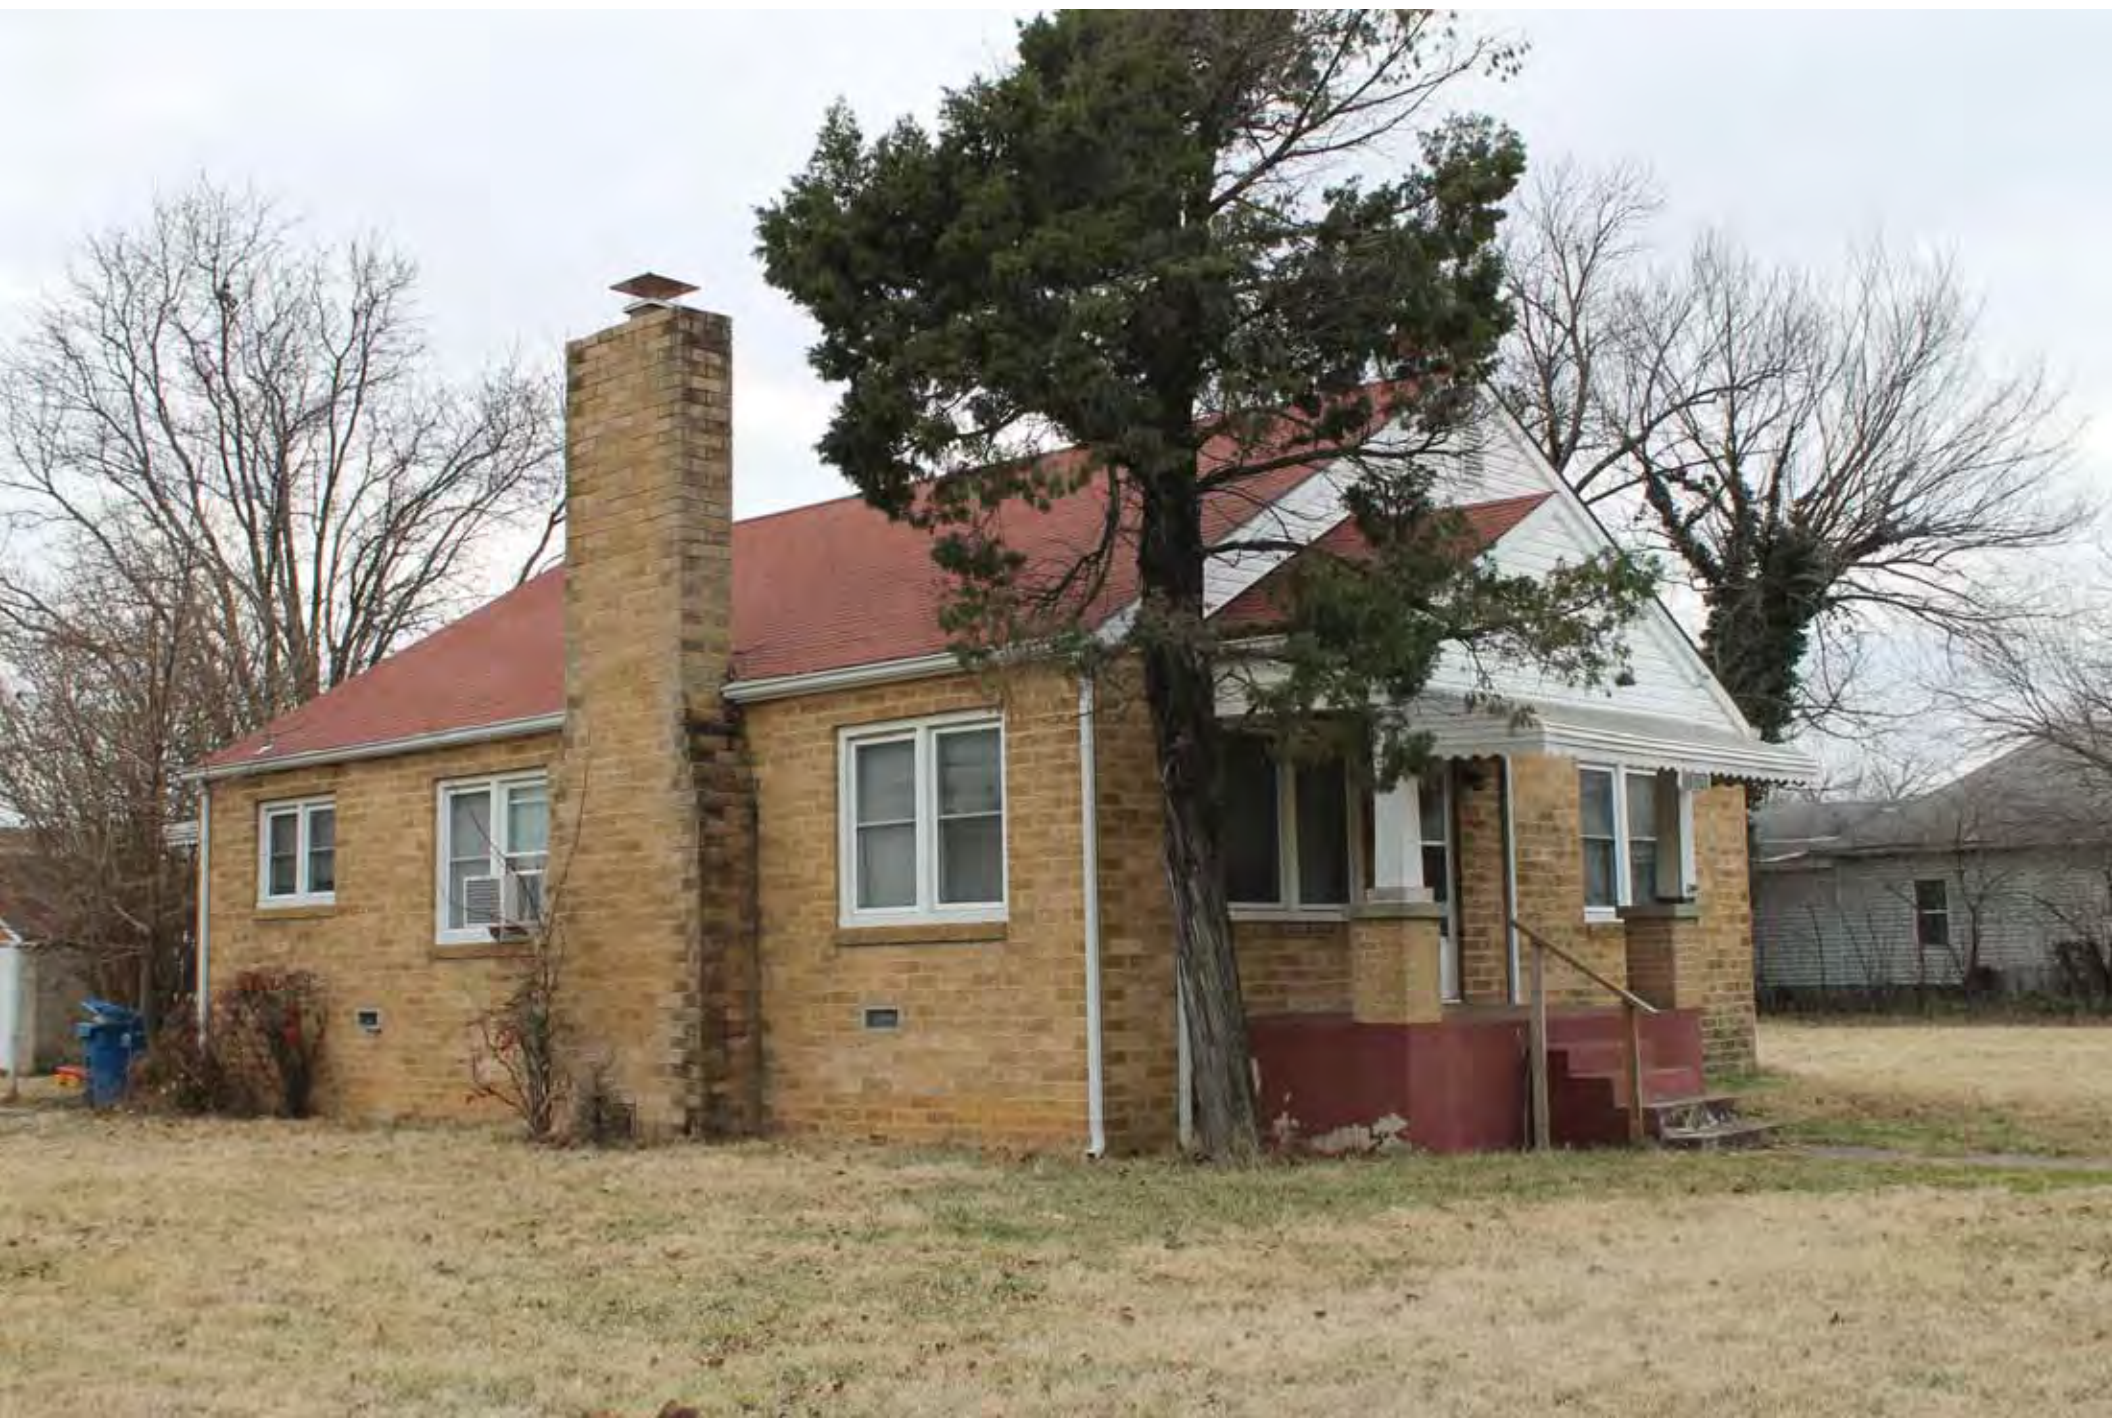
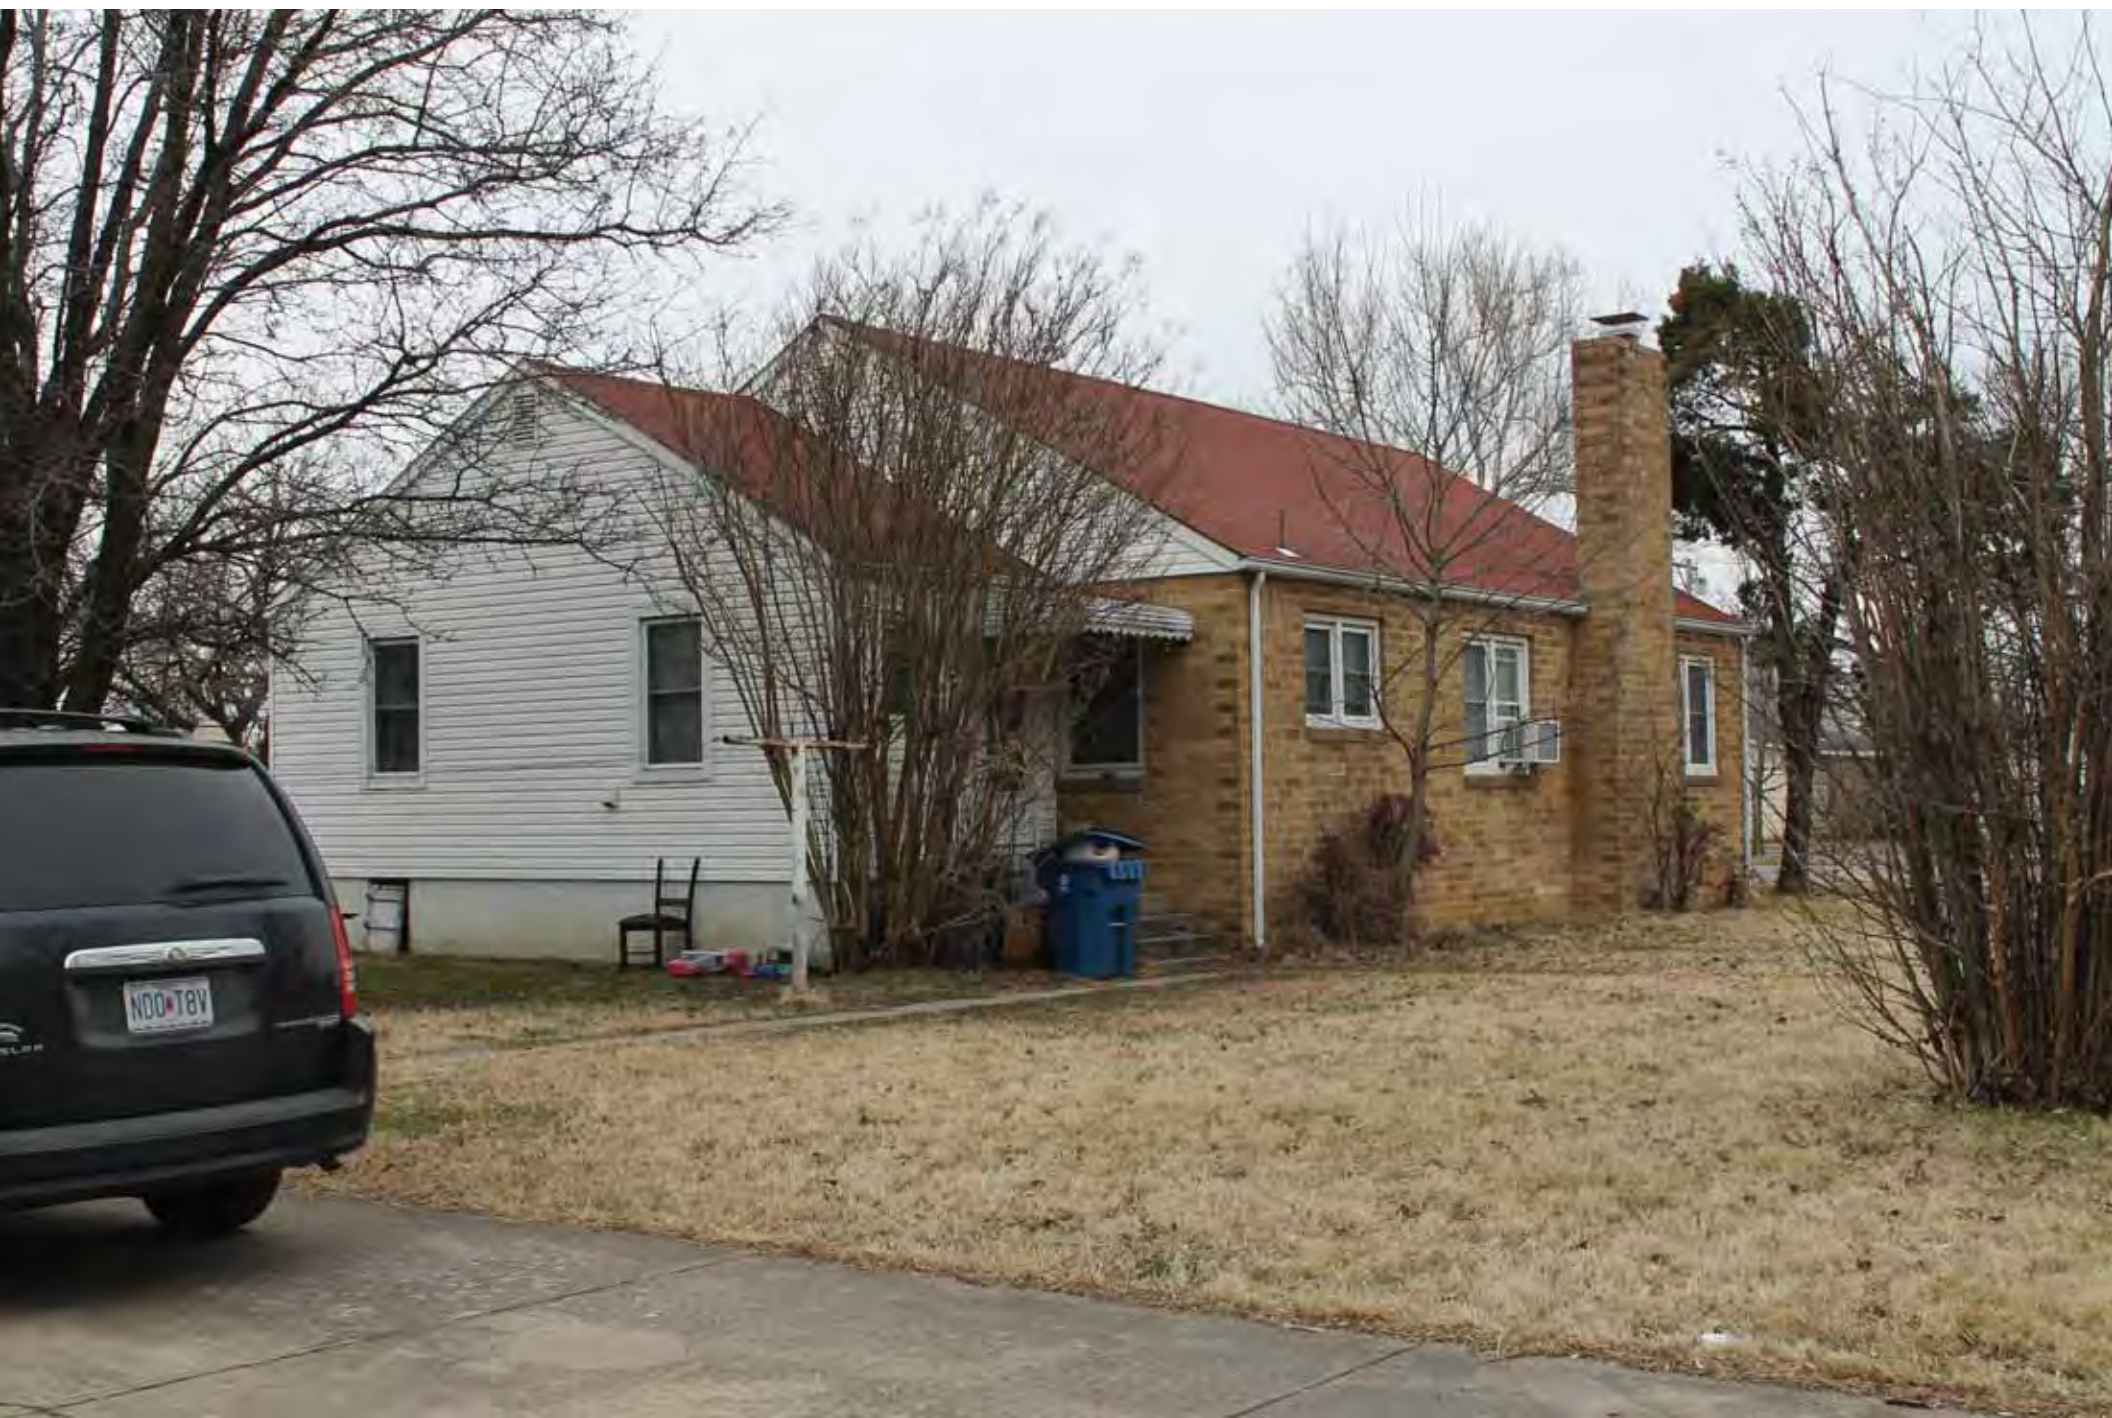
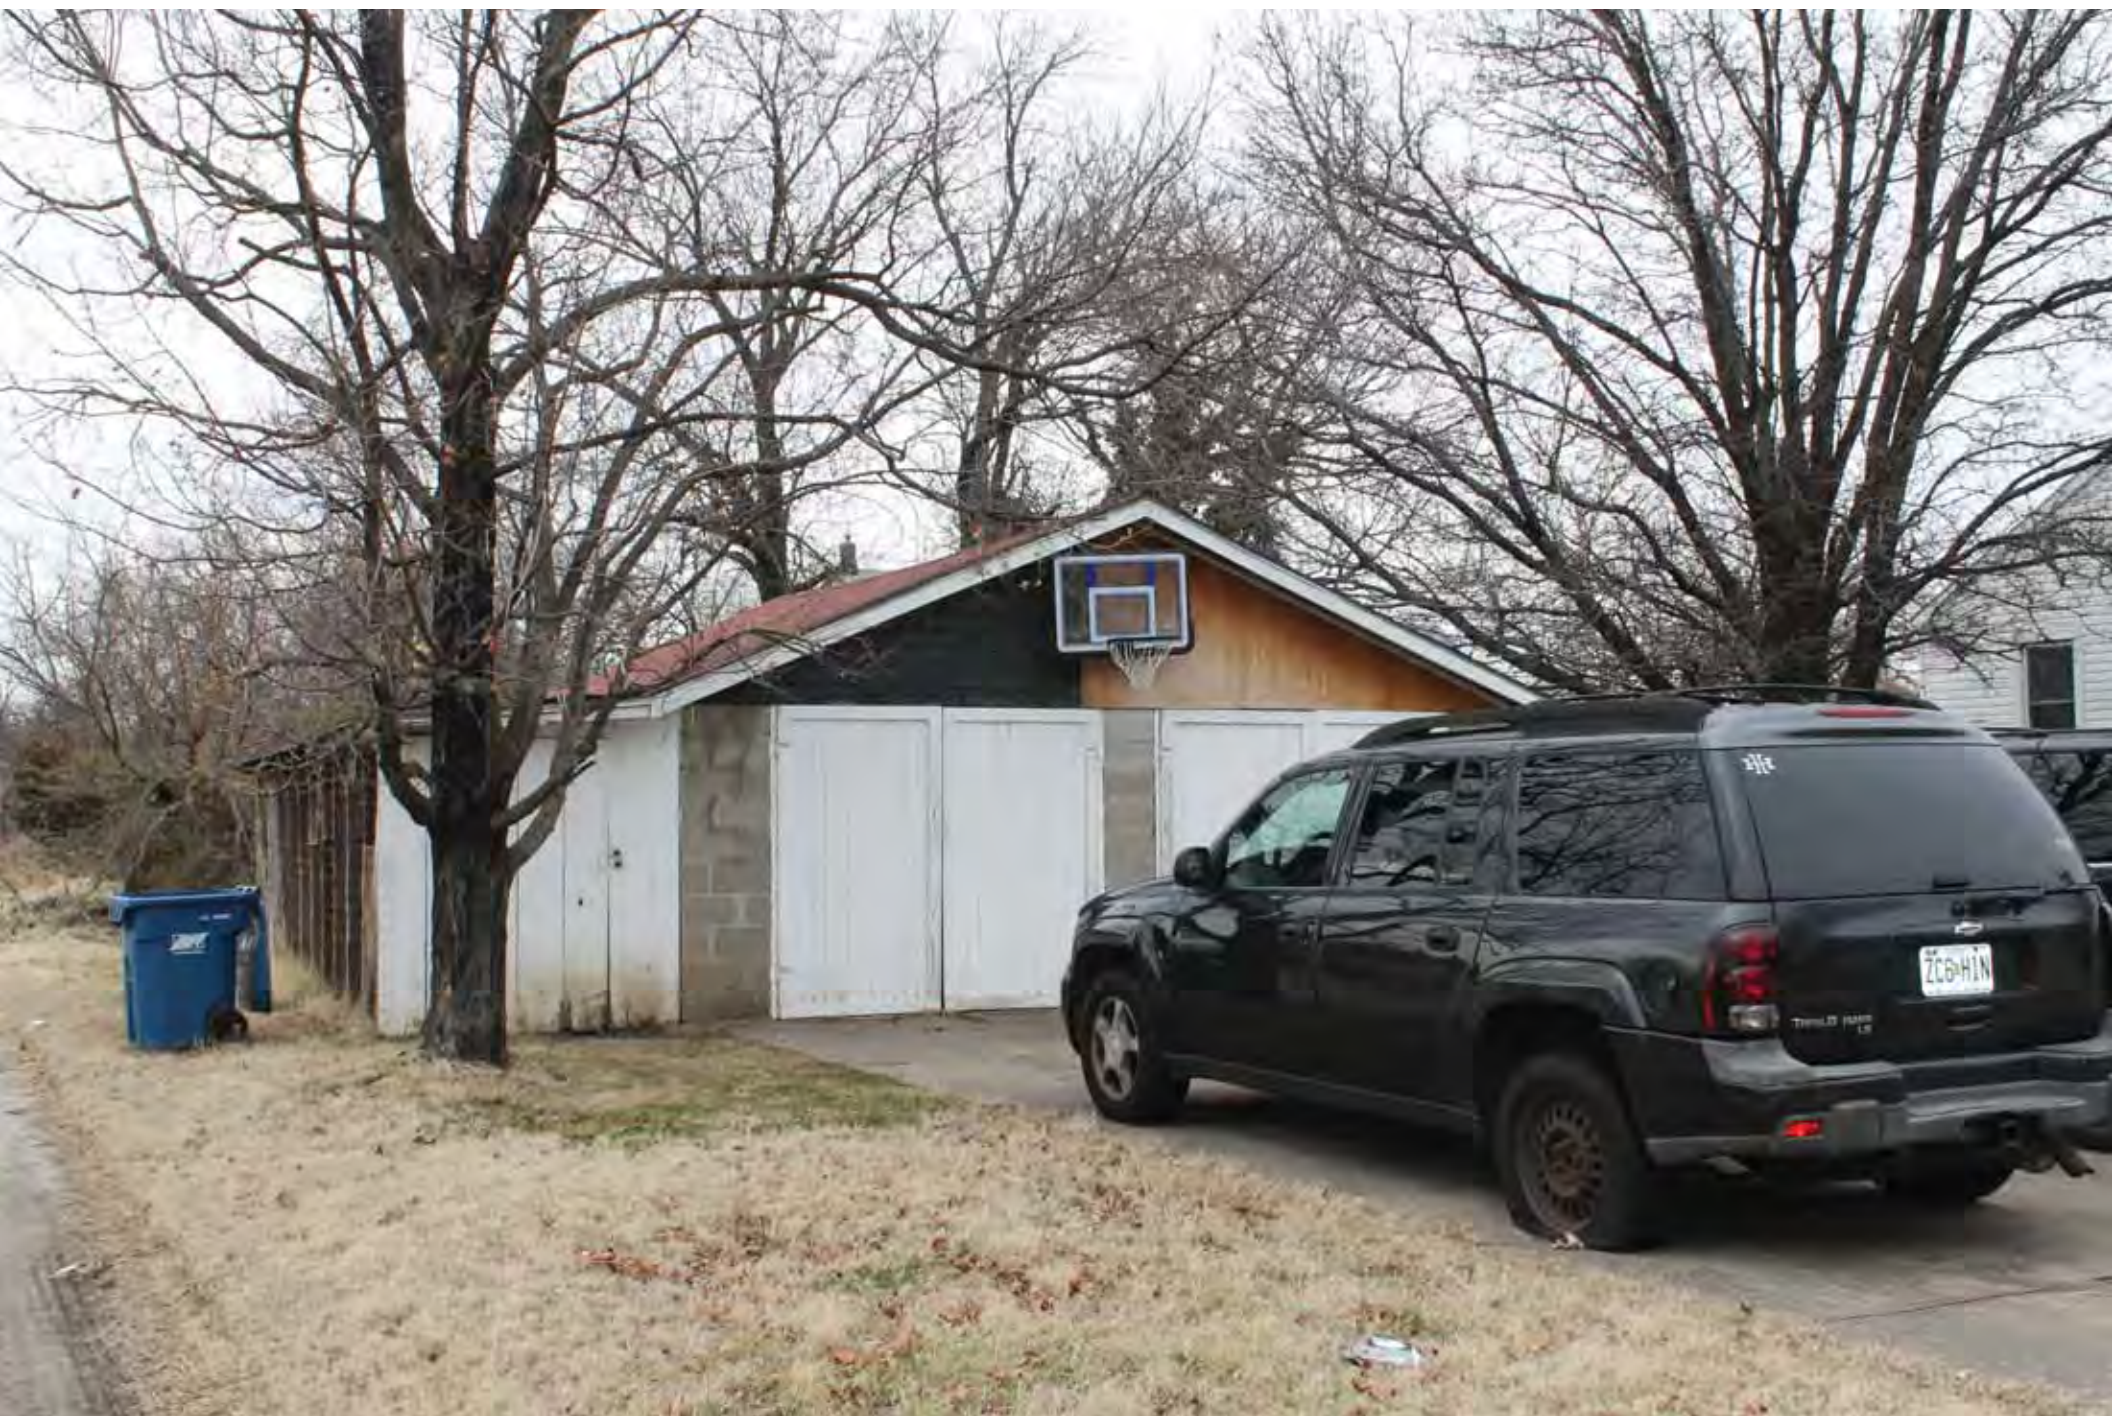
The property at 1118 E. Central Street features a single-story dwelling with a front gabled asphalt shingled roof and exterior blonde brick walls. On the primary (north) elevation is an off-center gabled porch supported by tapered piers on blonde brick posts. The porch has a concrete base. Above the porch steps is a metal shed awning. Within the porch bay is the primary entry. The door is flanked by paired double-hung windows. An exterior brick chimney is situated on the east elevation, also flanked by paired windows. Windows have original brick sills. The dwelling has a rear gabled small wing clad with vinyl siding.

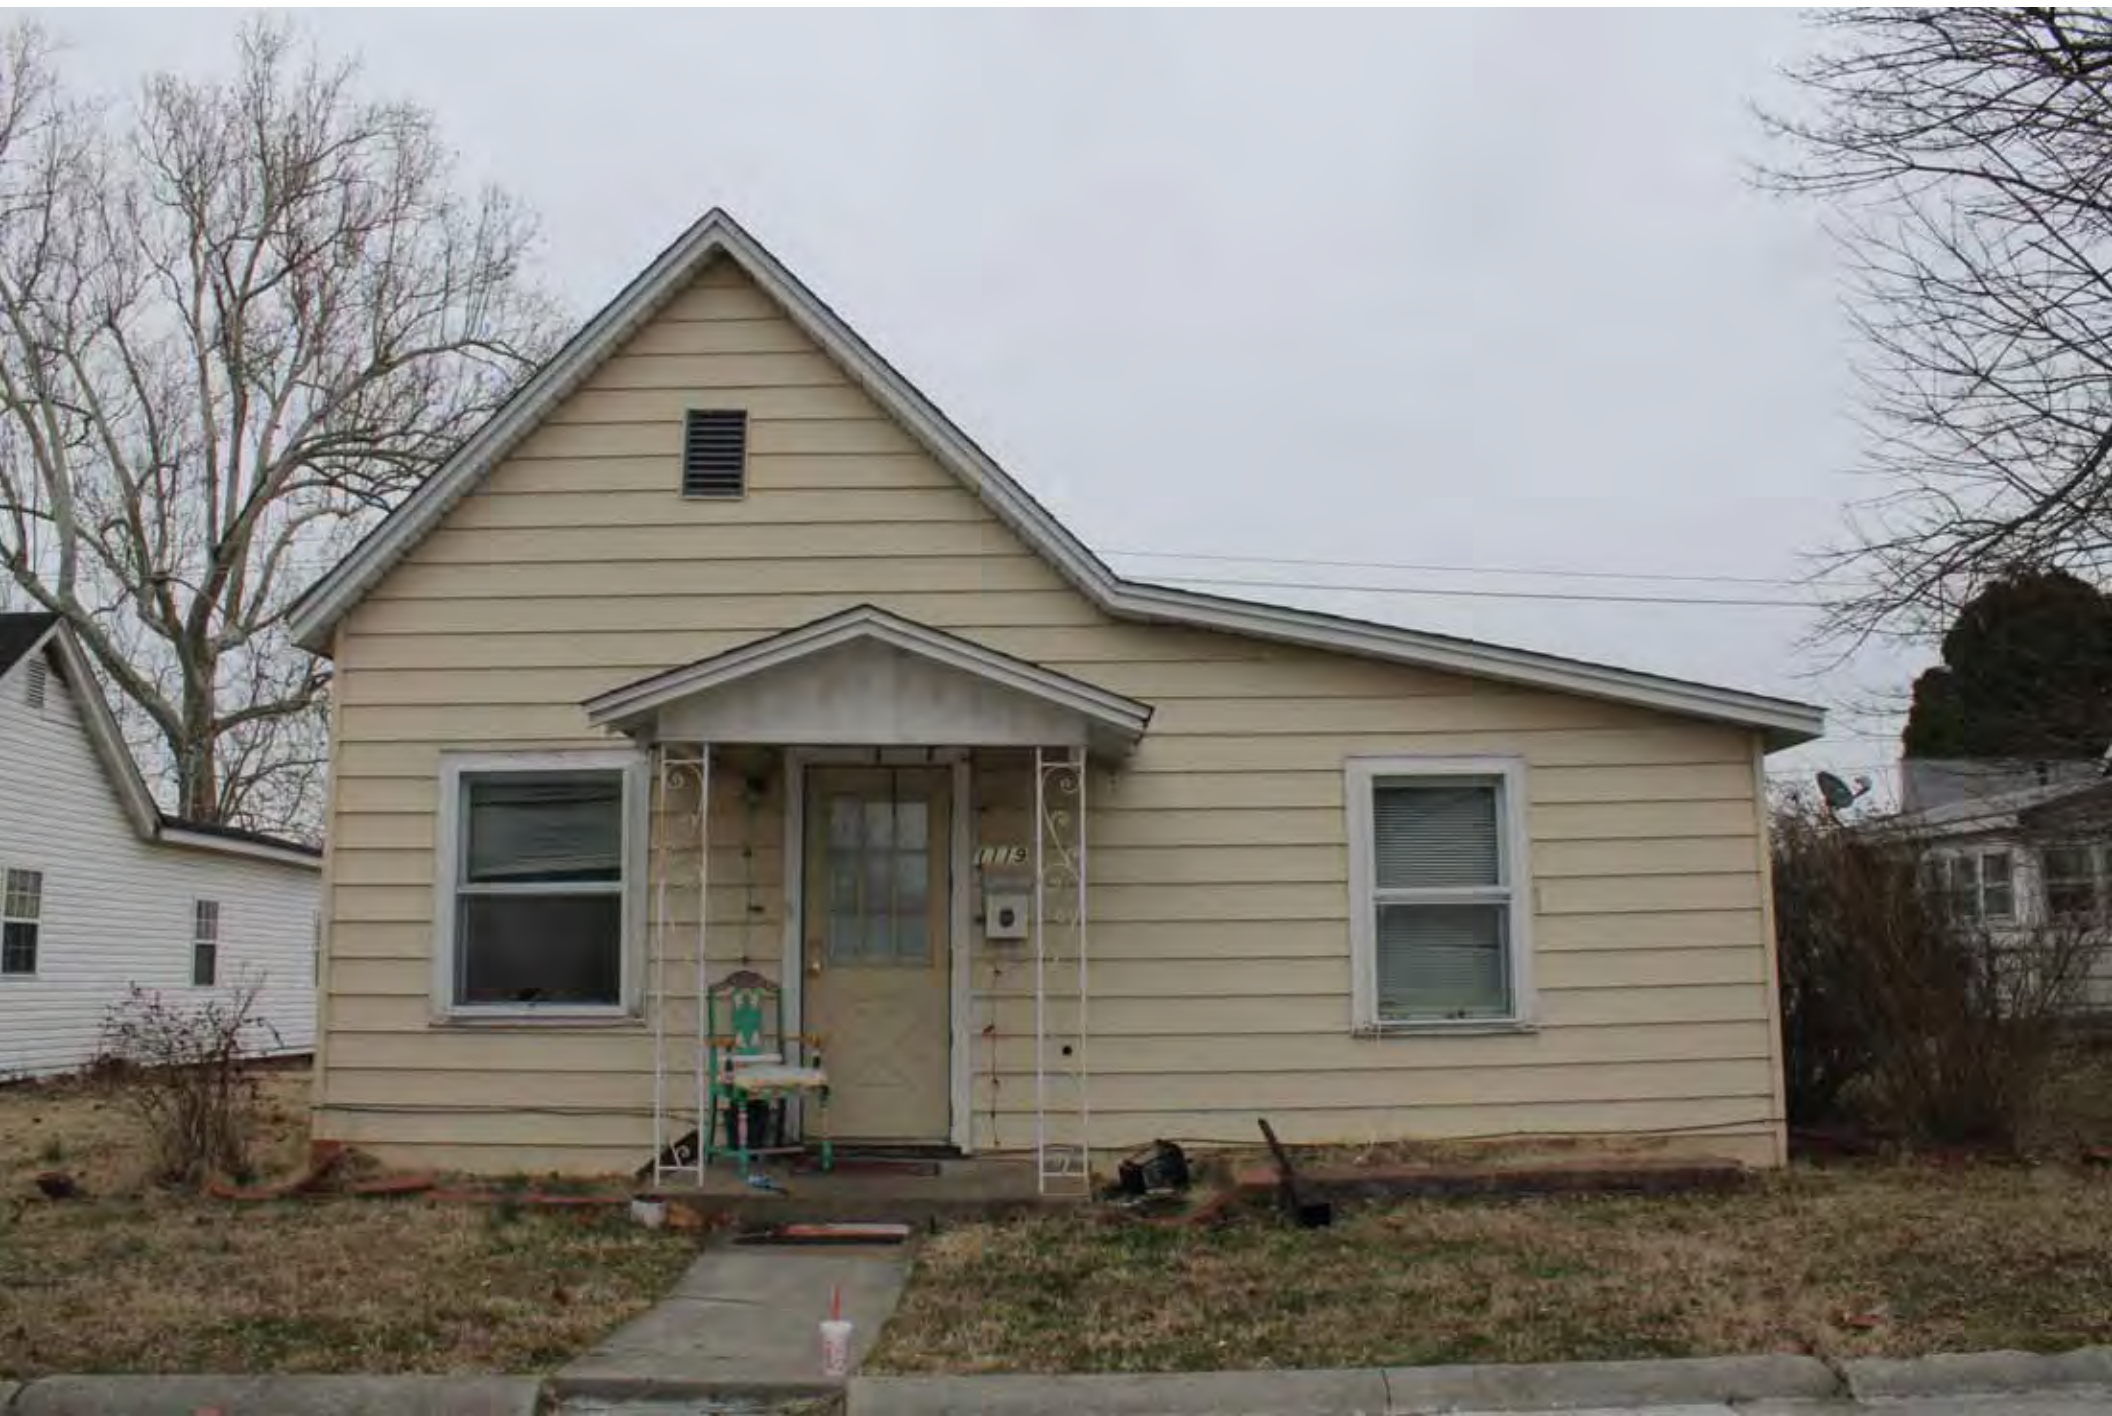
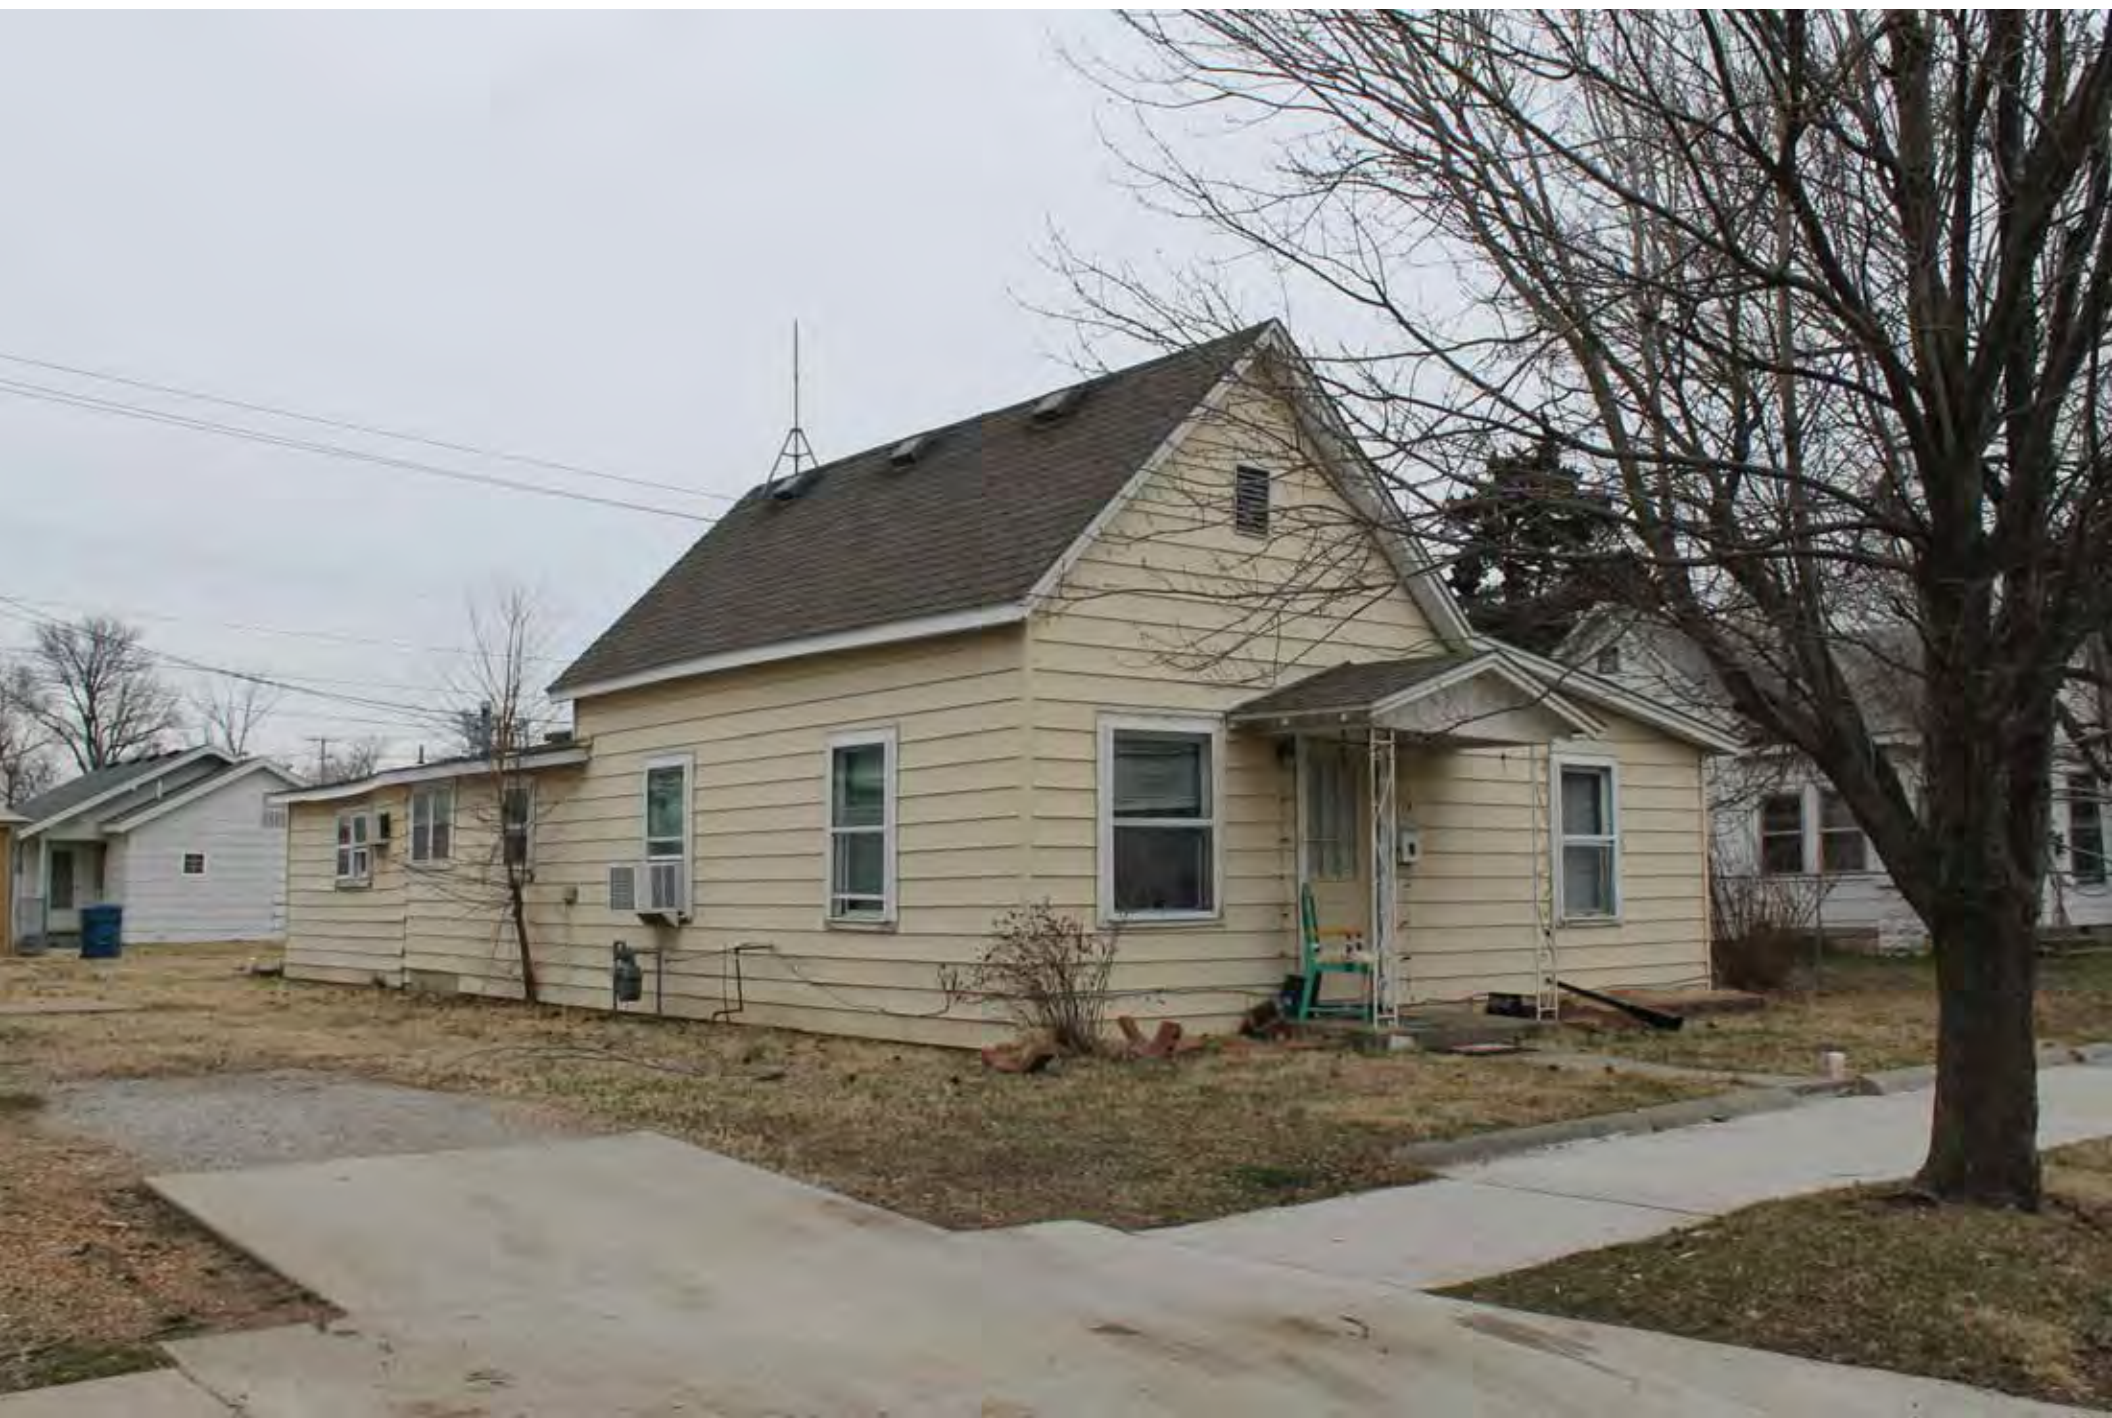
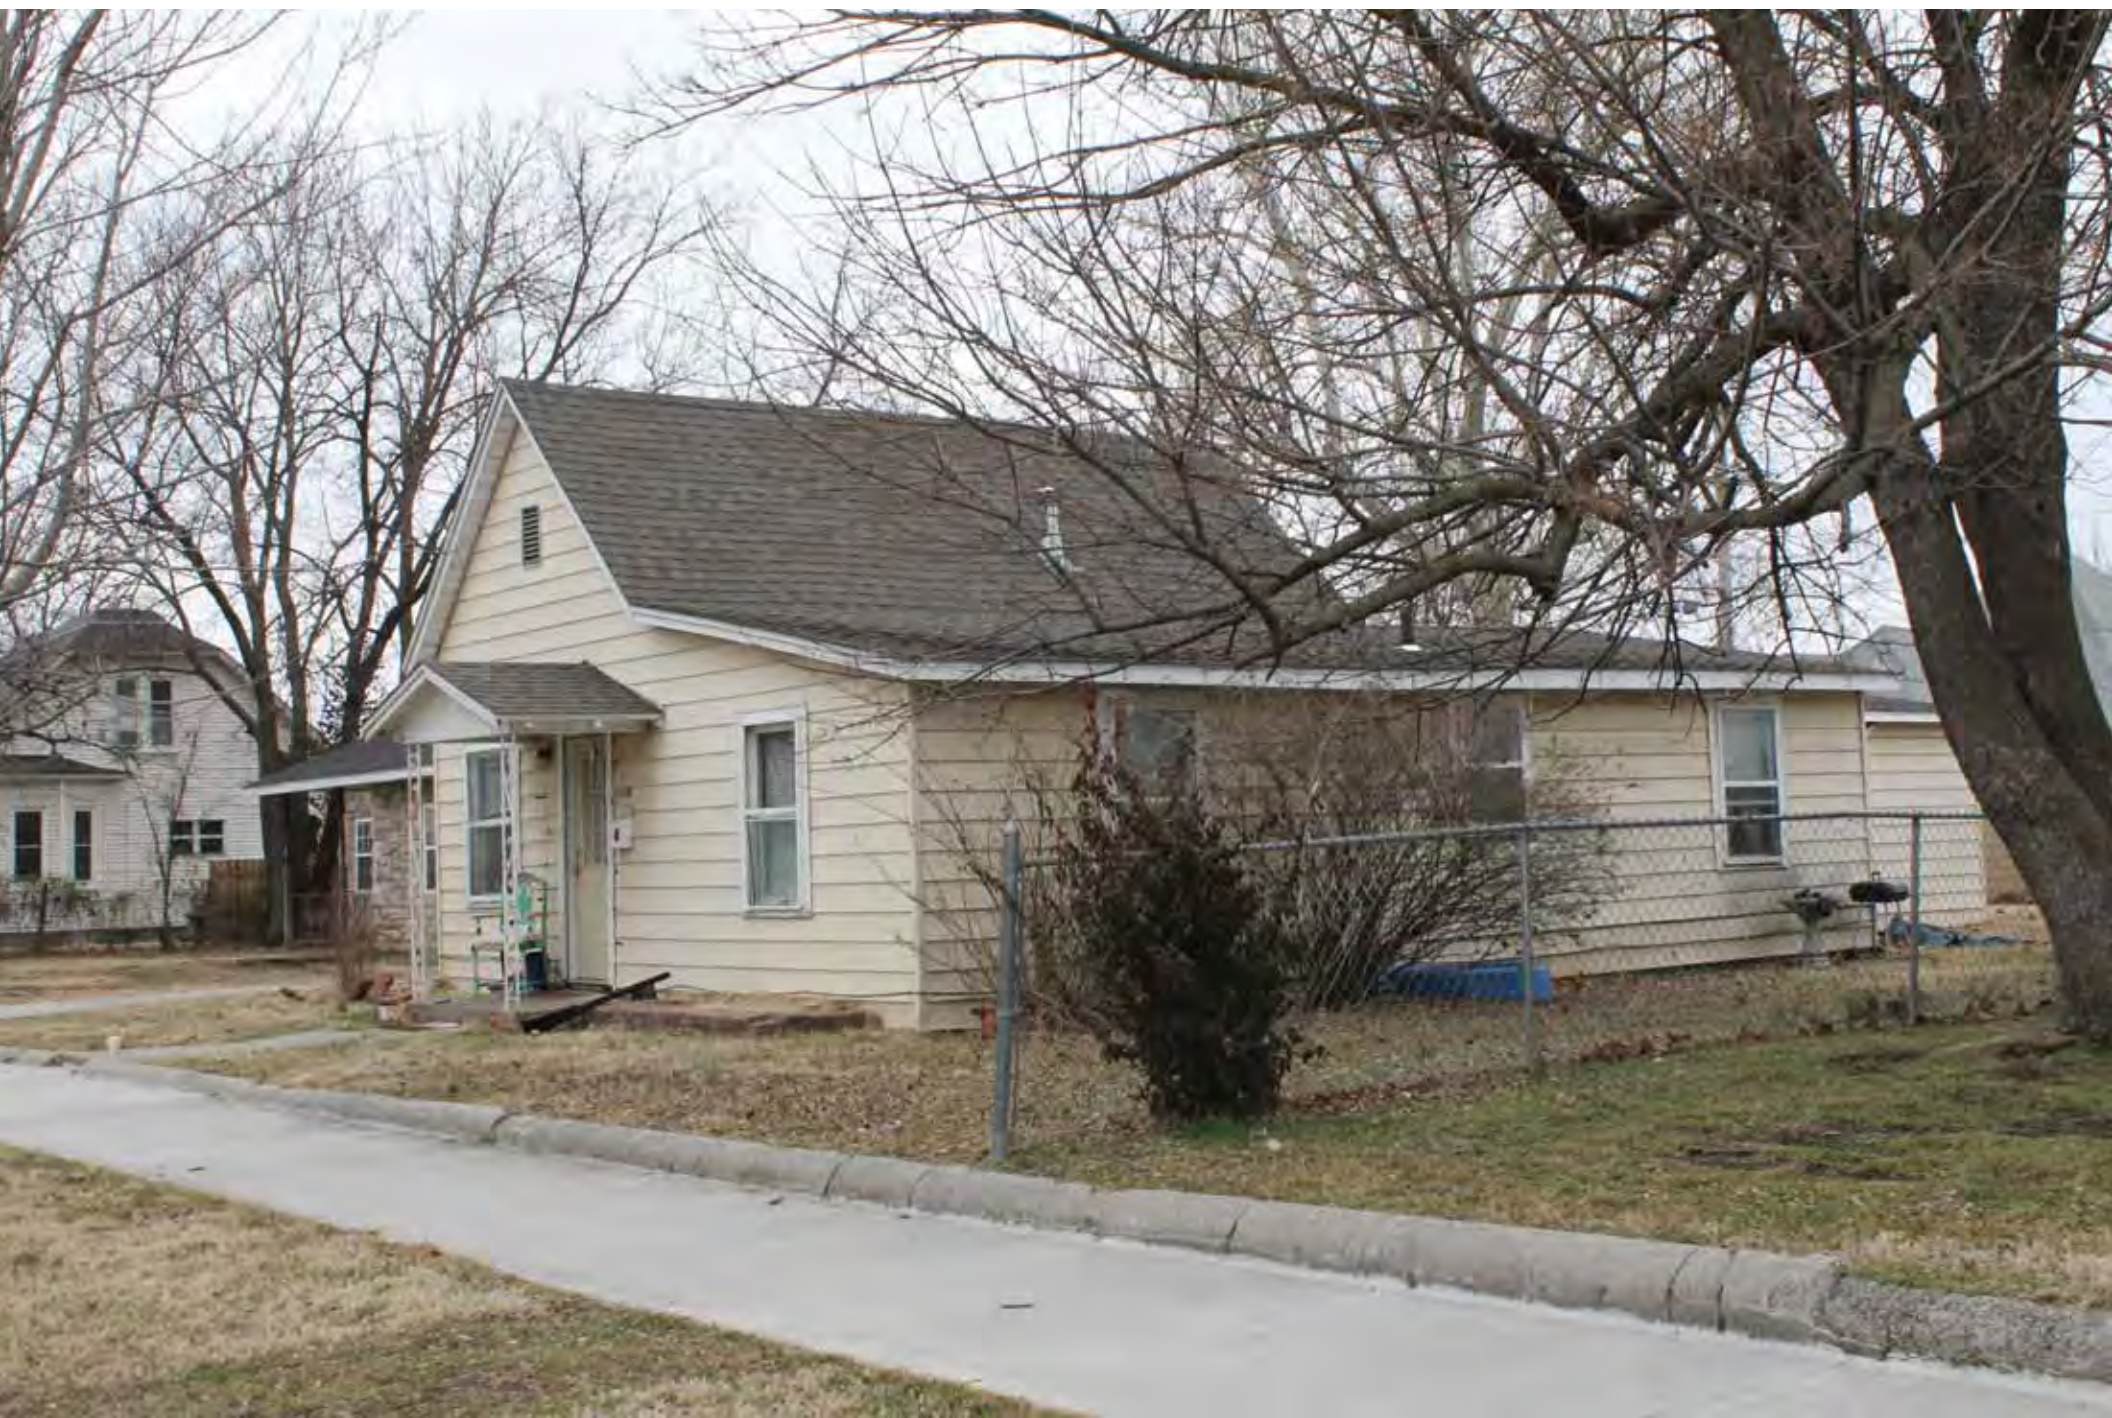
The property at 1119 E. Central Street features a single-story dwelling with a front gabled asphalt shingled roof and exterior vinyl siding. The house has an east shed wing and two rear (south) shed wings (unknown dates of construction). The primary (south) elevation holds a gabled portico supported by wrought iron columns resting on a concrete pad. Within the portico bay is an original 9-light paneled door. The portico is flanked by single one-over-one windows. The front gable has a louvered vent. Paired and single windows are visible on the side (east and west) elevations. All windows are one-over-one.
