MISSOURI DEPARTMENT OF NATURAL RESOURCES
STATE HISTORIC PRESERVATION OFFICE, P.O. Box 176, Jefferson City, MO 65102
ARCHITECTURAL/HISTORIC INVENTORY FORM

1. Survey No. JP-AS-007-001		2. Survey name: East Town (Original Joplin) Historic Survey Phase 2	
3. County: JASPER		4. Address (Street No.) 618	Street (name) E. 2 nd Street
5. City: Joplin	Vicinity: <input type="checkbox"/>	6. Geographical Reference:	7. Township/Range/Section: T: R: S:
8. Historic name (if known):		9. Present/other name (if known):	
10. Ownership: <input checked="" type="checkbox"/> Private <input type="checkbox"/> Public		11a. Historic use (if known): Domestic: Single Dwelling	11b. Current use: Domestic: Single Dwelling

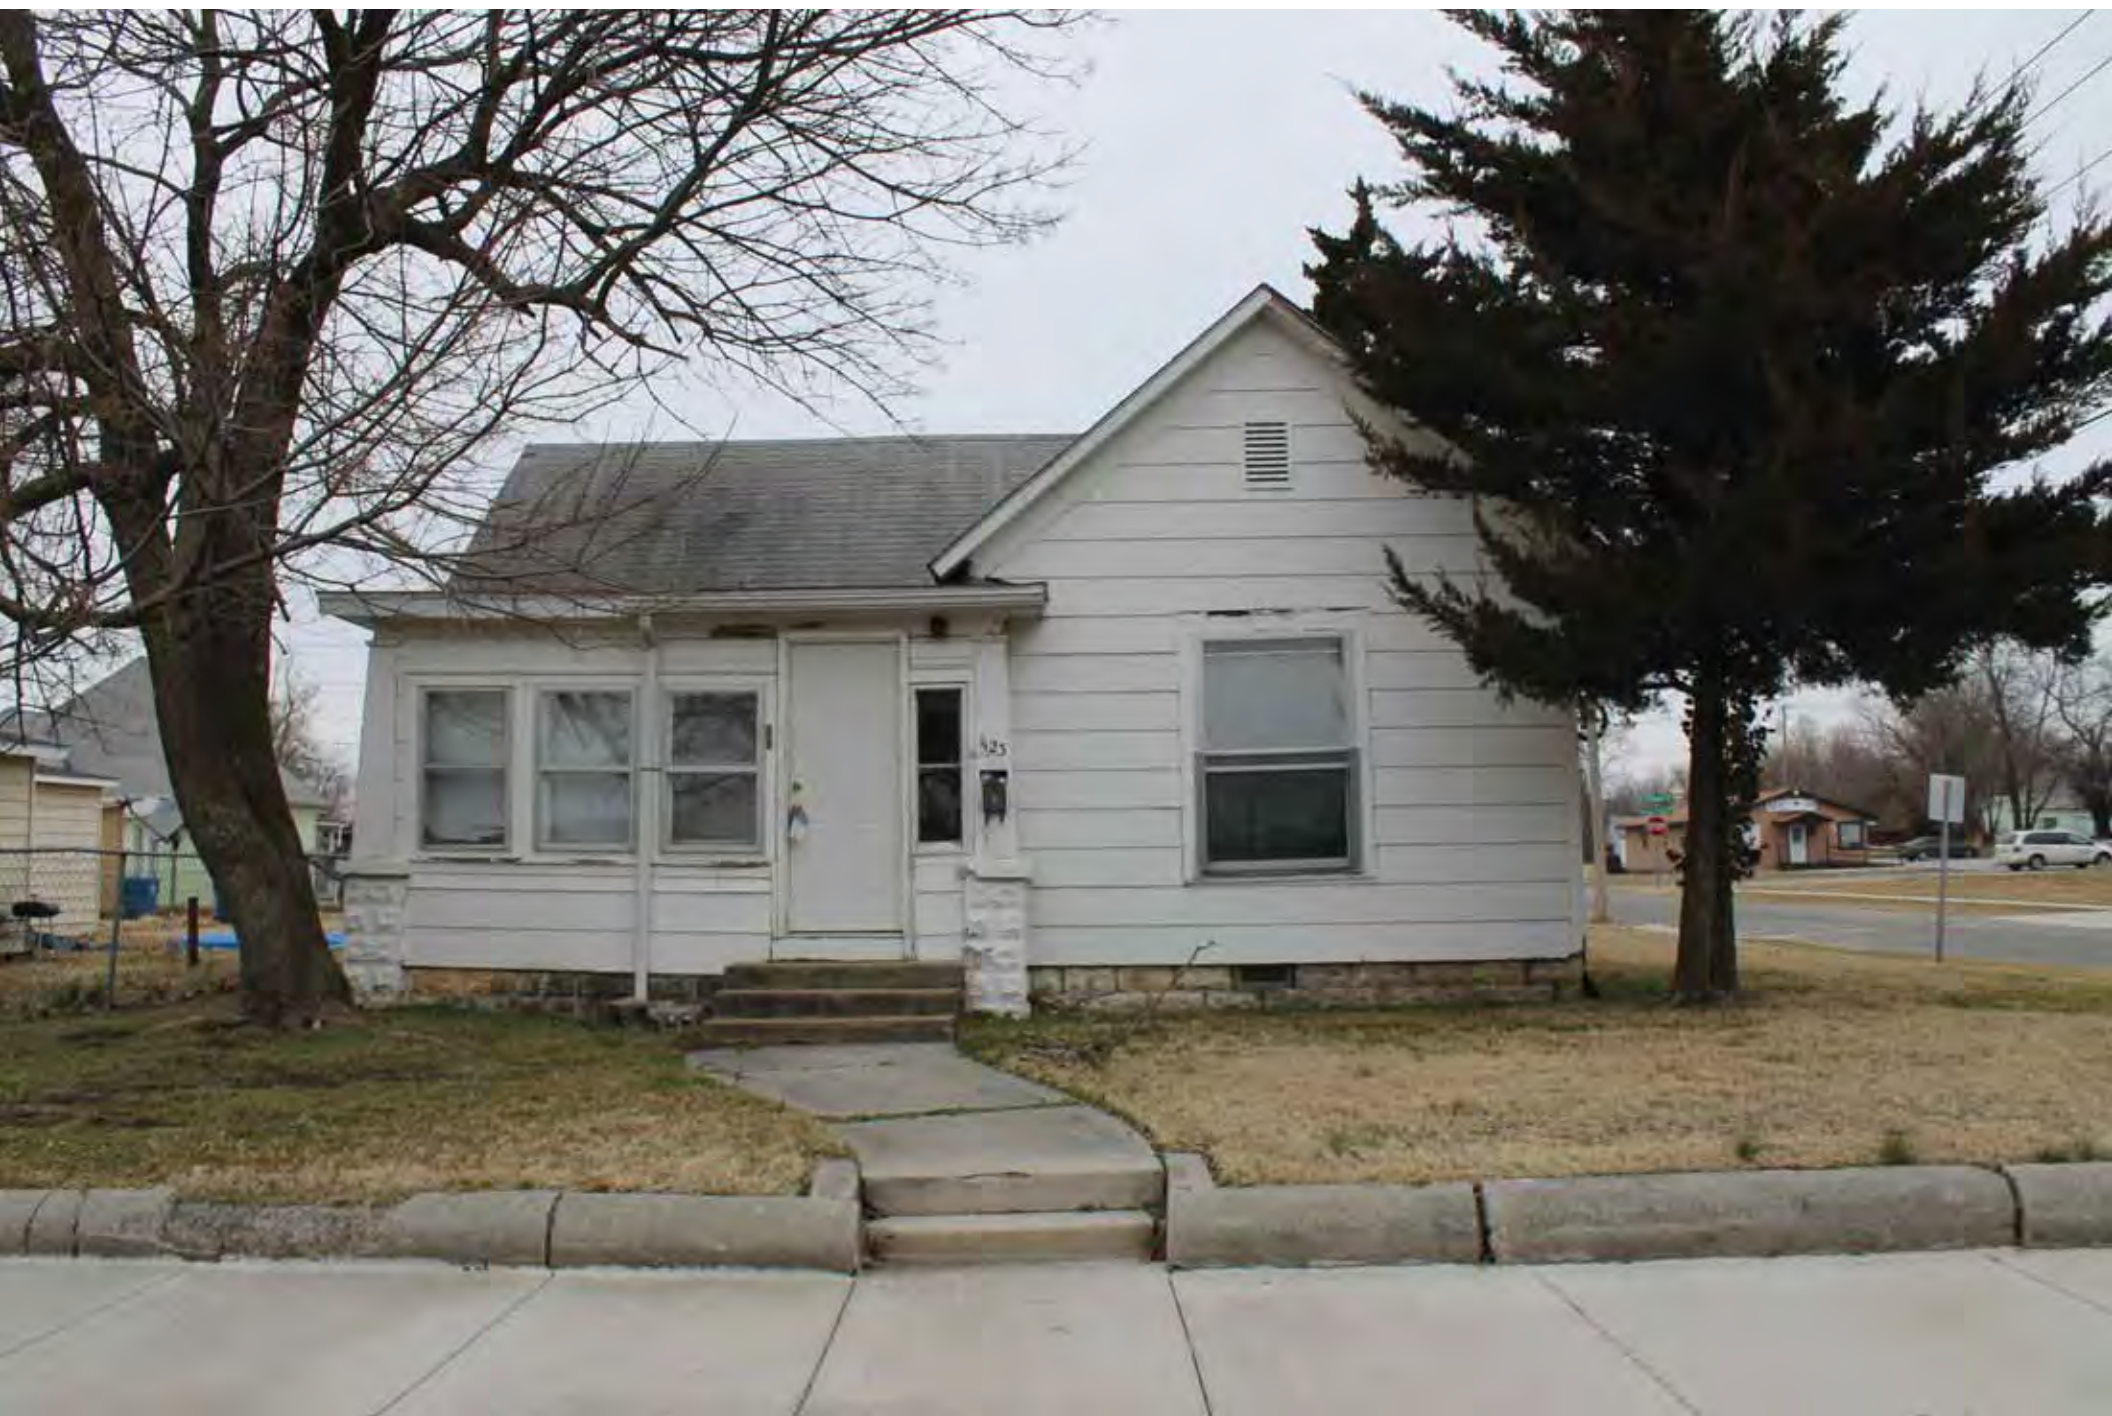
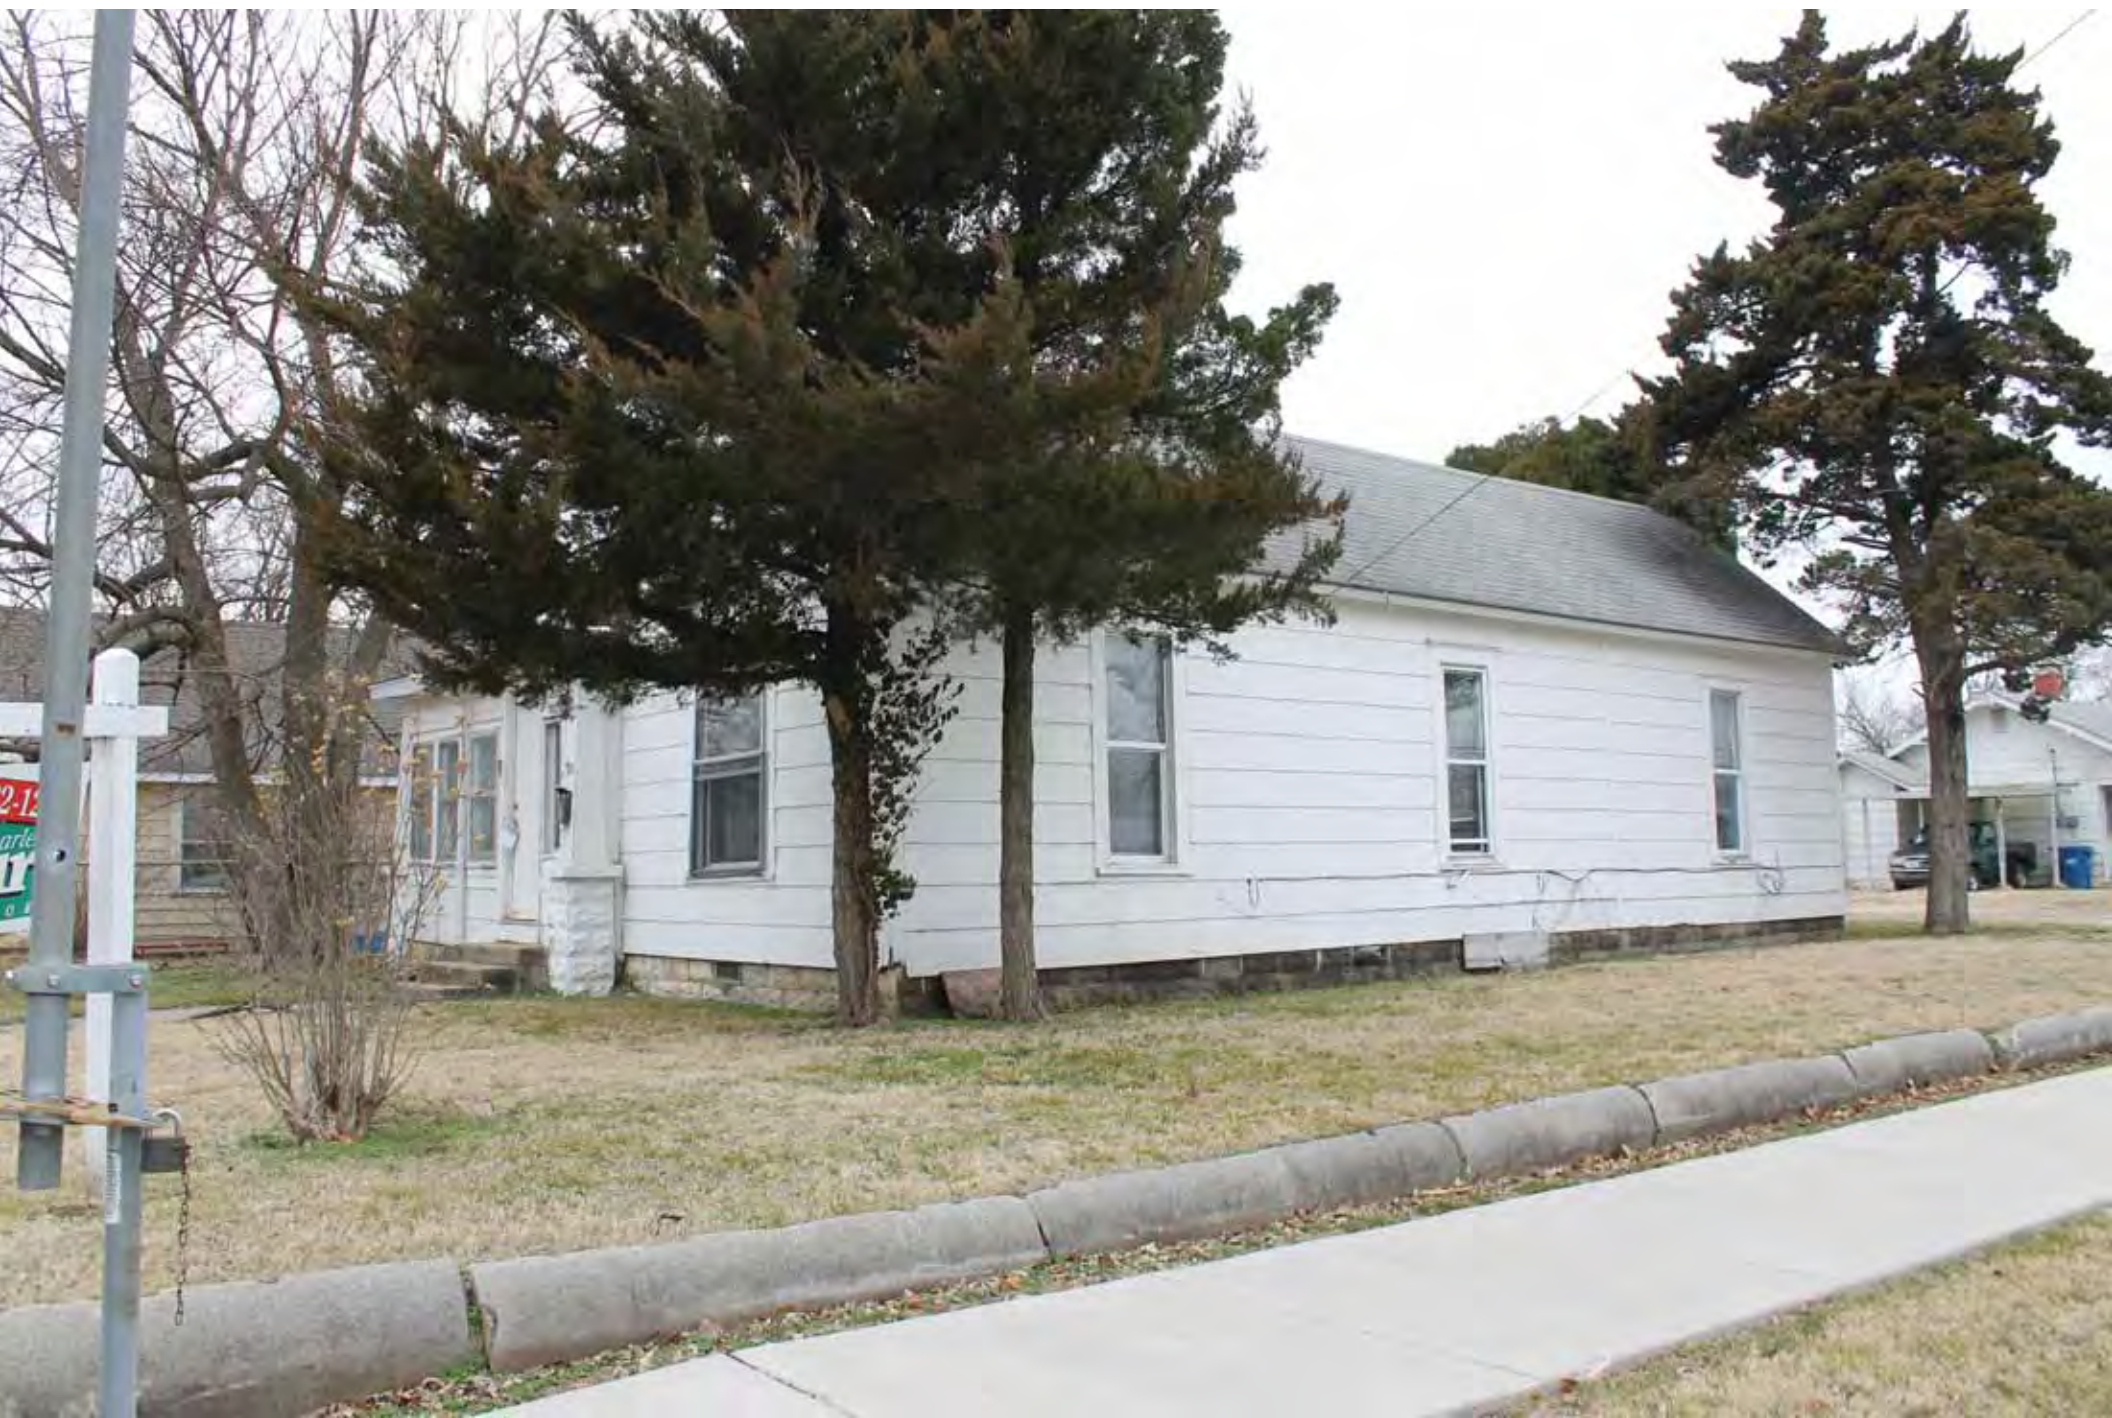
The property at 1104 E. Central Street features a single-story front-gable and wing plan dwelling. The house has a limestone foundation and exterior wide board siding that was likely added c. 1930 when the porch was enclosed. The enclosed porch area on the south elevation holds three one-over-one windows. Immediately east of the windows is a c. 2019 paneled door offset by a slender single-sash window. The front gable holds a wide one-over-one window. Intact original tapered columns on rusticated stone piers remain on either side of the enclosed porch. Side elevations retain one-over-one original windows. The front gable field holds a louvered vent.

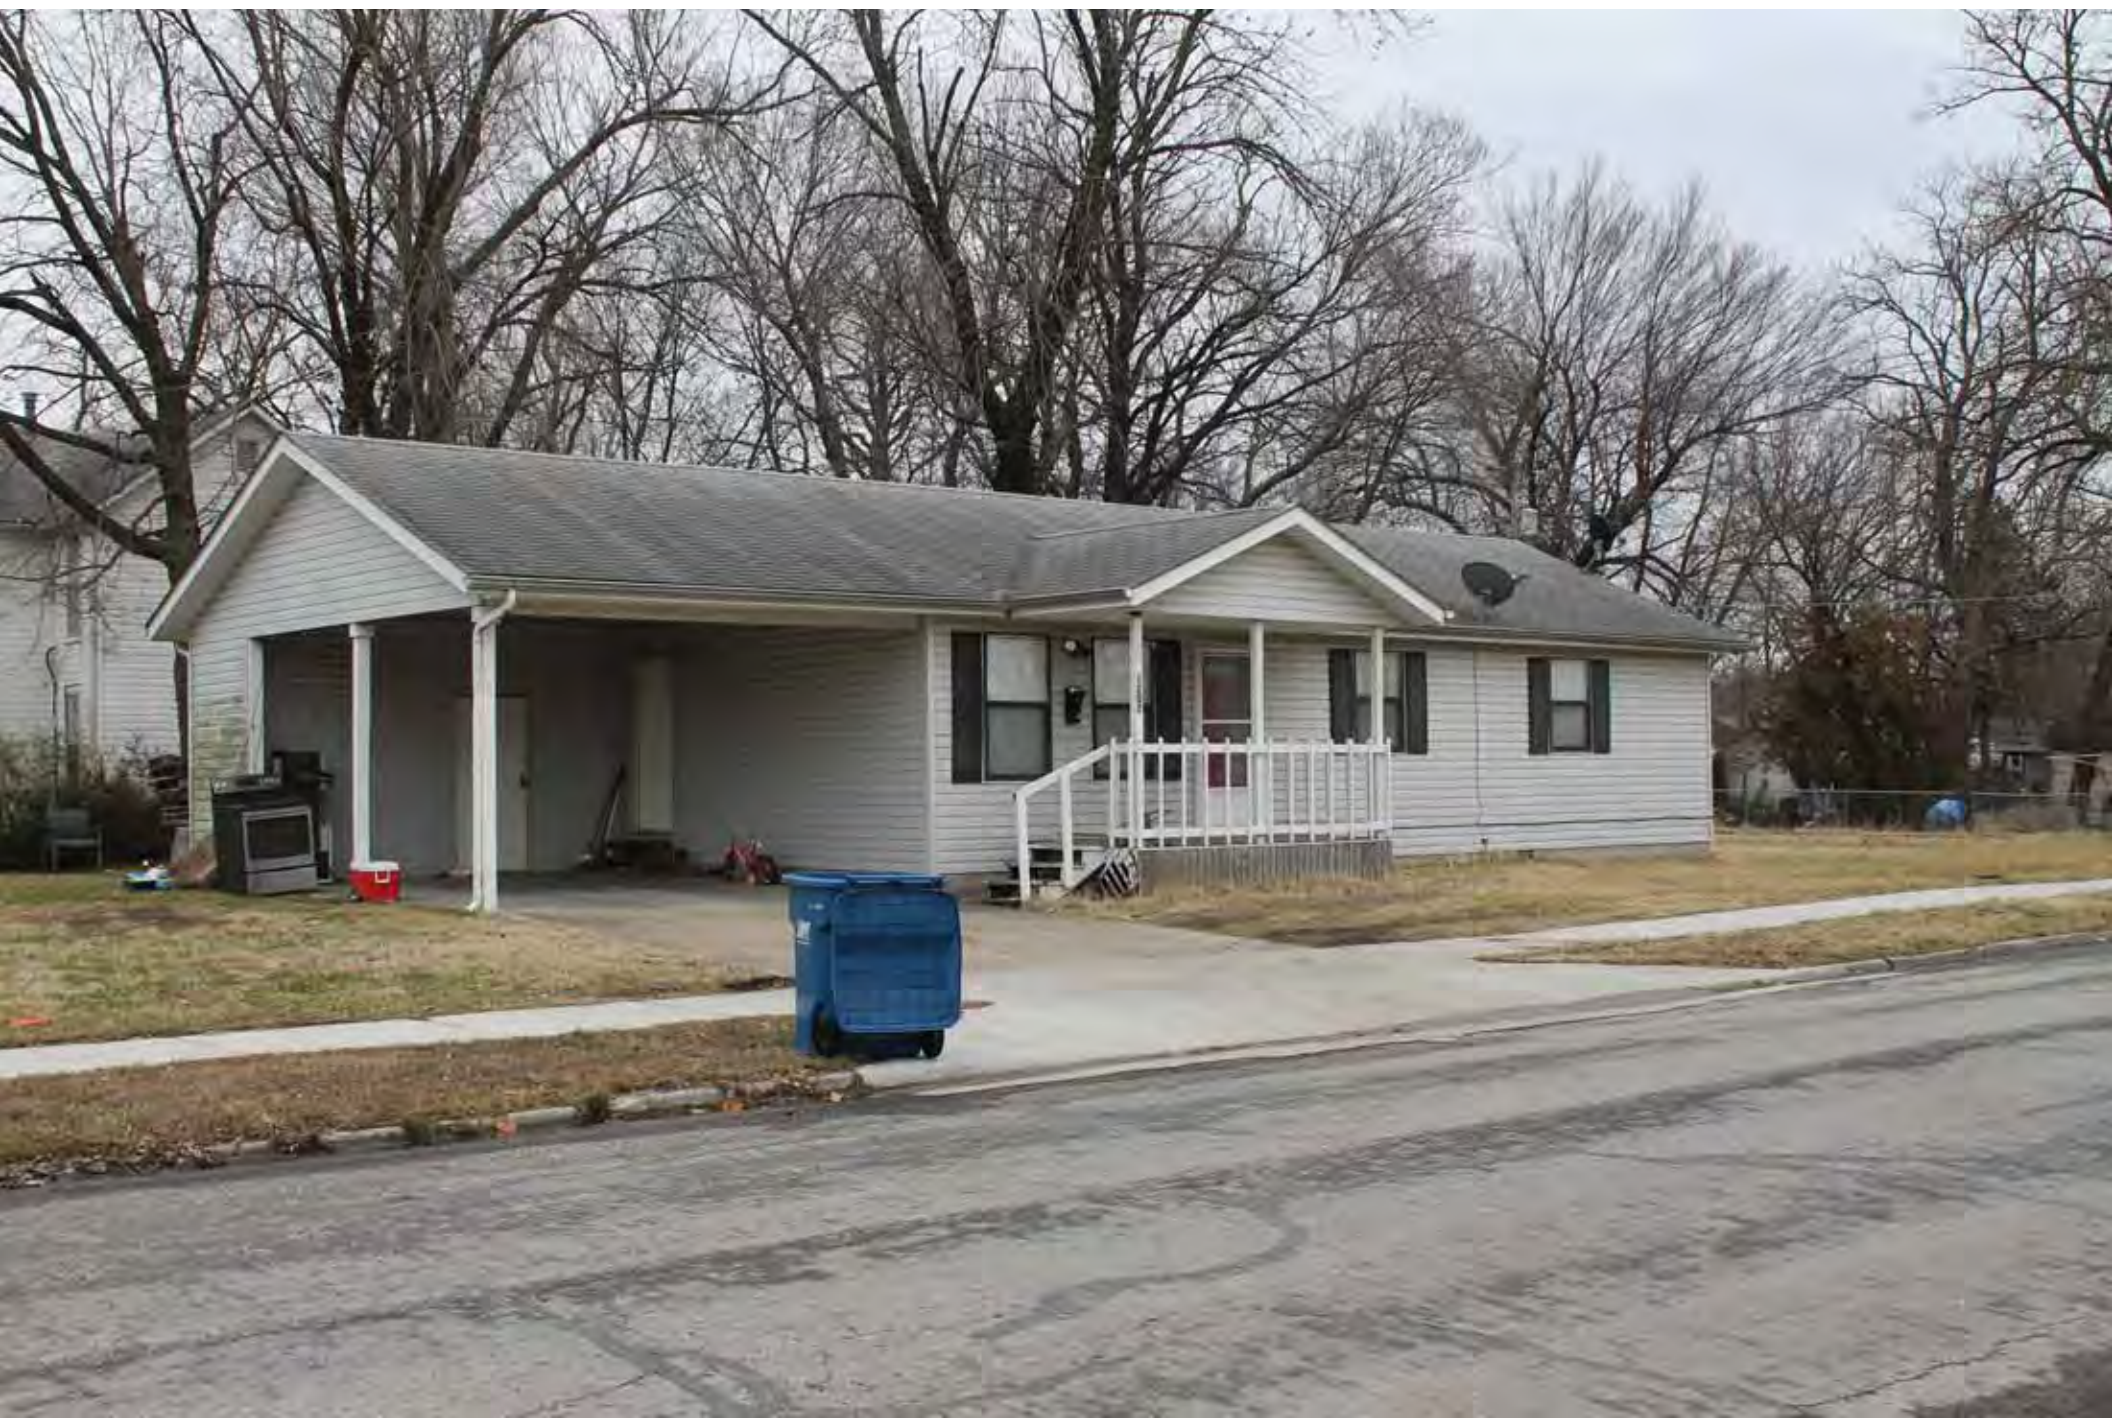
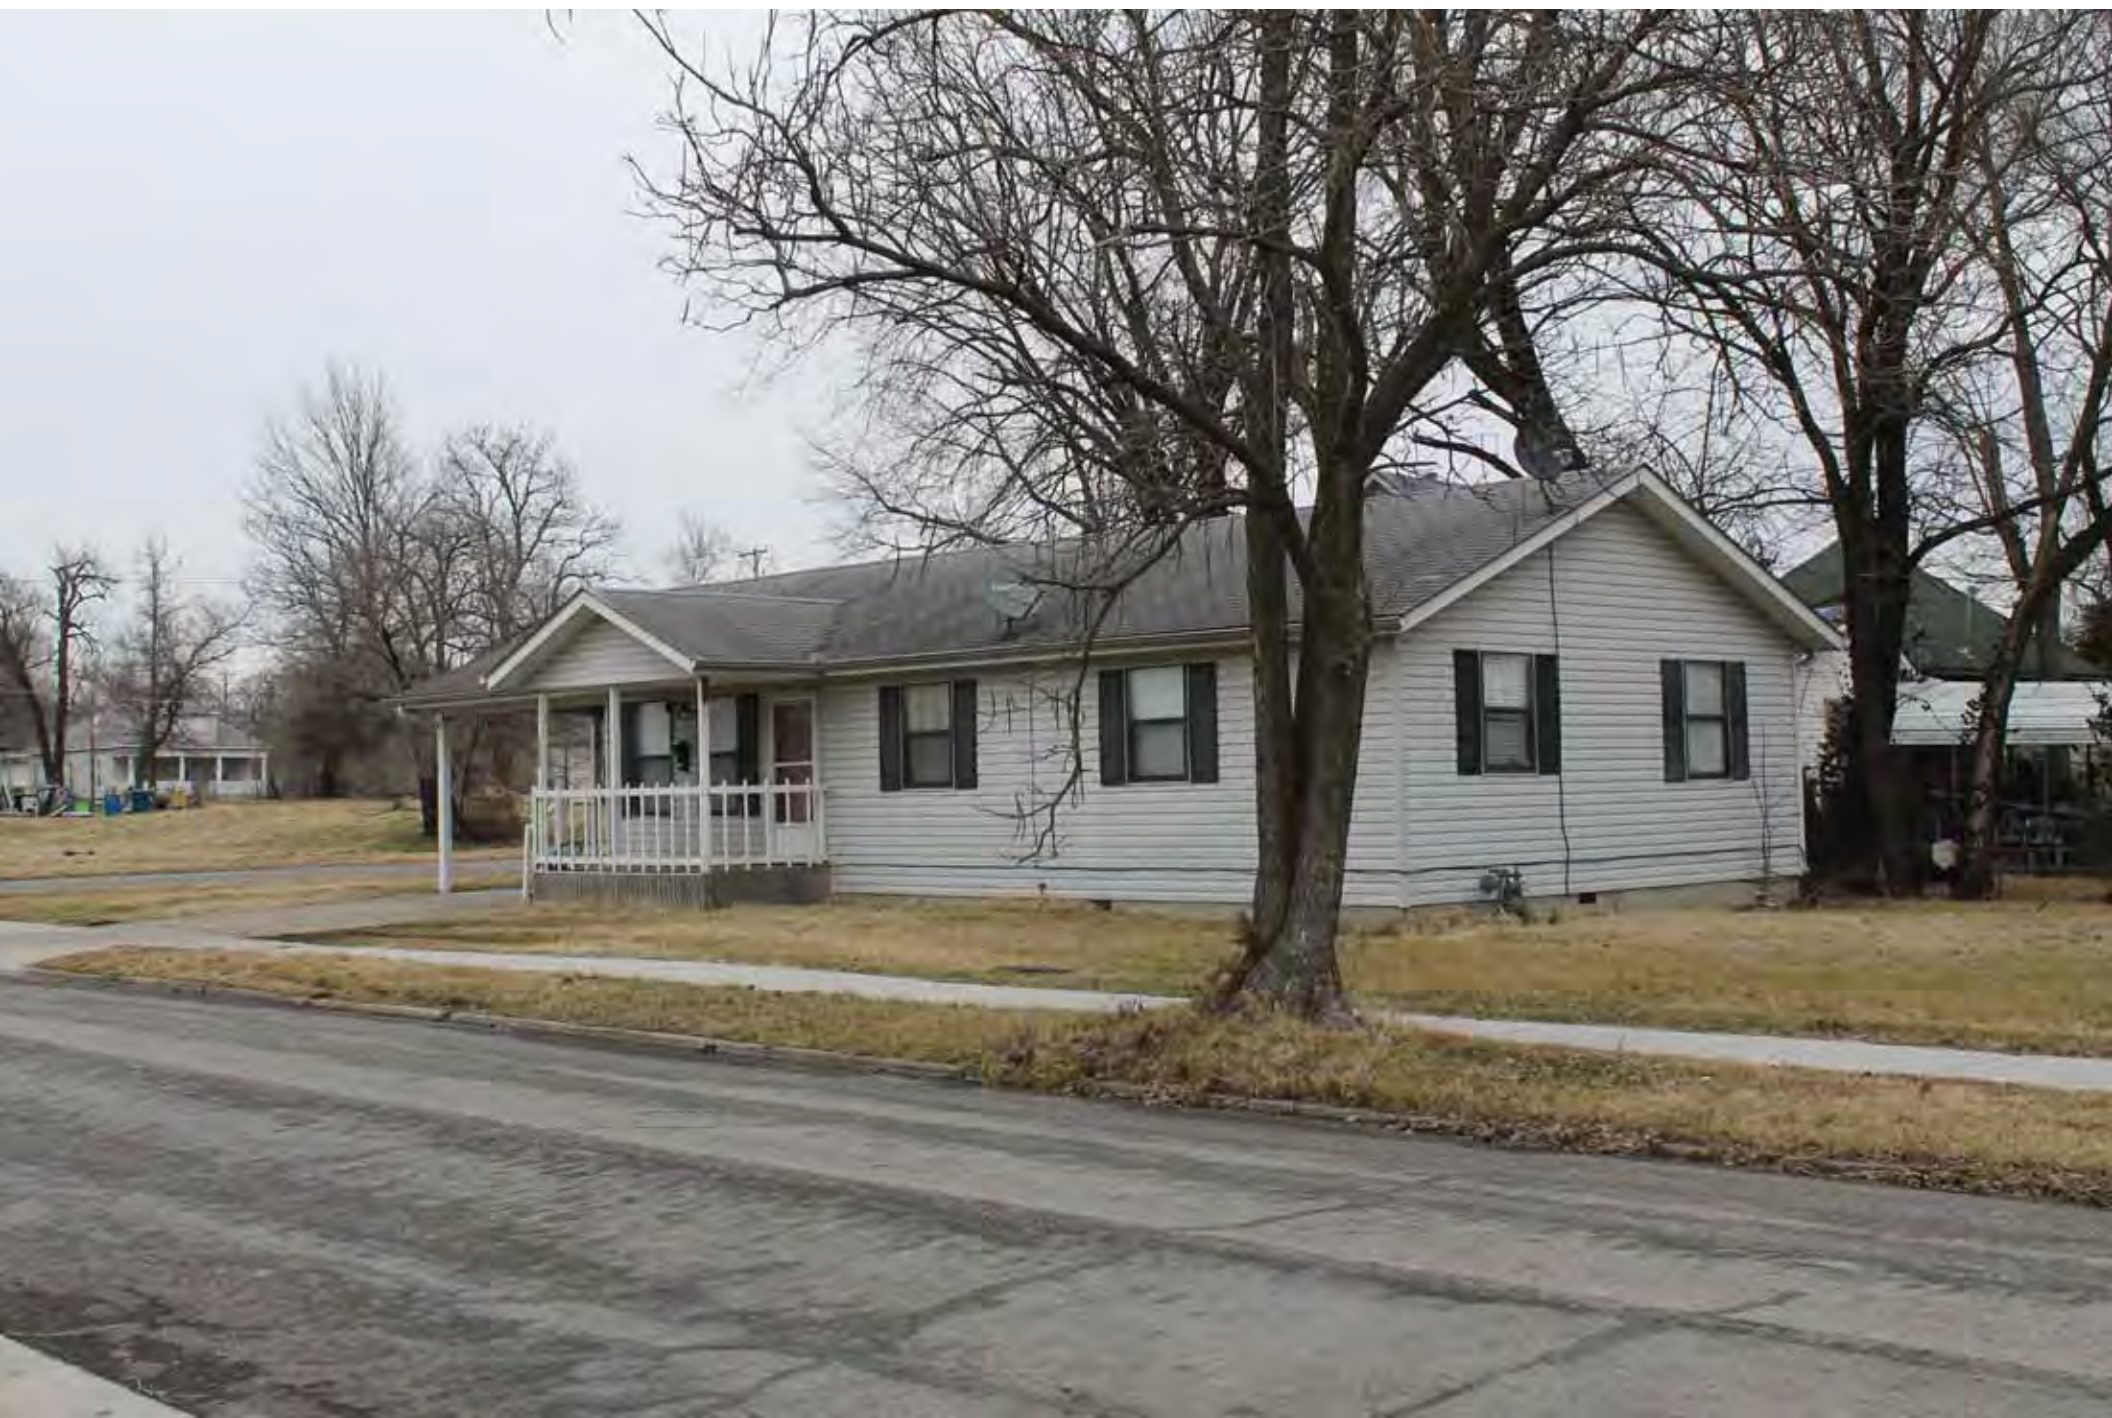
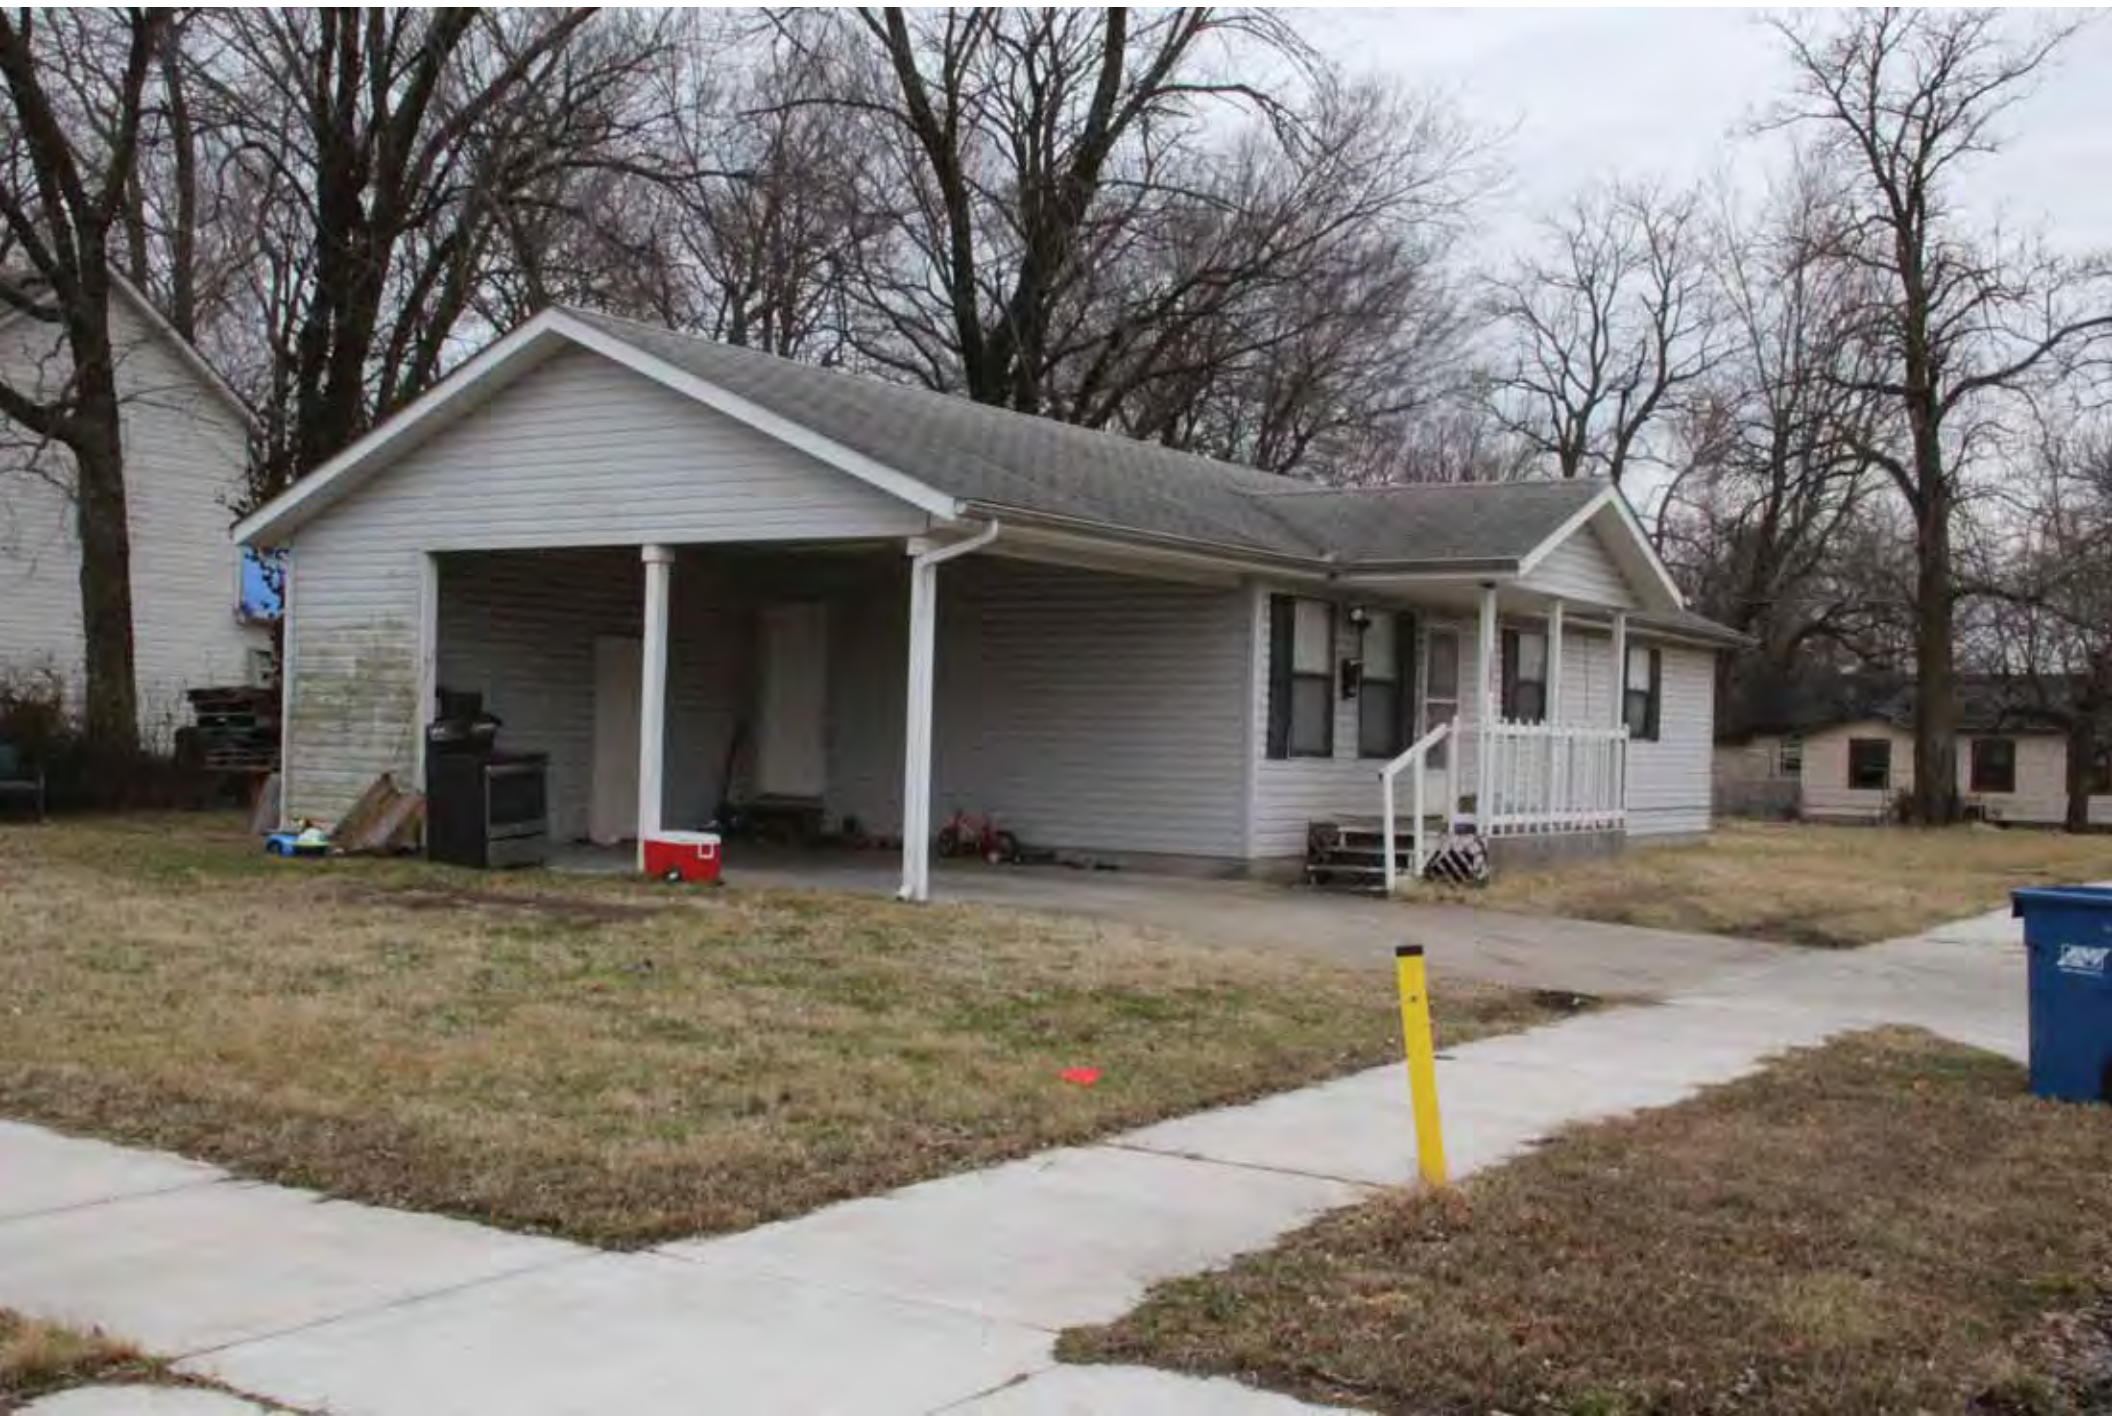
The property at 1202 E. Central Street features a single-story dwelling with an asphalt shingled gabled roof, exterior vinyl siding and a concrete foundation. Windows are one-over-one with faux shutters. The primary (west) elevation supports an off-center portico leading to a door with an upper fanlight. Offsetting the door on the north are two windows. Two windows (spaced further apart) are situated on the primary (west) elevation south of the entry/portico. At the north end of the dwelling is an incised carport with a concrete drive leading to/from S. Michigan Avenue. Within the carport, the exterior walls of the dwelling support doors on the west and north elevations. The portico is supported by two square columns.

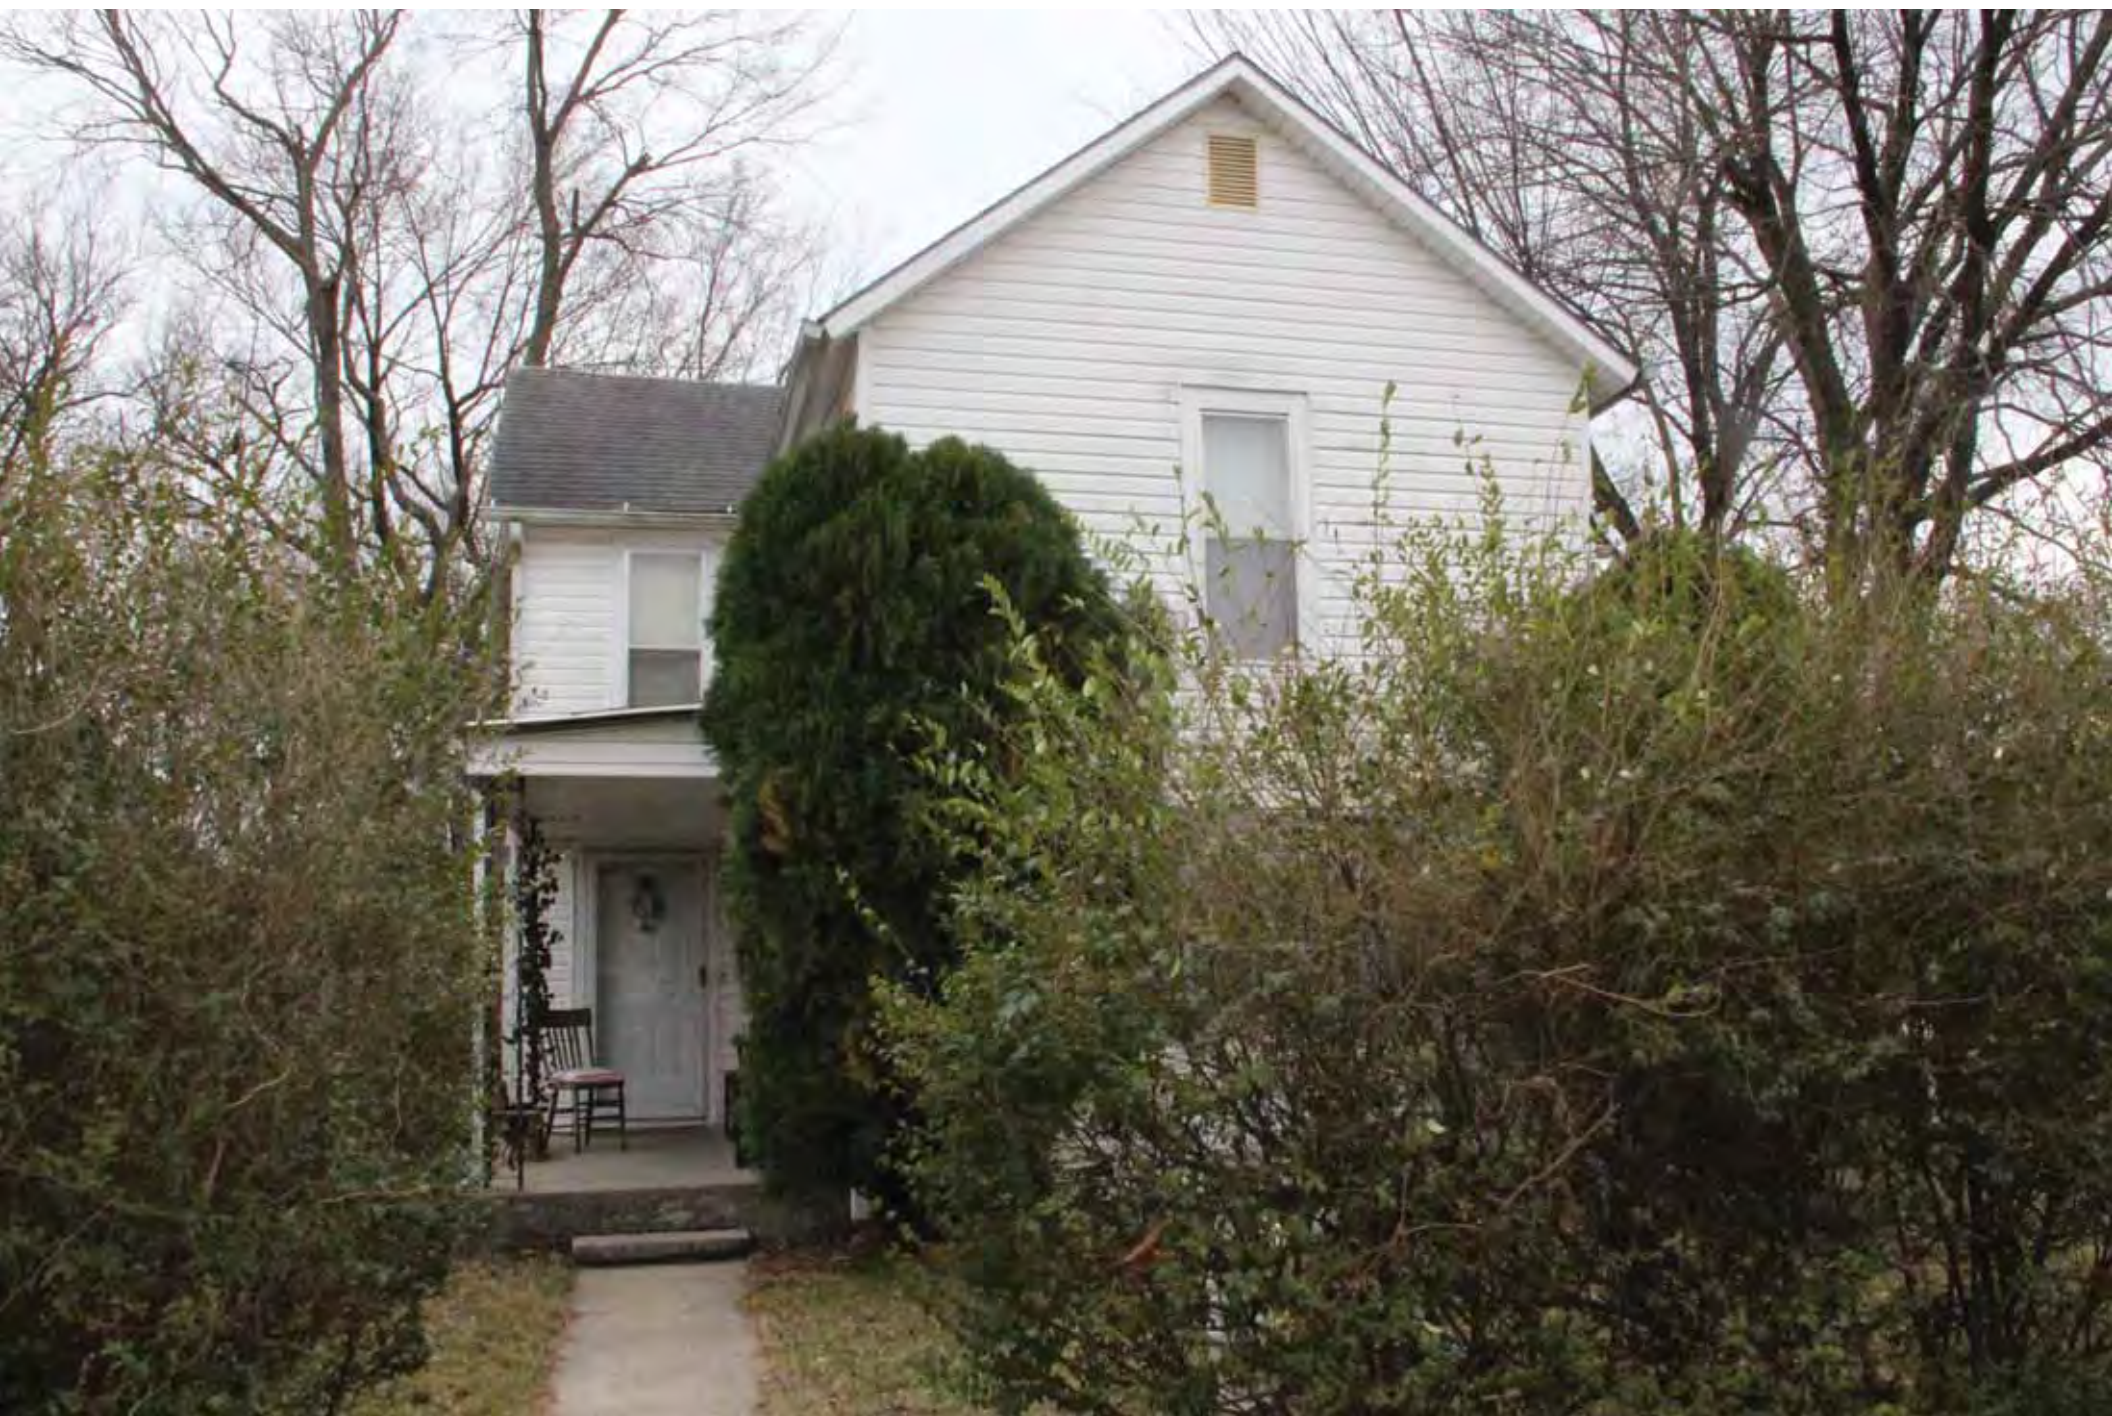
The property at 1208 E. Central Street features a two-story dwelling with an asphalt-shingled roof and exterior vinyl siding. Windows are 1/1 and appear original. The primary (north) elevation is largely obscured by mature foliage. This elevation features a corner (east end) porch created by the projecting front gabled wing on the west. The porch has a shed roof supported by chamfered columns. Within the porch bay is a contemporary (c. 2015) paneled door. The west wall of the porch (gabled wing) holds a single window. The front facing (north wall) gable holds single windows on the first and second stories. The dwelling has a real single-story gabled wing.
