MISSOURI DEPARTMENT OF NATURAL RESOURCES
STATE HISTORIC PRESERVATION OFFICE, P.O. Box 176, Jefferson City, MO 65102
ARCHITECTURAL/HISTORIC INVENTORY FORM

1. Survey No. JP-AS-007-001		2. Survey name: East Town (Original Joplin) Historic Survey Phase 2	
3. County: JASPER		4. Address (Street No.) 618	Street (name) E. 2 nd Street
5. City: Joplin	Vicinity: <input type="checkbox"/>	6. Geographical Reference:	7. Township/Range/Section: T: R: S:
8. Historic name (if known):		9. Present/other name (if known):	
10. Ownership: <input checked="" type="checkbox"/> Private <input type="checkbox"/> Public		11a. Historic use (if known): Domestic: Single Dwelling	11b. Current use: Domestic: Single Dwelling

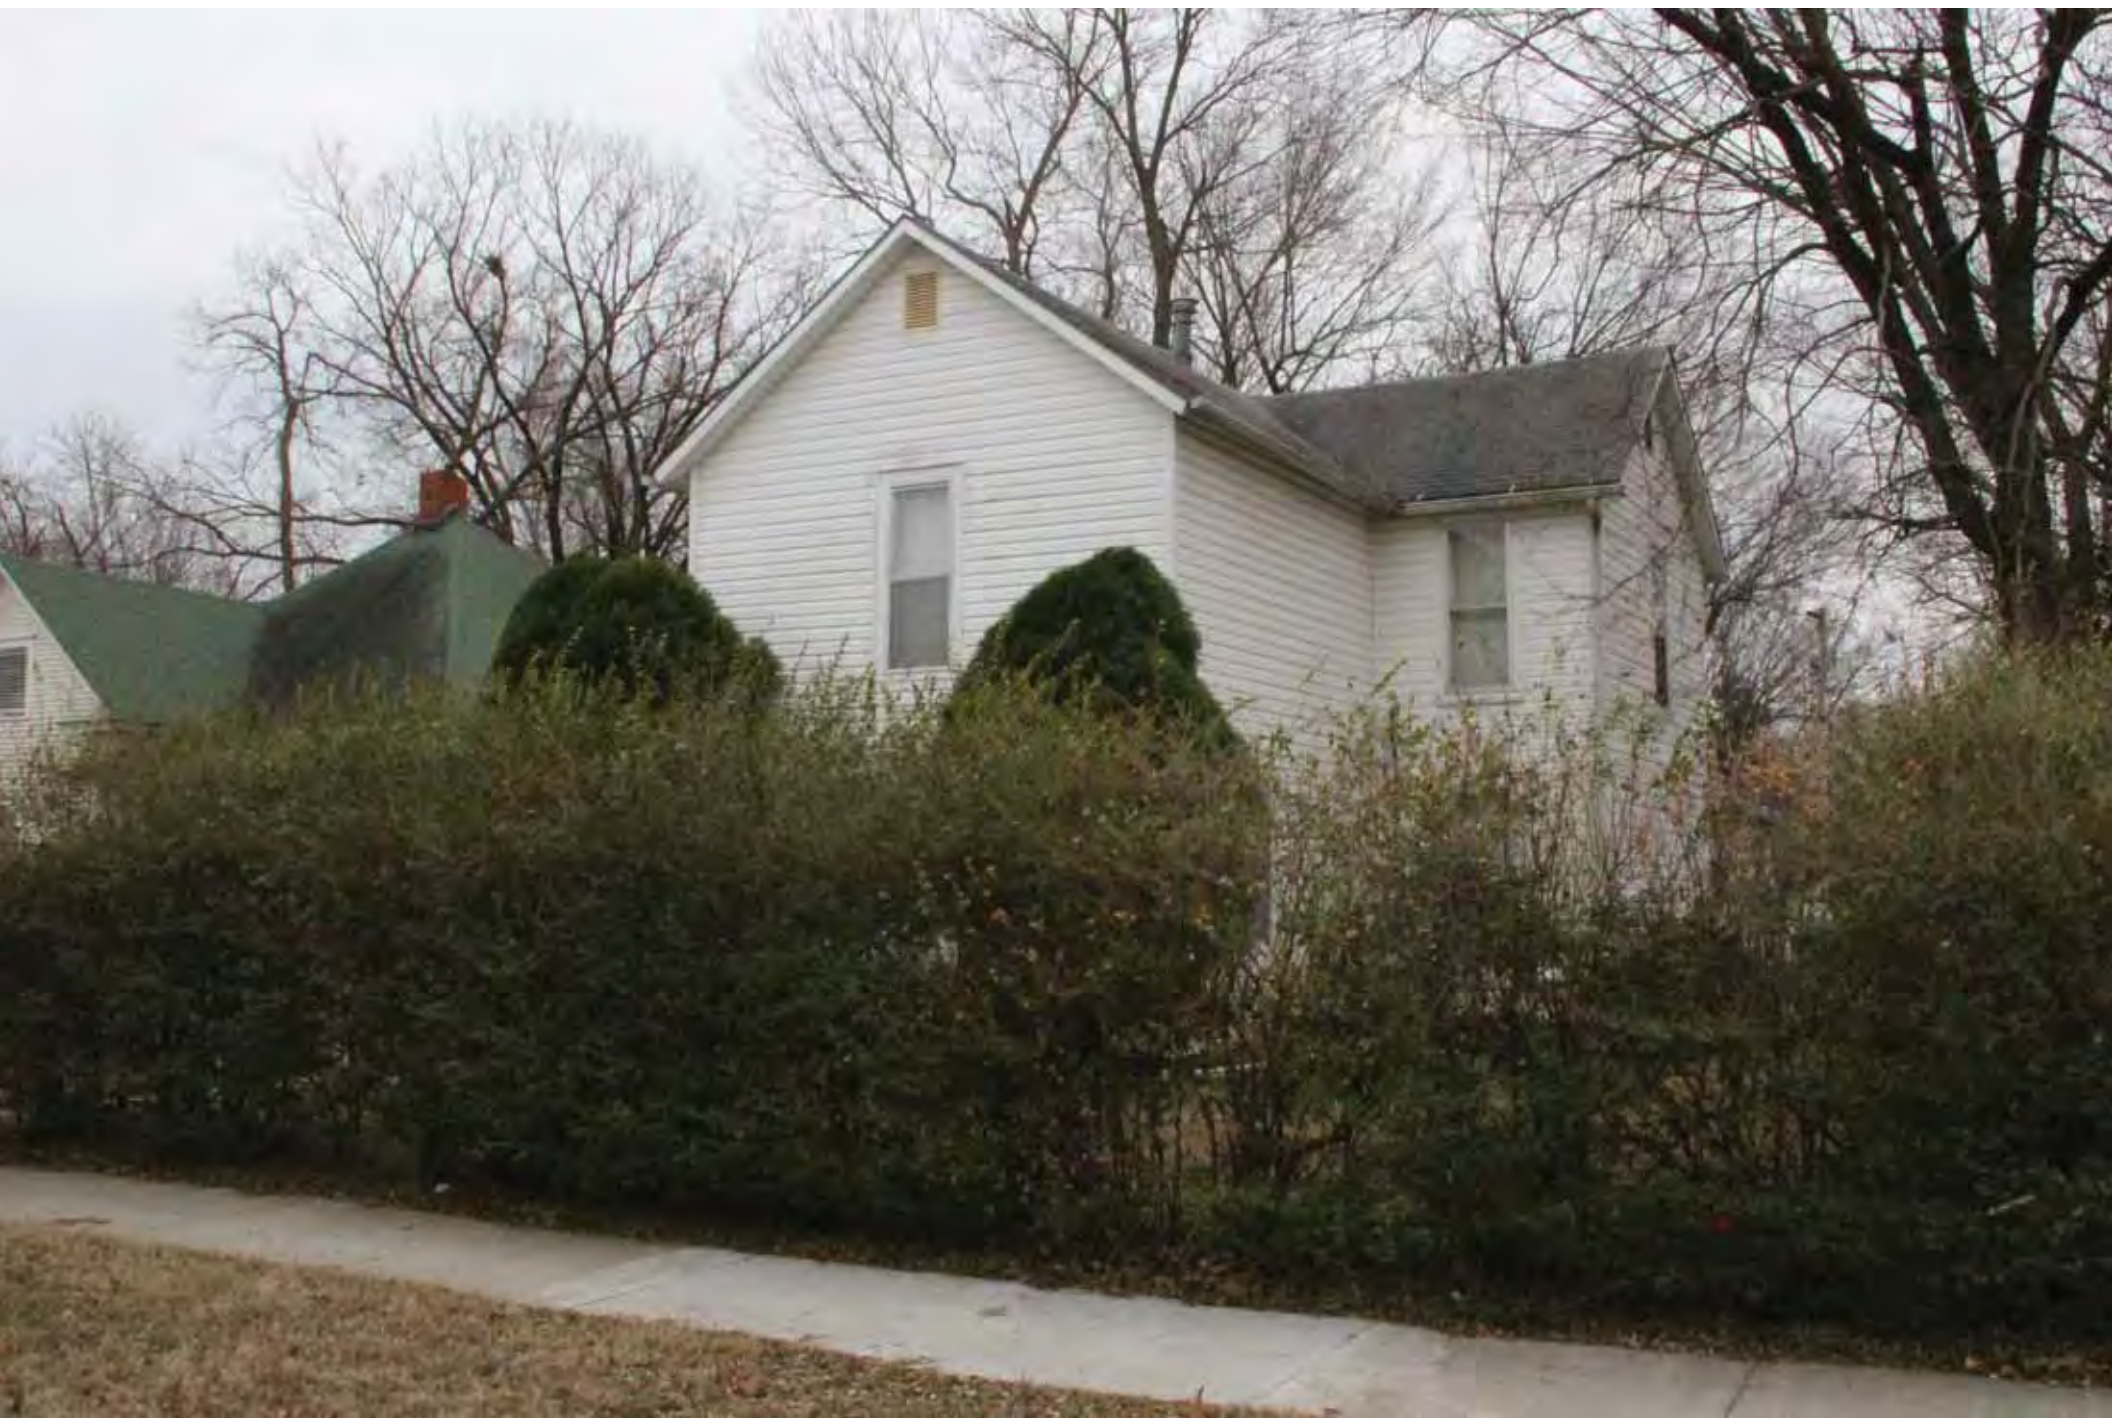
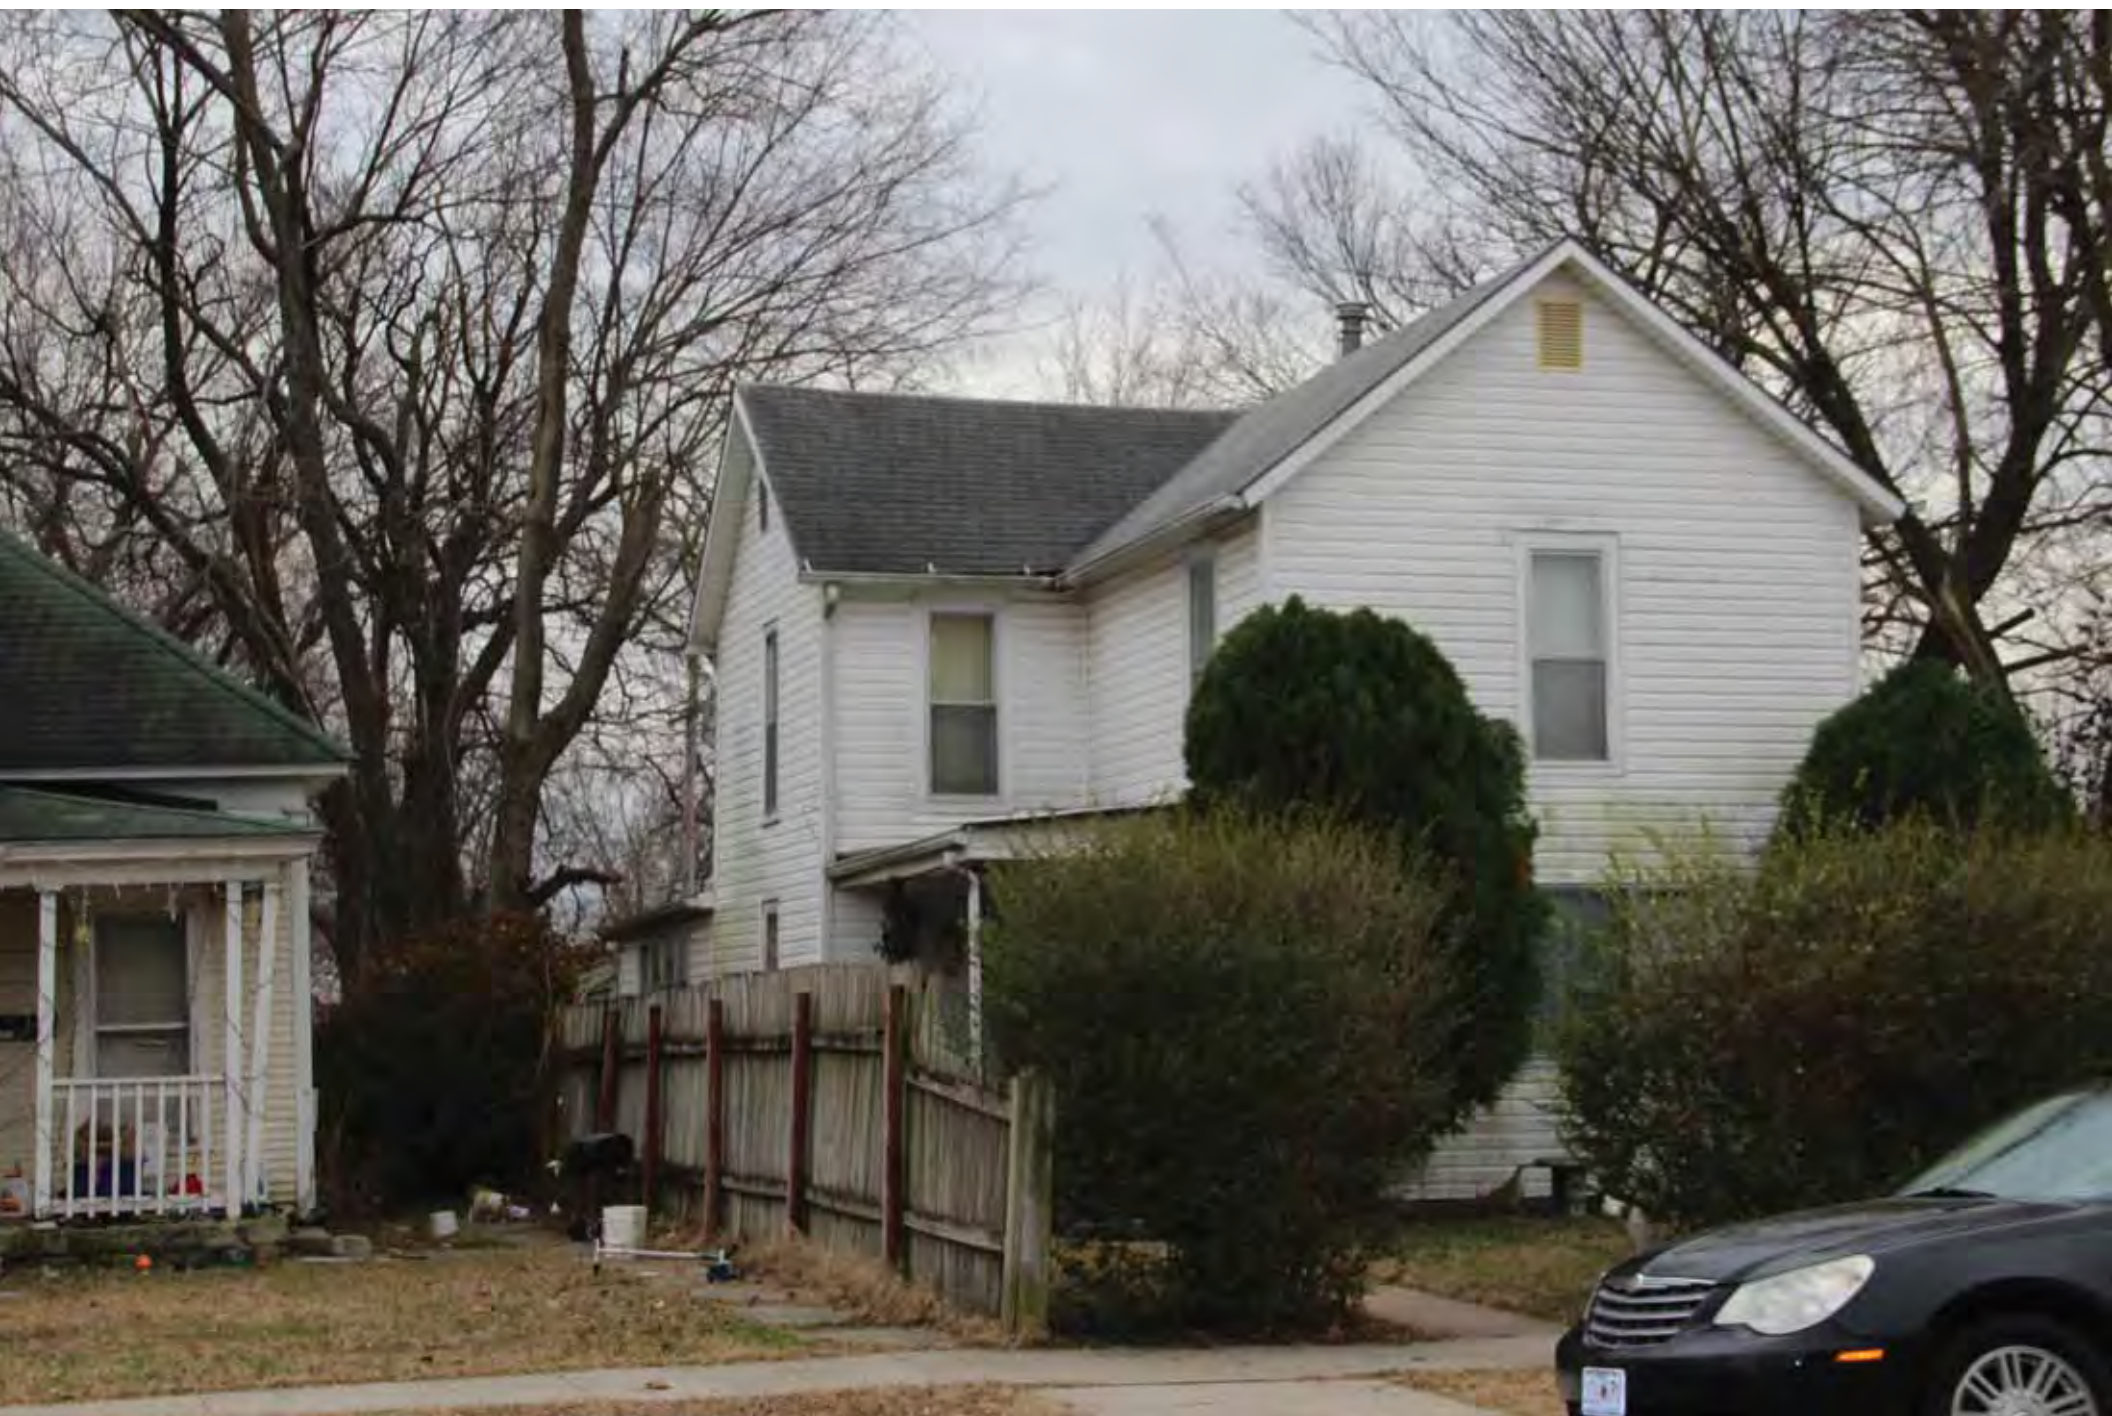
The property at 1208 E. Central Street features a two-story dwelling with an asphalt-shingled roof and exterior vinyl siding. Windows are 1/1 and appear original. The primary (north) elevation is largely obscured by mature foliage. This elevation features a corner (east end) porch created by the projecting front gabled wing on the west. The porch has a shed roof supported by chamfered columns. Within the porch bay is a contemporary (c. 2015) paneled door. The west wall of the porch (gabled wing) holds a single window. The front facing (north wall) gable holds single windows on the first and second stories. The dwelling has a real single-story gabled wing.

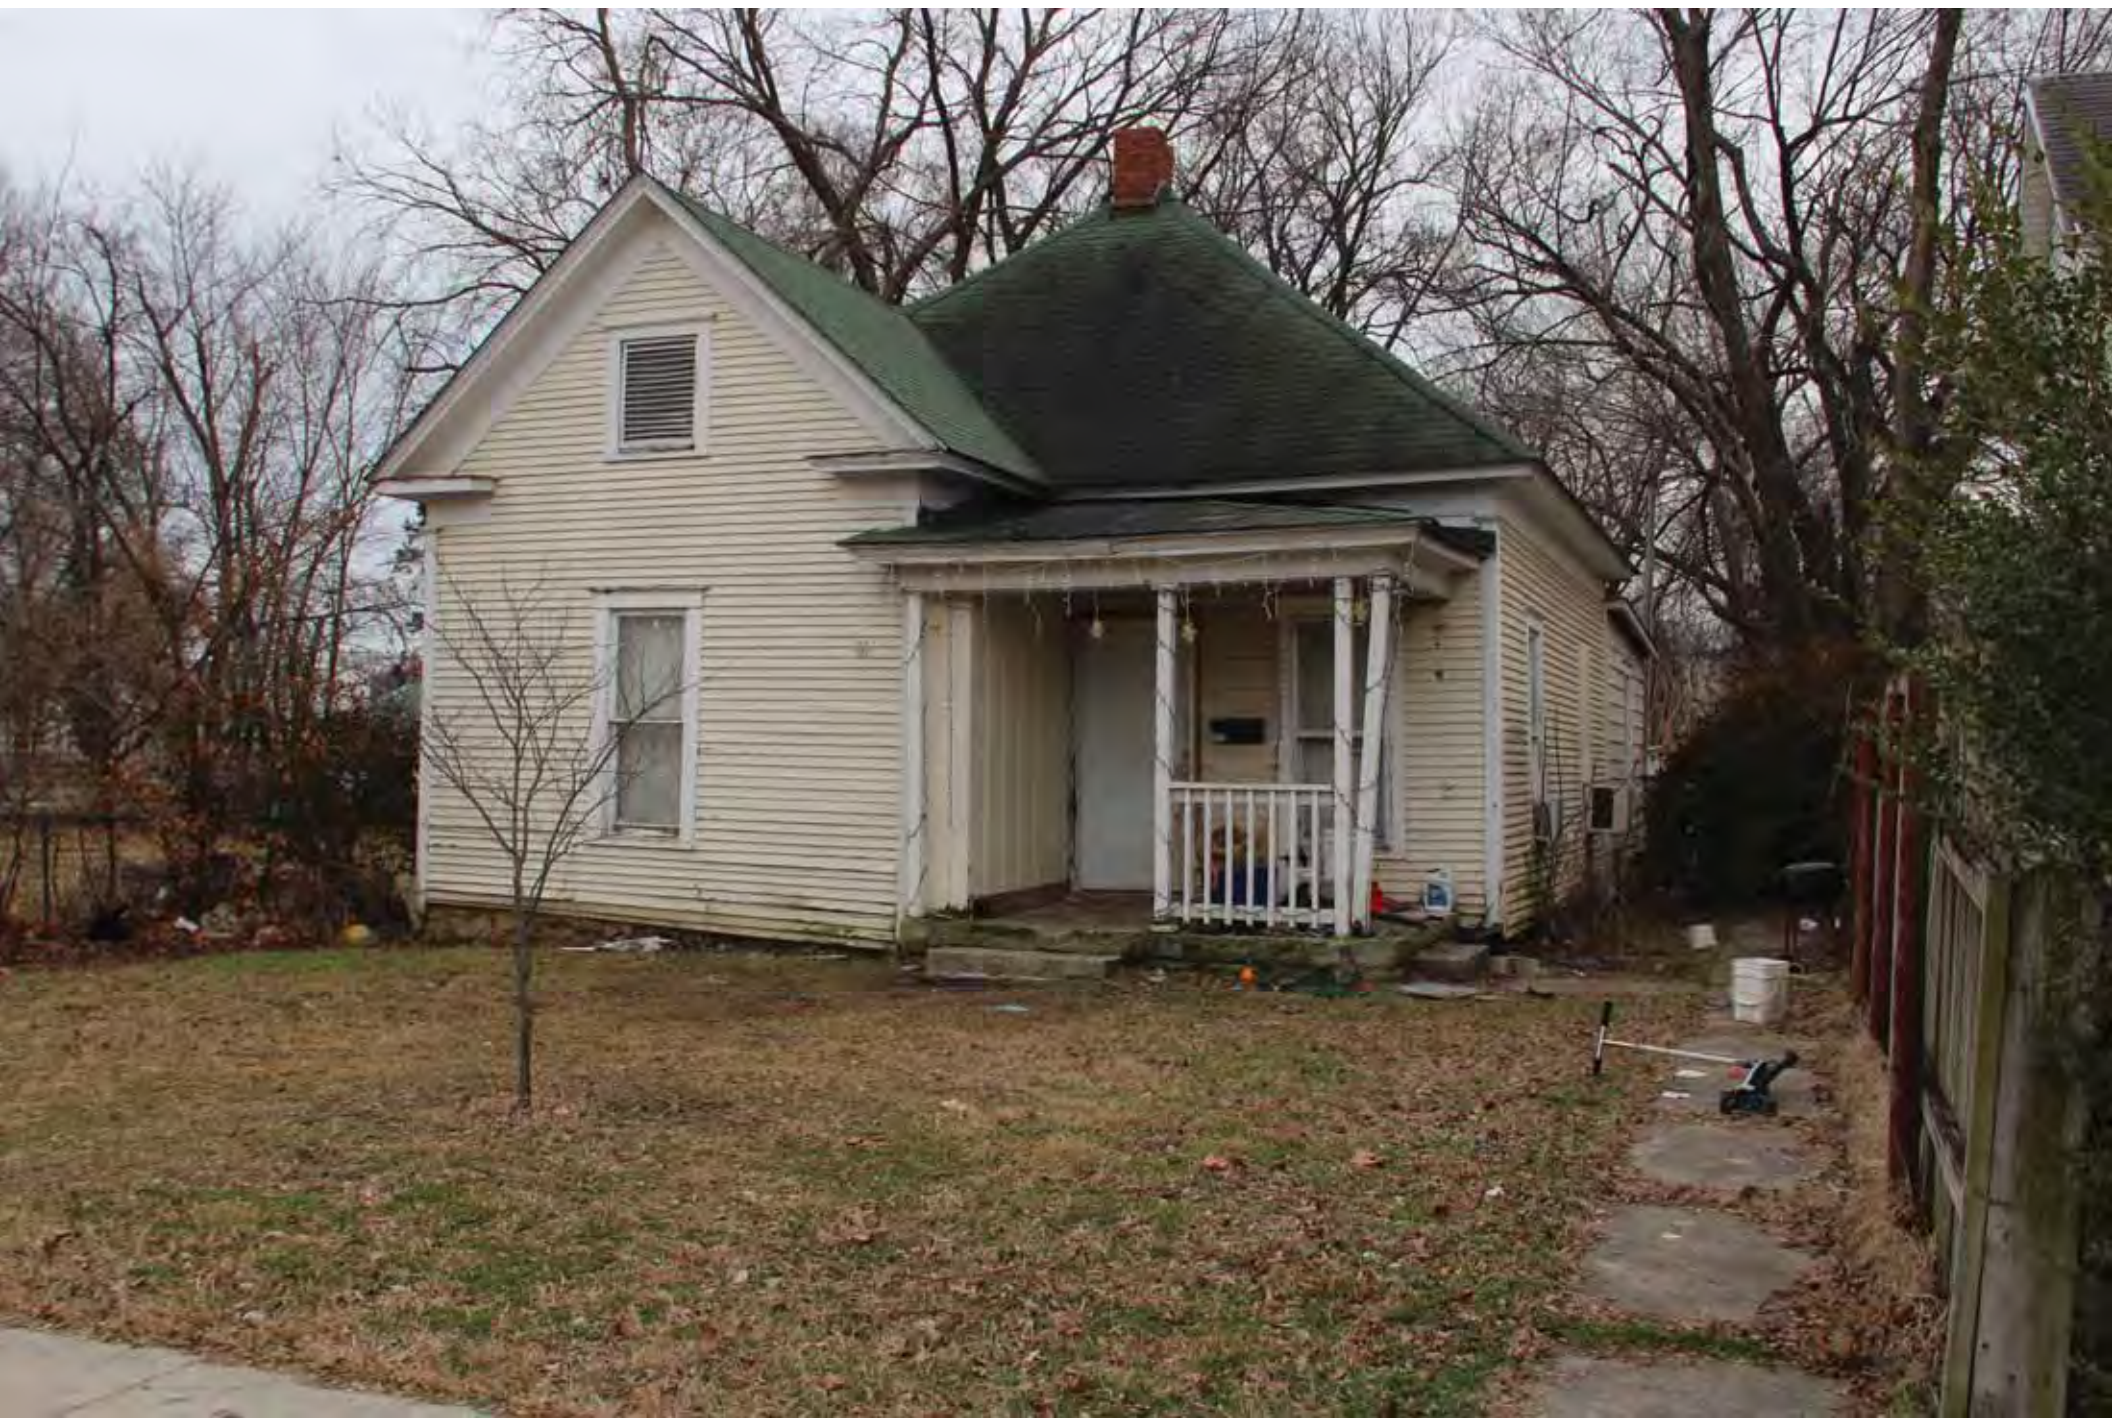
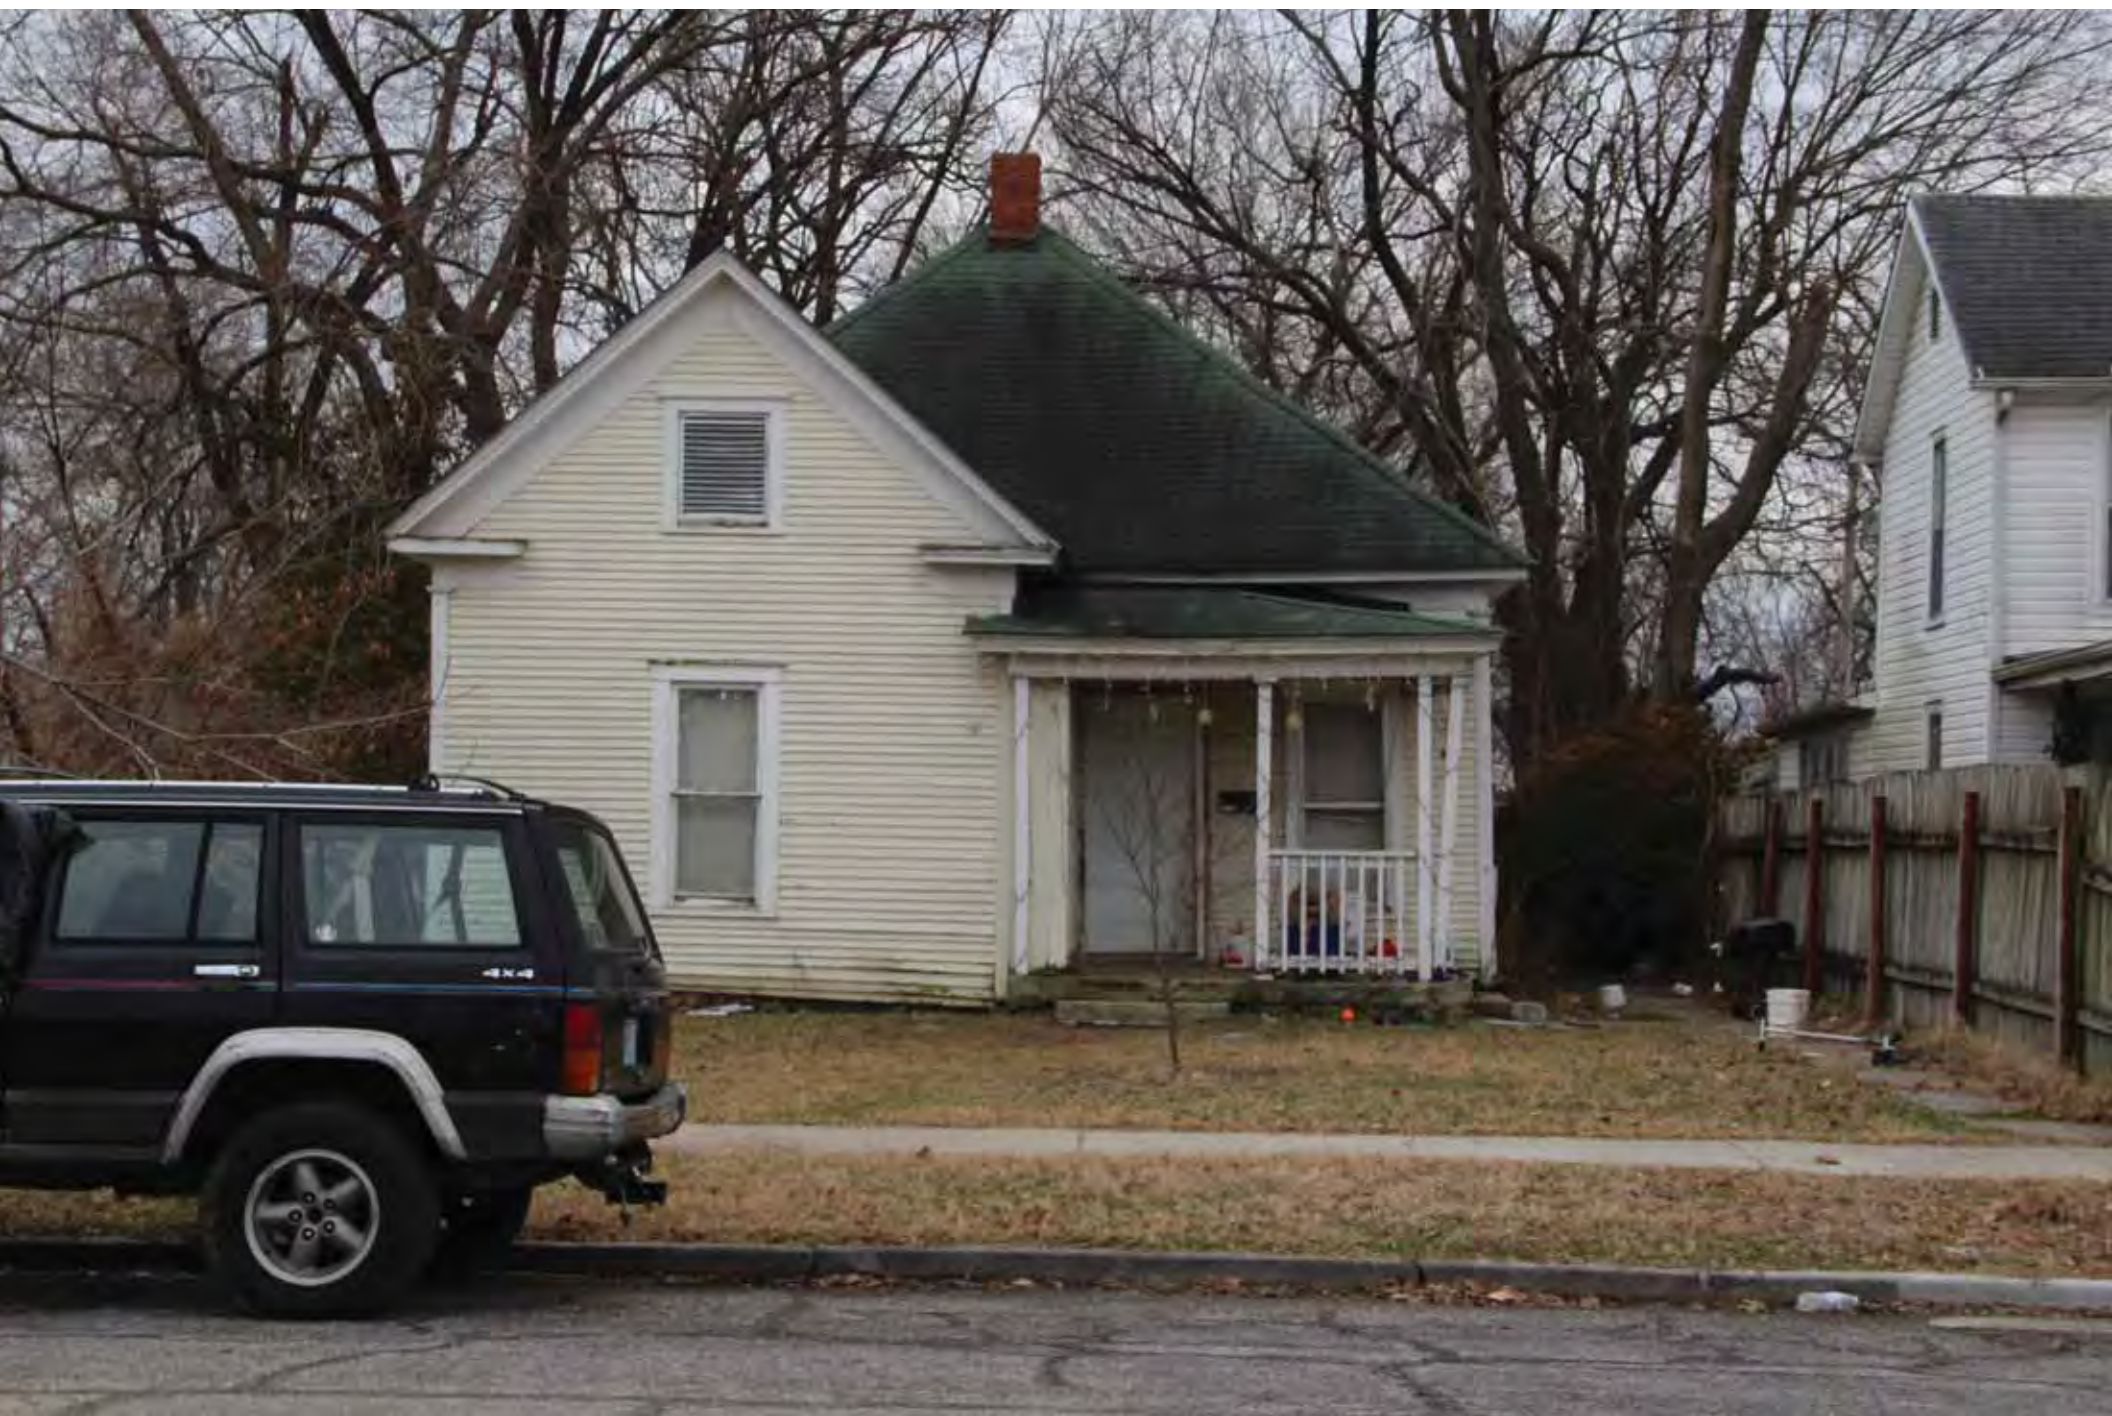
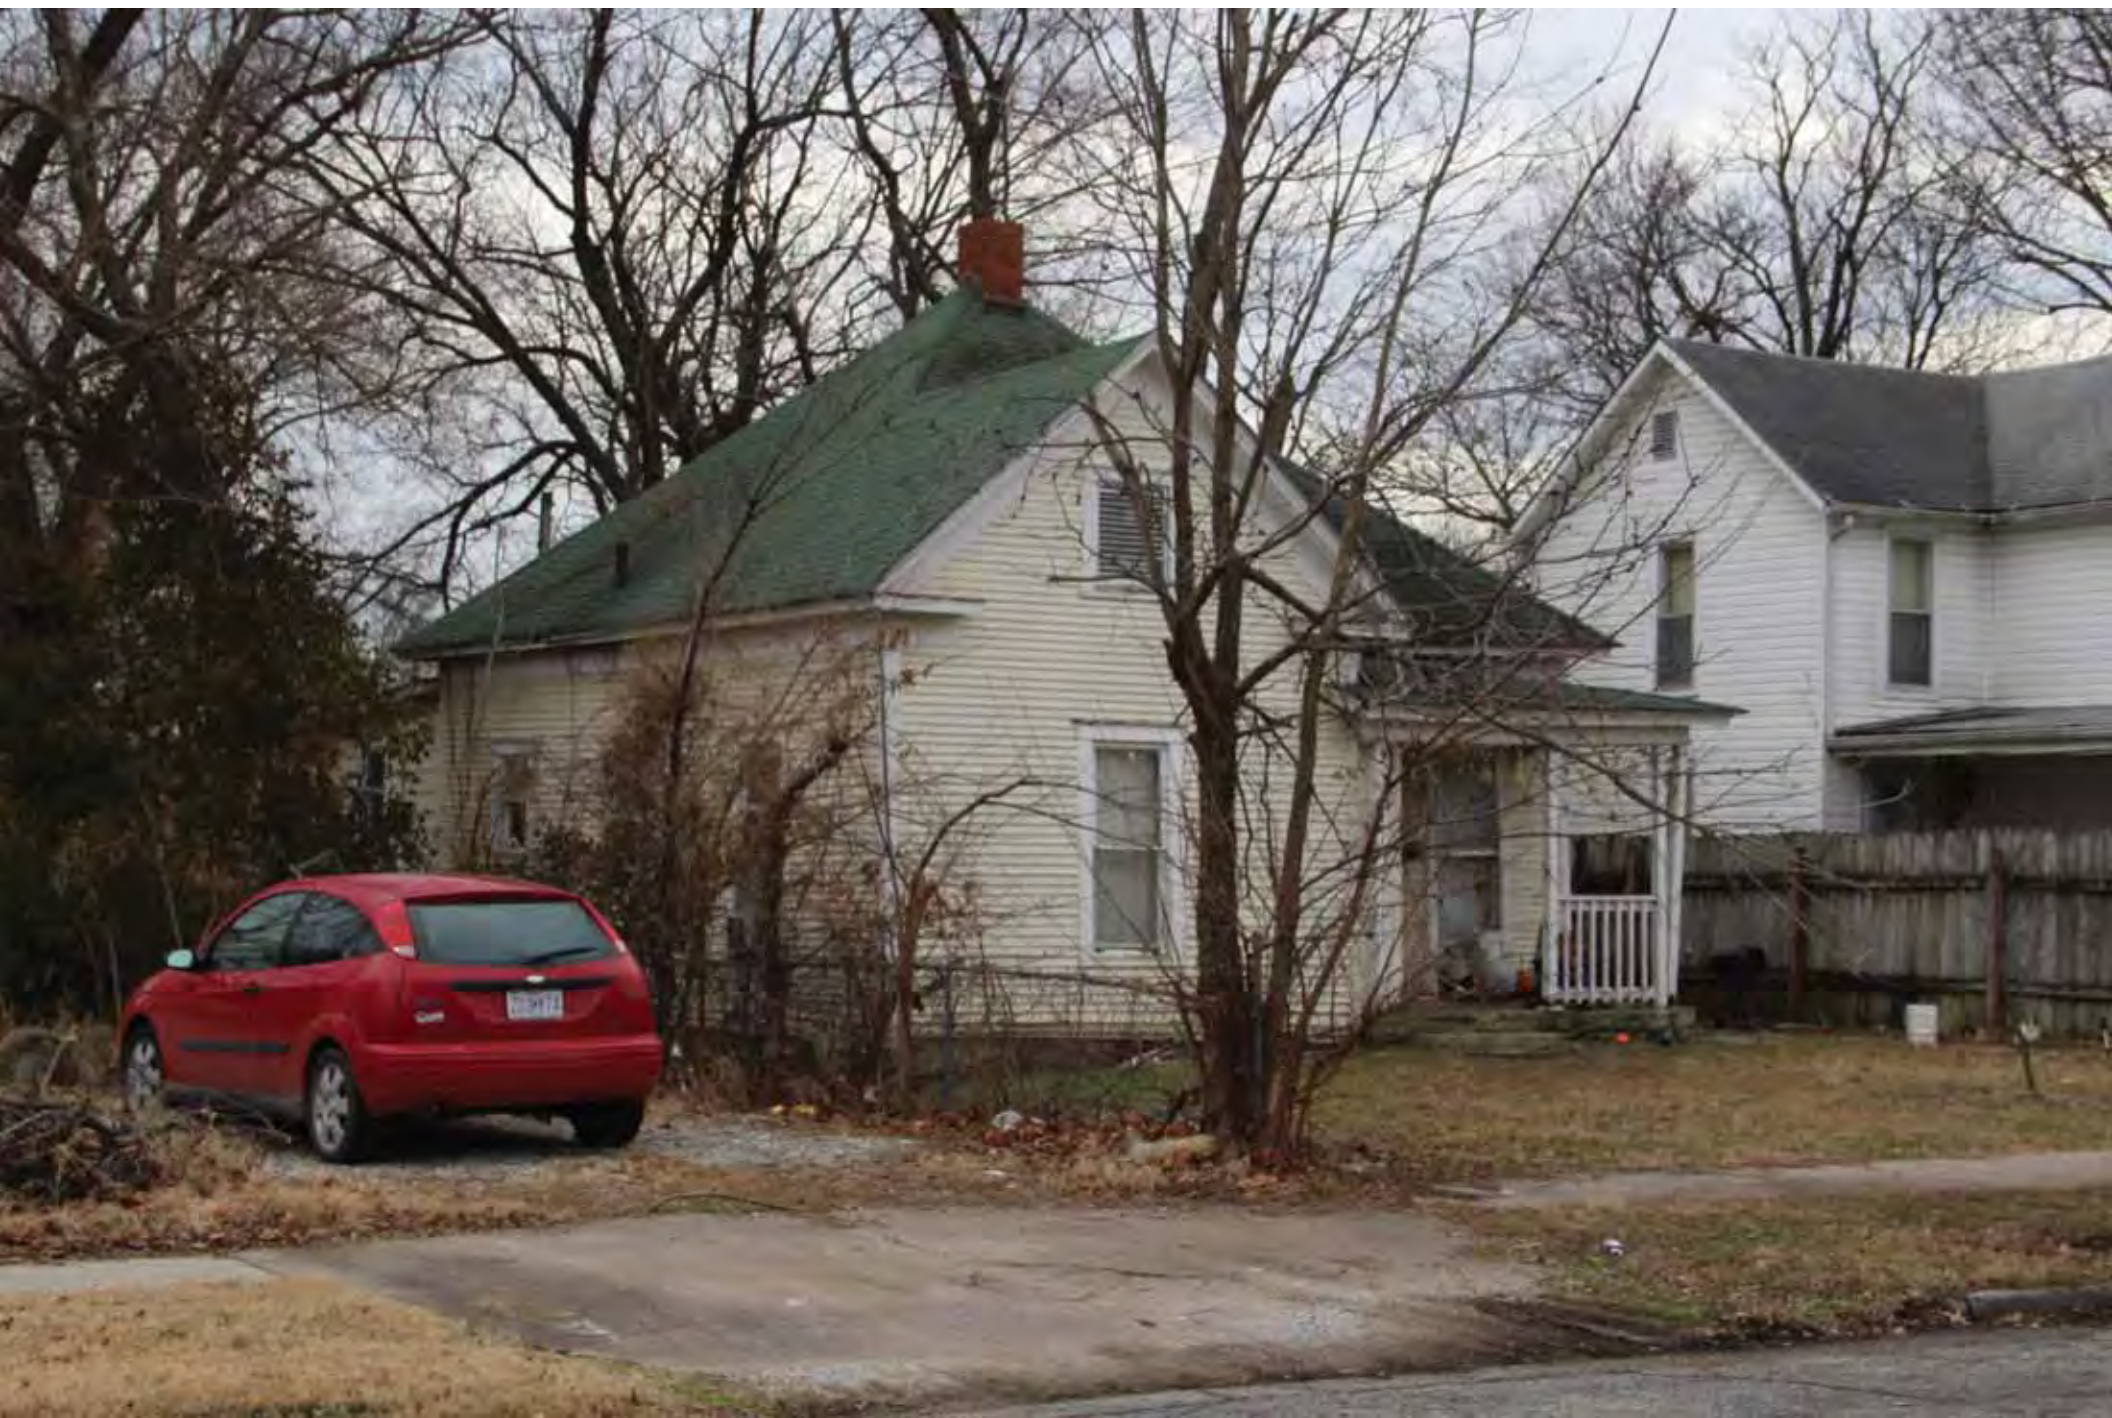
The property at 1212 E. Central Street features a Pyramidal Square plan dwelling with an asphalt shingled roof capped by a central brick chimney. The dwelling has exterior weatherboard siding and a limestone foundation. The porch is off center on the façade (north elevation), supported by square columns. The porch has a frame balustrade (c. 2015) and leads to the primary entry bay filled with a c. 2015 paneled door. Offsetting the door to the west is a one-over-one window. The dwelling has a facing front gable that extends north at the east end of the porch. The gabled wing's north elevation holds a single one-over-one window. Above the window are gable returns that embrace a louvered vent. The wing's east wall is clad with board and batten siding. The dwelling has single windows on side (east/west) elevations and a rear single-story shed wing.

This dwelling is a common early twentieth-century property type that does not appear to exhibit sufficient architectural significance to render the property individually eligible for the National Register under Criterion C (Architecture). The dwelling is not within an area recommended as a historic district. Research failed to associate the property with any important person (Criterion B) or historical event(s) (Criterion A). For these reasons, the property does not appear eligible for the National Register of Historic Places.

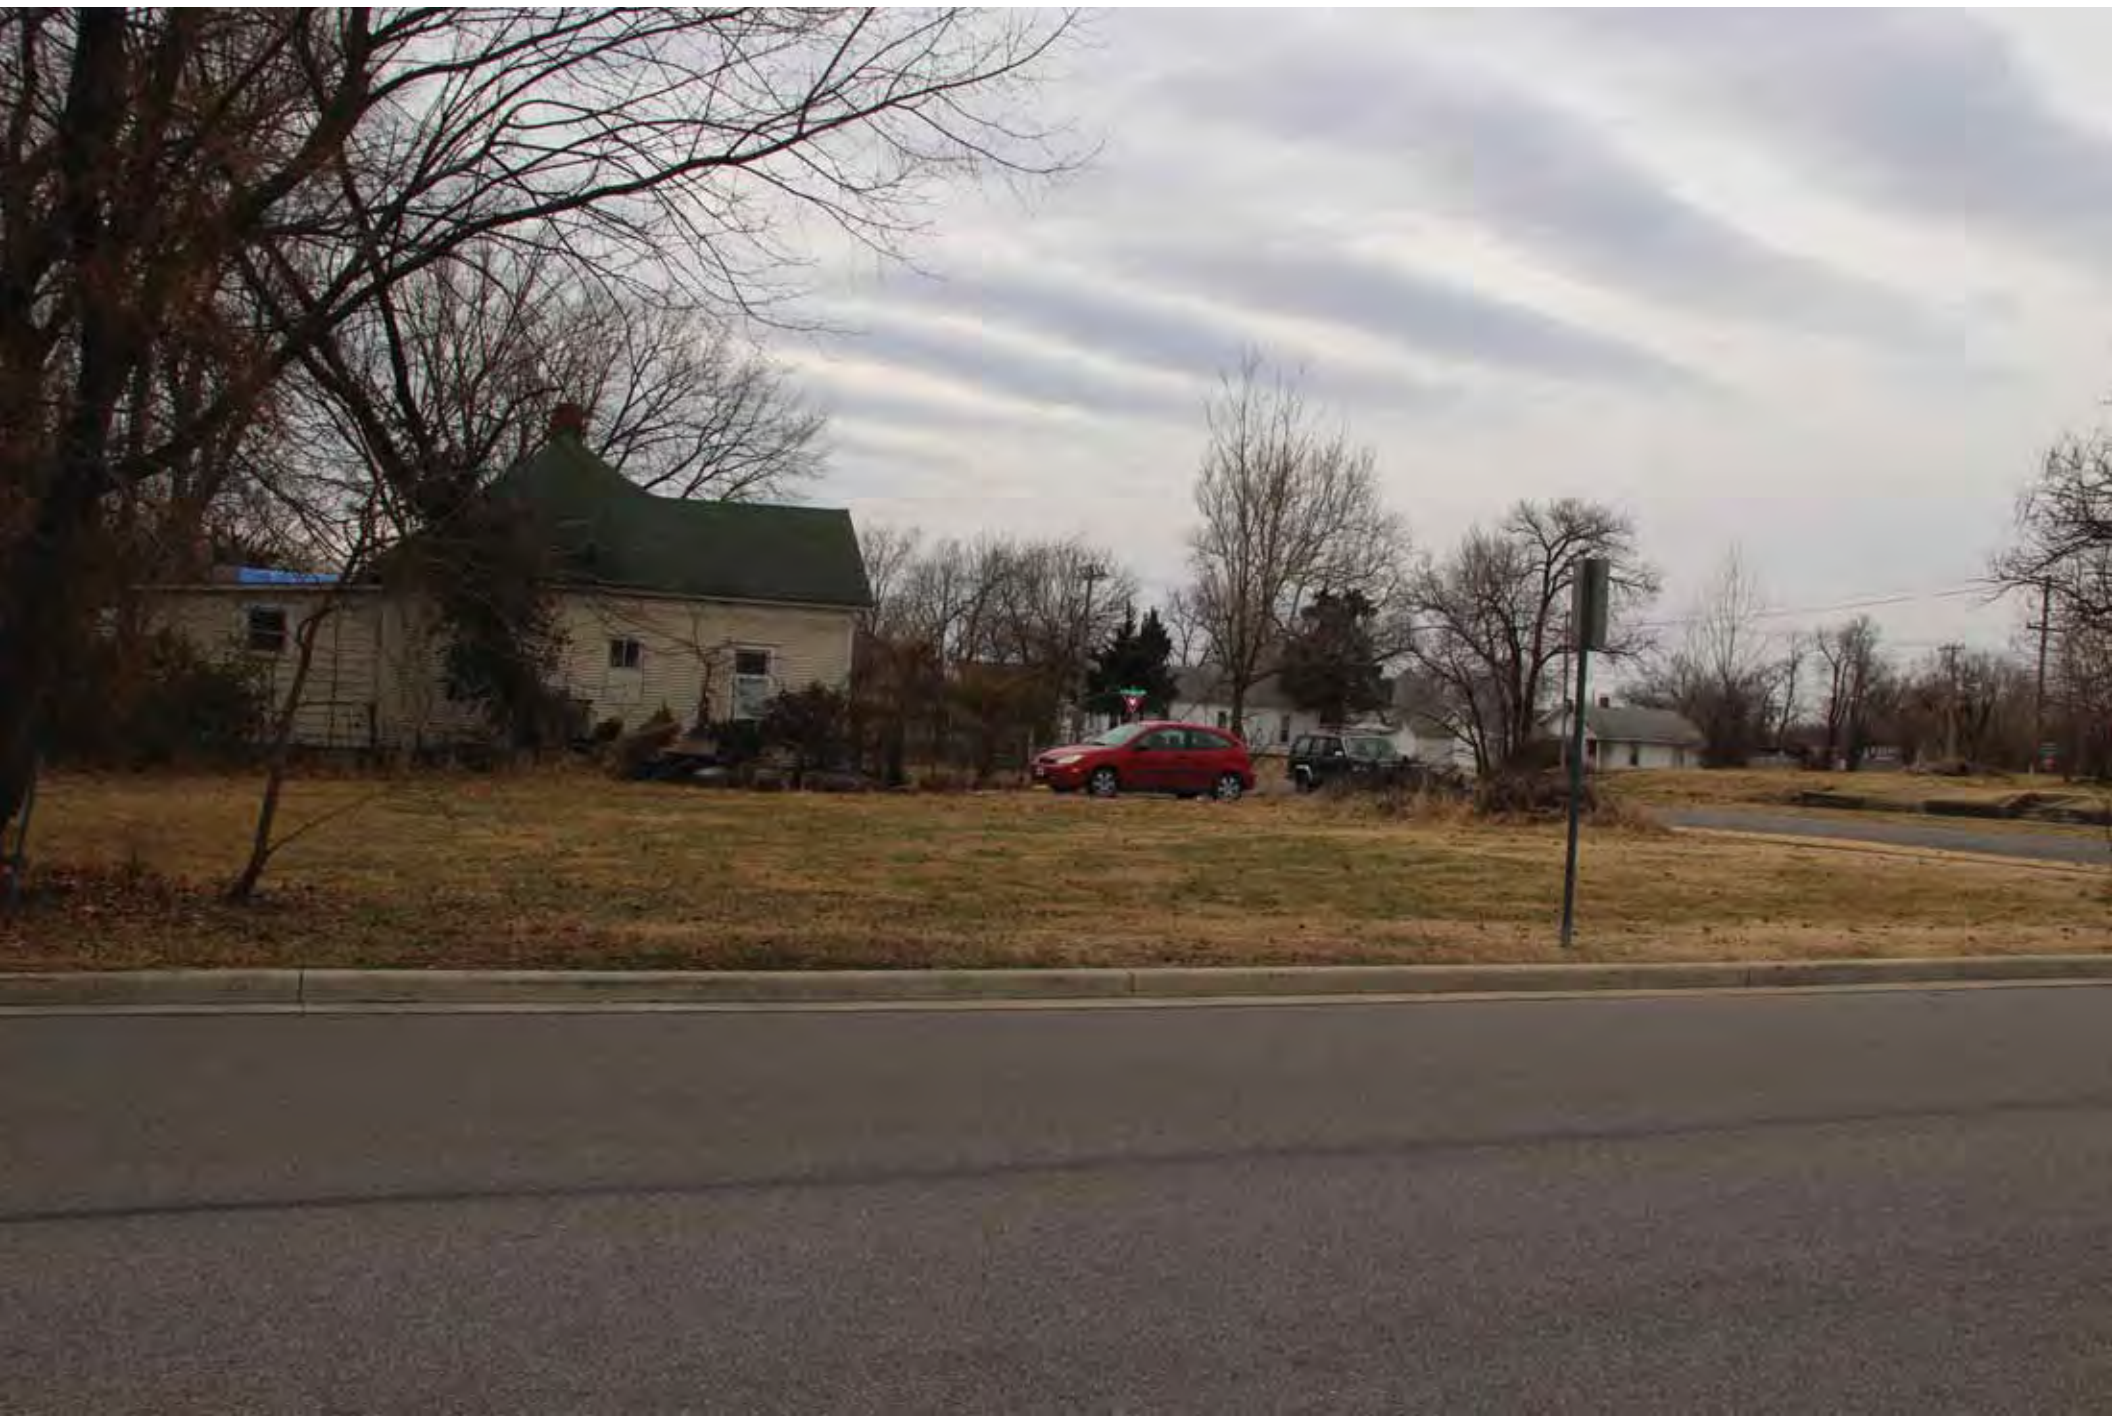
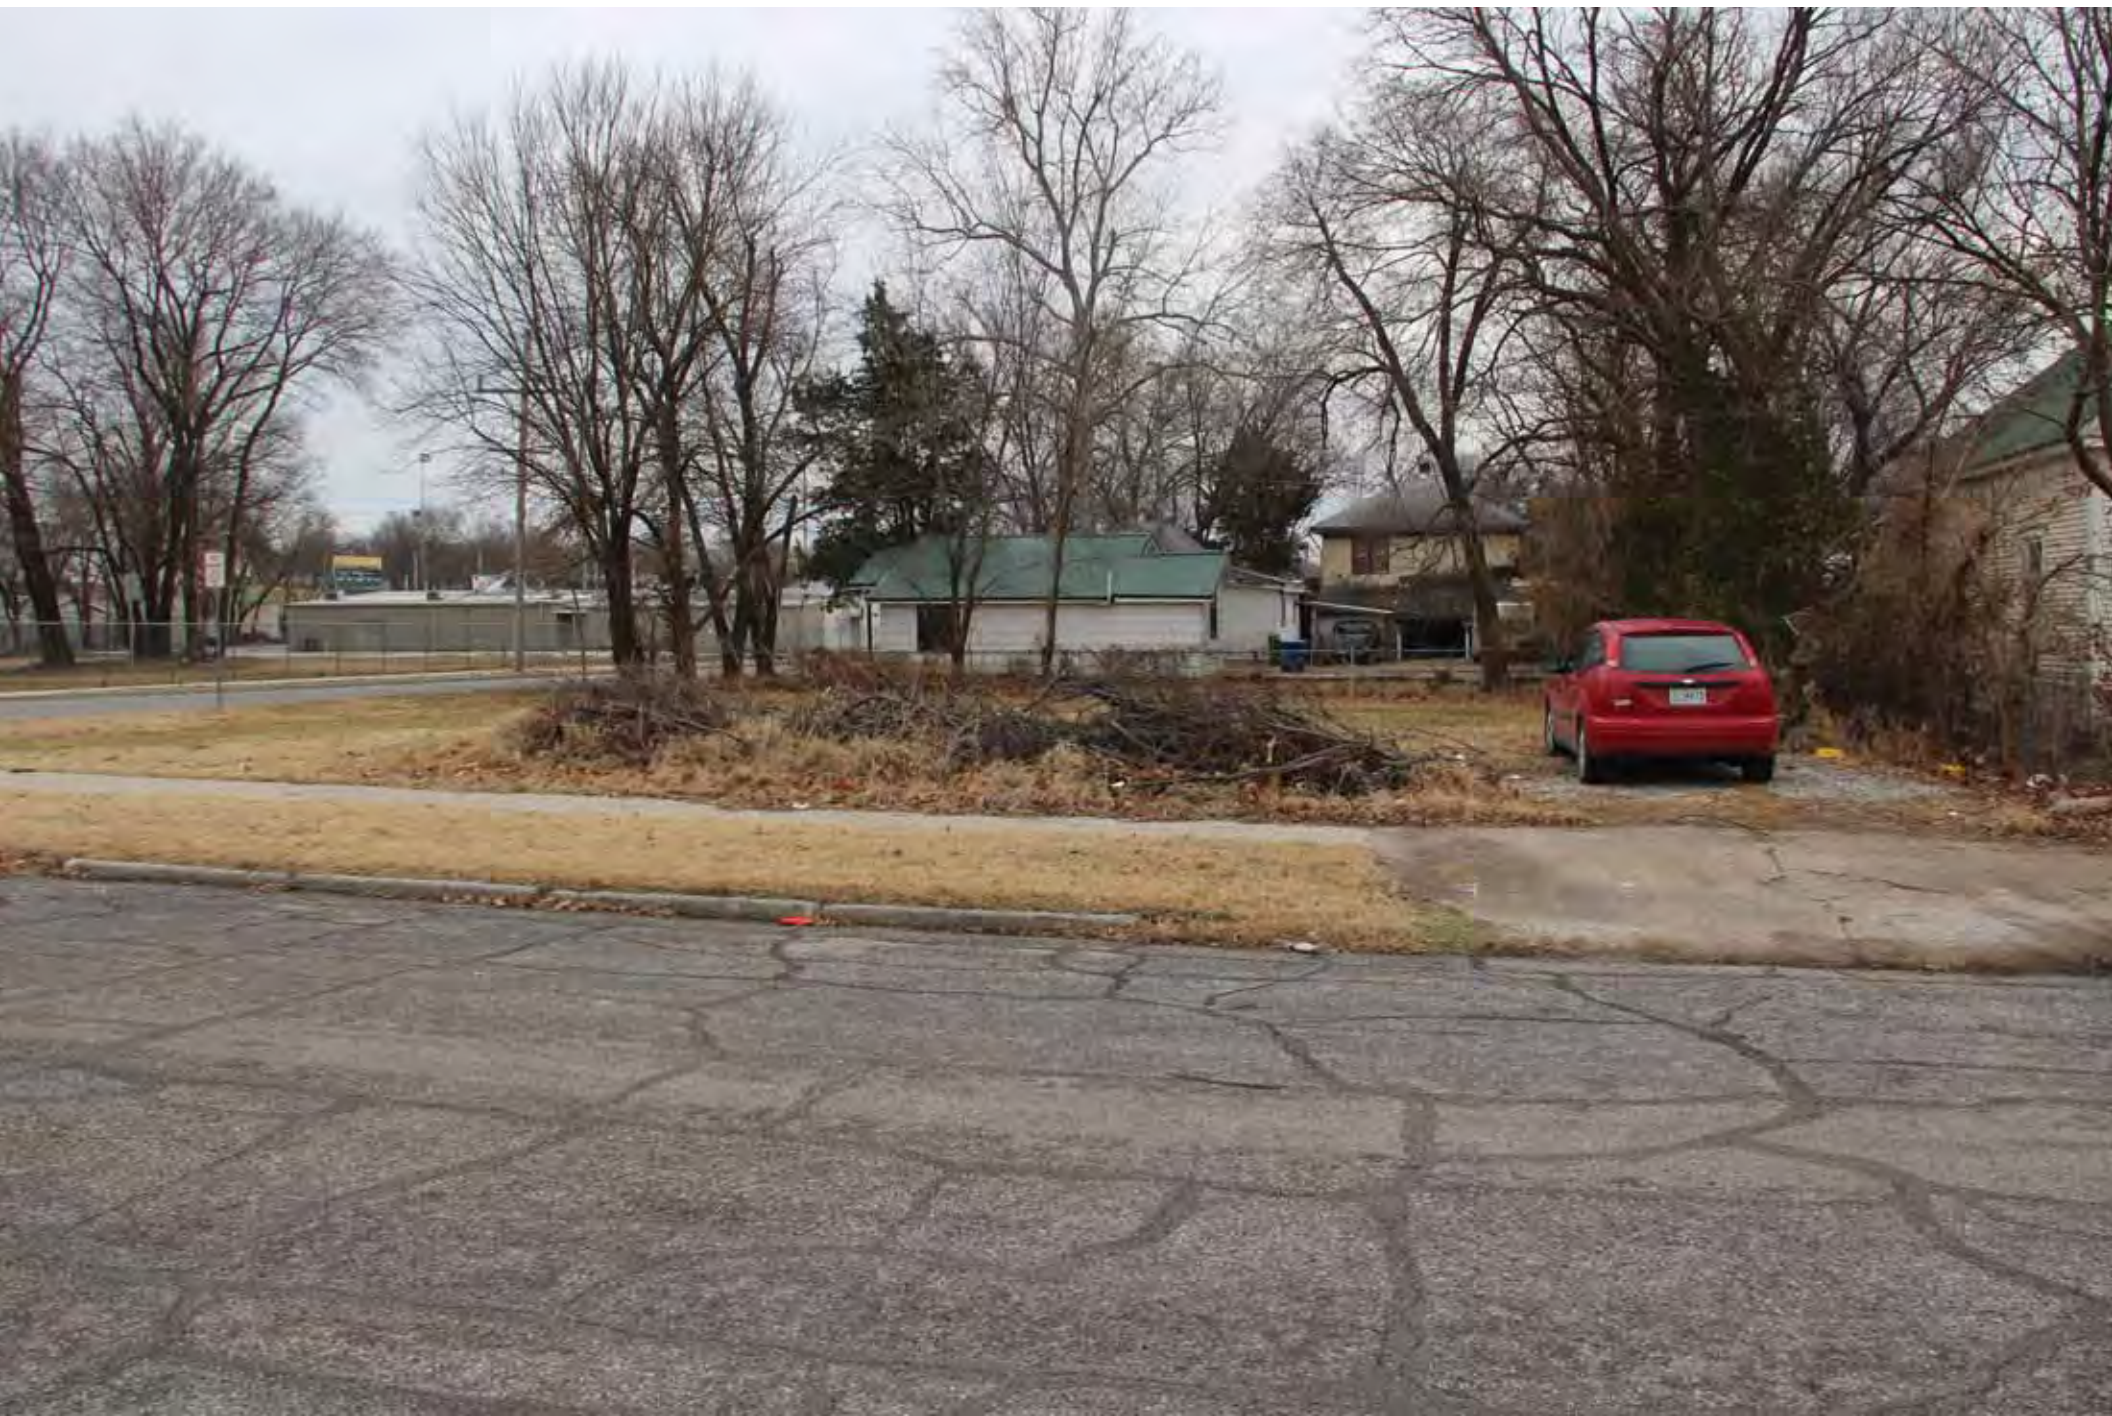
The property at 1212 E. Central Street is a vacant grassy lot that formerly held a single family dwelling. The lot is as described above.

Due to the removal of a dwelling (post 1950, date unknown), the lot does not retain integrity that would render it individually eligible for the National Register of Historic Places. The property is not situated in an area recommended as a historic district.
