MISSOURI DEPARTMENT OF NATURAL RESOURCES
STATE HISTORIC PRESERVATION OFFICE, P.O. Box 176, Jefferson City, MO 65102
ARCHITECTURAL/HISTORIC INVENTORY FORM

1. Survey No. JP-AS-007-001		2. Survey name: East Town (Original Joplin) Historic Survey Phase 2	
3. County: JASPER		4. Address (Street No.) 618	Street (name) E. 2 nd Street
5. City: Joplin	Vicinity: <input type="checkbox"/>	6. Geographical Reference:	7. Township/Range/Section: T: R: S:
8. Historic name (if known):		9. Present/other name (if known):	
10. Ownership: <input checked="" type="checkbox"/> Private <input type="checkbox"/> Public		11a. Historic use (if known): Domestic: Single Dwelling	11b. Current use: Domestic: Single Dwelling

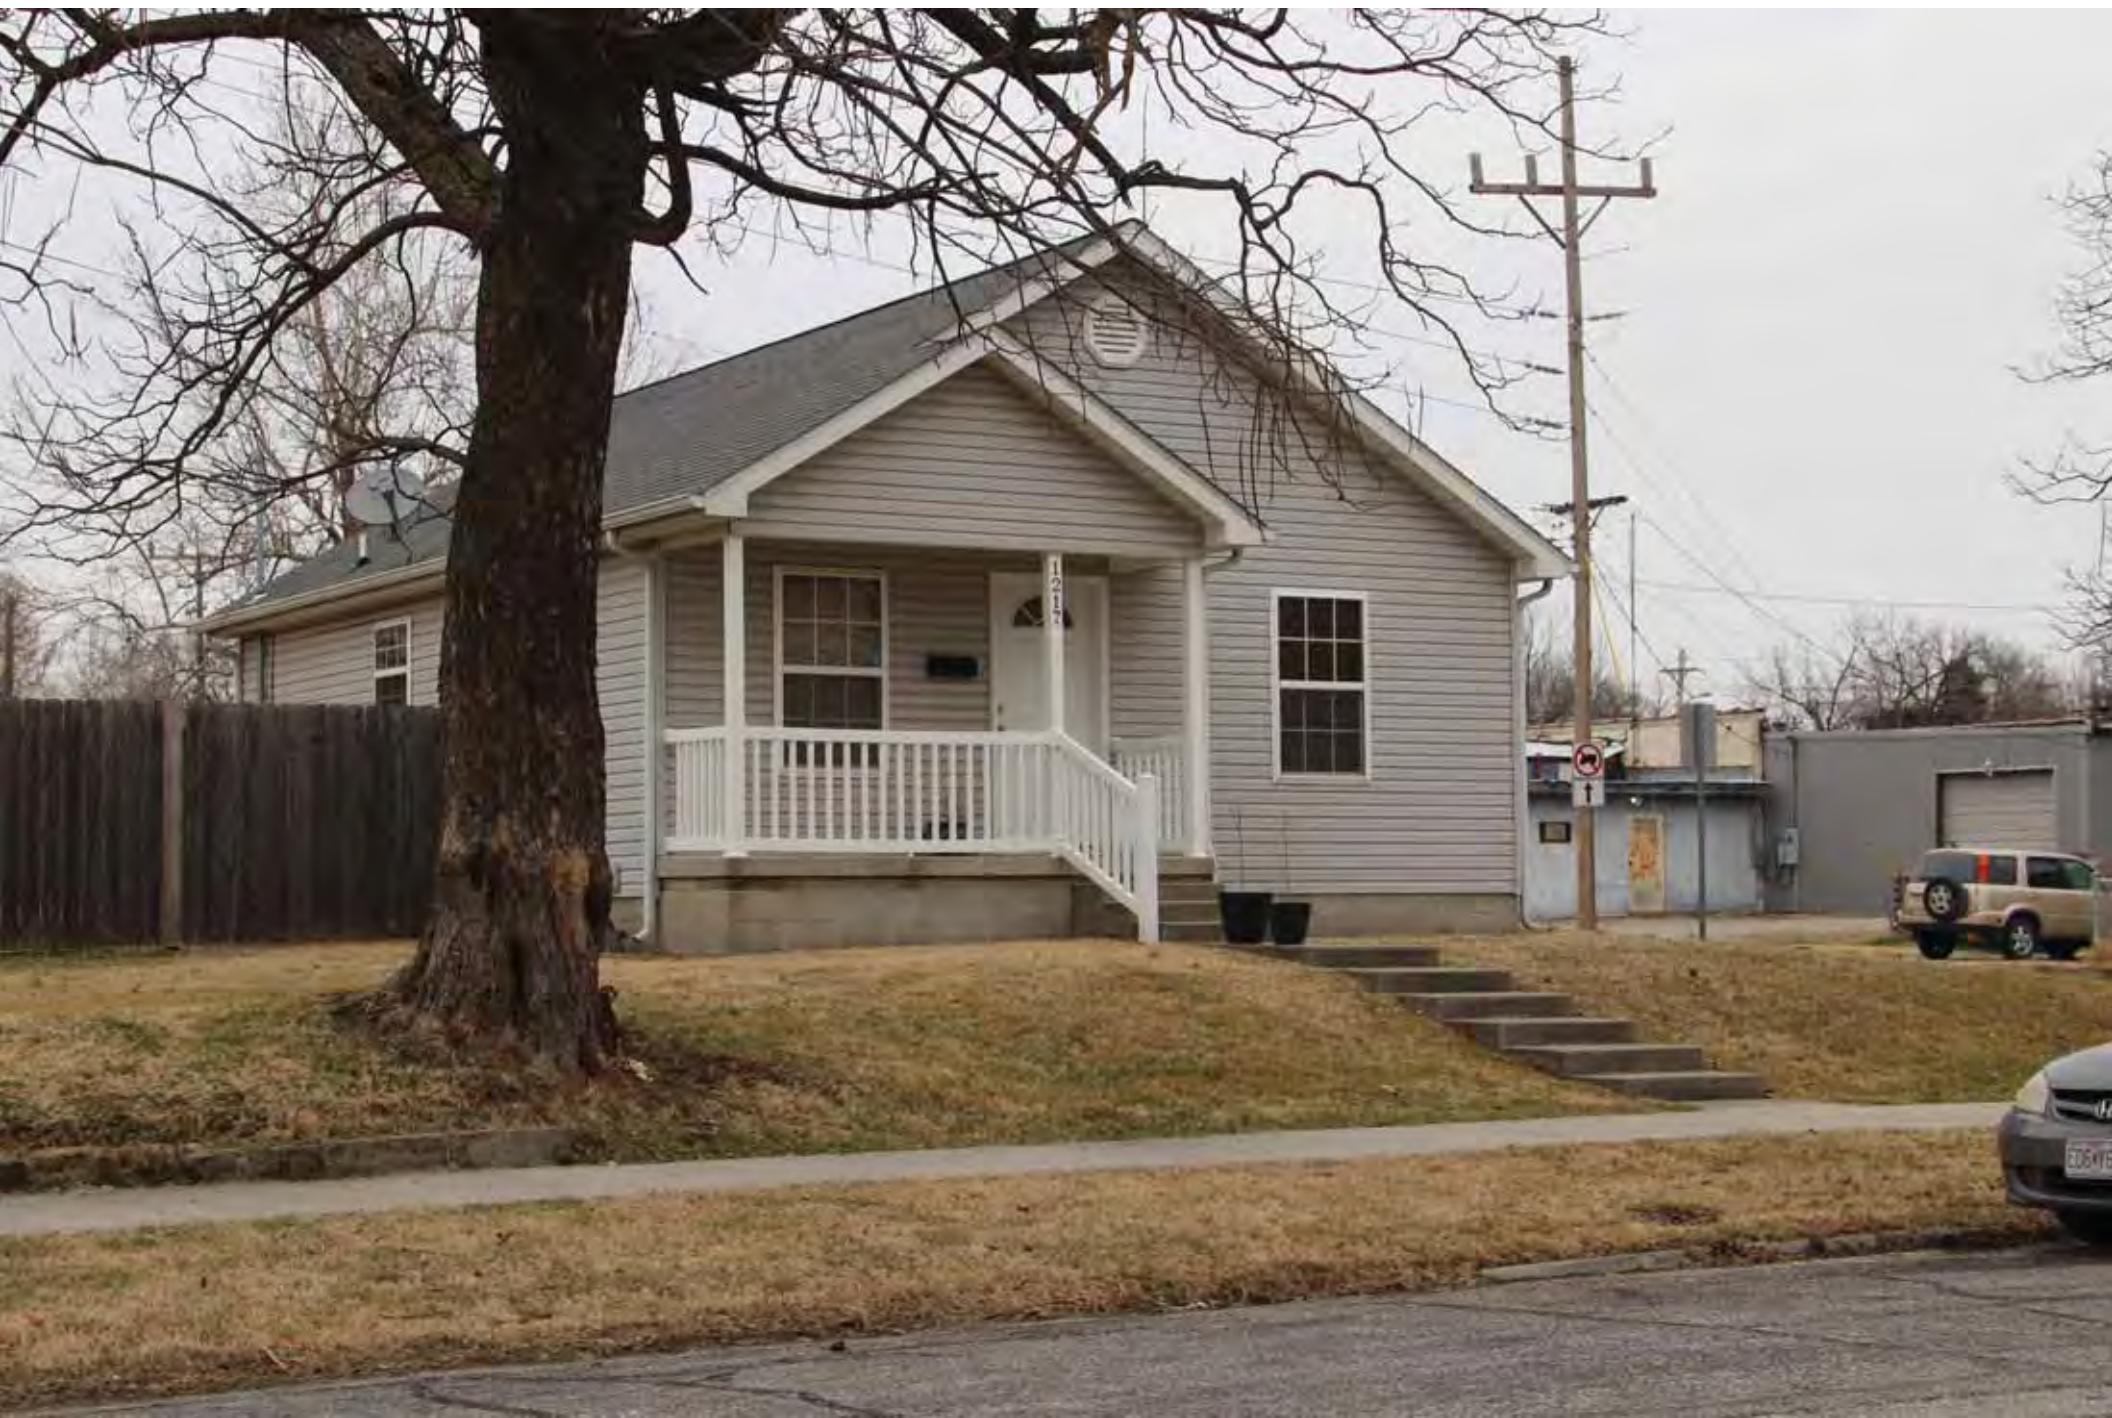
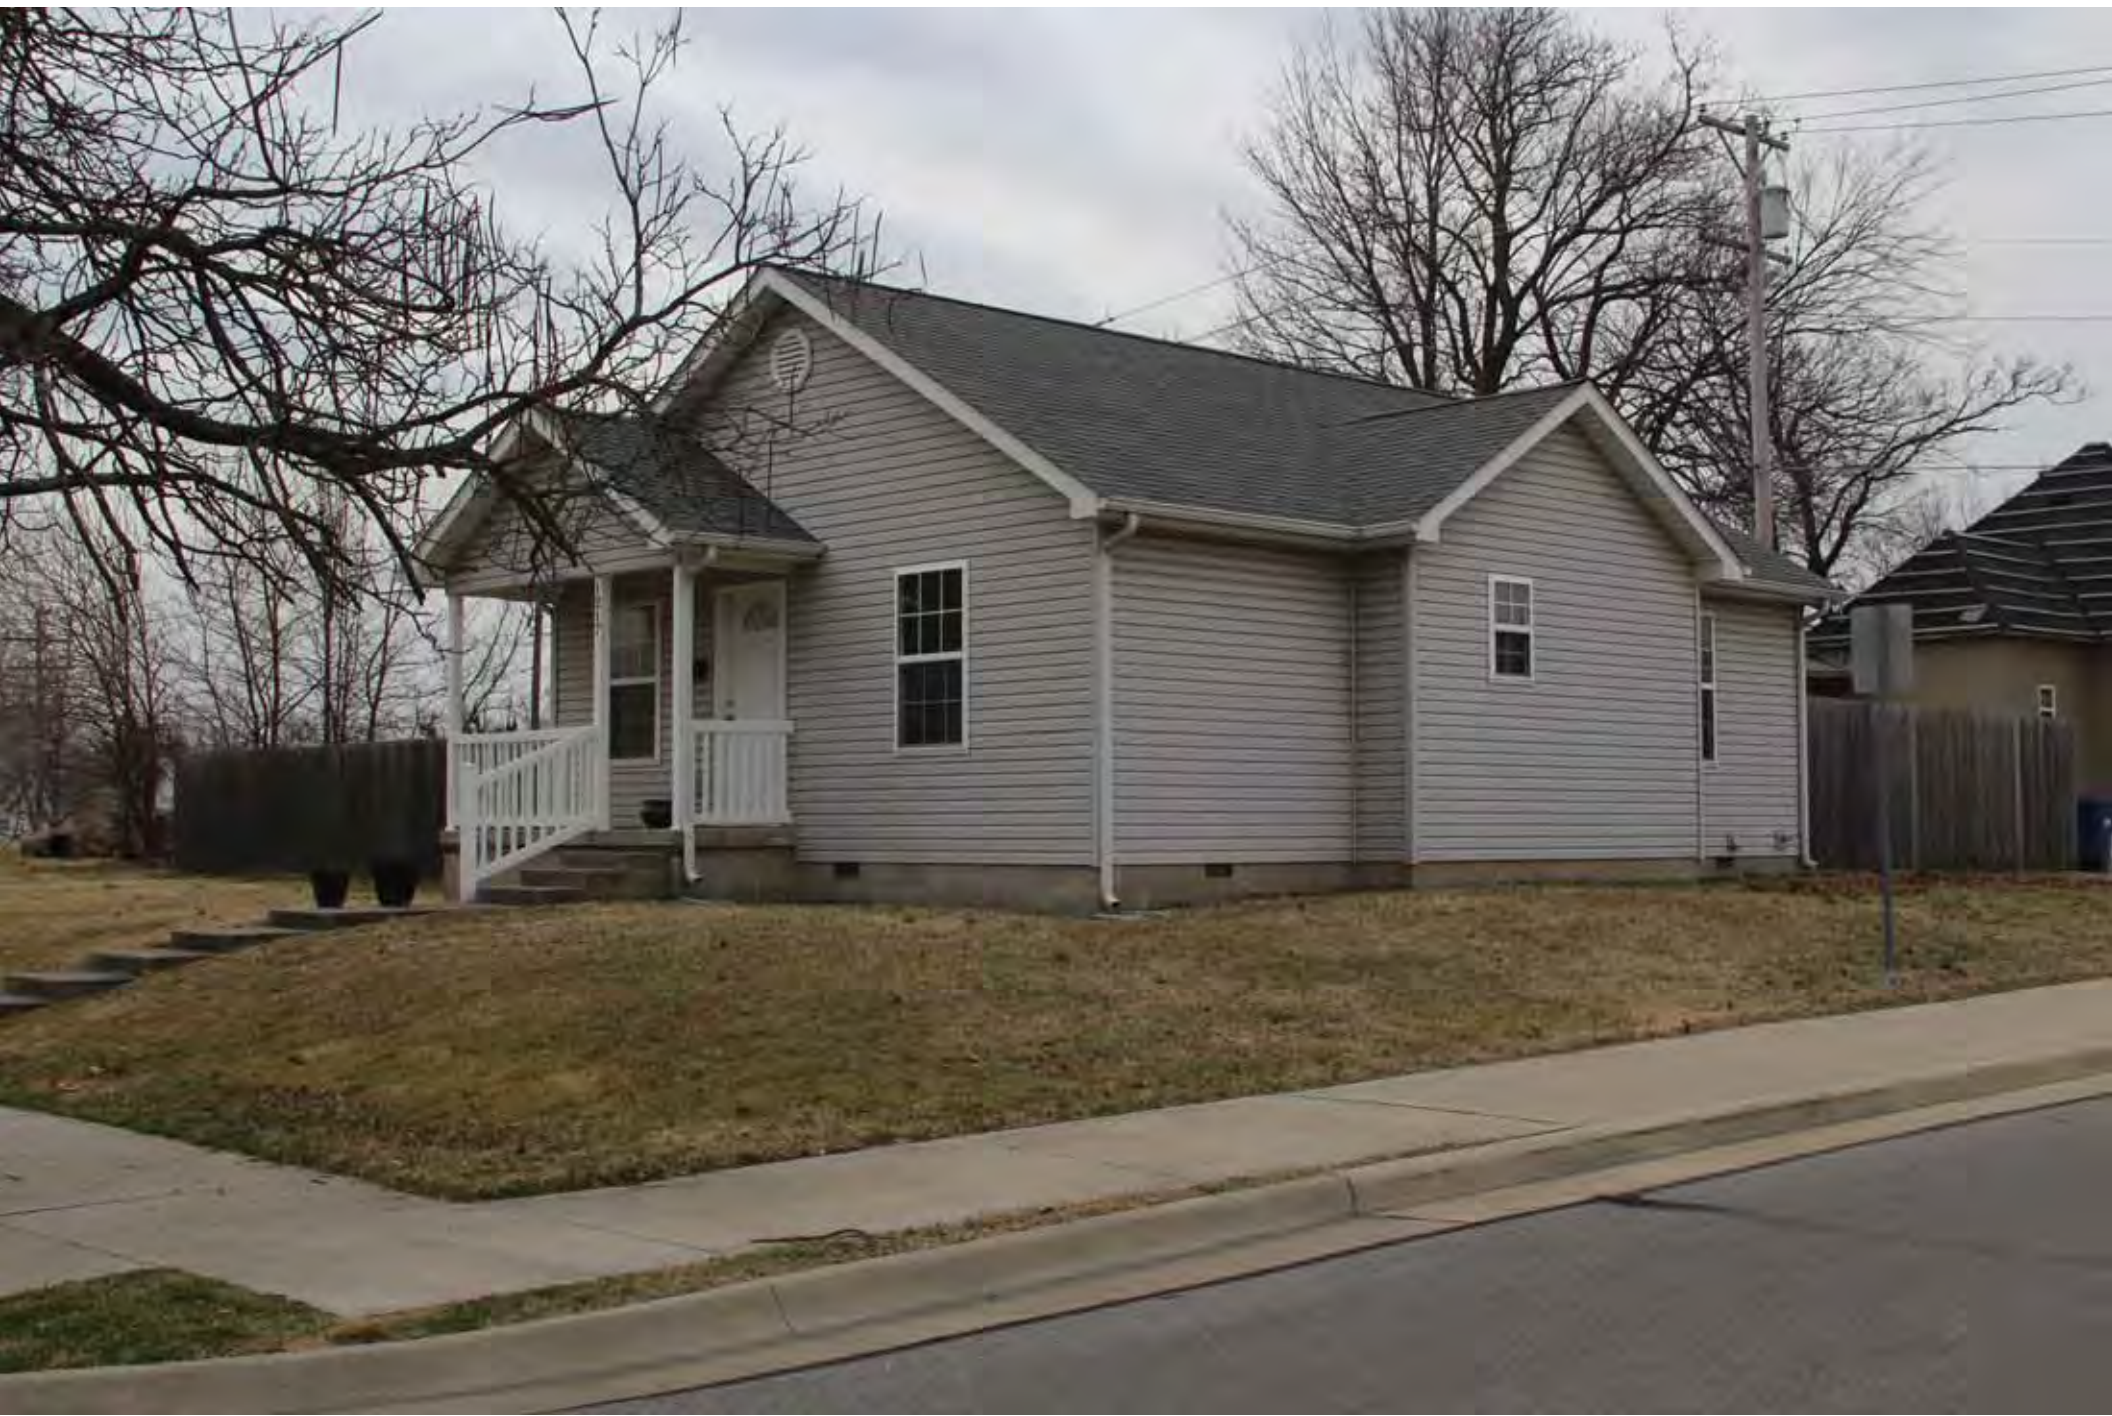
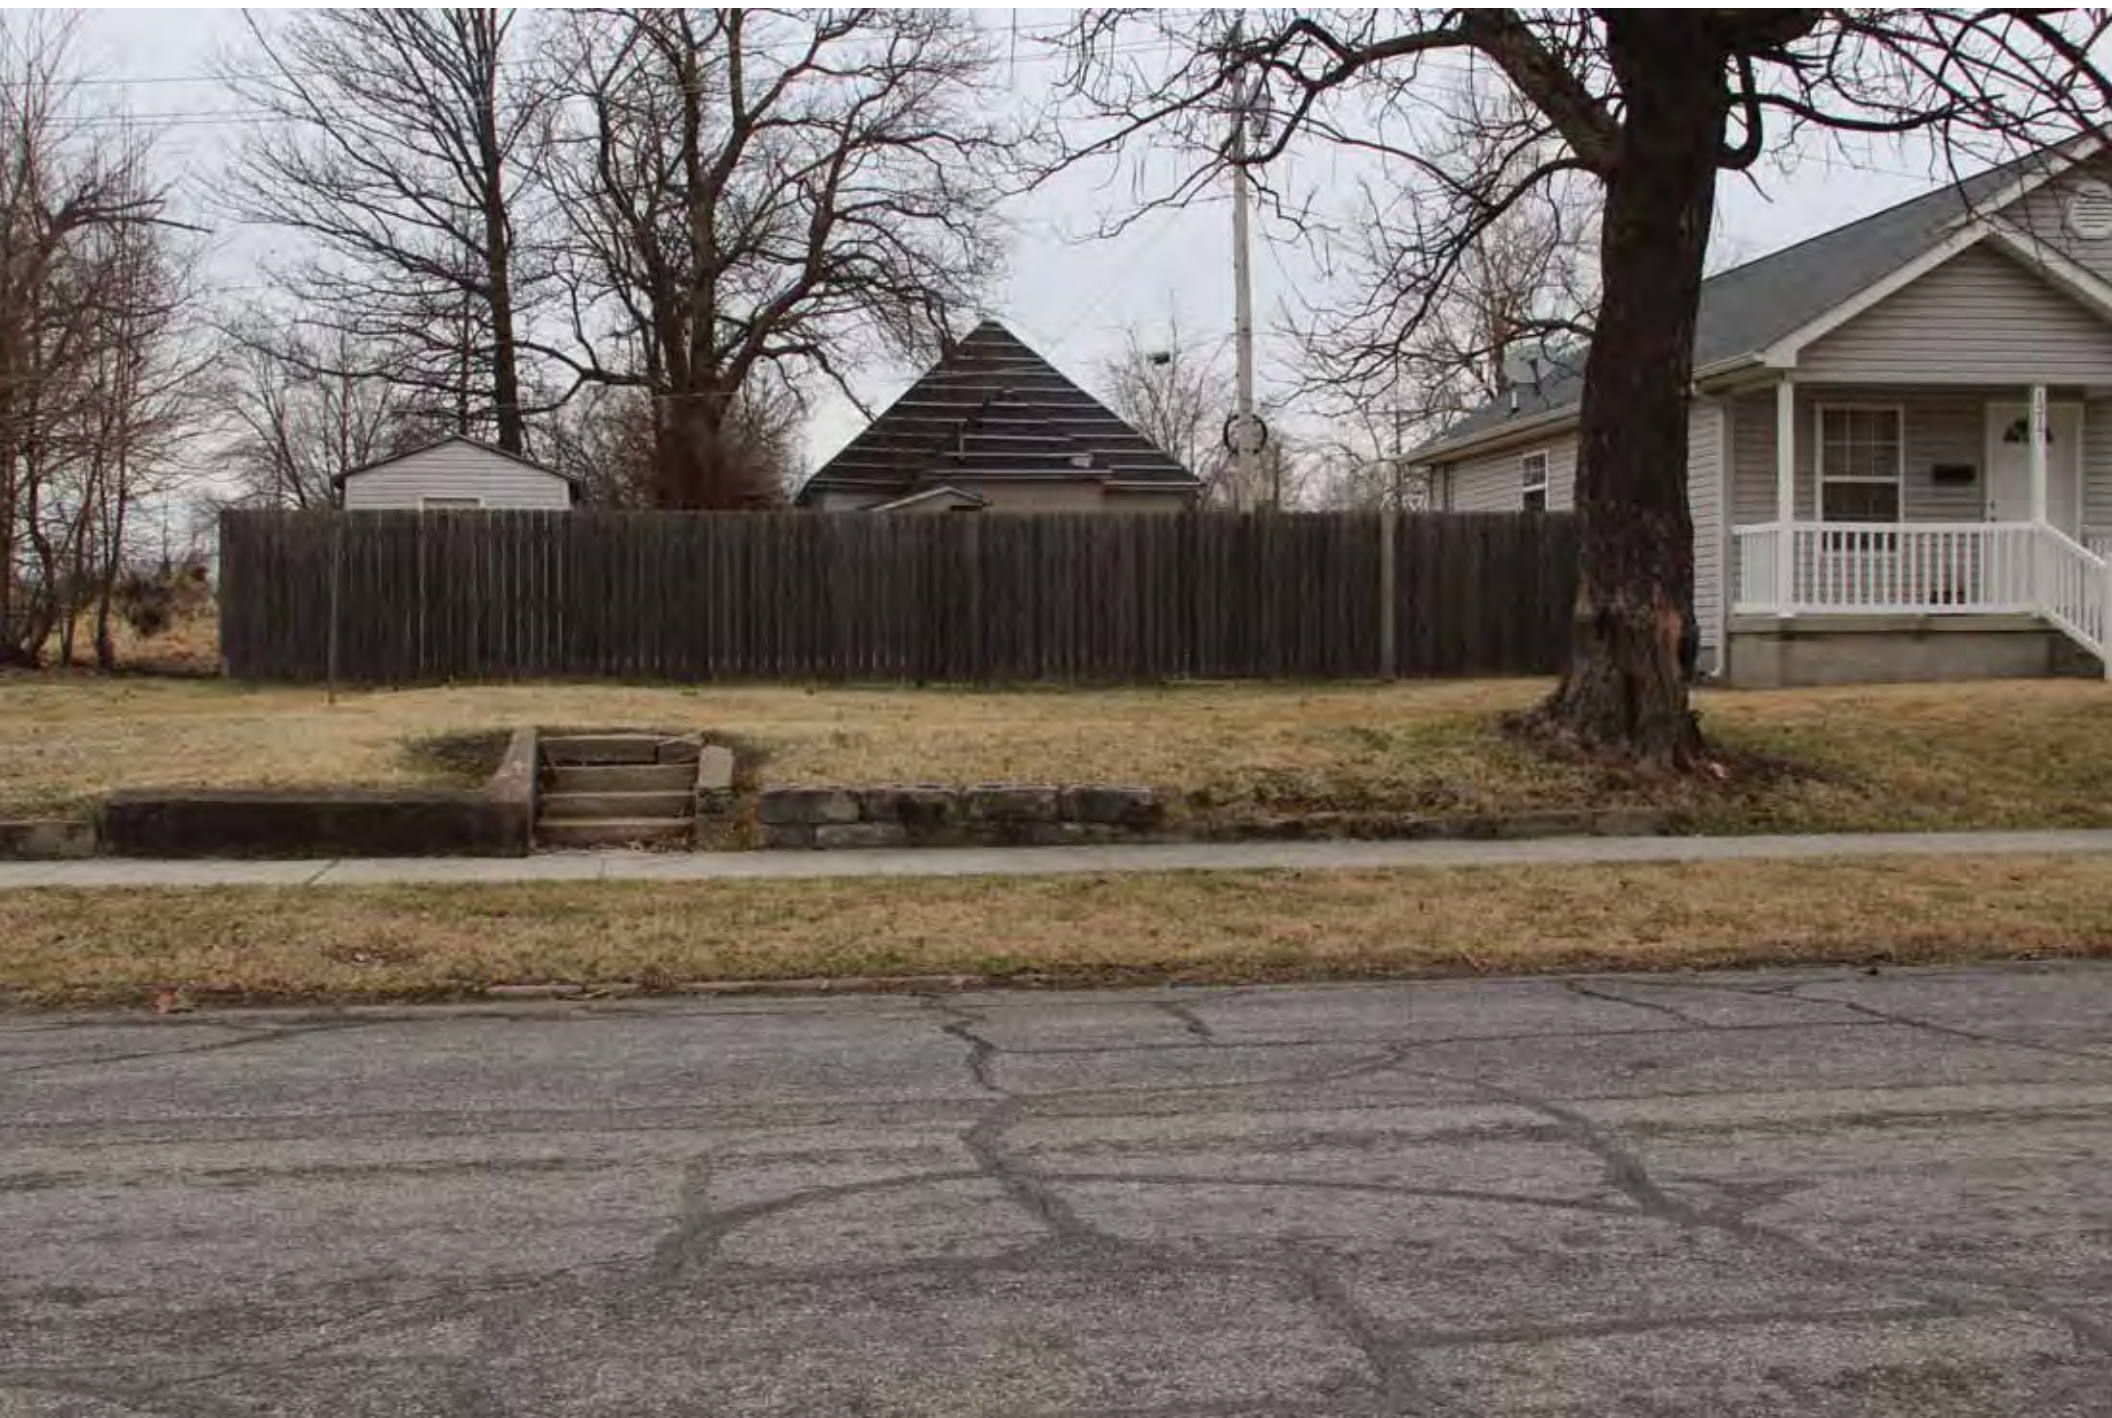
The property at 1217 E. Central Street features a gable-front plan single-story dwelling with an asphalt-shingled gabled roof, exterior vinyl siding and a concrete block foundation. On the primary (south) elevation is an off-center gabled porch supported by three columns. The porch has a vinyl balustrade and a concrete block foundation. Within the porch bay is a paneled door with an upper fanlight. The door is flanked by six-over-six windows. The front gable field holds an octagonal louvered vent. Side elevations (east and west) feature single six-over-six windows. The east elevation (facing S. High Avenue) has a projecting gabled bay with a small four-over-four window.

This dwelling is a common property type that is less than 50 years of age and does not exhibit features or historical associations of exceptional significance. The dwelling is not within an area recommended as a historic district. For these reasons, the property is not eligible for the National Register of Historic Places.
