MISSOURI DEPARTMENT OF NATURAL RESOURCES
STATE HISTORIC PRESERVATION OFFICE, P.O. Box 176, Jefferson City, MO 65102
ARCHITECTURAL/HISTORIC INVENTORY FORM

1. Survey No. JP-AS-007-001		2. Survey name: East Town (Original Joplin) Historic Survey Phase 2	
3. County: JASPER		4. Address (Street No.) 618	Street (name) E. 2 nd Street
5. City: Joplin	Vicinity: <input type="checkbox"/>	6. Geographical Reference:	7. Township/Range/Section: T: R: S:
8. Historic name (if known):		9. Present/other name (if known):	
10. Ownership: <input checked="" type="checkbox"/> Private <input type="checkbox"/> Public		11a. Historic use (if known): Domestic: Single Dwelling	11b. Current use: Domestic: Single Dwelling

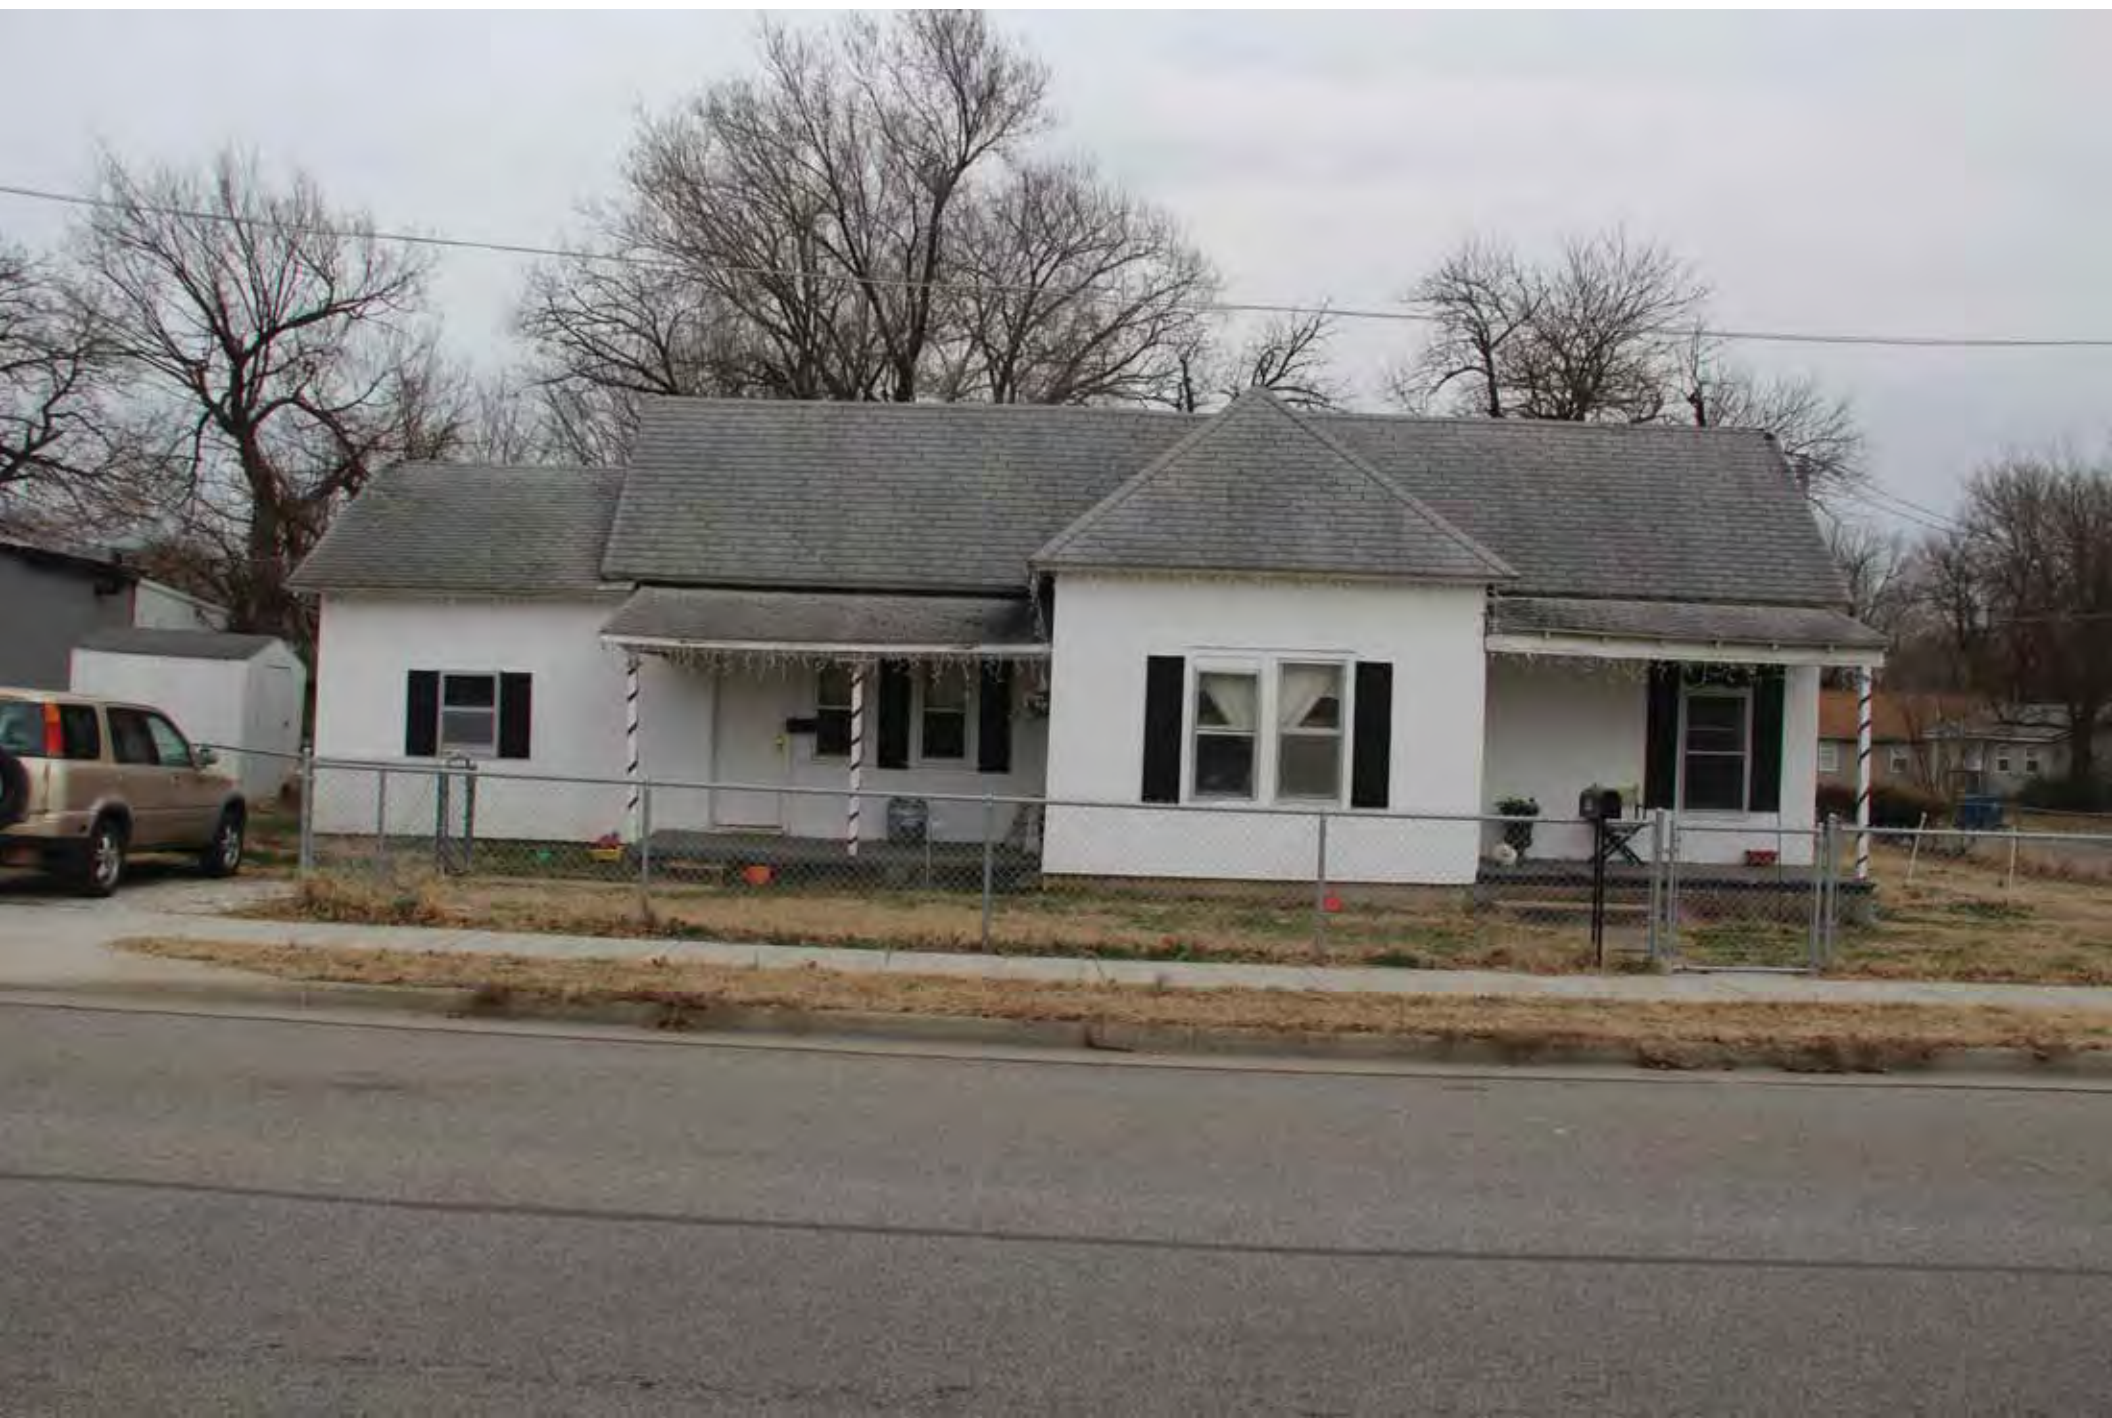
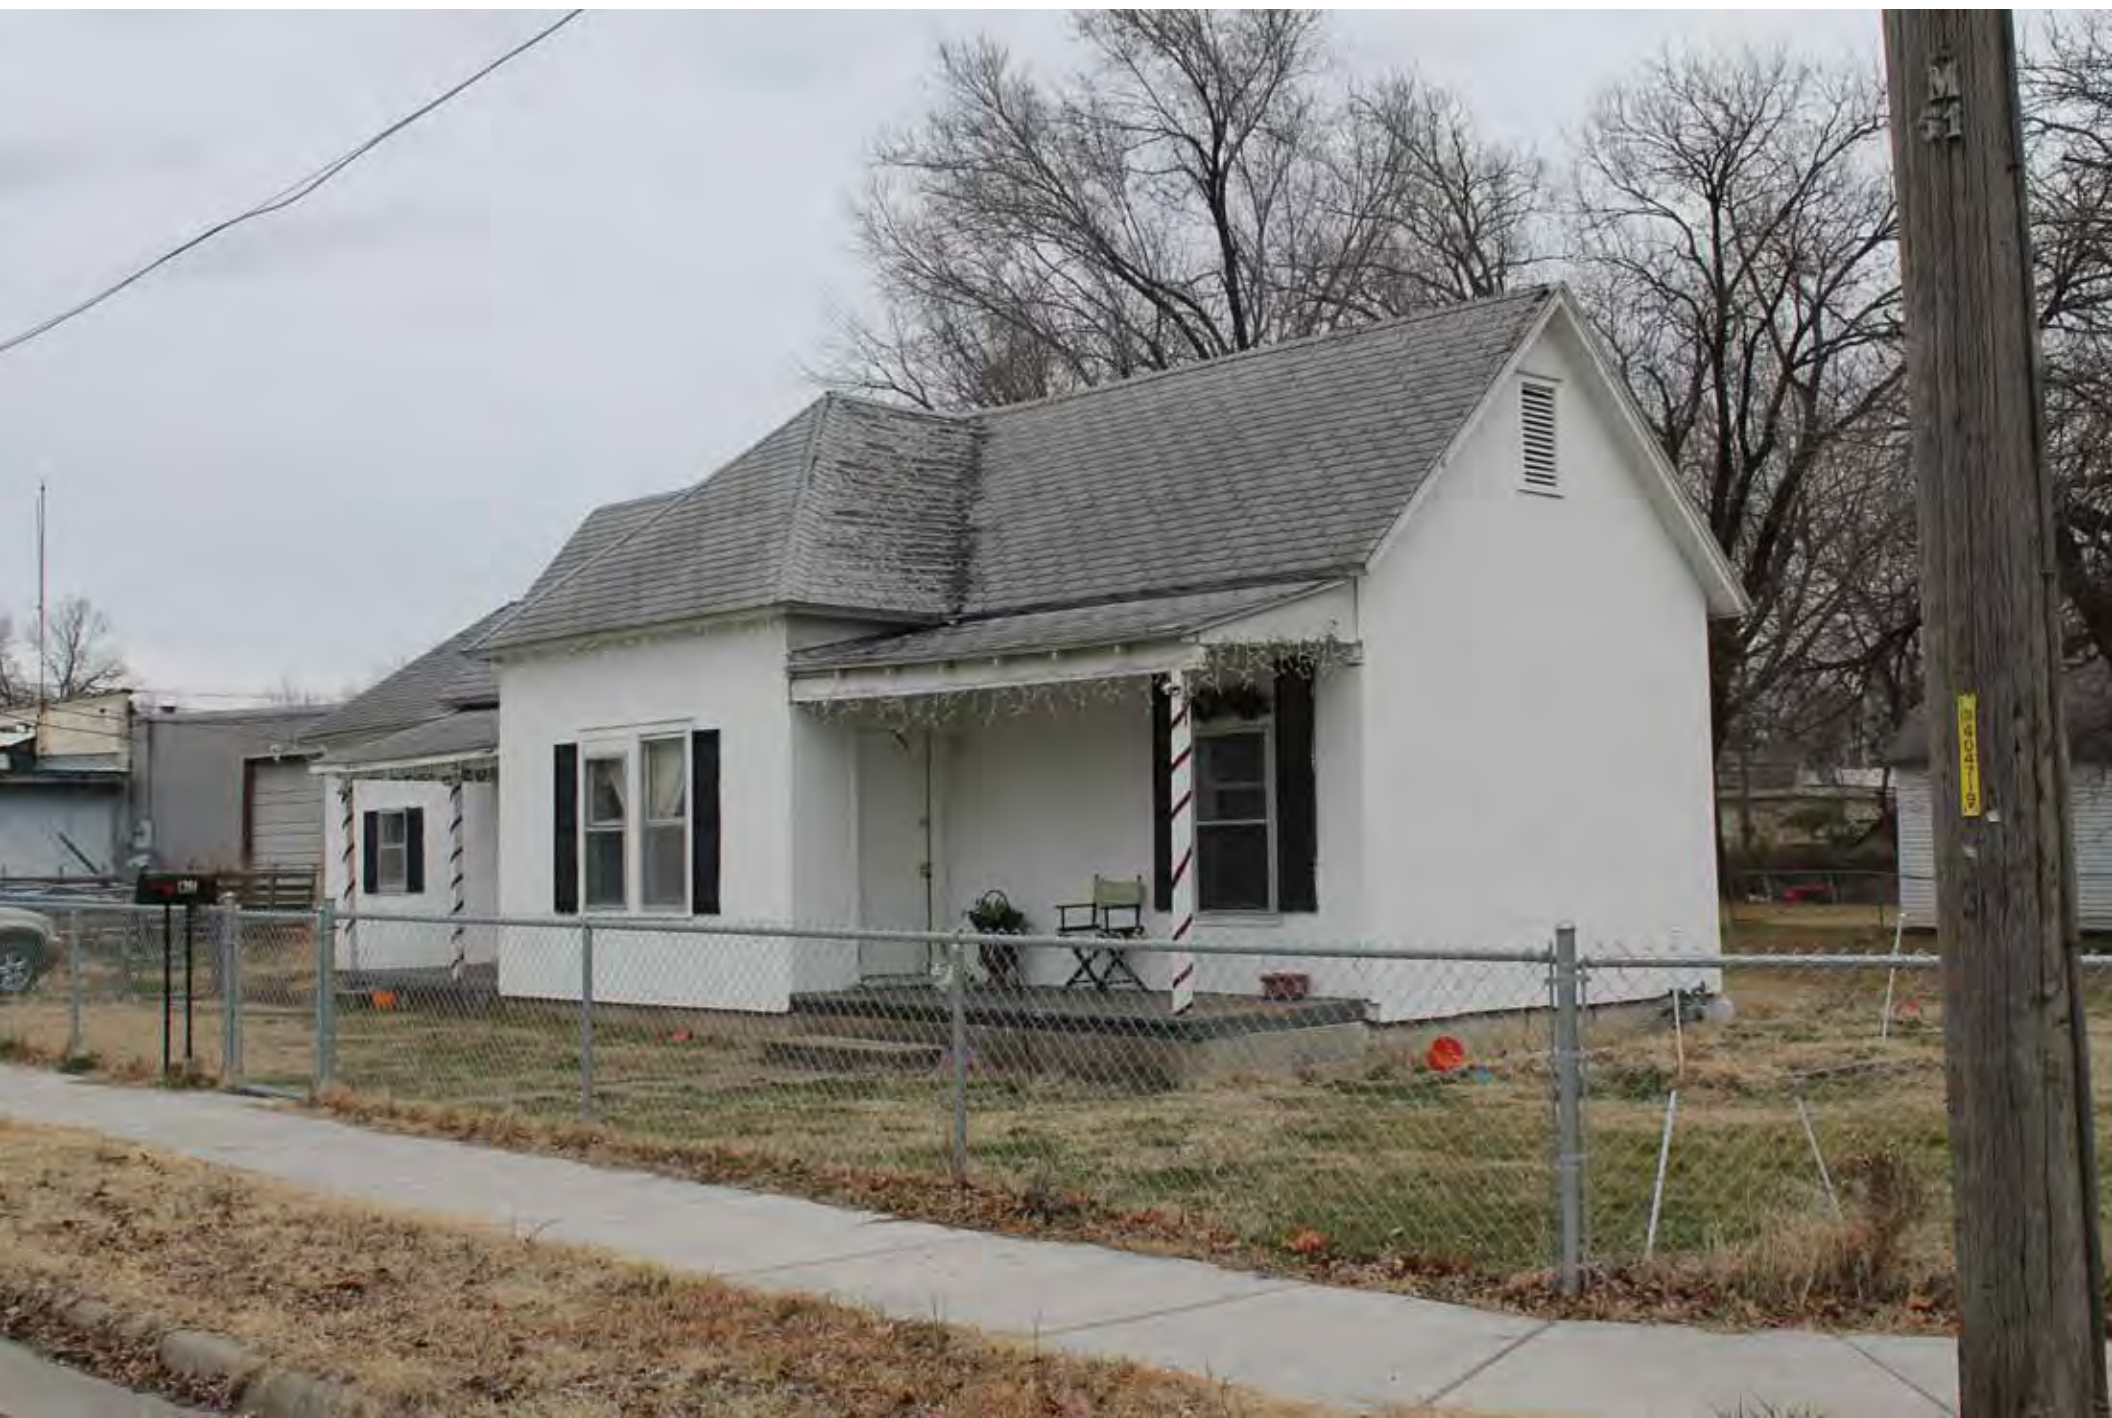
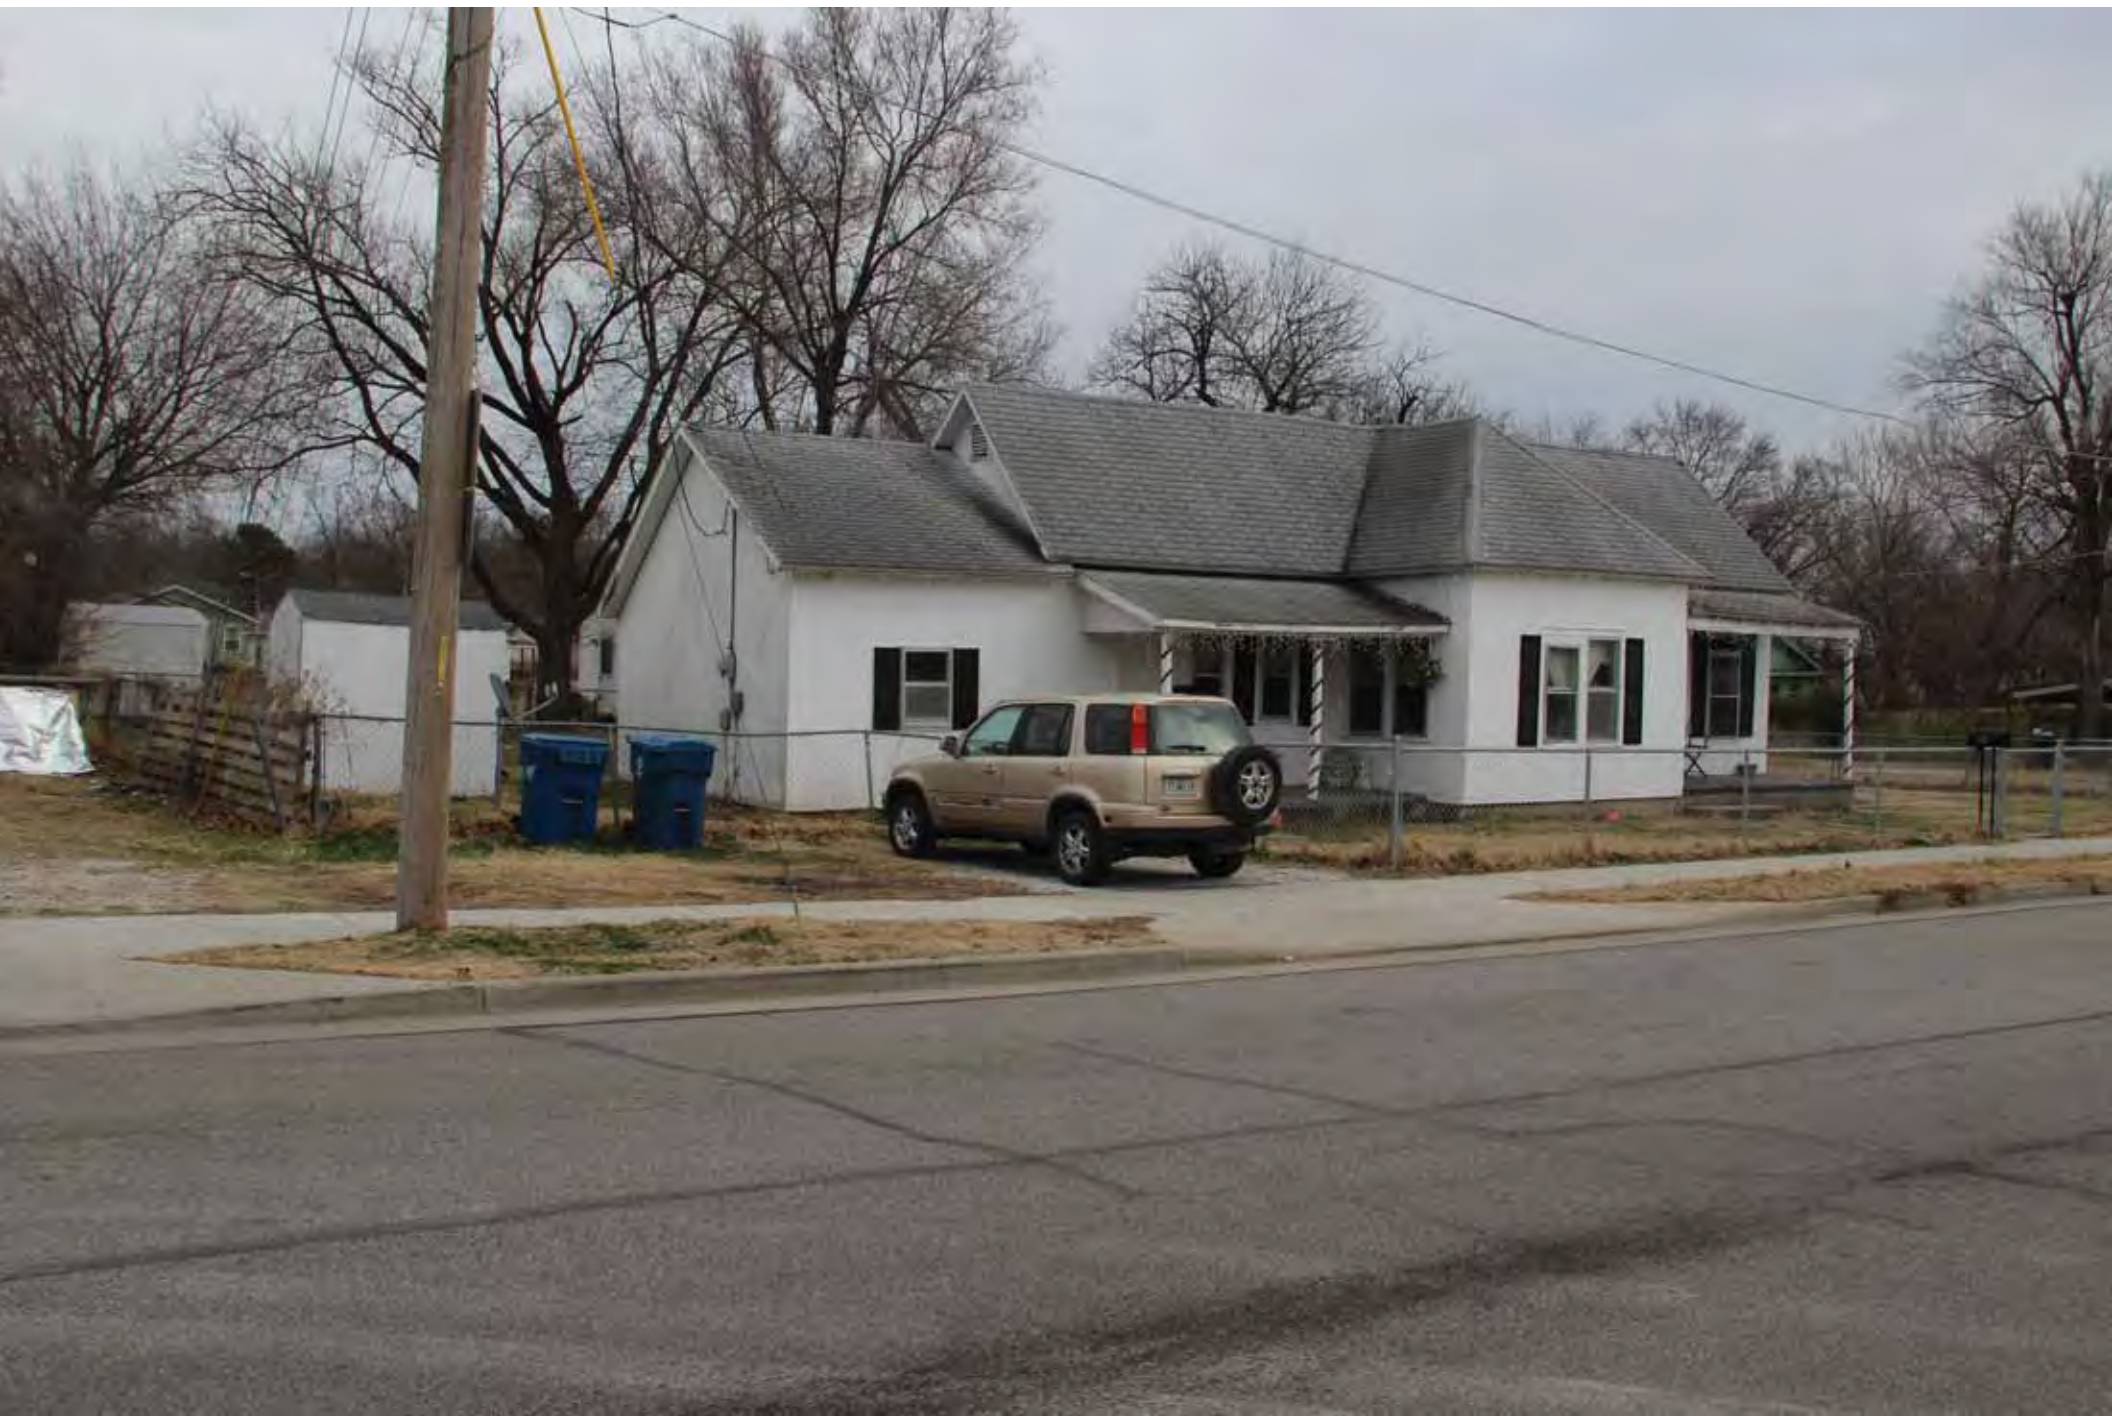
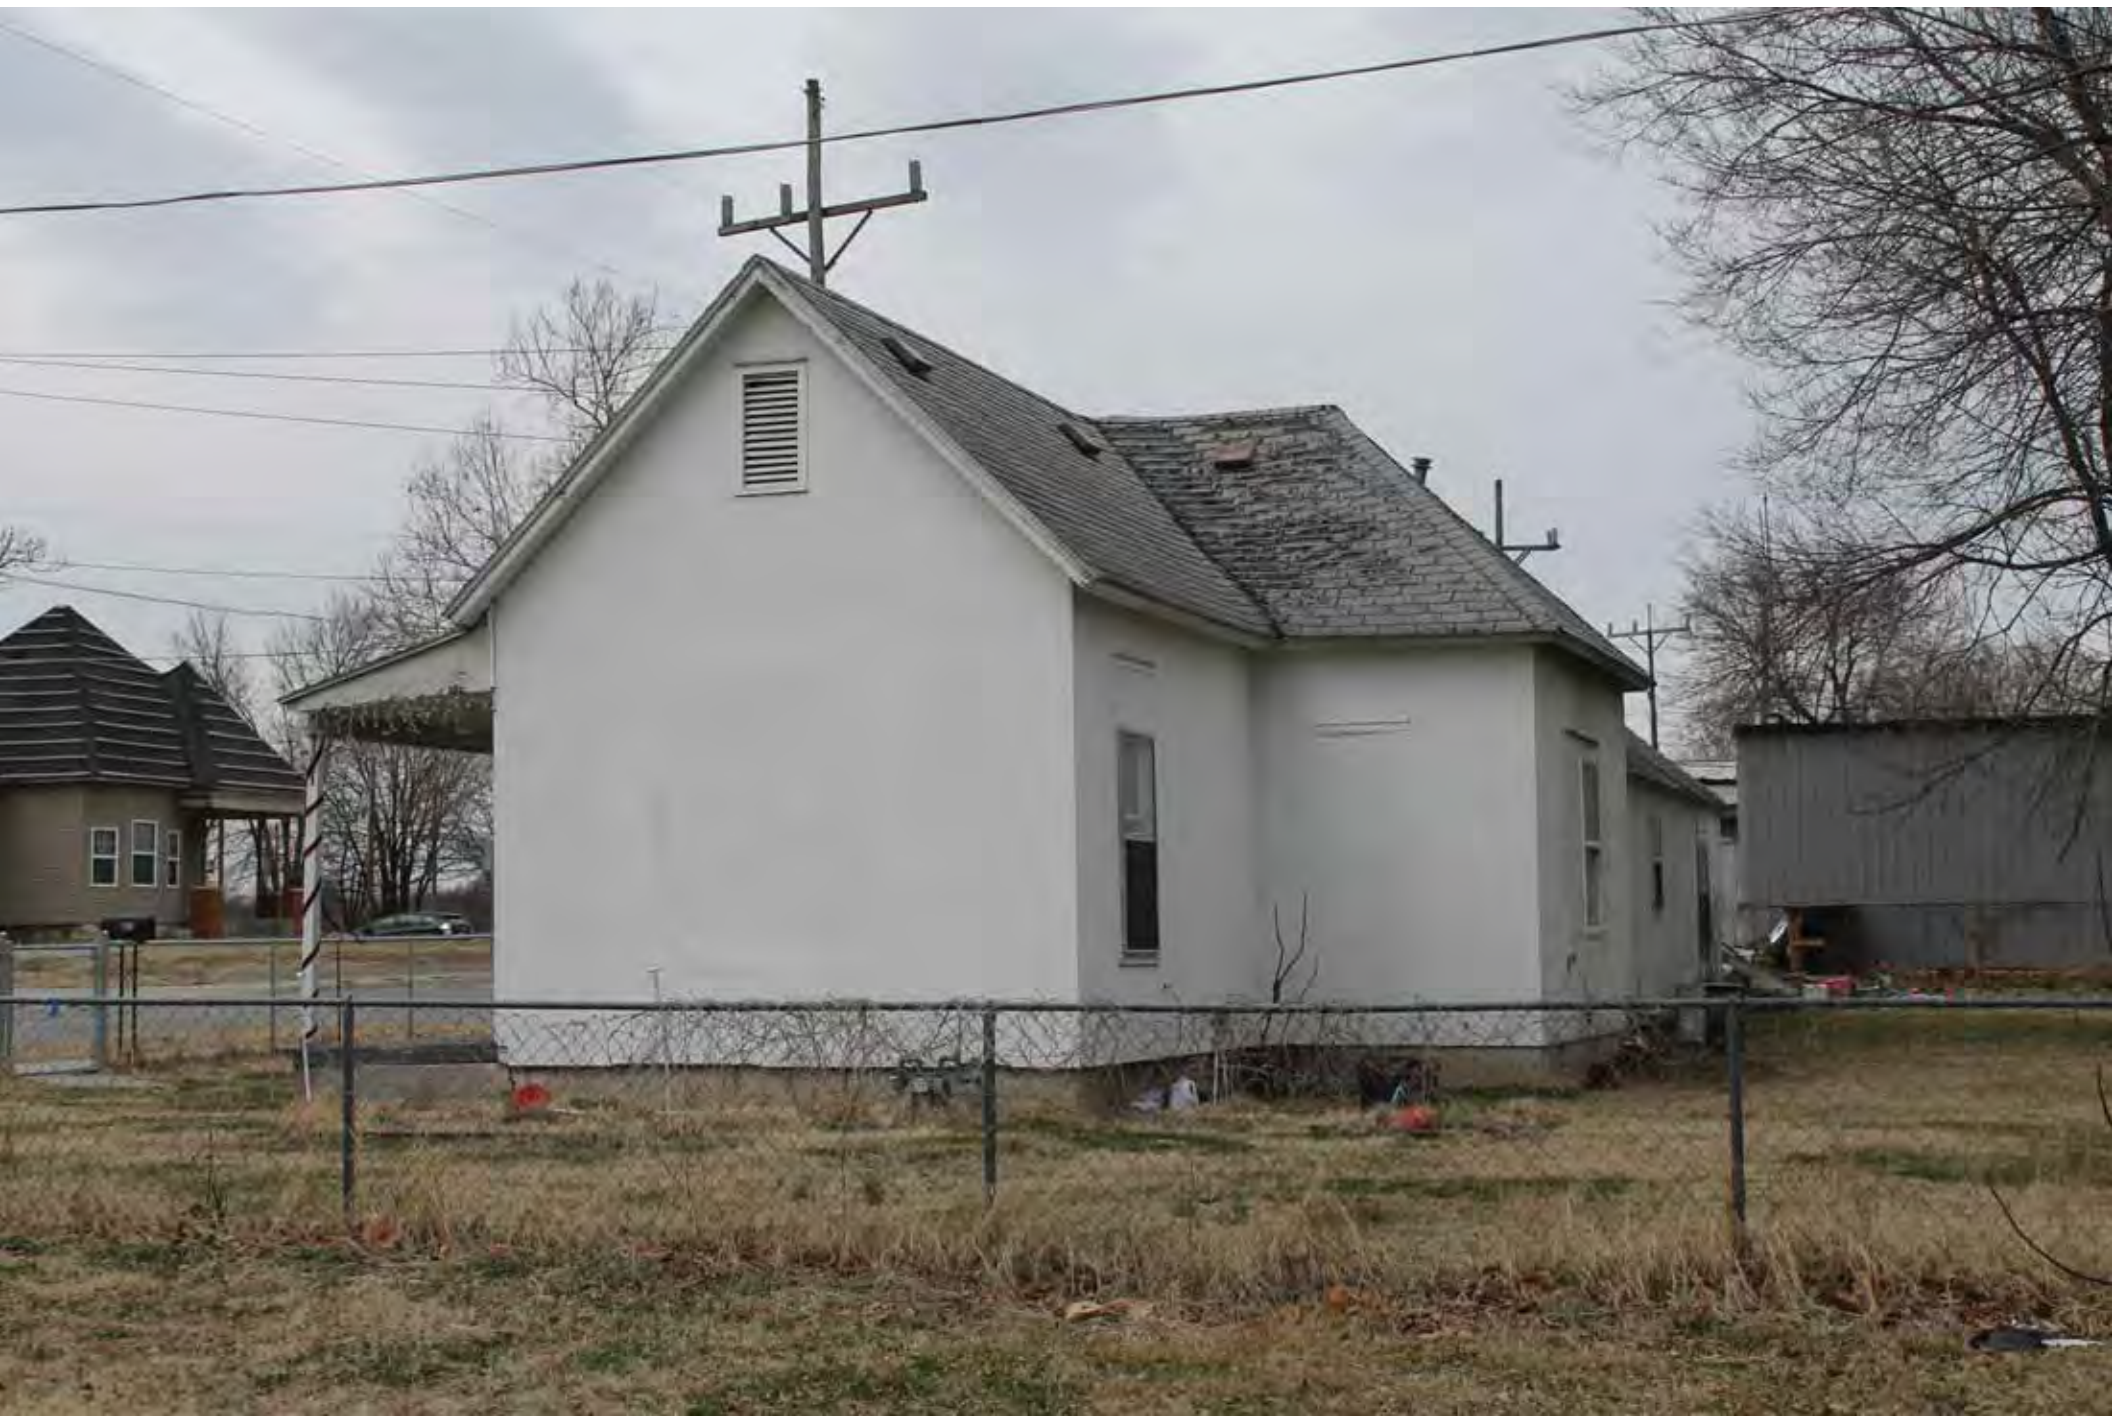
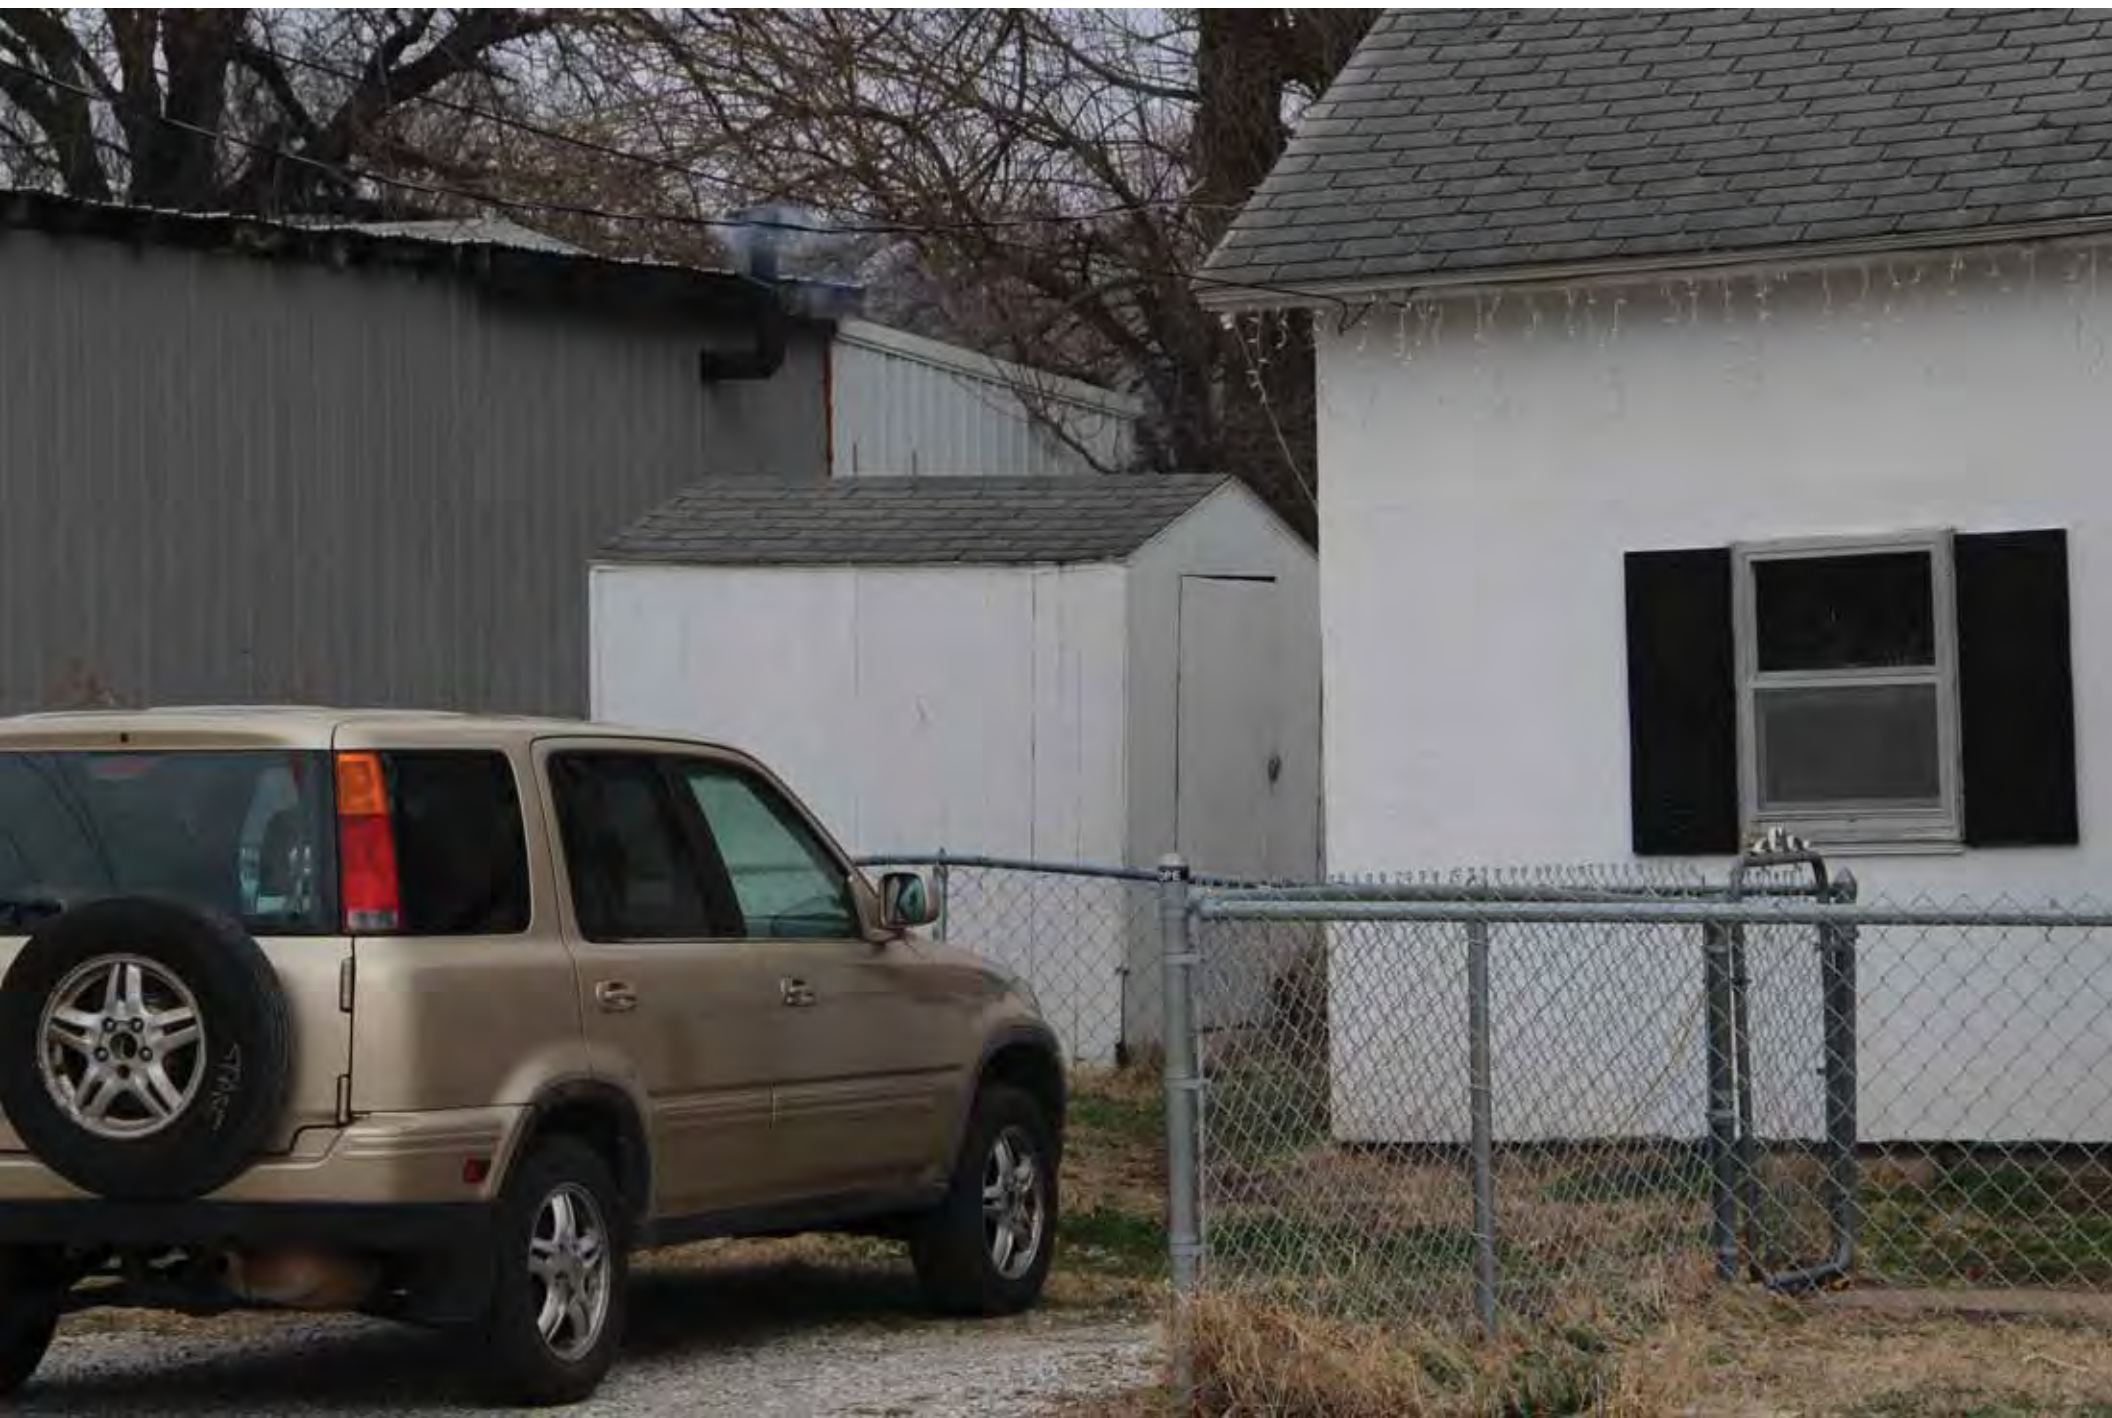
The property at 1301 E. Central Street features an end-gabled plan dwelling with a central cross-hipped wing. The west elevation, which faces S. High Avenue, appears to be the façade. There is no fenestration – other than a louvered vent in the gable field – on the south elevation facing E. Central Street. The dwelling is clad with stucco that does not appear original (c. 1980). The foundation is concrete block and the roof is covered with asphalt shingles. Flanking the west elevation's central hipped wing are shed porches. Within the south porch, a solid wood door faces south. Offsetting the entry on the west wall within the porch is a one-over-one window with faux shutters. This window and others (including one on the east elevation) appear to have had original transoms that have been covered. The west elevation's north shed porch holds a solid wood door on the west wall. Offsetting this entry bay are paired one-over-one windows. The west elevation of the central hipped wing features paired one-over-one windows with faux shutters. At the north end of the dwelling is a gabled wing. The west elevation of the wing holds a small one-over-one window with faux shutters. There is no fenestration on the north elevation. The rear (east) elevation has multiple windows and a secondary entry near the north end of the dwelling. One window bay on the rear wing's south elevation has been covered with stucco.

This dwelling is an altered early twentieth-century dwelling that does not exhibit significant architectural (Criterion C) features. Research failed to associate the property with any important person (Criterion B) or historical event(s) (Criterion A). The dwelling is not in an area recommended as a historic district. For these reasons, the property does not appear eligible for the National Register of Historic Places.

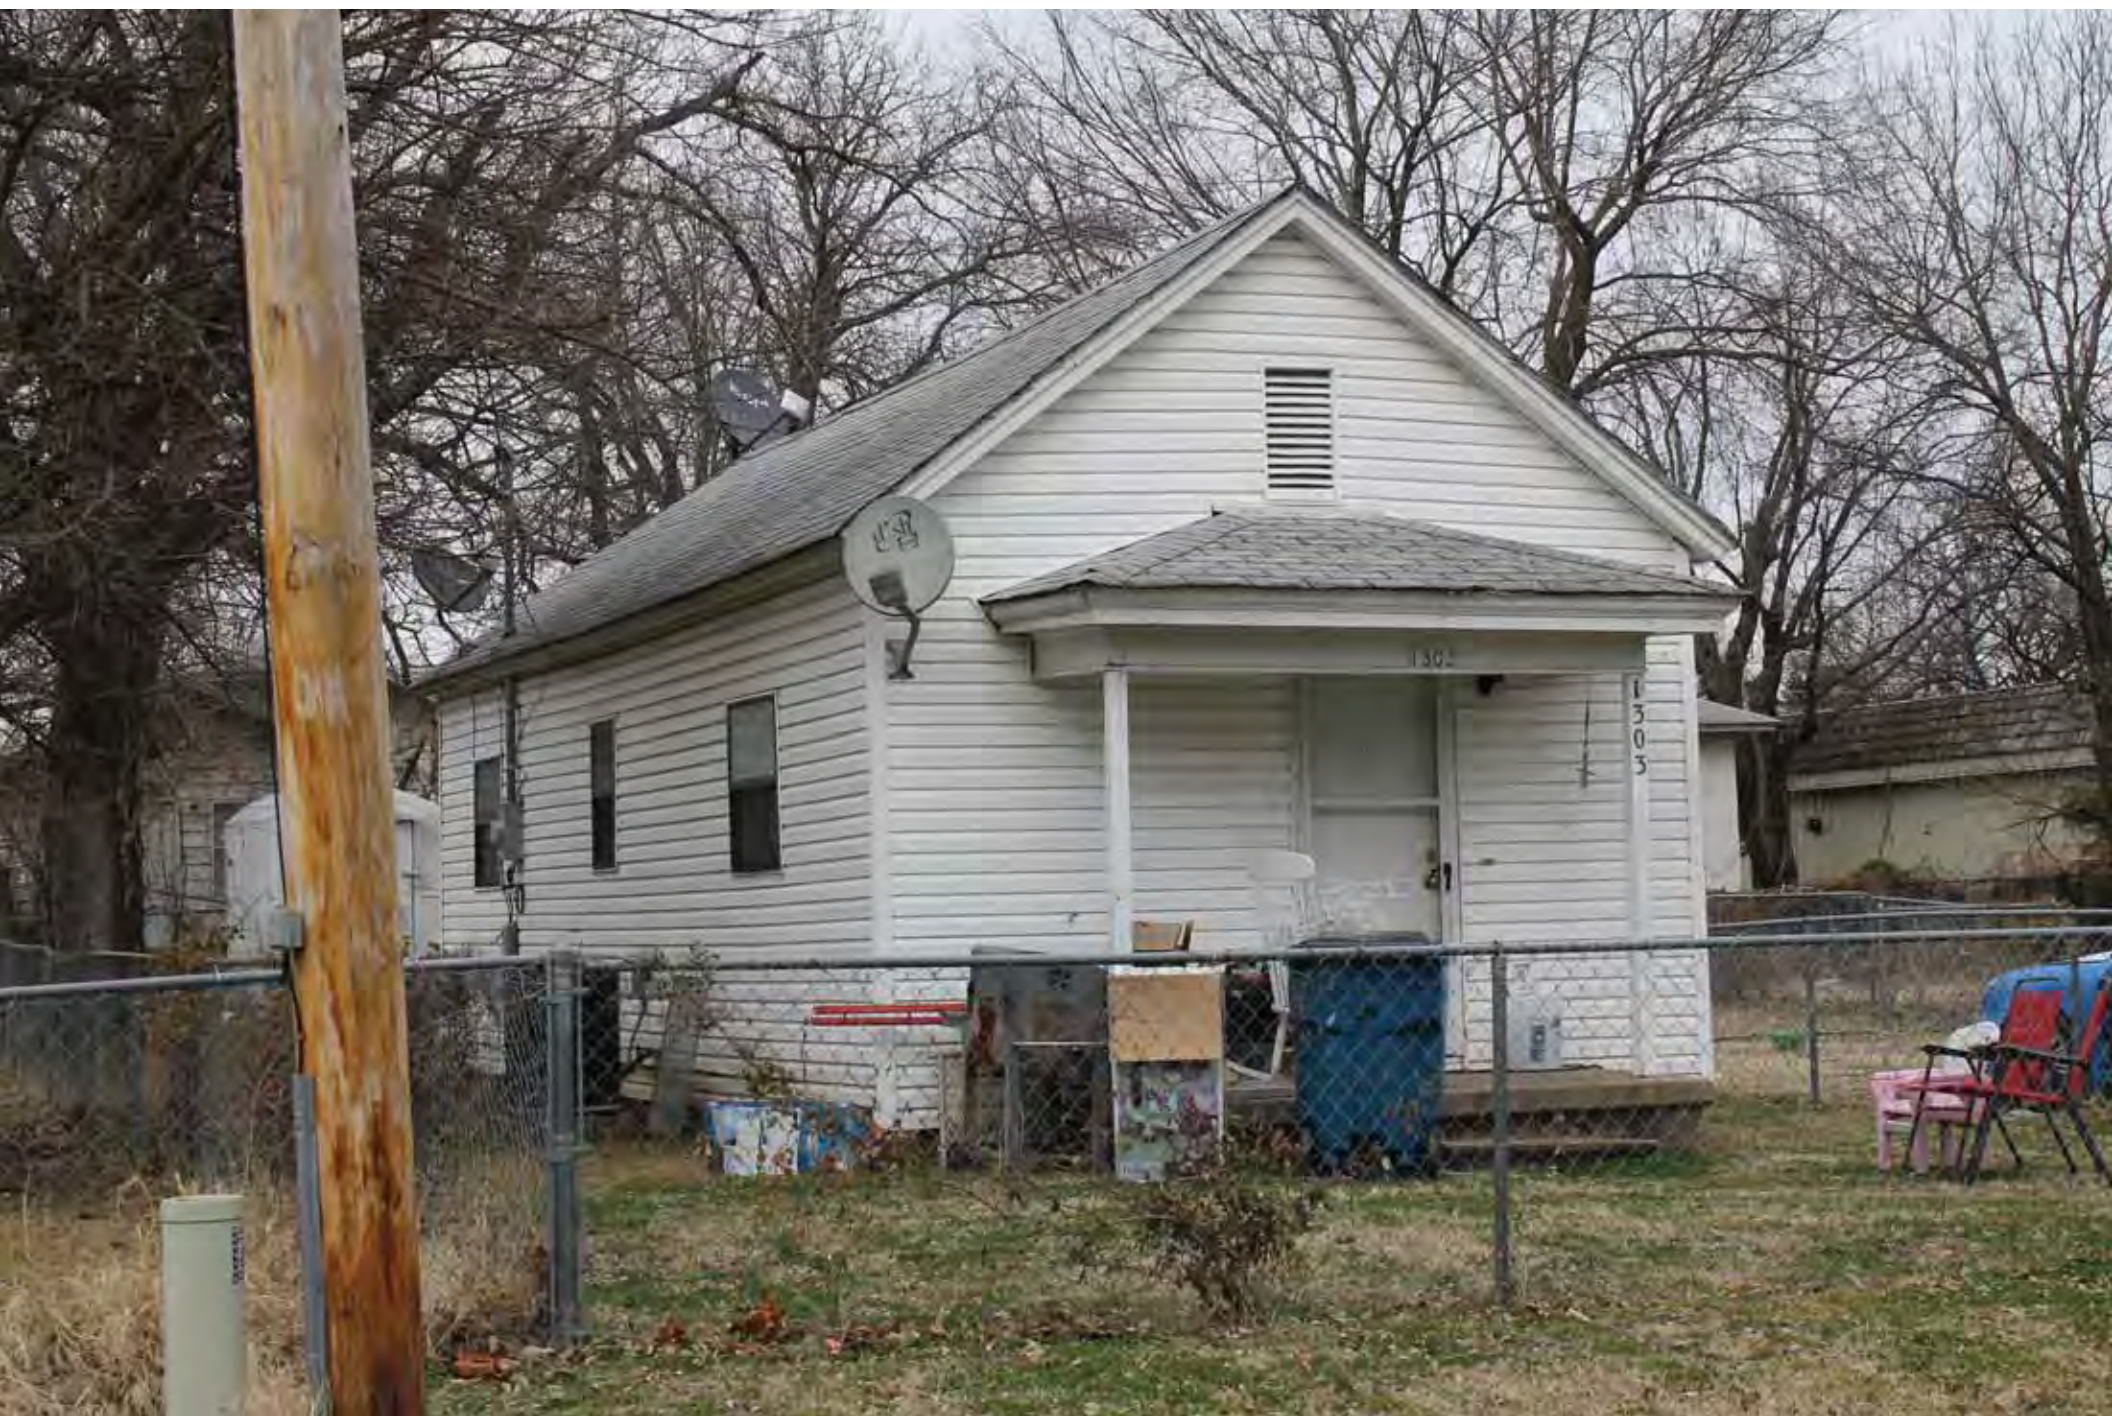
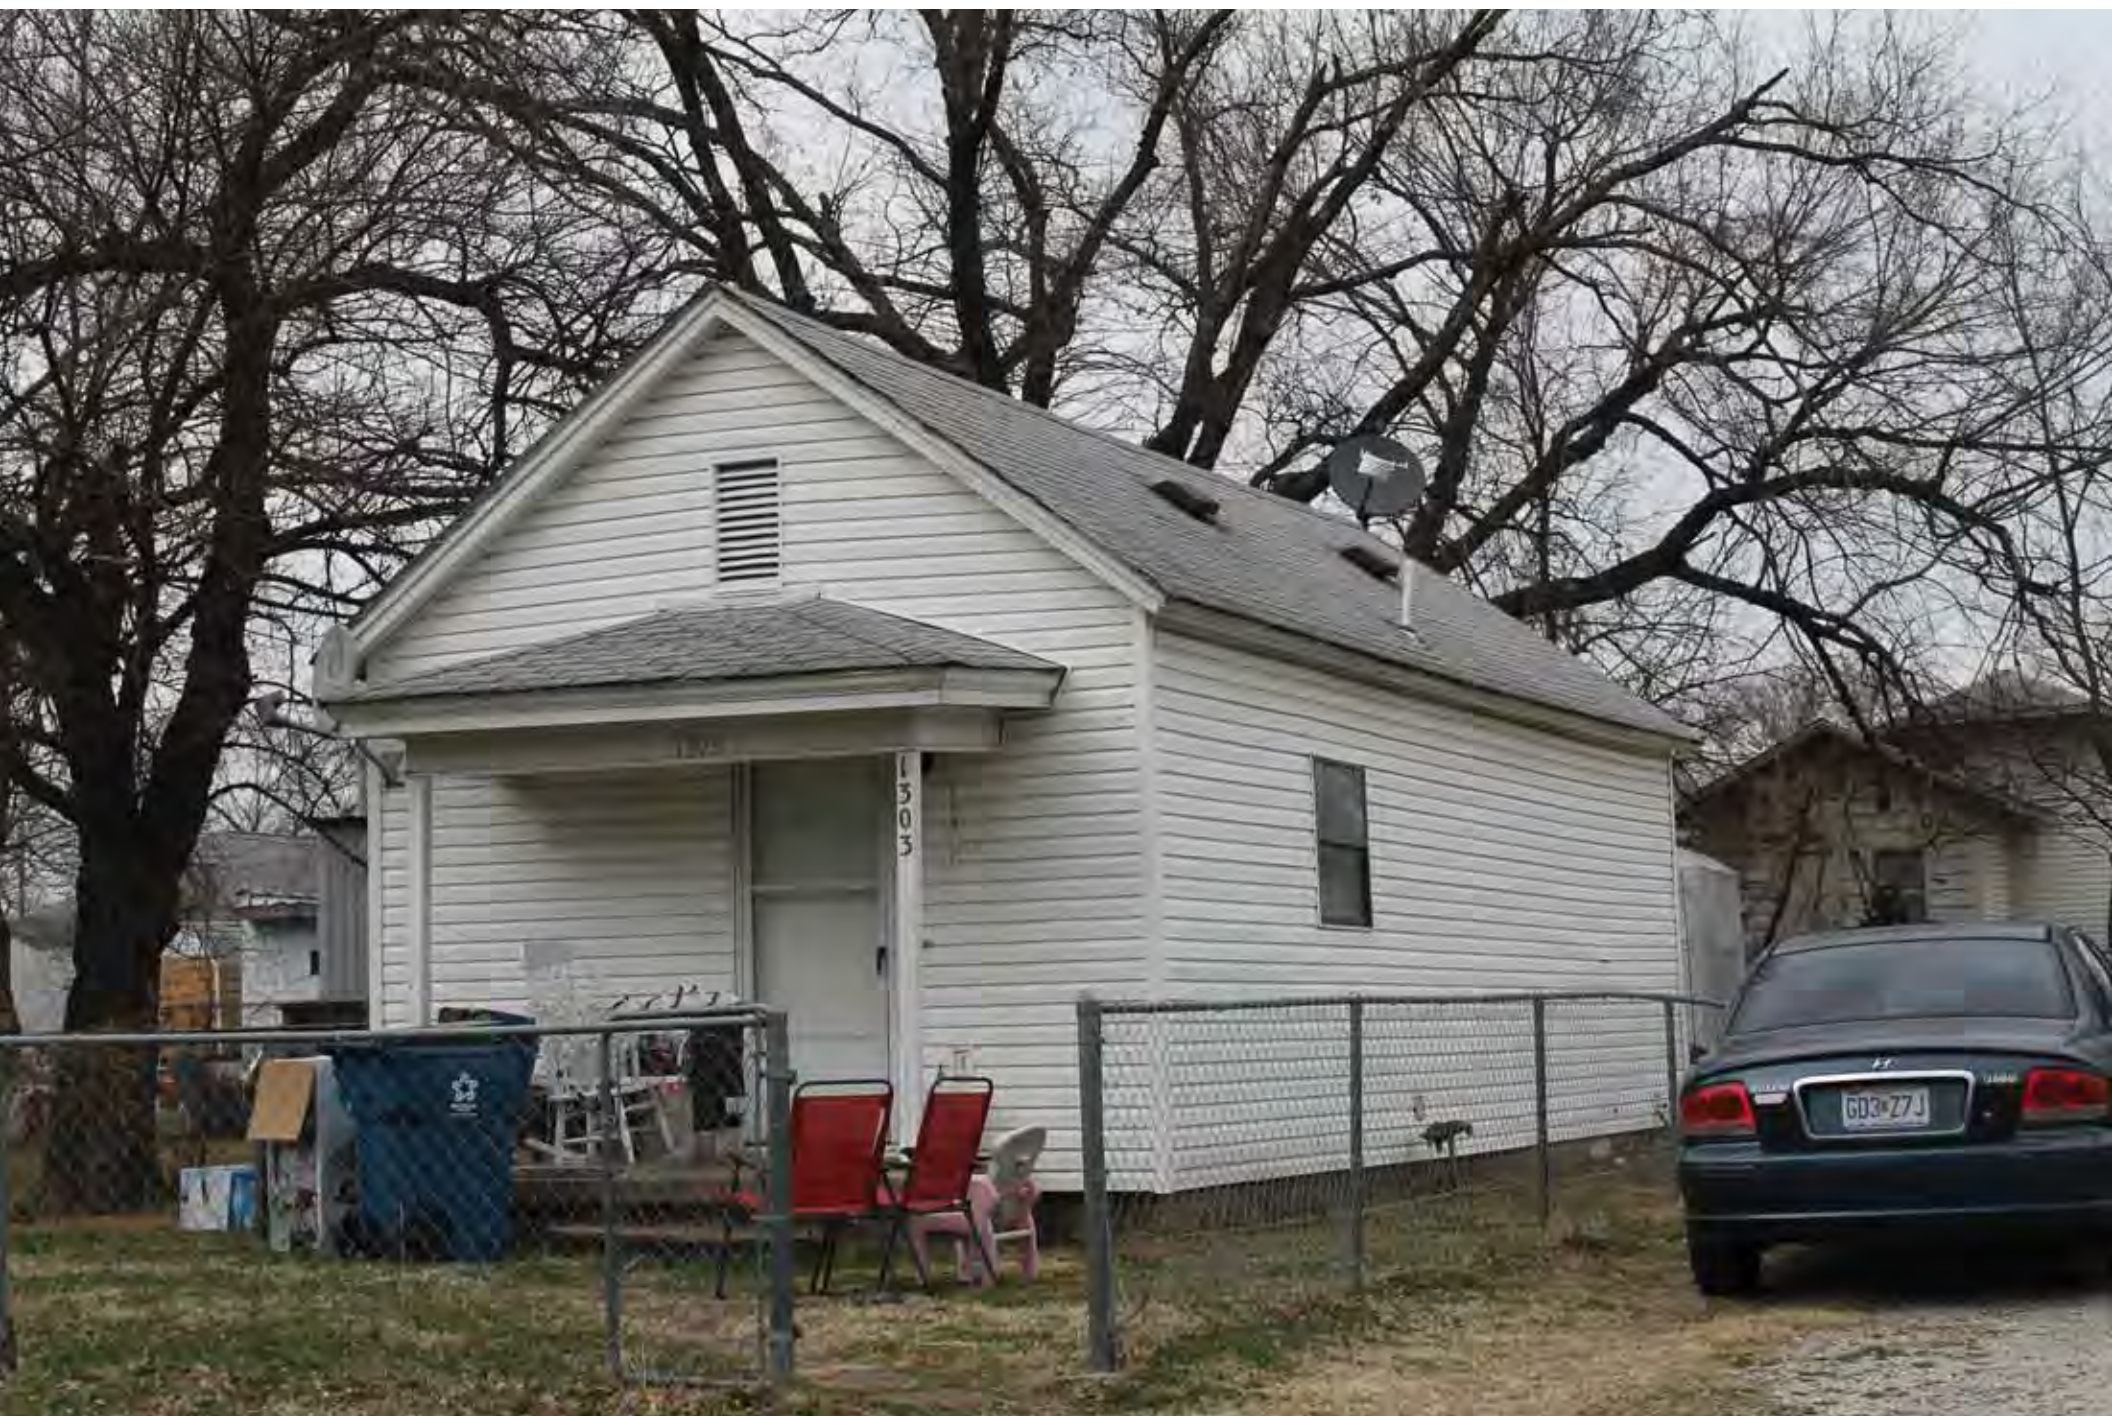
The property at 1303 E. Central Street features a shotgun plan (one-room wide) dwelling with an asphalt shingled gabled roof, exterior vinyl siding and a concrete foundation. Windows are replacement one-over-one. The primary (south) elevation features a central hipped roof porch supported by slender wood columns resting on a concrete base. Within the porch bay is a solid wood door. A louvered vent is featured in the front gable field. The west elevation holds three windows. The east elevation holds one window.

This dwelling has been altered (c. 2015) with the addition of vinyl siding and replacement windows, which compromises the property's architectural (Criterion C) integrity. The dwelling is not within an area recommended as a historic district. Research failed to associate the property with any important person (Criterion B) or historical event(s) (Criterion A). For these reasons, the property does not appear eligible for the National Register of Historic Places.
