MISSOURI DEPARTMENT OF NATURAL RESOURCES
STATE HISTORIC PRESERVATION OFFICE, P.O. Box 176, Jefferson City, MO 65102
ARCHITECTURAL/HISTORIC INVENTORY FORM

1. Survey No. JP-AS-007-001		2. Survey name: East Town (Original Joplin) Historic Survey Phase 2	
3. County: JASPER		4. Address (Street No.) 618	Street (name) E. 2 nd Street
5. City: Joplin	Vicinity: <input type="checkbox"/>	6. Geographical Reference:	7. Township/Range/Section: T: R: S:
8. Historic name (if known):		9. Present/other name (if known):	
10. Ownership: <input checked="" type="checkbox"/> Private <input type="checkbox"/> Public		11a. Historic use (if known): Domestic: Single Dwelling	11b. Current use: Domestic: Single Dwelling

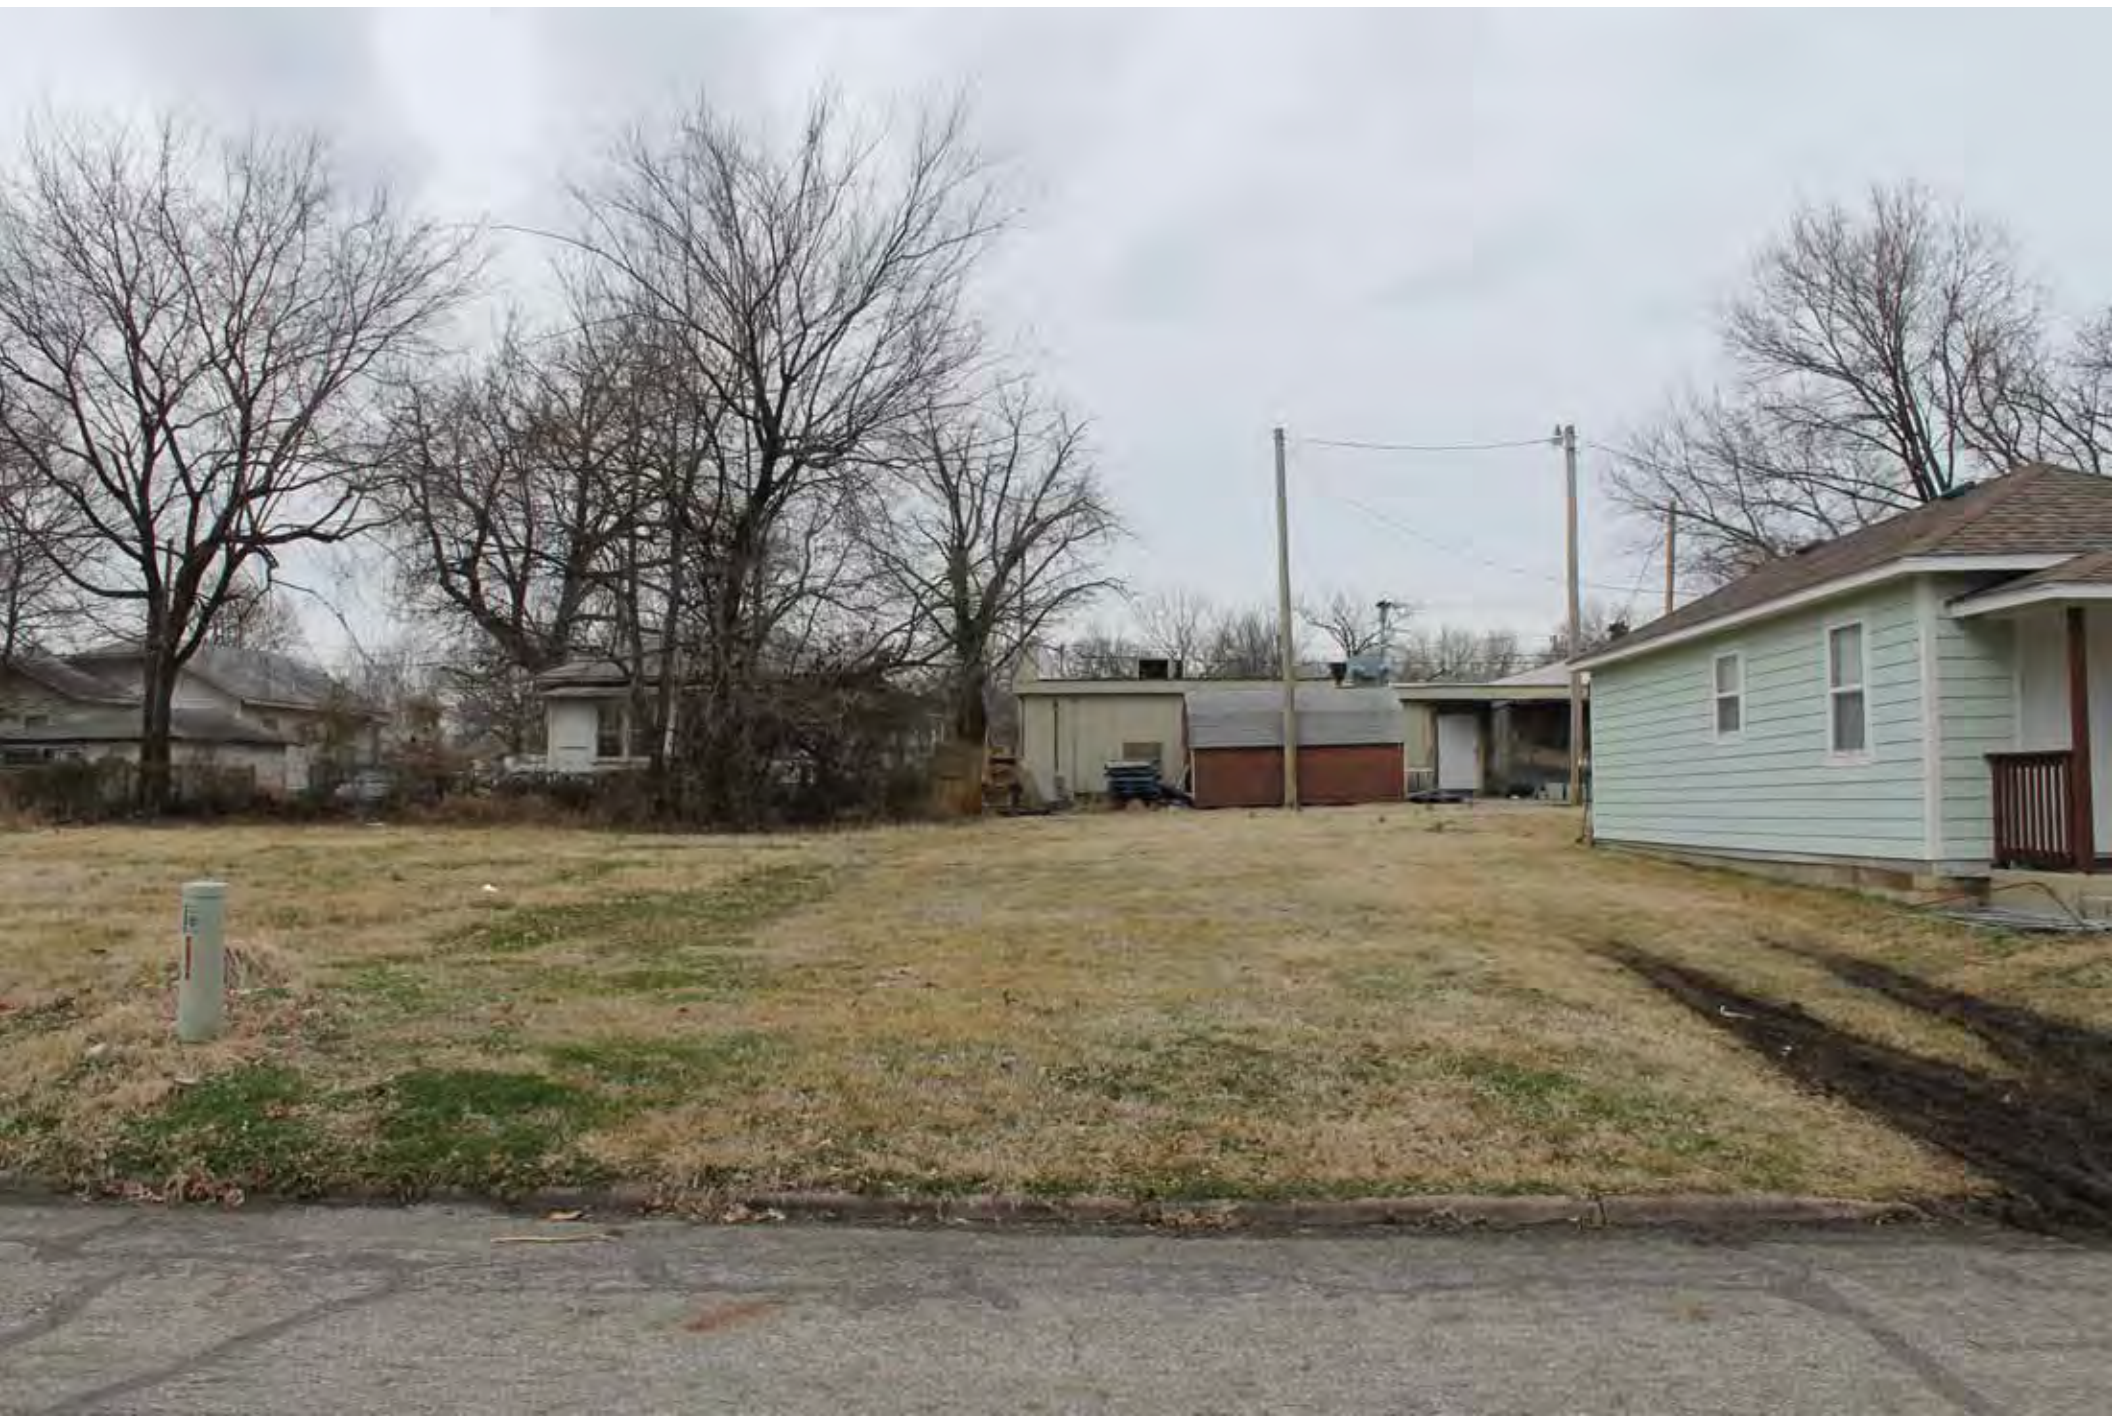
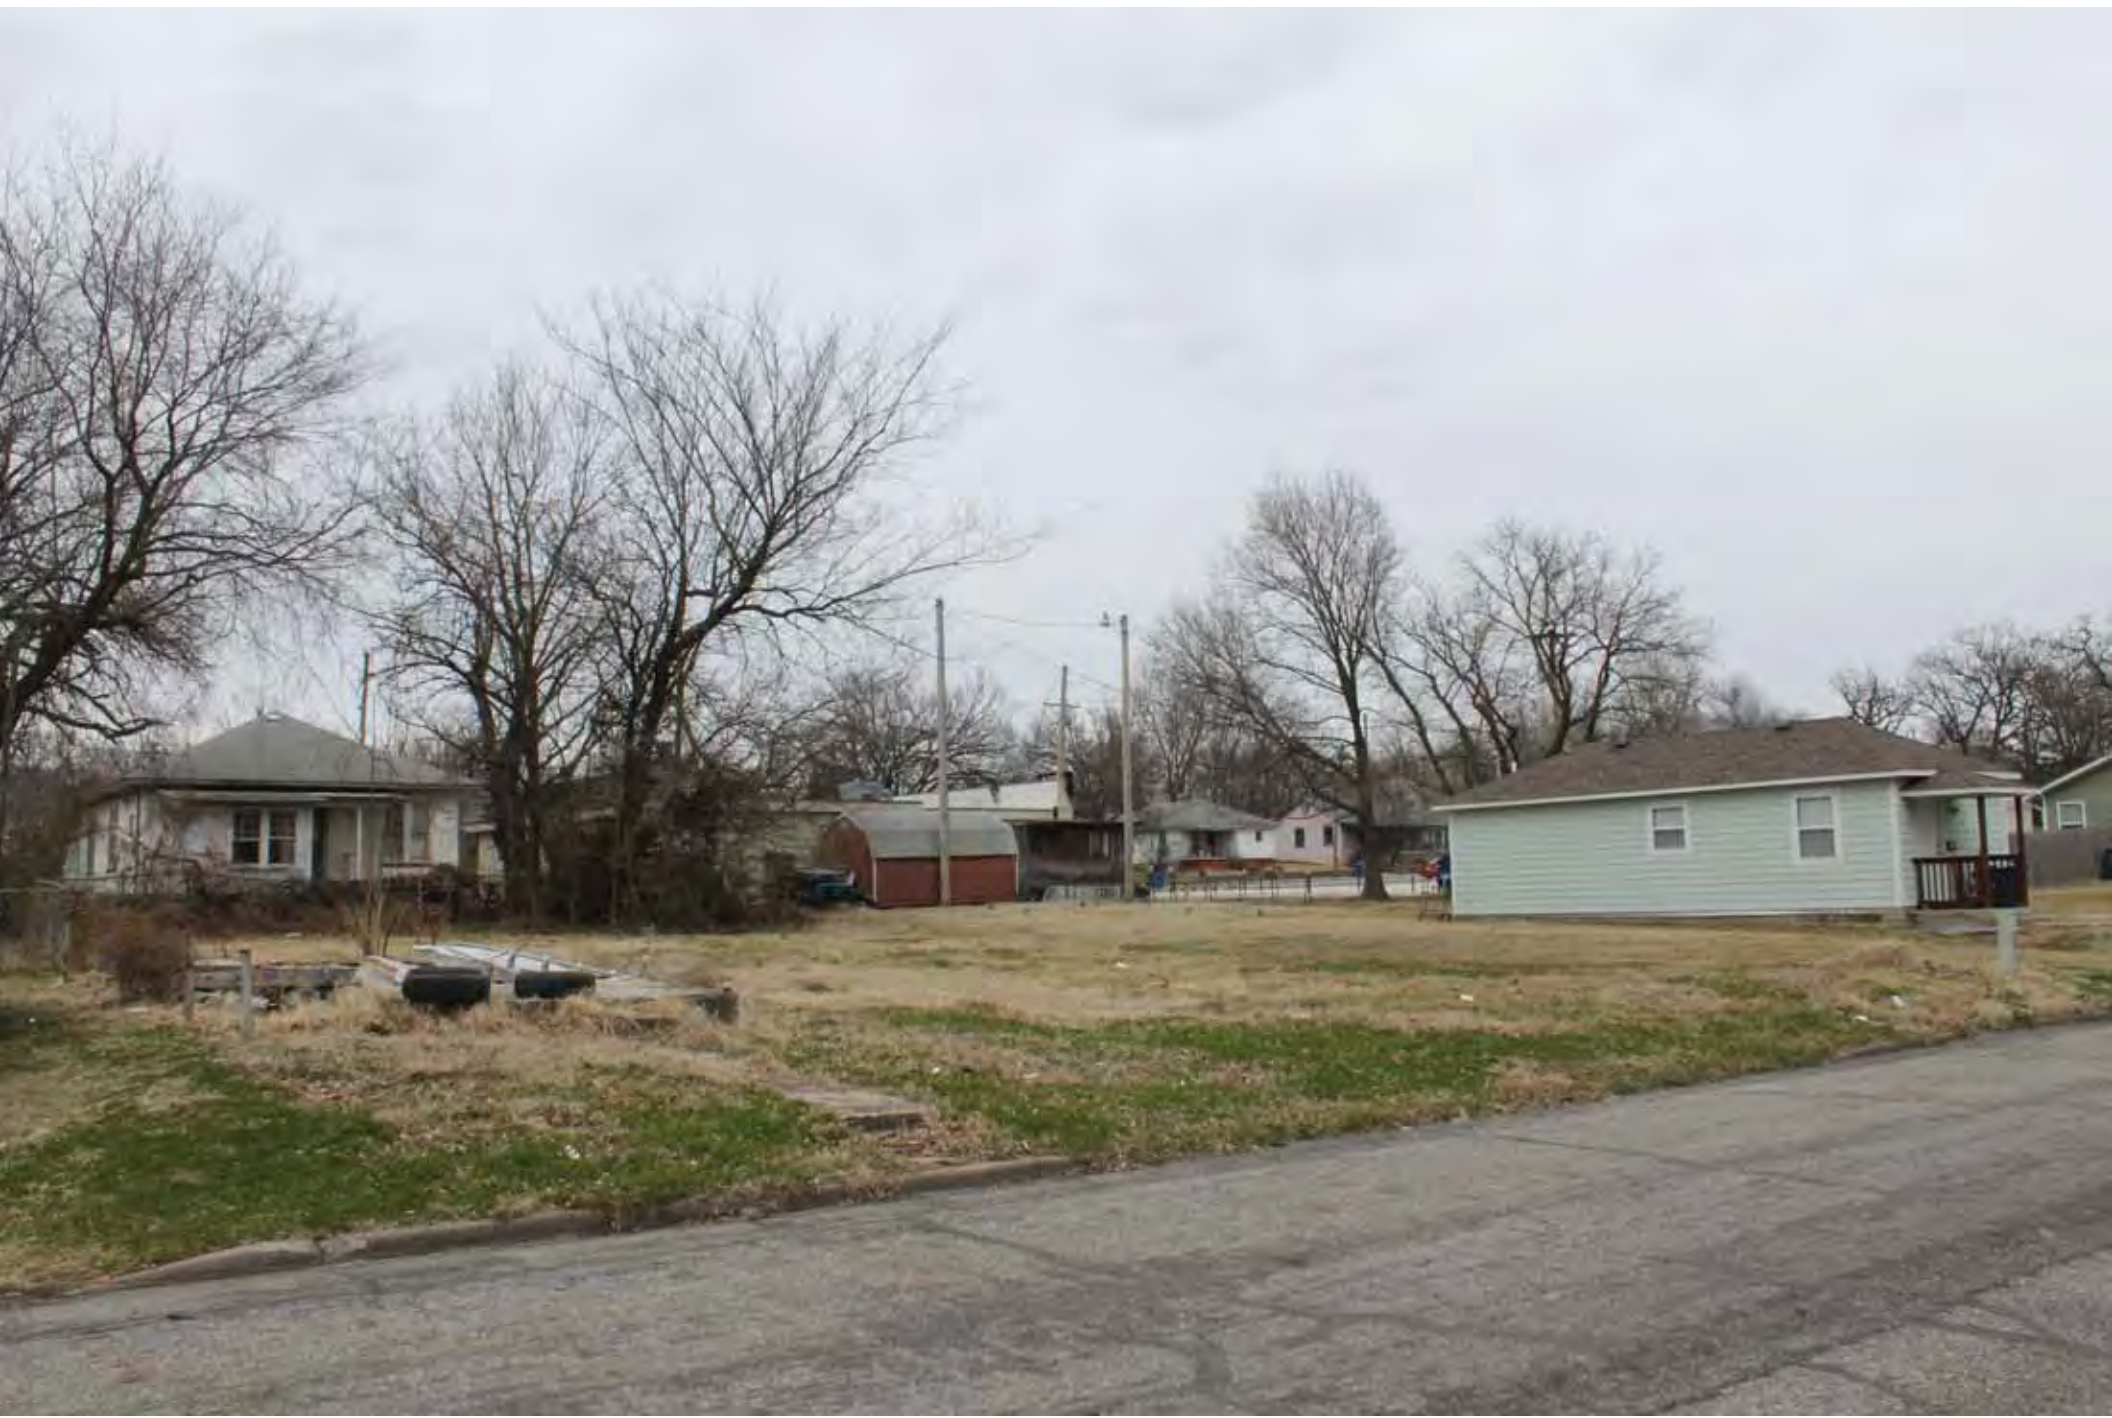
The property at 1307 E. Central Street is a vacant grassy lot that formerly held a single family dwelling. The lot is as described above.

Due to the removal of a dwelling (date unknown), the lot does not retain integrity that would render it individually eligible for the National Register of Historic Places. The property is not situated in an area recommended as a historic district.

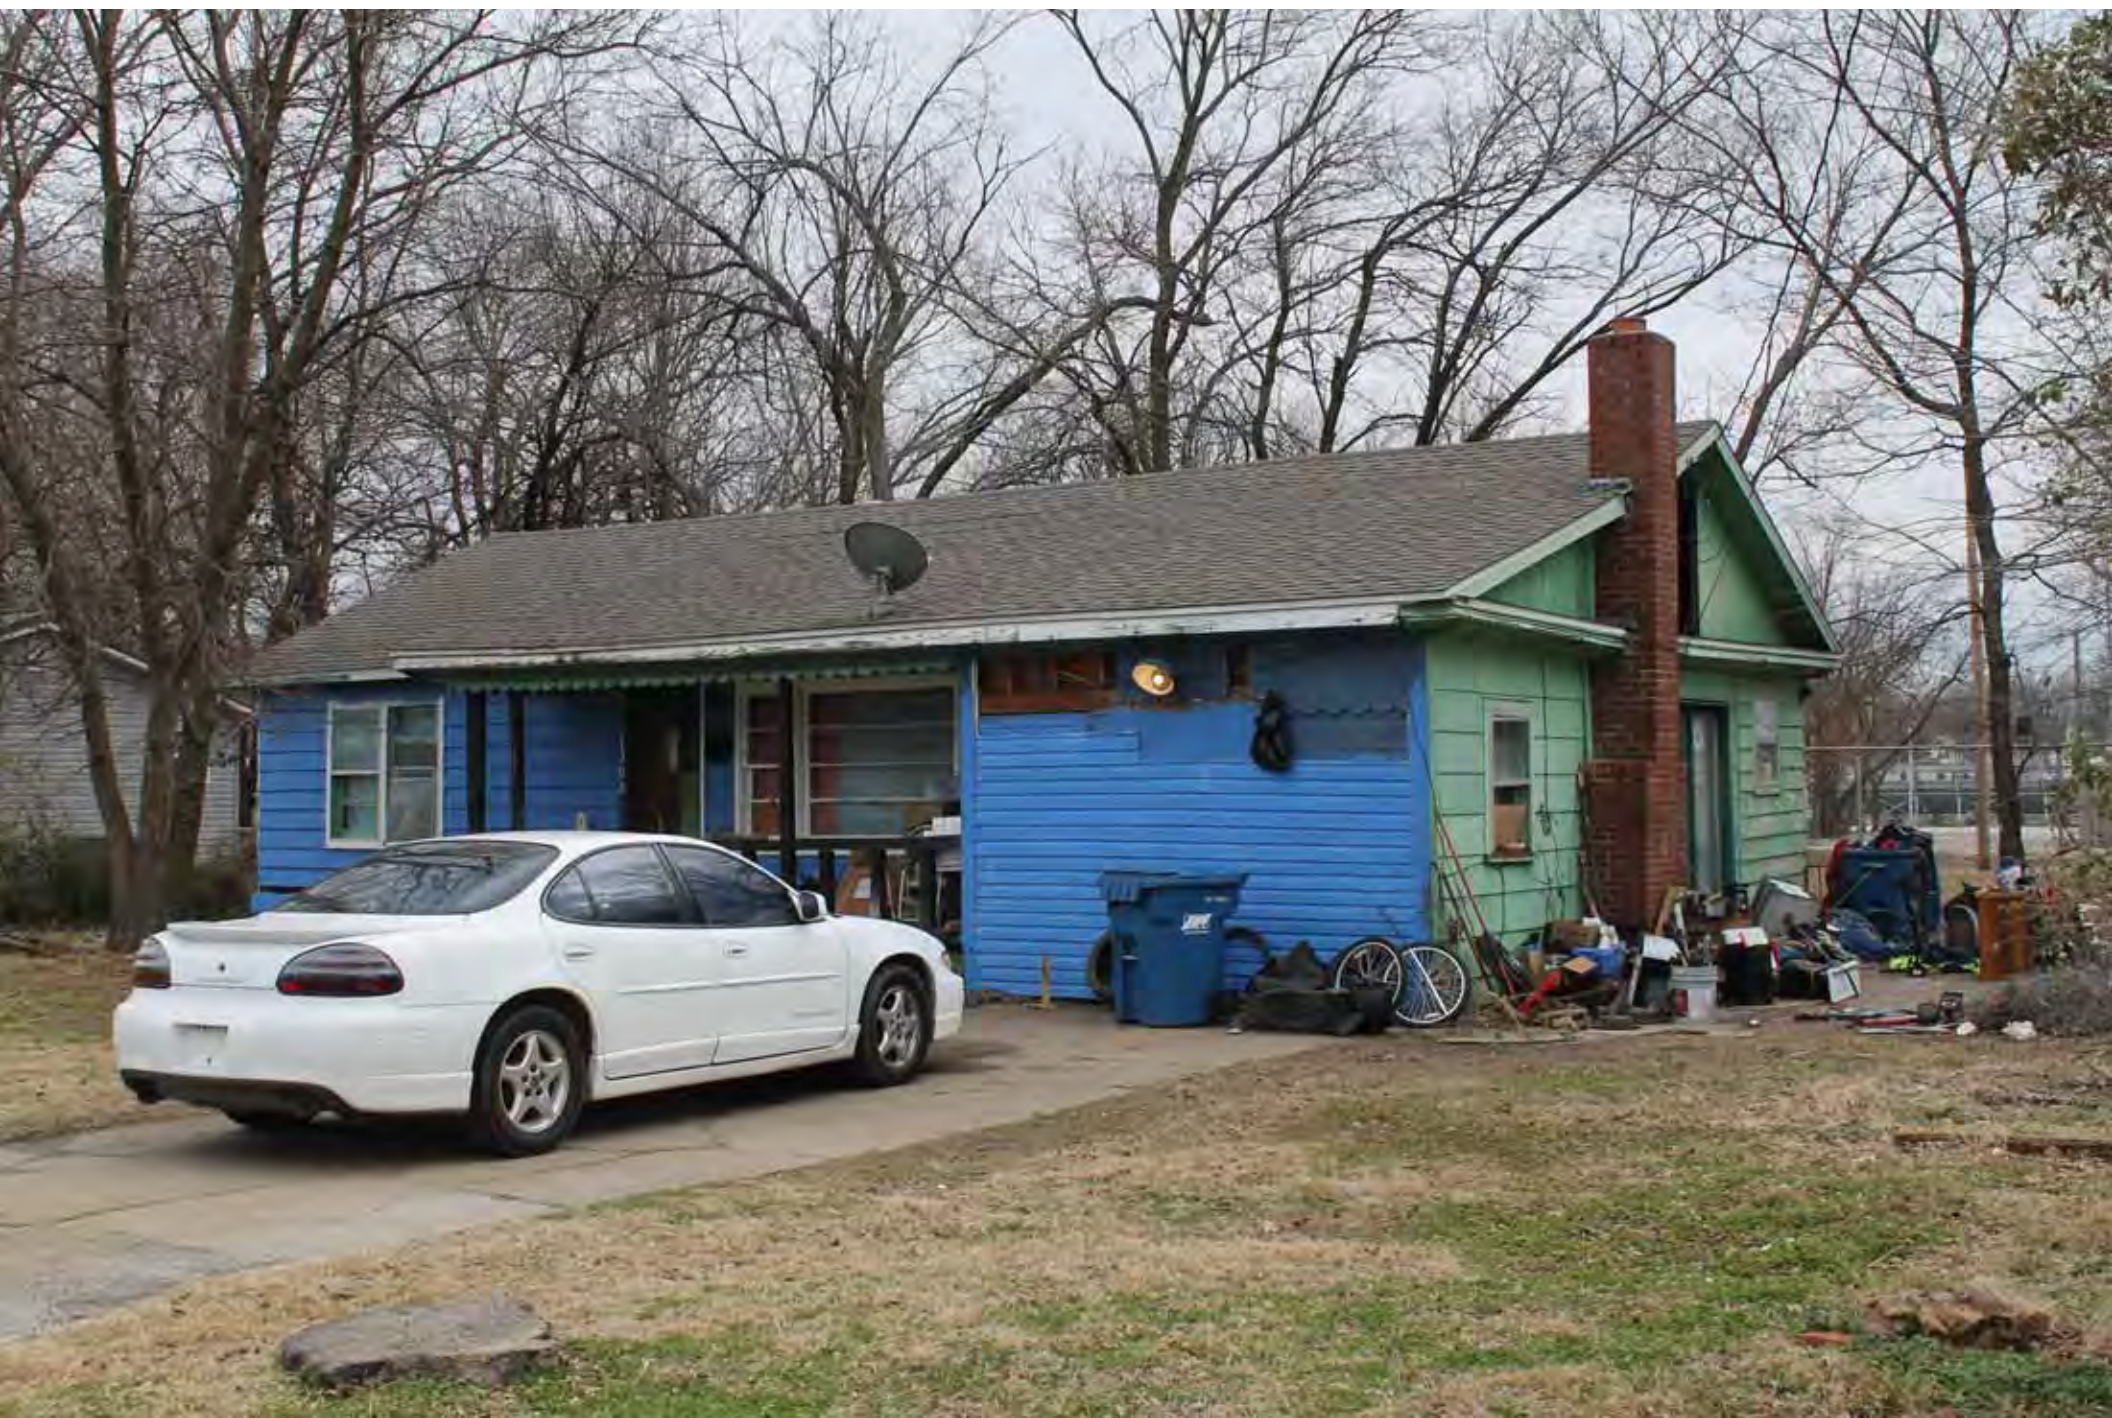
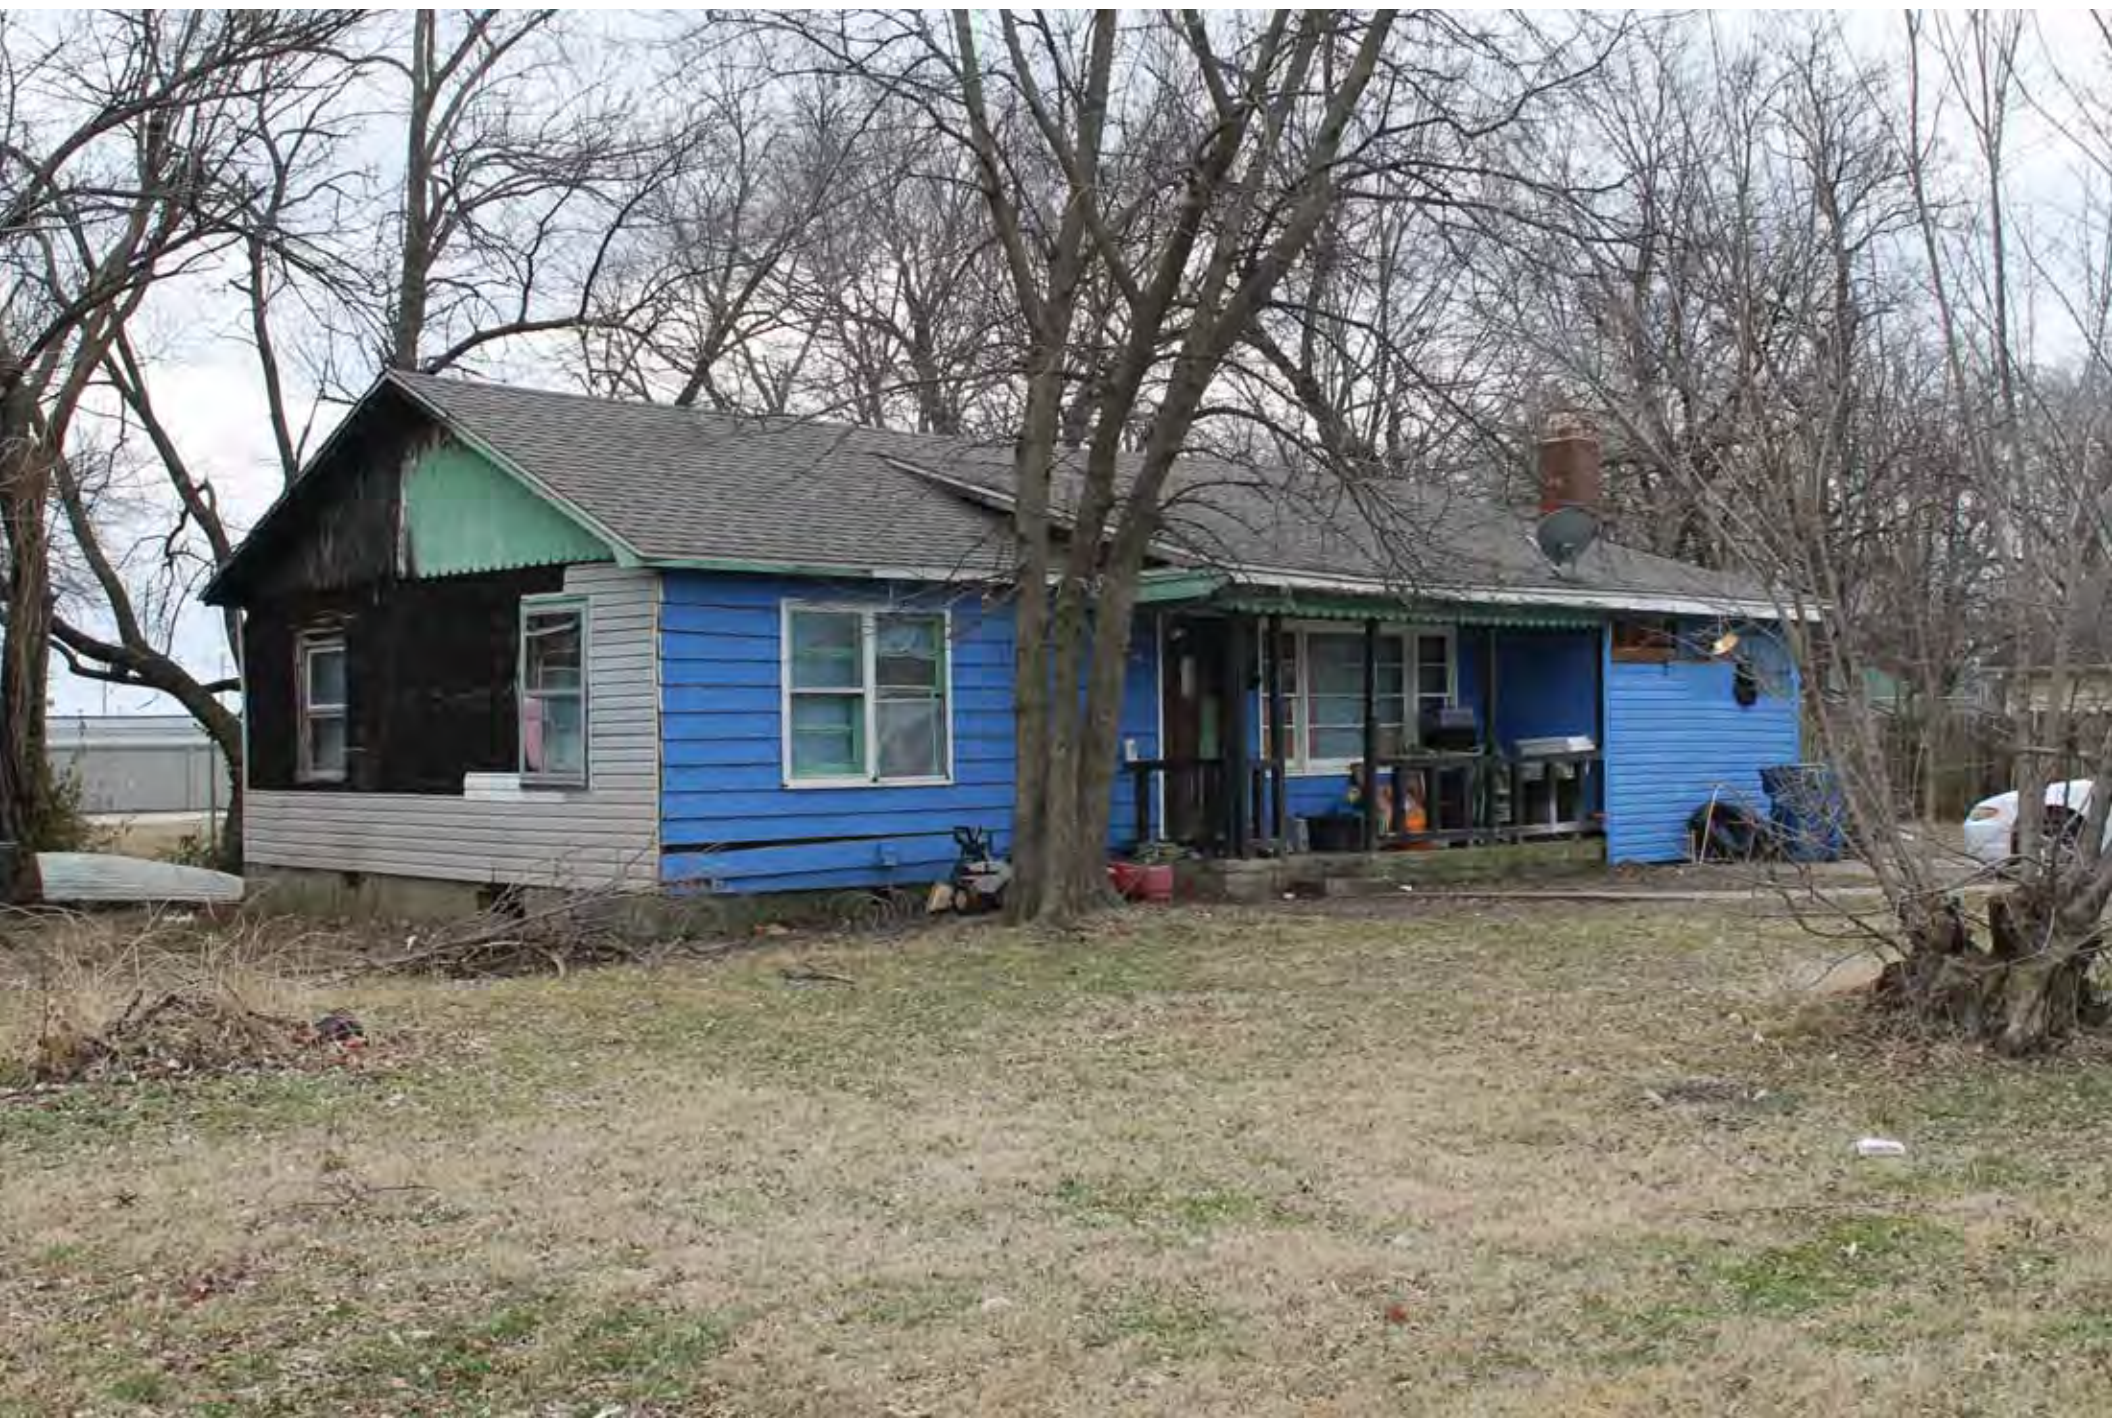
The property at 1308 E. Central Street features a Ranch style dwelling currently undergoing renovation. The dwelling has an asphalt-shingled gable roof, exterior vinyl and wood (east elevation only) siding and a concrete foundation. At the west elevation is an exterior brick chimney/flue. The primary (north) elevation holds an integral porch east of a projecting front wing. The porch is supported by wood columns and has a wood balustrade. Within the porch bay are a small vertical light wood door and an original multi-sash picture style window. East of the porch, the façade holds paired original two-over-two horizontal sash windows. Two windows of similar configuration are situated on the east elevation. The west elevation supports a sliding glass door south of the chimney. The chimney and door are flanked by windows.

This dwelling is undergoing alterations that include replacement of original wood siding with vinyl. The alteration compromises the dwelling's architectural (Criterion C) integrity. The dwelling is not within an area recommended as a historic district. Research failed to associate the property with any important person (Criterion B) or historical event(s) (Criterion A). For these reasons, the property does not appear eligible for the National Register of Historic Places.

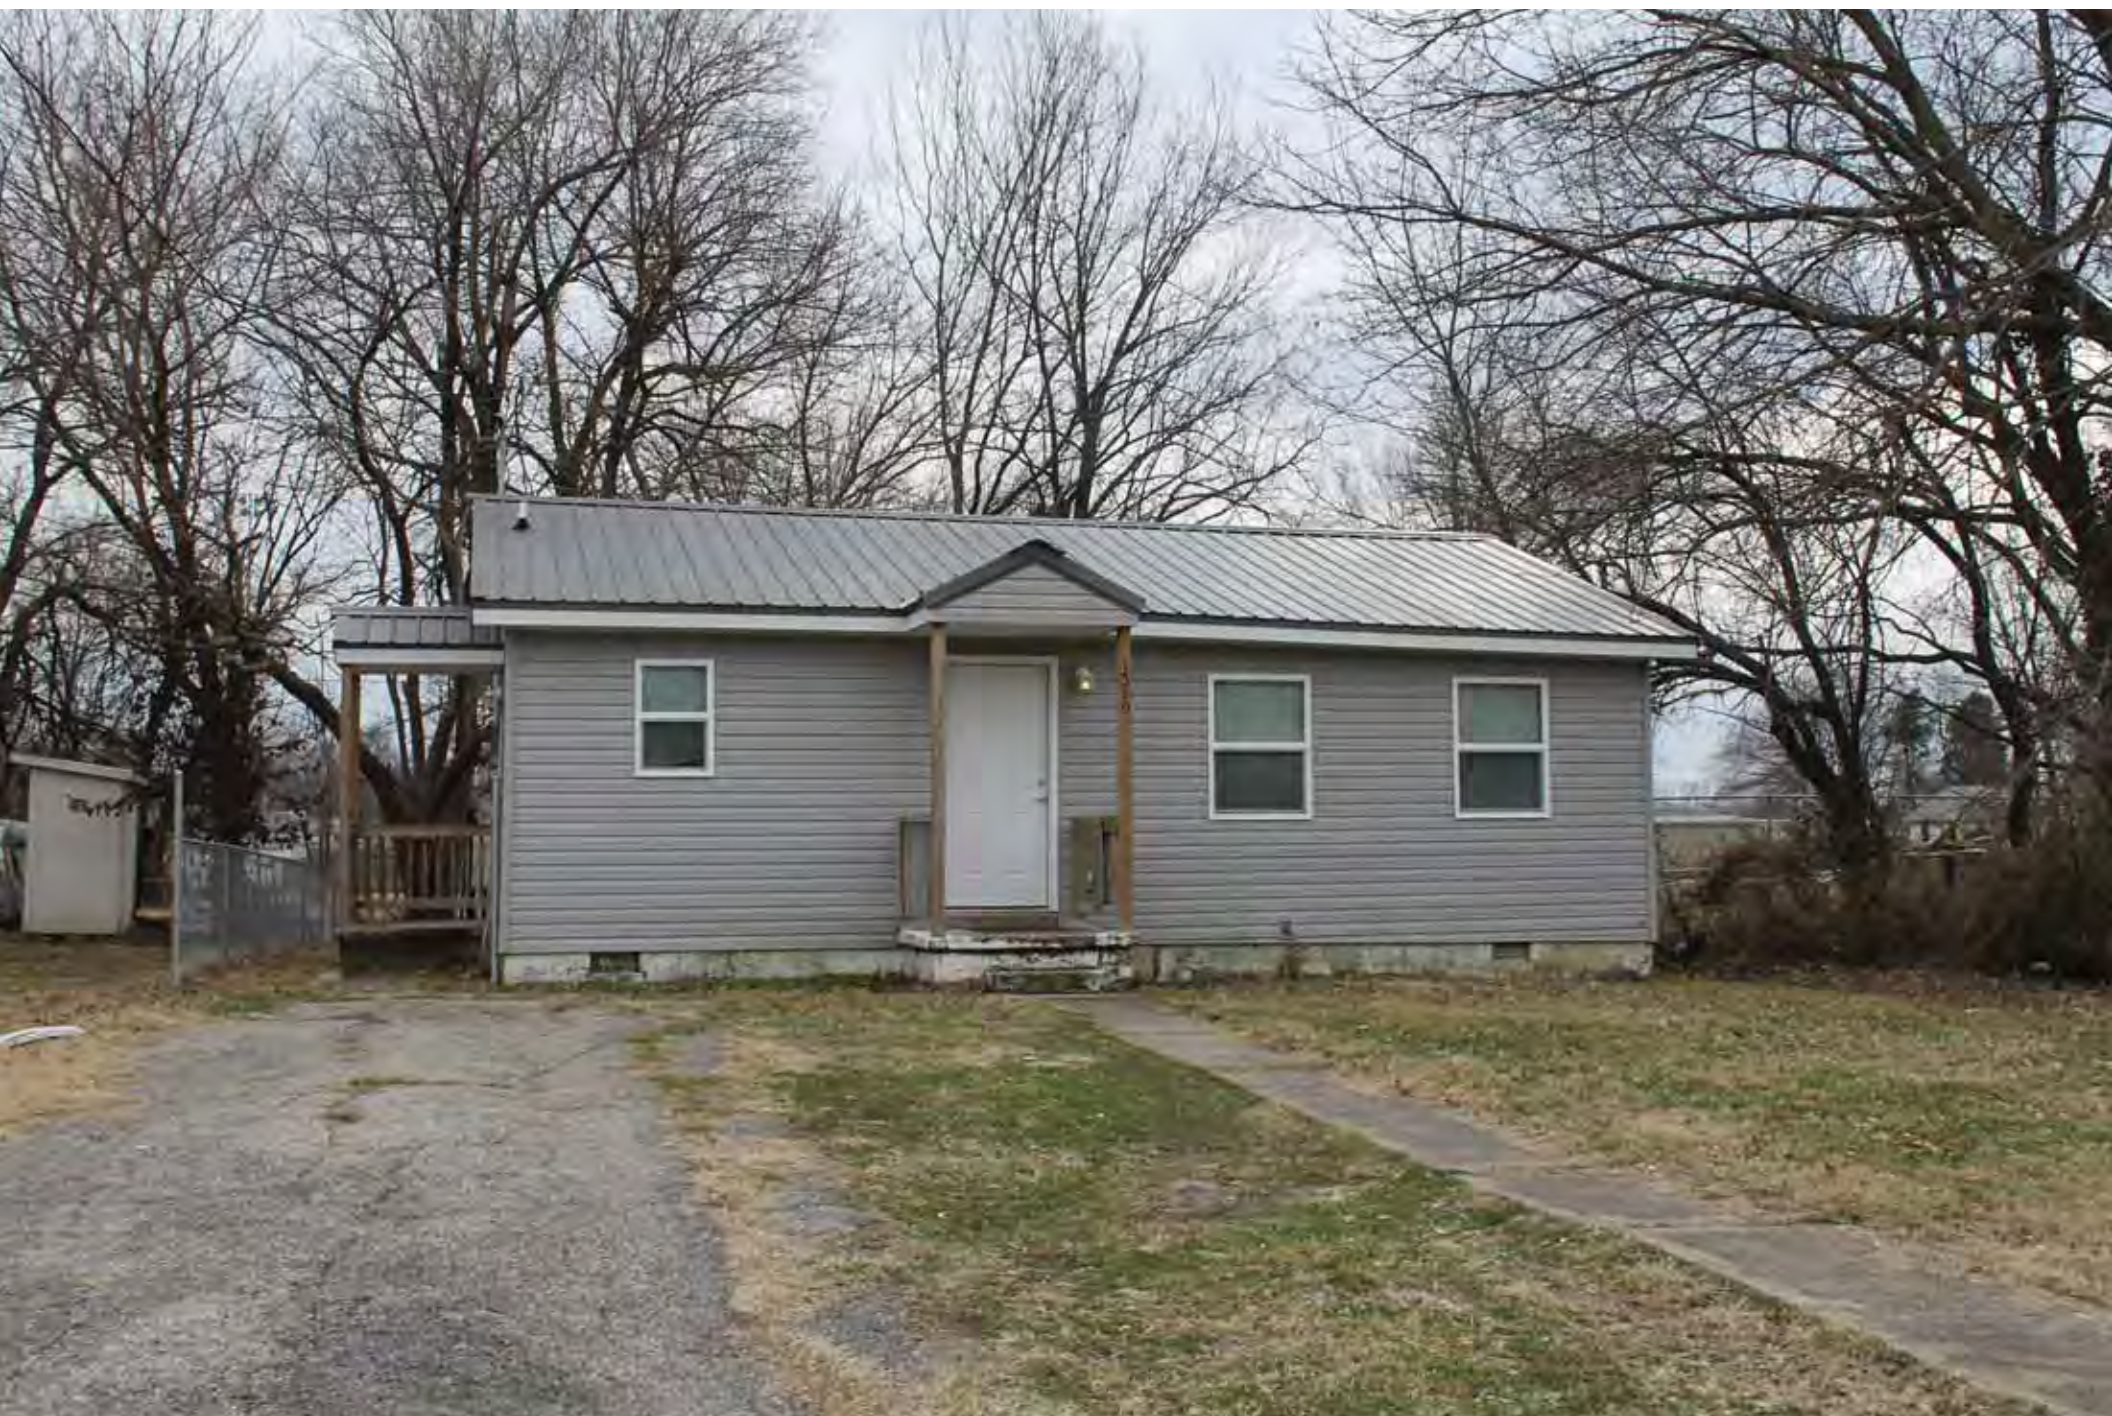
The property at 1310 E. Central Street features a single-story end gable plan dwelling with a metal clad roof, exterior vinyl siding and a concrete foundation. The primary (north) elevation holds a central concrete stoop with a gabled portico supported by two wood replacement columns. Within the portico bay is a paneled c. 2019 door. Two one-over-one windows are situated west of the door. A small one-over-one window is east of the central façade entry. The side (east elevation) supports a gabled porch with a metal roof and wood columns.

This dwelling is a common property type that has been altered with the addition of vinyl siding (c. 2019). The alteration compromises the dwelling's architectural (Criterion C) integrity. The dwelling is not within an area recommended as a historic district. Research failed to associate the property with any important person (Criterion B) or historical event(s) (Criterion A). For these reasons, the property does not appear eligible for the National Register of Historic Places.

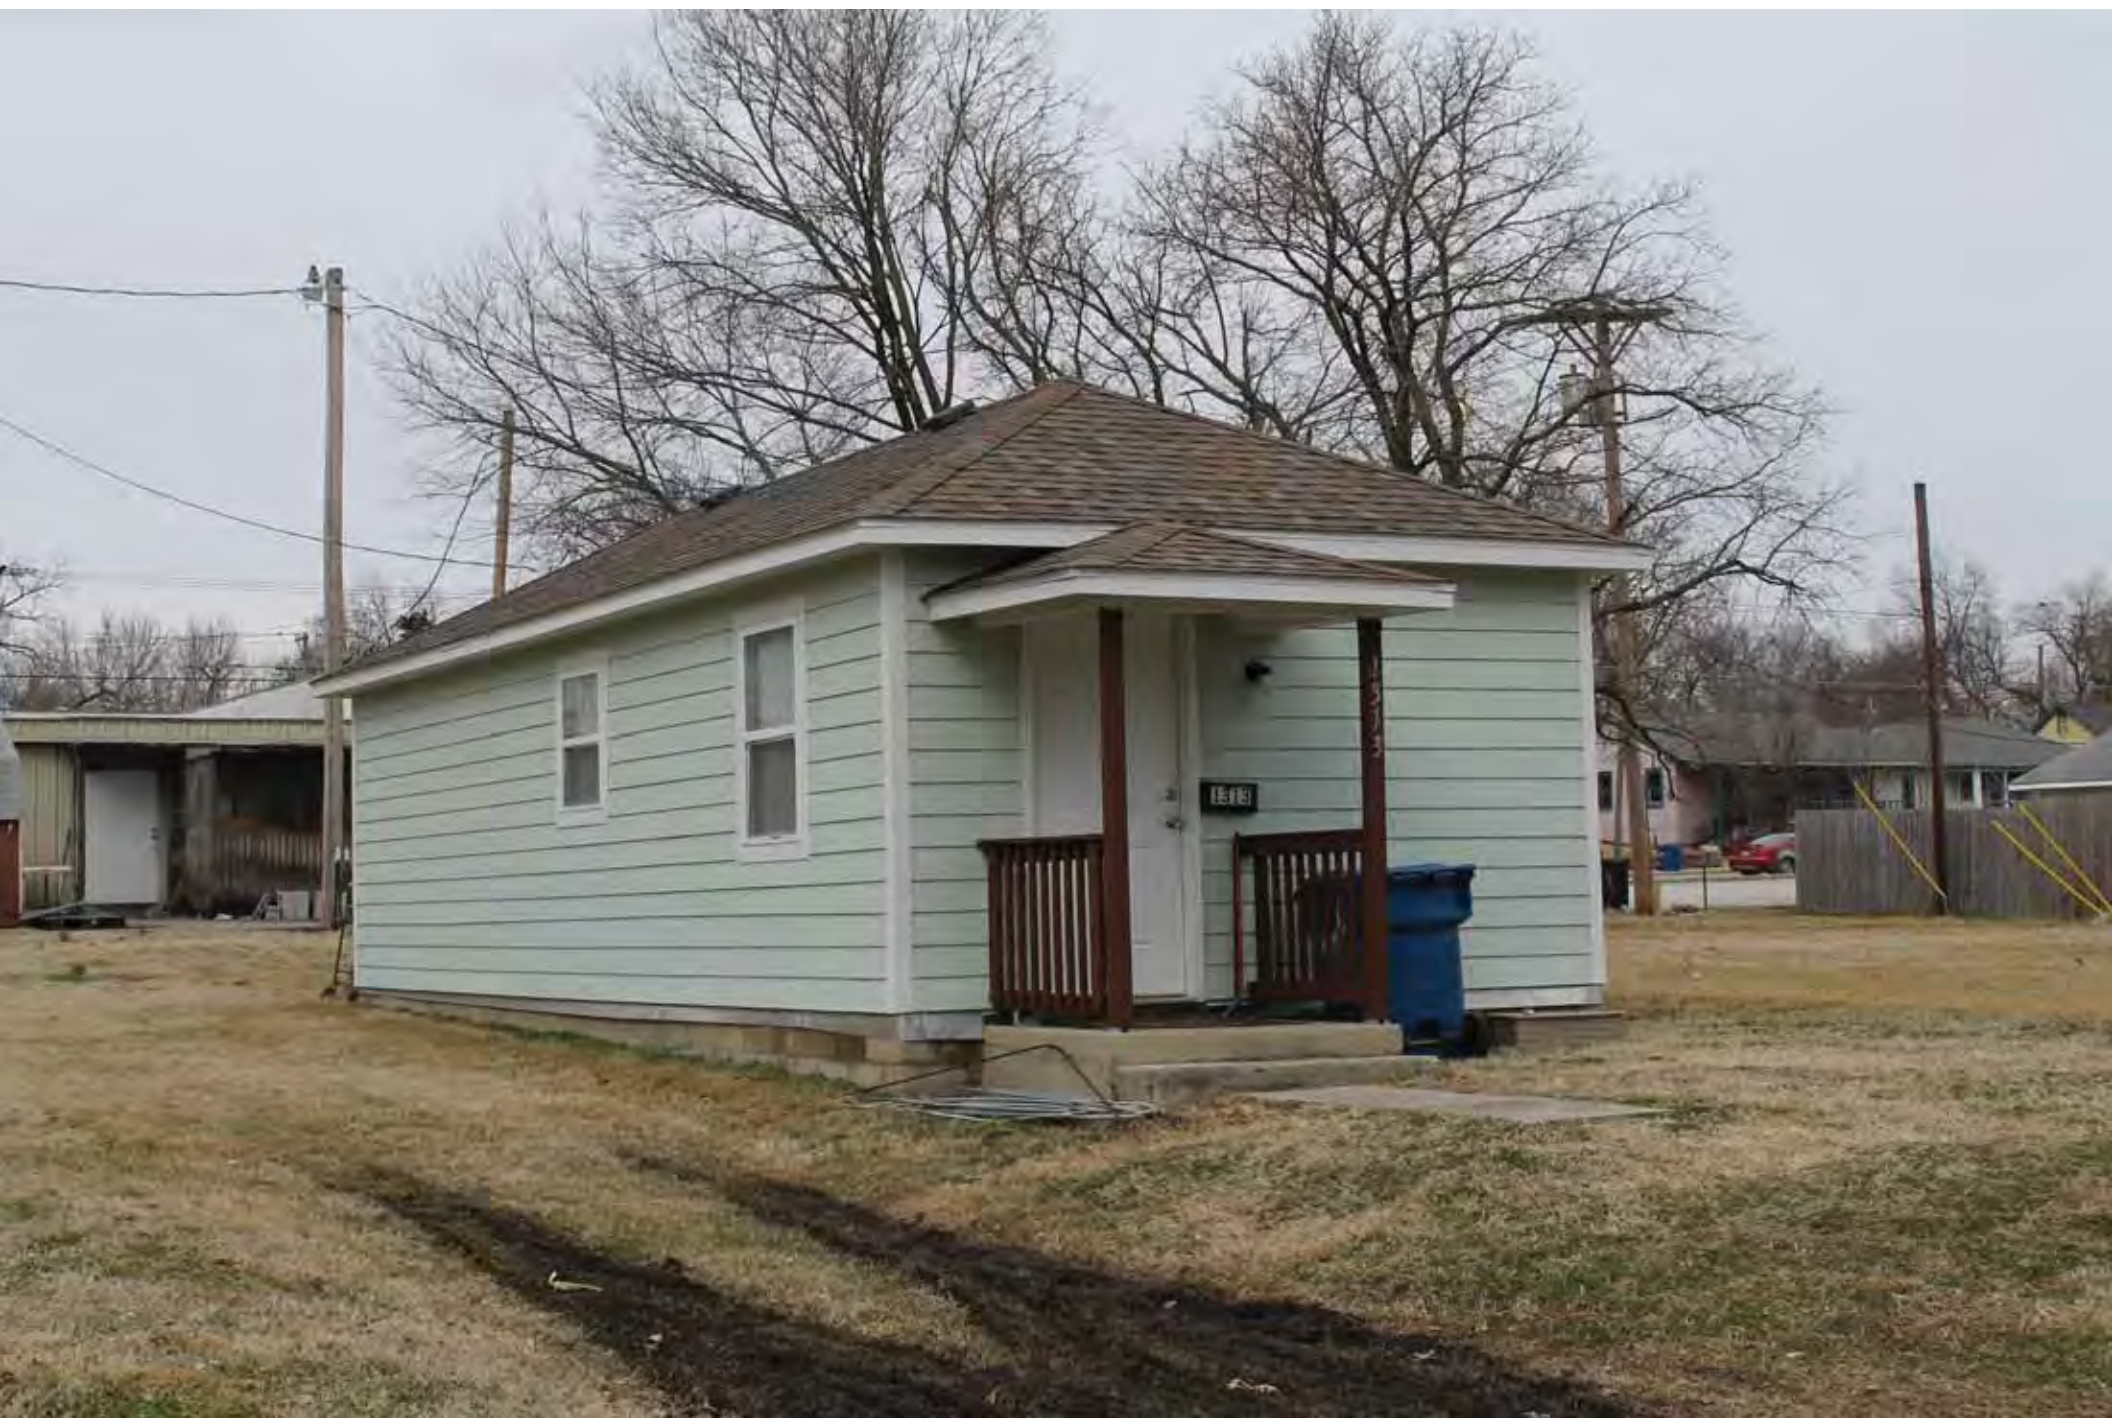
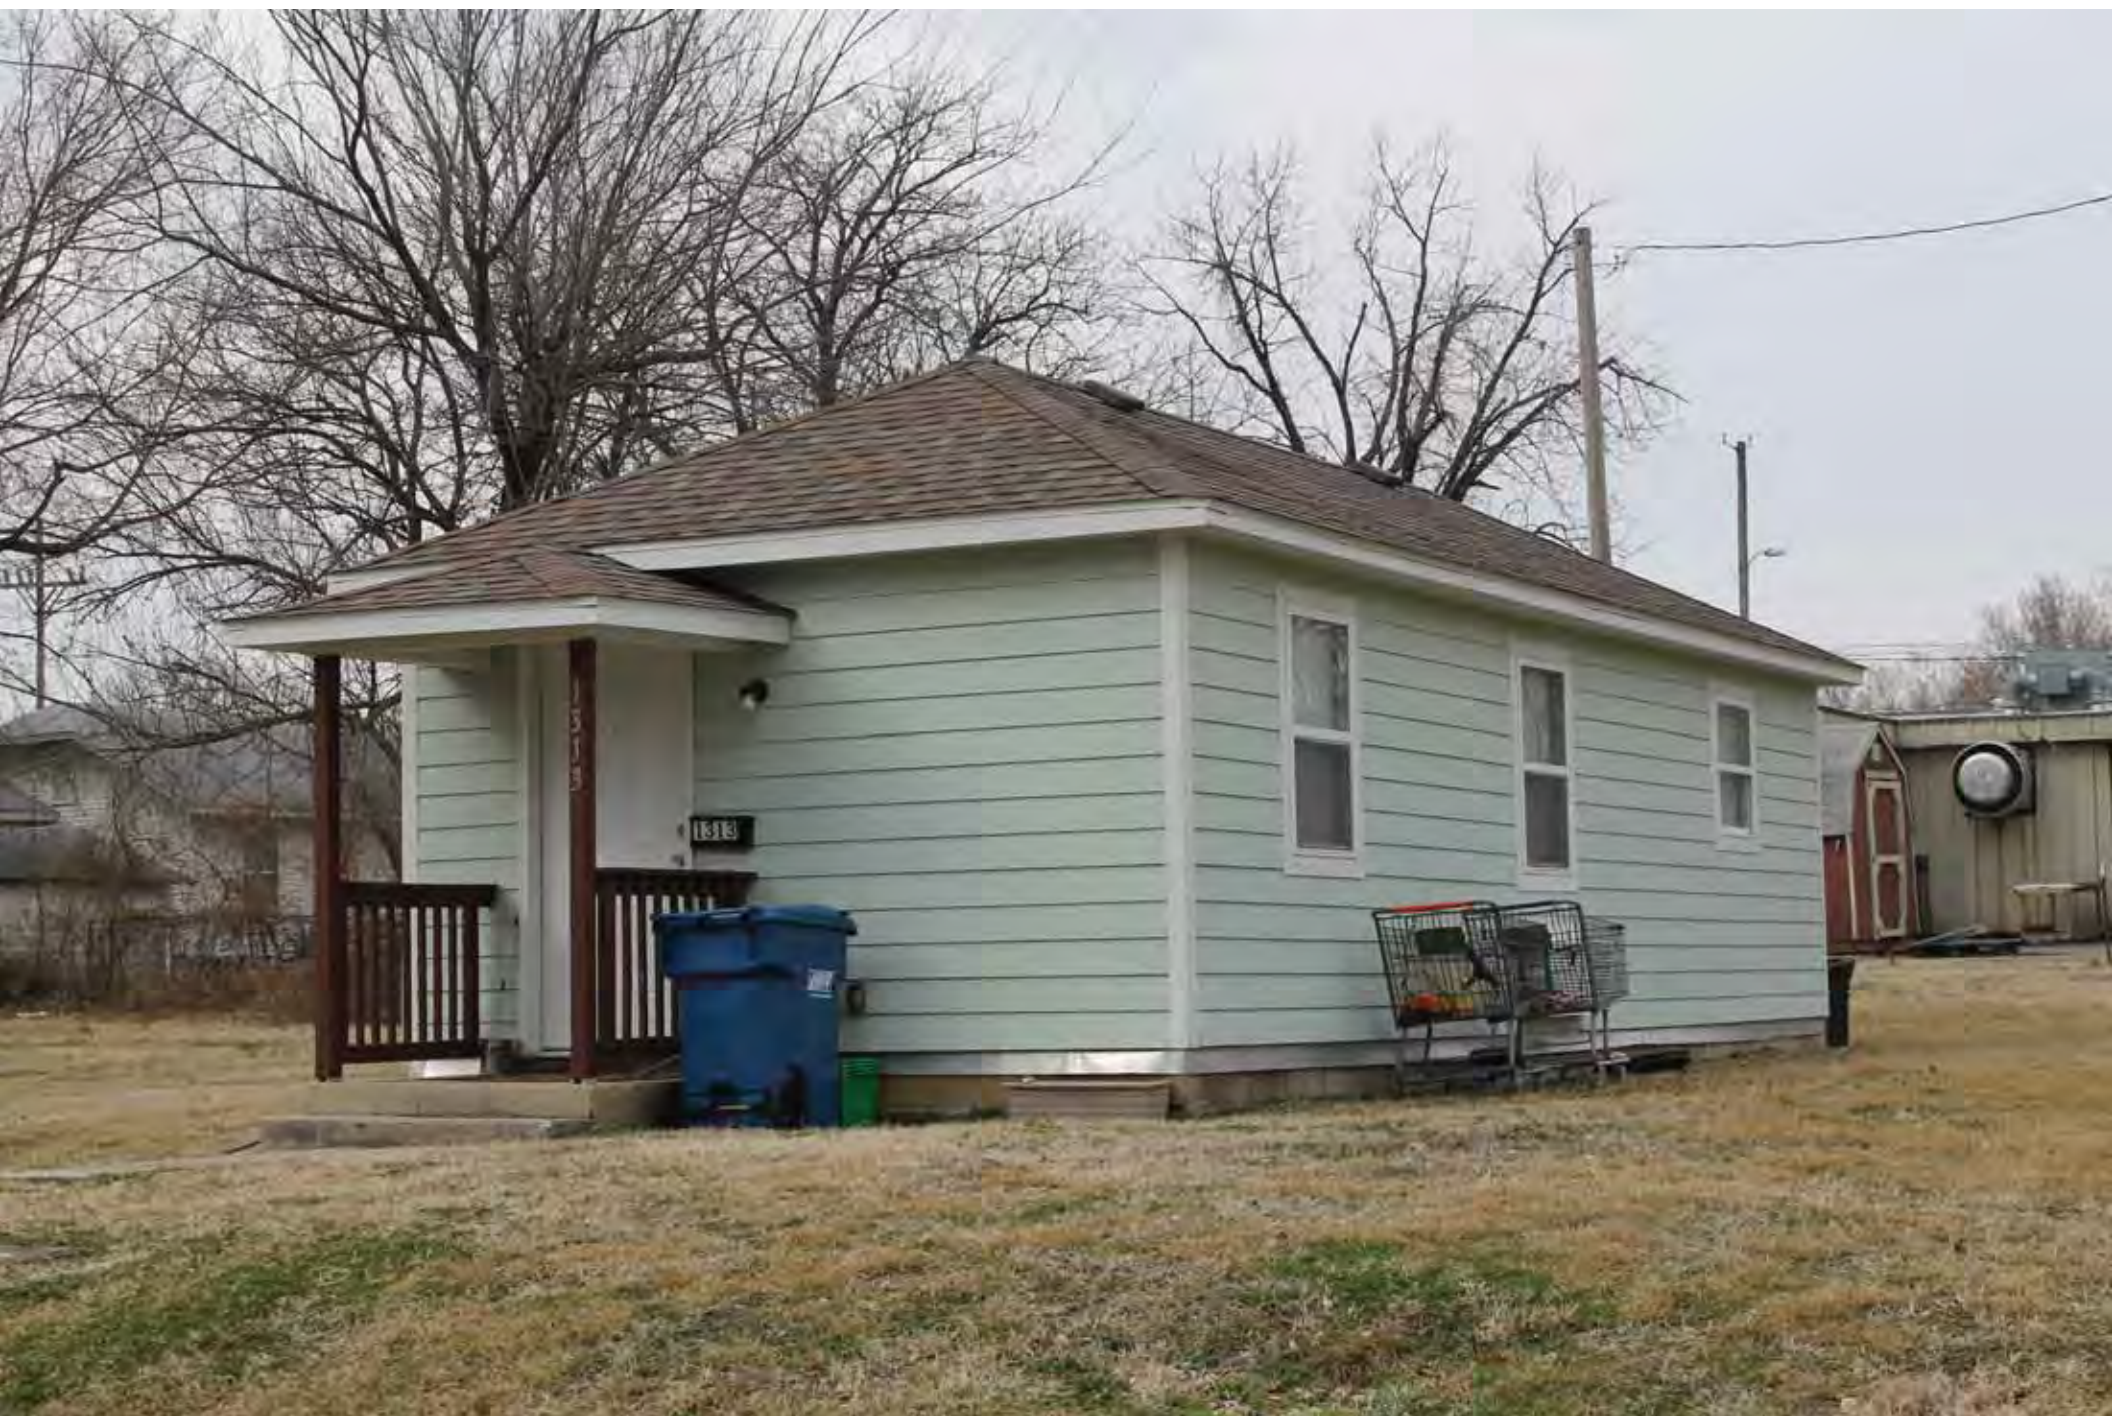
The property at 1313 E. Central Street features a shotgun plan (one-room wide) dwelling with an asphalt shingled hipped roof, exterior vinyl siding and a concrete block foundation. The façade (south elevation) holds an off-center hipped portico supported by wood columns resting on a concrete stoop. The stoop has a frame balustrade. Under the portico roof is a c. 2019 paneled door. The west elevation holds two windows. The east elevation holds three windows. All windows are replacement (c. 2019) one-over-one.

This dwelling has been altered recently (c. 2019) with the addition of vinyl siding and replacement windows, which compromises the property's architectural (Criterion C) integrity. The dwelling is not within an area recommended as a historic district. Research failed to associate the property with any important person (Criterion B) or historical event(s) (Criterion A). For these reasons, the property does not appear eligible for the National Register of Historic Places.
