MISSOURI DEPARTMENT OF NATURAL RESOURCES
STATE HISTORIC PRESERVATION OFFICE, P.O. Box 176, Jefferson City, MO 65102
ARCHITECTURAL/HISTORIC INVENTORY FORM

1. Survey No. JP-AS-007-001		2. Survey name: East Town (Original Joplin) Historic Survey Phase 2	
3. County: JASPER		4. Address (Street No.) 618	Street (name) E. 2 nd Street
5. City: Joplin	Vicinity: <input type="checkbox"/>	6. Geographical Reference:	7. Township/Range/Section: T: R: S:
8. Historic name (if known):		9. Present/other name (if known):	
10. Ownership: <input checked="" type="checkbox"/> Private <input type="checkbox"/> Public		11a. Historic use (if known): Domestic: Single Dwelling	11b. Current use: Domestic: Single Dwelling

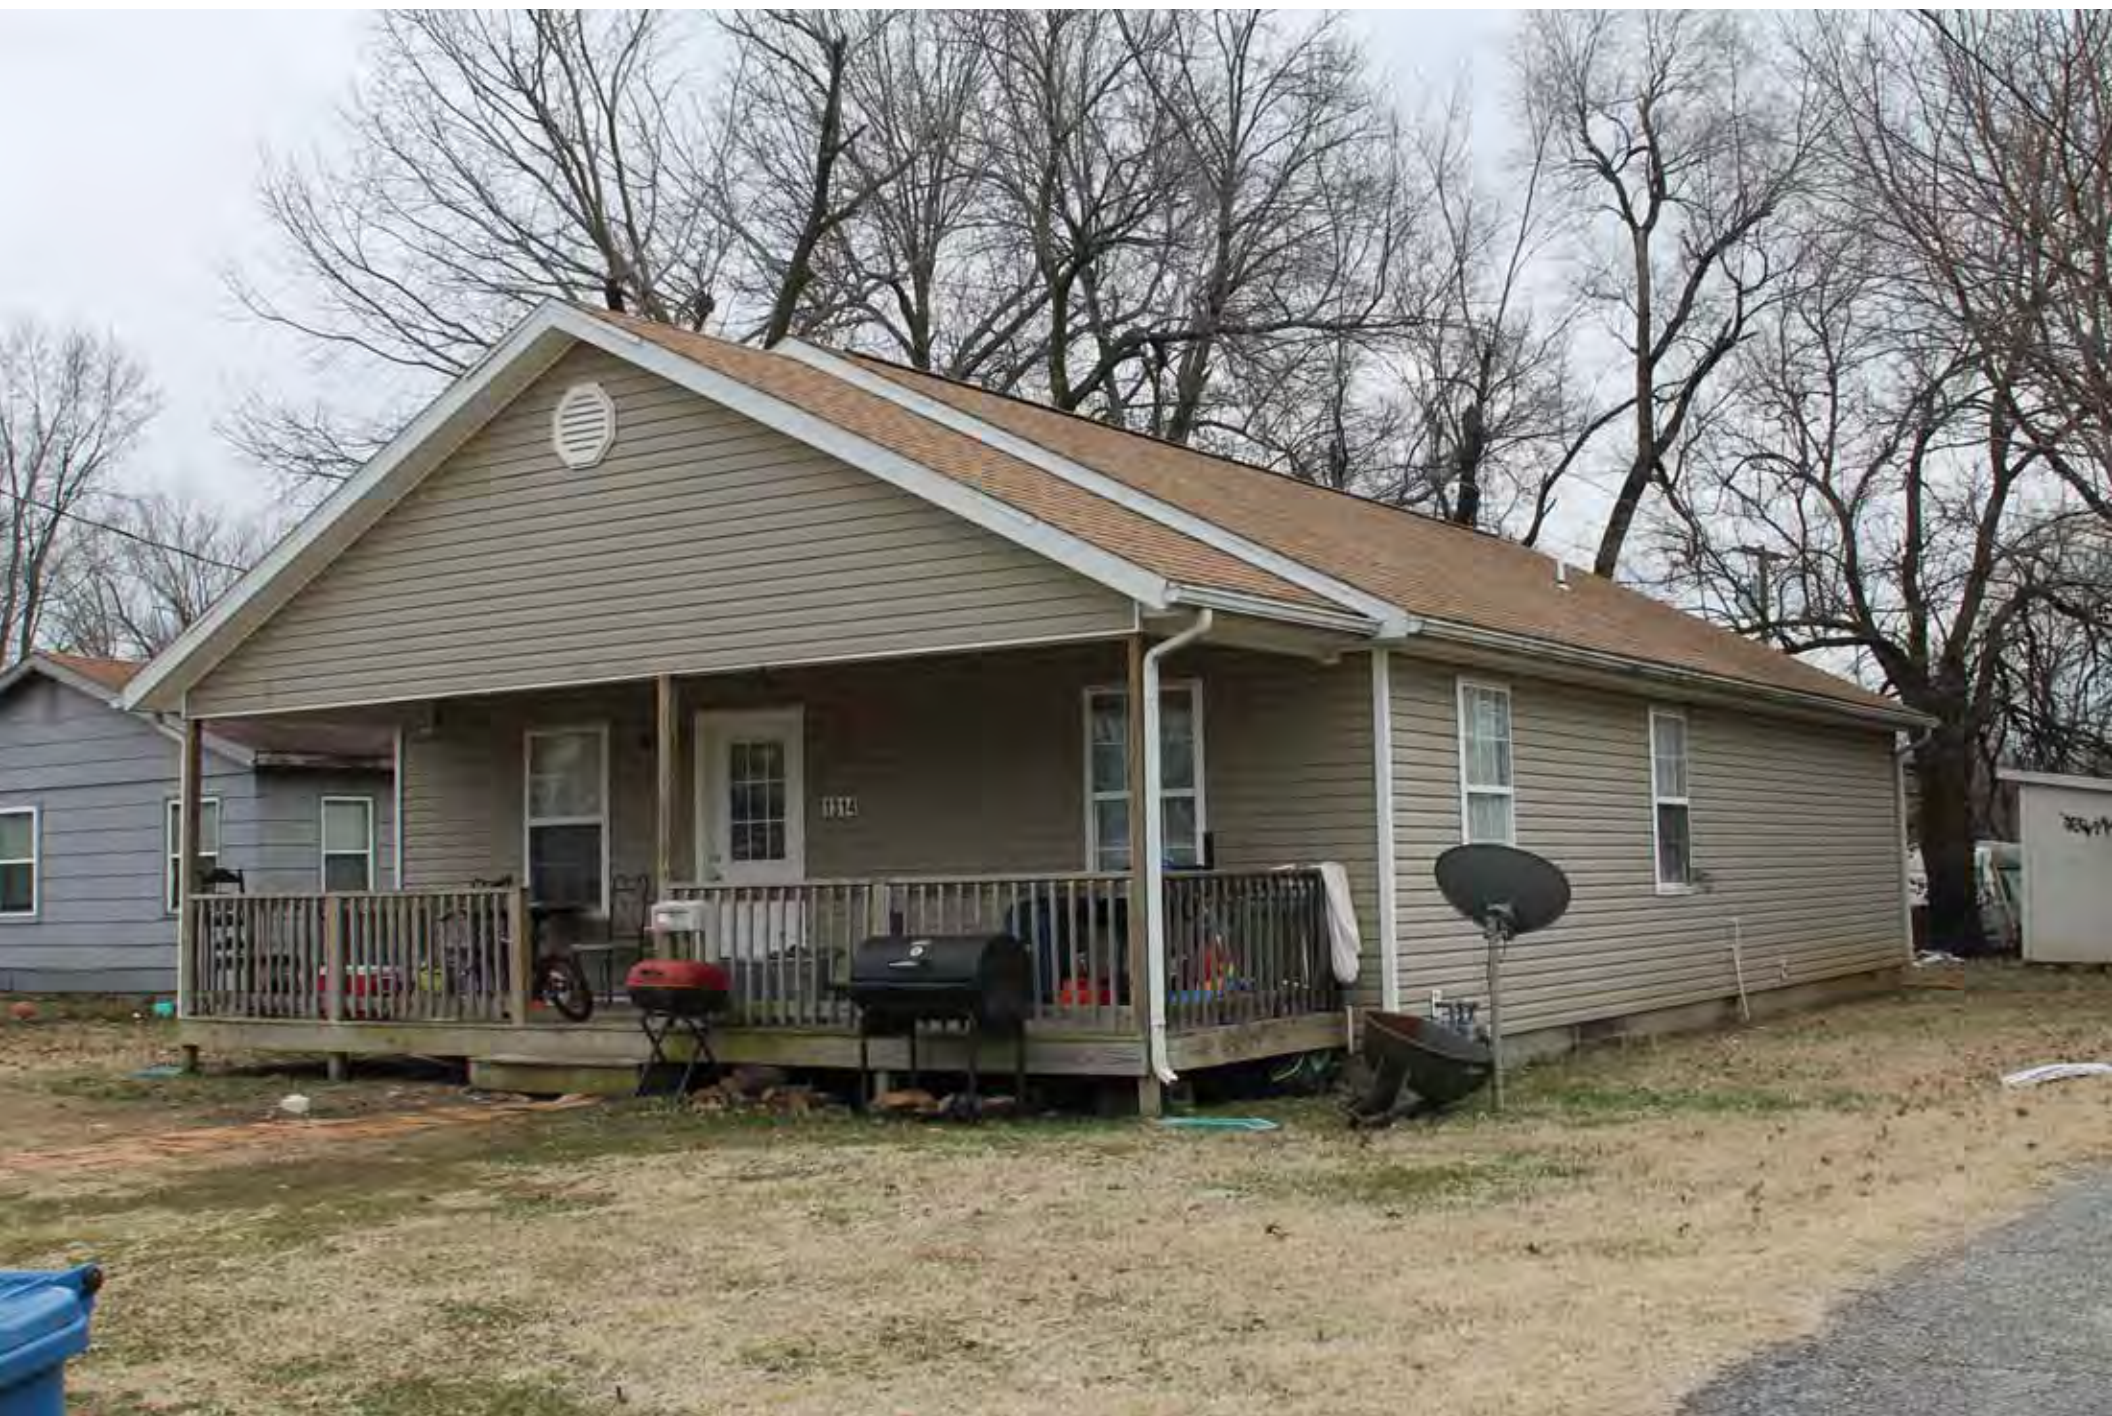
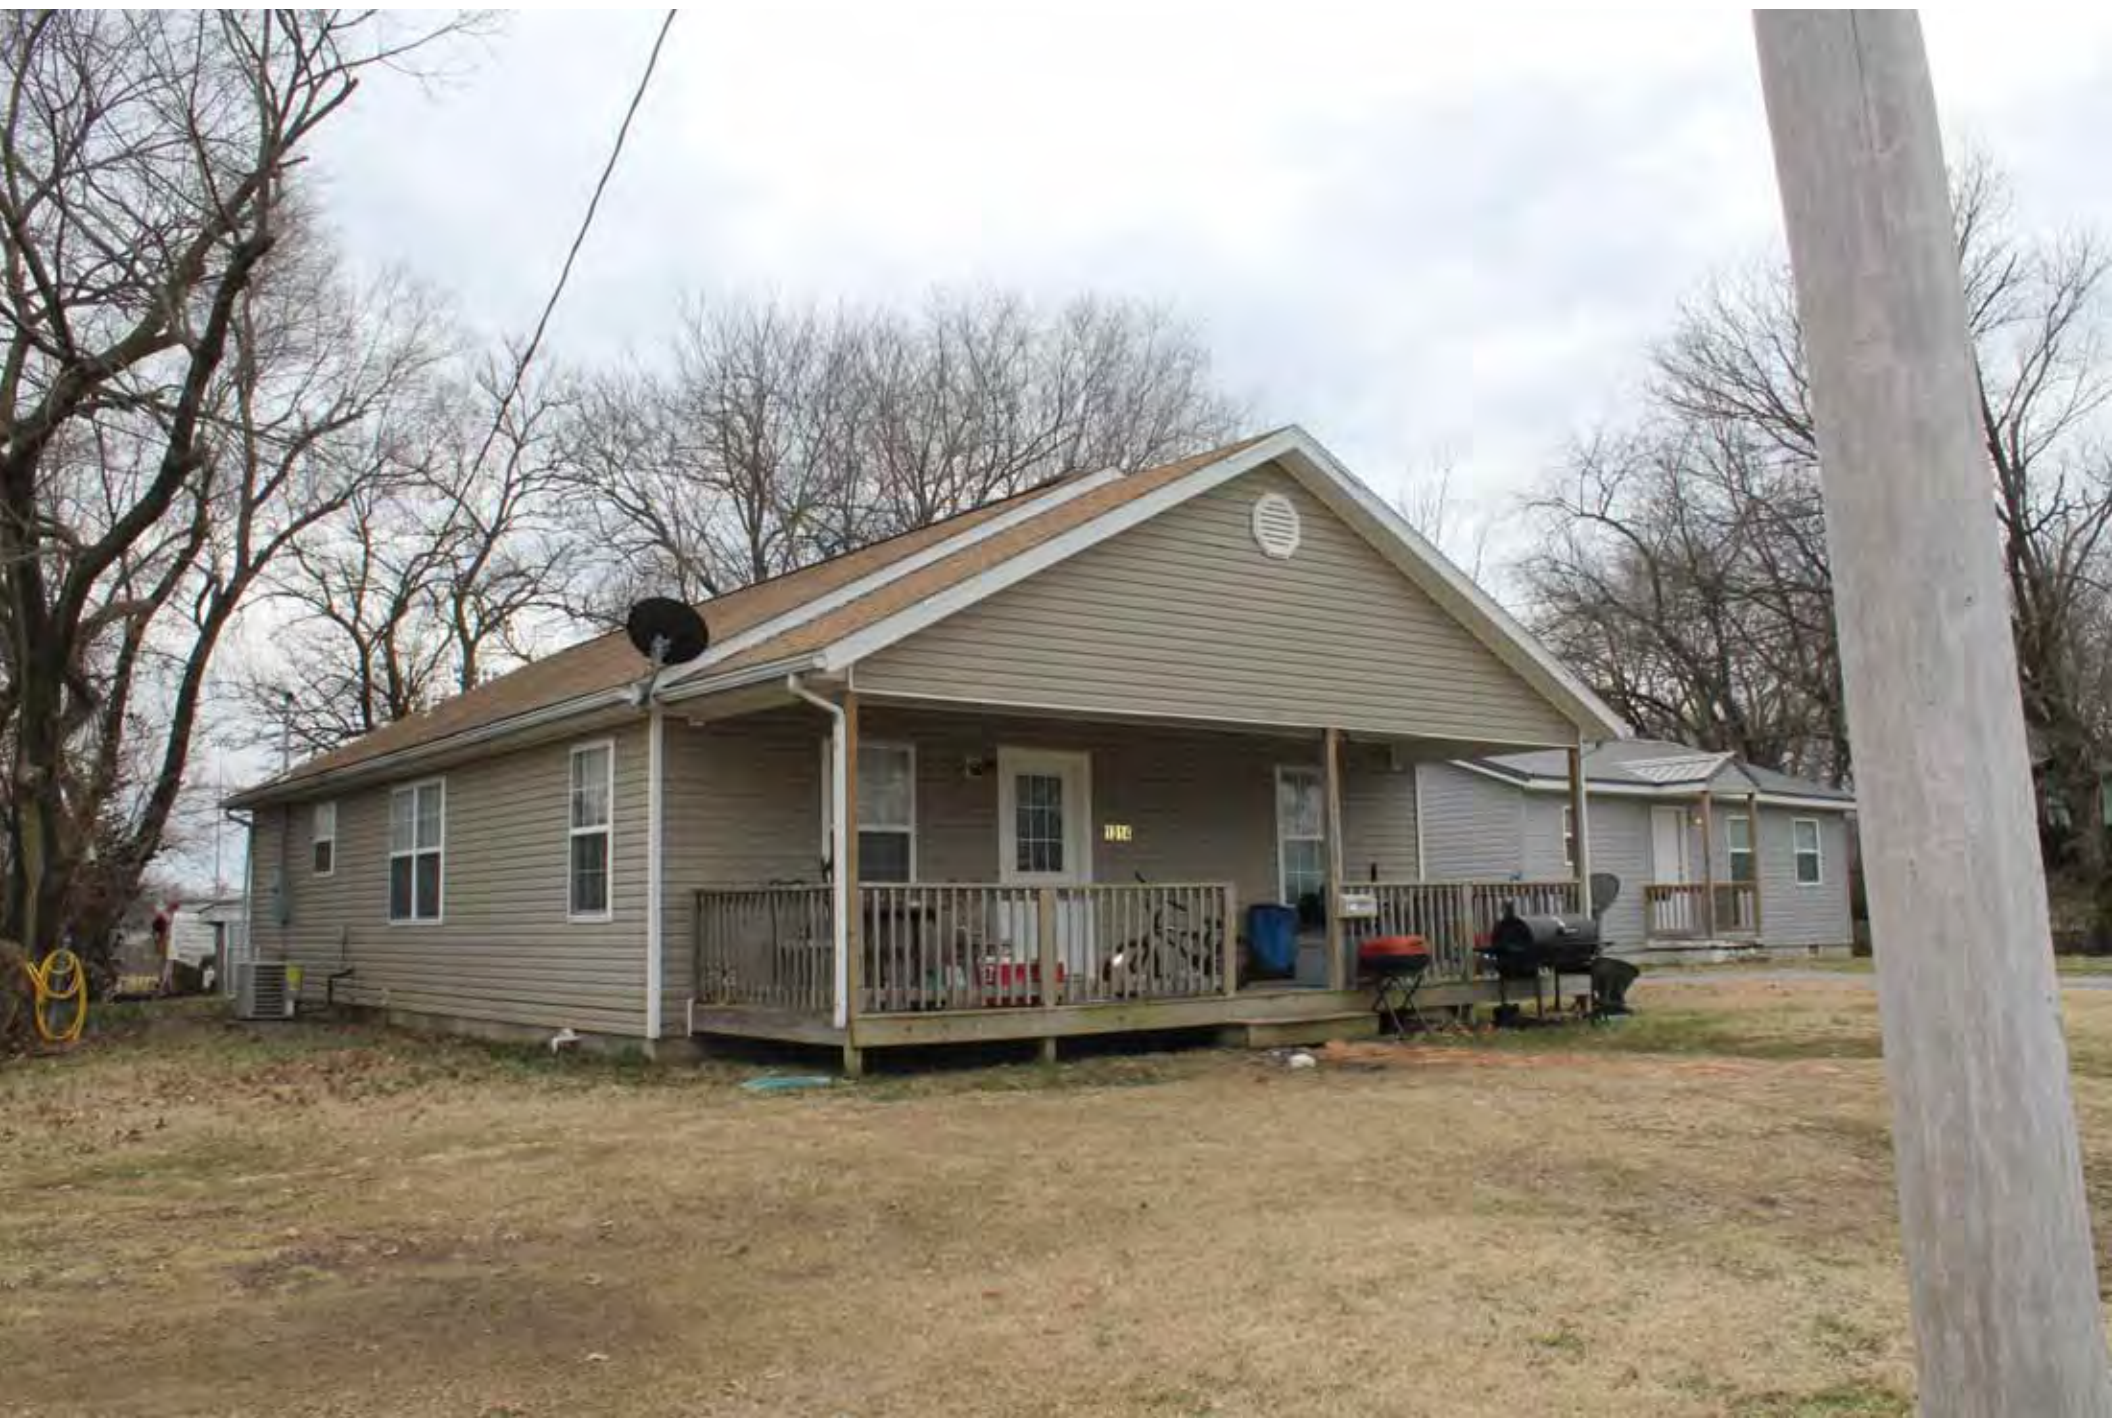
The property at 1314 E. Central Street features a contemporary dwelling with an asphalt shingled front-gable roof, exterior synthetic siding and a concrete foundation. The primary (north) elevation supports a full width gabled porch supported by wood columns. The porch has a frame balustrade. The primary entry is off-center within the porch bay, filled with a nine-light c. 2019 door. Flanking the door are six-over-six windows. The porch gable field holds an octagonal louvered vent. The west elevation holds two six-over-six windows. The east elevation holds paired and single windows of similar configuration.

The dwelling is a common property type that is less than 50 years of age. The property fails to exhibit exceptional architectural and/or historical significance. The dwelling is not within an area recommended as a historic district. For these reasons, the property does not appear eligible for the National Register of Historic Places.

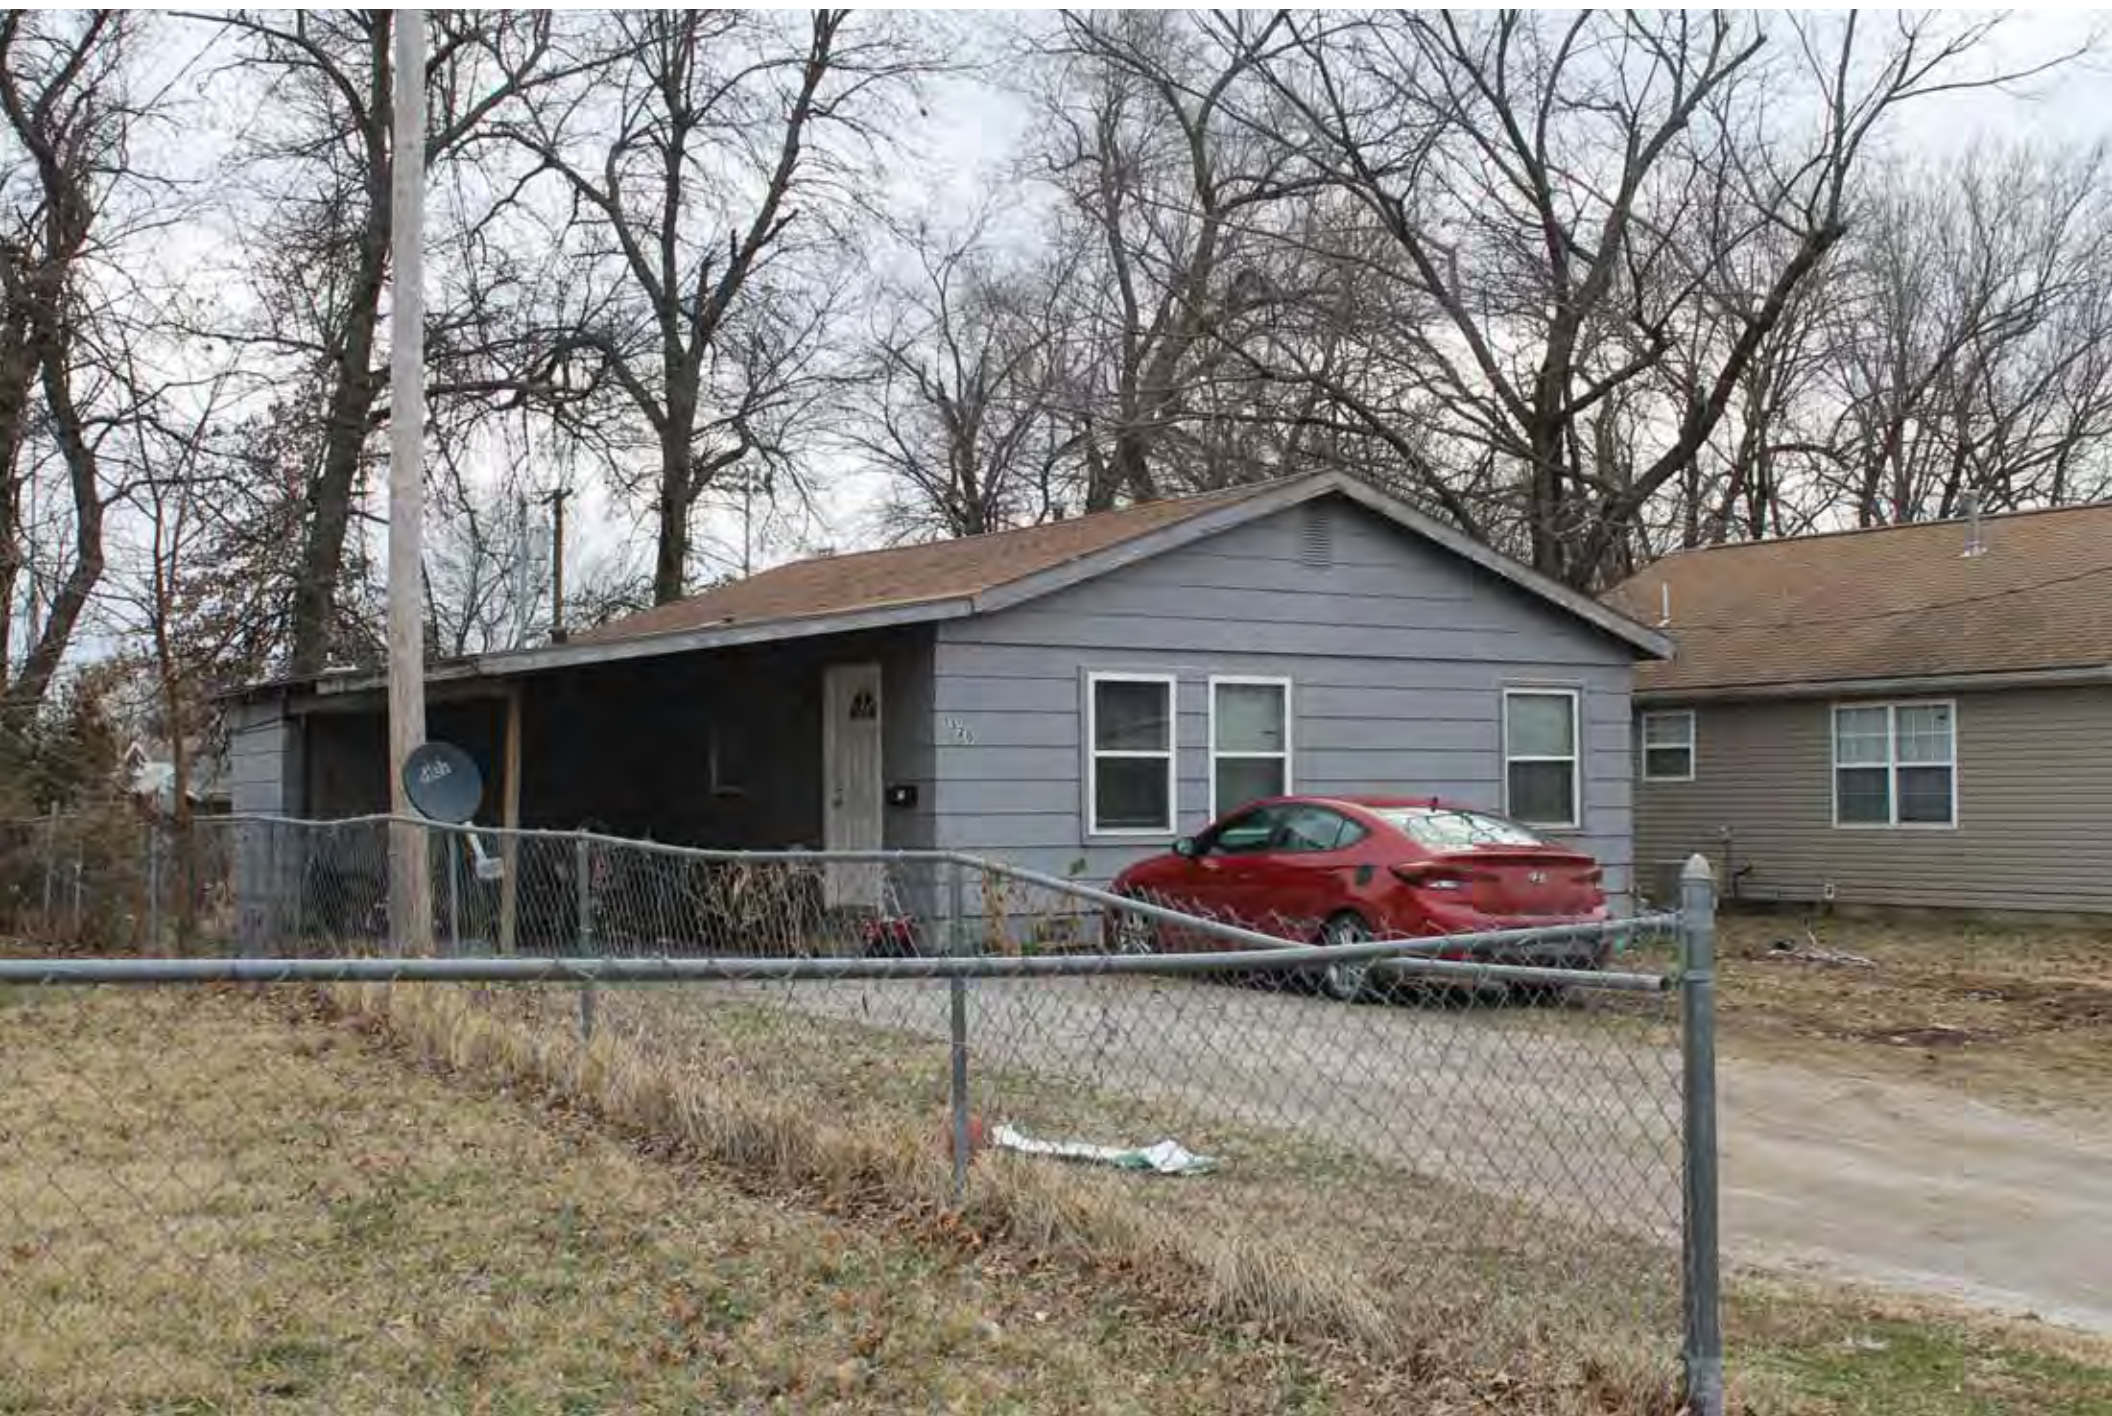
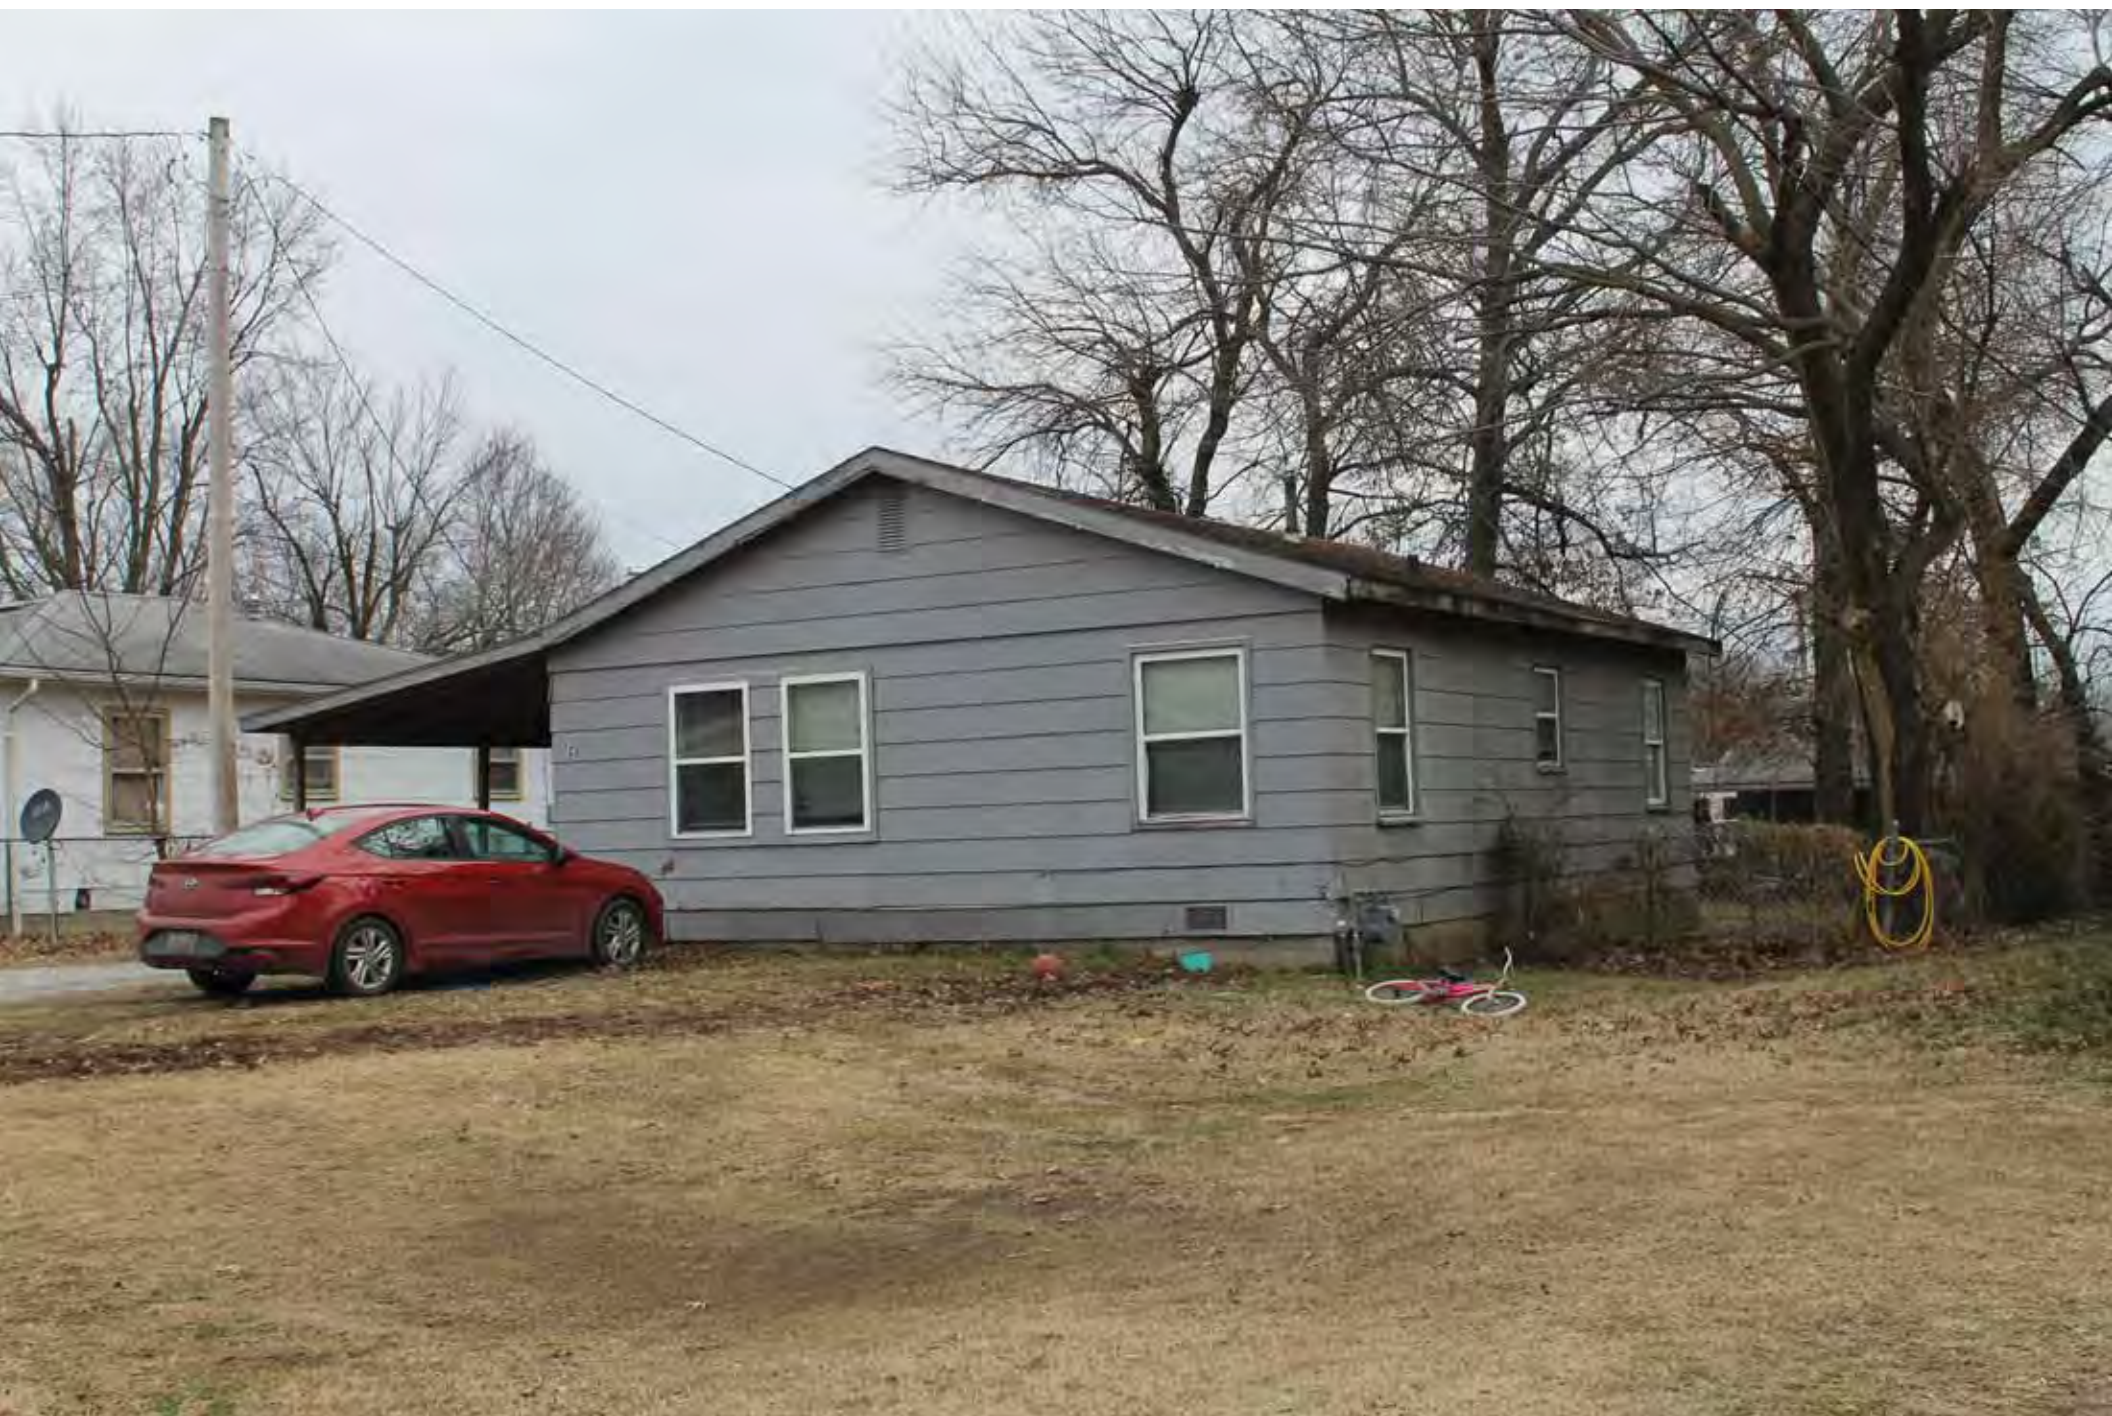
The property at 1320 E. Central Street features a single-story dwelling with an asphalt shingled front-gable roof, exterior wide board siding and a concrete foundation. The north elevation facing E. Central Street holds three windows. Windows are one-over-one and appear to be c. 2019 replacement. The front gable field holds a louvered vent. The east side of the house supports a shed extension that creates a carport and covers the primary entry, also located on the east (side) elevation facing the drive. The entry bay holds a c. 2019 paneled door with an upper fanlight. A one-over-one window offsets the entry to the south. The south end of the shed extension supports a small wing, likely used for storage purposes. The west elevation holds three windows.

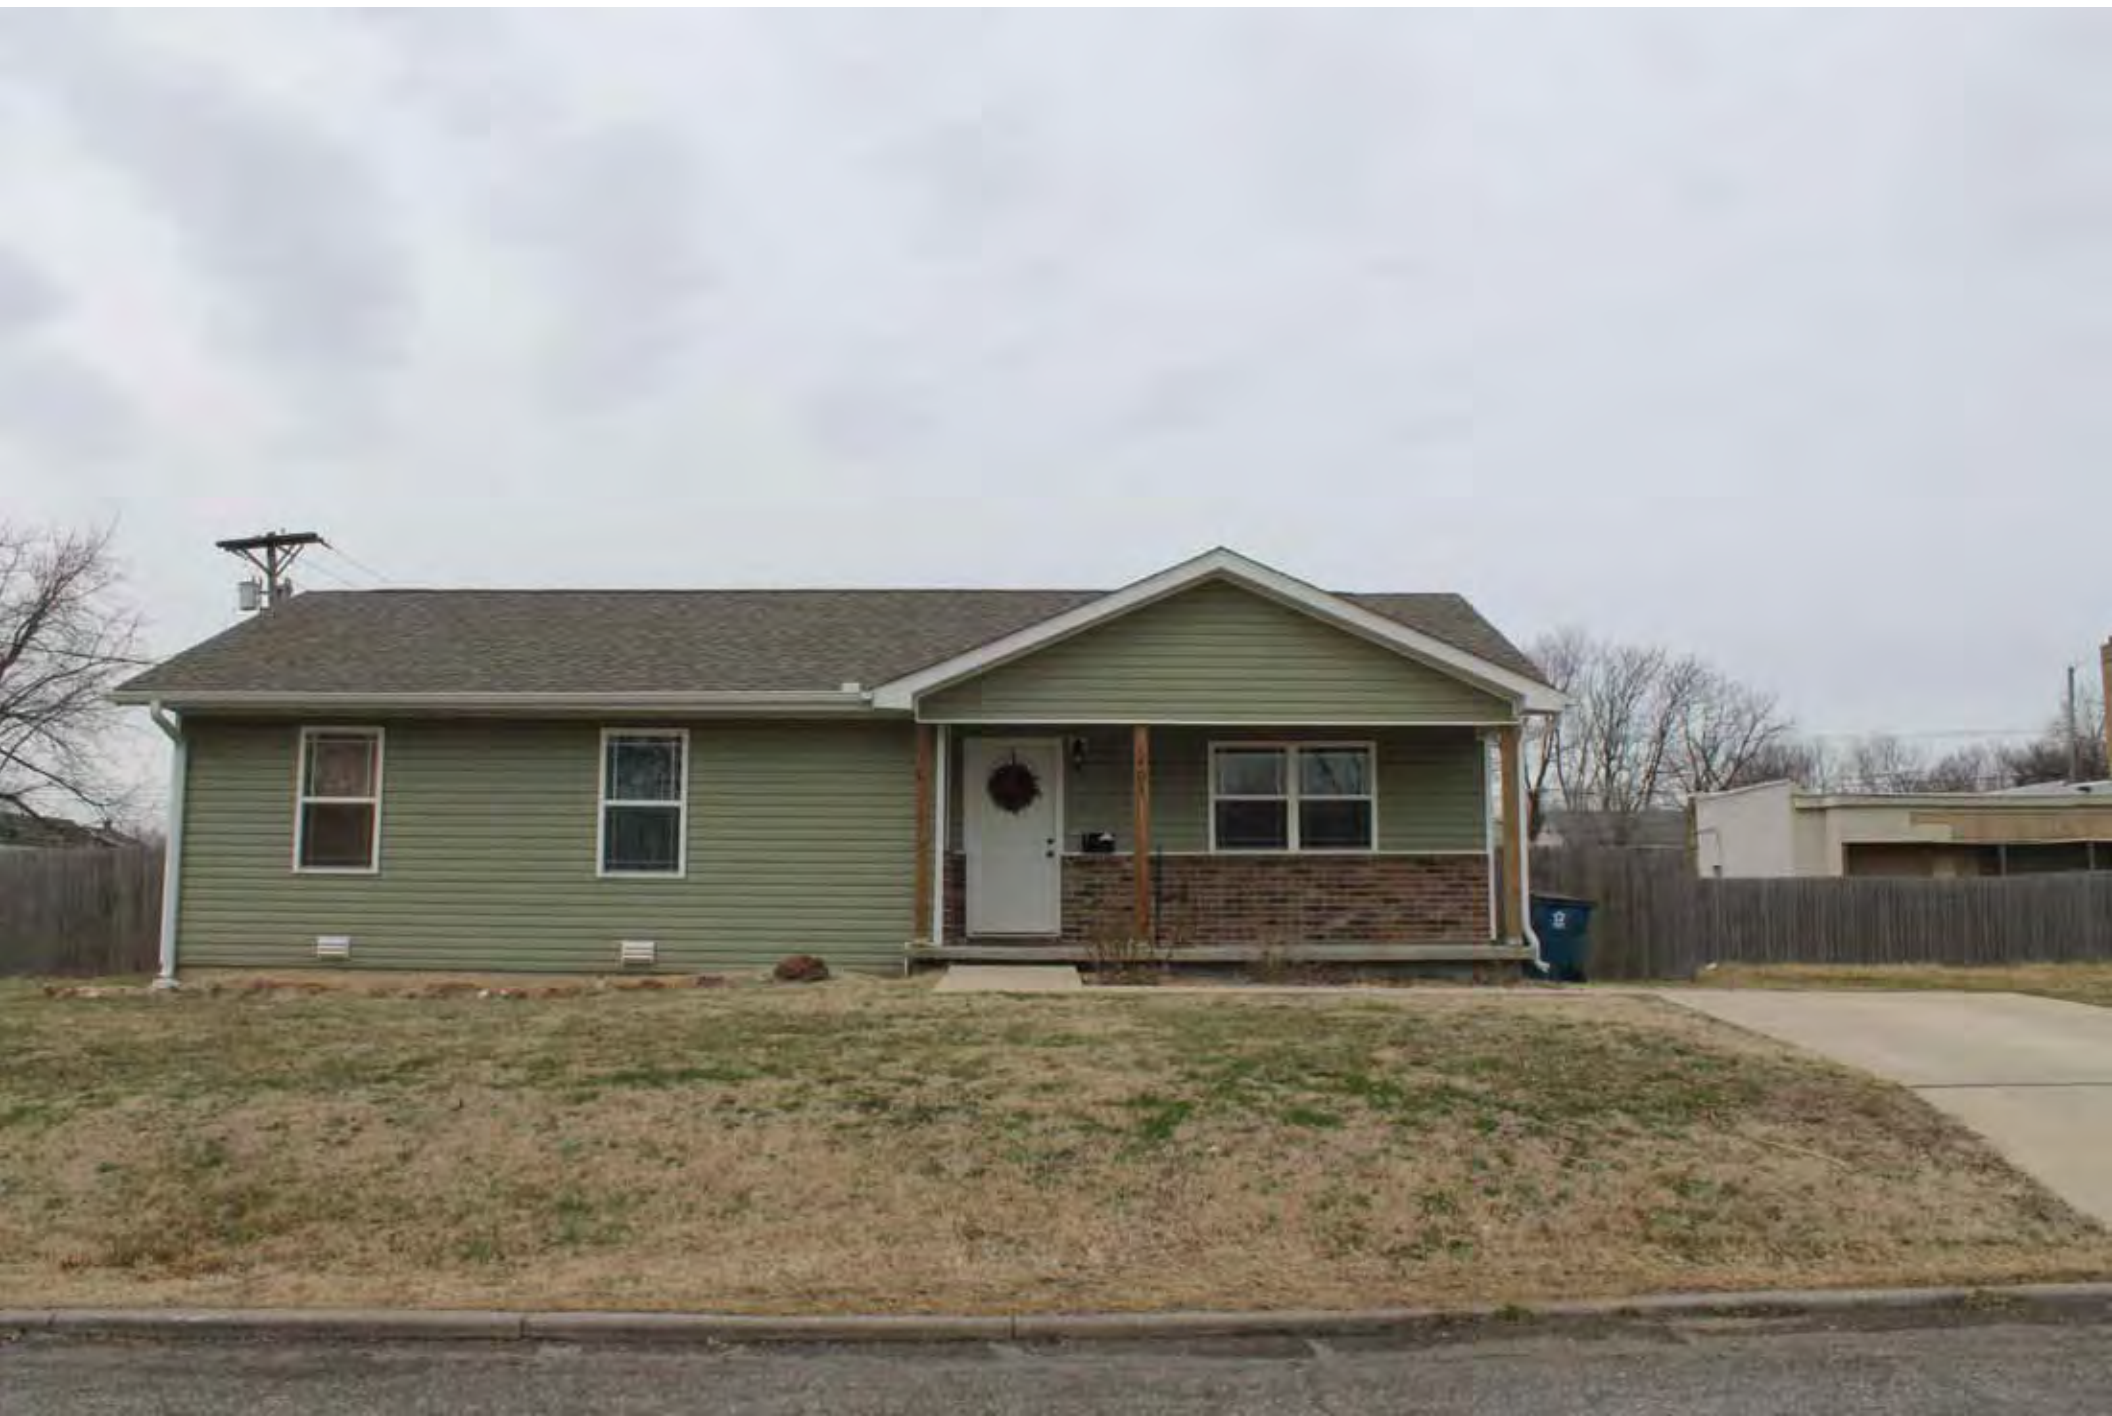
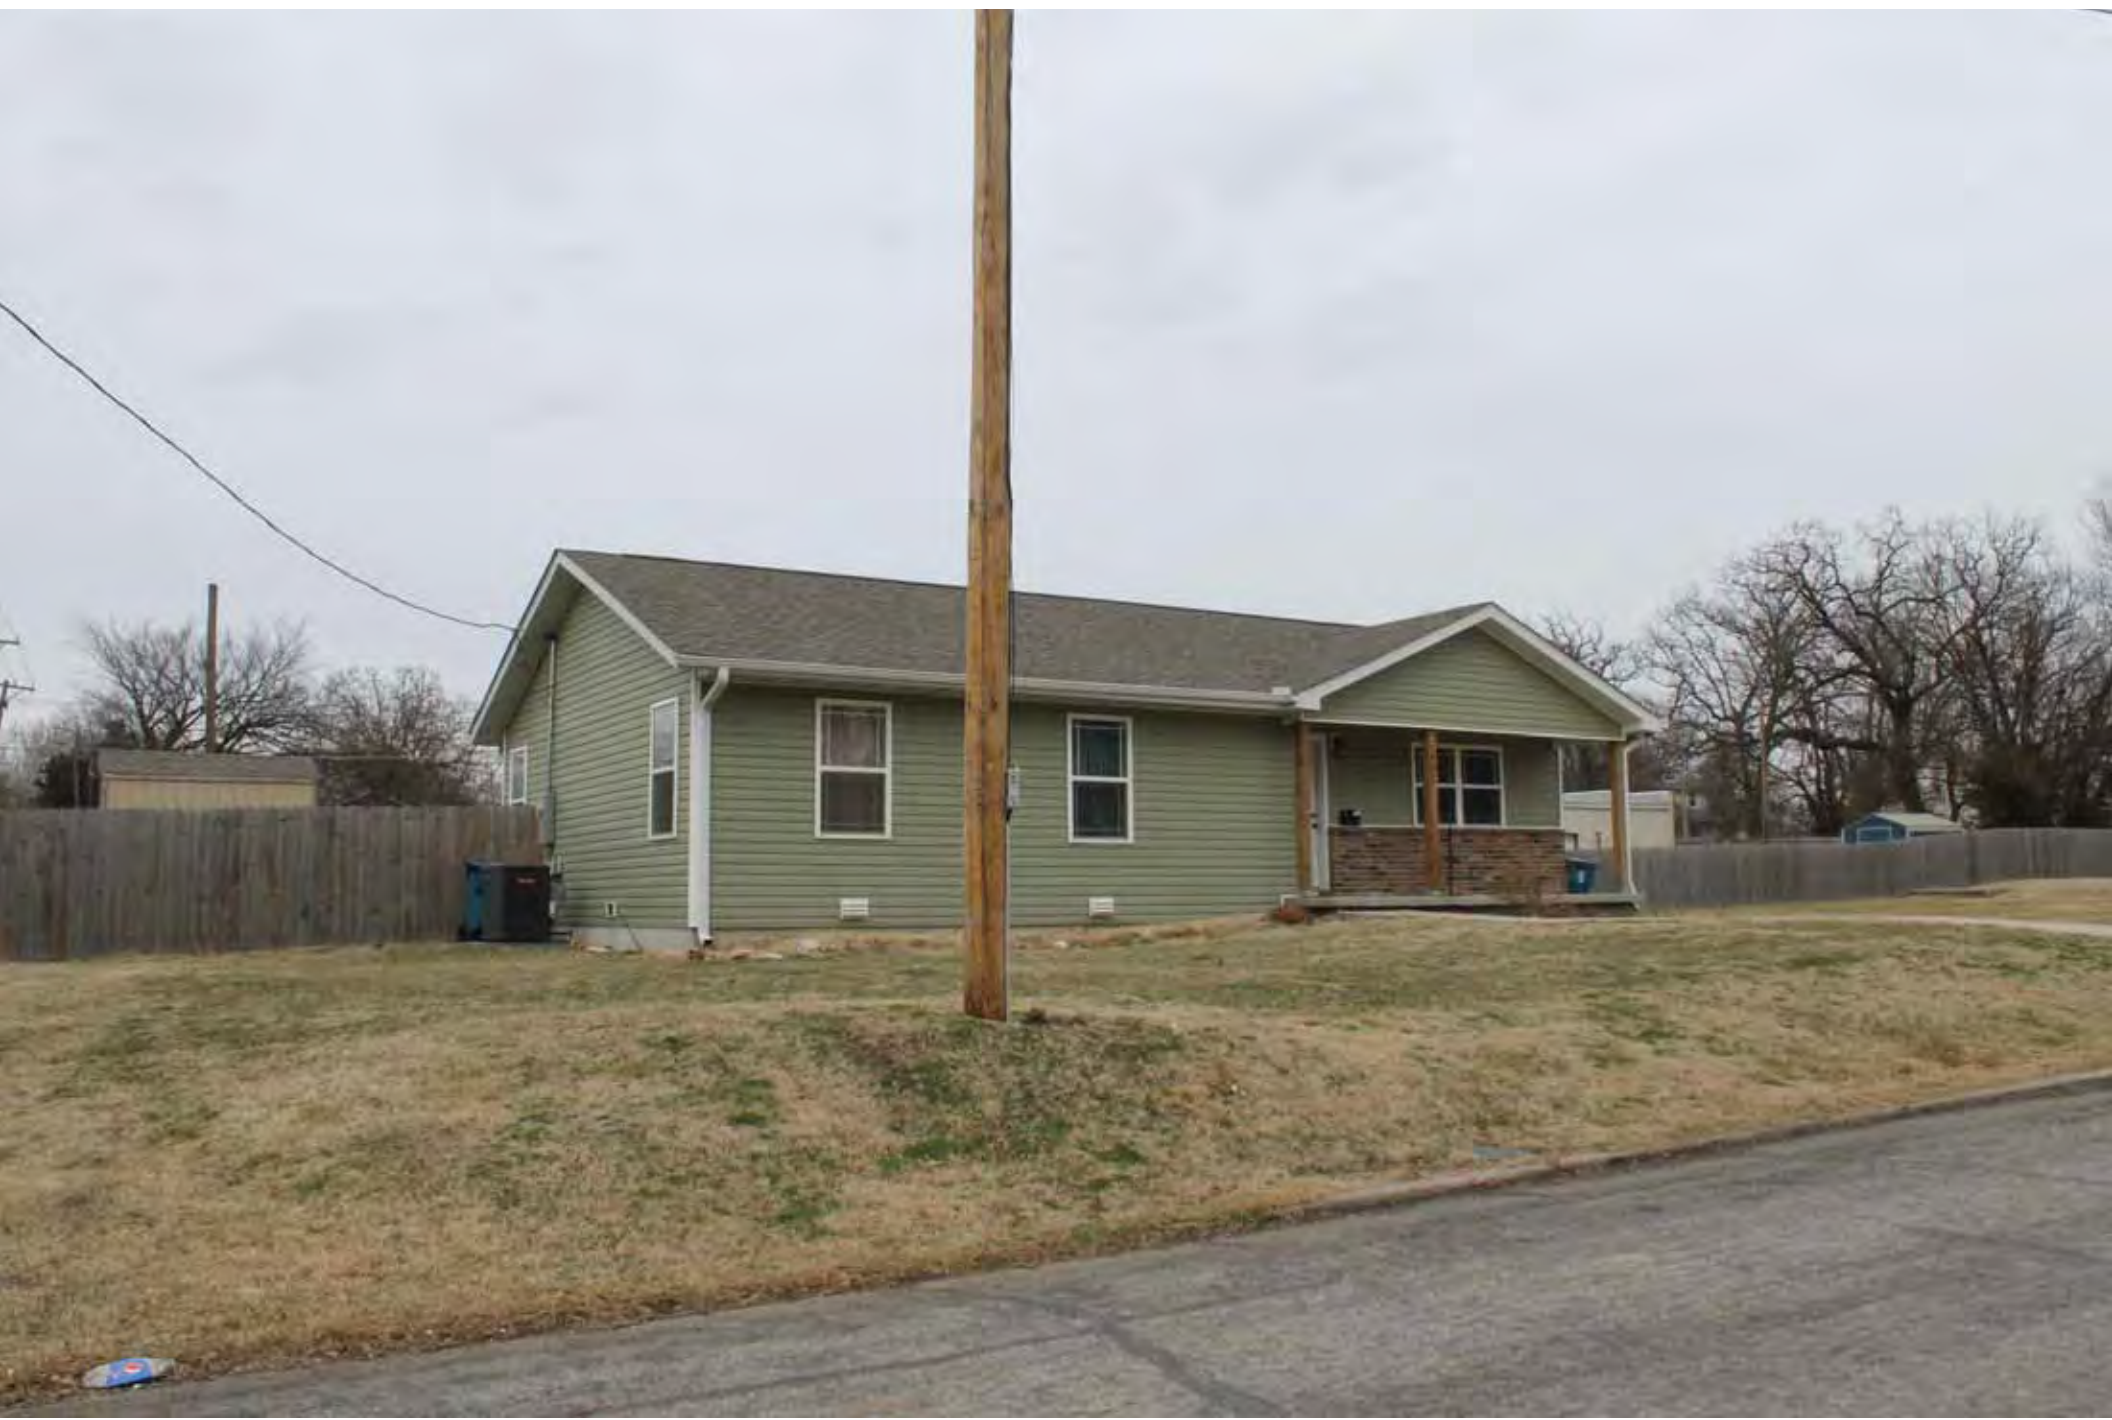
The property at 1401 E. Central Street features a contemporary Ranch style dwelling with an asphalt-shingled gable roof, exterior synthetic siding and a concrete foundation. The primary (south) elevation features a gabled porch with wood columns at the east end of the elevation. The porch wall is clad with brick on the lower south elevation. A paneled door with an upper circular light offsets the bricked area at the west. Above the brick, the south elevation holds paired windows. All windows have decorative muntins framing the outer sashes. The remaining façade projects south (framing the porch) and supports two windows. Side (east/west) elevations hold windows similar to those on the façade.
