MISSOURI DEPARTMENT OF NATURAL RESOURCES
STATE HISTORIC PRESERVATION OFFICE, P.O. Box 176, Jefferson City, MO 65102
ARCHITECTURAL/HISTORIC INVENTORY FORM

1. Survey No. JP-AS-007-001		2. Survey name: East Town (Original Joplin) Historic Survey Phase 2	
3. County: JASPER		4. Address (Street No.) 618	Street (name) E. 2 nd Street
5. City: Joplin	Vicinity: <input type="checkbox"/>	6. Geographical Reference:	7. Township/Range/Section: T: R: S:
8. Historic name (if known):		9. Present/other name (if known):	
10. Ownership: <input checked="" type="checkbox"/> Private <input type="checkbox"/> Public		11a. Historic use (if known): Domestic: Single Dwelling	11b. Current use: Domestic: Single Dwelling

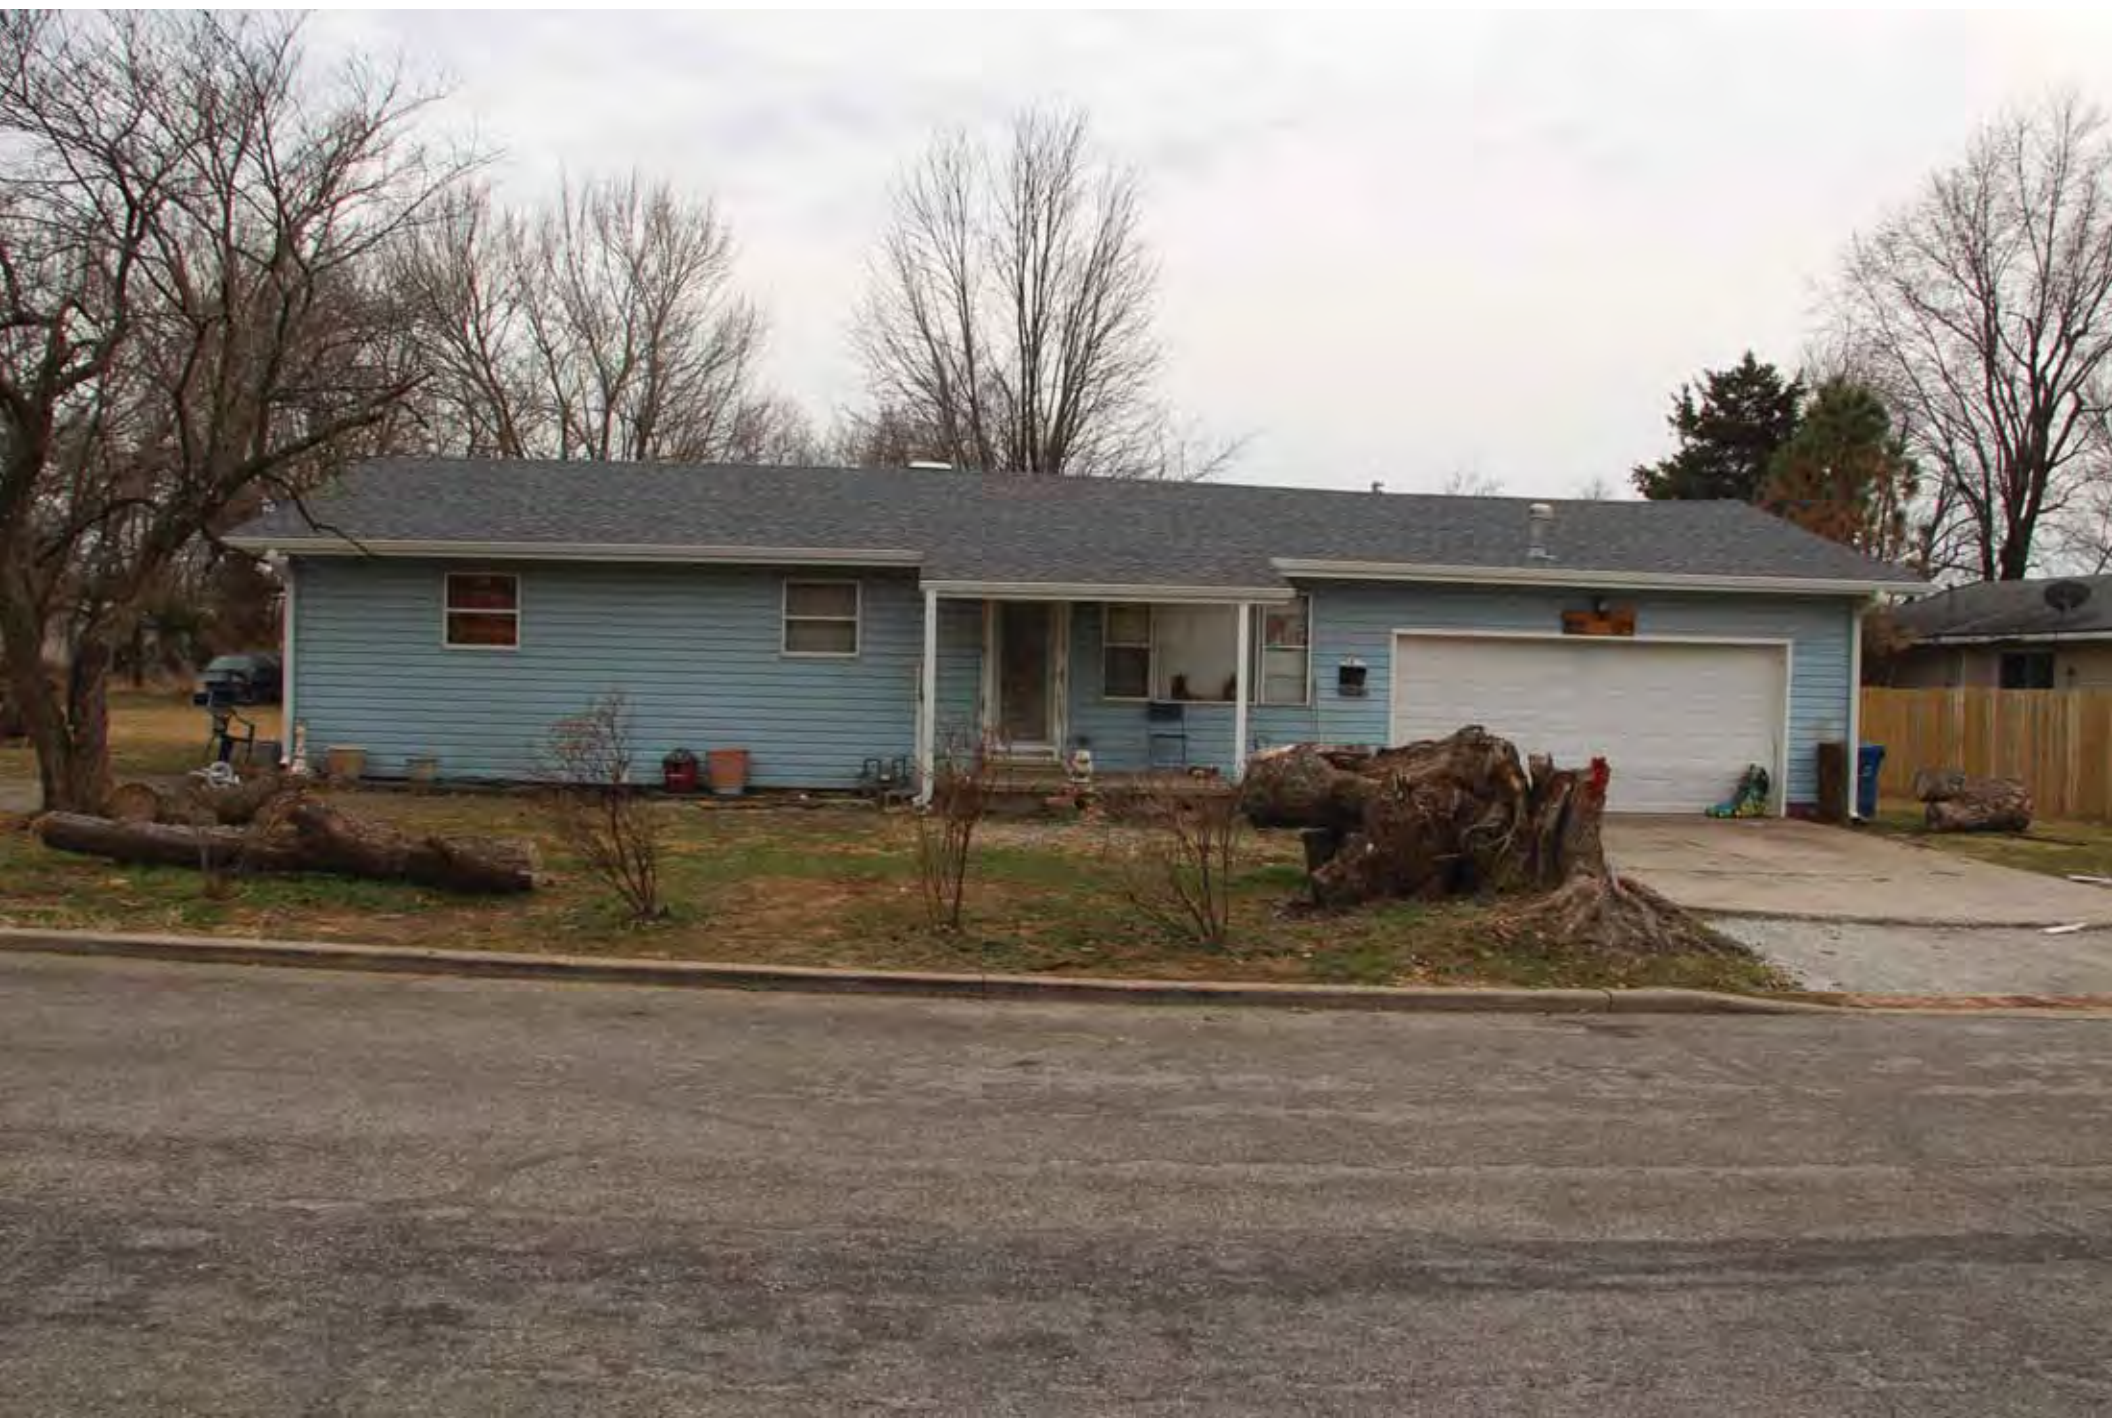
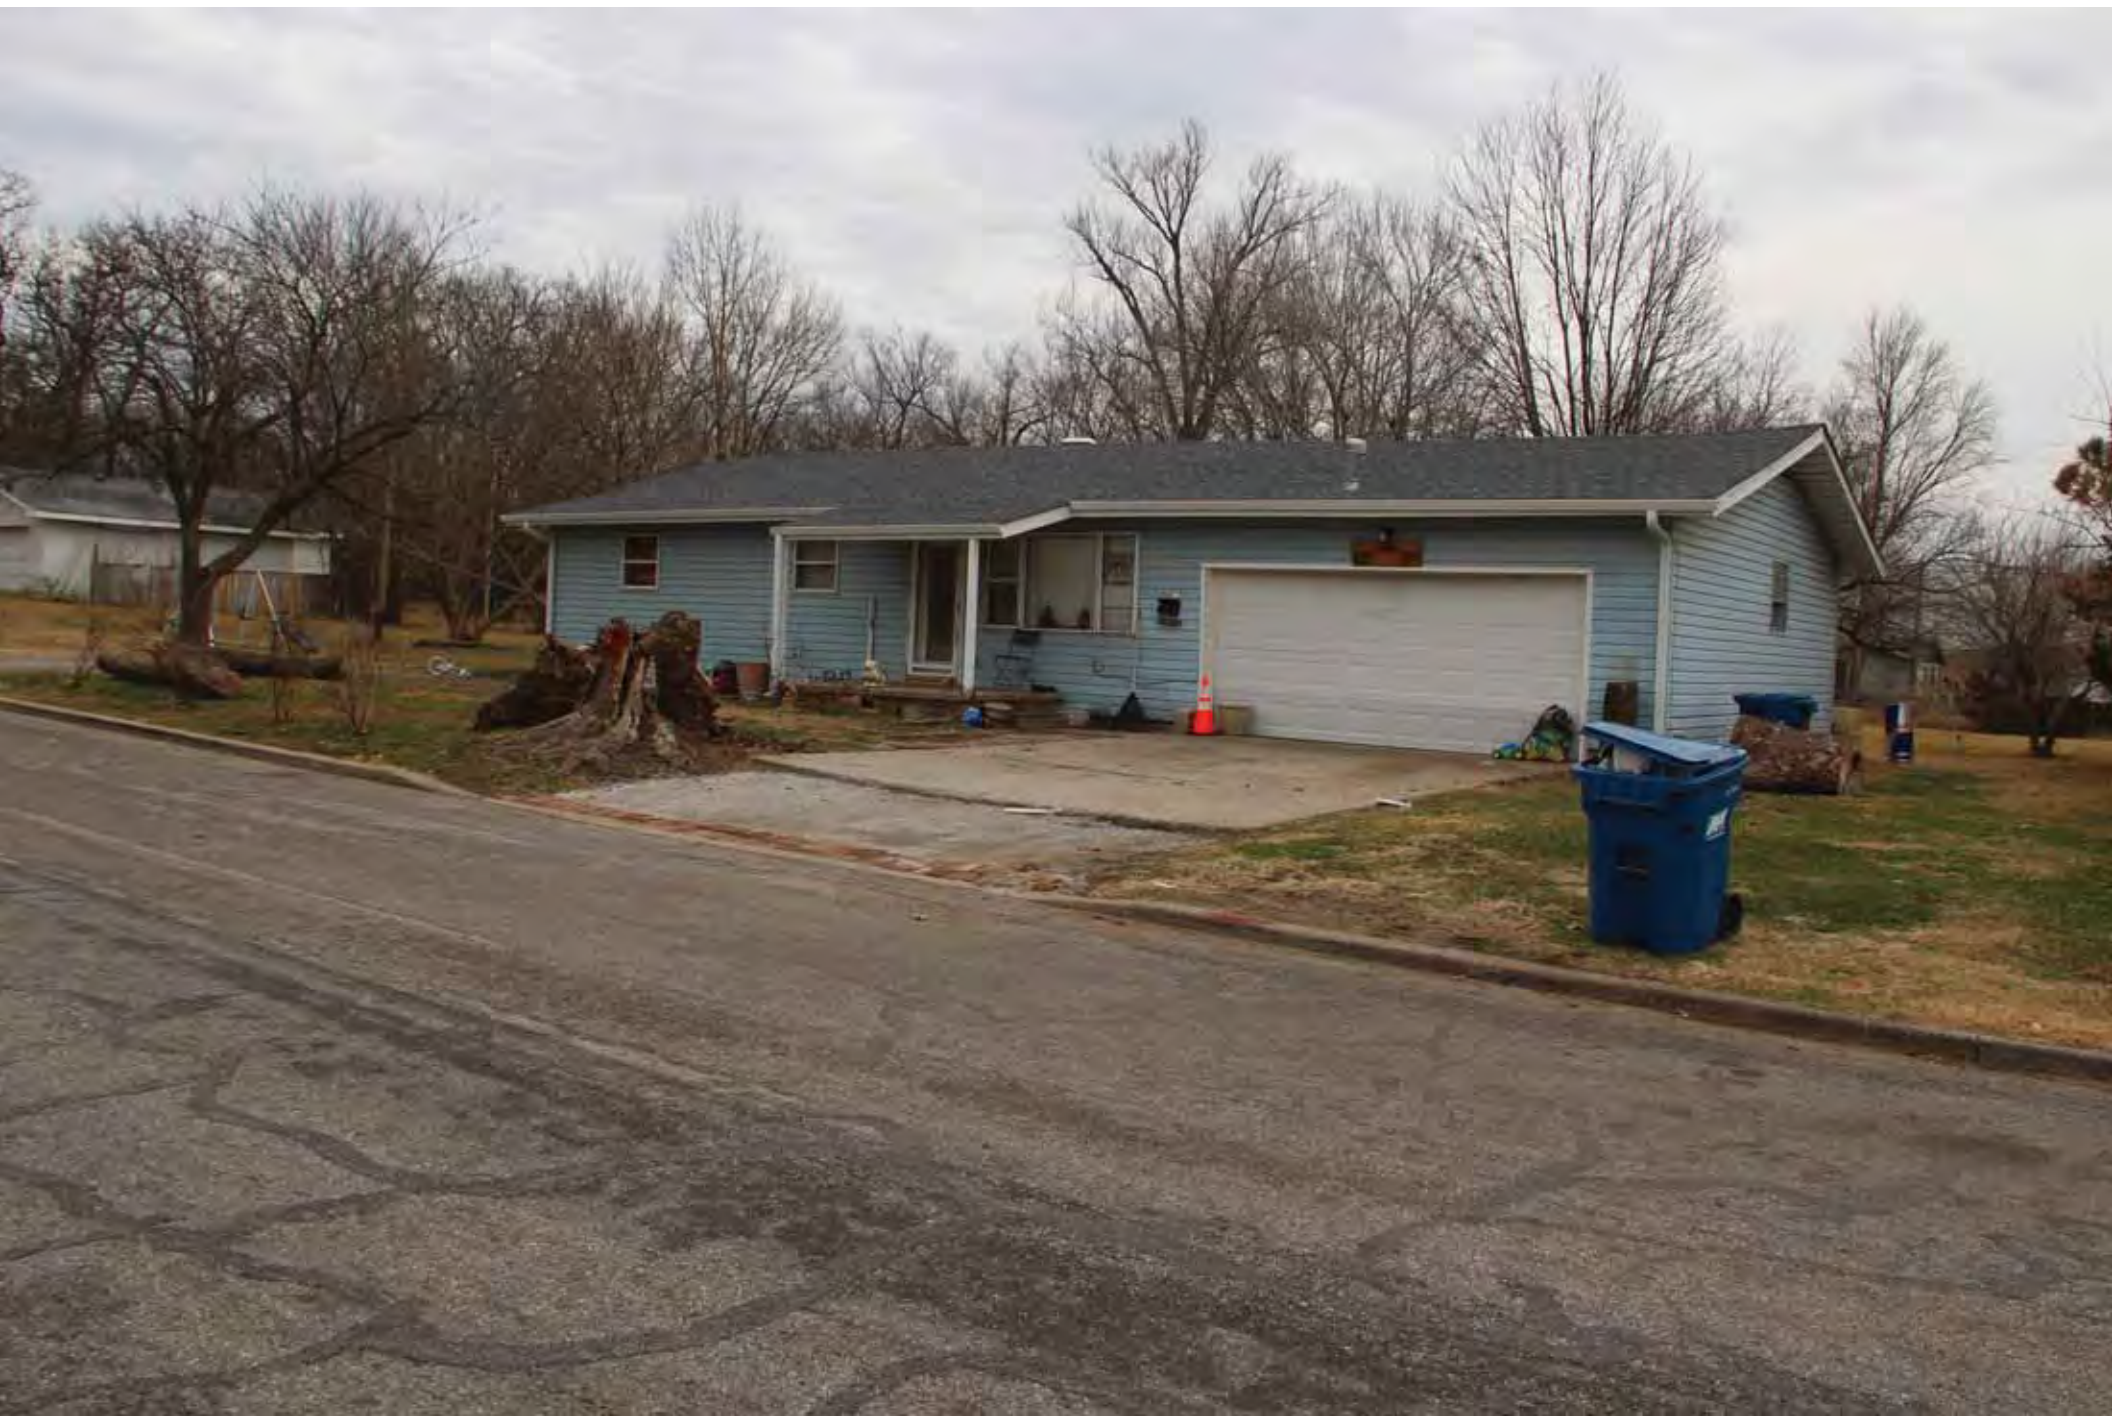
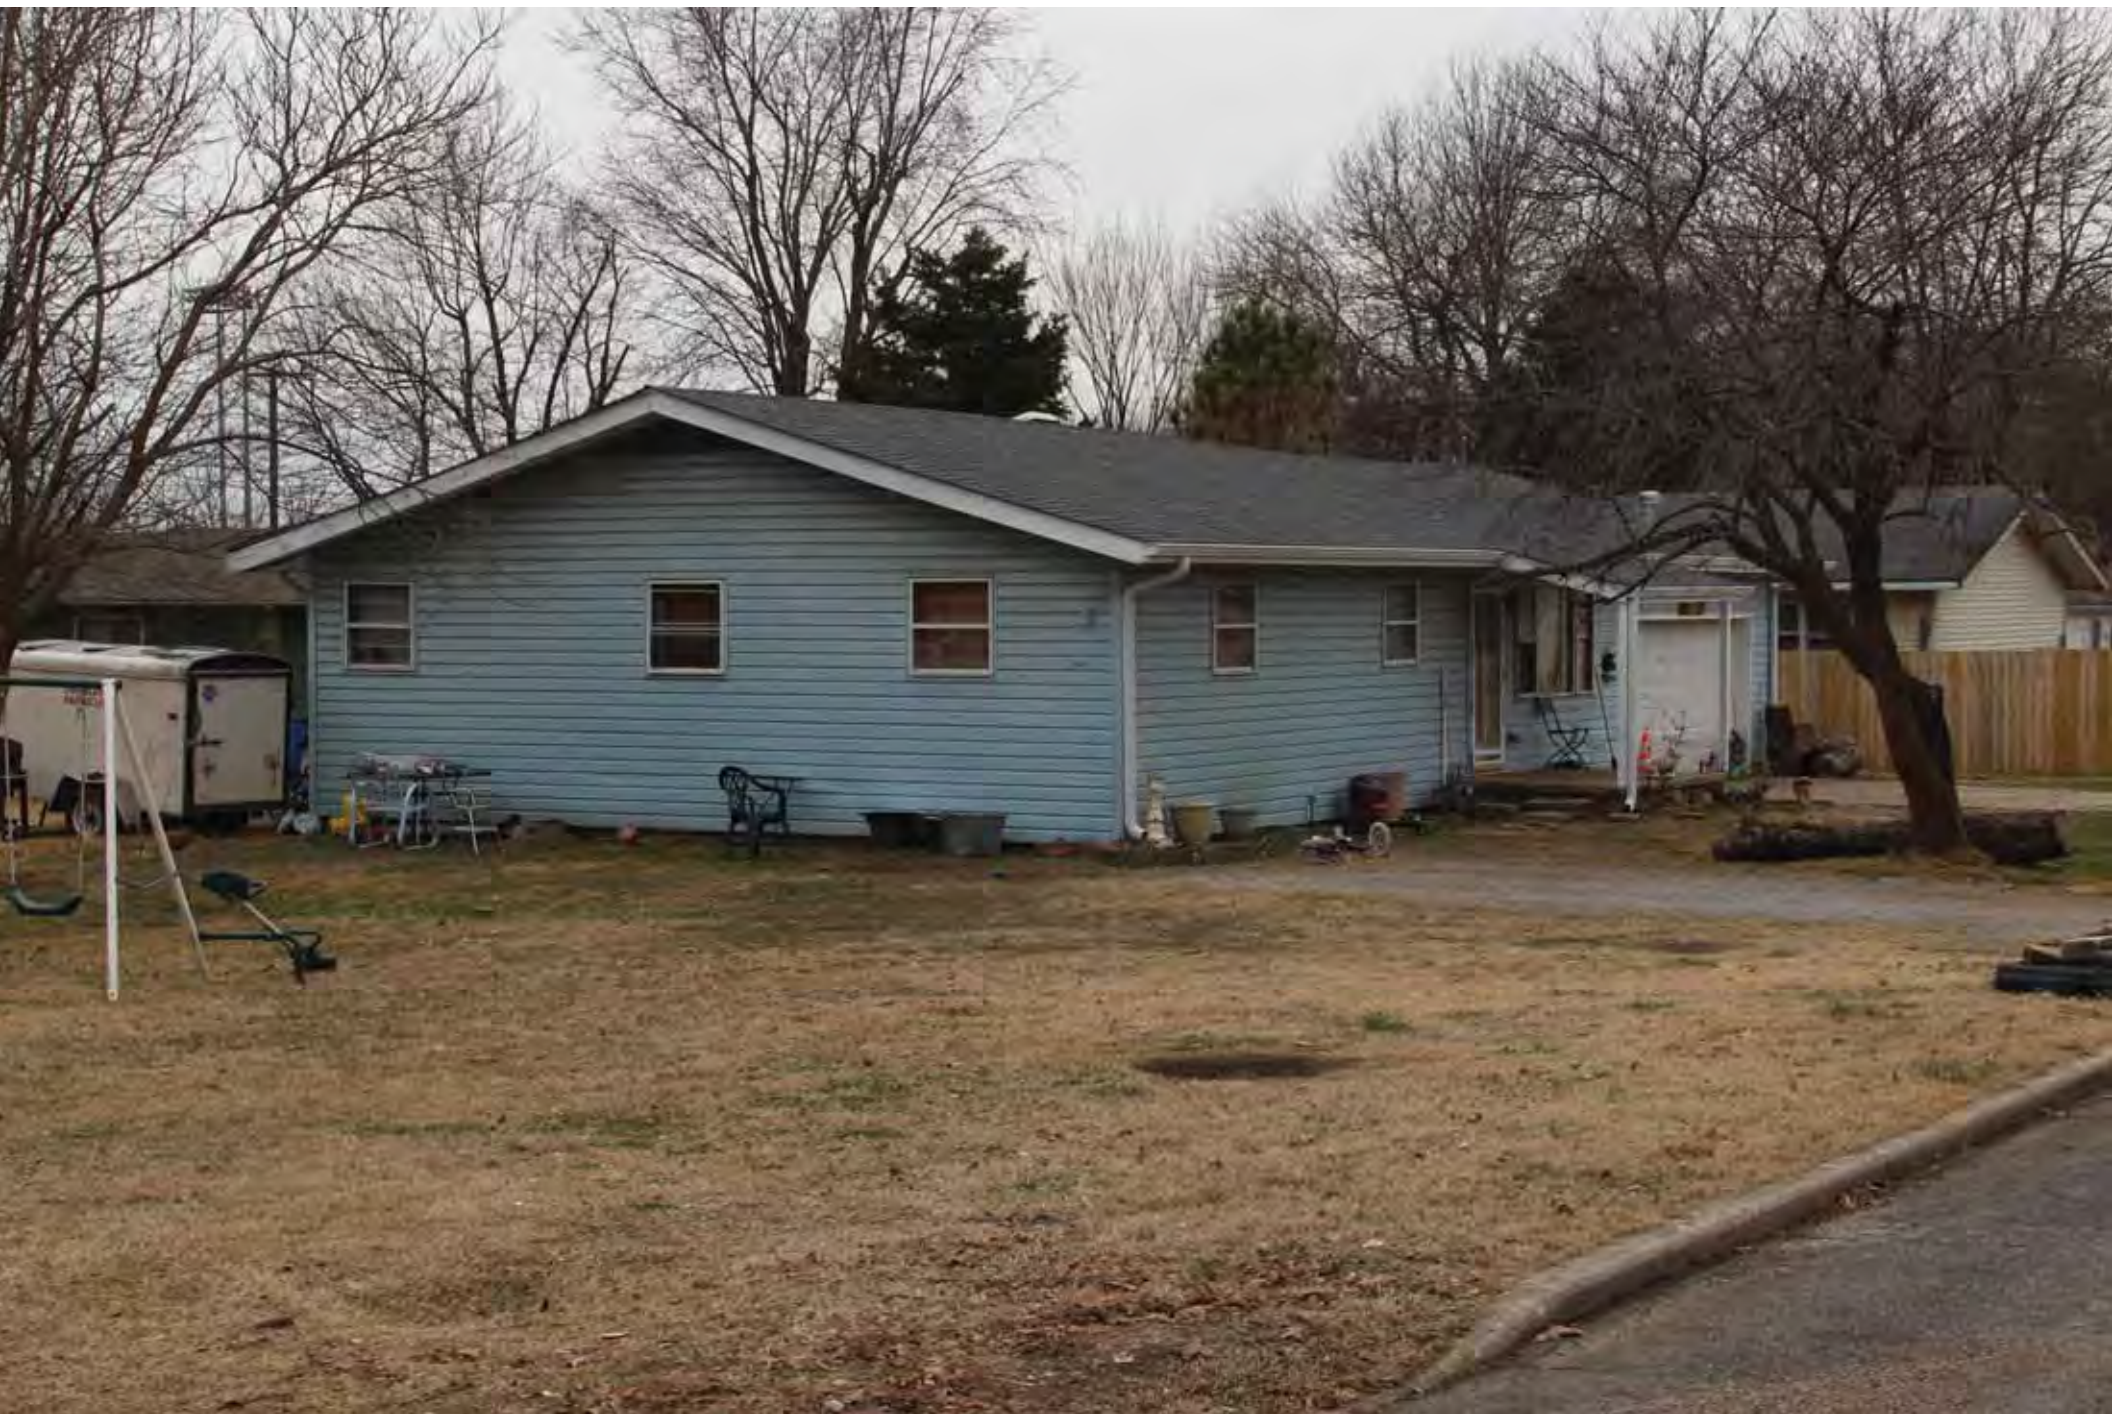
The property at 1408 E. Central Street features a contemporary Ranch style dwelling with an asphalt-shingled gable roof, exterior synthetic siding and a concrete foundation. The primary (south) elevation features a shed porch supported by two slender columns on a concrete base. Within the porch bay is a single-light door offset by a picture style window. Two small double-hung windows offset the porch on the east. The west end of the façade features an overhead track door (garage bay). The side (east/west) elevations support small windows similar to those on the façade. There are two windows on the east elevation and one window on the west elevation.

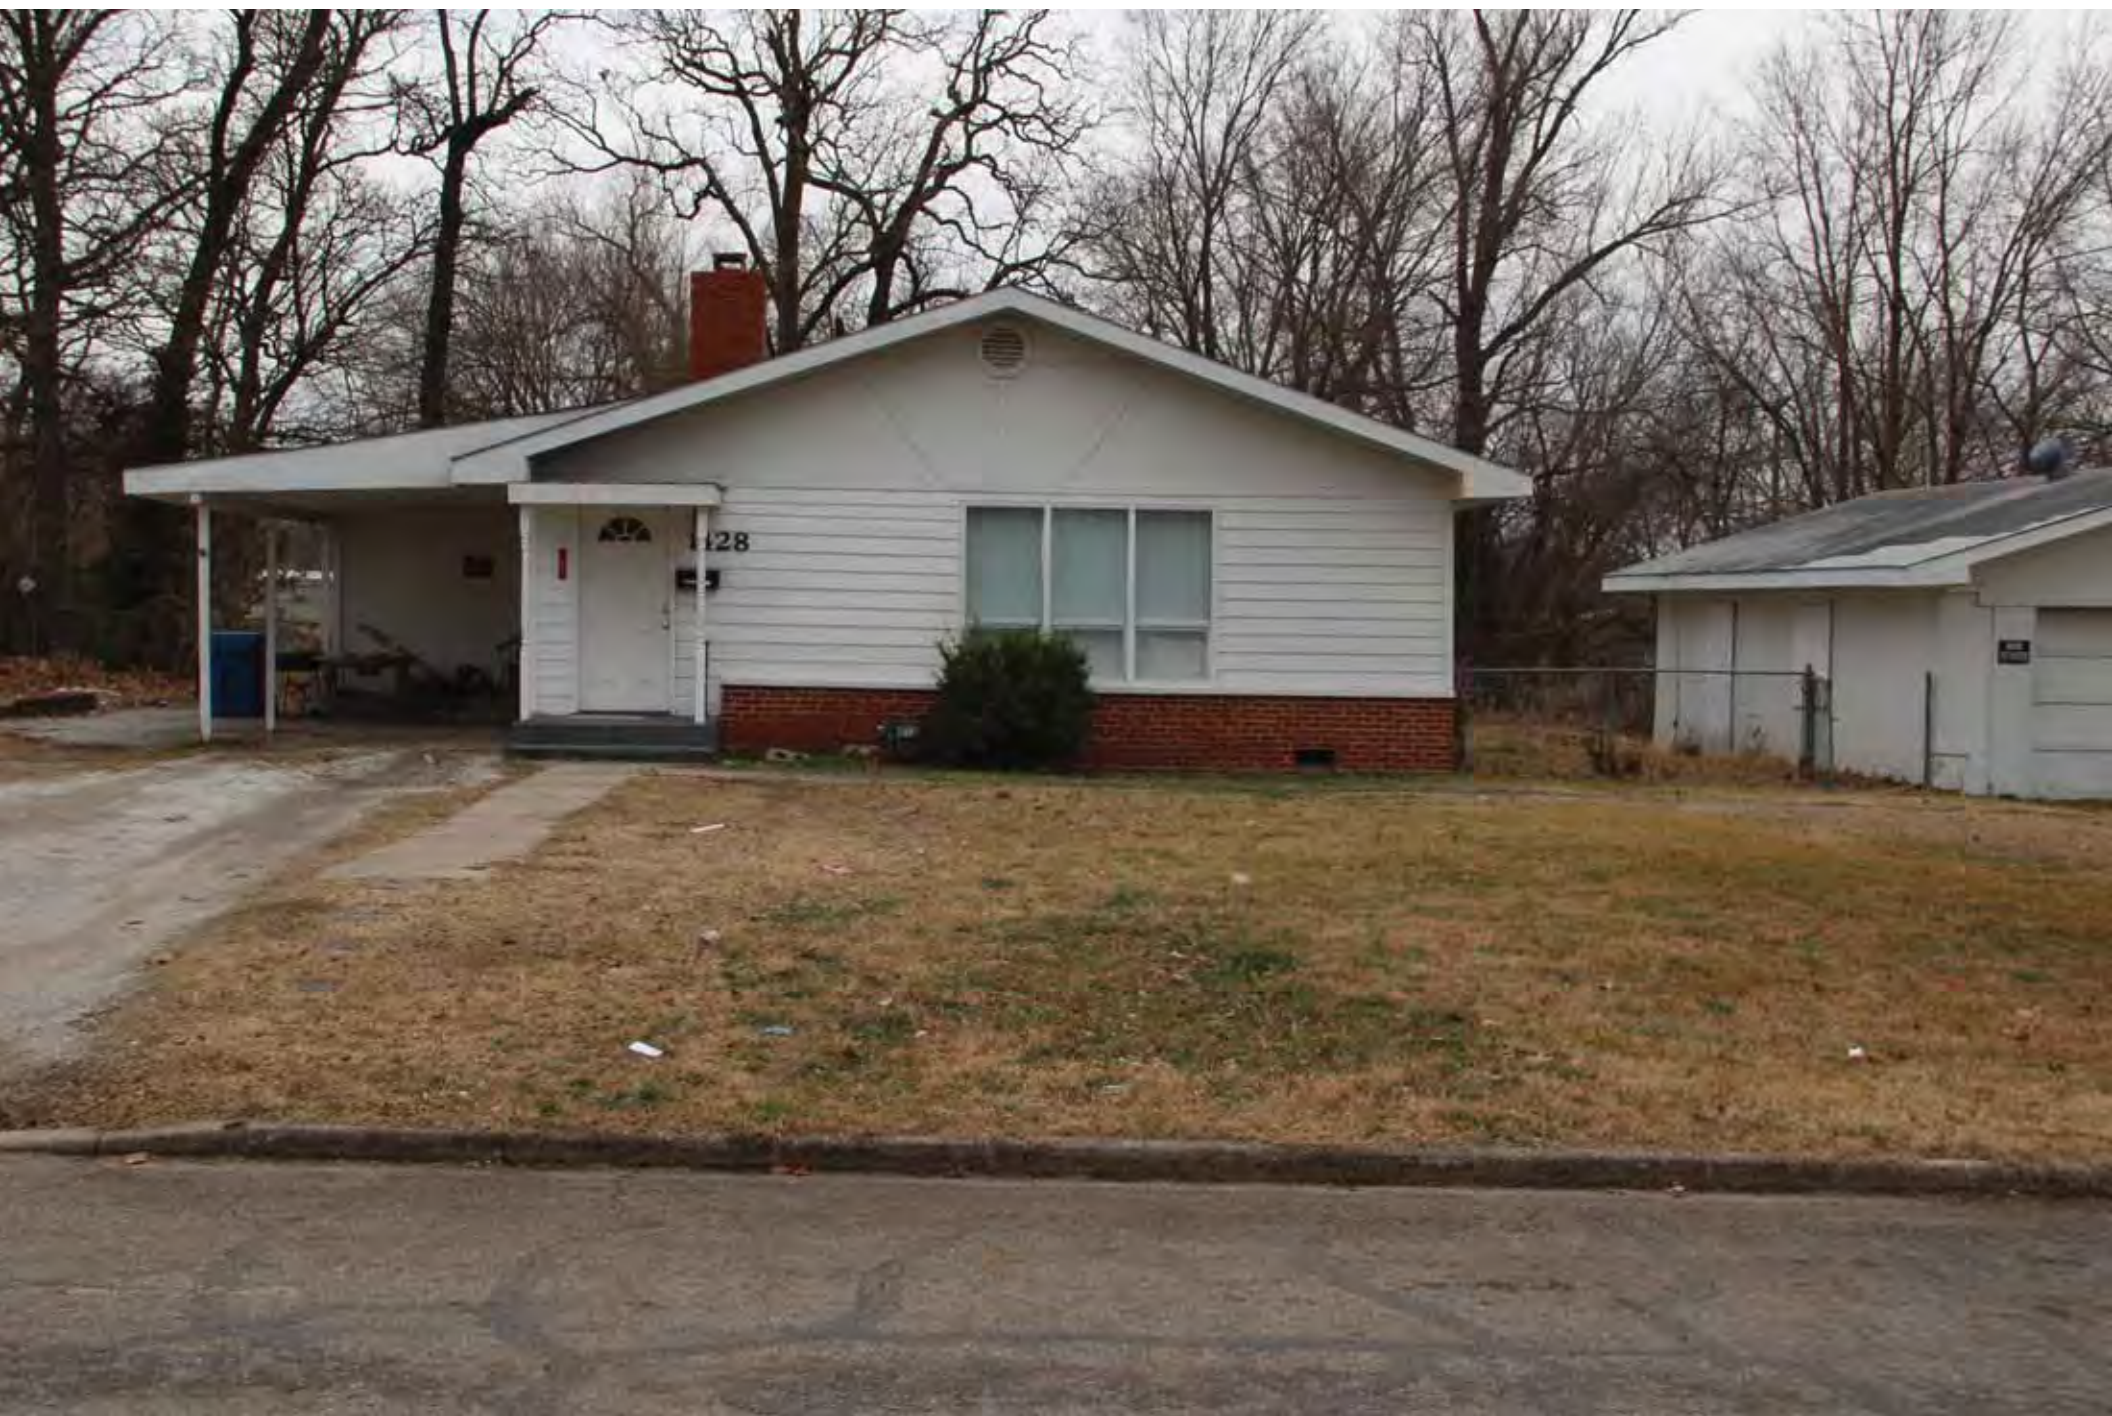
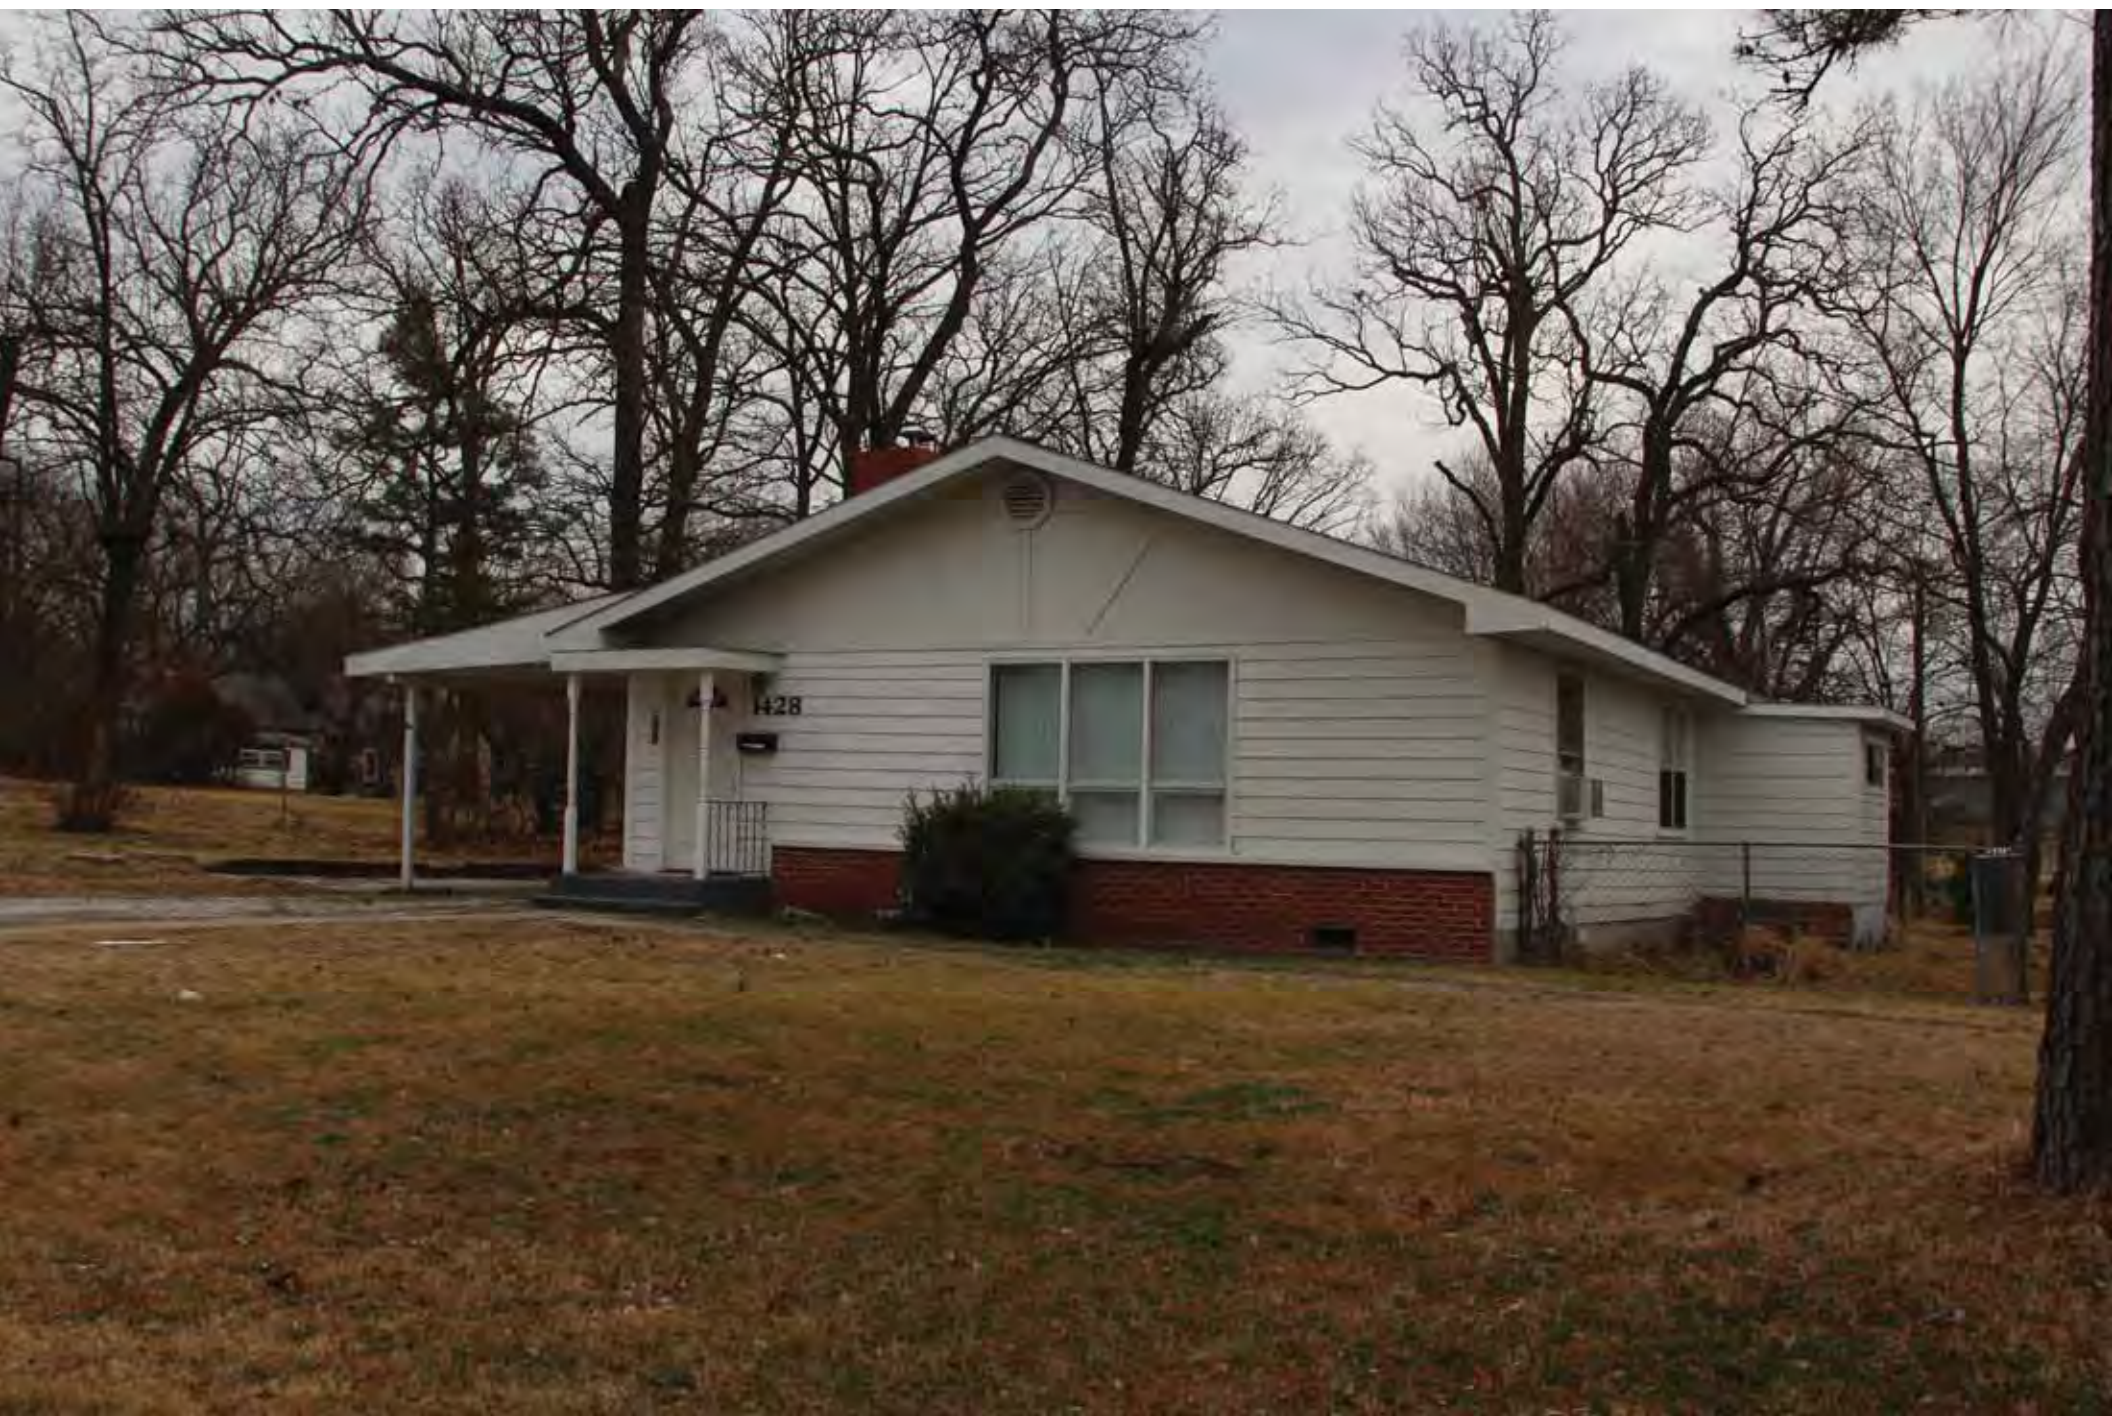
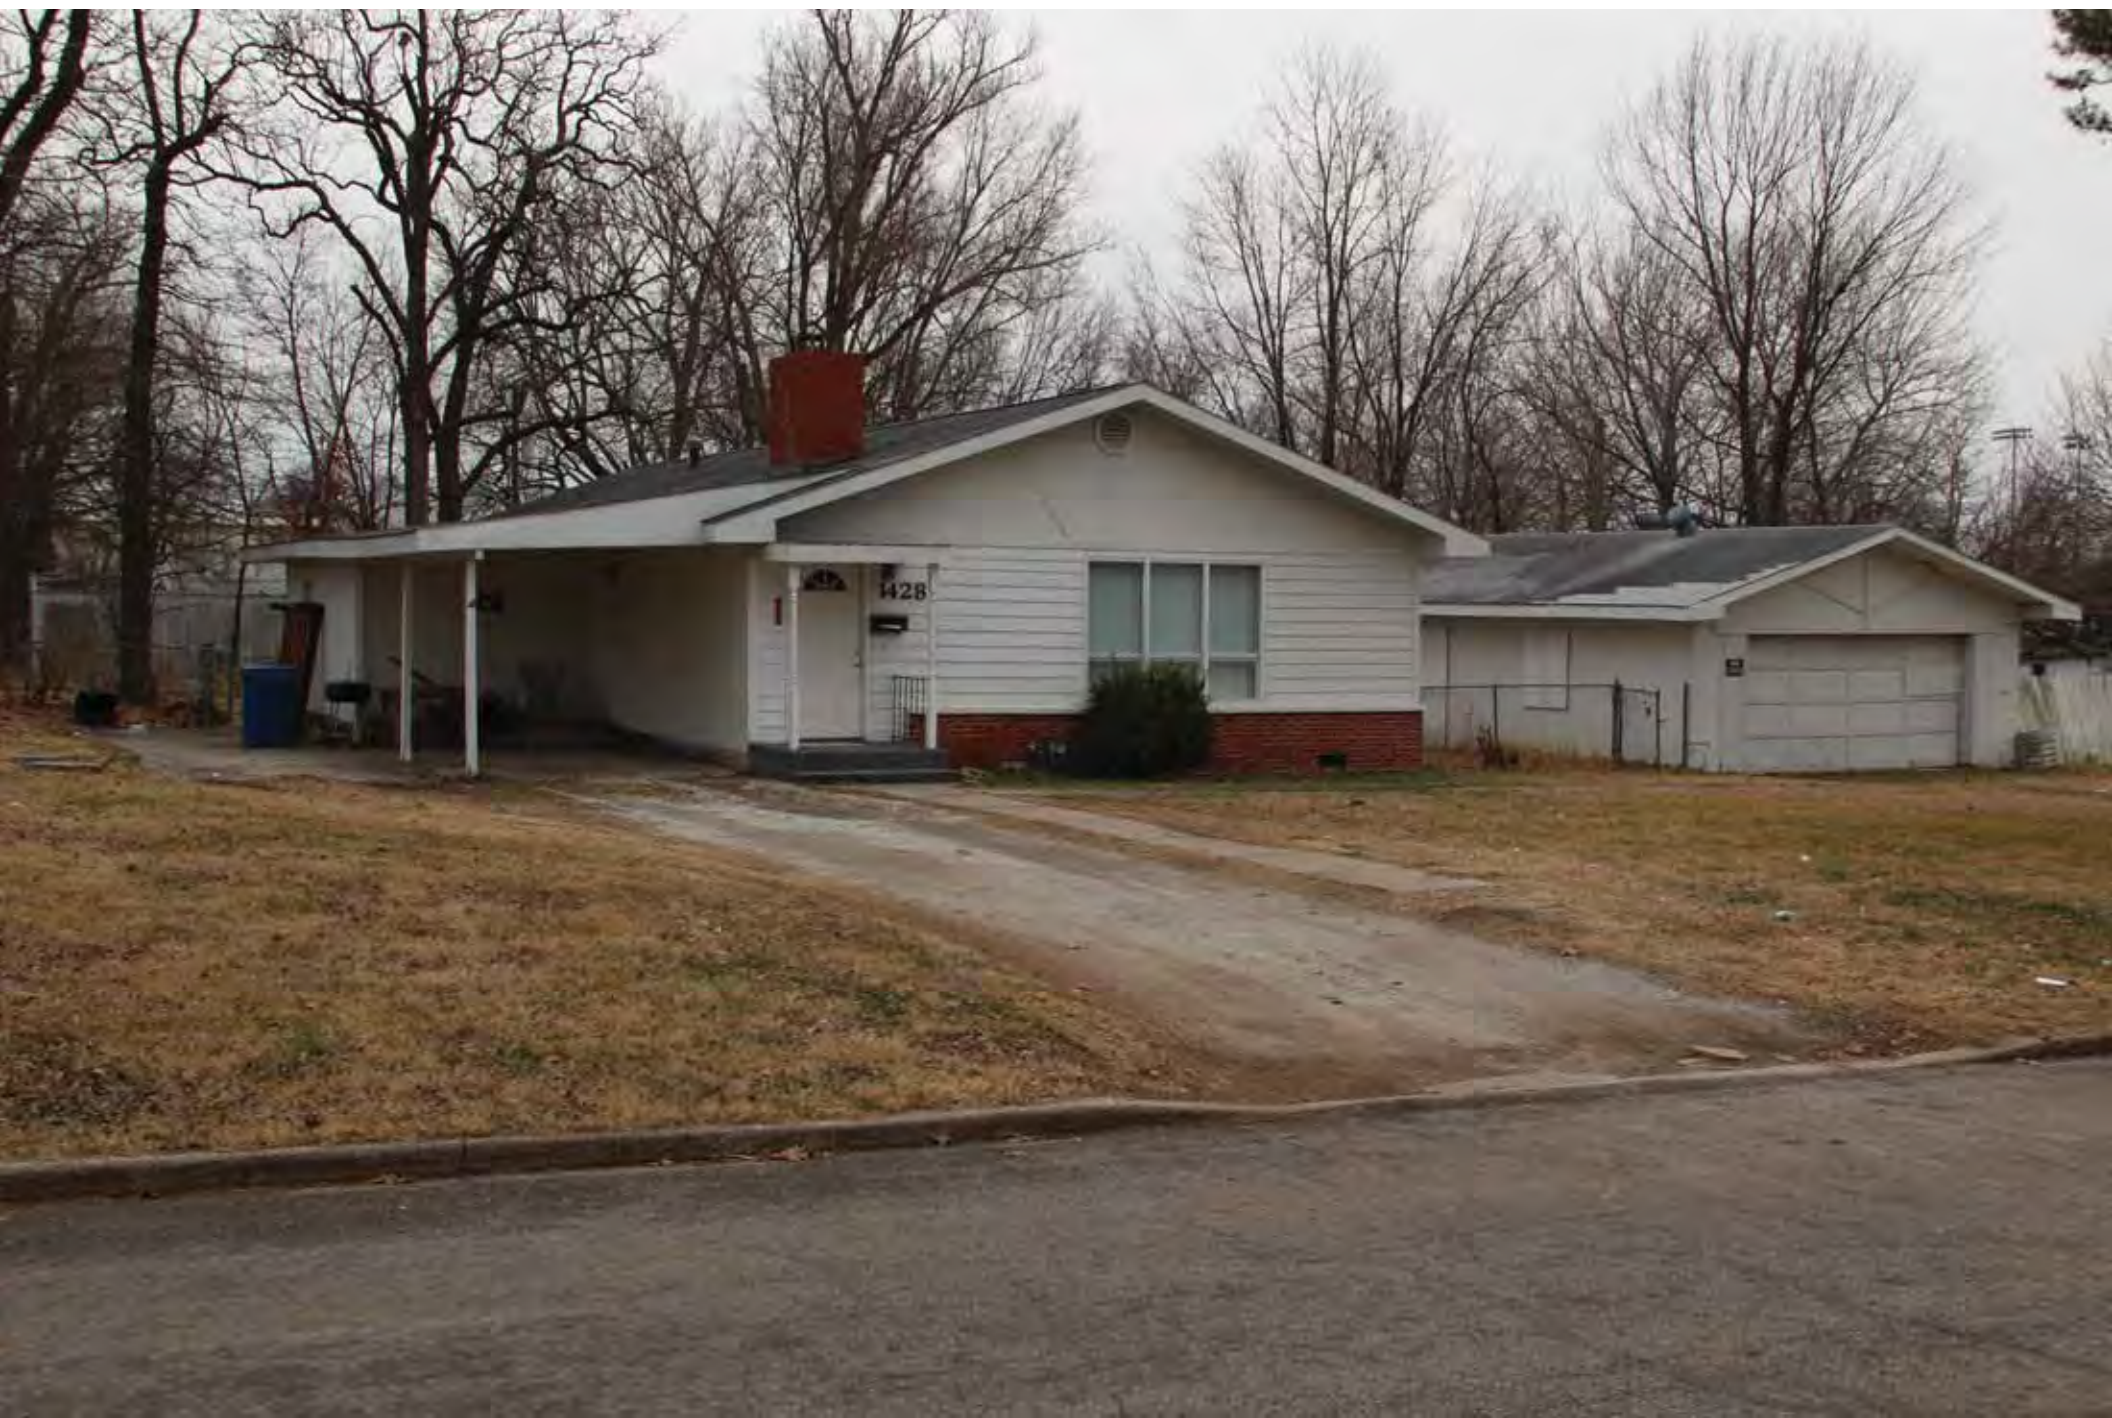
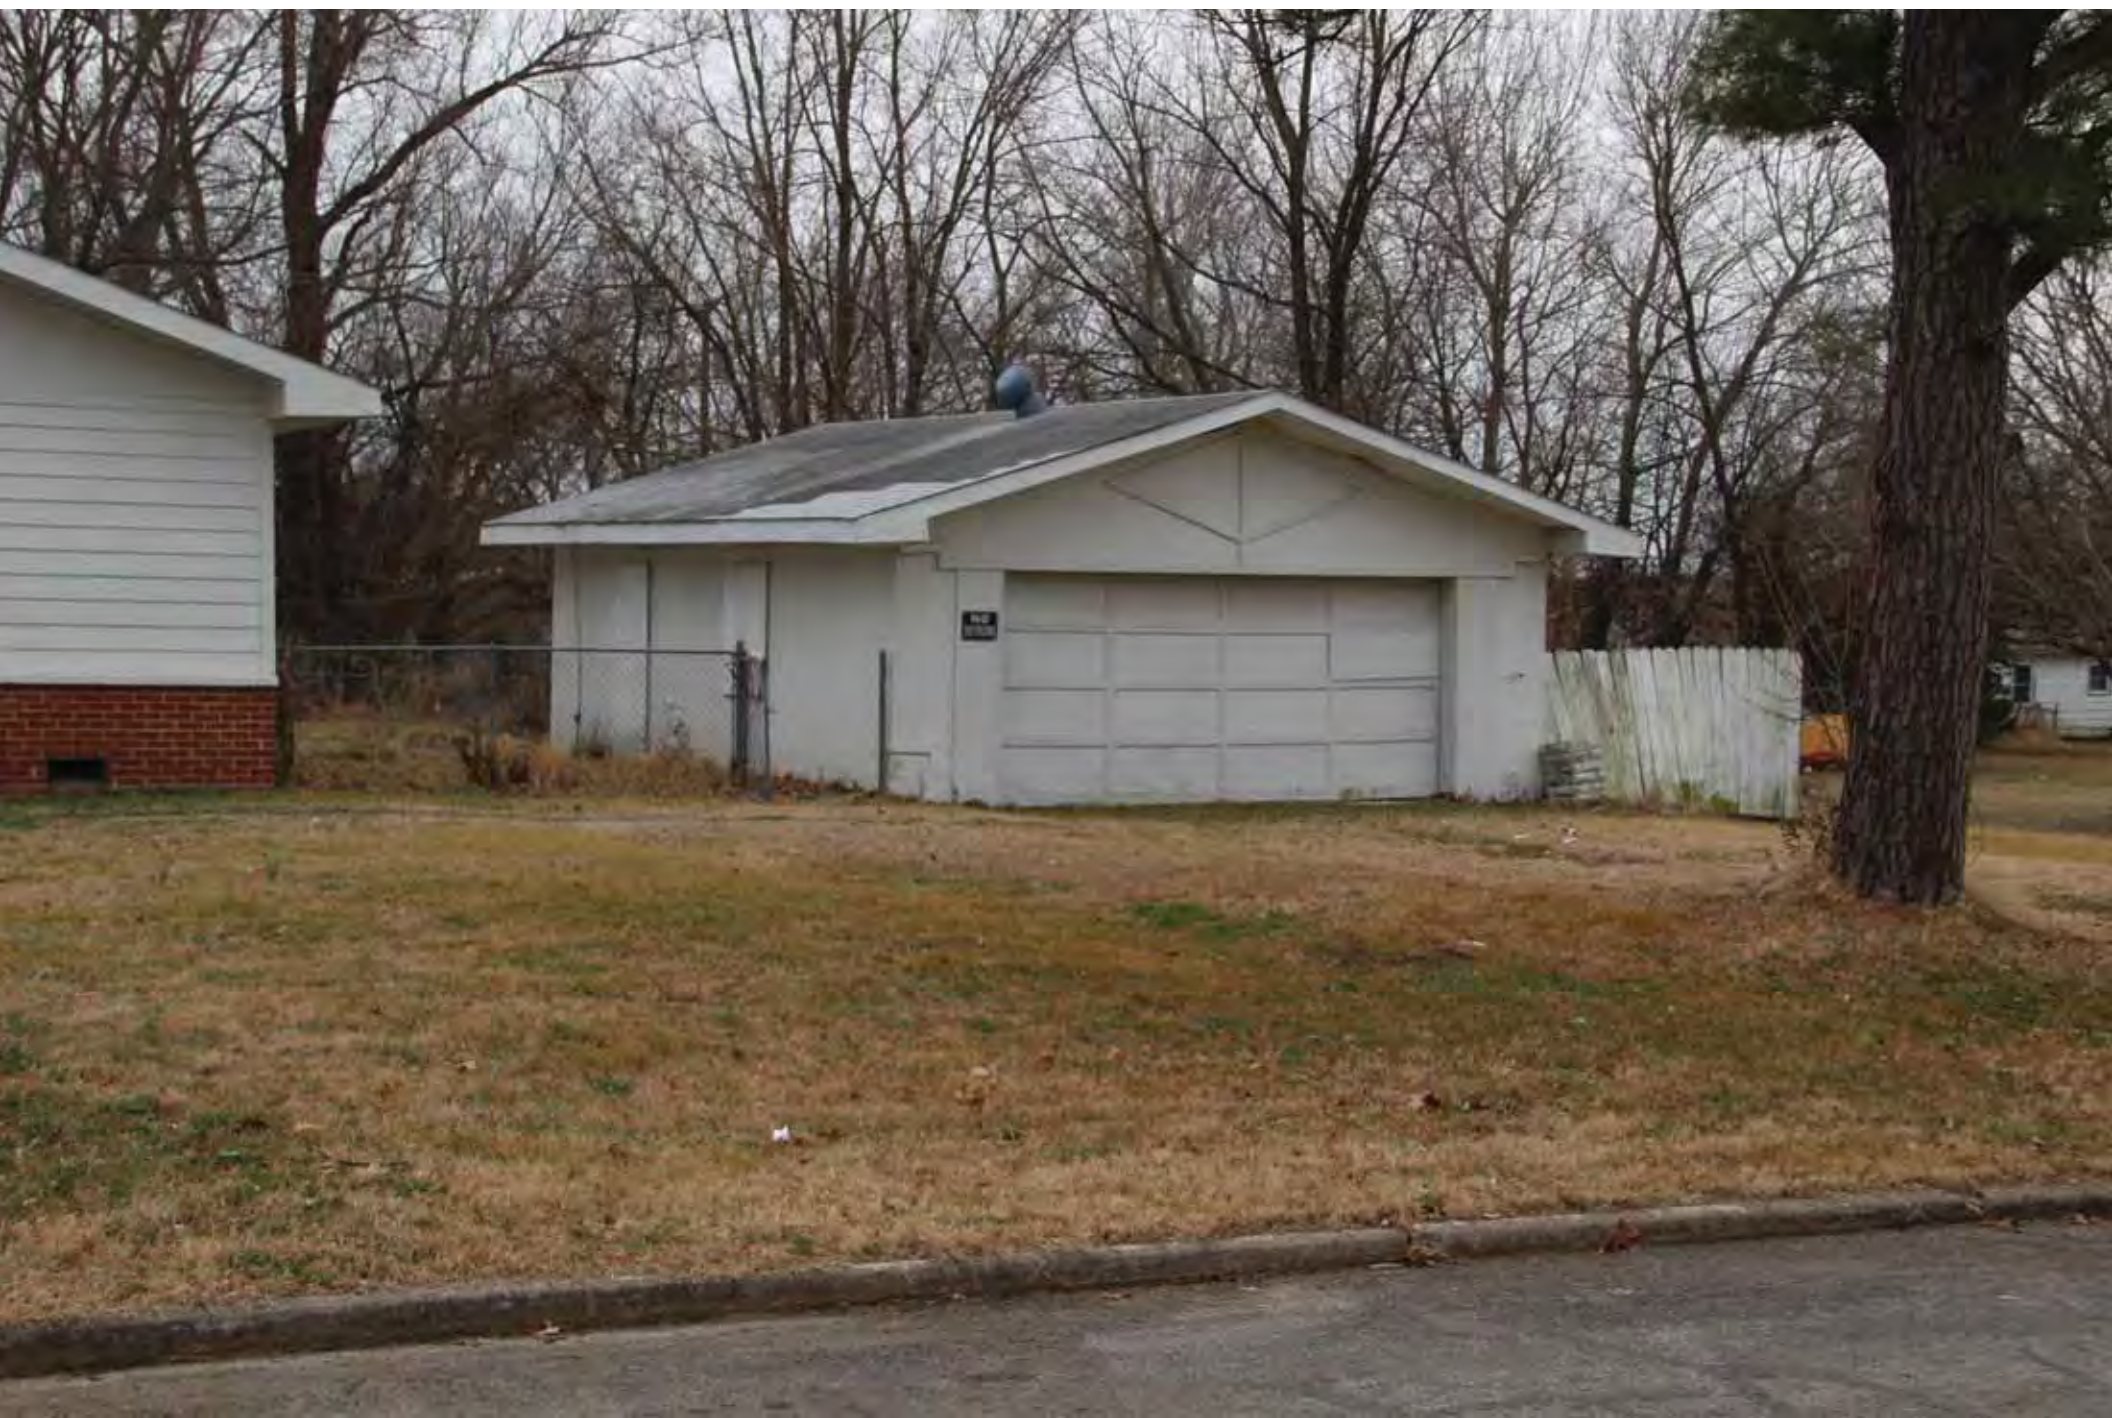
The property at 1428 E. Central Street features a contemporary Ranch style dwelling with an asphalt-shingled gable-front roof, exterior synthetic and brick siding and a concrete foundation. The primary (north) elevation has an off-center flat roof portico with milled contemporary columns. The portico covers an entry bay with a paneled upper fanlight door. Offsetting the door on the west is a six-light fixed window bay (1997). The elevation is clad with vinyl. Brick spans the lower elevation near the foundation. The front gable field supports stucco with decorative wood framing below an octagonal louvered vent. The roof extends to form a shed carport on the east end of the house. The east elevation (under the carport) supports a secondary entry bay. An interior original brick chimney is visible near the east end of the house. The west elevation supports paired and single windows. The house has a rear shed wing at the southwest corner.
