MISSOURI DEPARTMENT OF NATURAL RESOURCES
STATE HISTORIC PRESERVATION OFFICE, P.O. Box 176, Jefferson City, MO 65102
ARCHITECTURAL/HISTORIC INVENTORY FORM

1. Survey No. JP-AS-007-001		2. Survey name: East Town (Original Joplin) Historic Survey Phase 2	
3. County: JASPER		4. Address (Street No.) 618	Street (name) E. 2 nd Street
5. City: Joplin	Vicinity: <input type="checkbox"/>	6. Geographical Reference:	7. Township/Range/Section: T: R: S:
8. Historic name (if known):		9. Present/other name (if known):	
10. Ownership: <input checked="" type="checkbox"/> Private <input type="checkbox"/> Public		11a. Historic use (if known): Domestic: Single Dwelling	11b. Current use: Domestic: Single Dwelling

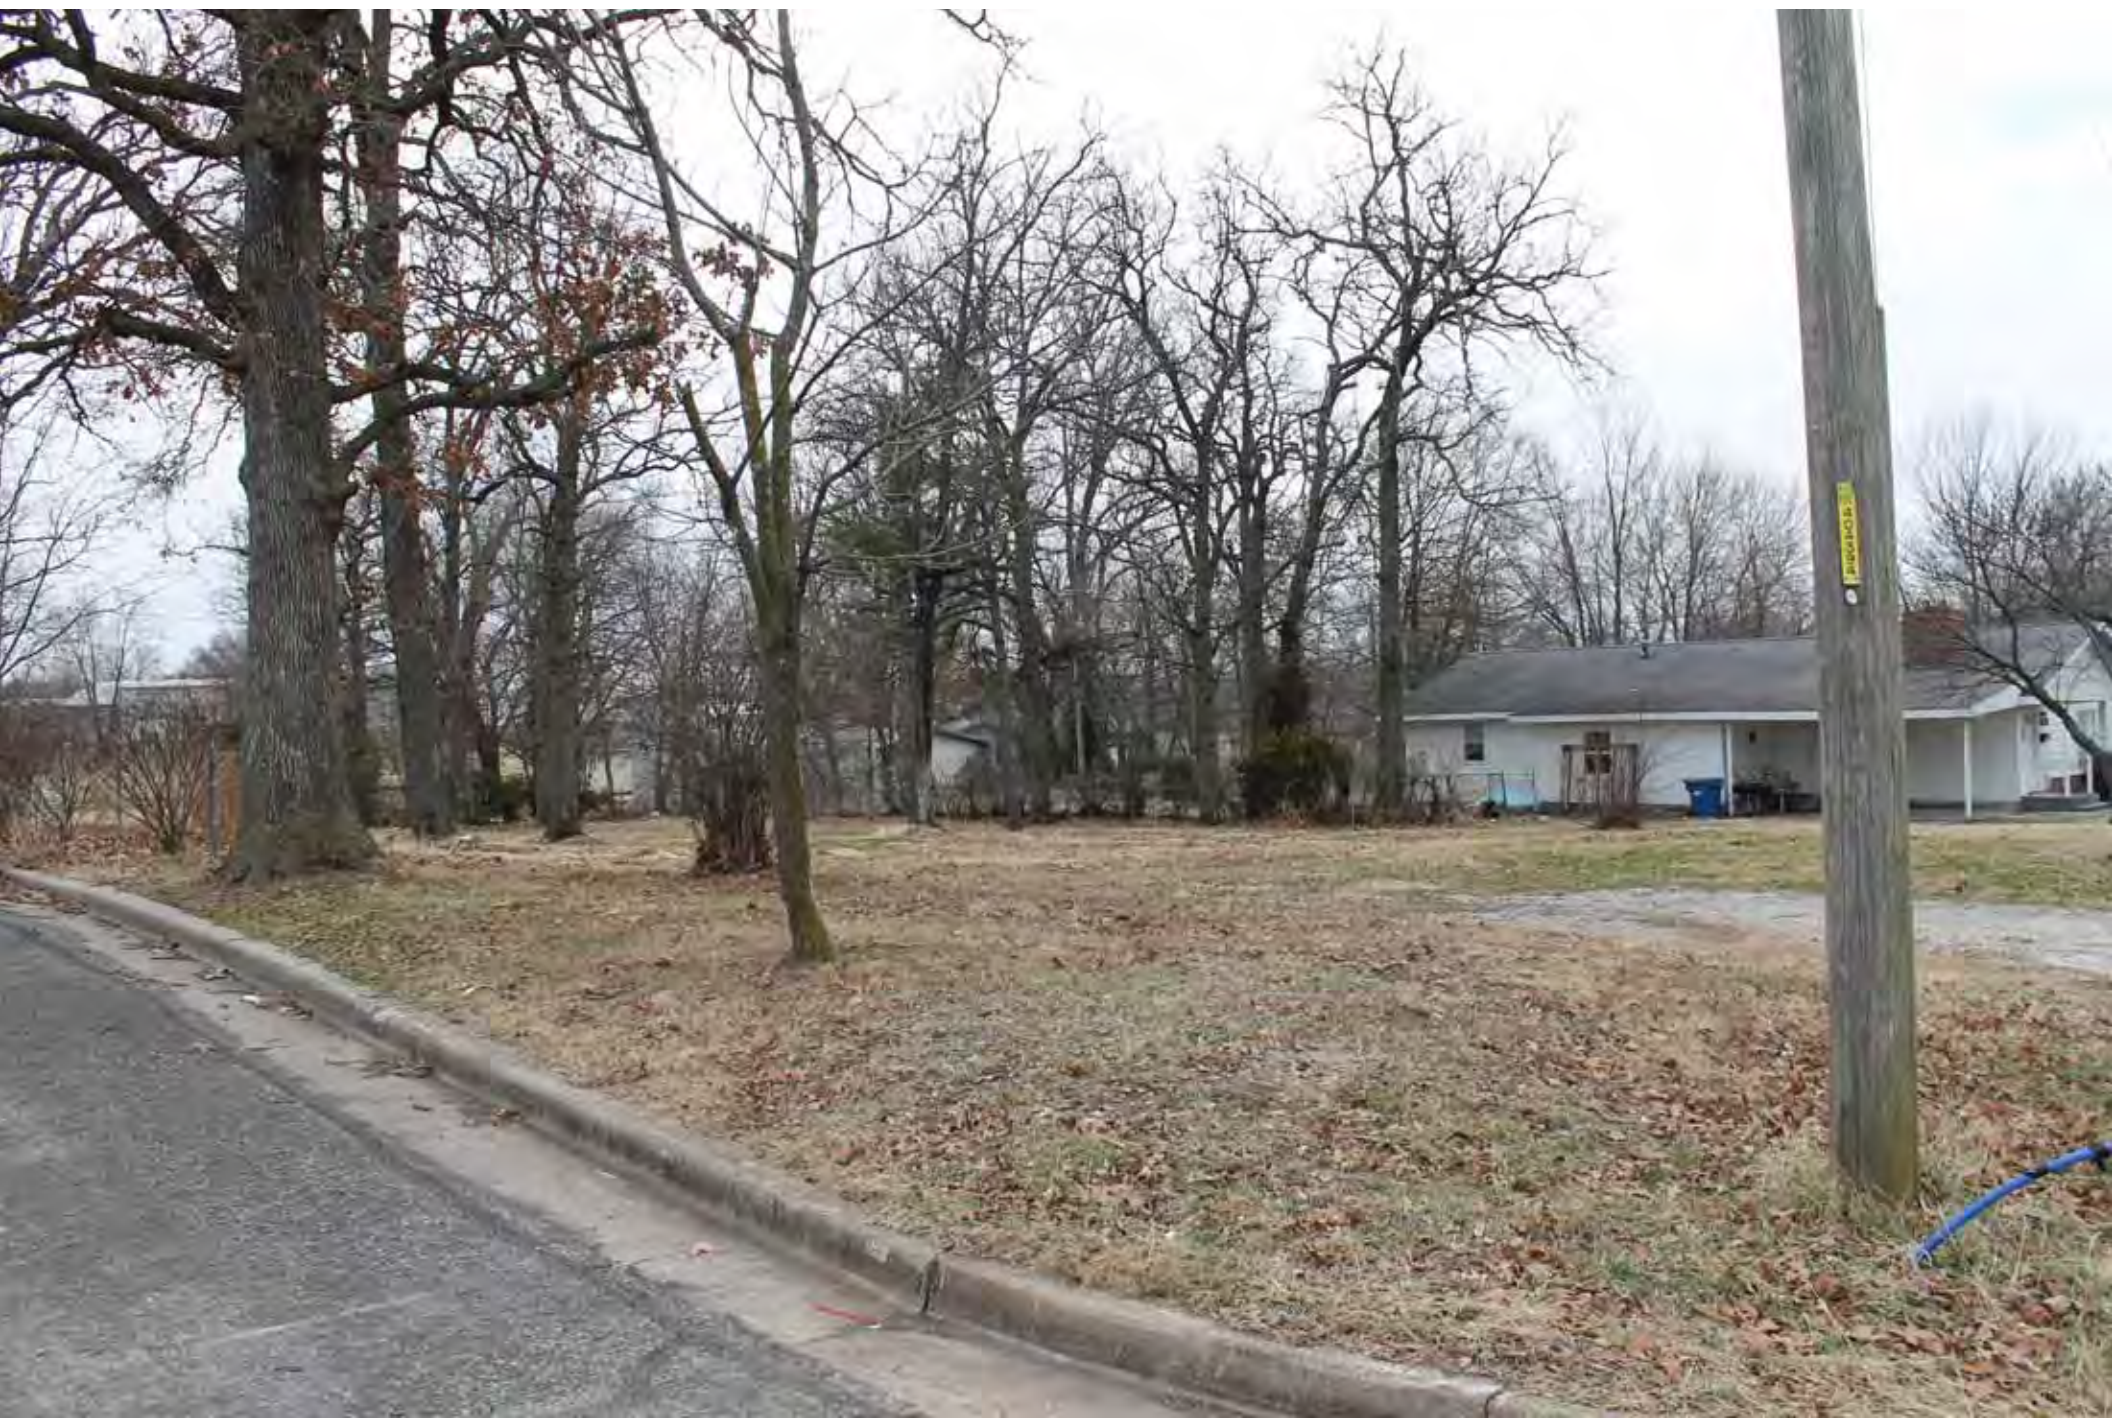
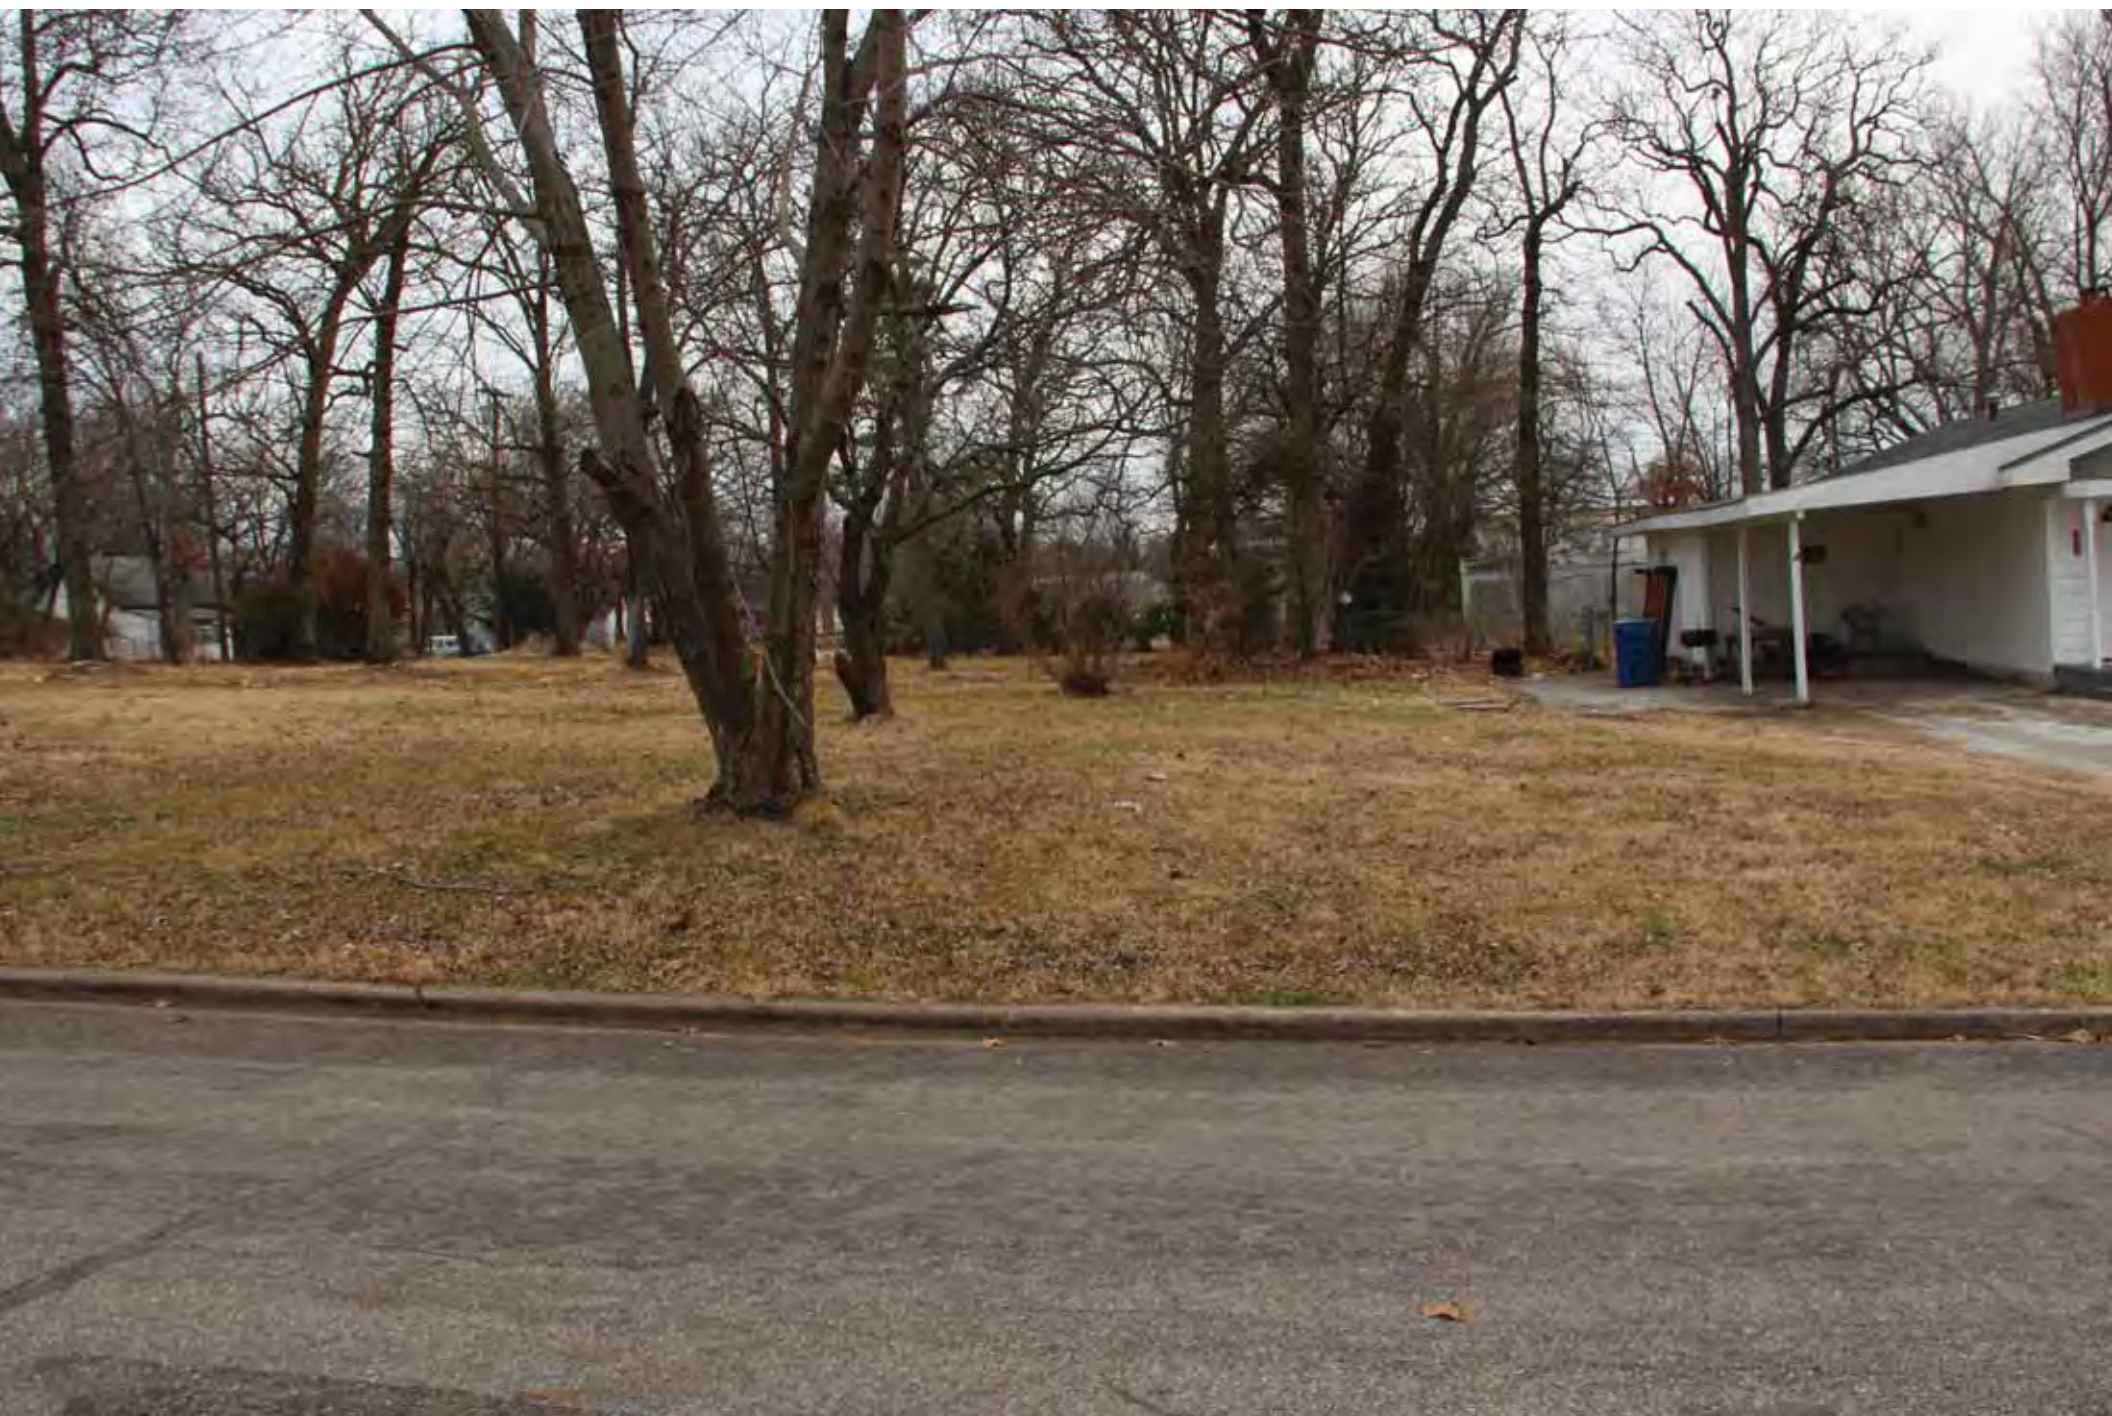
The property at 1430 E. Central Street is a vacant grassy lot that formerly held a single family dwelling. The lot is as described above.

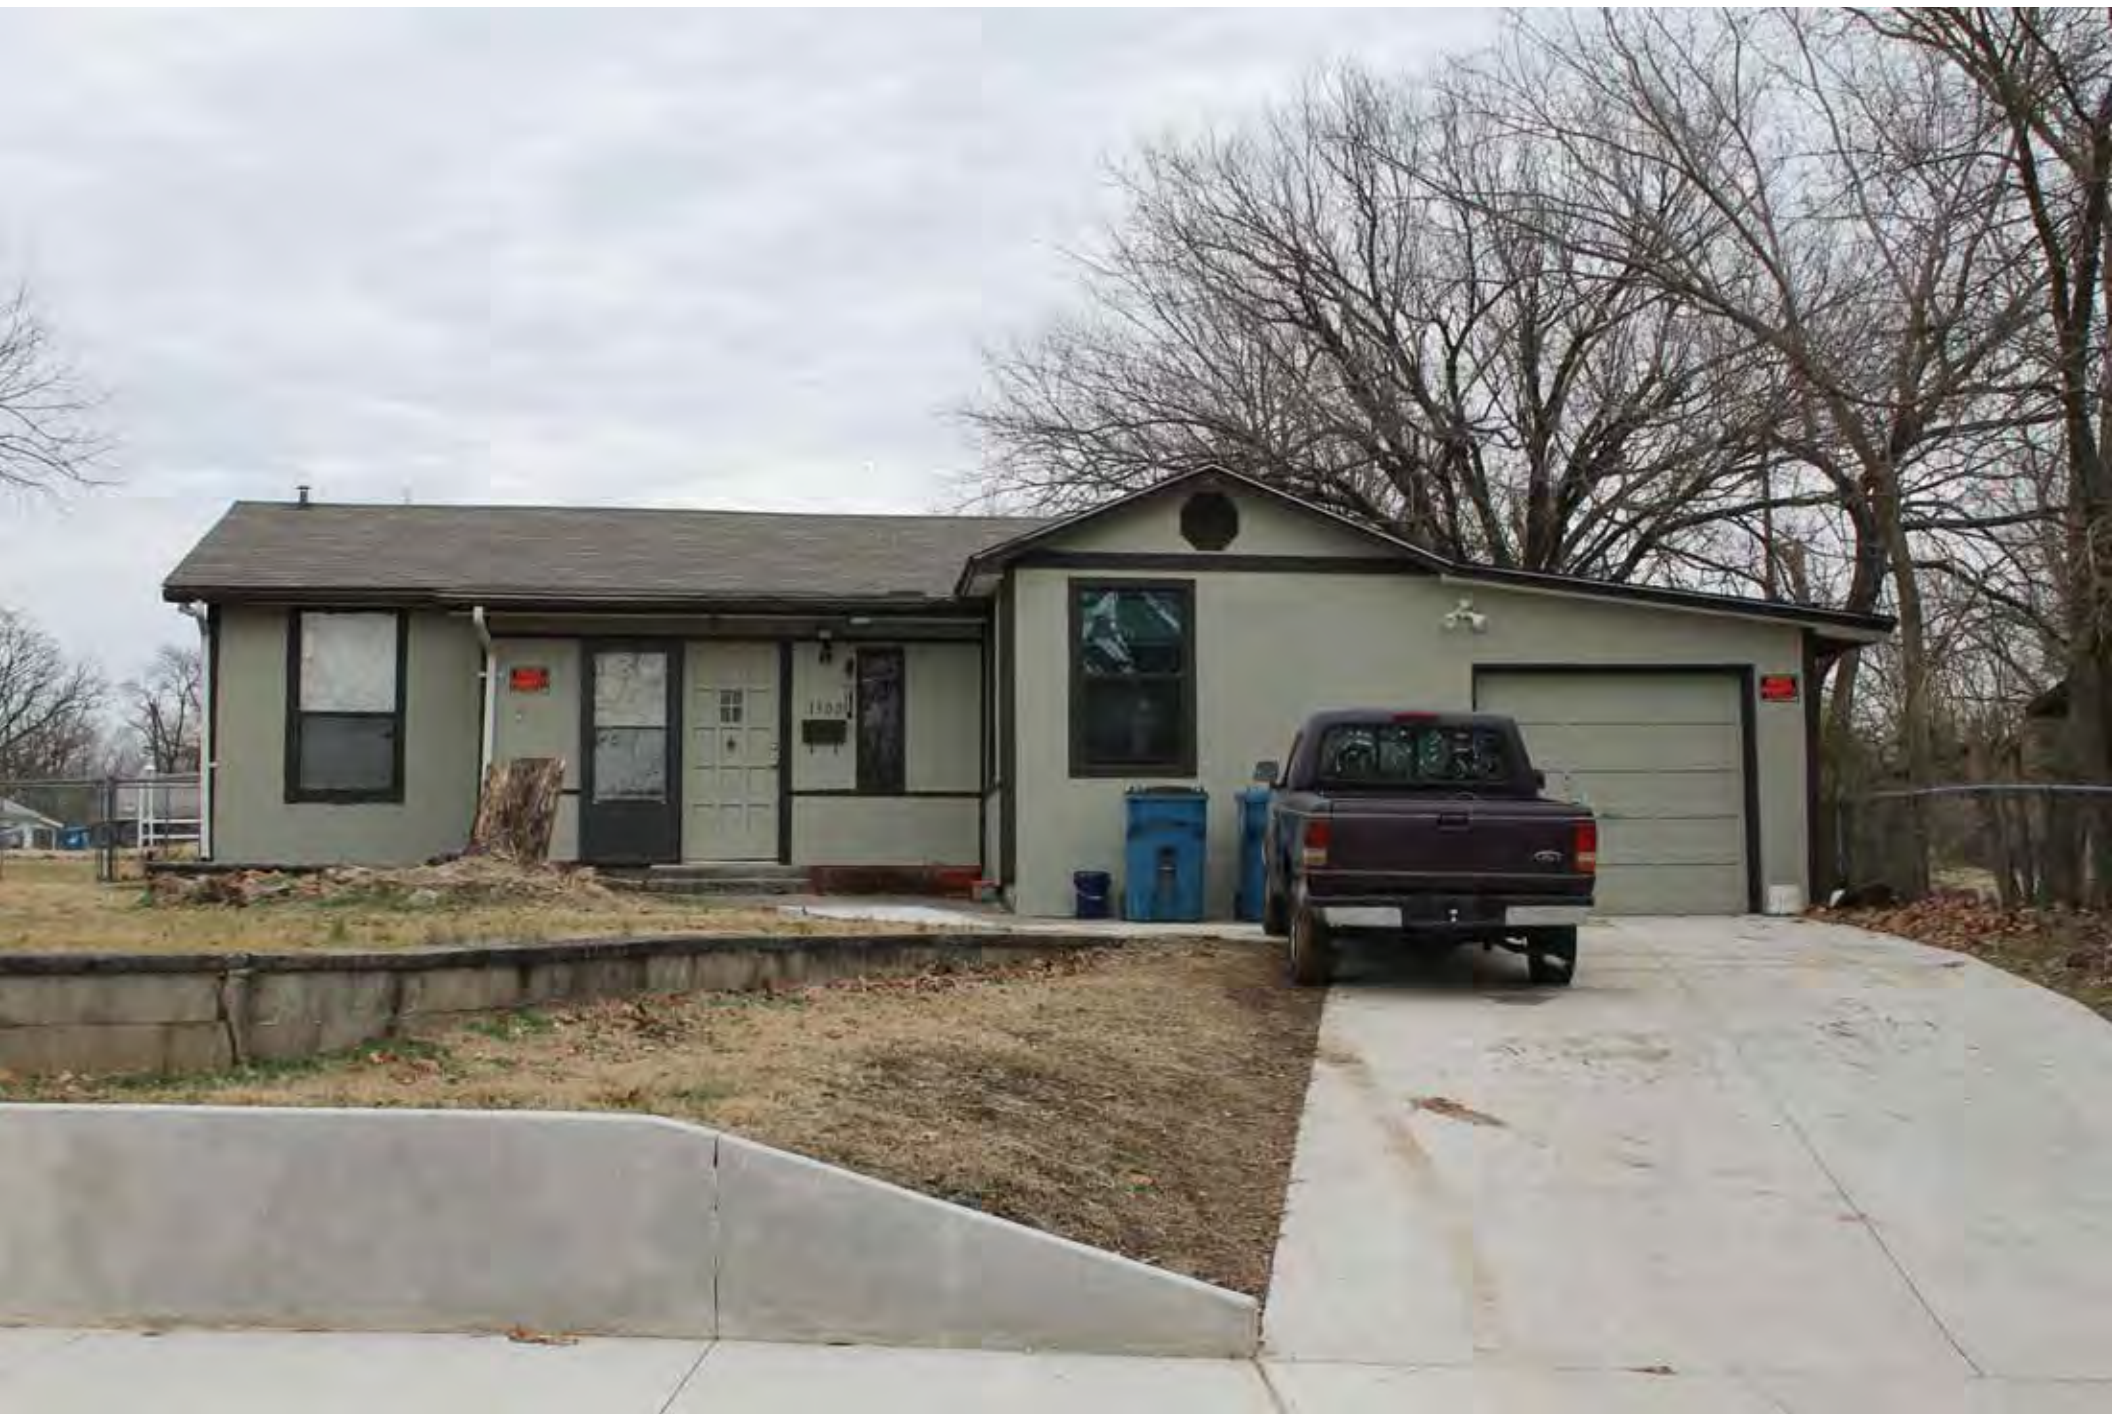
The property at 1502 E. Central Street features a single-story dwelling with an asphalt-shingled gabled roof, exterior vinyl panels and Dryvit, and a concrete foundation. The façade (north elevation) features a garage bay at the west end with an overhead track door. Offsetting the garage bay is a gabled wing with a single off-center one-over-one window. The gable field holds an octagonal louvered vent. The east wall of the gabled wing holds a one-over-one window. Offsetting the wing on the west, the elevation has what appears to be an enclosed shed porch. The primary entry is centered on the north wall of the enclosed porch and retains what appears to be an original paneled door with a four-light window. A concrete stoop fronts the door, which is offset by a fixed sash window on the west. The remaining façade holds a one-over-one window at the east end. The east elevation holds two windows – both are one-over-one.

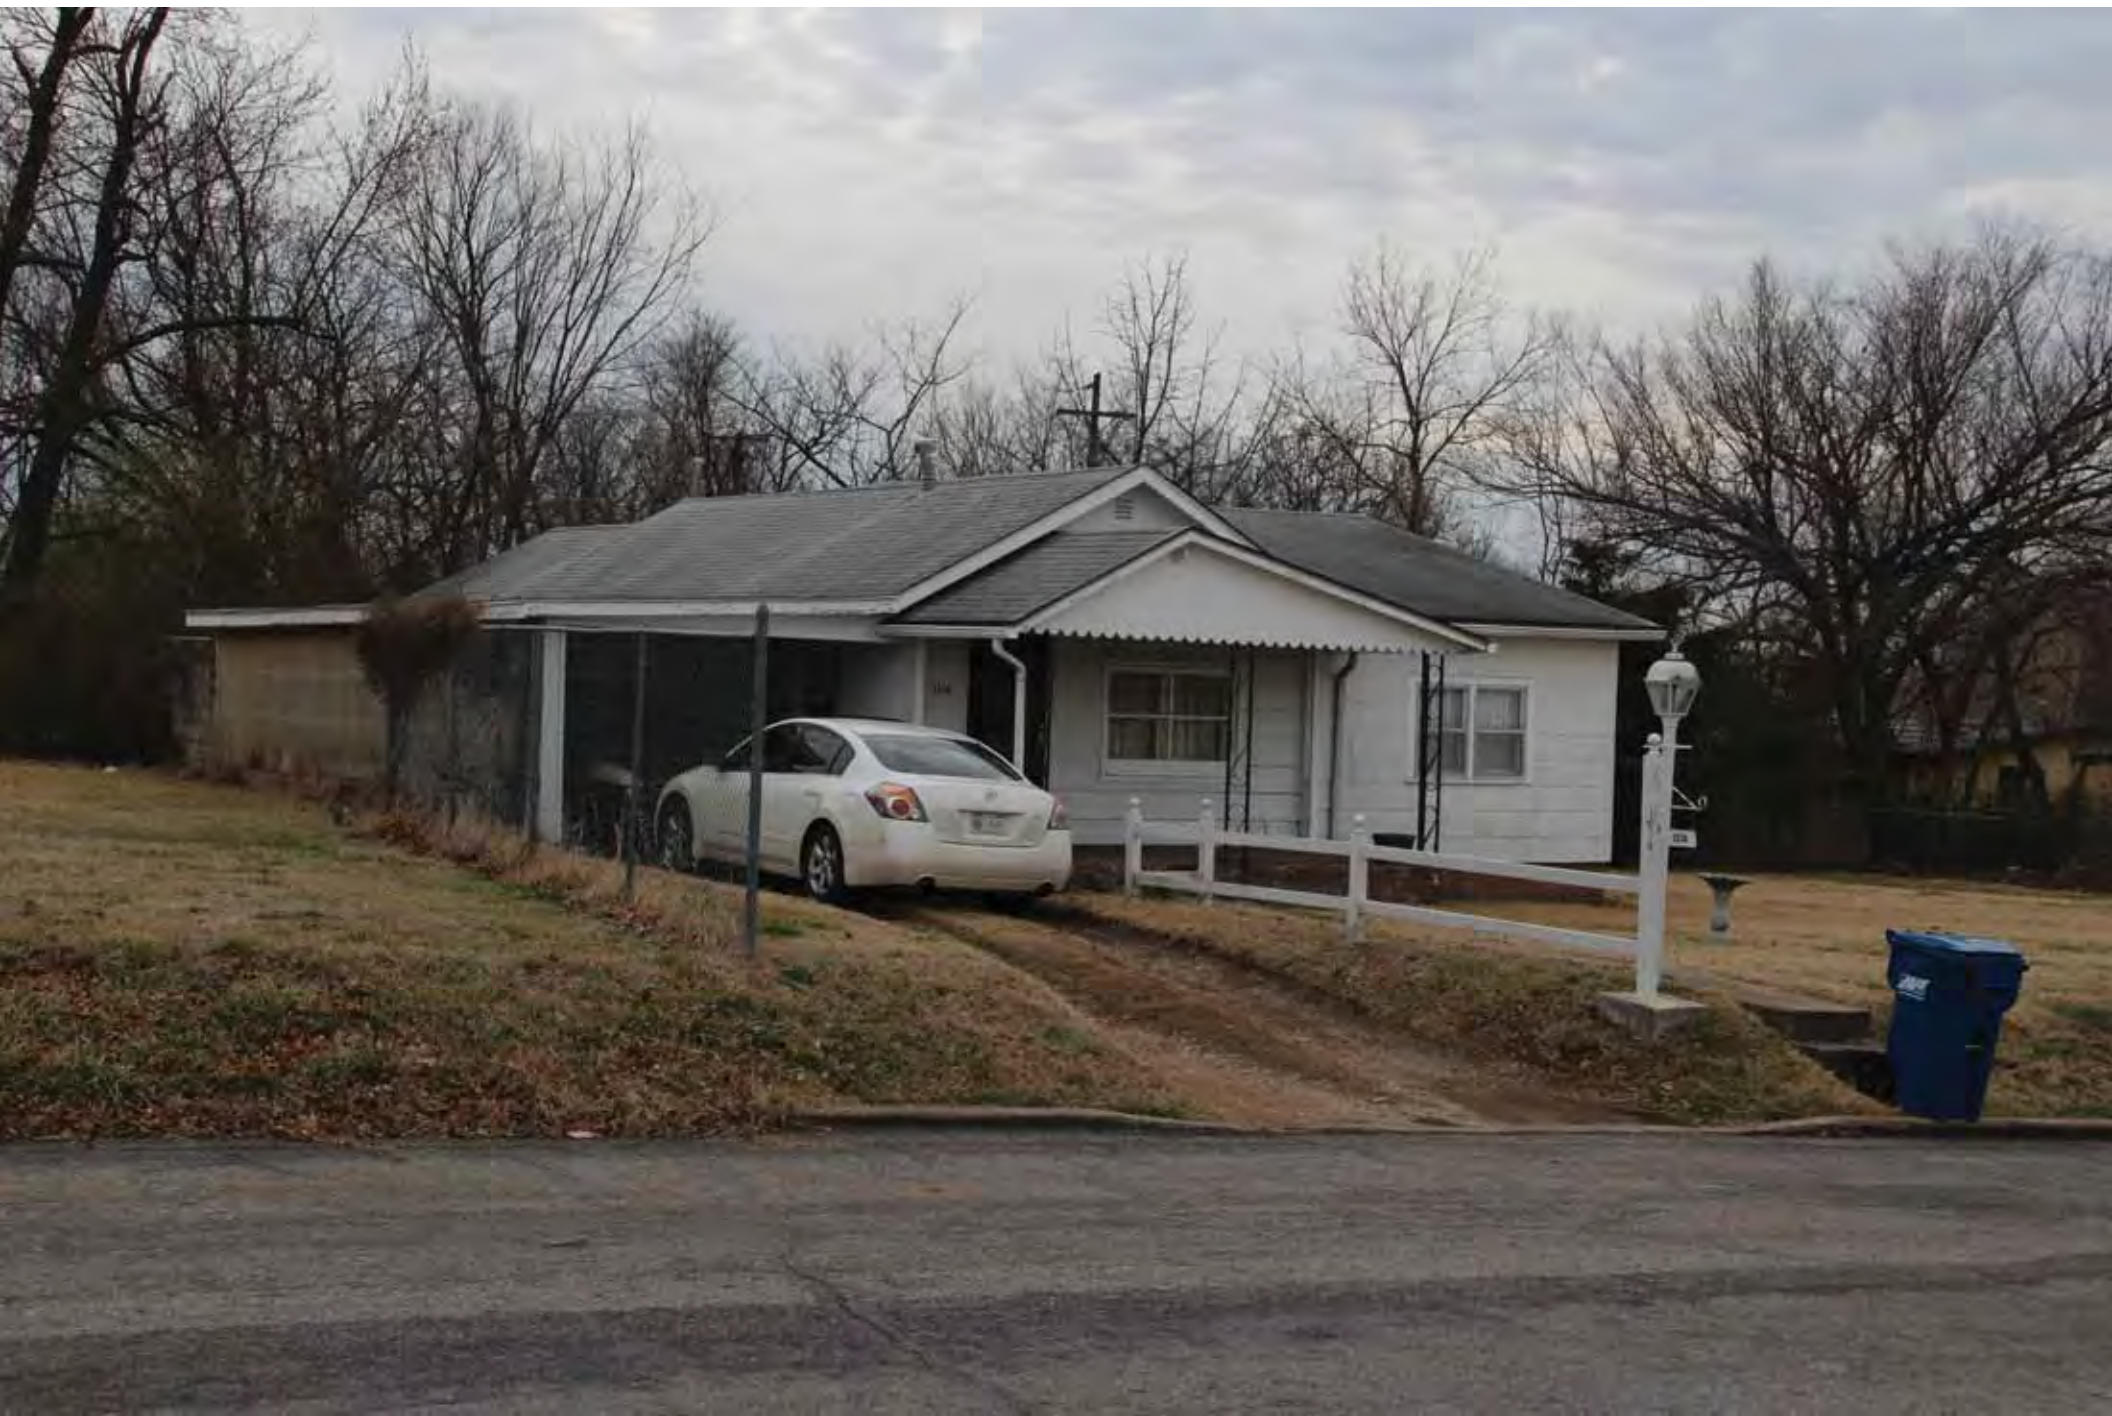
The property at 1516 E. Central Street features a single-story dwelling with an asphalt-shingled cross-gabled roof, exterior wide wood siding and a concrete foundation. The façade (north elevation) features an off-center gabled porch supported by wrought iron columns. The entry is situated at the east end of the façade (within the porch bay), offset by two sets of original paired three-over-one windows. The porch gable field is composed of original scalloped edge wood panels. Above the porch, the gable field of the façade holds a louvered vent. The gabled central roofline extends to the east, creating a carport at the east end of the dwelling. The carport is partially obscured by fabric type siding at the southeast corner. A secondary entry is on the east wall of the house facing the covered parking area. The door is offset by a three-over-one window. The west (side) elevation features three original windows of three-over-one composition.

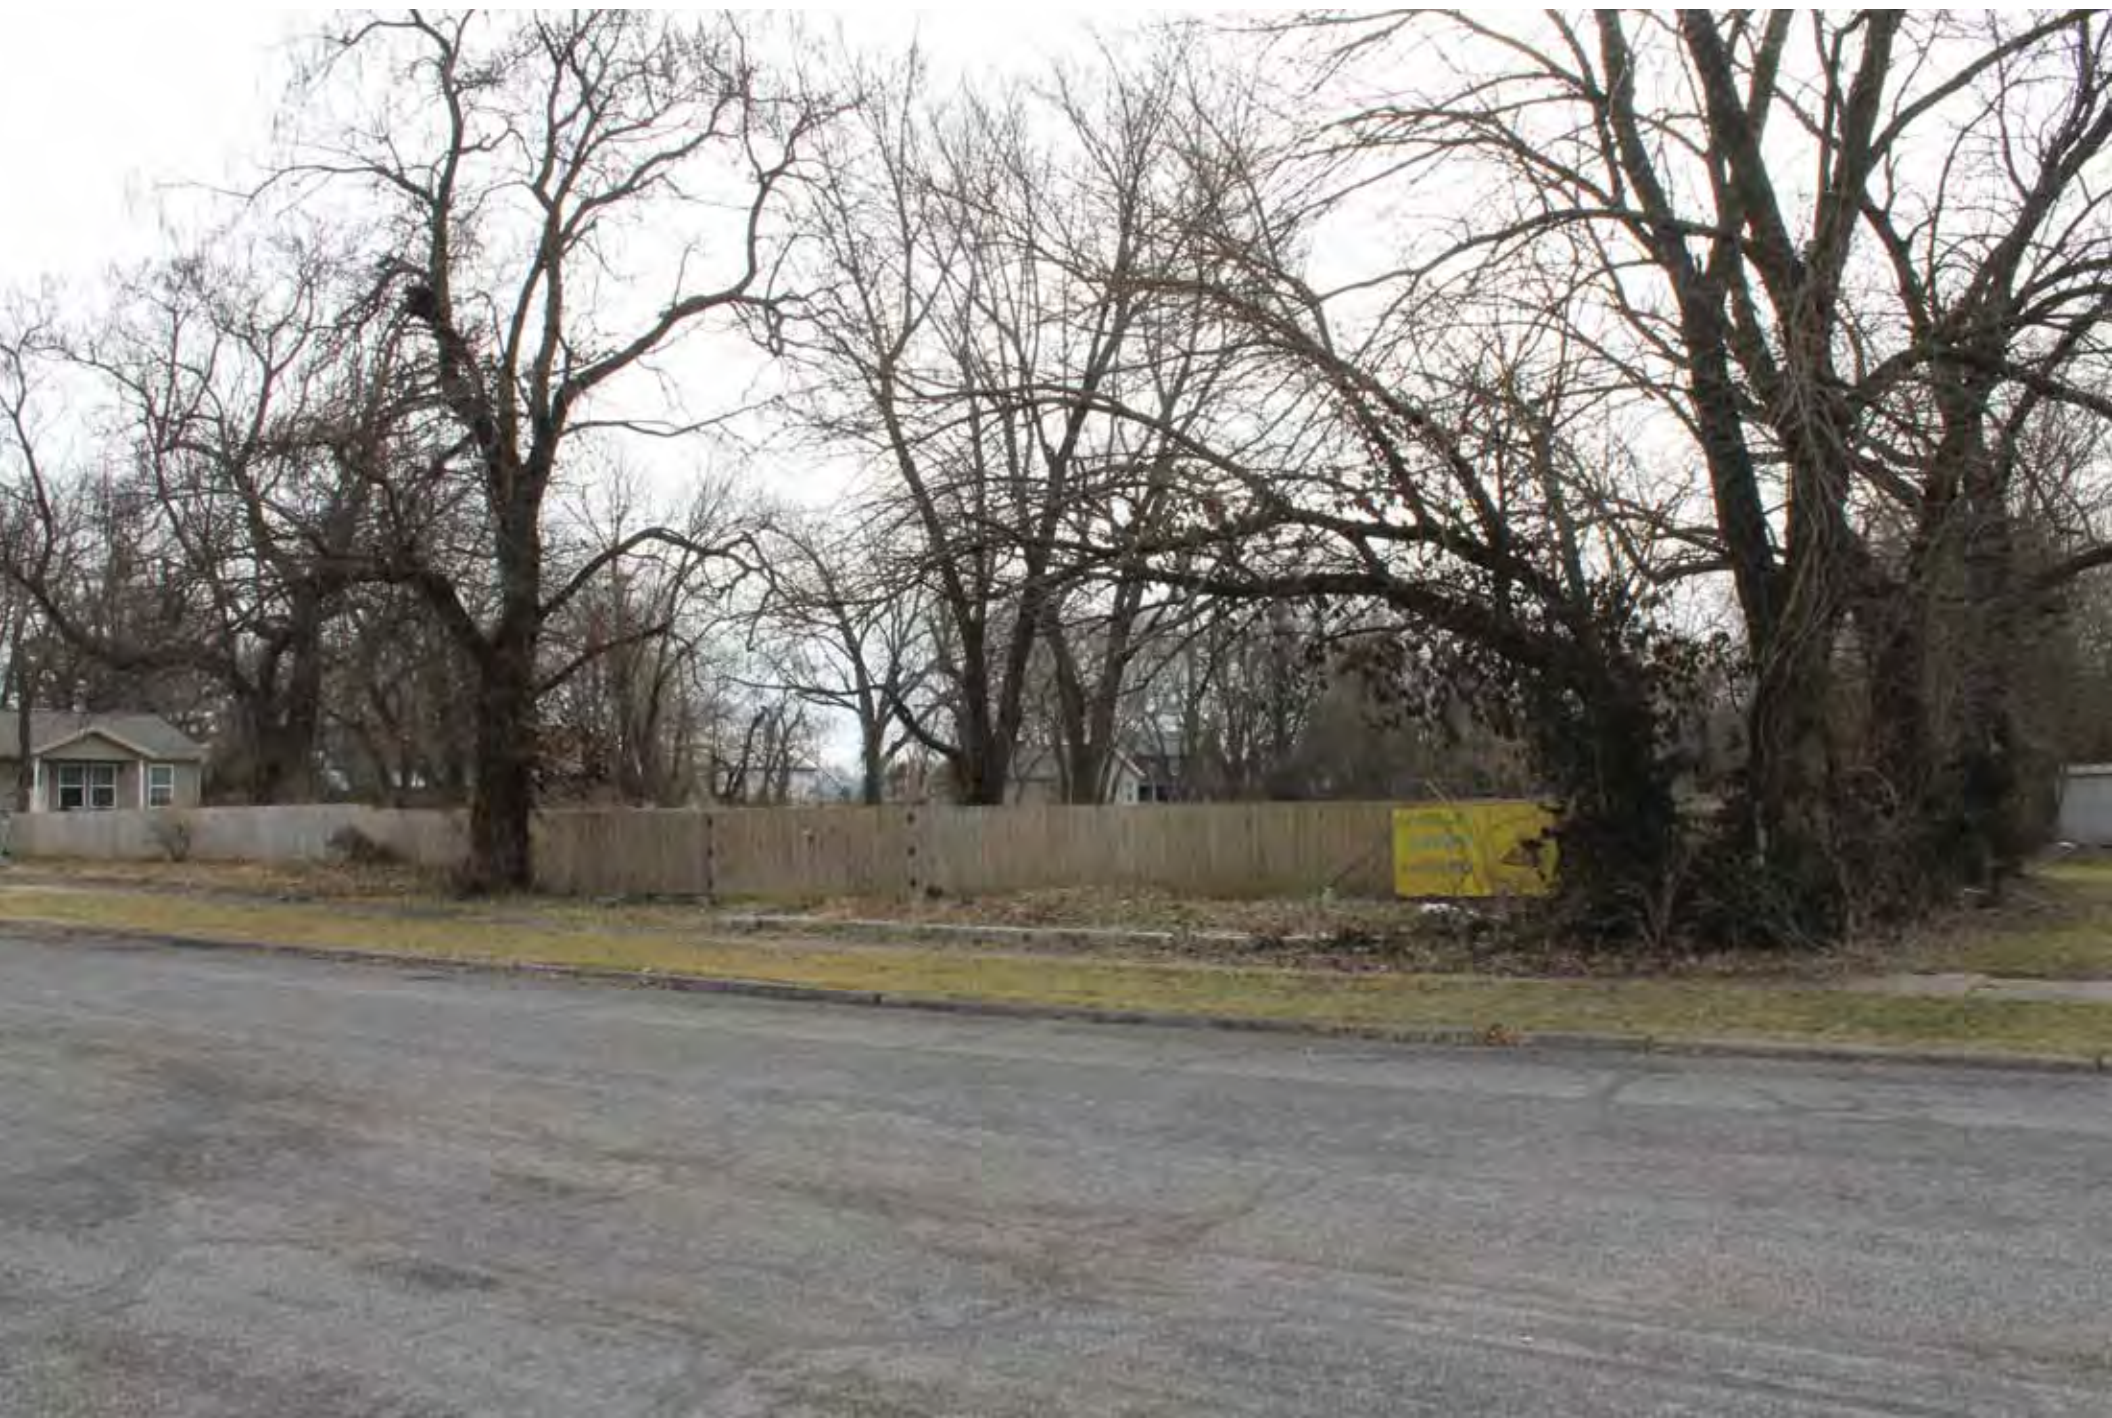
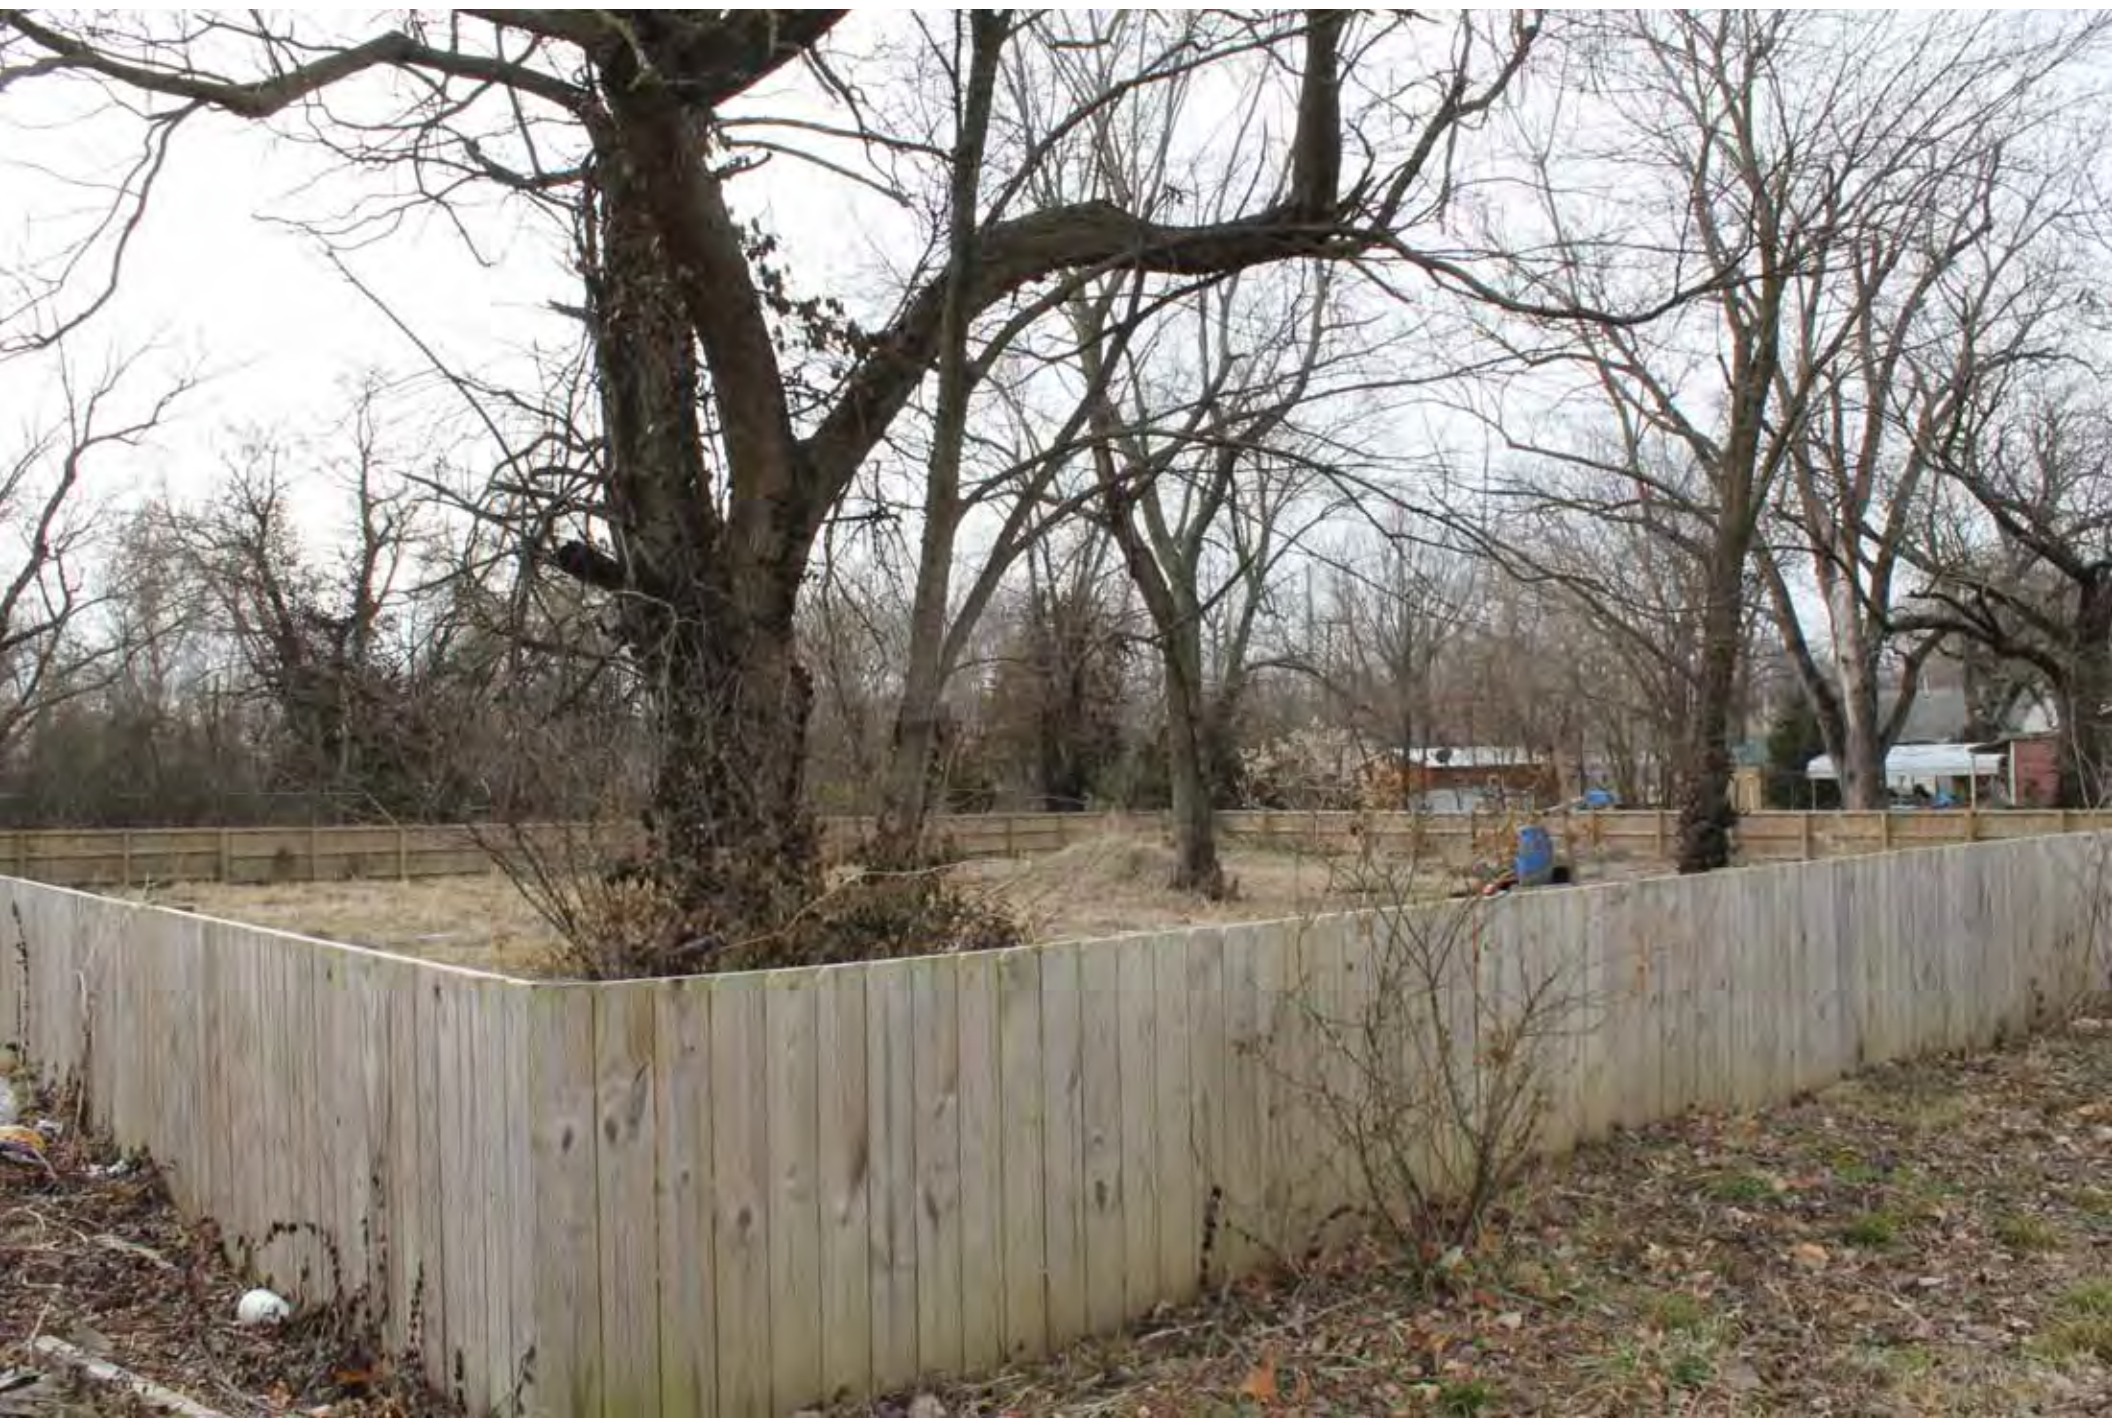
The property at the southwest intersection of E. Central Street and S. Railroad Avenue is a vacant lot as described above.

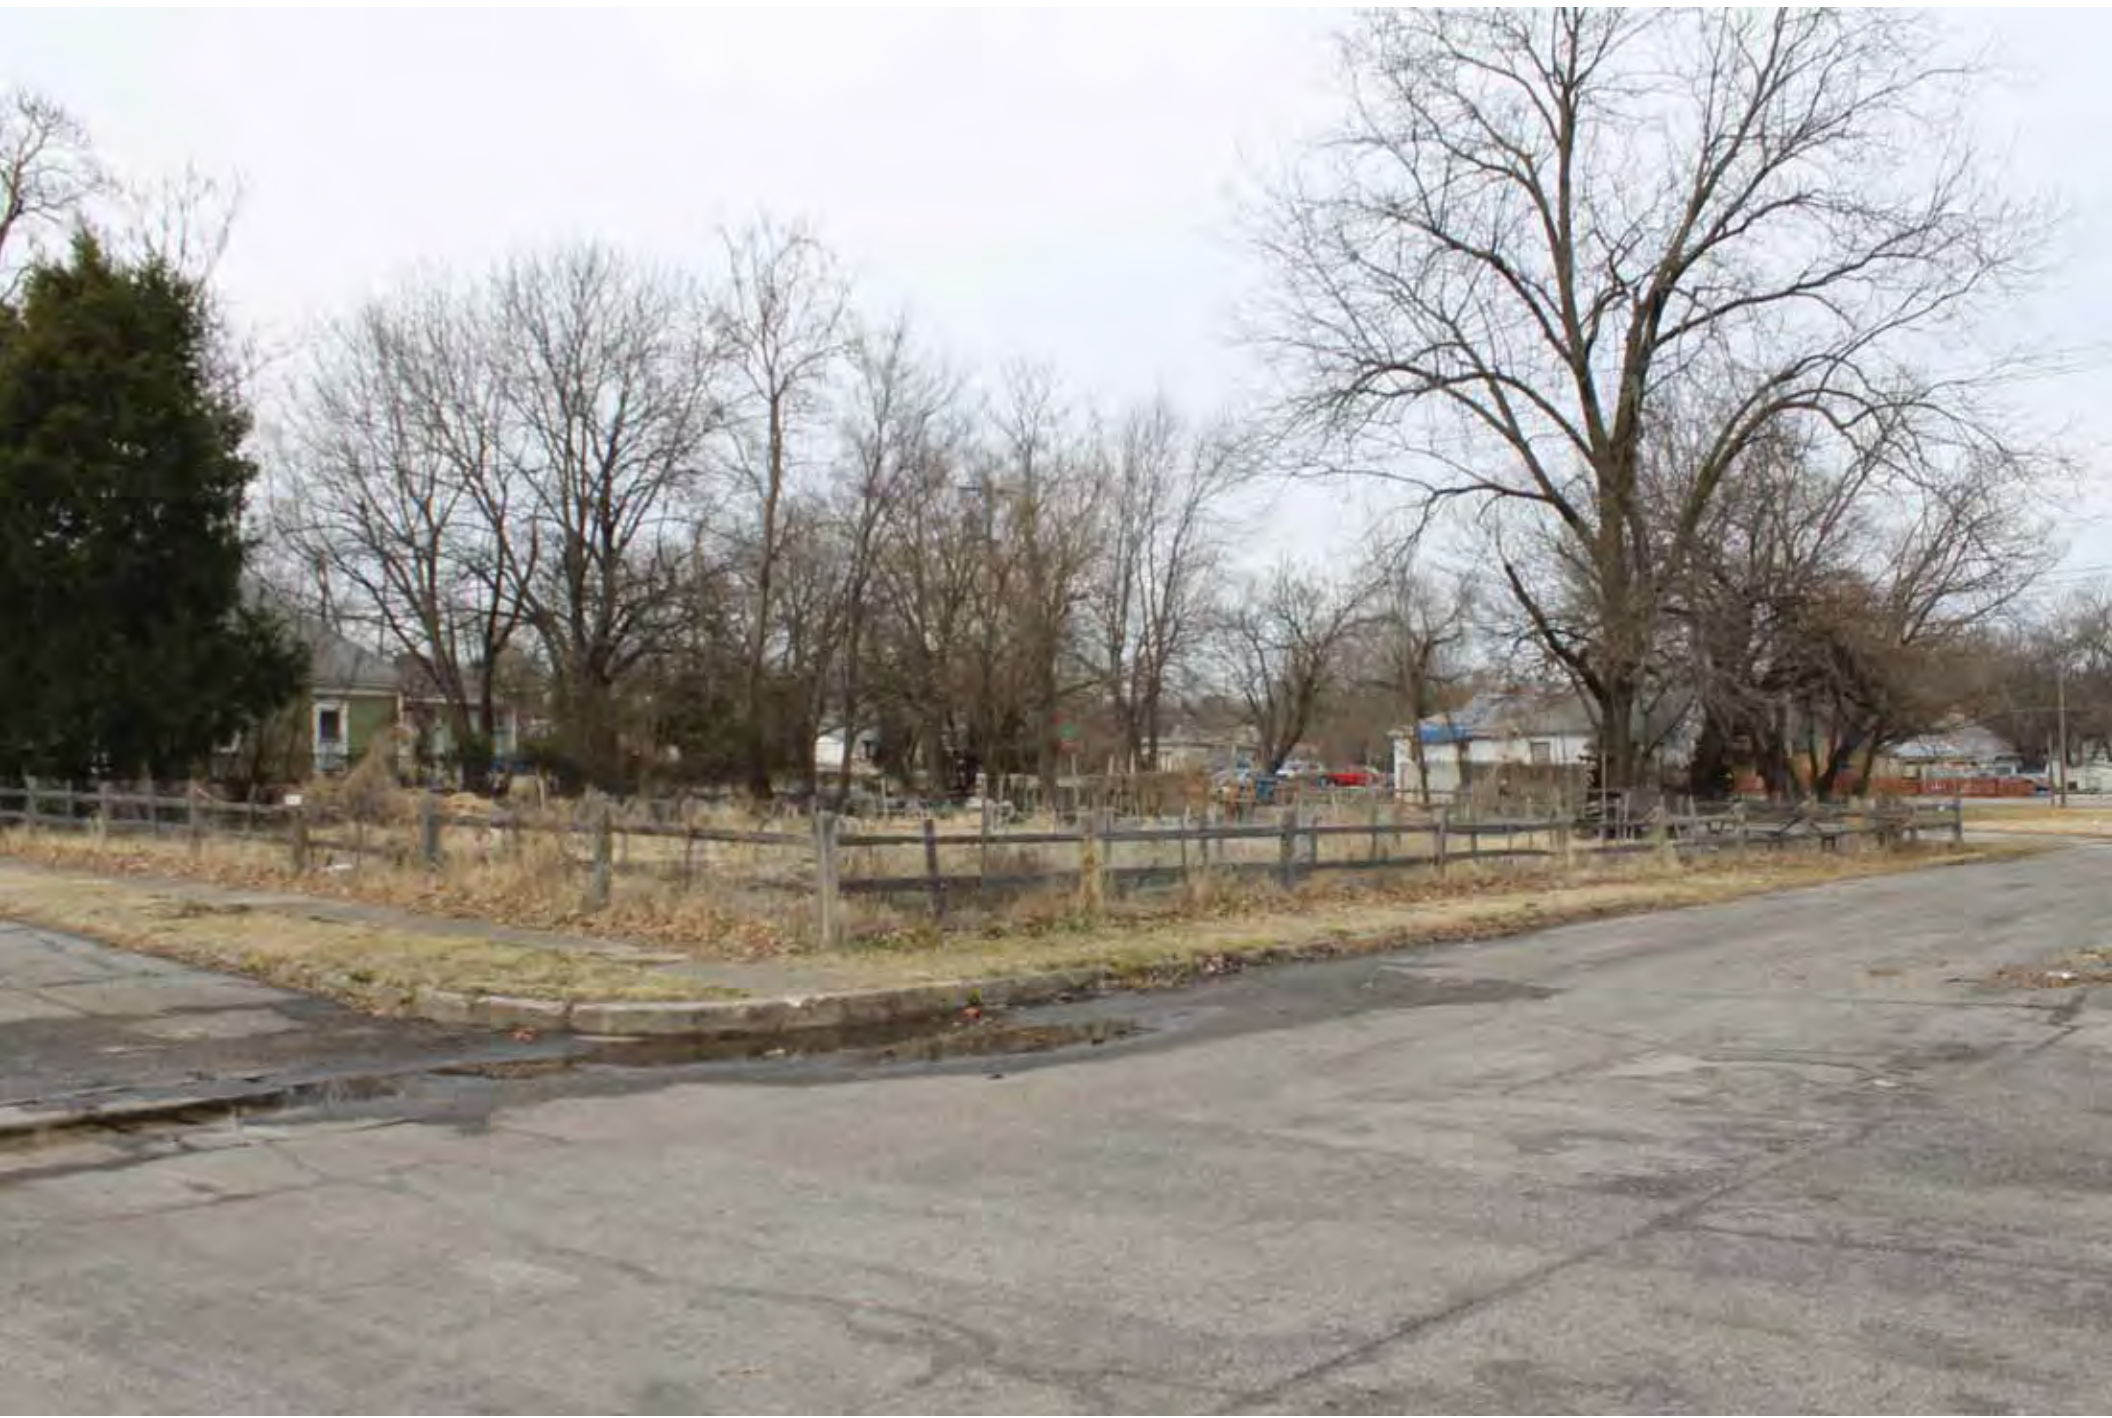
The property east of 813 E. Central Street is a vacant lot as described above.
