MISSOURI DEPARTMENT OF NATURAL RESOURCES
STATE HISTORIC PRESERVATION OFFICE, P.O. Box 176, Jefferson City, MO 65102
ARCHITECTURAL/HISTORIC INVENTORY FORM

1. Survey No. JP-AS-007-001		2. Survey name: East Town (Original Joplin) Historic Survey Phase 2	
3. County: JASPER		4. Address (Street No.) 618	Street (name) E. 2 nd Street
5. City: Joplin	Vicinity: <input type="checkbox"/>	6. Geographical Reference:	7. Township/Range/Section: T: R: S:
8. Historic name (if known):		9. Present/other name (if known):	
10. Ownership: <input checked="" type="checkbox"/> Private <input type="checkbox"/> Public		11a. Historic use (if known): Domestic: Single Dwelling	11b. Current use: Domestic: Single Dwelling

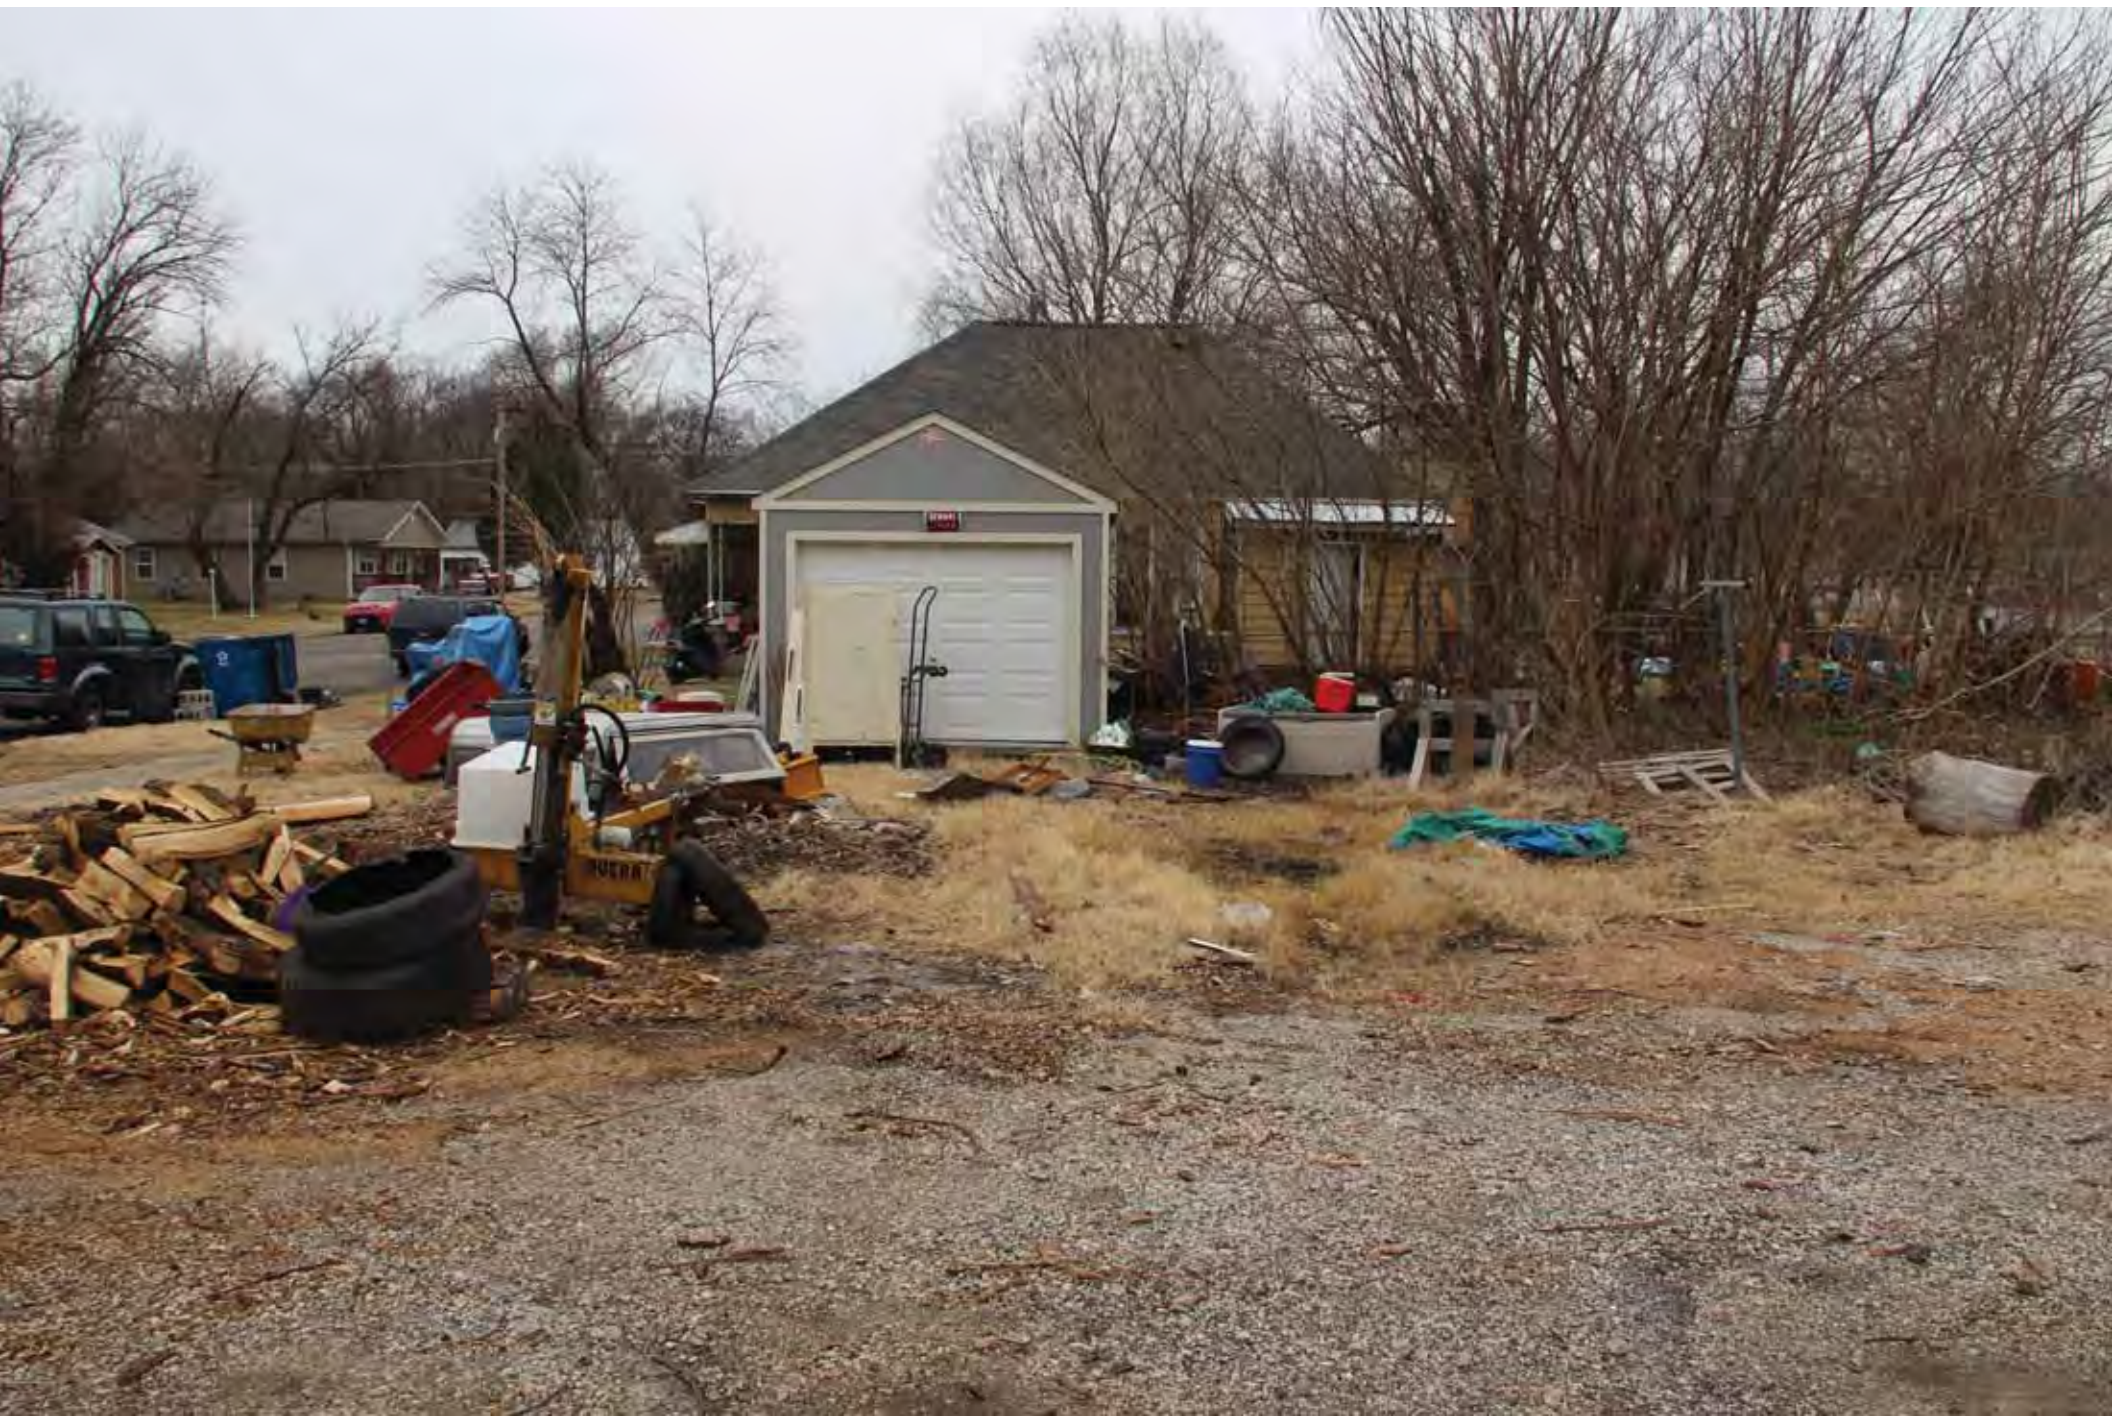
The property east of 917 E. Central Street is a vacant lot as described above.

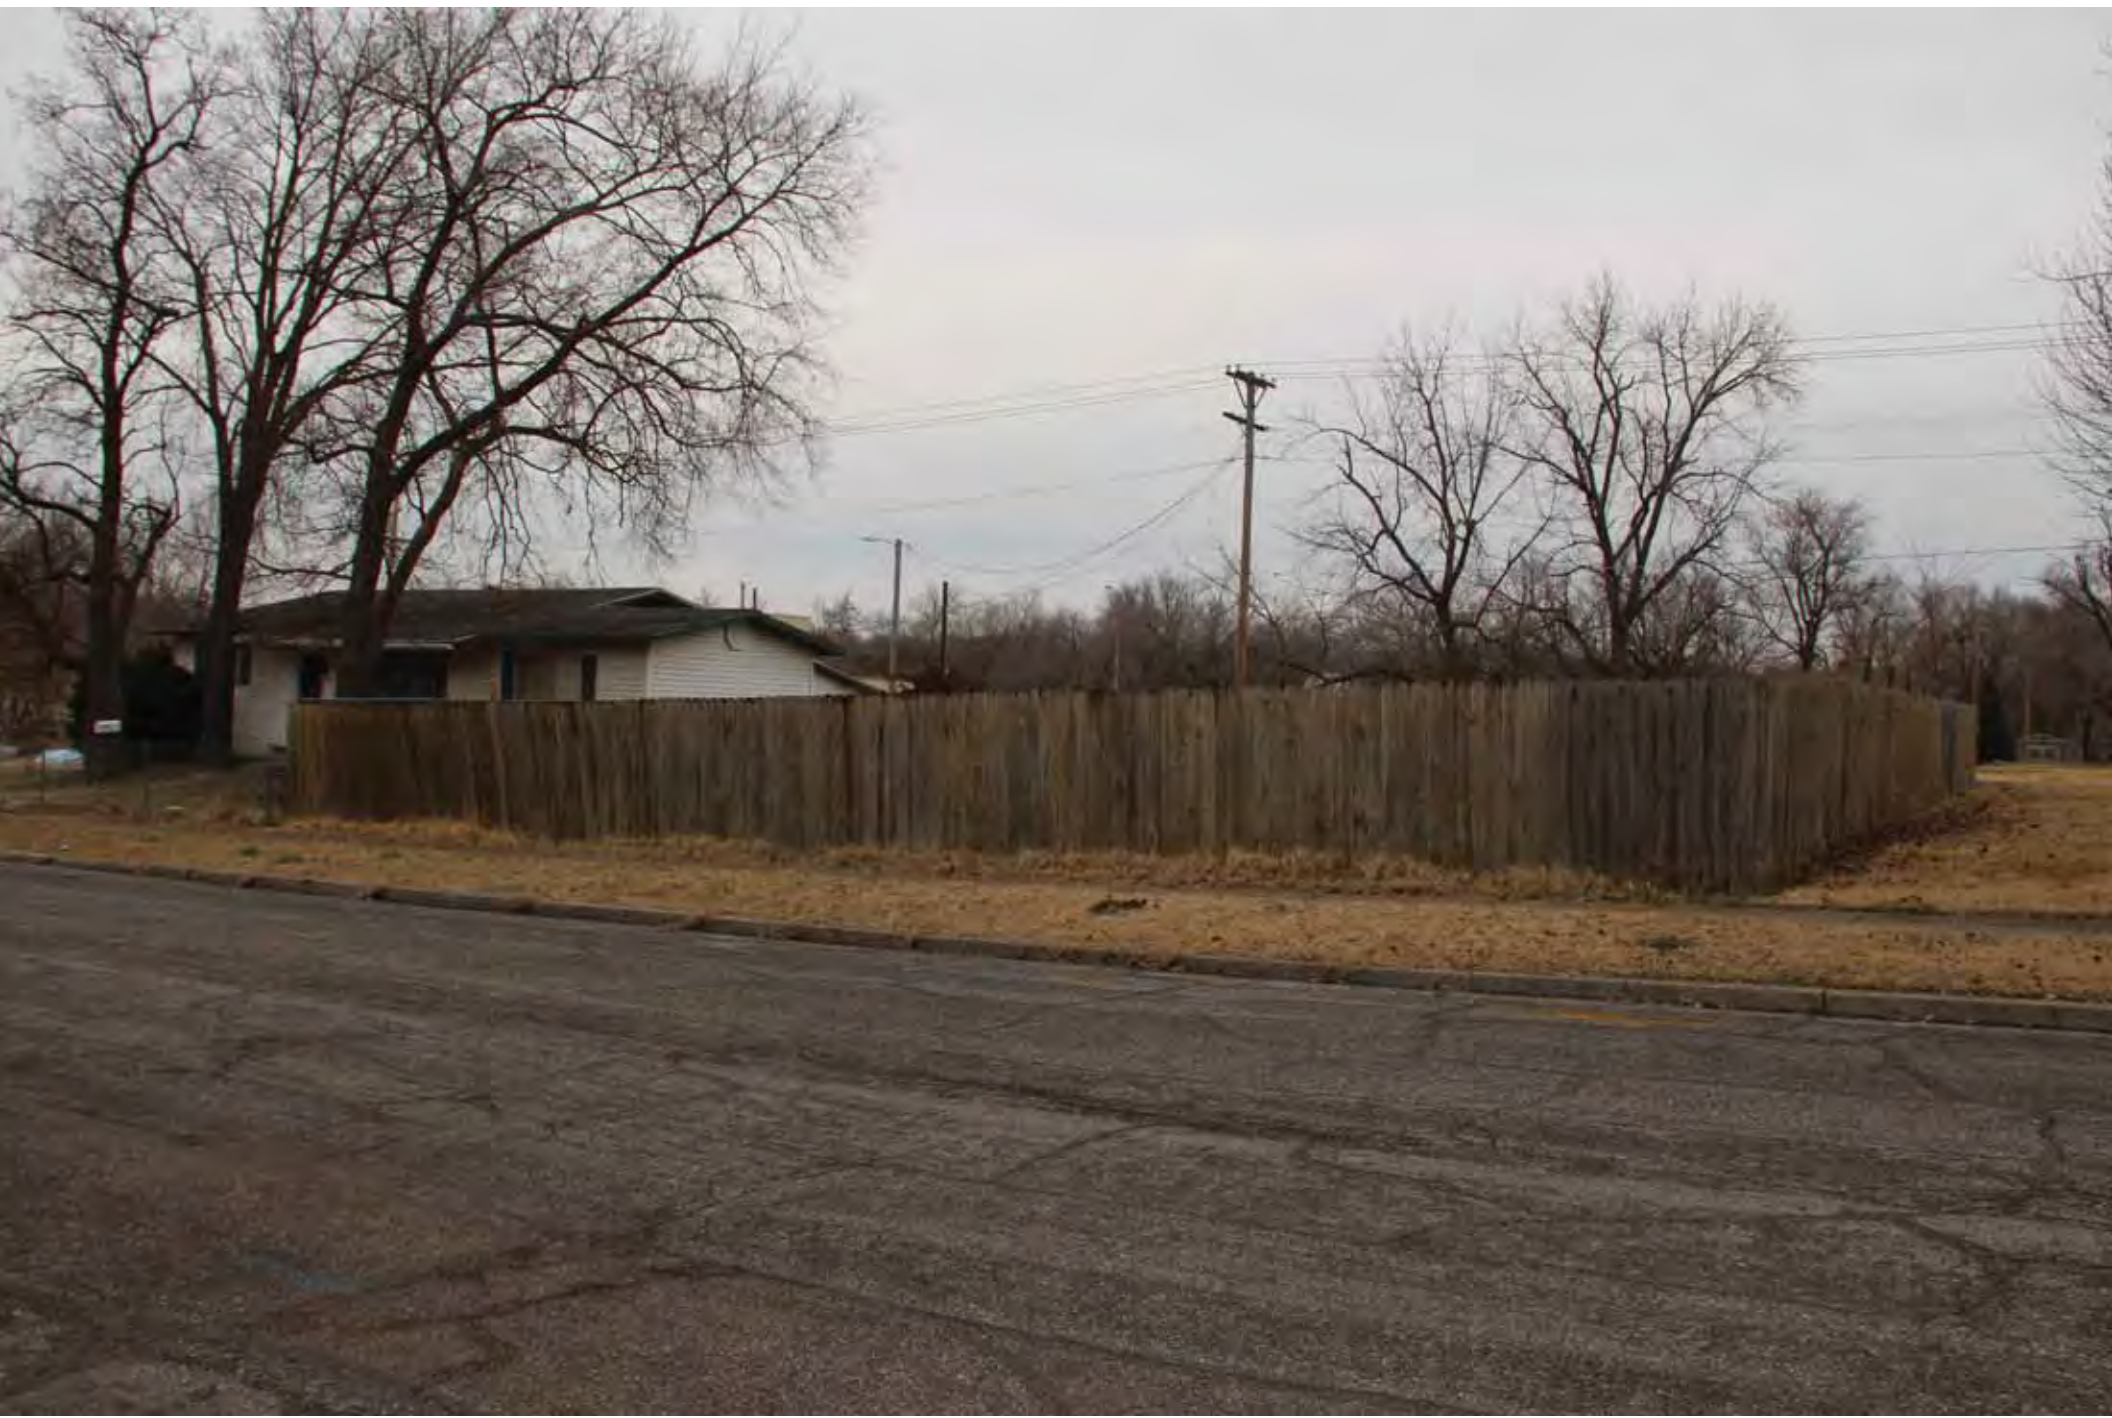
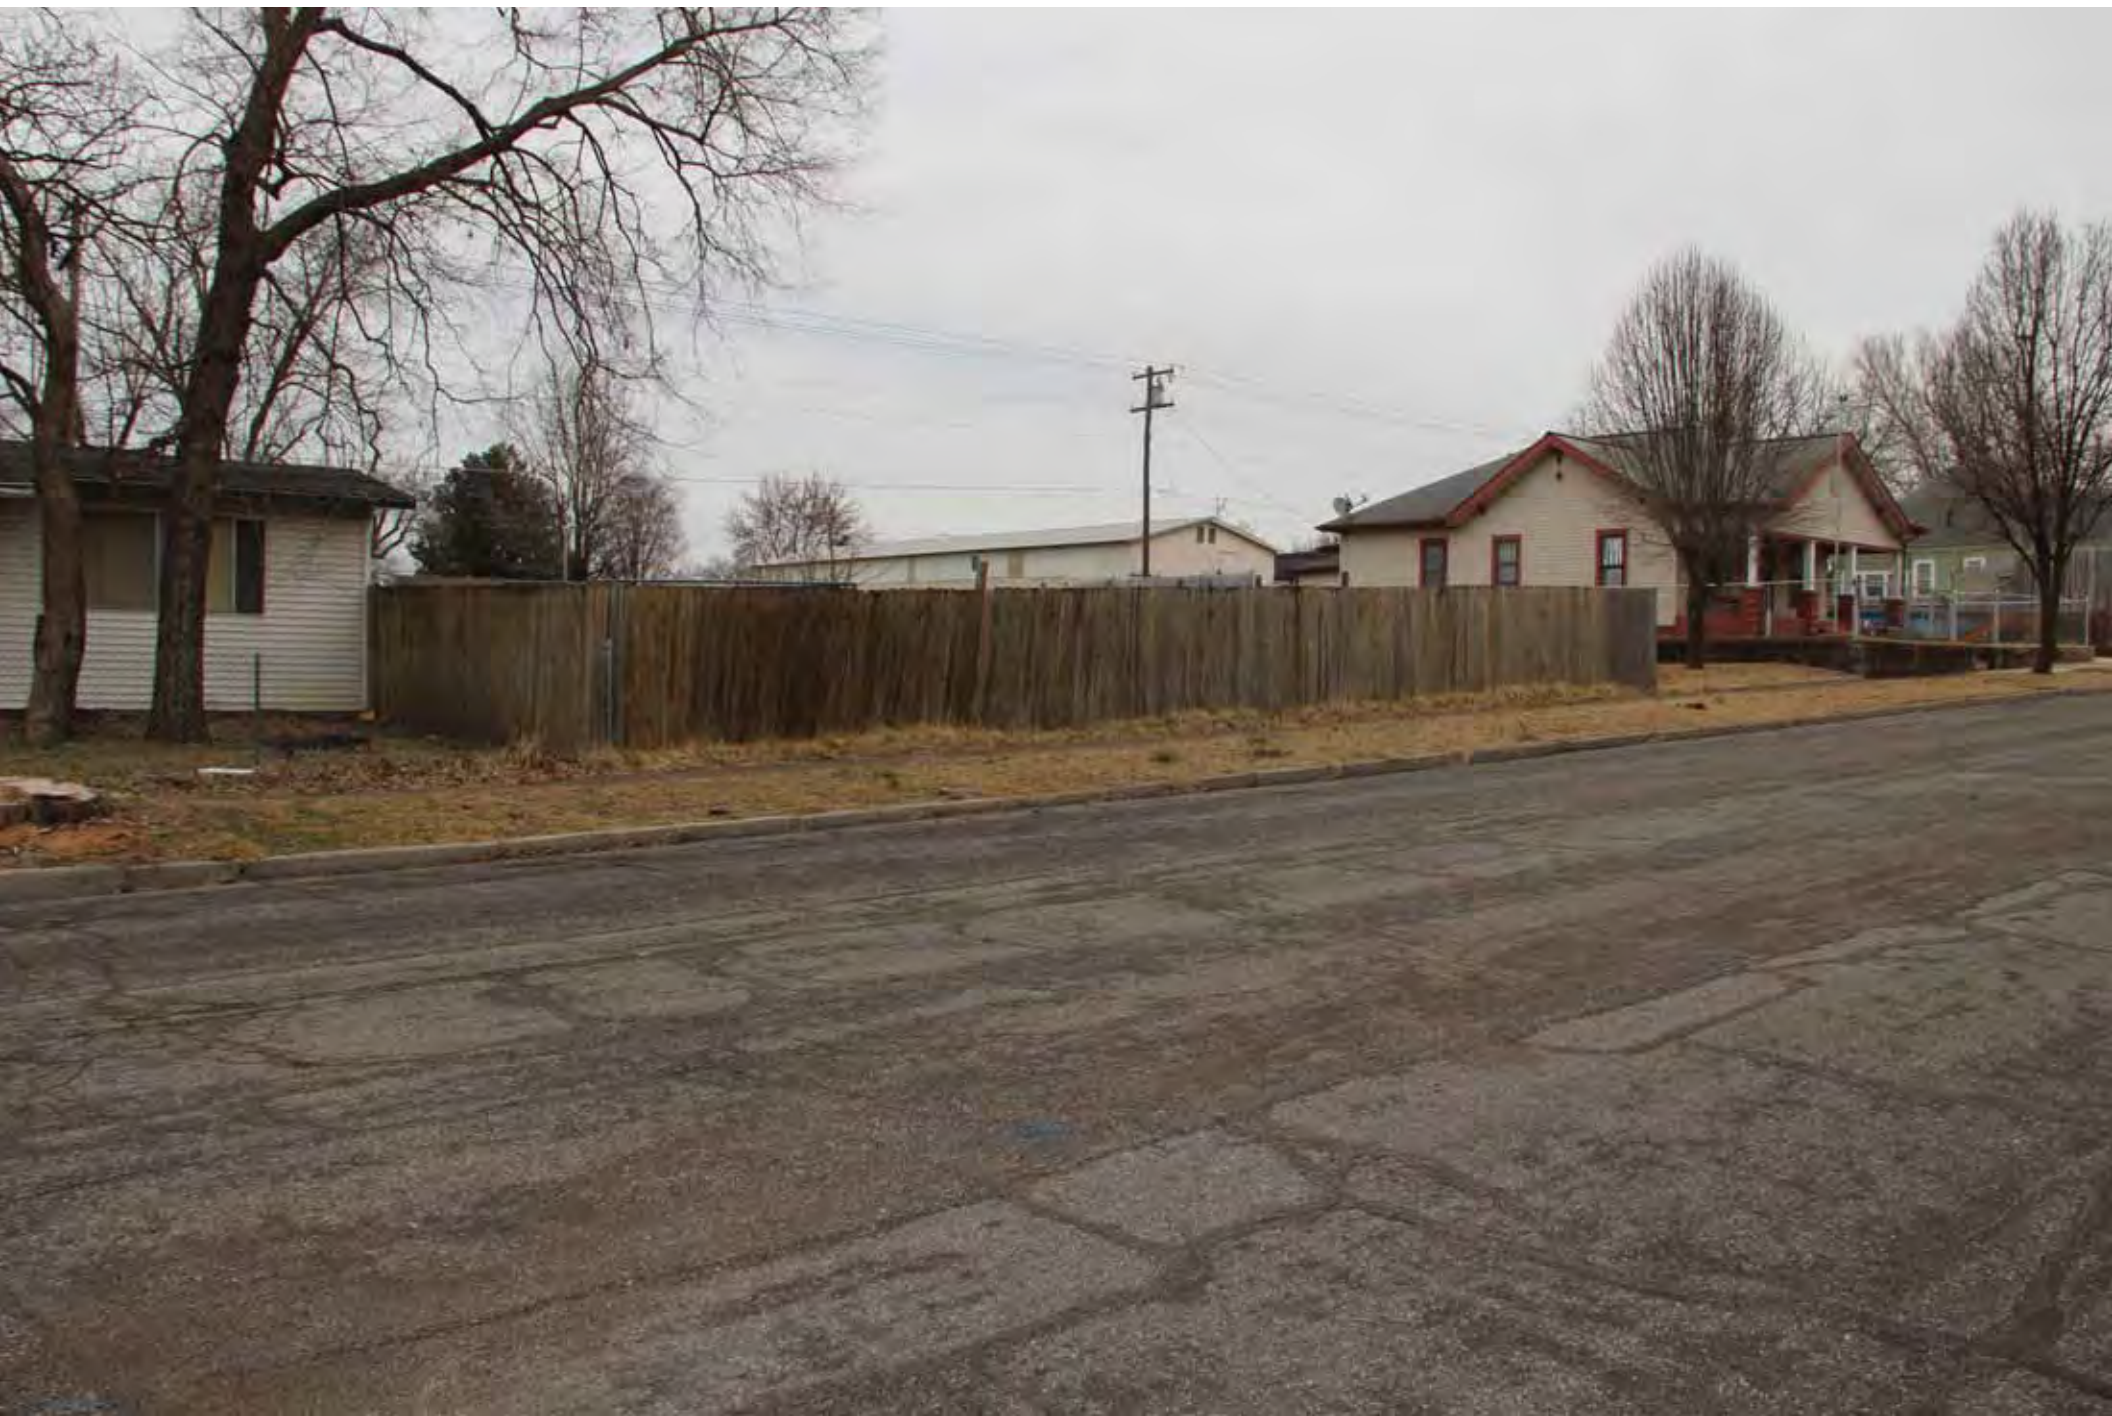
The property east of 1005 E. Central Street is a vacant lot as described above.

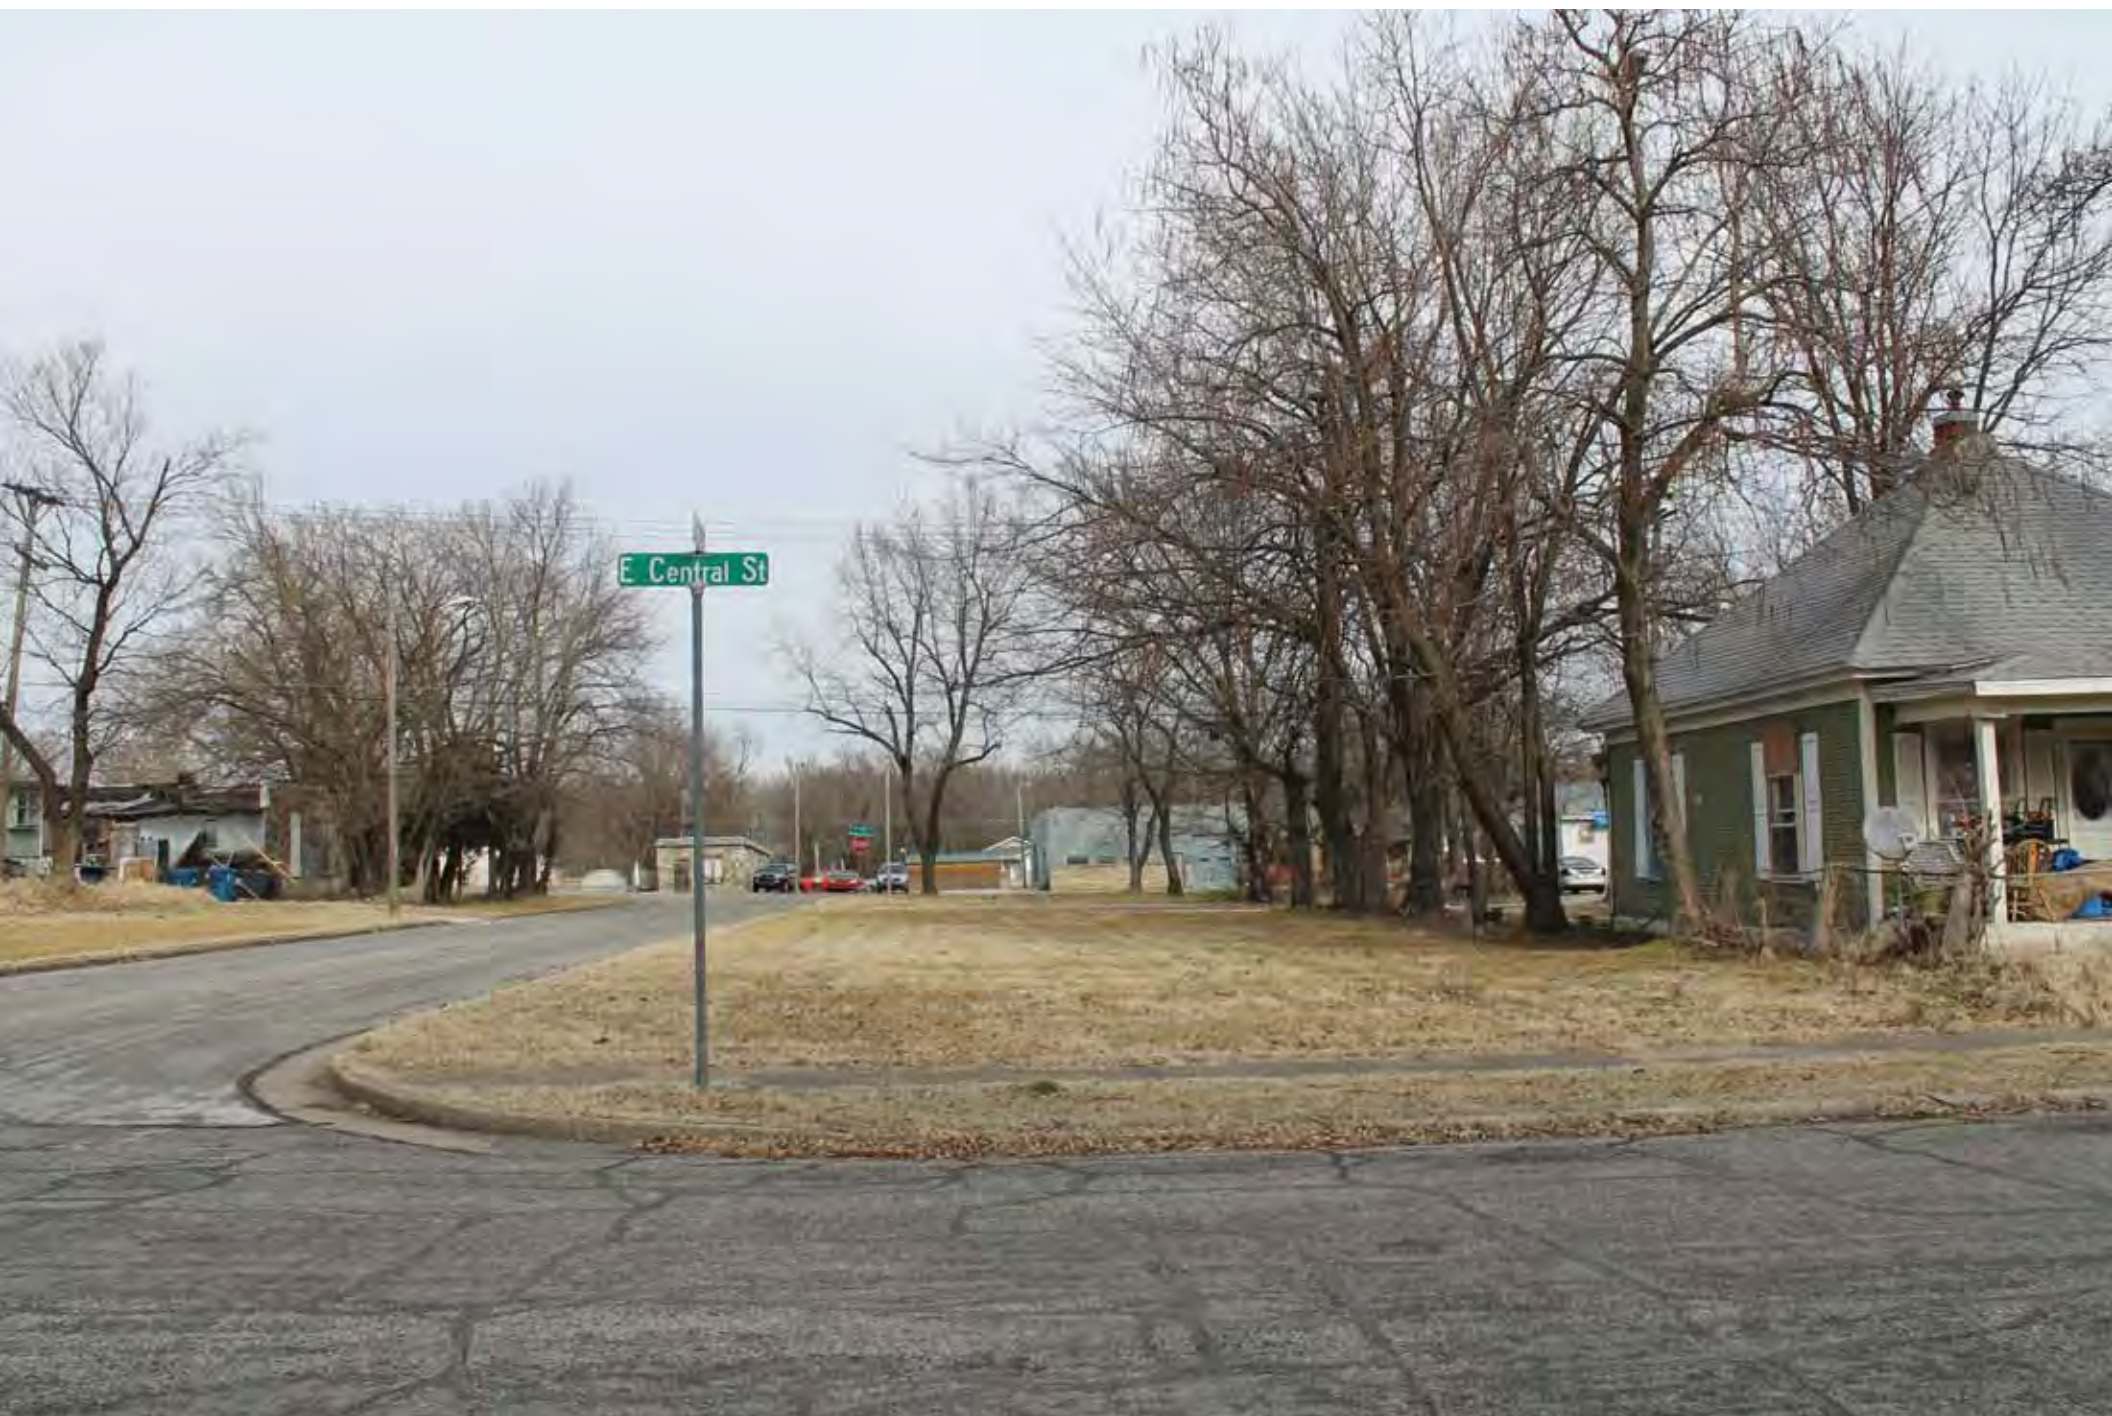
The property west of 813 E. Central Street is a vacant grass covered lot as described above.

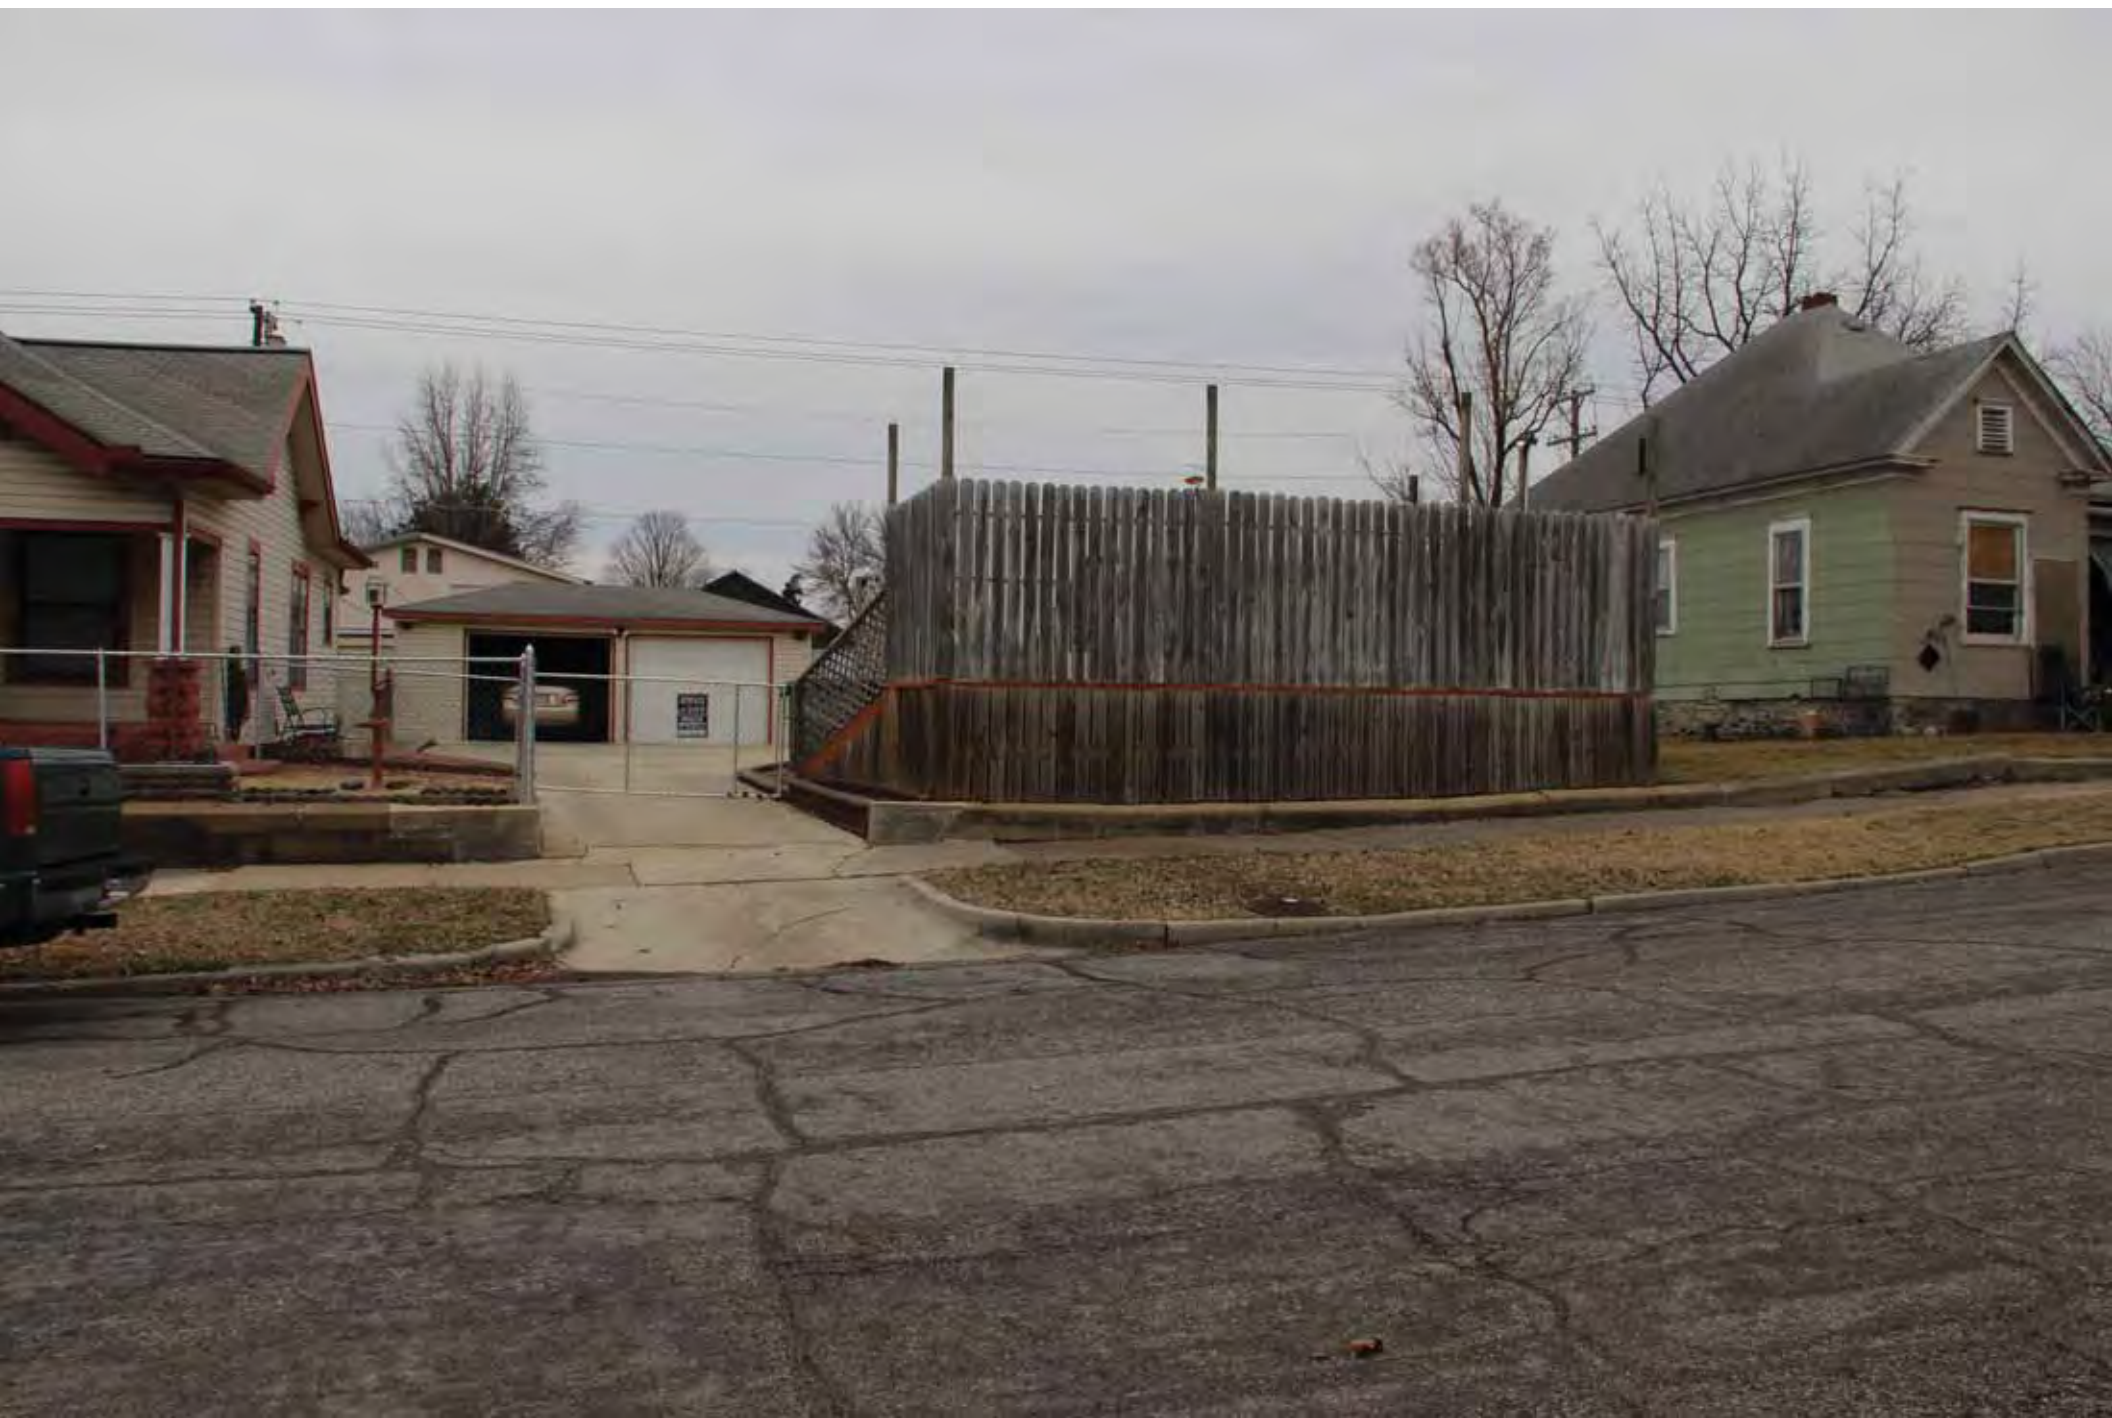
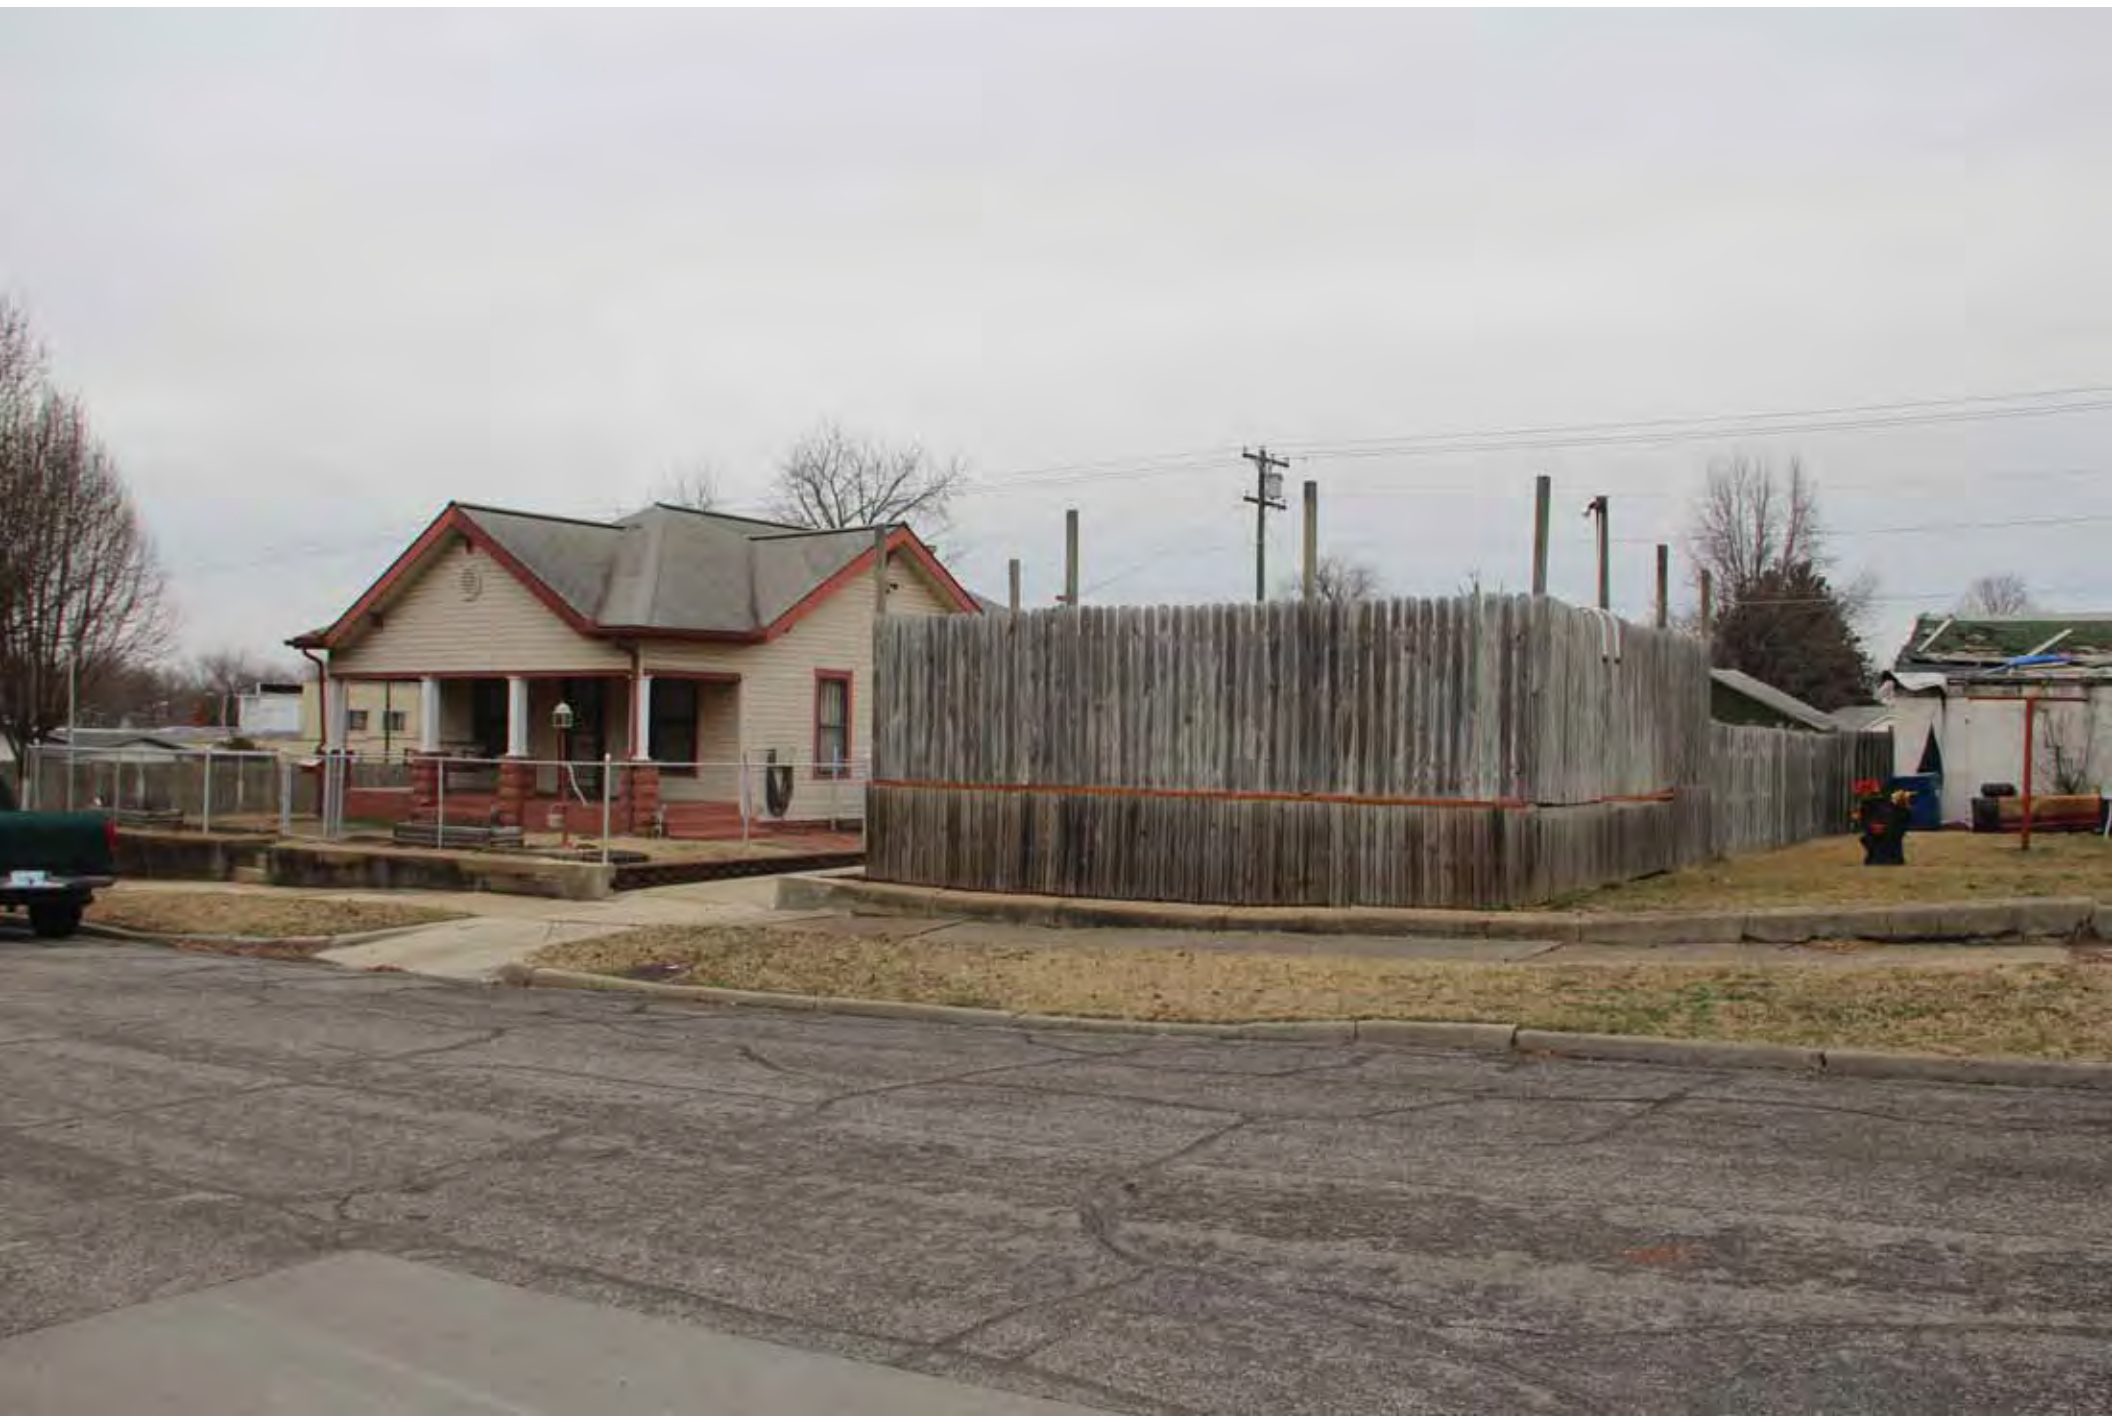
The property west of 1017 E. Central Street is a vacant lot as described above.
