MISSOURI DEPARTMENT OF NATURAL RESOURCES
STATE HISTORIC PRESERVATION OFFICE, P.O. Box 176, Jefferson City, MO 65102
ARCHITECTURAL/HISTORIC INVENTORY FORM

1. Survey No. JP-AS-007-001		2. Survey name: East Town (Original Joplin) Historic Survey Phase 2	
3. County: JASPER		4. Address (Street No.) 618	Street (name) E. 2 nd Street
5. City: Joplin	Vicinity: <input type="checkbox"/>	6. Geographical Reference:	7. Township/Range/Section: T: R: S:
8. Historic name (if known):		9. Present/other name (if known):	
10. Ownership: <input checked="" type="checkbox"/> Private <input type="checkbox"/> Public		11a. Historic use (if known): Domestic: Single Dwelling	11b. Current use: Domestic: Single Dwelling

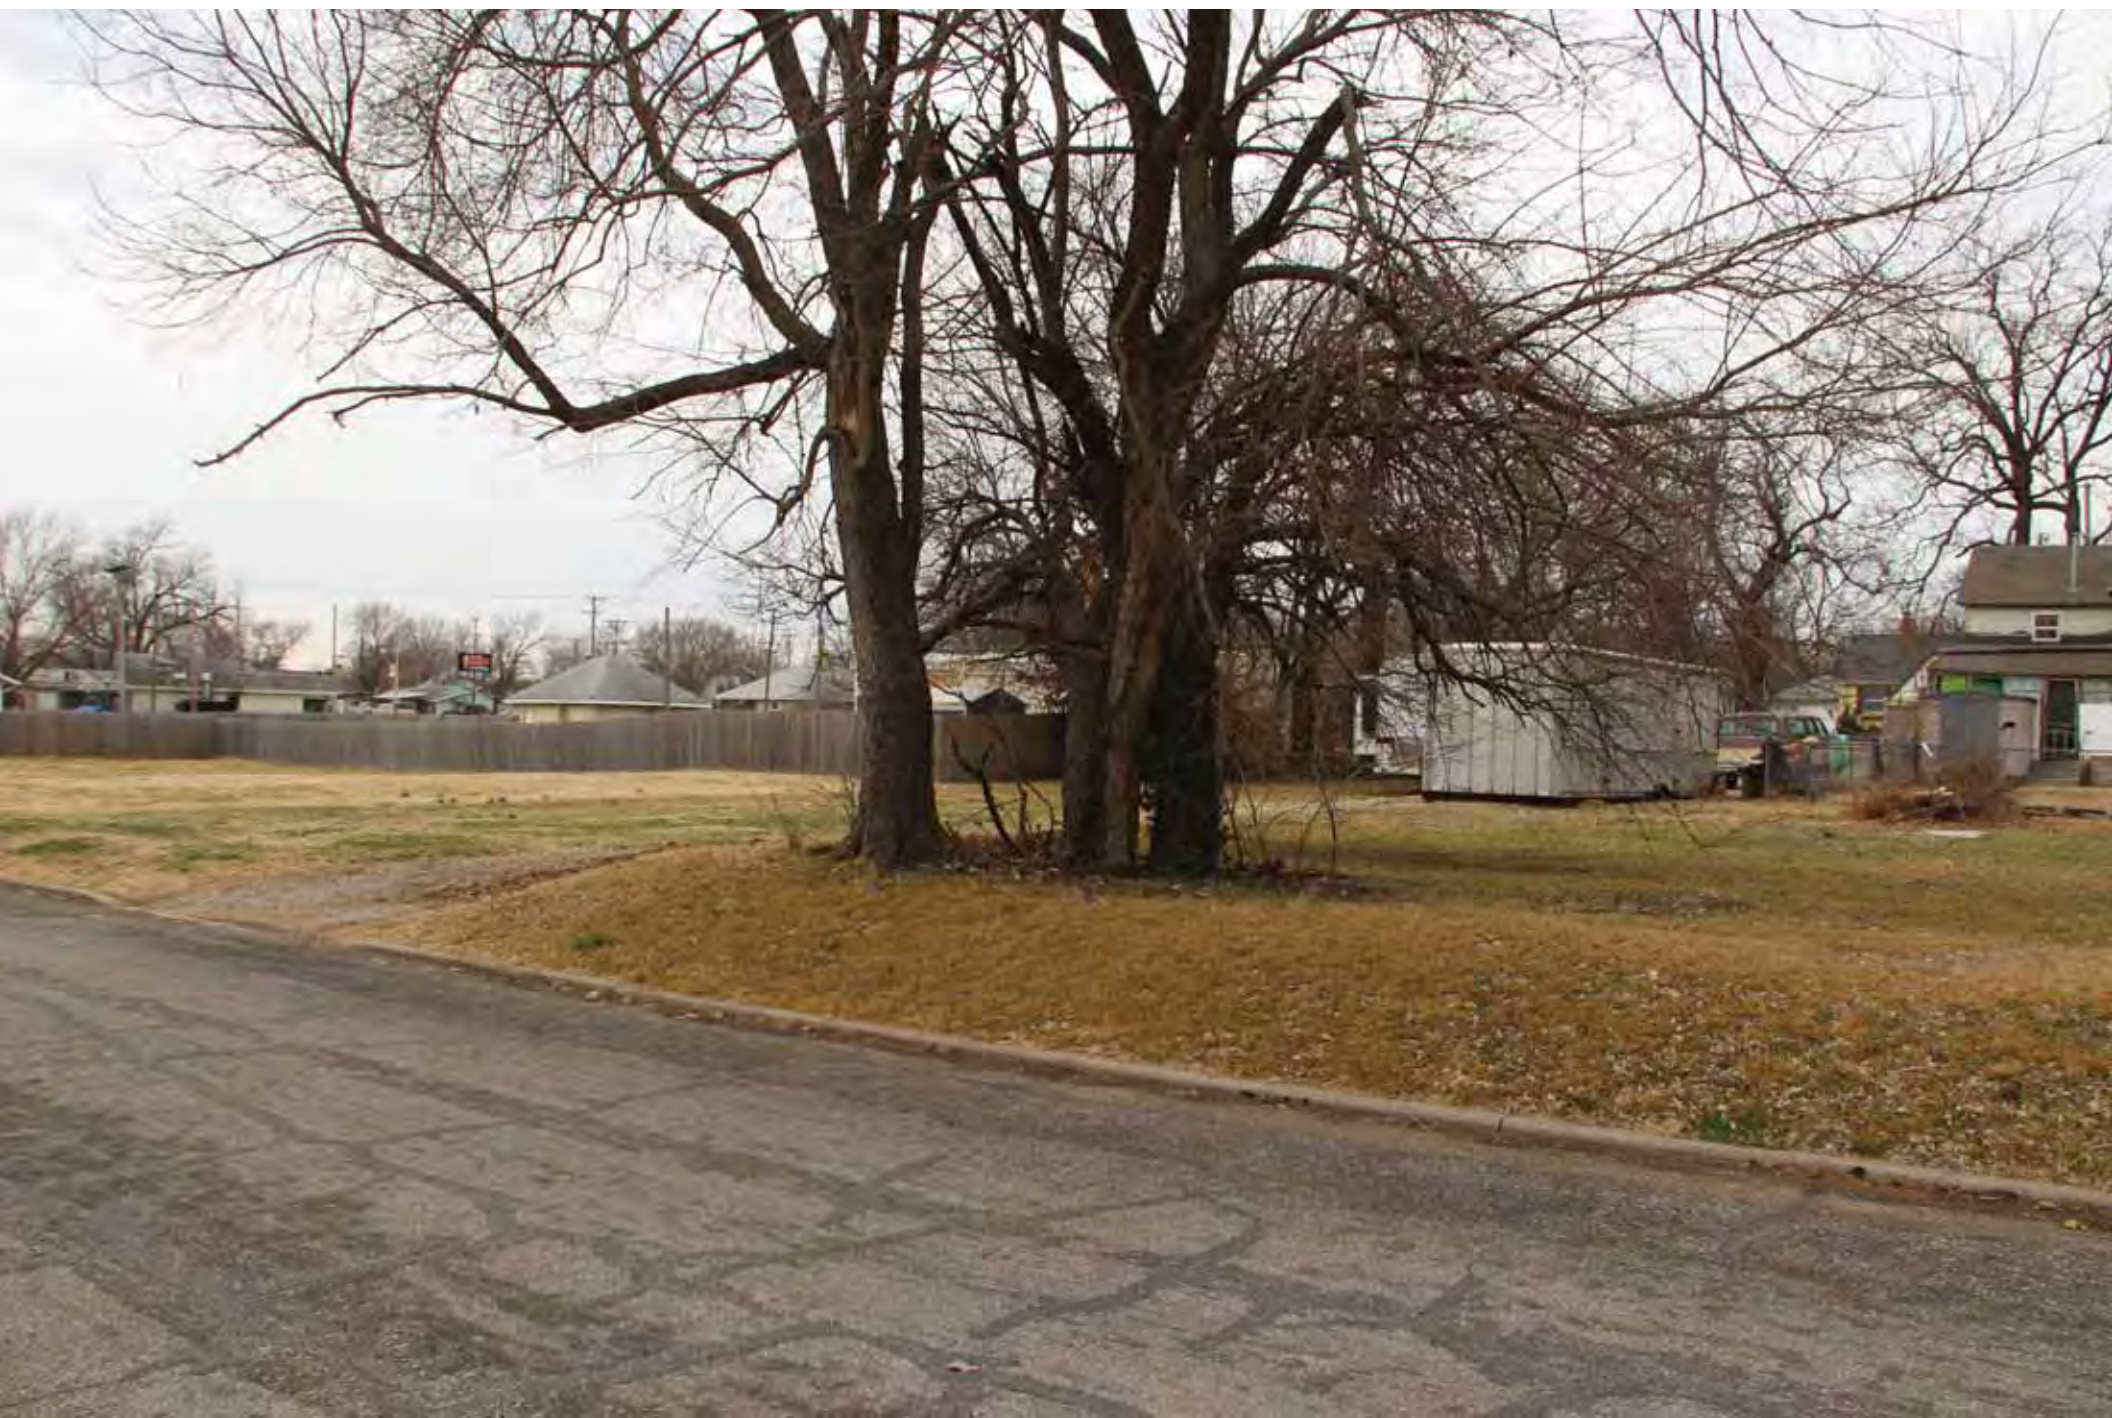
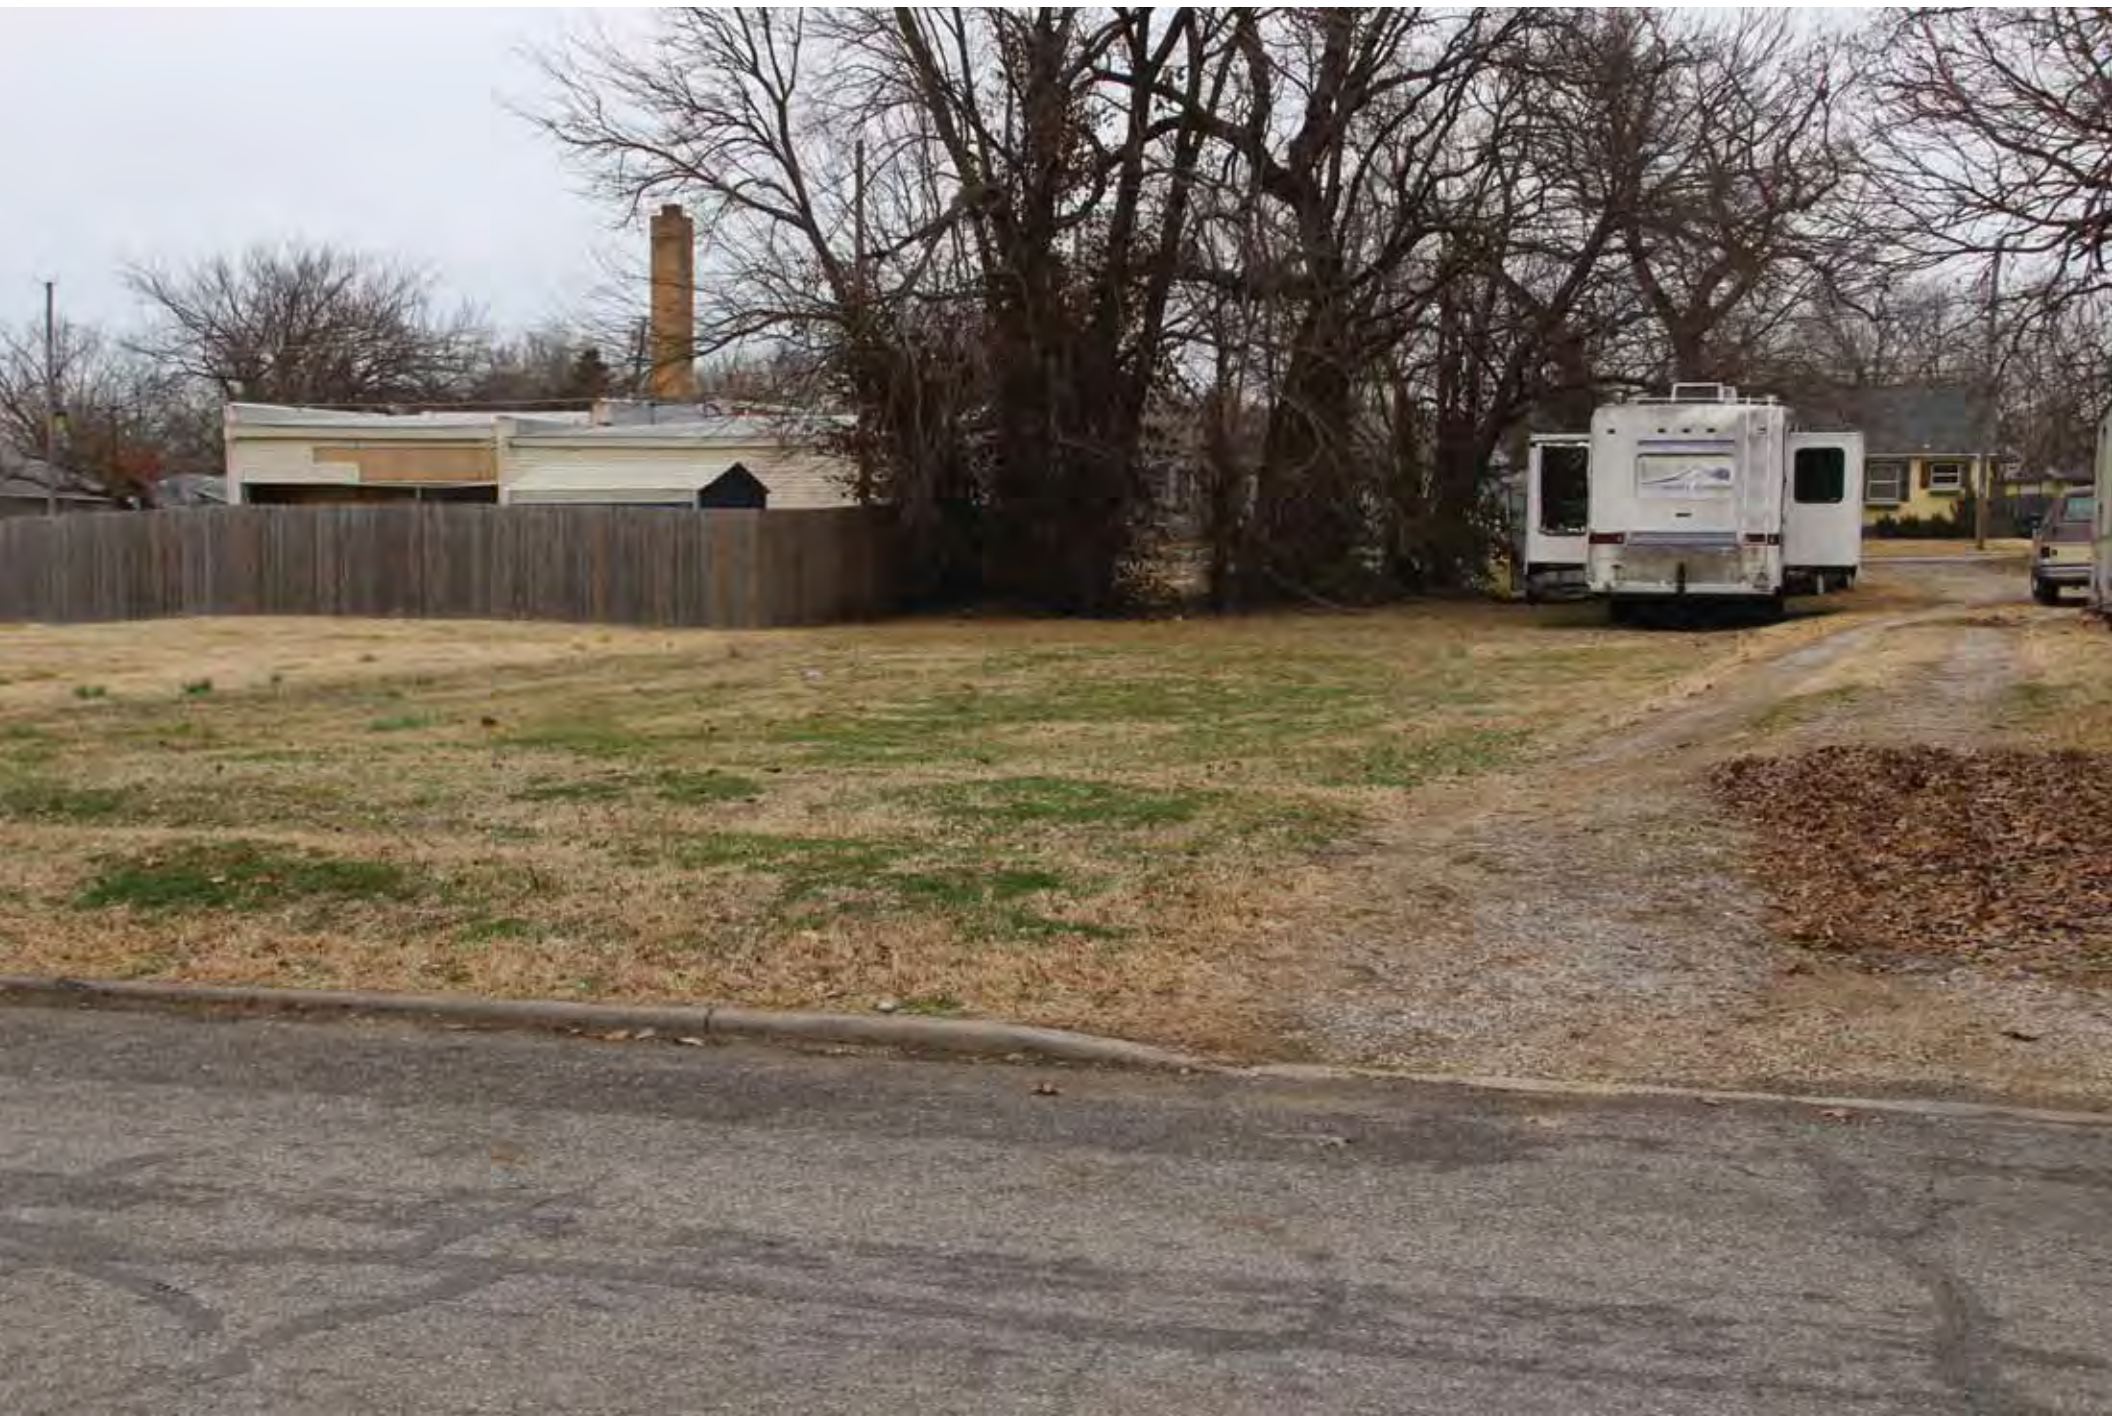
<p>41. (cont.) Description of primary resource. Expand box as necessary, or add continuation pages.</p> <p>The property east of 1401 E. Central Street is a vacant grassy lot that formerly held two single family dwellings. The lot is as described above.</p>

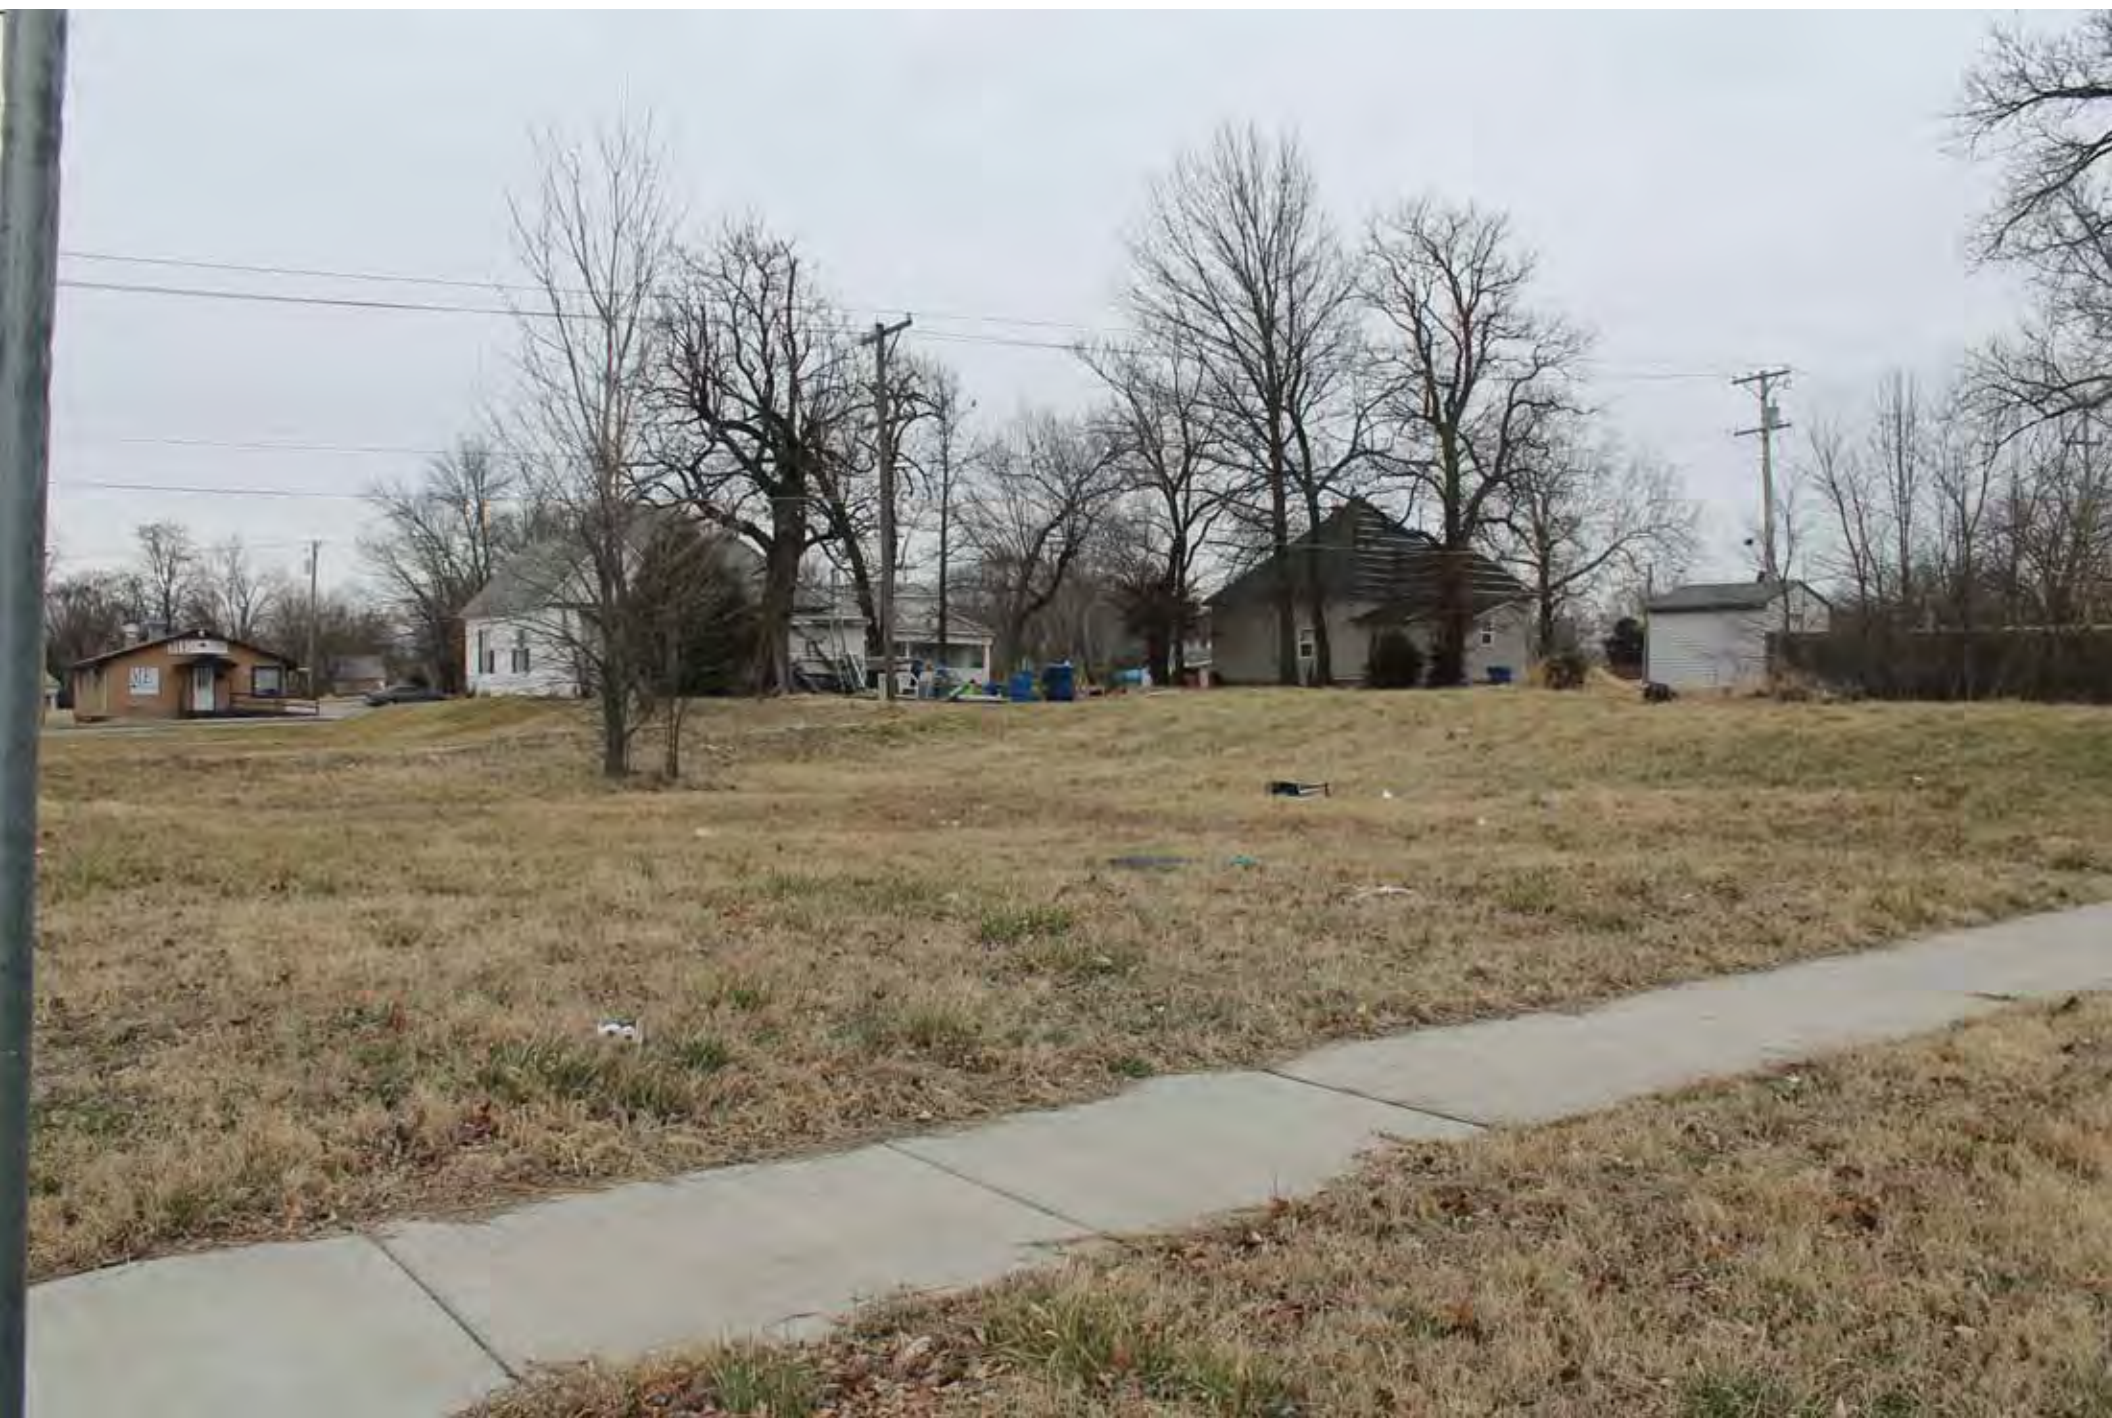
The property at the northeast intersection of E. Central and S. Michigan Streets is a vacant grassy lot that formerly held two single family dwellings. The lot is as described above.

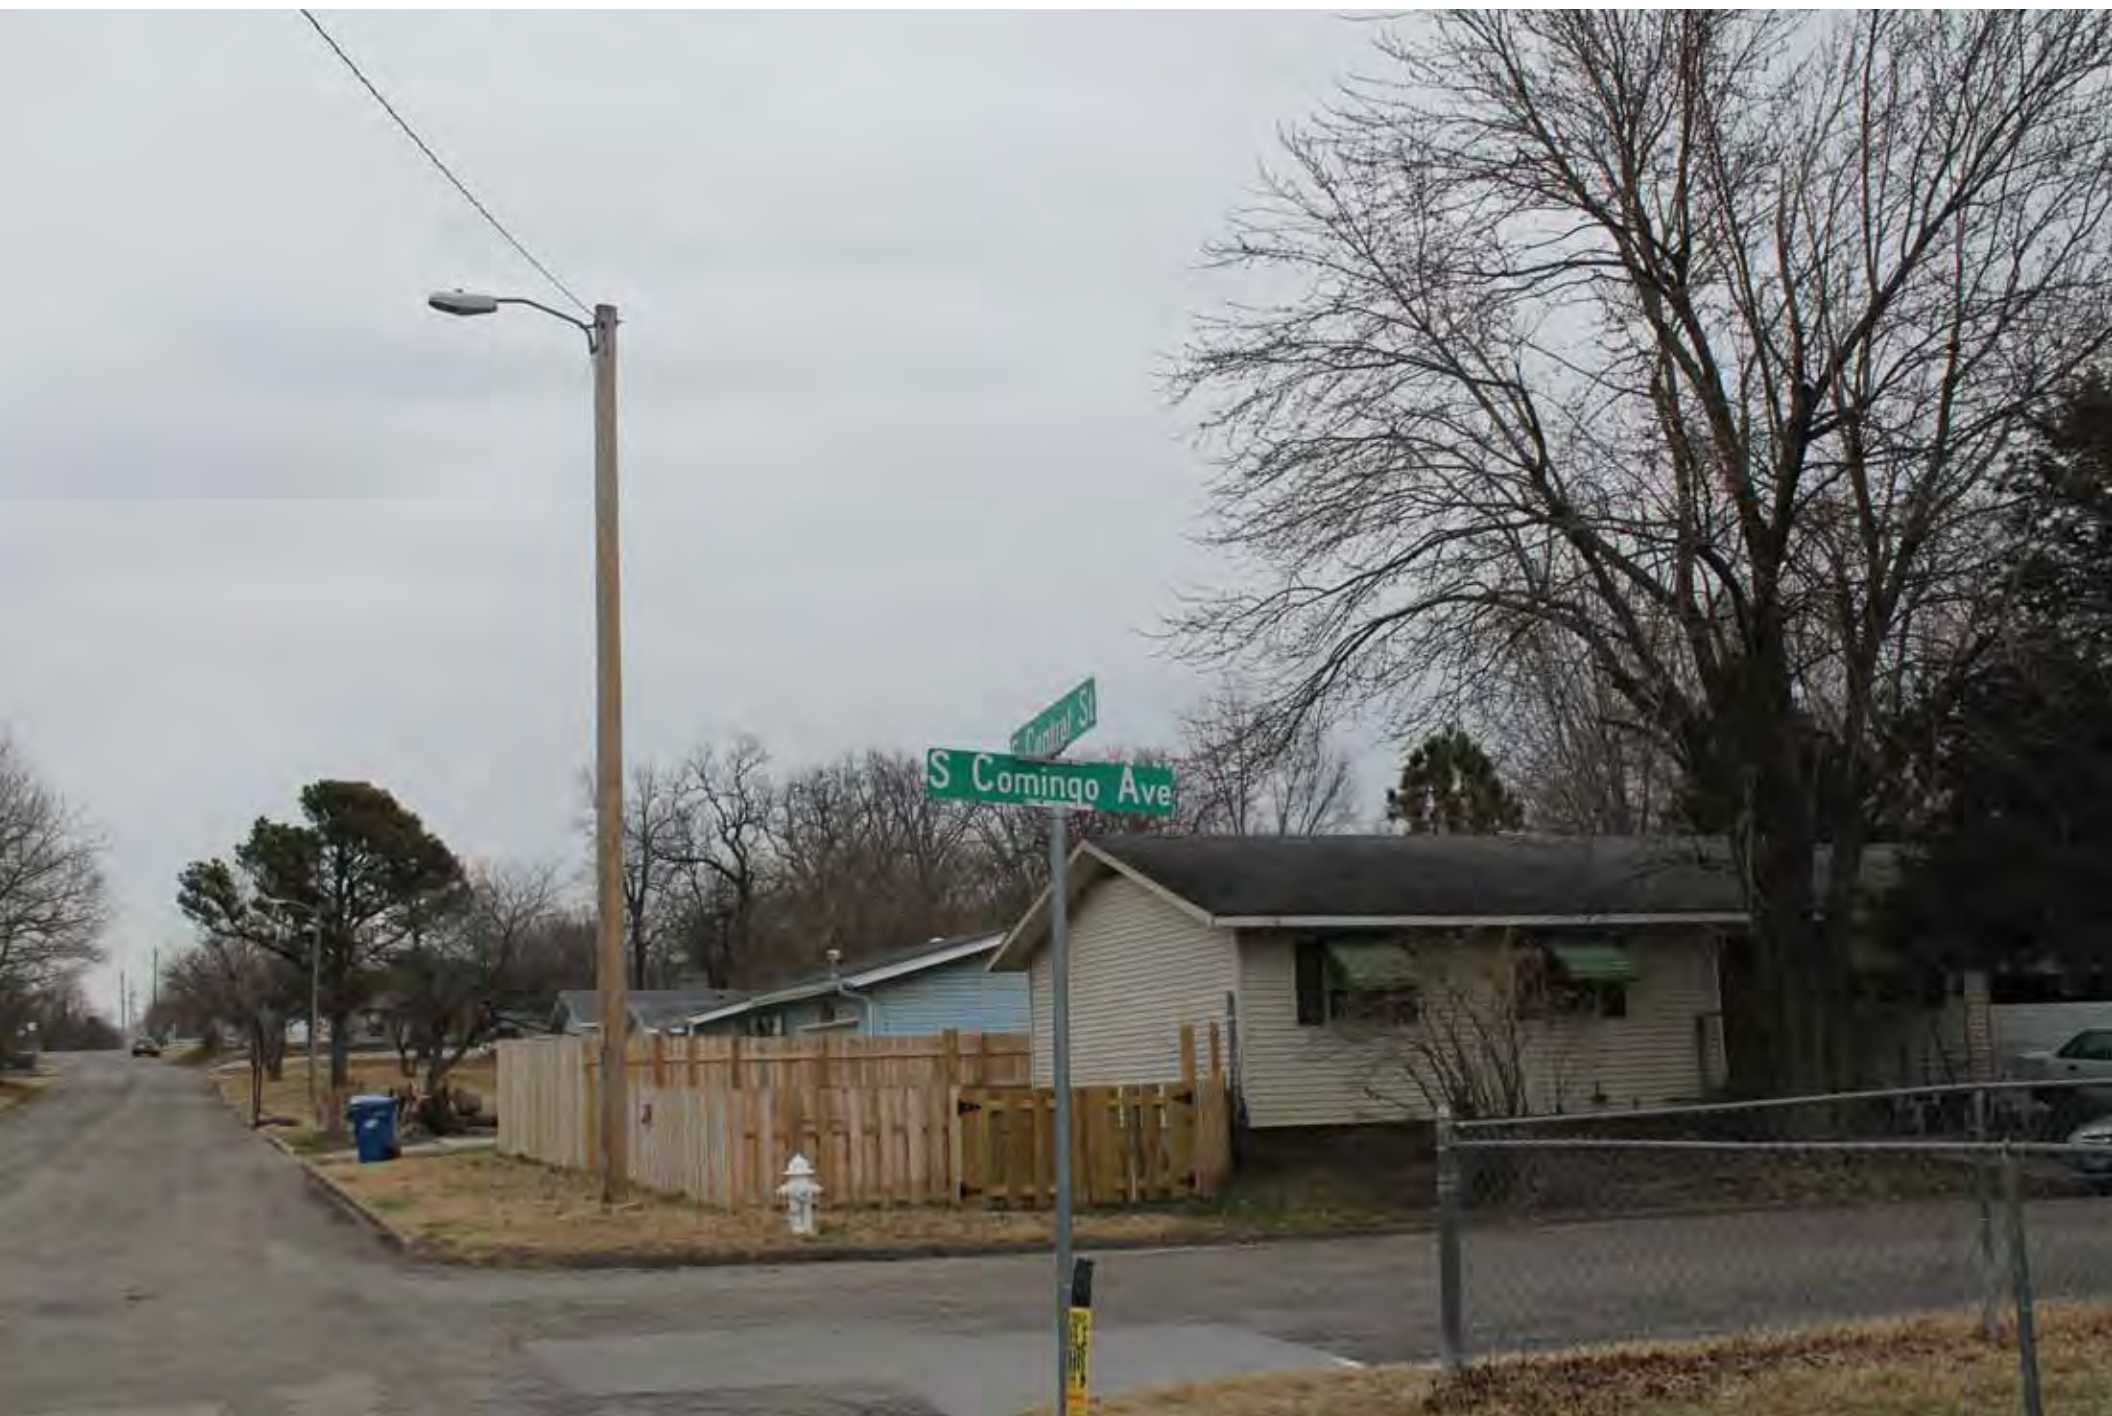
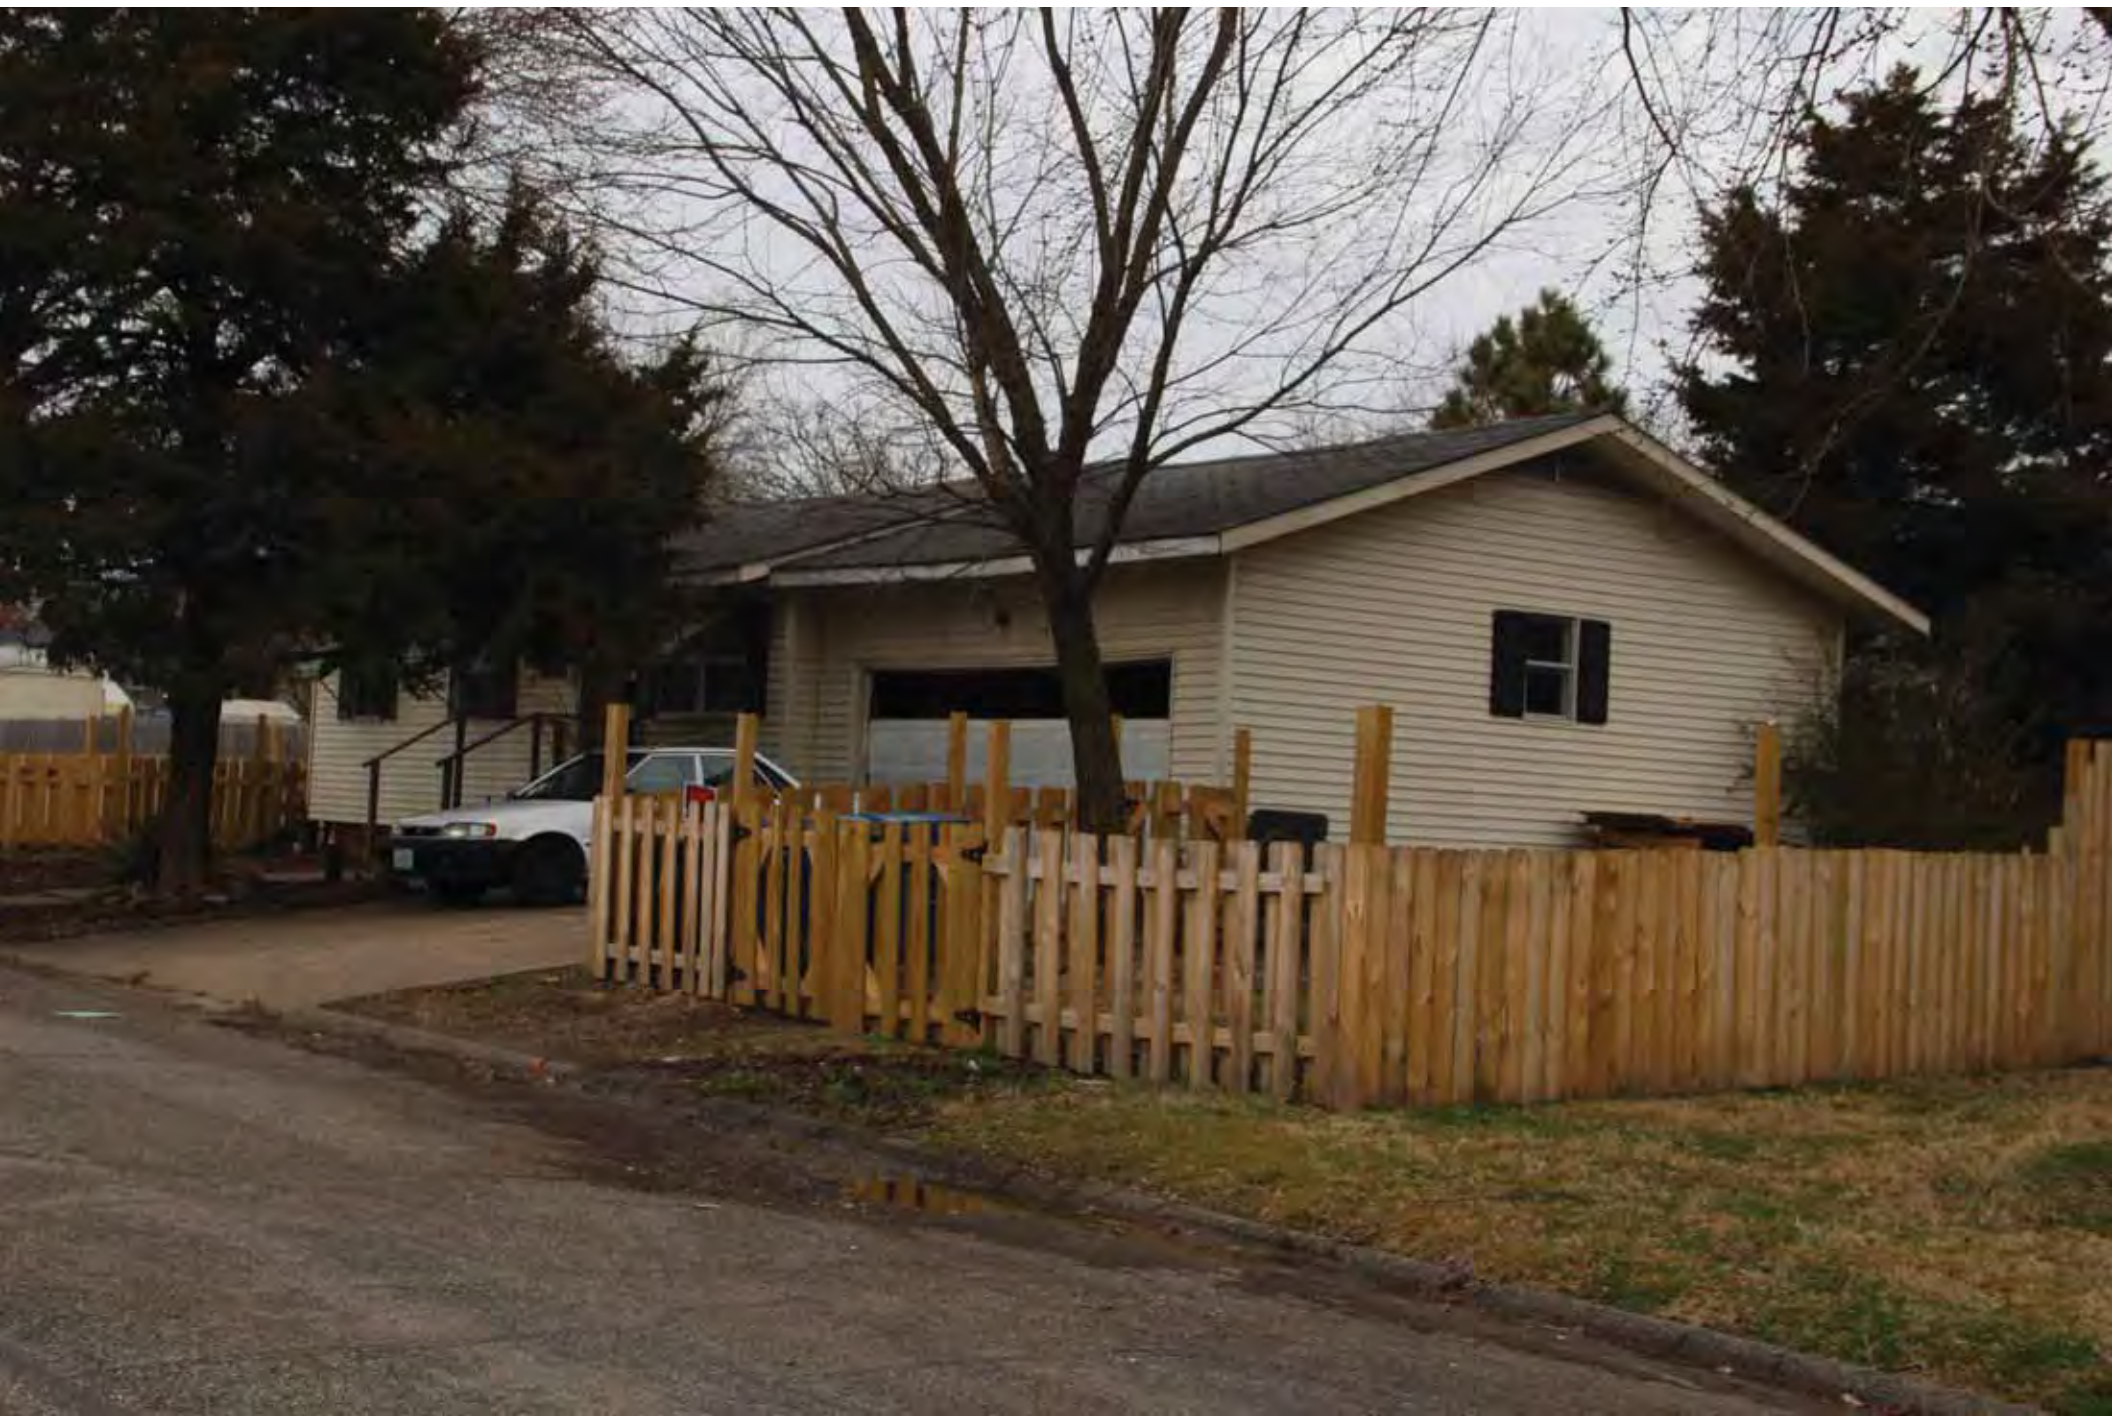
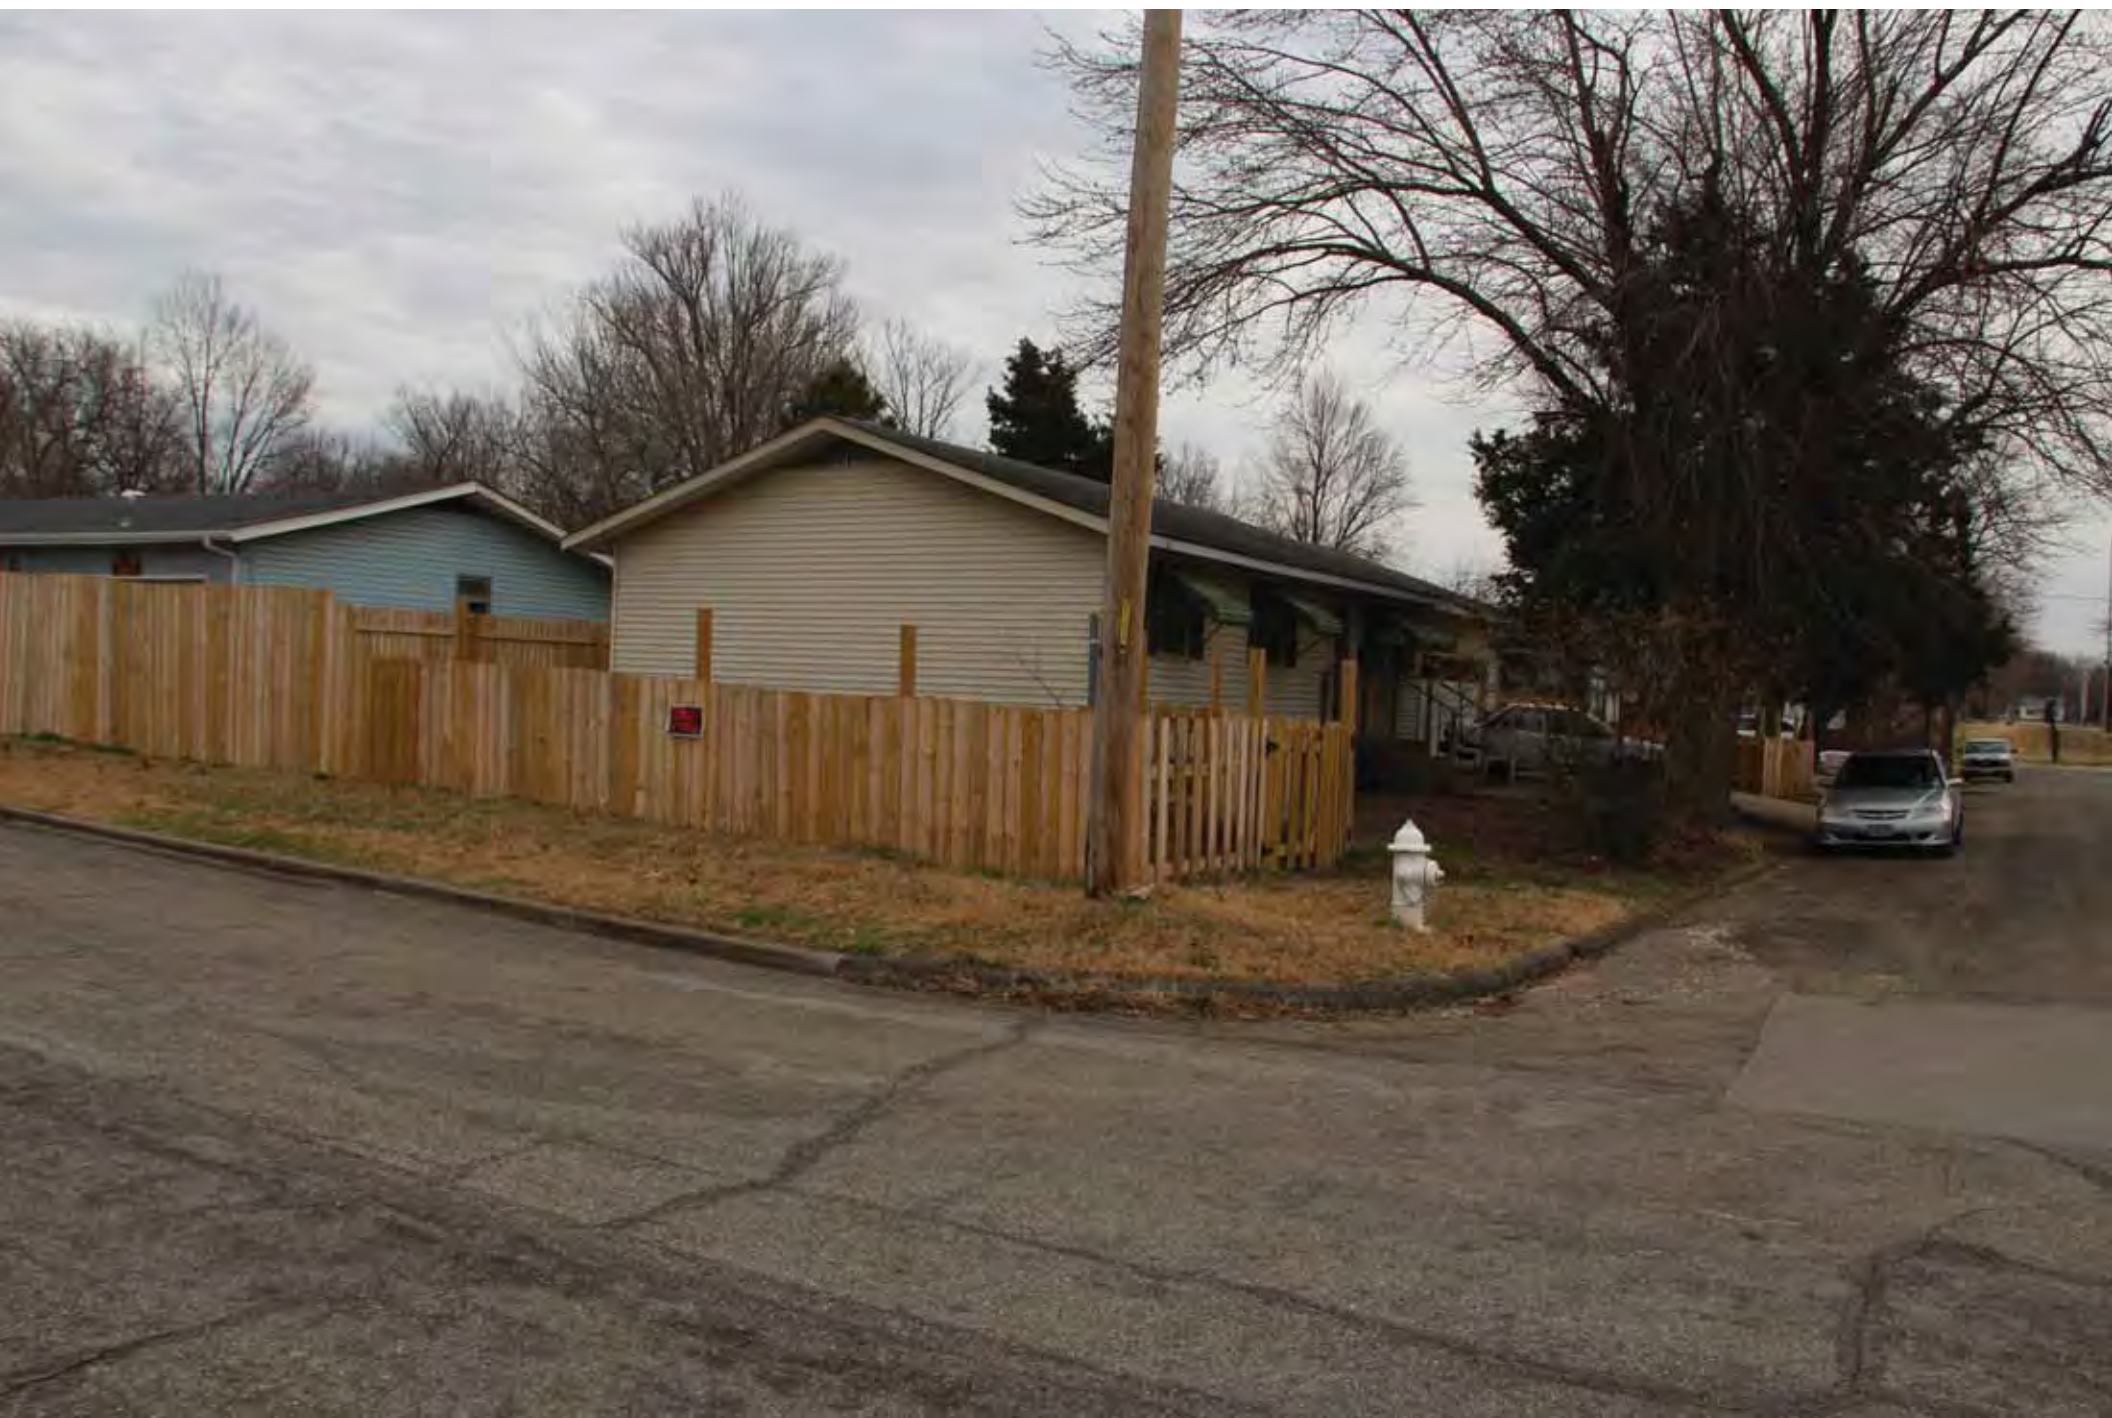
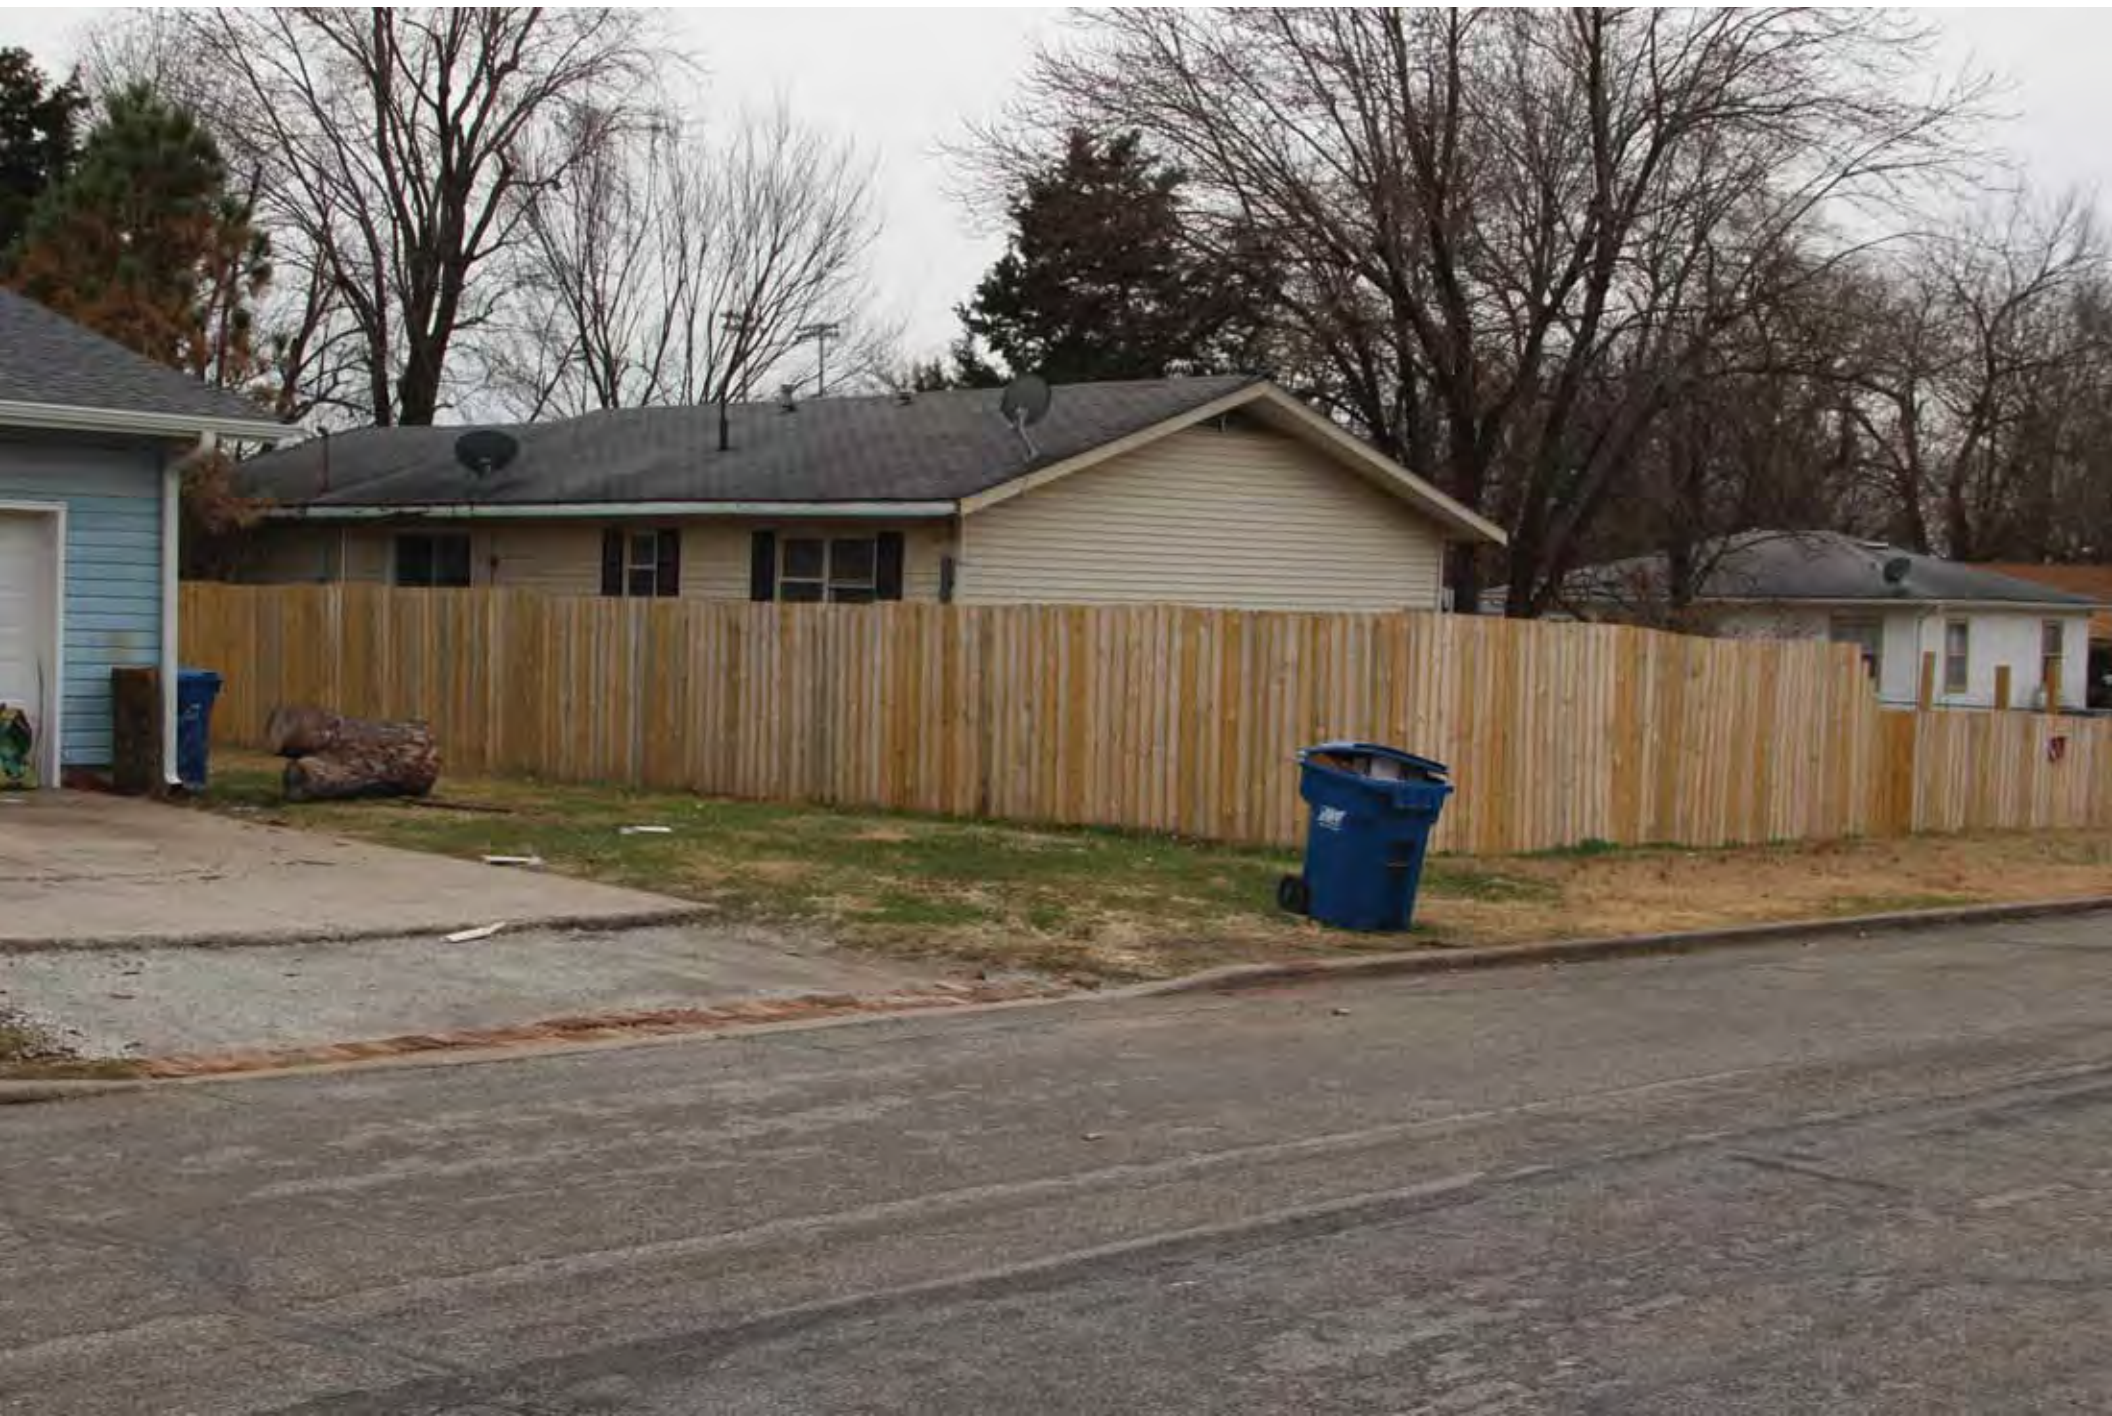
The property at 205 S. Comingo Avenue features an altered Ranch style dwelling with an asphalt shingled end gable plan roof, exterior vinyl siding and a concrete foundation. The primary (west) elevation faces S. Comingo Avenue and features an off-center concrete stoop with frame handrails leading to the primary entry. The entry bay is flanked by one-over-one windows that appear to be replacement – all windows have faux shutters. Windows and the front entry bay are capped by metal awnings. At the south end of the dwelling is an attached garage with an overhead track door on the west elevation. The north elevation of the dwelling has no fenestration. The south elevation (garage wing) has one double-hung window. The rear (east) elevation has a sliding glass door near the south end of the elevation. The rear entry bay is offset by single and paired windows similar in configuration to those on the façade.
