MISSOURI DEPARTMENT OF NATURAL RESOURCES
STATE HISTORIC PRESERVATION OFFICE, P.O. Box 176, Jefferson City, MO 65102
ARCHITECTURAL/HISTORIC INVENTORY FORM

1. Survey No. JP-AS-007-001		2. Survey name: East Town (Original Joplin) Historic Survey Phase 2	
3. County: JASPER		4. Address (Street No.) 618	Street (name) E. 2 nd Street
5. City: Joplin	Vicinity: <input type="checkbox"/>	6. Geographical Reference:	7. Township/Range/Section: T: R: S:
8. Historic name (if known):		9. Present/other name (if known):	
10. Ownership: <input checked="" type="checkbox"/> Private <input type="checkbox"/> Public		11a. Historic use (if known): Domestic: Single Dwelling	11b. Current use: Domestic: Single Dwelling

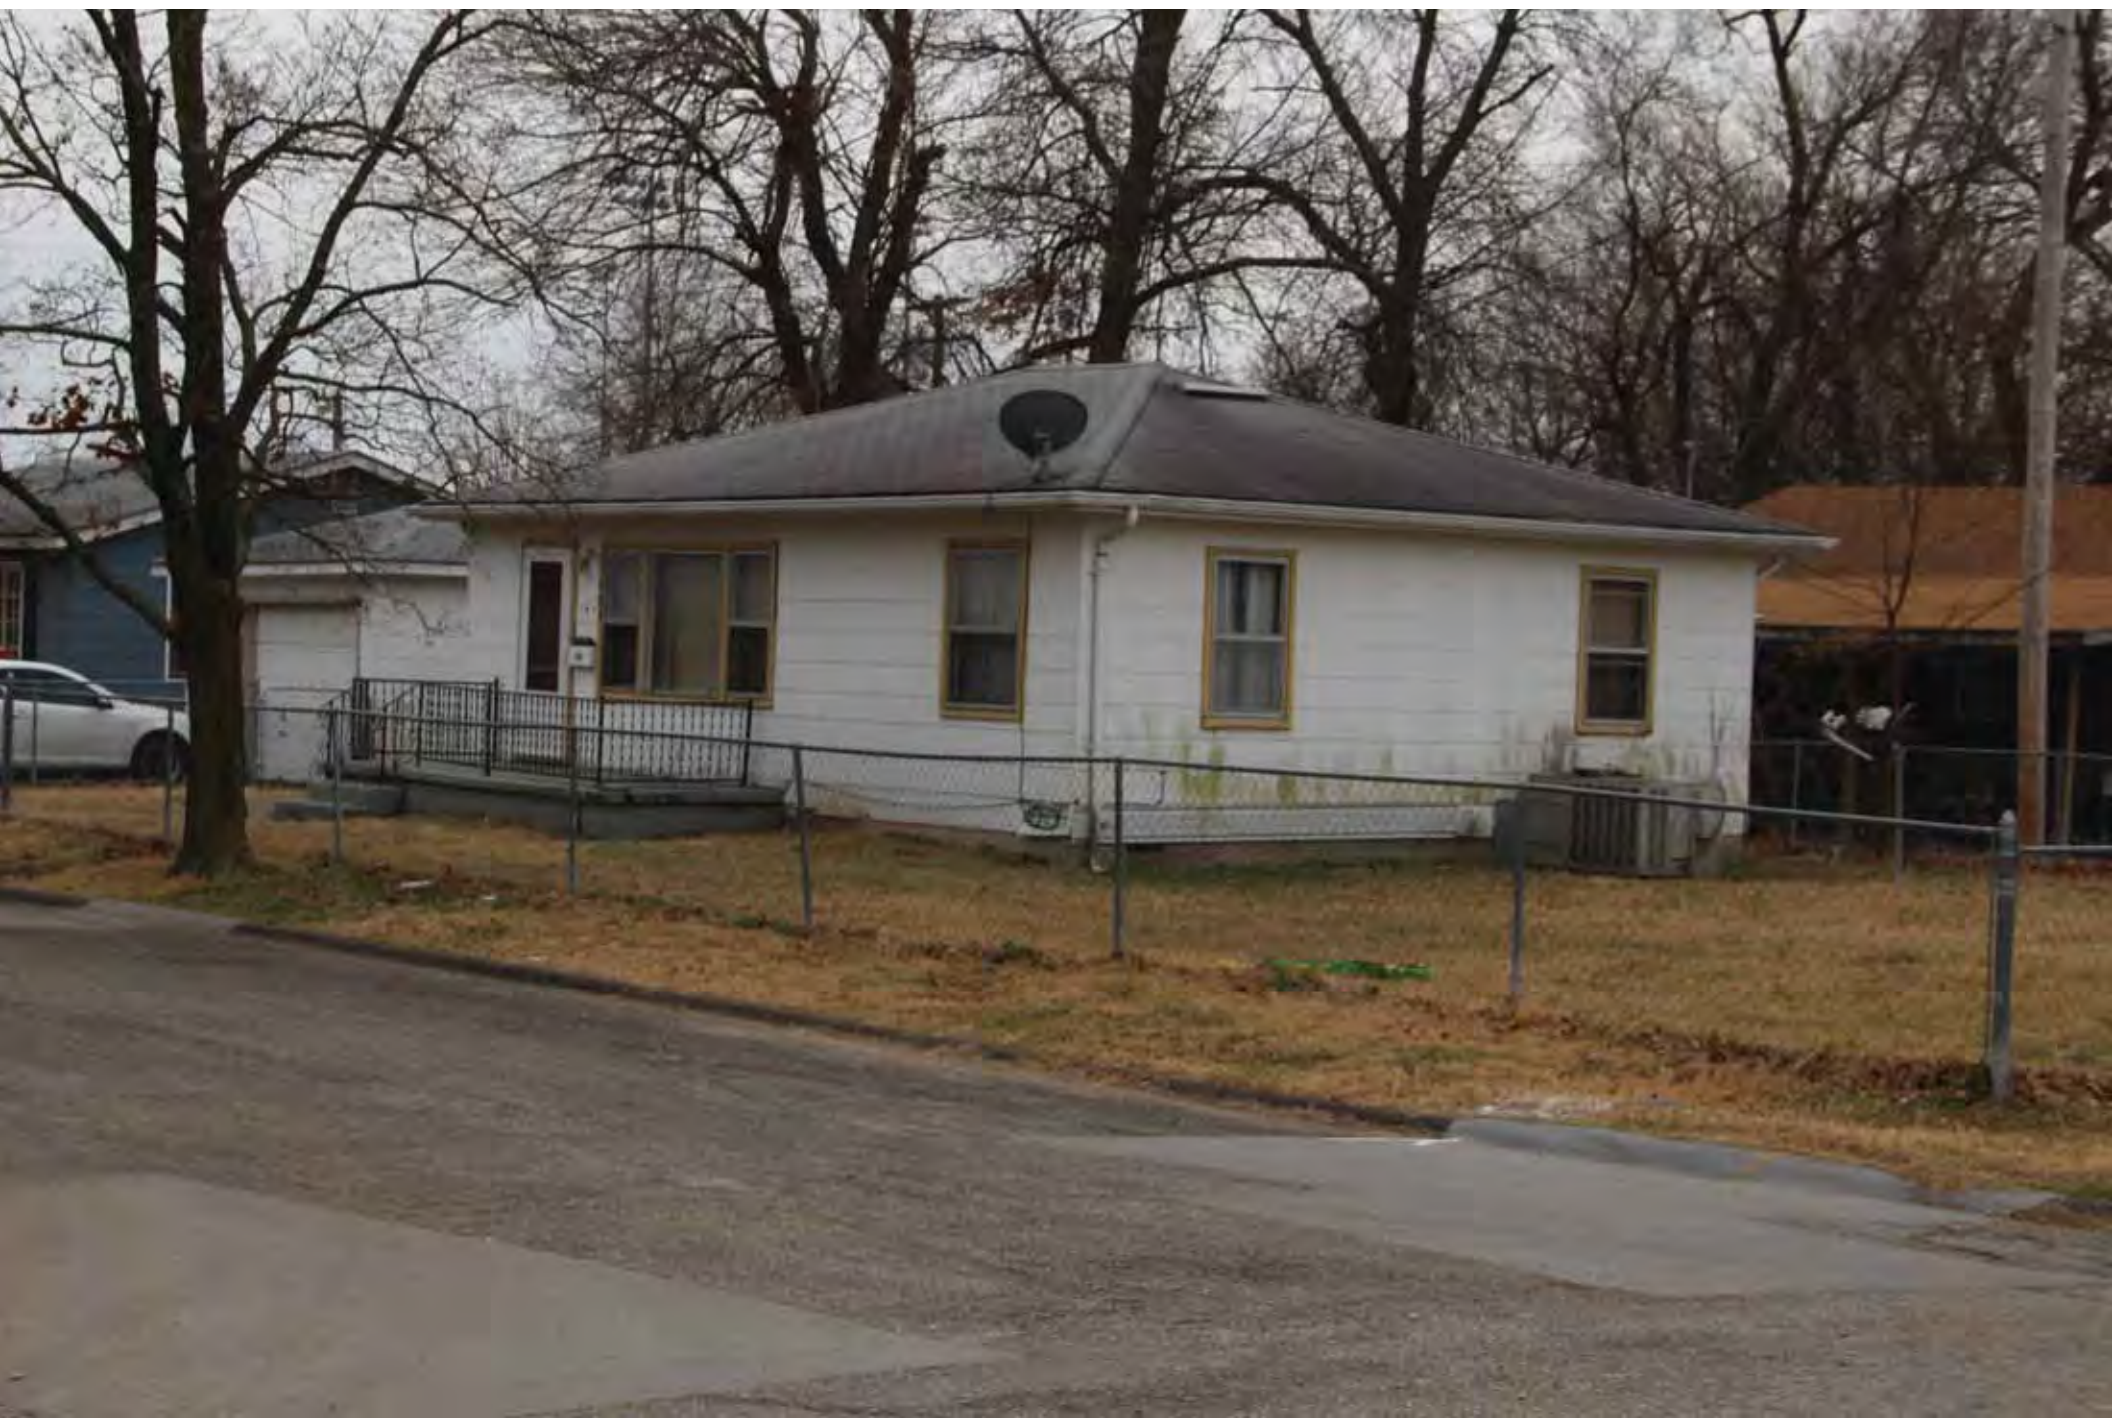
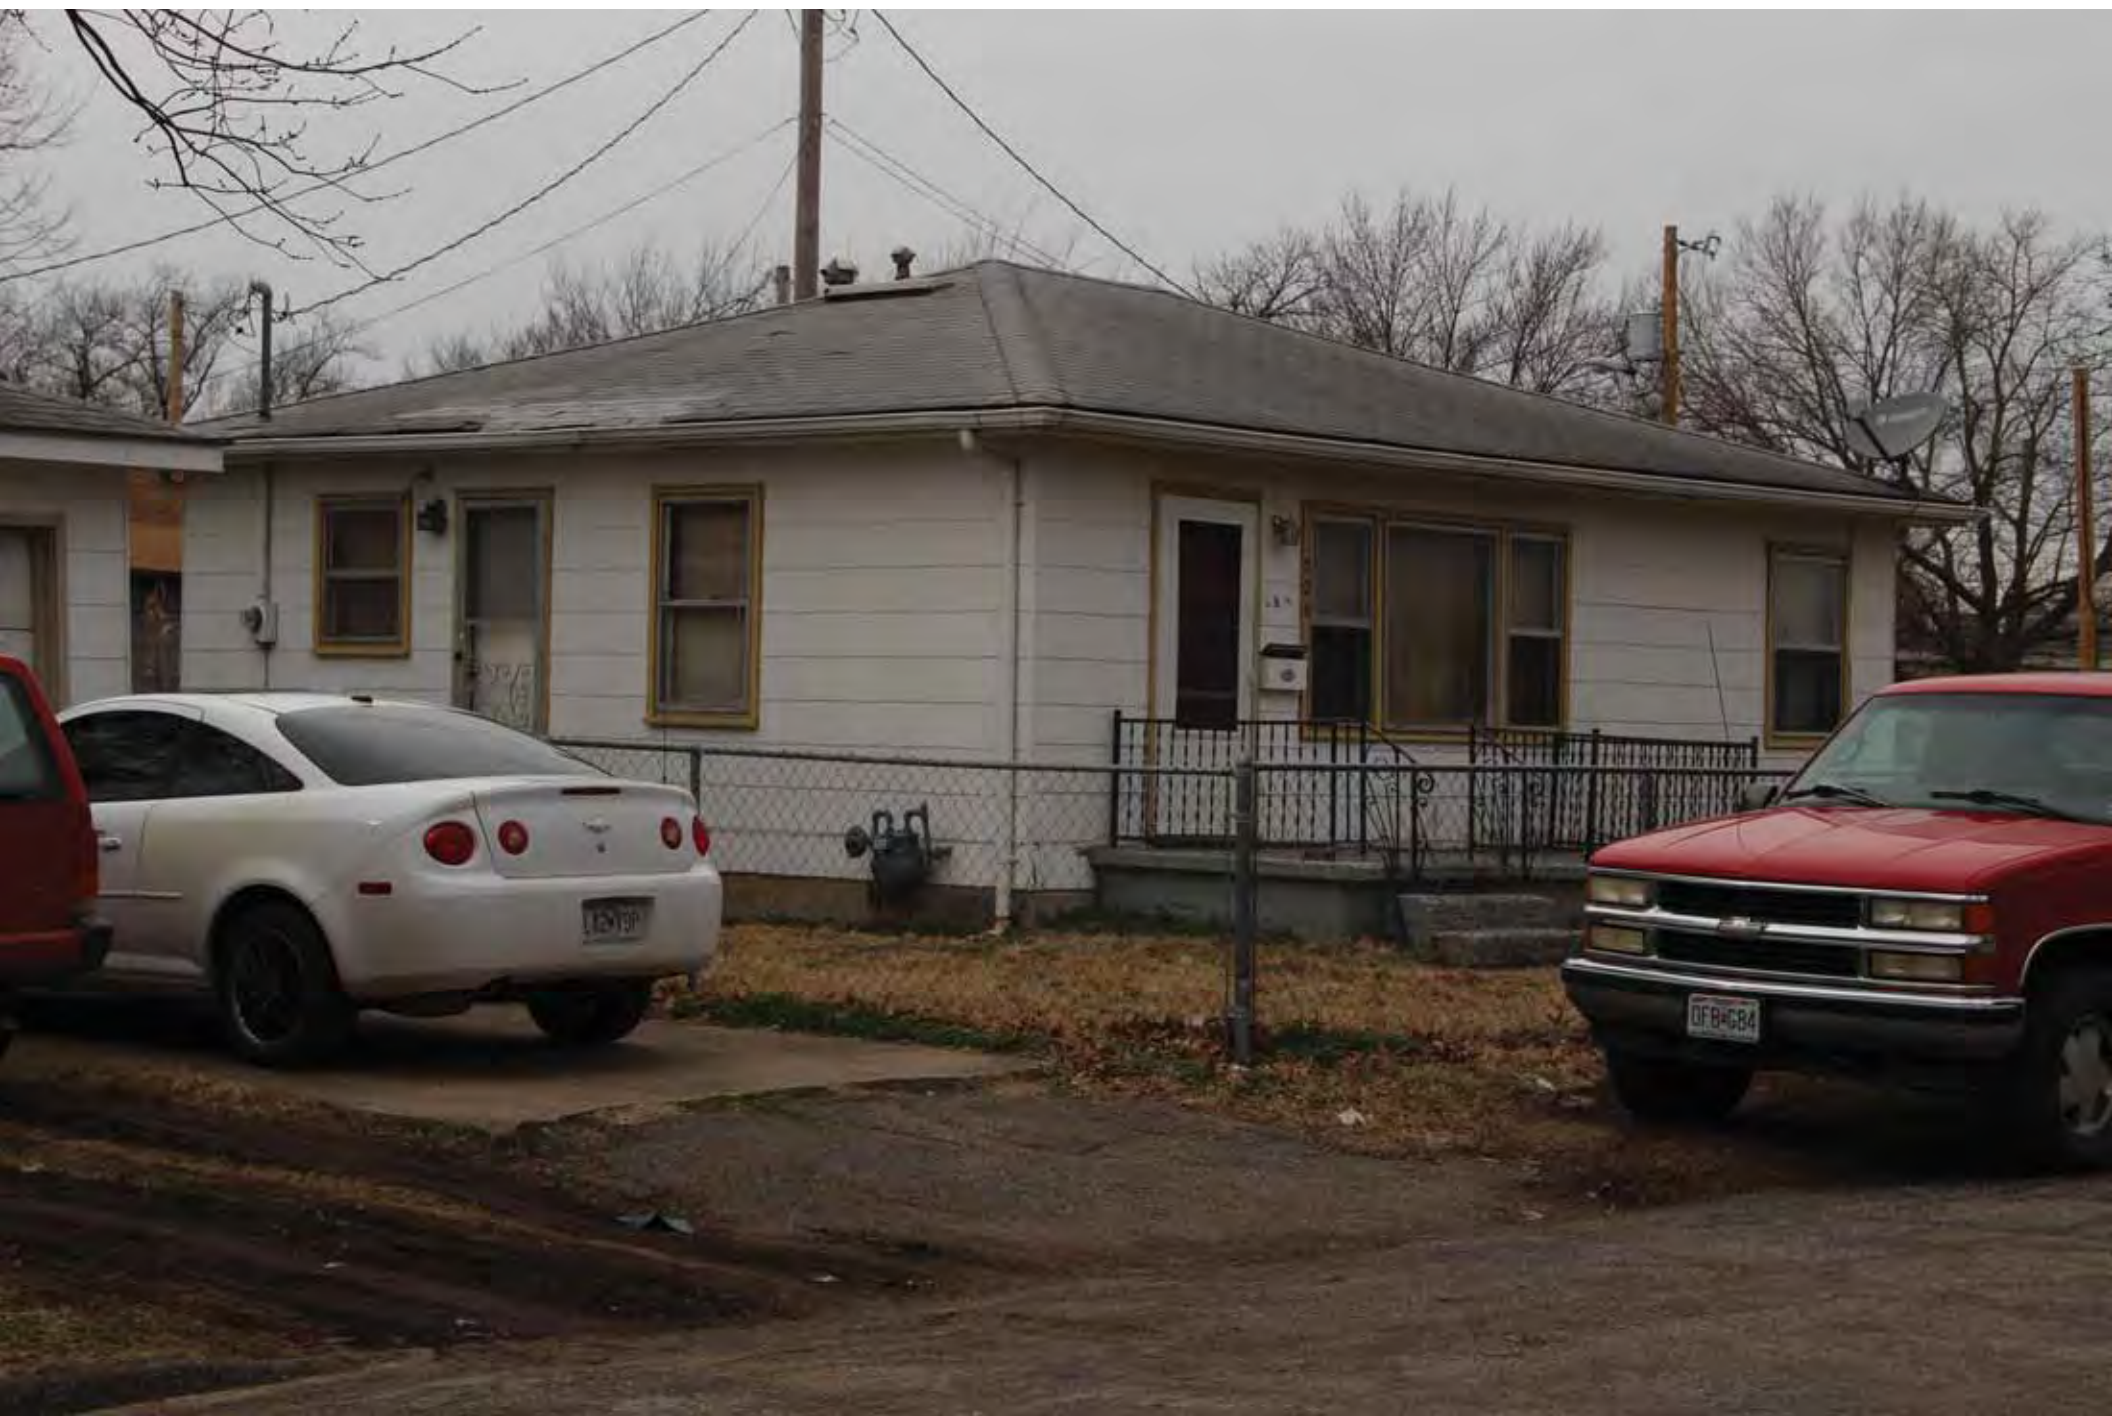
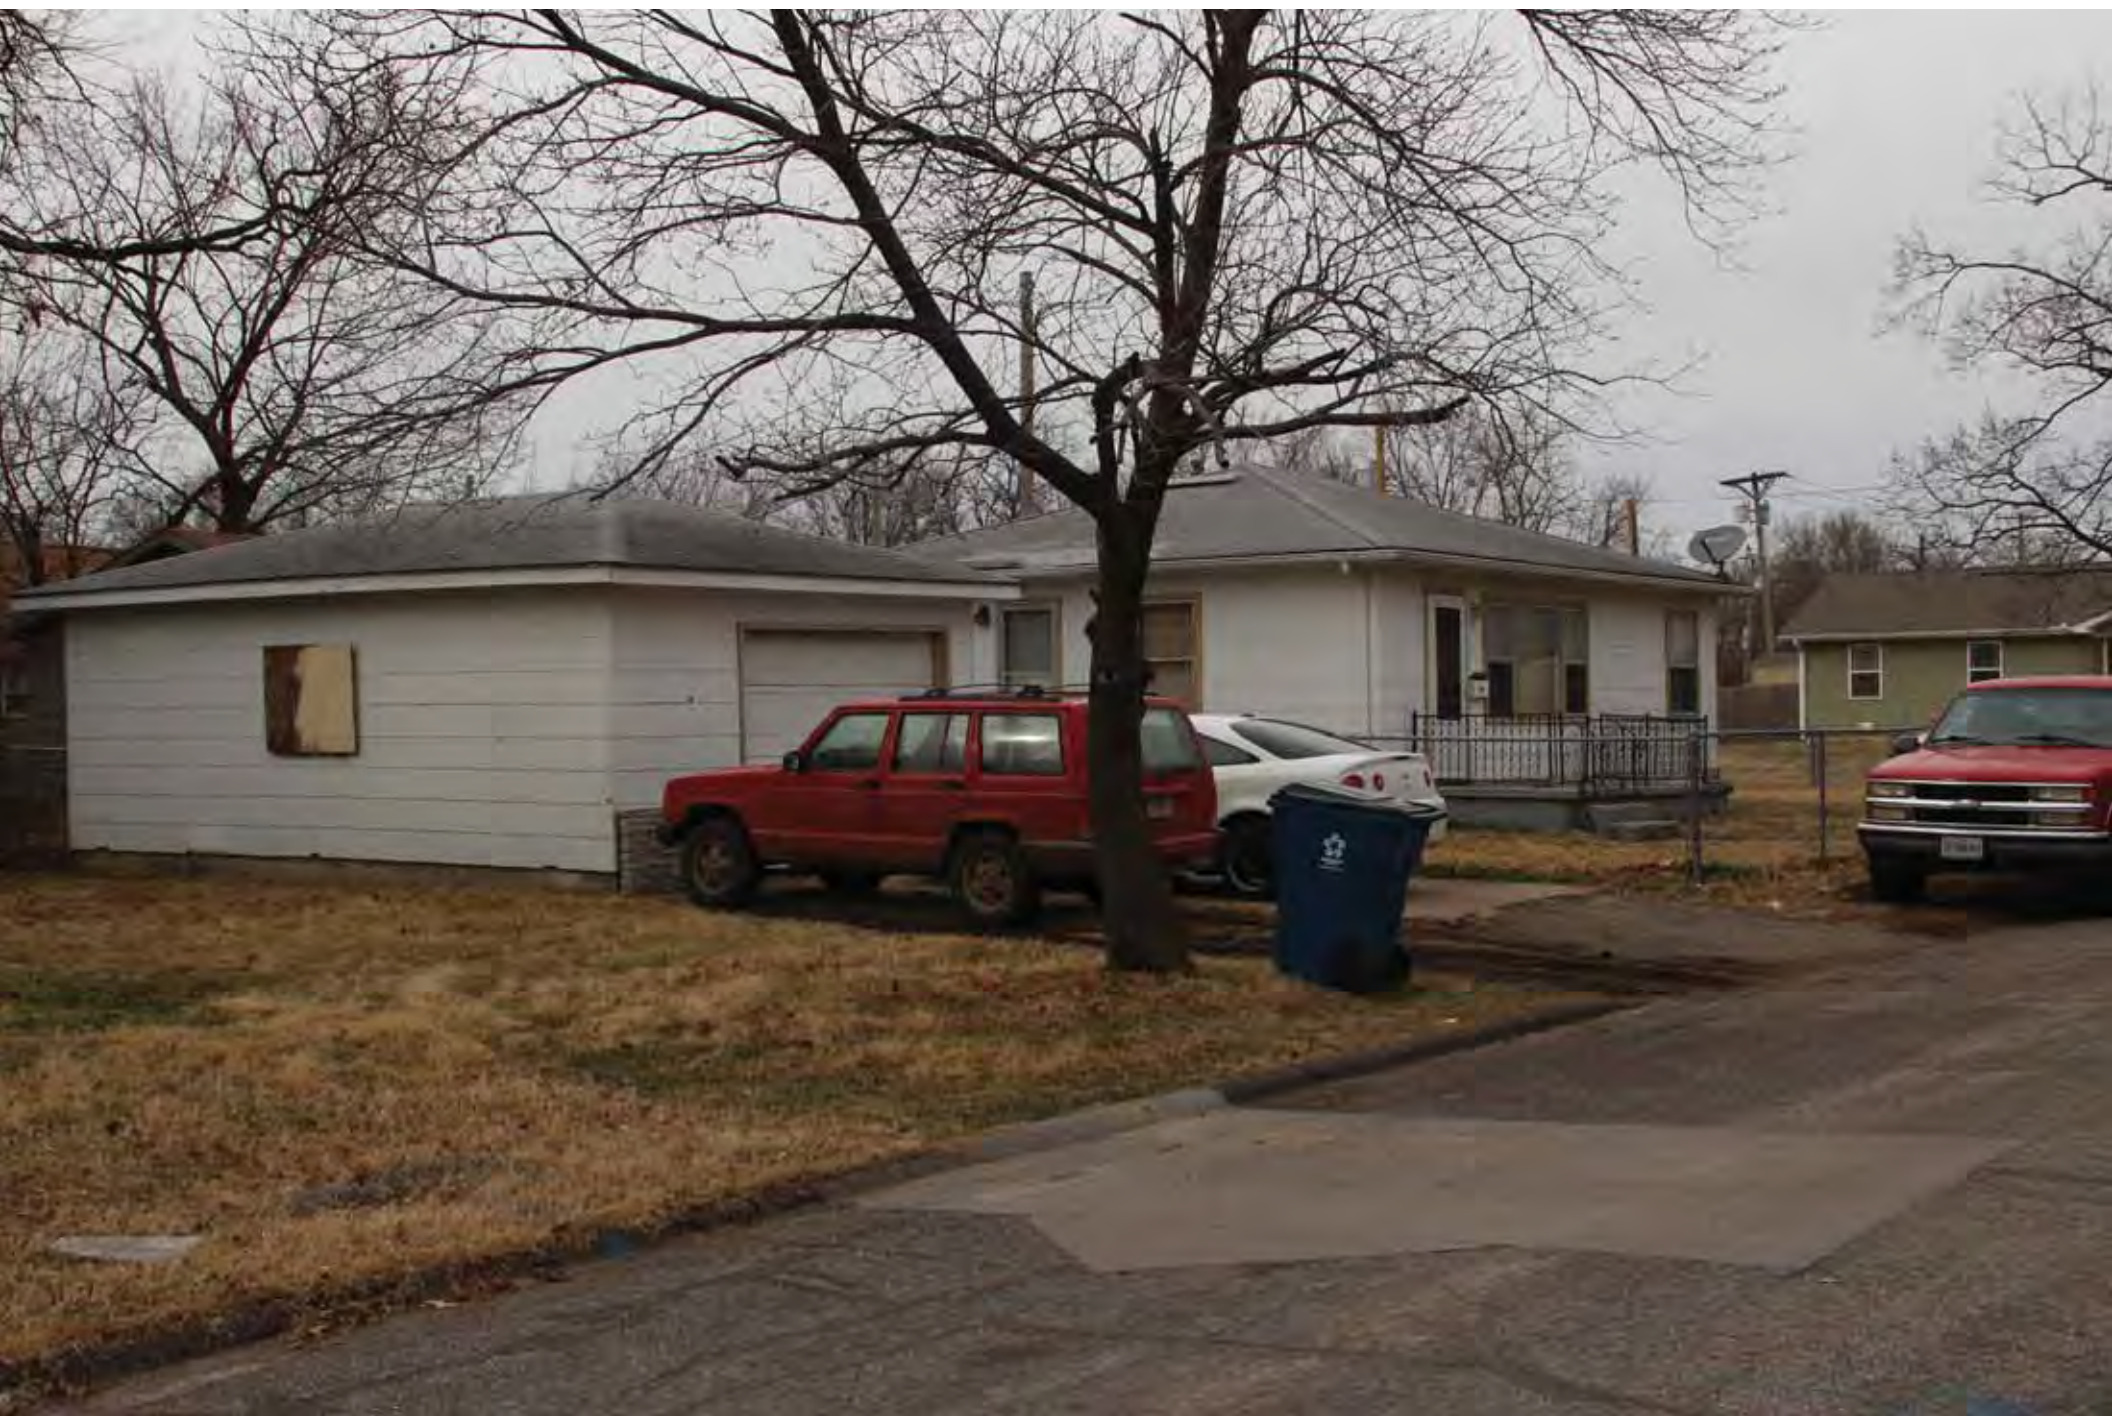
The property at 206 S. Comingo Avenue supports a mid-twentieth century dwelling that exhibits features of both the Ranch and Minimal Traditional styles. The massing and simplistic design of the dwelling, void of embellishments is reflective of Minimal Traditional whereas the primary elevation's picture style window is influenced by the Ranch style, popular by the 1950s. The dwelling has a hipped asphalt shingled roof, exterior original asbestos shingle siding and a concrete foundation. The primary (west) elevation features an off-center concrete stoop with a wrought iron balustrade. The primary entry is situated at the south end of the elevation, offset by a picture style window. The north elevation holds two double-hung windows. The south elevation faces the drive and garage. This elevation has a secondary entry with a solid door flanked by individual one-over-one windows.

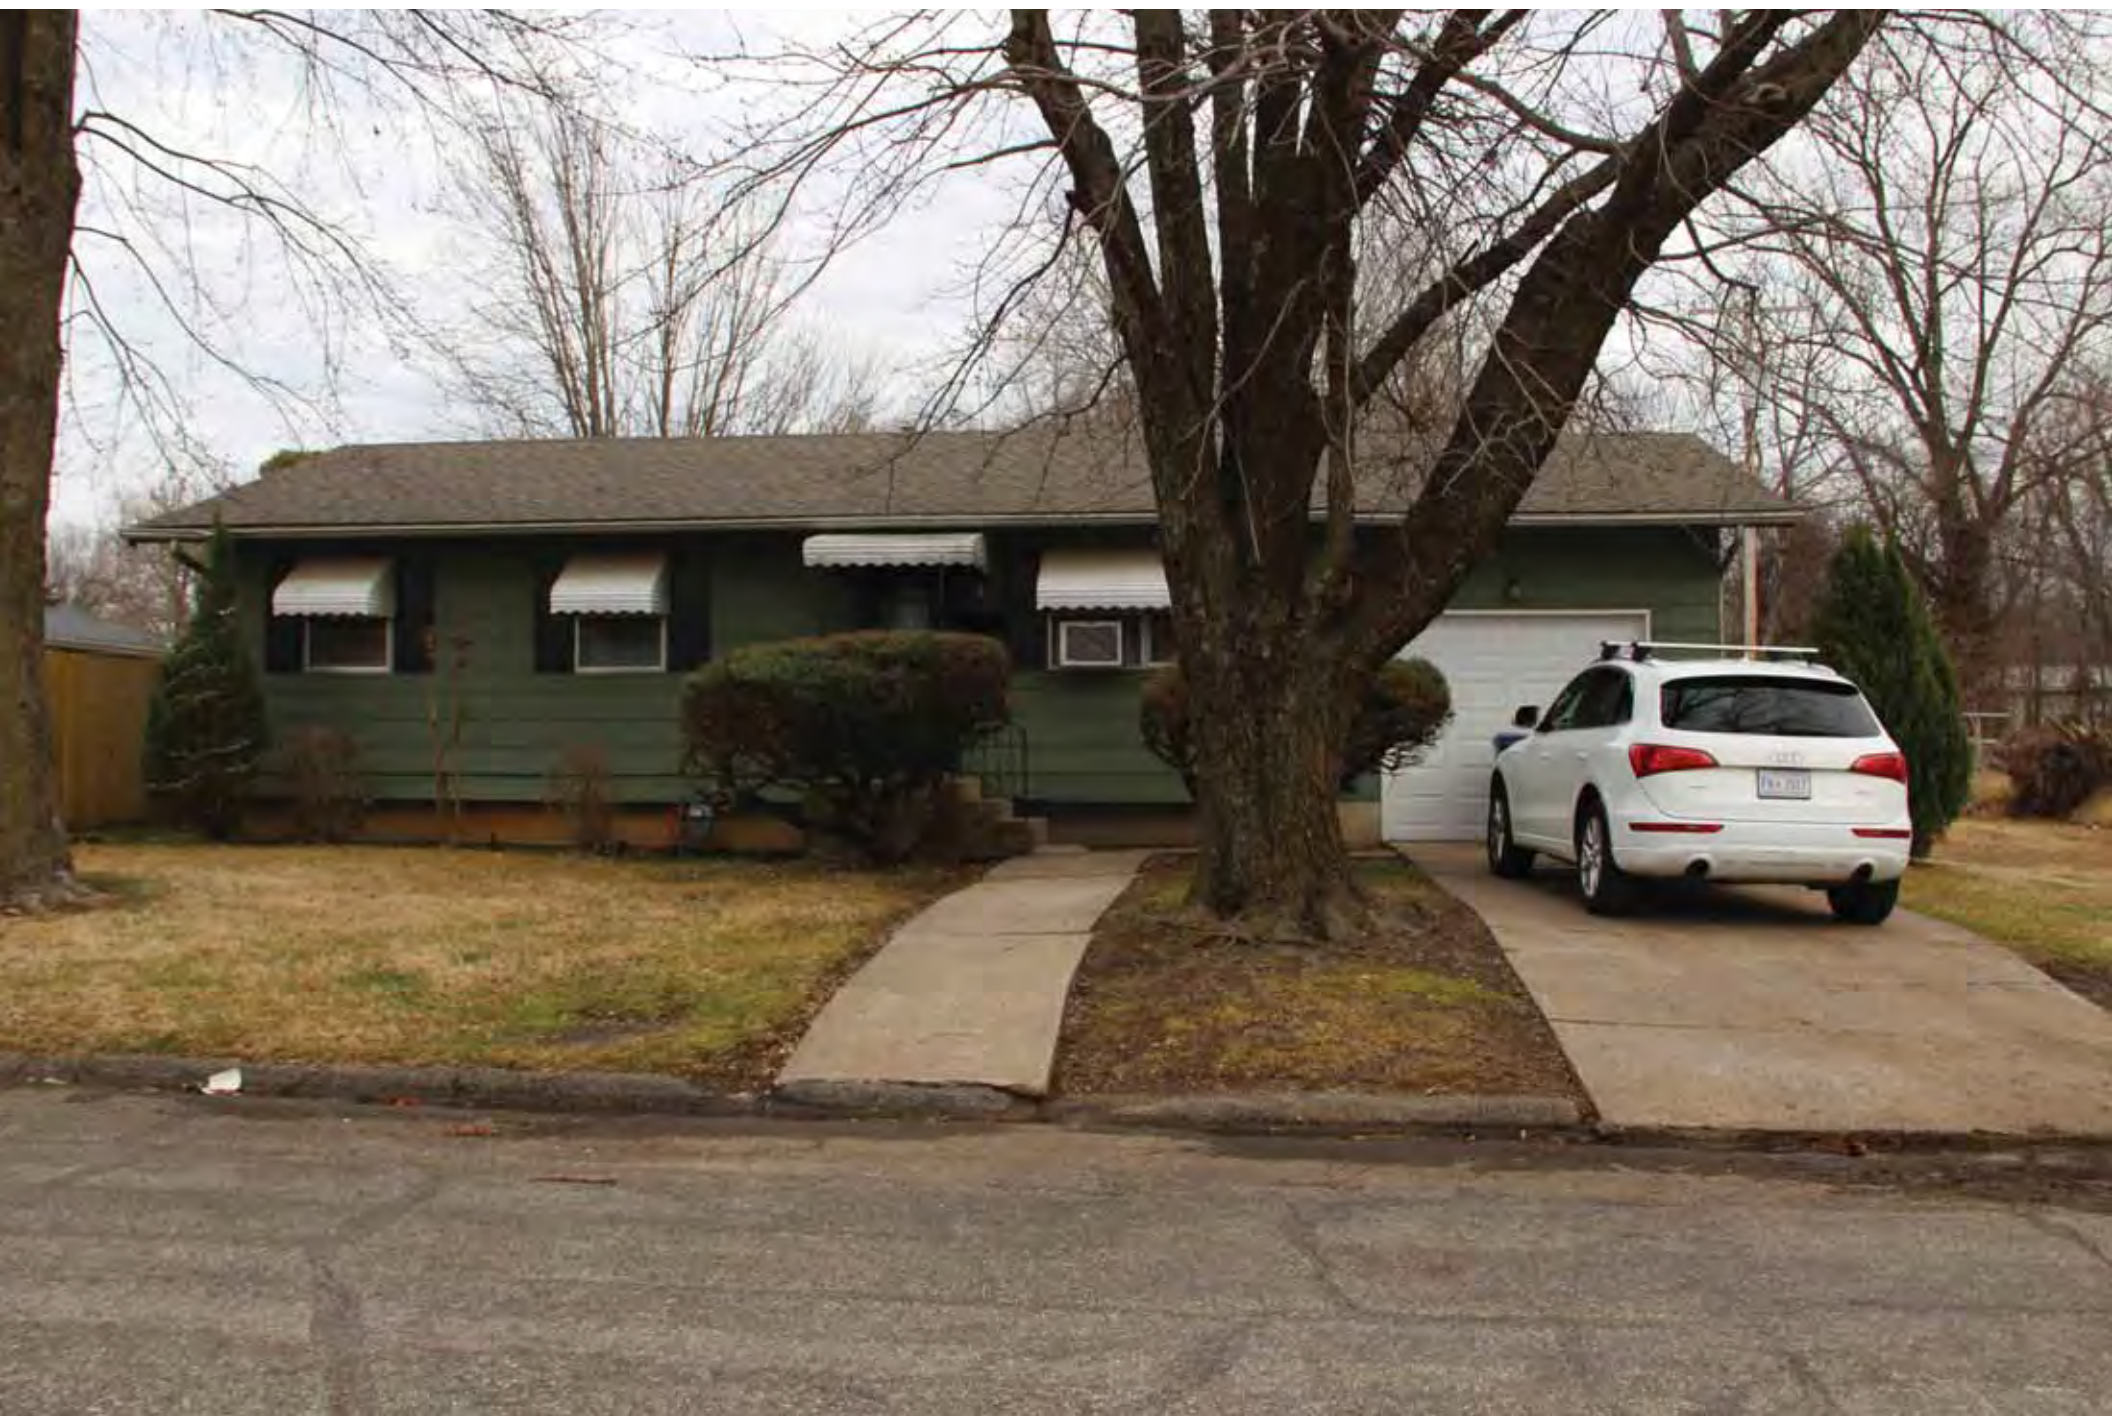
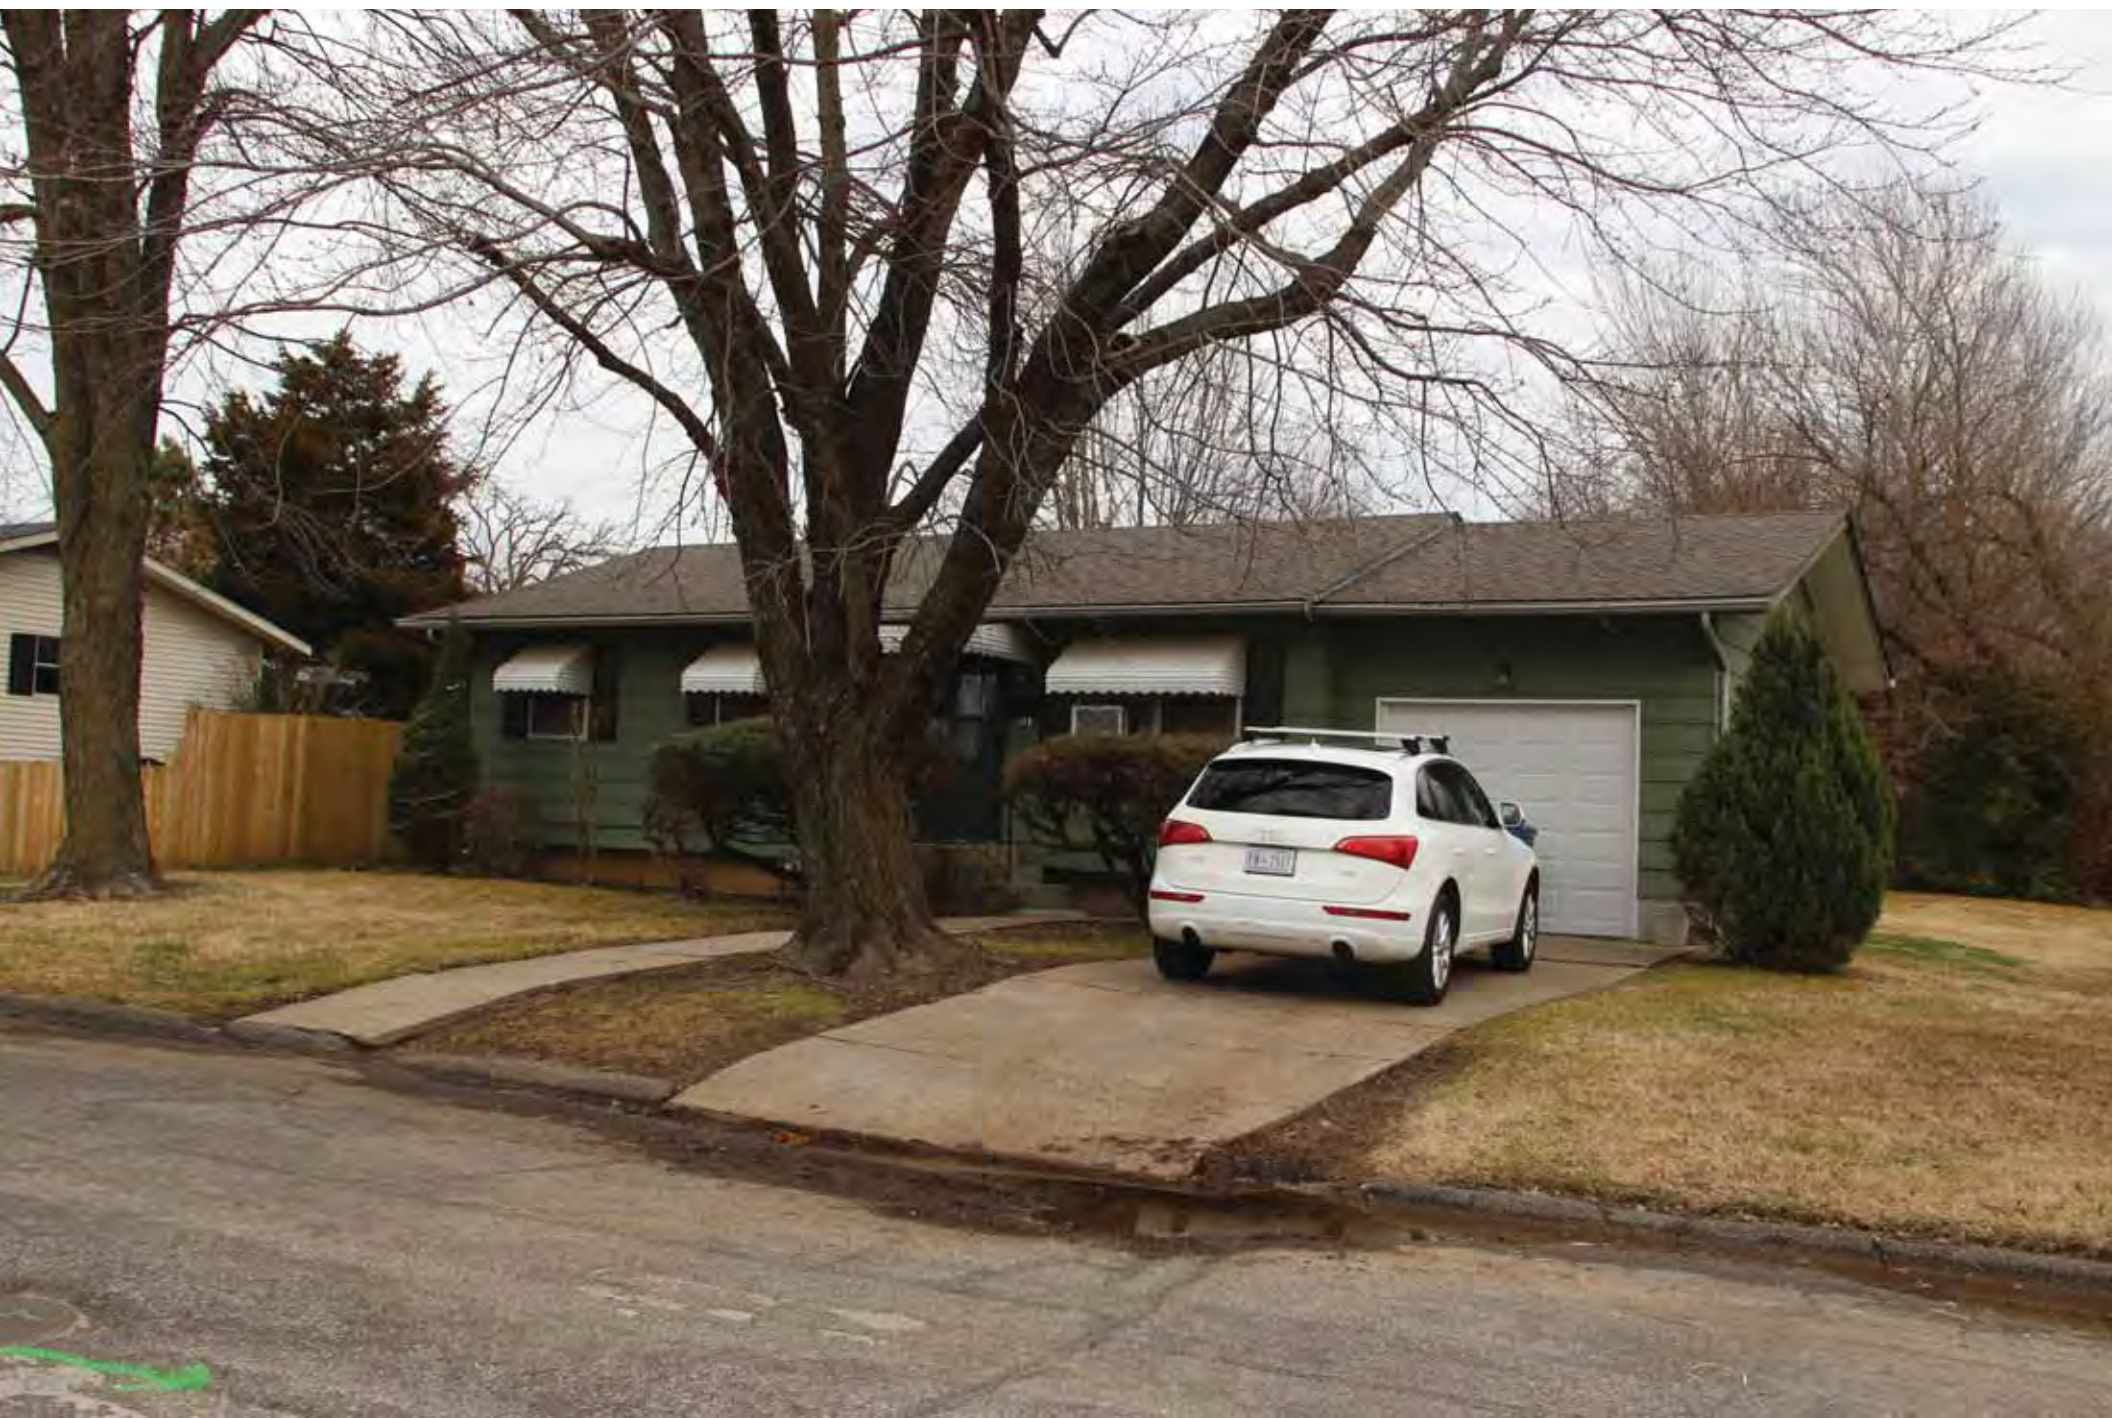
The property at 211 S. Comingo Avenue supports a Ranch style dwelling with an asphalt shingled gabled roof, exterior wide board siding and a concrete foundation. The primary (west) elevation supports an off-center concrete stoop with a wrought iron hand rail. The stoop leads to an entry bay filled with a replacement oval light door. Flanking the door are paired and single one-over-one windows. The entry bay and windows support metal awnings. At the south end of the façade is an overhead track door, providing access to an attached garage. The south elevation (garage wing) holds a single one-over-one window. There is no fenestration on the north elevation of the dwelling.

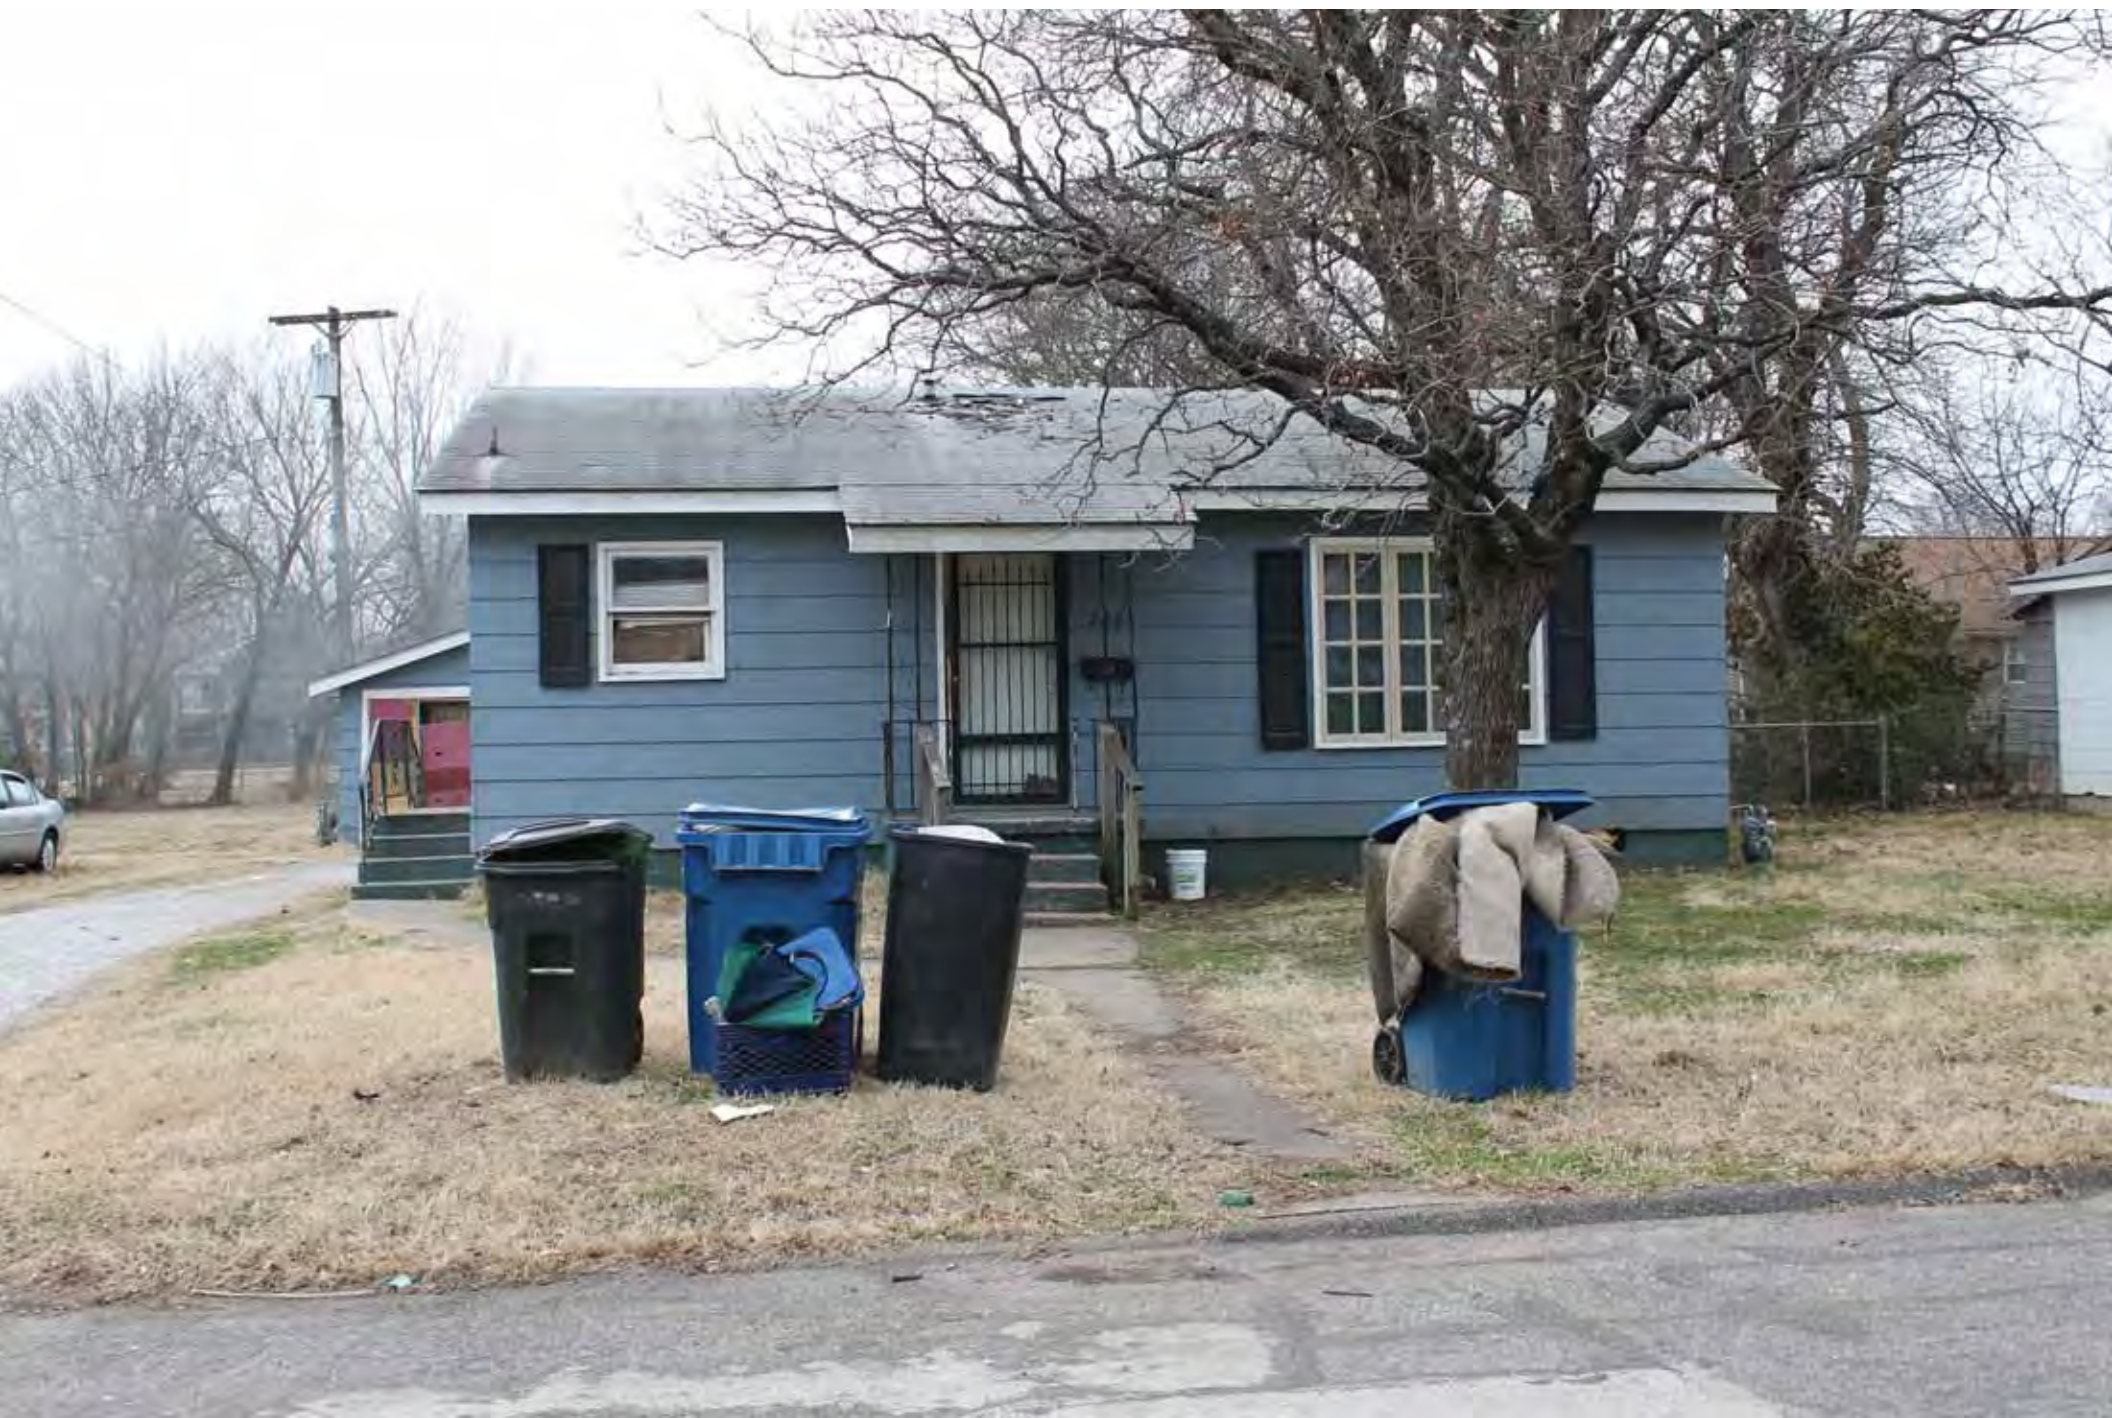
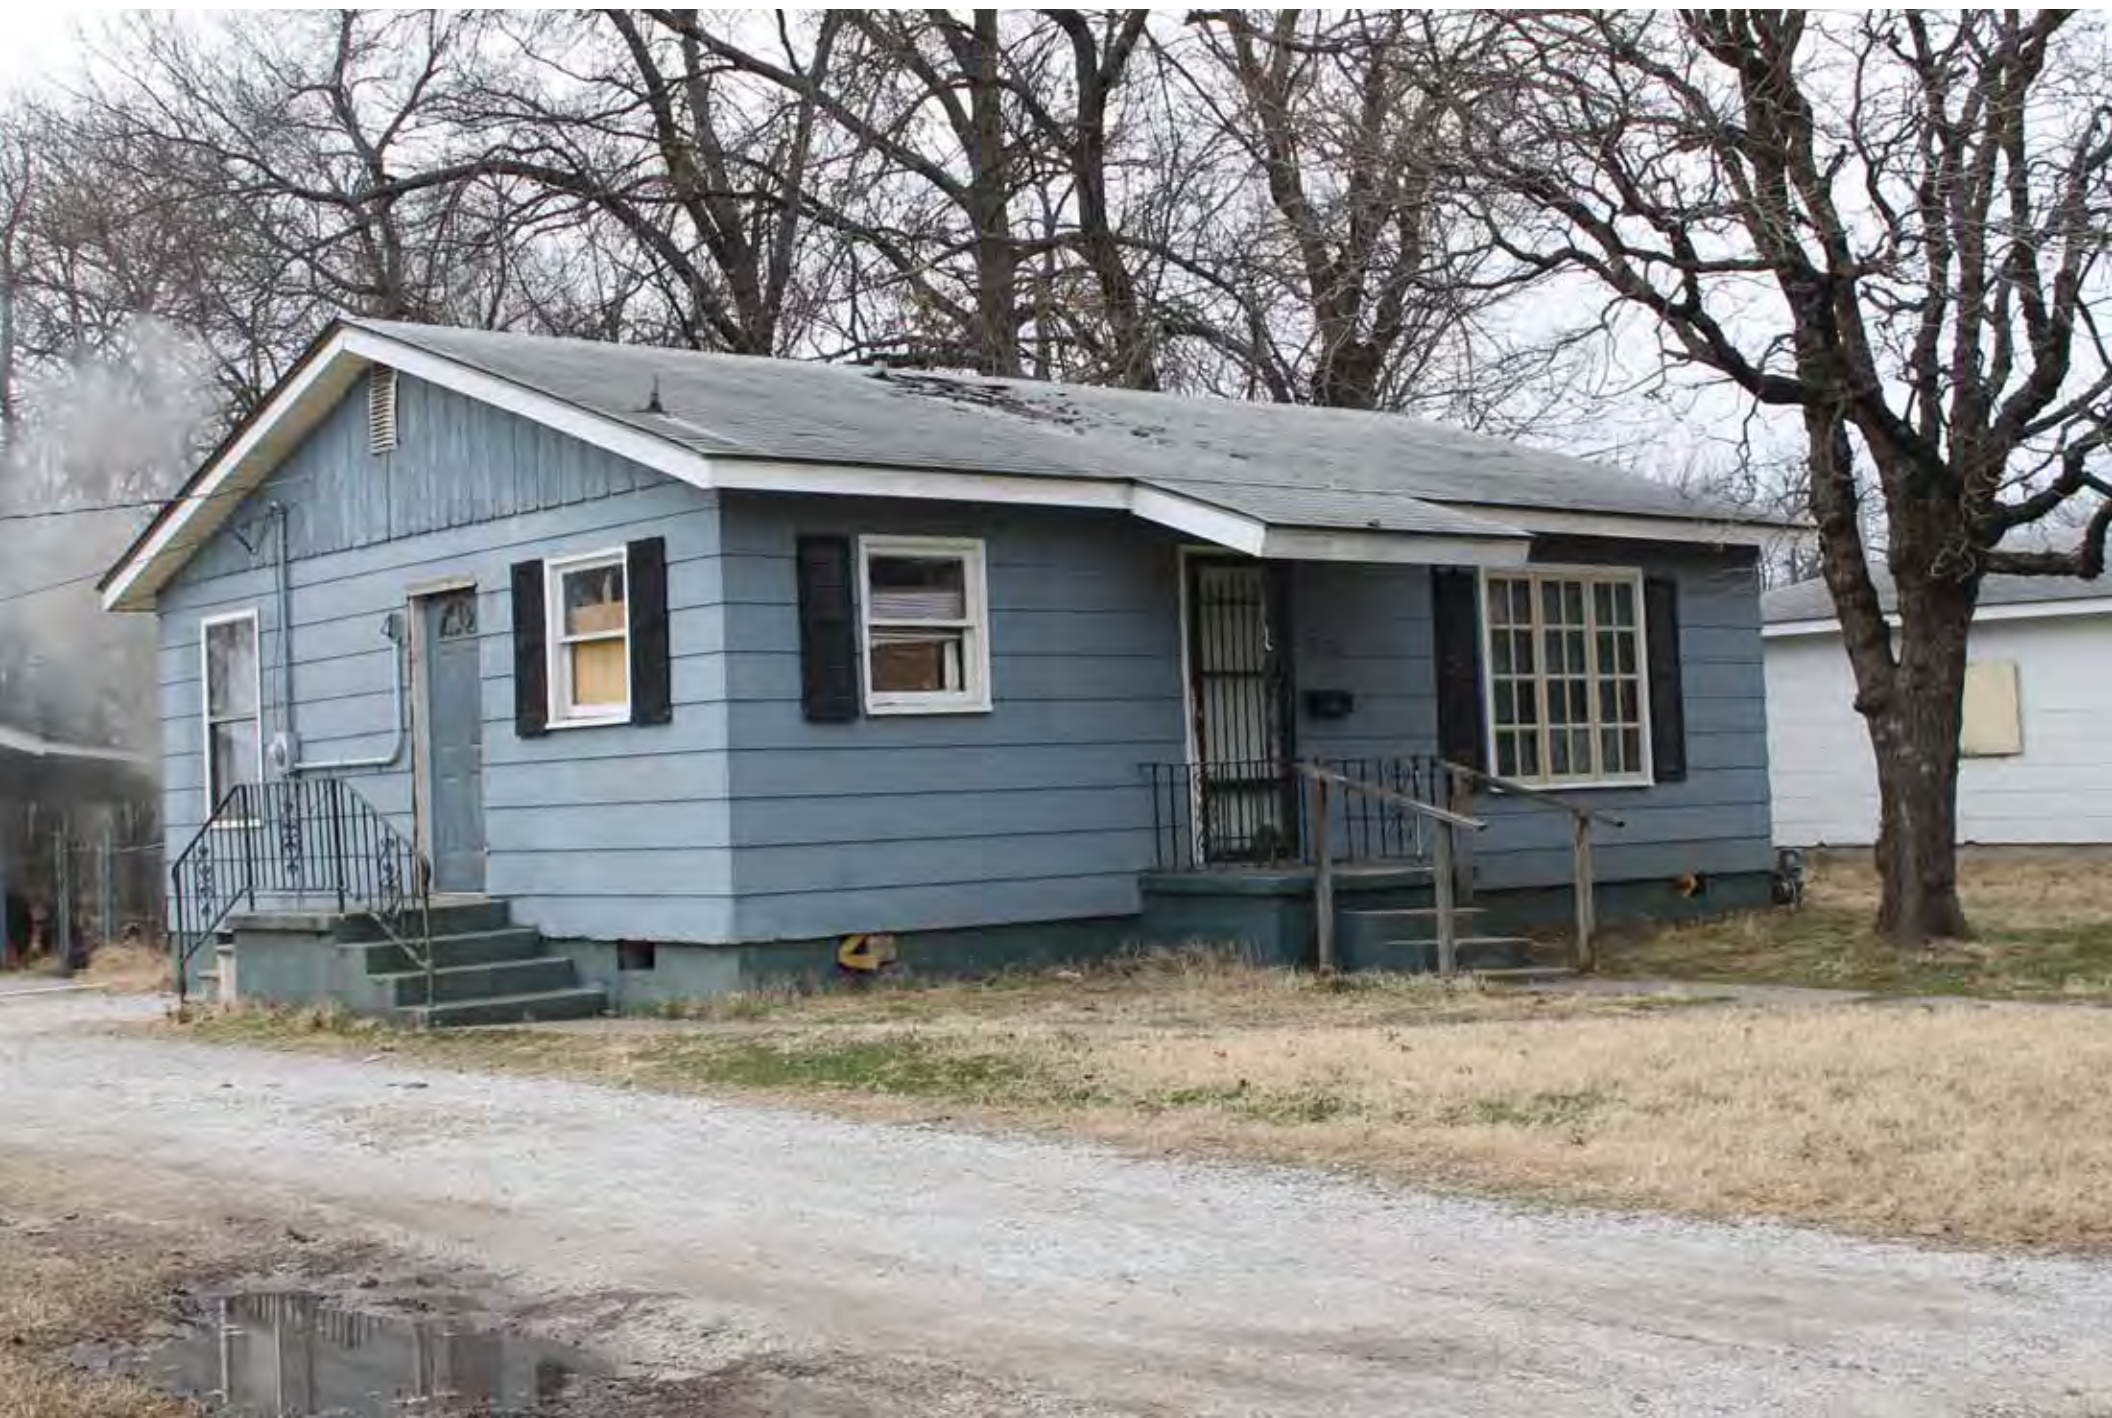
The property at 220 S. Comingo Avenue supports a single-story dwelling with an asphalt shingled gabled roof, exterior wide board siding and a concrete foundation. The primary (east) elevation has a concrete stoop with wood handrails. The stoop leads to a slightly off center entry bay filled with a solid wood replacement (c. 2015) door. Flanking the door are a one-over-one original window (south) and multi-light replacement (c. 2015) window (north). Windows have faux shutters. The roofline projects above the entry bay to form a shed awning supported by wrought iron columns. The south elevation holds a secondary entry offset by a single double-hung window. A concrete stoop leads to the south elevation door.
