MISSOURI DEPARTMENT OF NATURAL RESOURCES
STATE HISTORIC PRESERVATION OFFICE, P.O. Box 176, Jefferson City, MO 65102
ARCHITECTURAL/HISTORIC INVENTORY FORM

1. Survey No. JP-AS-007-001		2. Survey name: East Town (Original Joplin) Historic Survey Phase 2	
3. County: JASPER		4. Address (Street No.) 618	Street (name) E. 2 nd Street
5. City: Joplin	Vicinity: <input type="checkbox"/>	6. Geographical Reference:	7. Township/Range/Section: T: R: S:
8. Historic name (if known):		9. Present/other name (if known):	
10. Ownership: <input checked="" type="checkbox"/> Private <input type="checkbox"/> Public		11a. Historic use (if known): Domestic: Single Dwelling	11b. Current use: Domestic: Single Dwelling

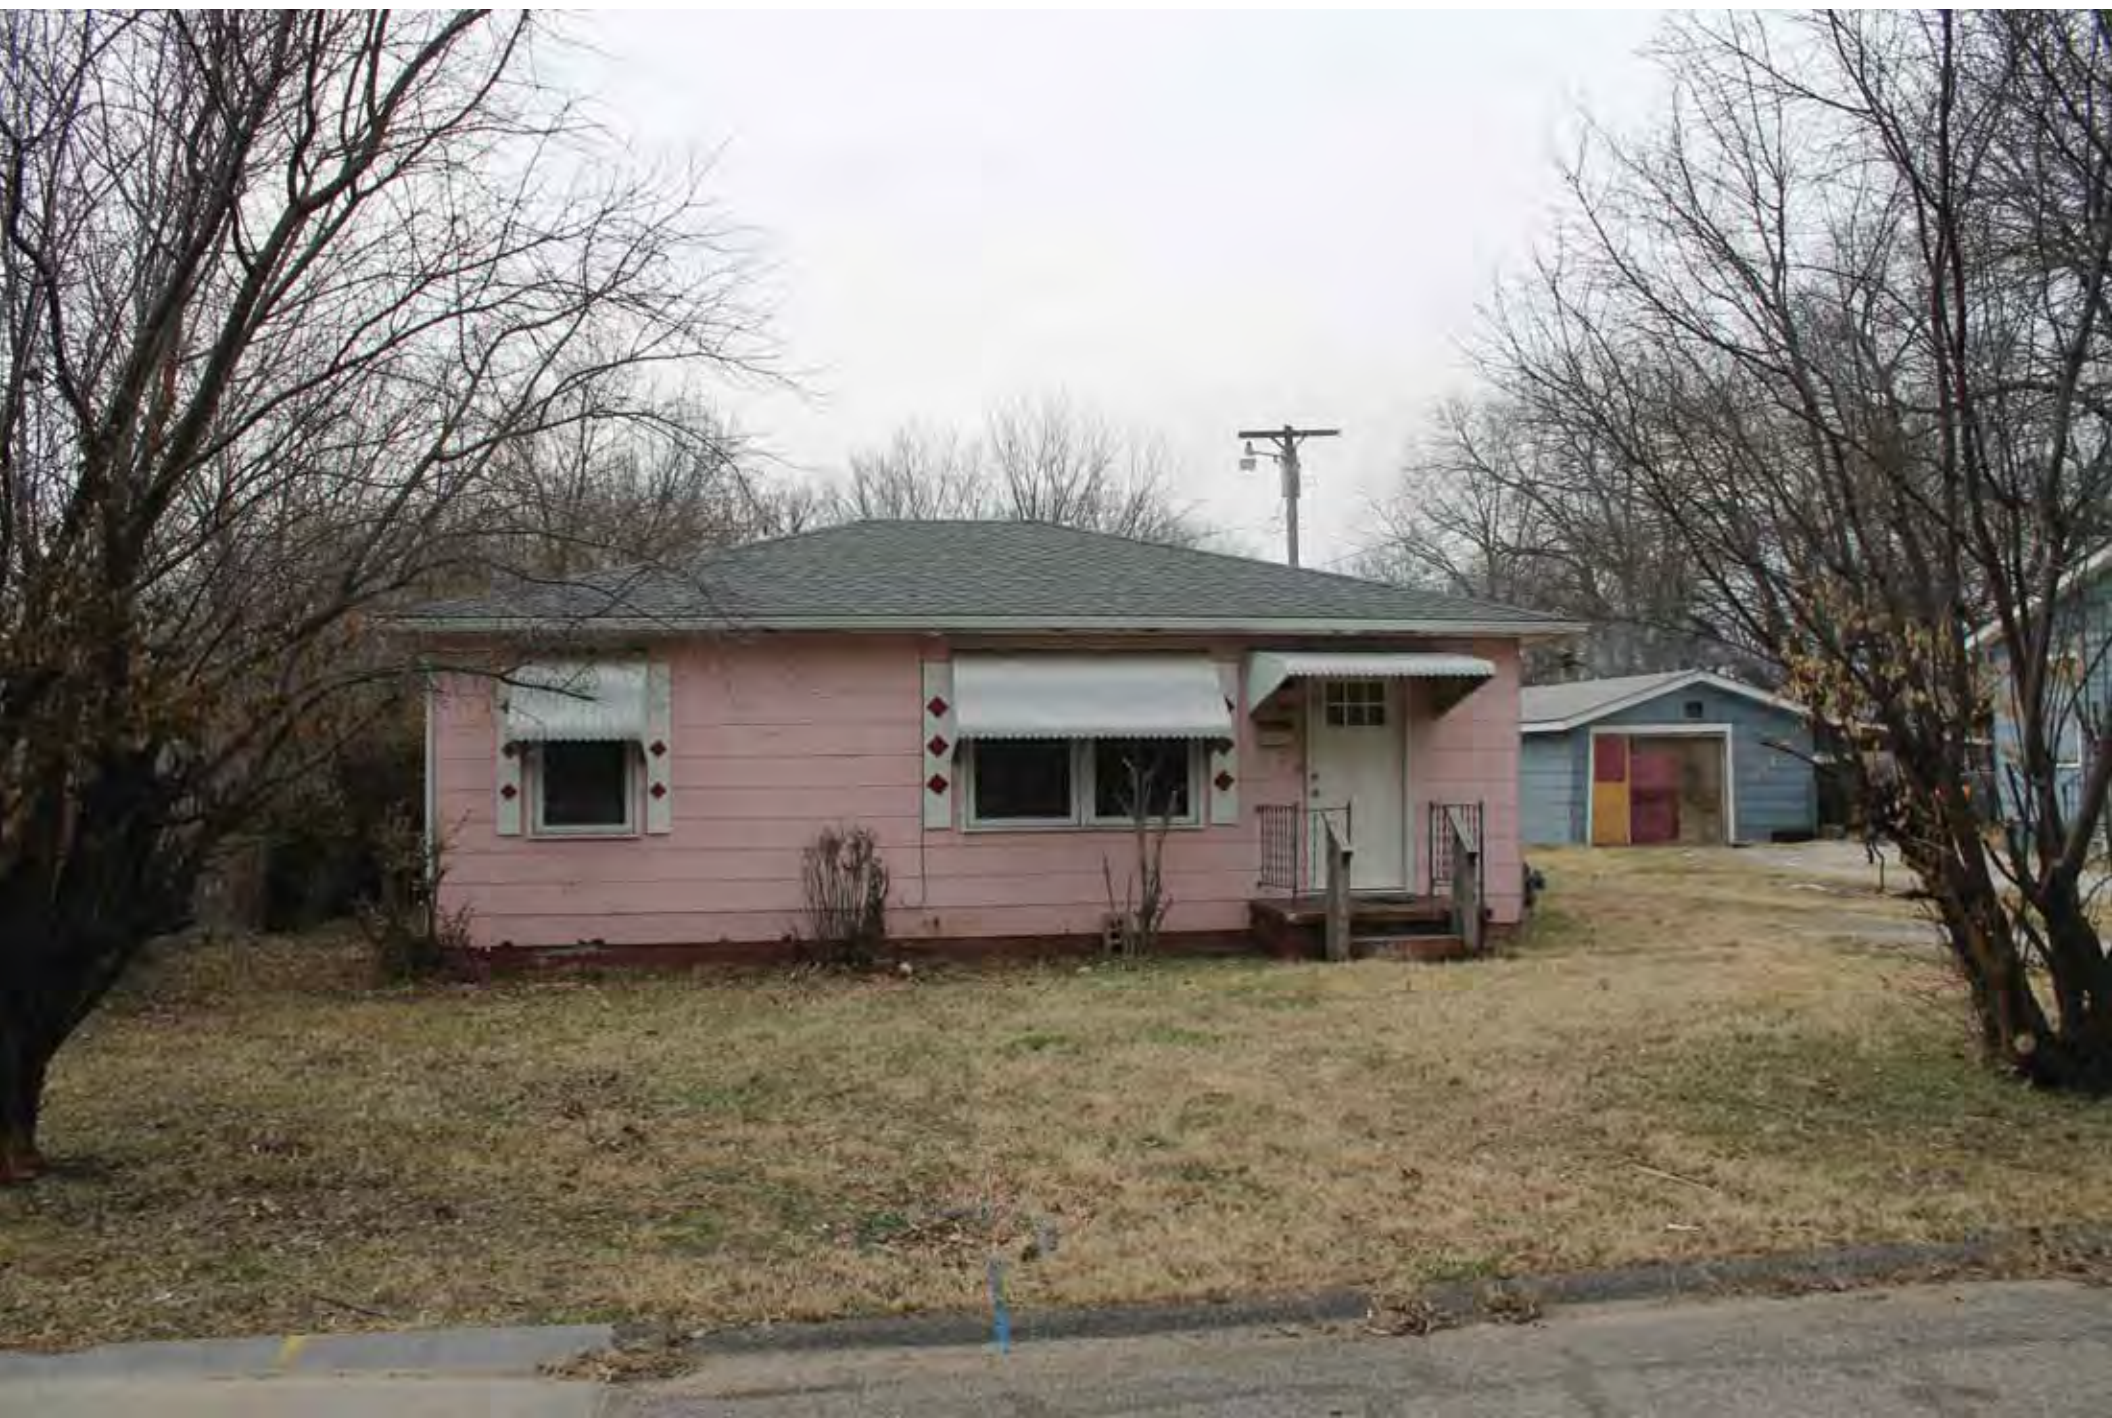
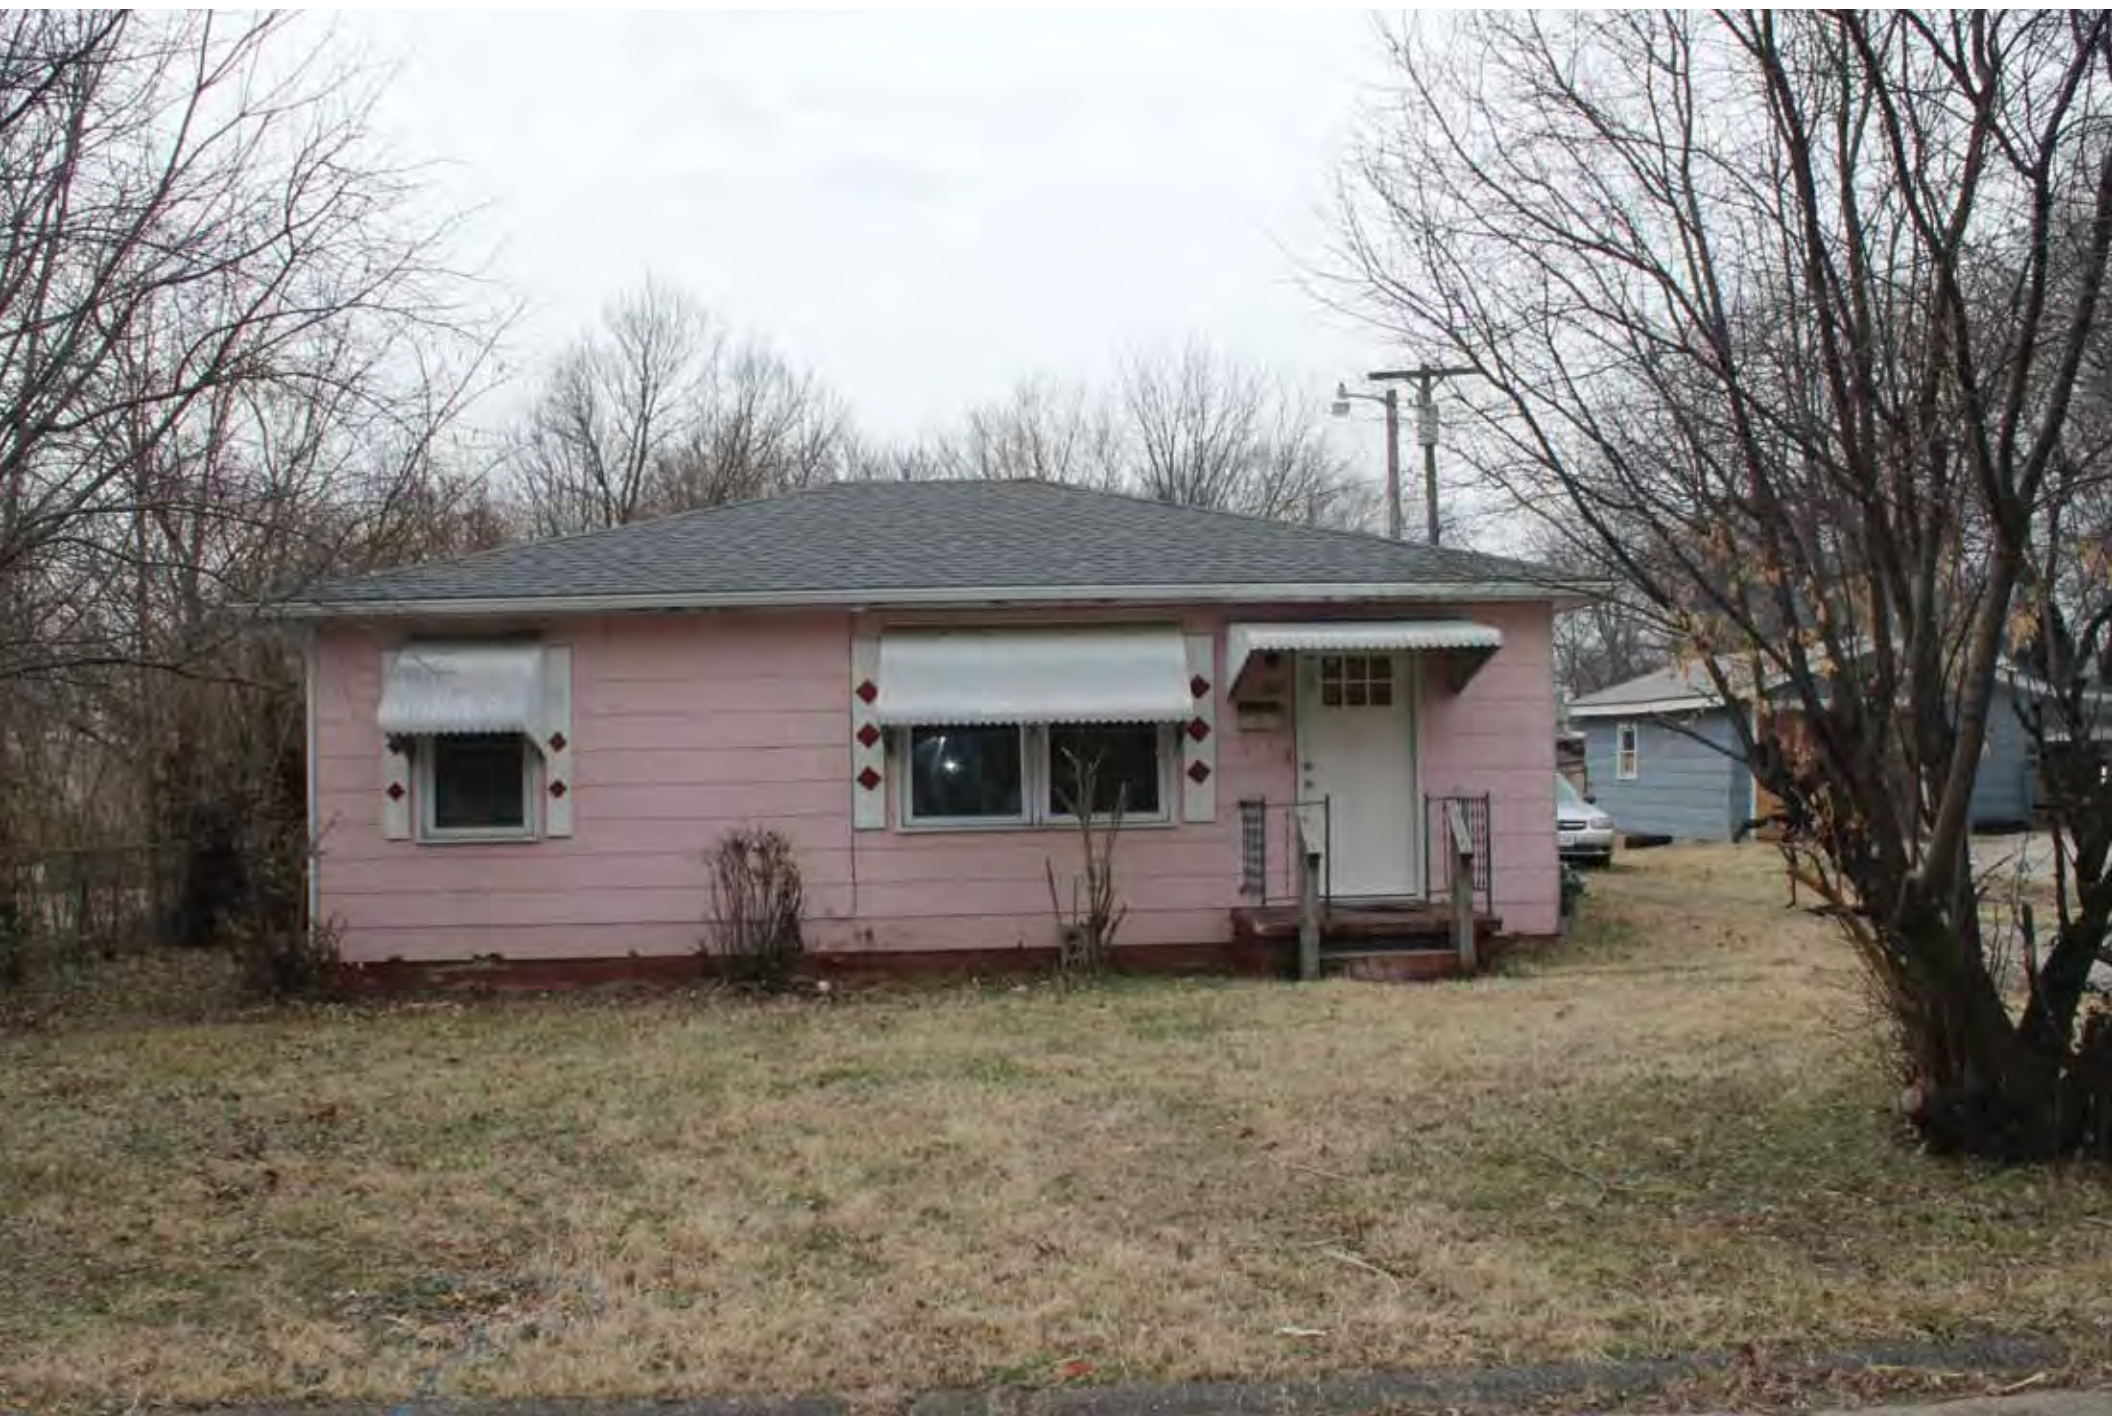
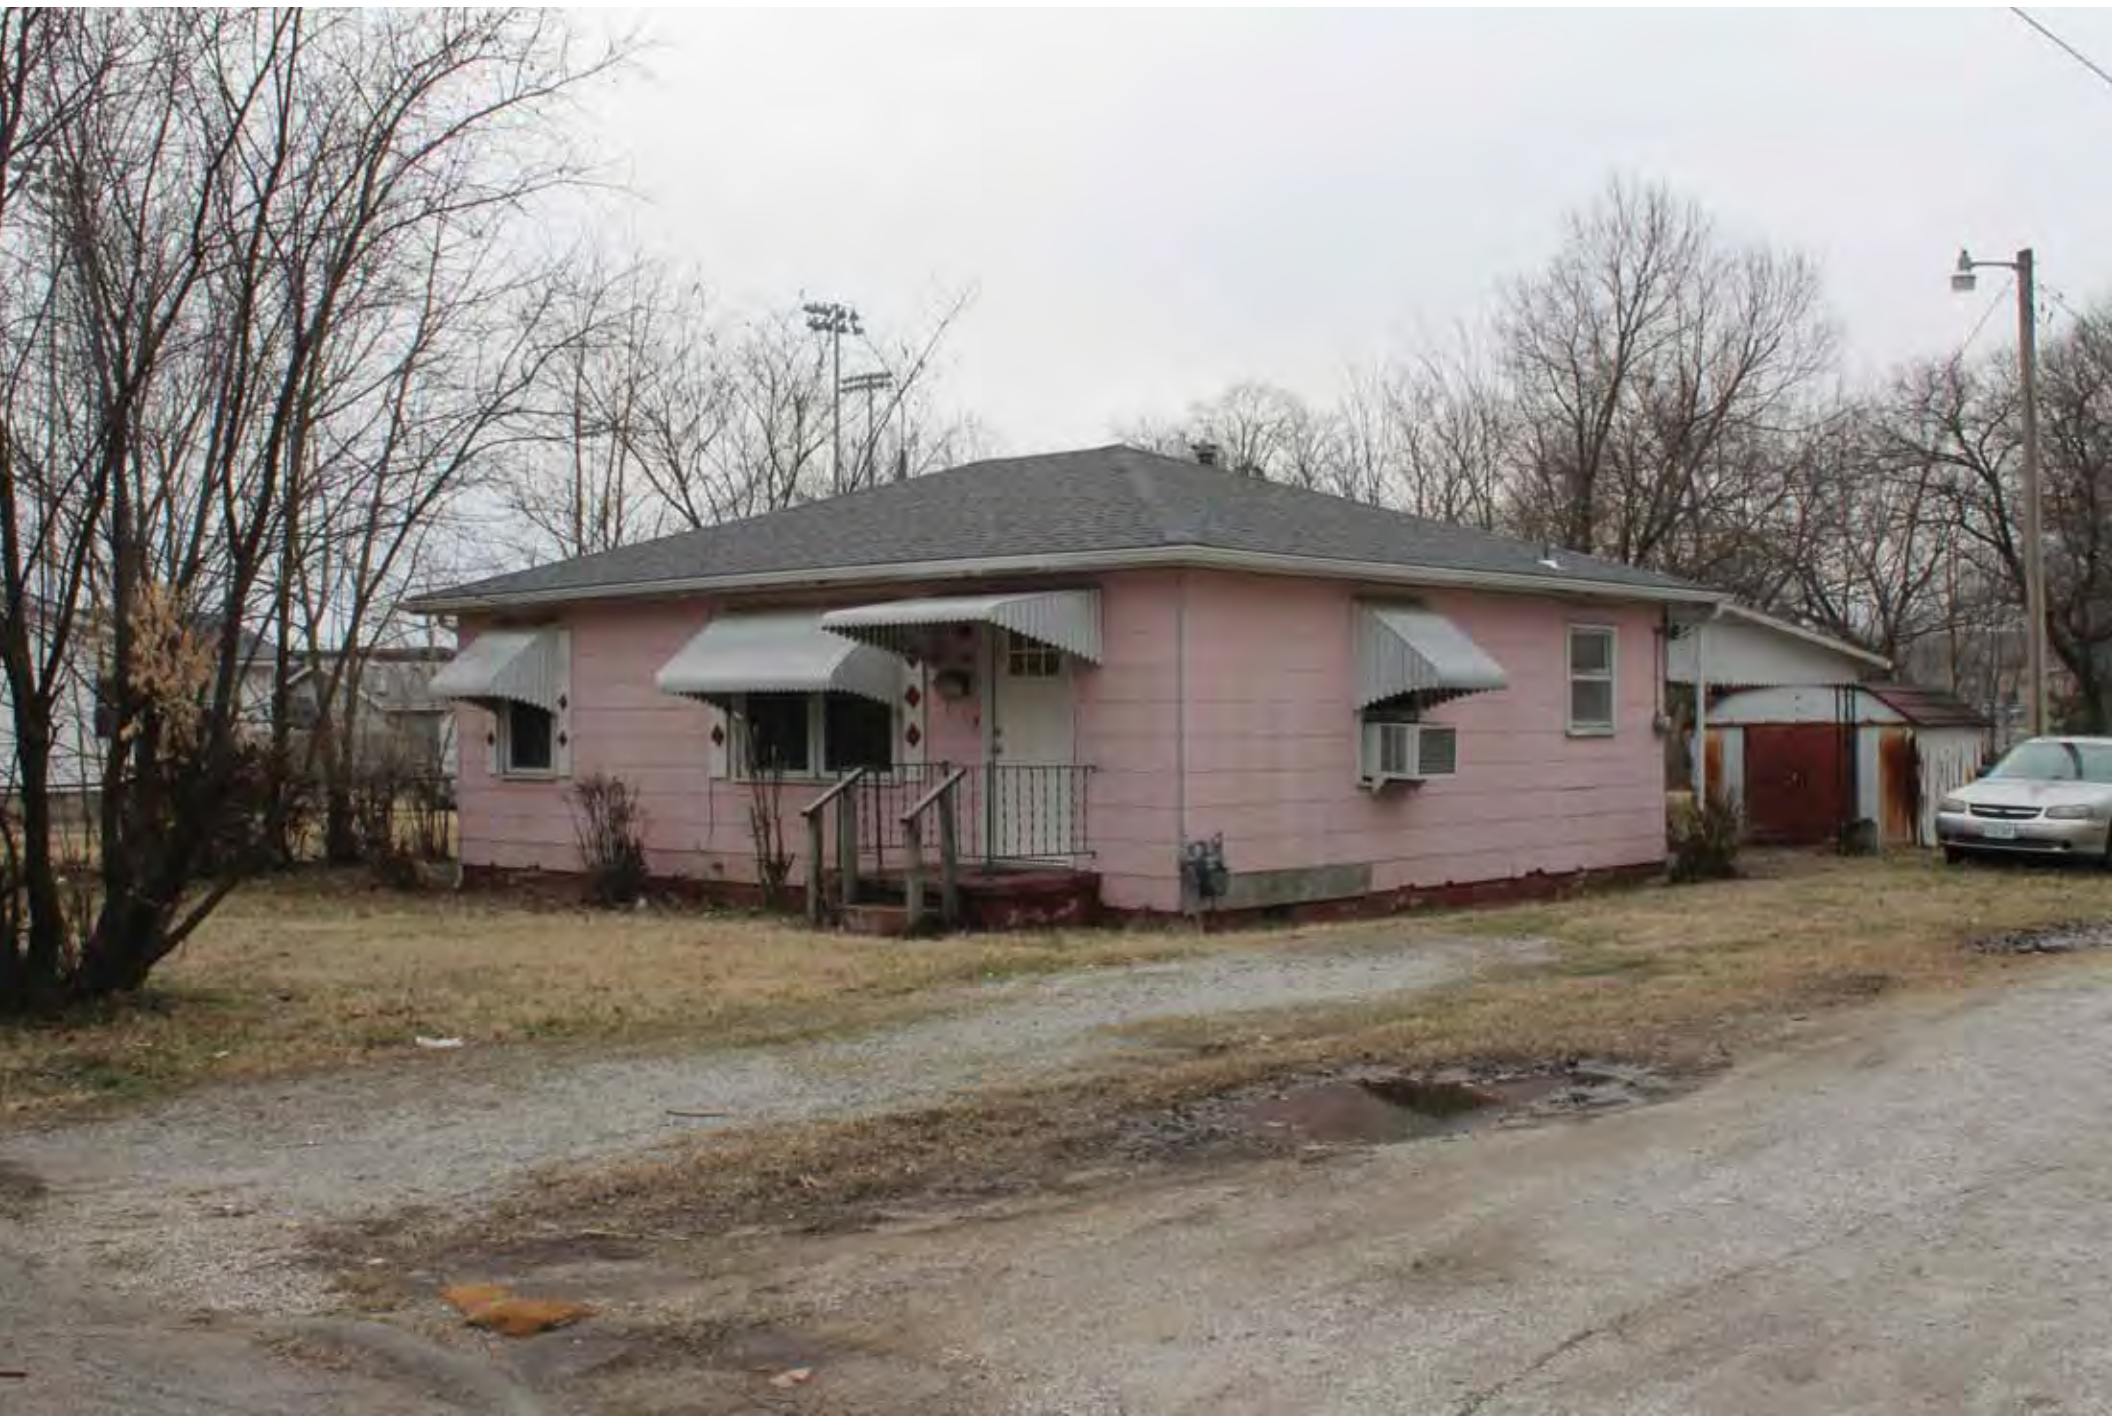
The property at 226 S. Comingo Avenue supports a single-story dwelling with an asphalt shingle hipped roof, exterior asbestos shingles and a concrete foundation. The primary (east) elevation supports an off-center concrete stoop (north end) with wood handrails and a wrought iron balustrade. The stoop leads to an entry bay filled with a replacement (c. 2015) Craftsman style door. The entry is offset by paired and single double-hung windows. Metal awnings are above the windows and the door. The façade windows feature faux wood shingles with painted diamond patterns. The north elevation supports two double-hung windows, one of which has a metal awning. The south elevation holds two windows. The rear elevation features a shed porch style awning above a concrete pad supported by wrought iron columns.

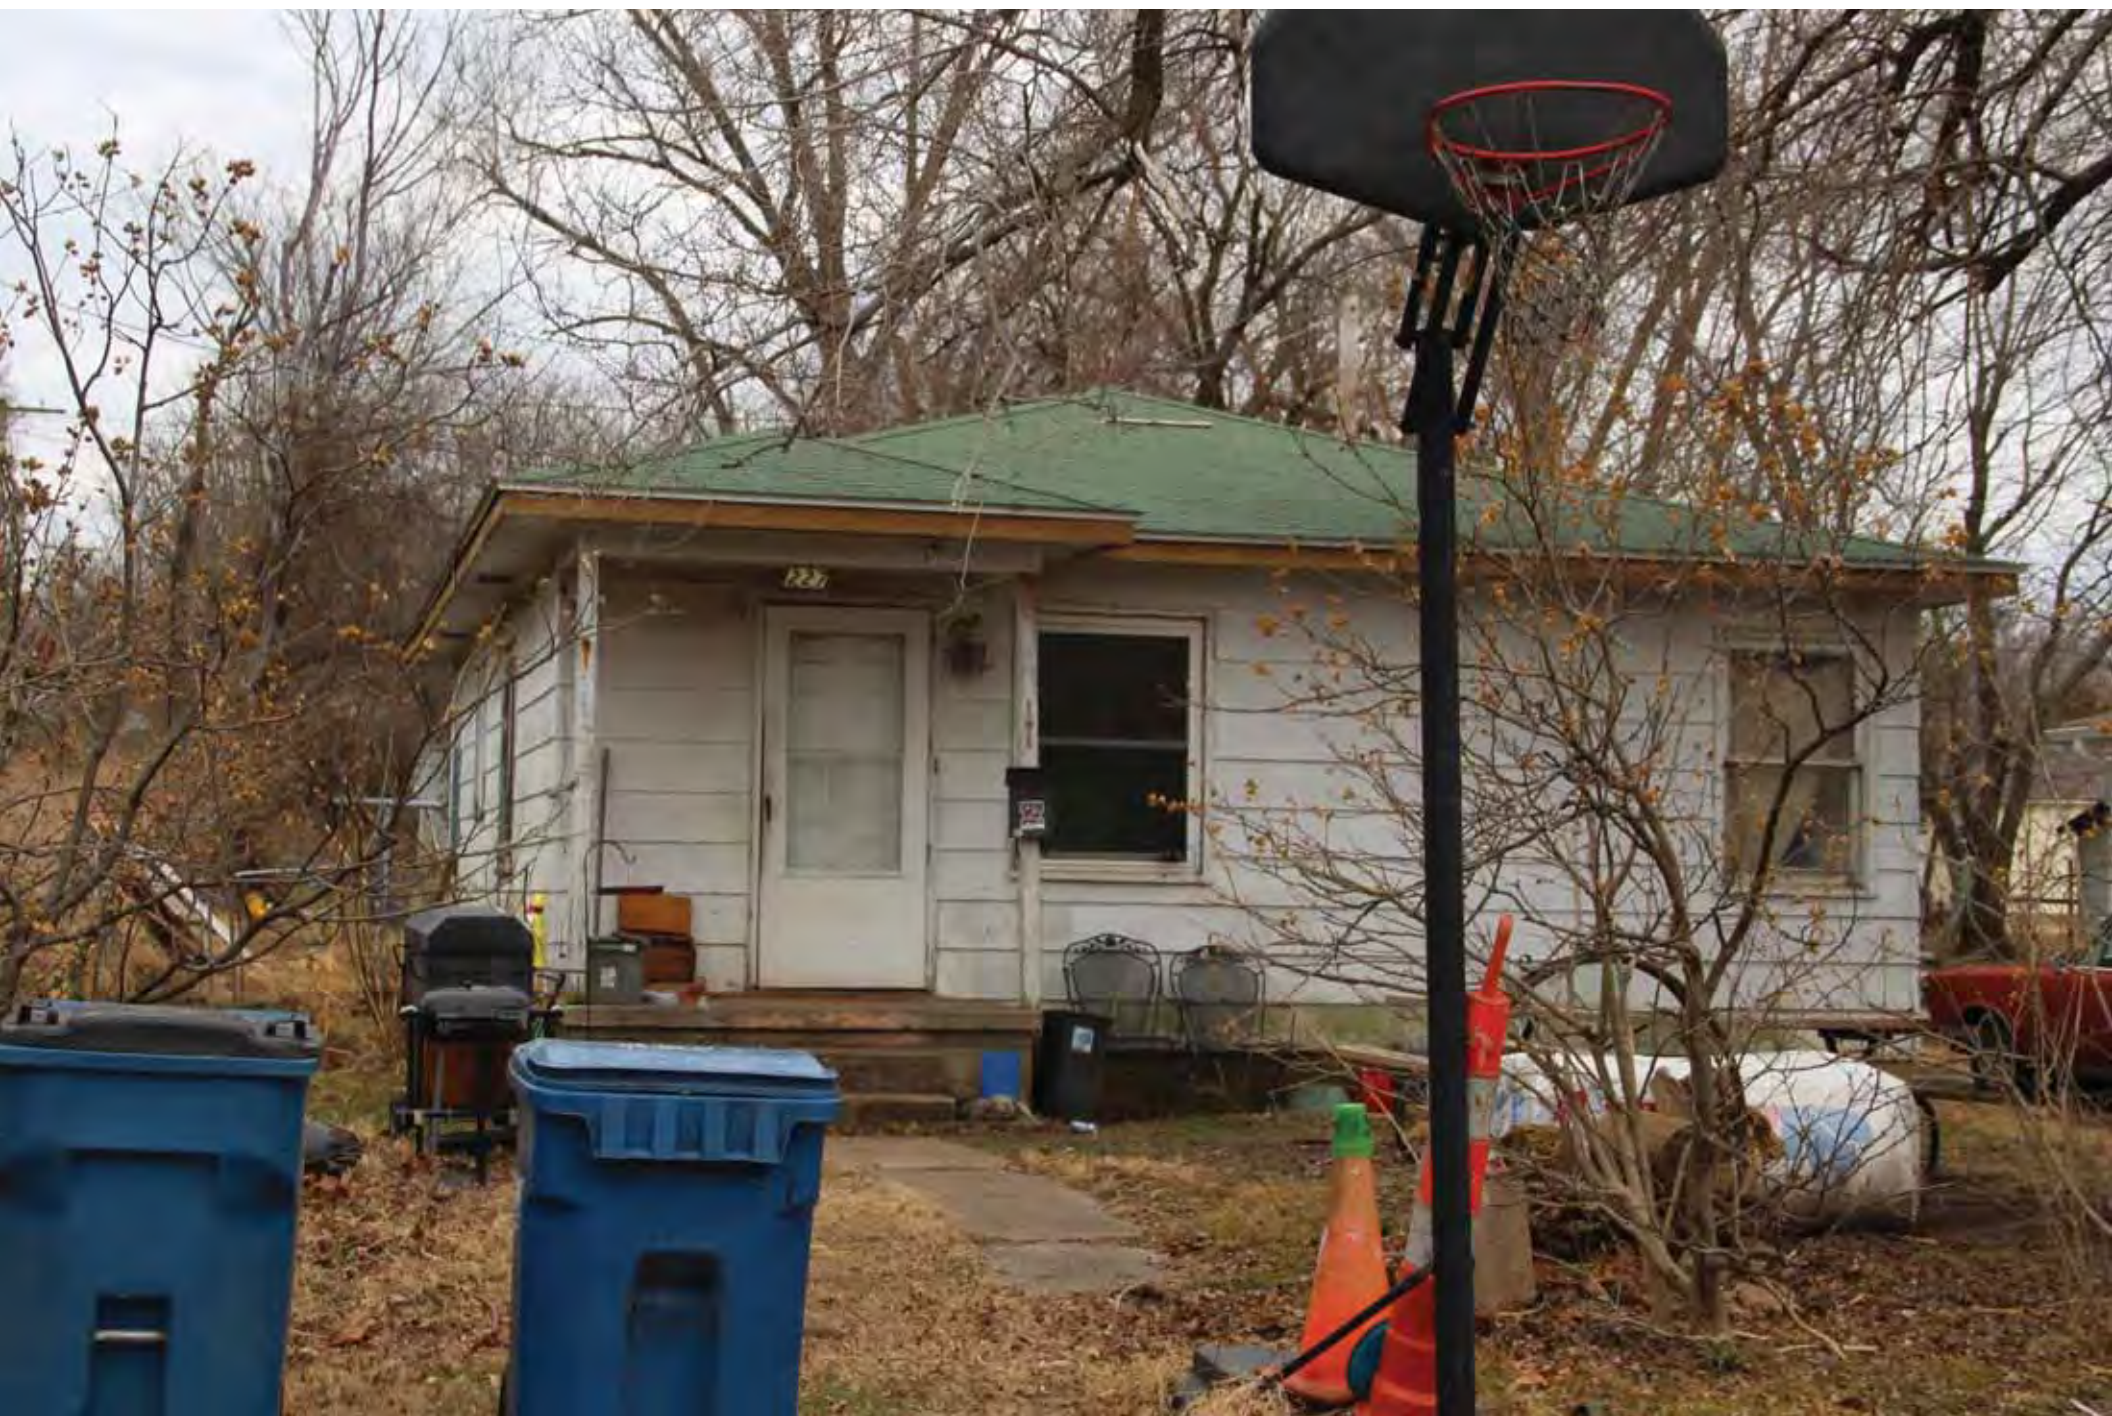
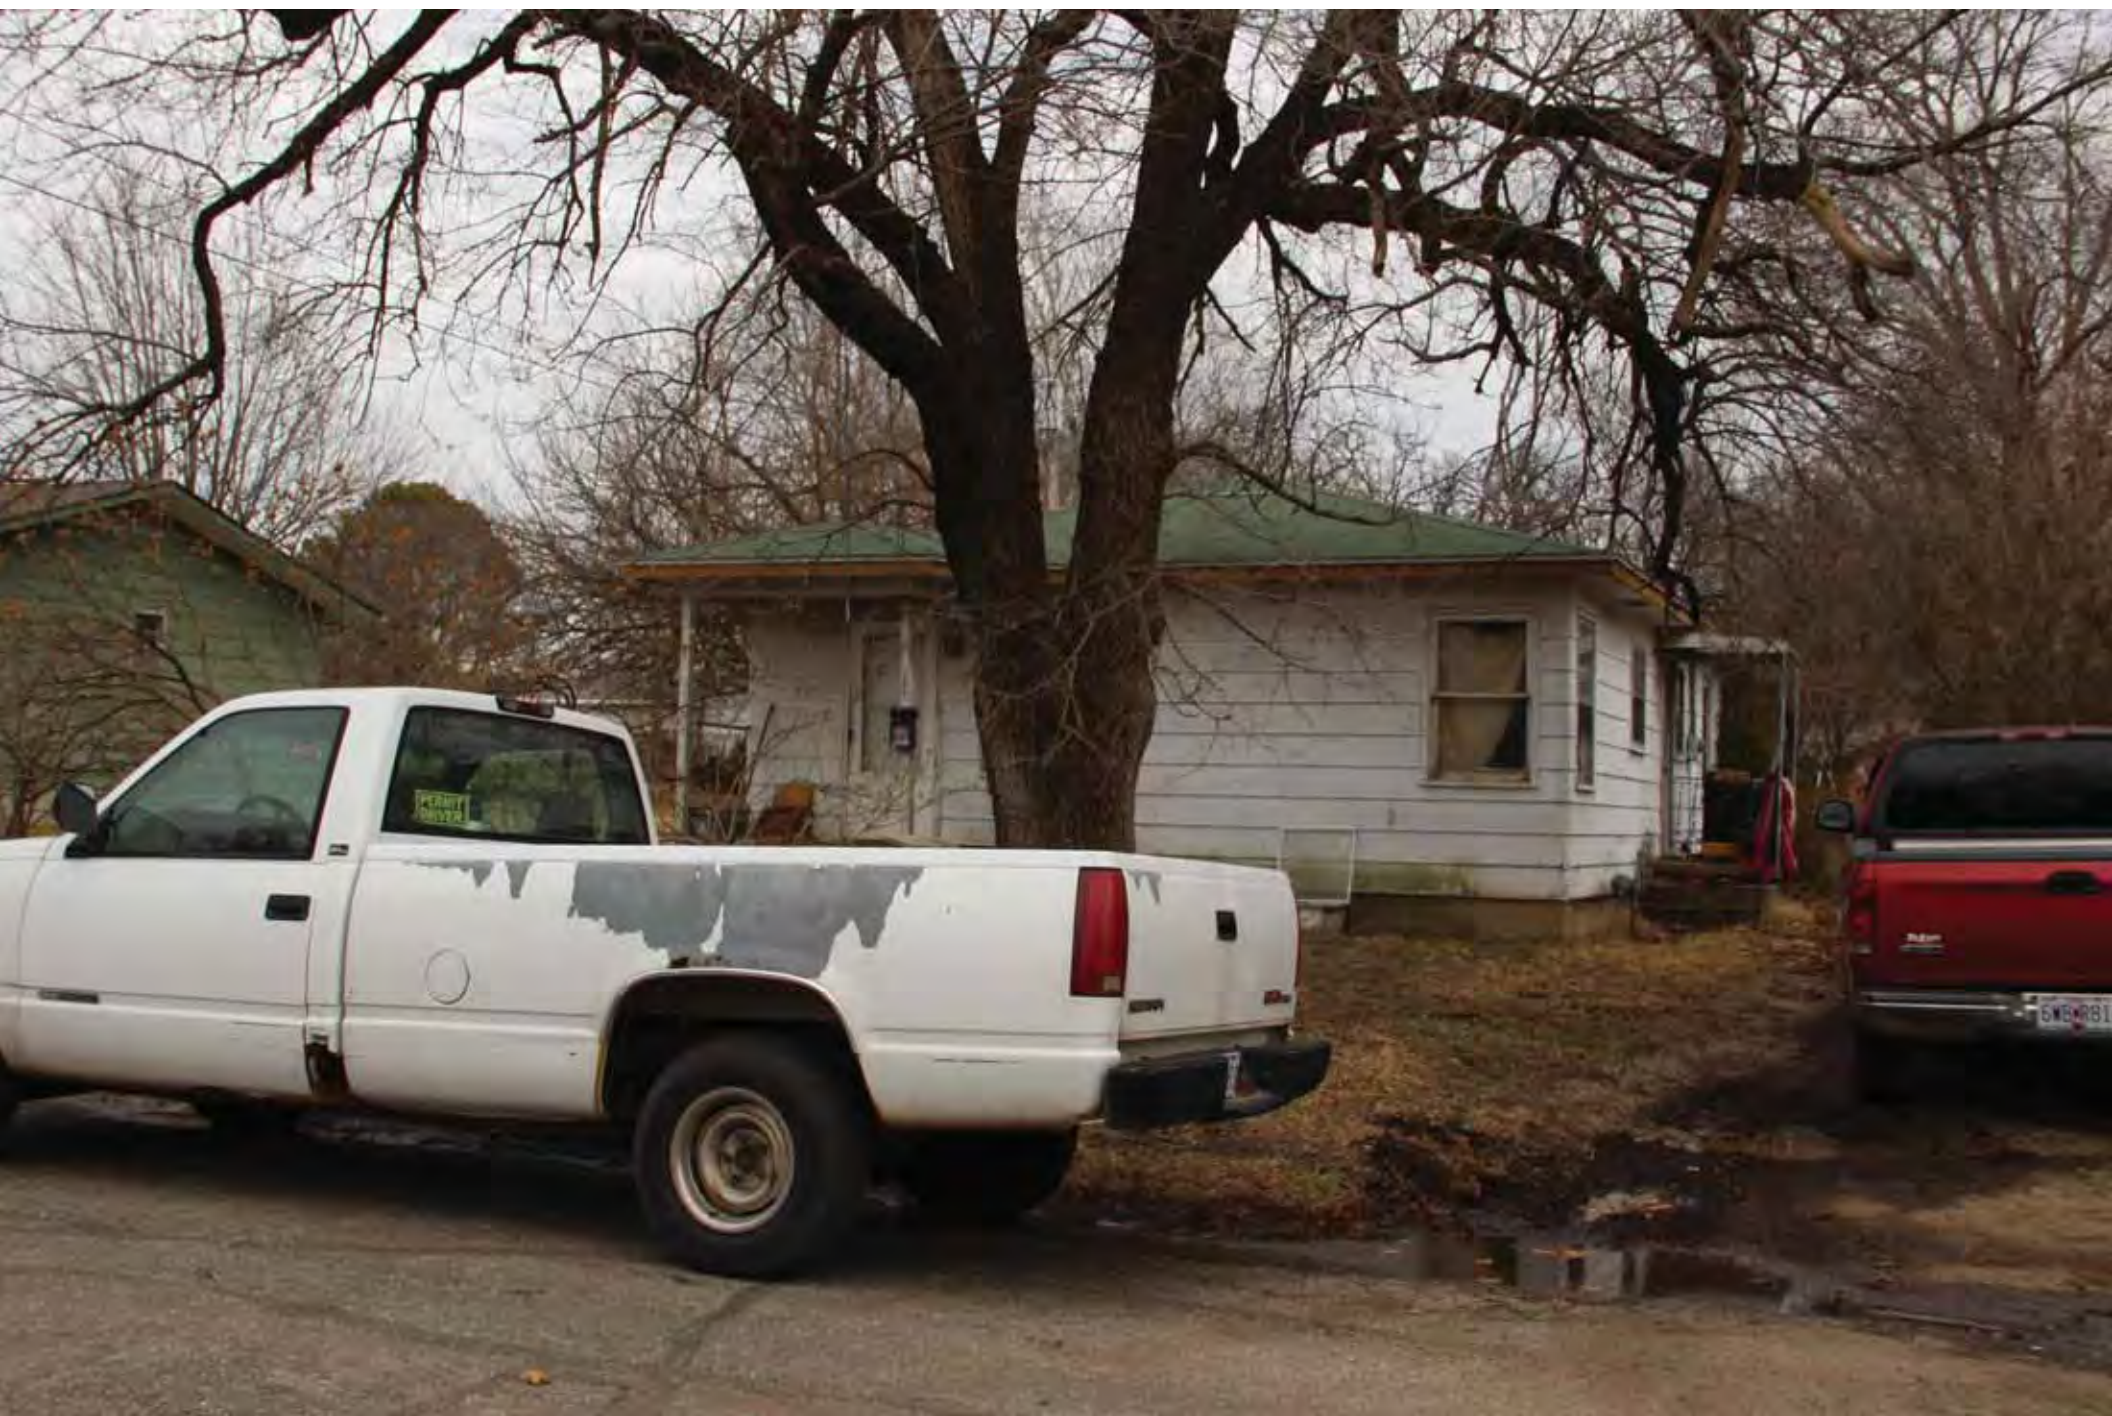
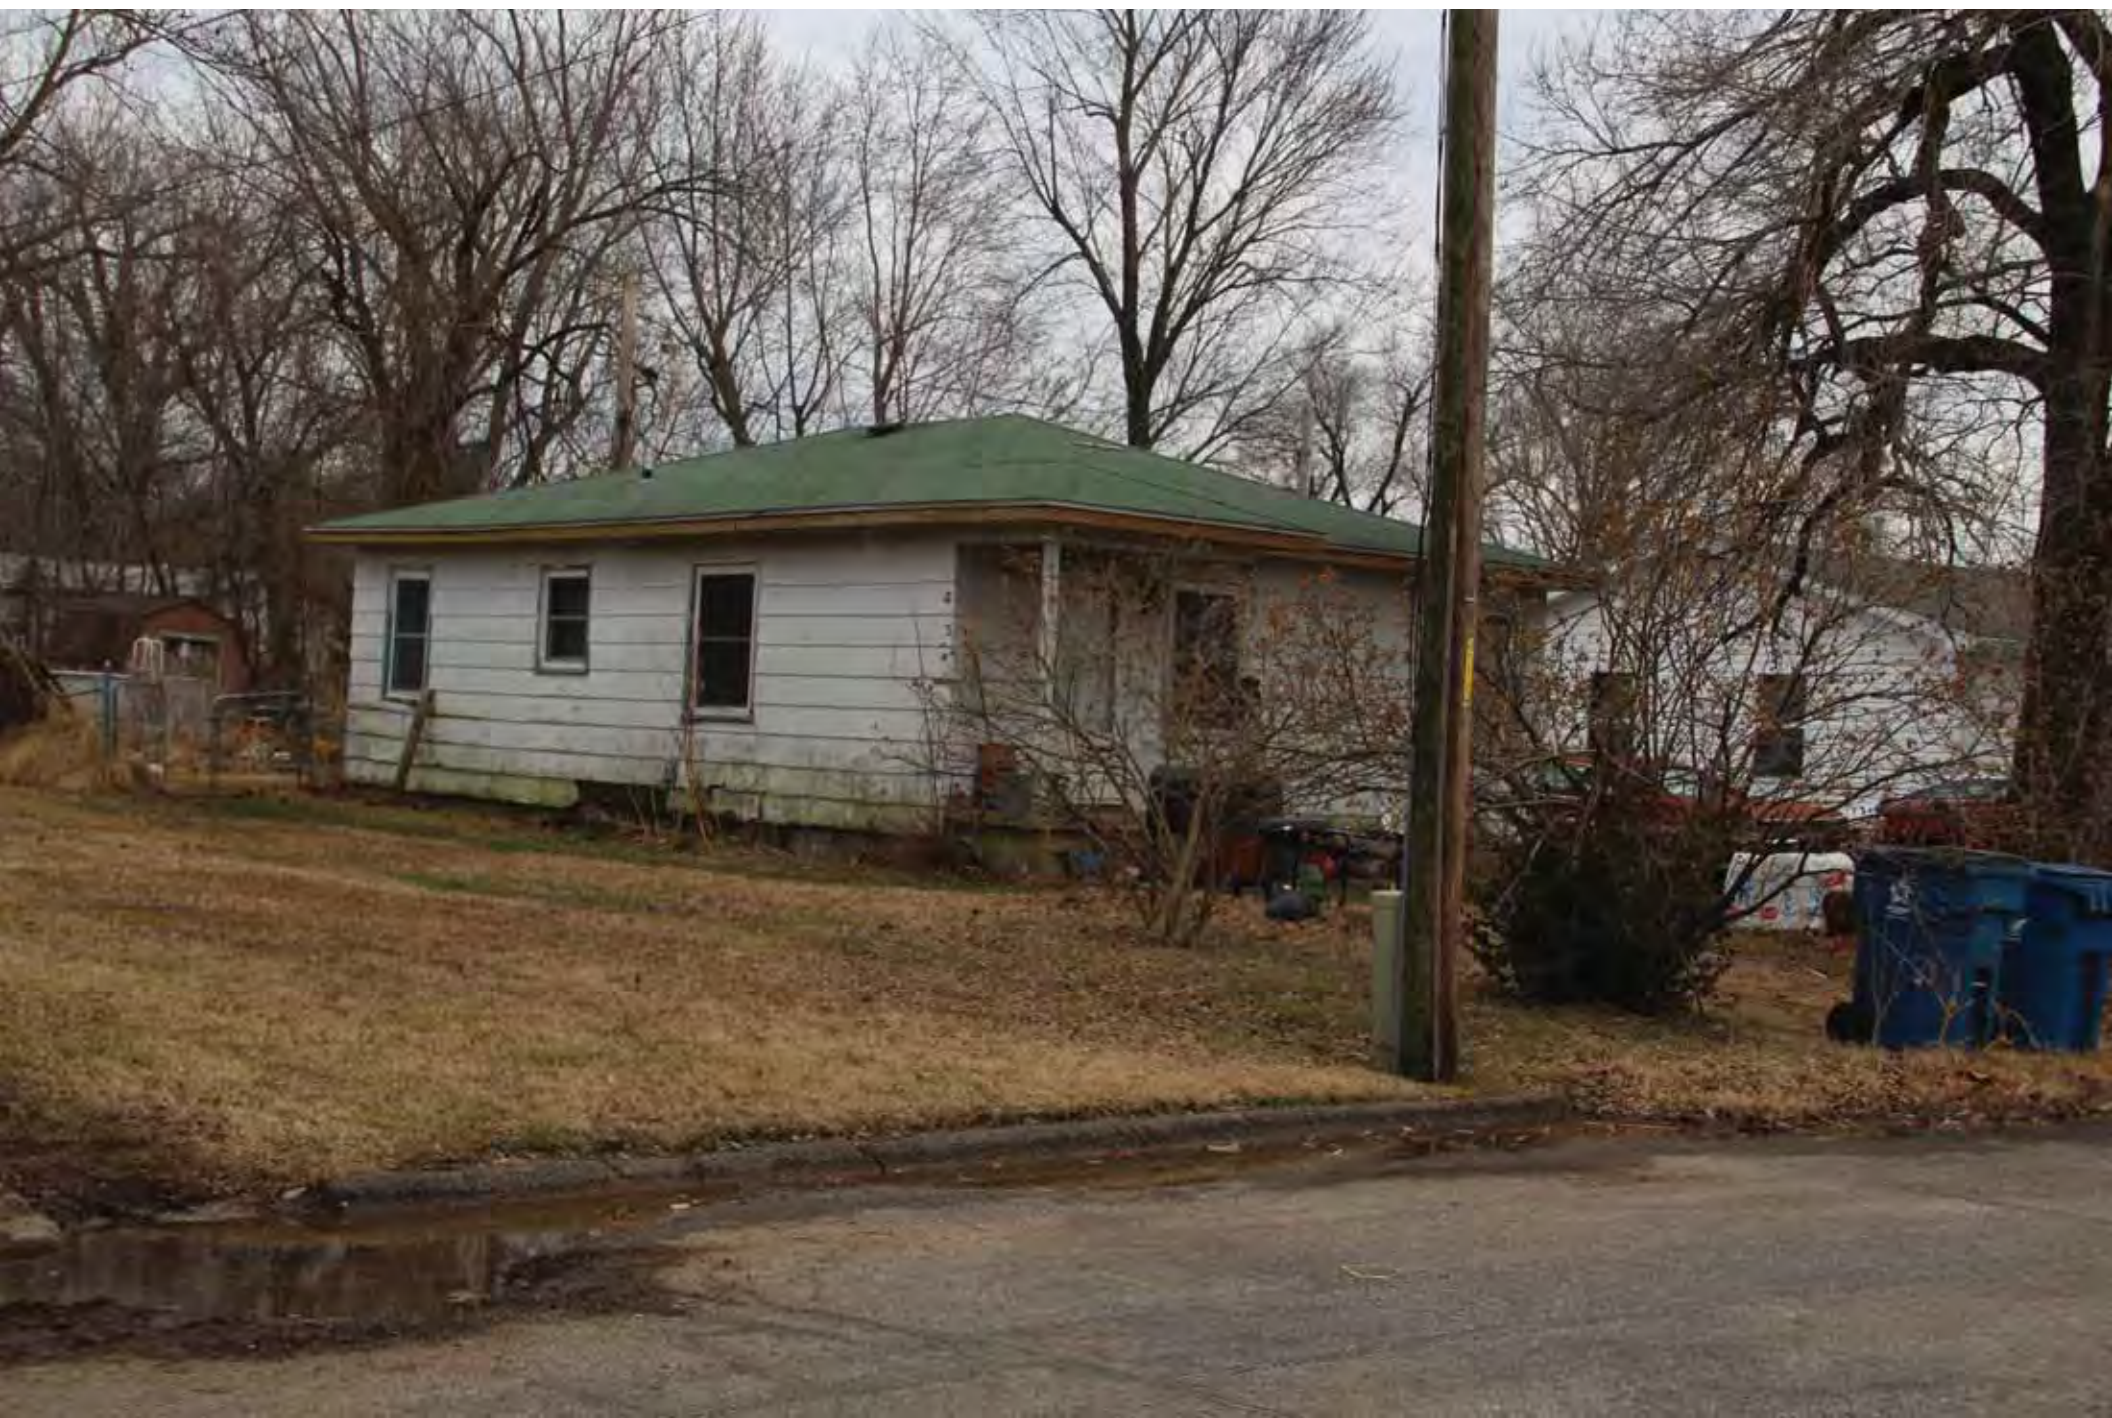
The property at 227 S. Comingo Avenue supports a single-story dwelling with an asphalt shingle hipped roof, exterior wide board siding and a concrete foundation. The façade (west) elevation supports a hipped portico at the north end of the elevation. The portico has a concrete stoop base. Two slender wood columns support the portico roof. Within the portico bay is a replacement (c. 2015) paneled door. The entry bay is offset by two one-over-one windows. The north elevation supports three double-hung windows. The south elevation supports four windows and a secondary entry. A shed metal roof portico with concrete stoop fronts the entry bay on the south elevation. The stoop has a wrought iron balustrade.
