MISSOURI DEPARTMENT OF NATURAL RESOURCES
STATE HISTORIC PRESERVATION OFFICE, P.O. Box 176, Jefferson City, MO 65102
ARCHITECTURAL/HISTORIC INVENTORY FORM

1. Survey No. JP-AS-007-001		2. Survey name: East Town (Original Joplin) Historic Survey Phase 2	
3. County: JASPER		4. Address (Street No.) 618	Street (name) E. 2 nd Street
5. City: Joplin	Vicinity: <input type="checkbox"/>	6. Geographical Reference:	7. Township/Range/Section: T: R: S:
8. Historic name (if known):		9. Present/other name (if known):	
10. Ownership: <input checked="" type="checkbox"/> Private <input type="checkbox"/> Public		11a. Historic use (if known): Domestic: Single Dwelling	11b. Current use: Domestic: Single Dwelling

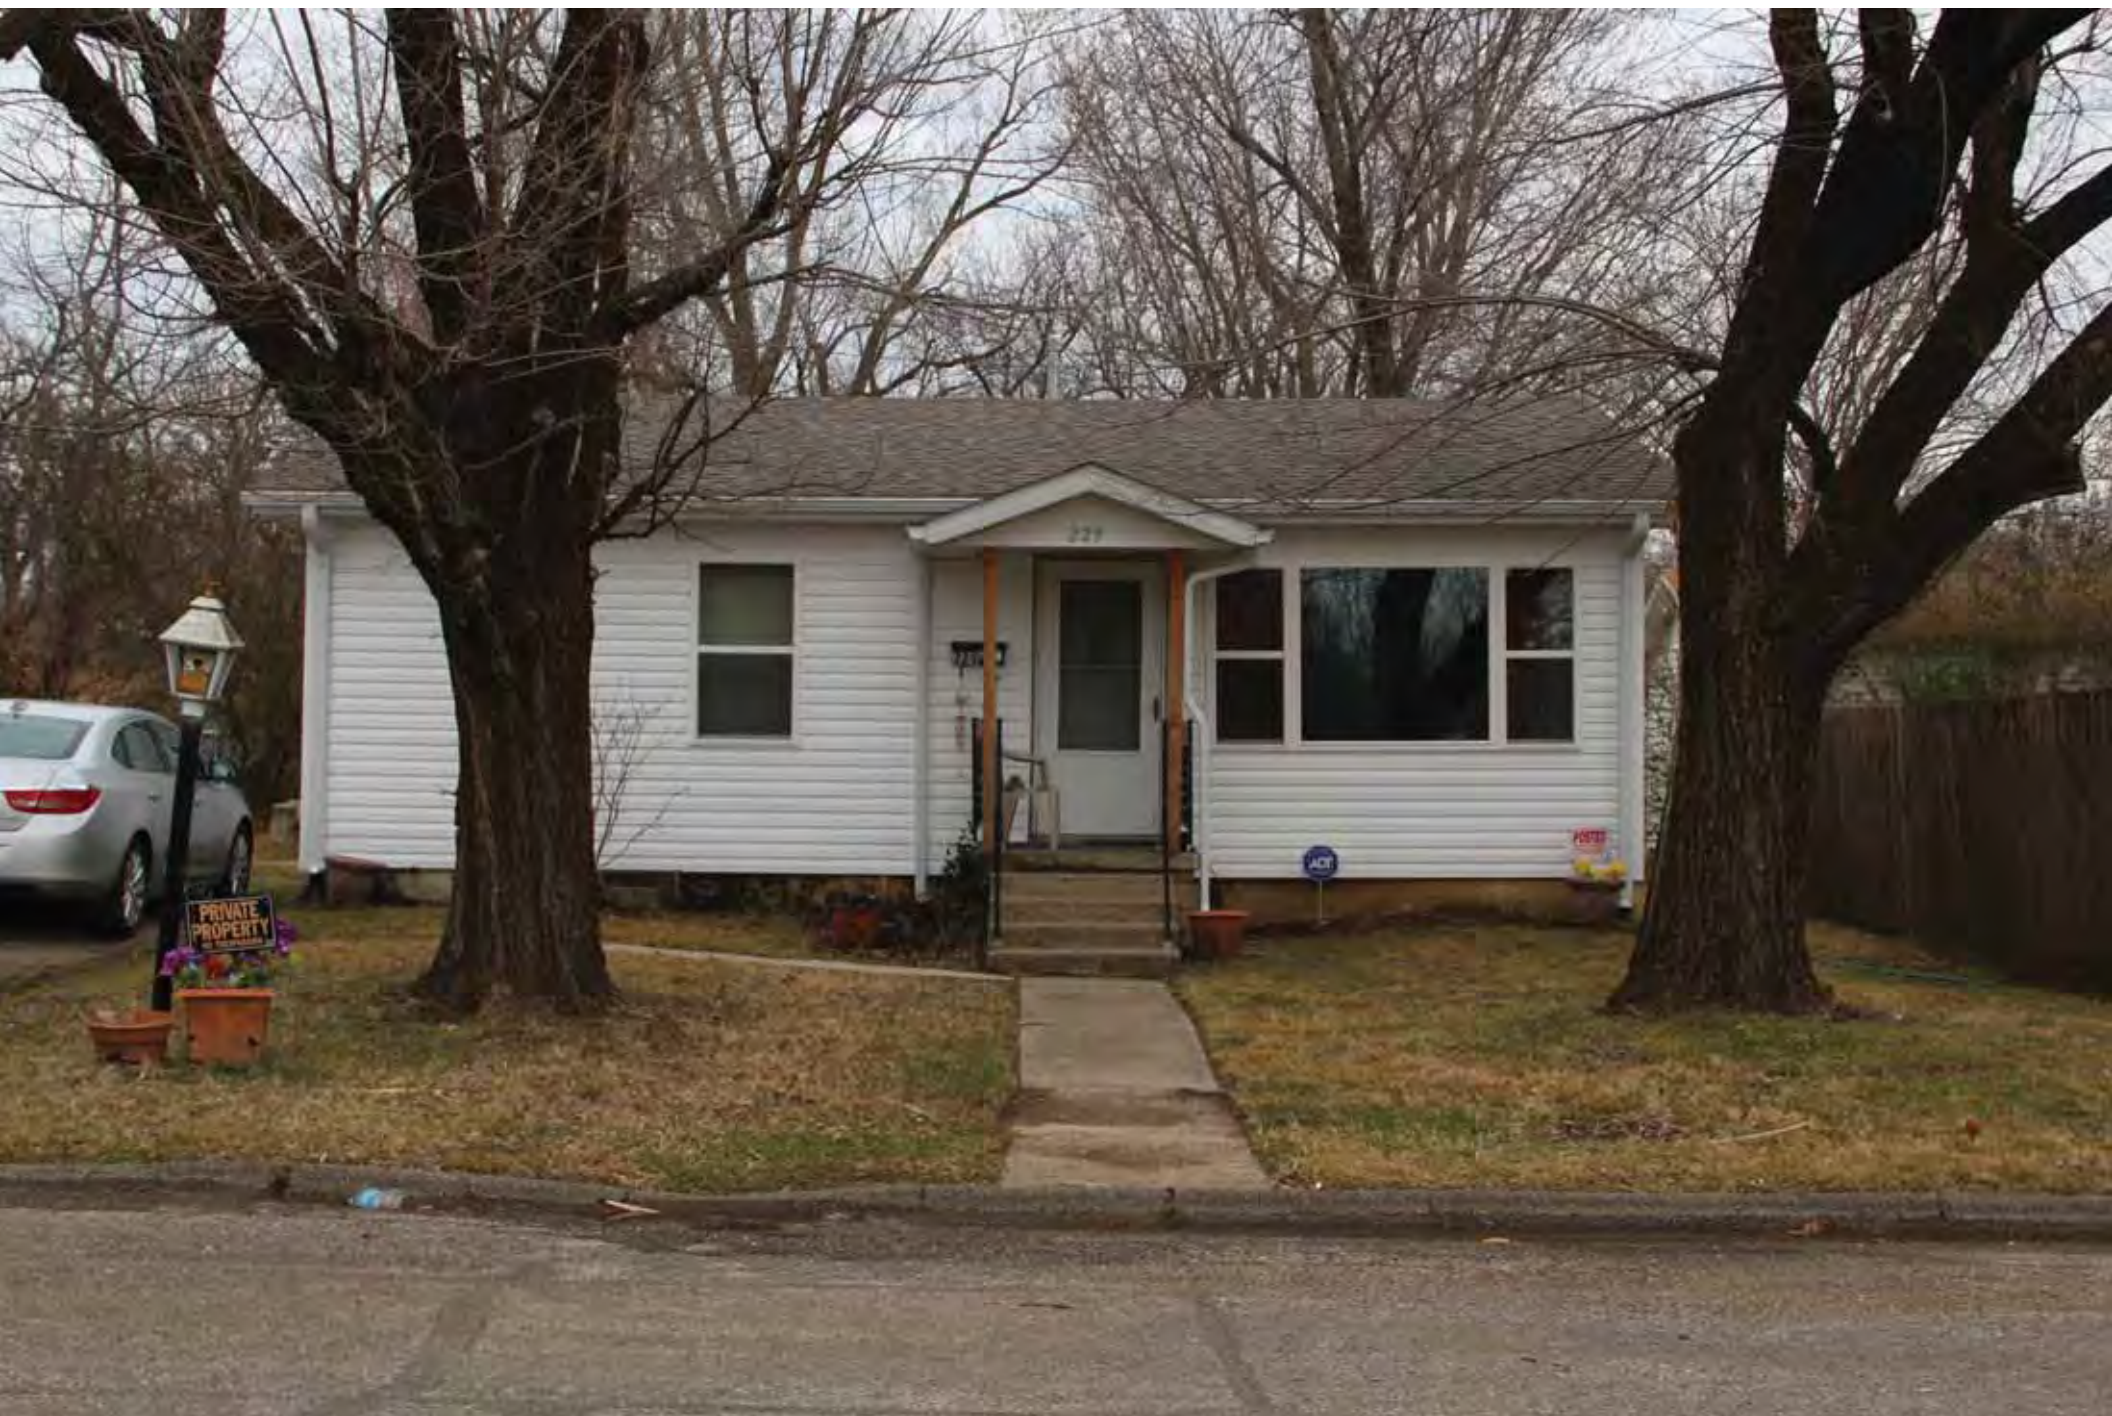
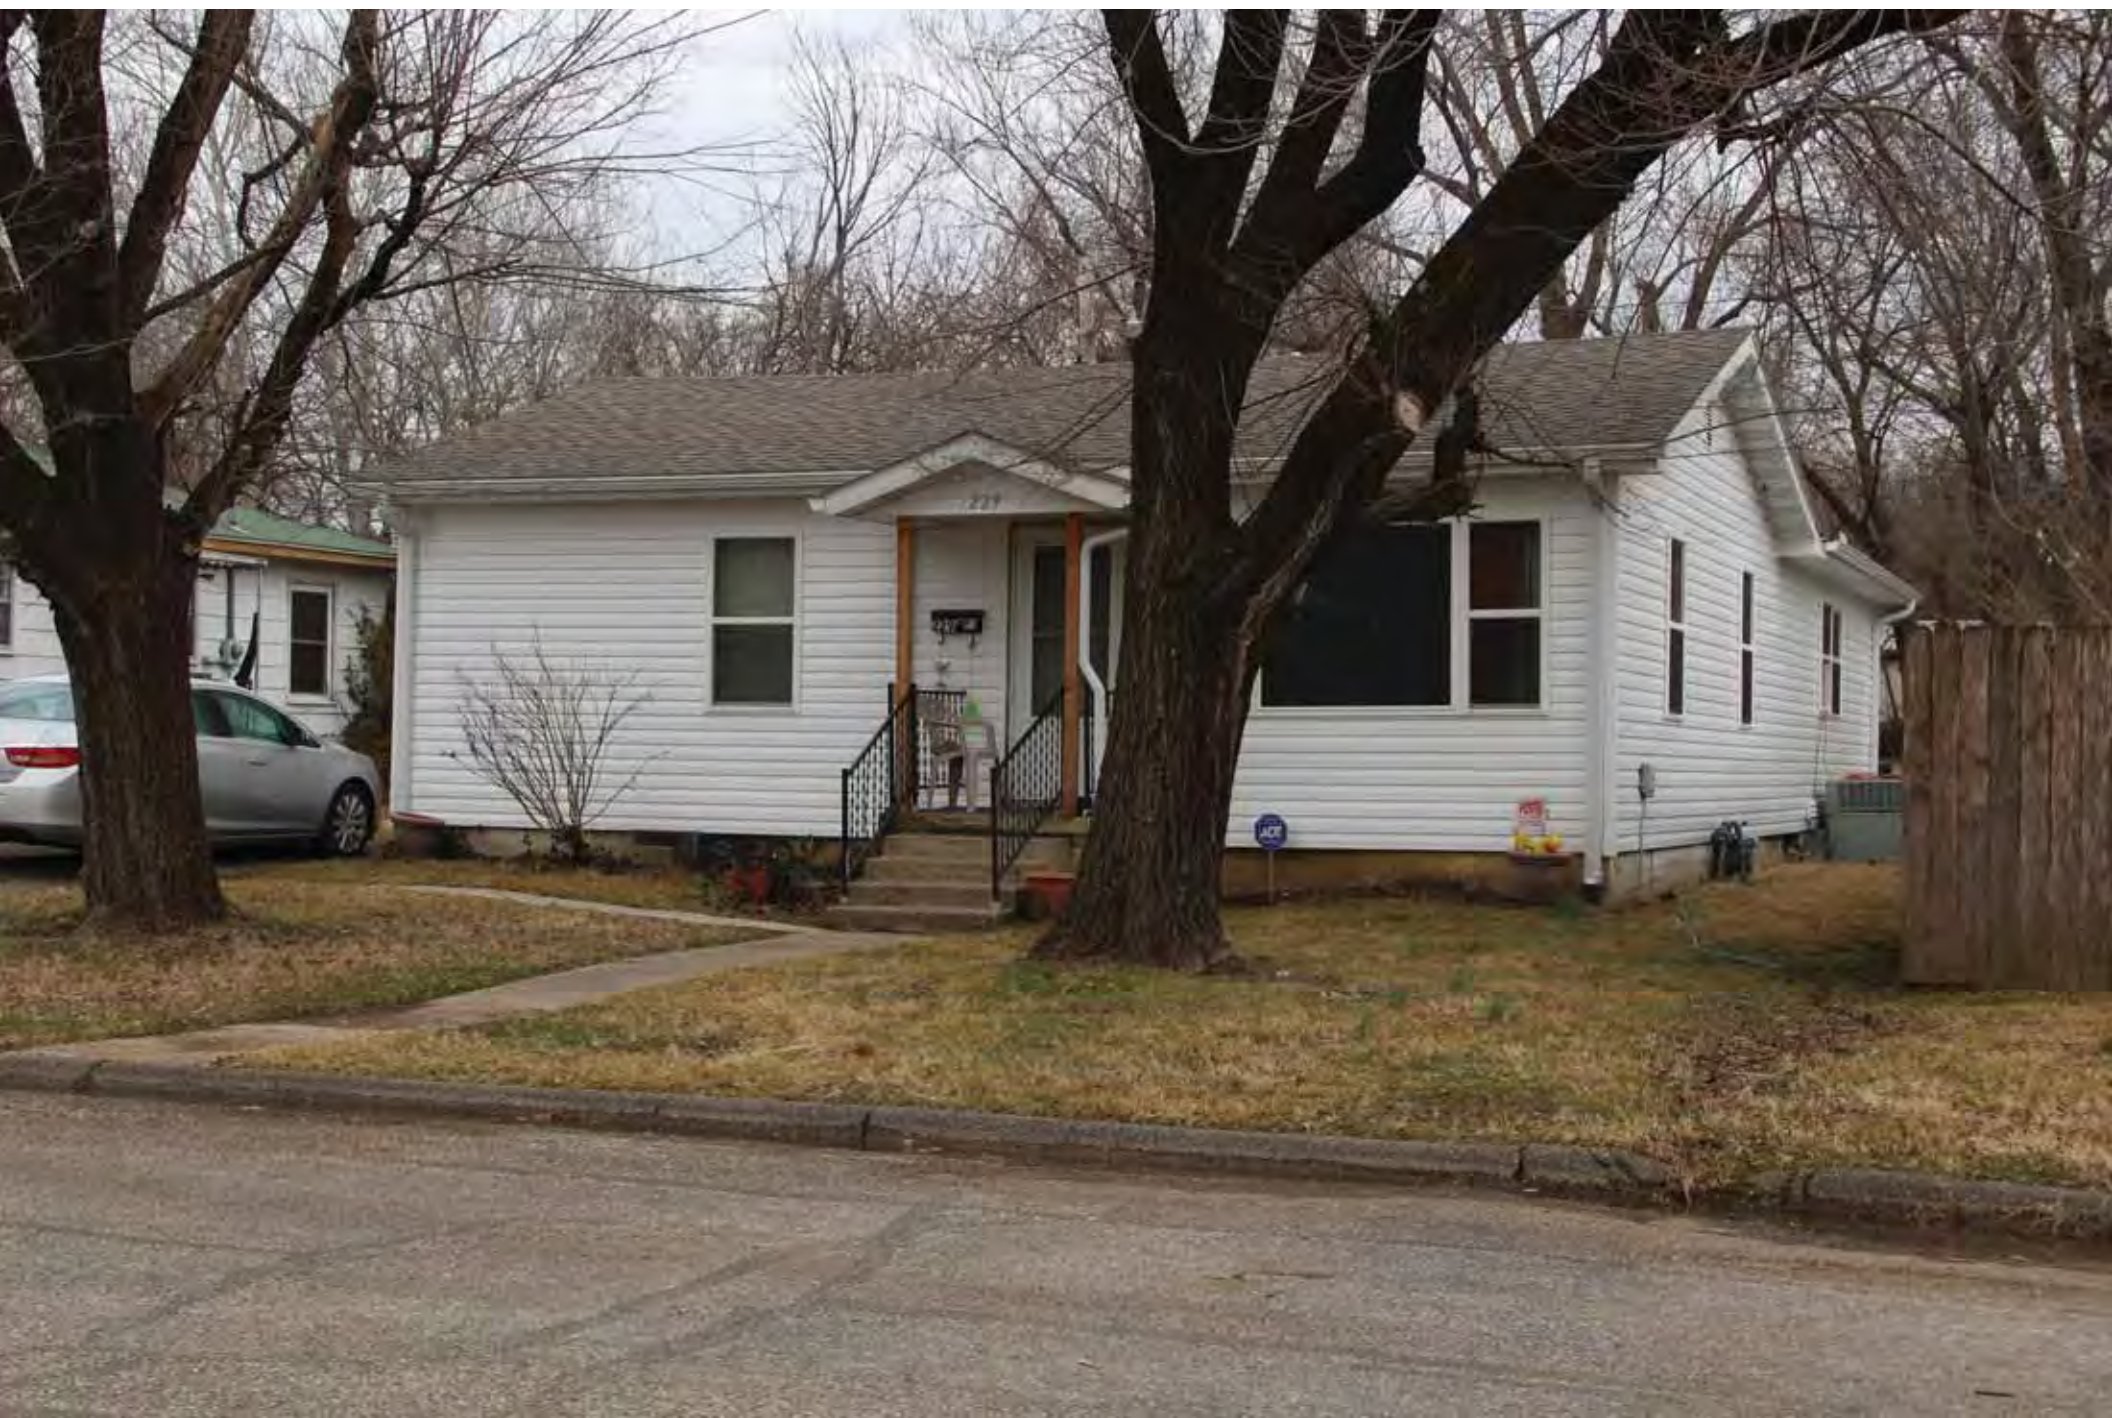
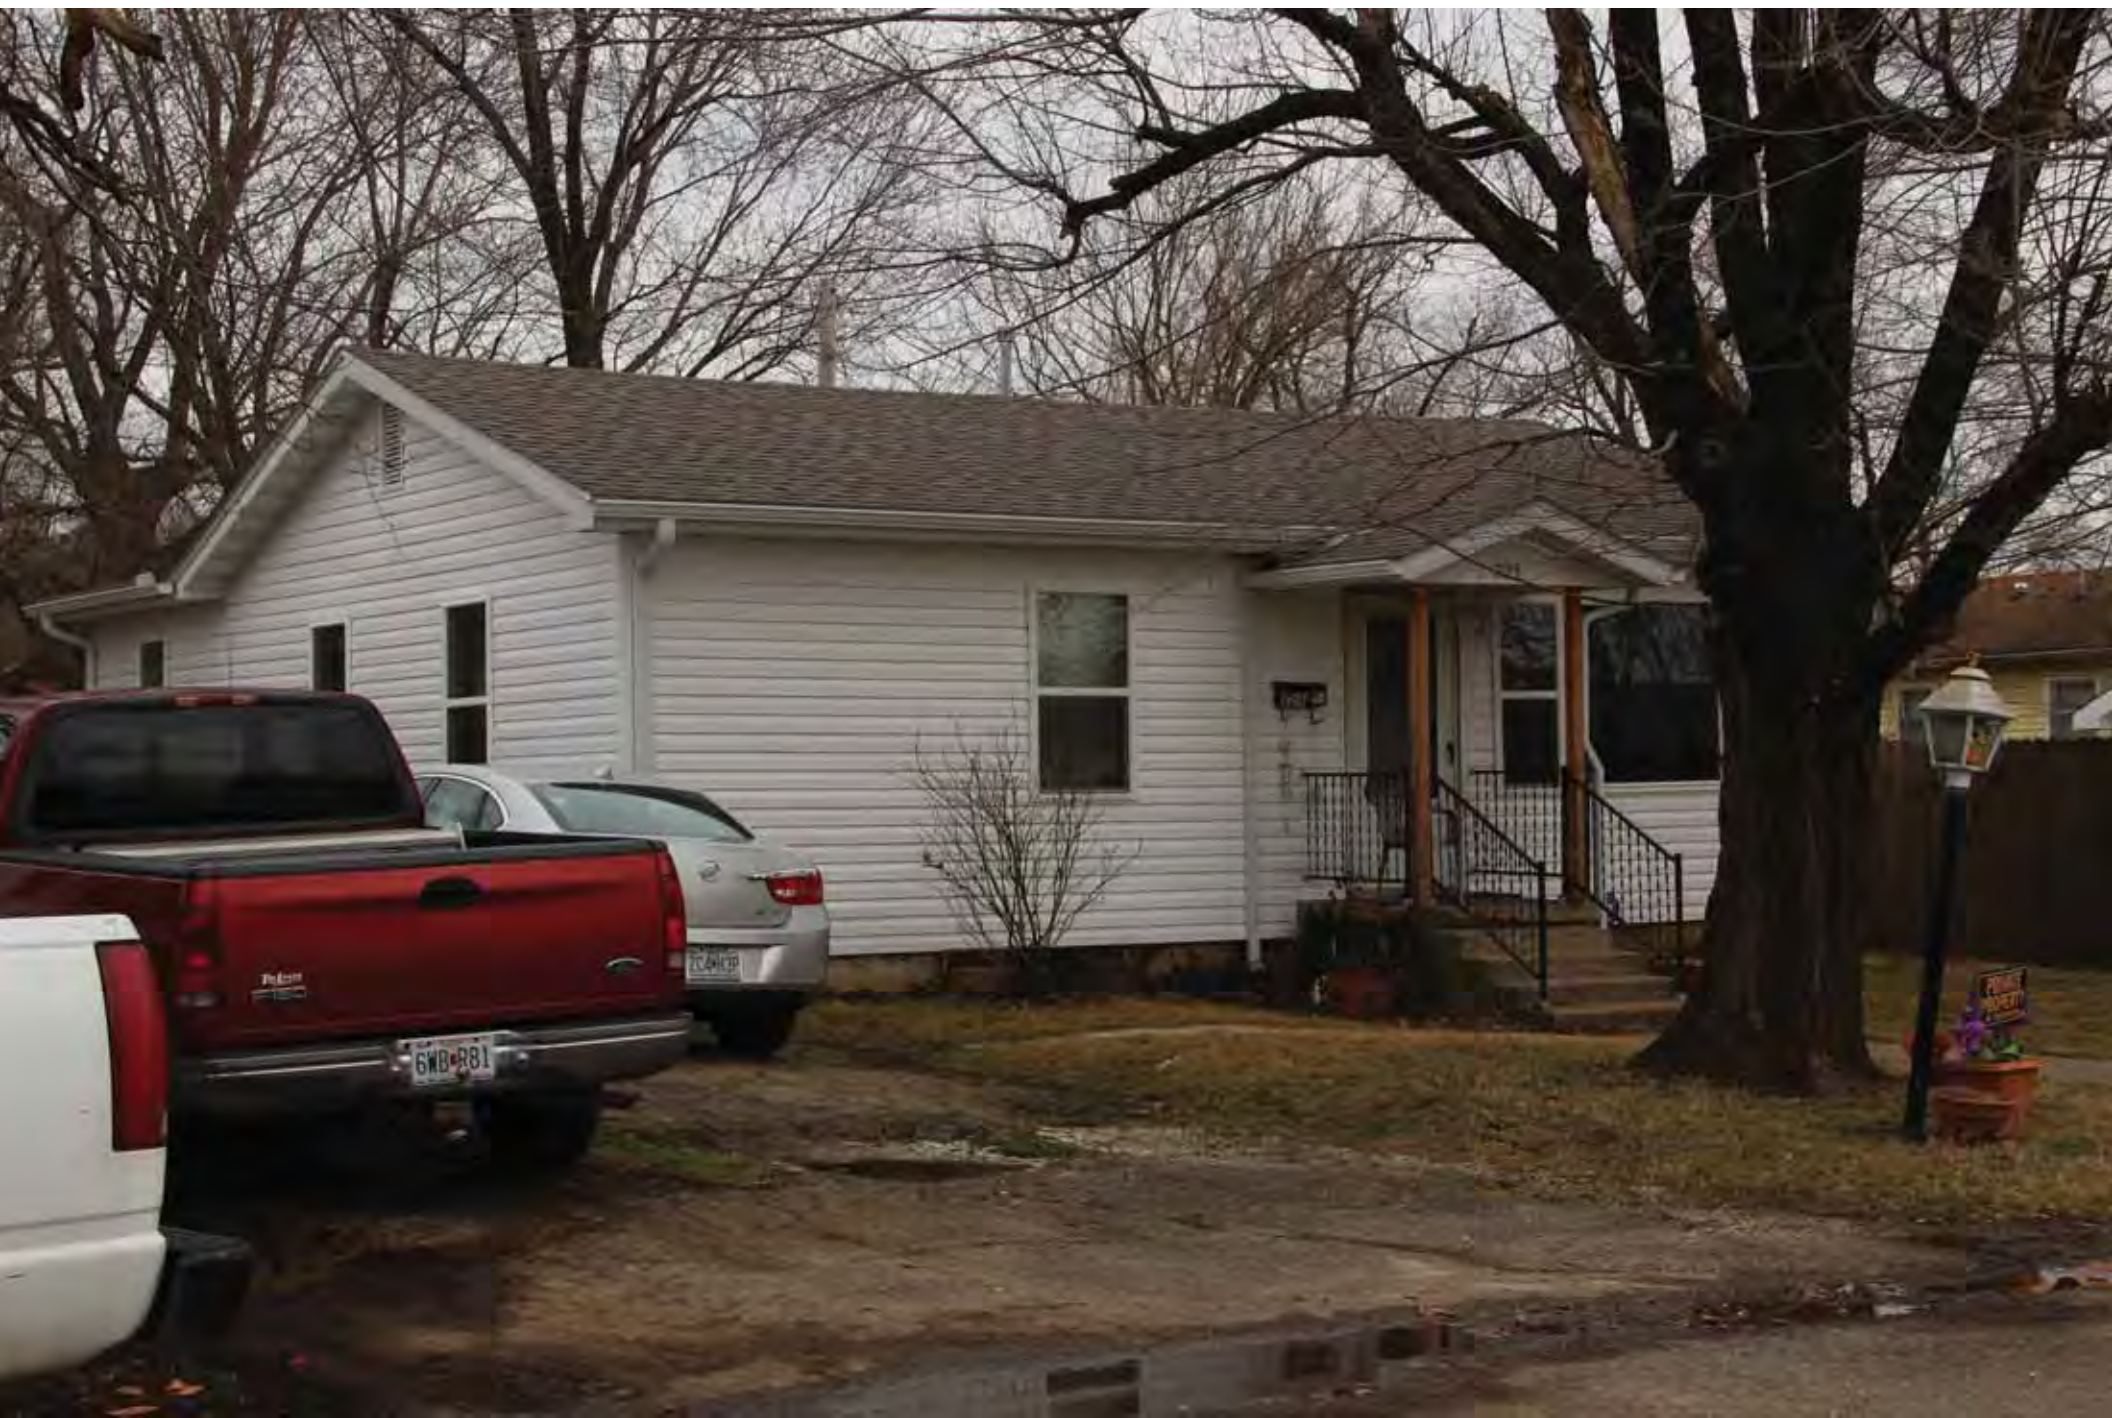
The property at 229 S. Comingo Avenue supports a single-story dwelling with an asphalt shingled gabled roof, exterior vinyl siding and a concrete foundation. The primary (west) elevation supports a central gabled portico with wood replacement columns resting on a concrete base. The stoop is surrounded by a wrought iron balustrade. Within the portico bay is a solid paneled door. Flanking the door are a double-hung window (north) and picture style window (south). Windows appear to support replacement lights (c. 2018). The dwelling supports a rear shed wing. The south elevation holds two single windows and one set of paired windows (shed wing). North elevation window composition is similar with exception of the paired shed wing windows – on the north this area holds a single double-hung window. Gable fields hold louvered vents.

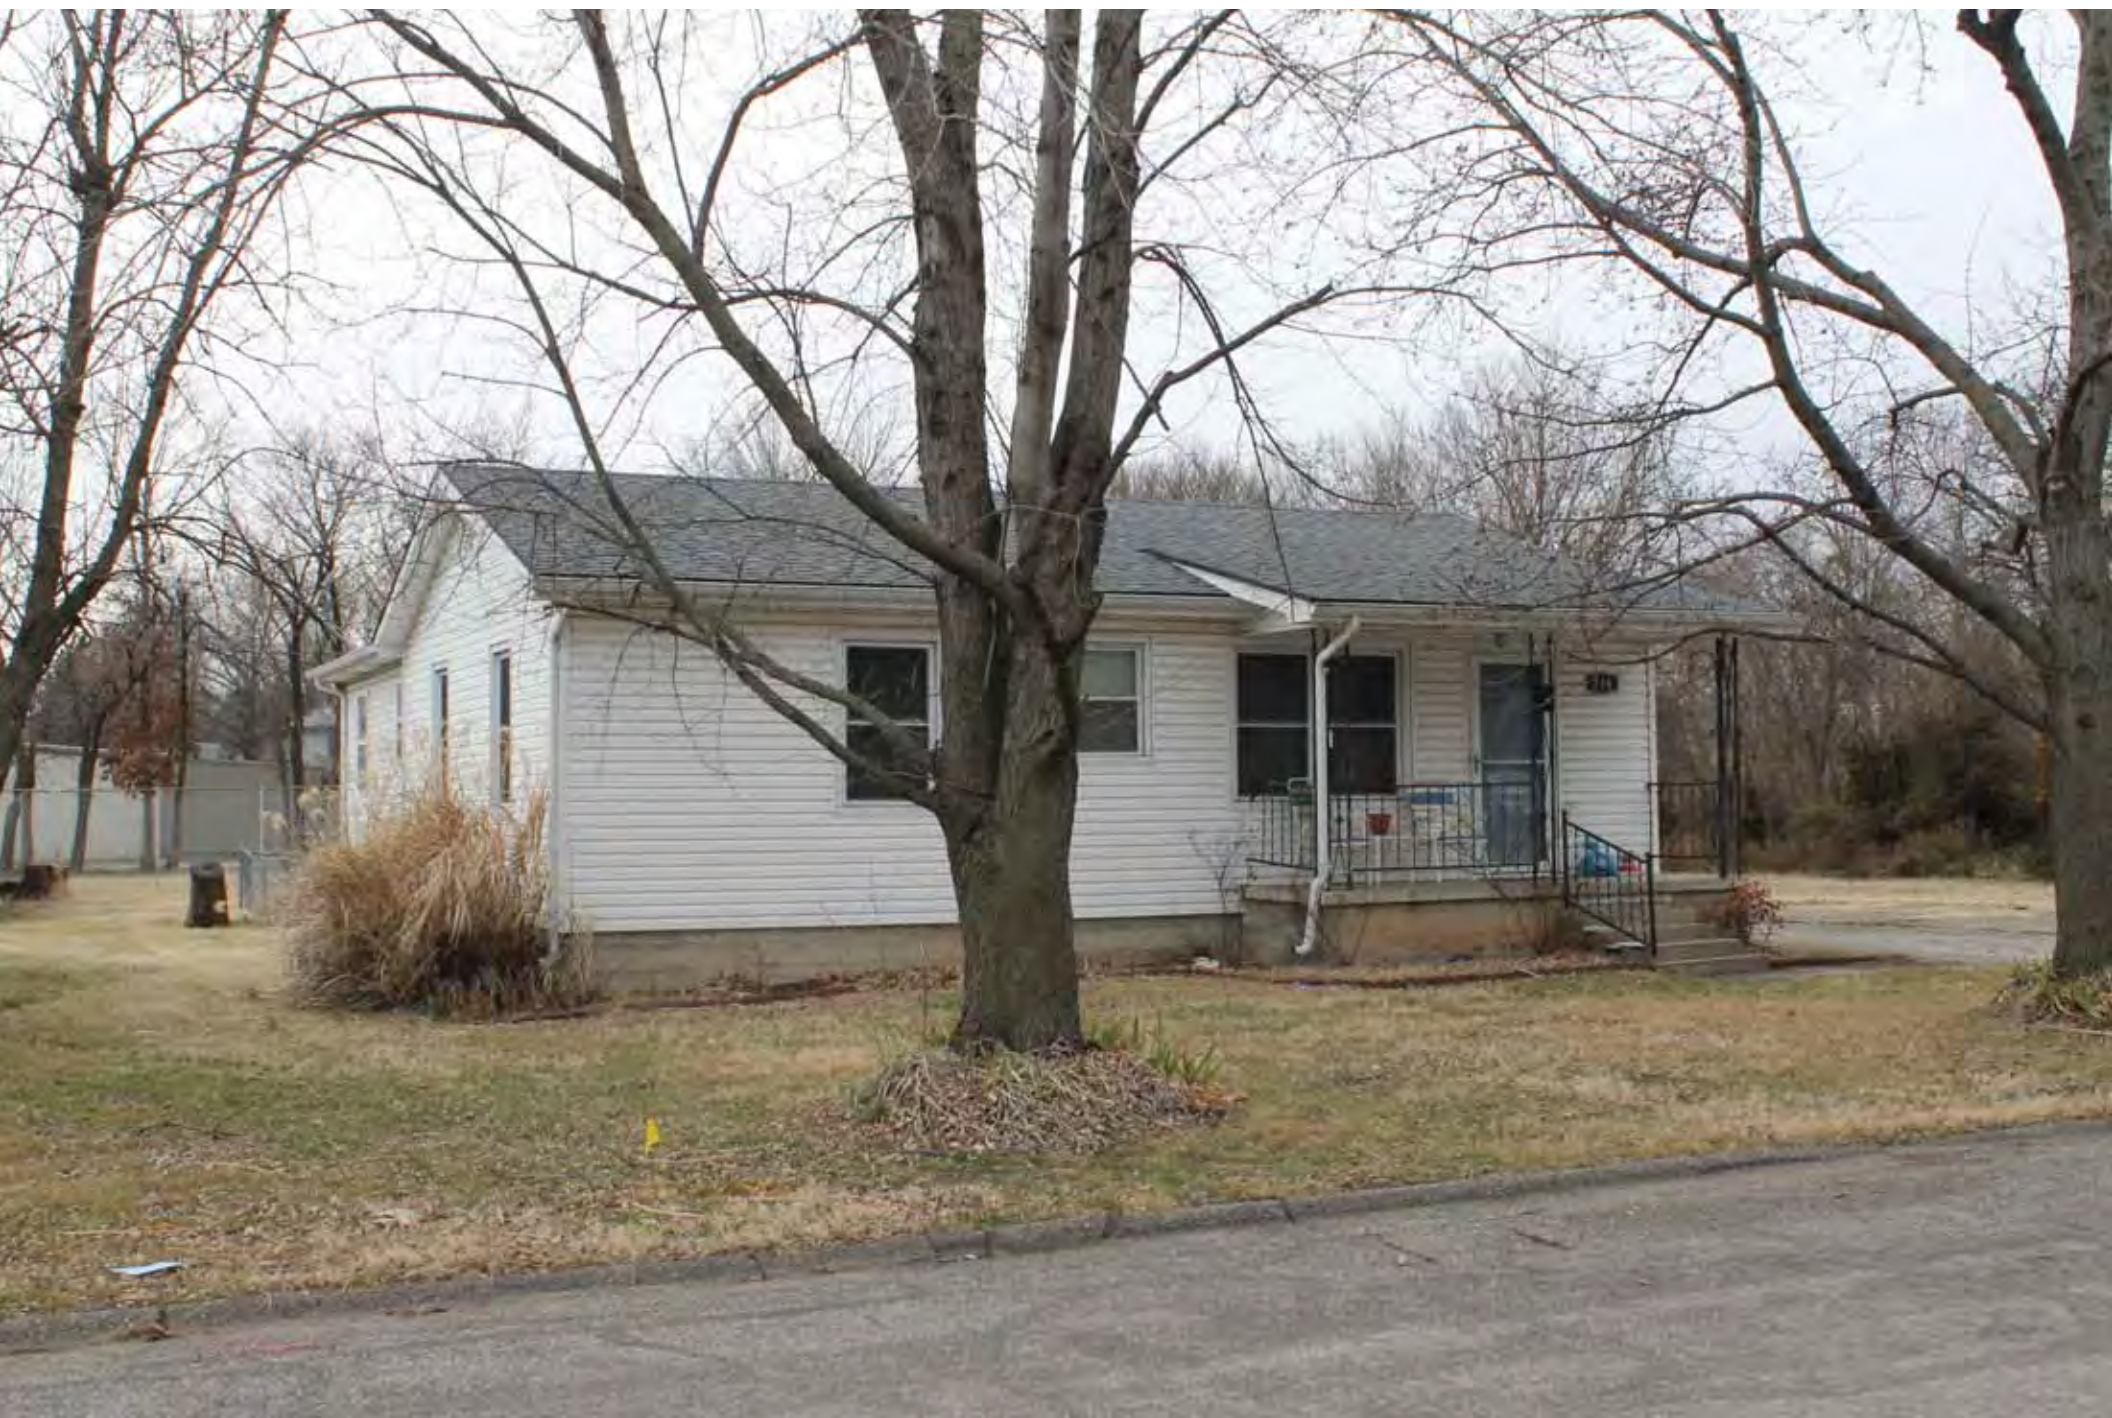
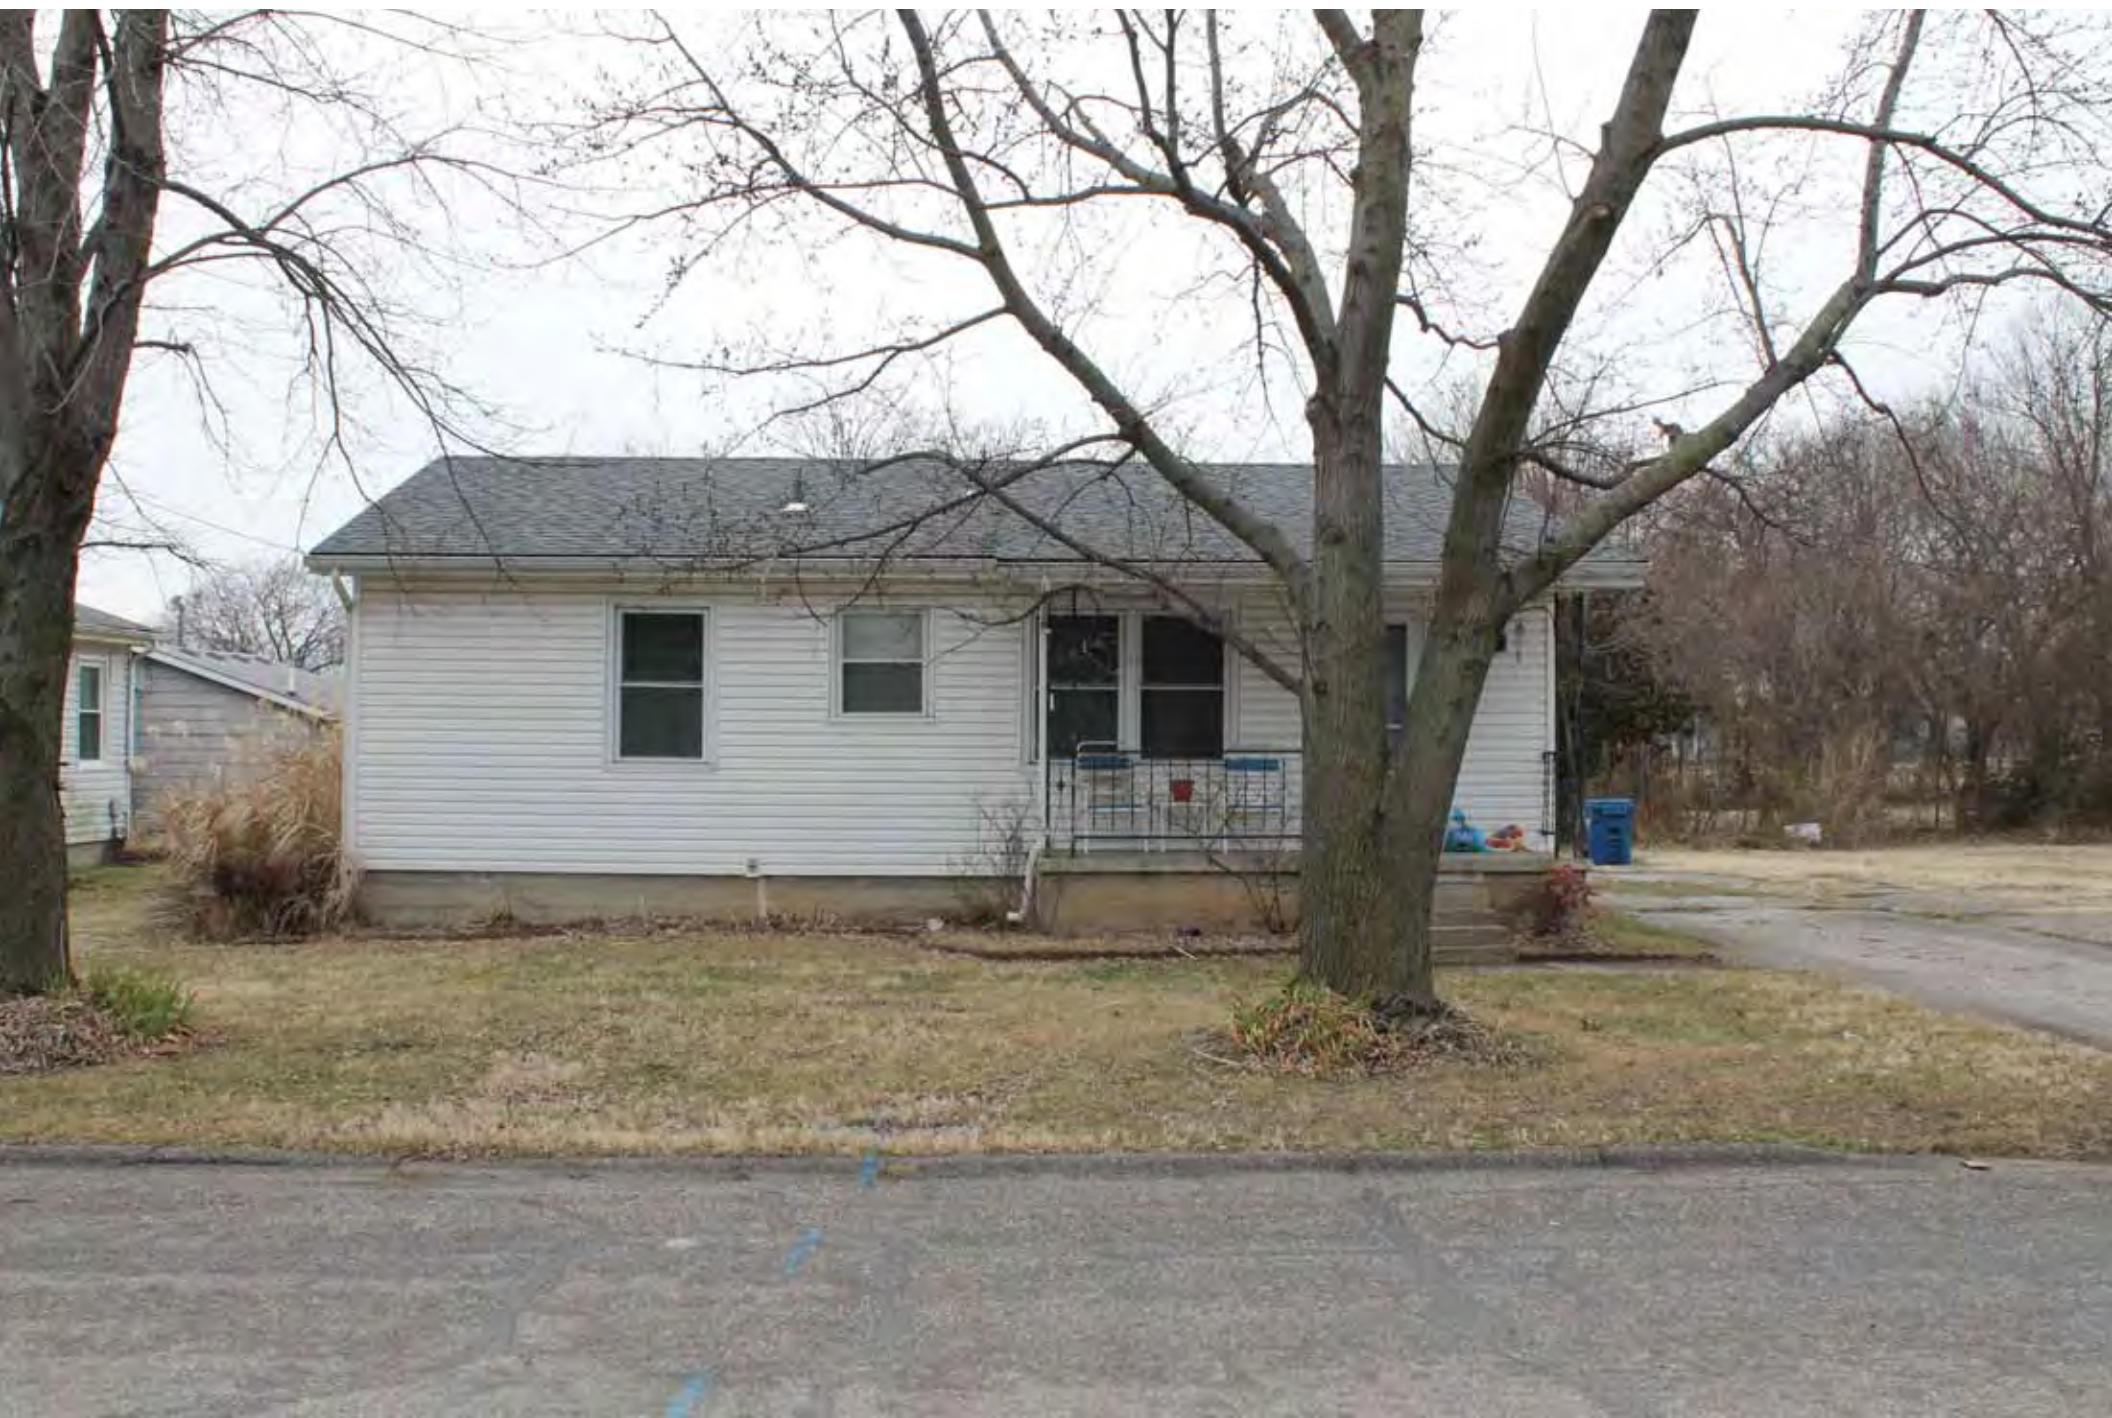
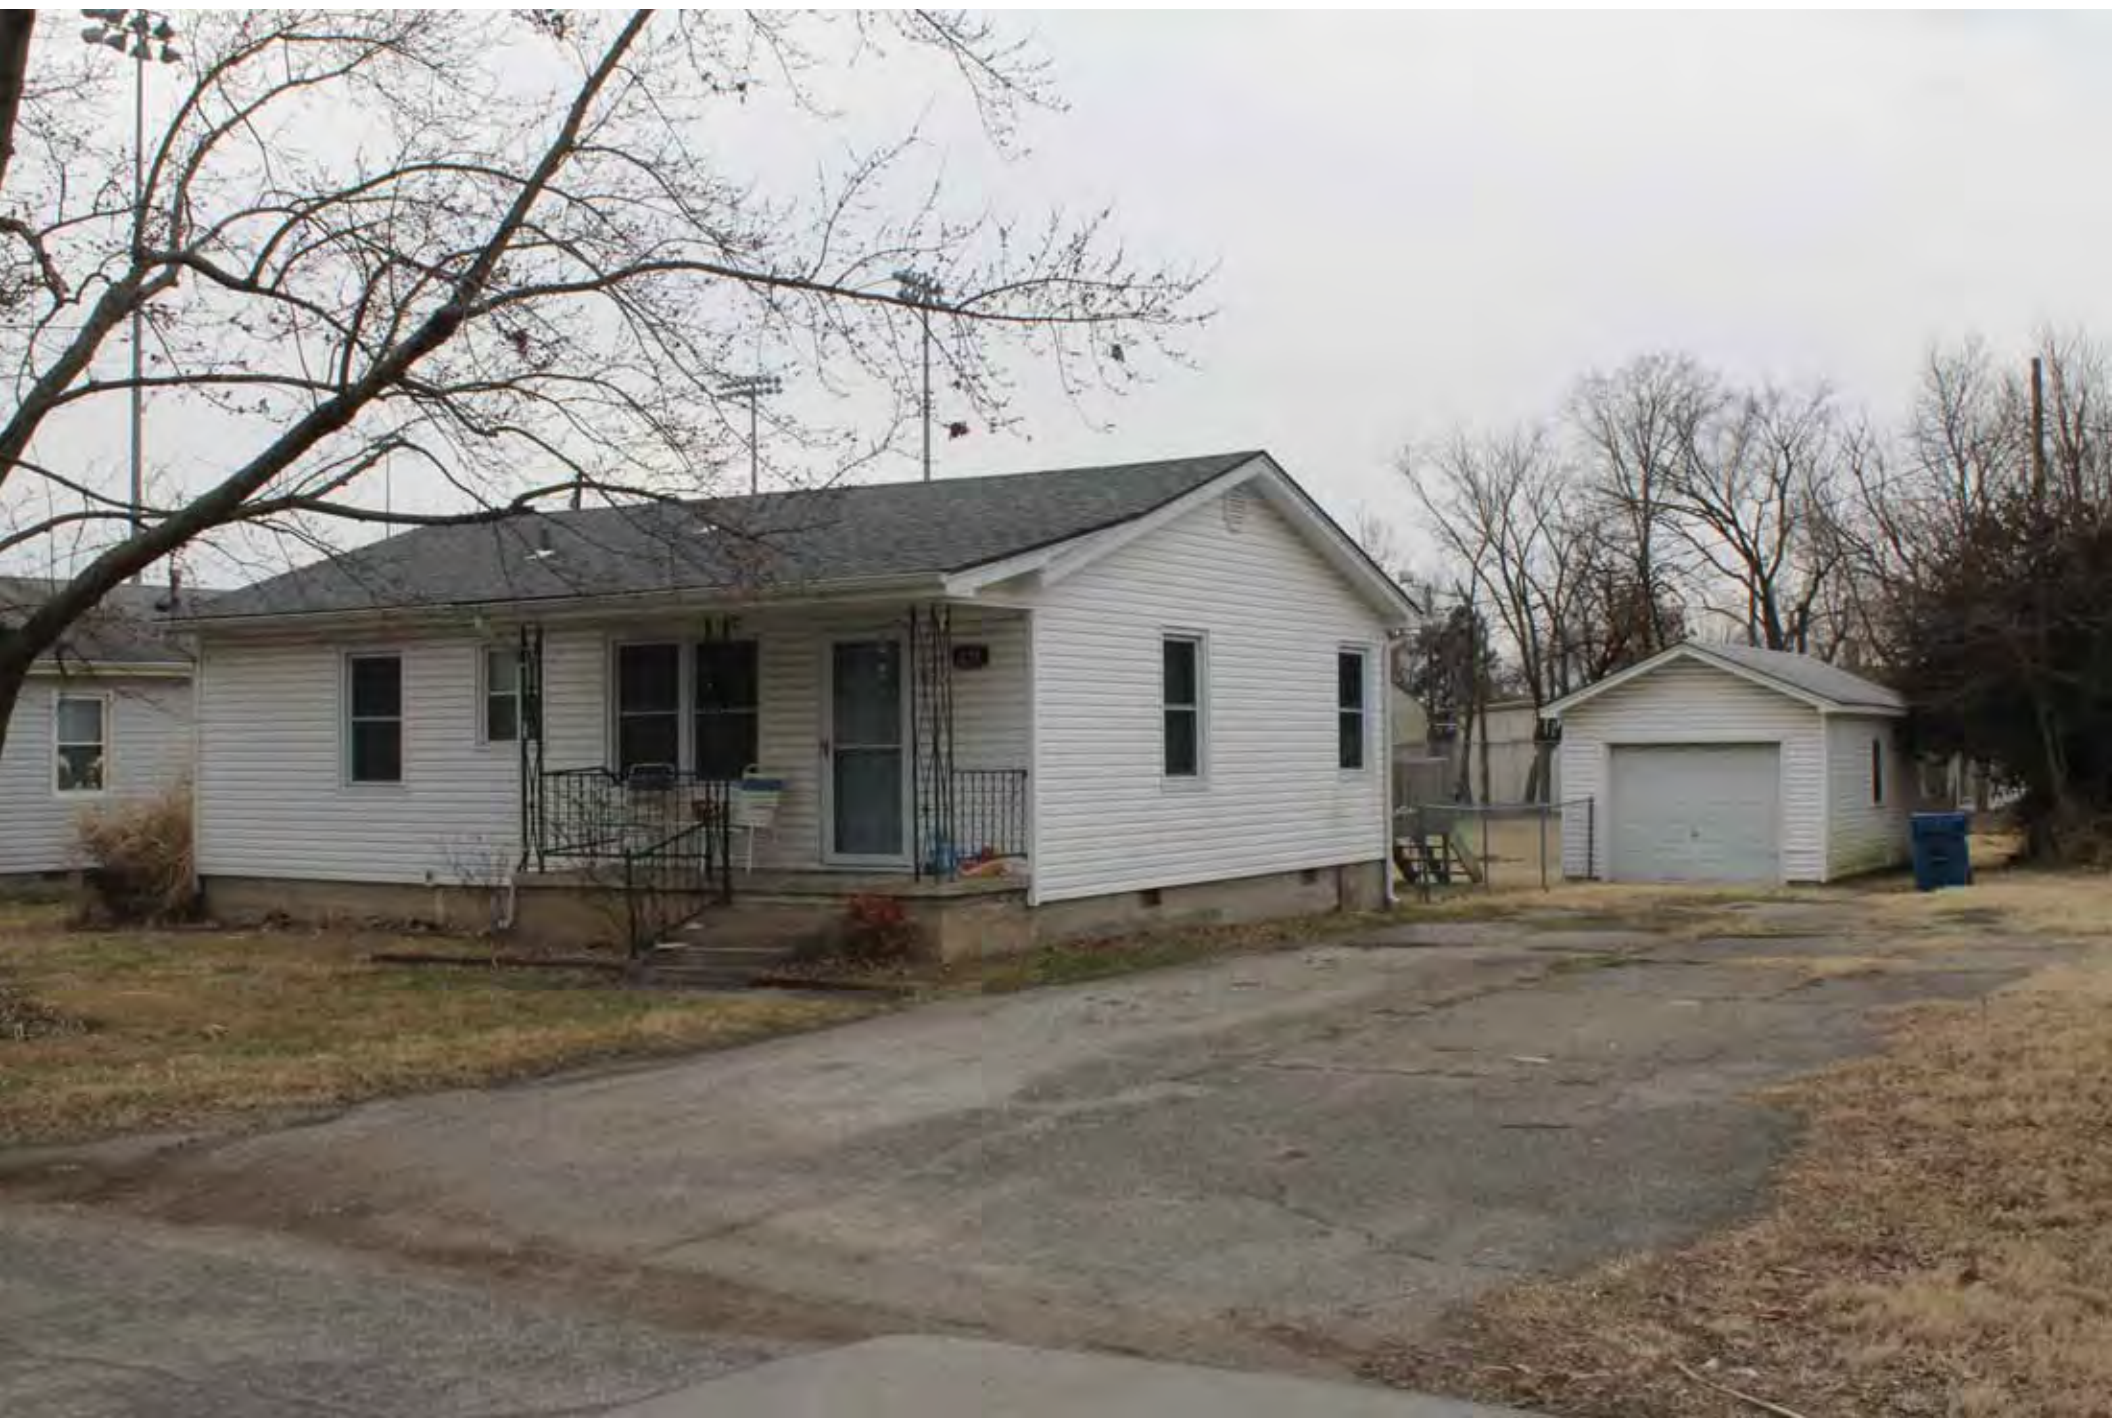
The property at 234 S. Comingo Avenue supports a single-story dwelling with an asphalt shingled gable roof, exterior c. 2018 vinyl siding and a concrete foundation. The primary (east) elevation supports an off-center shed porch supported by wrought iron columns. The porch has a concrete base and is surrounded by a wrought iron balustrade. Within the porch bay is a paneled door. Offsetting the door are paired and single one-over-one windows (three bays). The north elevation holds two one-over-one windows, as does the south elevation. Windows appear to have been replaced c. 2018. The dwelling has a rear shed wing and rear deck on the west elevation. Eaves are enclosed. Gable fields hold contemporary vents.
