MISSOURI DEPARTMENT OF NATURAL RESOURCES
STATE HISTORIC PRESERVATION OFFICE, P.O. Box 176, Jefferson City, MO 65102
ARCHITECTURAL/HISTORIC INVENTORY FORM

1. Survey No. JP-AS-007-001		2. Survey name: East Town (Original Joplin) Historic Survey Phase 2	
3. County: JASPER		4. Address (Street No.) 618	Street (name) E. 2 nd Street
5. City: Joplin	Vicinity: <input type="checkbox"/>	6. Geographical Reference:	7. Township/Range/Section: T: R: S:
8. Historic name (if known):		9. Present/other name (if known):	
10. Ownership: <input checked="" type="checkbox"/> Private <input type="checkbox"/> Public		11a. Historic use (if known): Domestic: Single Dwelling	11b. Current use: Domestic: Single Dwelling

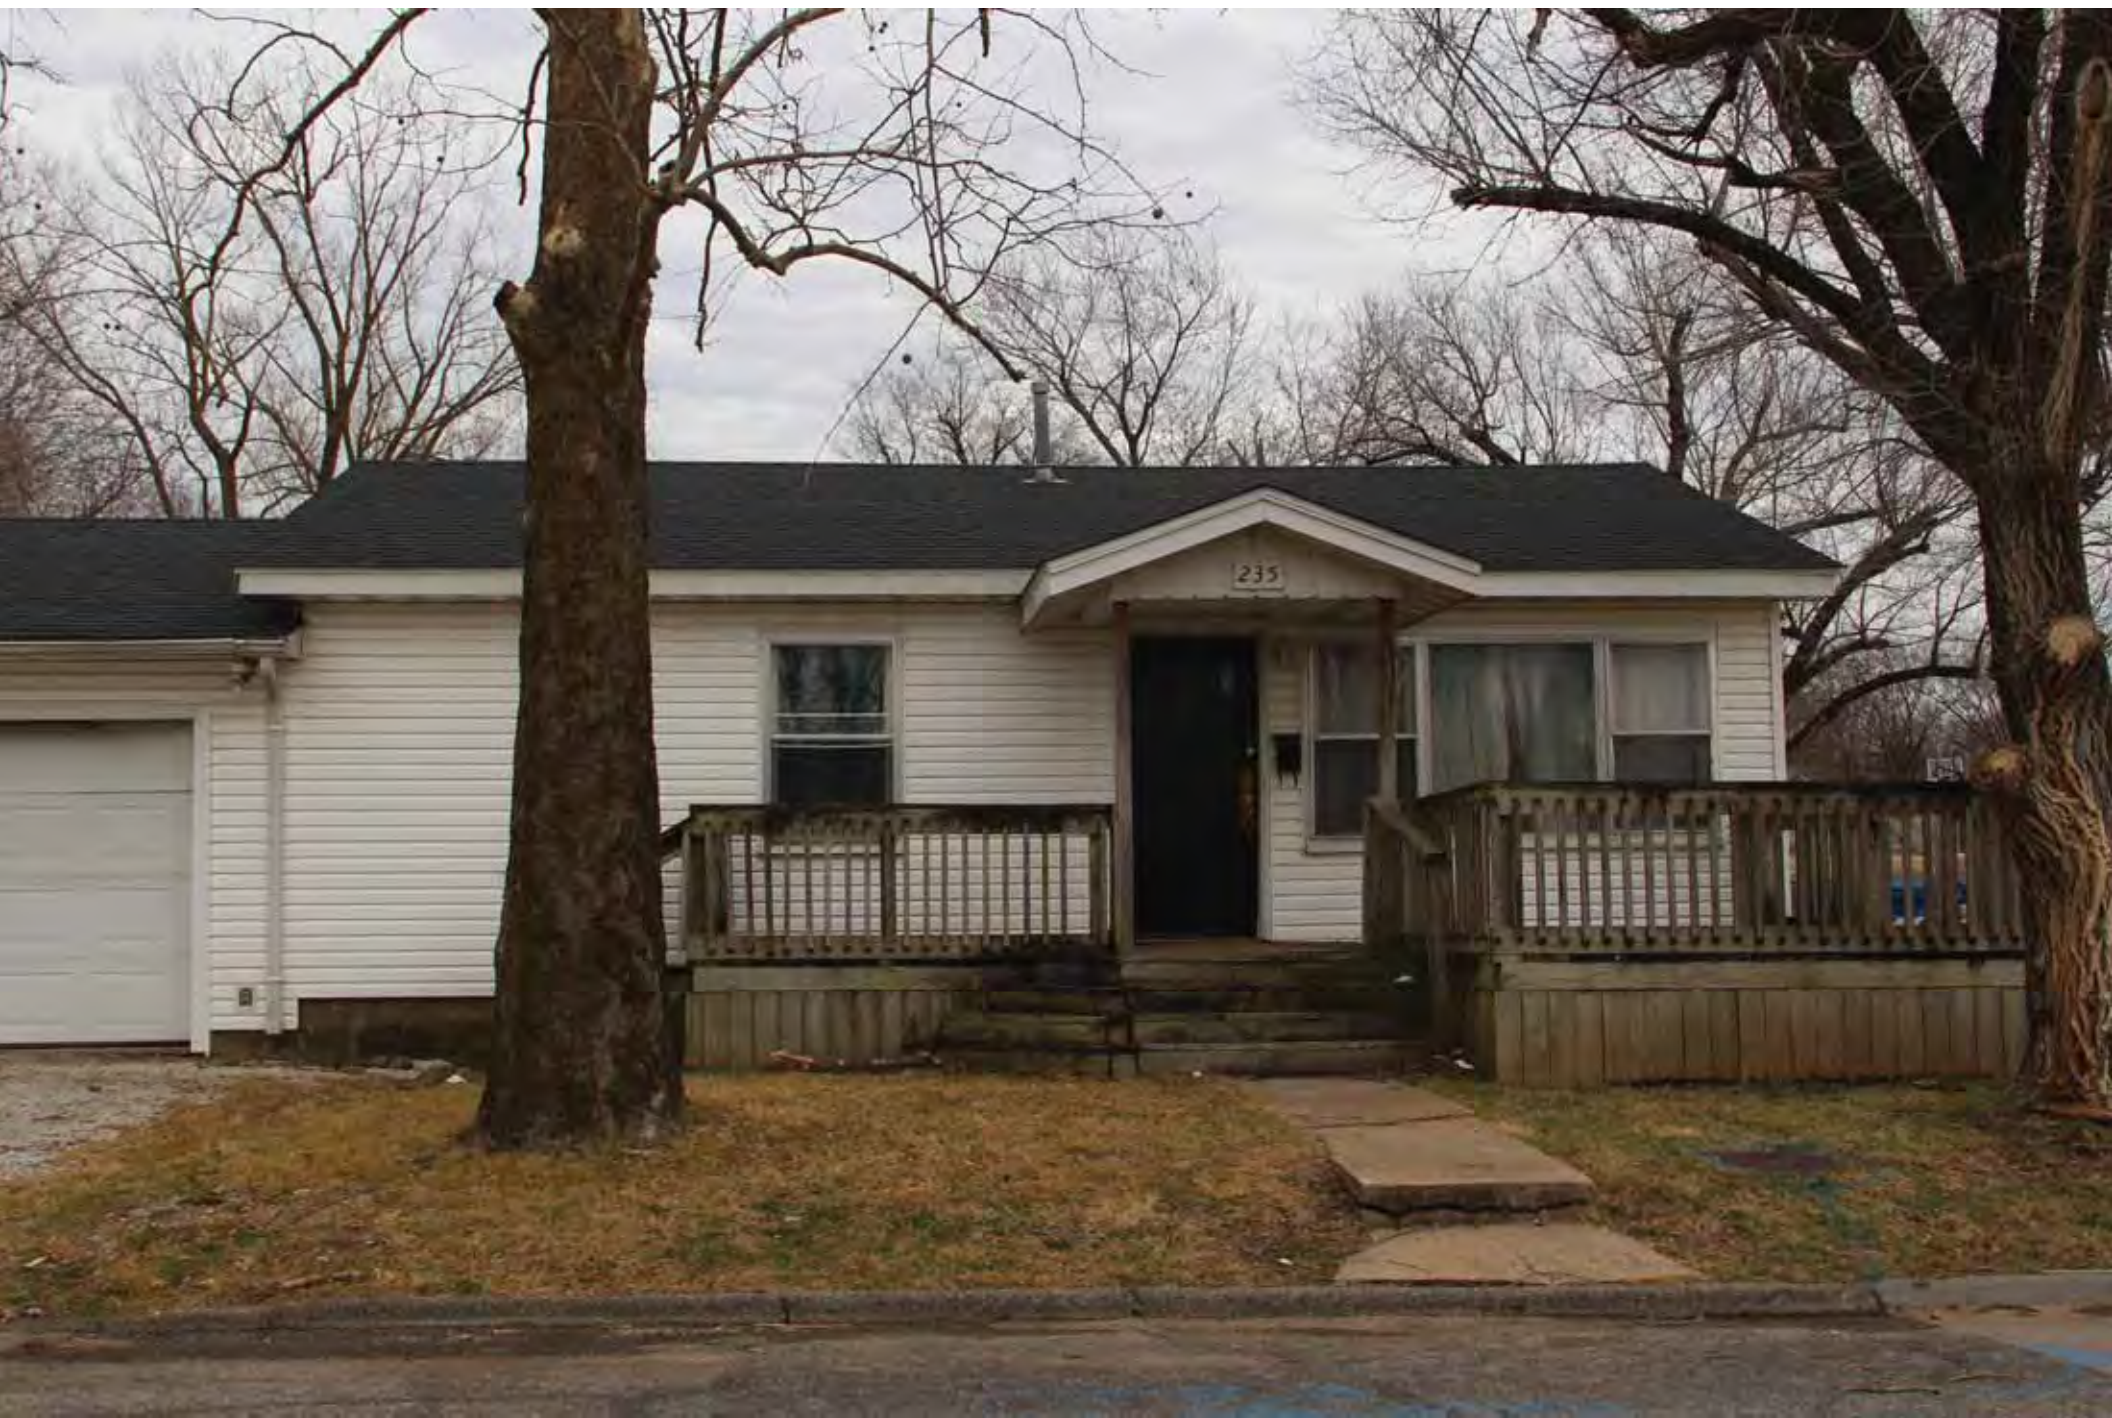
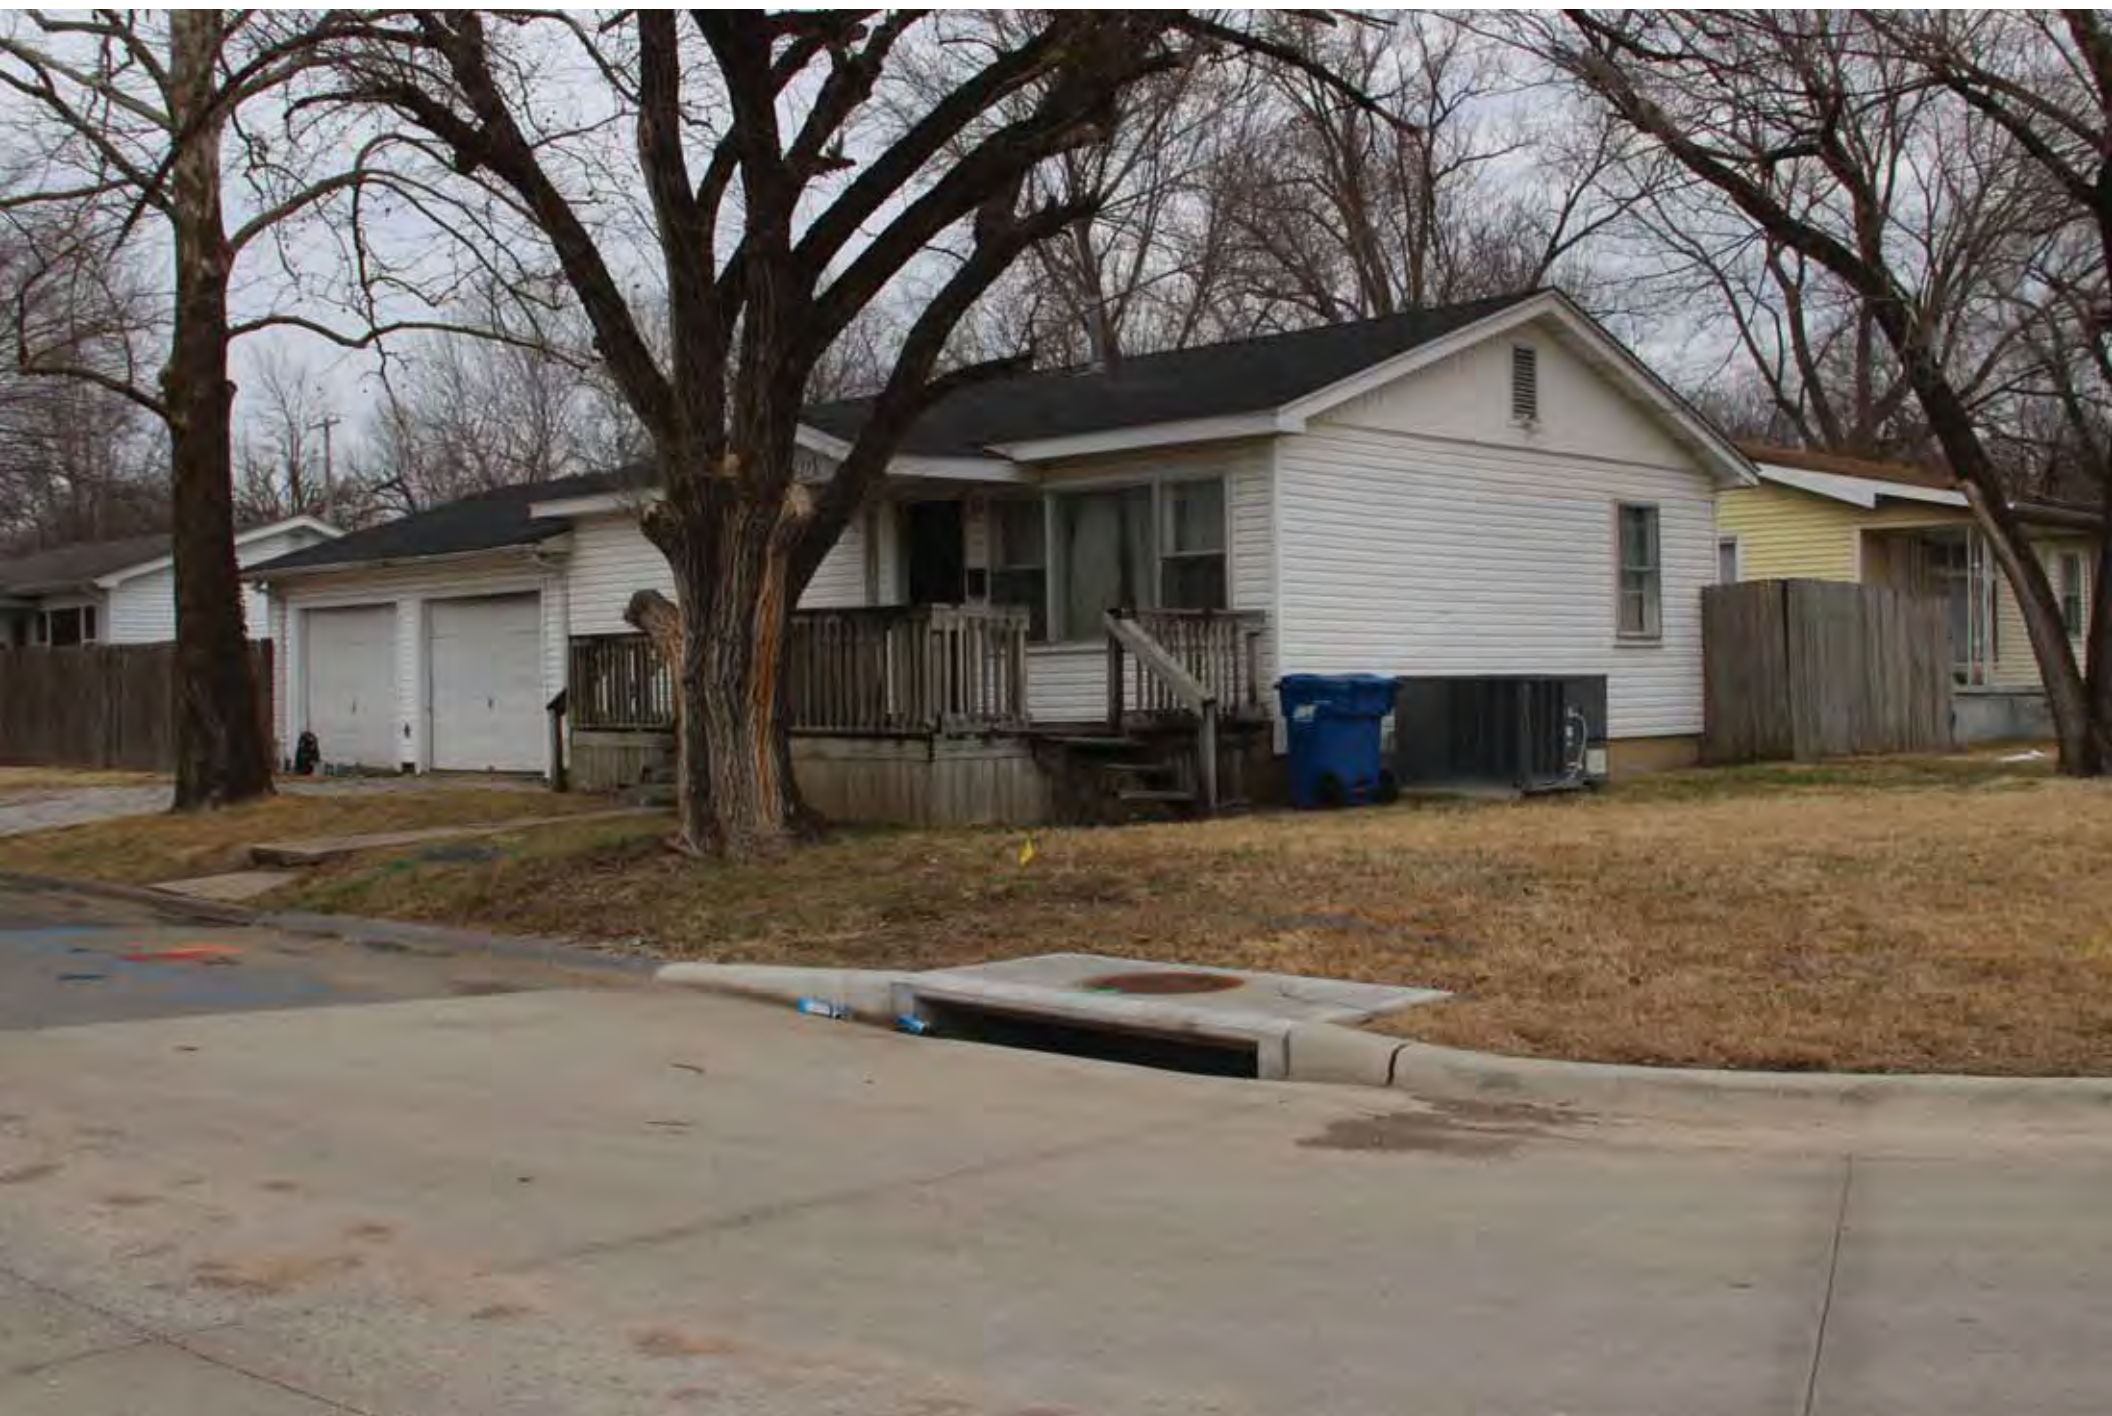
The property at 235 S. Comingo Avenue supports a single-story dwelling with an asphalt-shingled gabled roof, exterior vinyl siding (c. 2018) and a concrete foundation. The primary (west) elevation supports an off-center gabled portico supported by two slender wood columns. The portico posts rest on a wood deck that spans the façade. Within the portico bay is a paneled door. Flanking the door are a one-over-one window (north) and picture style window (south). At the north end of the dwelling is an attached two-car garage wing. The west elevation of the wing has two overhead track doors. The south elevation supports a single double-hung window. Gable fields hold original vertical board siding and louvered vents.

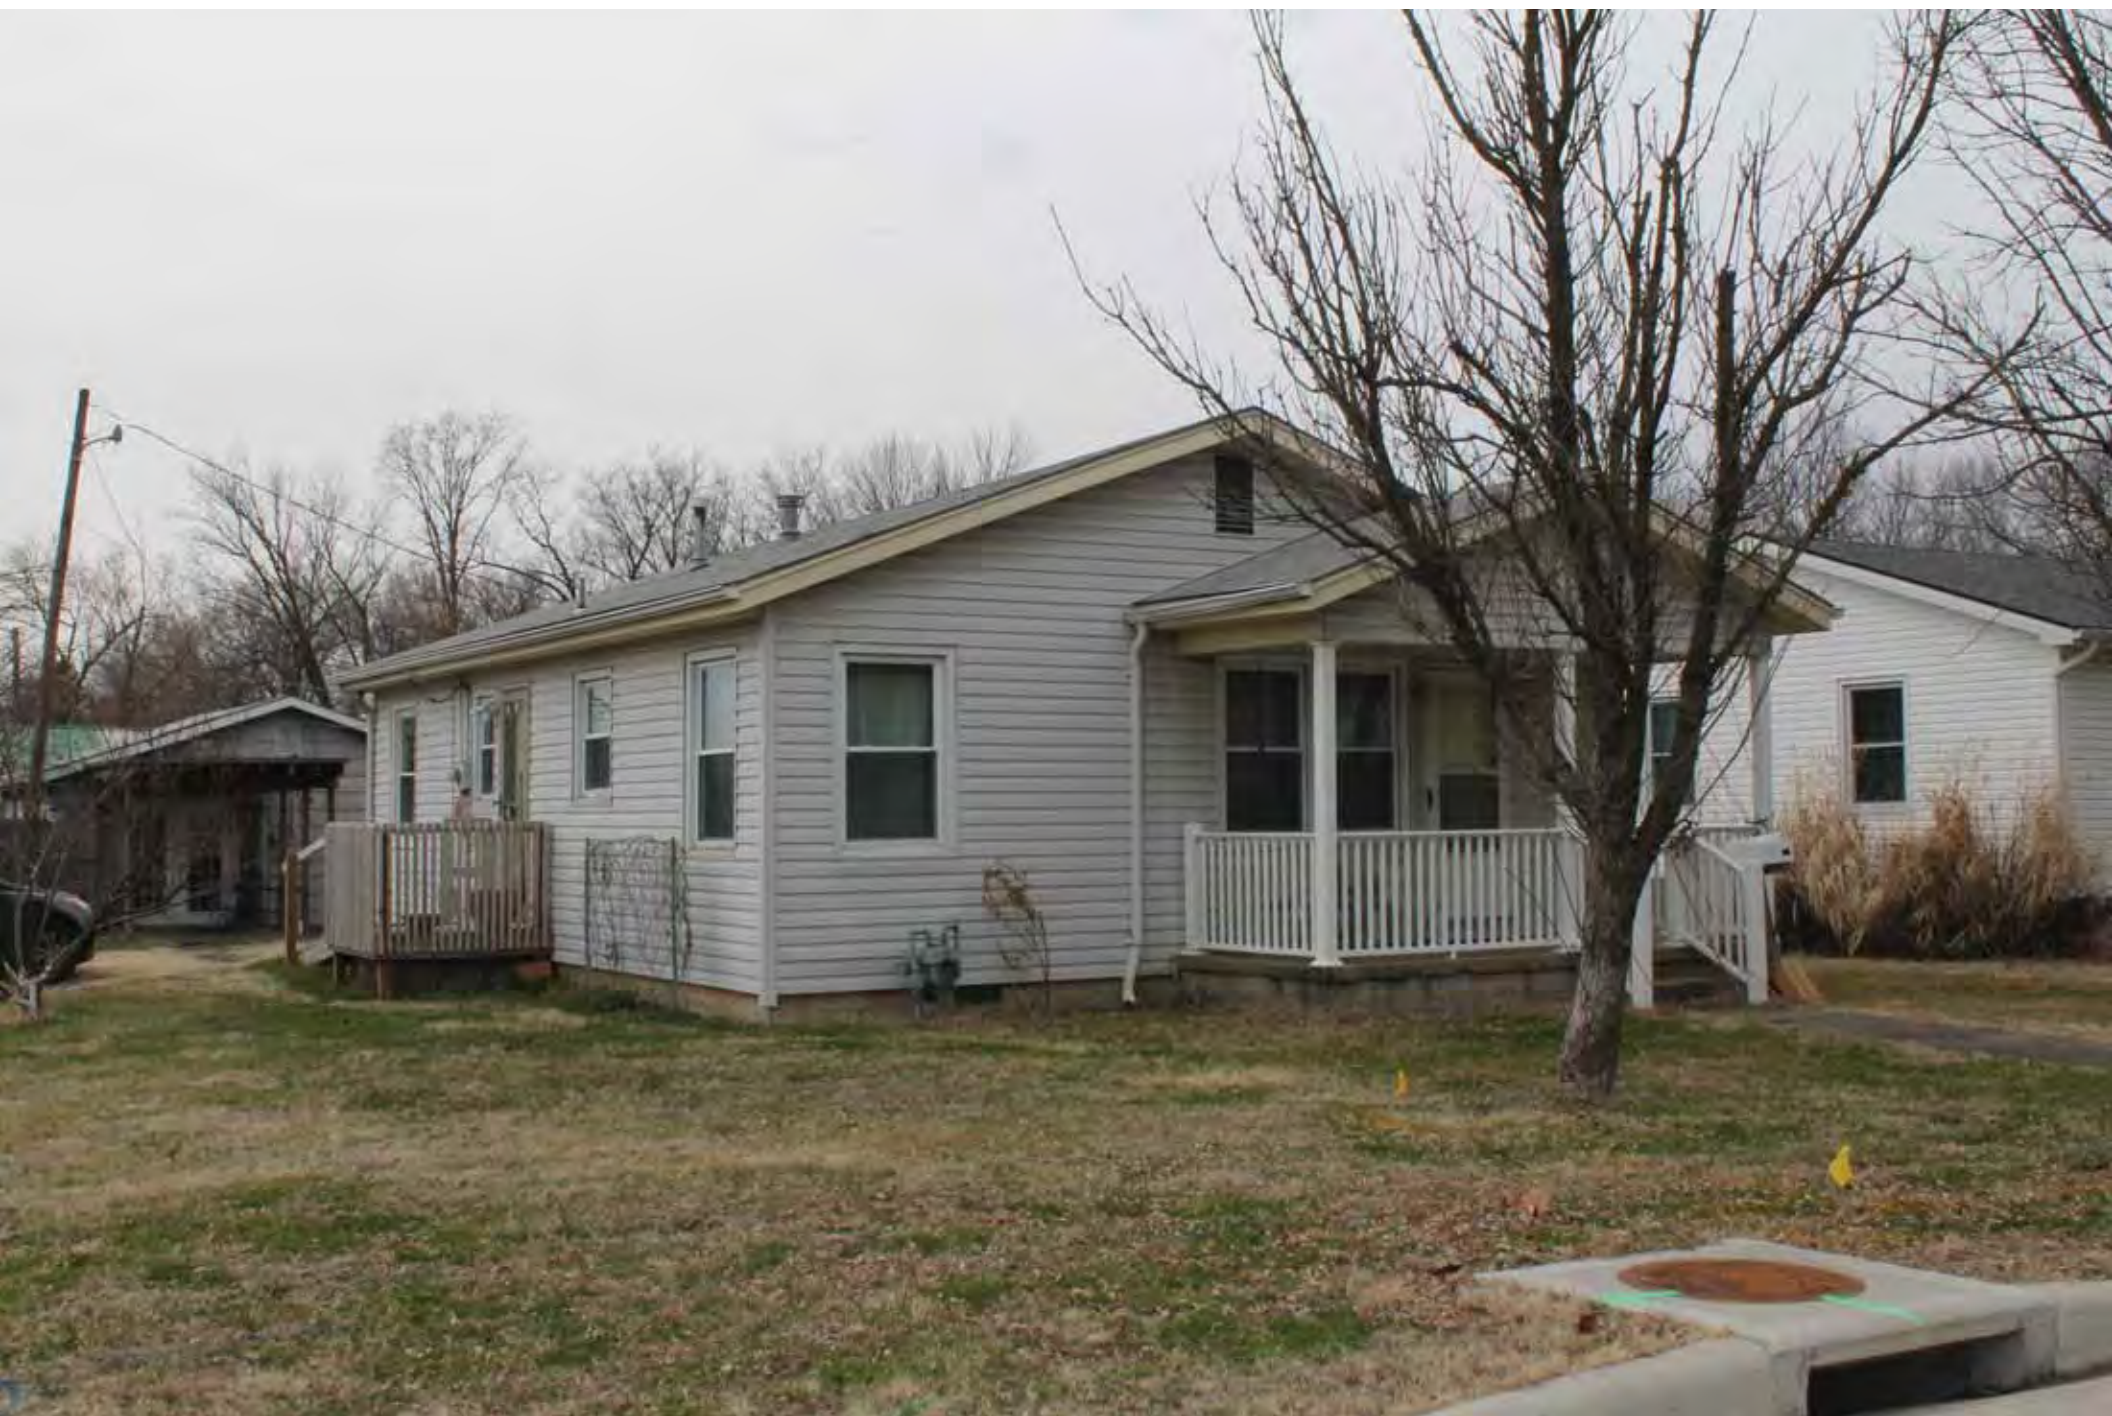
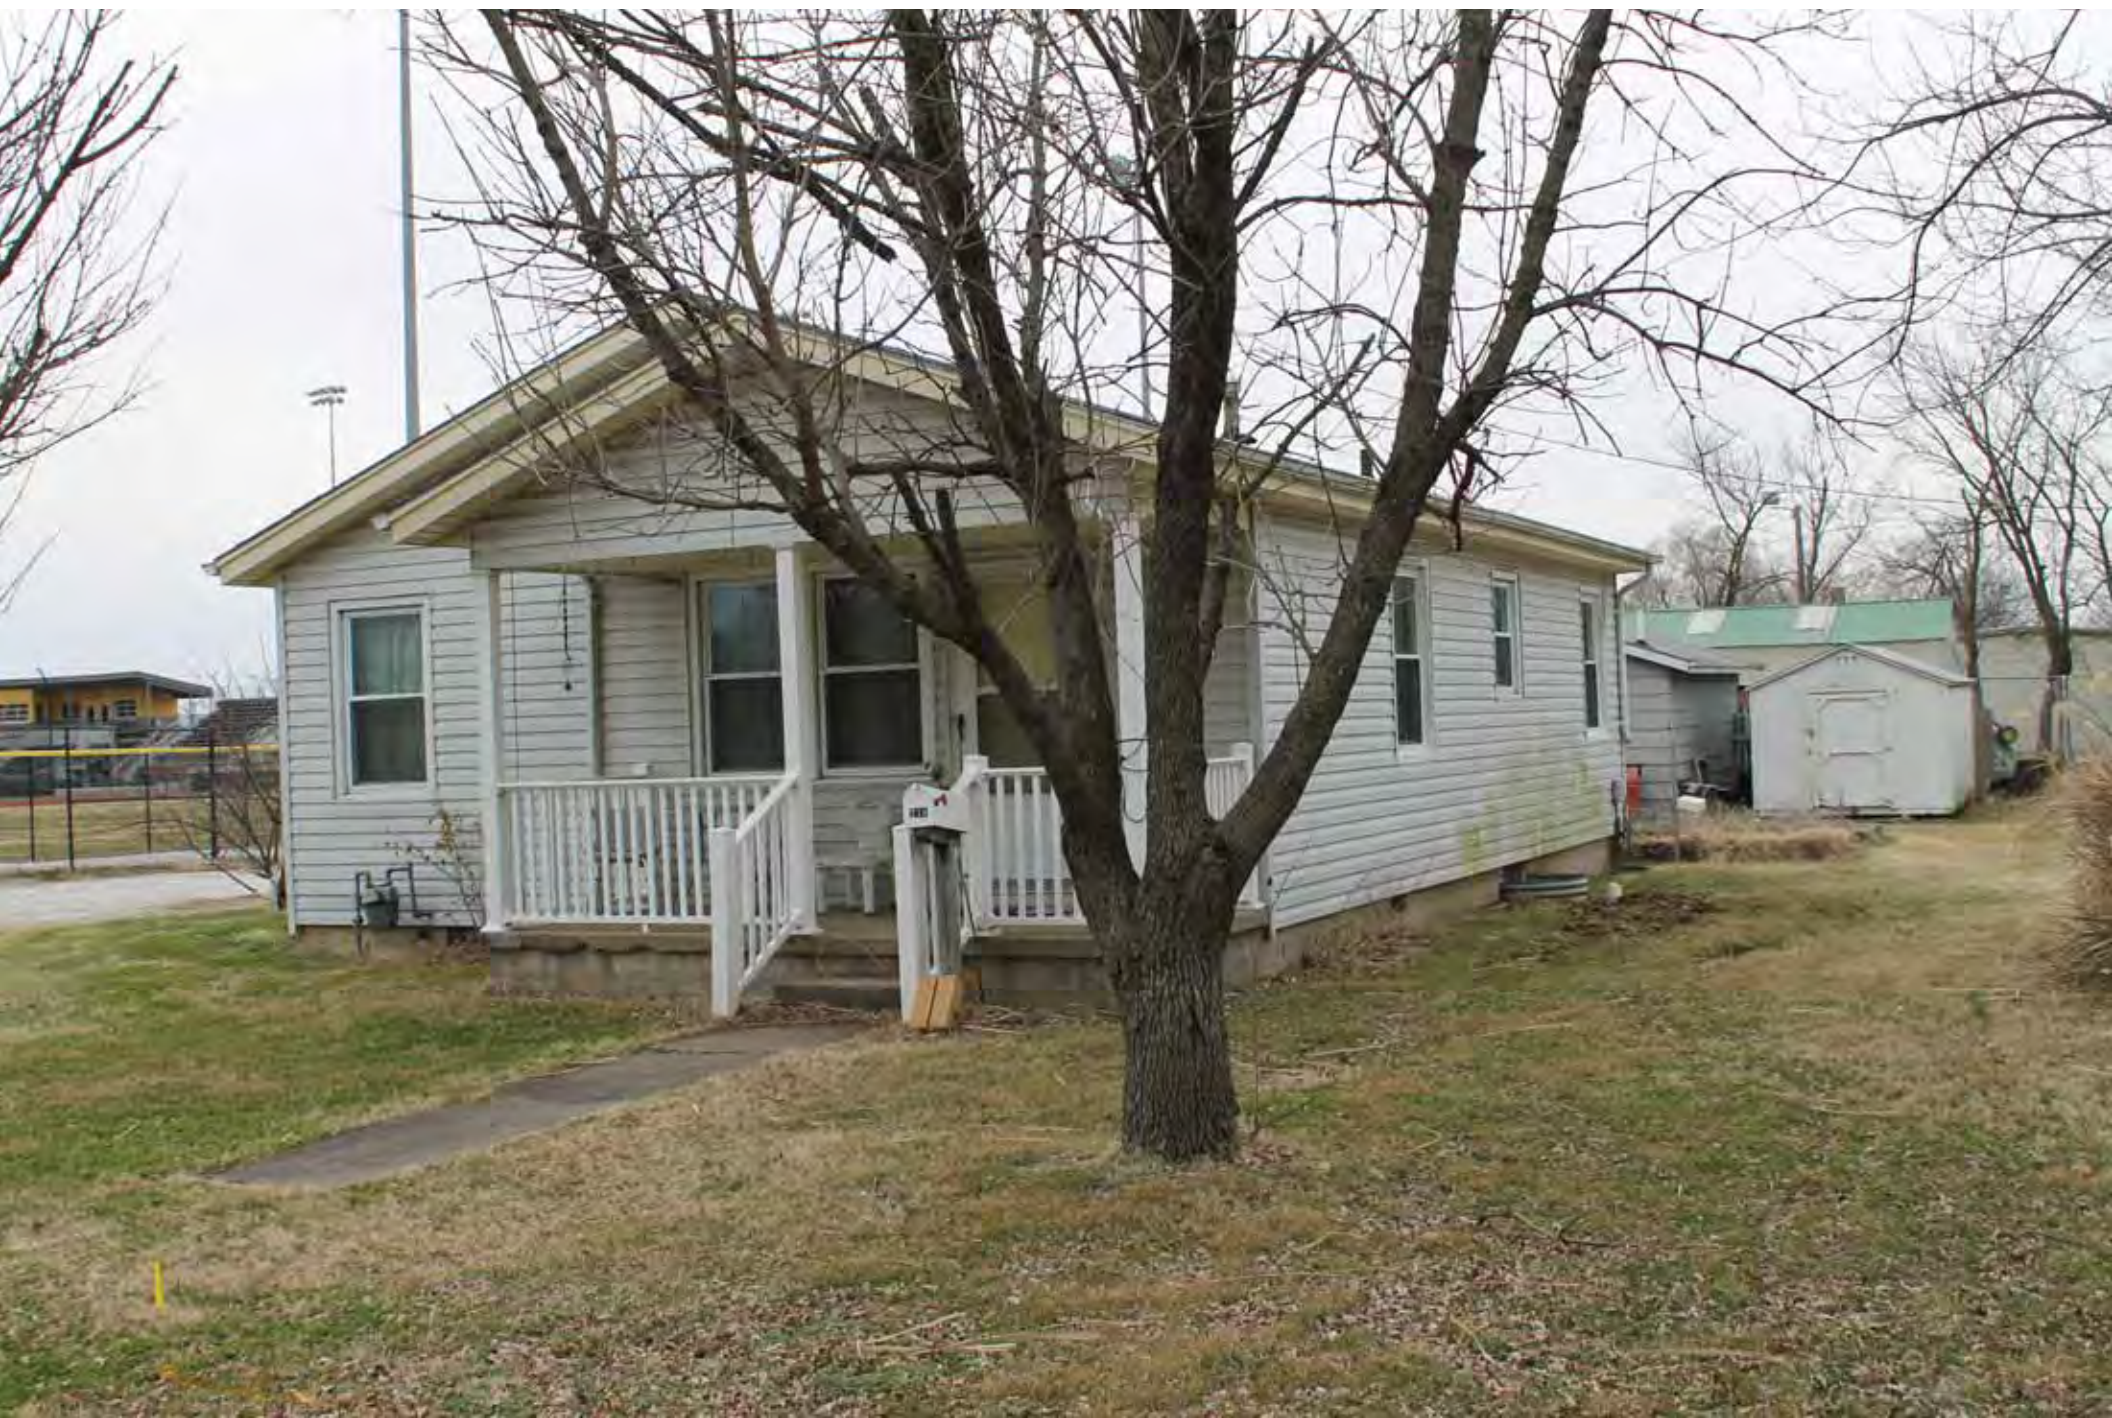
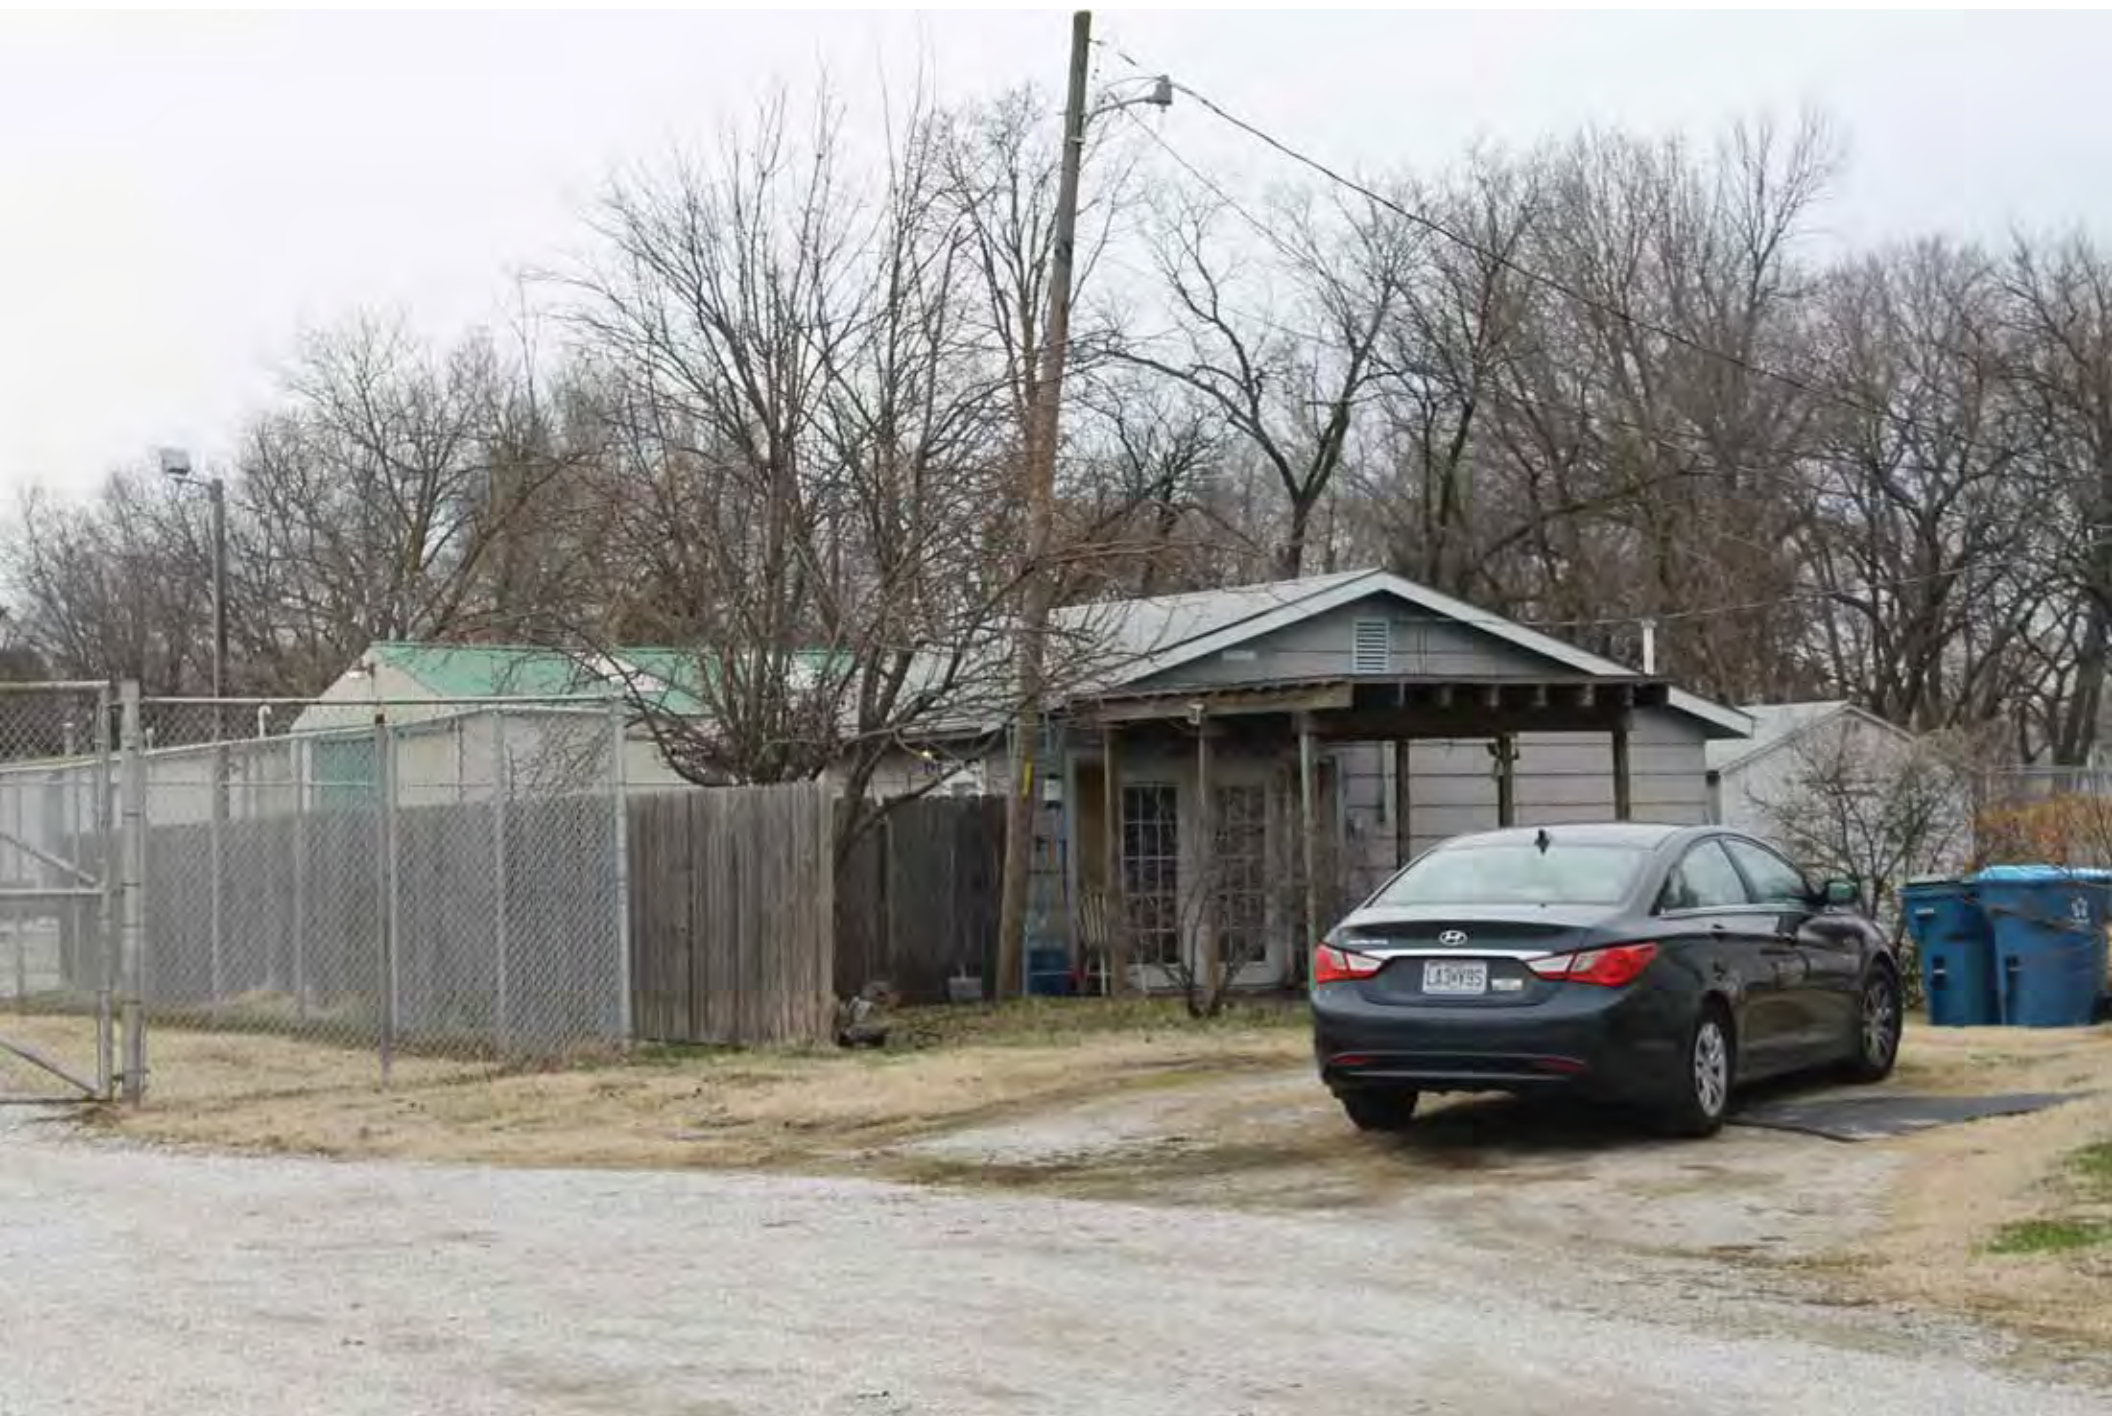
The property at 238 S. Comingo Avenue supports a single-story dwelling with an asphalt-shingled gabled roof, exterior vinyl siding (c. 2010) and a concrete foundation. The primary (east) elevation supports an off-center gabled porch supported by vinyl columns. A vinyl balustrade surrounds the concrete porch base. Within the porch bay is a paneled door offset by paired one-over-one windows. South of the paired windows, the façade supports a single double-hung window. Window lights are replacement design (c. 2010). The north elevation supports three double-hung windows. The south elevation has a secondary entry bay and small frame deck. The elevation also supports four one-over-one windows. Gable fields have louvered vents.
