MISSOURI DEPARTMENT OF NATURAL RESOURCES
STATE HISTORIC PRESERVATION OFFICE, P.O. Box 176, Jefferson City, MO 65102
ARCHITECTURAL/HISTORIC INVENTORY FORM

1. Survey No. JP-AS-007-001		2. Survey name: East Town (Original Joplin) Historic Survey Phase 2	
3. County: JASPER		4. Address (Street No.) 618	Street (name) E. 2 nd Street
5. City: Joplin	Vicinity: <input type="checkbox"/>	6. Geographical Reference:	7. Township/Range/Section: T: R: S:
8. Historic name (if known):		9. Present/other name (if known):	
10. Ownership: <input checked="" type="checkbox"/> Private <input type="checkbox"/> Public		11a. Historic use (if known): Domestic: Single Dwelling	11b. Current use: Domestic: Single Dwelling

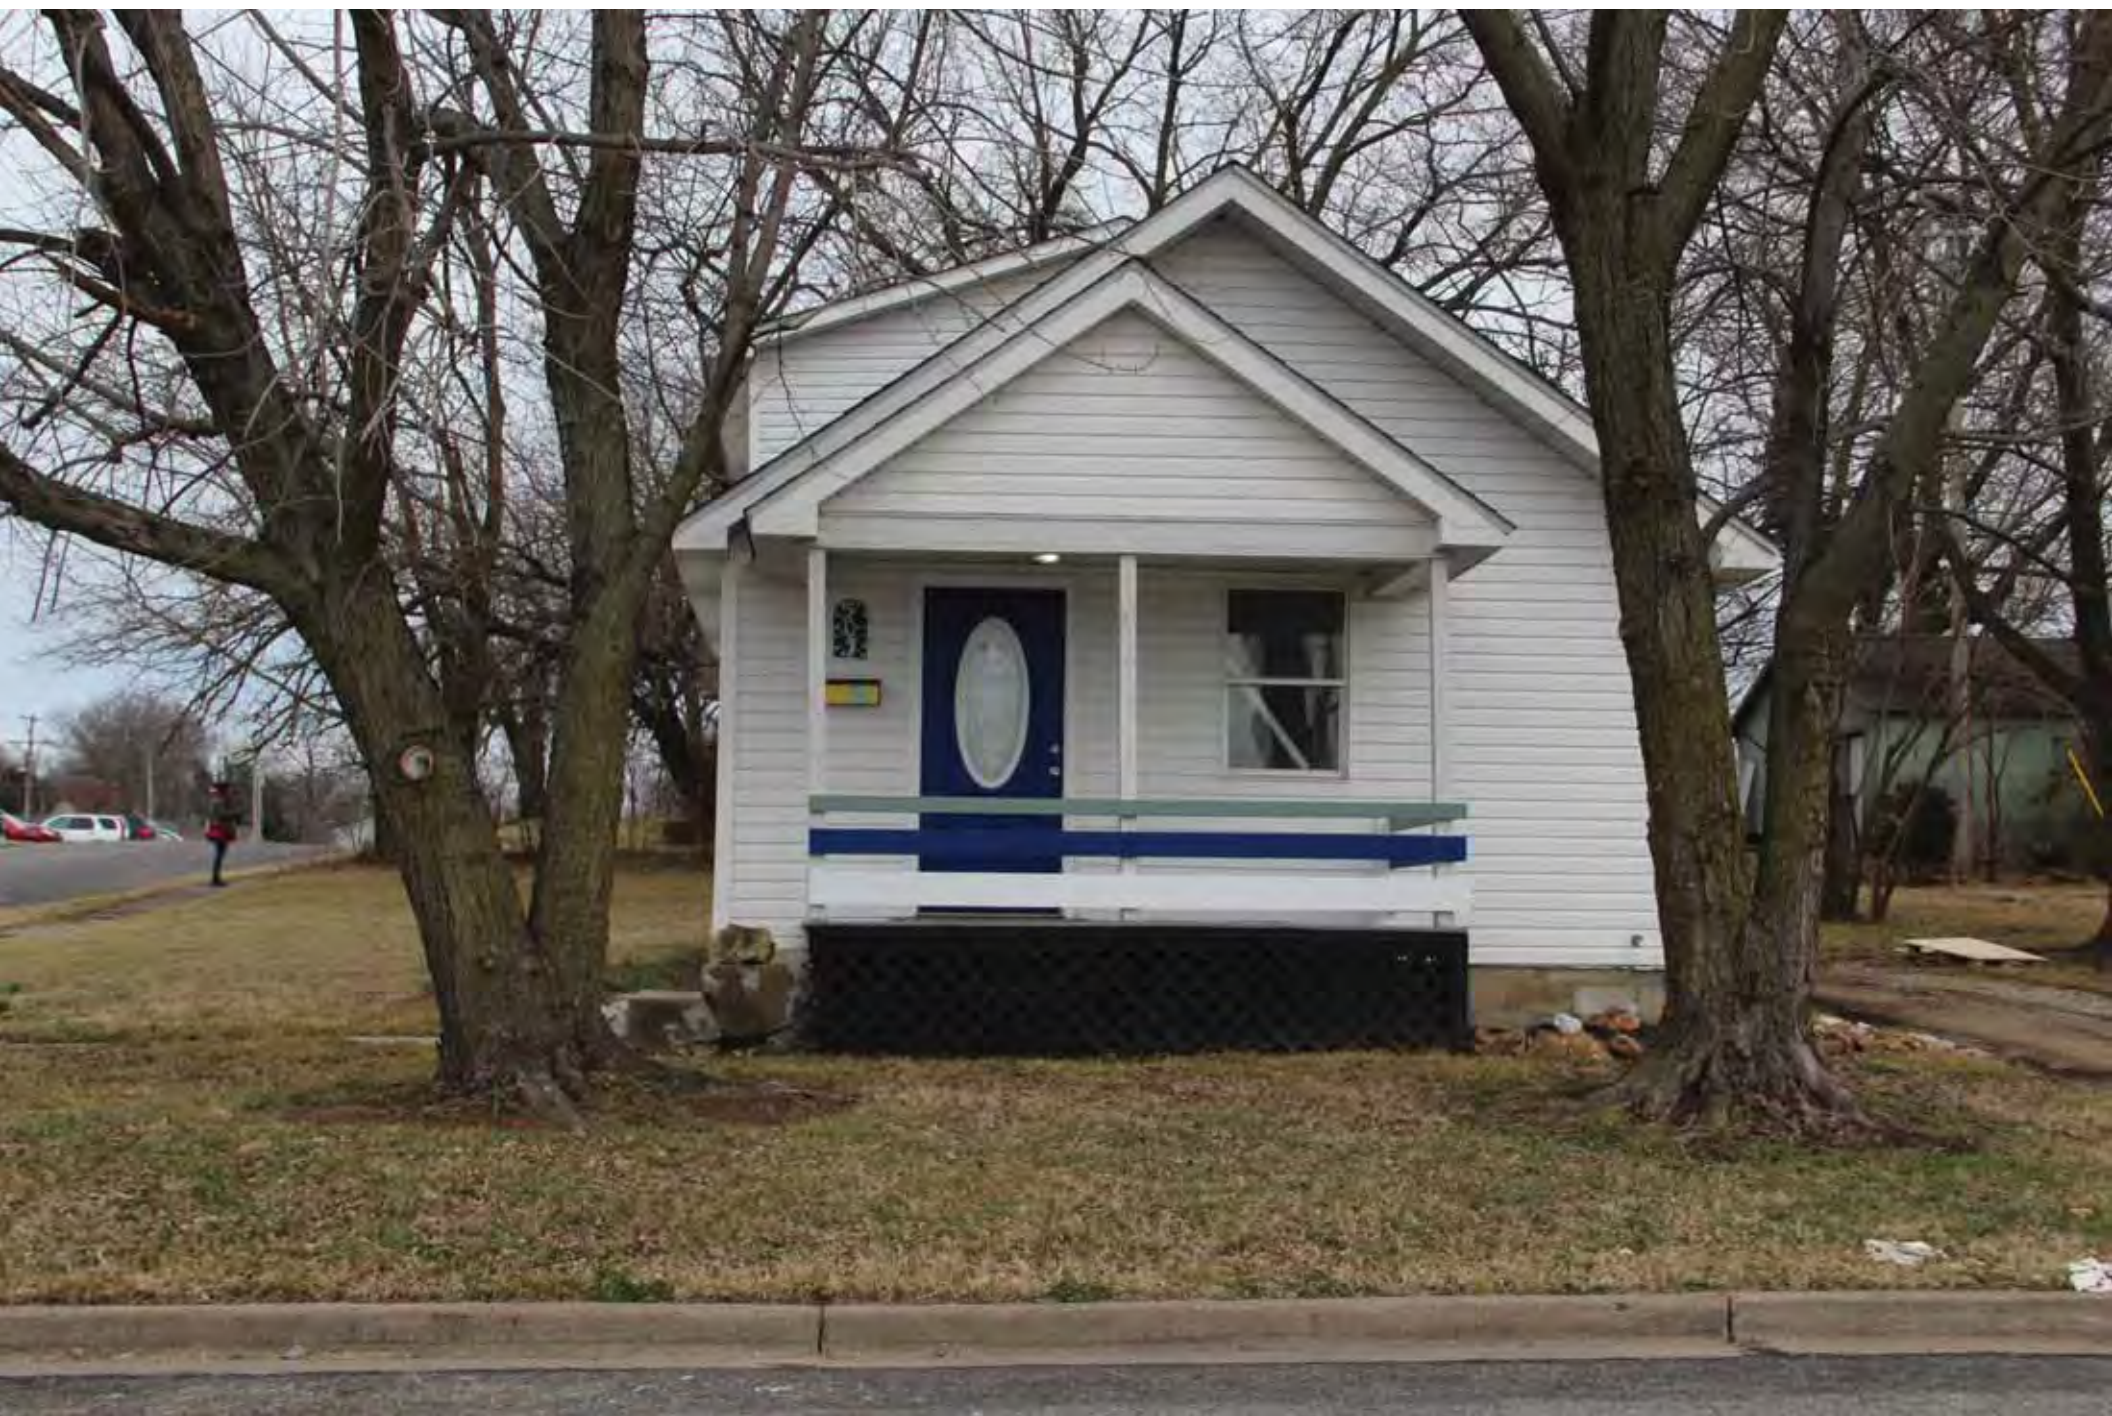
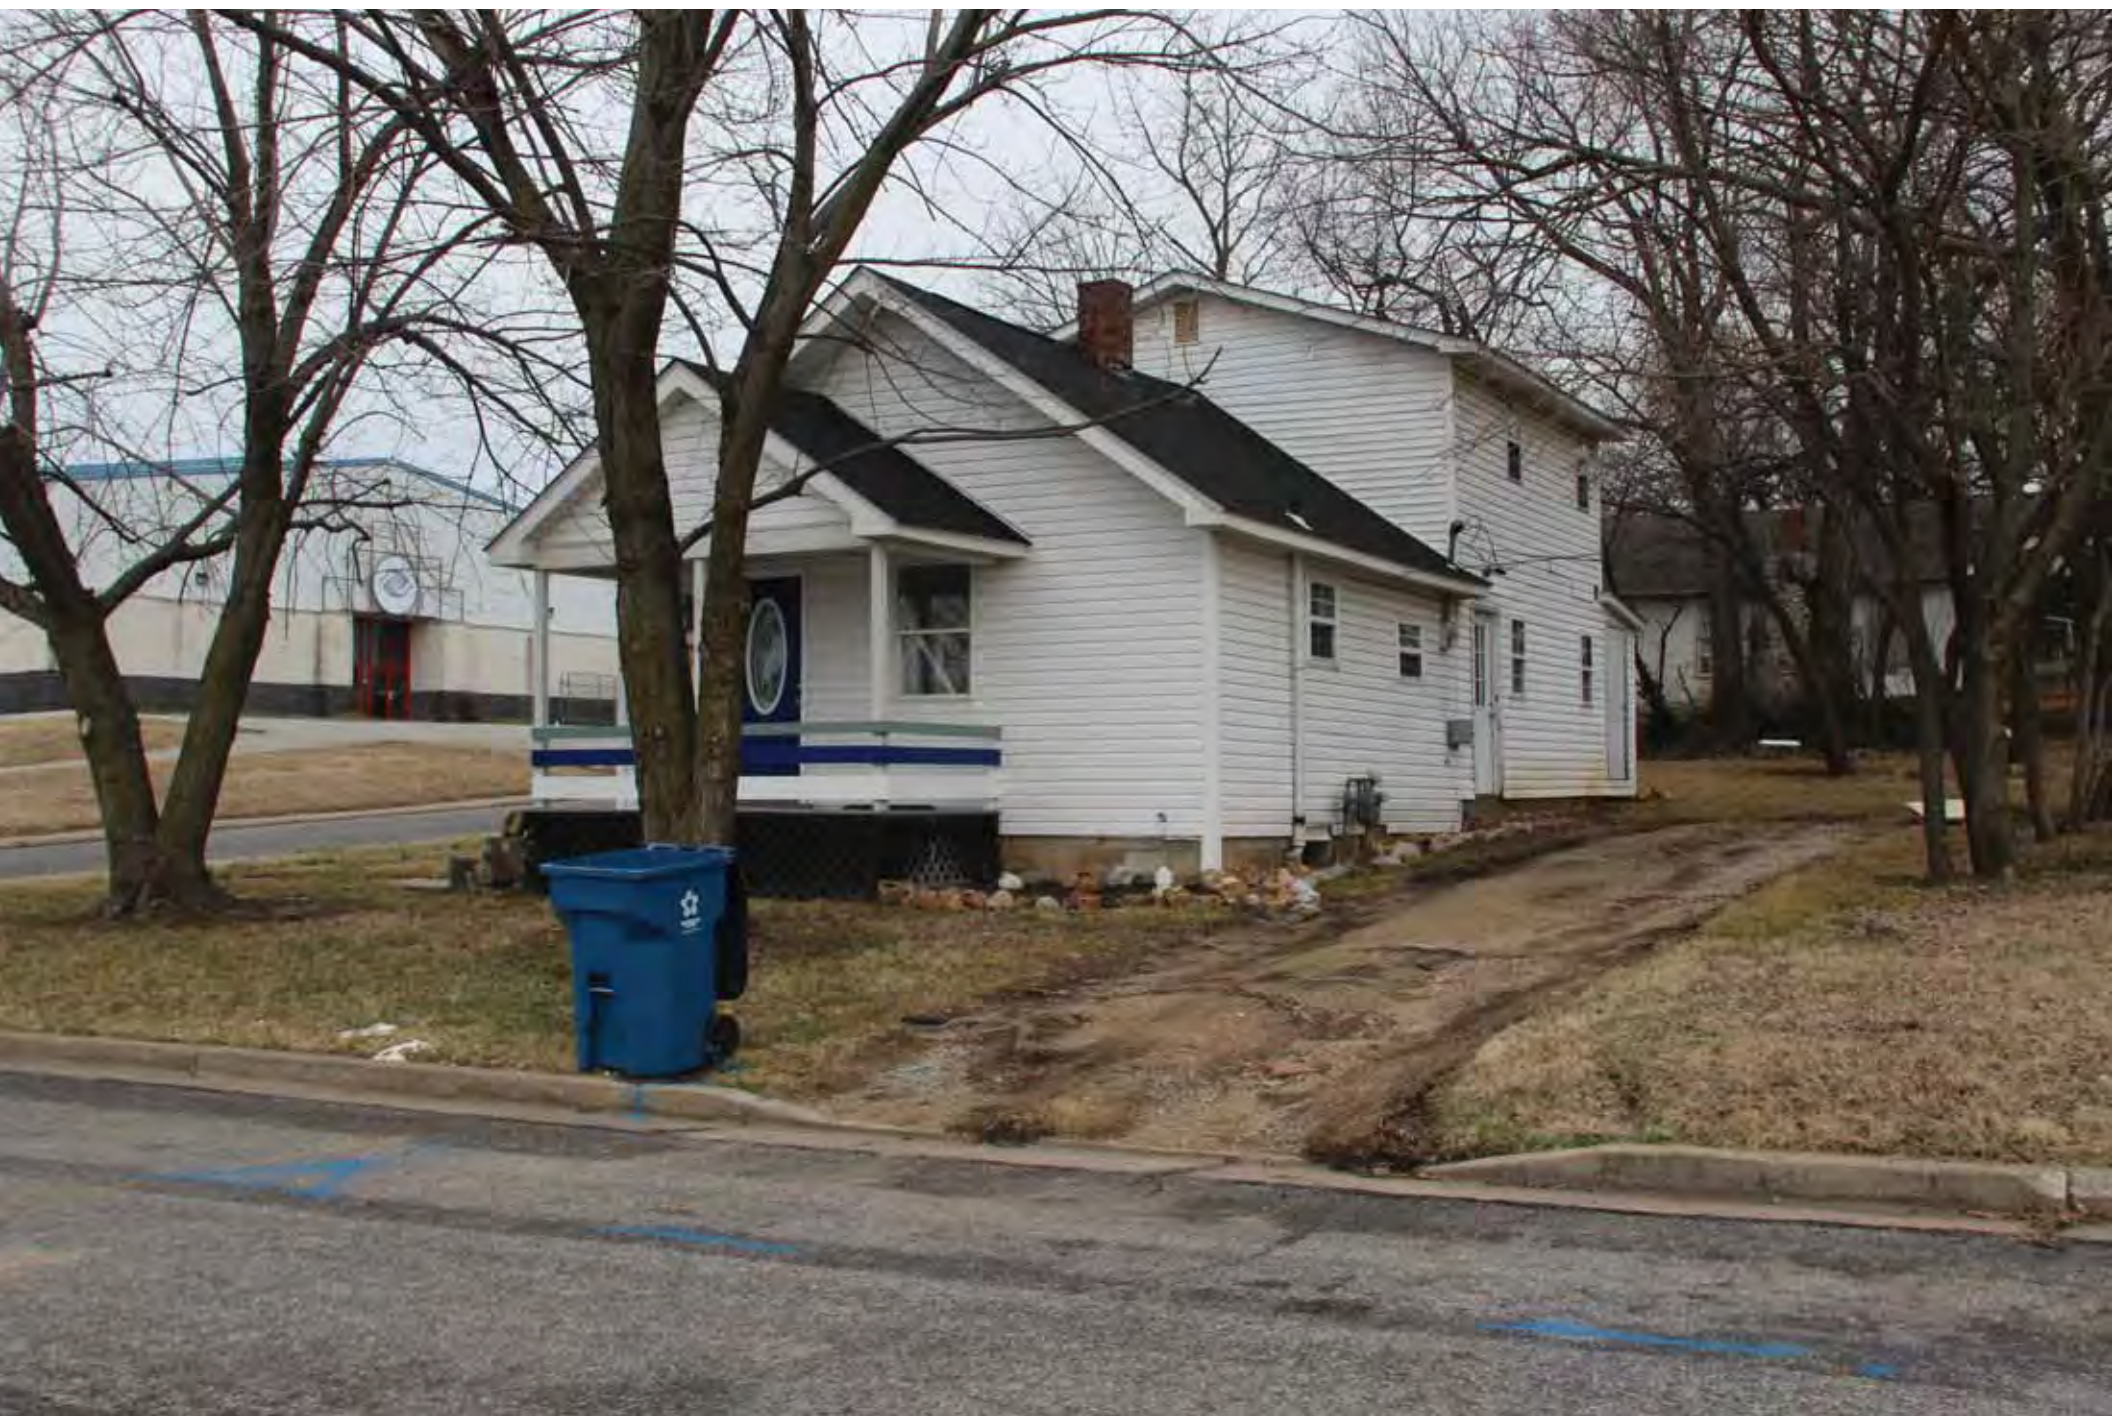
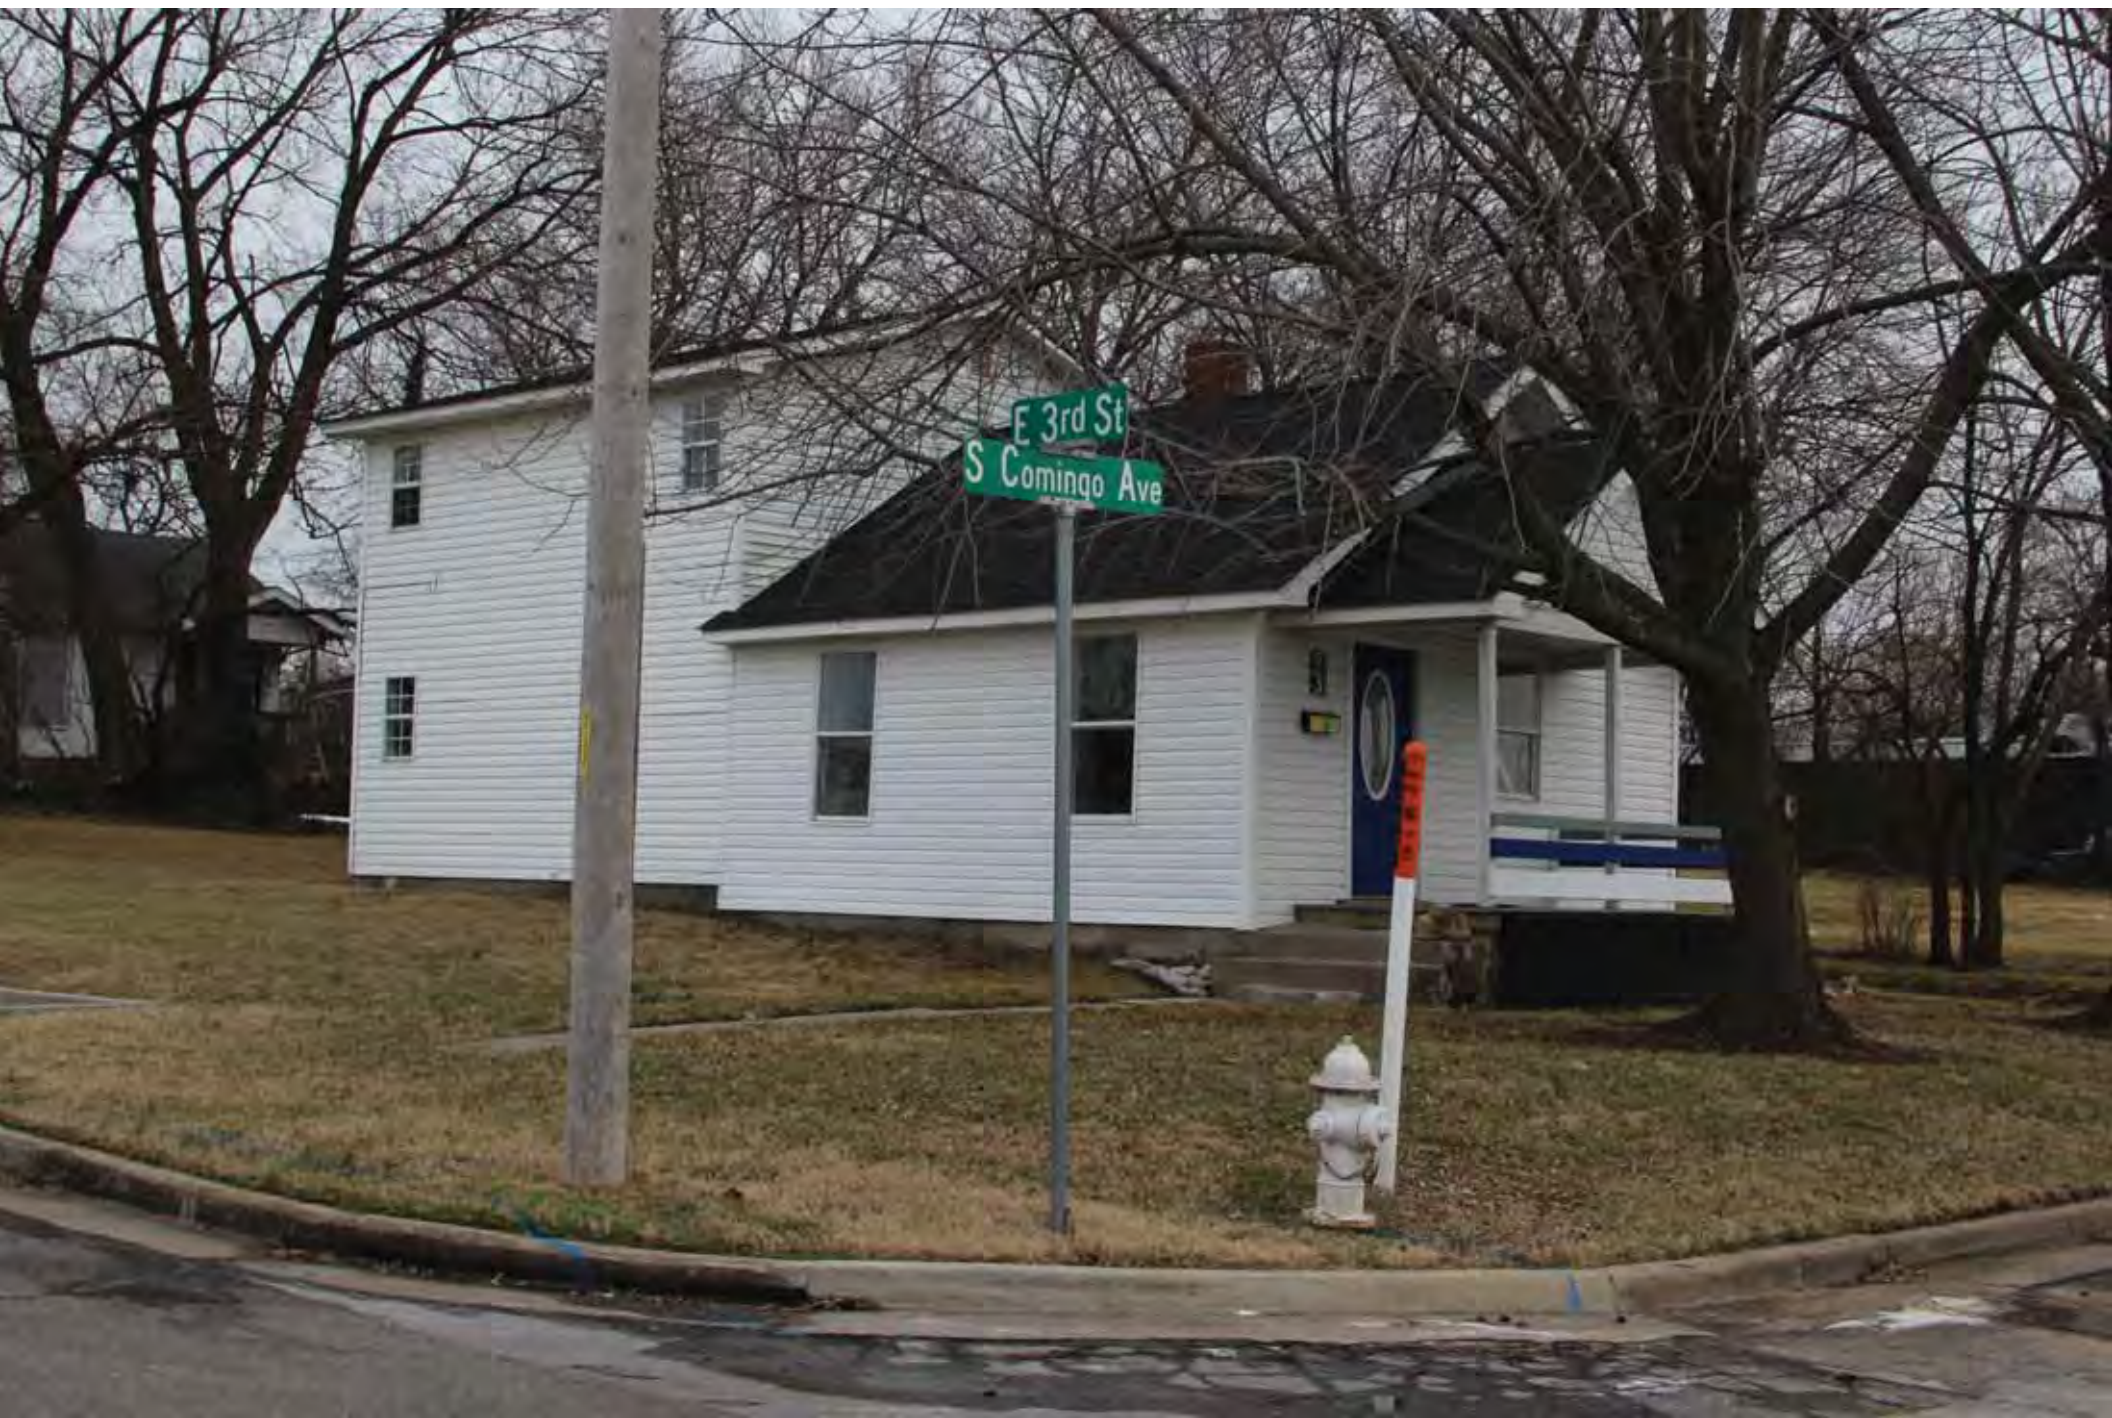
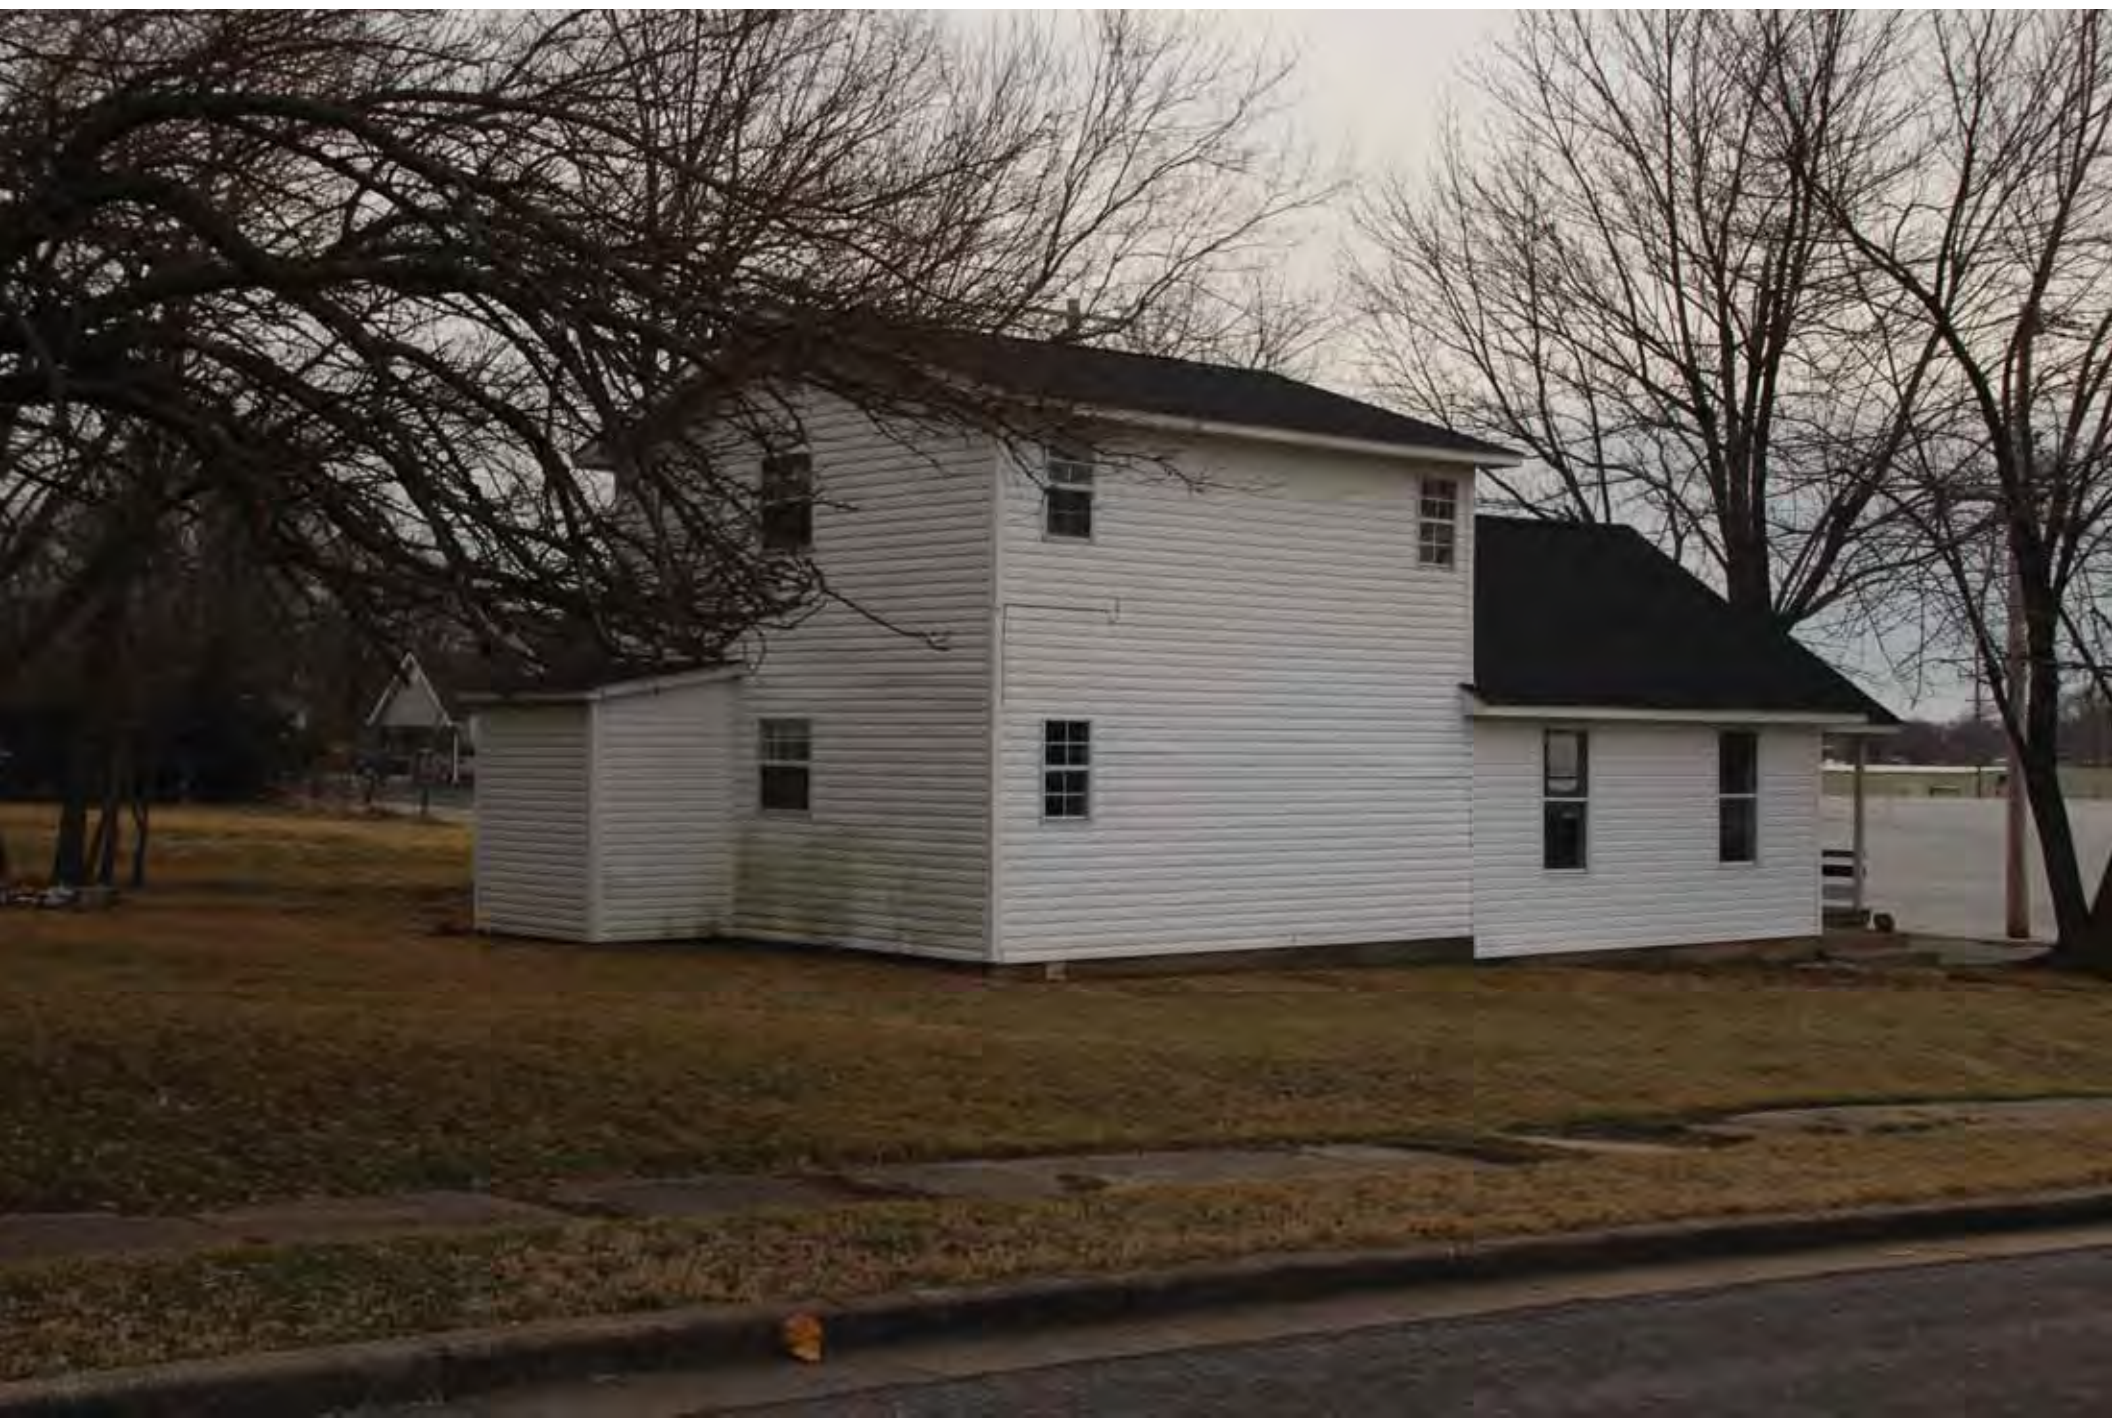
The dwelling has been extensively altered with c. 2015 exterior siding, replacement of original doors and windows and the addition of a rear two-story wing (c. 2015). These alterations have compromised the dwelling's integrity, rendering it ineligible for the National Register of Historic Places. The dwelling is not within an area recommended as a historic district.

The property at 303 S. Comingo Avenue supports a gable-front plan dwelling with a single-story primary wing and rear two-story wing. The dwelling has an asphalt shingled roof and exterior vinyl siding. The foundation is concrete. The primary (west) elevation supports a gabled porch with three columns. The porch foundation is covered with lattice. Three synthetic bands surround the porch to create a balustrade. Within the porch bay is a contemporary oval light door offset by a one-over-one replacement window. The central roofline ridge of the one-story gabled roof supports a brick chimney. The south elevation of the one-story wing holds two small four-over-four windows. The south elevation of the two-story wing supports two windows on the first and second stories – windows are symmetrically aligned. The south elevation also supports a multi-light contemporary door (west end of the two-story wing) and a solid door within a small rear shed single-story wing (south elevation). The north elevation holds two windows on the single-story wing. The north elevation of the two-story wing holds one window on the first floor and two windows on the second floor. The rear (east) elevation (two-story wing) has one window on each floor. The wing also supports (as noted above) a small single-story shed wing. The shed wing is void of fenestration on the east and north elevations.
