MISSOURI DEPARTMENT OF NATURAL RESOURCES
STATE HISTORIC PRESERVATION OFFICE, P.O. Box 176, Jefferson City, MO 65102
ARCHITECTURAL/HISTORIC INVENTORY FORM

1. Survey No. JP-AS-007-001		2. Survey name: East Town (Original Joplin) Historic Survey Phase 2	
3. County: JASPER		4. Address (Street No.) 618	Street (name) E. 2 nd Street
5. City: Joplin	Vicinity: <input type="checkbox"/>	6. Geographical Reference:	7. Township/Range/Section: T: R: S:
8. Historic name (if known):		9. Present/other name (if known):	
10. Ownership: <input checked="" type="checkbox"/> Private <input type="checkbox"/> Public		11a. Historic use (if known): Domestic: Single Dwelling	11b. Current use: Domestic: Single Dwelling

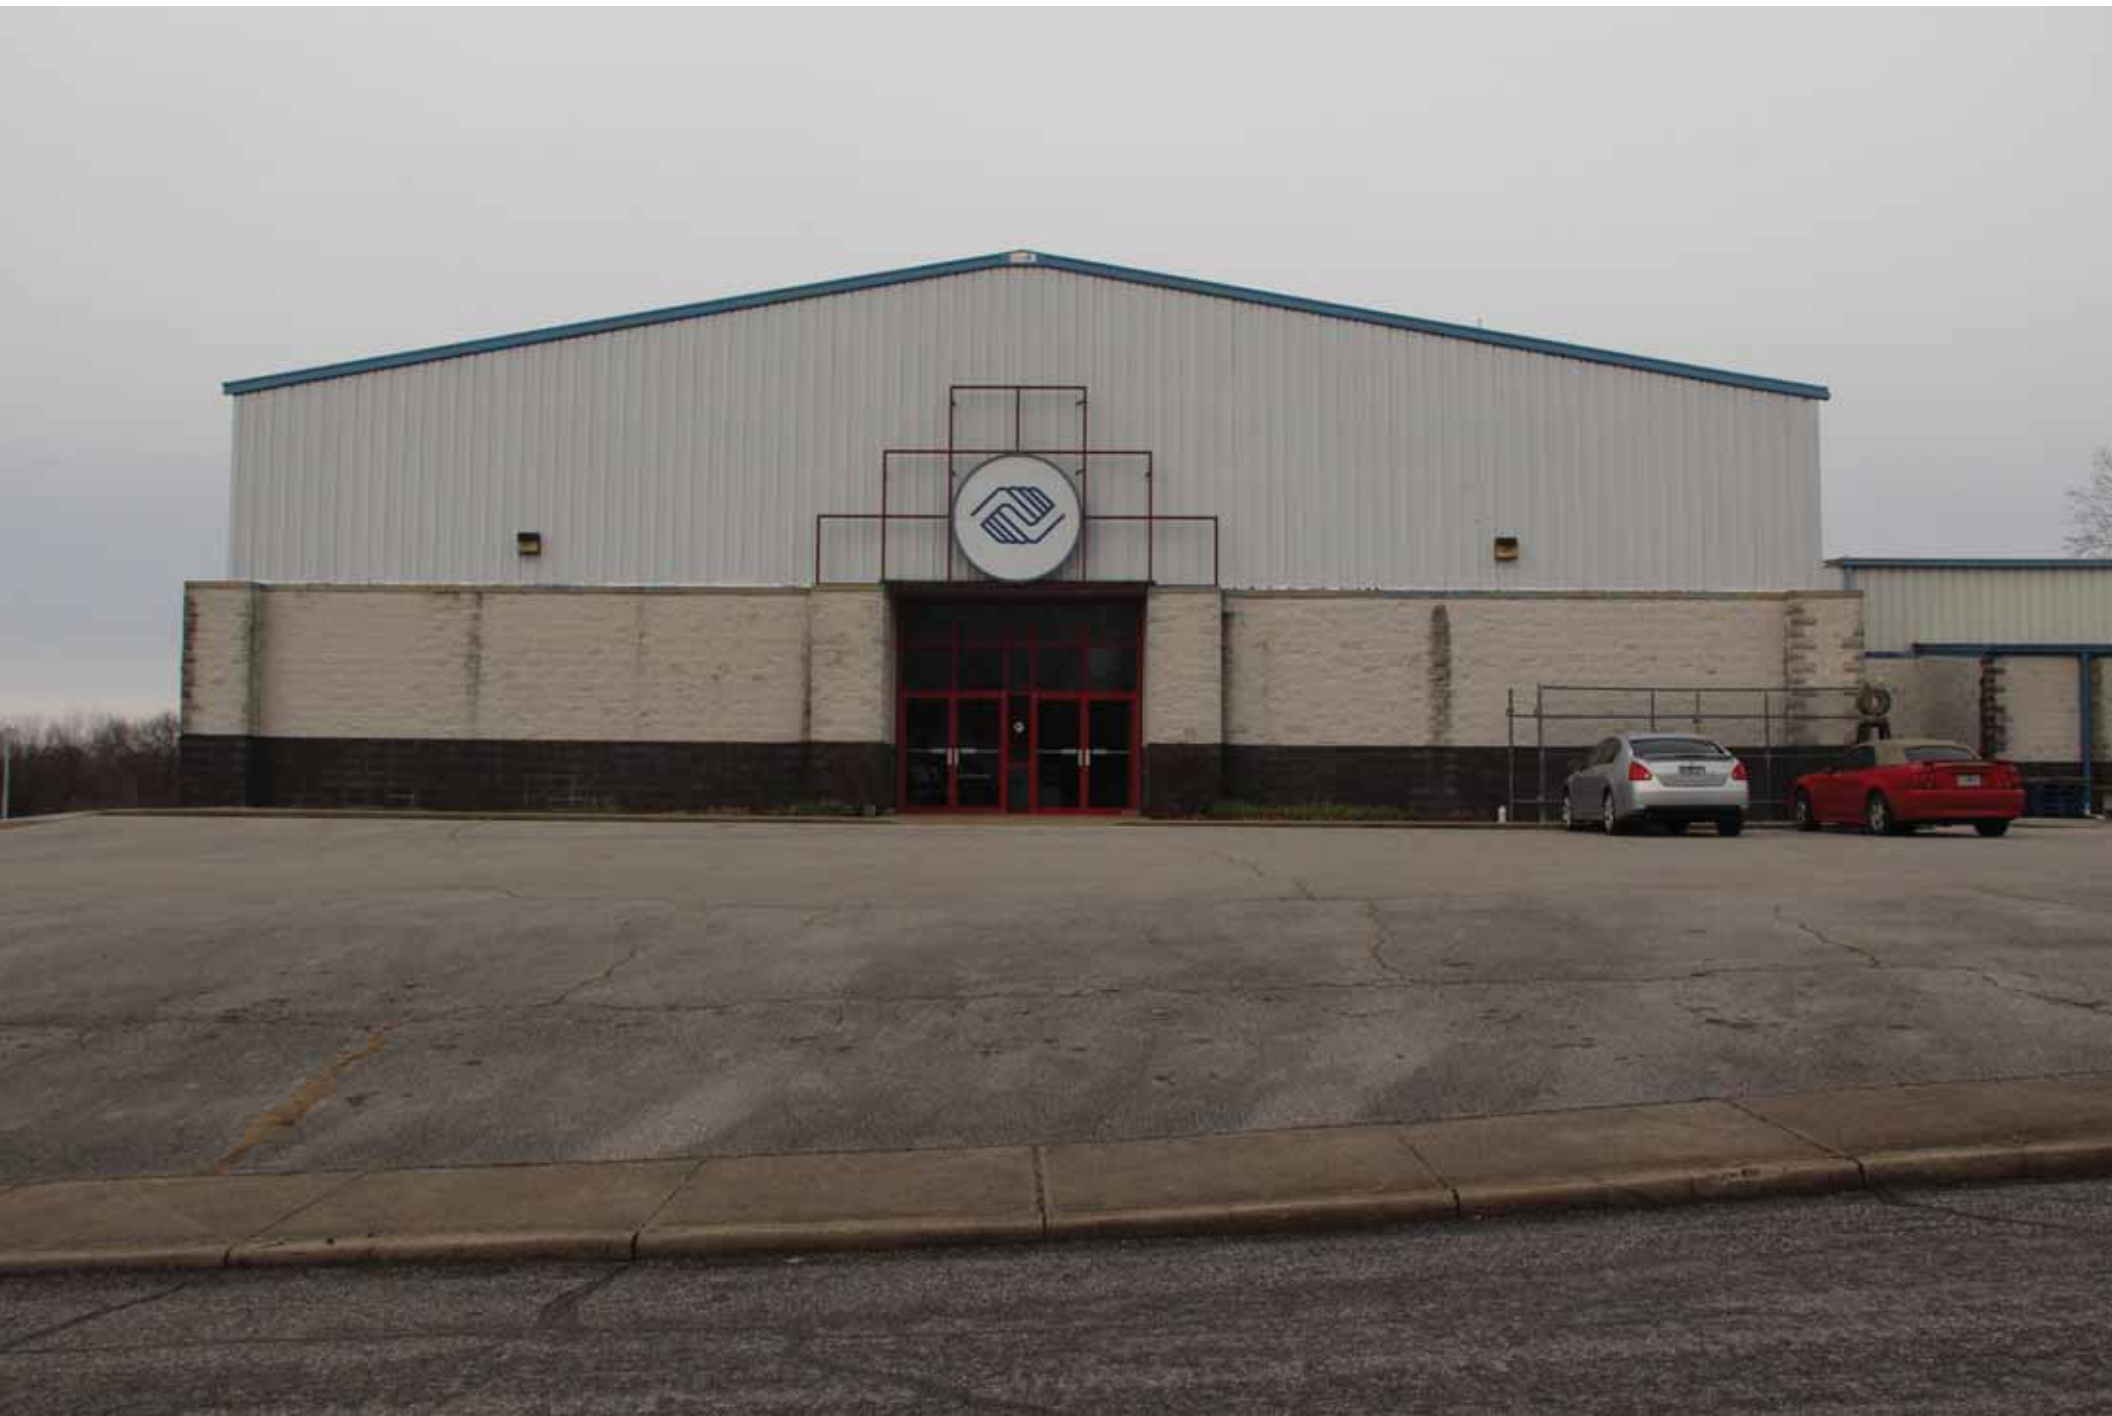
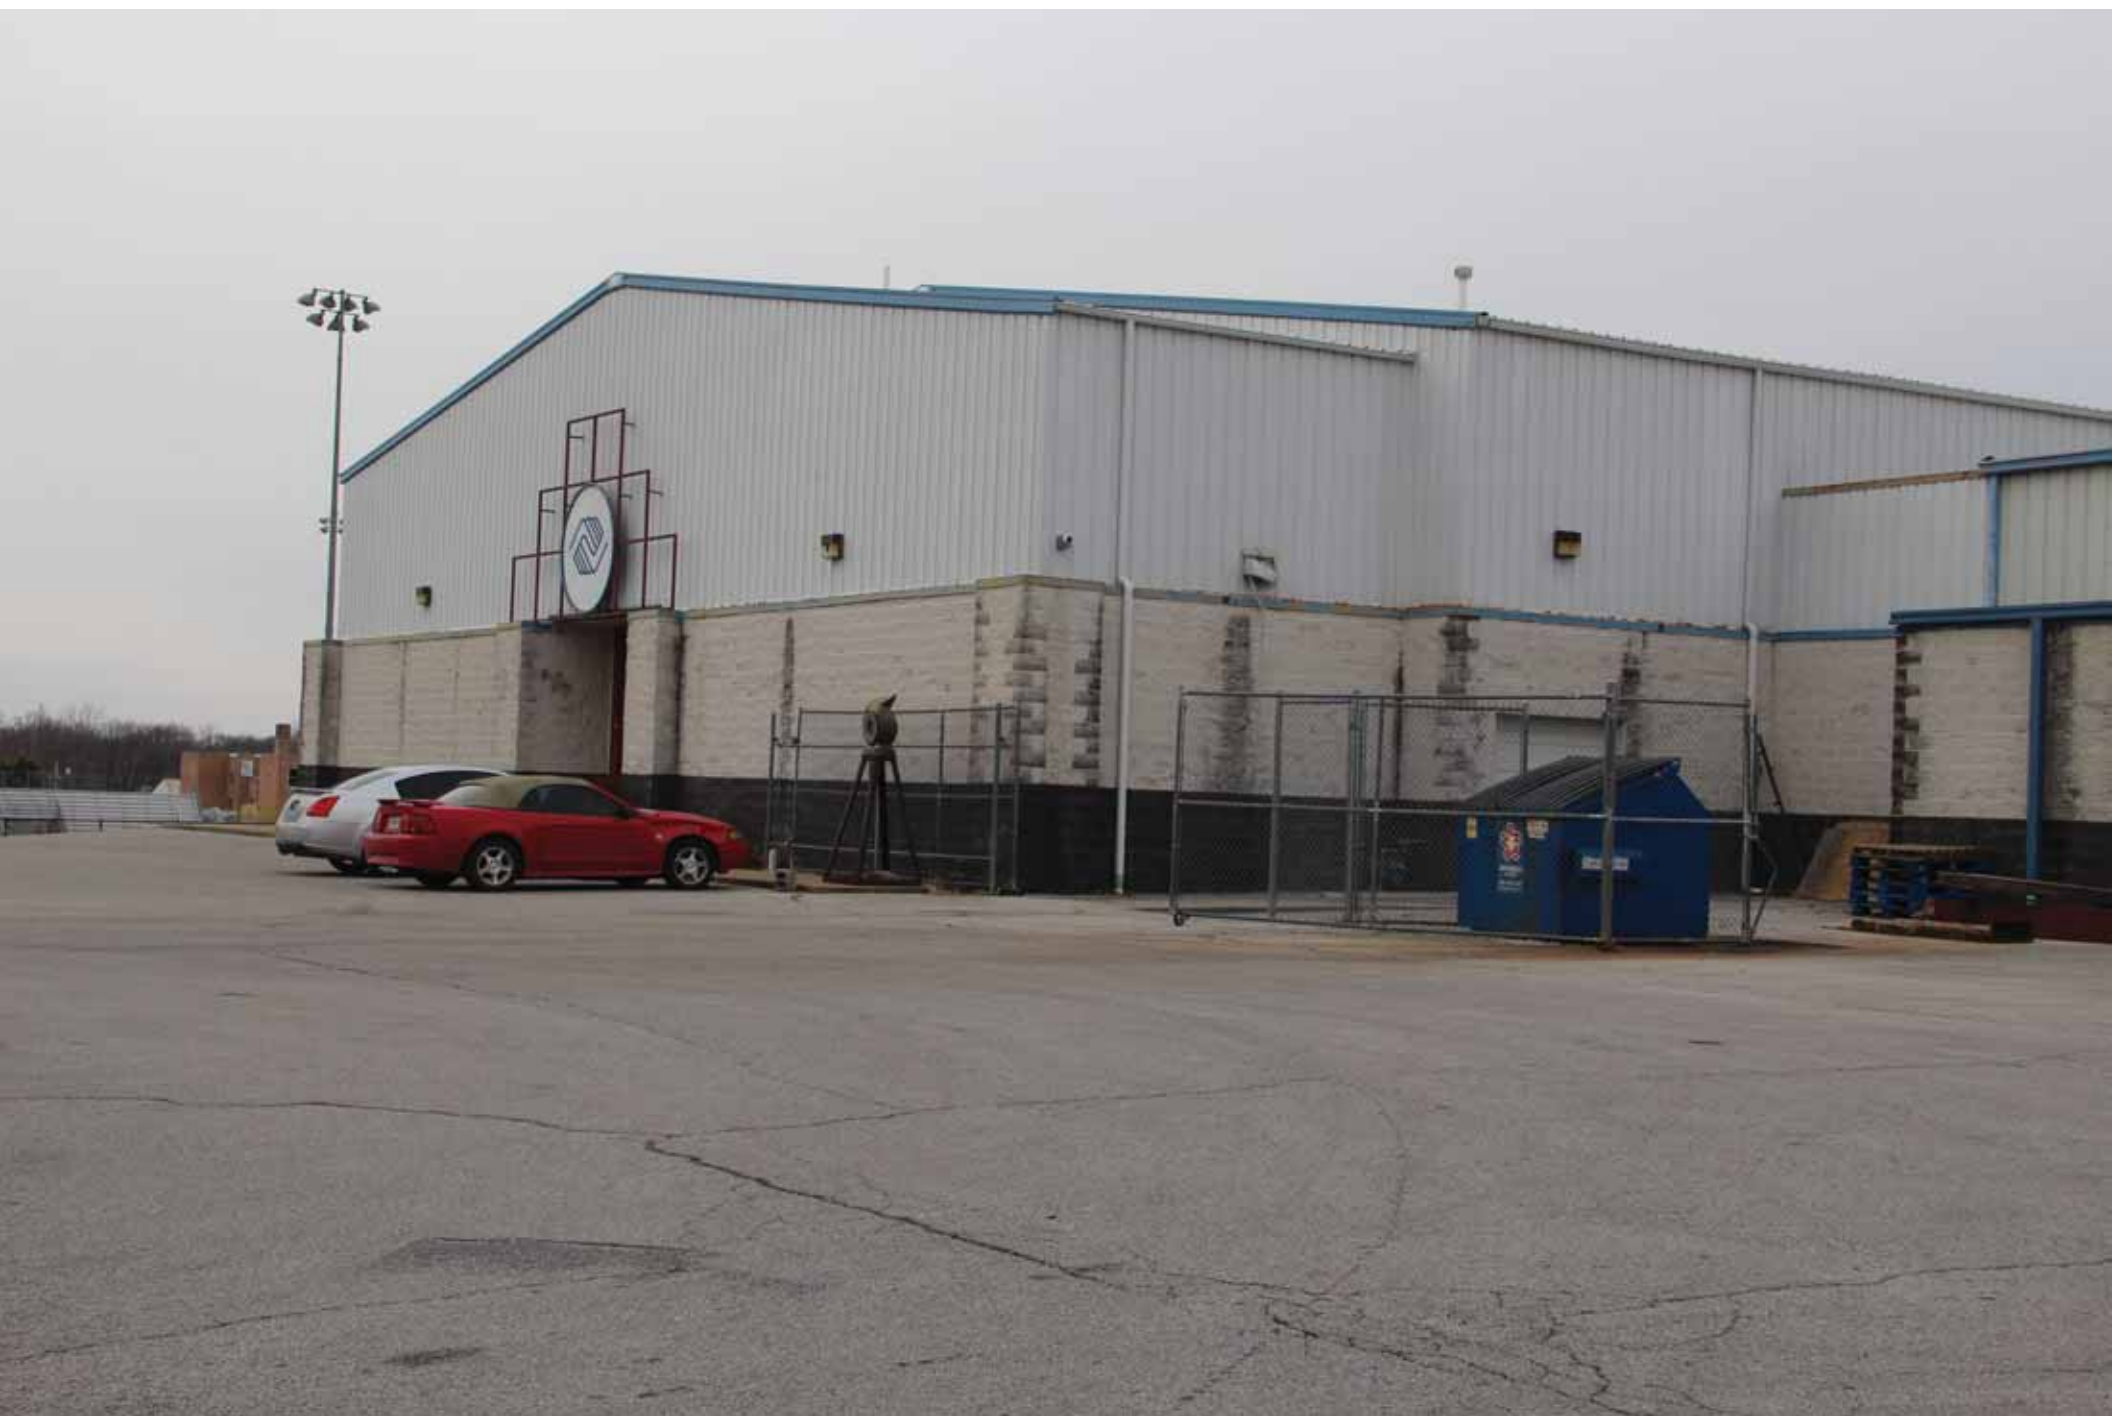
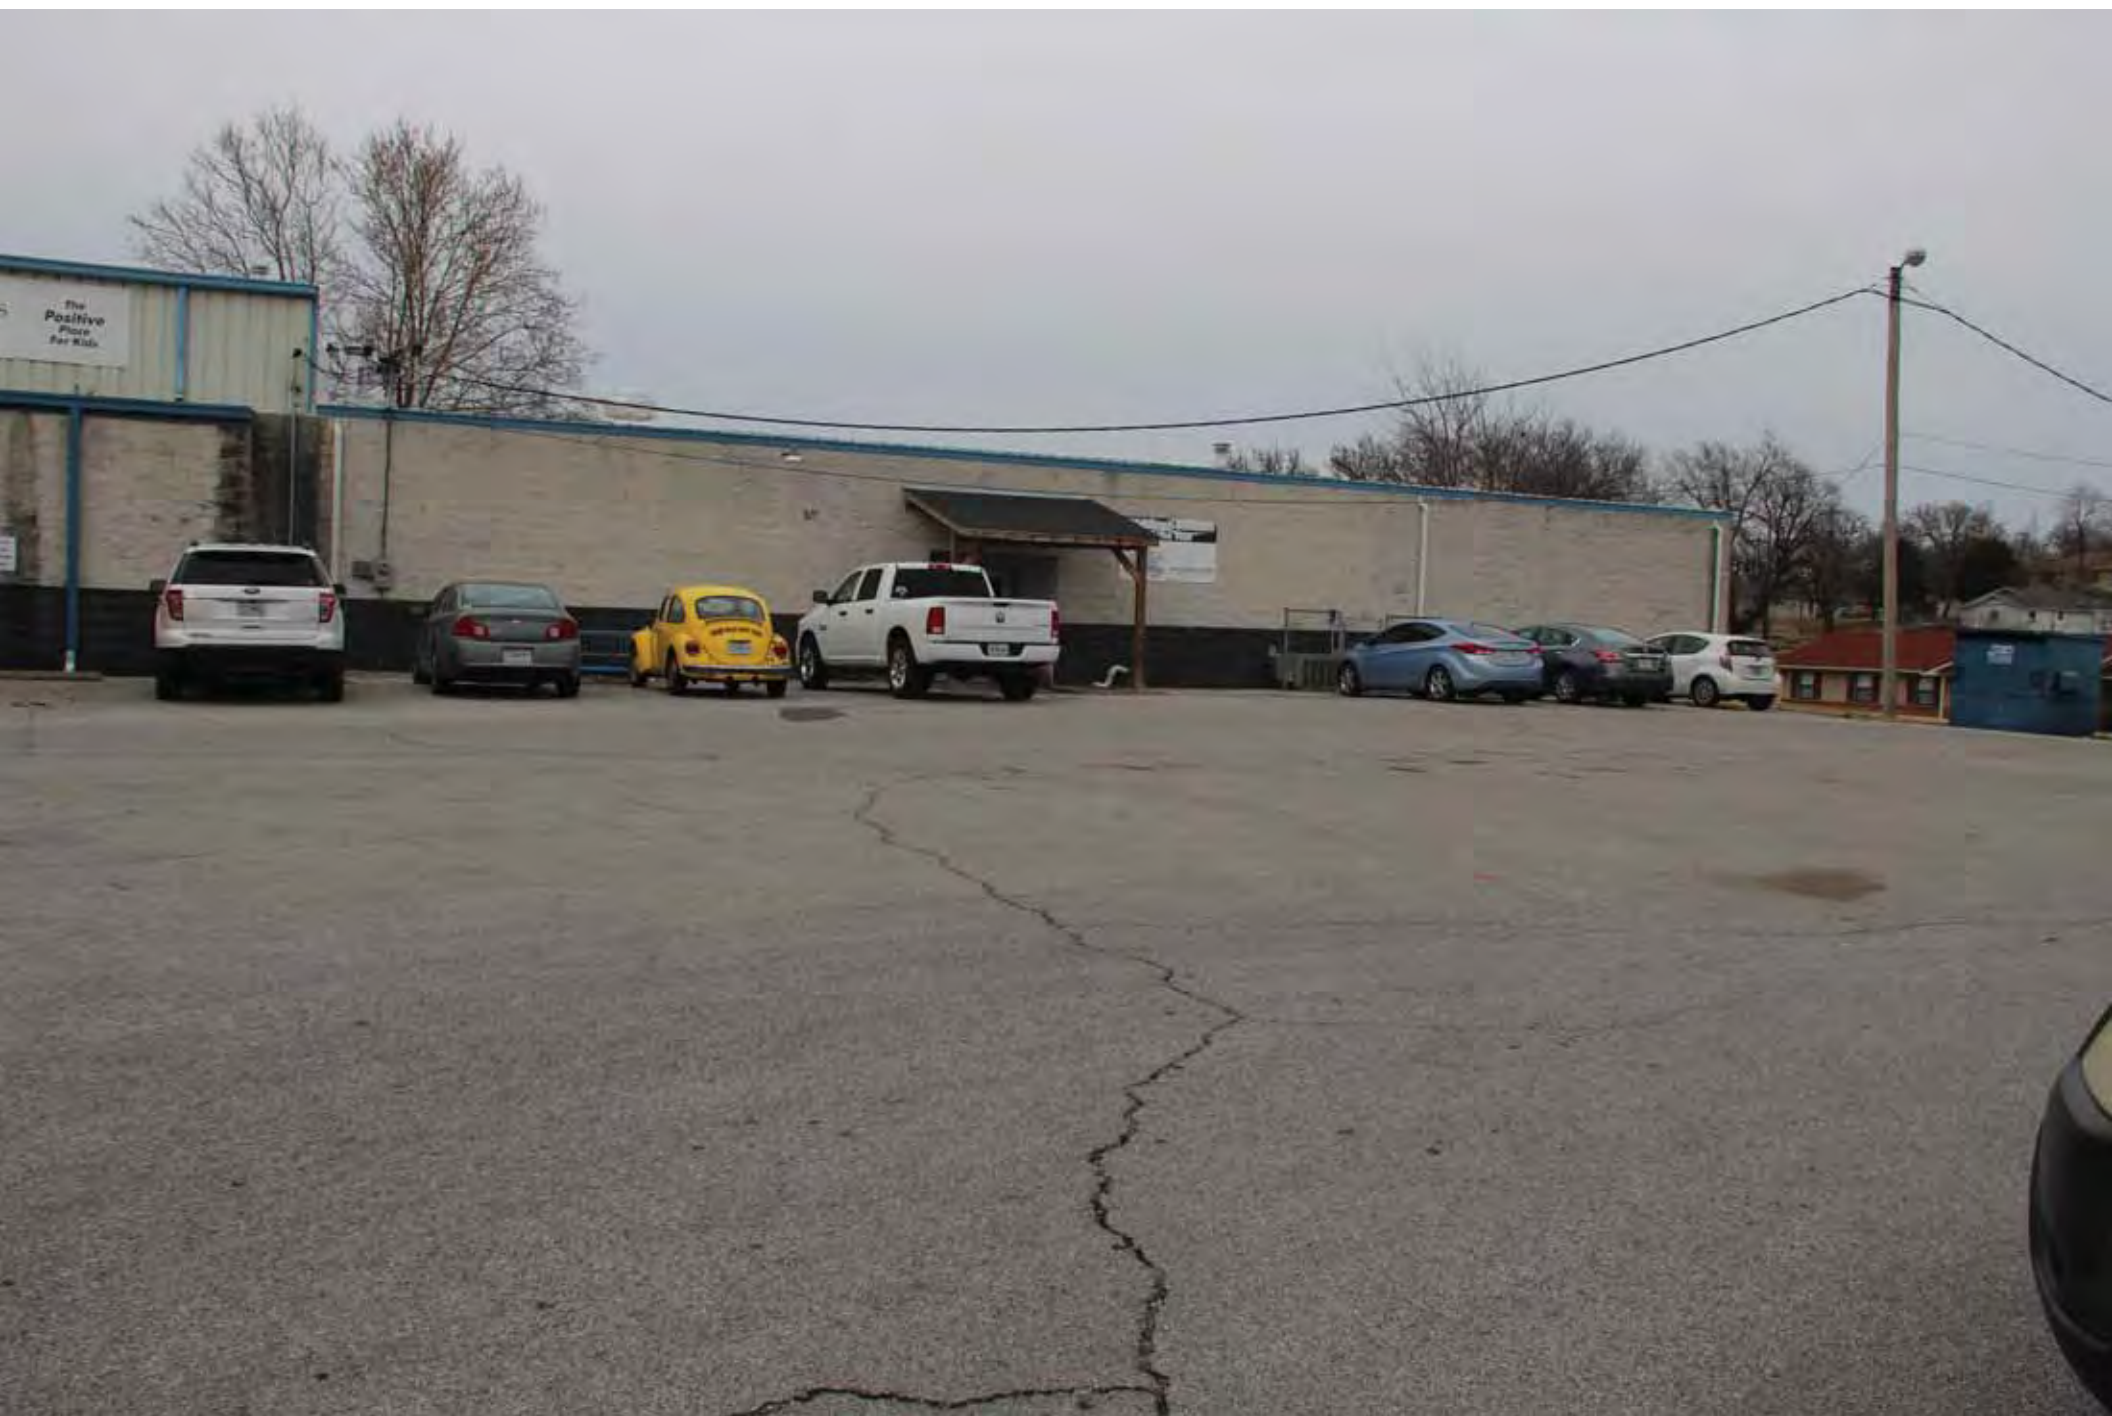
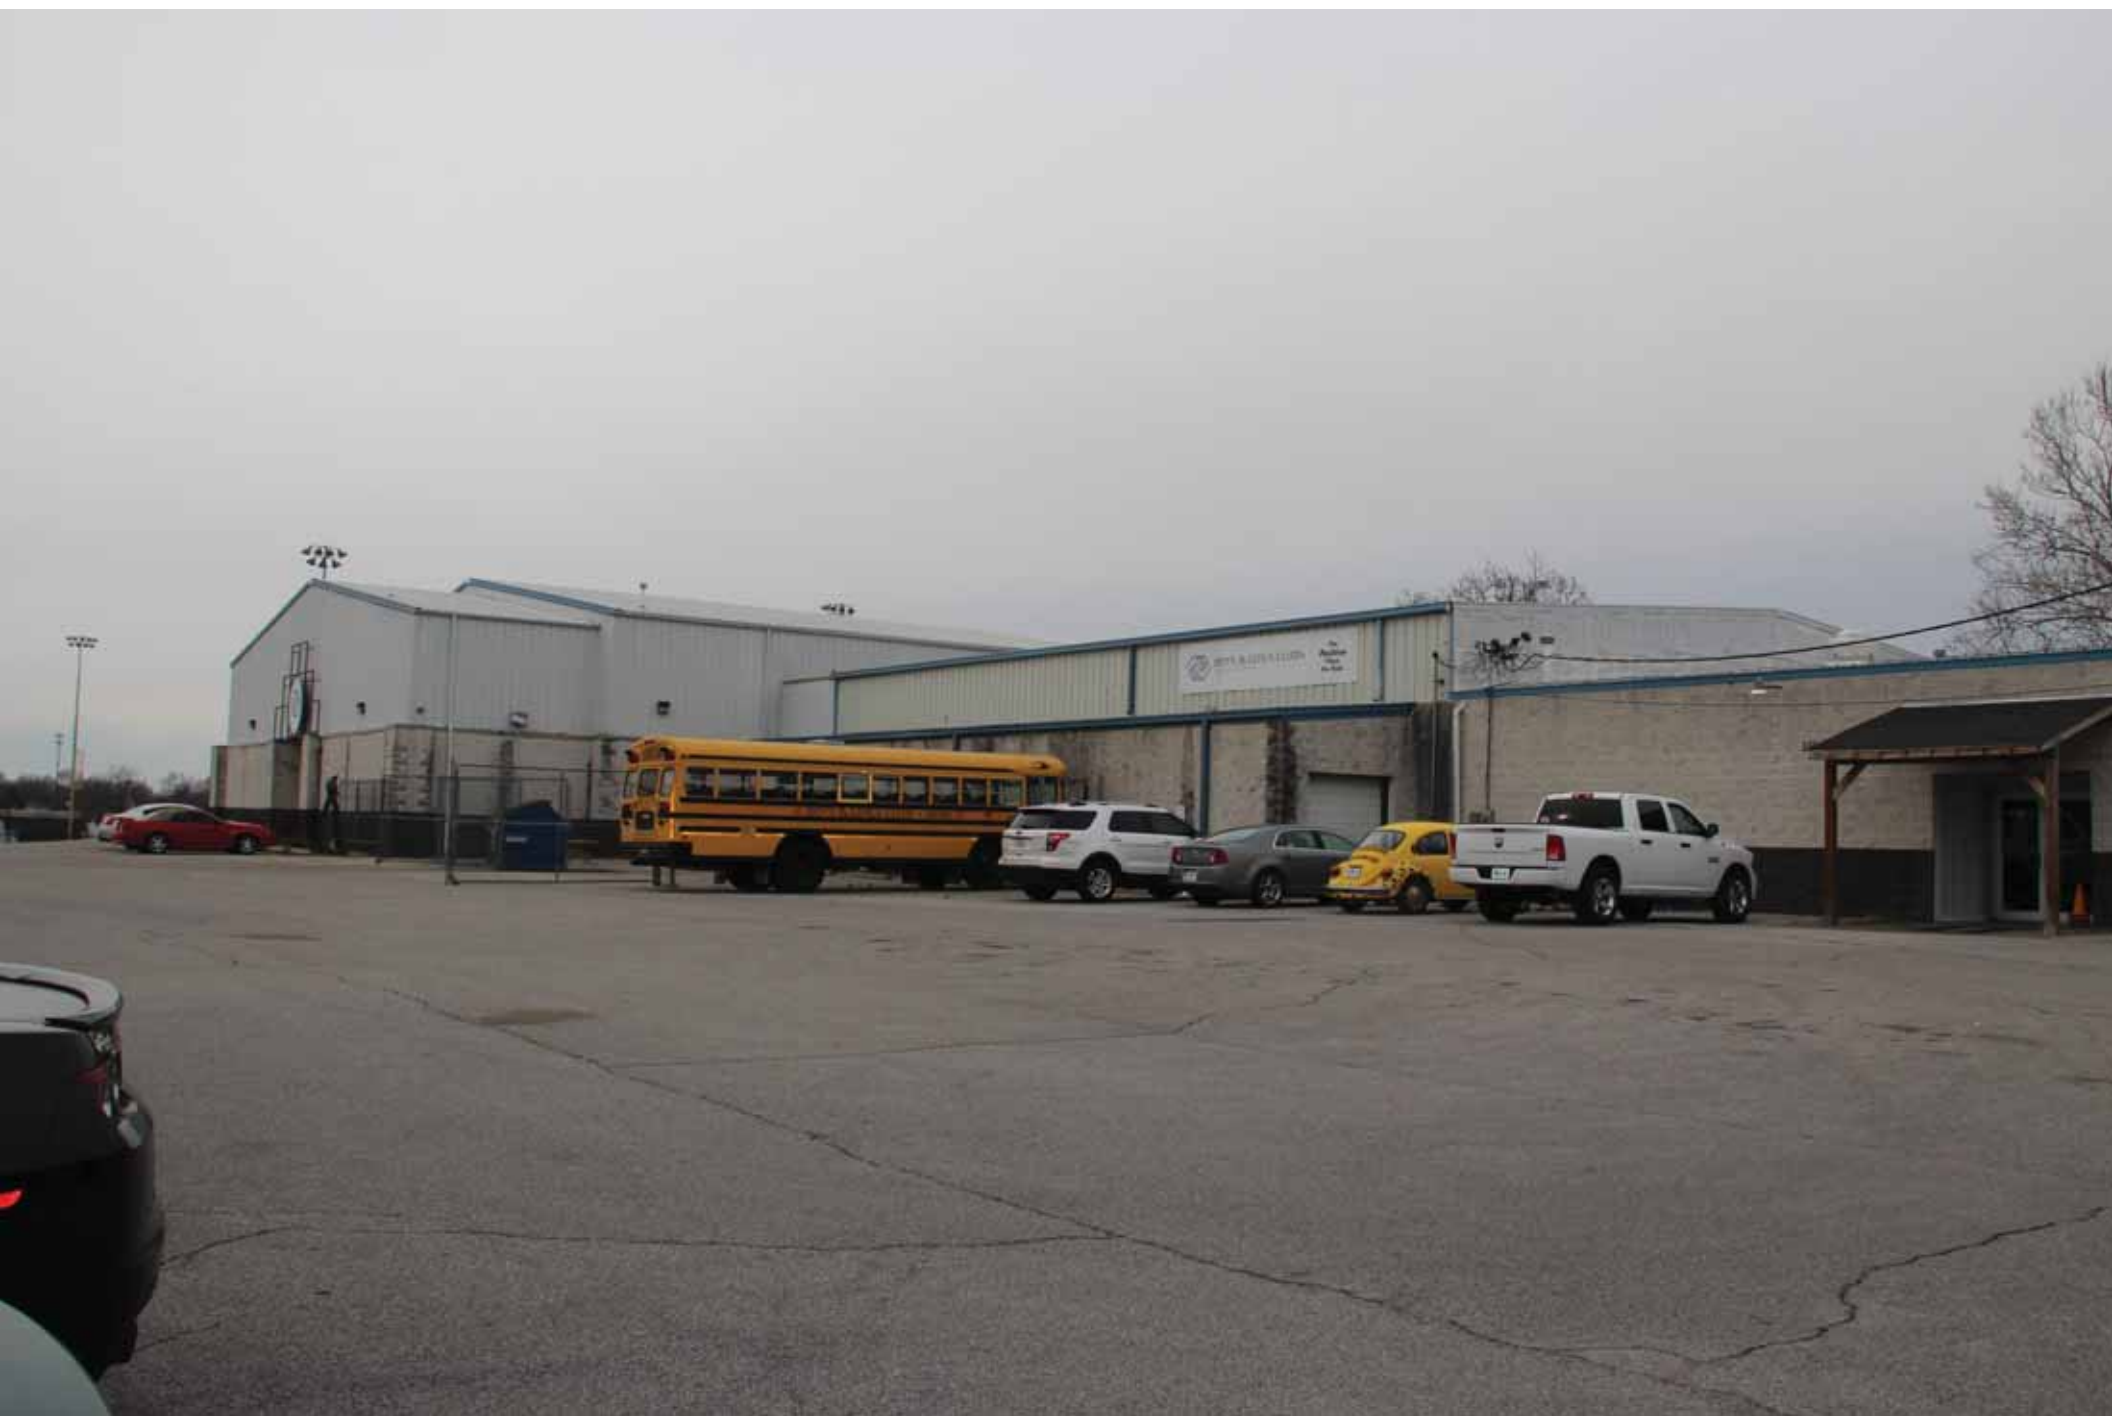
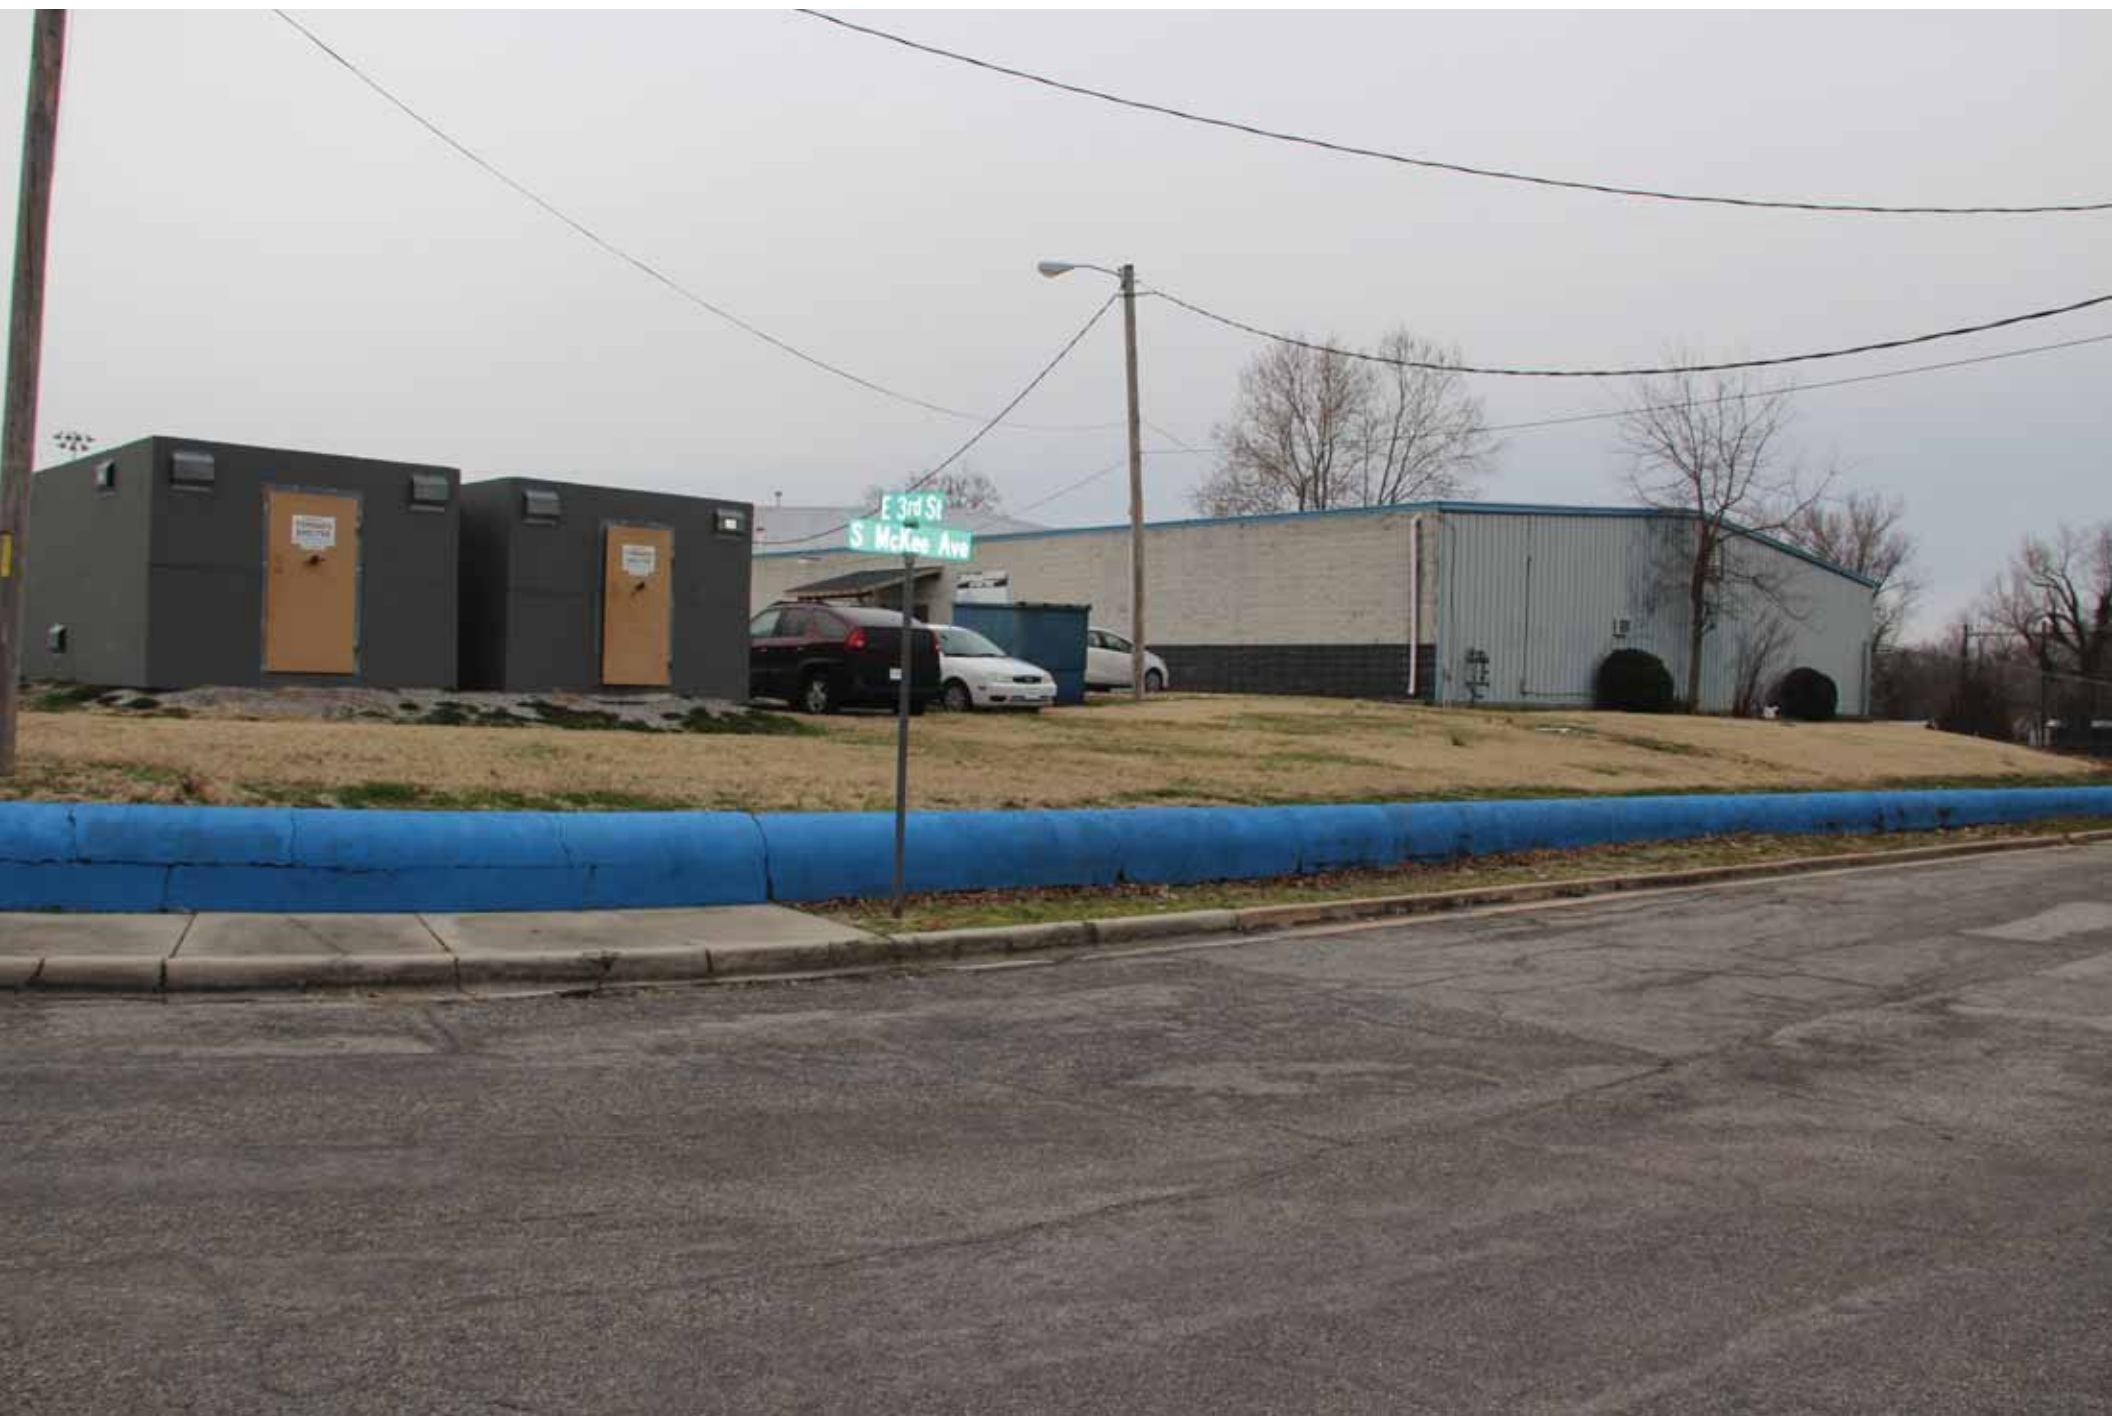
The property addressed as 317 S. Comingo Avenue is a large warehouse complex composed of three prefabricated metal buildings with gabled roofs. The buildings are adjoined to create a single building. The south elevation of the adjoined wings is the primary elevation. All of the elevations facing south have exterior concrete walls scored to mimic stone. The concrete walls are darker near the foundation, creating a seamless band of darker color along the entire south elevation of all three wings. Corners are quoined.

A central linear wing connecting a 2.0-story west wing to the above described east wing is constructed of prefabricated metal. The wing has a gabled roof and front concrete faced shed wing facing south. The shed wing supports an overhead track door on the east elevation. A solid metal door is situated near the west end of the central wing's south elevation.

The largest of the three wings (constructed in 2019) is situated at the west end of the complex. This wing has a front gabled roof. The upper south wall is clad with prefabricated metal; the lower area is clad with scored concrete. A central recessed entrance is filled with two sets of paired glass doors framed with metal. The doors are capped by large fixed lights and divided by a slender band of fixed lights. Metal framing is attached to the wall above the entry bay. This framing supports the Boys and Girls Club logo. Engaged wide concrete pilasters flank the entry bay on the wing.
