MISSOURI DEPARTMENT OF NATURAL RESOURCES
STATE HISTORIC PRESERVATION OFFICE, P.O. Box 176, Jefferson City, MO 65102
ARCHITECTURAL/HISTORIC INVENTORY FORM

1. Survey No. JP-AS-007-001		2. Survey name: East Town (Original Joplin) Historic Survey Phase 2	
3. County: JASPER		4. Address (Street No.) 618	Street (name) E. 2 nd Street
5. City: Joplin	Vicinity: <input type="checkbox"/>	6. Geographical Reference:	7. Township/Range/Section: T: R: S:
8. Historic name (if known):		9. Present/other name (if known):	
10. Ownership: <input checked="" type="checkbox"/> Private <input type="checkbox"/> Public		11a. Historic use (if known): Domestic: Single Dwelling	11b. Current use: Domestic: Single Dwelling

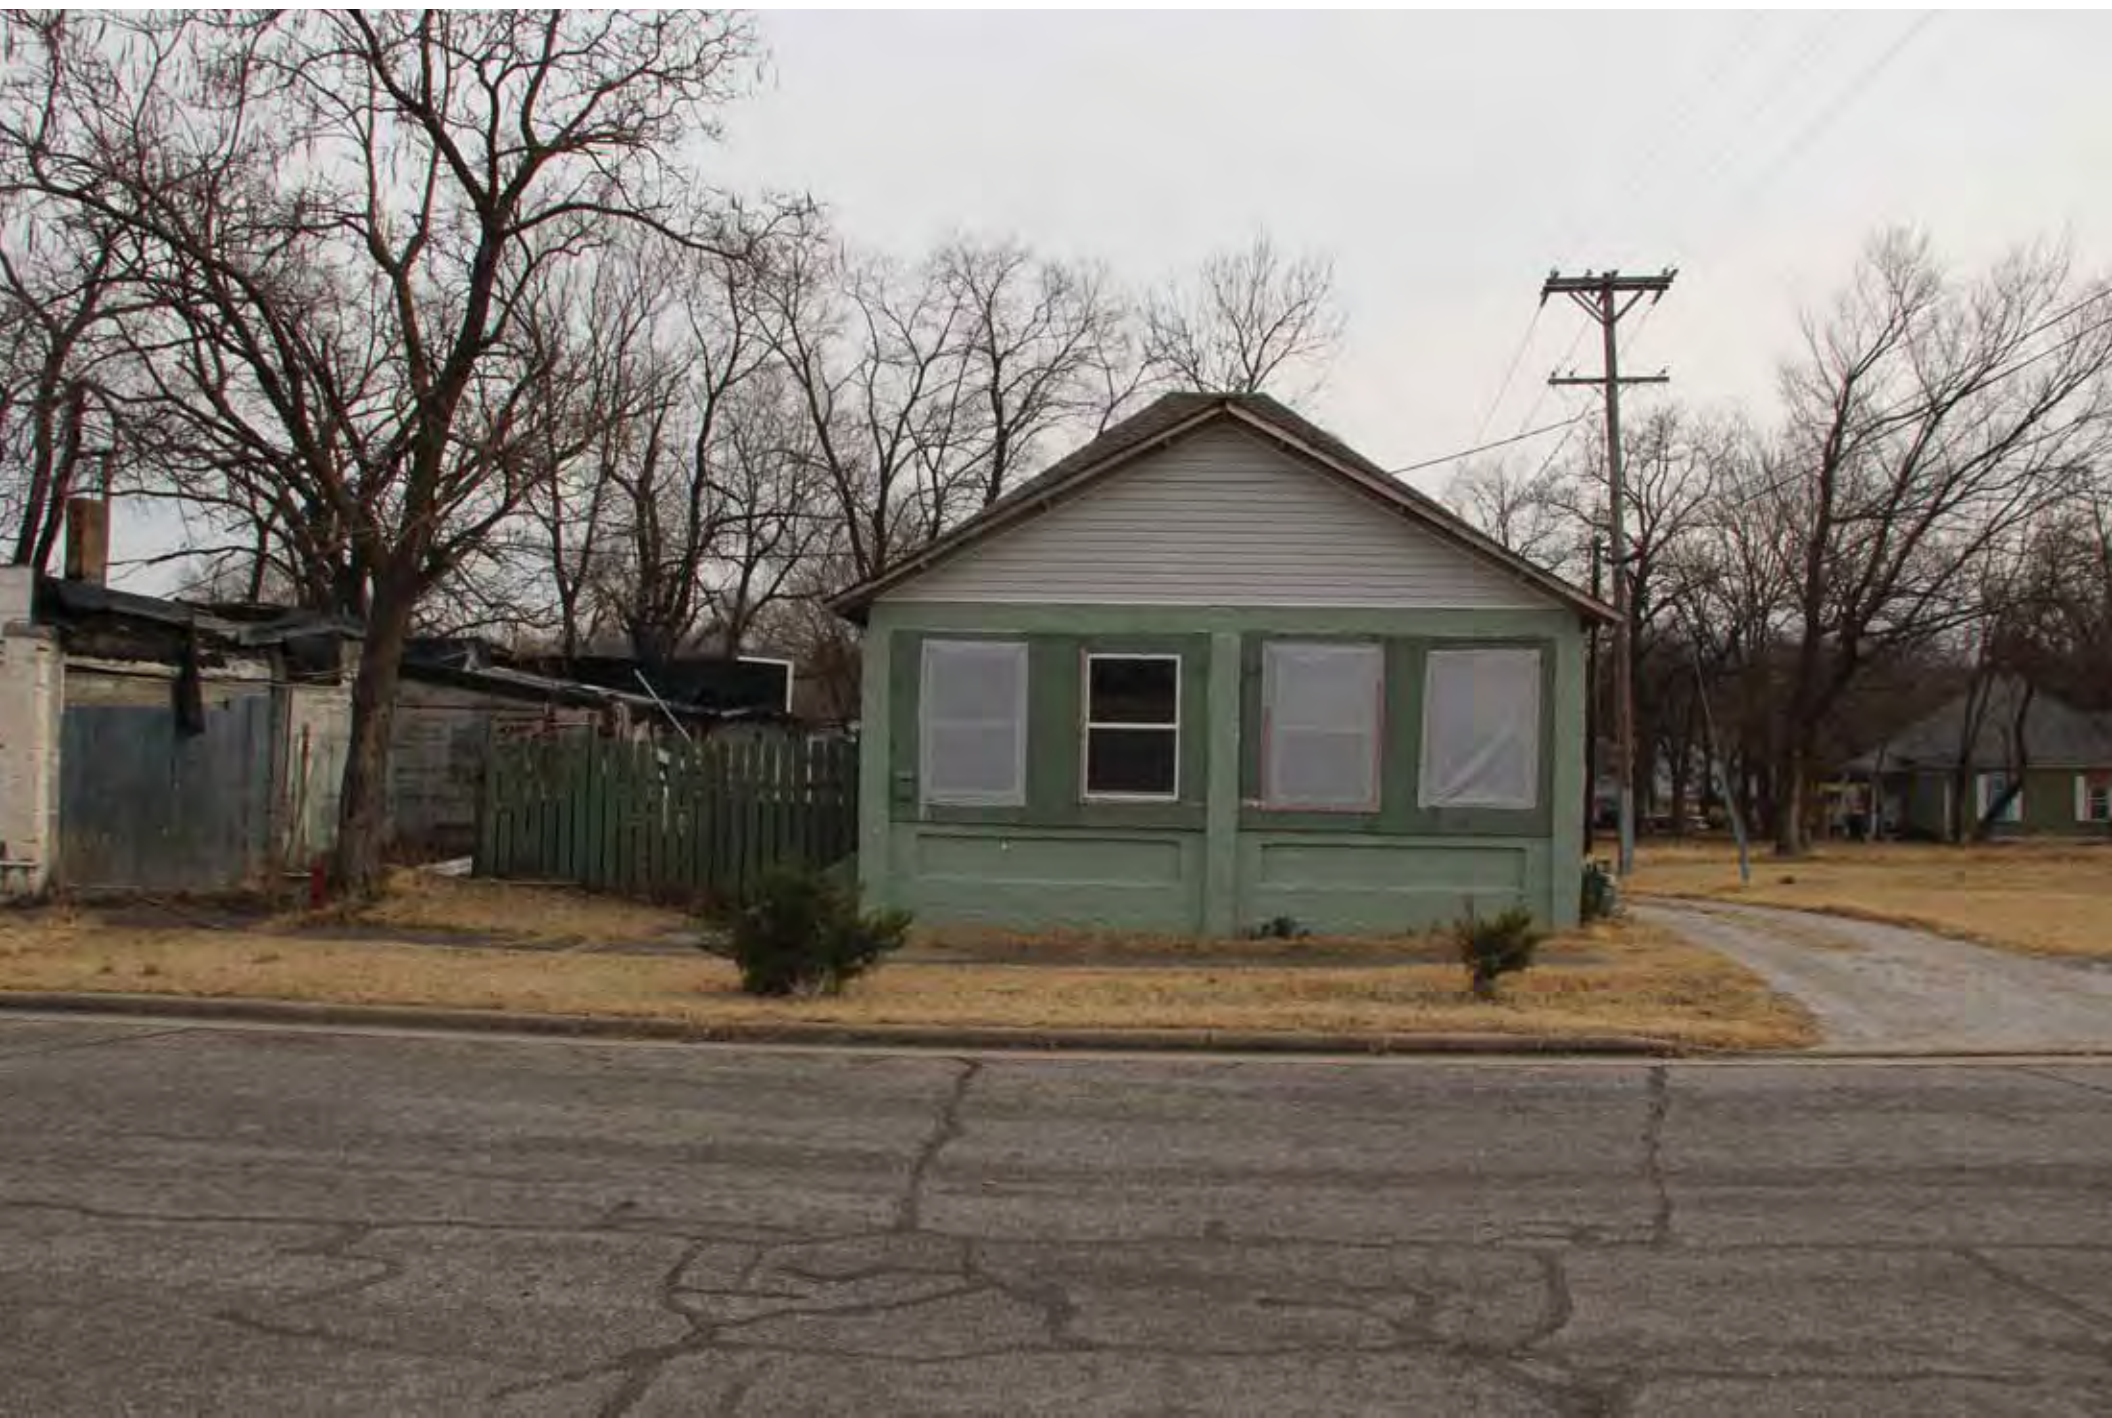
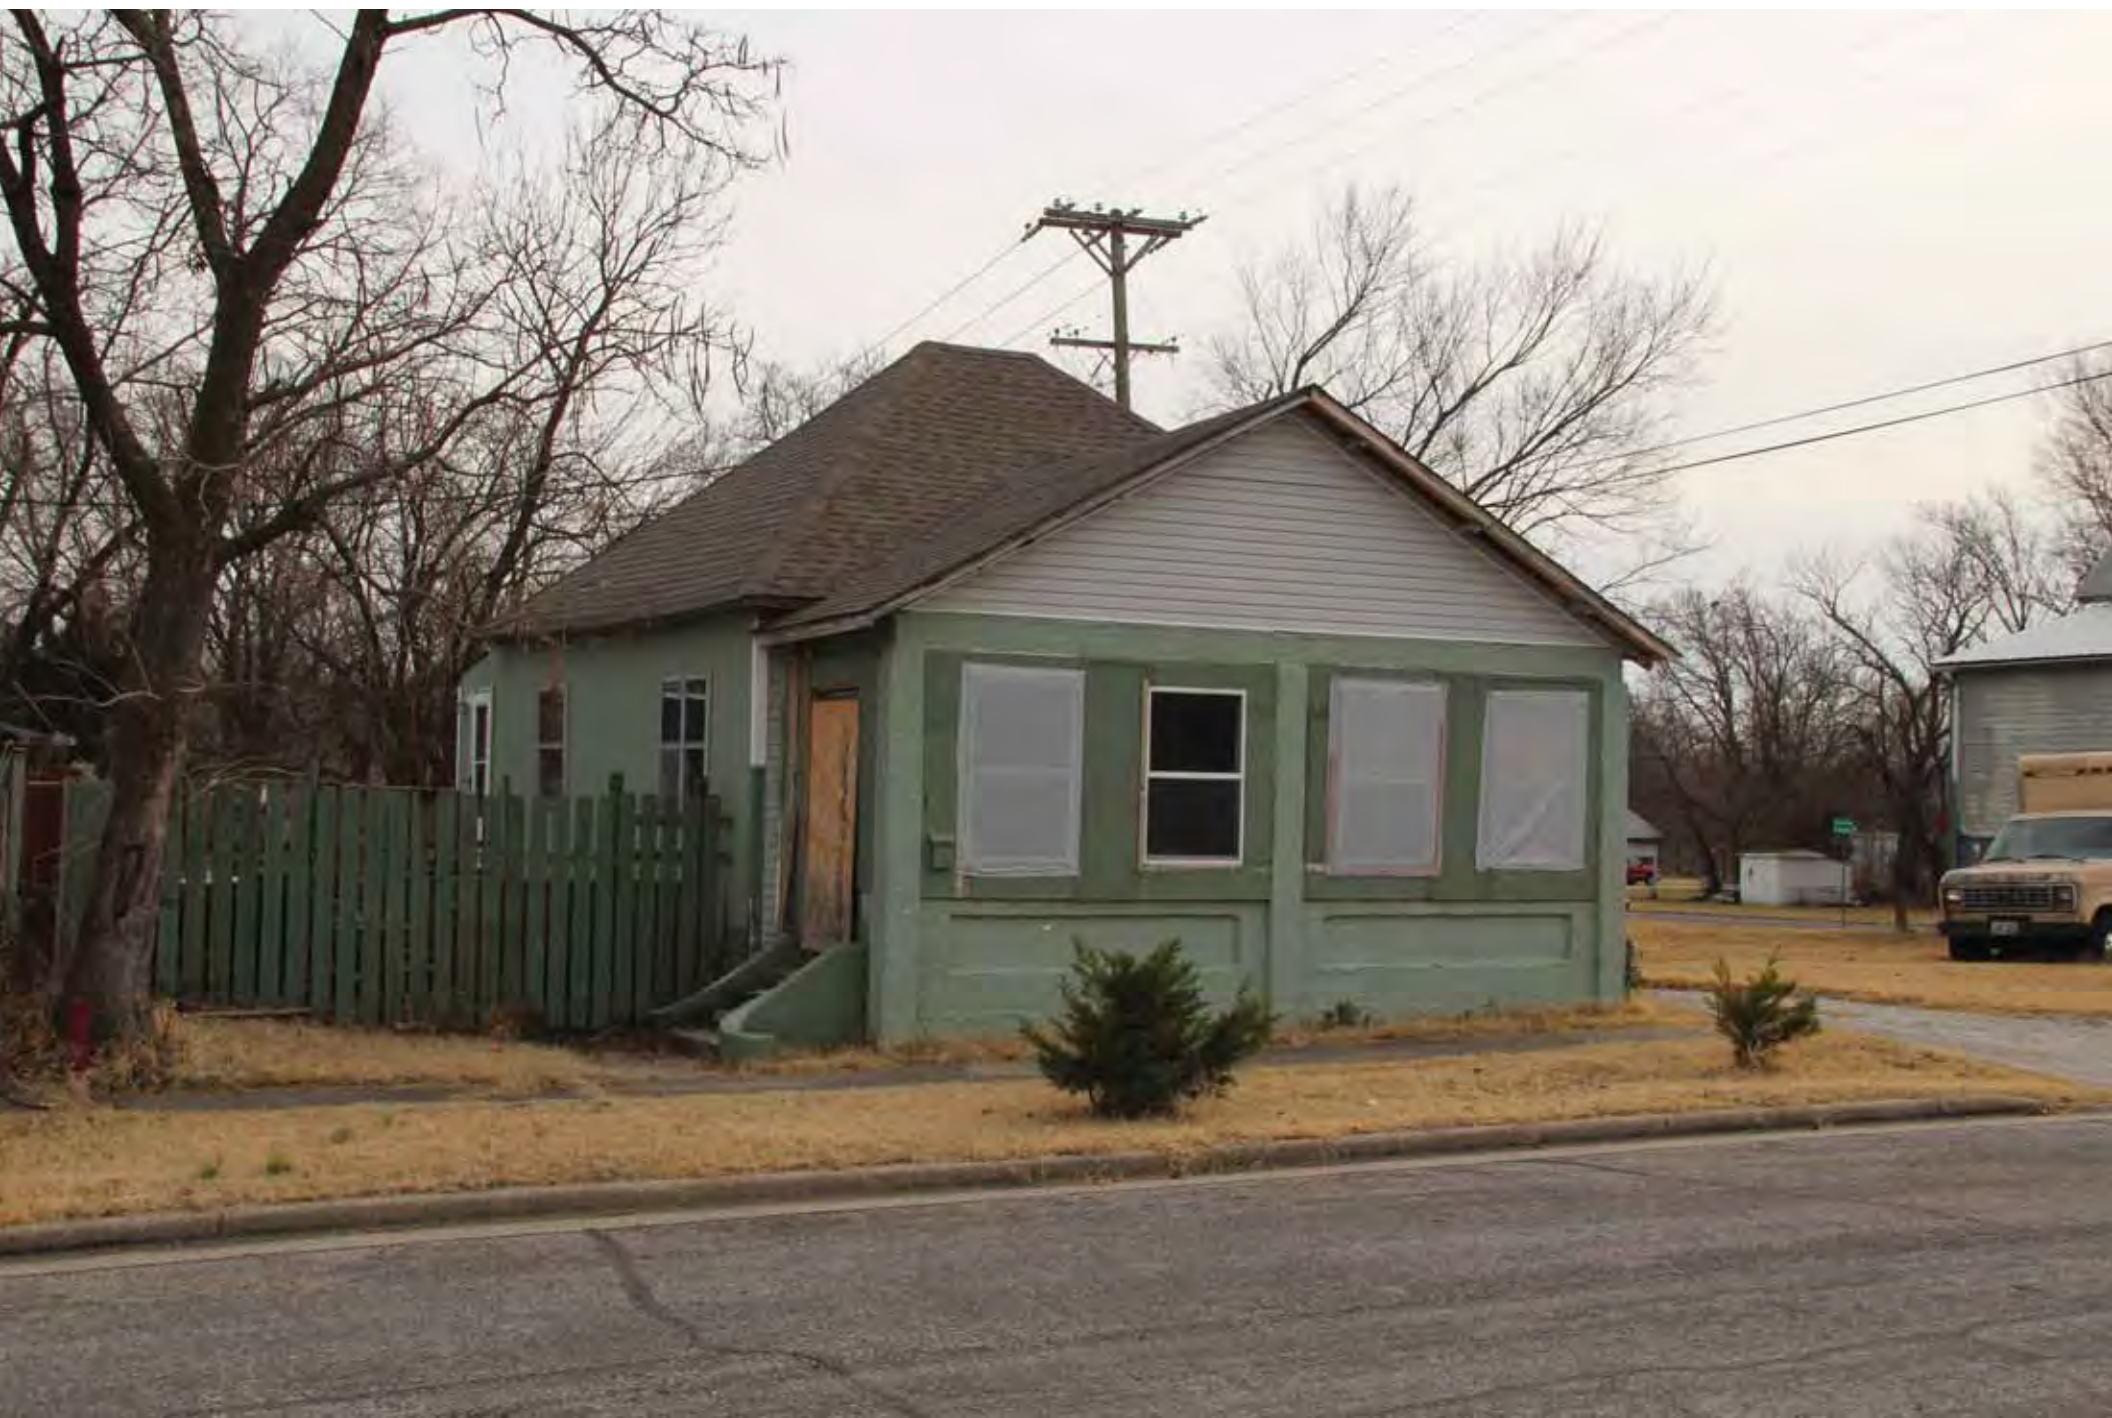
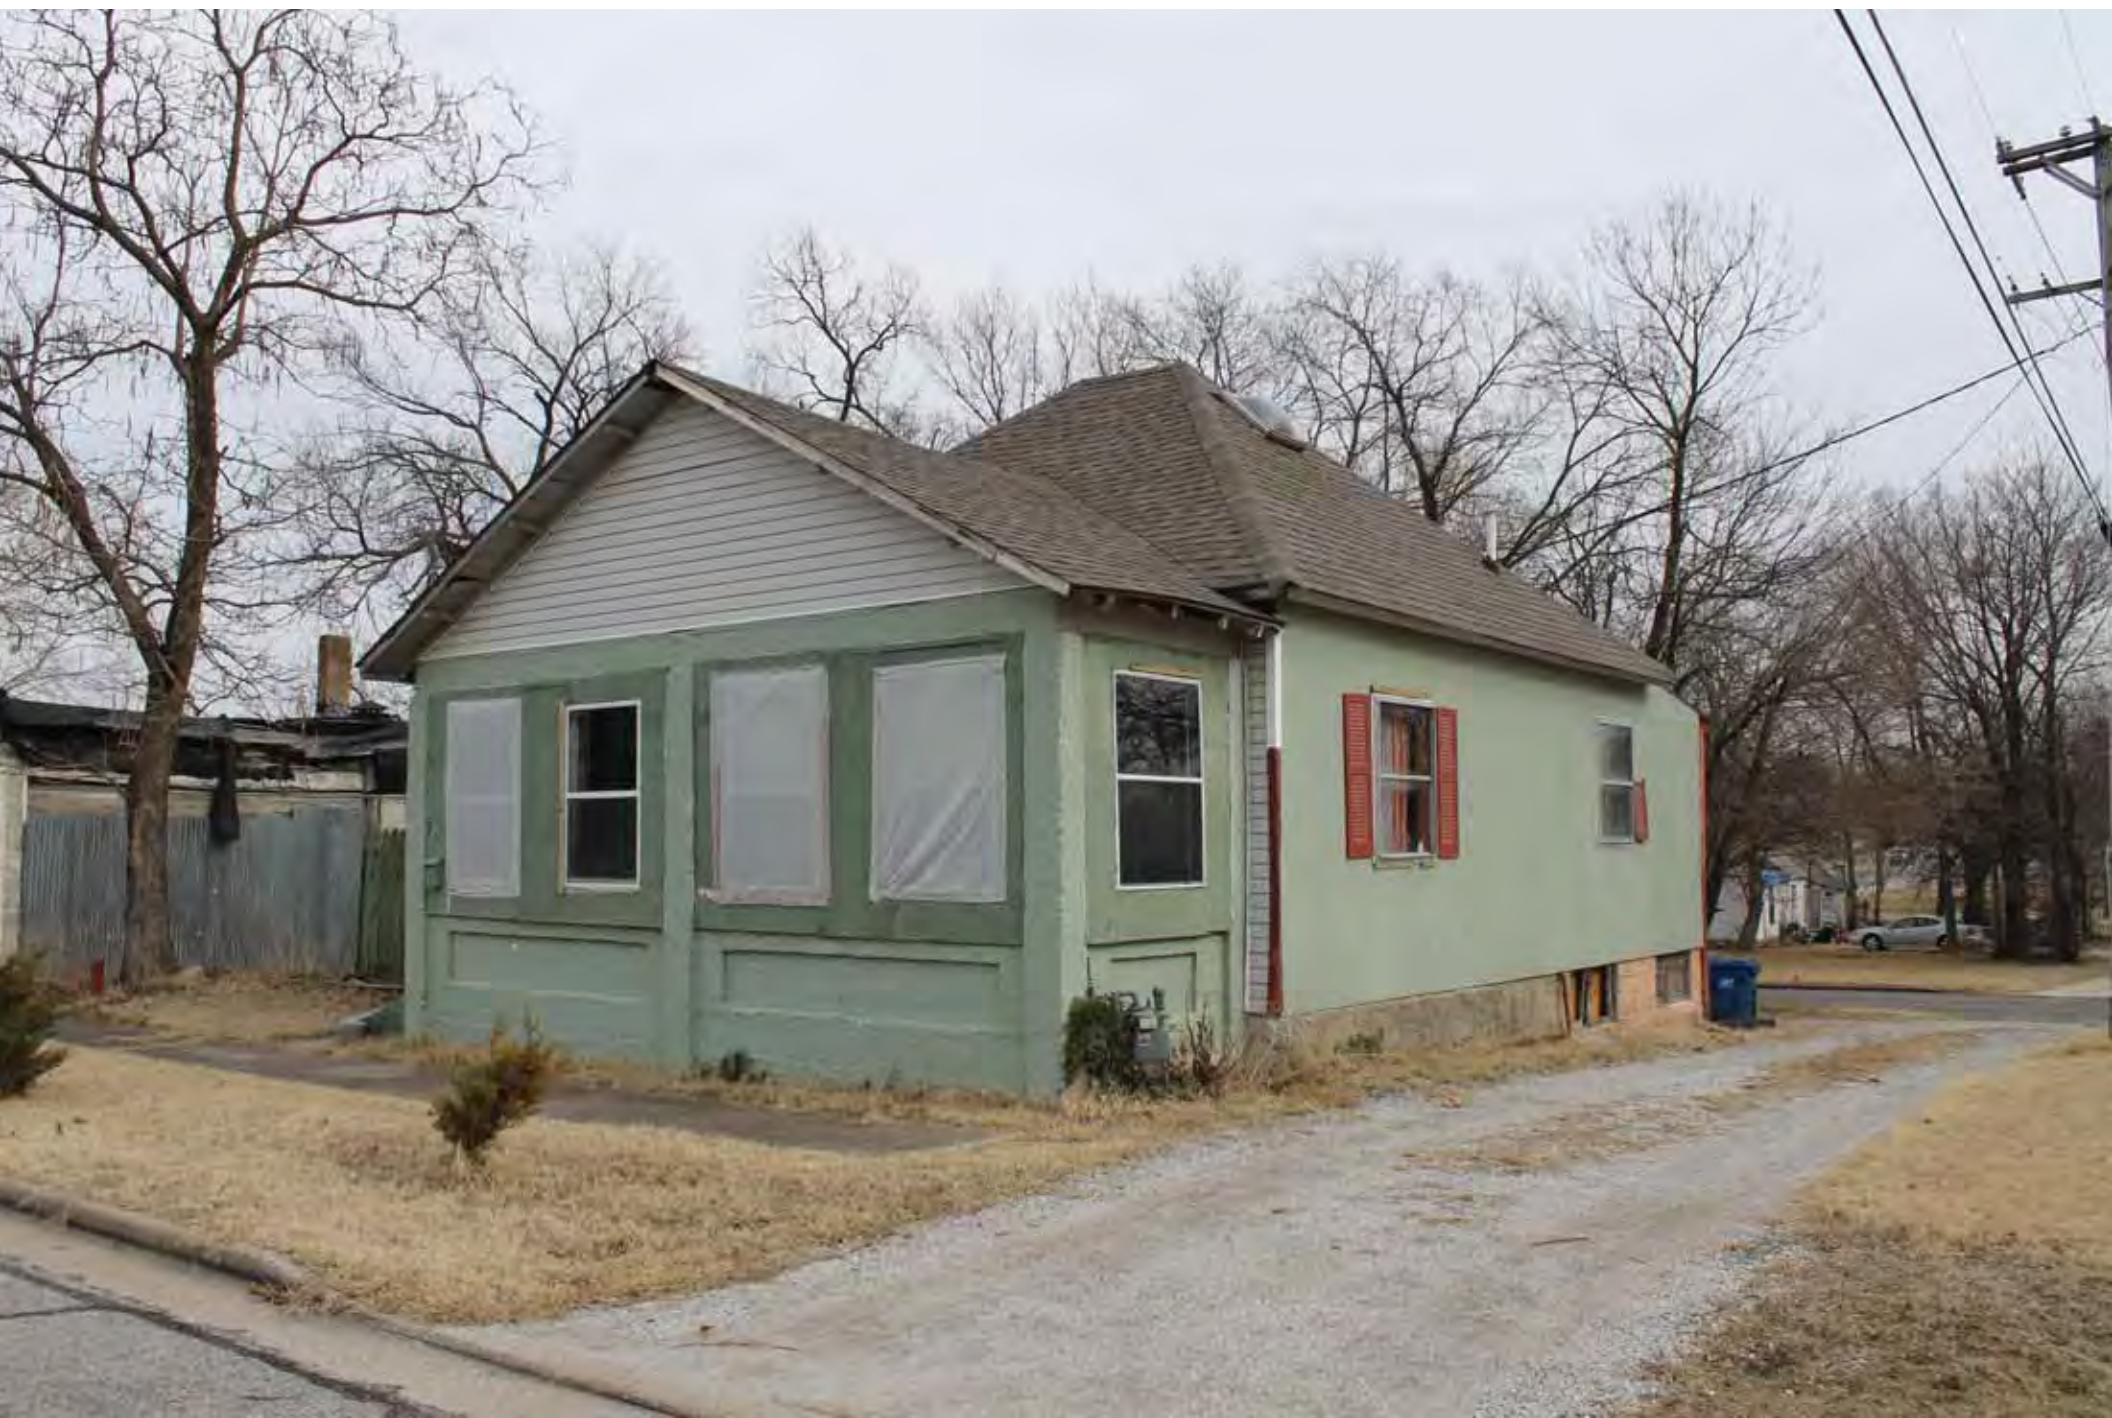
This dwelling has been extensively altered. The dwelling does not retain integrity that would render it individually eligible for the National Register of Historic Places. The dwelling is not situated in an area recommended as a historic district.

The property at 109 S. Cox Avenue features a one story dwelling, with a hipped roof covered in asphalt siding. On the front of the house is a front facing gable porch, which has been enclosed. The exterior of the entire house is covered in painted stucco. The front façade has four one-over-one vinyl windows. Each side of the house has one-over-one vinyl replacement windows with metal non-functioning shutters.

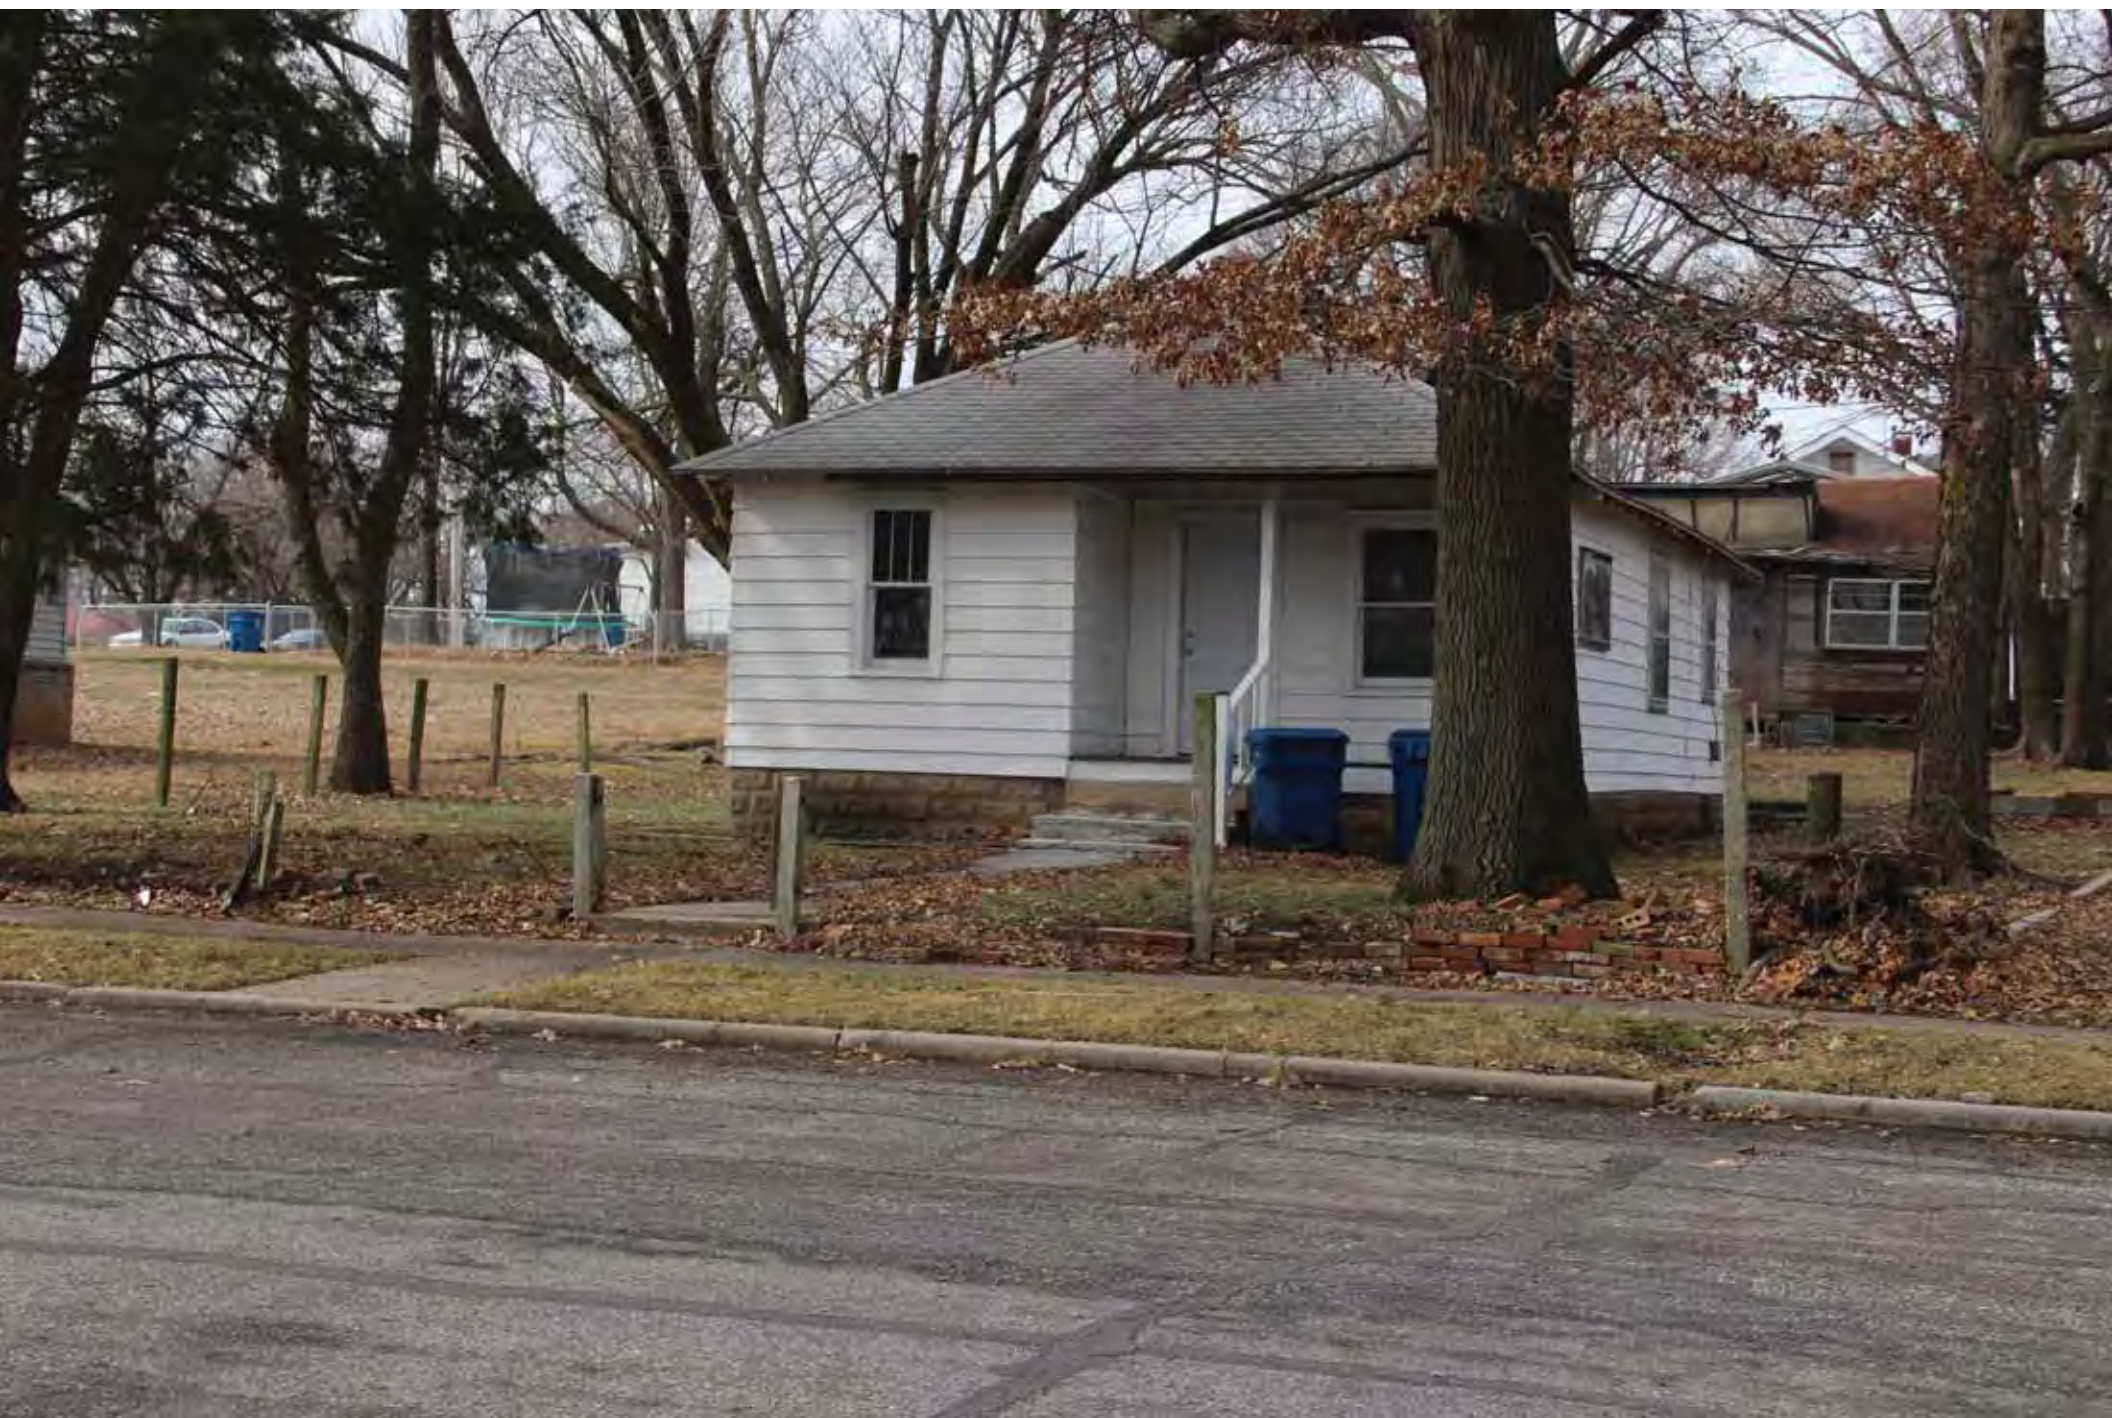
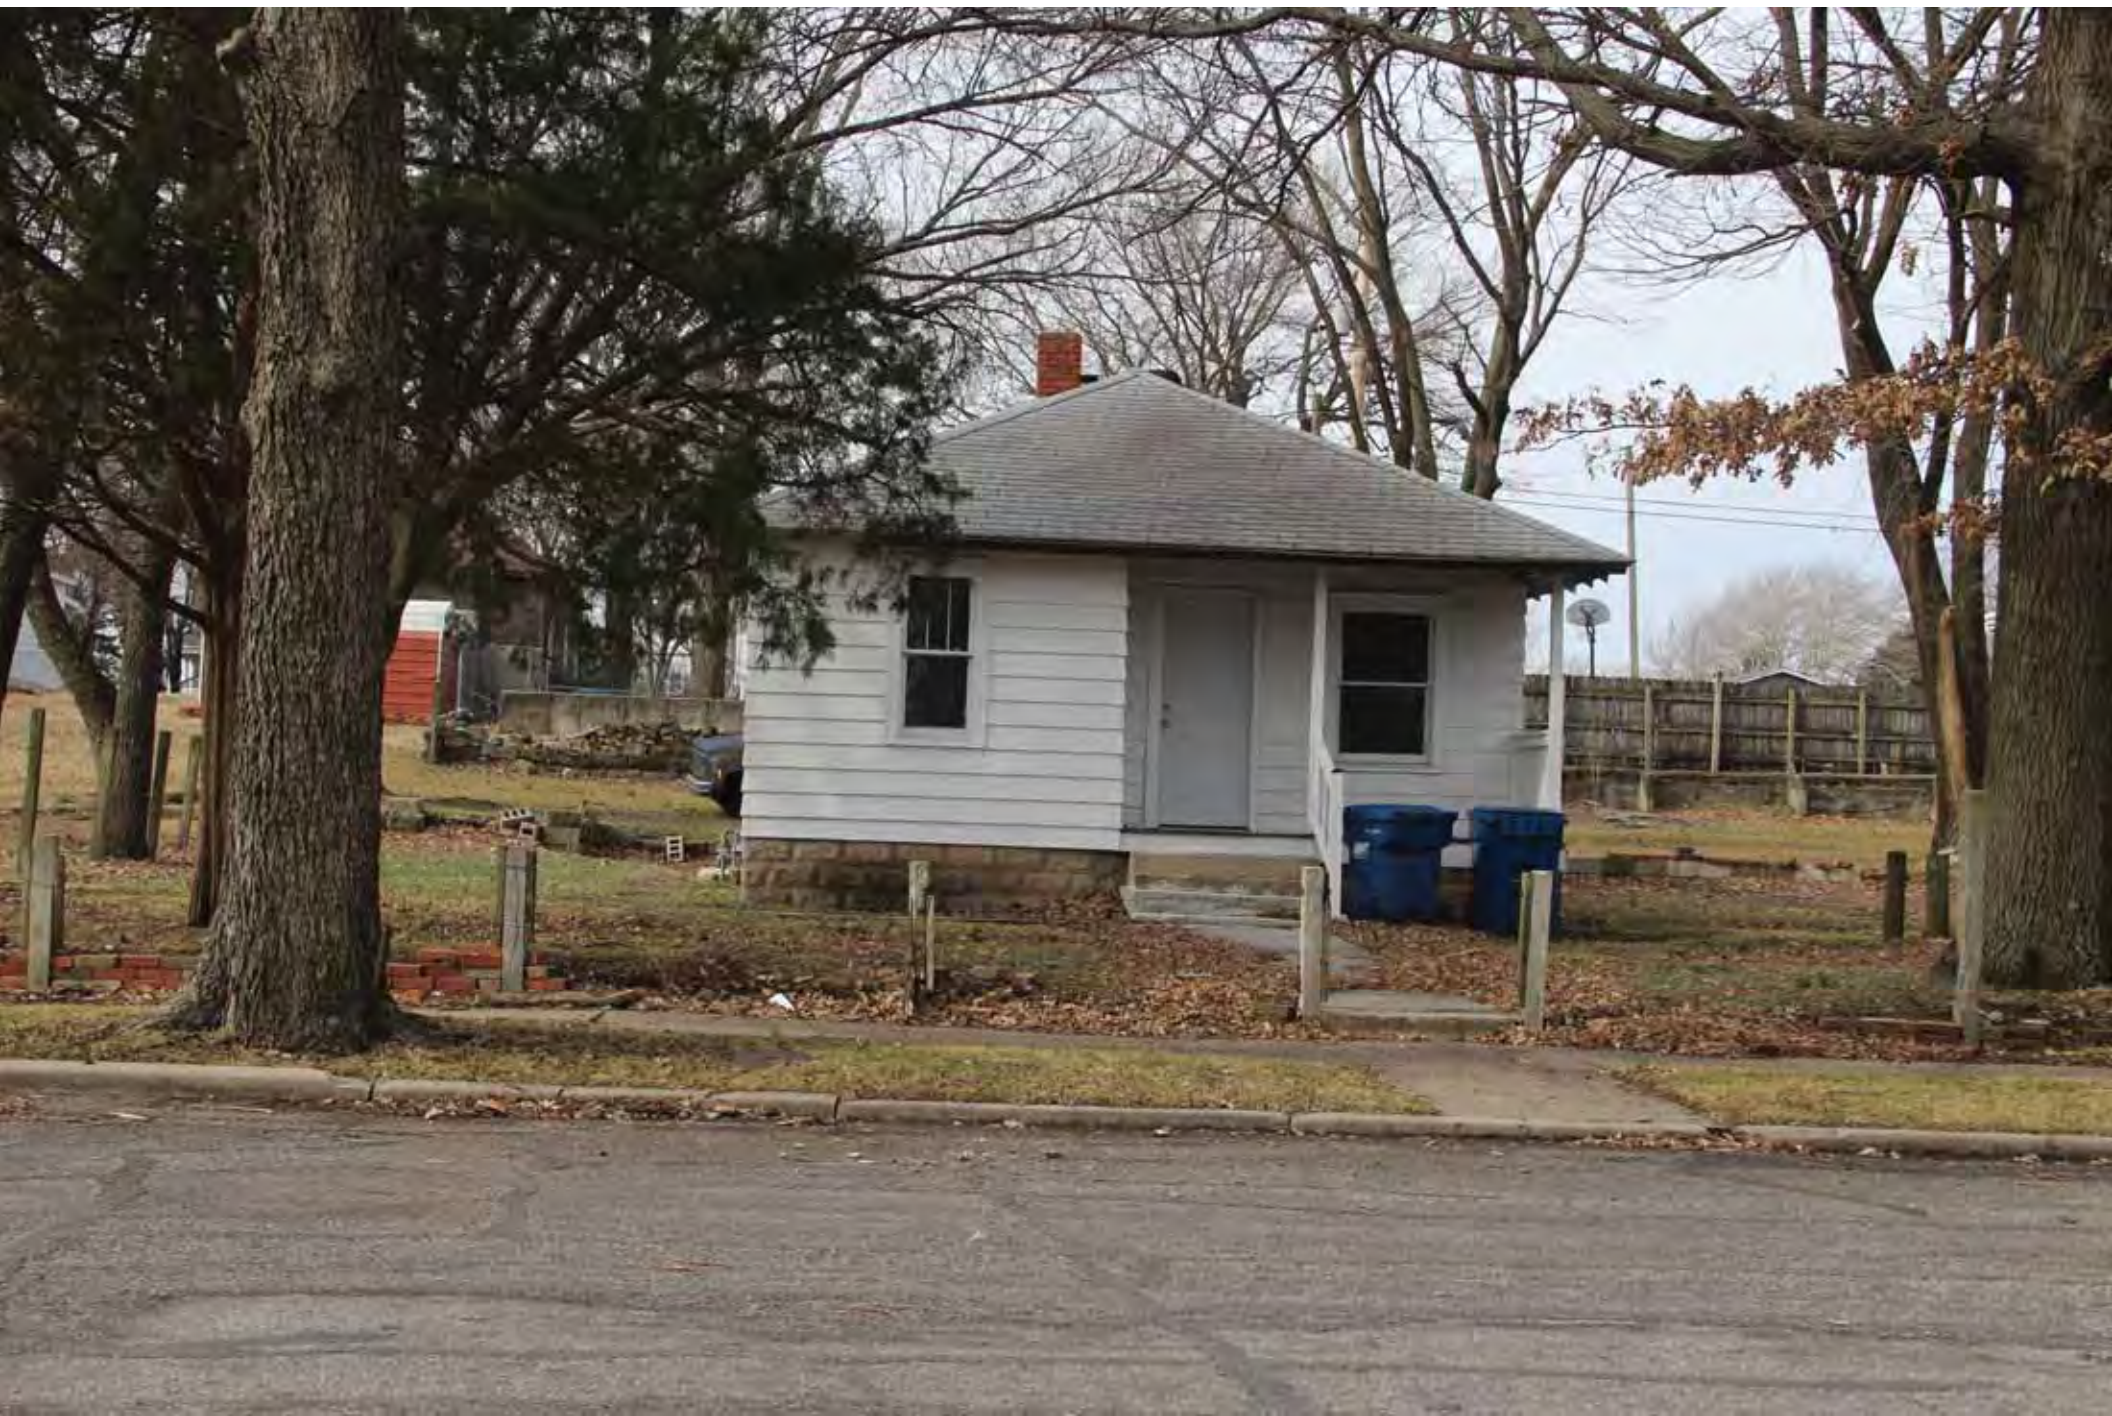
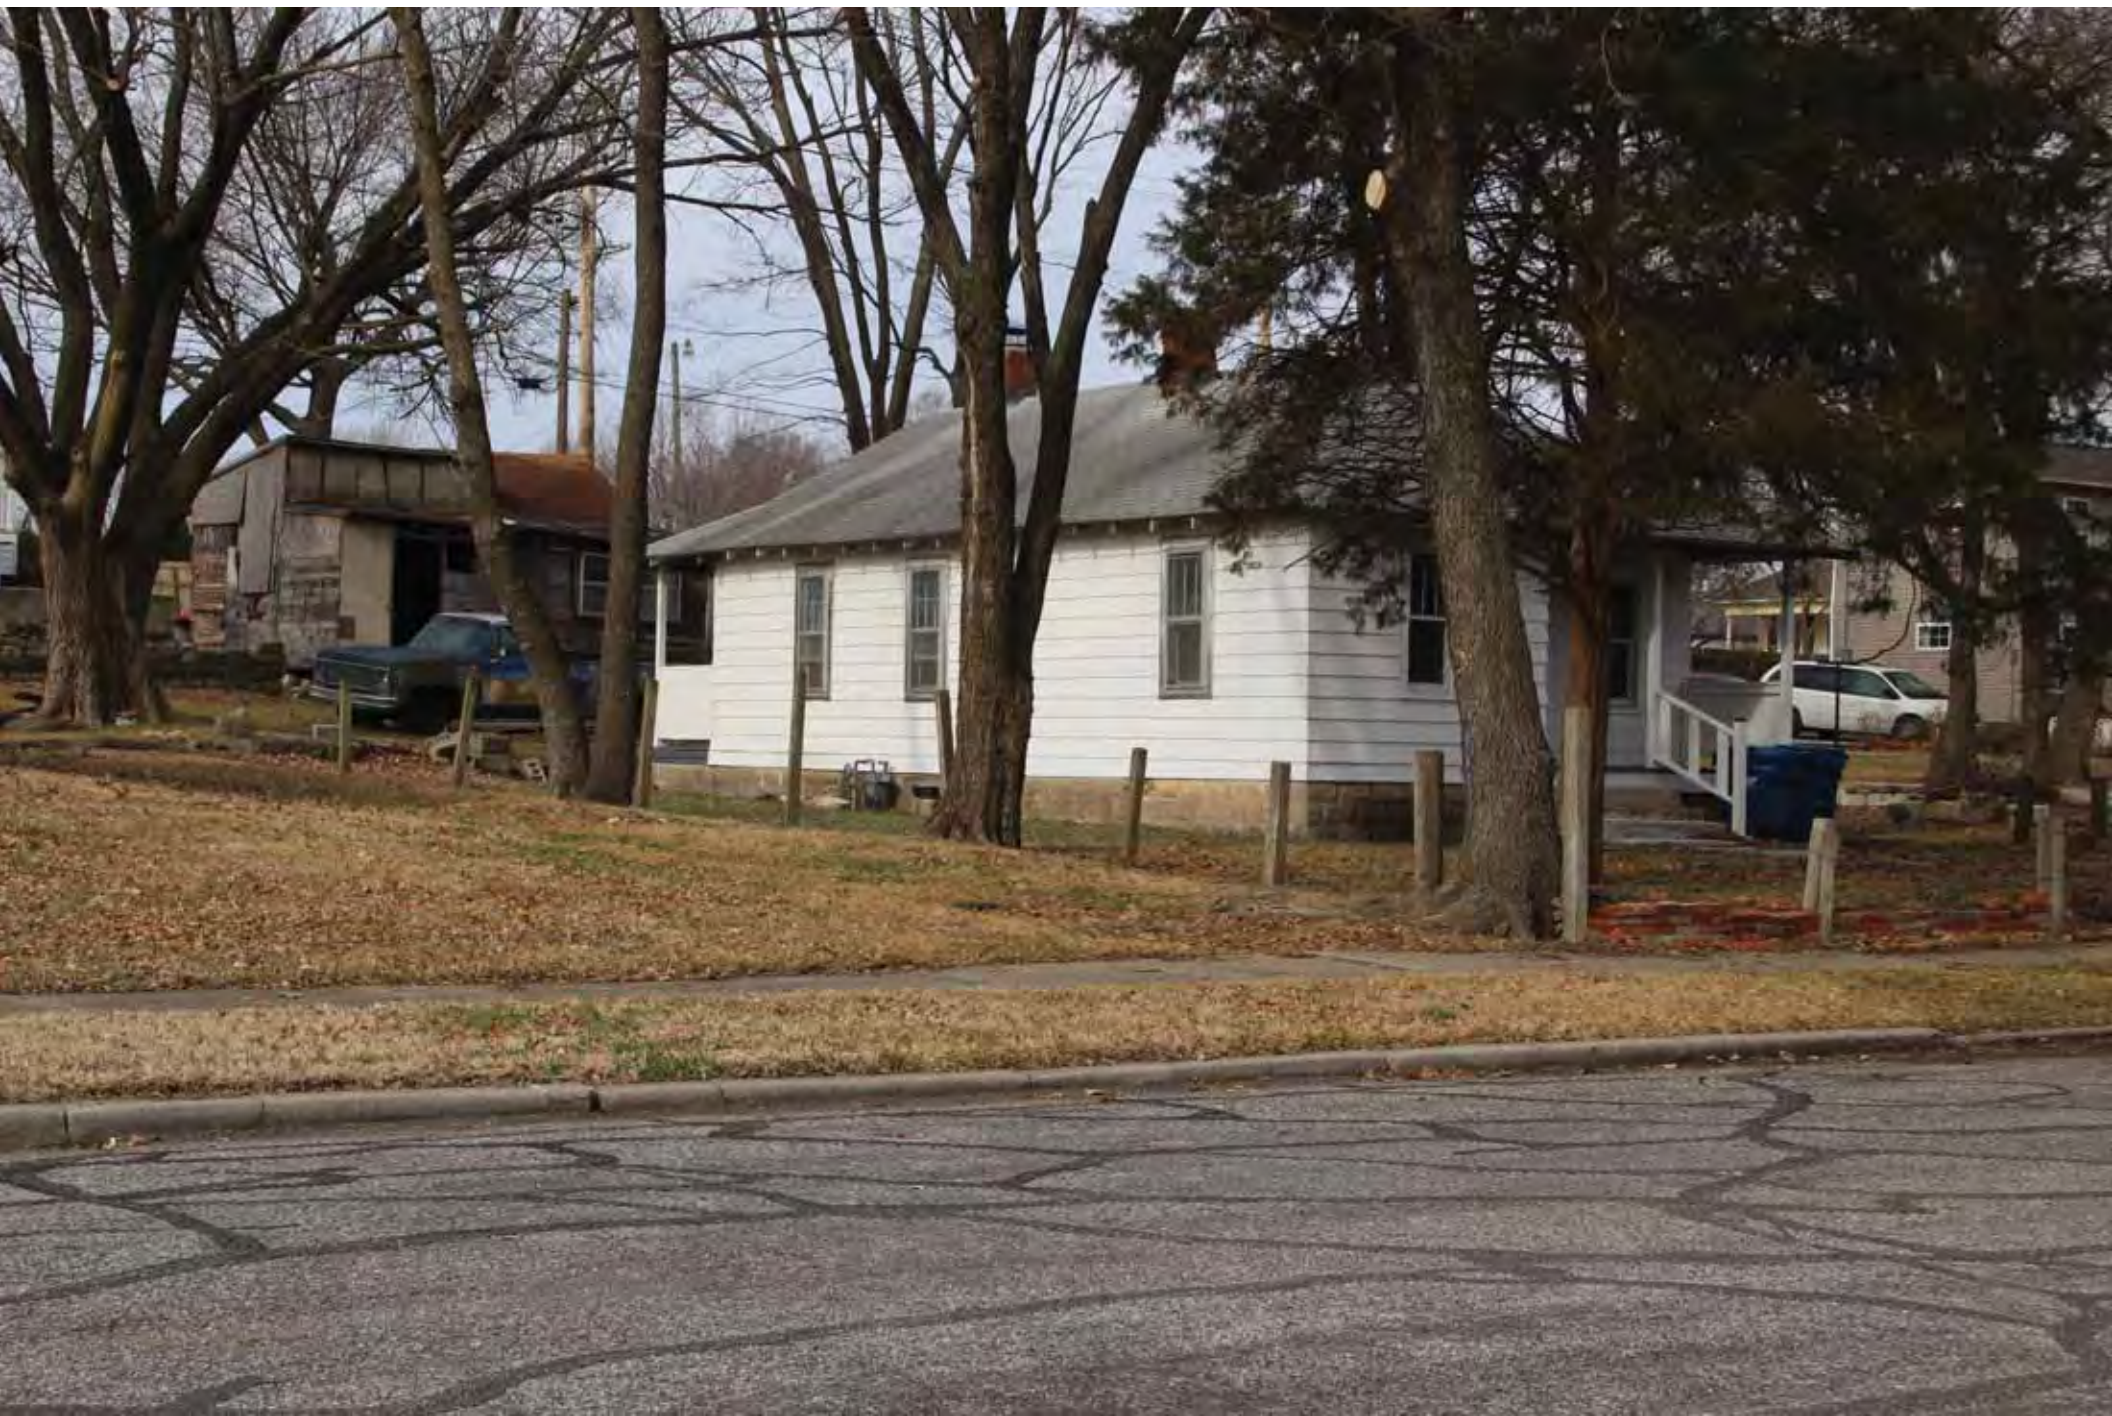
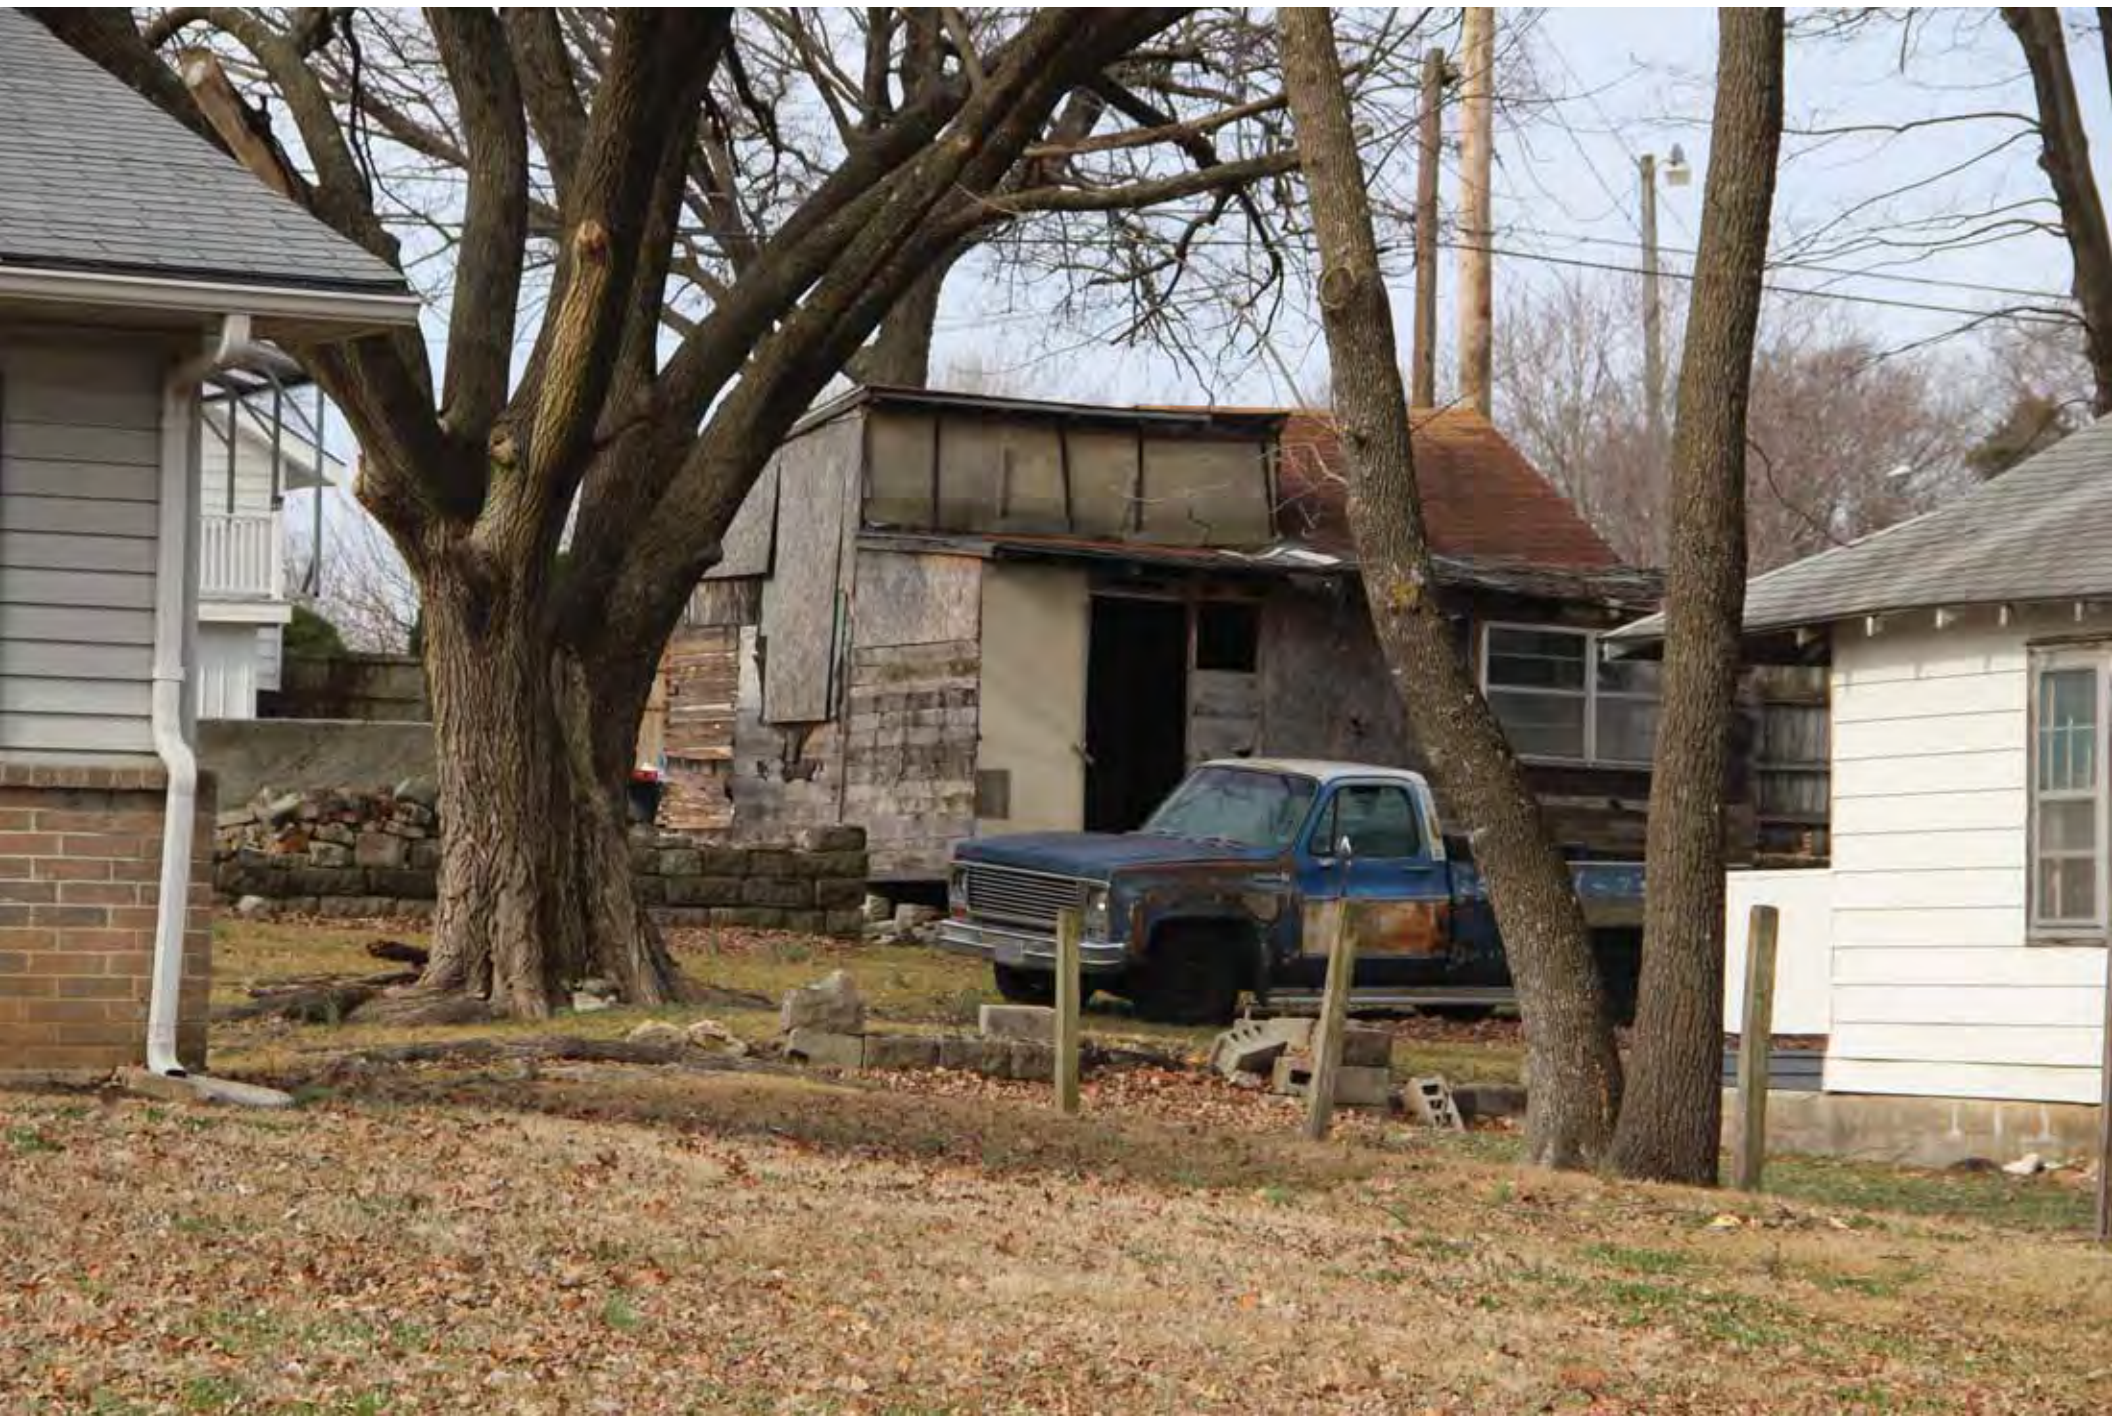
The building is on S. Cox Avenue (west). Behind the house is a wooden outbuilding in poor condition, built of unpainted boards. The outbuilding is not individually eligible for the National Register. There is a lot to the north of the house.

The property at 109 S. Cox Avenue is a one story dwelling, with a low-pitched hipped roof covered in asphalt siding. Under the hipped roof, on the right side, or north corner of the front façade, is a small veranda or porch. It shelters the front entrance, a metal replacement door, and a single one-over-one vinyl replacement window. To the left of this porch there is a one-over-one vinyl replacement window on the front façade. The exterior of the entire house is covered in replacement siding. The foundation of the house is rough-cut concrete block. There is an interior brick chimney.
