MISSOURI DEPARTMENT OF NATURAL RESOURCES
STATE HISTORIC PRESERVATION OFFICE, P.O. Box 176, Jefferson City, MO 65102
ARCHITECTURAL/HISTORIC INVENTORY FORM

1. Survey No. JP-AS-007-001		2. Survey name: East Town (Original Joplin) Historic Survey Phase 2	
3. County: JASPER		4. Address (Street No.) 618	Street (name) E. 2 nd Street
5. City: Joplin	Vicinity: <input type="checkbox"/>	6. Geographical Reference:	7. Township/Range/Section: T: R: S:
8. Historic name (if known):		9. Present/other name (if known):	
10. Ownership: <input checked="" type="checkbox"/> Private <input type="checkbox"/> Public		11a. Historic use (if known): Domestic: Single Dwelling	11b. Current use: Domestic: Single Dwelling

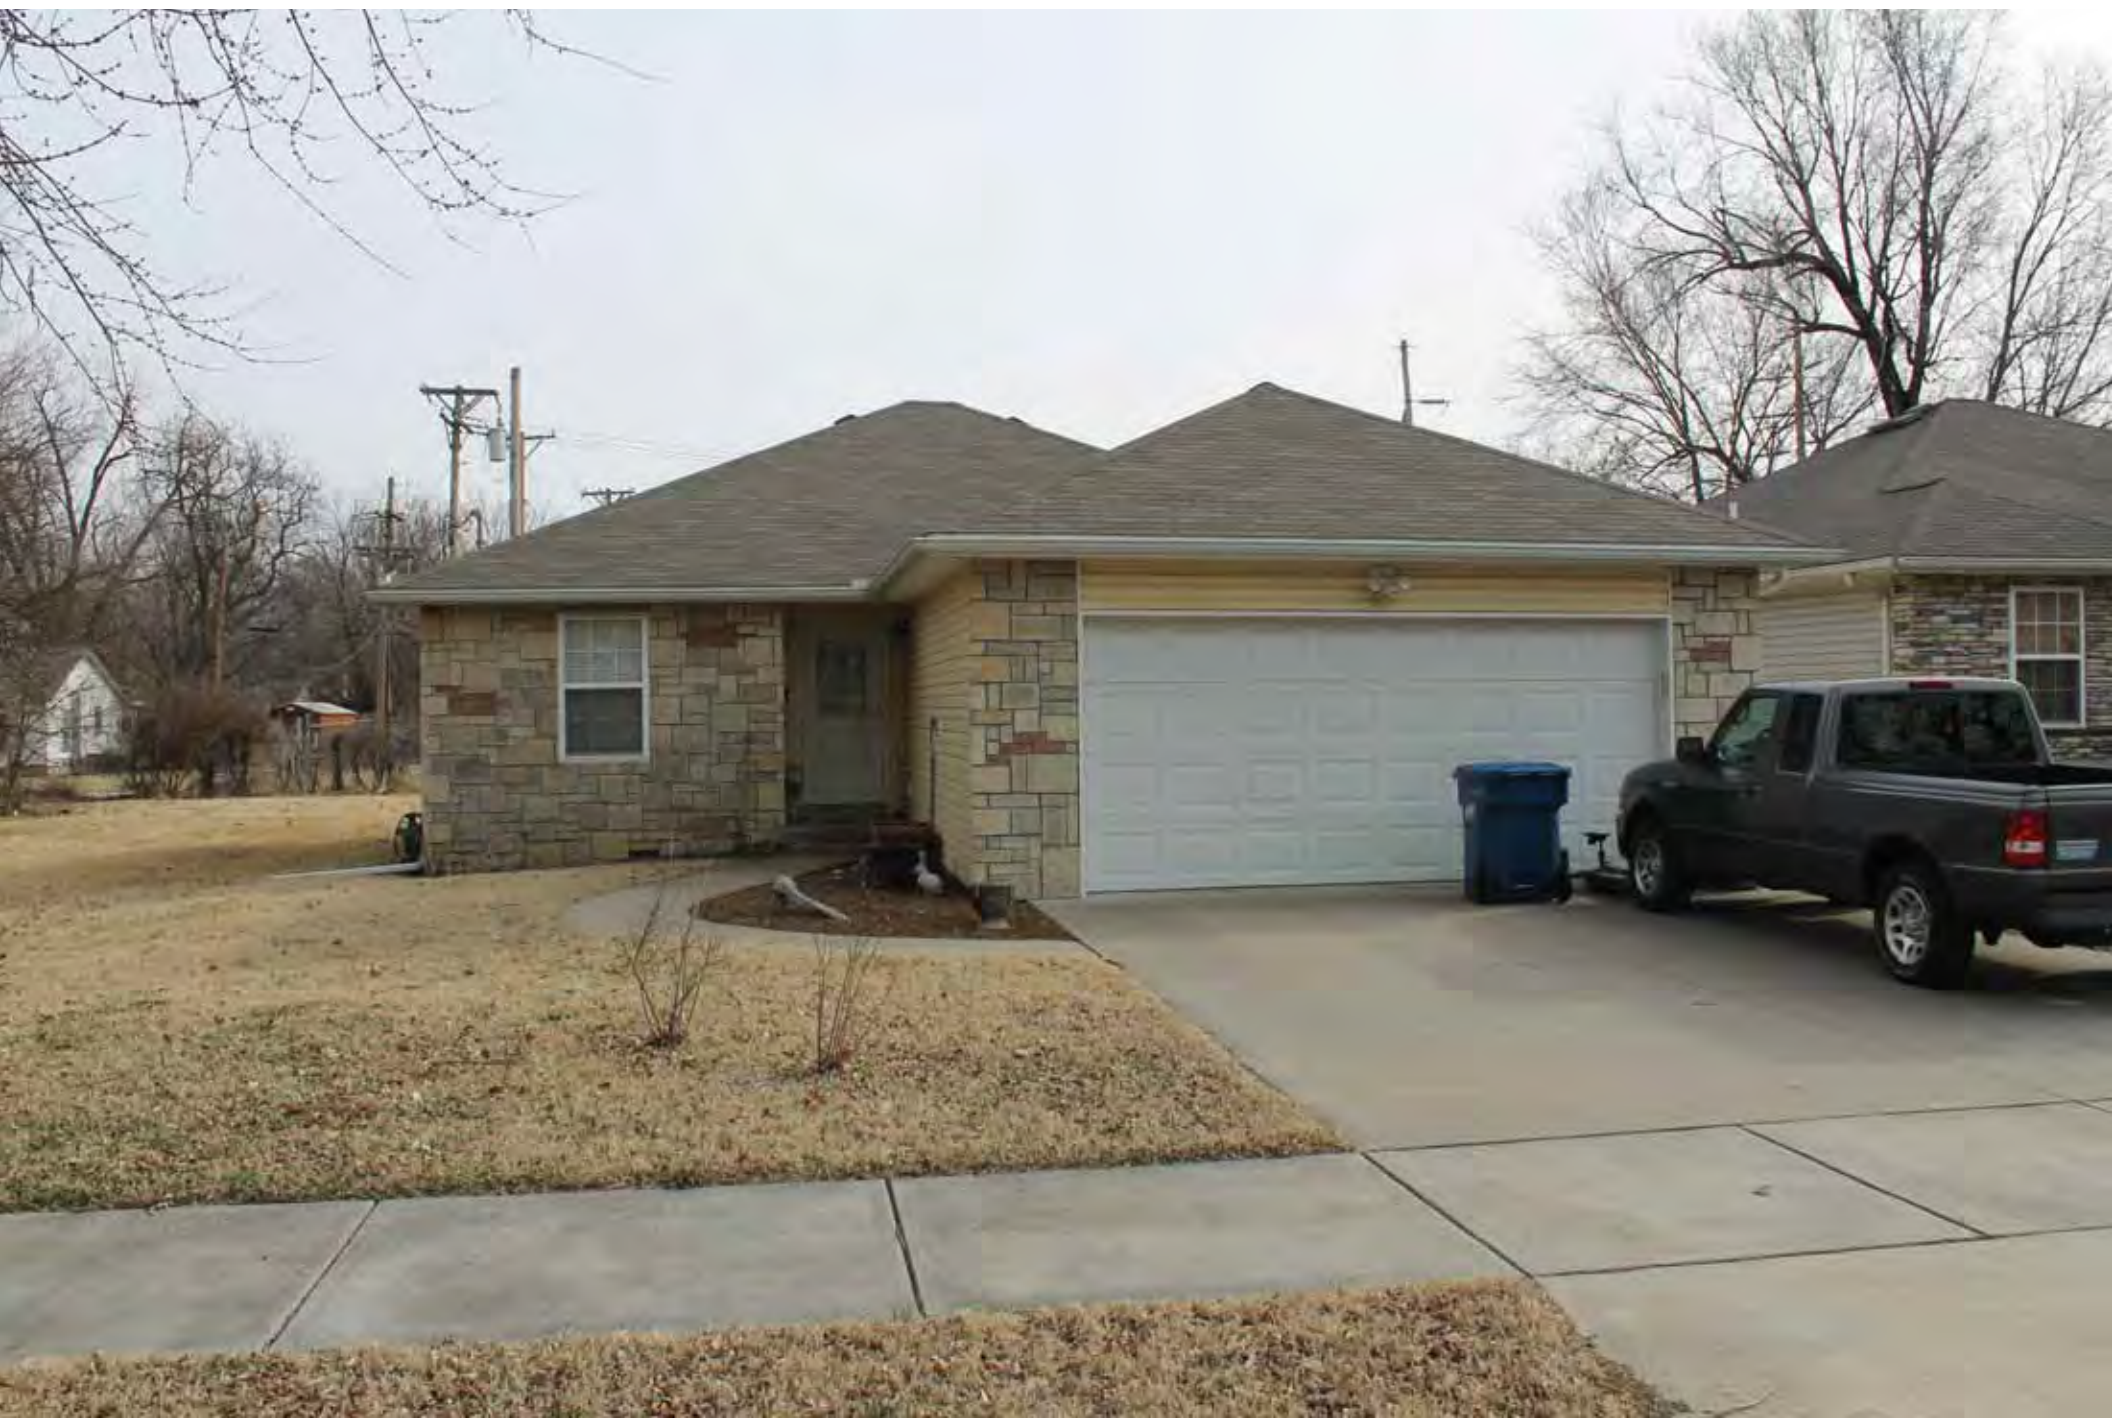
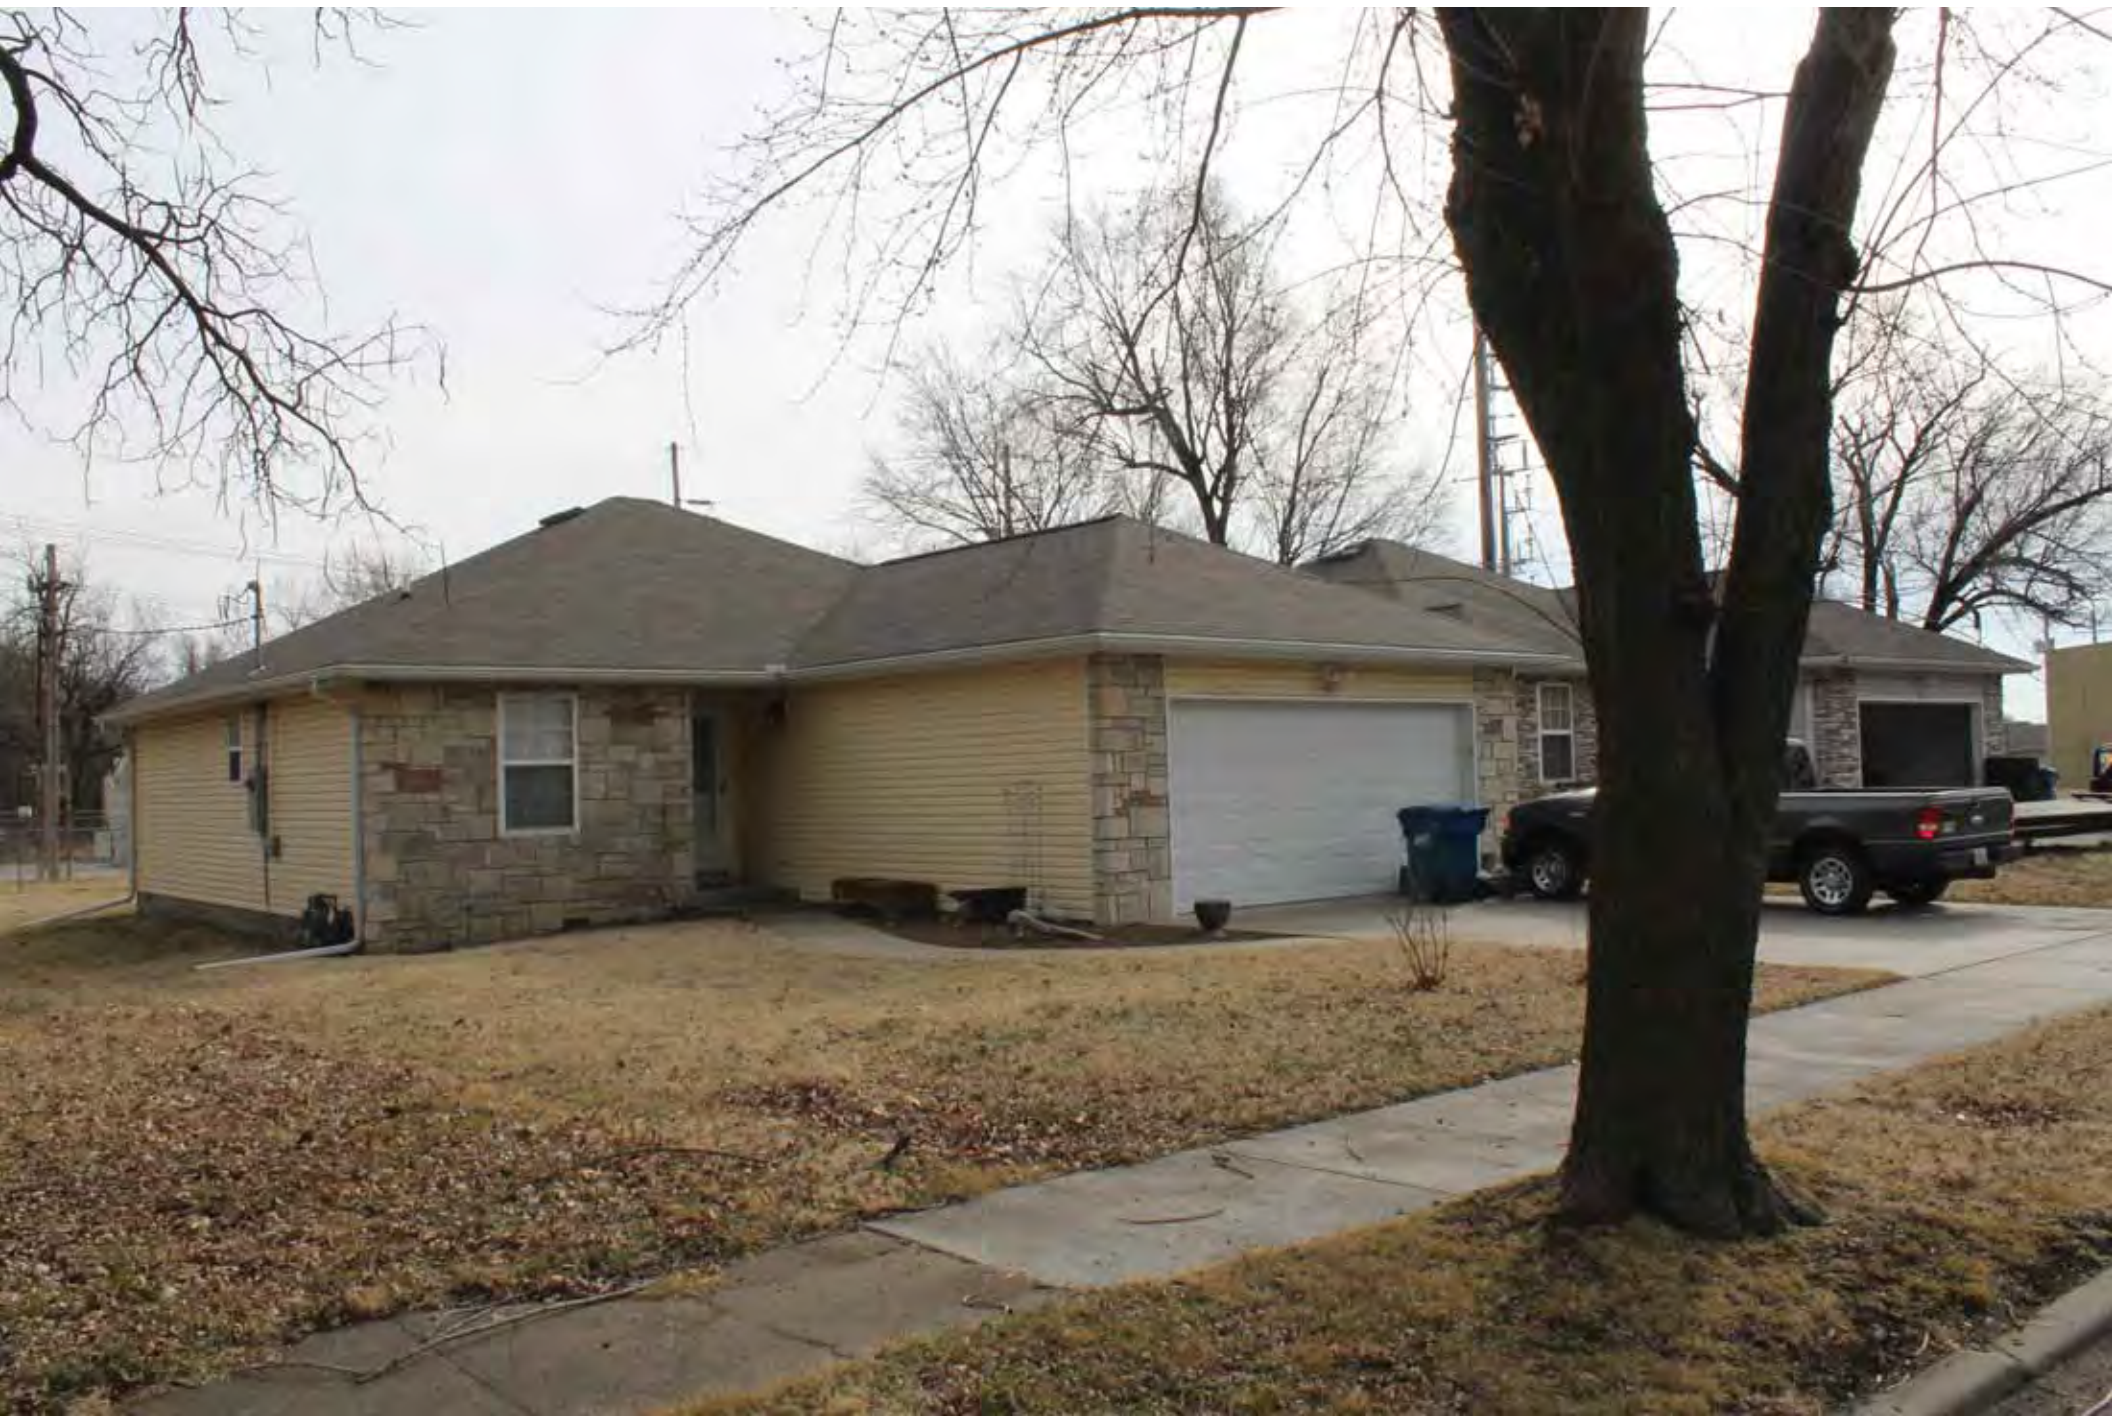
The property at 217 S. Cox Avenue is a one-story ranch house, with a low-pitched hipped roof covered in asphalt siding. It has an L-shaped plan with an attached garage on the south end of the house, which extends toward the street. On the north side of the front façade is the front door, slightly recessed beneath the hipped roof. To the left of the door is a six-over-six single vinyl window. The front façade is covered in a formstone veneer, and the rest of the house is covered in vinyl siding.

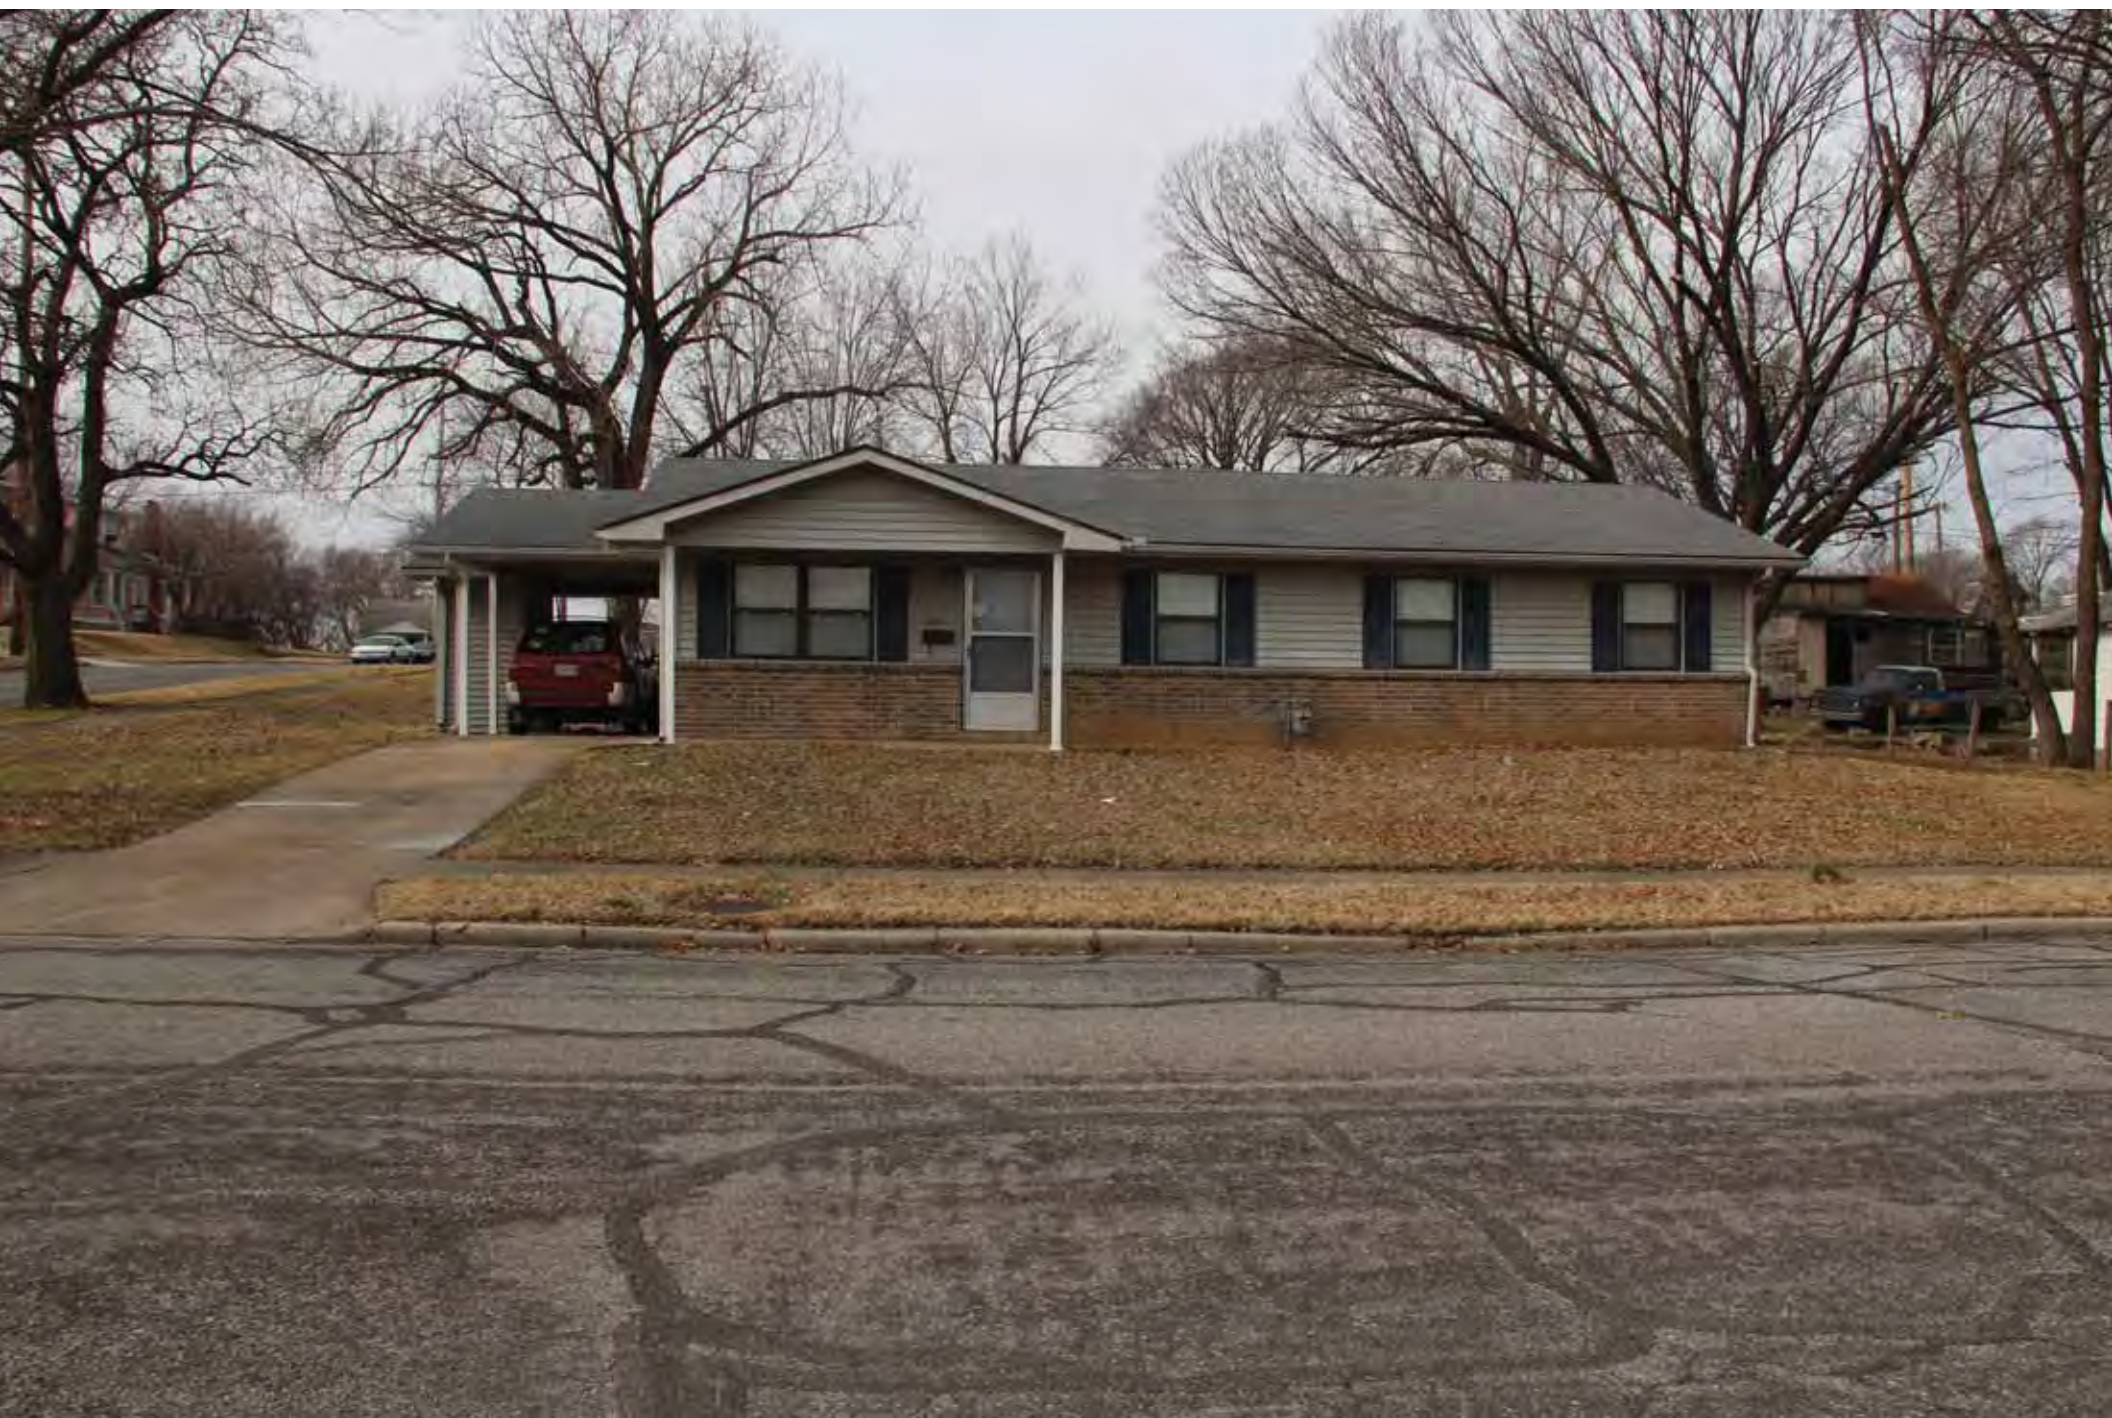
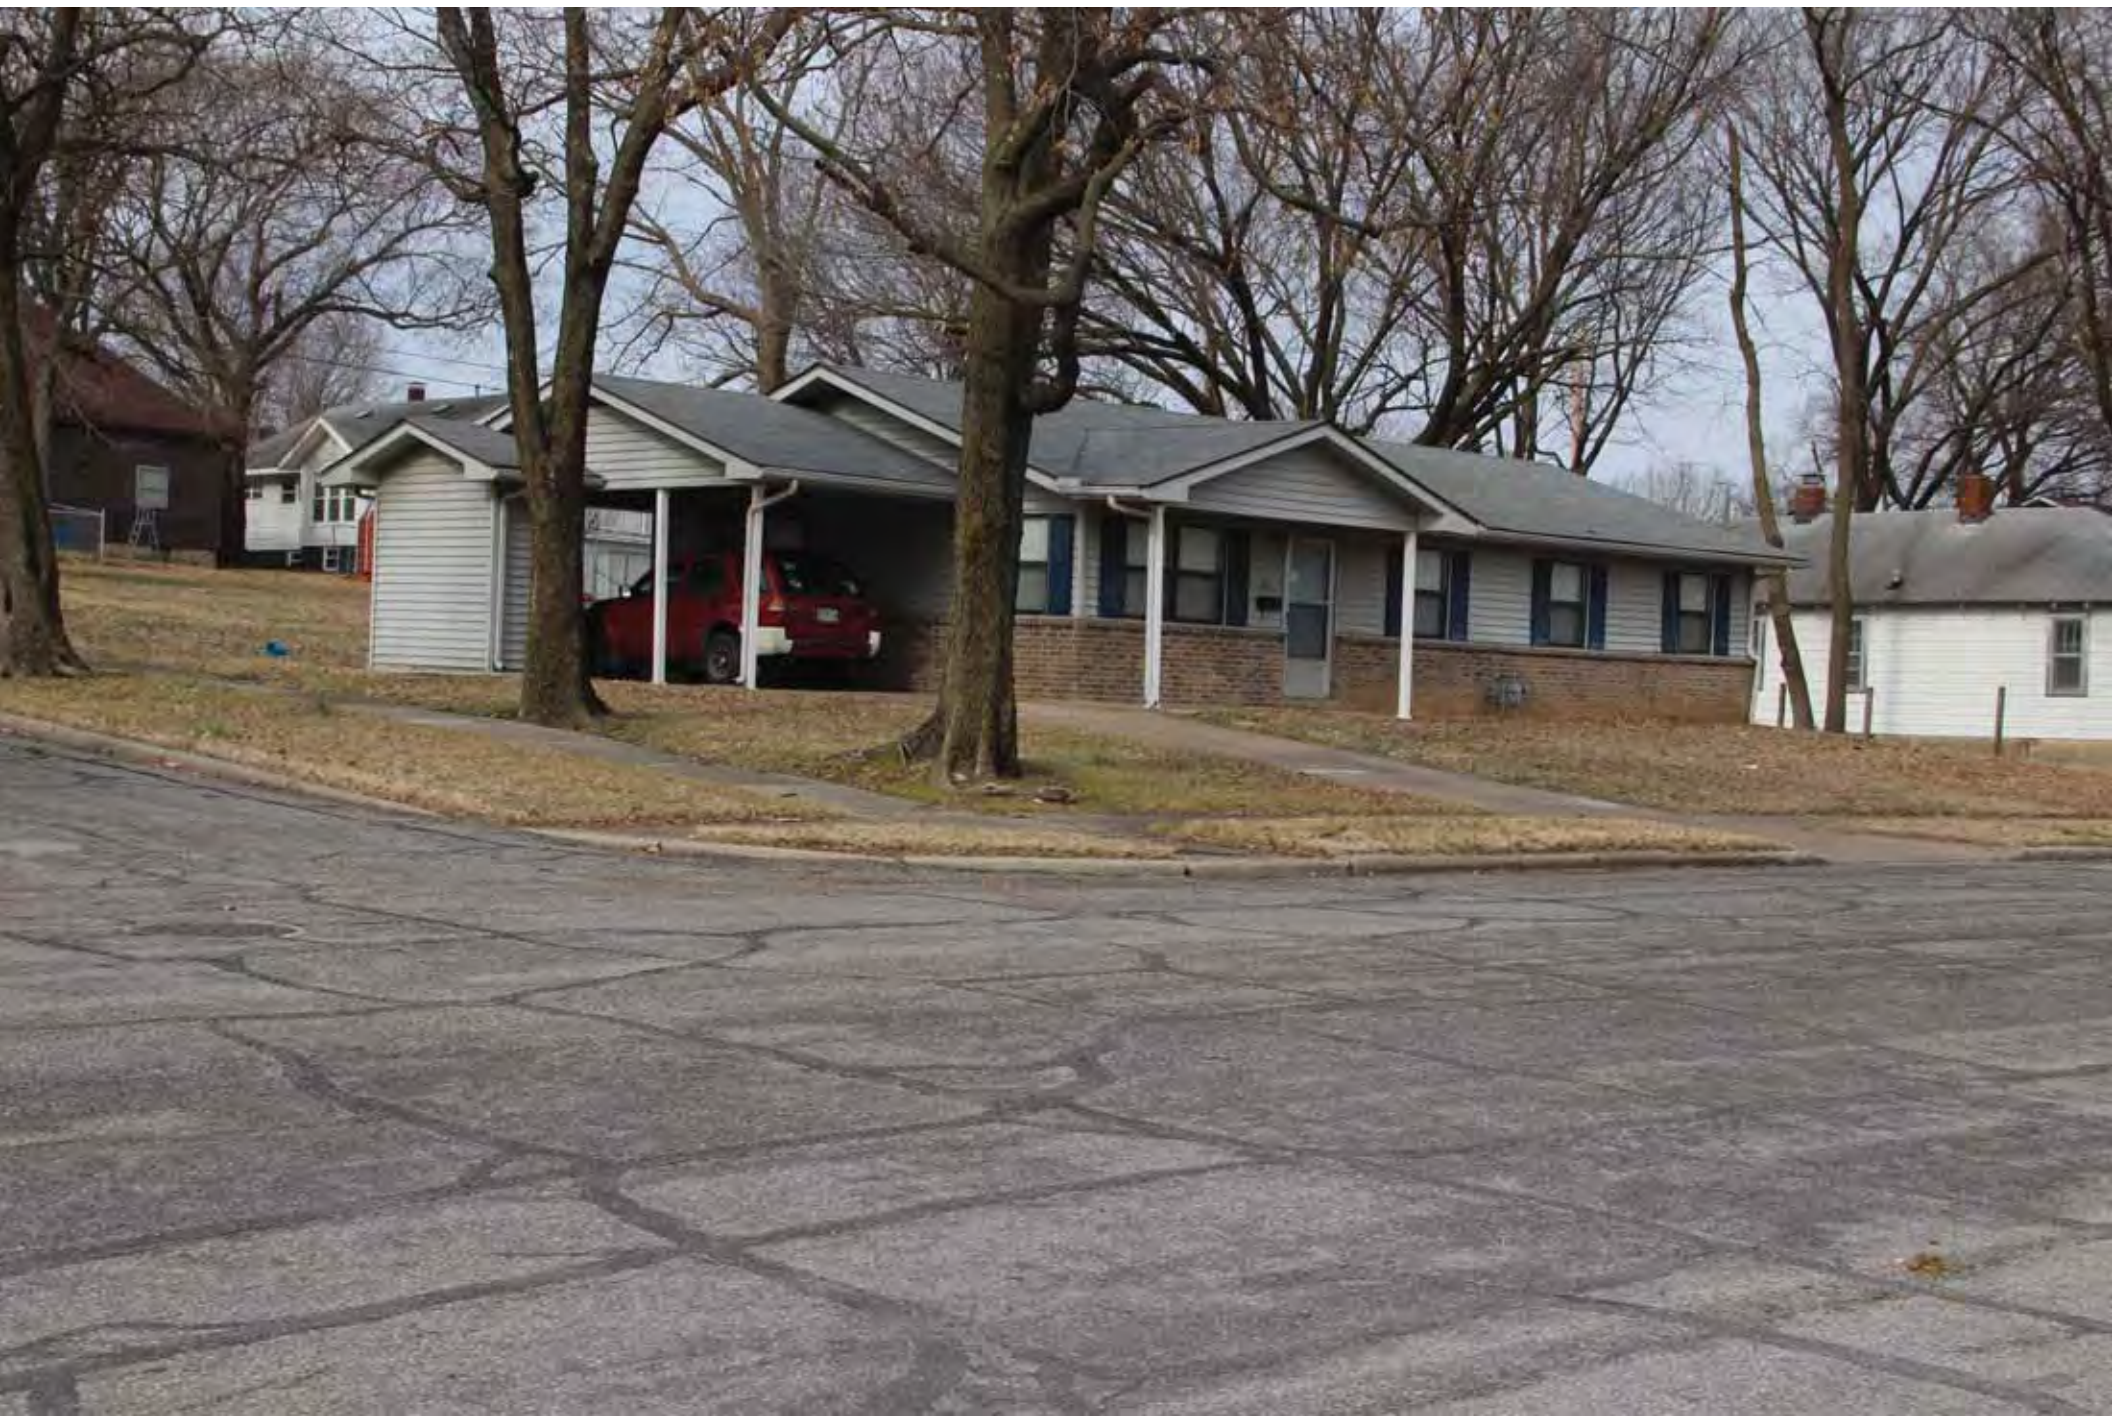
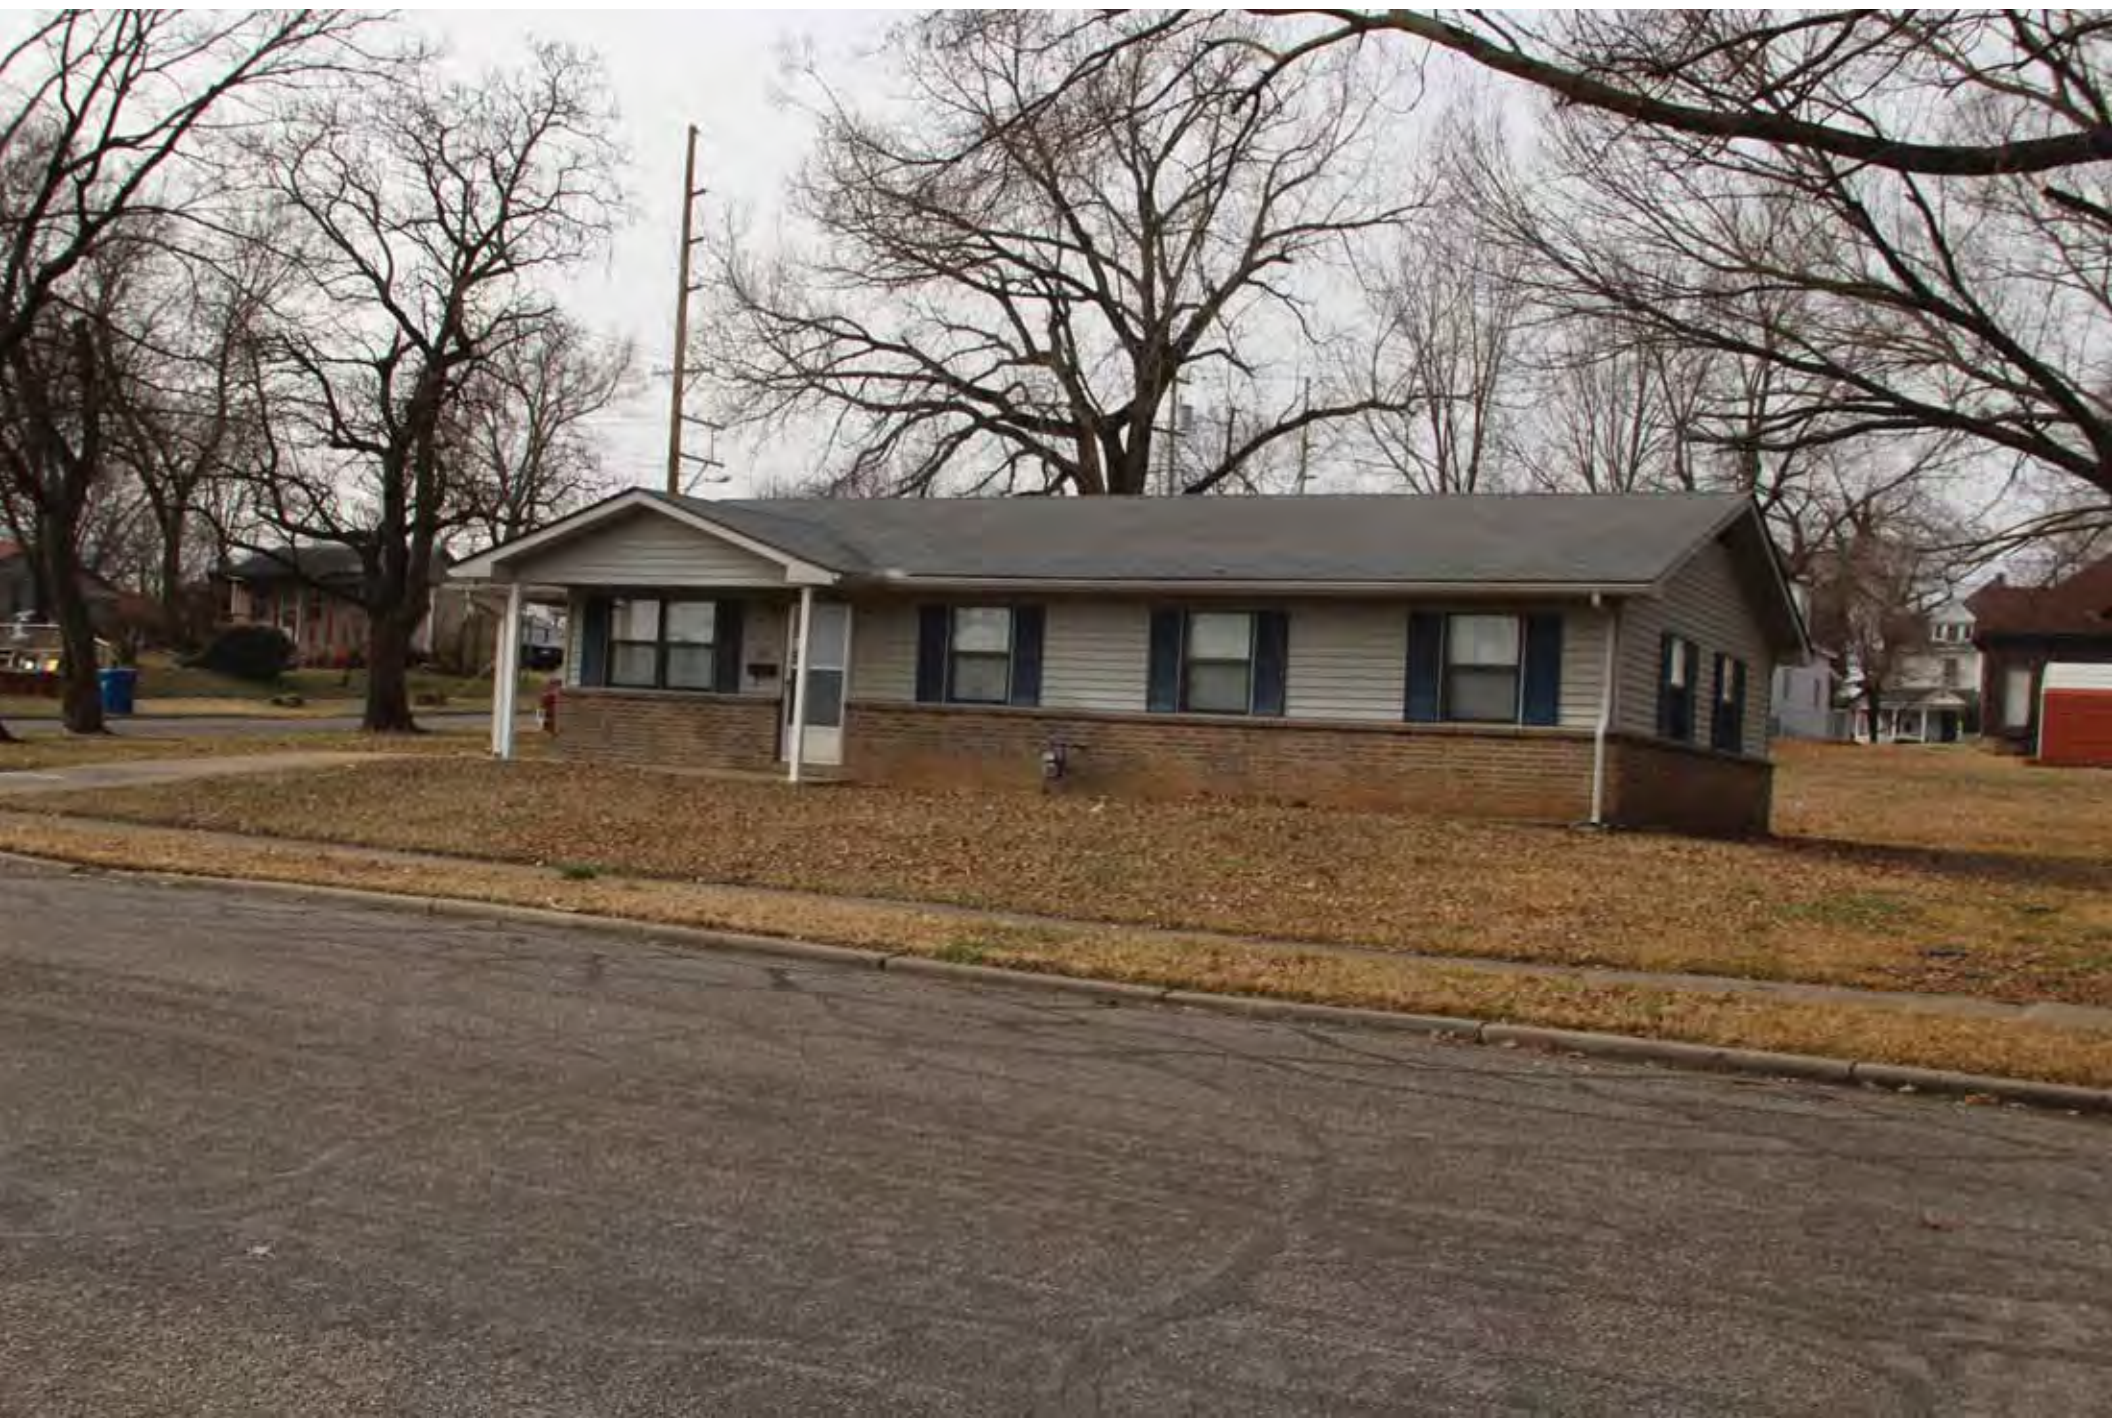
The property at 224 S. Cox Avenue is a one-story ranch house, with a low-pitched gable roof covered in asphalt siding. It has rectangular plan with an attached open carport on the south end of the house. On the front façade, just to the north of the carport, is a front-facing gable roofed open porch. It shelters a double one-over-one window and the front door. To the right, or north, of the porch are three single one-over-one vinyl windows, each with non-functioning metal shutters.
