MISSOURI DEPARTMENT OF NATURAL RESOURCES
STATE HISTORIC PRESERVATION OFFICE, P.O. Box 176, Jefferson City, MO 65102
ARCHITECTURAL/HISTORIC INVENTORY FORM

1. Survey No. JP-AS-007-001		2. Survey name: East Town (Original Joplin) Historic Survey Phase 2	
3. County: JASPER		4. Address (Street No.) 618	Street (name) E. 2 nd Street
5. City: Joplin	Vicinity: <input type="checkbox"/>	6. Geographical Reference:	7. Township/Range/Section: T: R: S:
8. Historic name (if known):		9. Present/other name (if known):	
10. Ownership: <input checked="" type="checkbox"/> Private <input type="checkbox"/> Public		11a. Historic use (if known): Domestic: Single Dwelling	11b. Current use: Domestic: Single Dwelling

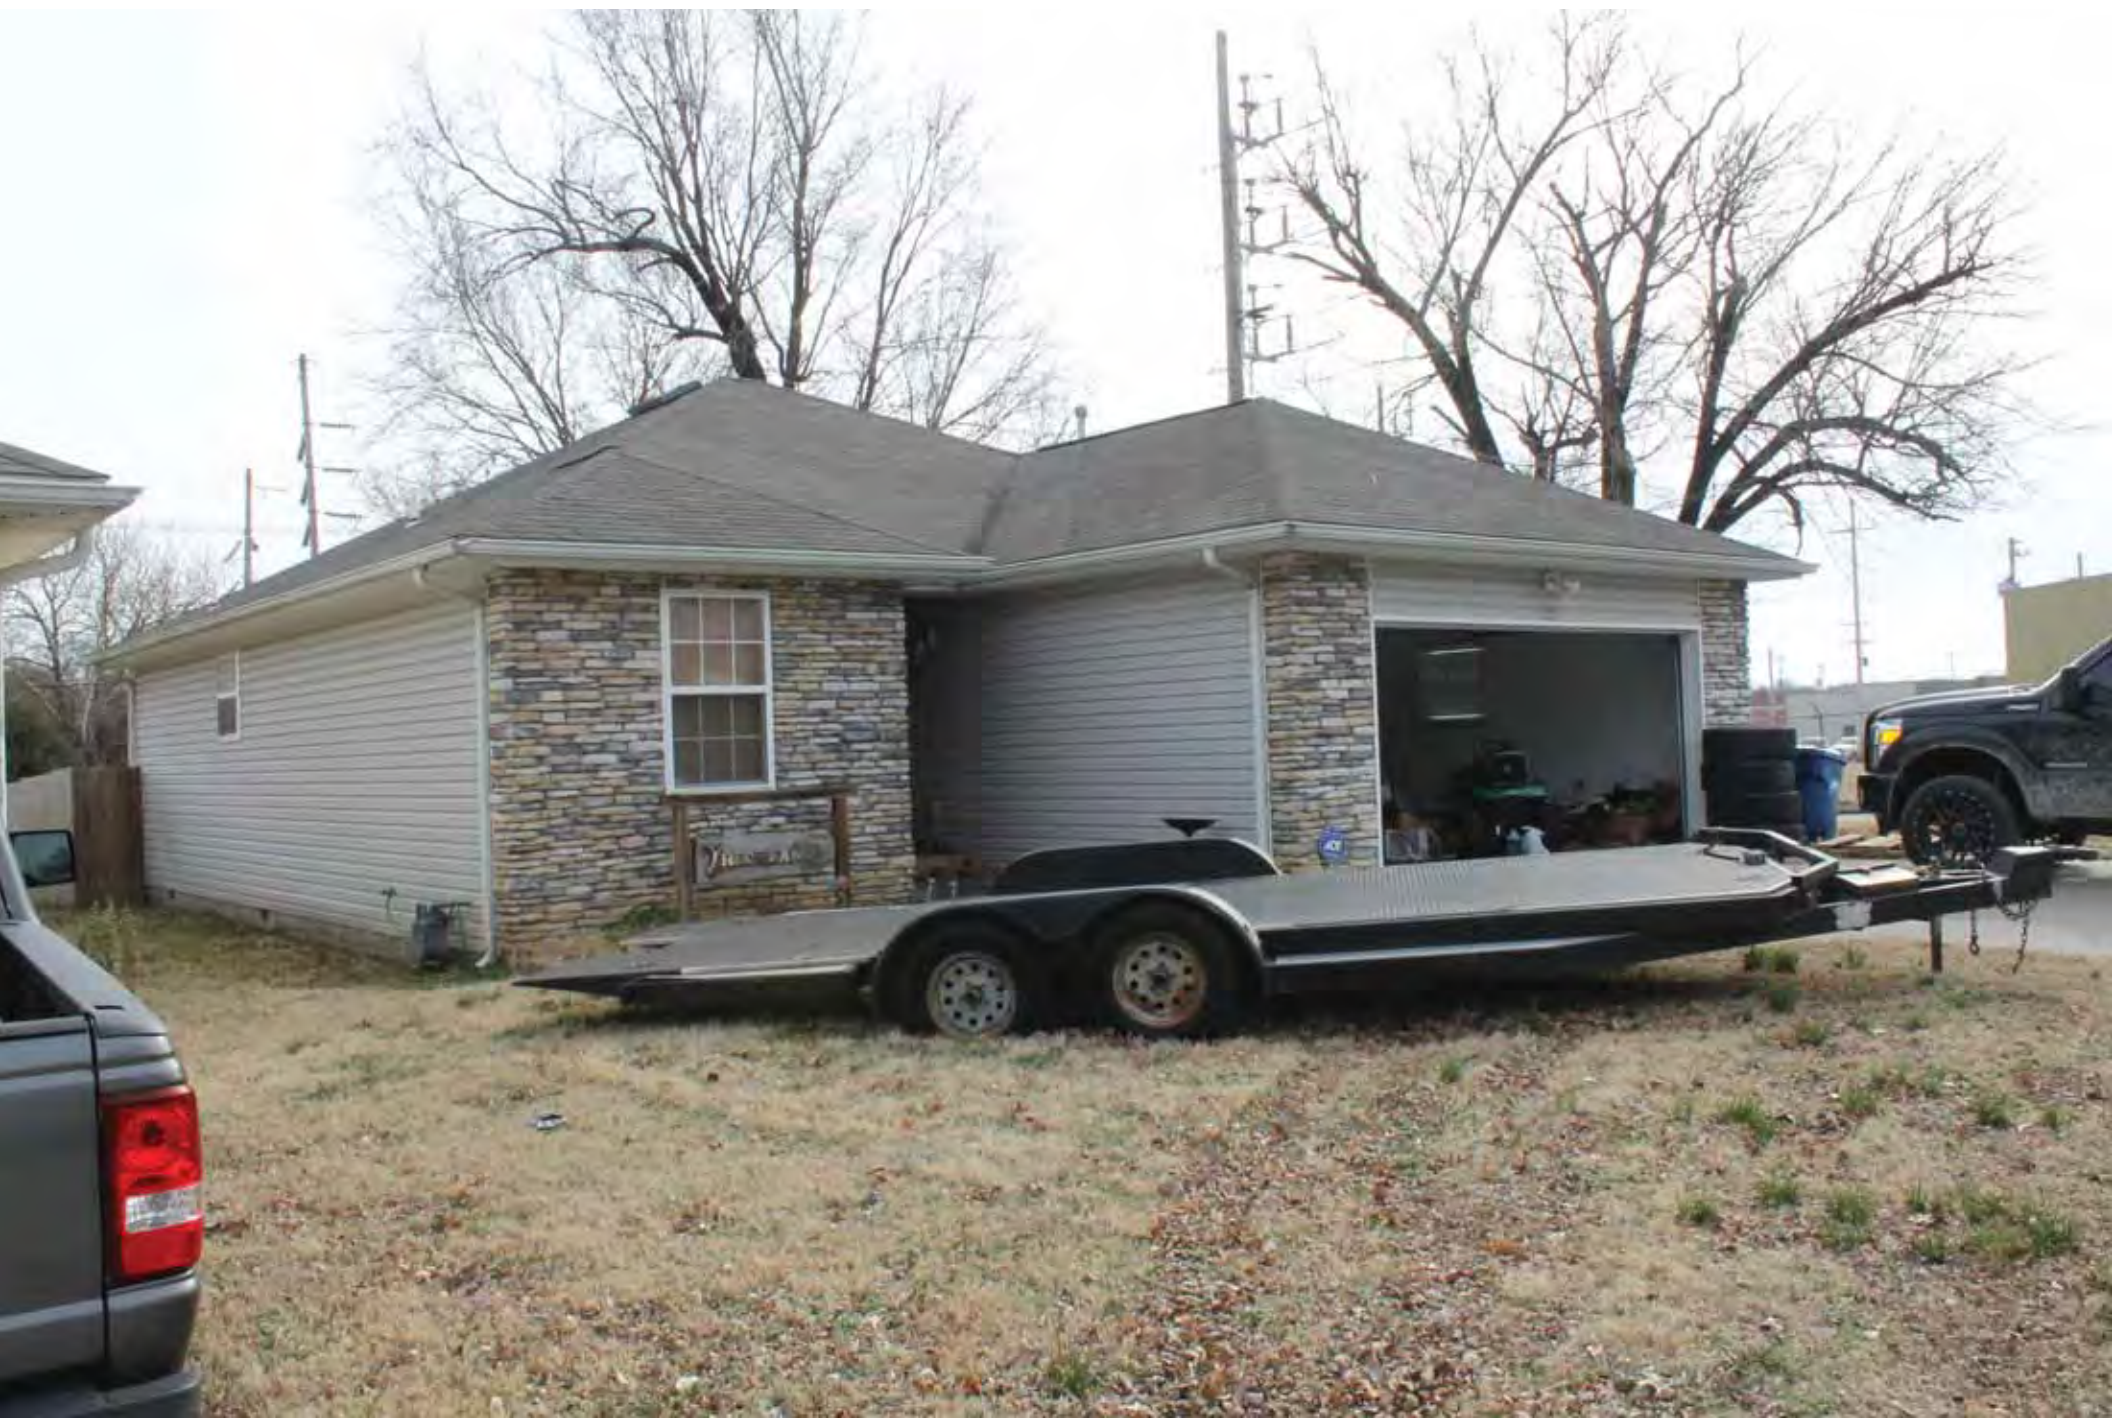
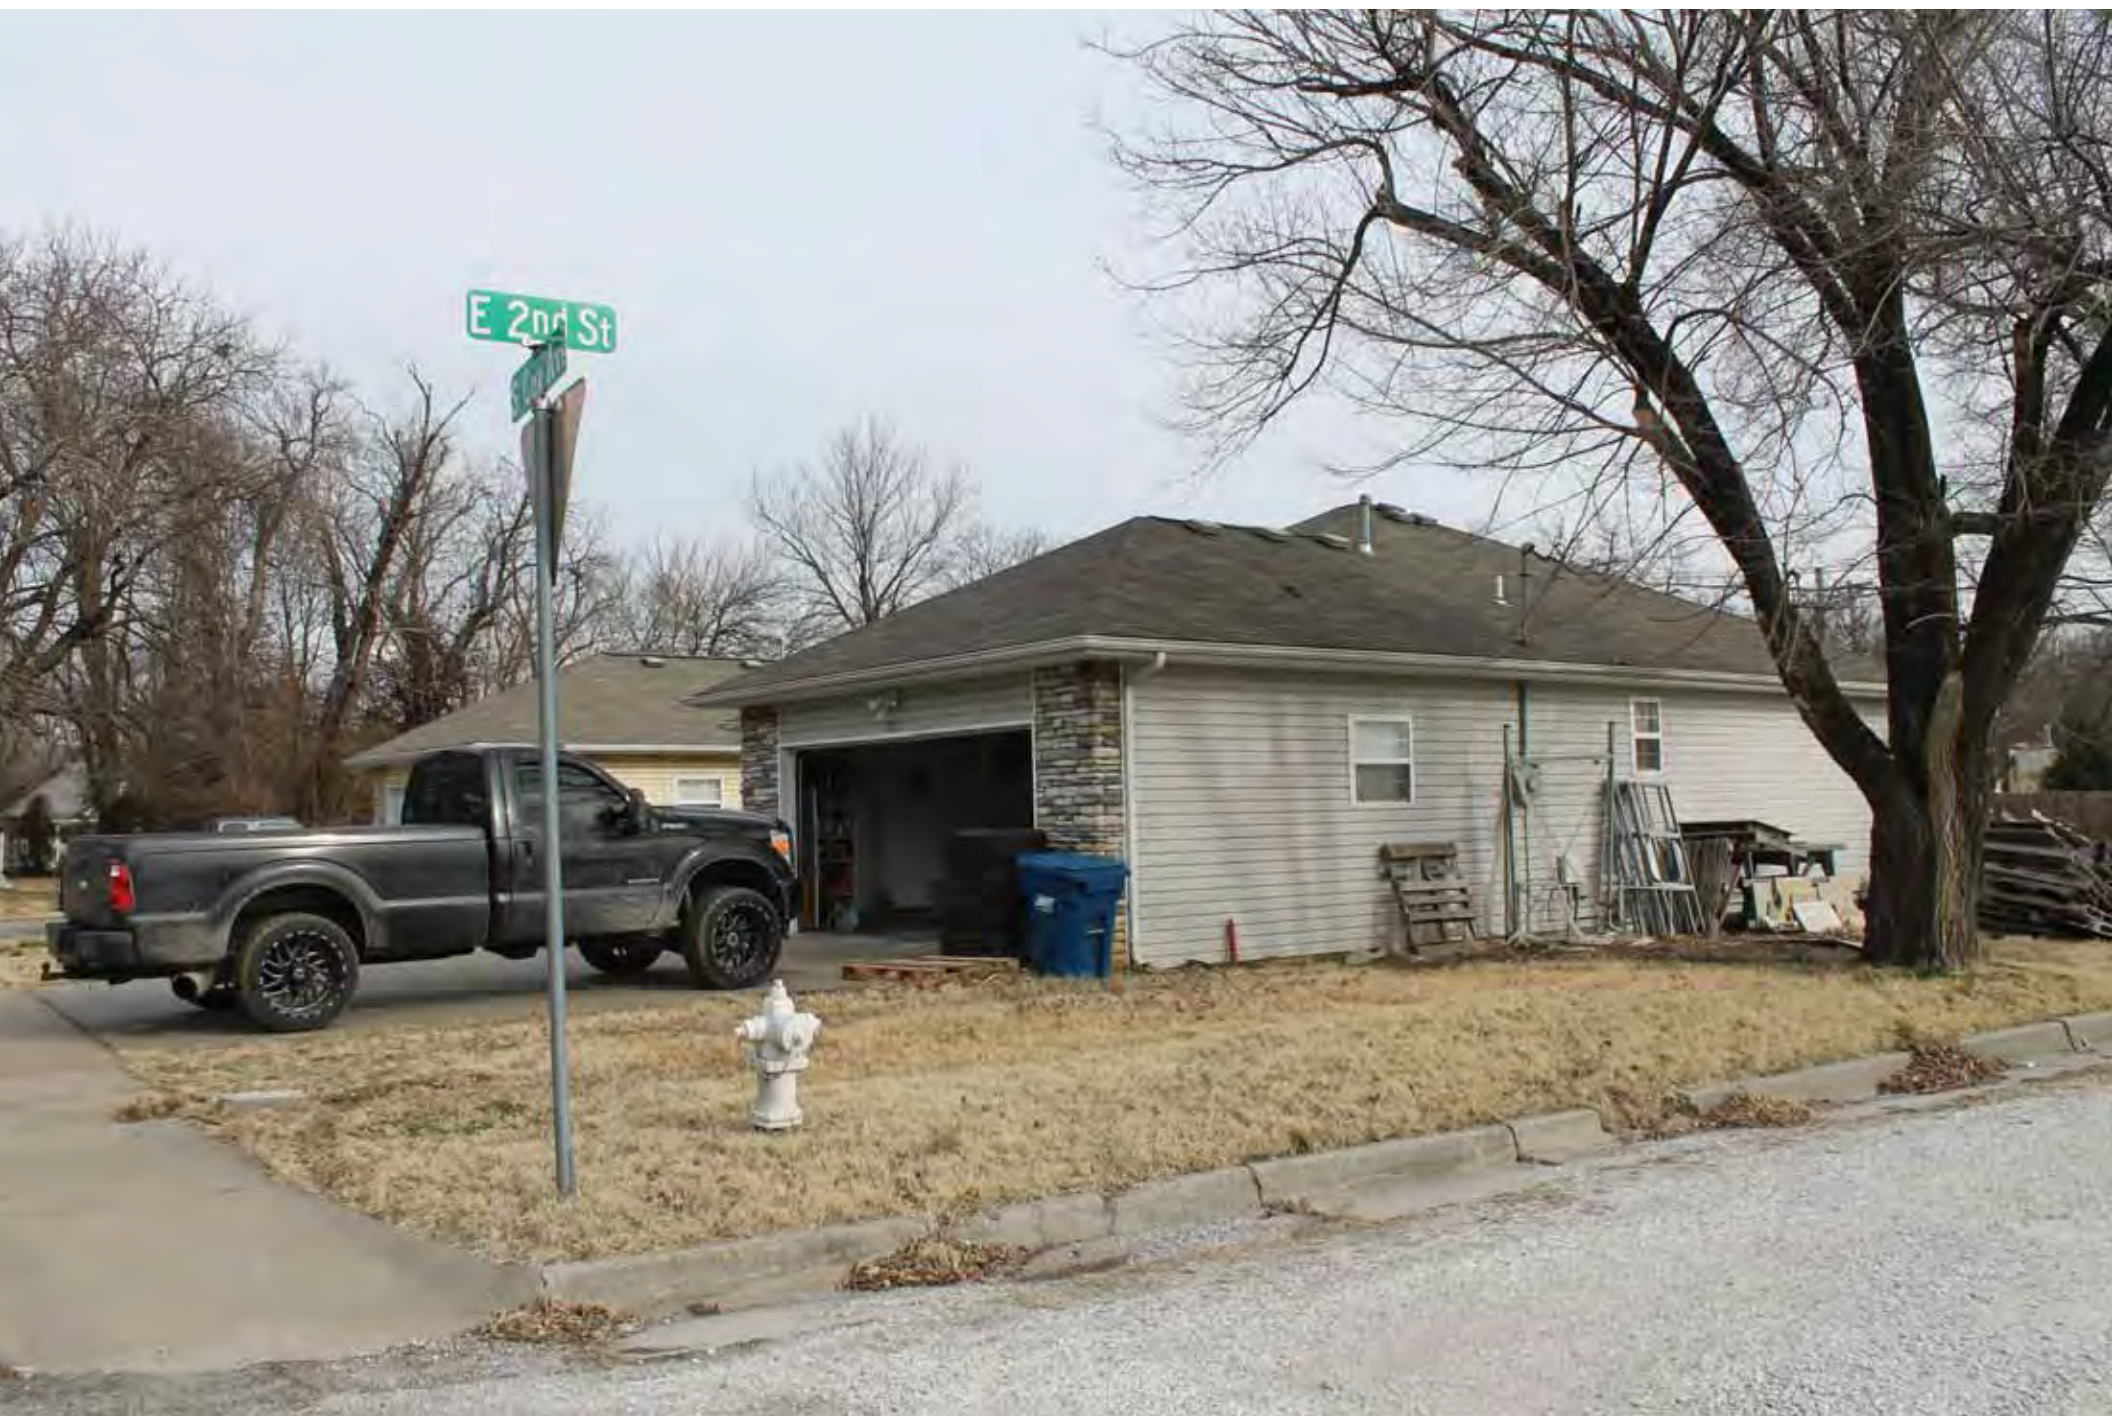
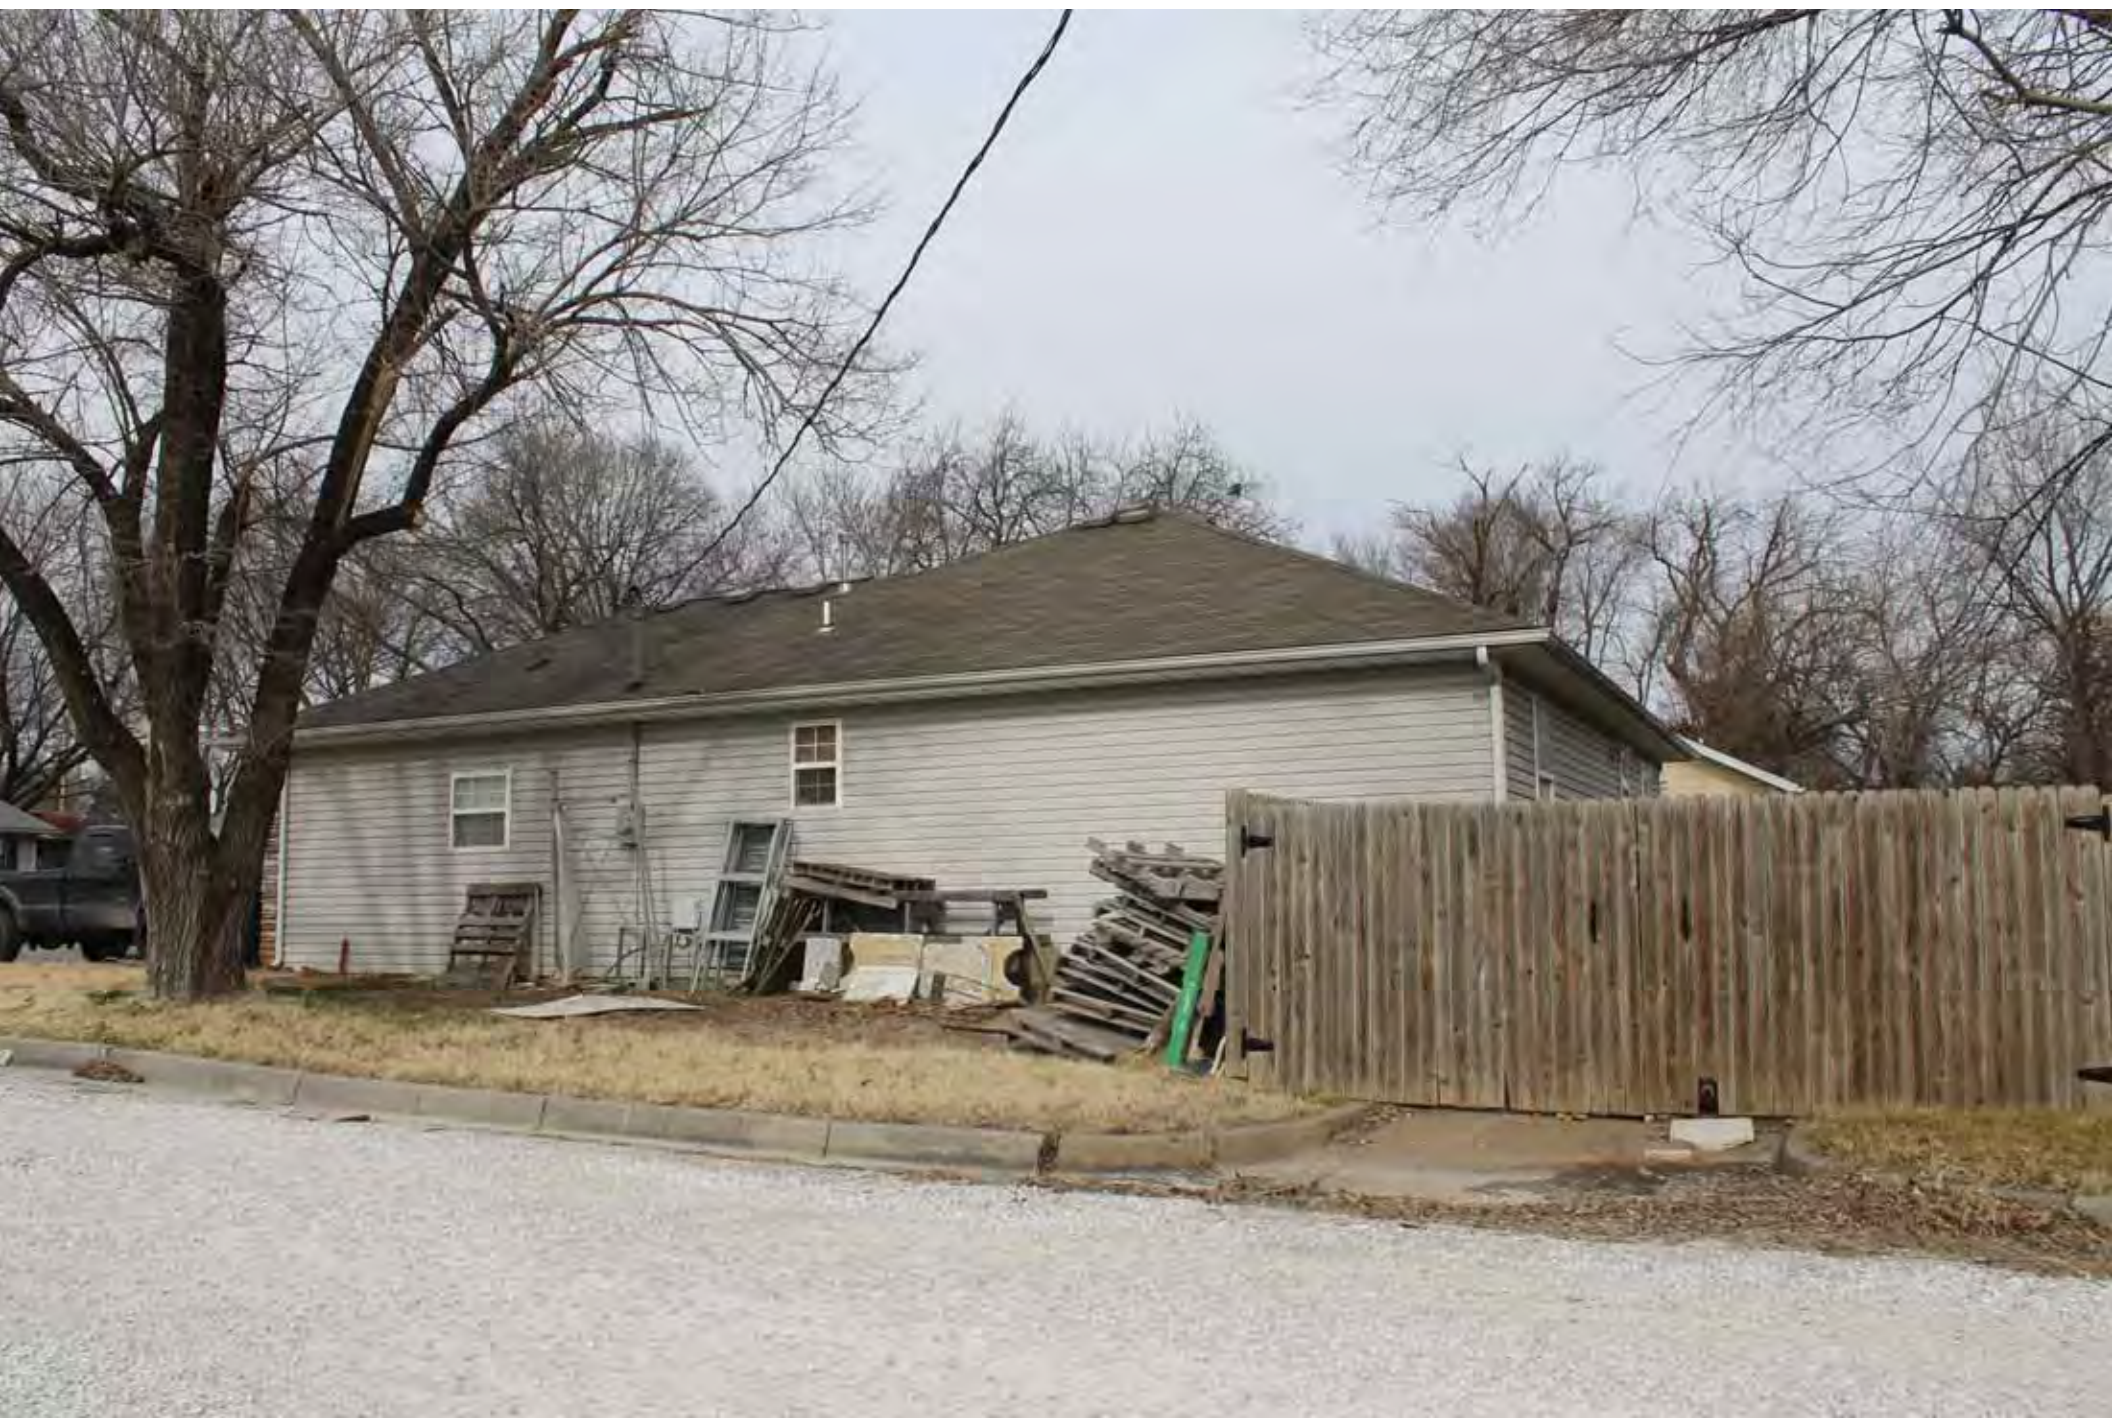
The property at 227 S. Cox Avenue is a one-story Ranch house, with a low-pitched hipped roof covered in asphalt siding. It has an L-shaped plan with an attached garage on the south end of the house, which extends toward the street. On the north side of the front façade is the front door, slightly recessed beneath the hipped roof. To the left of the door is a six-over-six single vinyl window. The front façade is covered in a formstone veneer, and the rest of the house is covered in vinyl siding.

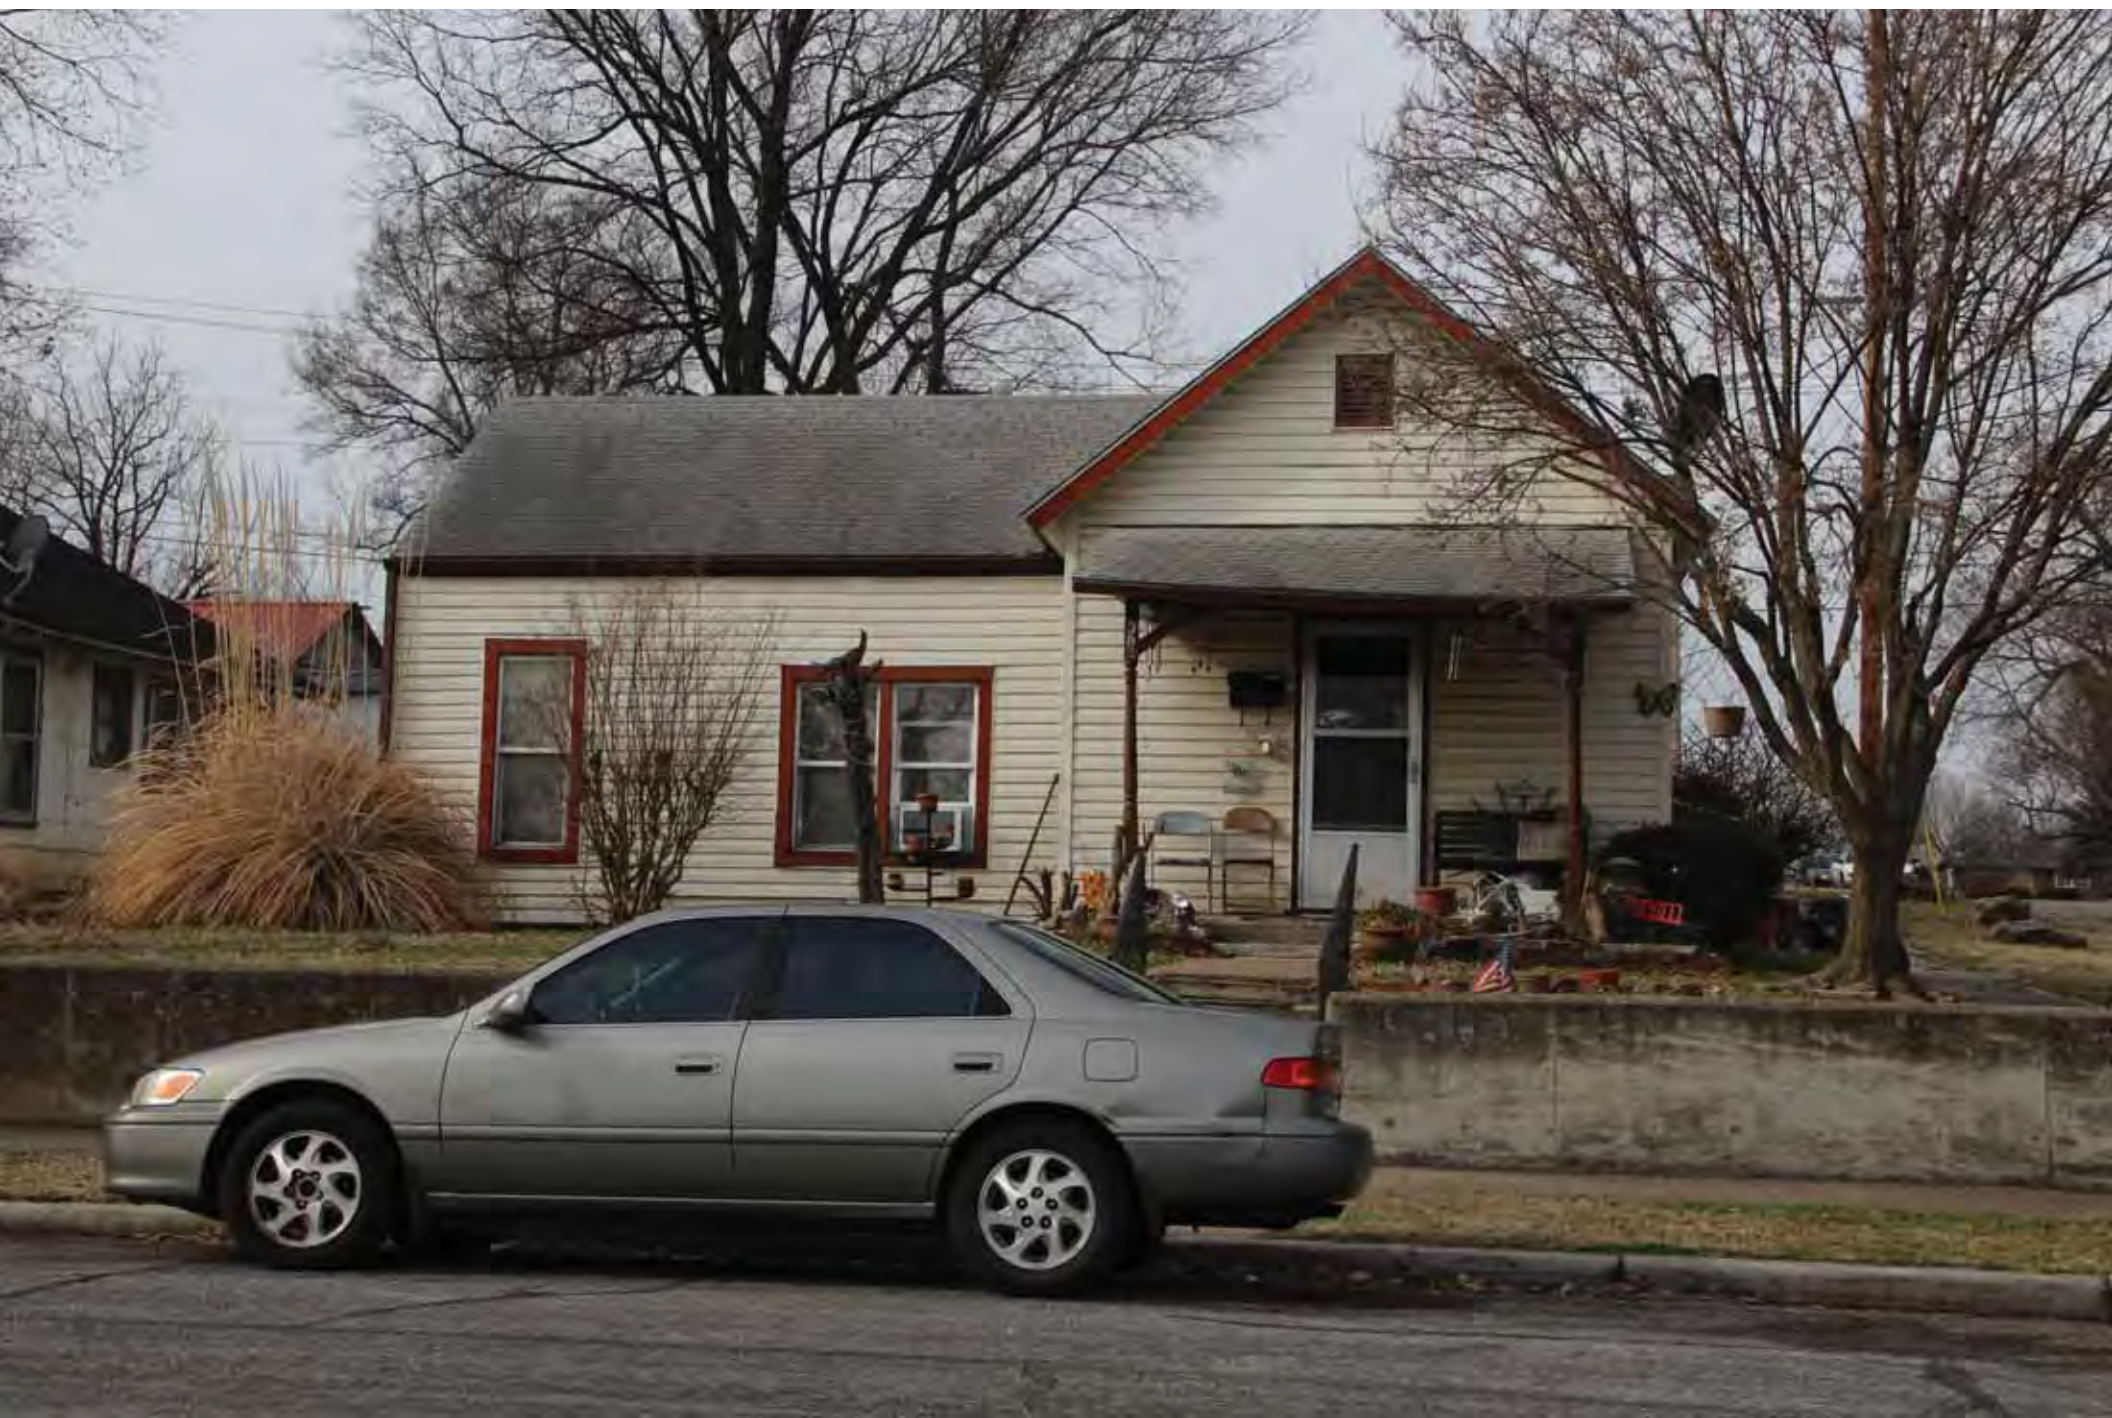
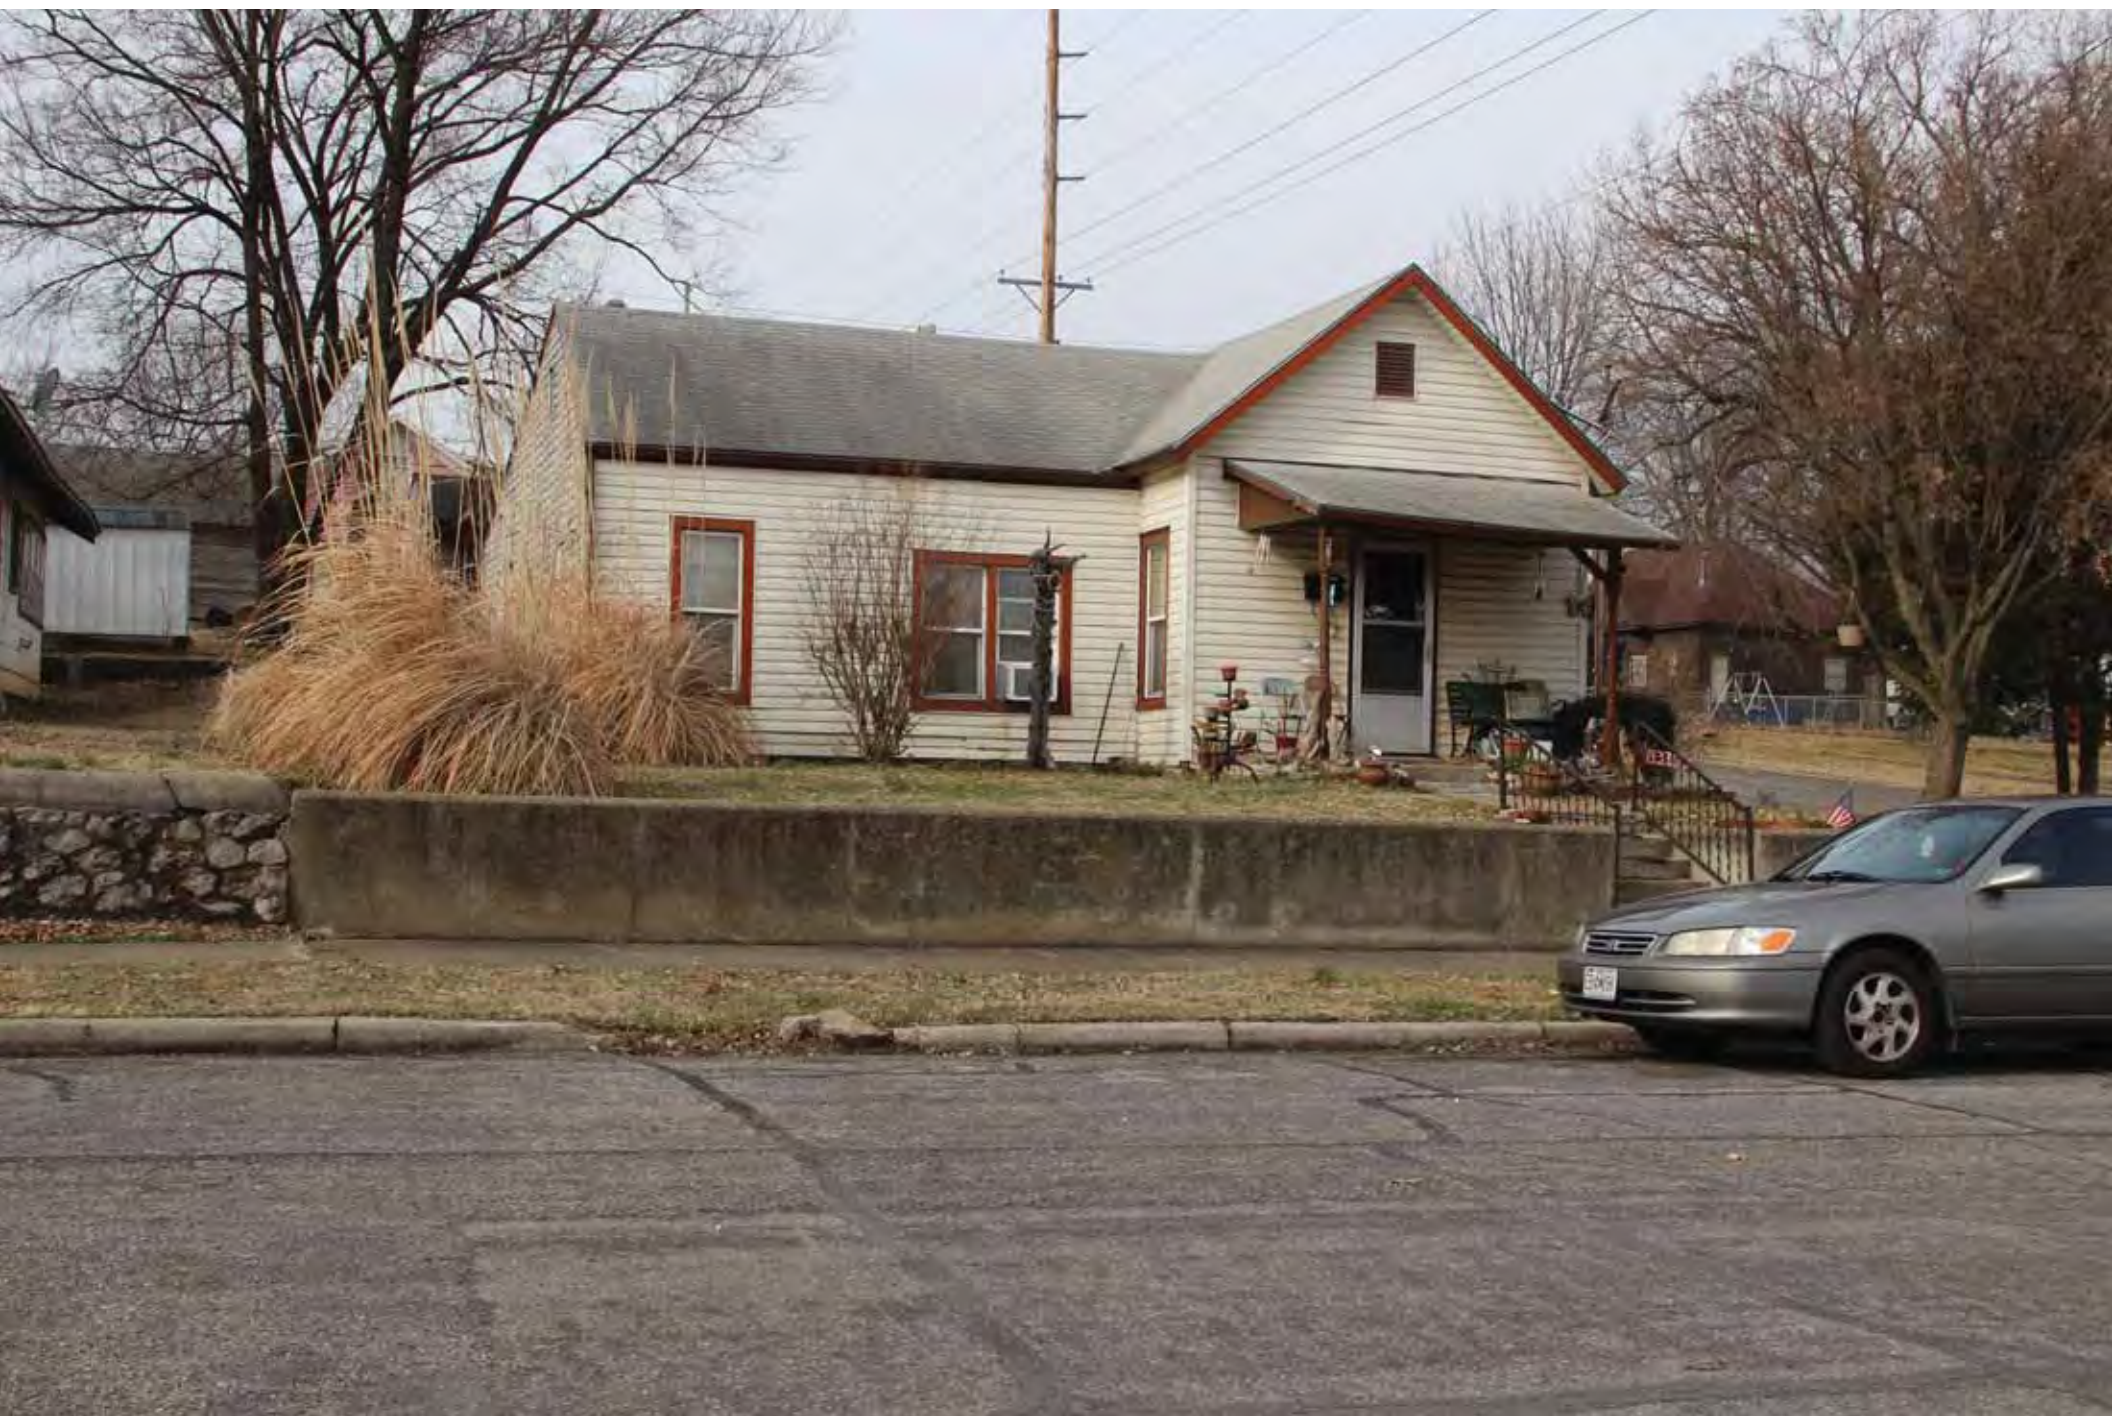
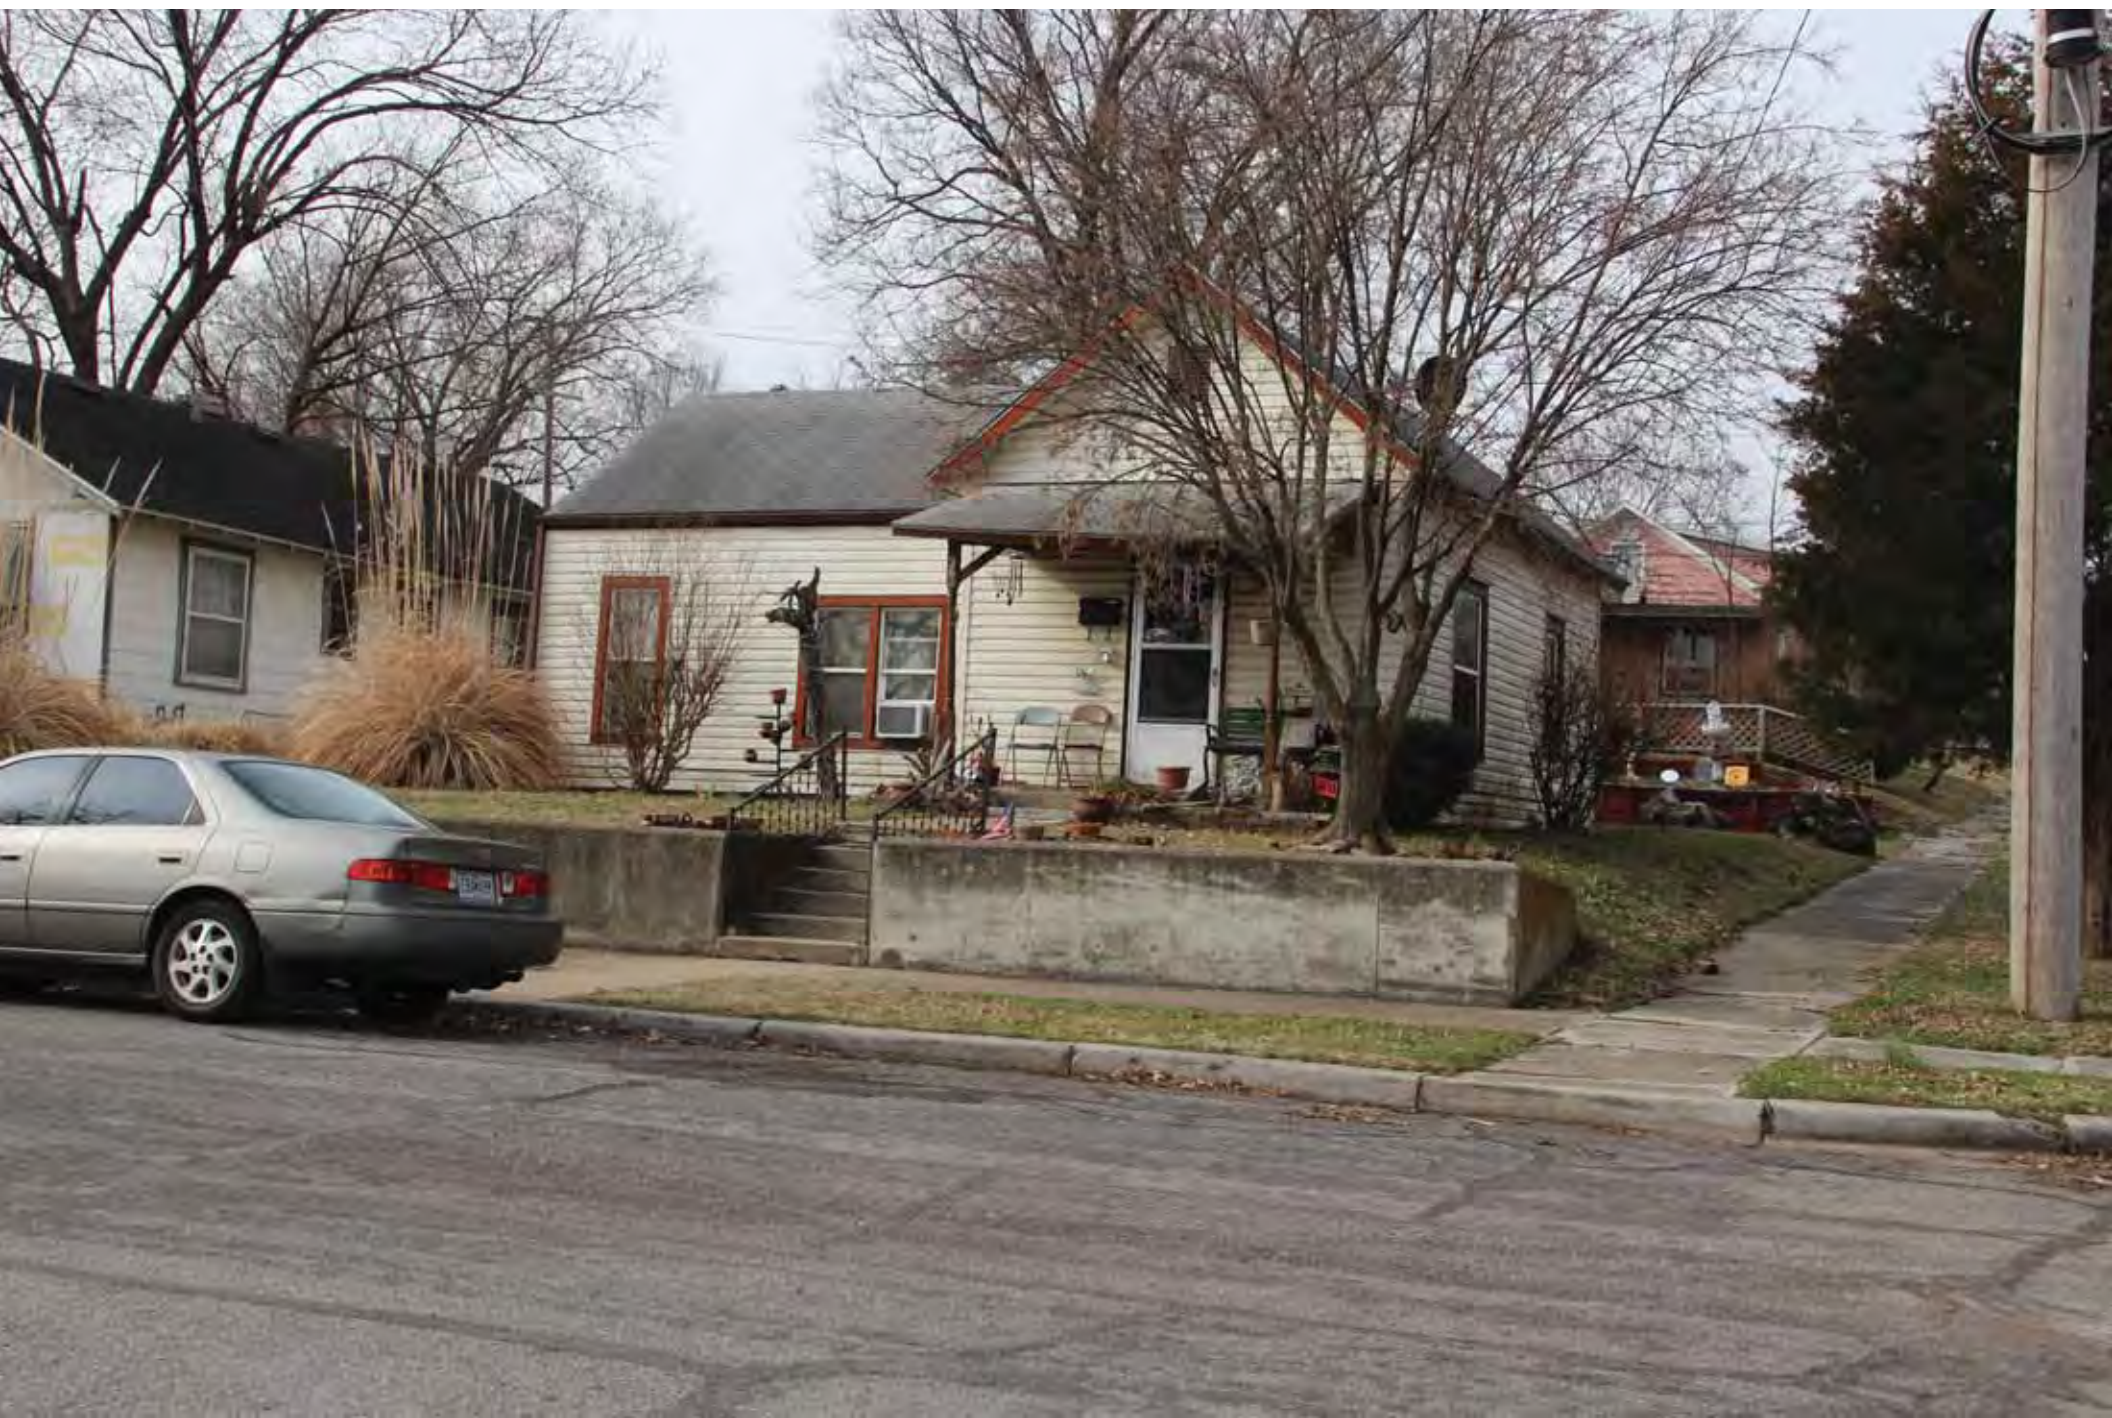
The property at 302S. Cox Avenue is a one-story dwelling, with a cross-gabled roof covered in asphalt siding. On the right (north) front of the house is a front facing gable end, with a small non-historic frame porch with a wooden shed roof. In the middle of this gable end, below the roof of the open porch, is a single entrance door. To the south or left of the porch there is a double one-over-one window and a single one-over-one window, each with exterior surrounds.
