MISSOURI DEPARTMENT OF NATURAL RESOURCES
STATE HISTORIC PRESERVATION OFFICE, P.O. Box 176, Jefferson City, MO 65102
ARCHITECTURAL/HISTORIC INVENTORY FORM

1. Survey No. JP-AS-007-001		2. Survey name: East Town (Original Joplin) Historic Survey Phase 2	
3. County: JASPER		4. Address (Street No.) 618	Street (name) E. 2 nd Street
5. City: Joplin	Vicinity: <input type="checkbox"/>	6. Geographical Reference:	7. Township/Range/Section: T: R: S:
8. Historic name (if known):		9. Present/other name (if known):	
10. Ownership: <input checked="" type="checkbox"/> Private <input type="checkbox"/> Public		11a. Historic use (if known): Domestic: Single Dwelling	11b. Current use: Domestic: Single Dwelling

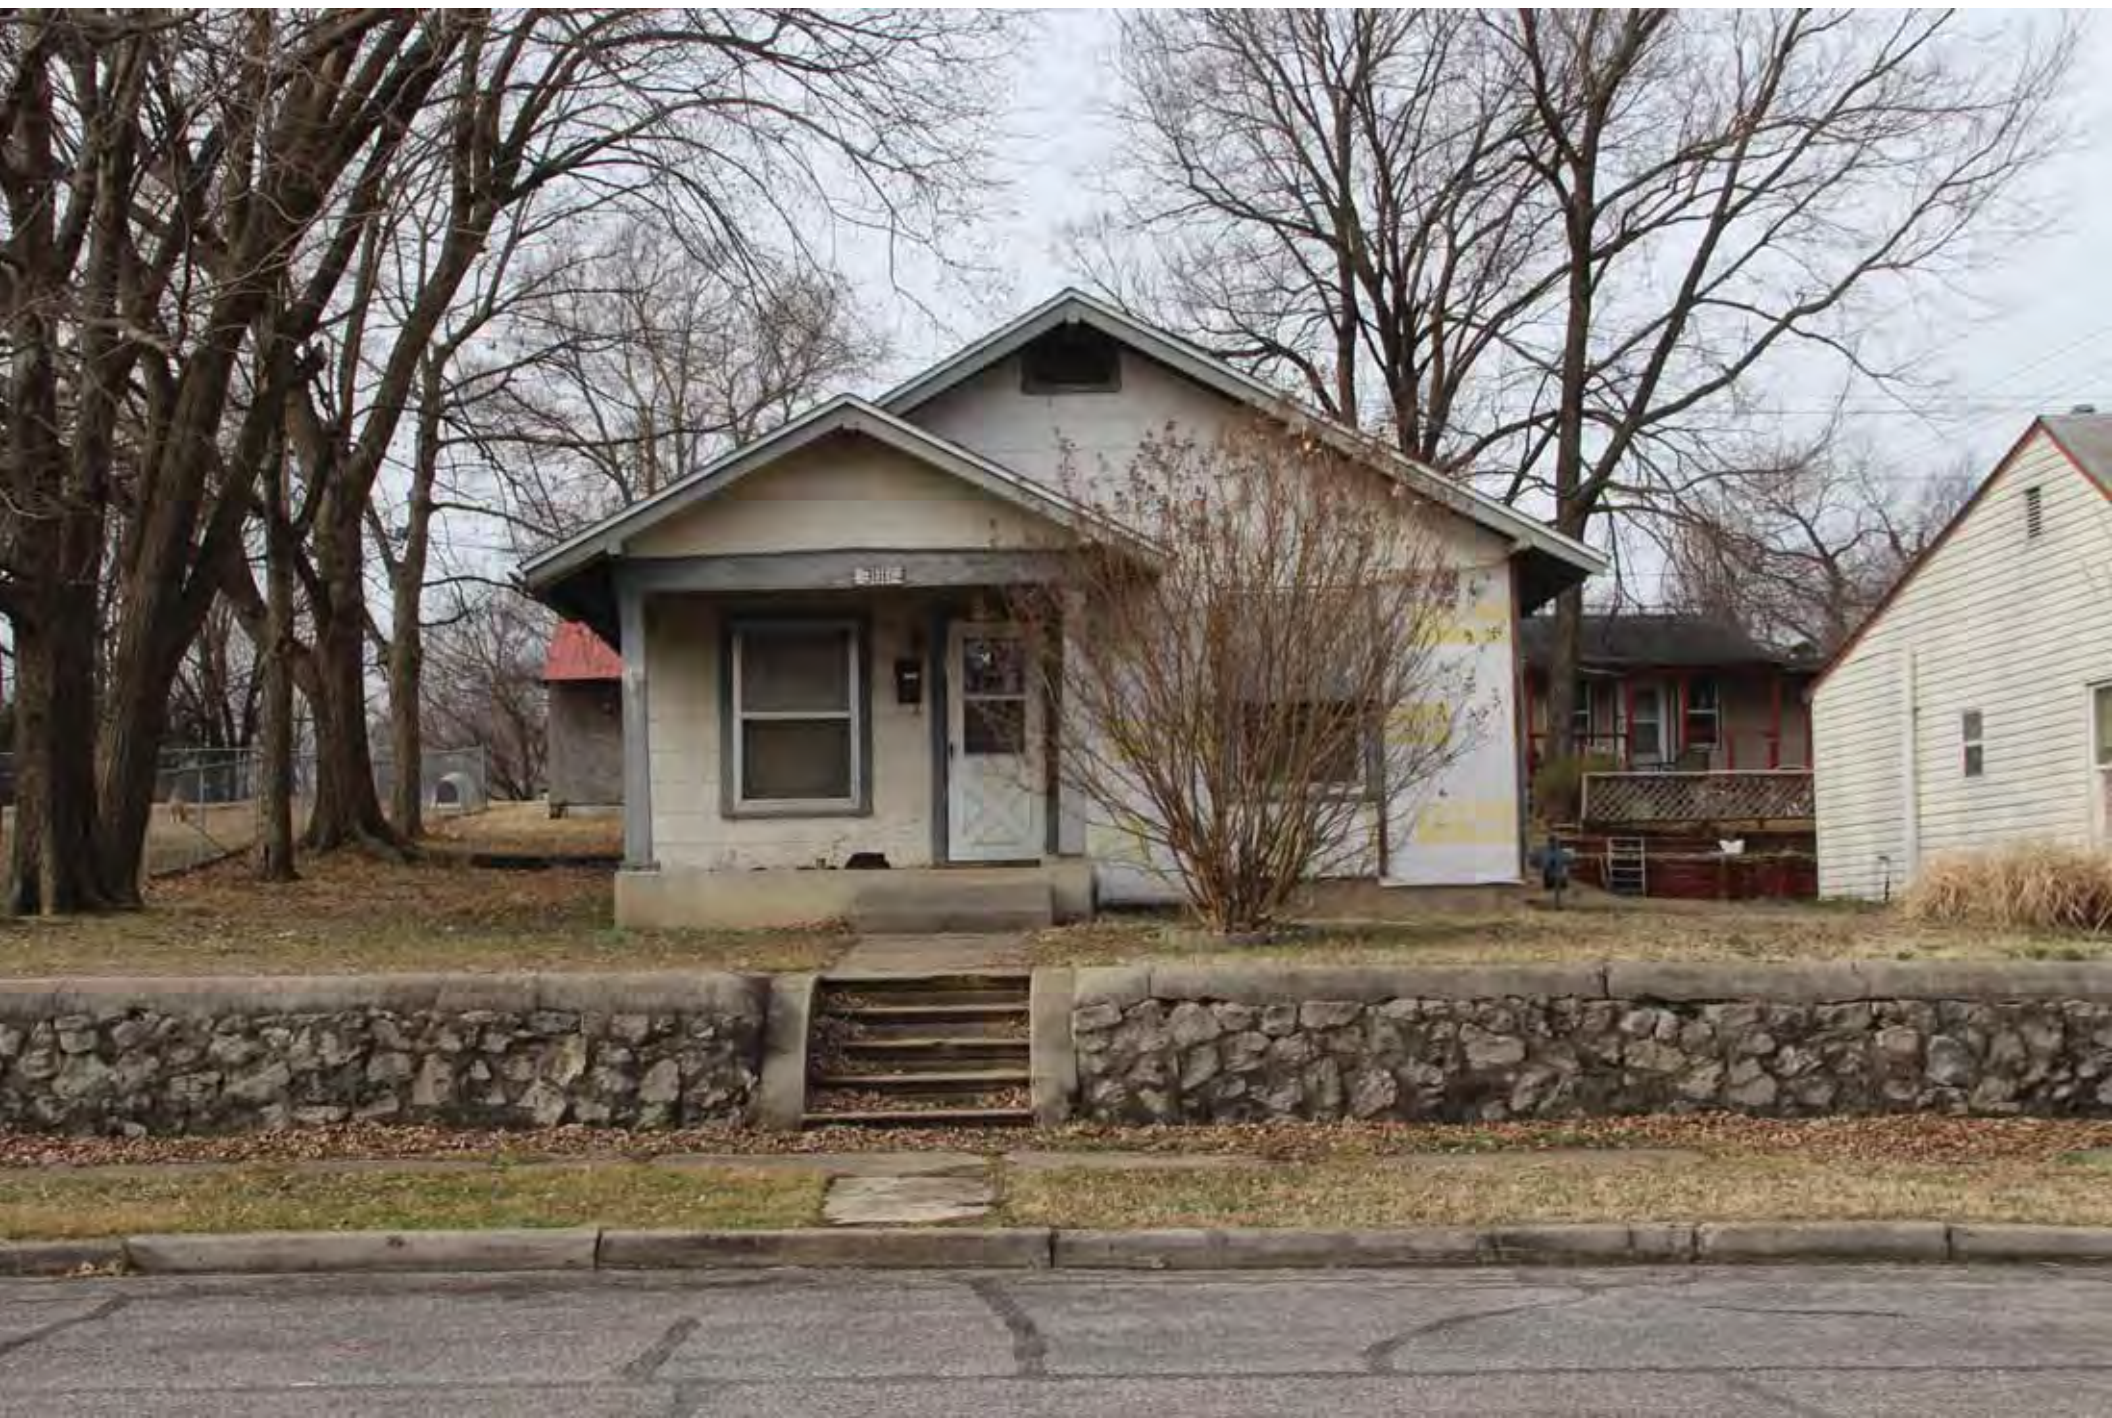
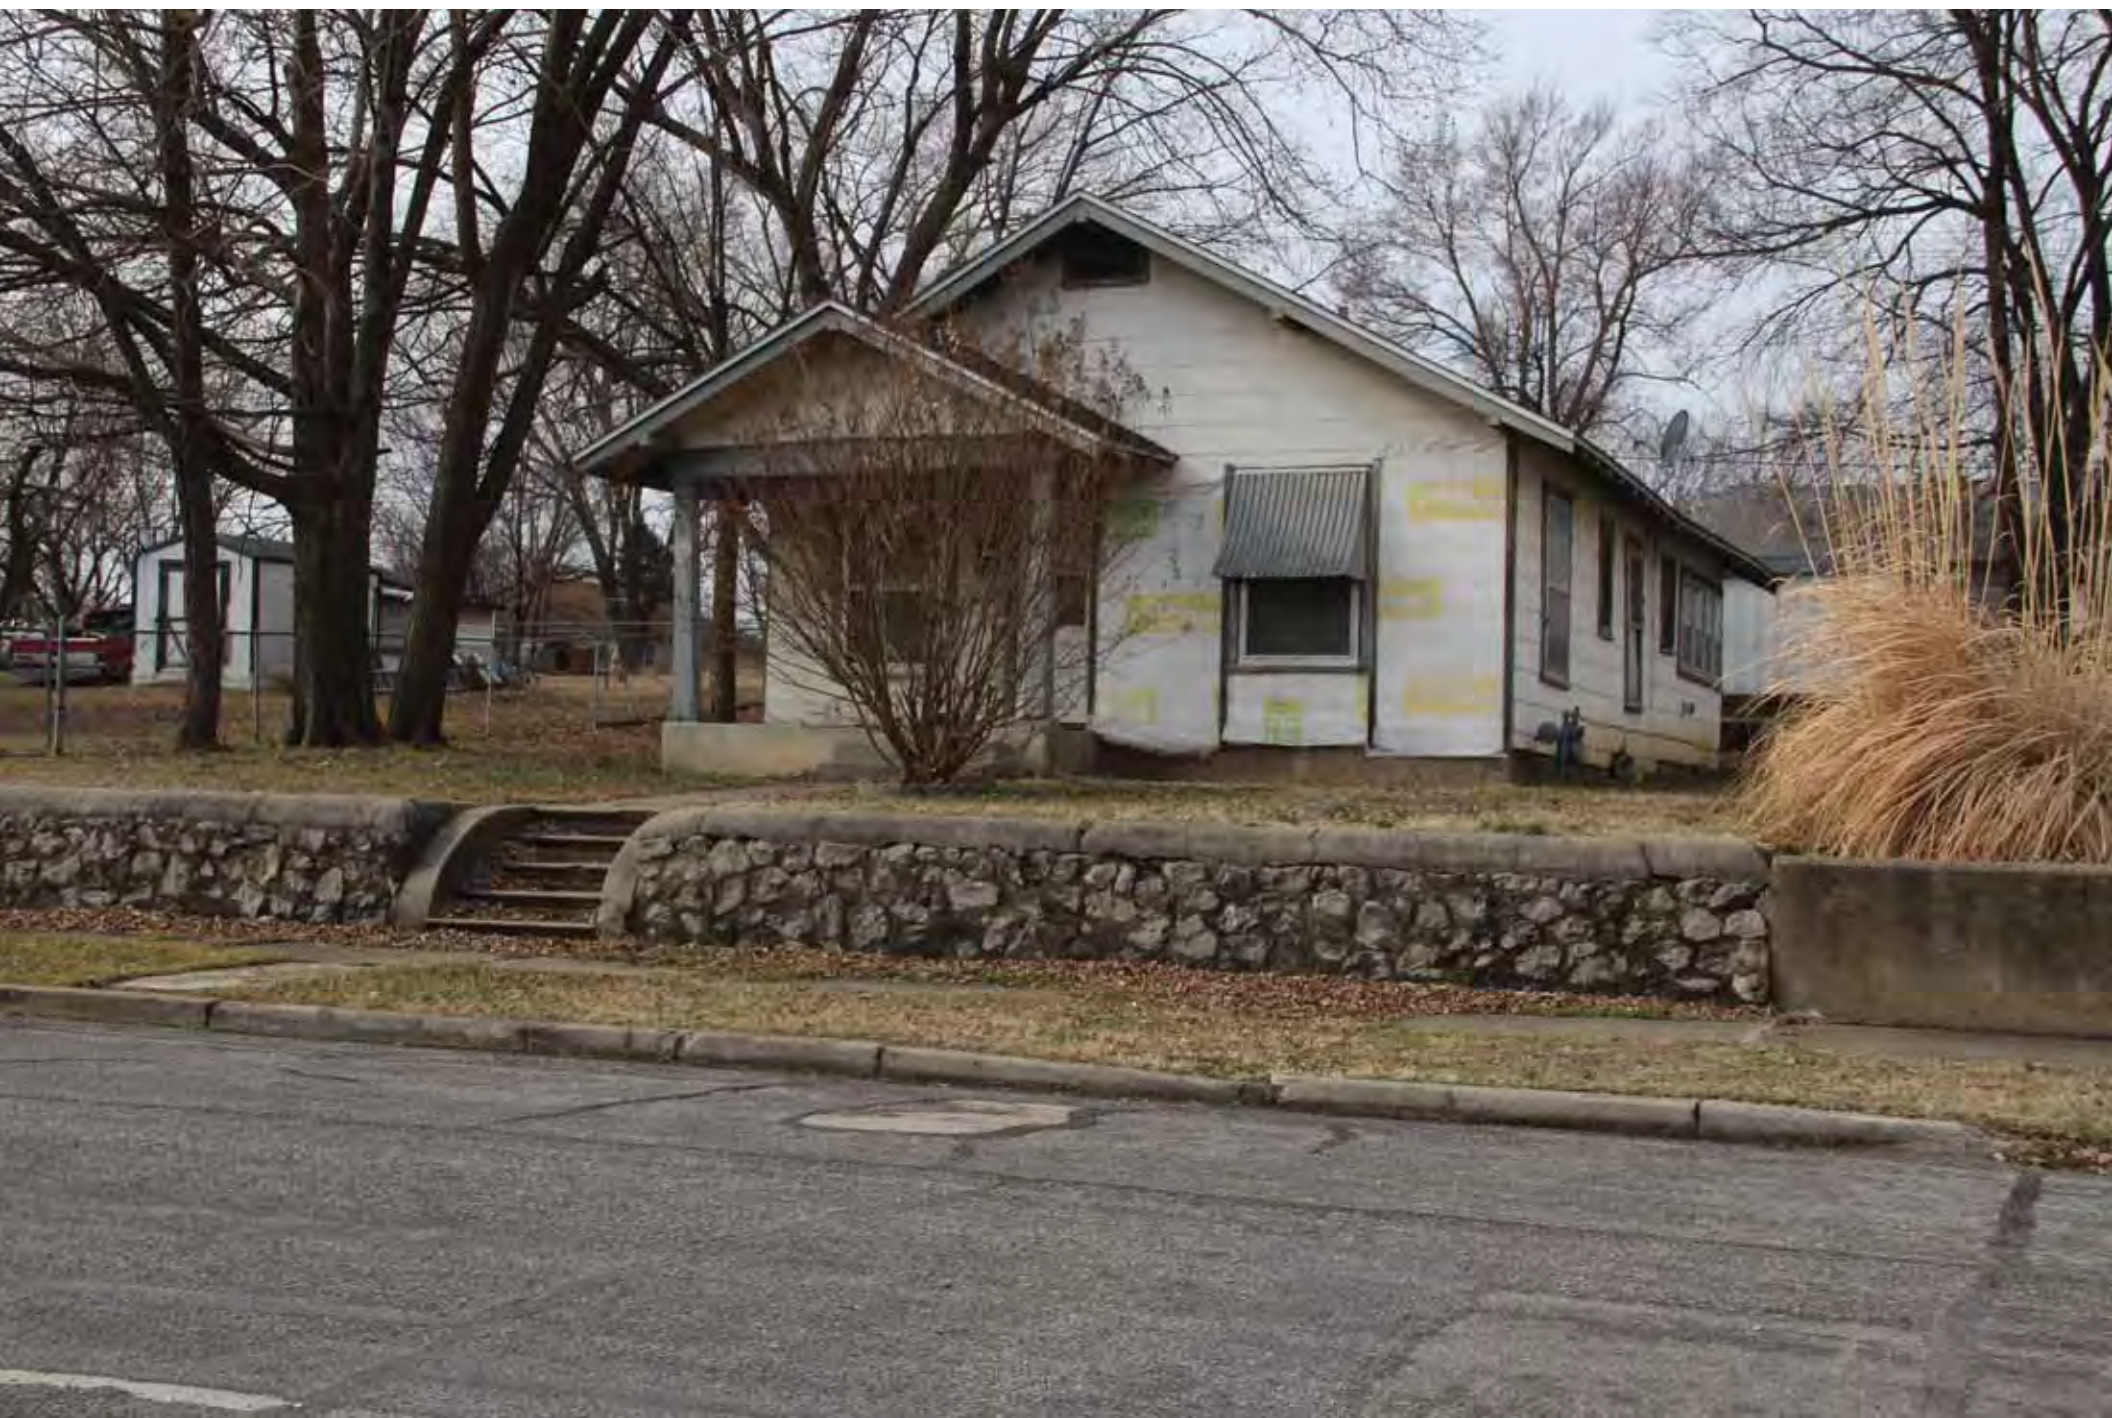
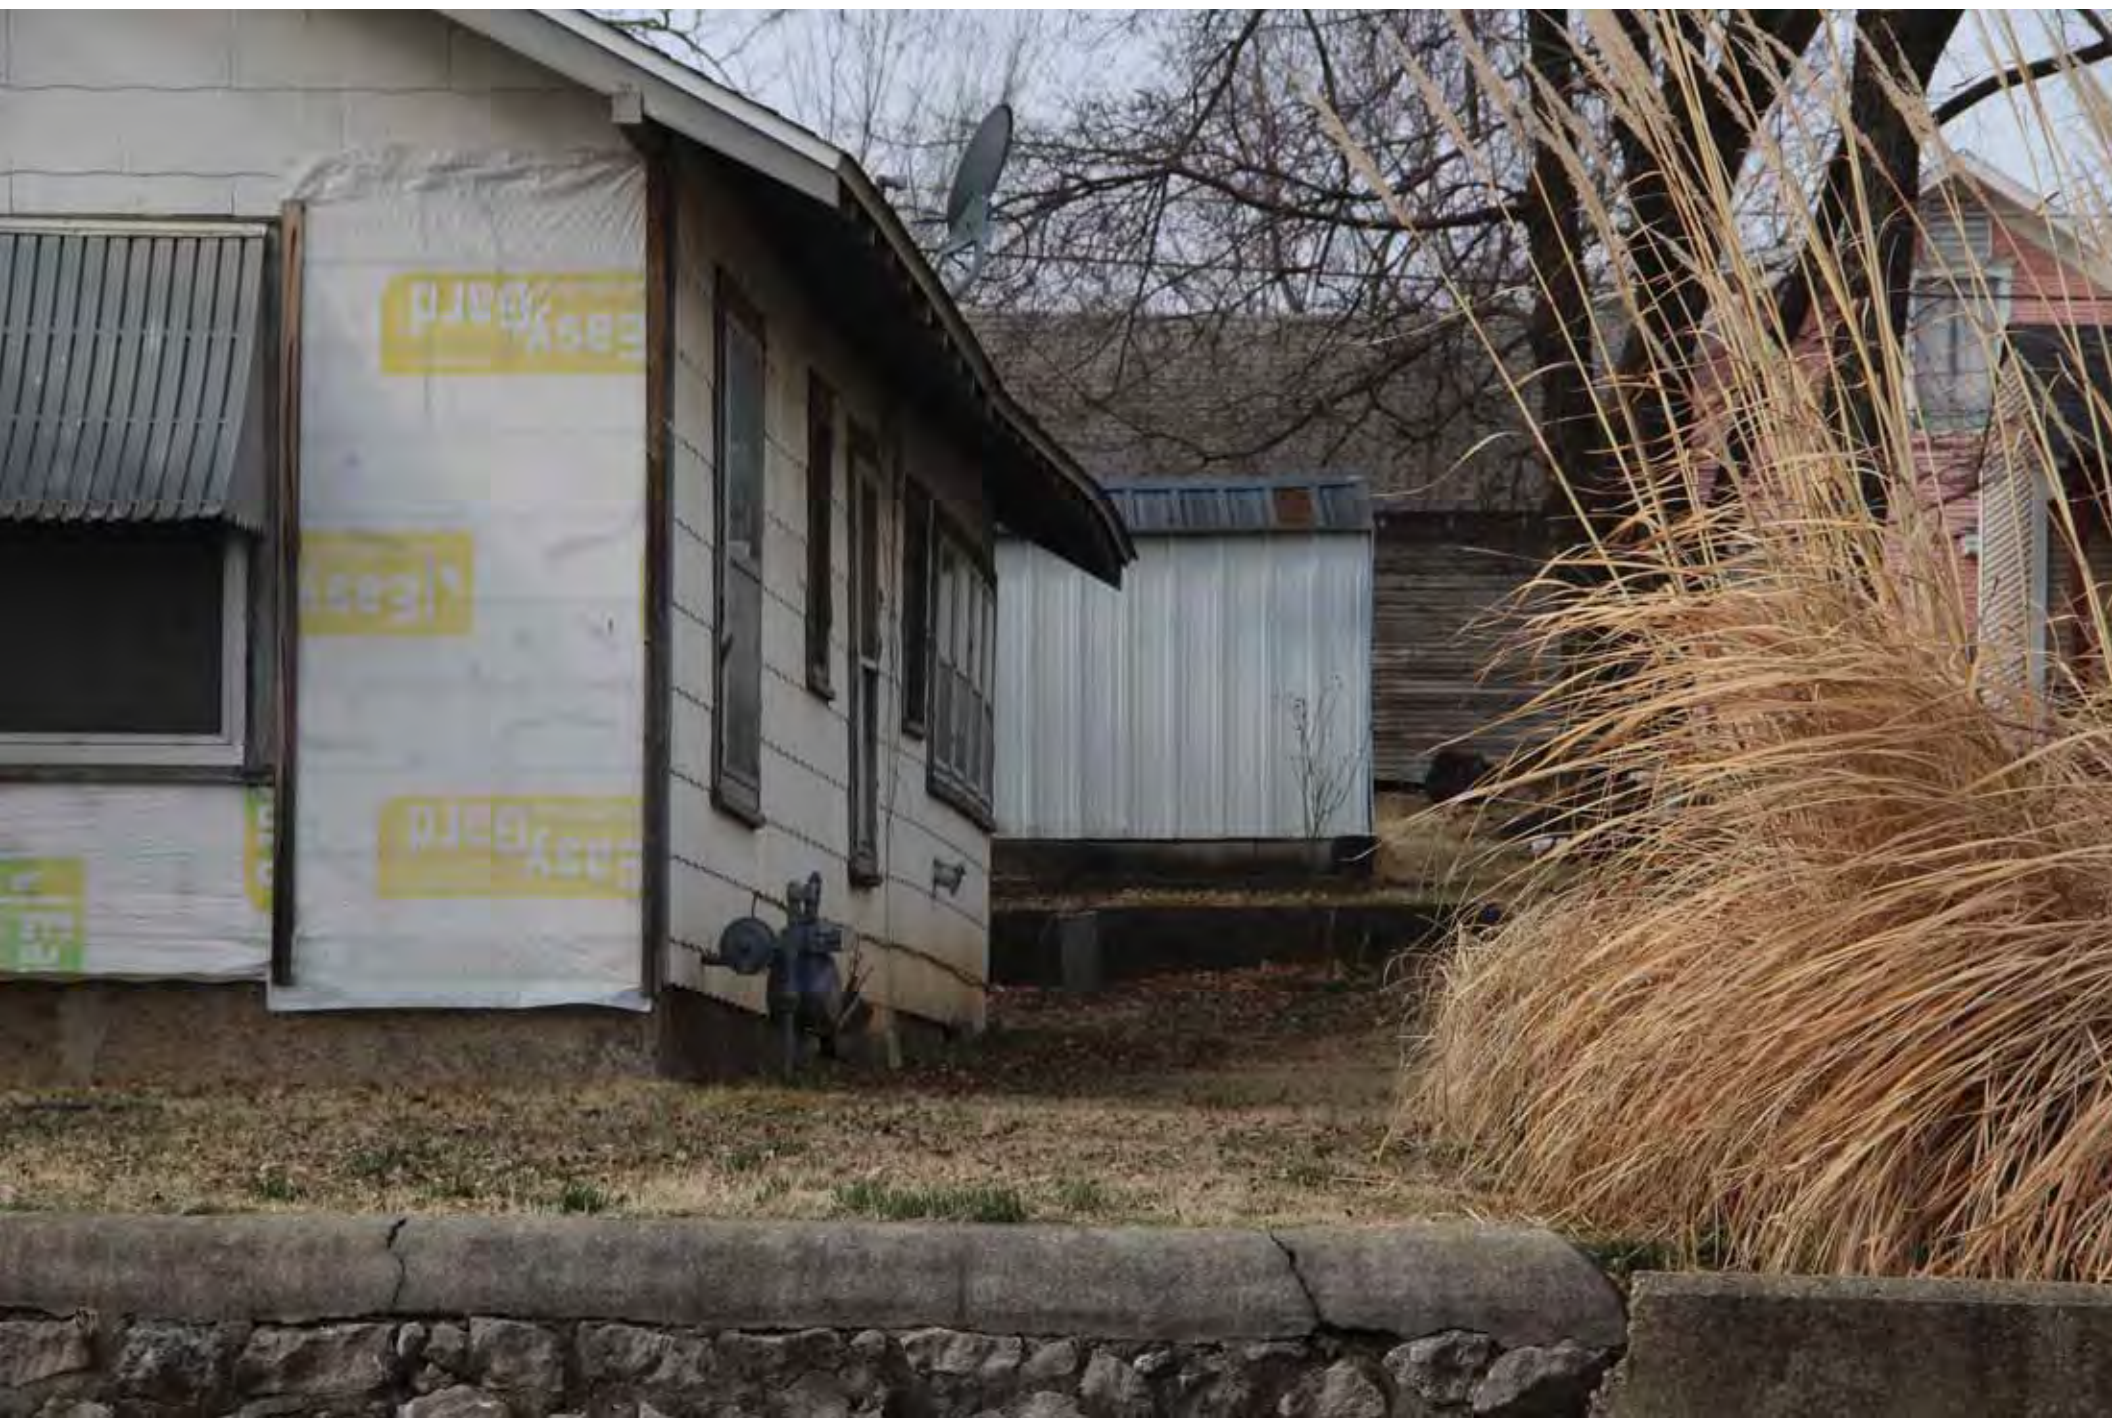
The property at 306 S. Cox Avenue is a one-story dwelling, with a front-facing gable roof with exposed rafters, covered in asphalt siding. The original open front porch is intact, and has a front-facing gable end on square wooden supports. It shelters a single one-over-one window and the front door. To the right, or north of this porch is one bay, a single window covered by a metal awning. On the sides of the house are three single one-over-one windows.

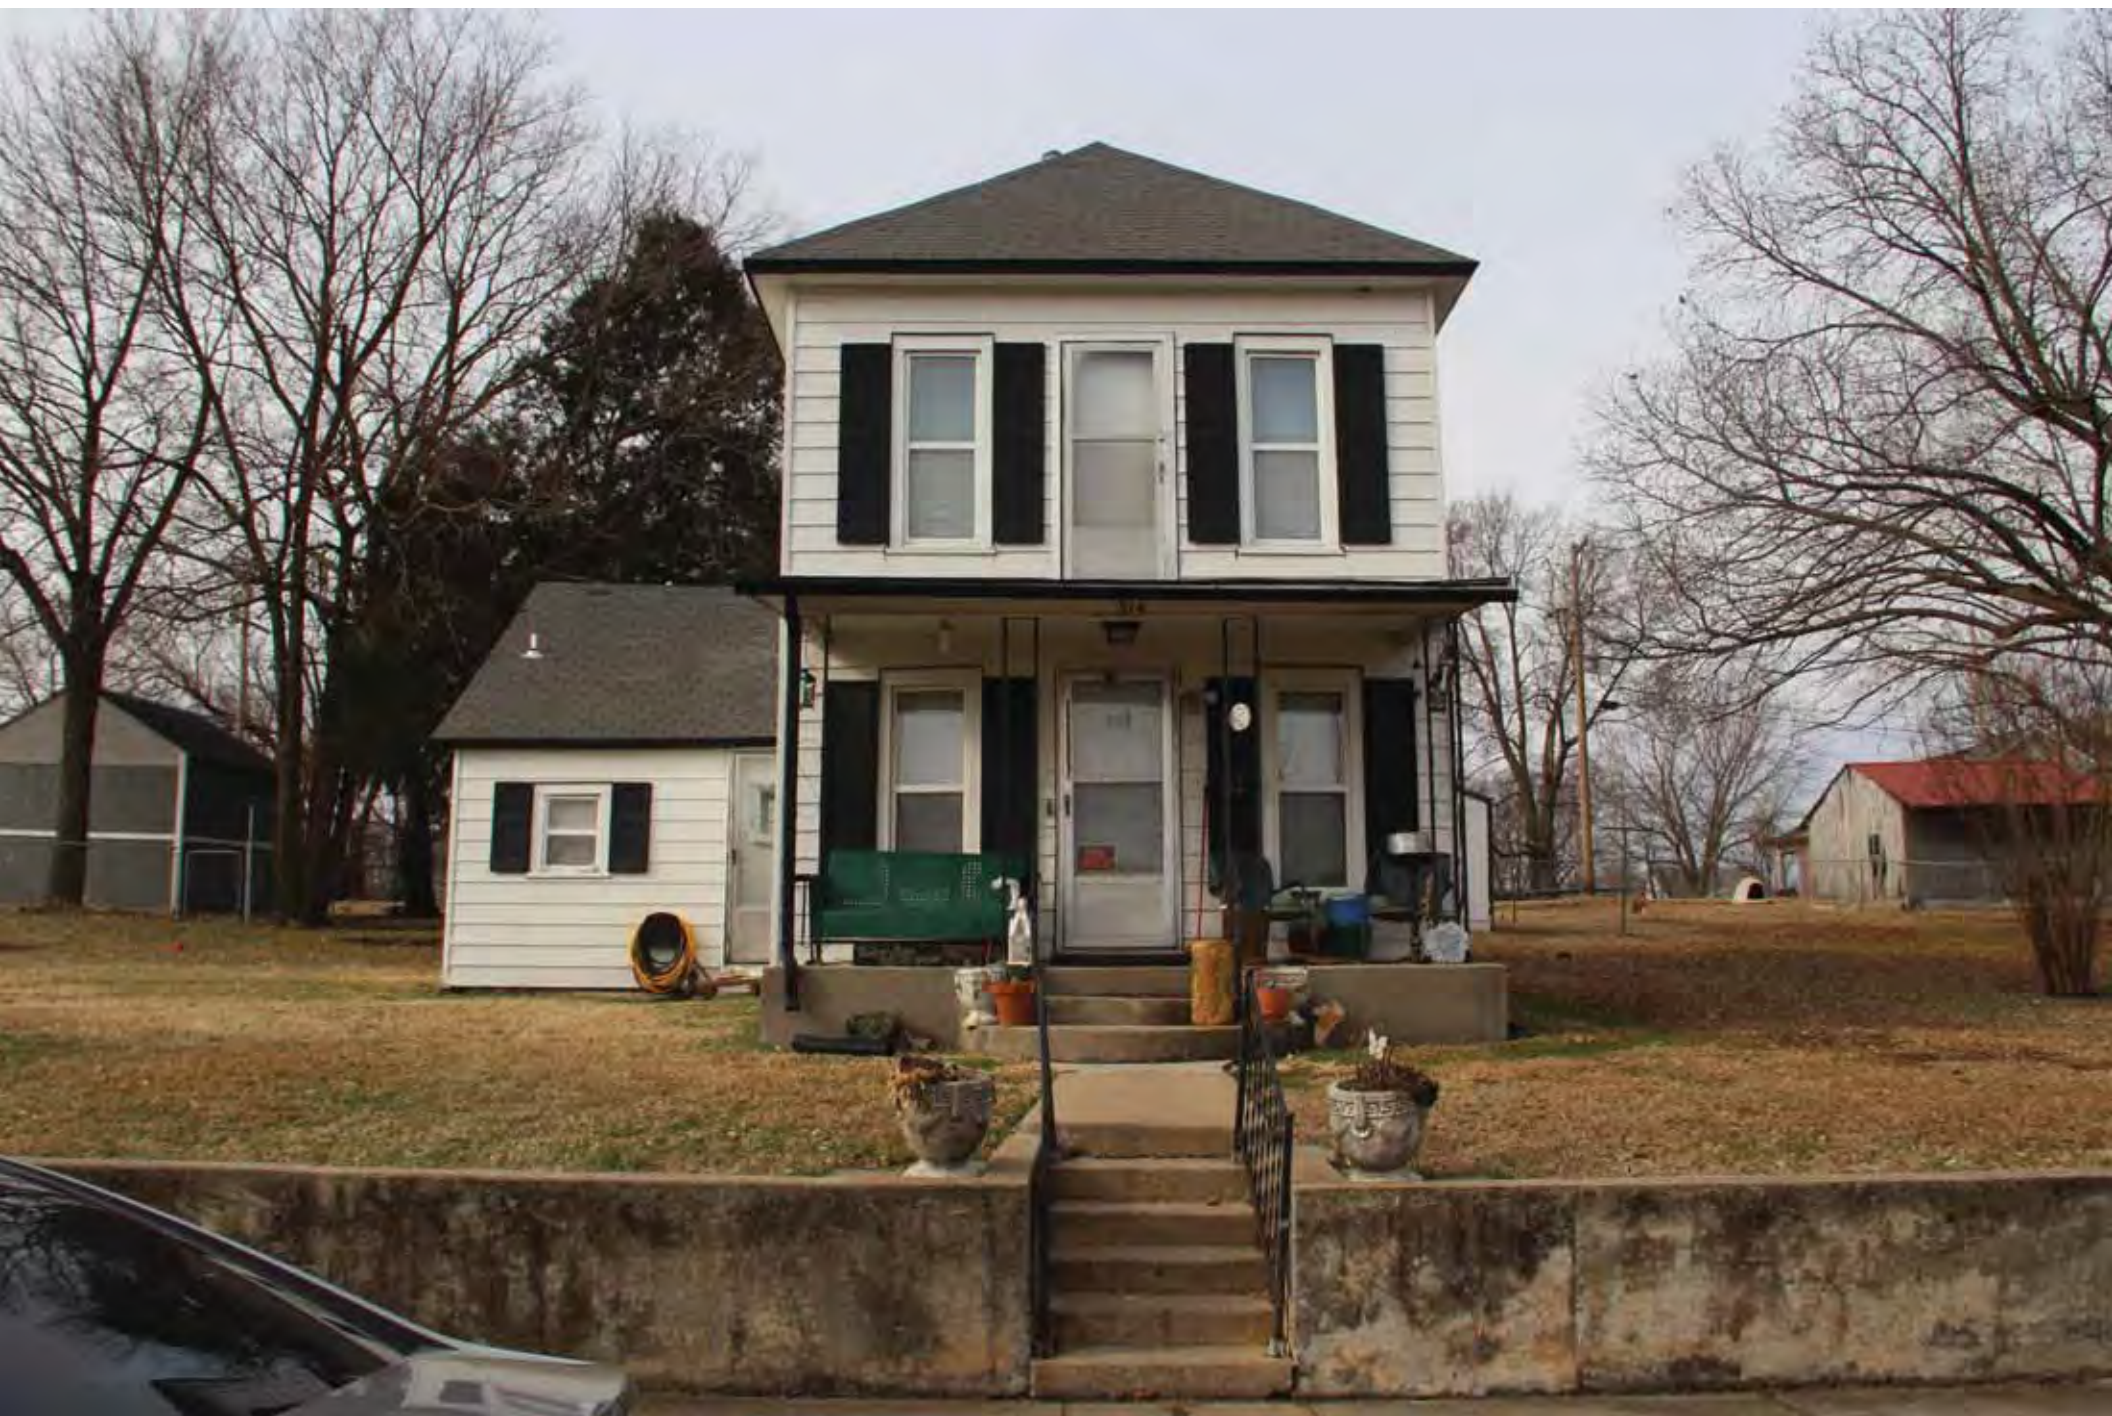
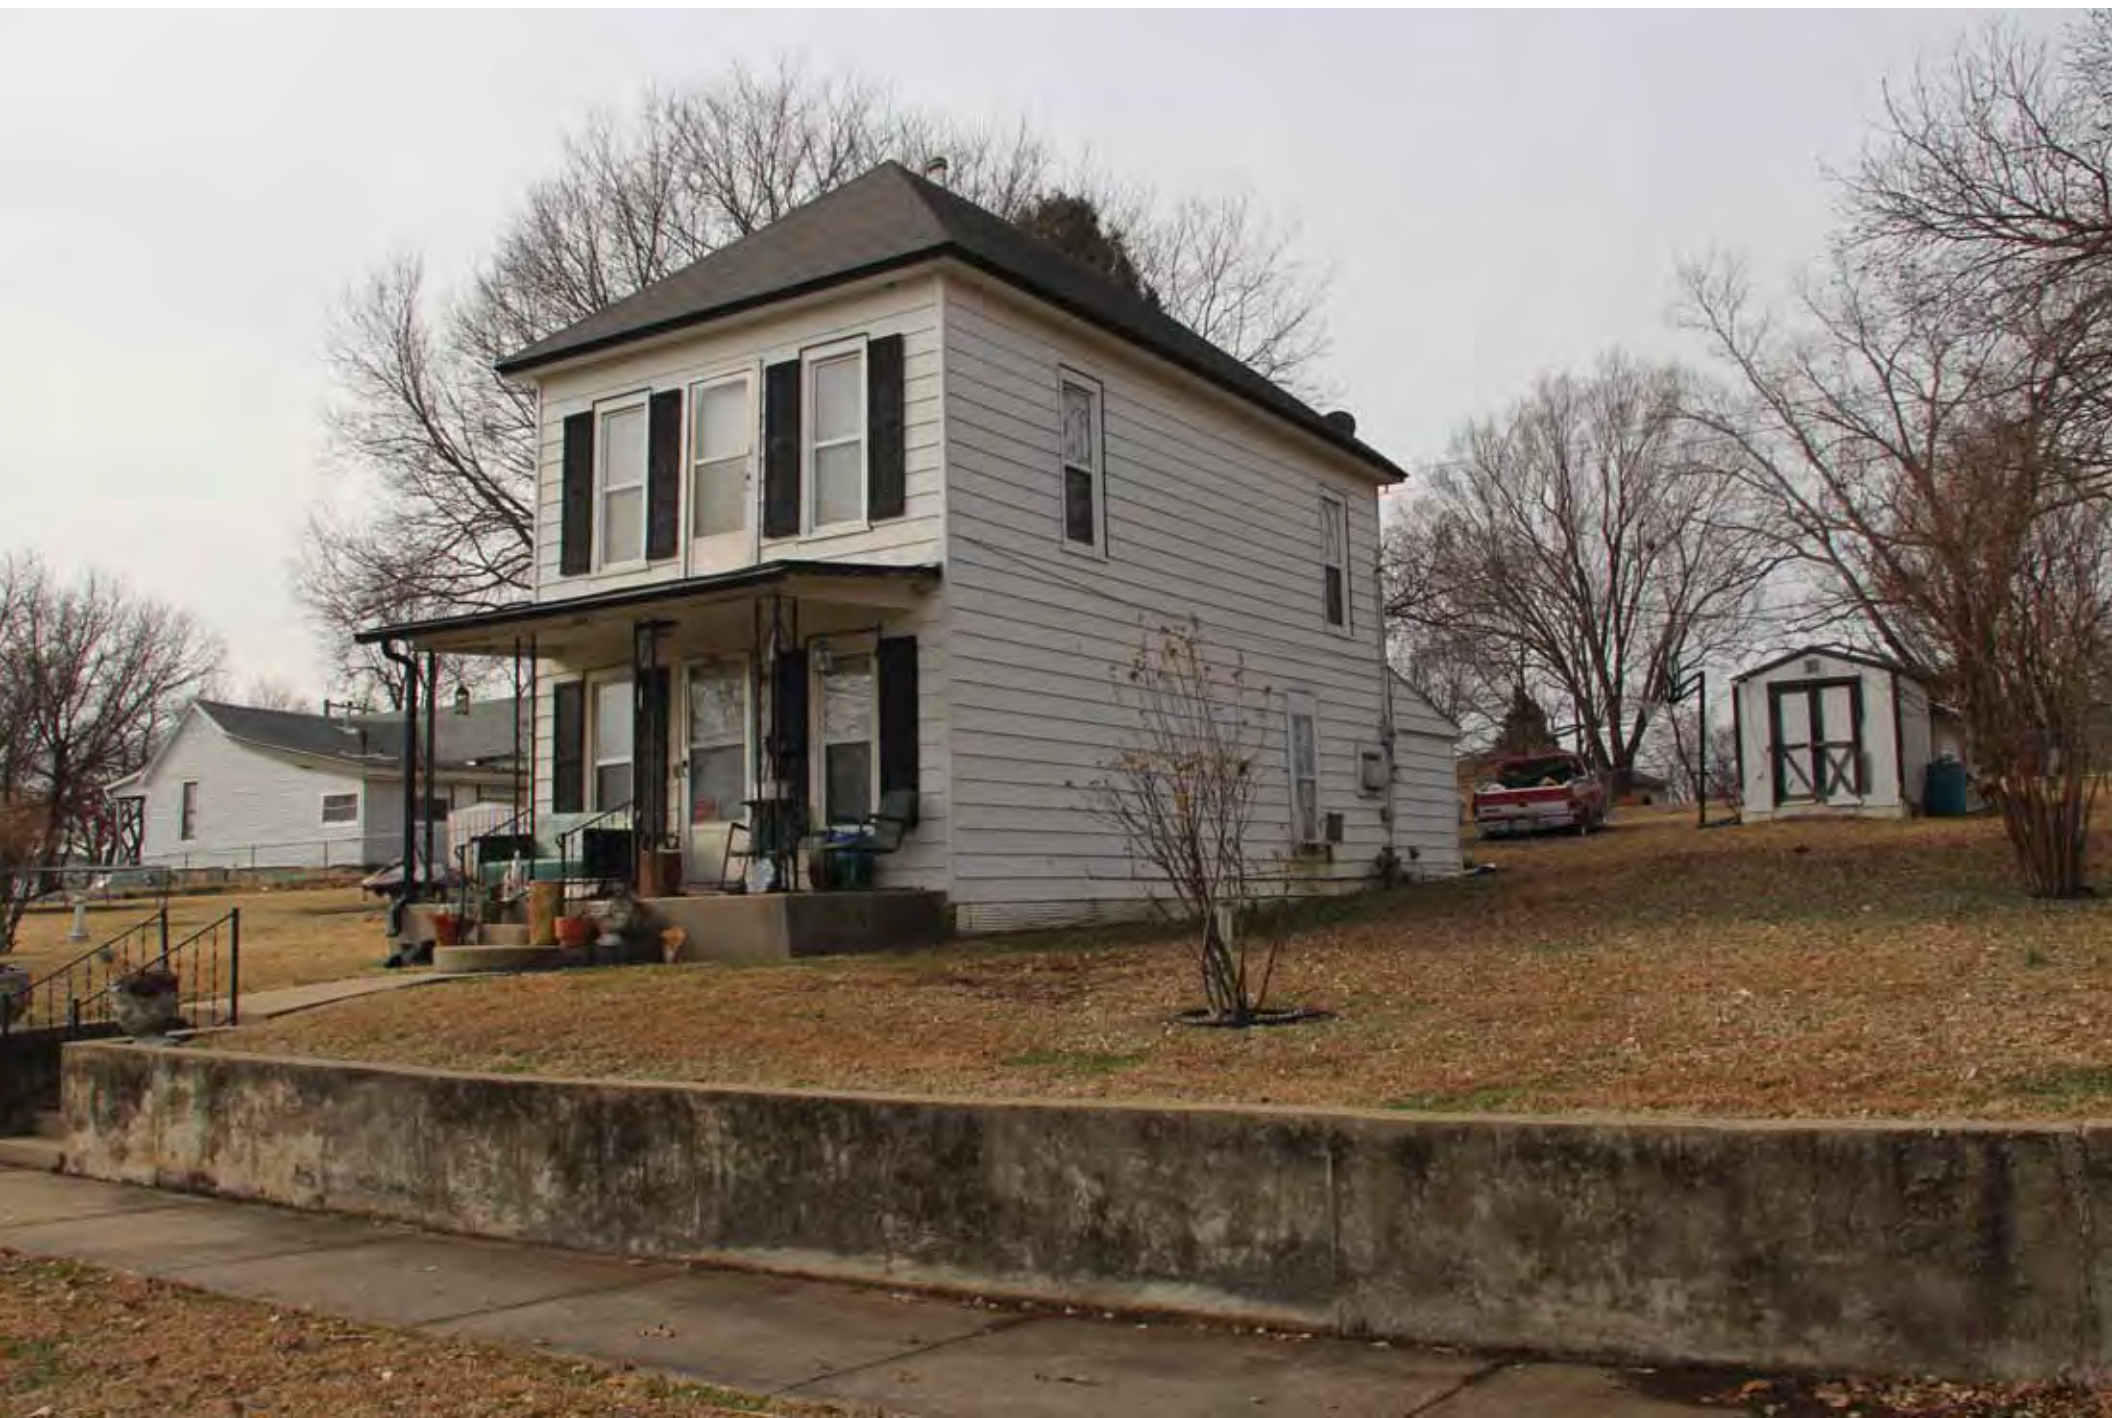
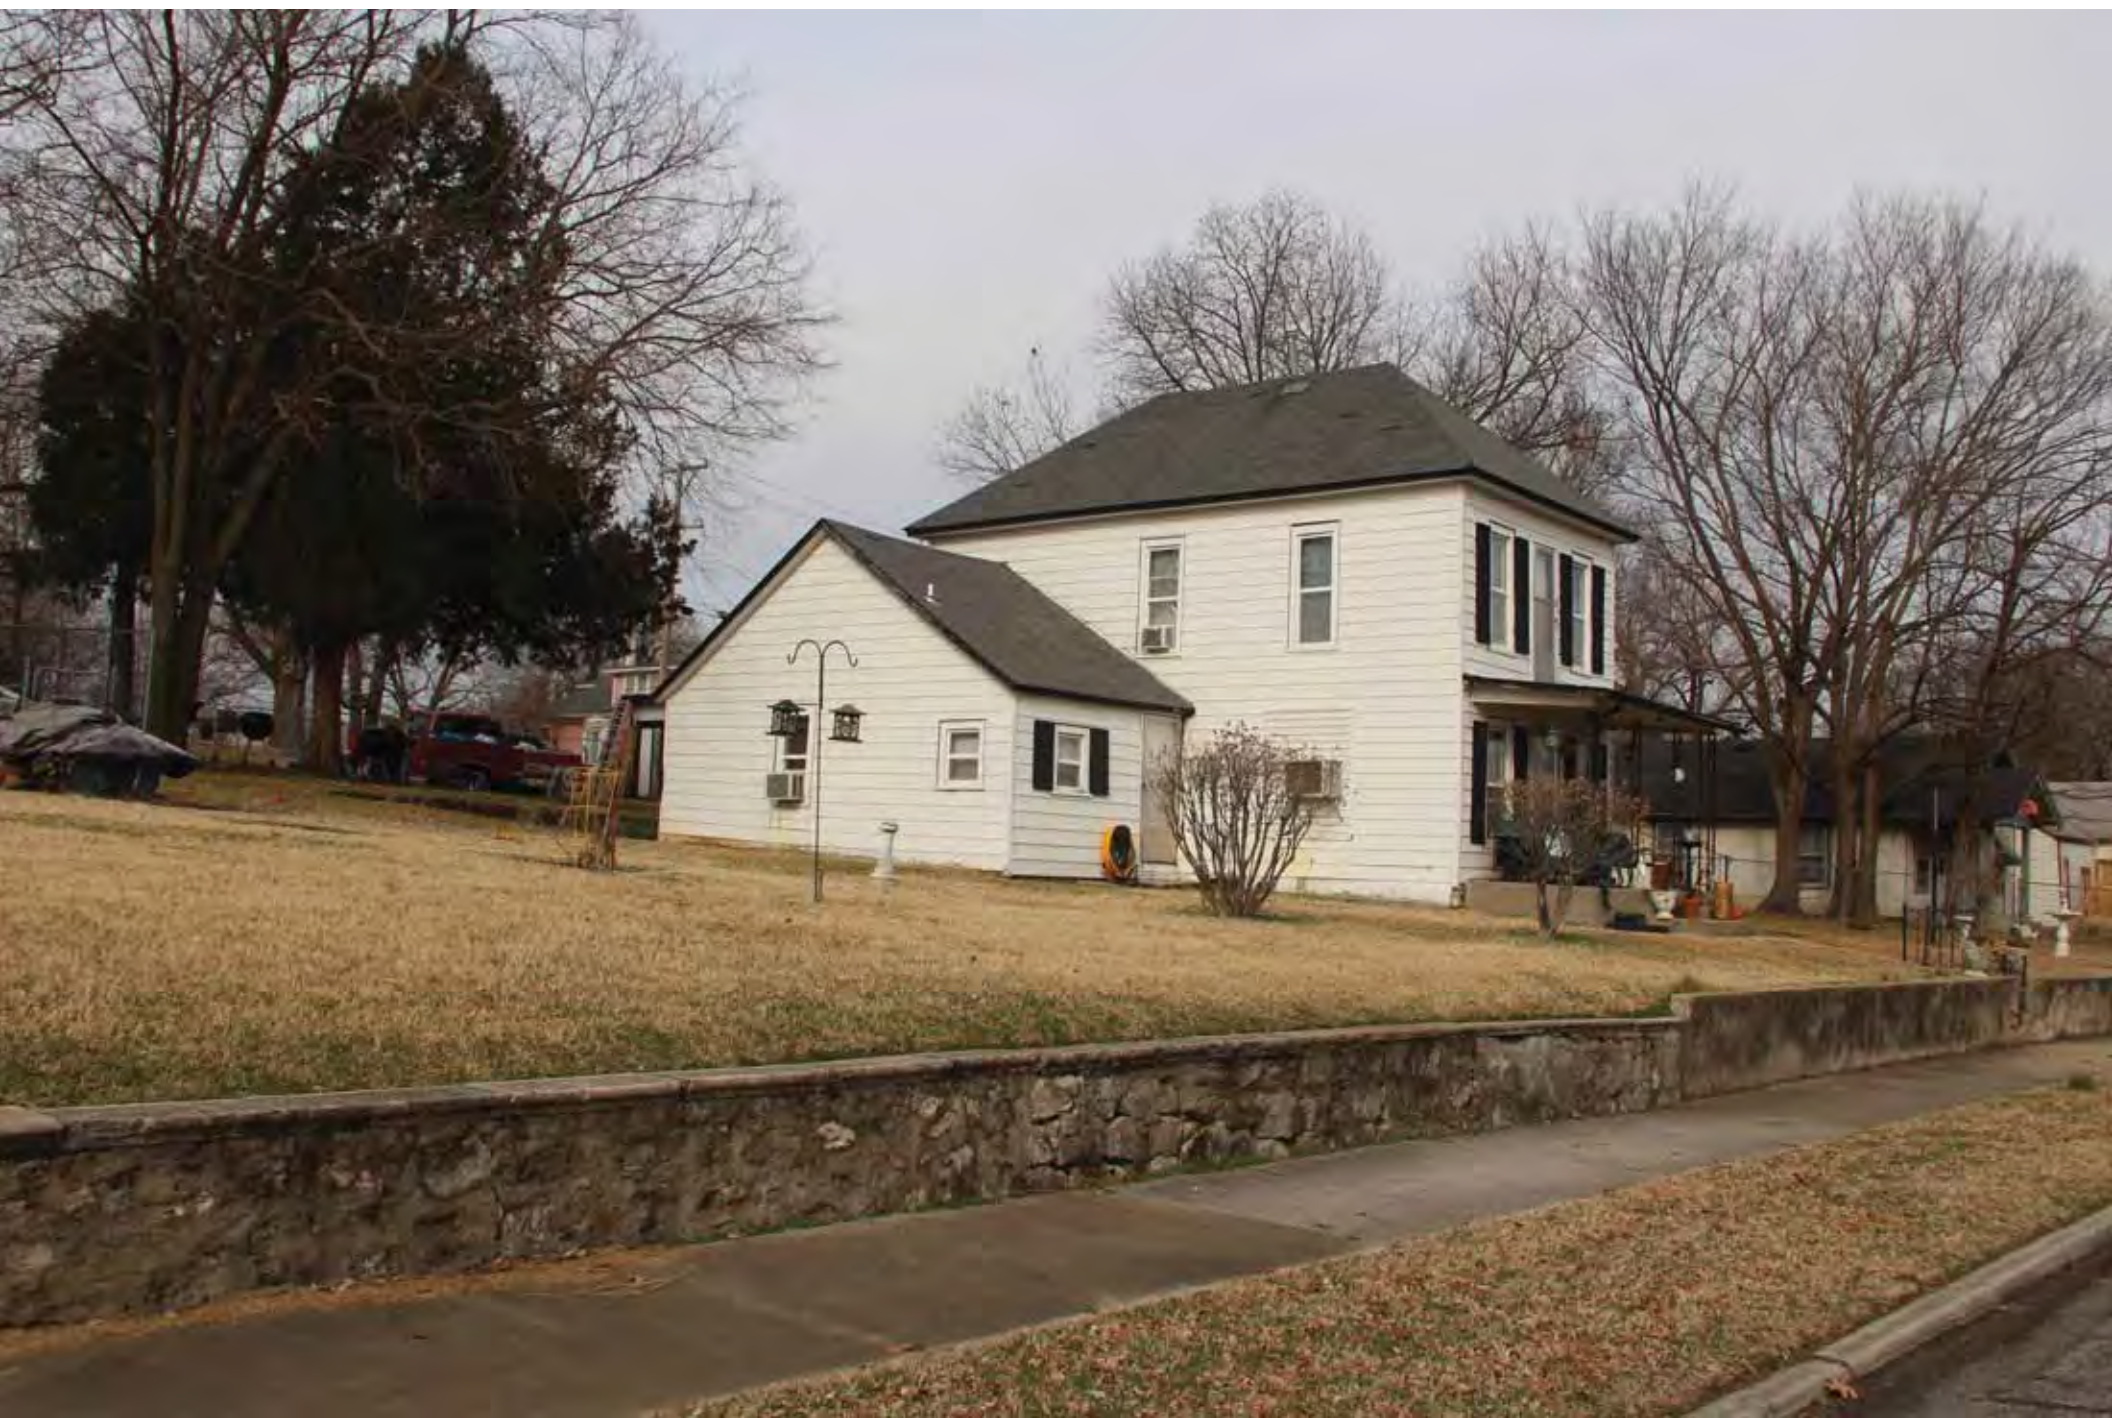
The property at 314 S. Cox Avenue is a two-story frame dwelling, with a hipped roof covered in asphalt siding. The entire house is covered in metal siding. The front façade is symmetrical, with a central door flanked by single one-over-one replacement windows and each of the two floors. The windows have non-functioning metal shutters. There is a non-historic front porch with a flat roof on metal supports and a concrete foundation. On the south side of the building is a one-room, one-story addition, with a side-gabled roof. It has it's own entrance and a small window on the front façade.
