MISSOURI DEPARTMENT OF NATURAL RESOURCES
STATE HISTORIC PRESERVATION OFFICE, P.O. Box 176, Jefferson City, MO 65102
ARCHITECTURAL/HISTORIC INVENTORY FORM

1. Survey No. JP-AS-007-001		2. Survey name: East Town (Original Joplin) Historic Survey Phase 2	
3. County: JASPER		4. Address (Street No.) 618	Street (name) E. 2 nd Street
5. City: Joplin	Vicinity: <input type="checkbox"/>	6. Geographical Reference:	7. Township/Range/Section: T: R: S:
8. Historic name (if known):		9. Present/other name (if known):	
10. Ownership: <input checked="" type="checkbox"/> Private <input type="checkbox"/> Public		11a. Historic use (if known): Domestic: Single Dwelling	11b. Current use: Domestic: Single Dwelling

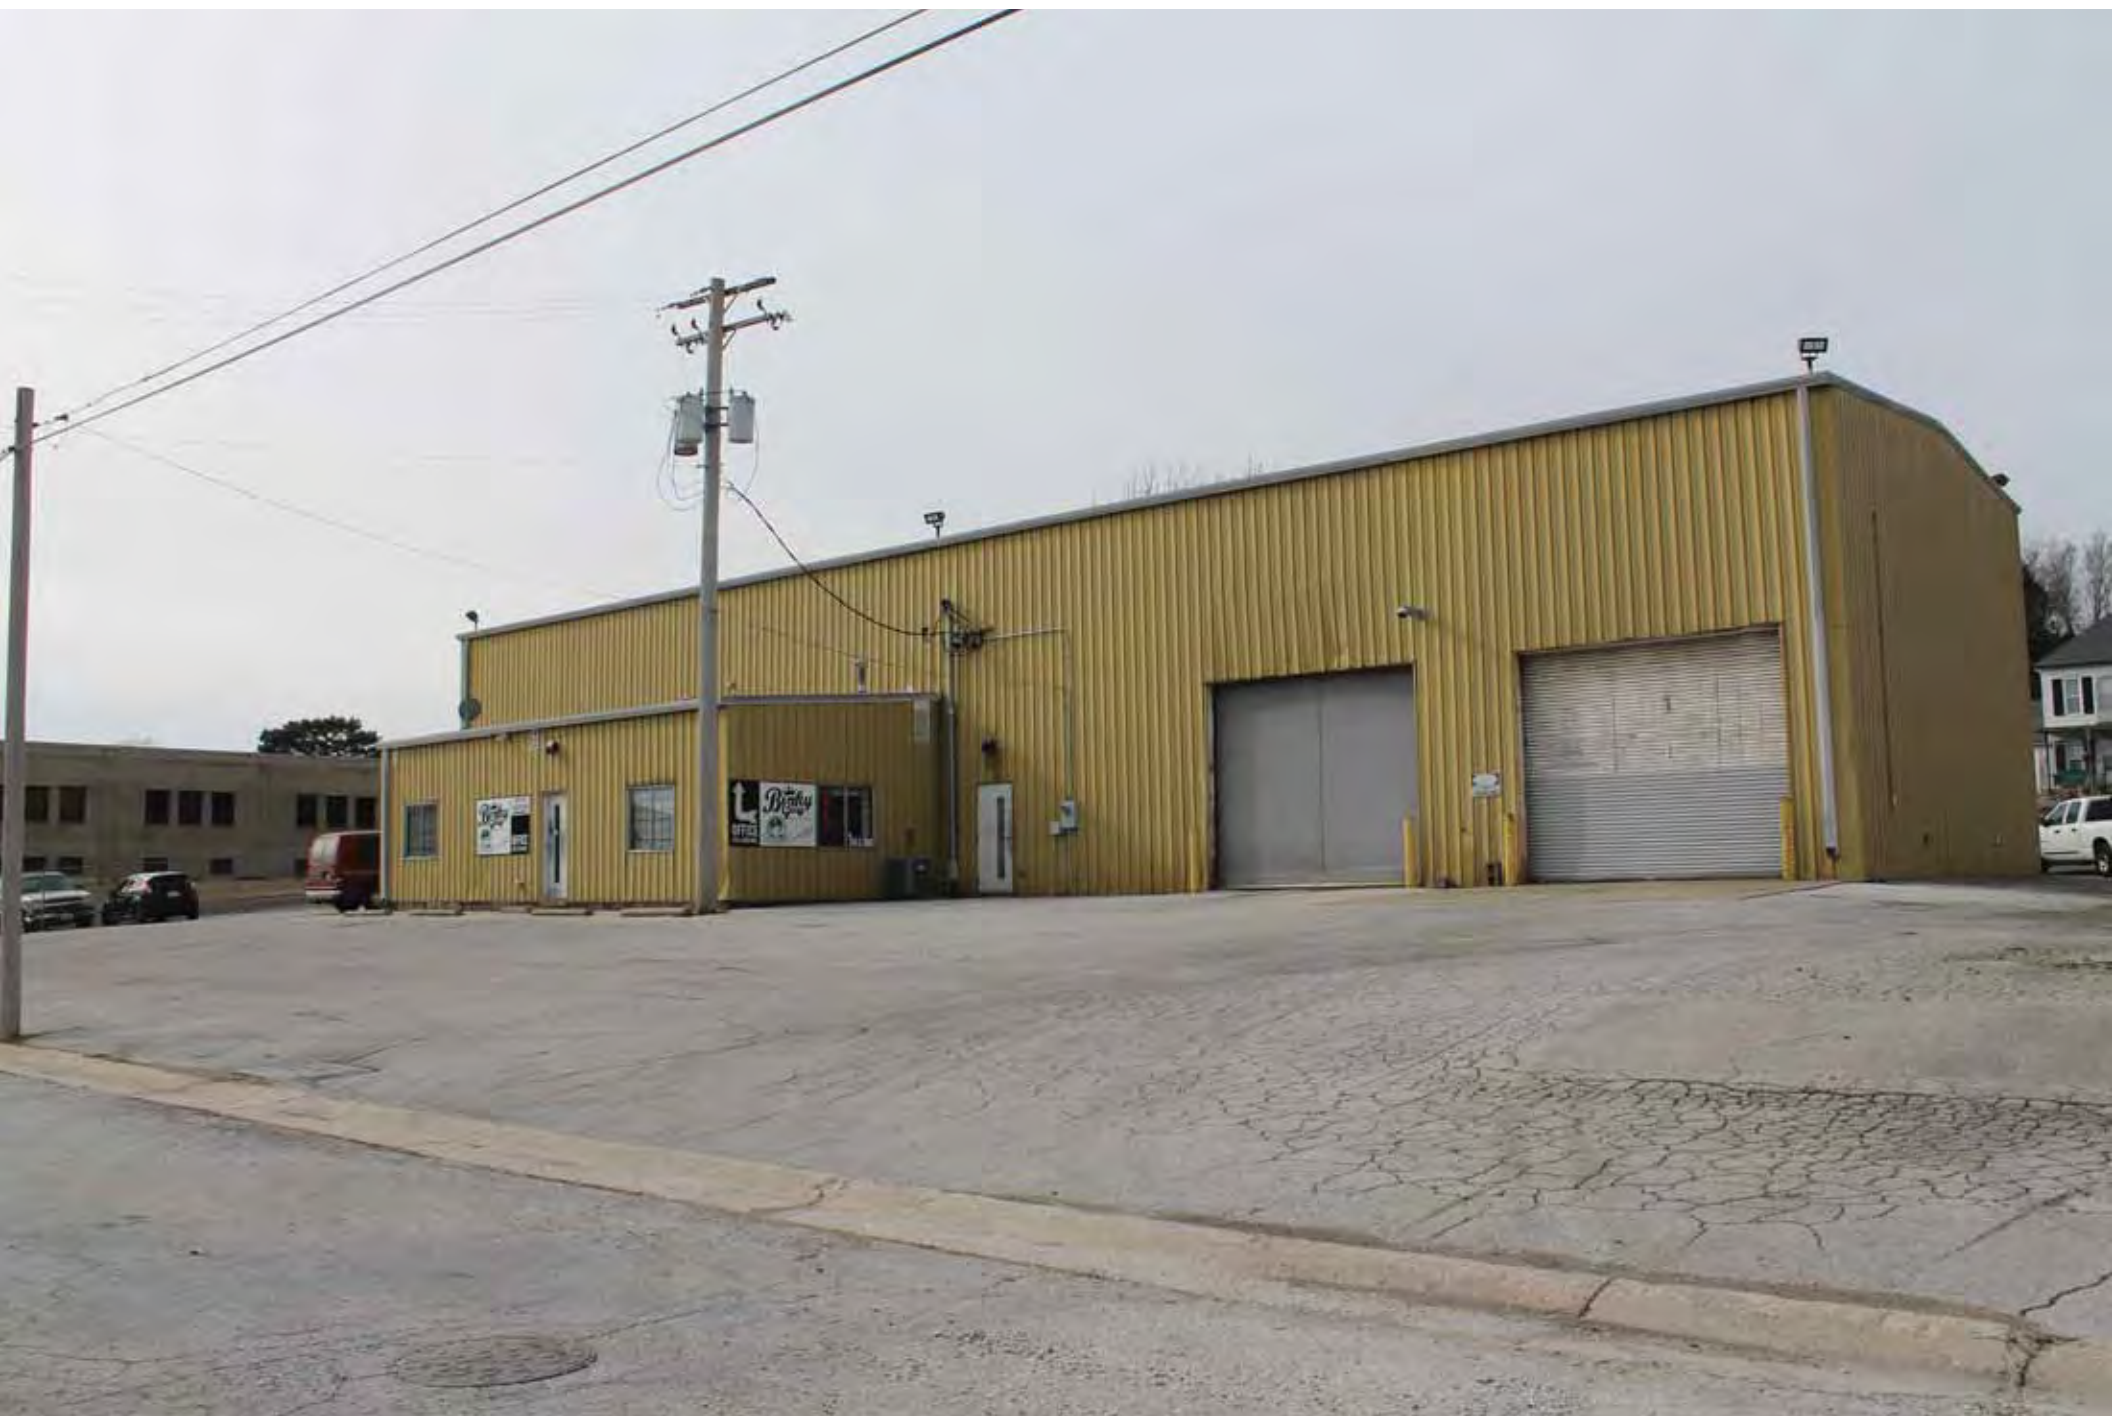
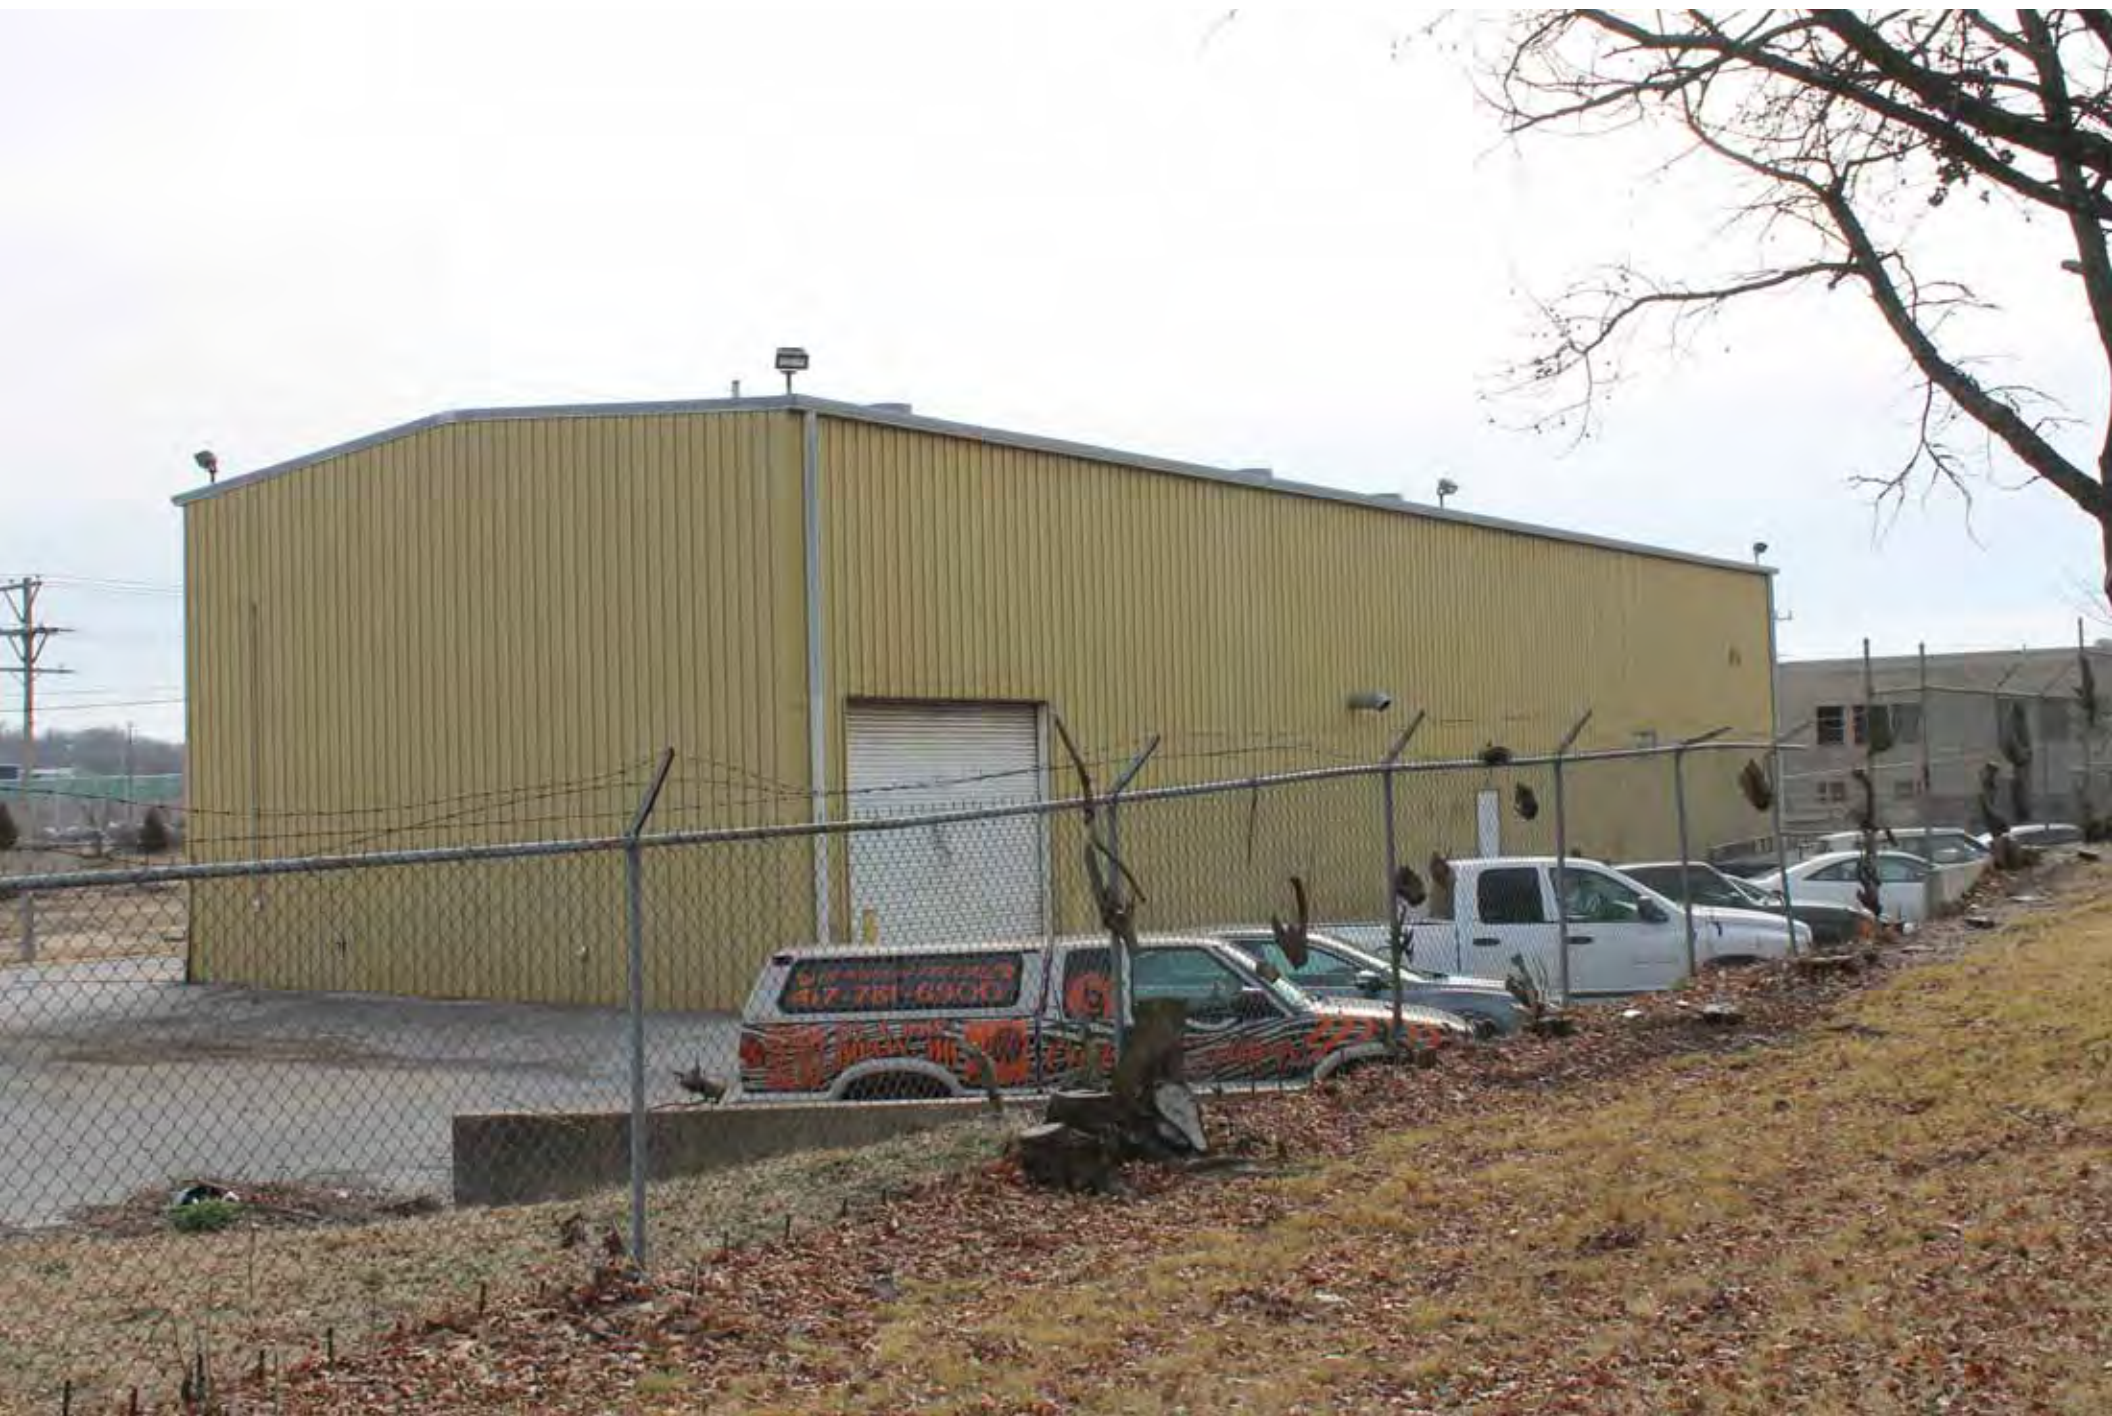
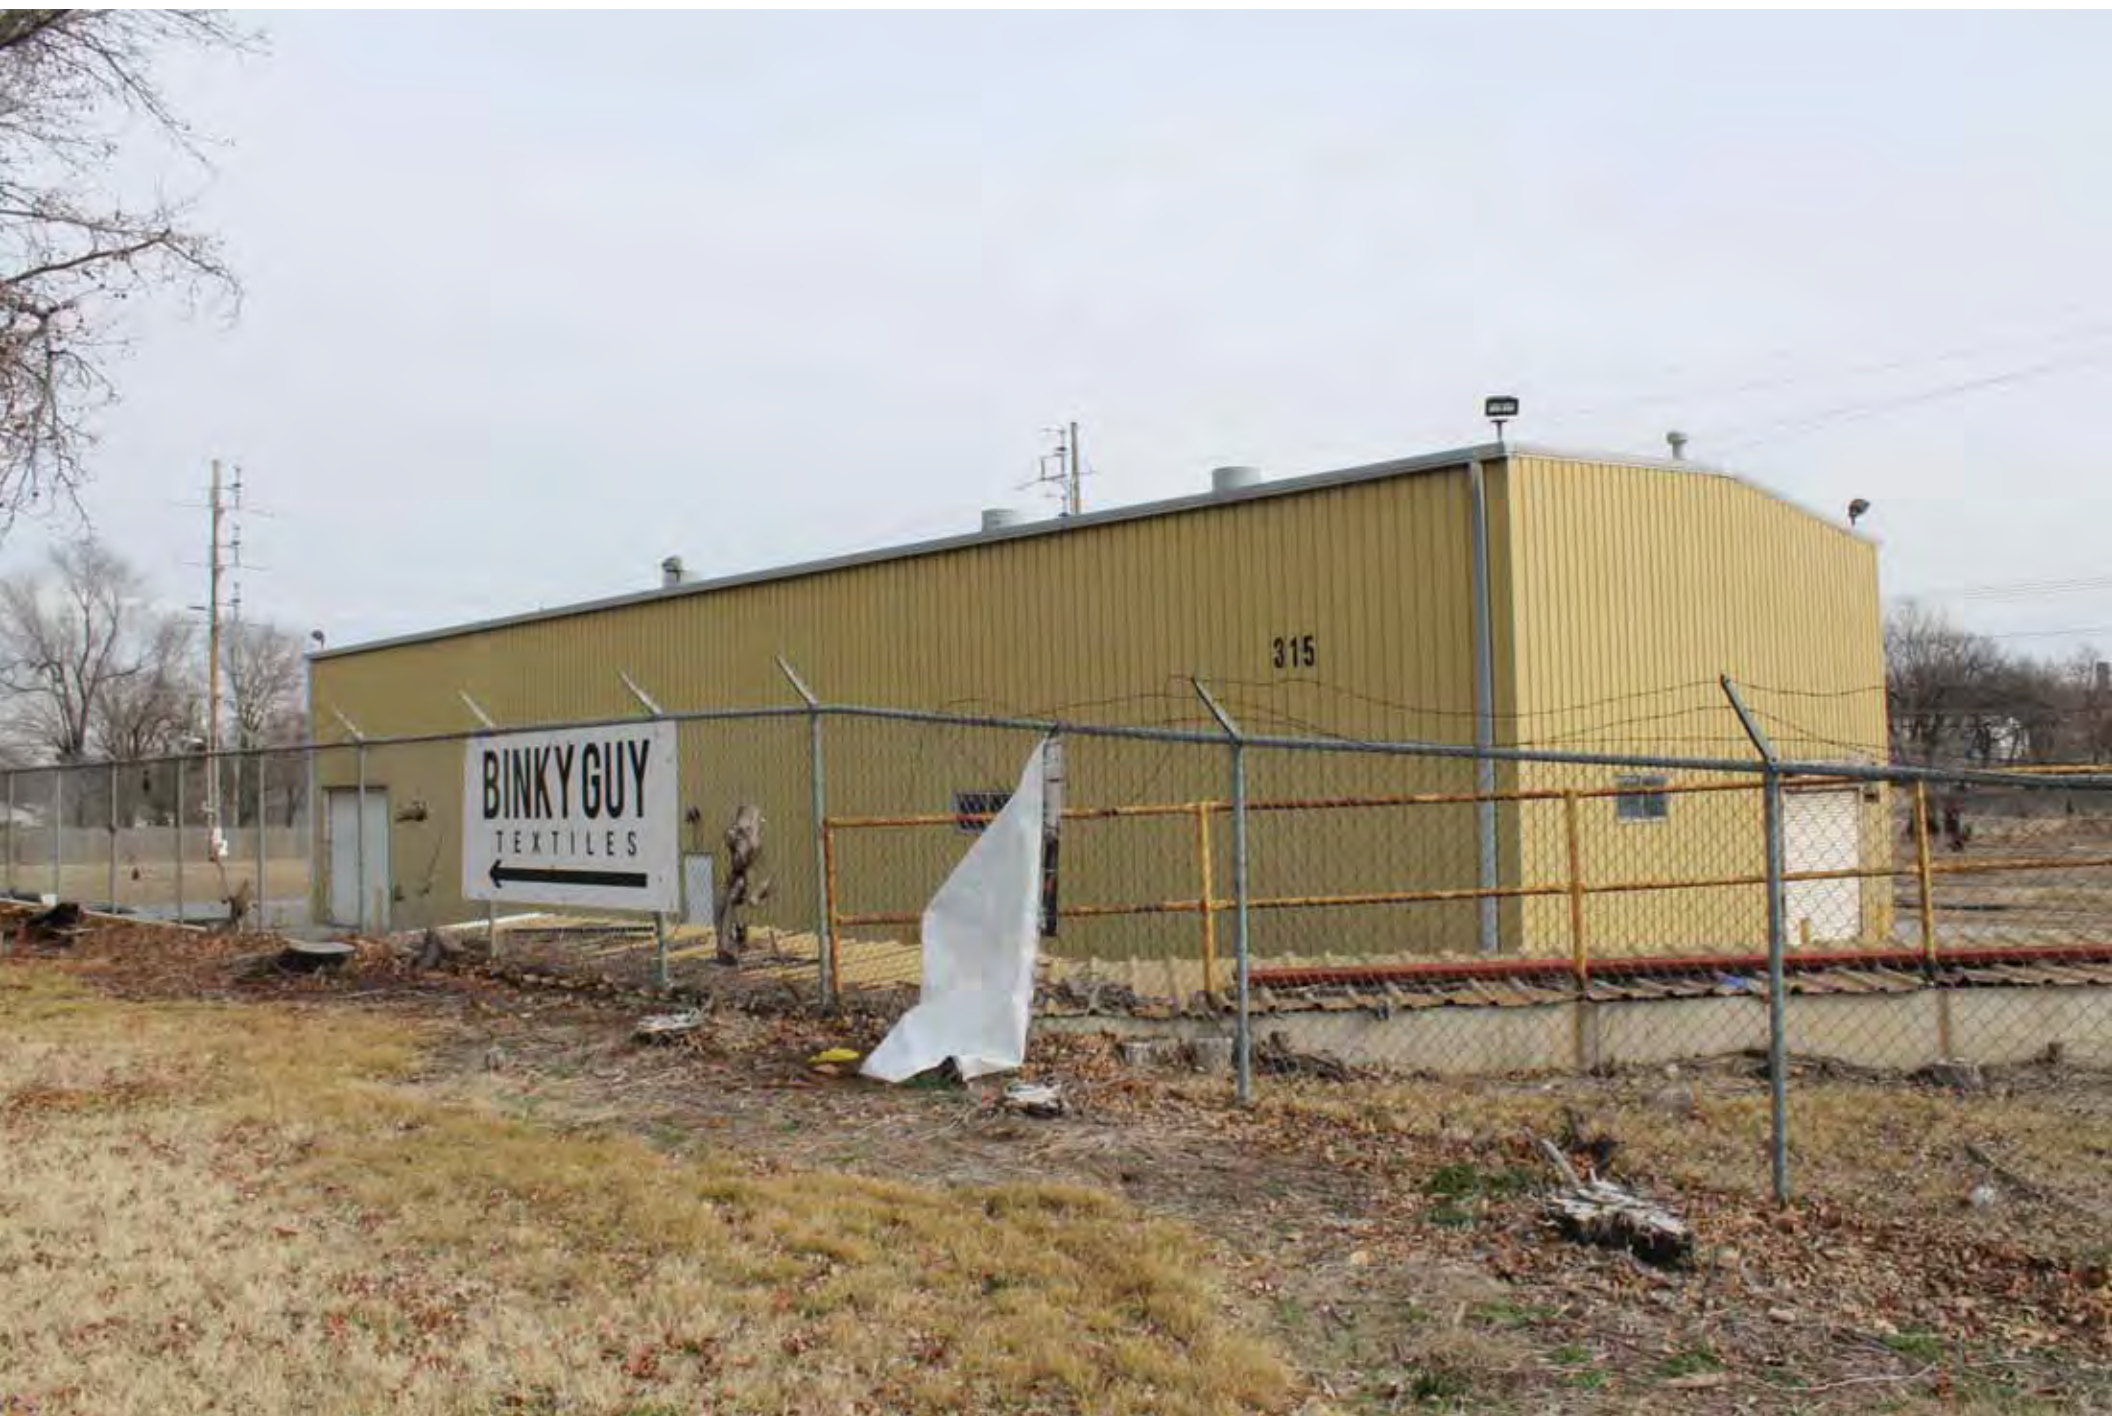
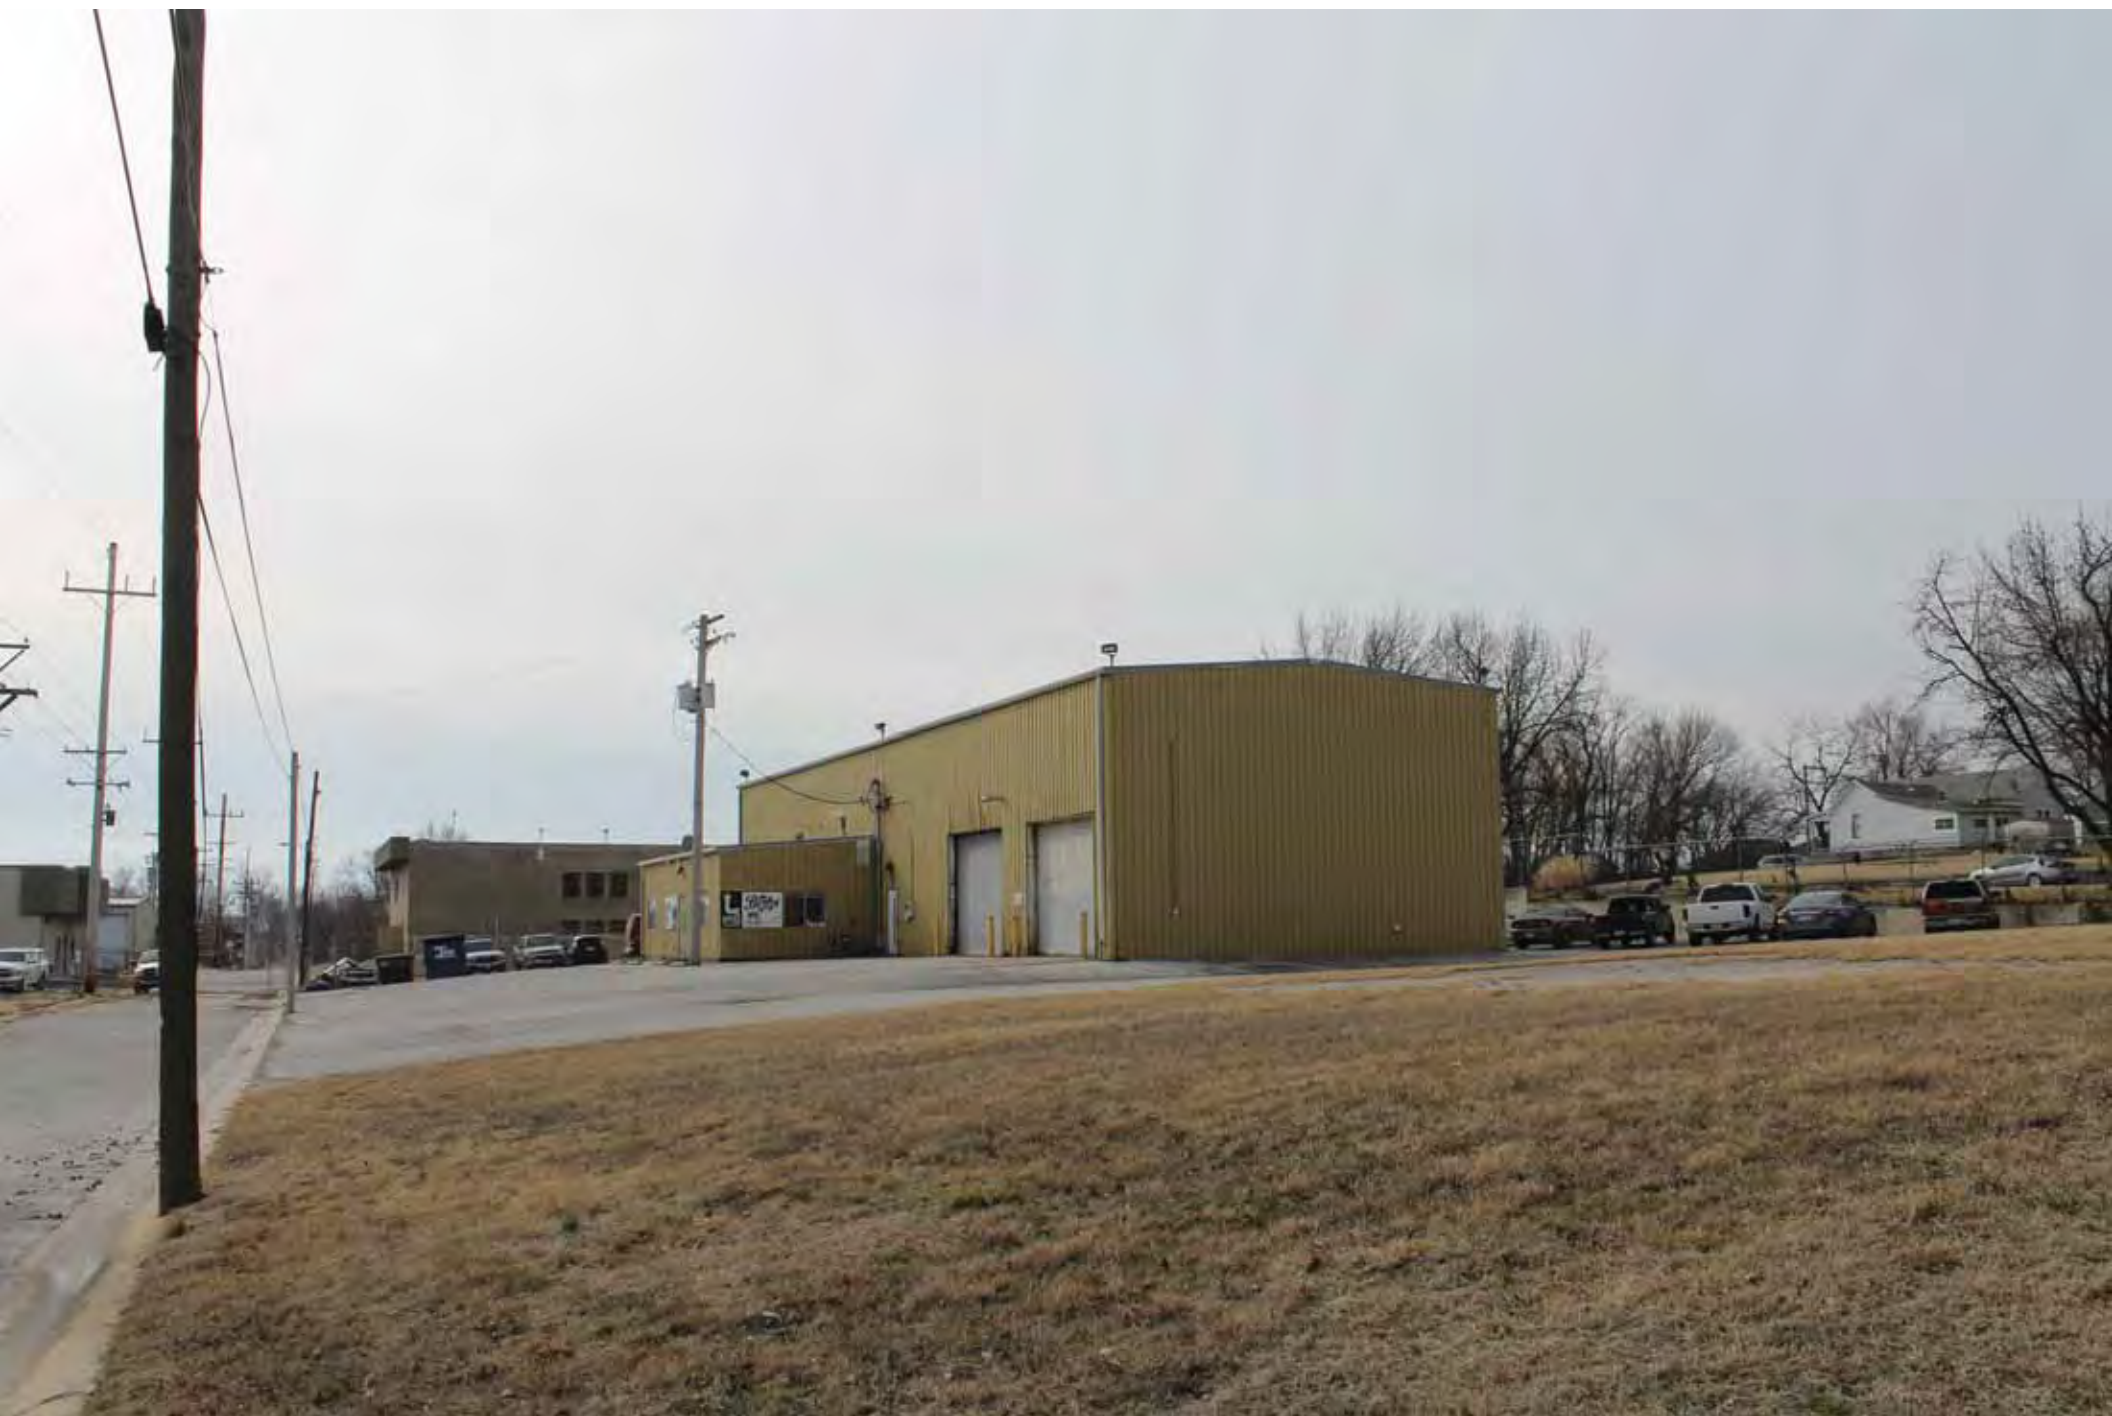
The building associated with this parcel is a 2.0-story rectangular plan prefabricated metal warehouse. The building faces east and has a metal low gabled roof, exterior metal walls and a slab concrete foundation. The east elevation faces a large asphalt lot and could be considered the primary elevation. It has two large garage bays with metal track doors. To the south of the garage bays is a single entrance door. The main commercial entrance is situated at the south end of this elevation, at a small one-story addition, with a low-pitched metal roof. The entry bay holds a single door flanked by two small metal casement windows. The north and south elevations have no windows. On the west side elevation, or the rear of the building, there is a single garage bay with metal garage door.
