MISSOURI DEPARTMENT OF NATURAL RESOURCES
STATE HISTORIC PRESERVATION OFFICE, P.O. Box 176, Jefferson City, MO 65102
ARCHITECTURAL/HISTORIC INVENTORY FORM

1. Survey No. JP-AS-007-001		2. Survey name: East Town (Original Joplin) Historic Survey Phase 2	
3. County: JASPER		4. Address (Street No.) 618	Street (name) E. 2 nd Street
5. City: Joplin	Vicinity: <input type="checkbox"/>	6. Geographical Reference:	7. Township/Range/Section: T: R: S:
8. Historic name (if known):		9. Present/other name (if known):	
10. Ownership: <input checked="" type="checkbox"/> Private <input type="checkbox"/> Public		11a. Historic use (if known): Domestic: Single Dwelling	11b. Current use: Domestic: Single Dwelling

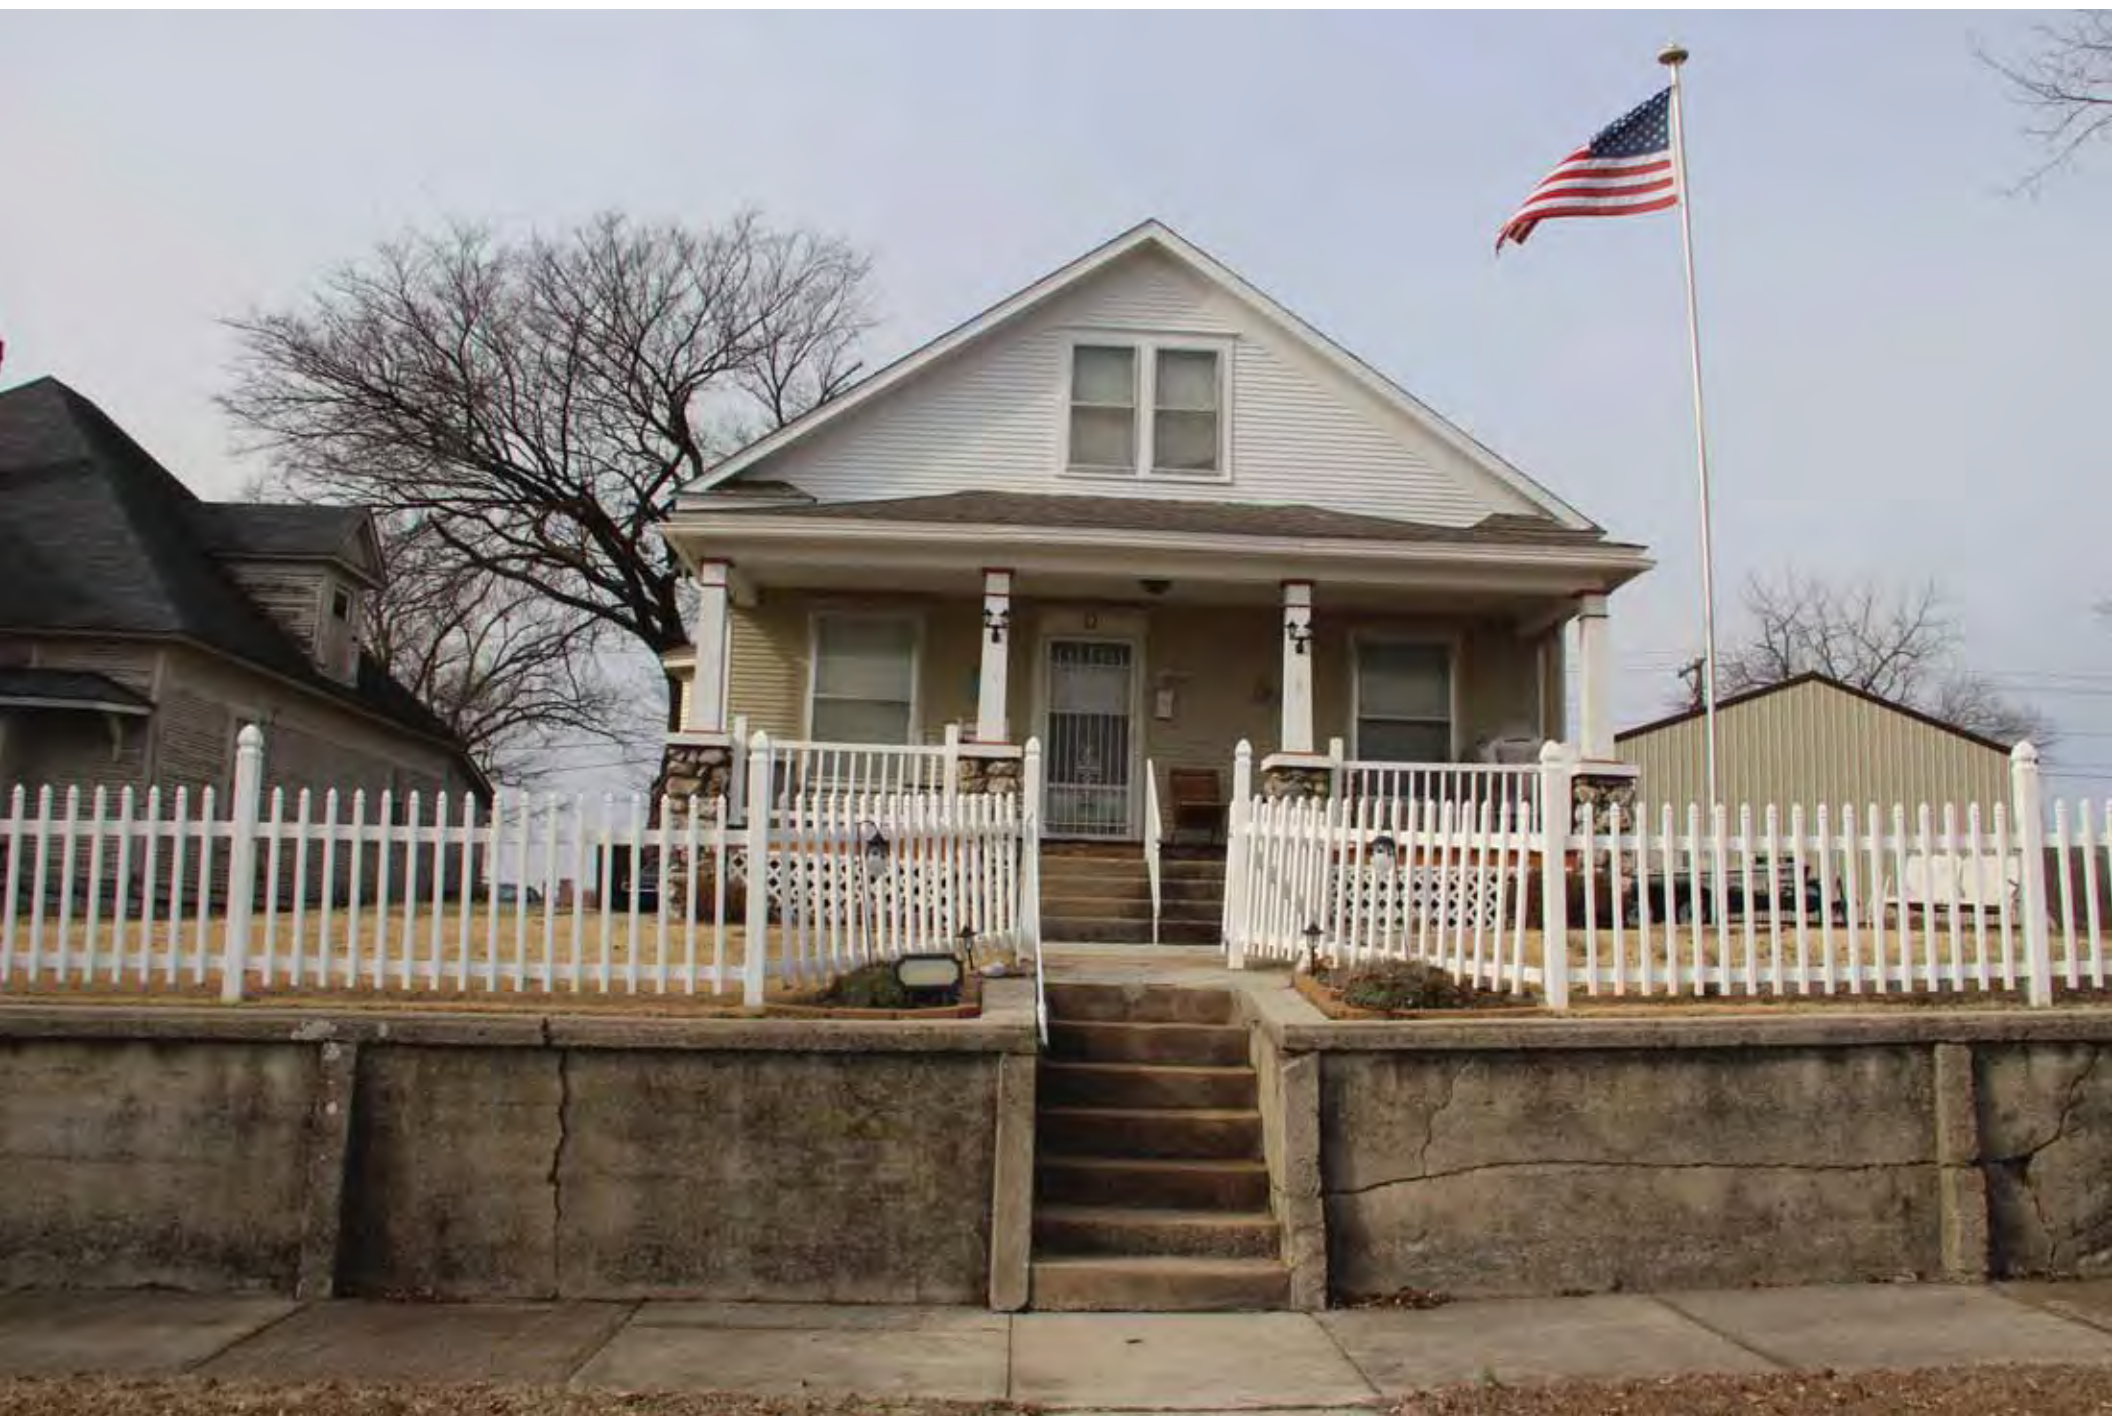
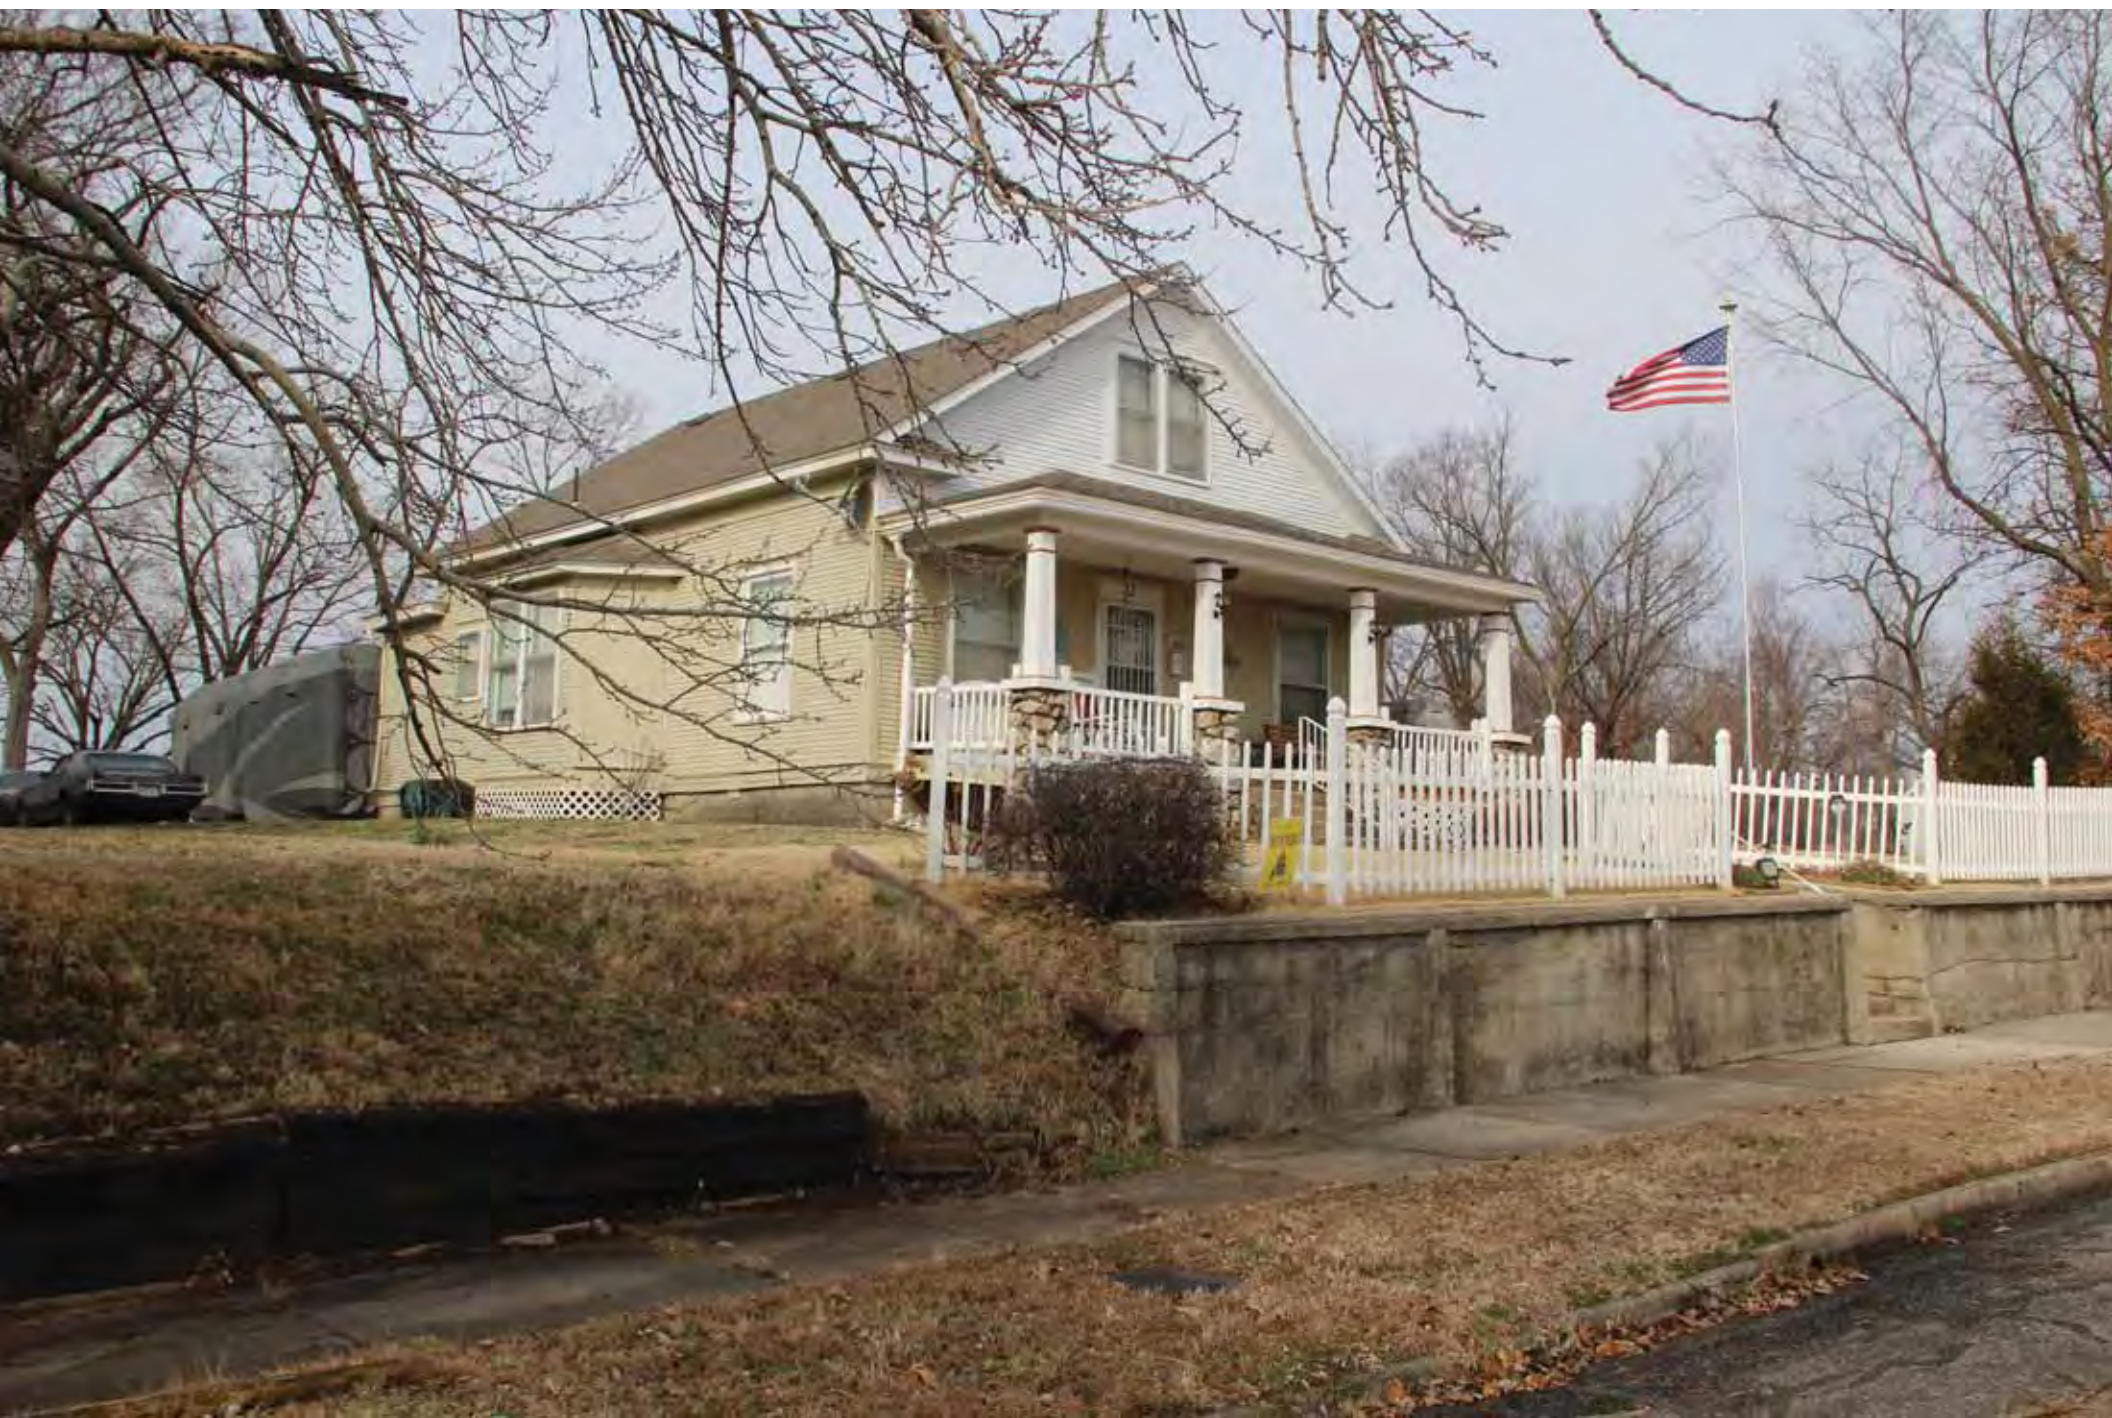
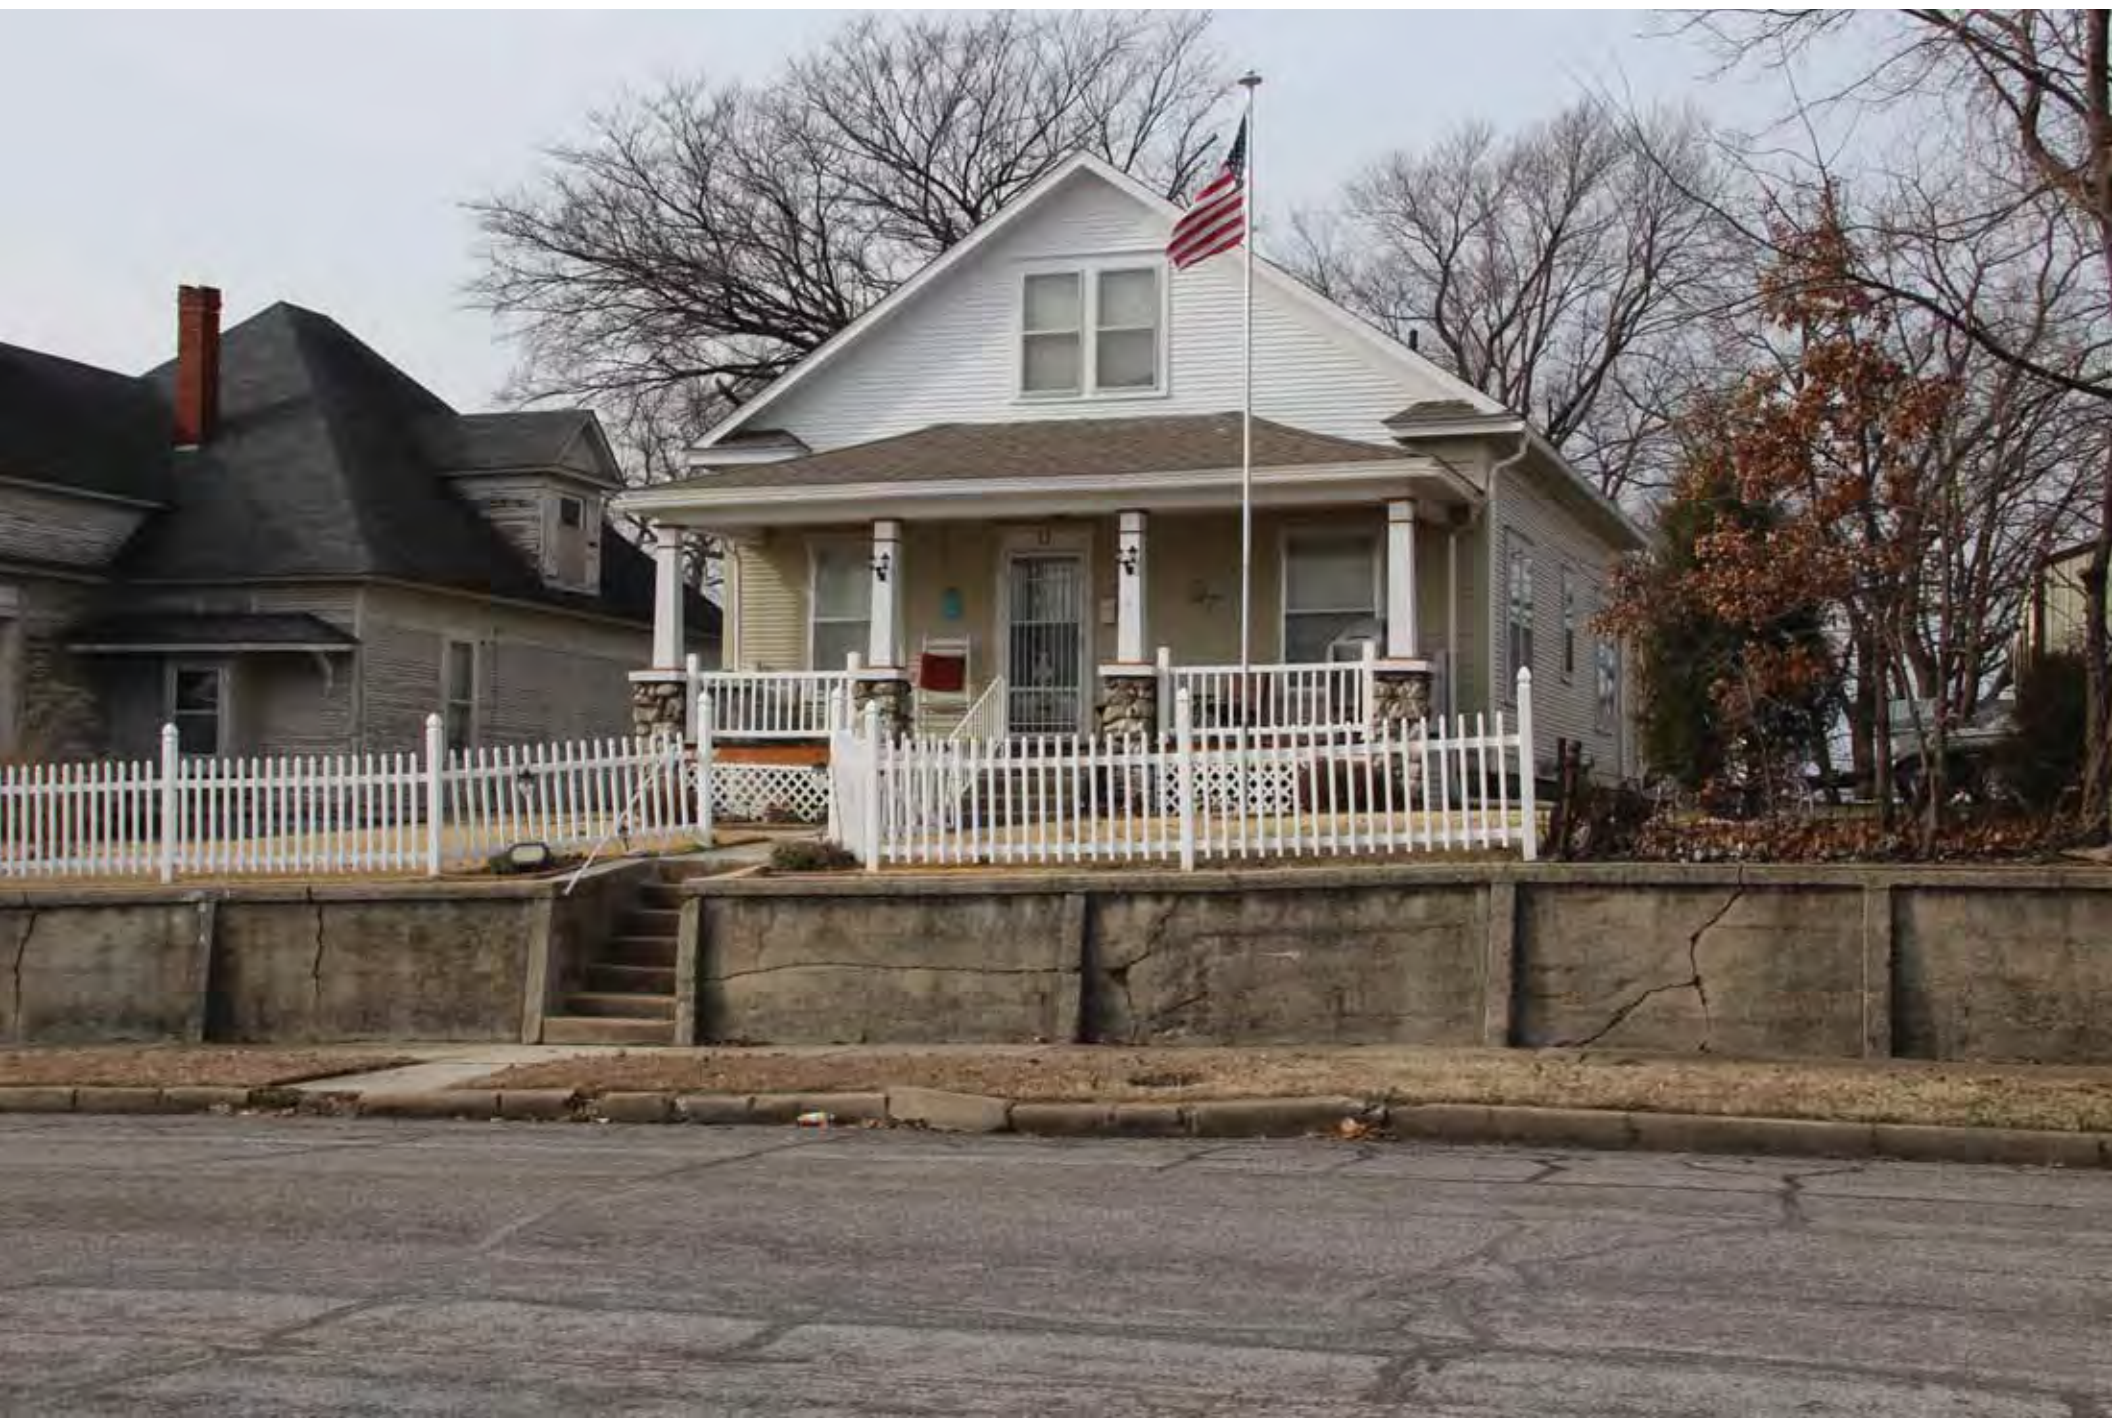
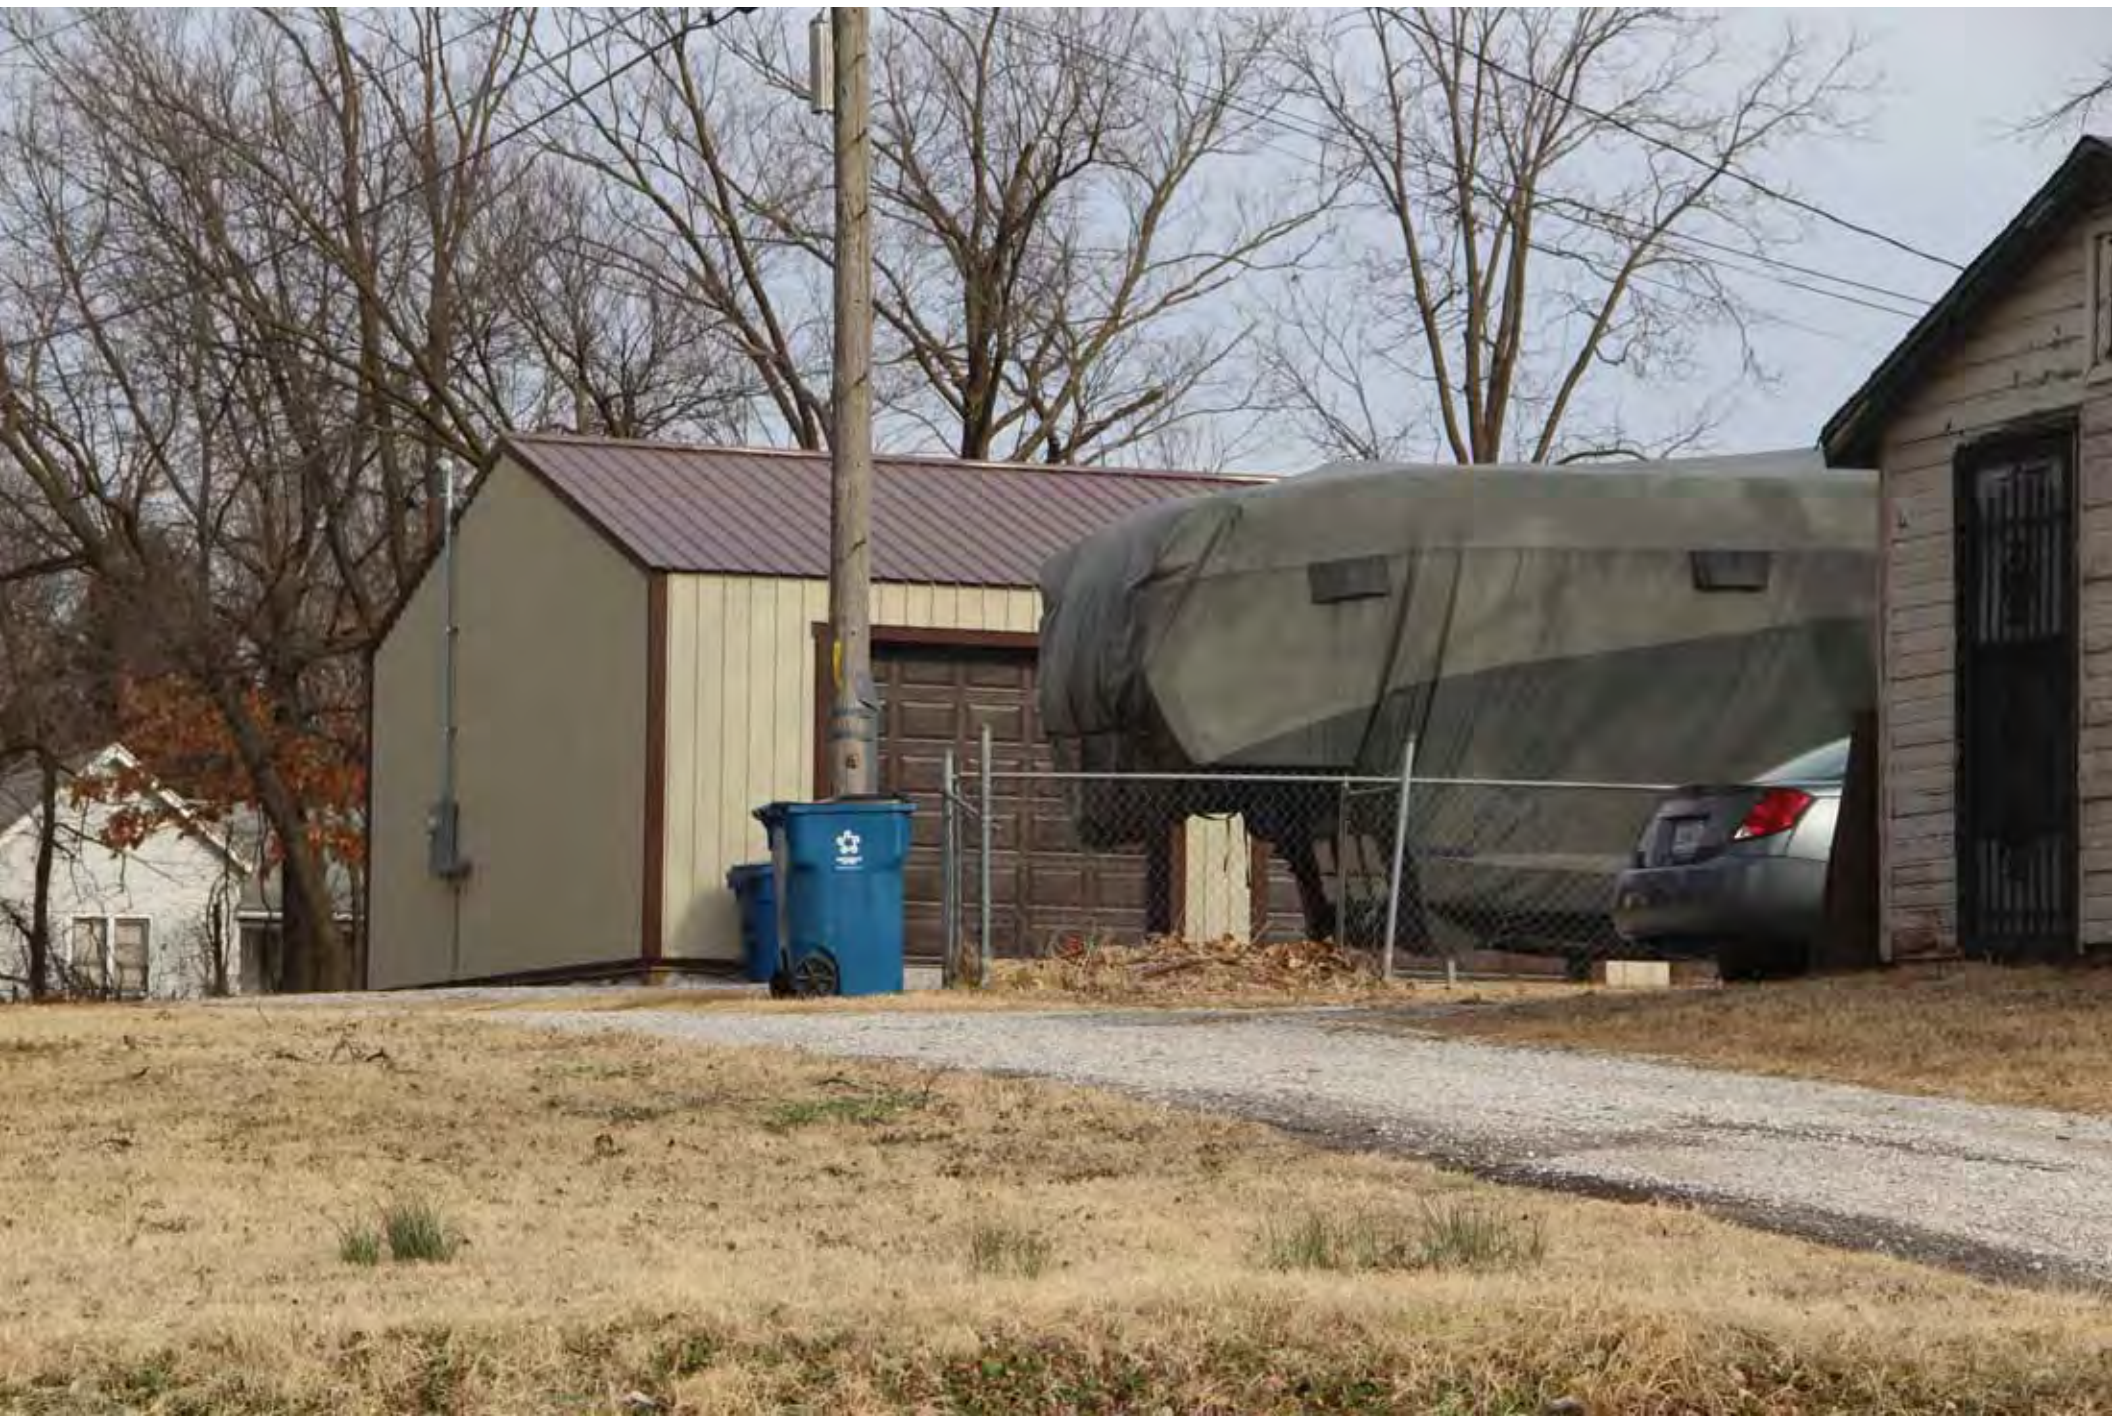
The dwelling does not retain sufficient integrity that would render it individually eligible for the National Register of Historic Places. The dwelling is not situated in an area recommended as a historic district.

The property at 414 S. Cox Avenue is a one-story dwelling, with a front-facing gabled roof covered in asphalt siding. On the front façade is the original open front porch, with a low-pitched hipped roof. It is supported on square tapered wooden posts on stone covered concrete piers. The porch shelters a central door flanked on either side by single one-over-one windows. At the half story level, above the front porch, is a single one-over-one small window. On the north side of the house is a double one-over-one window, a small casement window, and a single one-over-one window. All have wooden surrounds on the exterior. The entire house is covered in the original wood siding.
