MISSOURI DEPARTMENT OF NATURAL RESOURCES
STATE HISTORIC PRESERVATION OFFICE, P.O. Box 176, Jefferson City, MO 65102
ARCHITECTURAL/HISTORIC INVENTORY FORM

1. Survey No. JP-AS-007-001		2. Survey name: East Town (Original Joplin) Historic Survey Phase 2	
3. County: JASPER		4. Address (Street No.) 618	Street (name) E. 2 nd Street
5. City: Joplin	Vicinity: <input type="checkbox"/>	6. Geographical Reference:	7. Township/Range/Section: T: R: S:
8. Historic name (if known):		9. Present/other name (if known):	
10. Ownership: <input checked="" type="checkbox"/> Private <input type="checkbox"/> Public		11a. Historic use (if known): Domestic: Single Dwelling	11b. Current use: Domestic: Single Dwelling

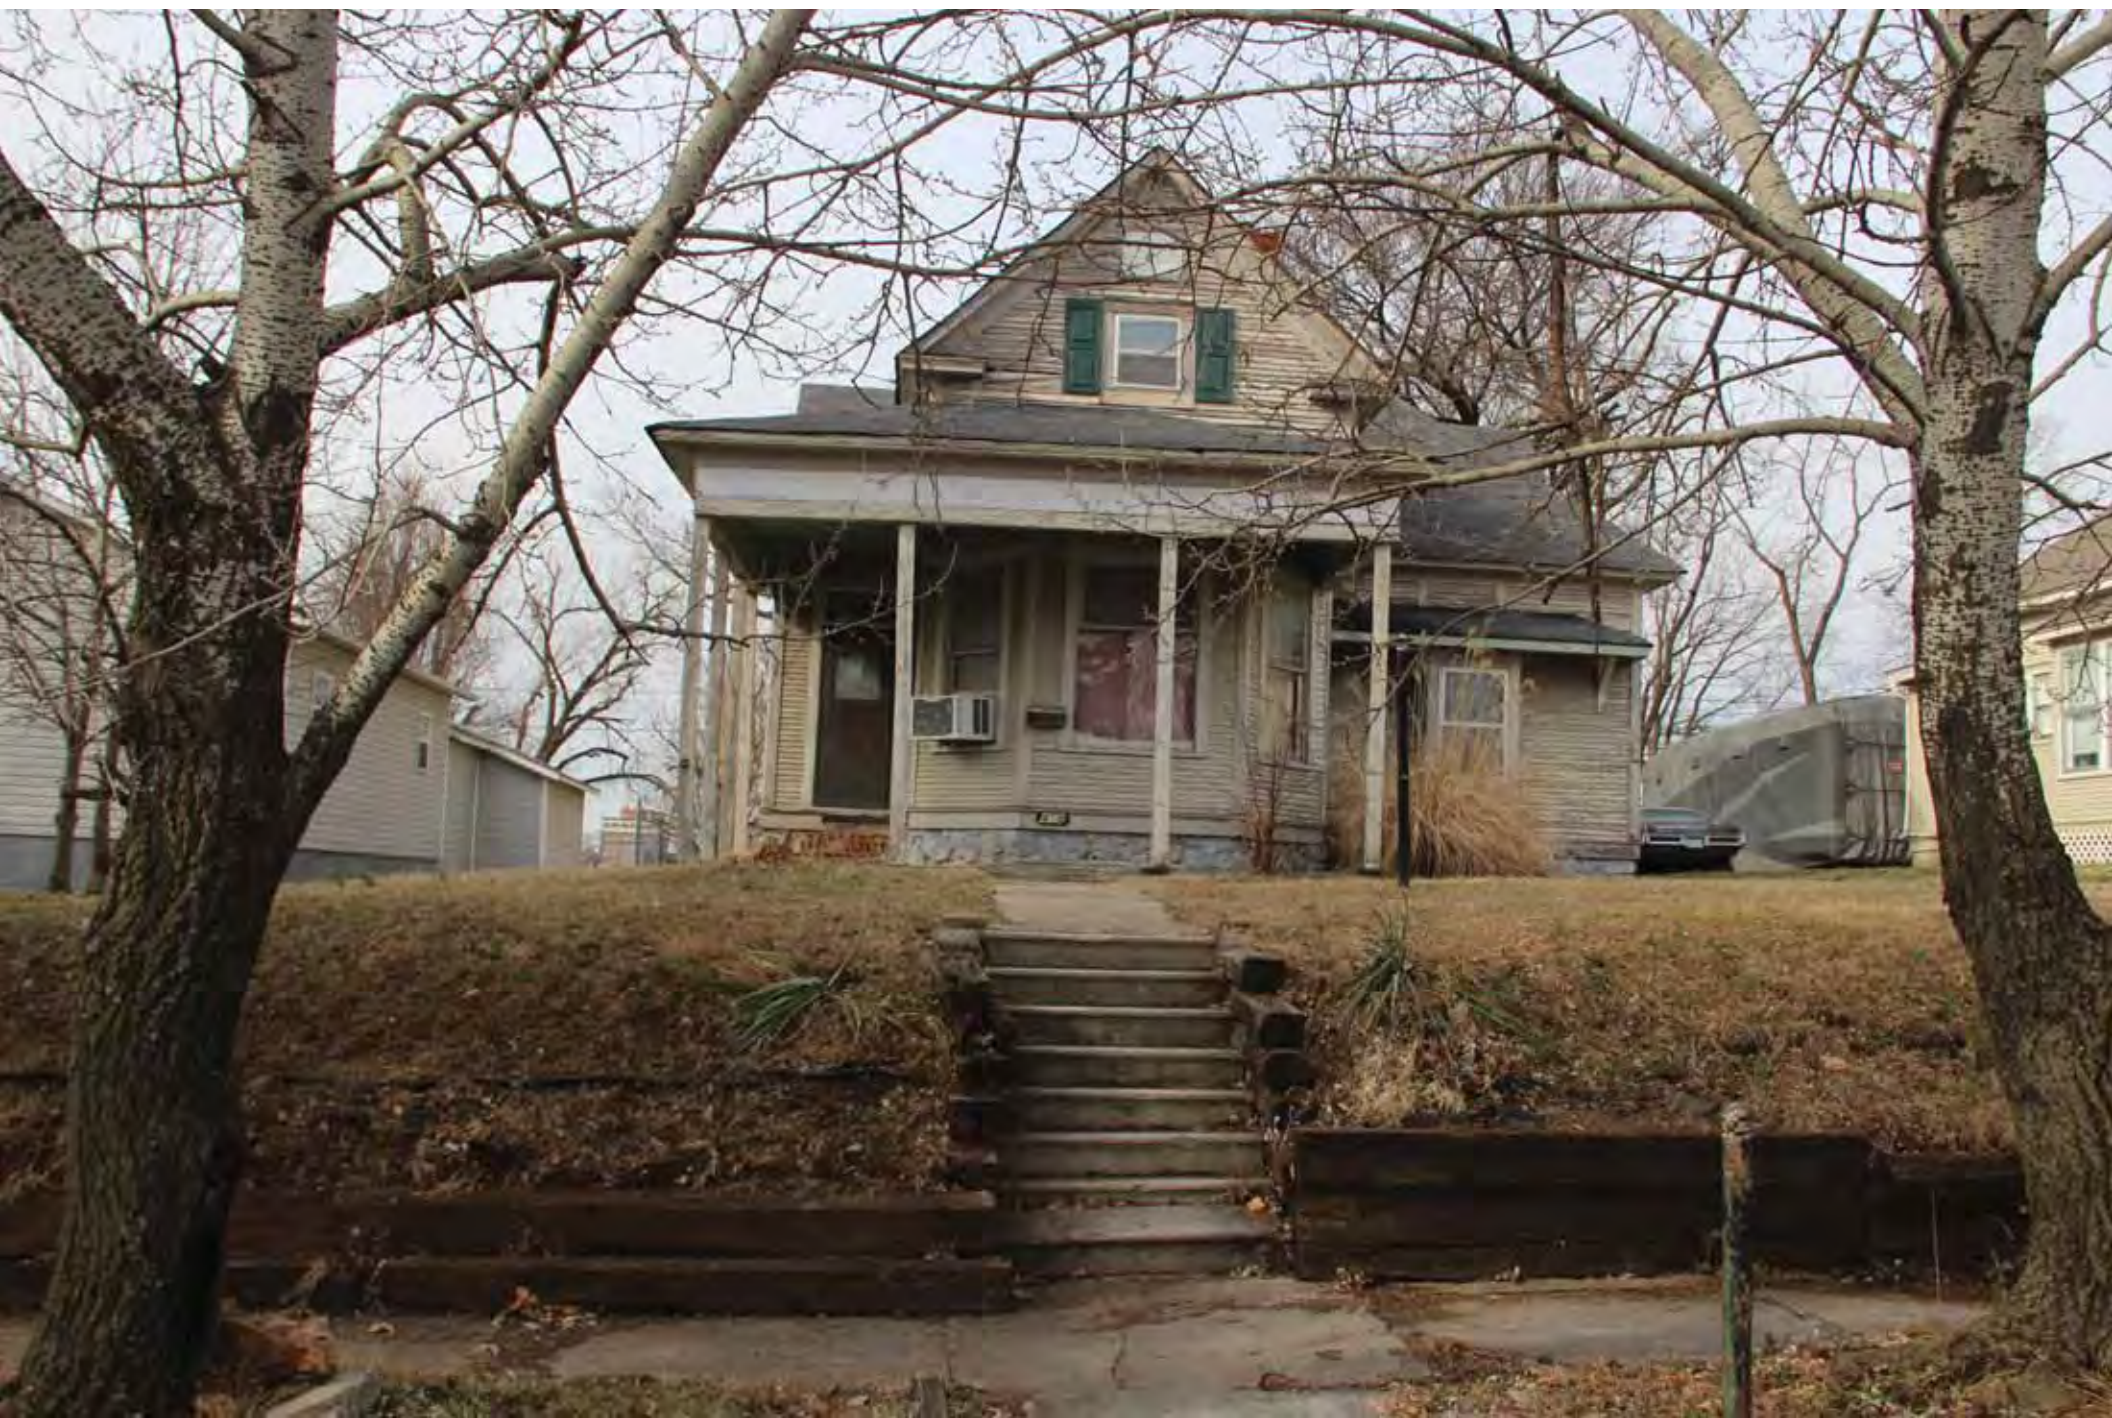
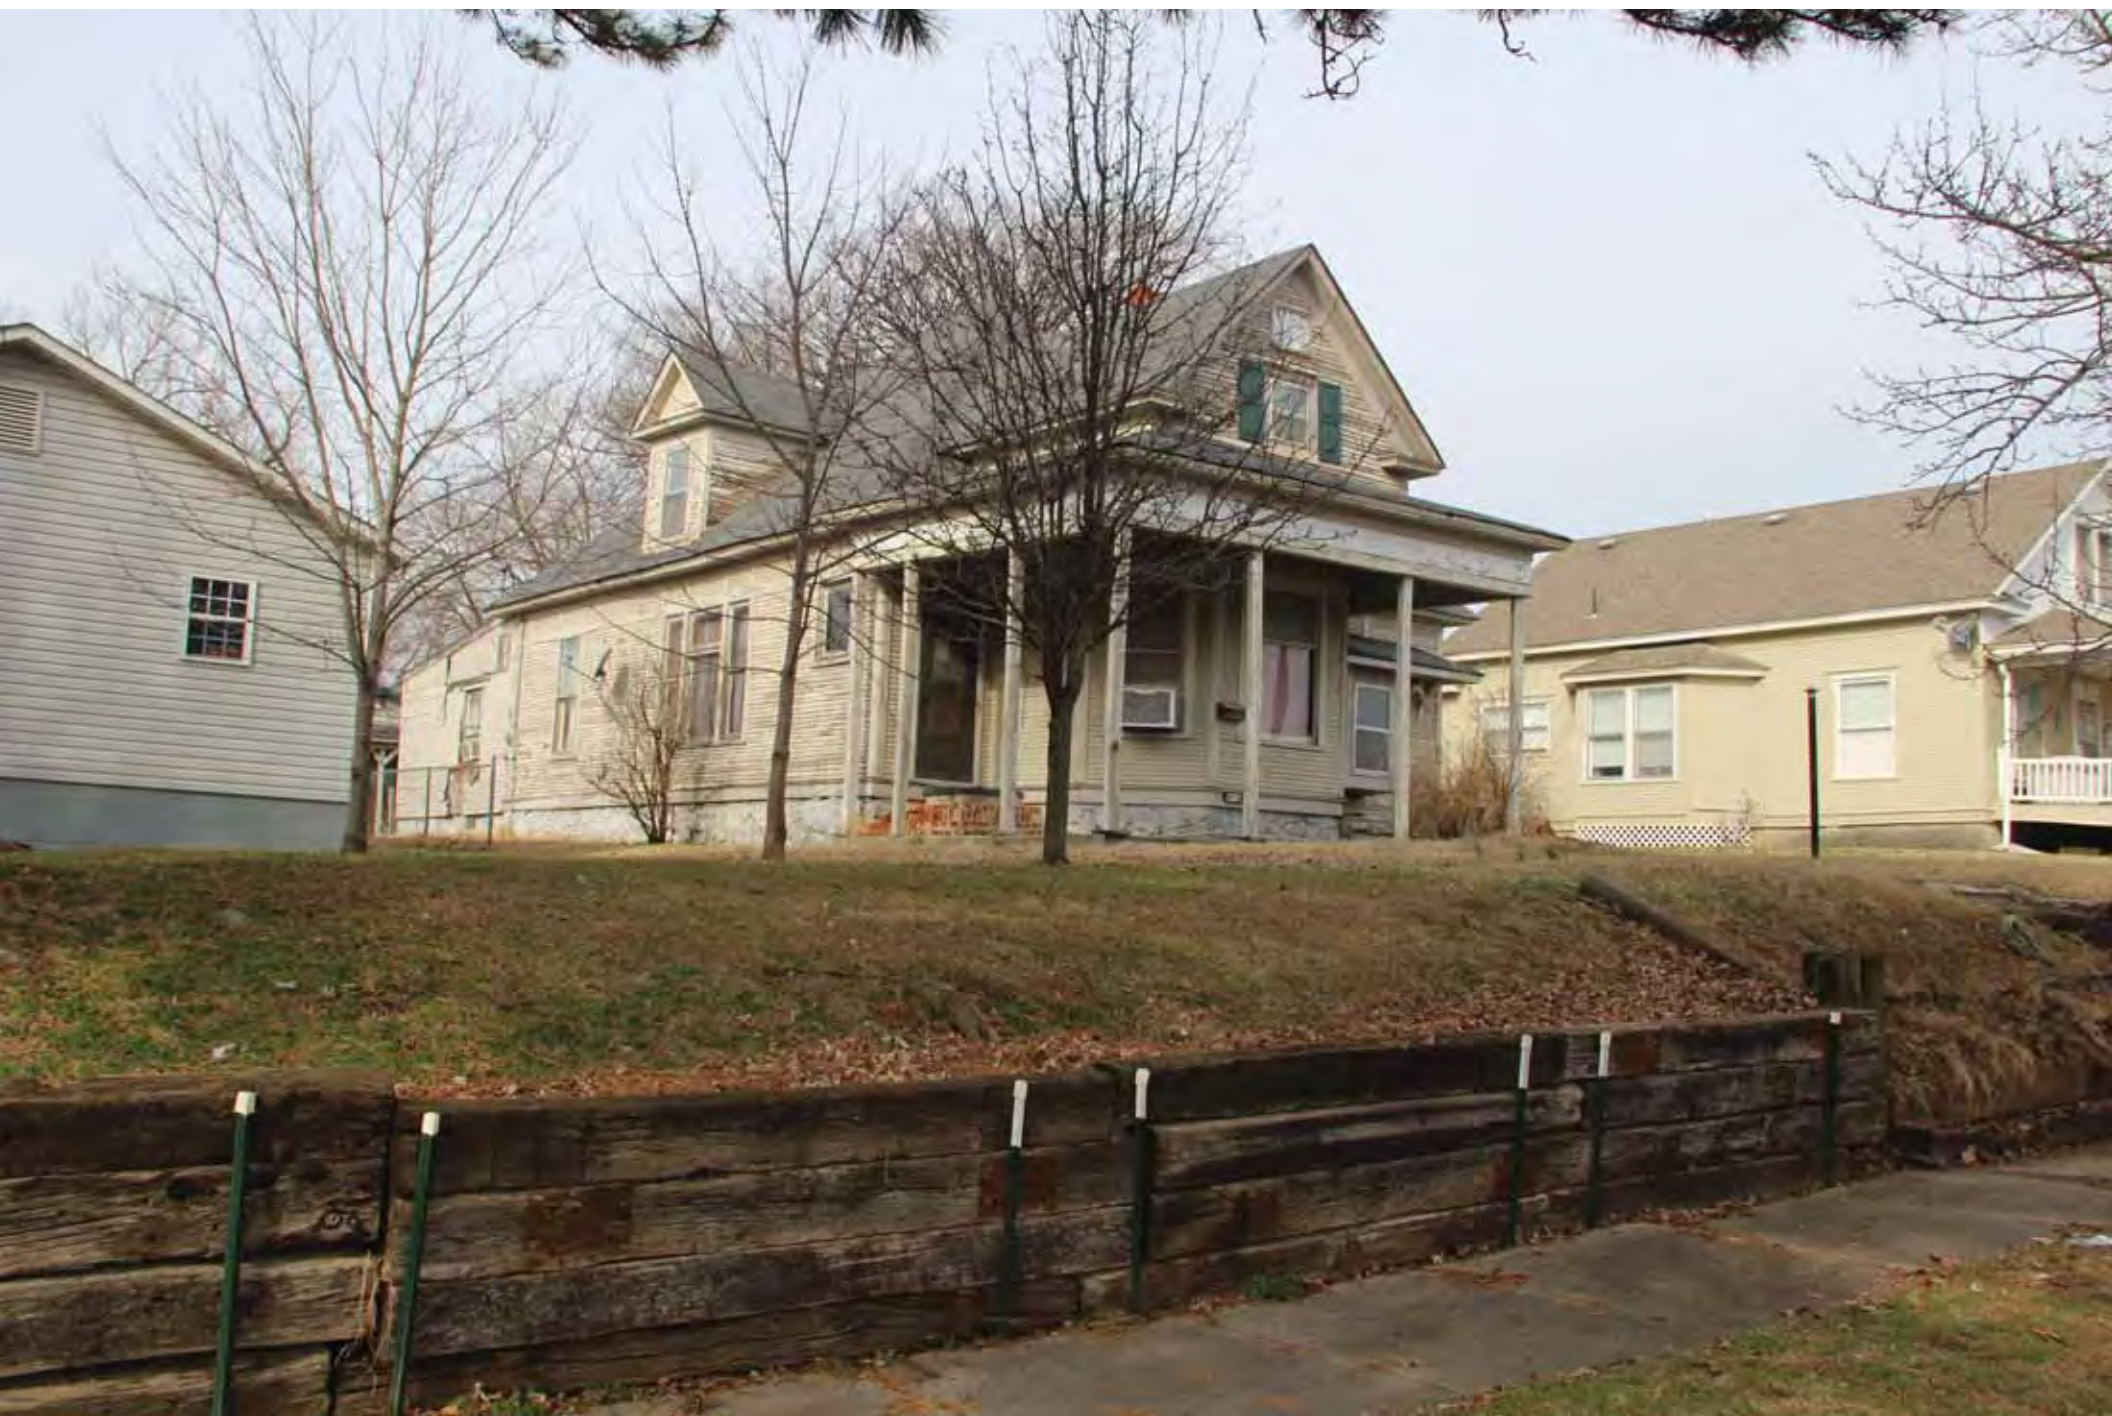
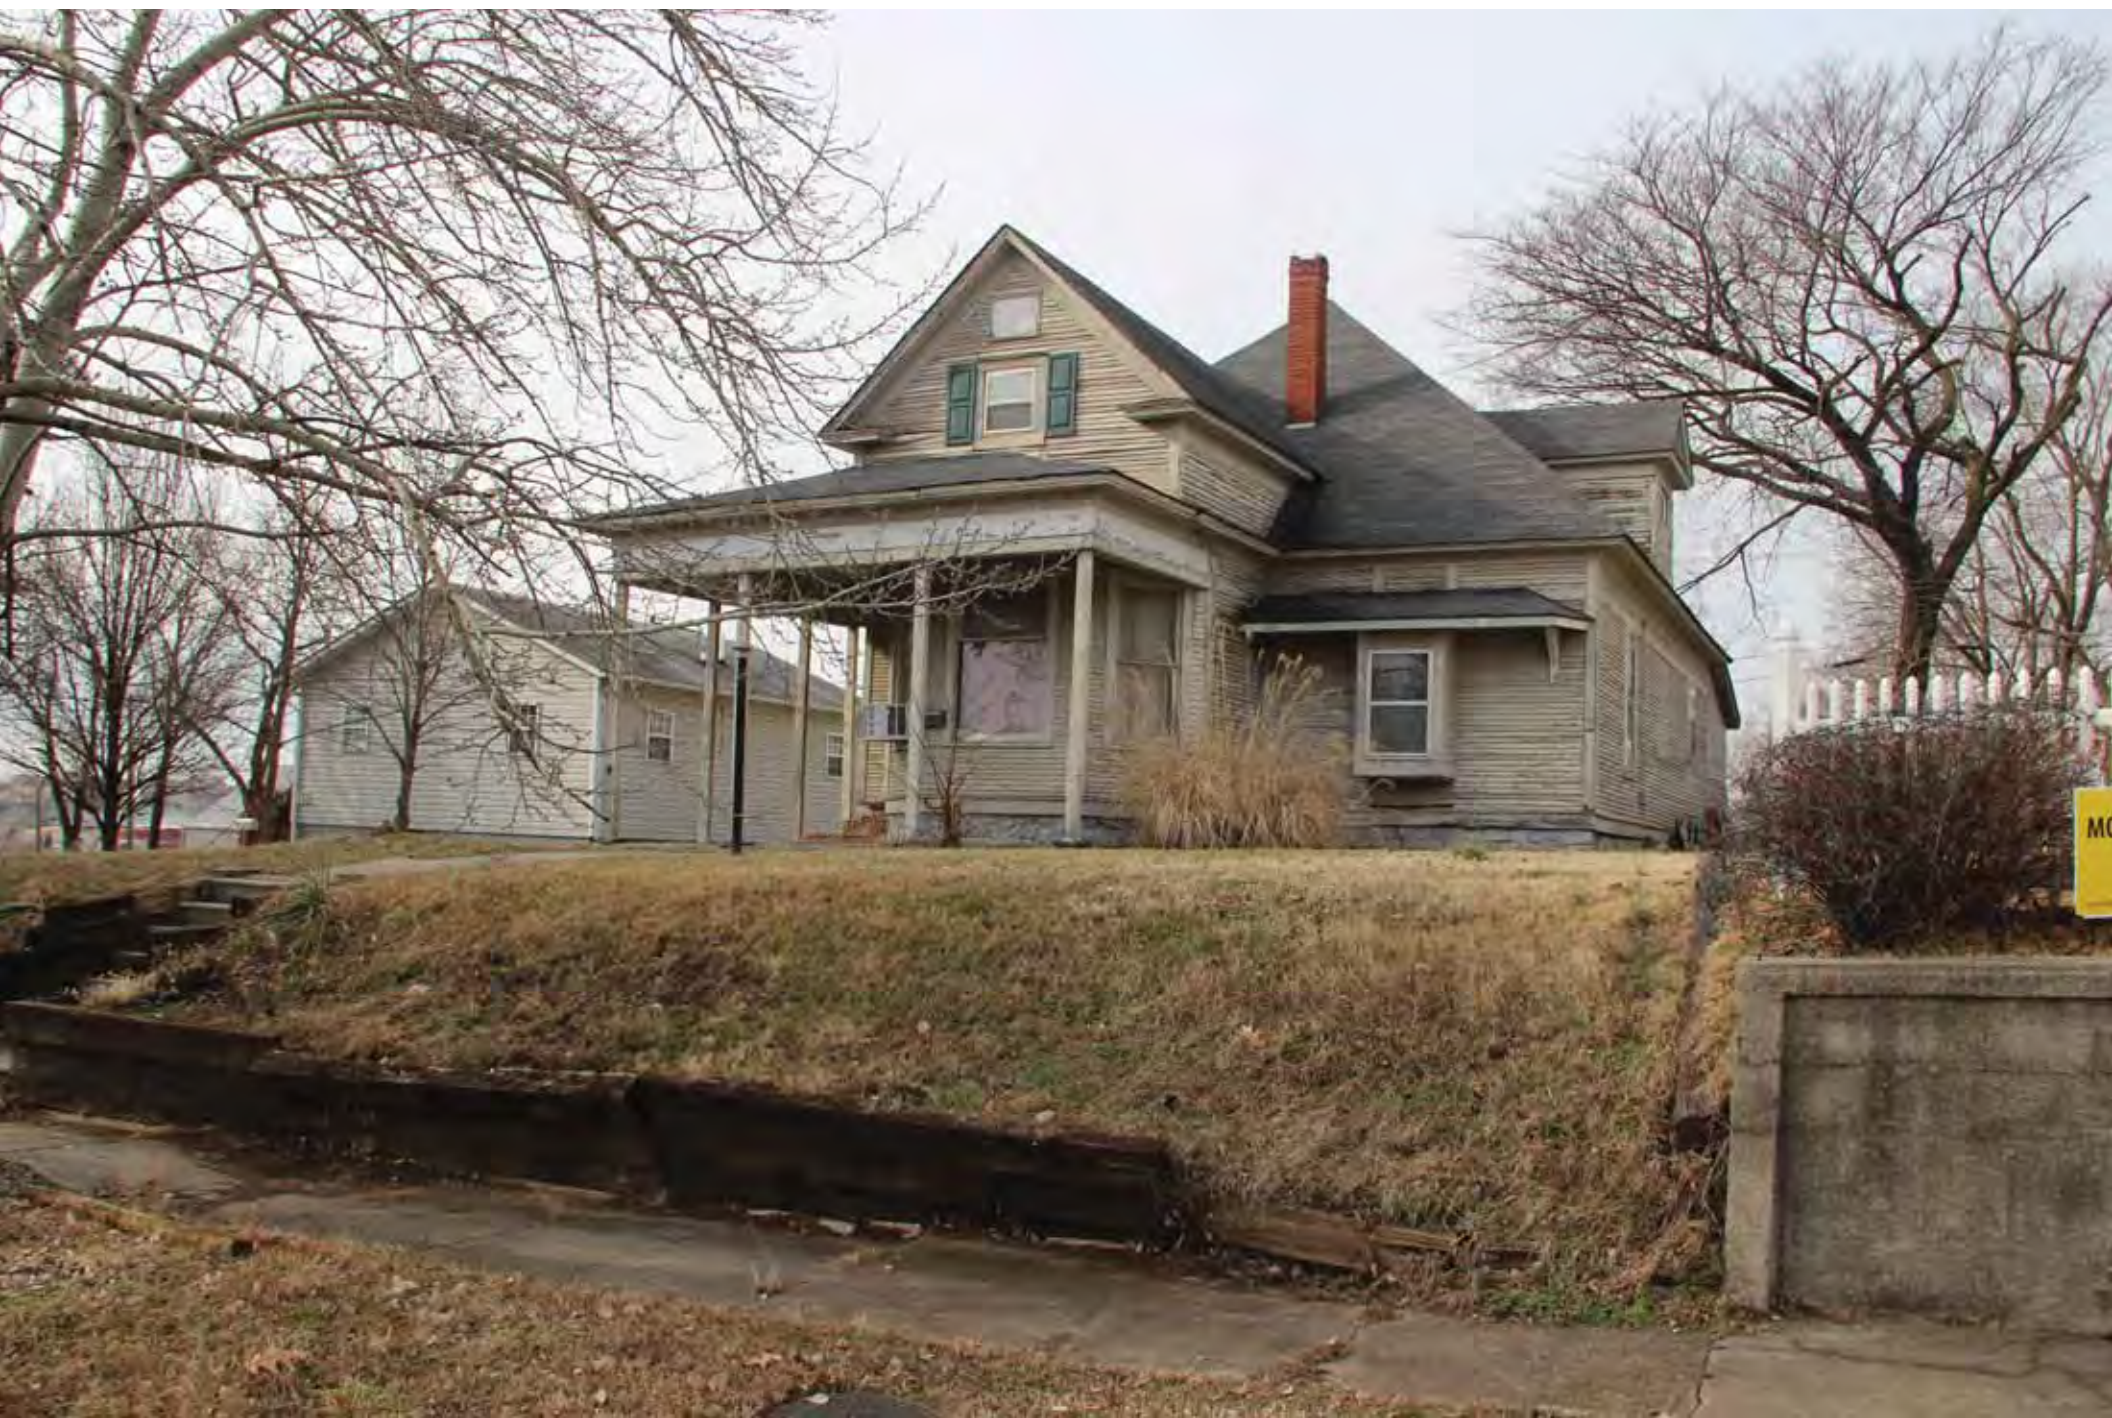
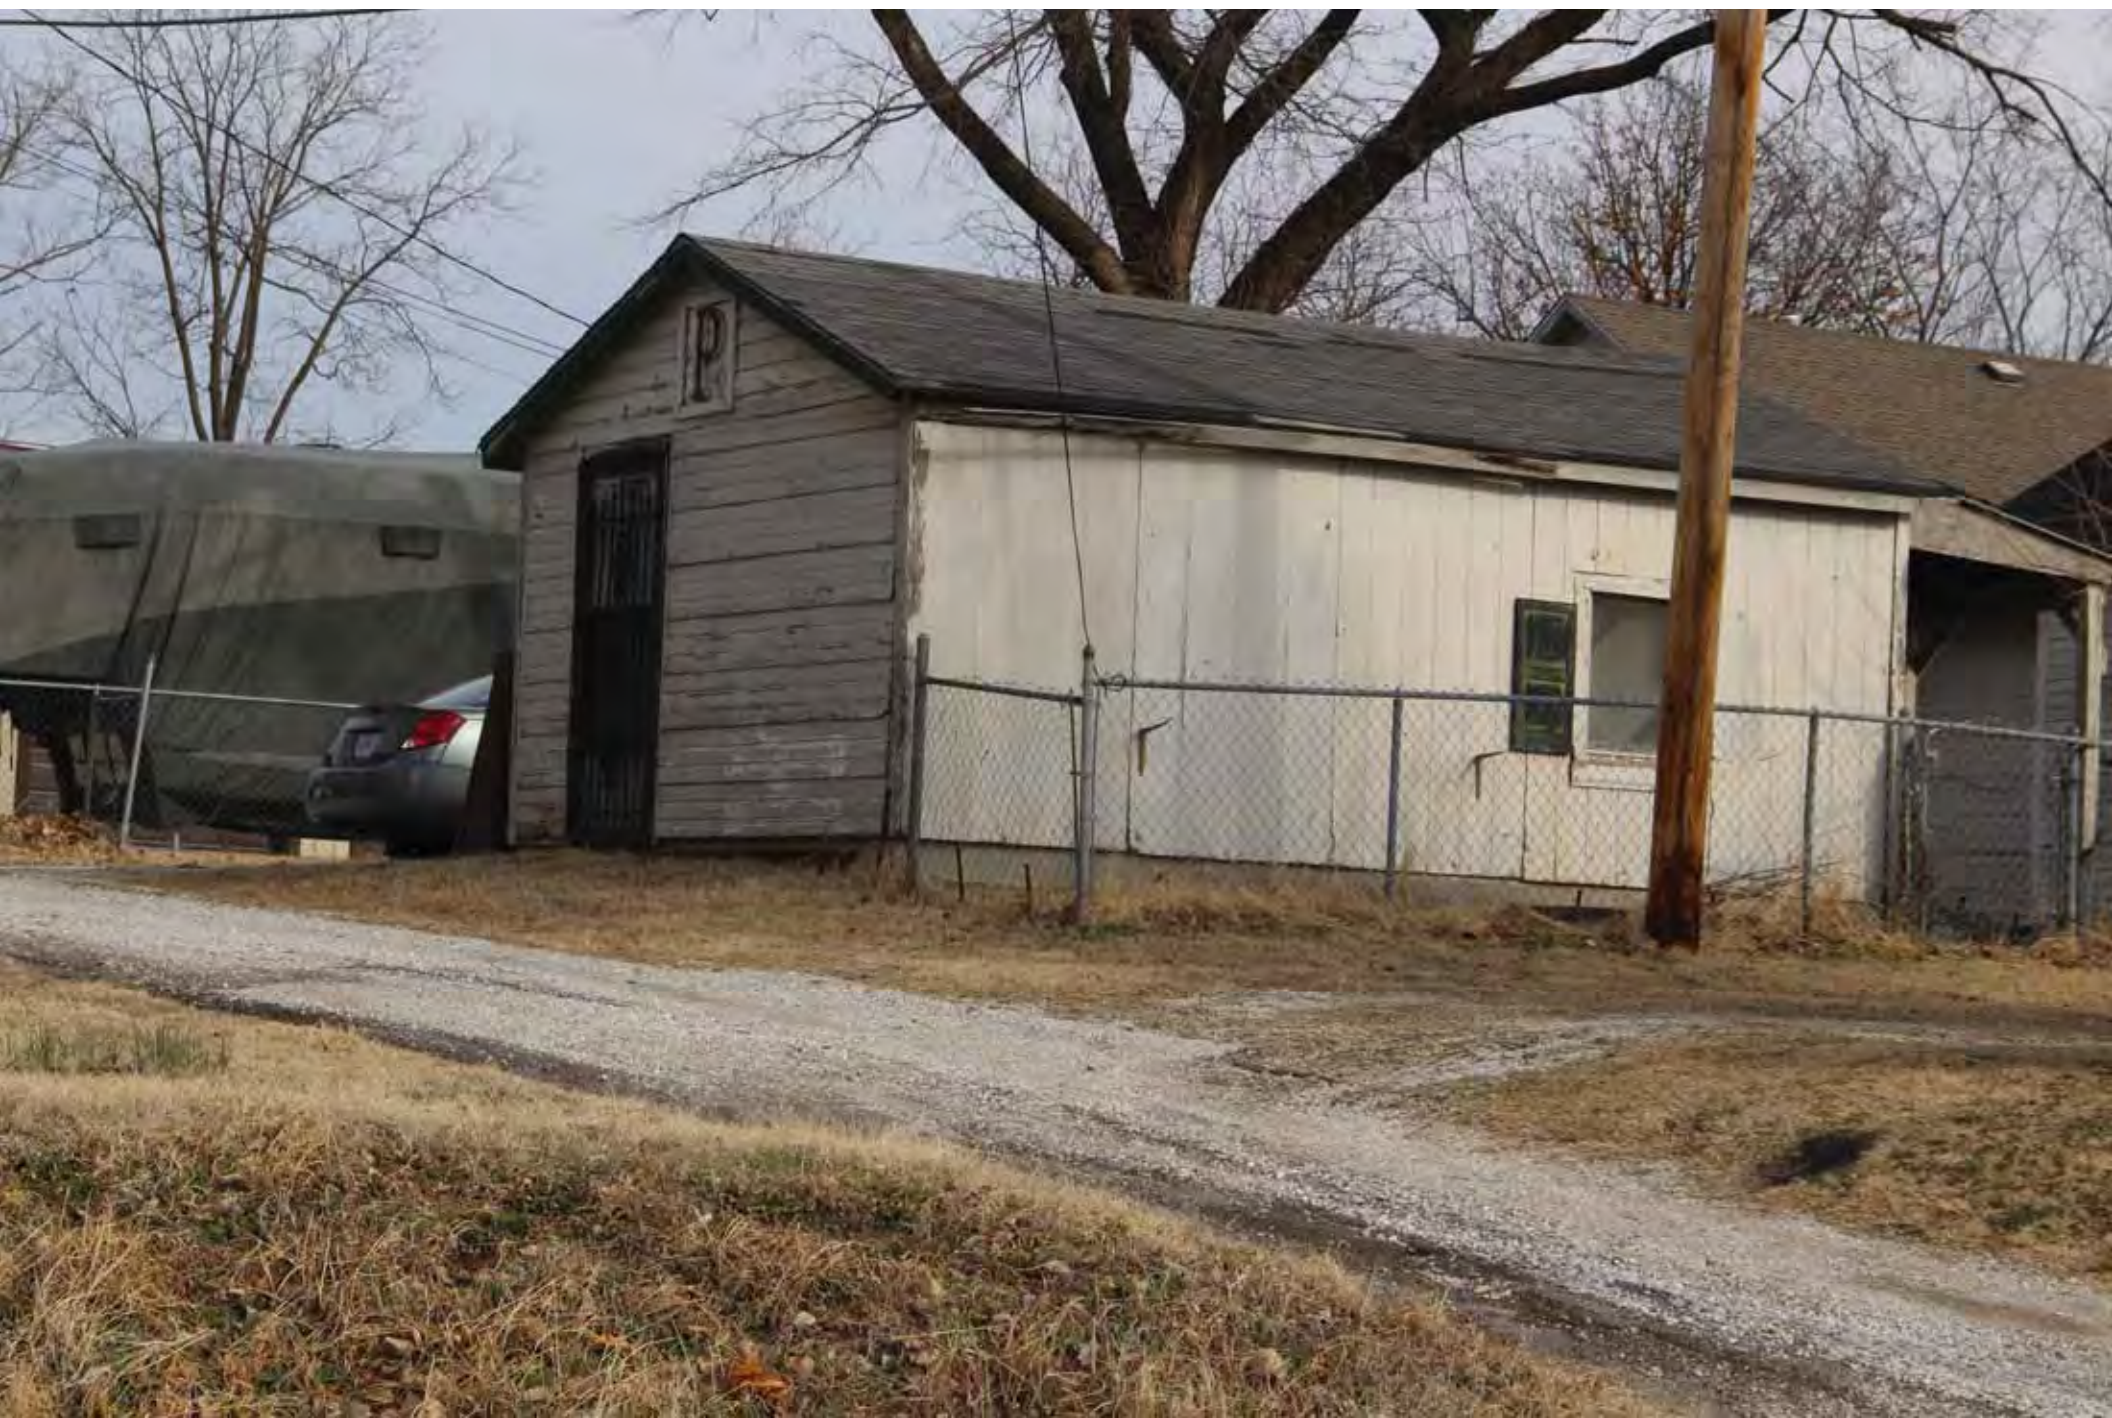
The dwelling does not retain sufficient integrity that would render it individually eligible for the National Register of Historic Places. The dwelling is not situated in an area recommended as a historic district.

The property at 418 S. Cox Avenue is a 1.5 story dwelling, with a complicated roofline. It is hipped with a front-facing gabled roof end on the front façade. The entire roof is covered in asphalt siding. On the front façade is the original open front porch, with a low-pitched hipped roof. The porch wraps around to the south side of the house. It is supported on newer square wooden posts. The porch shelters a bay window with three single one-over-one windows. To the south of the bay window, slightly recessed, is the entrance door. At the half story level, above the front porch, is a single one-over-one small window. To the north of the front porch is a single one-over-one window, below a wooden awning. The house has an interior brick chimney. On the north and south sides of the house there is a dormer with a gable pediment end roof.
