MISSOURI DEPARTMENT OF NATURAL RESOURCES
STATE HISTORIC PRESERVATION OFFICE, P.O. Box 176, Jefferson City, MO 65102
ARCHITECTURAL/HISTORIC INVENTORY FORM

1. Survey No. JP-AS-007-001		2. Survey name: East Town (Original Joplin) Historic Survey Phase 2	
3. County: JASPER		4. Address (Street No.) 618	Street (name) E. 2 nd Street
5. City: Joplin	Vicinity: <input type="checkbox"/>	6. Geographical Reference:	7. Township/Range/Section: T: R: S:
8. Historic name (if known):		9. Present/other name (if known):	
10. Ownership: <input checked="" type="checkbox"/> Private <input type="checkbox"/> Public		11a. Historic use (if known): Domestic: Single Dwelling	11b. Current use: Domestic: Single Dwelling

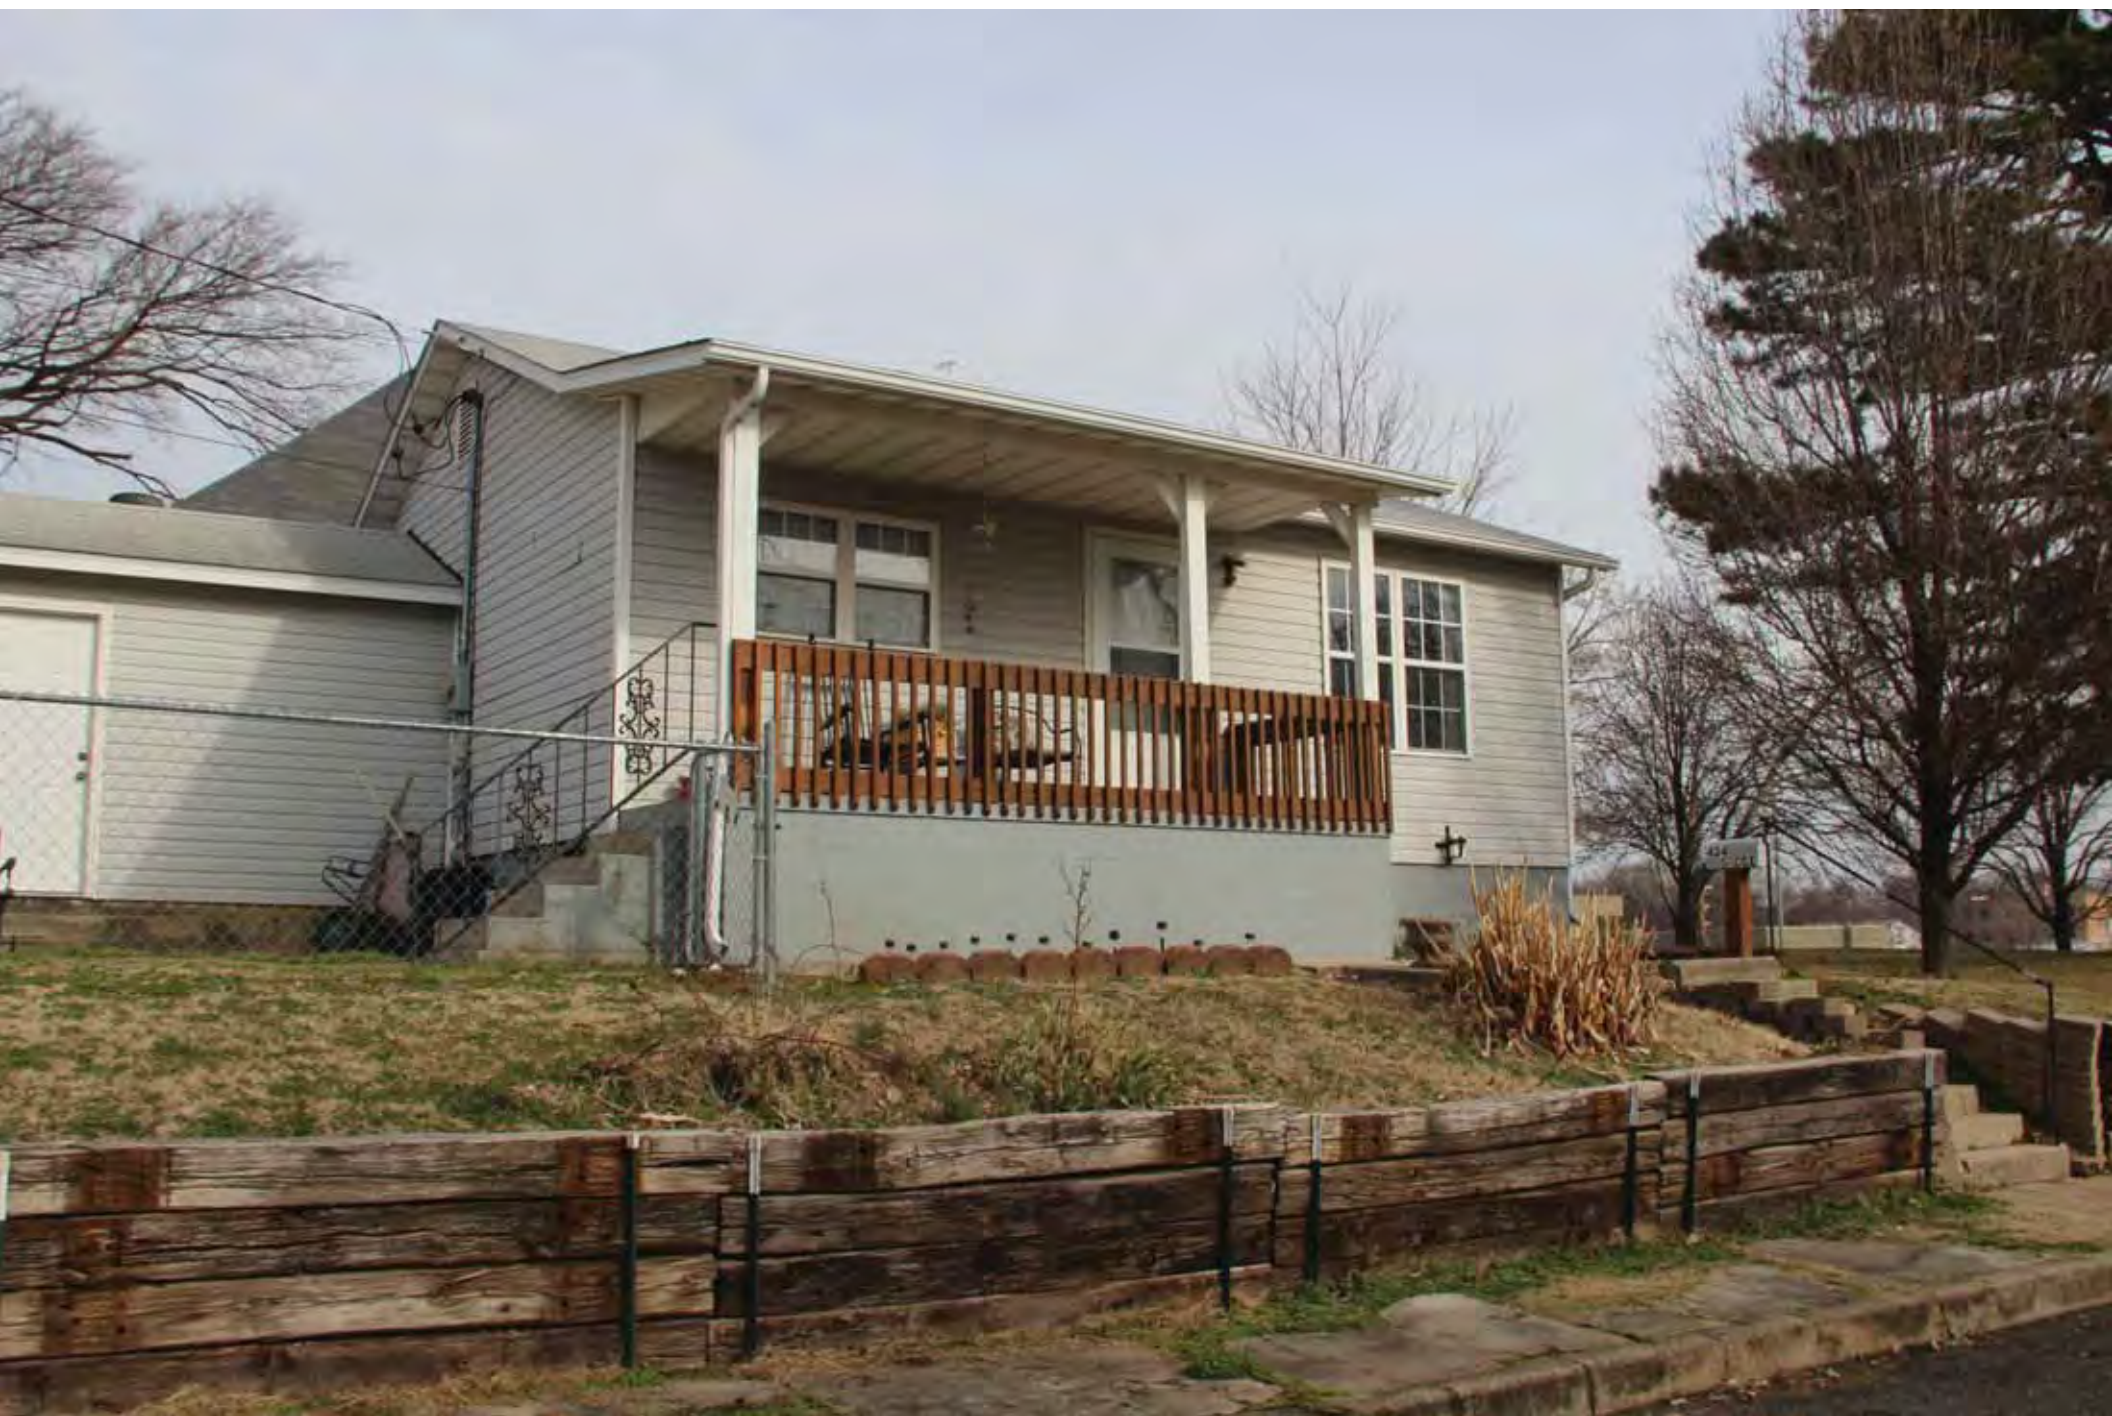
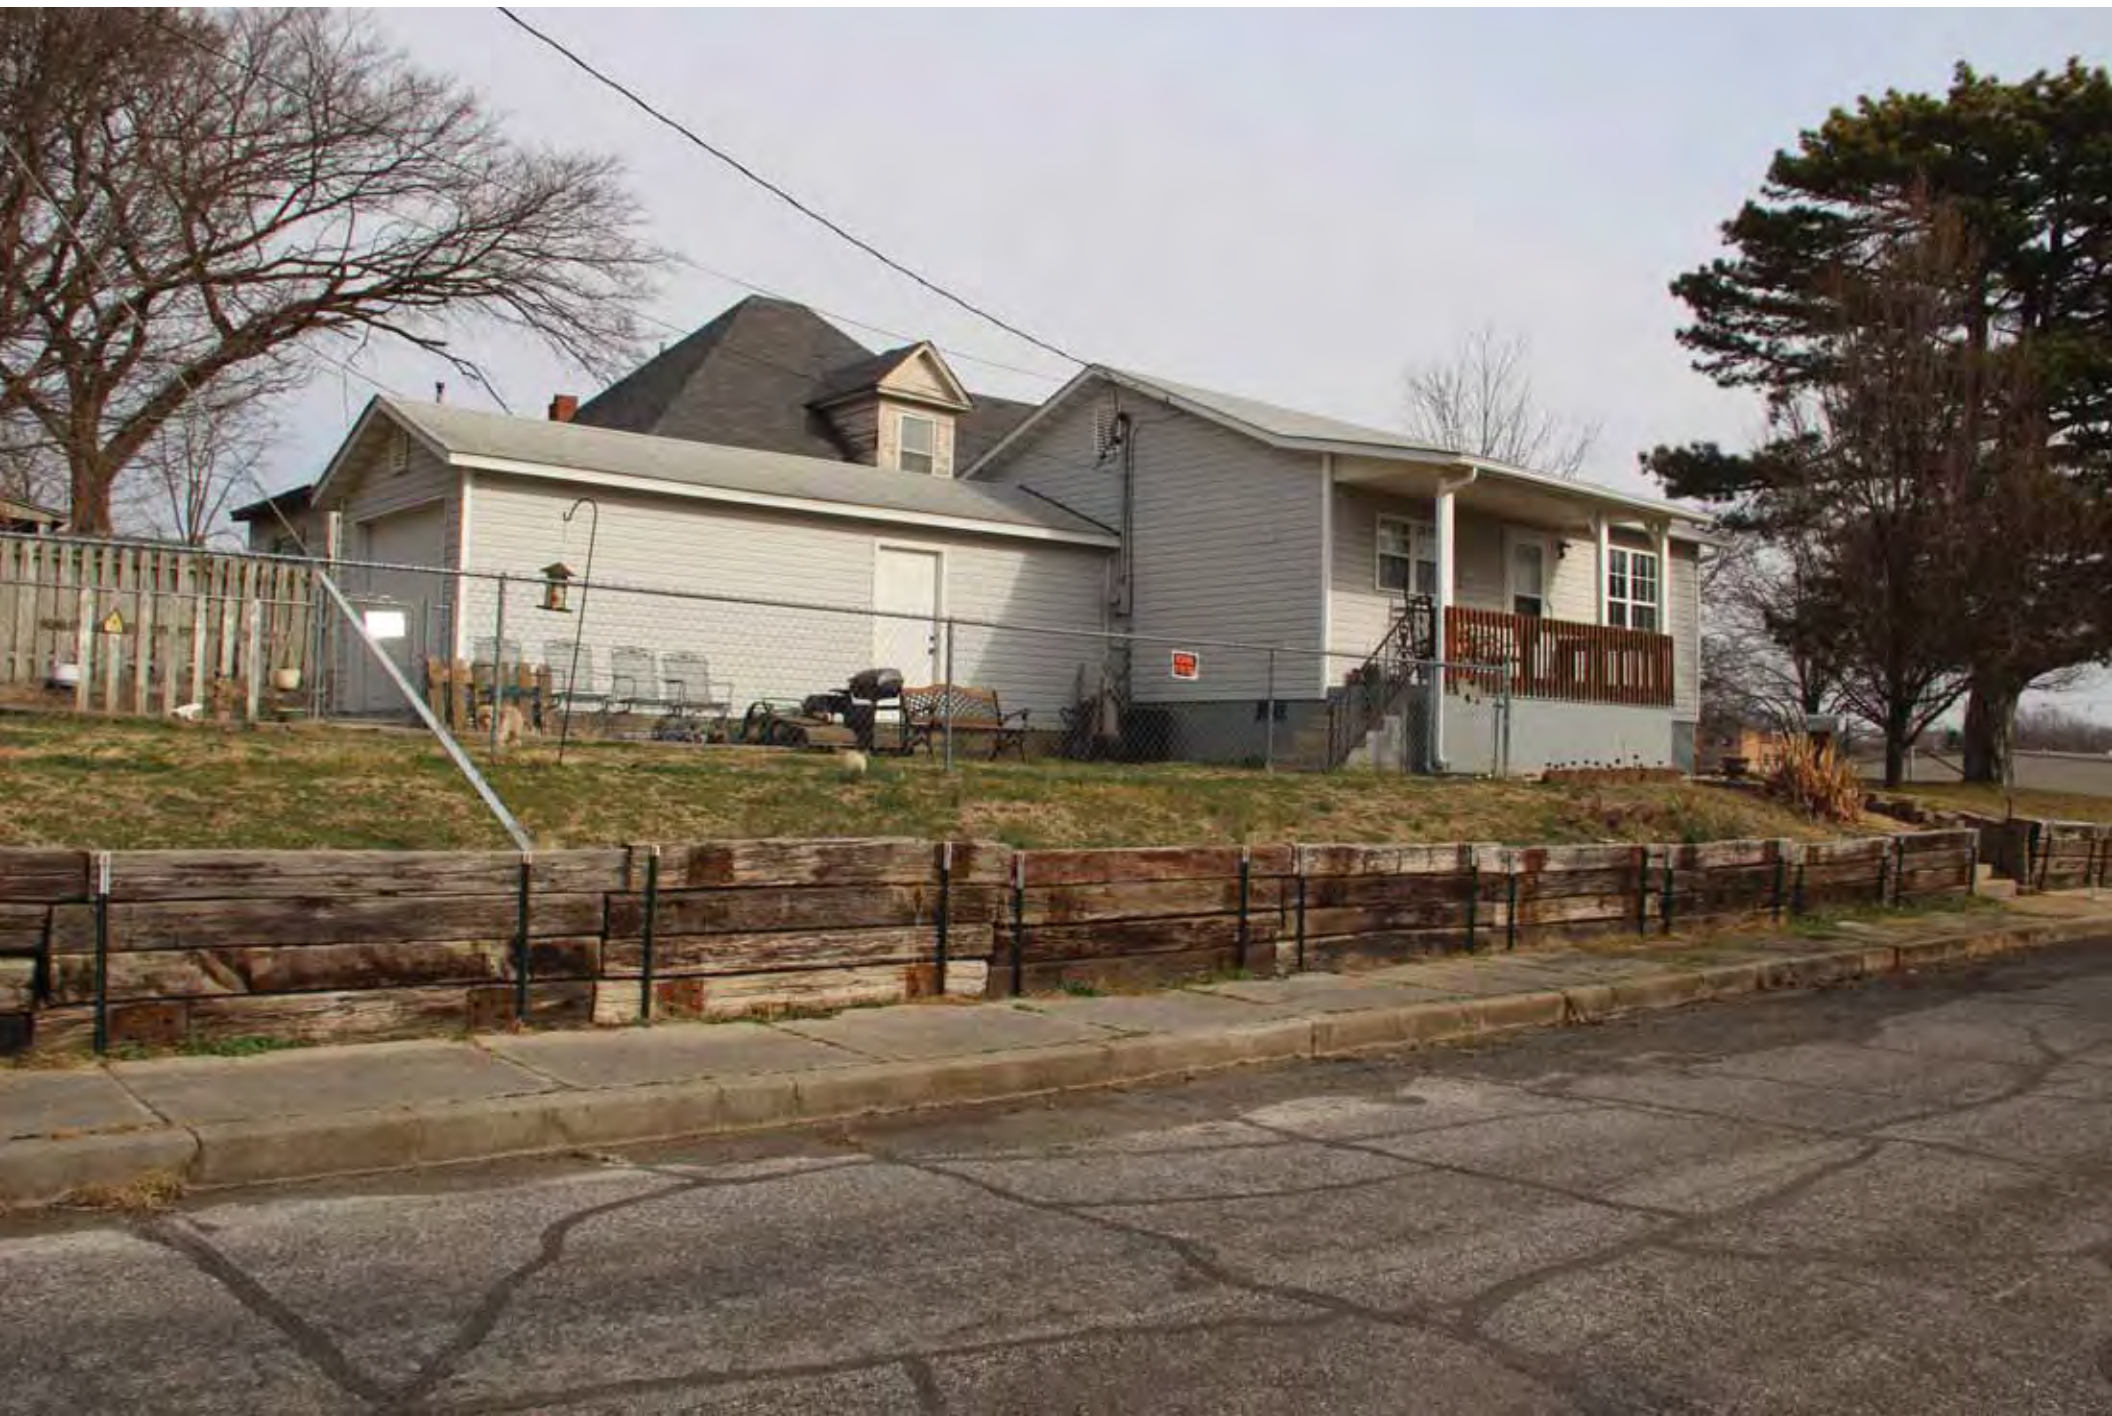
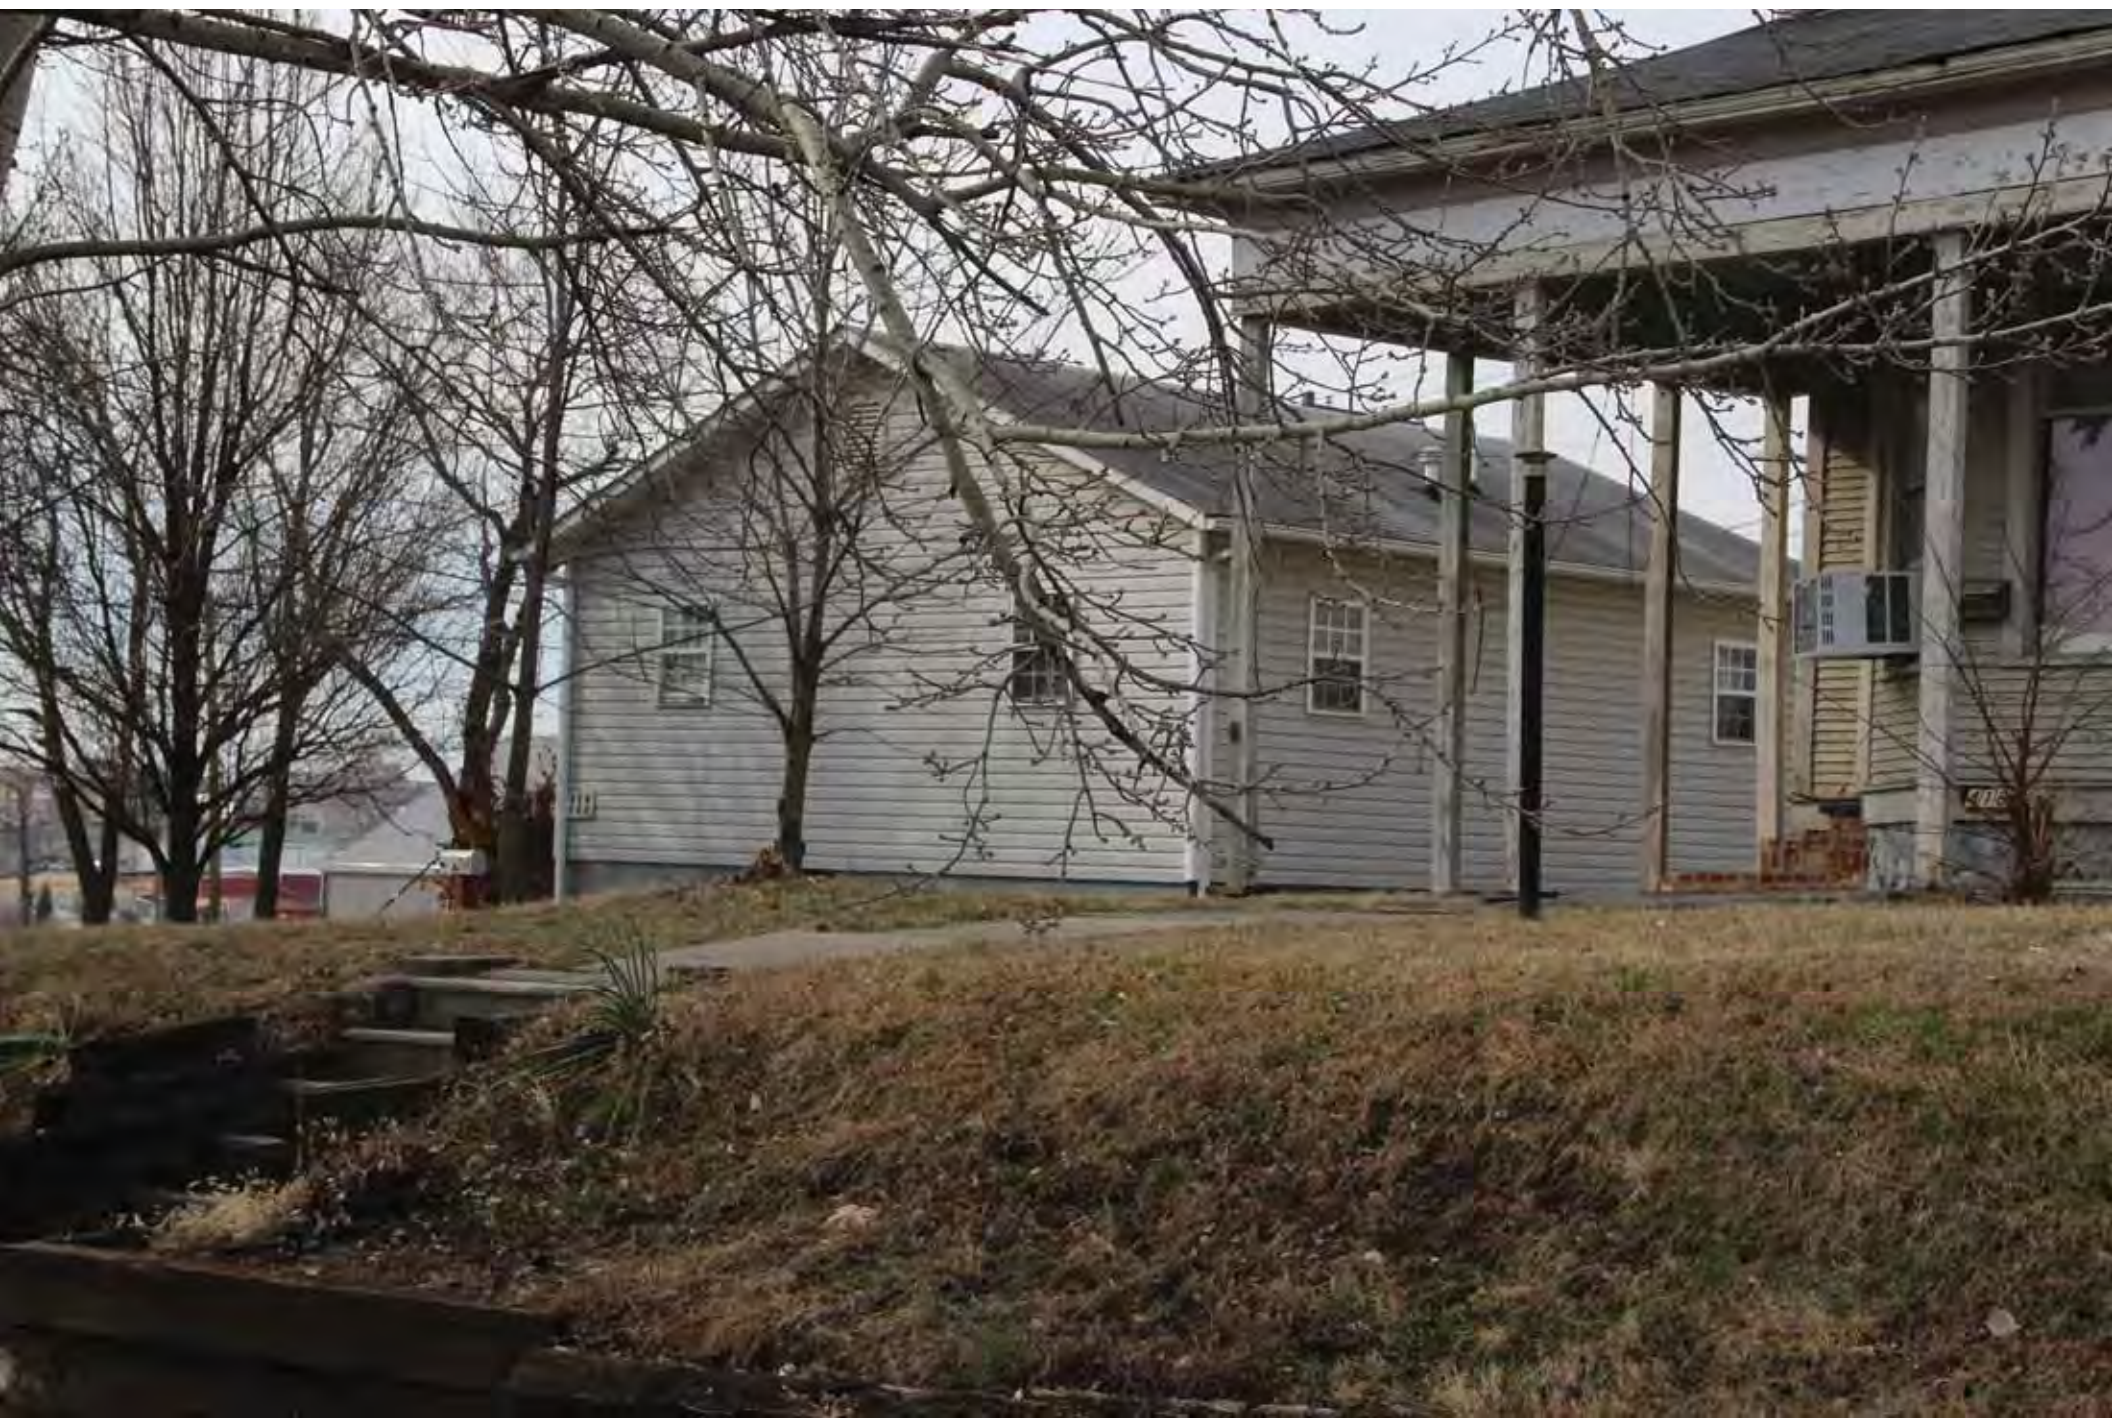
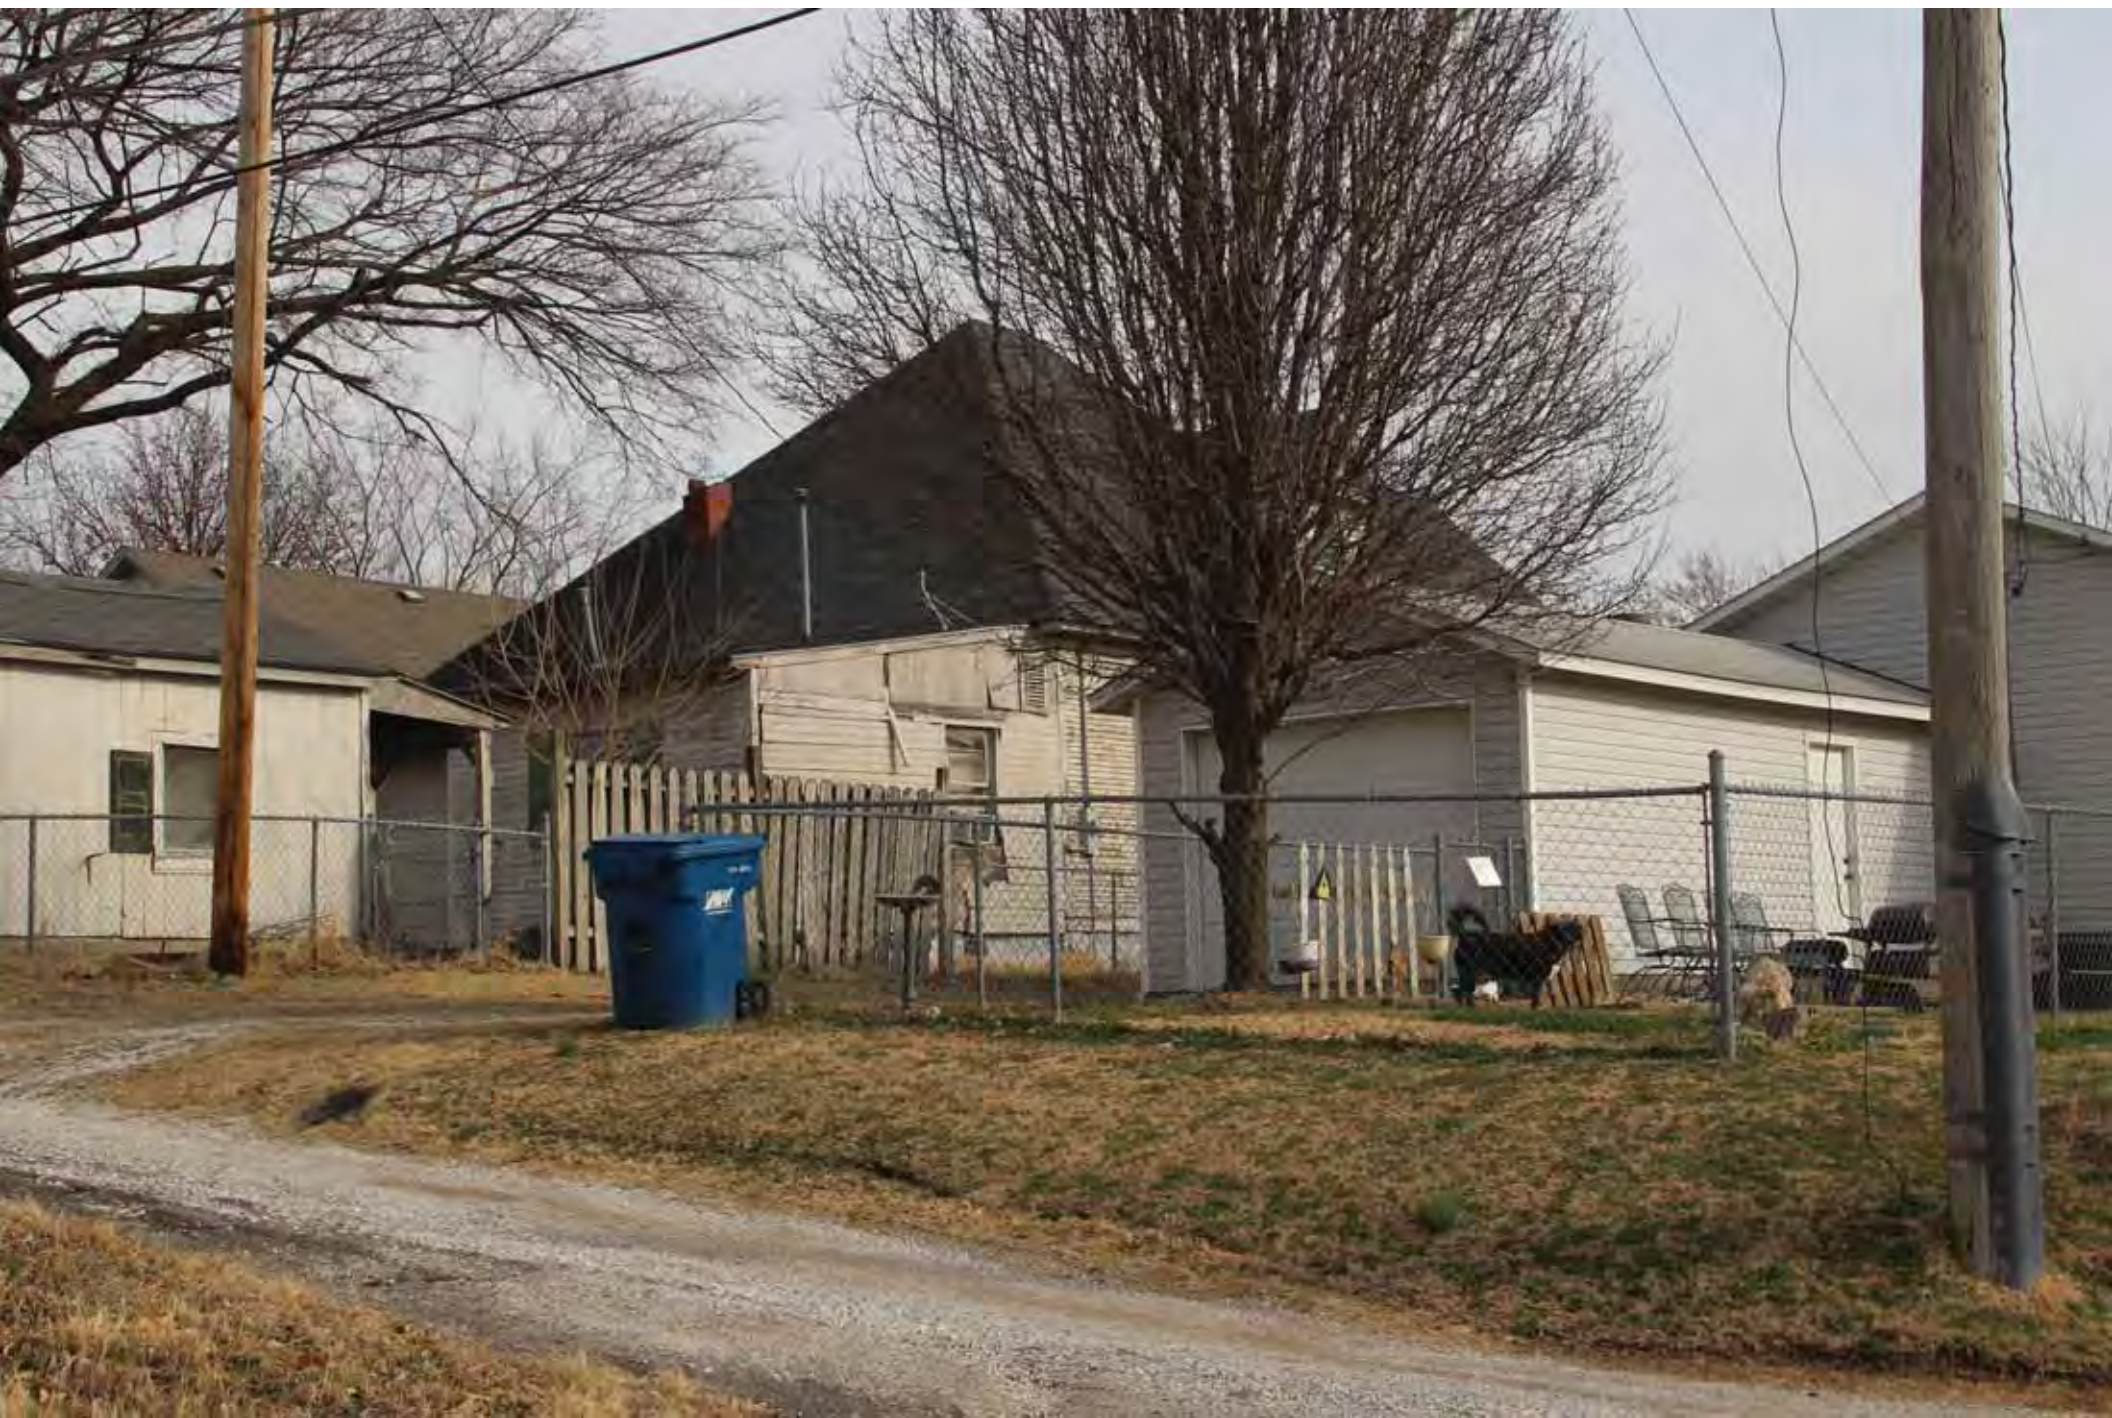
The property at 424 S. Cox Avenue is a one-story ranch house, with a low-pitched gable roof covered in asphalt siding. It has rectangular plan with an attached garage on the west end of the house. The front façade faces E. 3rd Street, and has an open wooden front porch on a concrete foundation. The porch shelters the central front door. To the left, or west, of the front door is a double one-over-one vinyl replacement window. To the right, or east, of the door is a six-over-six single vinyl window. The entire house is covered in vinyl siding.

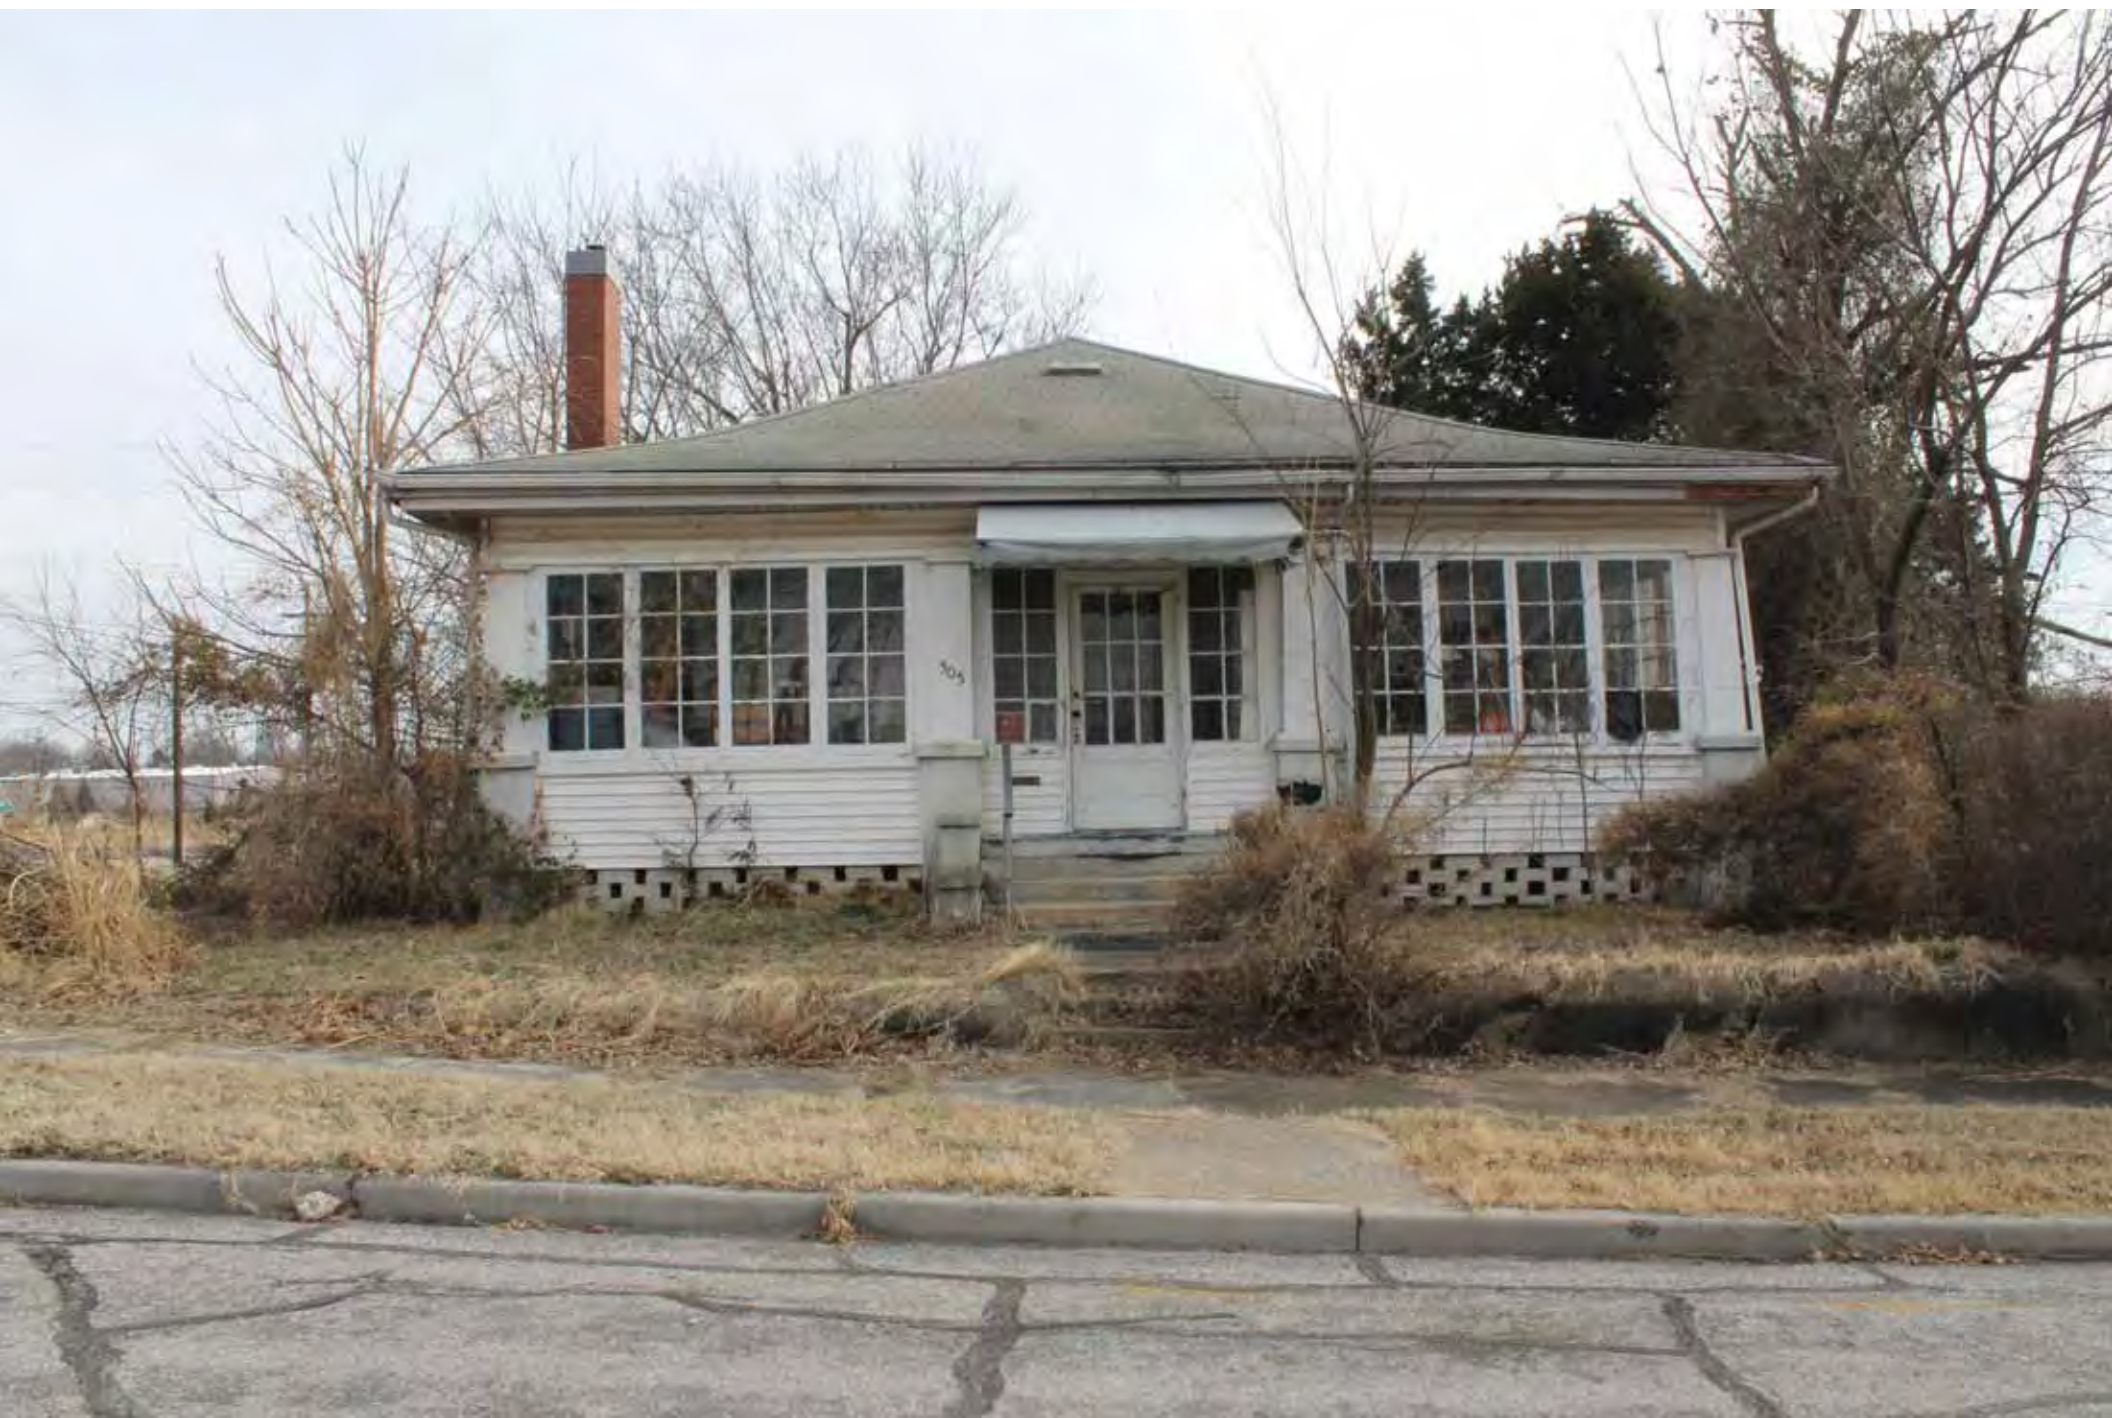
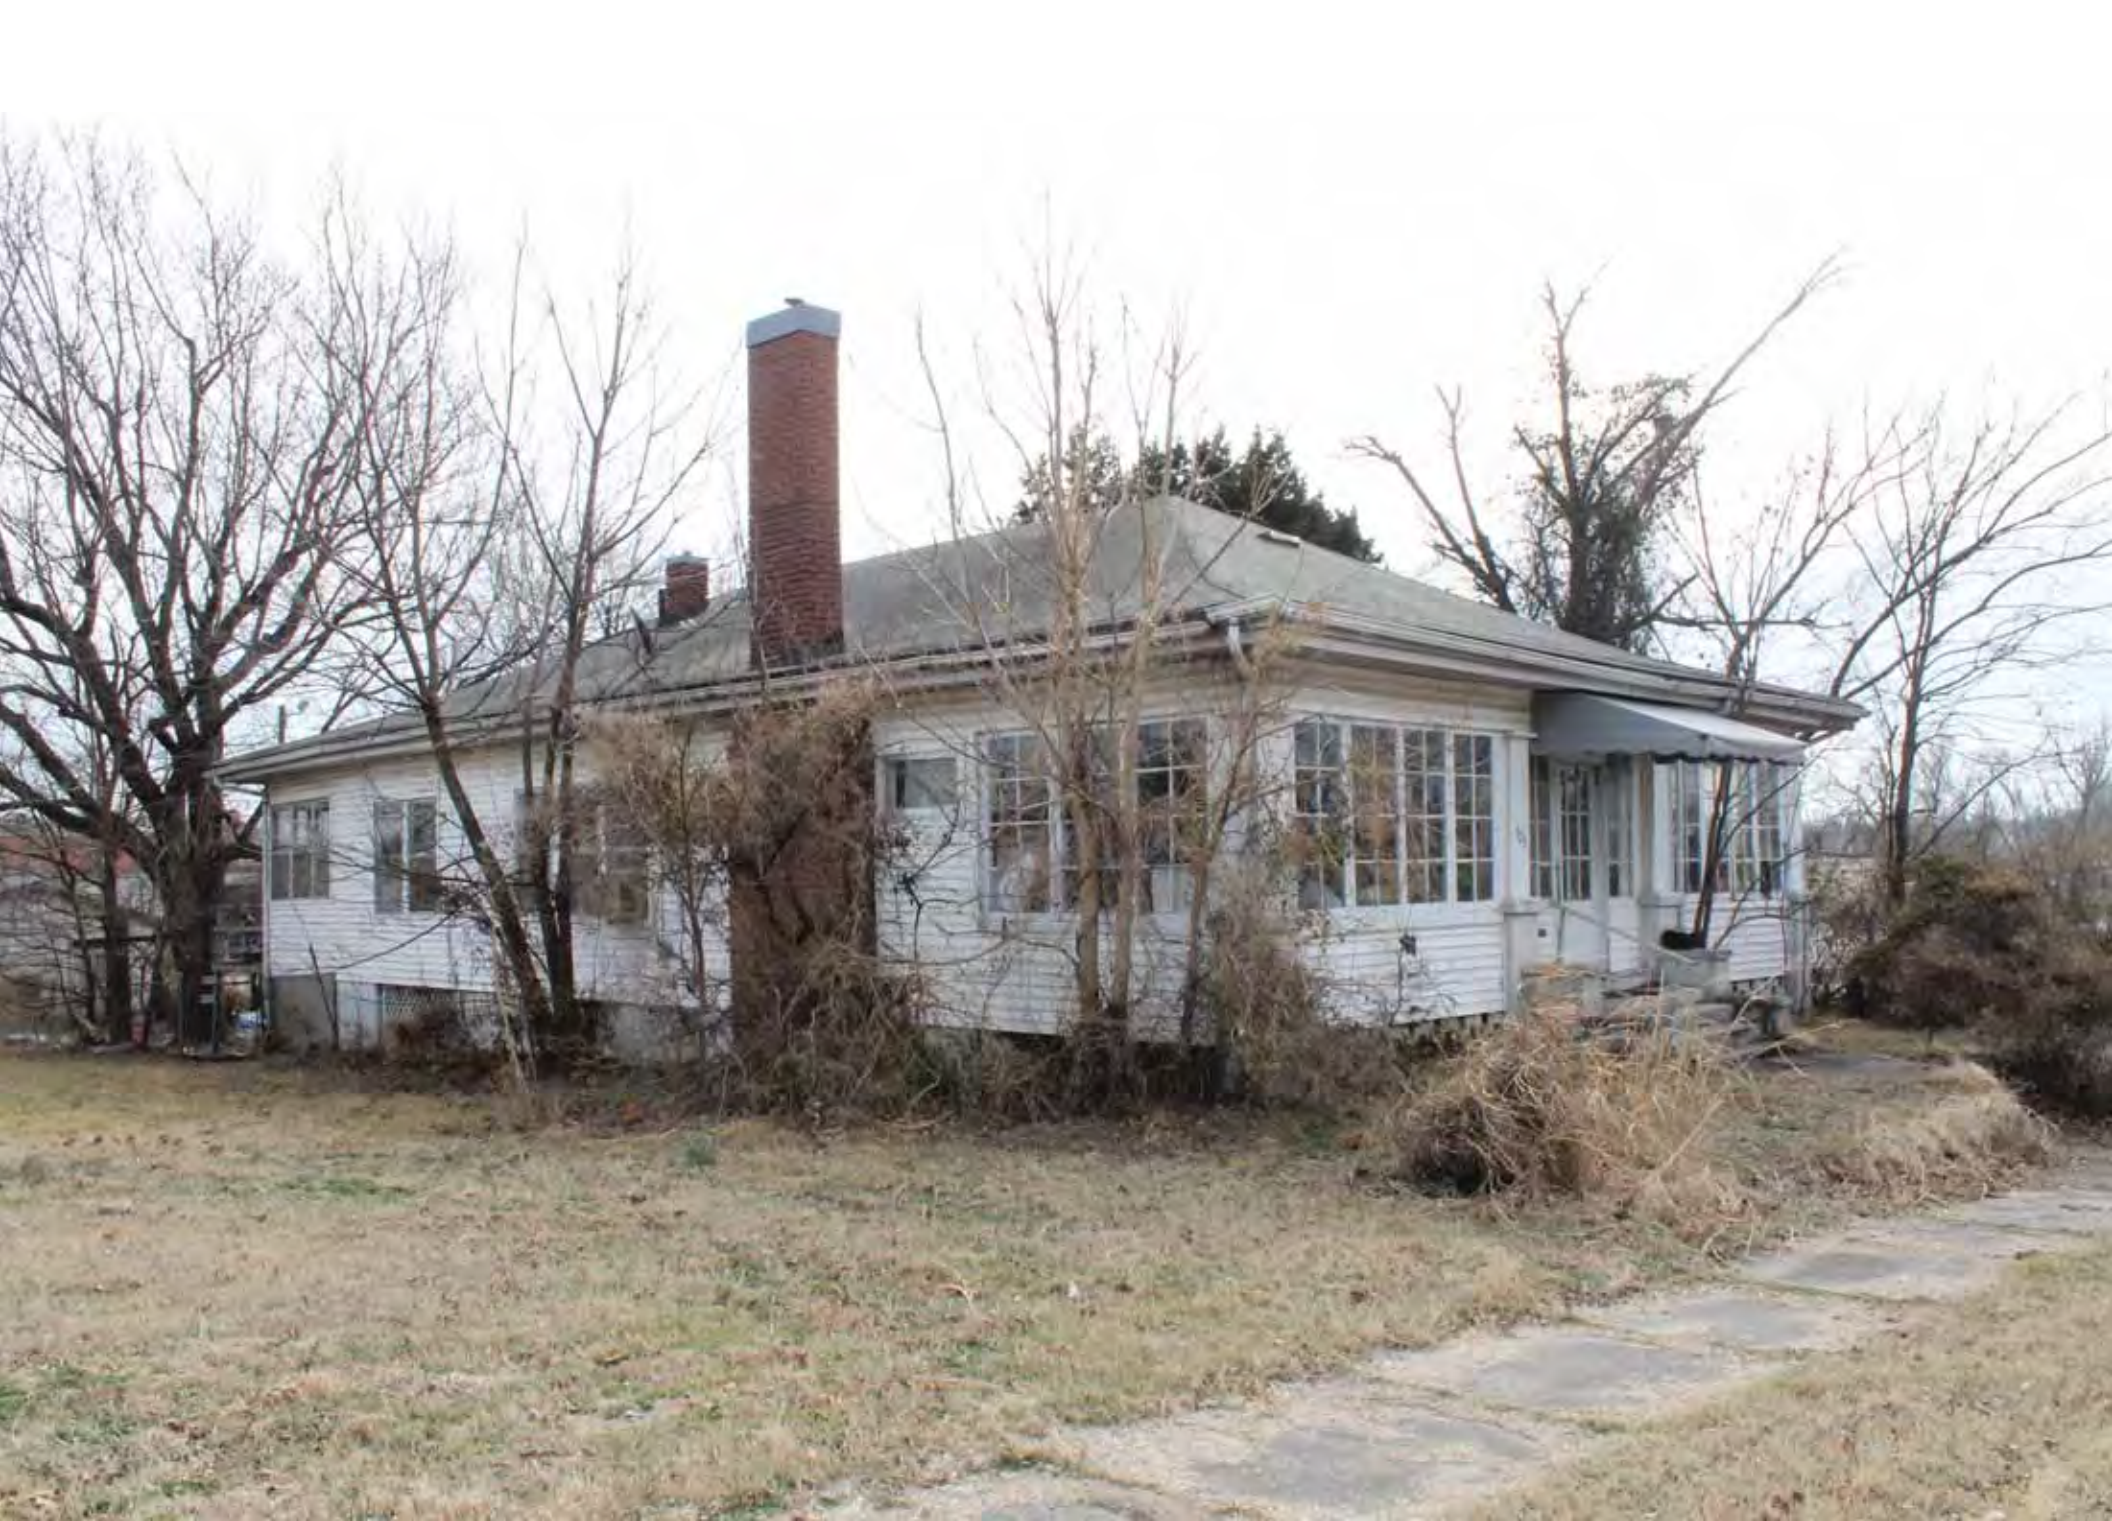
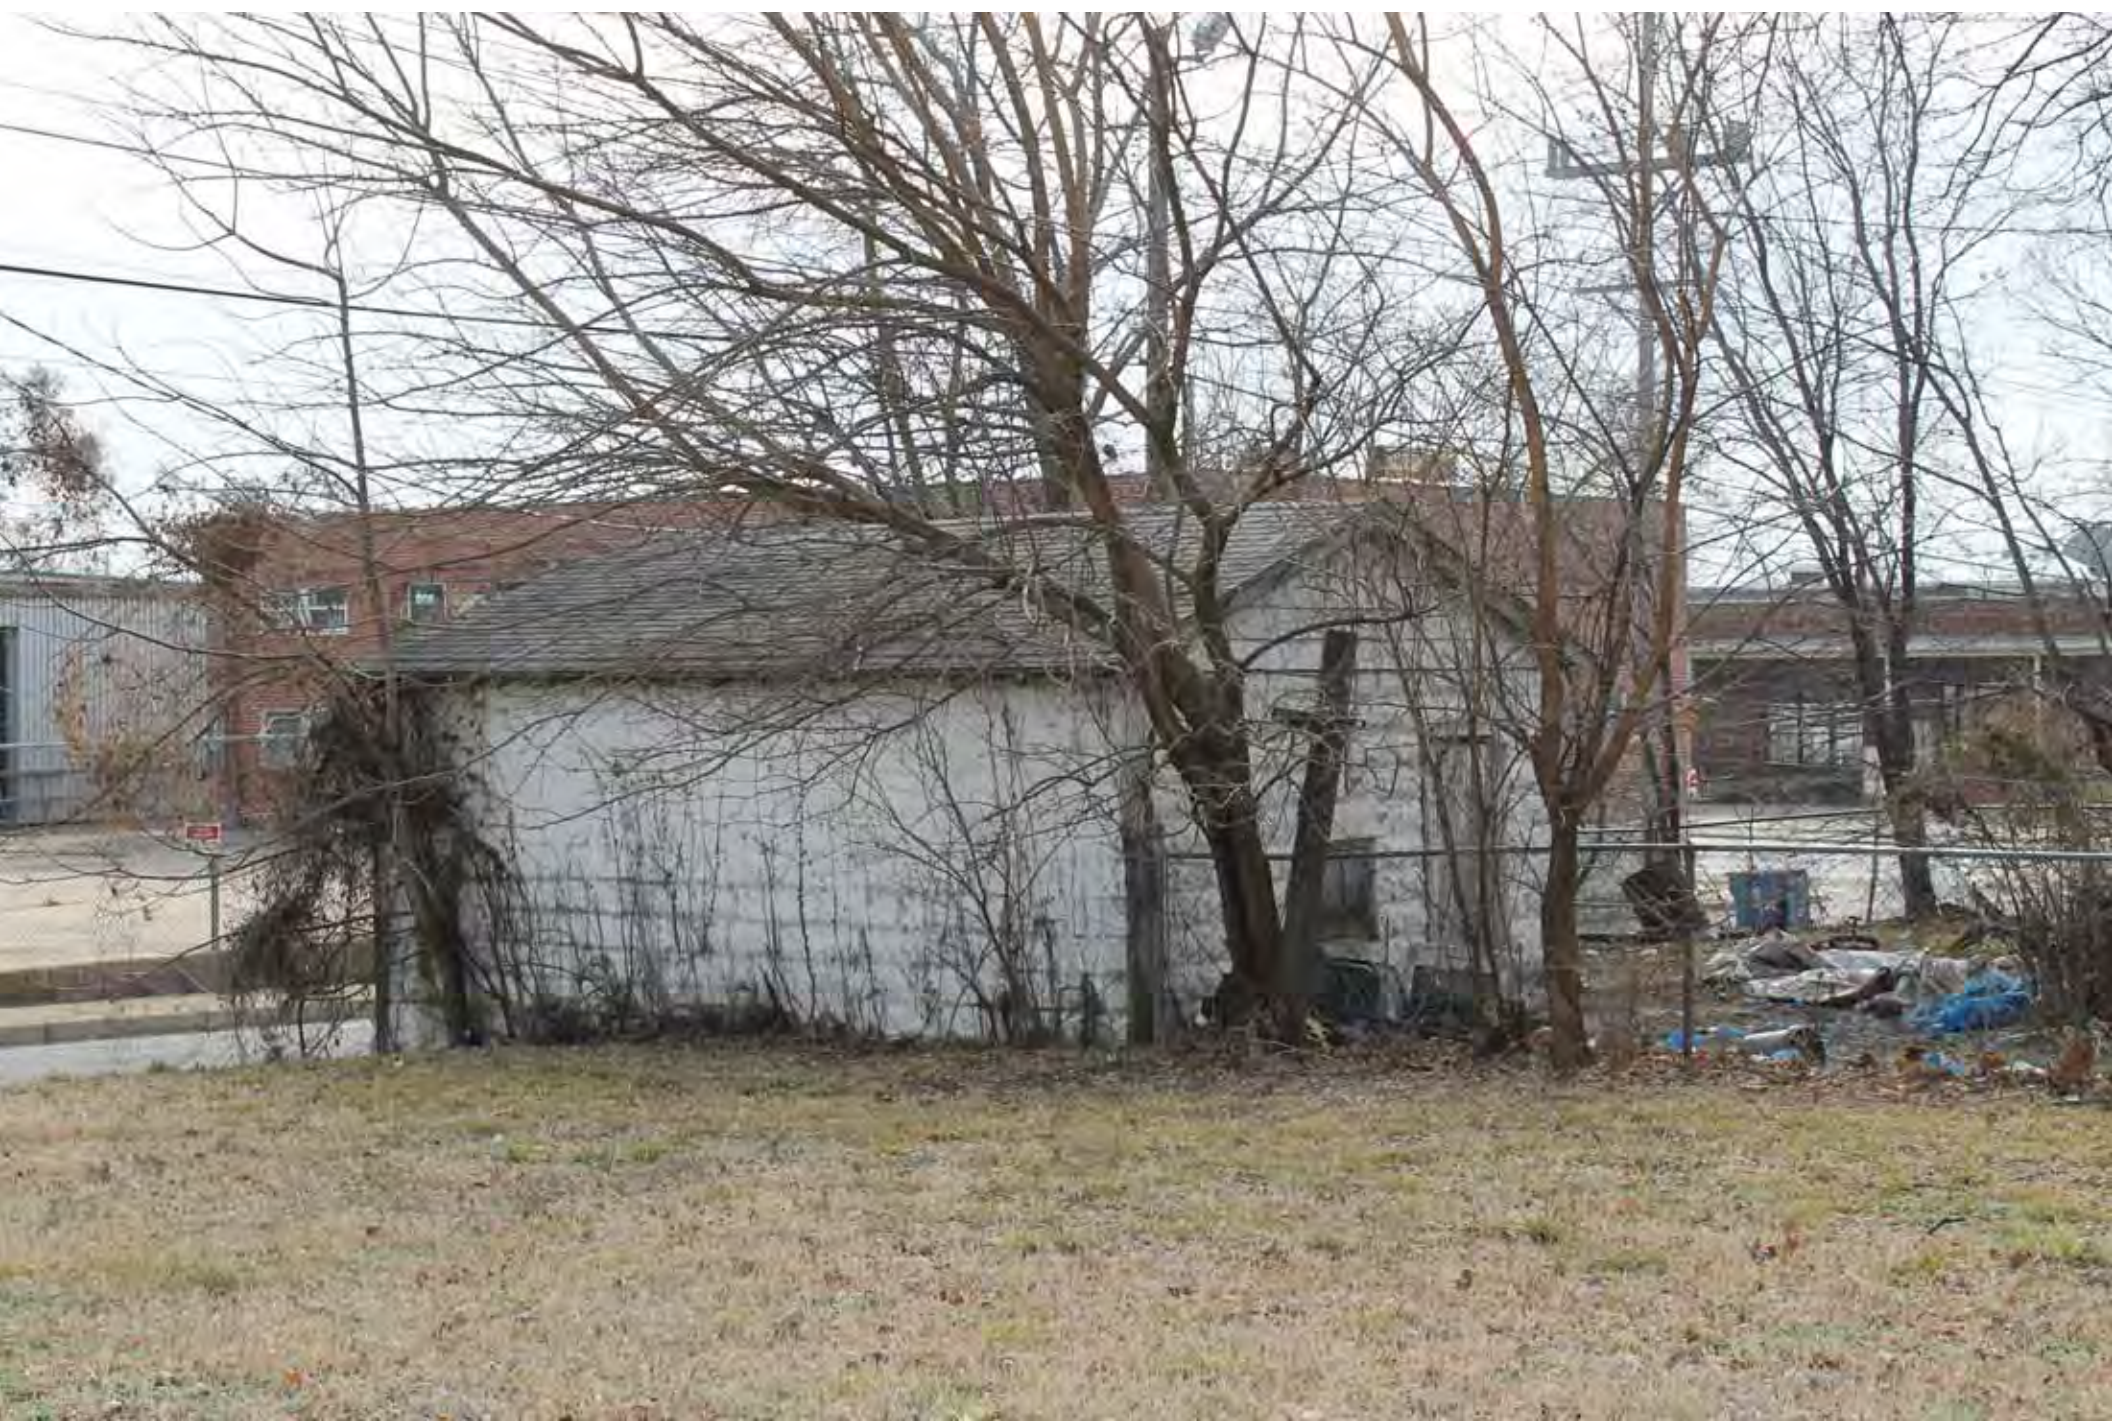
The dwelling does not retain sufficient integrity that would render it individually eligible for the National Register of Historic Places. The dwelling is not situated in an area recommended as a historic district.

The property at 505 S. Cox Avenue is a one-story frame dwelling. It has a low-pitched hipped roof covered in asphalt siding. On the front façade the enclosed front porch, that likely was open originally. The porch has a series of 8-paned wooden casement windows, with four windows to the right and left of the central front door. The front façade is symmetrical, with a central wooden door flanked on either side by sidelights, identical to the 8-paned casement windows of the porch. The porch sits on concrete blocks and there are concrete stairs to the front door. On the north side or elevation of the house is an exterior brick chimney. It has a few double one-over-one windows. At the rear of the house is an enclosed back porch.
