MISSOURI DEPARTMENT OF NATURAL RESOURCES
STATE HISTORIC PRESERVATION OFFICE, P.O. Box 176, Jefferson City, MO 65102
ARCHITECTURAL/HISTORIC INVENTORY FORM

1. Survey No. JP-AS-007-001		2. Survey name: East Town (Original Joplin) Historic Survey Phase 2	
3. County: JASPER		4. Address (Street No.) 618	Street (name) E. 2 nd Street
5. City: Joplin	Vicinity: <input type="checkbox"/>	6. Geographical Reference:	7. Township/Range/Section: T: R: S:
8. Historic name (if known):		9. Present/other name (if known):	
10. Ownership: <input checked="" type="checkbox"/> Private <input type="checkbox"/> Public		11a. Historic use (if known): Domestic: Single Dwelling	11b. Current use: Domestic: Single Dwelling

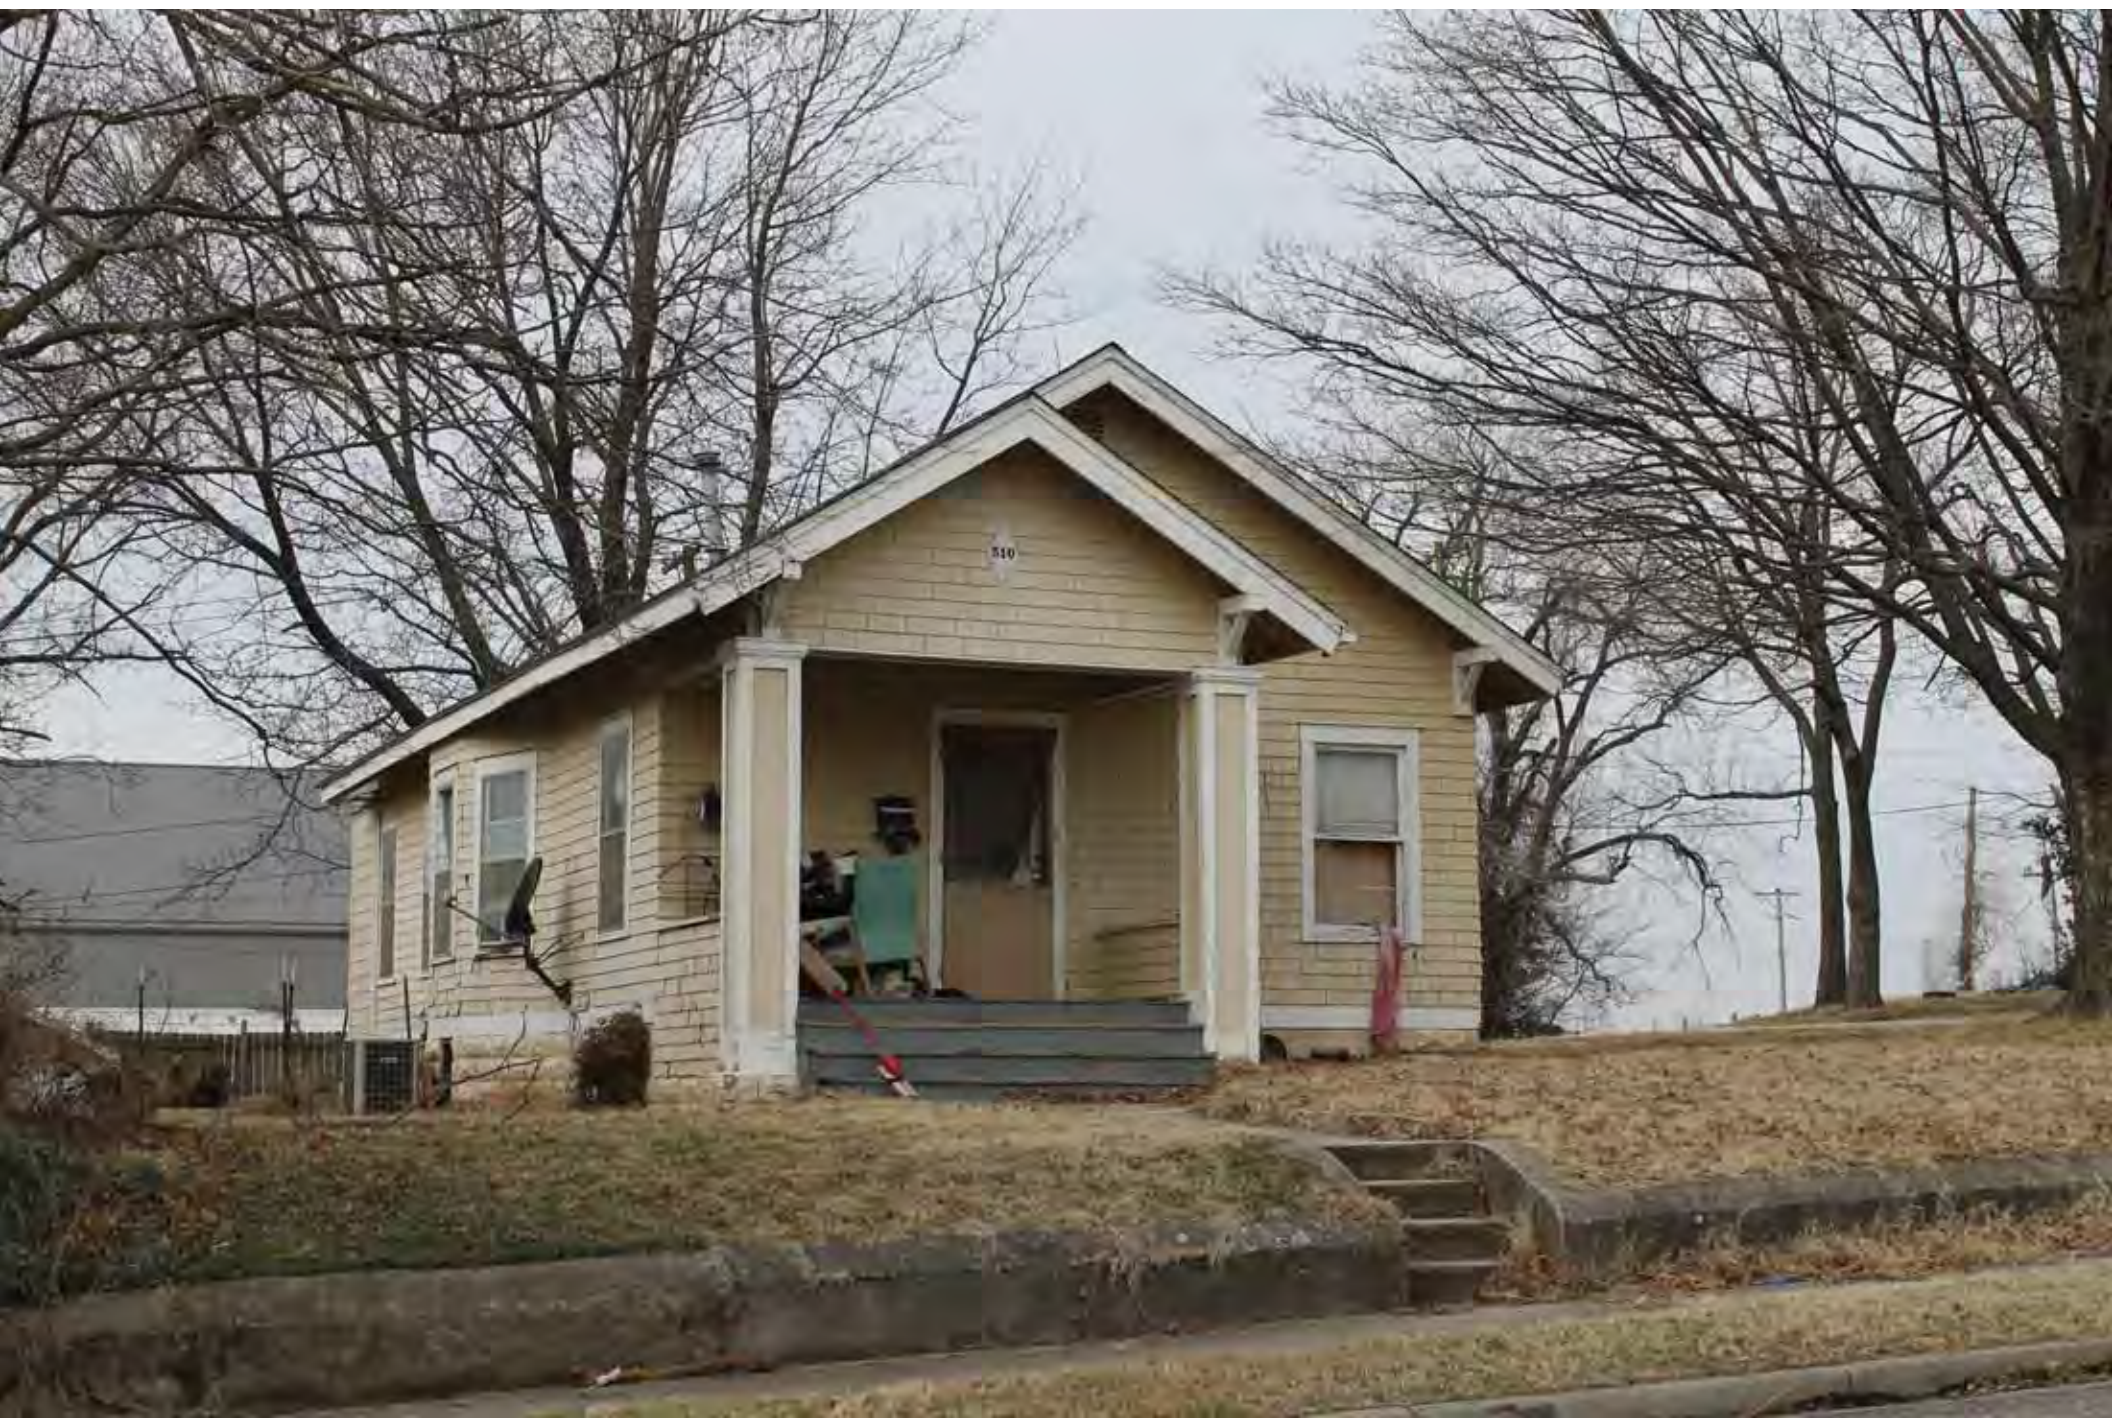
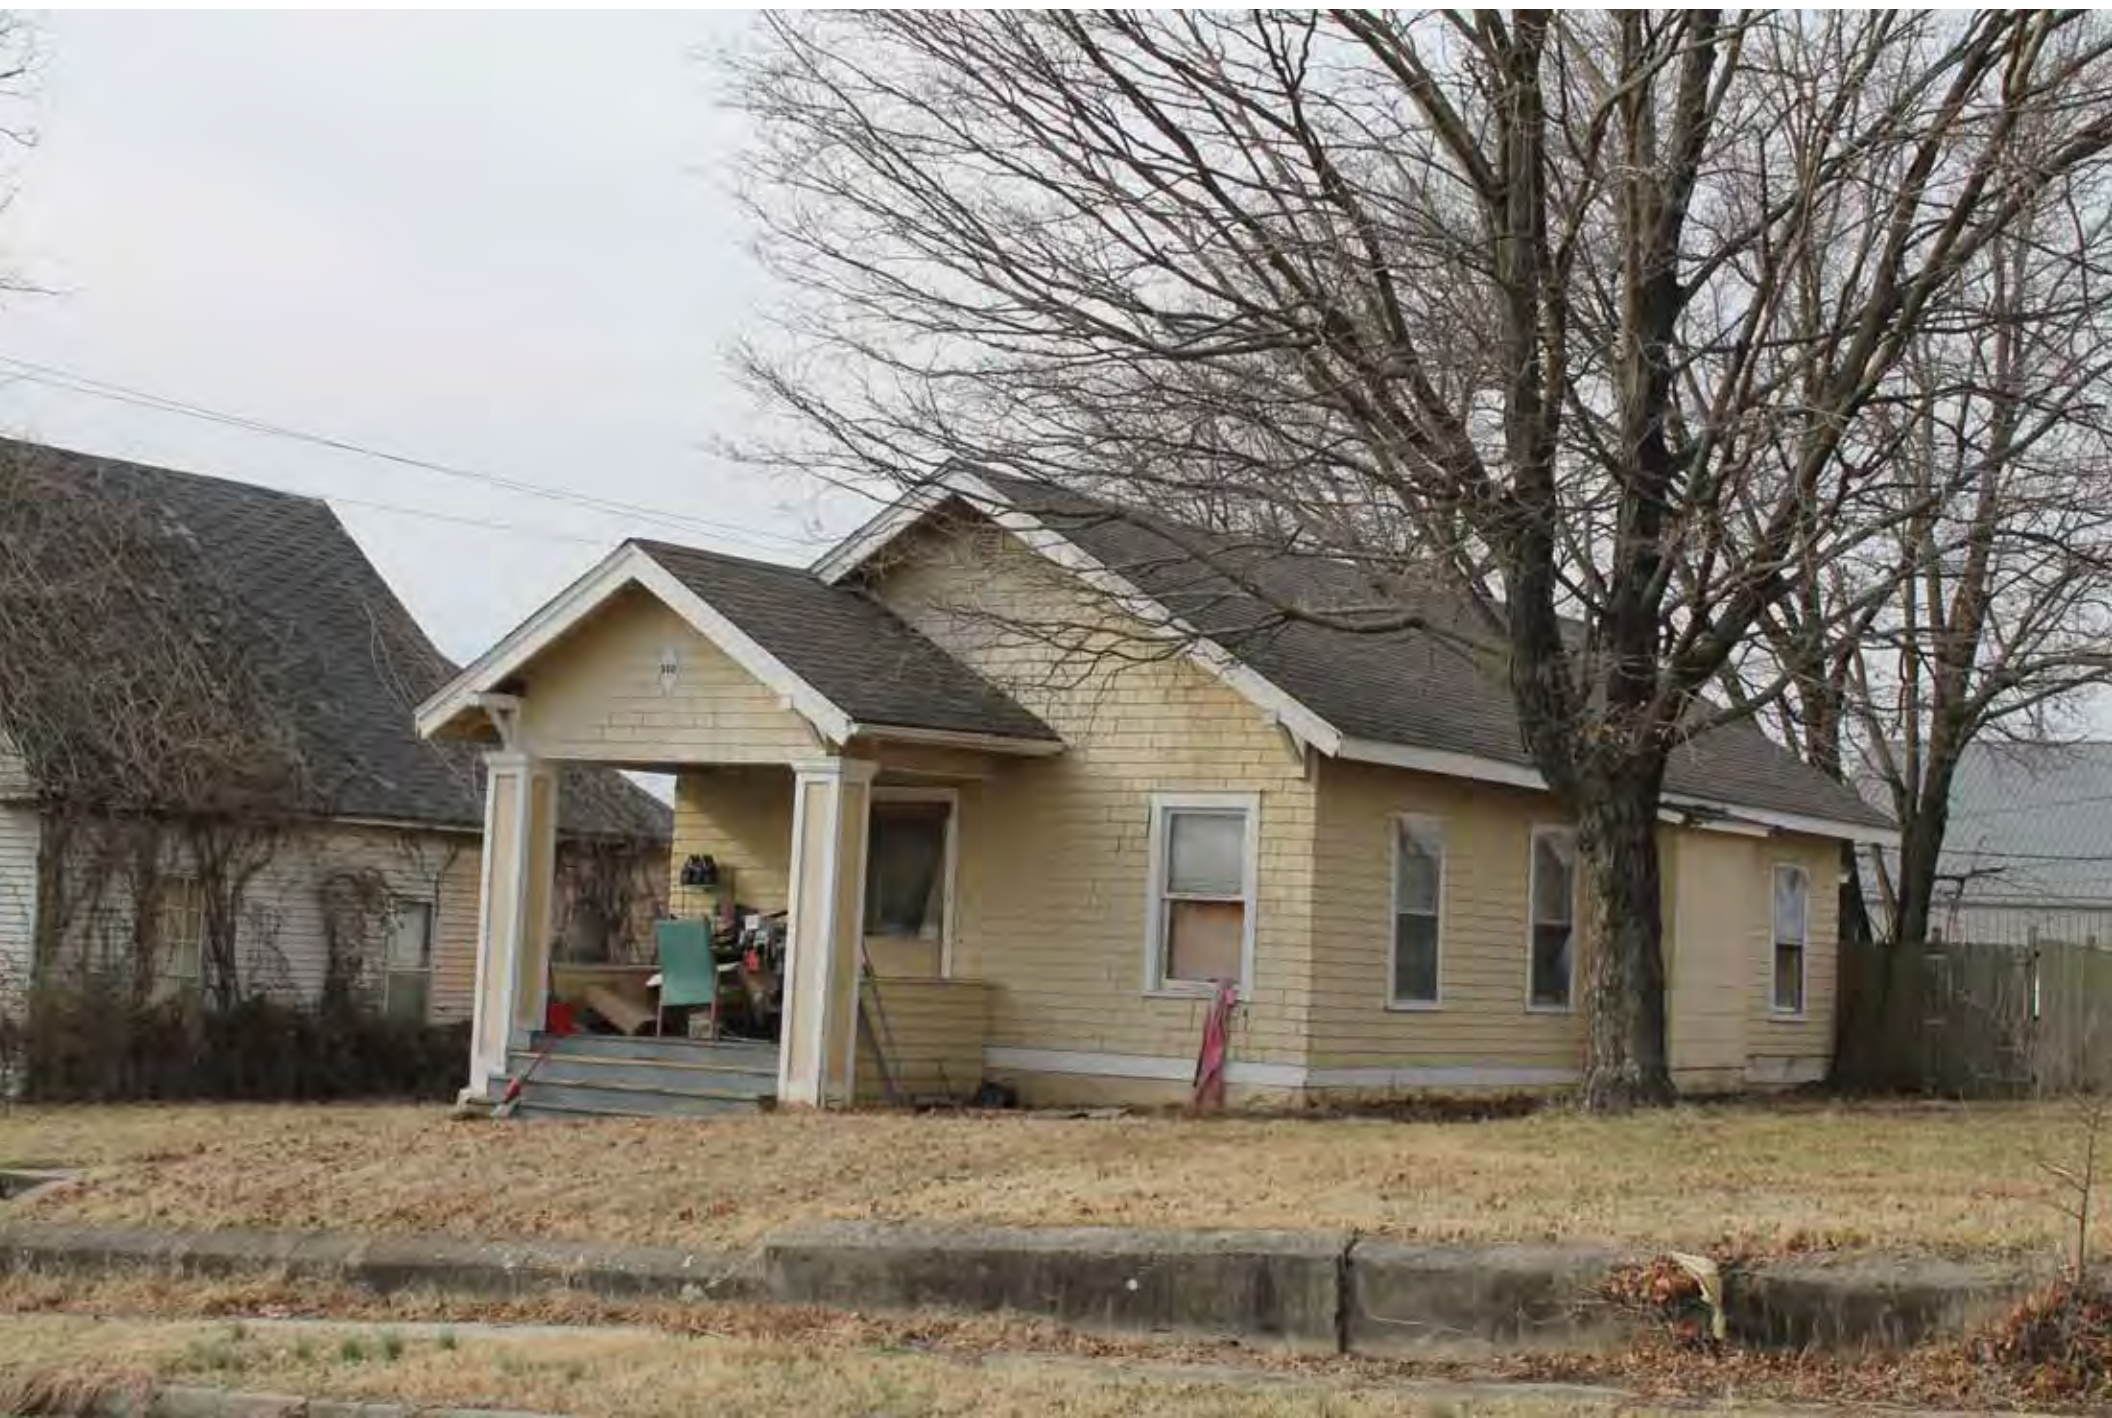
The dwelling does not retain sufficient integrity that would render it individually eligible for the National Register of Historic Places. The dwelling is not situated in an area recommended as a historic district.

The property at 510 S. Cox Avenue is a one-story dwelling, with a front facing gable roof with overhanging eaves. The entire roof is covered in asphalt siding. On the left front elevation is the original open front porch, with a gable roof. It is supported on square wooden posts. The porch shelters a single front door. To the north of the front porch is a single one-over-one window, with a wooden surround. On the north side elevation of the house a small square bay window has been enclosed and covered with siding. There are three single one-over-one windows. On the south side elevation of the house is a three-sided bay window which is still intact.

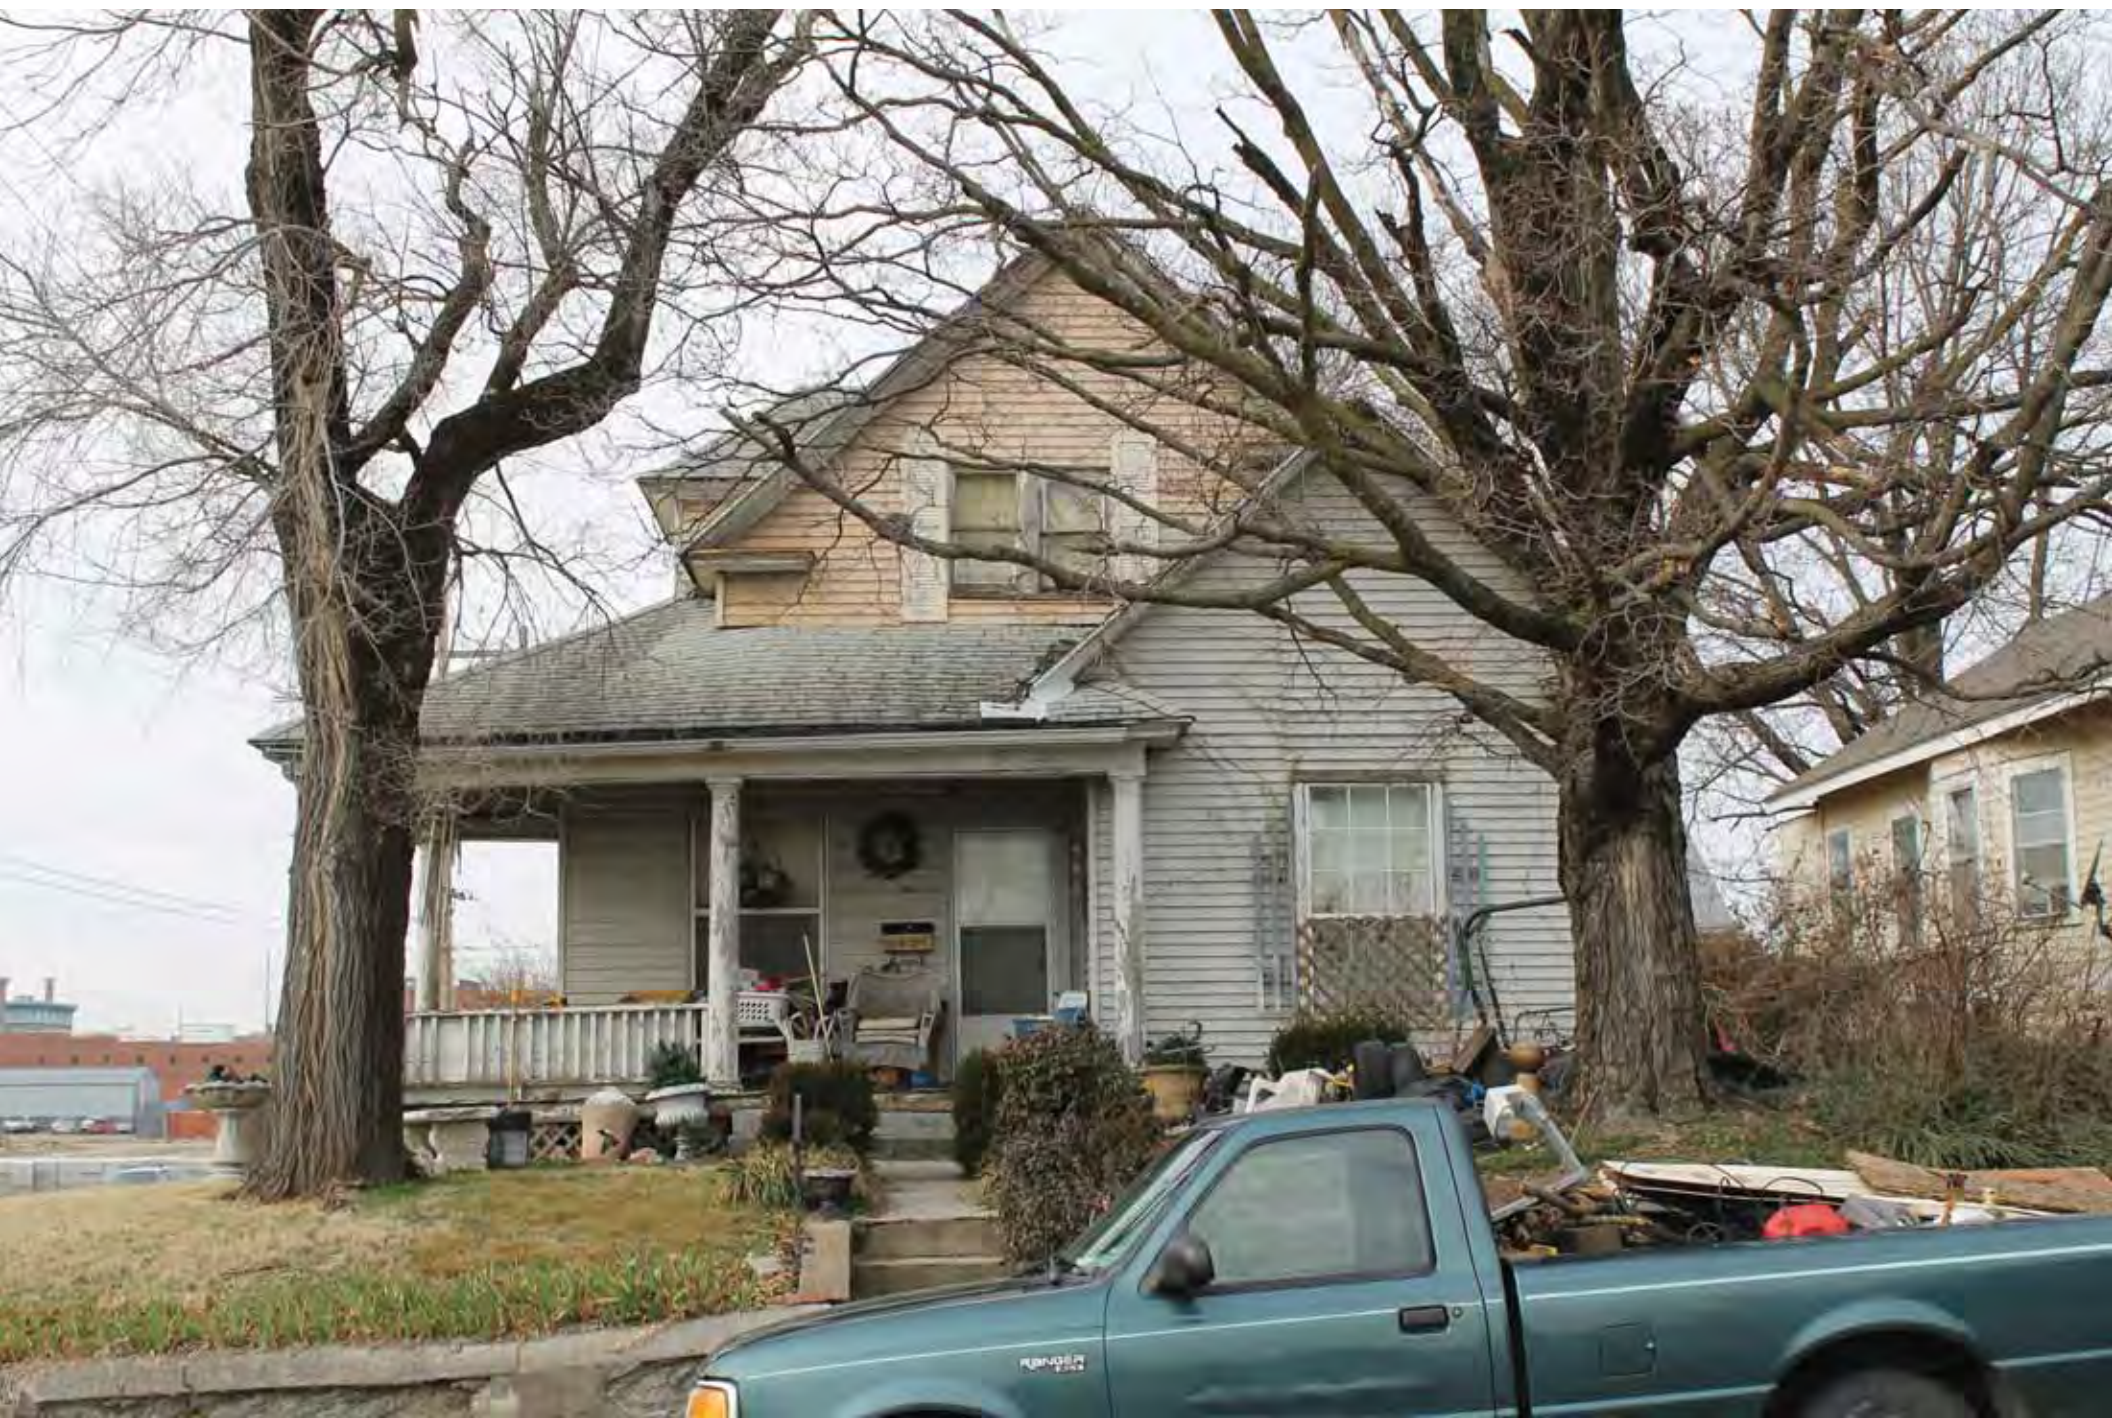
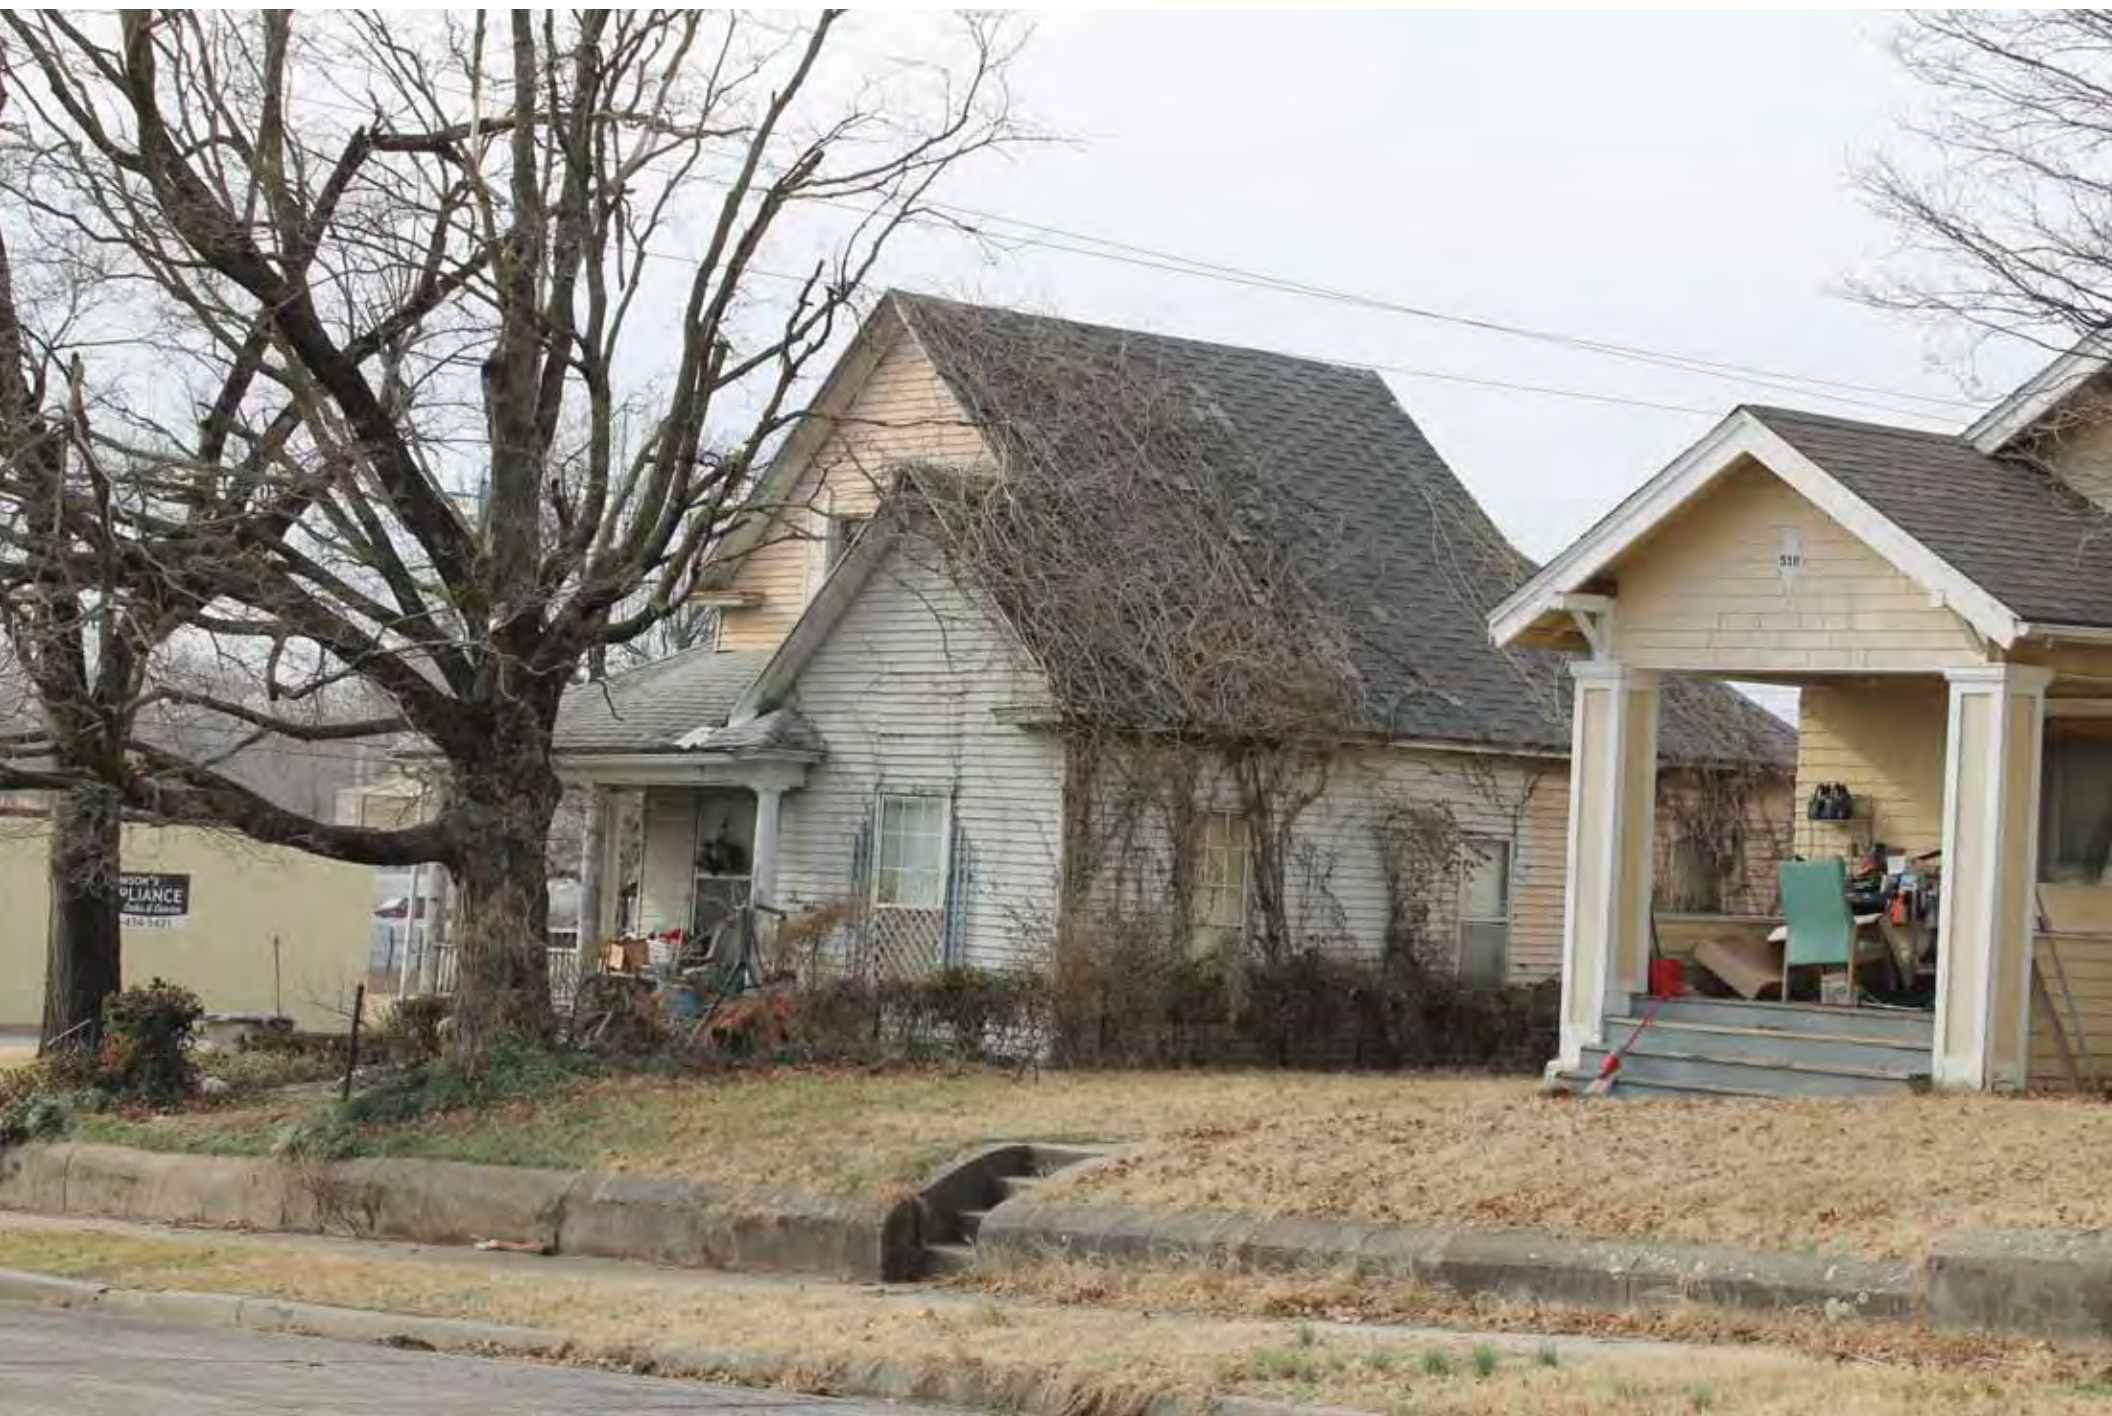
The dwelling does not retain sufficient integrity that would render it individually eligible for the National Register of Historic Places. The dwelling is not situated in an area recommended as a historic district.

The property at 512 S. Cox Avenue is a 1.5 story dwelling, with a complicated roofline with a front facing gable roof with returned eaves on the front façade. The entire roof is covered in asphalt siding. On the left front elevation is the original open front porch, which wraps around to the south side of the house. It is supported on round wooden columns. At the front elevation the porch shelters a single front door, and a large one-over-one window. To the north of the front porch is another gable end with returned eaves, one-story in height. At the front elevation it has a single vinyl replacement window. At the half story level, above the front porch, are double one-over-one wood windows, with non-functioning shutters. On the south elevation is a hipped roof dormer.

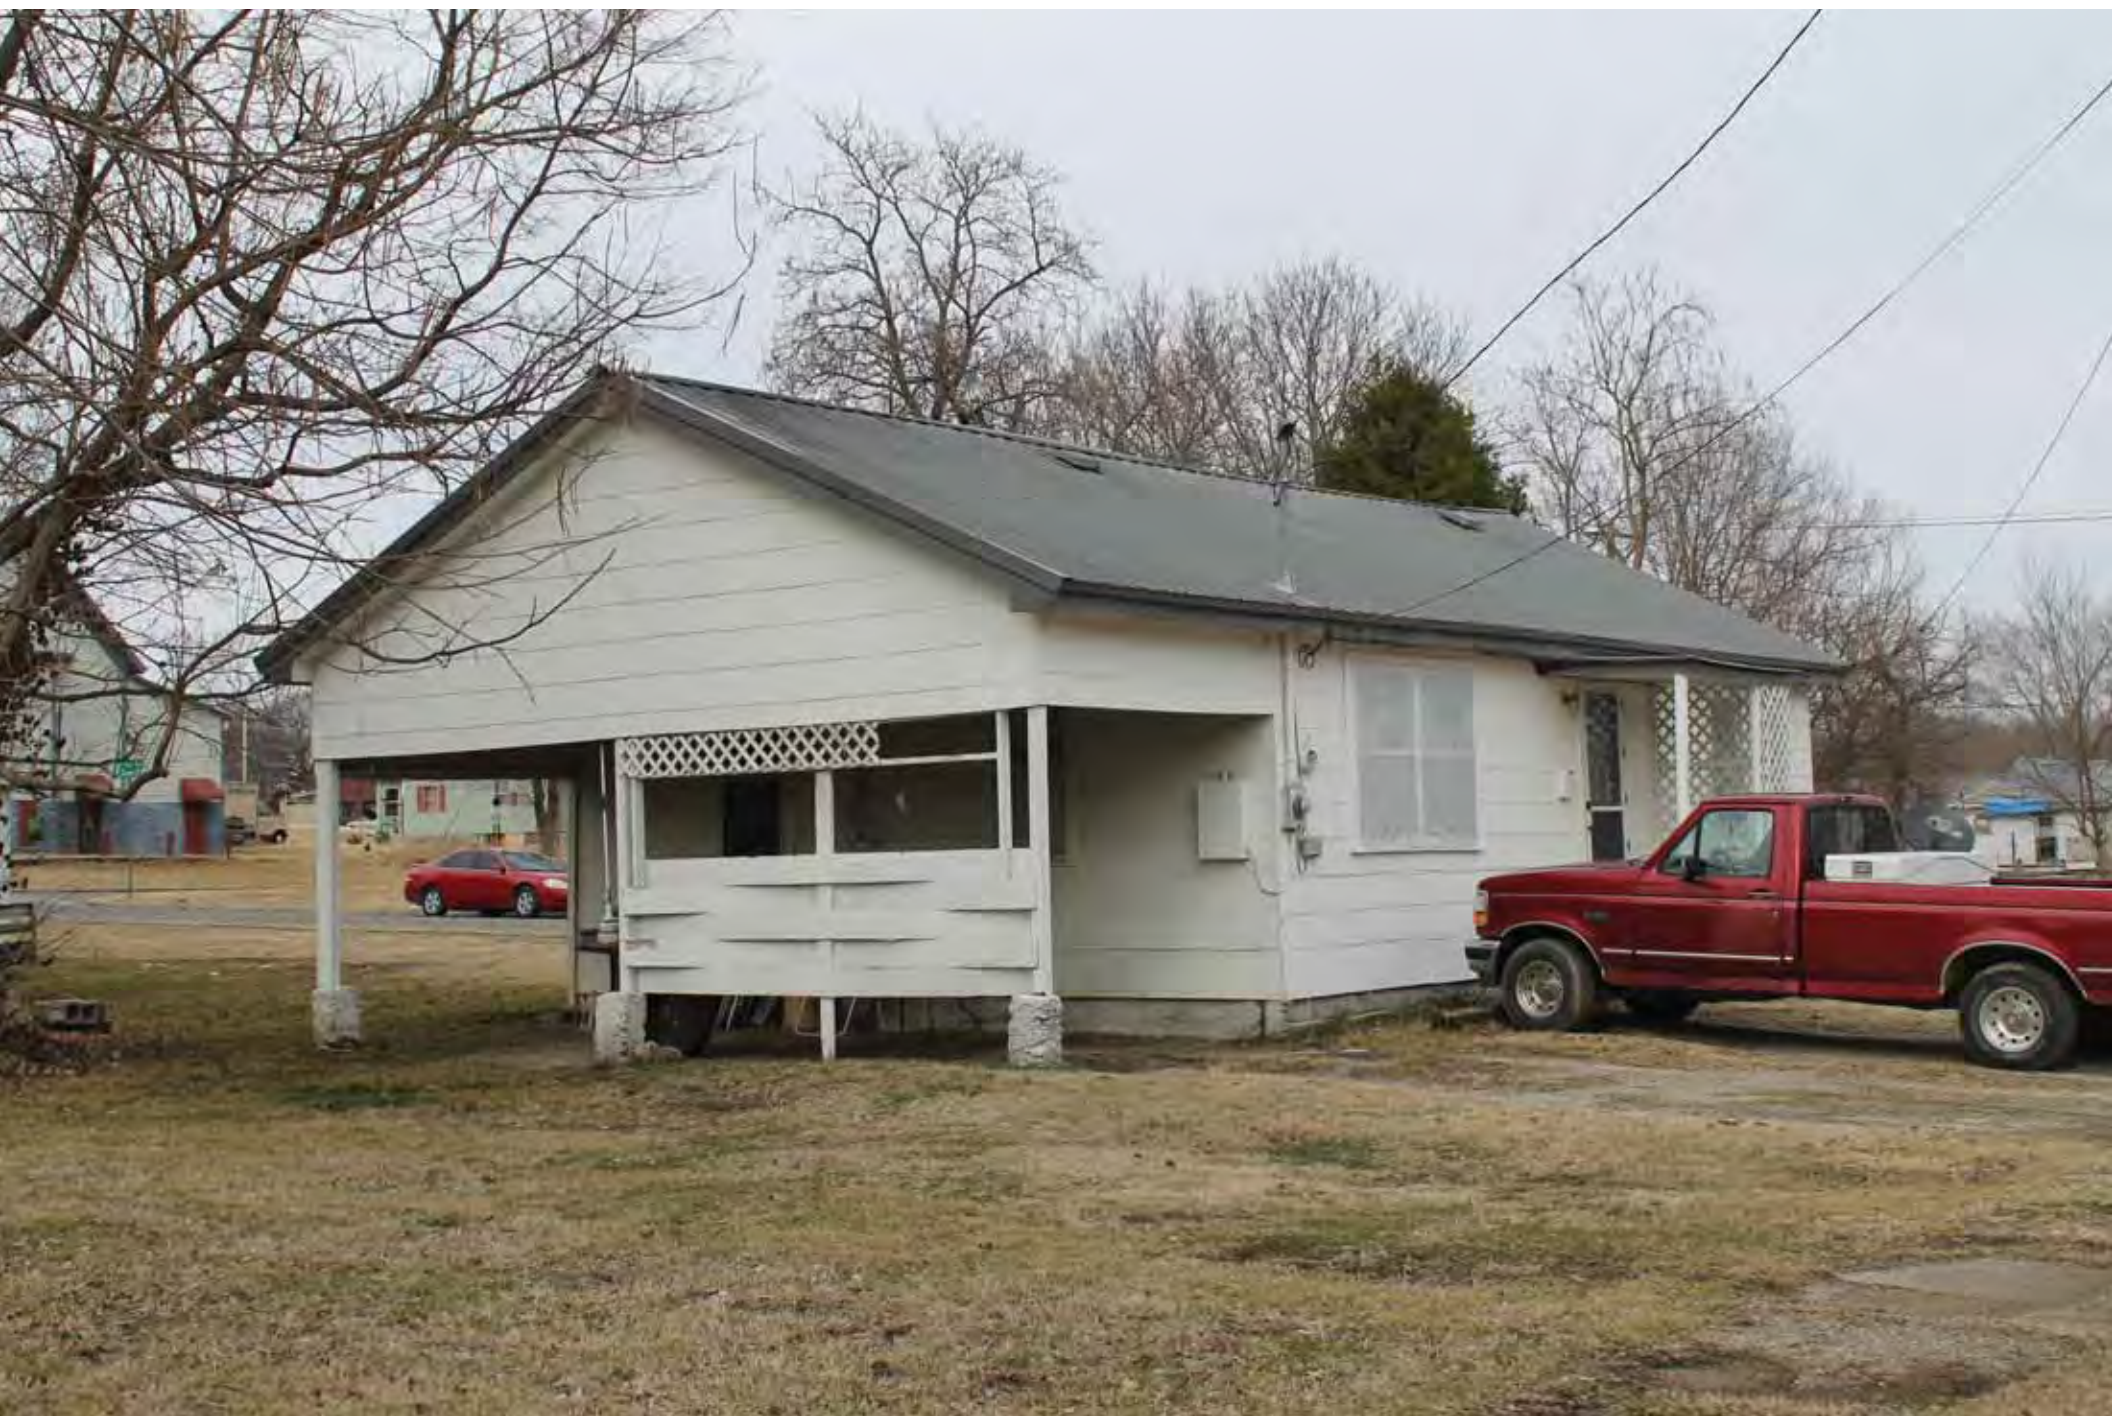
The property at 202 S. Division Avenue features a one story dwelling, with a side gabled roof. The roof is covered in metal. In the middle of the front façade is a simple entrance door. There is a small concrete and wood front porch that leads to the door. The porch has a flat roof. Flanking the entrance on either side are double one-over-one windows. On the south side of the house is an attached carport that is also under the gable roof of the house. On the north elevation is a small double window. On the rear of the house is a small addition that houses a rear entrance. It has a shed roof, also covered in metal. To the south of this addition, on the rear elevation, are there separate one-over-one windows.
